# Annual Inspection Report 2020

# ANNUAL INSPECTION REPORT

As detailed in the following sections, EAC Consulting has found the MDX System to be in good working order and condition.

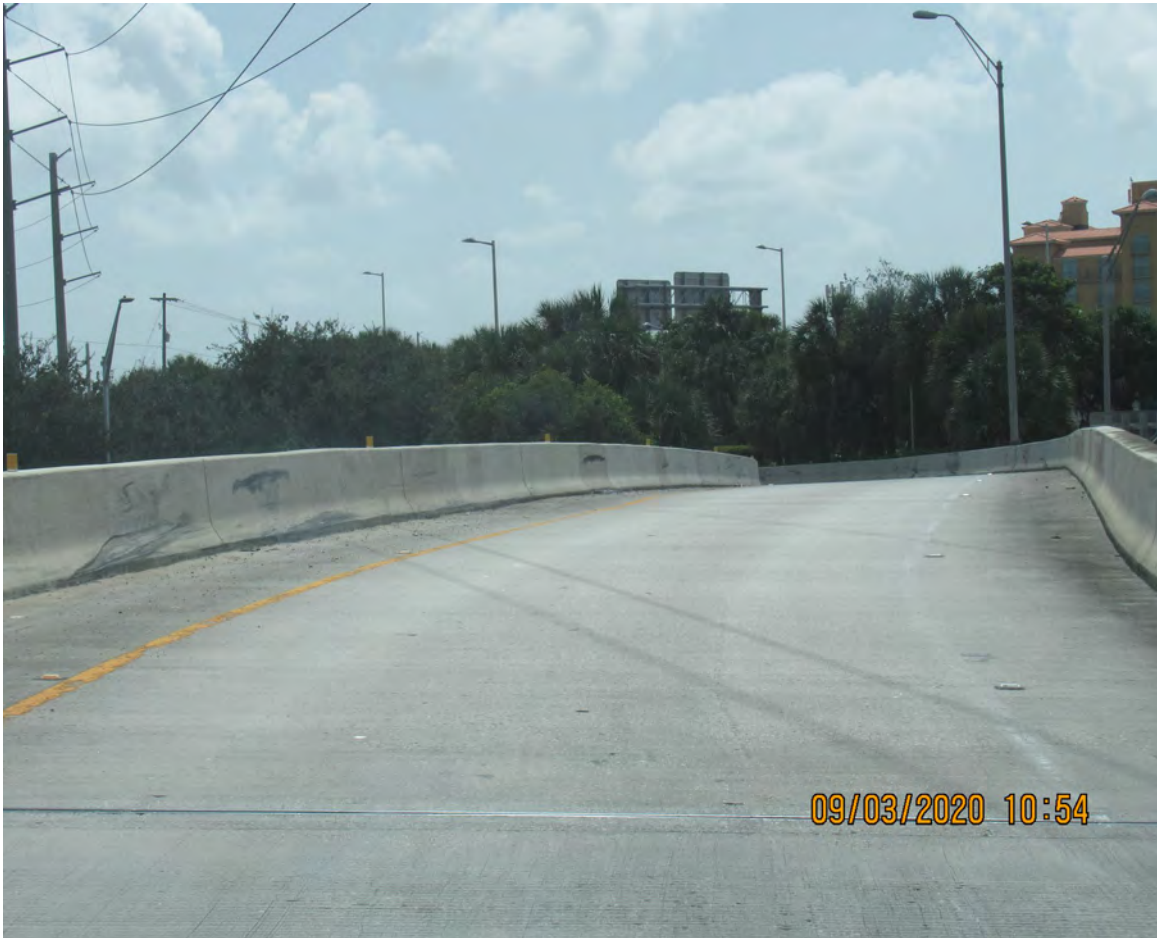
**ROADWAY INSPECTION  
LOCATION: MILE MARKER 0.85 MILES  
EASTBOUND ON-RAMP FROM NW 36<sup>th</sup> STREET**

**DETERIORATED STRIPING ON BRIDGE No. 870962**

**ITEMS NOTED TO BE ADDRESSED BY MDX EMERGENCY PUSH BUTTON  
CONTRACTS**

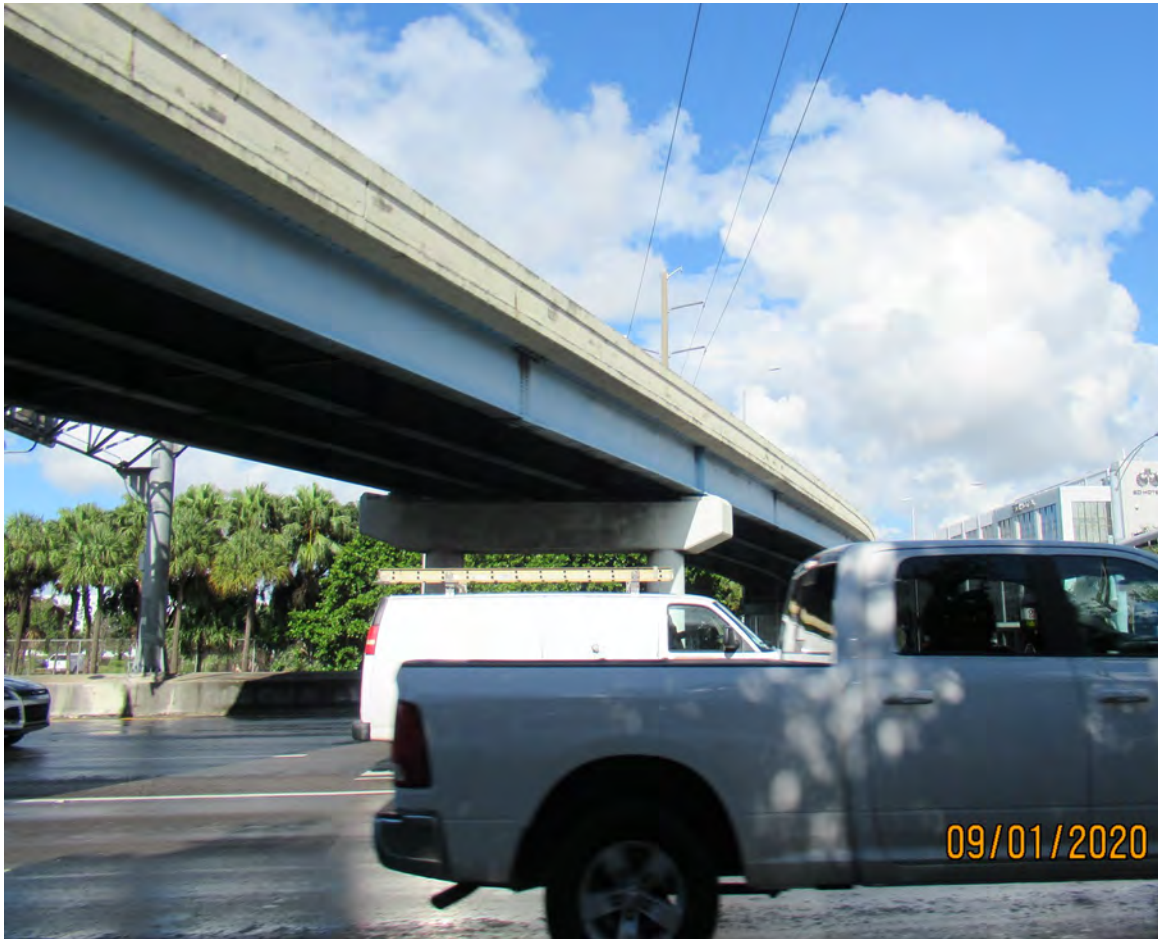
**ROADWAY INSPECTION  
LOCATION: MILE MARKER 0.85 MILES  
EASTBOUND ON-RAMP FROM NW 36<sup>th</sup> STREET**

**DETERIORATED PAINT ON COLUMNS, PIER CAPS, TRAFFIC RAILING AND MSE  
WALL (BRIDGE No. 870962)**

**ITEMS NOTED TO BE ADDRESSED BY MDX PROJECT #30037**

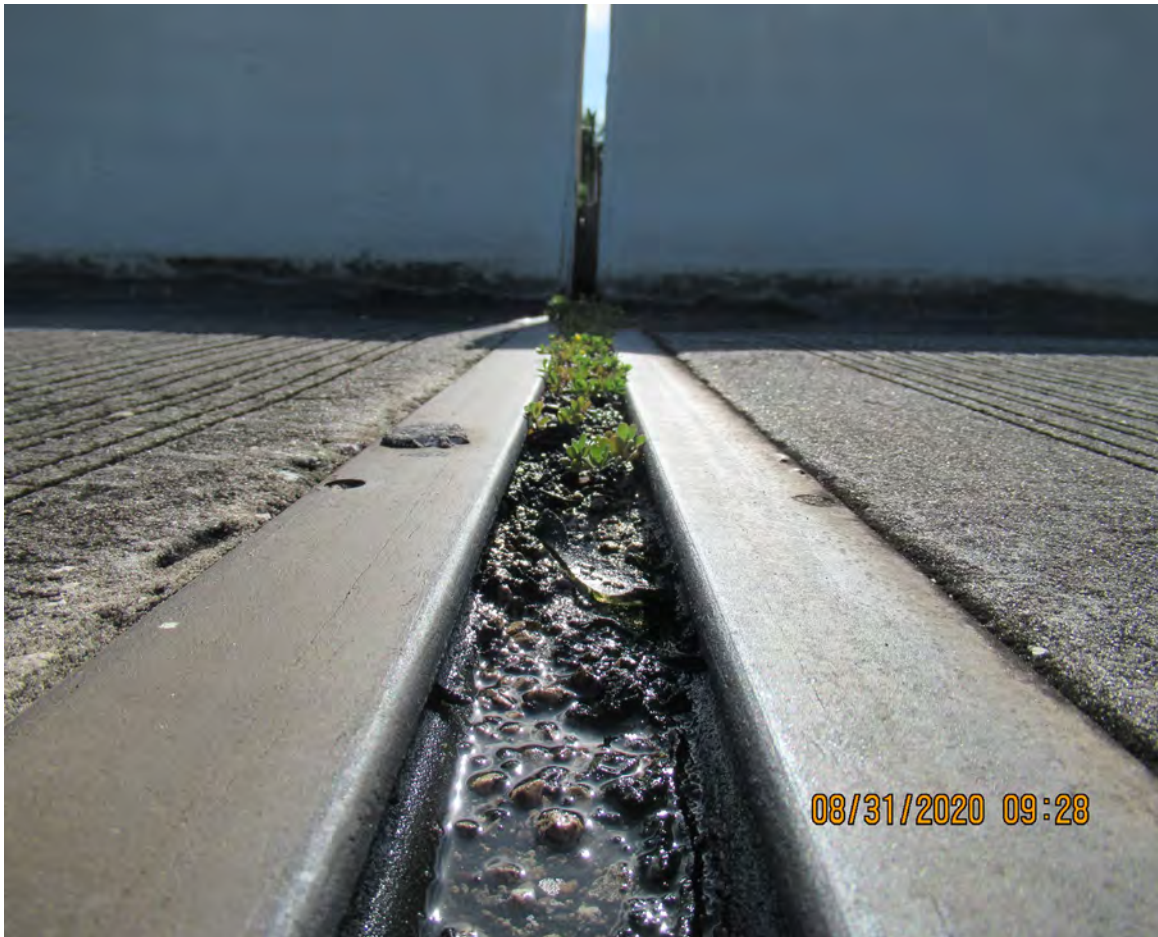
**ROADWAY INSPECTION  
LOCATION: MILE MARKER 0.0 TO 0.4 MILES  
EASTBOUND MAINLINE**

**SILT AND DEBRIS ON BRIDGE JOINTS (BRIDGE No. 870725)**

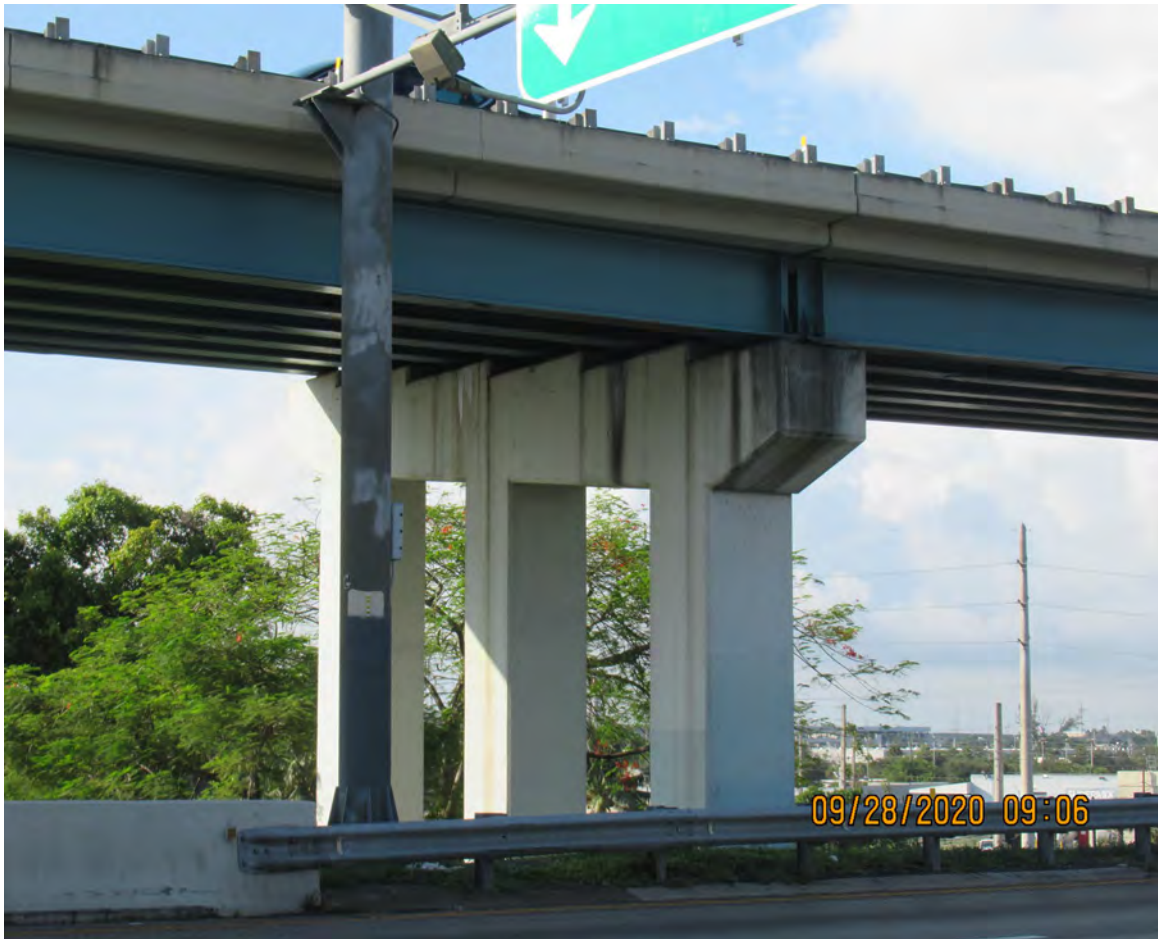
**ROADWAY INSPECTION  
LOCATION: MILE MARKER 1.20 MILES  
EASTBOUND MAINLINE**

**STAINS ON PIER CAPS & COLUMNS DUE TO LEAKING SLIDING PLATE JOINTS  
(BRIDGE No. 870238) TYPICAL AT VARIOUS LOCATIONS**

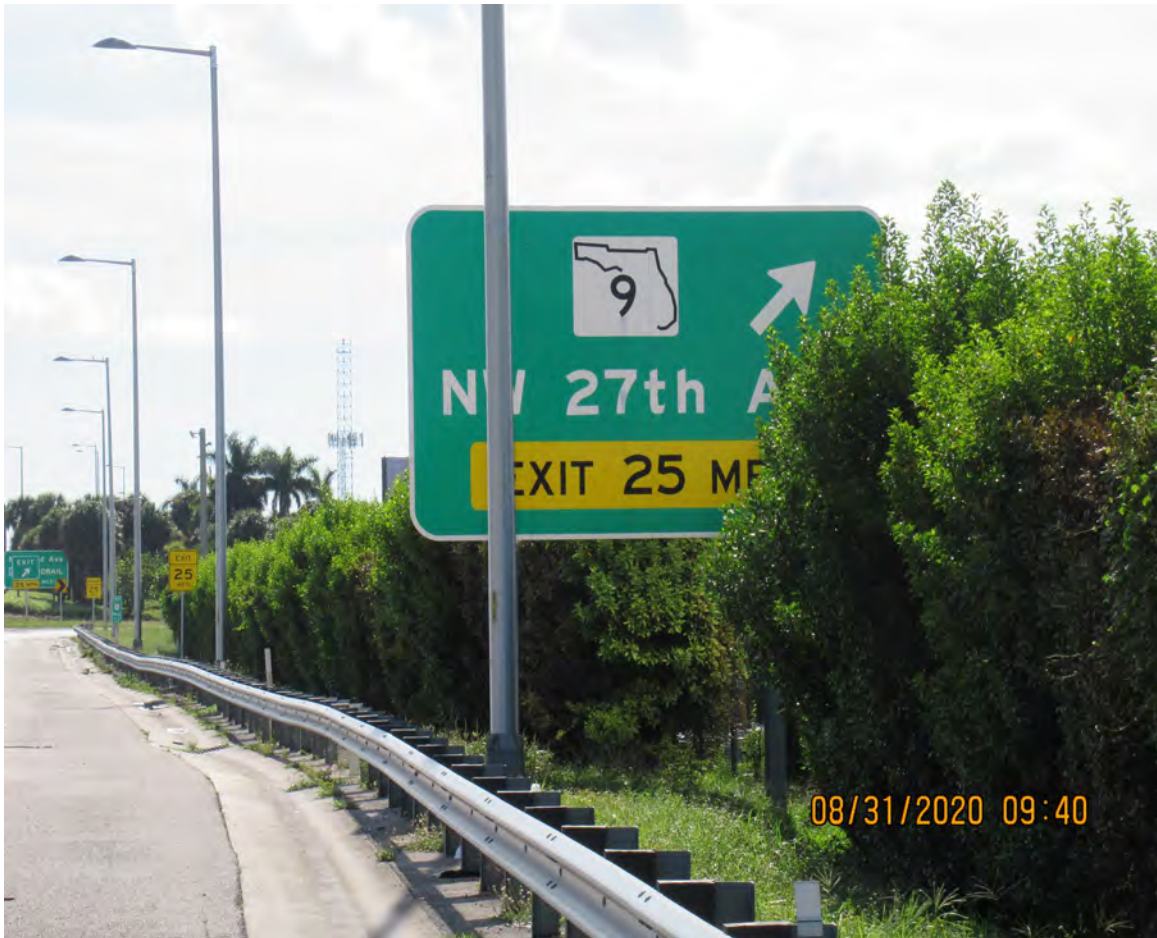
**ROADWAY INSPECTION  
LOCATION: MILE MARKER 2.20 MILES  
EASTBOUND MAINLINE (RIGHT SHOULDER)**

**OVERGROWN VEGETATION PARTIALLY OBSTRUCTING SIGN**

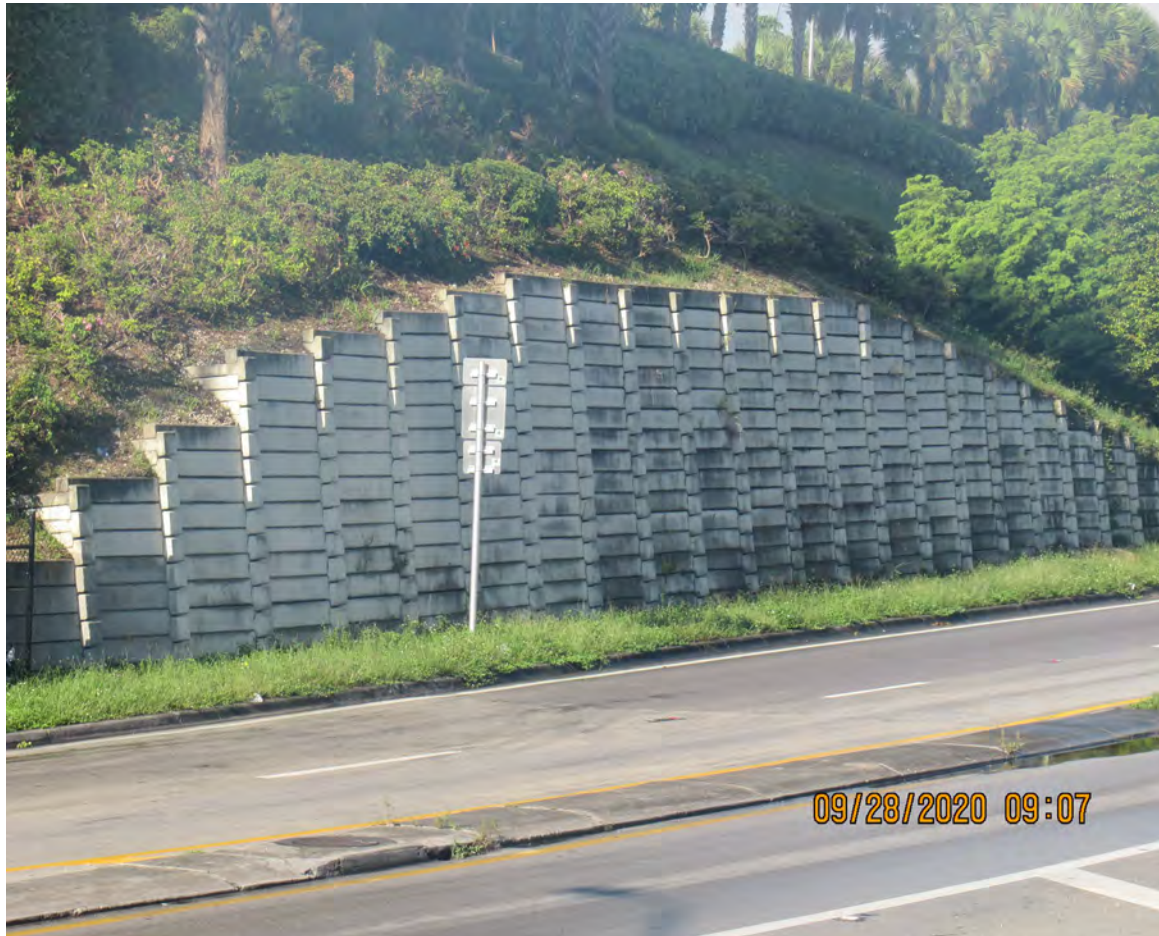
**ROADWAY INSPECTION  
LOCATION: MILE MARKER 0.86 MILES  
EASTBOUND ON-RAMP FROM OKEECHOBEE RD.  
(RIGHT SHOULDER)**

**DETERIORATED CLASS V COATING ON RETAINING WALL**

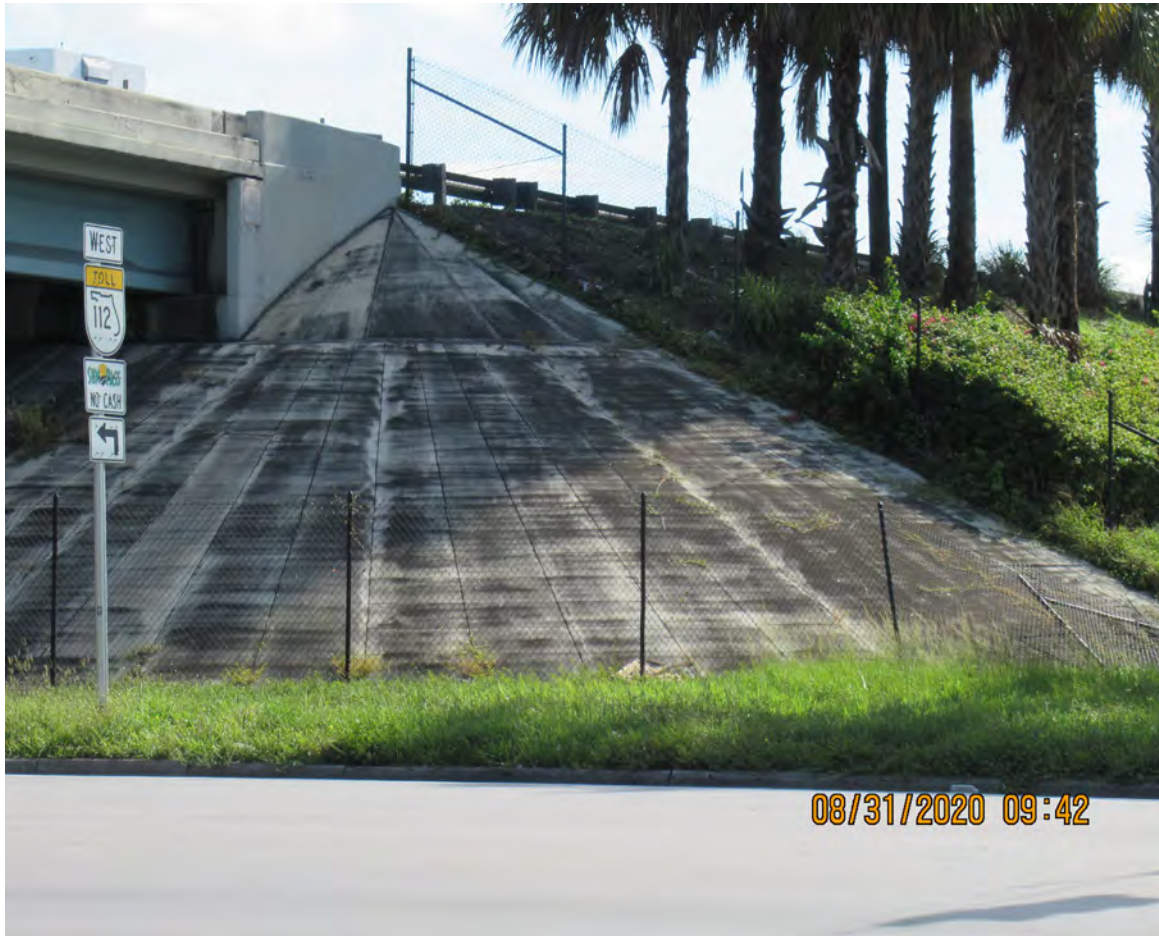
**ROADWAY INSPECTION  
LOCATION: MILE MARKER 2.96 MILES  
EASTBOUND MAINLINE**

**DETERIORATED CLASS V COATING ON SLOPE  
(TYPICAL THROUGHOUT THE CORRIDOR)**

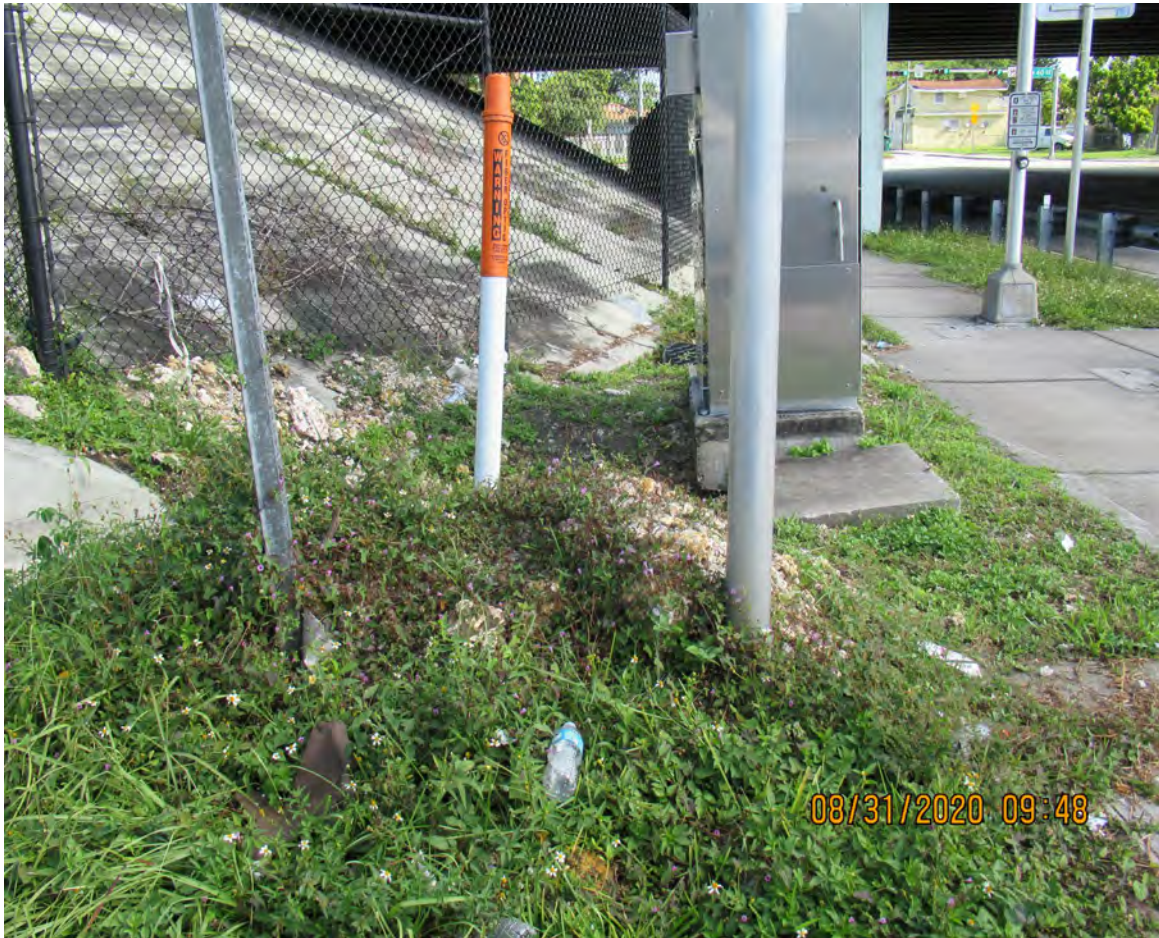
**ROADWAY INSPECTION  
LOCATION: MILE MARKER 3.90 MILES  
EASTBOUND OFF-RAMP TO NW 12<sup>TH</sup> AVENUE**

**UNFINISHED ITS WORK**

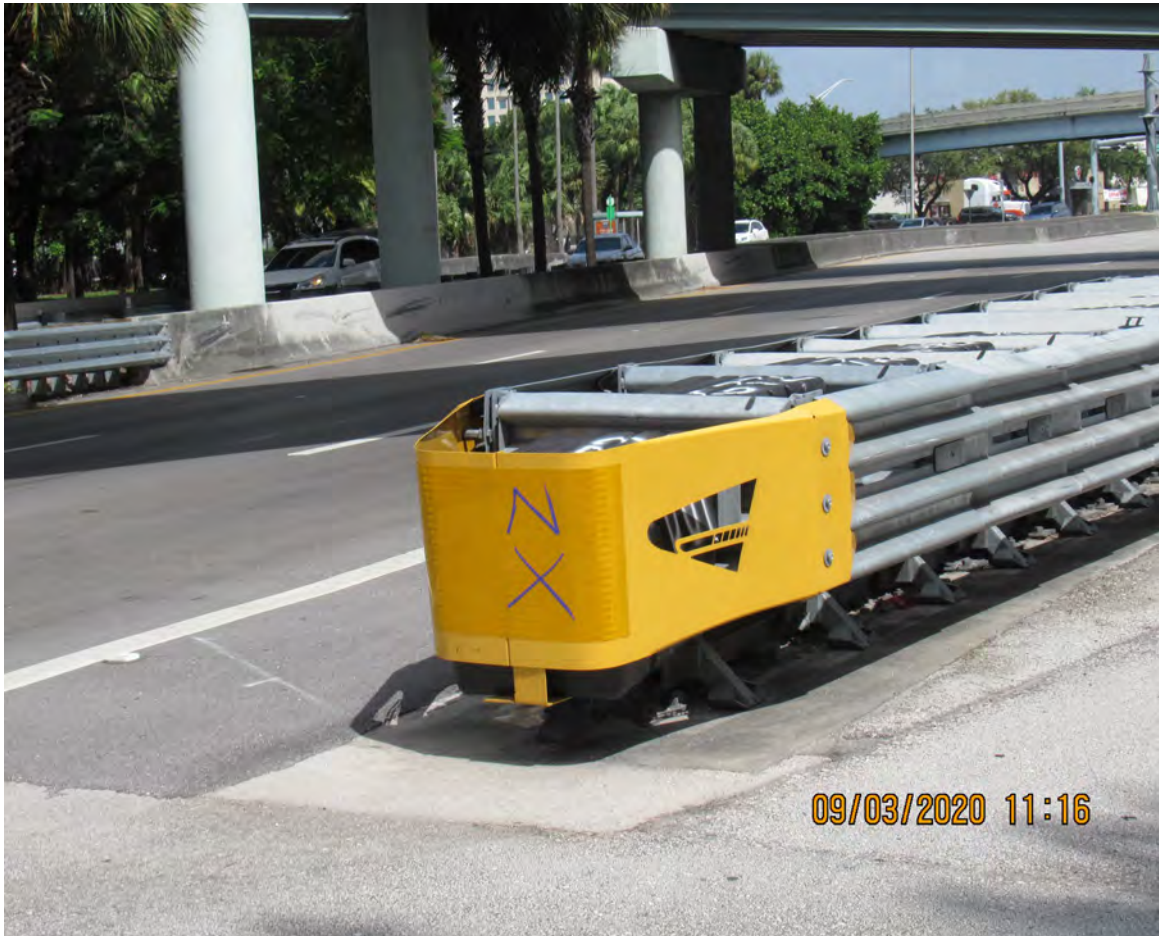
**ROADWAY INSPECTION  
LOCATION: MILE MARKER 0.86 MILES  
EASTBOUND ON-RAMP FROM Le JEUNE RD.  
(LEFT SHOULDER)**

**GRAFFITI ON ATTENUATOR REFLECTIVE SHEETING**

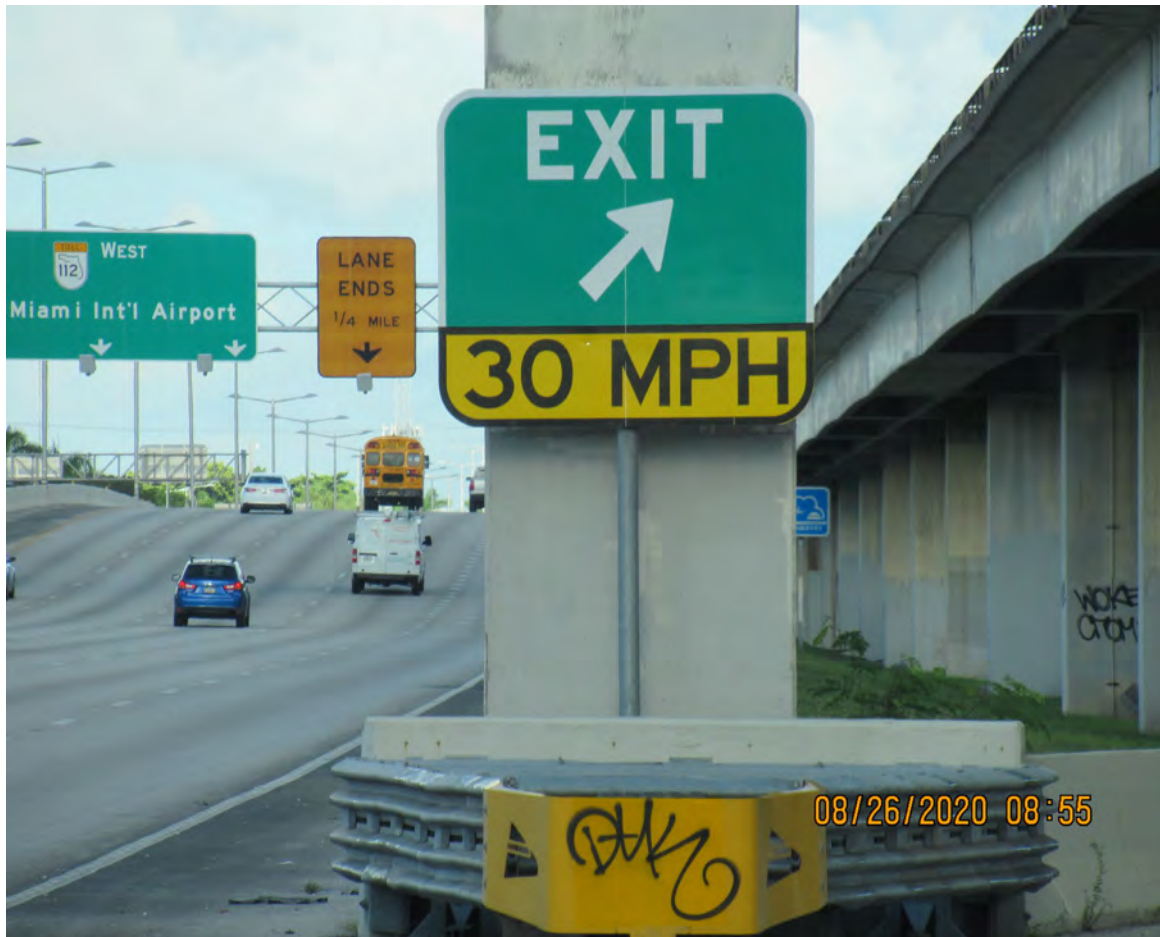
ROADWAY INSPECTION  
LOCATION: MILE MARKER 3.31 MILES  
WESTBOUND MAINLINE (RIGHT SHOULDER)

**GRAFFITI ON ATTENUATOR REFLECTIVE SHEETING**

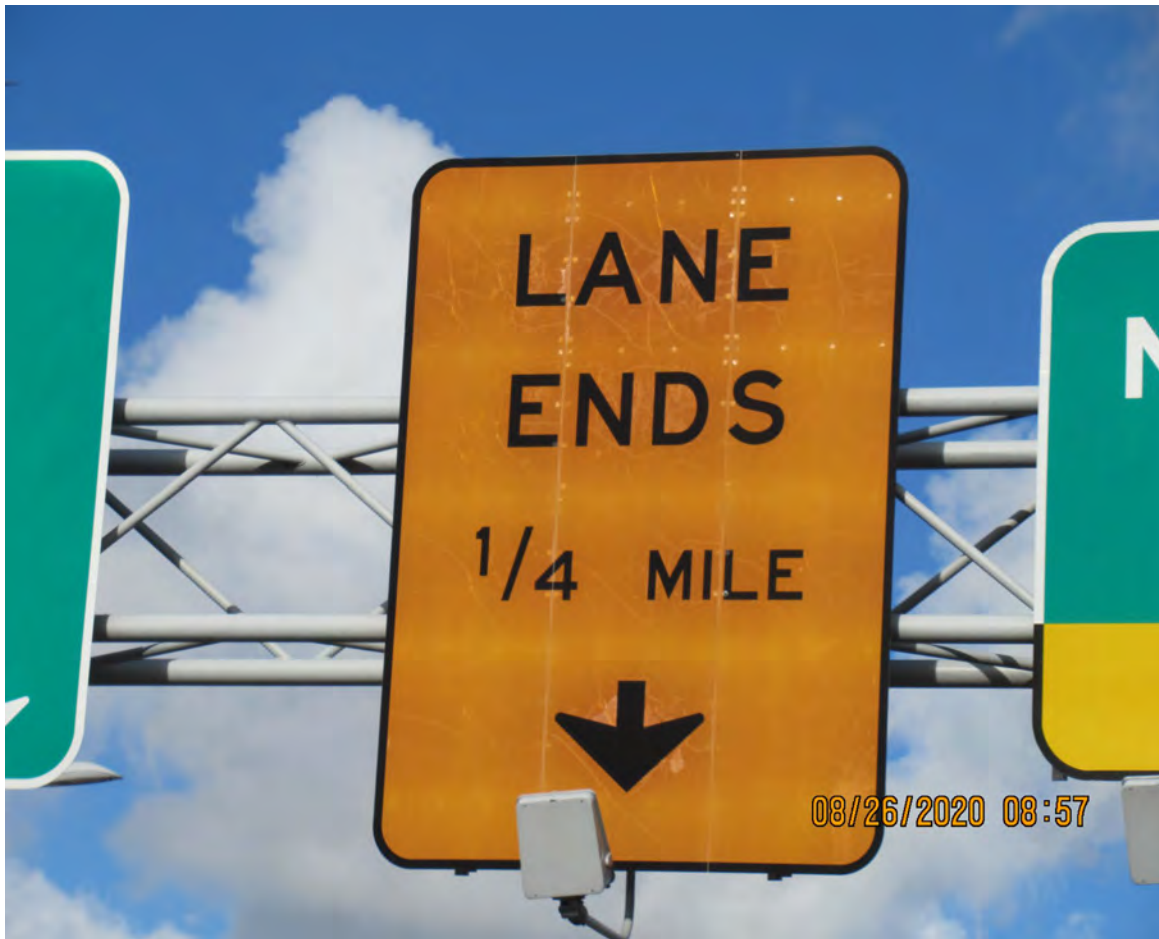
**ROADWAY INSPECTION  
LOCATION: MILE MARKER 3.52 MILES  
WESTBOUND MAINLINE**

**DETERIORATED REFLECTIVE SHEETING ON  
LANE ENDS 1/4 MILE SIGN PANEL**

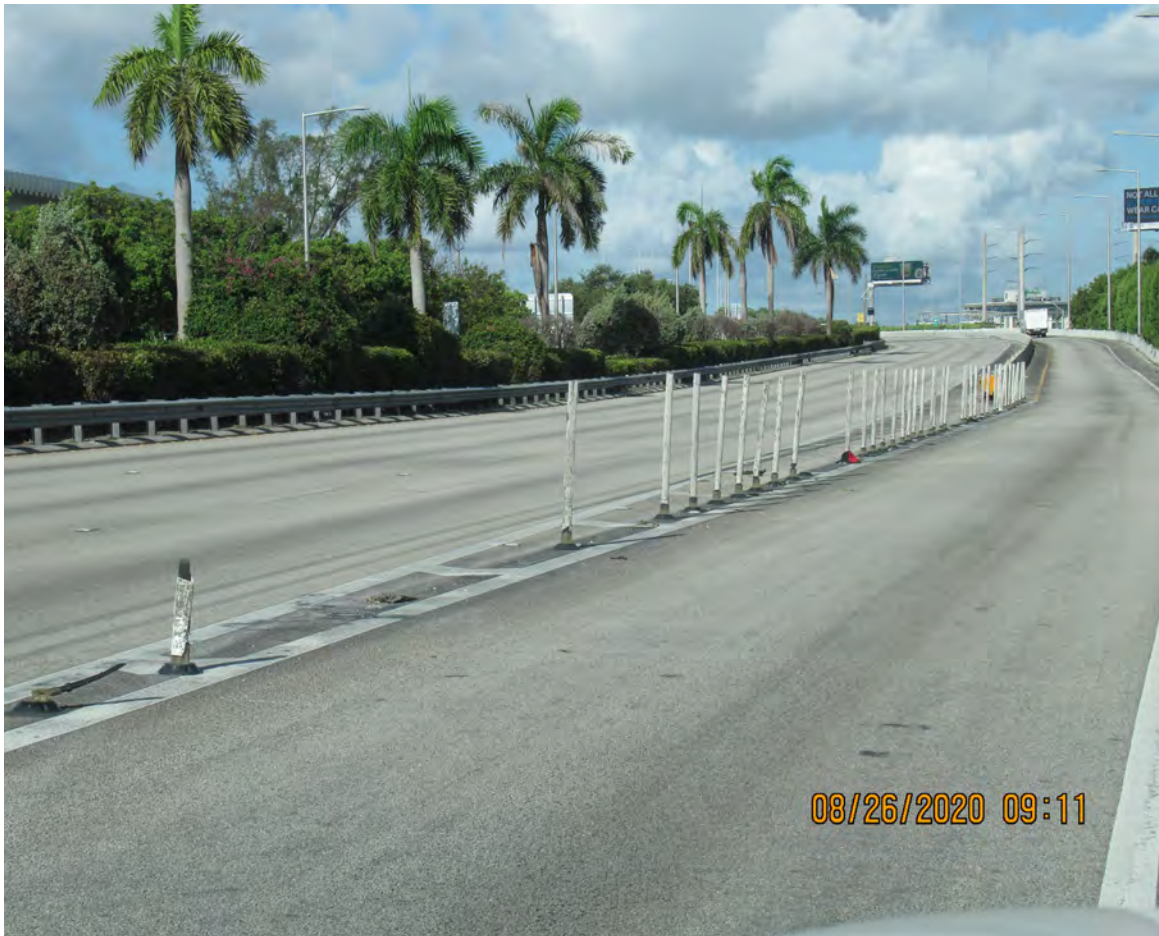
**ROADWAY INSPECTION**  
**LOCATION: MILE MARKER 1.63 MILES**  
**WESTBOUND MAINLINE**

**DAMAGED / MISSING DELENIATORS**

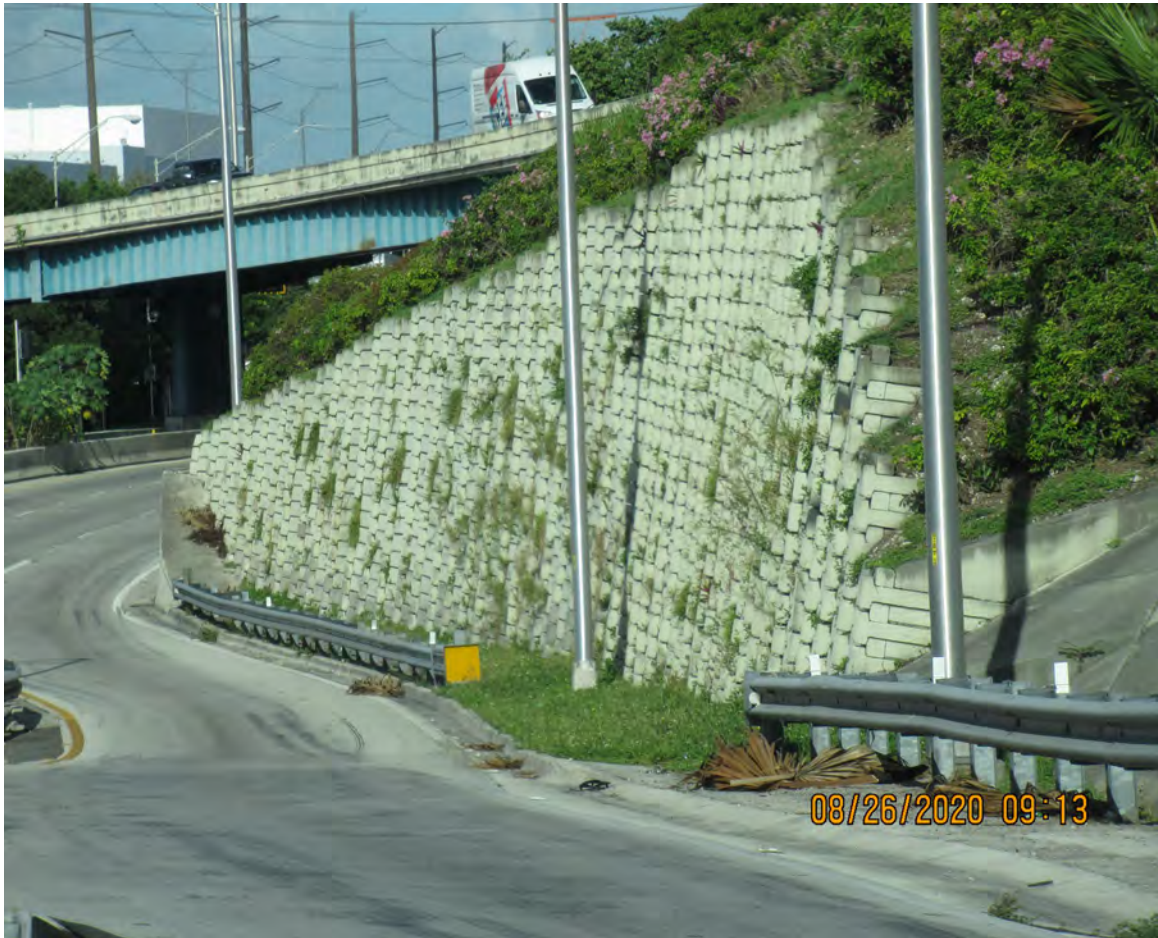
**ROADWAY INSPECTION  
LOCATION: MILE MARKER 1.28 MILES  
WESTBOUND OFF-RAMP TO NW 36<sup>th</sup> ST**

**VEGETATION ON RETAINING WALL**

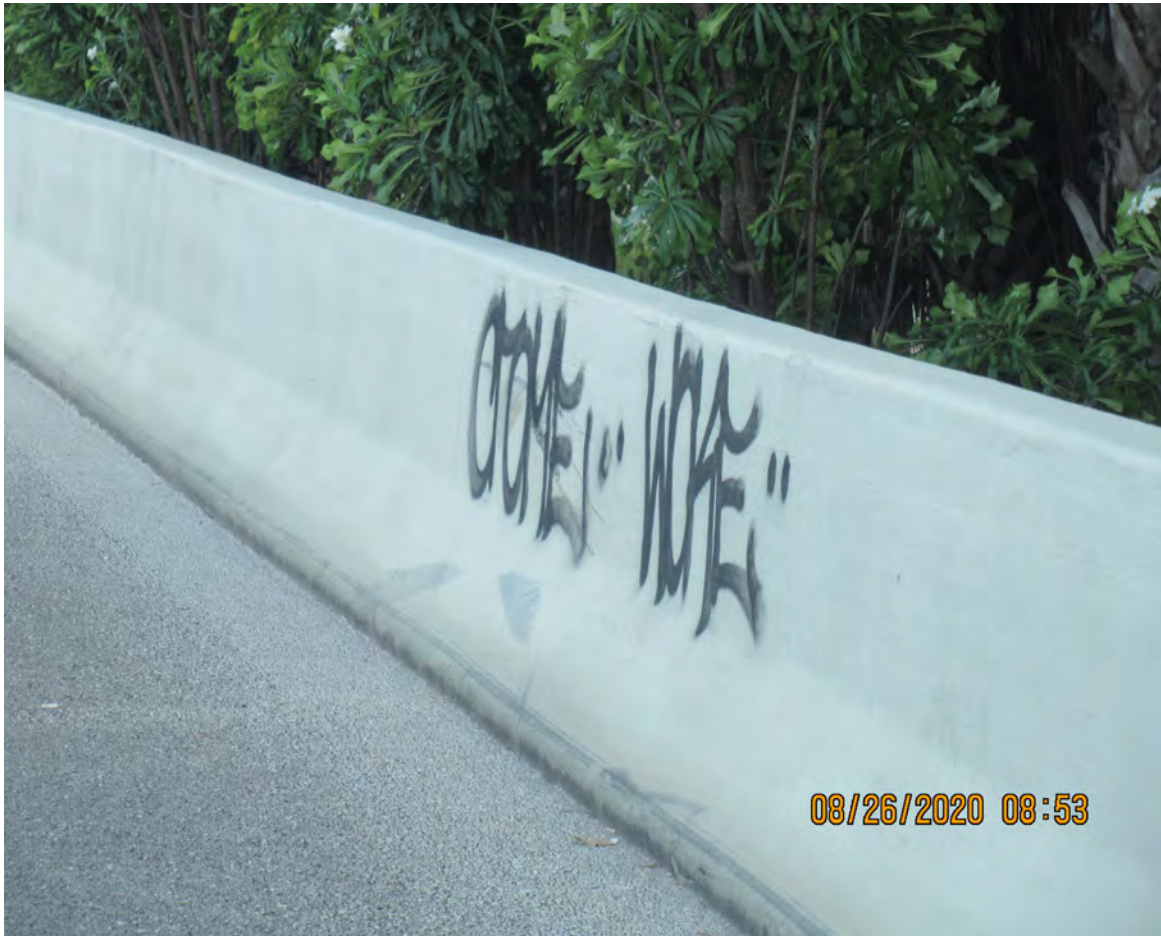
**ROADWAY INSPECTION  
LOCATION: MILE MARKER MP 0.10 MILES  
WESTBOUND MAINLINE (RIGHT SHOULDER)**

**GRAFFITI ON BARRIER WALL**

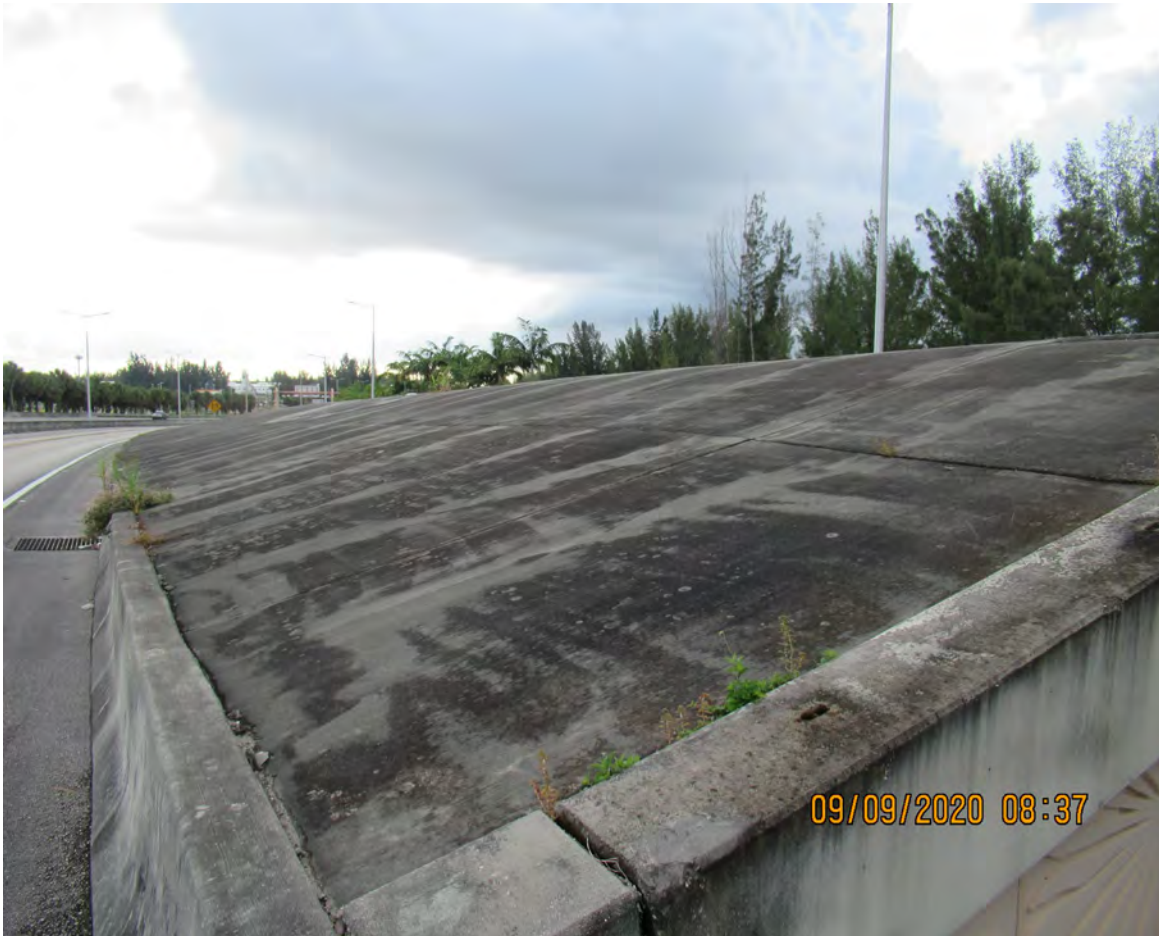
**ROADWAY INSPECTION  
LOCATION: MILE MARKER 0.65 MILES  
EASTBOUND ON RAMP FROM NW 137<sup>TH</sup> AVENUE  
(RIGHT SHOULDER)**

**DETERIORATED CLASS V COATING ON CONCRETE MEDIAN**

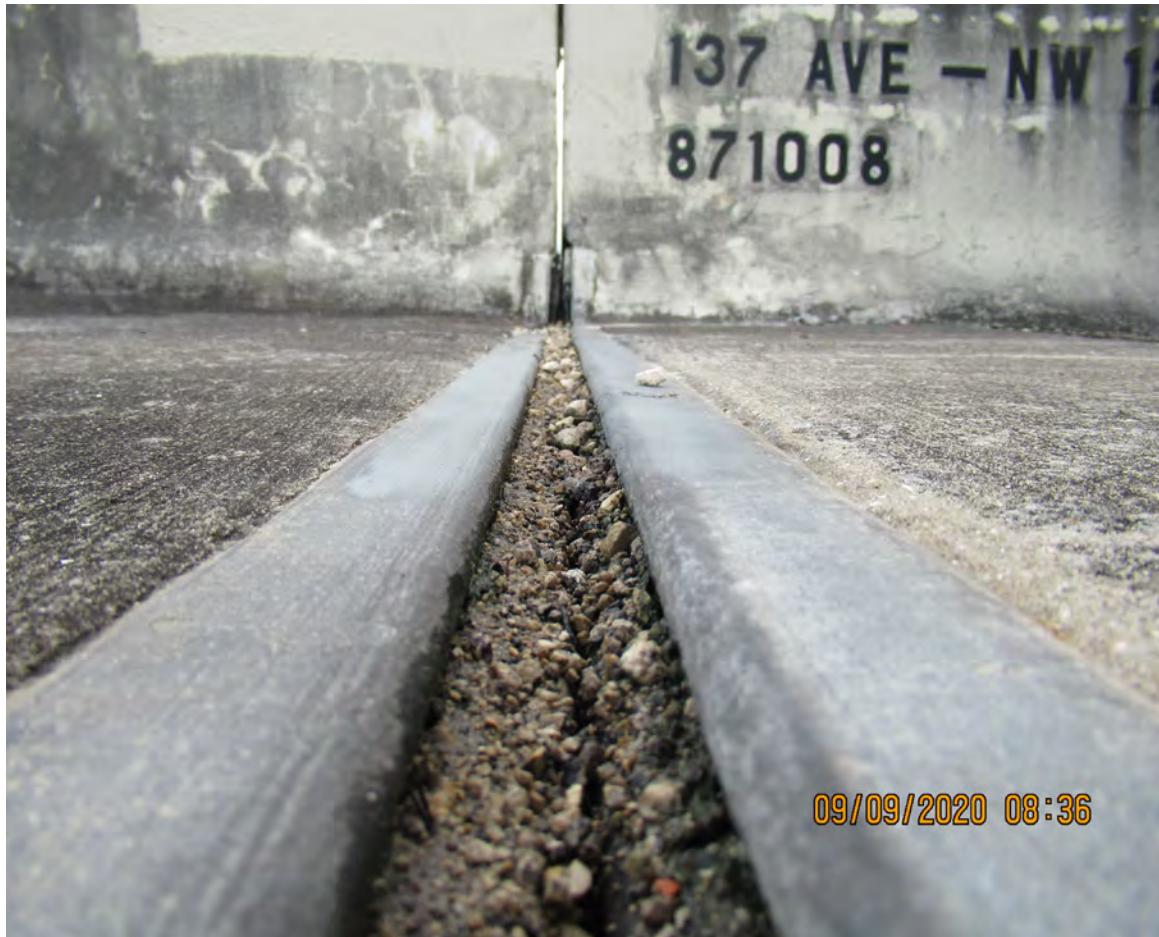
**ROADWAY INSPECTION  
LOCATION: MILE MARKER 1.50 MILES  
EASTBOUND MAINLINE**

**SEDIMENT & DEBRIS ON BRIDGE EXPANSION JOINT (BRIDGE # 871008)  
(TYPICAL AT BRIDGE # 871002 & 871004)**

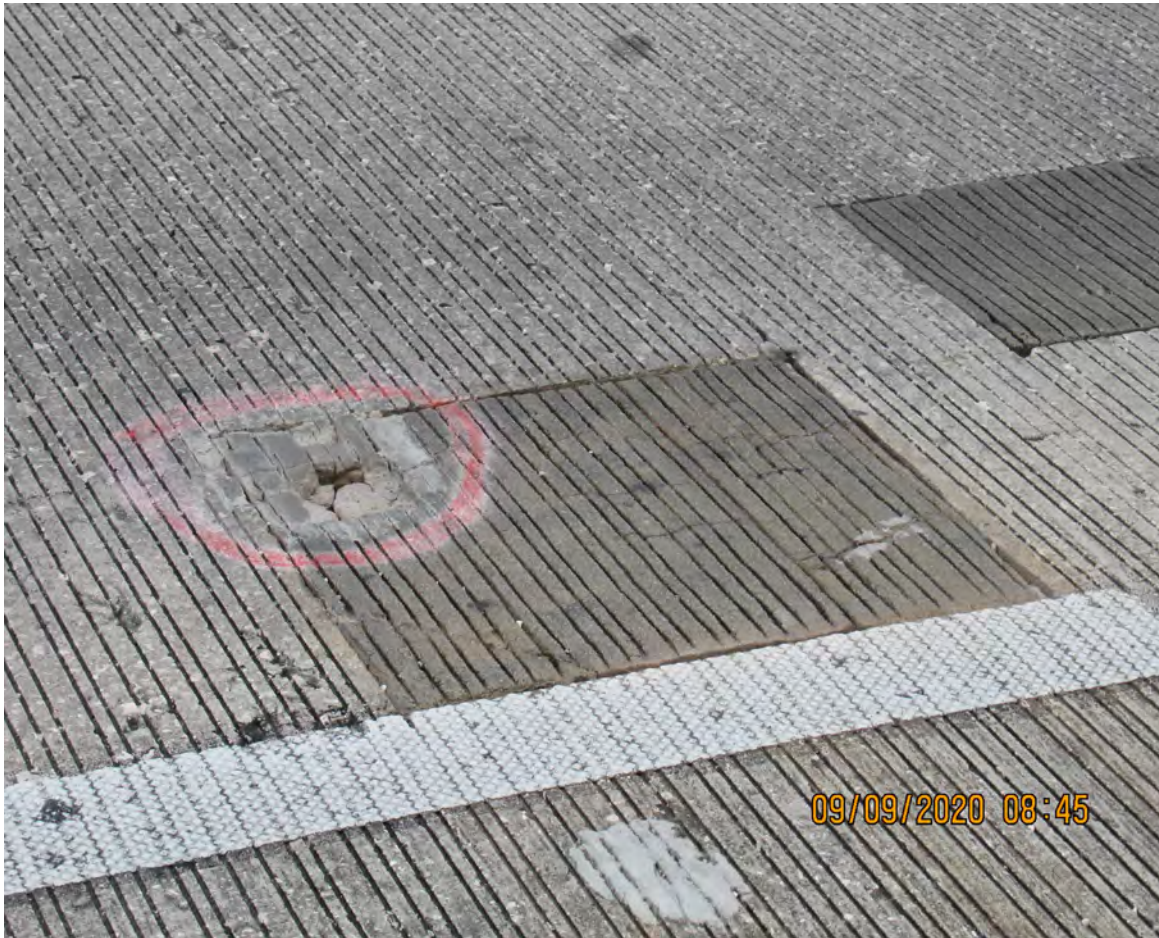
**ROADWAY INSPECTION  
LOCATION: MILE MARKER 1.50 MILES  
EASTBOUND MAINLINE**

**SPALL ON BRIDGE DECK (BRIDGE No. 871002)**

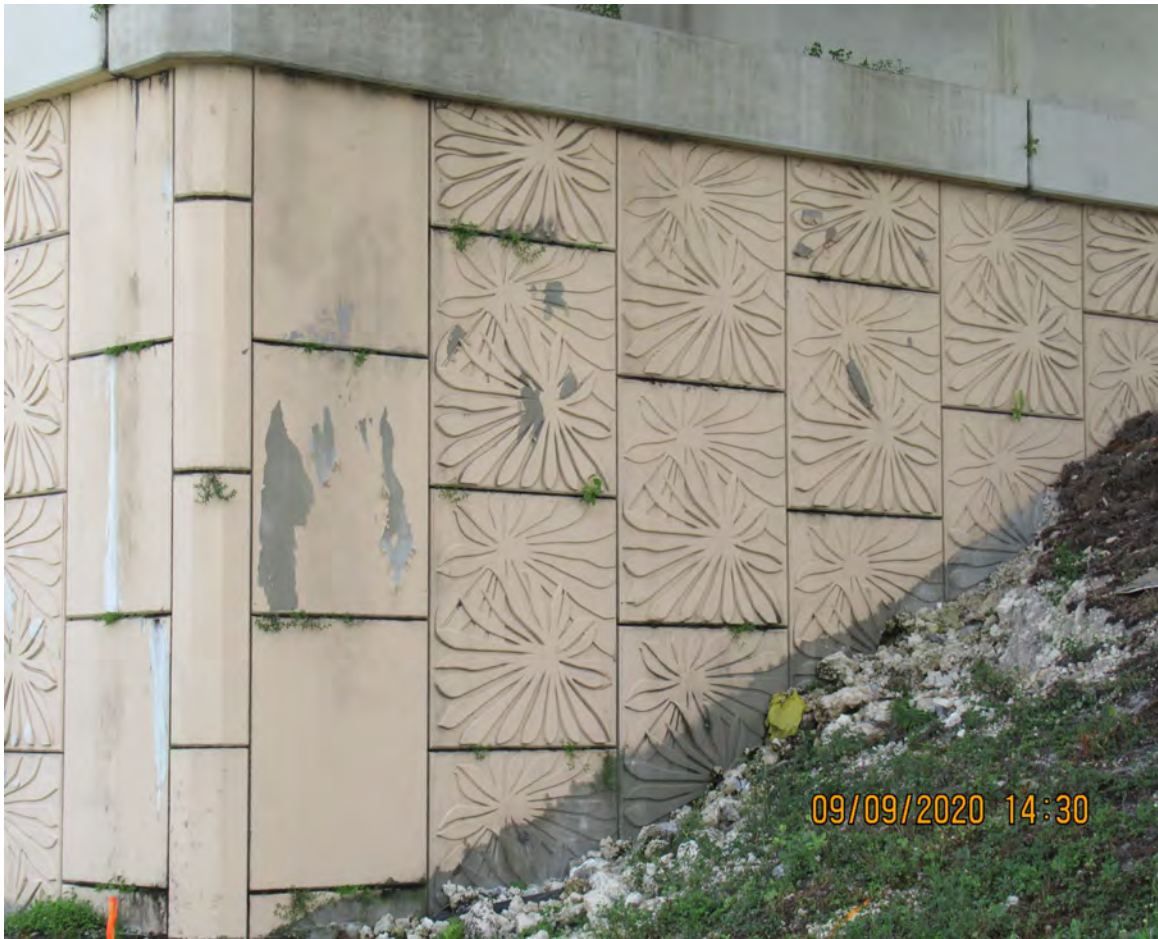
**ROADWAY INSPECTION  
LOCATION: MILE MARKER 6.85 MILES  
EASTBOUND MAINLINE (RIGHT SHOULDER)**

**EROSION / PEELING CLASS V COATING AT BENT 12 (BRIDGE # 871050)**

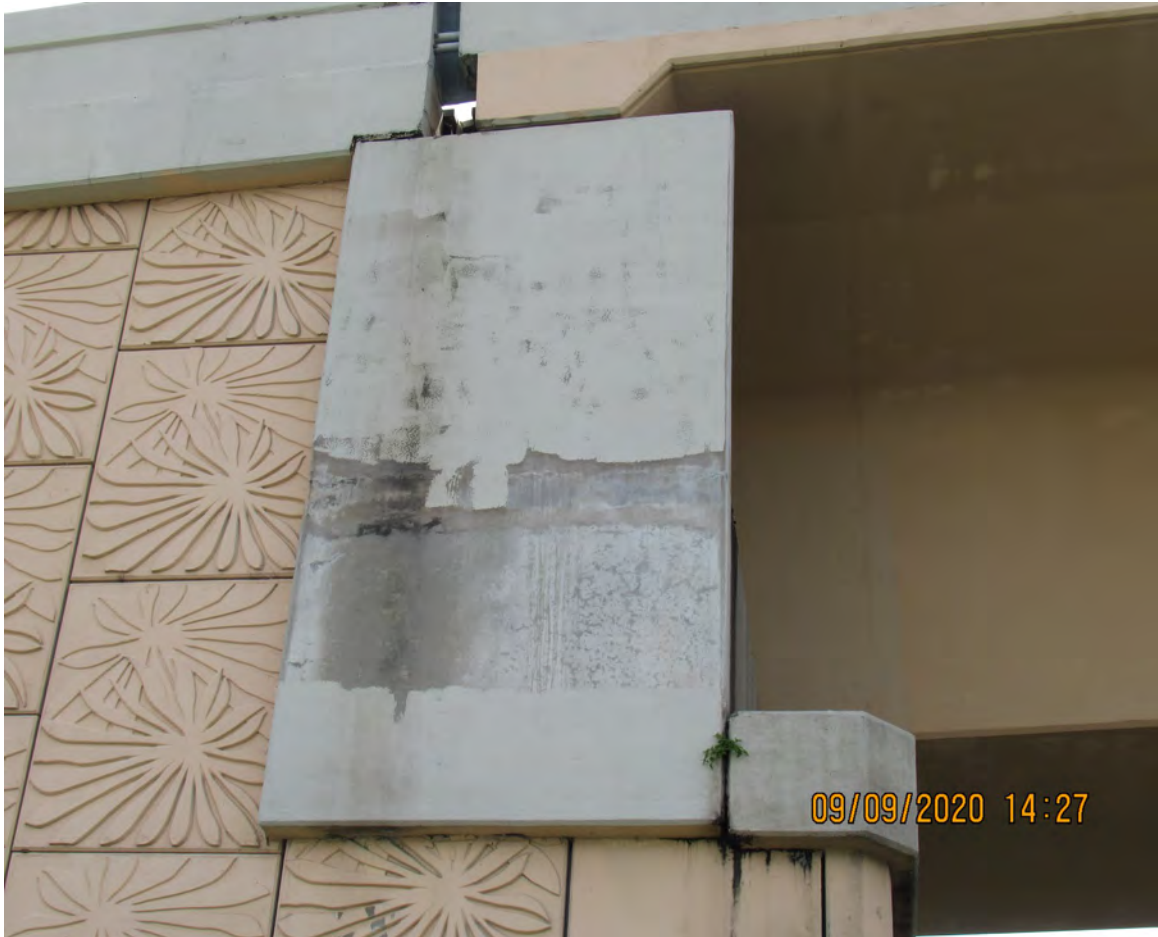
**ROADWAY INSPECTION  
LOCATION: MILE MARKER 6.85 MILES  
EASTBOUND MAINLINE (RIGHT SHOULDER)**

**DETERIORATED CLASS V COATING ON WING WALL AT BENT 12  
(BRIDGE # 871050)**

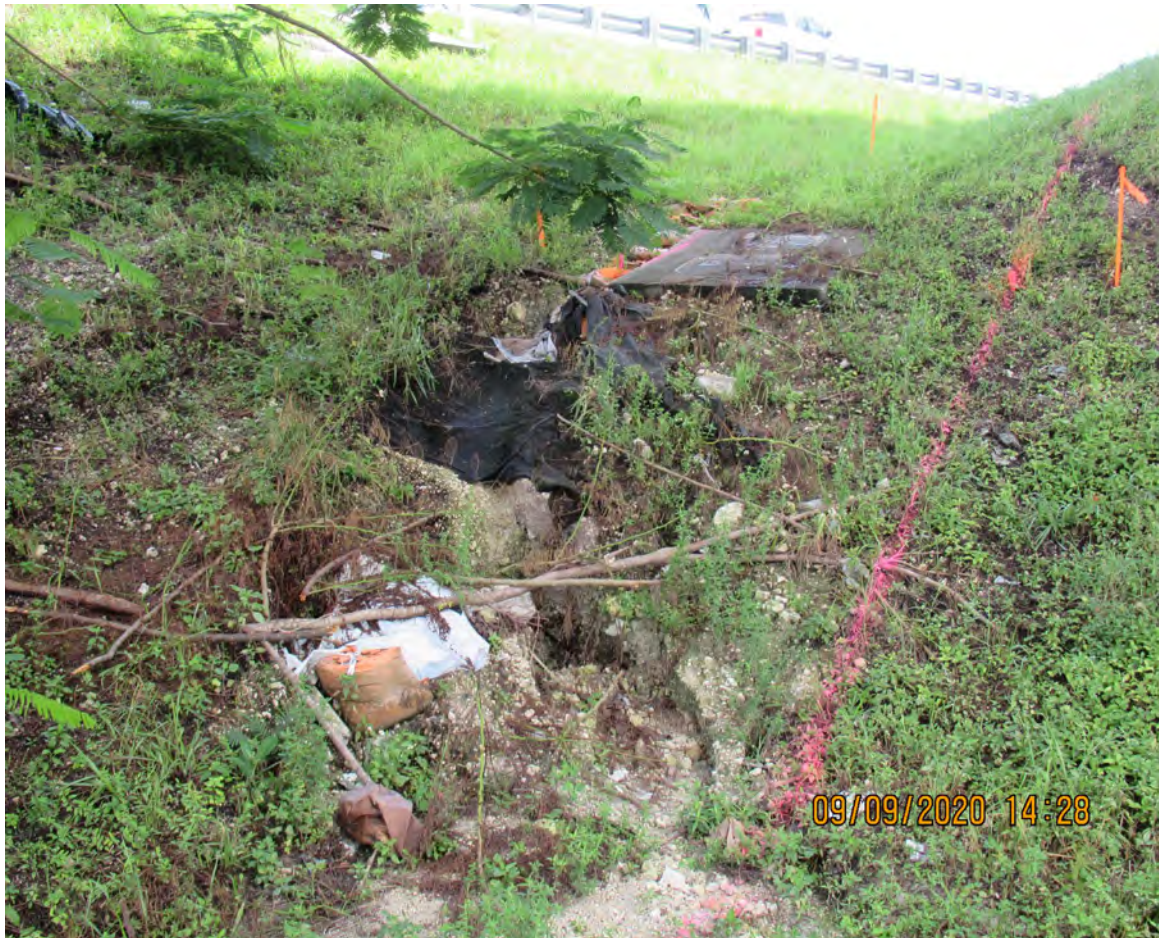
**ROADWAY INSPECTION  
LOCATION: MILE MARKER 6.84 MILES  
EASTBOUND MAINLINE (RIGHT SHOULDER)**

**EROSION ON SLOPE (BRIDGE 871050 Span 11)**
