# Annual Inspection Report 2020

# ANNUAL INSPECTION REPORT

As detailed in the following sections, EAC Consulting has found the MDX System to be in good working order and condition.

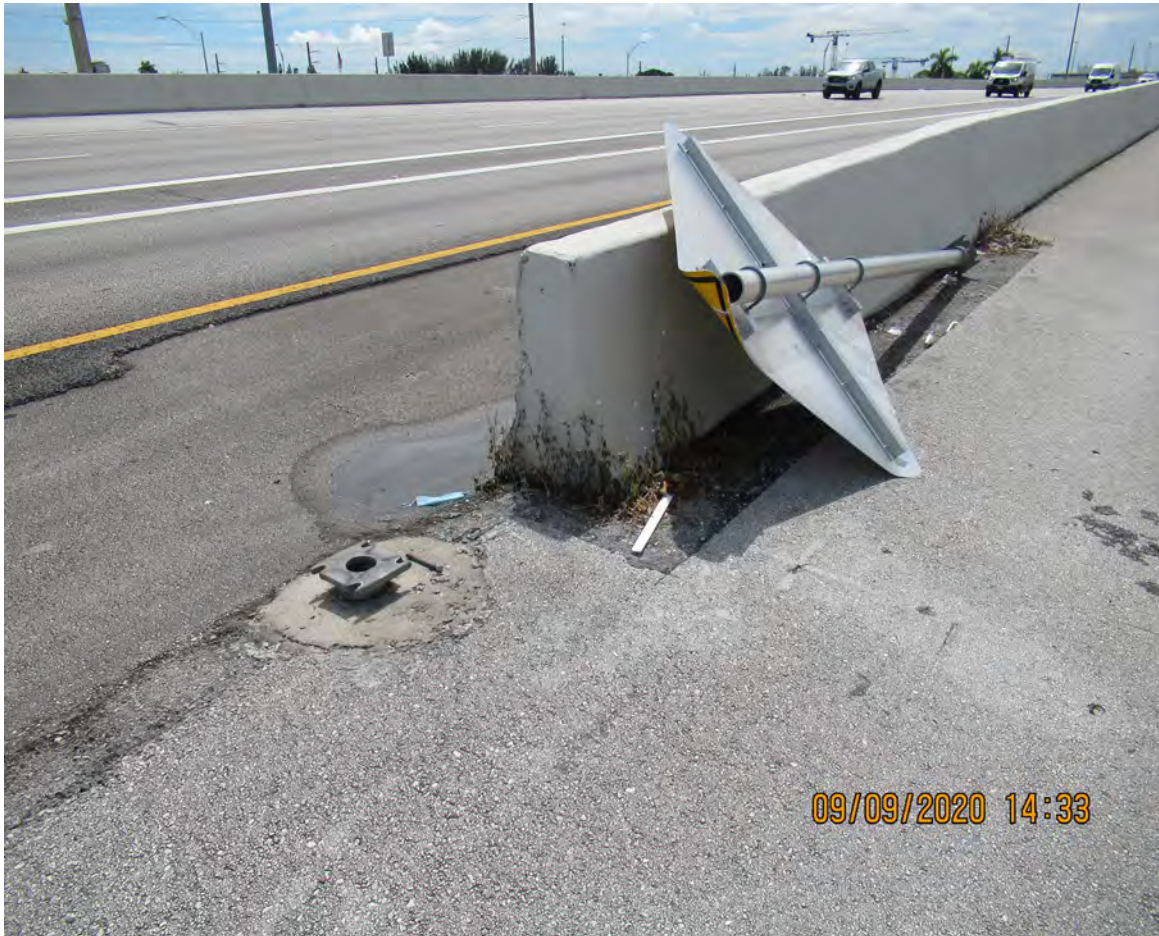
**ROADWAY INSPECTION  
LOCATION: MILE MARKER 7.12  
EASTBOUND MAINLINE (RIGHT SHOULDER)**

**KNOCKED DOWN SIGN FROM VEHICULAR IMPACT**

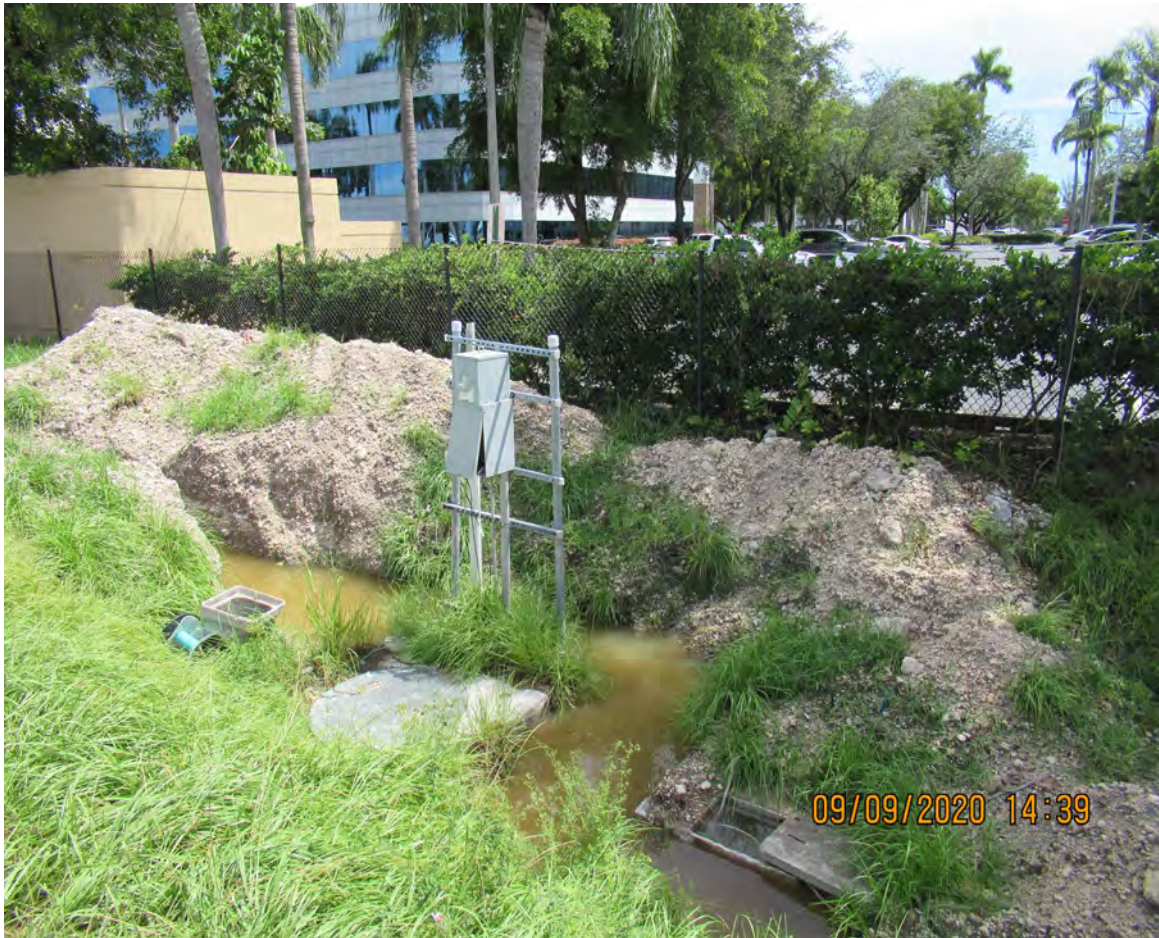
**ROADWAY INSPECTION  
LOCATION: MILE MARKER 8.32  
EASTBOUND MAILINE (RIGHT SHOULDER)**

**PENDING ITS PULL BOX GRADE ADJUSTMENTS**

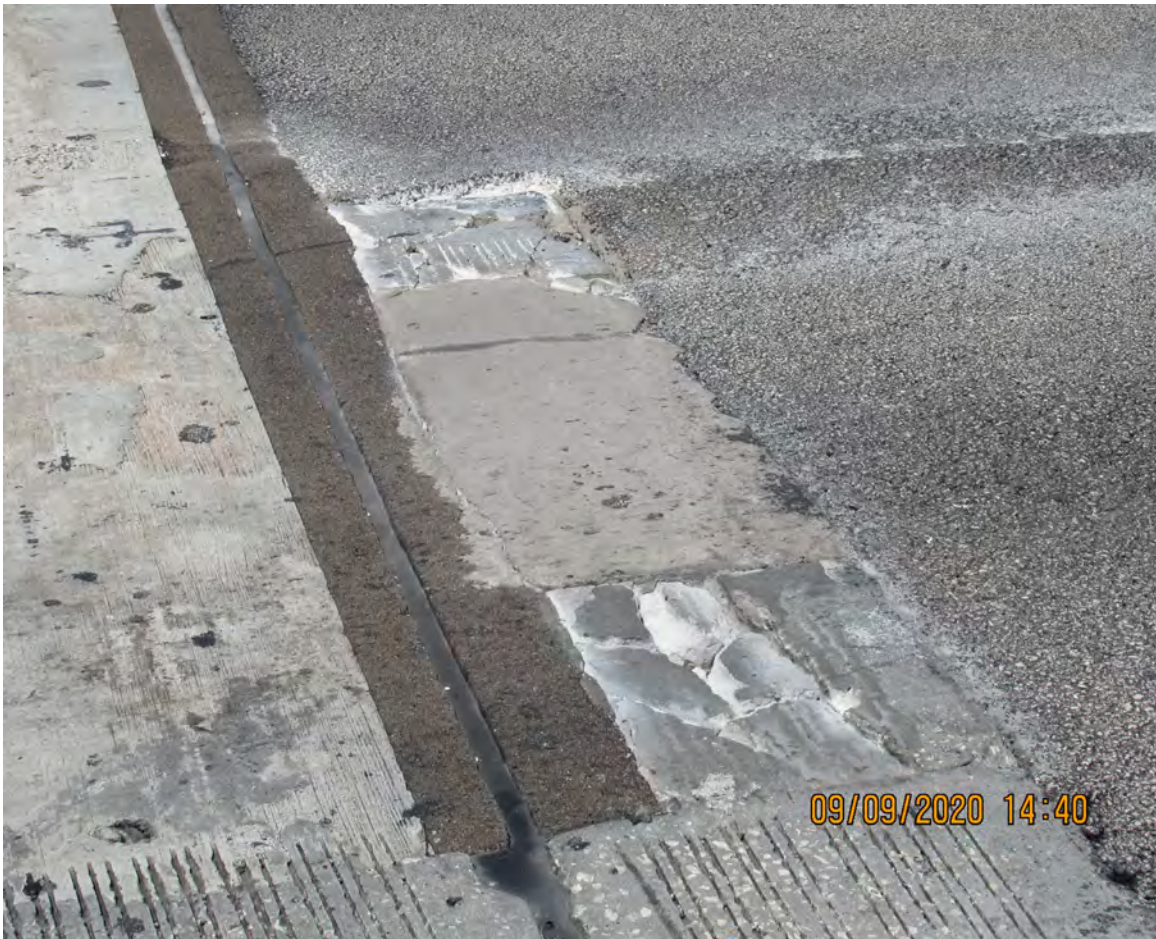
**ROADWAY INSPECTION  
LOCATION: MILE MARKER 8.73  
EASTBOUND MAILINE (OUTSIDE LANE, BENT No. 2)**

**DETERIORATED APPROACH SLAB REPAIR**

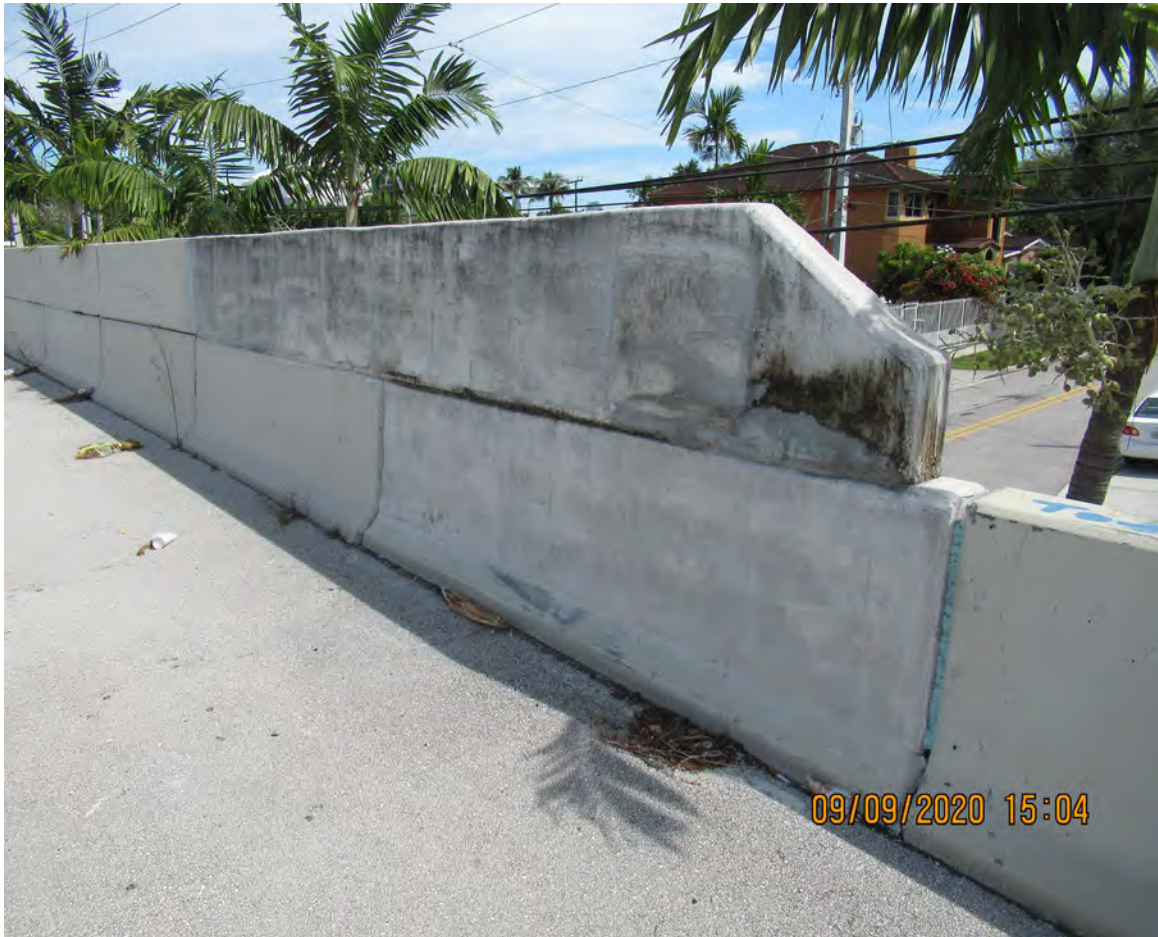
**ROADWAY INSPECTION  
LOCATION: MILE MARKER 12.54  
EASTBOUND MAILINE (RIGHT SHOULDER)**

**DETERIORATED CLASS V COATING ON BARRIER AND OPAQUE WALLS**

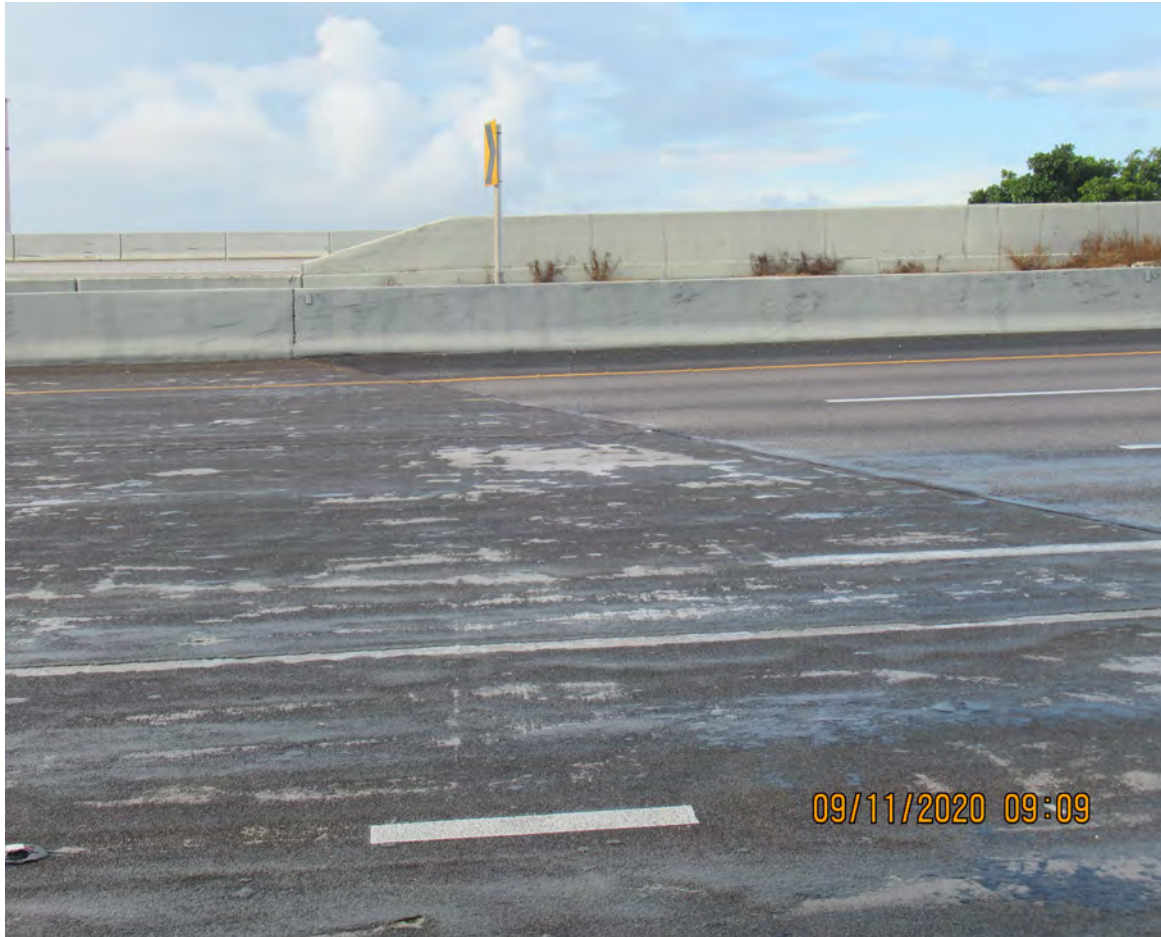
**ROADWAY INSPECTION  
LOCATION: MILE MARKER 12.4 MILES  
WESTBOUND MAINLINE**

**DETERIORATED BRIDGE DECK OVERLAY (BRIDGE # 870145)  
AND (BRIDGE # 870135)**

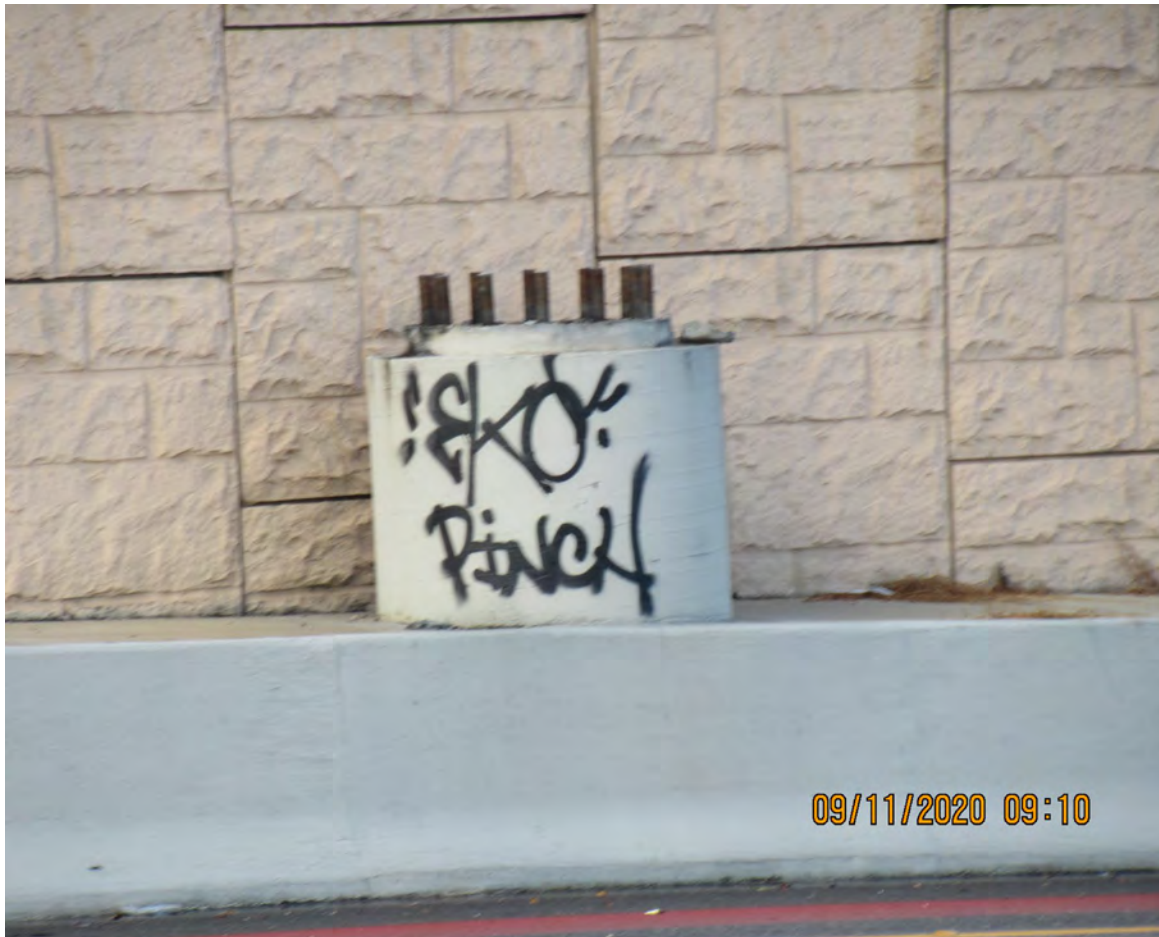
**ROADWAY INSPECTION  
LOCATION: MILE MARKER 12.1 MILES  
WESTBOUND MAINLINE (LEFT SHOULDER)**

**GRAFITTI ON DRILL-SHAFT**

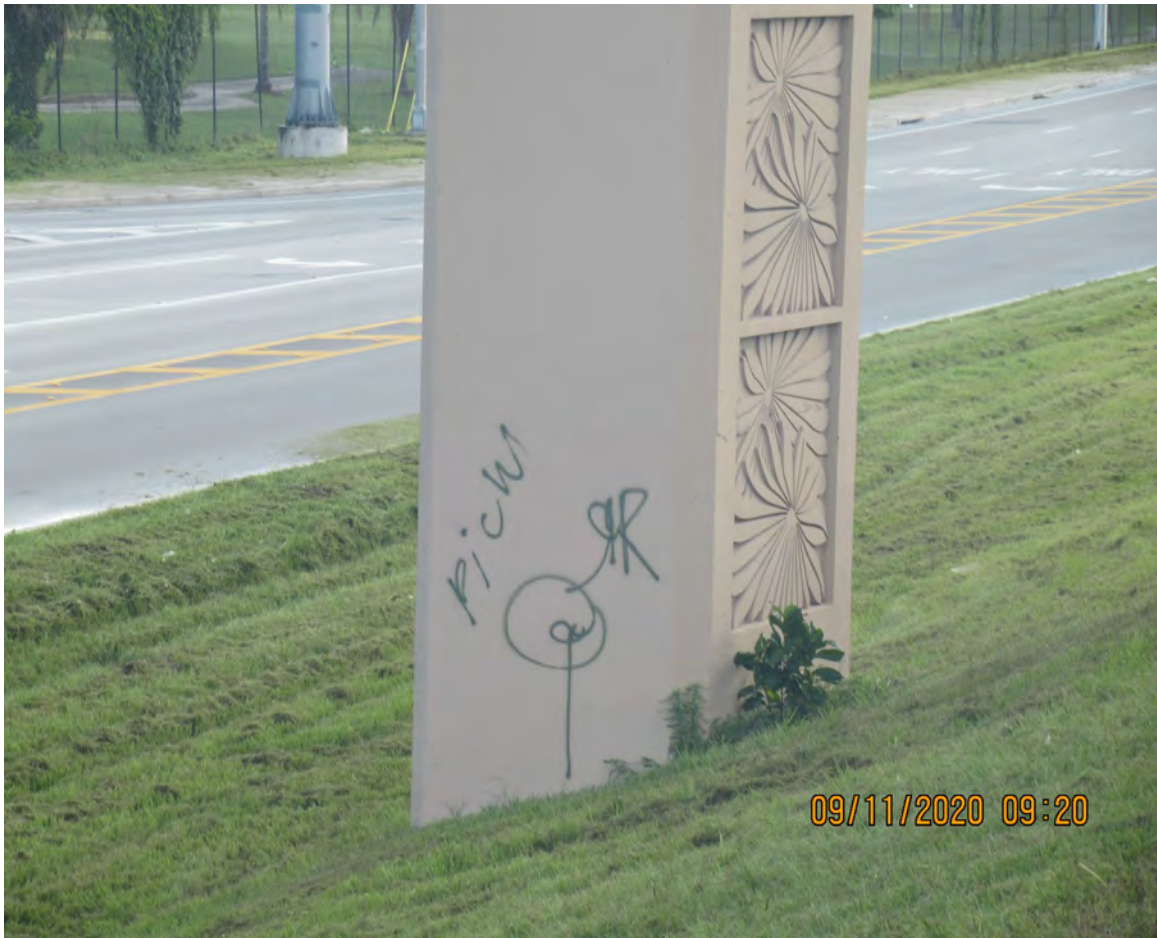
**ROADWAY INSPECTION  
LOCATION: MILE MARKER 10.39 MILES  
WESTBOUND MAINLINE (RIGHT SHOULDER)**

**GRAFITTI ON BRIDGE COLUMN**

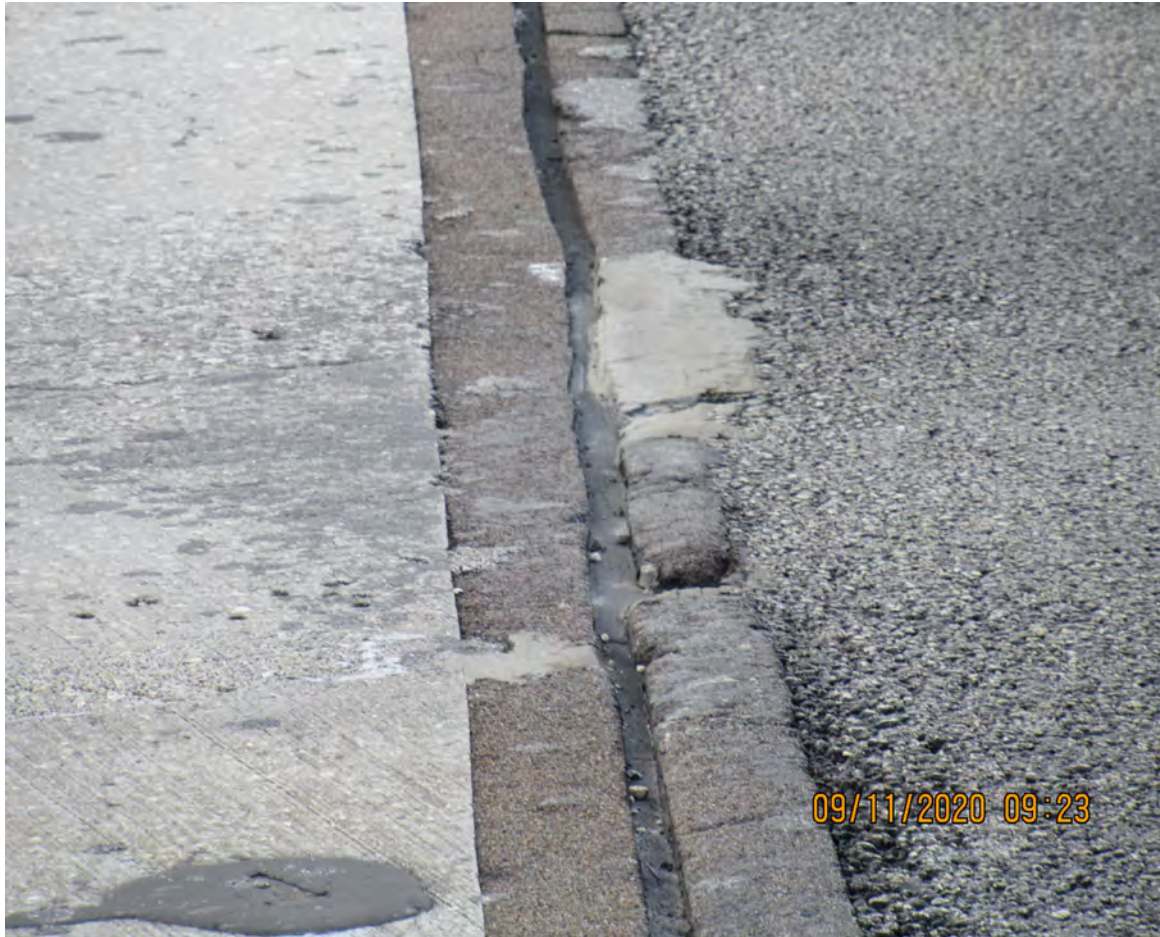
**ROADWAY INSPECTION  
LOCATION: MILE MARKER 10.31 MILES  
WESTBOUND MAINLINE**

**DAMAGED POLYMER NOSING JOINT HEADER (BRIDGE No. 870138)**

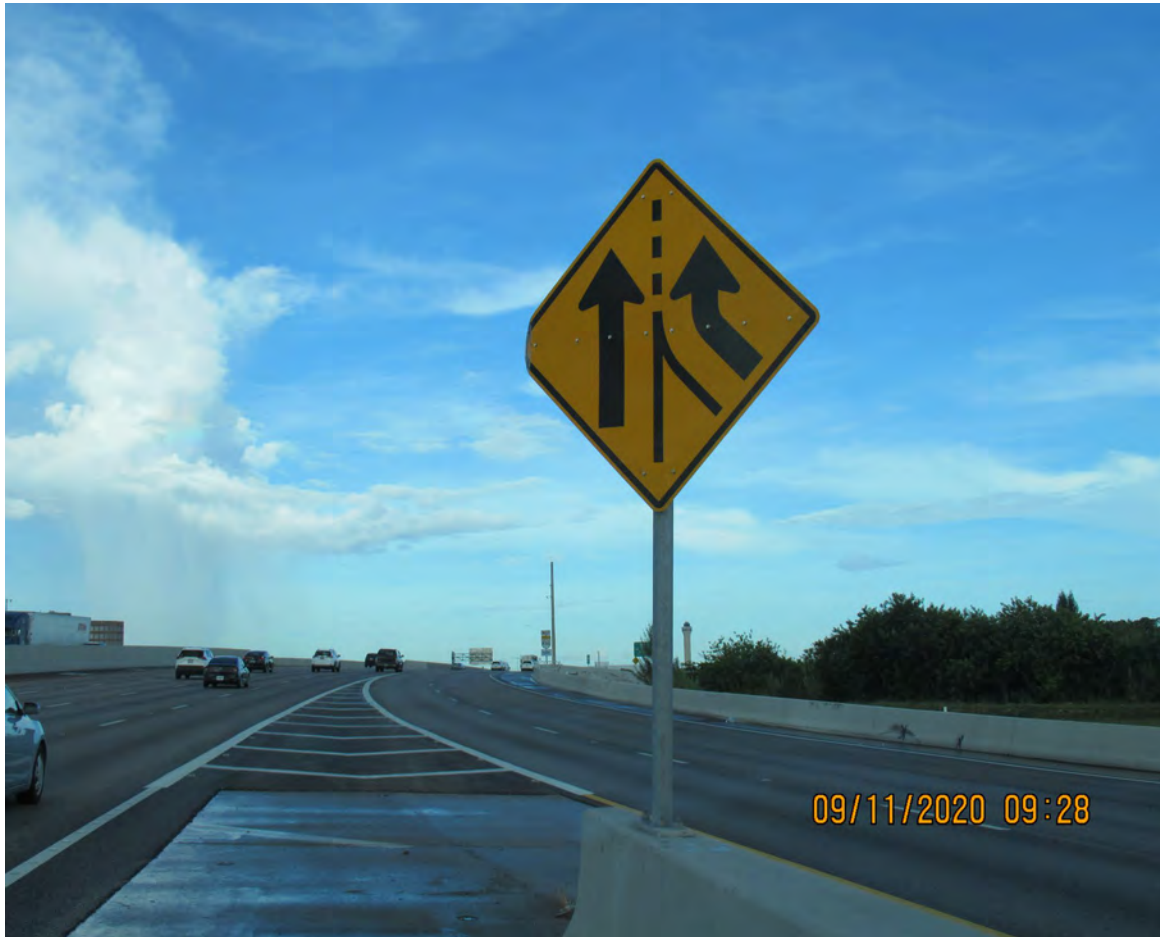
**ROADWAY INSPECTION  
LOCATION: MILE MARKER 10.03 MILES  
WESTBOUND MAINLINE (RIGHT SHOULDER)**

**TWISTED SIGN PANEL / BENT LEFT CORNER OF SIGN PANEL**

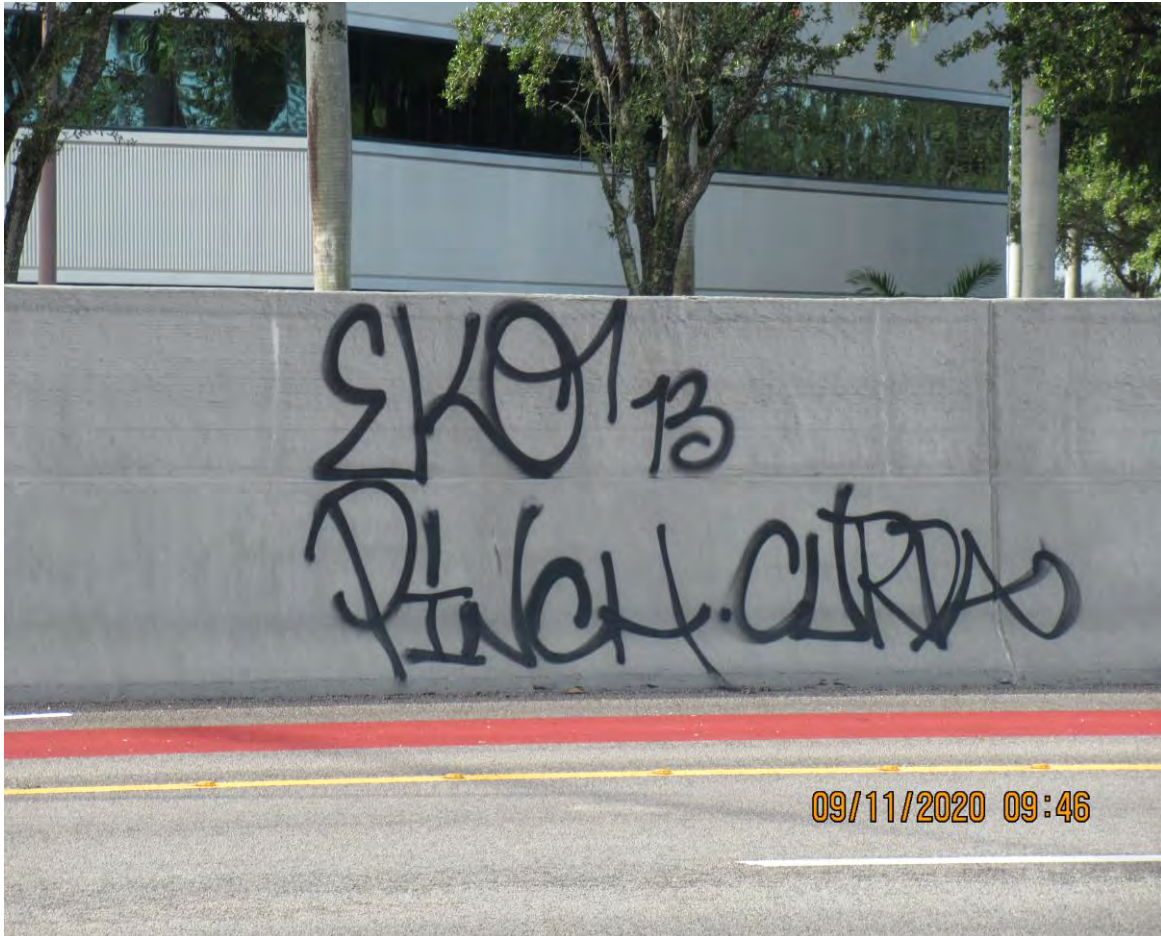
**ROADWAY INSPECTION  
LOCATION: MILE MARKER 8.20 MILES  
WESTBOUND MAINLINE (LEFT SHOULDER)**

**GRAFFITI ON MEDIAN BARRIER WALL**

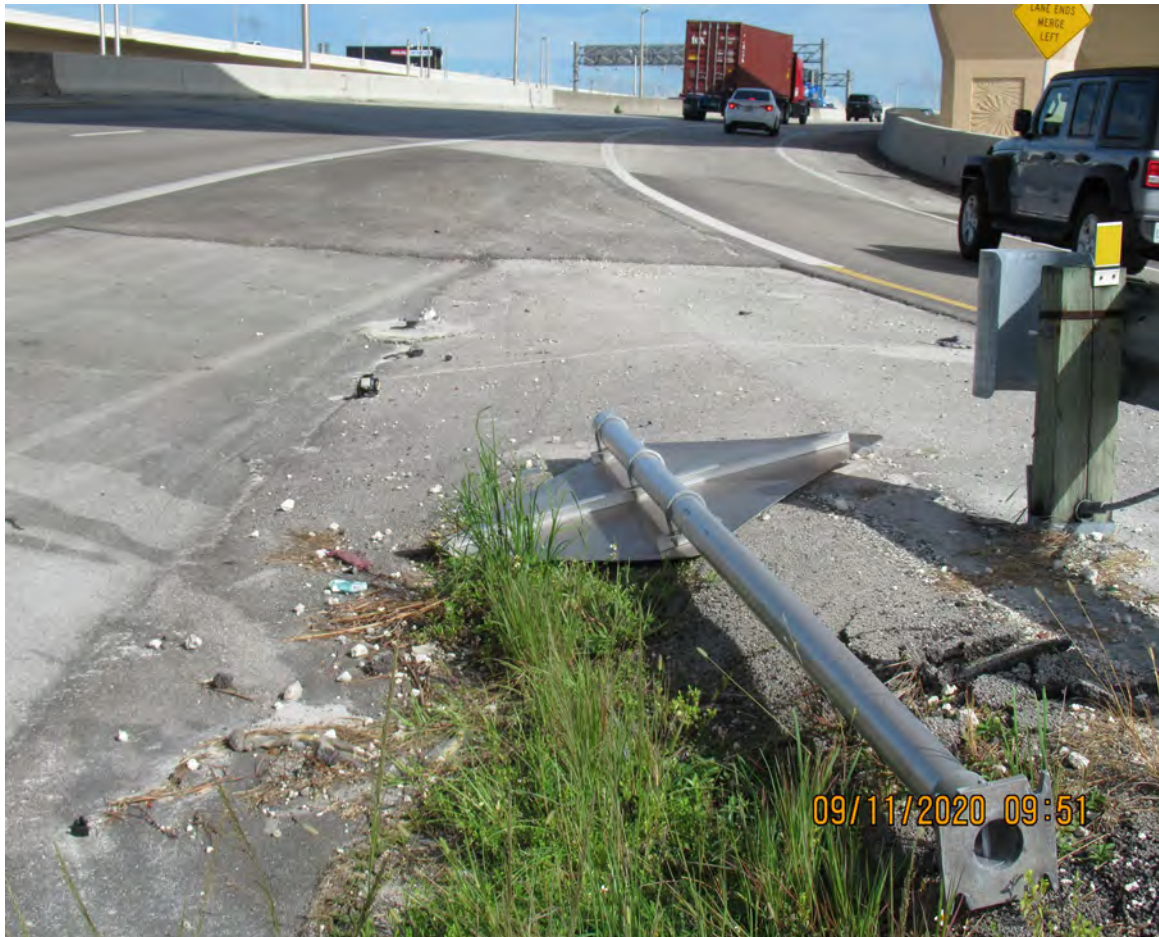
**ROADWAY INSPECTION  
LOCATION: MILE MARKER 6.67 MILES  
WESTBOUND OFF-RAMP TO SR 826 NORTHBOUND  
(RIGHT SHOULDER)**

**DOWN MERGE SIGN DUE TO VEHICULAR ACCIDENT**

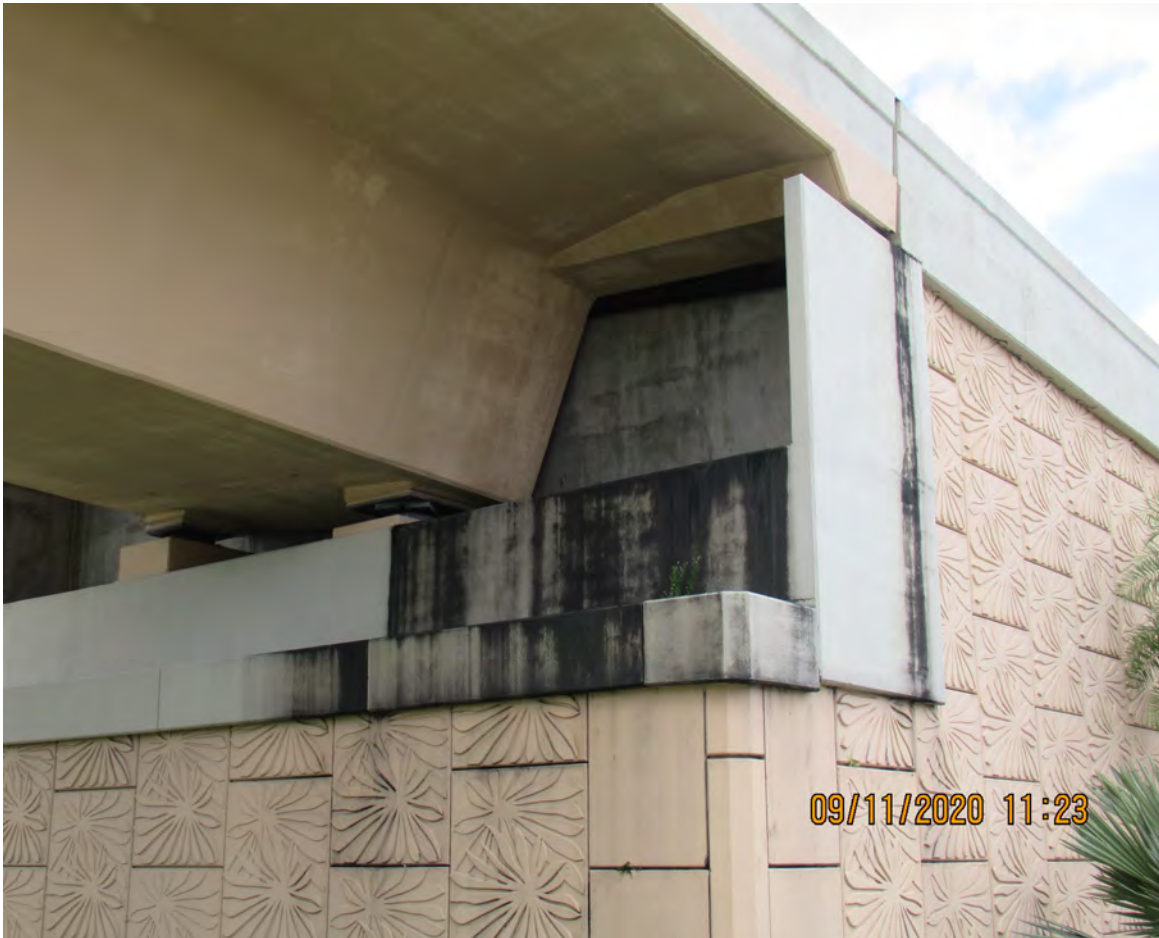
**ROADWAY INSPECTION  
LOCATION: MILE MARKER 6.74 MILES  
SR 836 WESTBOUND OFF- RAMP TO SR 826 SOUTHBOUND**

**WATER STAINS FROM CLOGGED BRIDGE DRAINAGE (BRIDGE # 871046)**

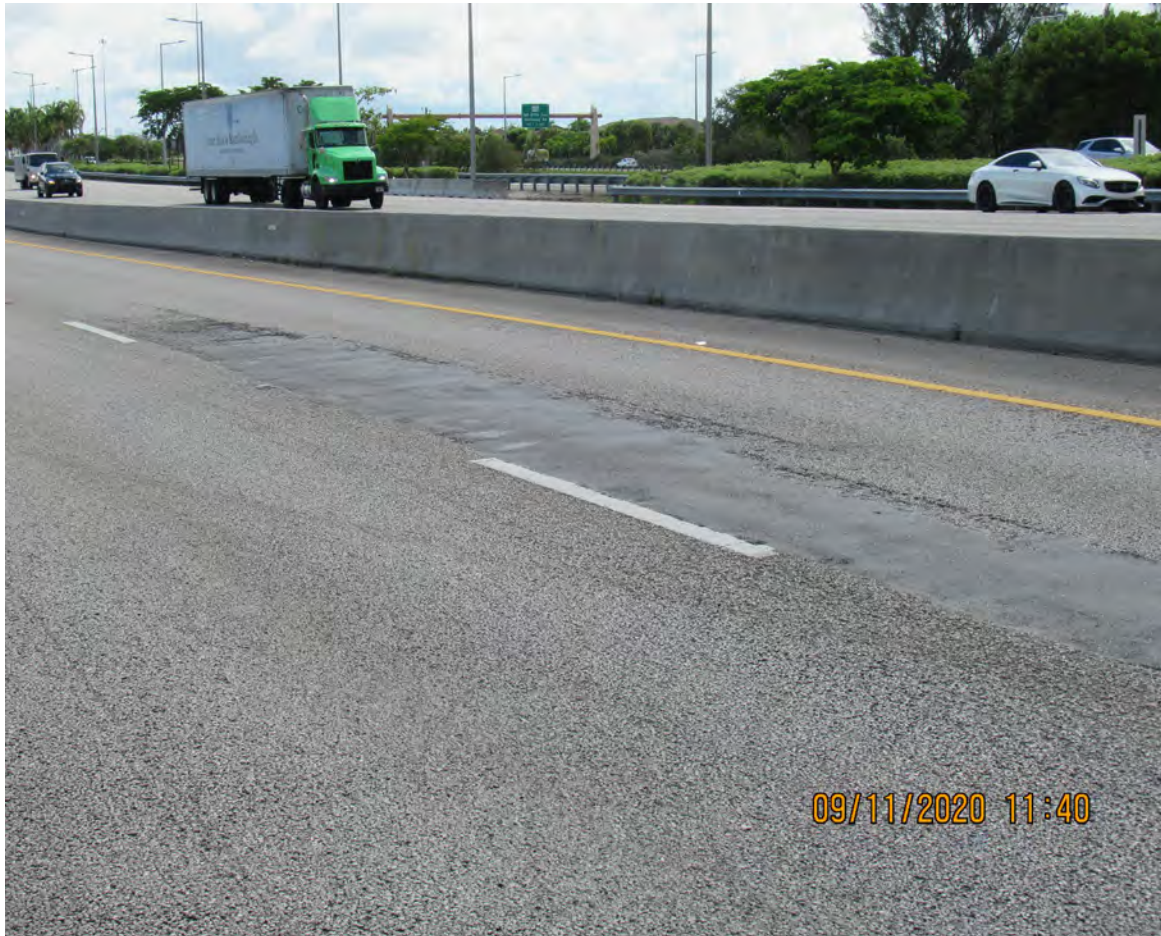
**ROADWAY INSPECTION  
LOCATION: MILE MARKER 3.78 MILES  
WESTBOUND OFF-RAMP TO NW 107<sup>th</sup> AVENUE NORTH**

**DETERIORATED ASPHALT REPAIR**

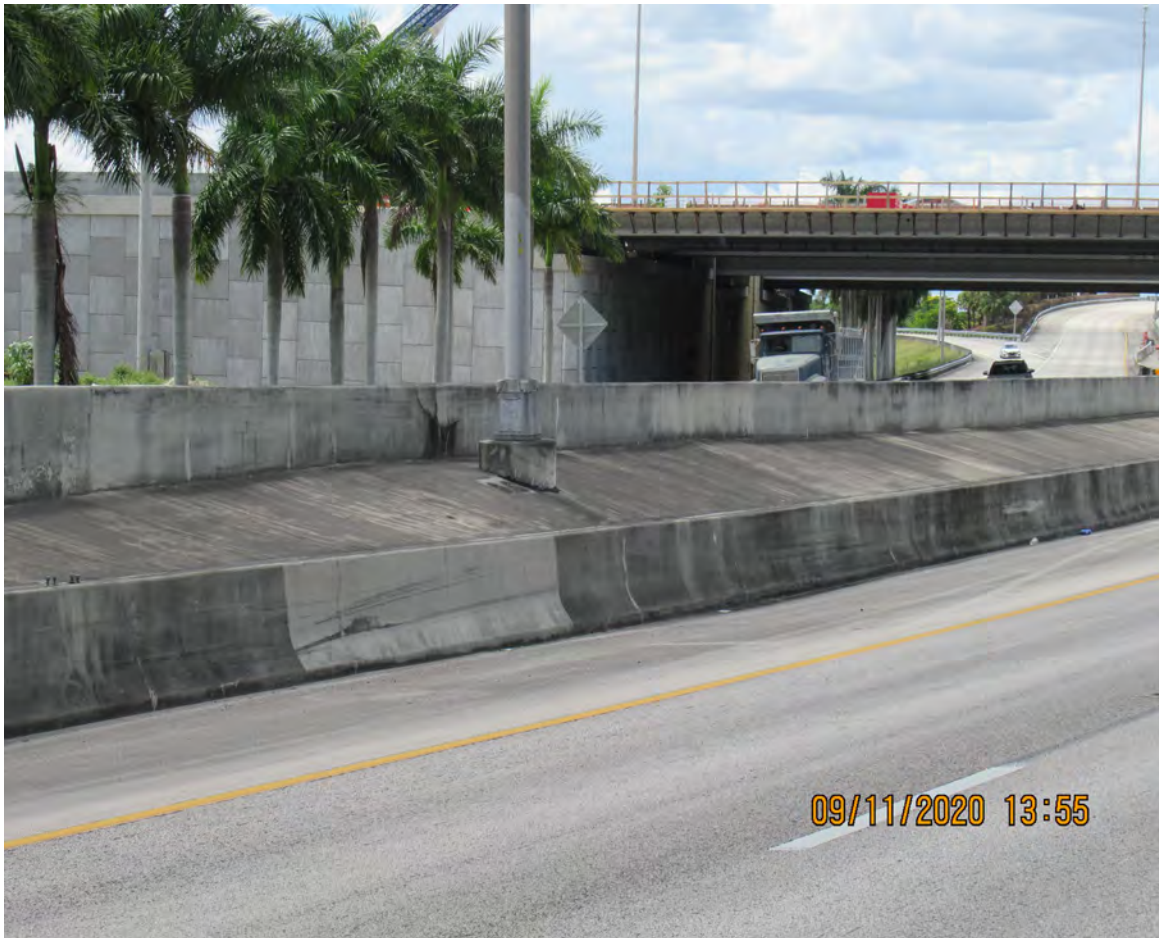
**ROADWAY INSPECTION  
LOCATION: MILE MARKER 4.80 TO 0.00 MILES  
WESTBOUND MAINLINE (LEFT SHOULDER)**

**DETERIORATED CLASS V COATING ON BARRIER WALL AND CONCRETE MEDIAN**

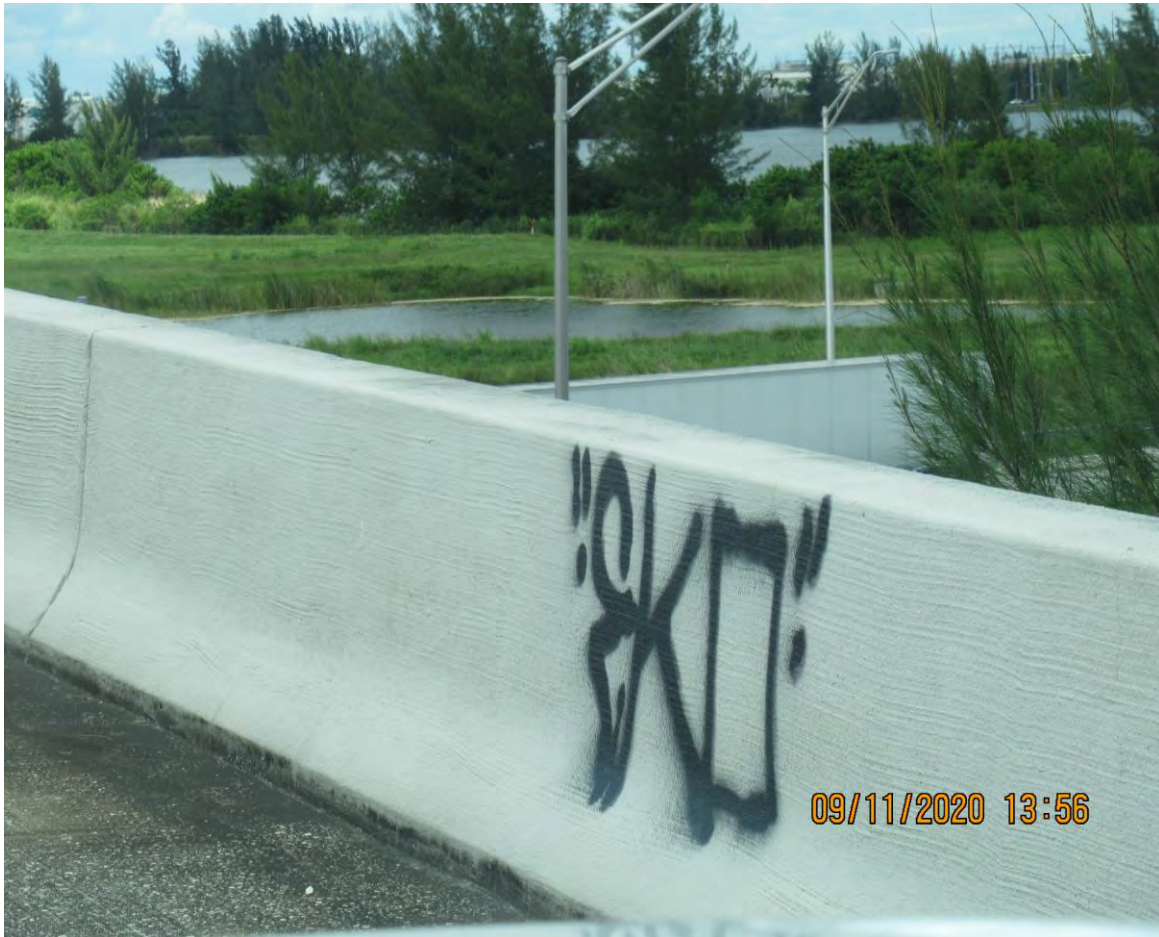
**ROADWAY INSPECTION  
LOCATION: MILE MARKER 2.20 MILES  
WESTBOUND MAINLINE (RIGHT SHOULDER)**

**GRAFFITI ON BARRIER WALL (BRIDGE No. 871003)**

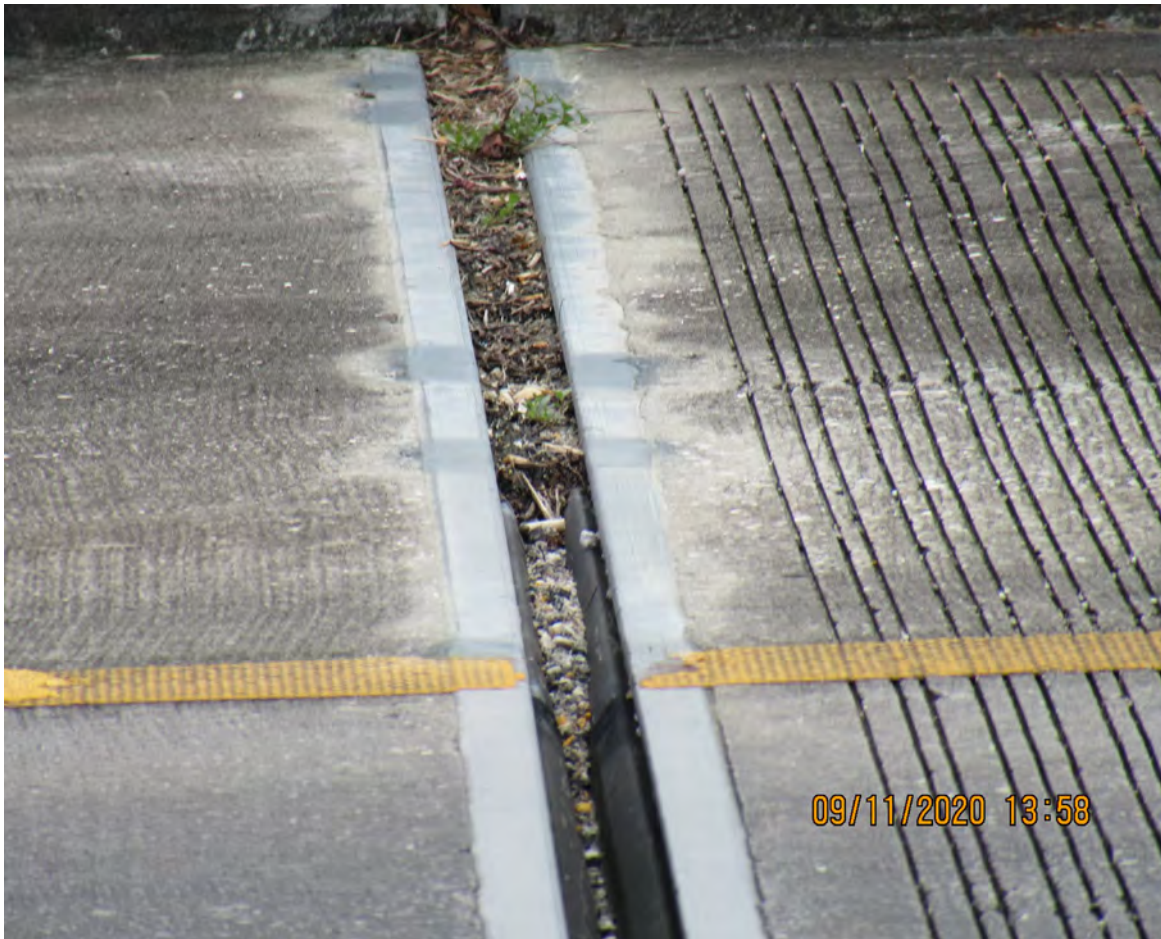
**ROADWAY INSPECTION  
LOCATION: MILE MARKER 2.20 MILES  
WESTBOUND MAINLINE**

**SEDIMENT AND DEBRIS ACCUMULATED ON BRIDGE  
EXPANSION JOINTS (BRIDGE No. 871003)**

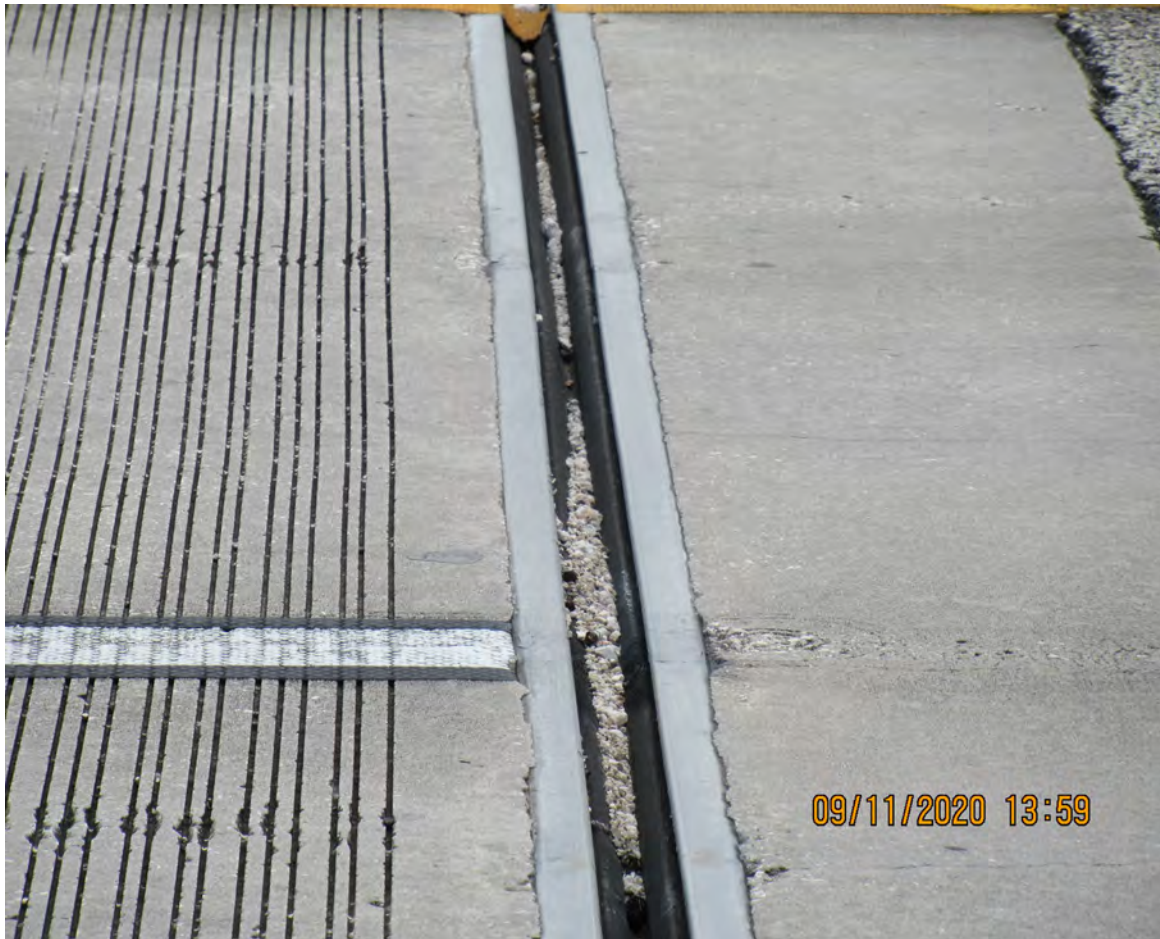
**ROADWAY INSPECTION  
LOCATION: MILE MARKER 1.55 MILES  
WESTBOUND MAINLINE**

**SEDIMENT AND DEBRIS ACCUMULATED ON BRIDGE  
EXPANSION JOINTS (BRIDGE No. 871002)**

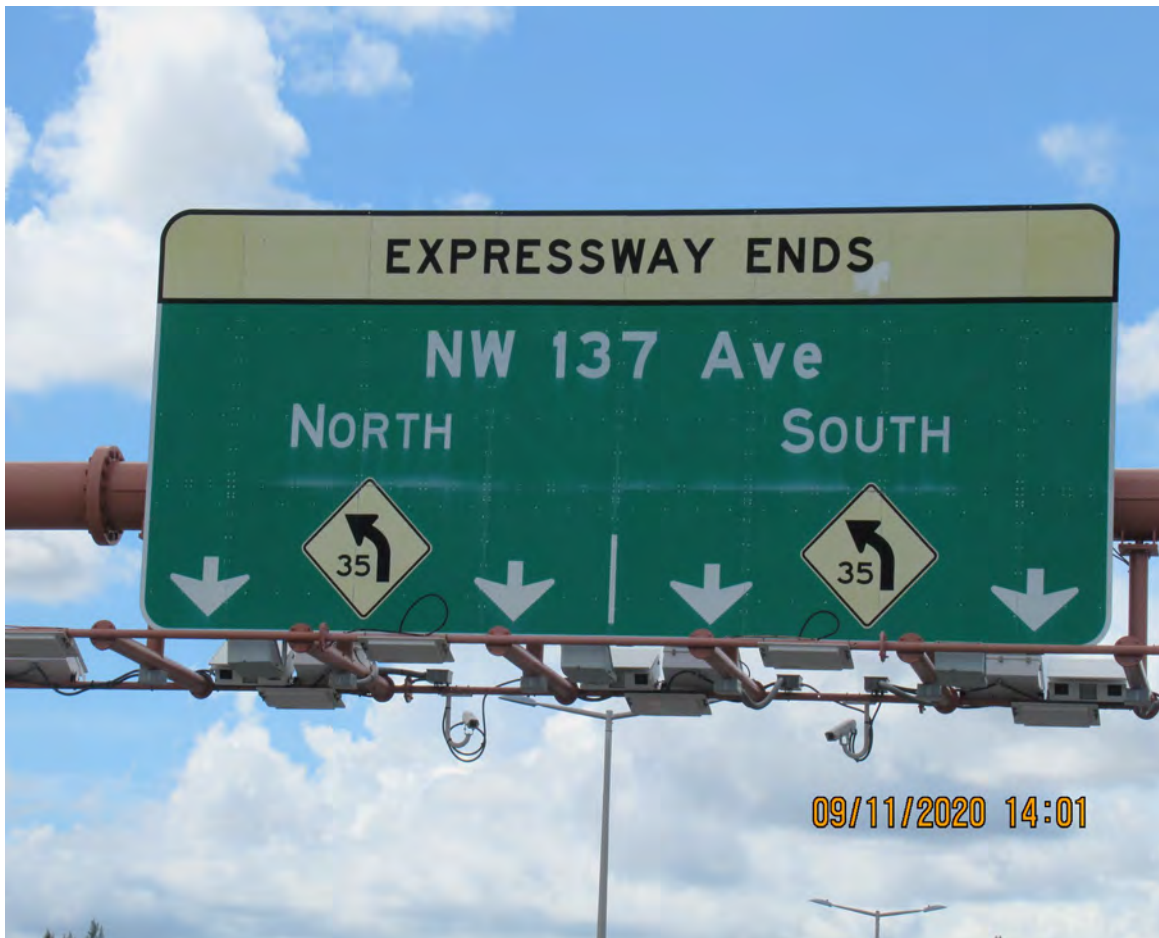
**ROADWAY INSPECTION  
LOCATION: MILE MARKER 0.85 MILES  
WESTBOUND MAINLINE**

**DETERIORATED REFLECTIVE SHEETING ON SIGN PANEL**

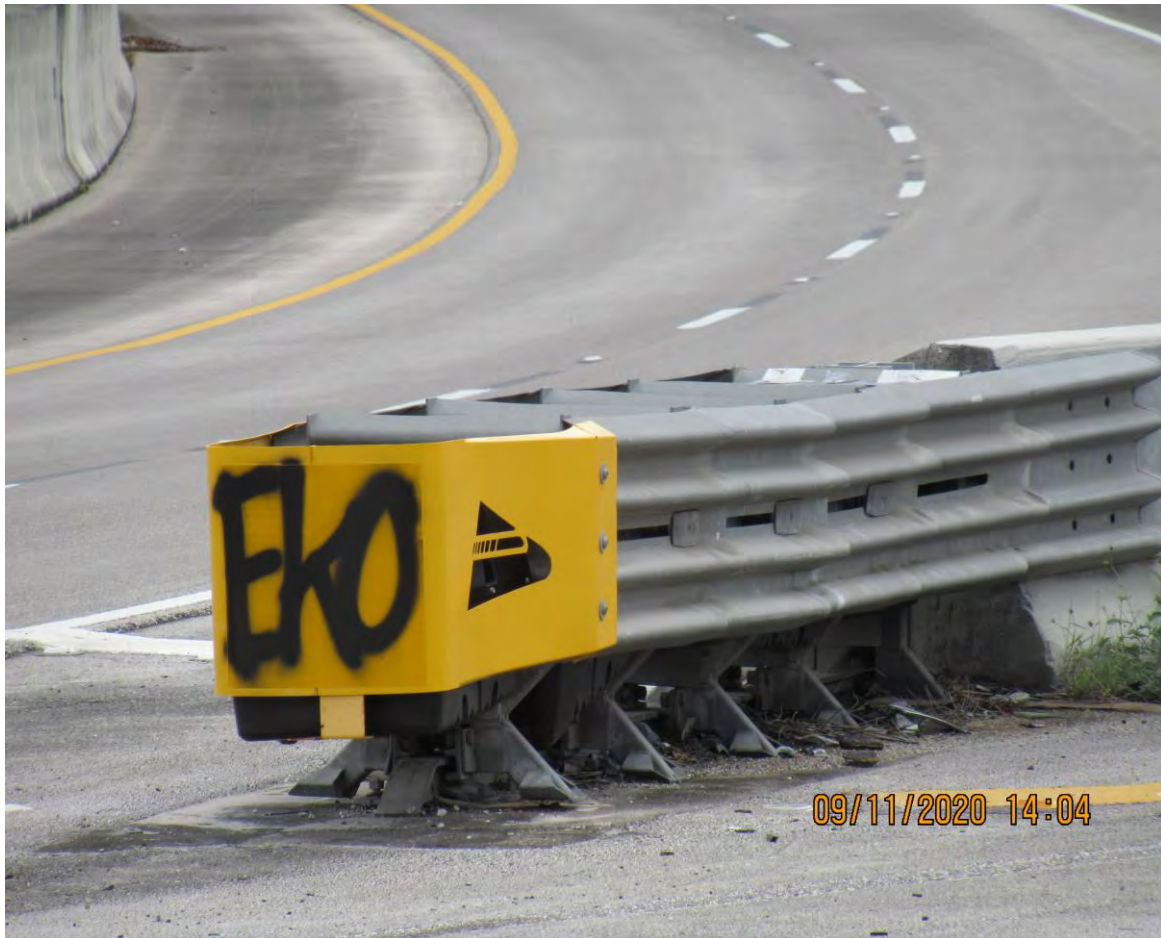
**ROADWAY INSPECTION  
LOCATION: MILE MARKER 6.60 MILES  
WESTBOUND OFF-RAMP TO NW 137<sup>th</sup> AVENUE**

**GRAFFITI ON ATTENUATOR REFLECTIVE SHEETING**

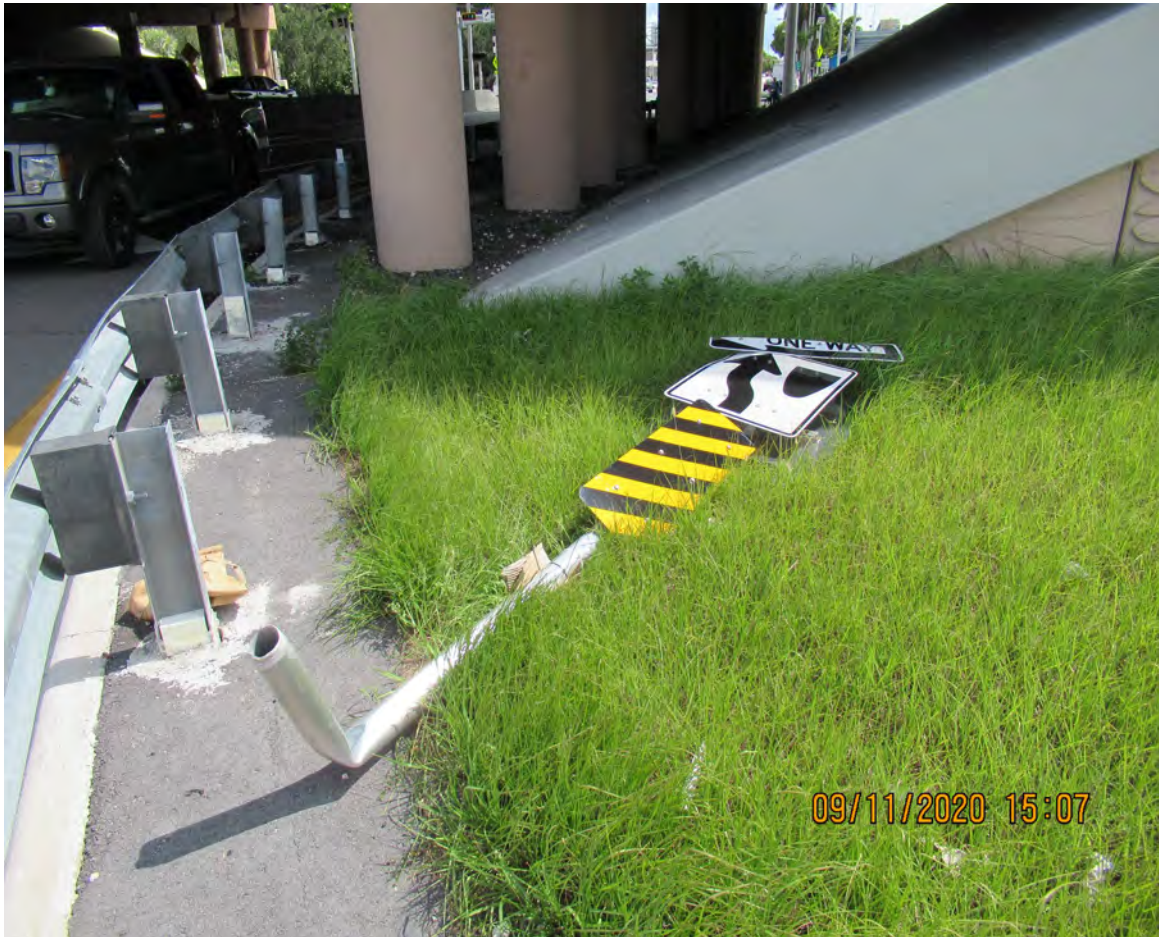
**ROADWAY INSPECTION  
LOCATION: MILE MARKER 8.69 MILES  
WESTBOUND ON-RAMP FROM NW 57<sup>th</sup> AVENUE**

**DAMAGED GUIDE SIGN DUE TO VEHICULAR ACCIDENTS**
