# Annual Inspection Report 2020

# ANNUAL INSPECTION REPORT

As detailed in the following sections, EAC Consulting has found the MDX System to be in good working order and condition.

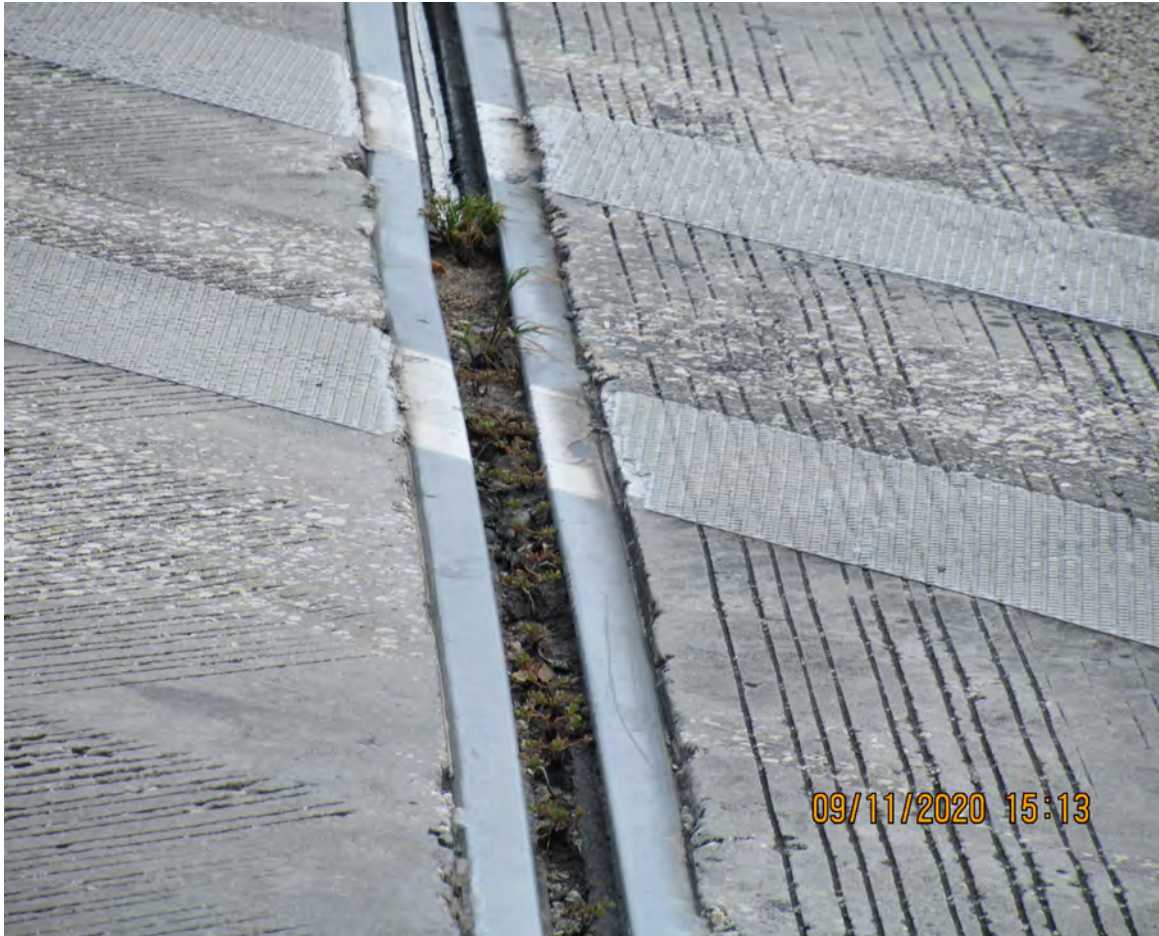
**ROADWAY INSPECTION  
LOCATION: MILE MARKER 6.68 MILES  
WESTBOUND CD RAMP TO NW 87<sup>th</sup> AVENUE**

**SILT AND DEBRIS ACCUMULATED ON BRIDGE EXPANSION JOINTS  
(BRIDGE # 871081)**

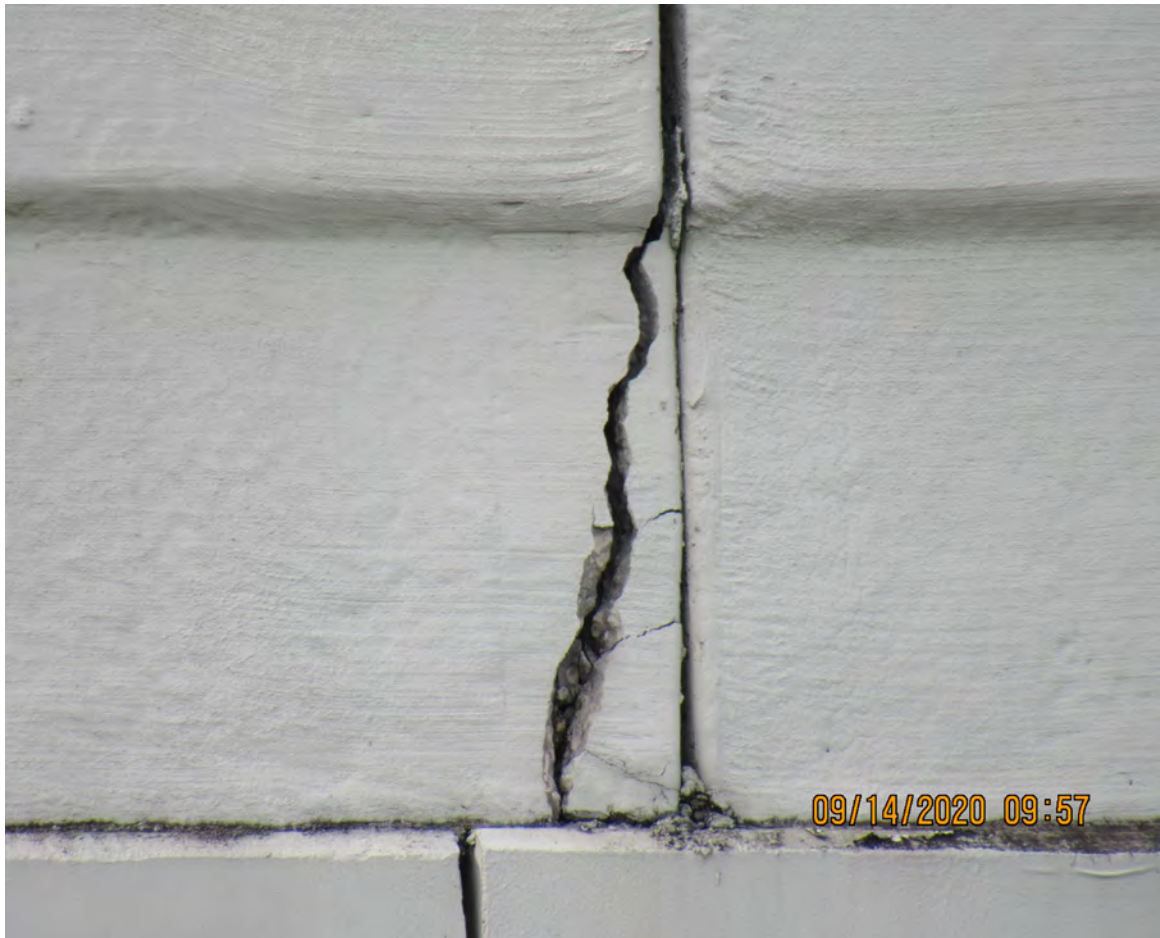
**ROADWAY INSPECTION  
LOCATION: MILE MARKER 6.78 MILES  
WESTBOUND OFF-RAMP TO SR 826 SOUTHBOUND  
(RIGHT SHOULDER)**

**CRACKED BARRIER WALL**

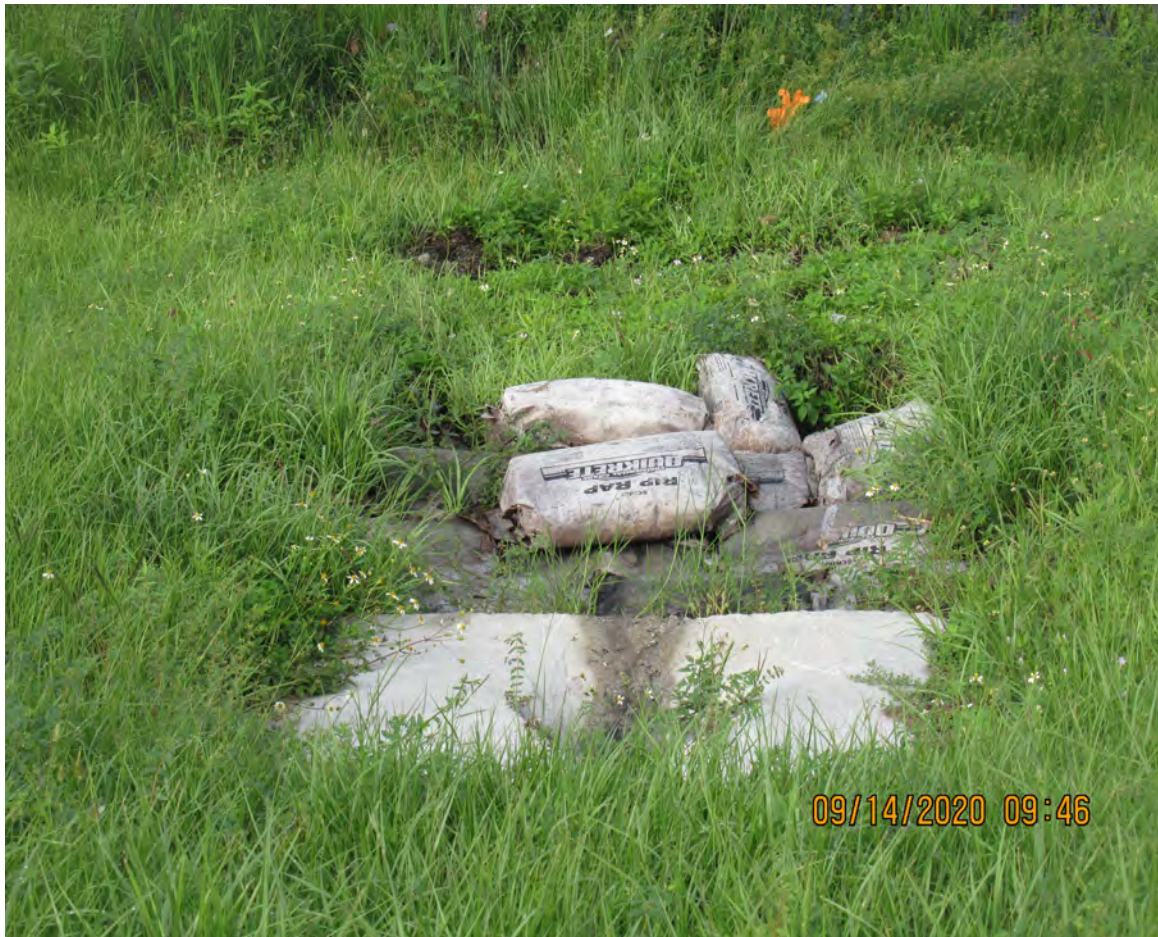
**ROADWAY INSPECTION  
LOCATION: MILE MARKER 10.36 MILES  
NORTHBOUND ON-RAMP FROM LE JEUNE RD. TO SR 836  
WESTBOUND (RIGHT SHOULDER)**

**UNFINISHED OUTFALL REPAIR**

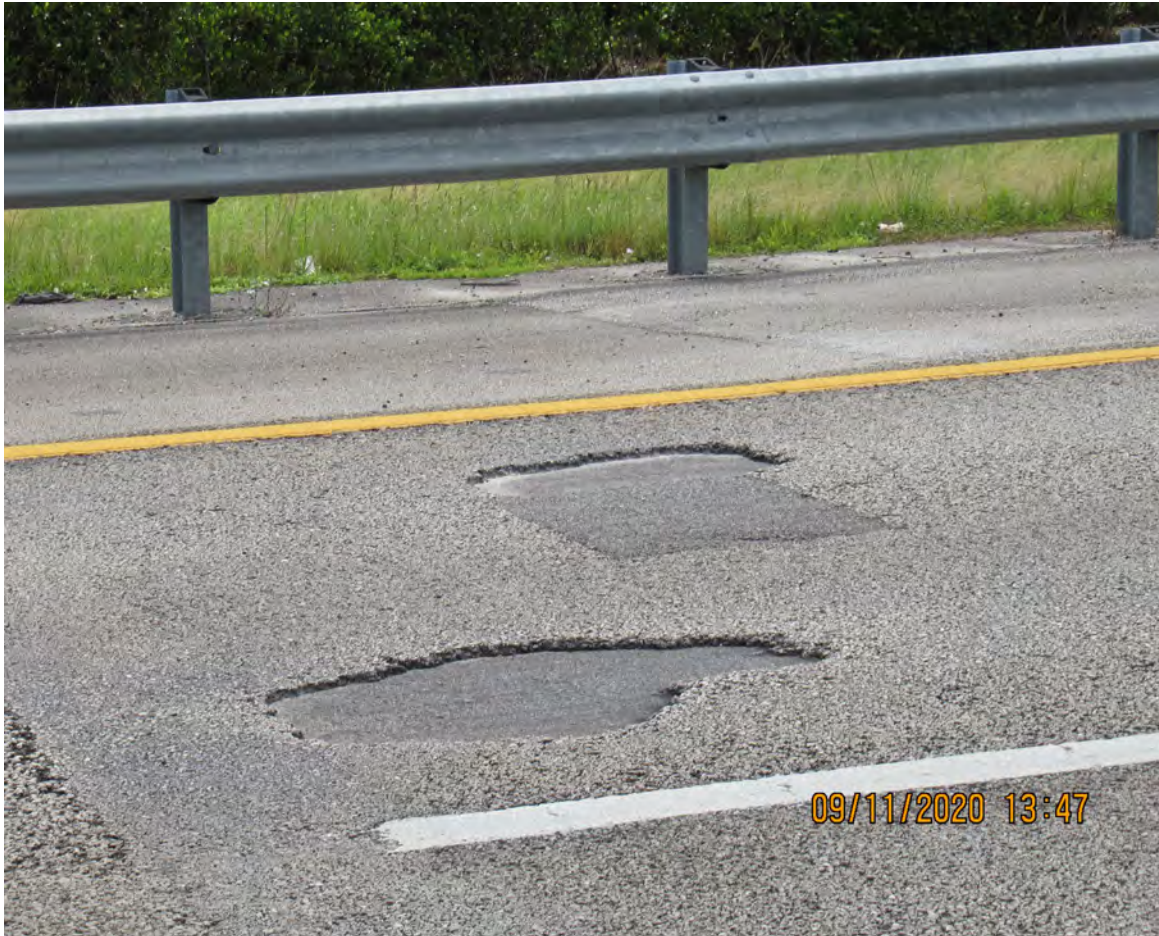
**ROADWAY INSPECTION  
LOCATION: MILE MARKER 4.20 MILES  
WESTBOUND MAINLINE (INSIDE LANE)**

**DAMAGED ASPHALT PAVEMENT FRICTION COURSE**

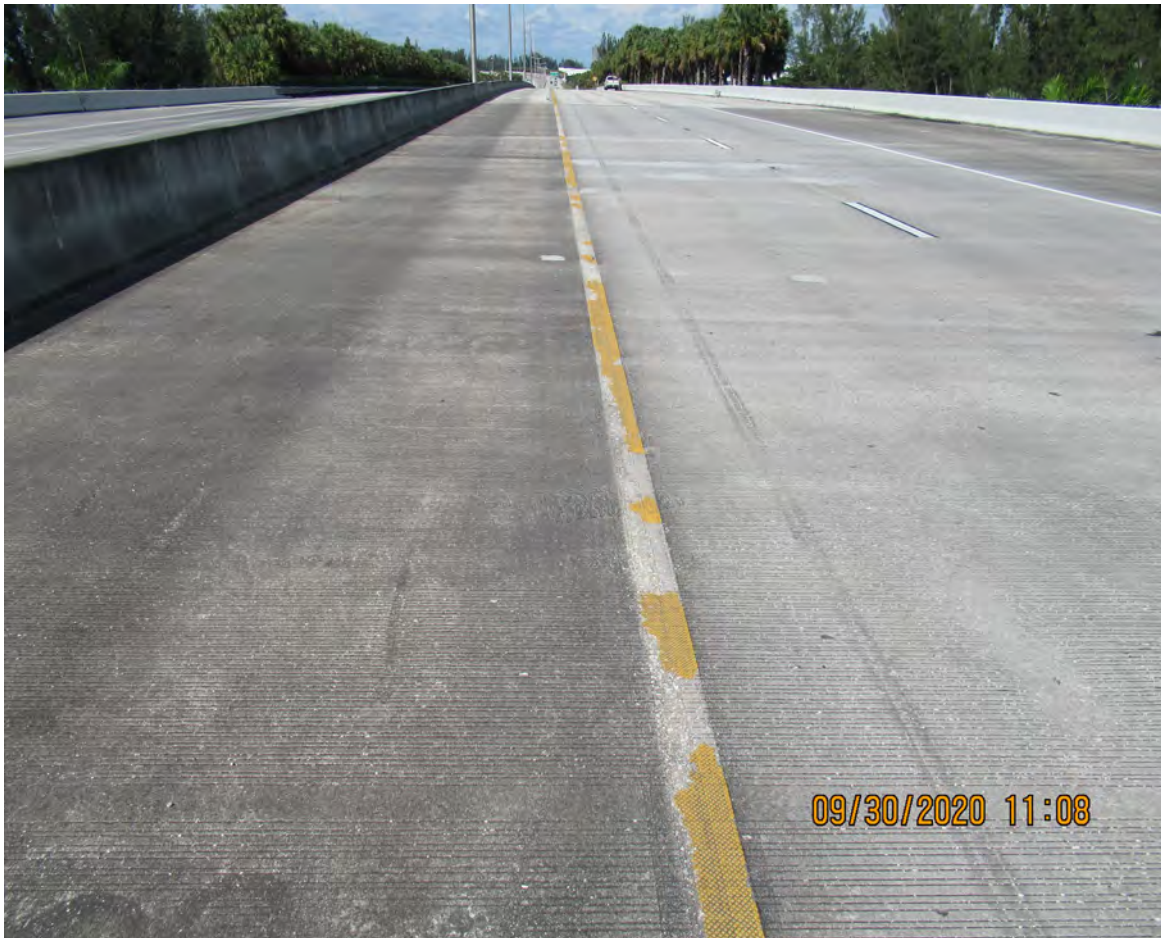
**ROADWAY INSPECTION  
LOCATION: MILE MARKER 1.55 MILES  
WESTBOUND MAINLINE**

**DETERIORATED HIGH PERFORMANCE TAPE (BRIDGE No. 871002)  
TYPICAL AT VARIOUS LOCATIONS**

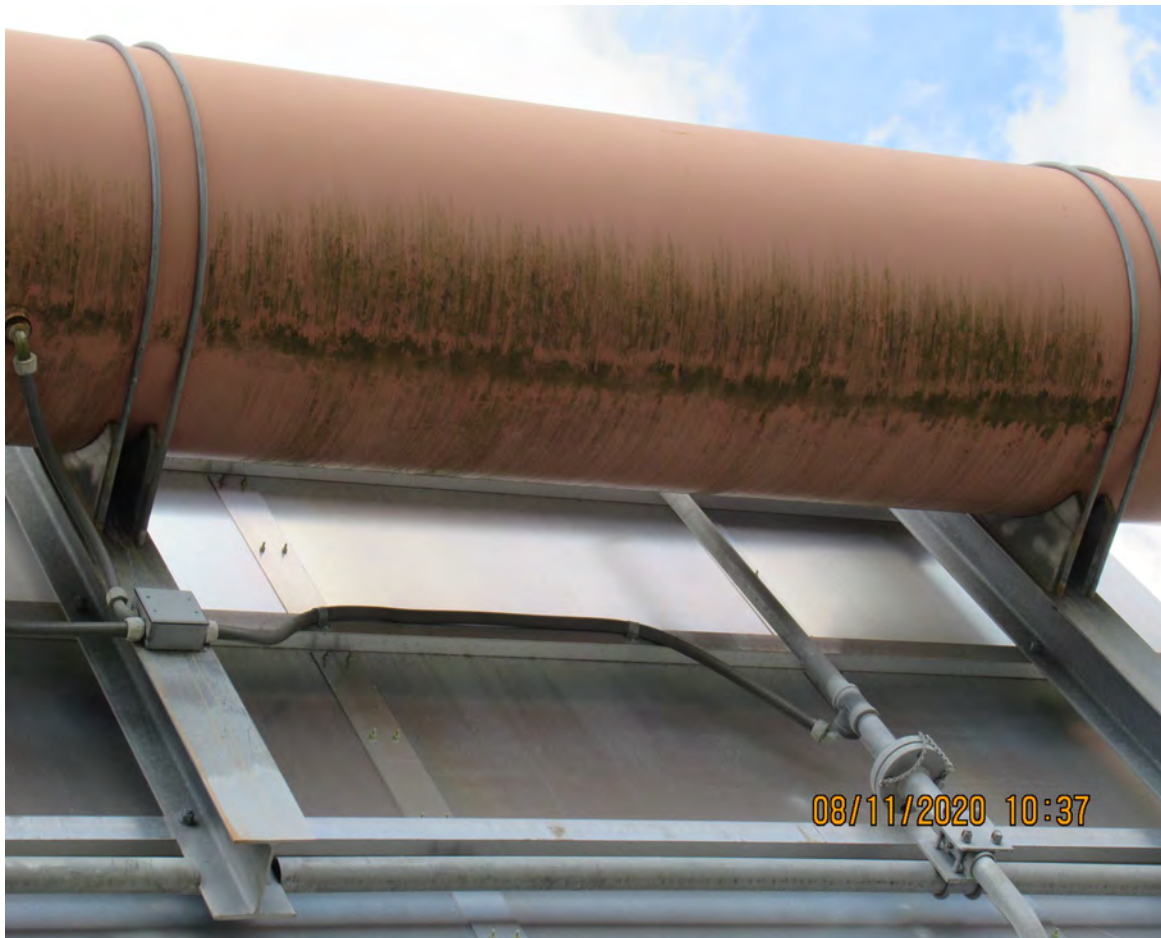
**ROADWAY INSPECTION  
LOCATION: MILE MARKER 3.37 MILES  
NORTHBOUND MAINLINE (RIGHT SHOULDER)**

**DETERIORATED PAINT ON SIGN STRUCTURE MONOTUBE (STRUCTURE # 87A053)**

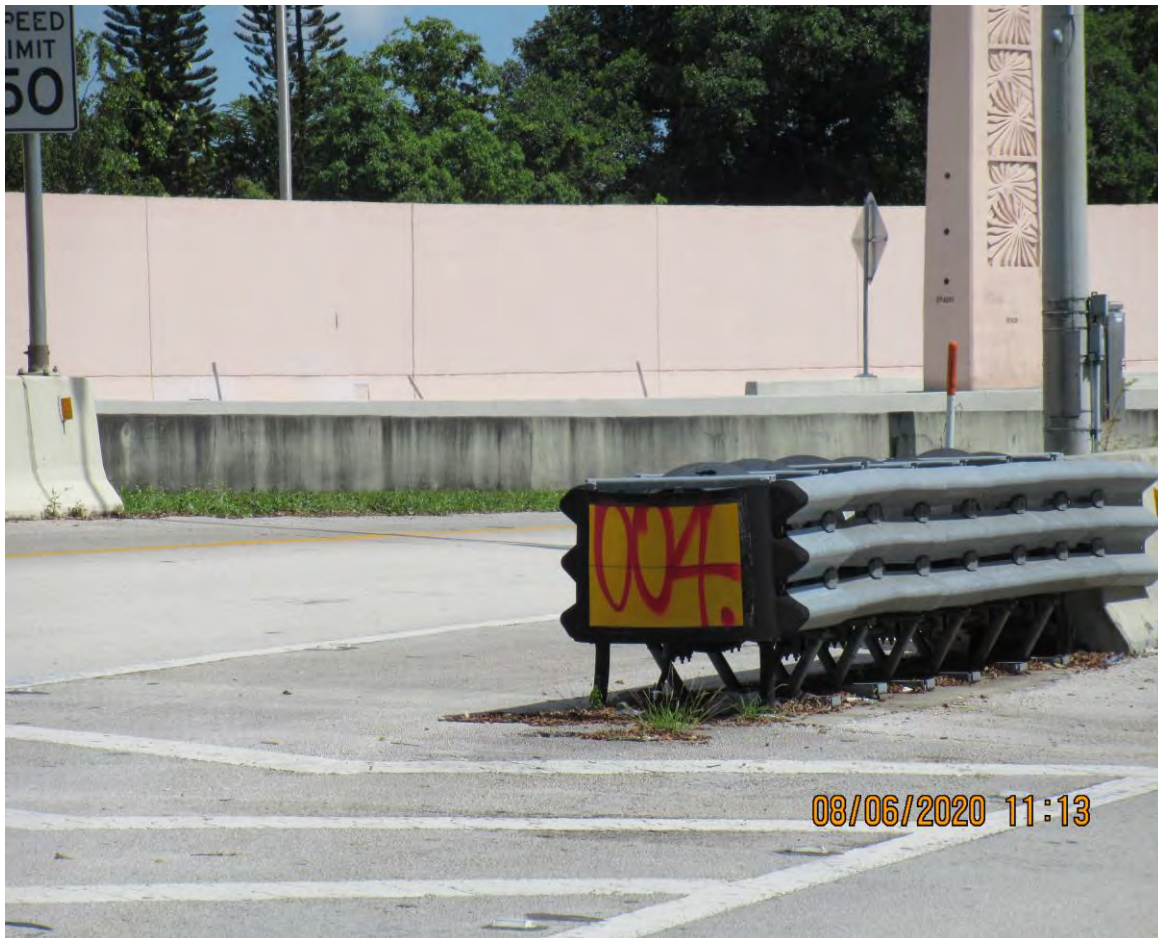
**ROADWAY INSPECTION**  
**LOCATION: MILE MARKER 3.88 MILES**  
**NORTHBOUND ON-RAMP FROM KENDALL DR.**

**GRAFFITI ON ATTENUATOR REFLECTIVE SHEETING**

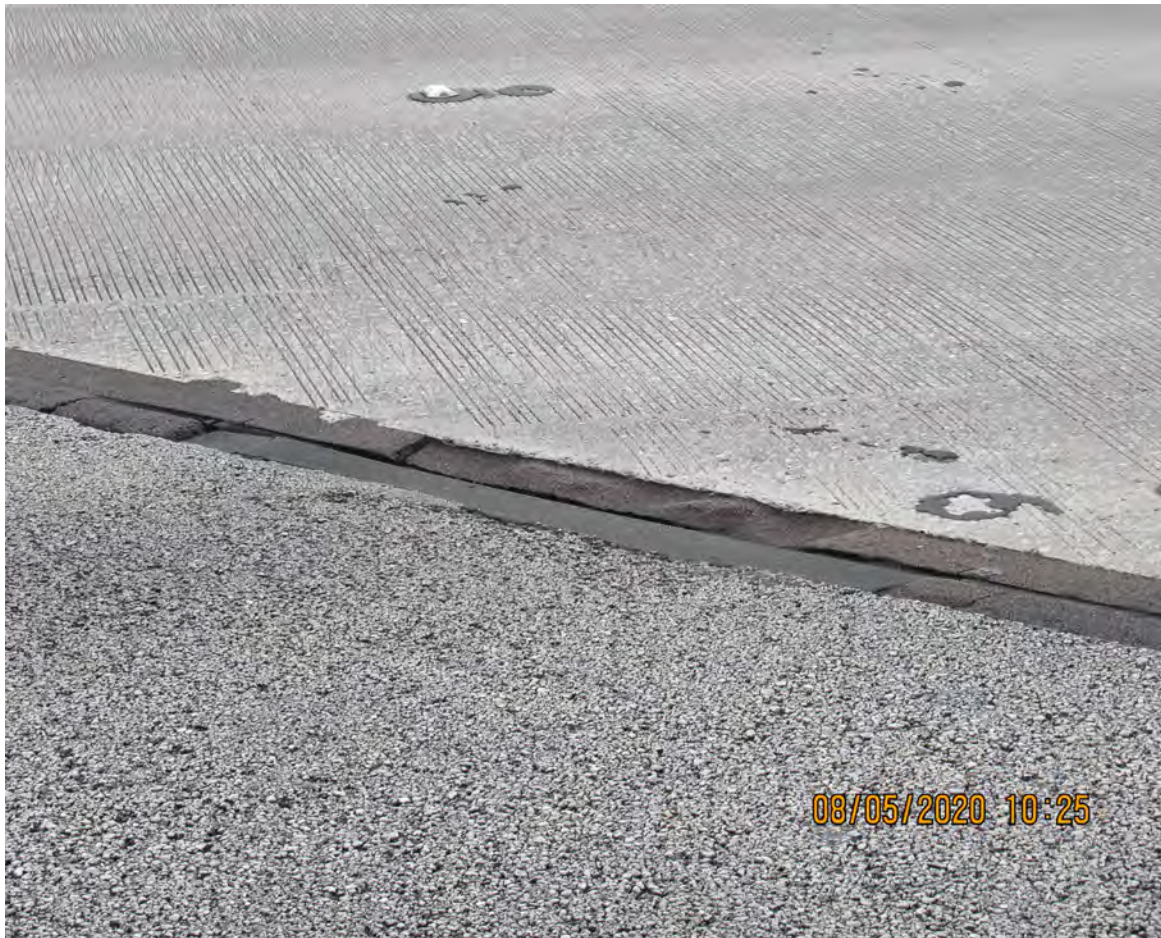
**ROADWAY INSPECTION  
LOCATION: MILE MARKER 5.0 MILES  
SOUTHBOUND MAINLINE**

**DETERIORATED POLYMER NOSING BRIDGE JOINT HEADER (BRIDGE # 870522)**

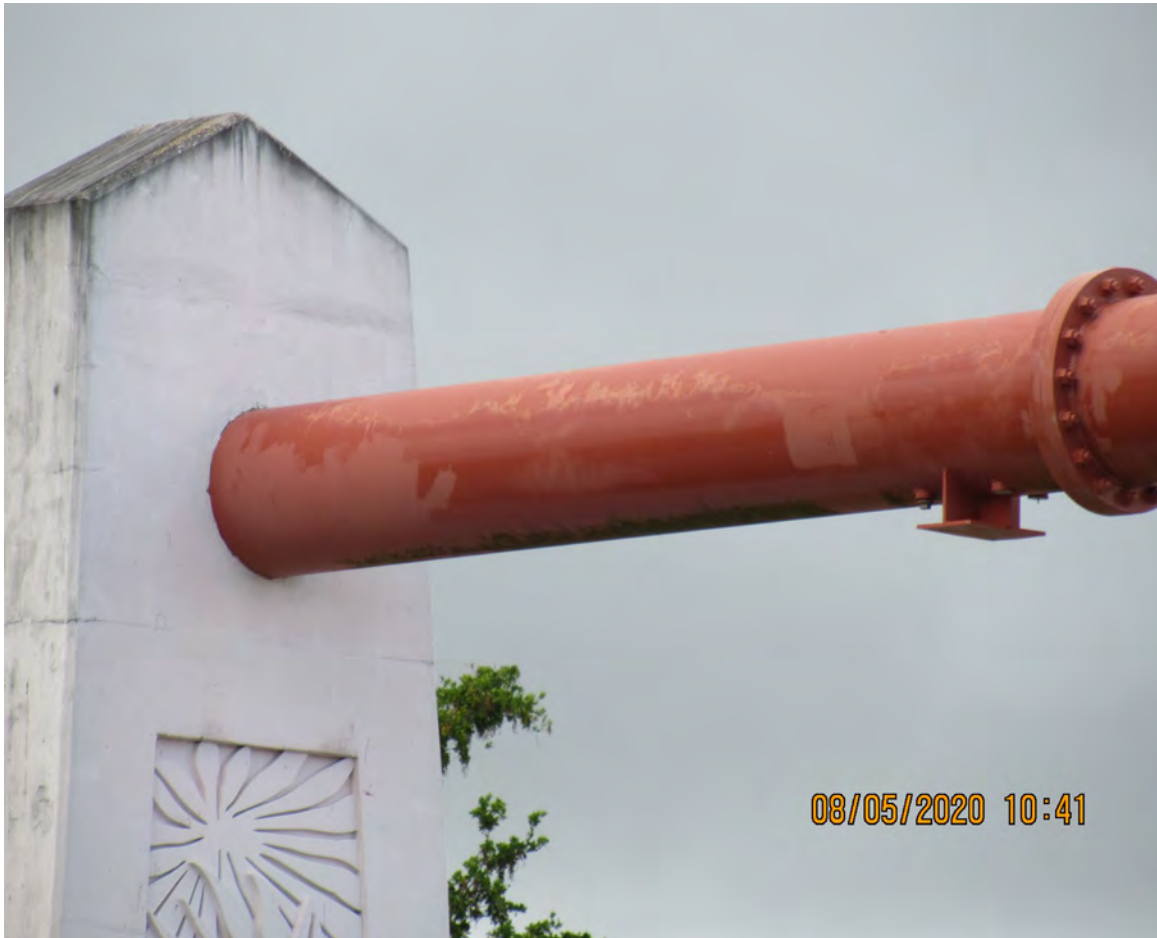
**ROADWAY INSPECTION  
LOCATION: MILE MARKER 2.74 MILES  
SOUTHBOUND MAINLINE**

**DETERIORATED PAINT ON ORT GANTRY MONOTUBE STRUCTURE**

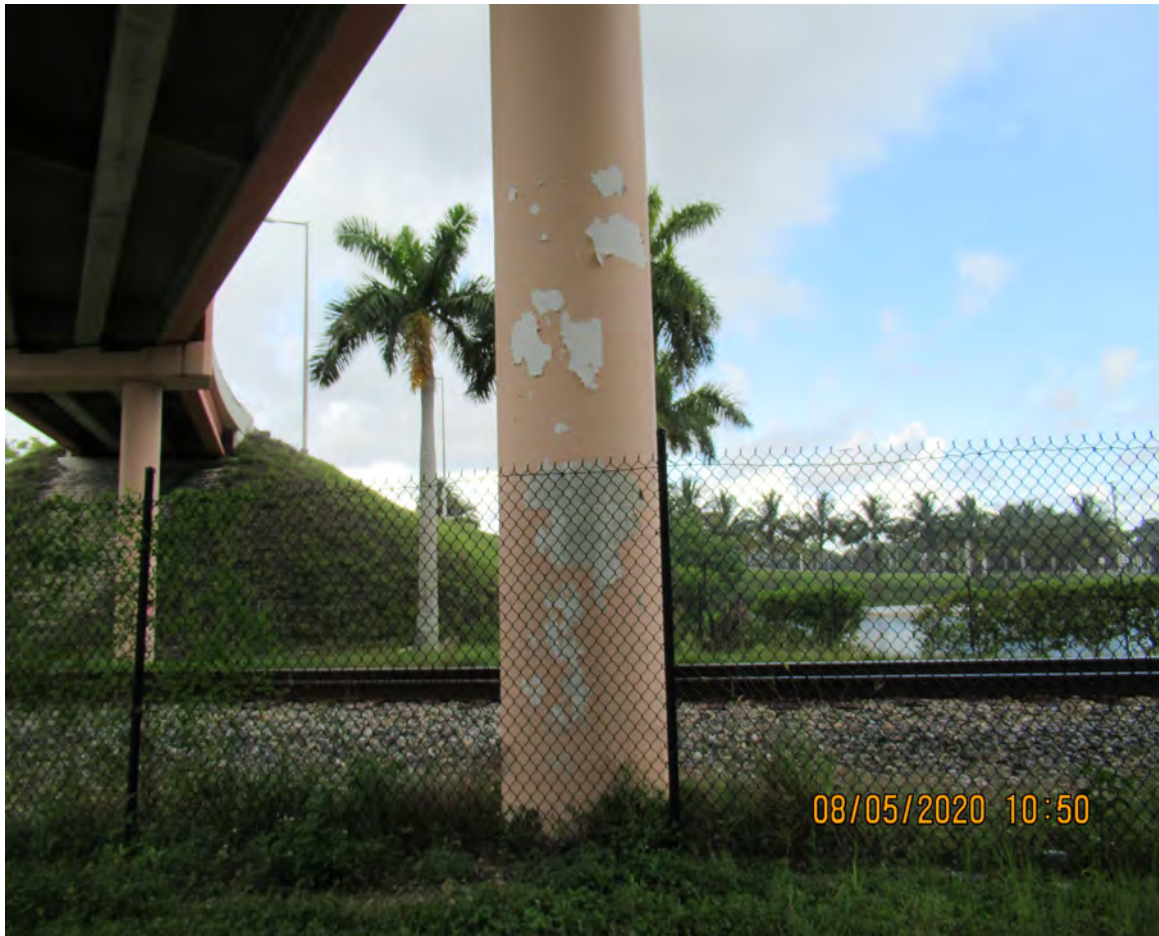
**ROADWAY INSPECTION  
LOCATION: MILE MARKER 2.16 MILES  
SOUTHBOUND OFF-RAMP TO SW 107<sup>TH</sup> AVENUE**

**DETERIORATED CLASS V COATING ON BRIDGE STRUCTURE  
(BRIDGE # 870543) TYPICAL THROUGHOUT THE CORRIDOR**

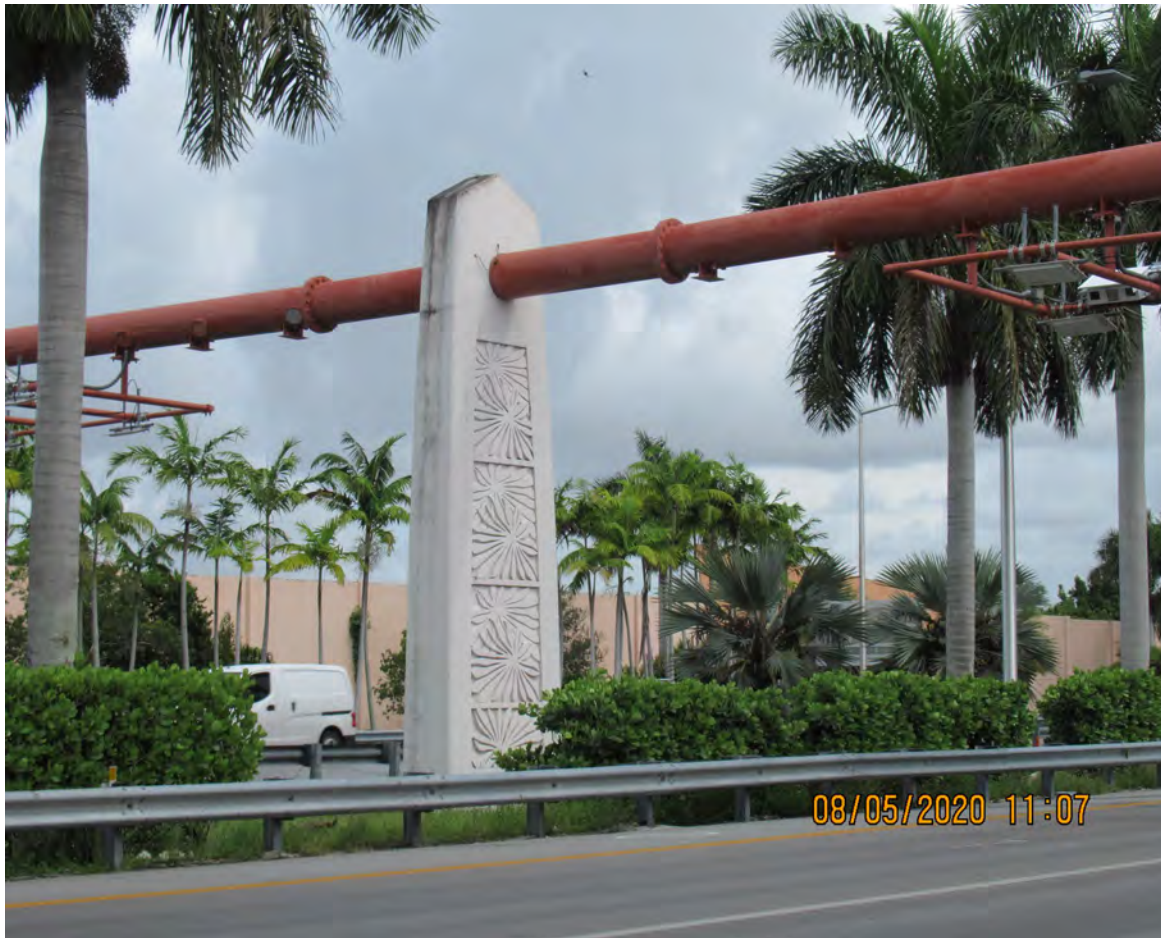
**ROADWAY INSPECTION  
LOCATION: MILE MARKER 1.36 MILES  
SOUTHBOUND MAINLINE**

**DETERIORATED PAINT ON SIGN STRUCTURE UPRIGHTS AND  
MONOTUBE (STRUCTURE # 87S937)**

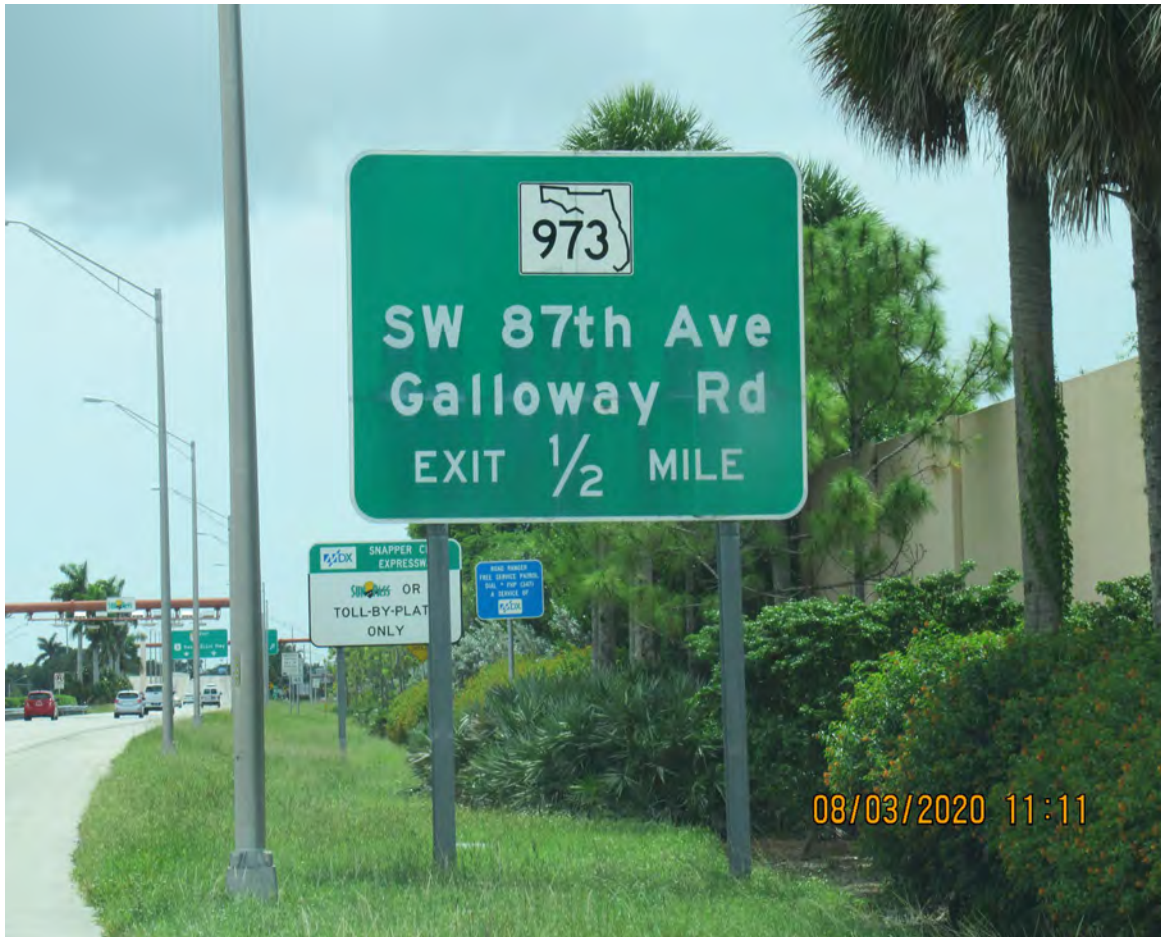
**ROADWAY INSPECTION**  
**LOCATION: MILE MARKER 0.65 MILES**  
**EASTBOUND MAINLINE**

**DETERIORATED REFLECTIVE SHEETING ON SIGN PANEL**

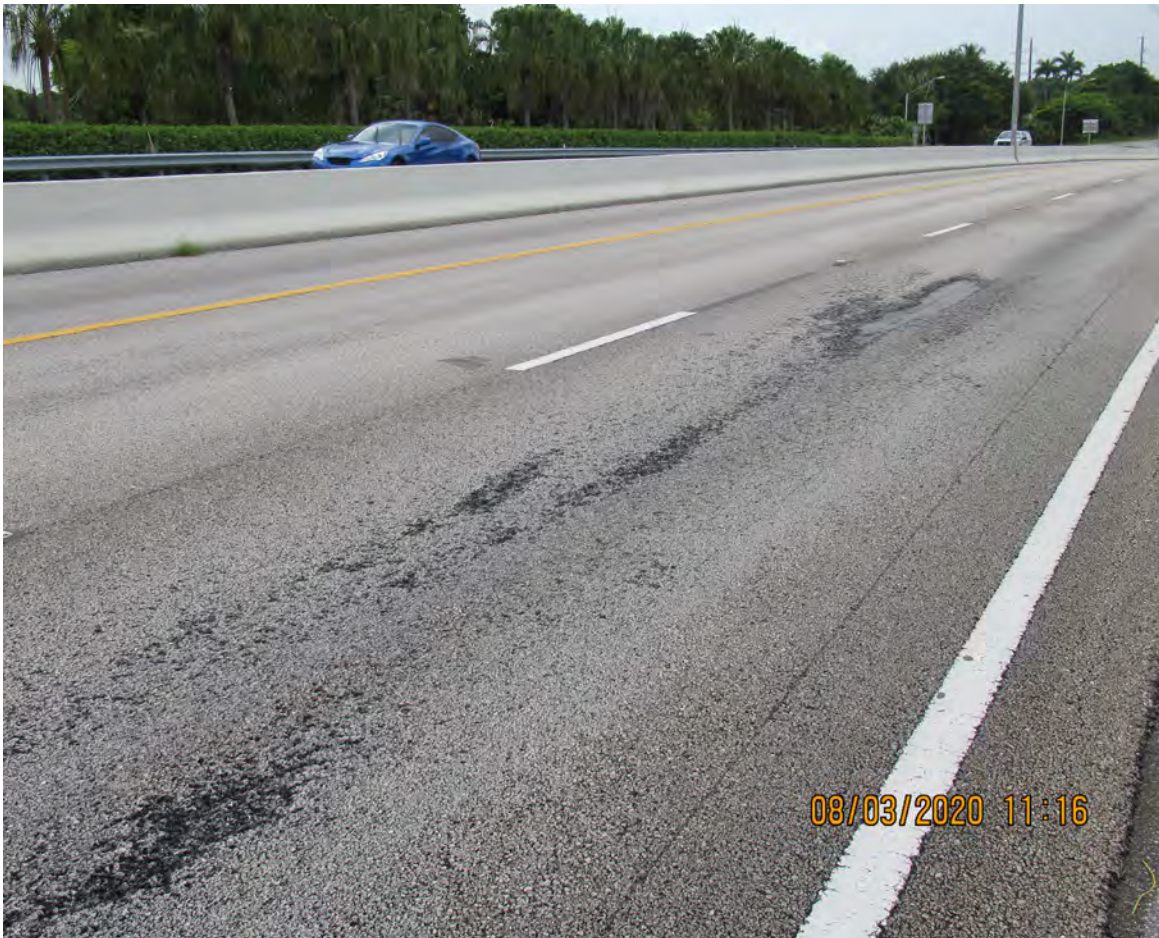
**ROADWAY INSPECTION  
LOCATION: MILE MARKER 1.30 MILES  
EASTBOUND MAINLINE**

**DETERIORATED ASPHALT PAVEMENT**

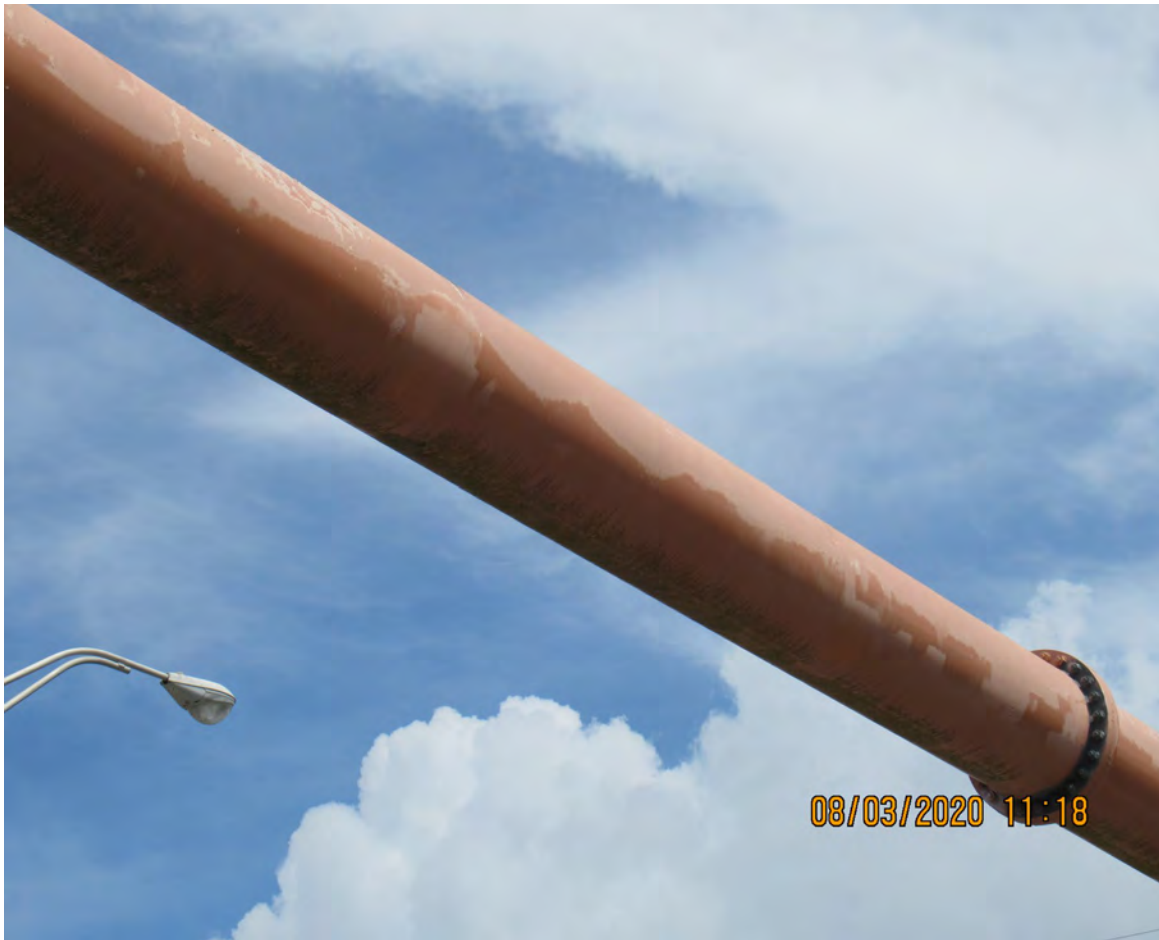
**ROADWAY INSPECTION  
LOCATION: MILE MARKER 1.51 MILES  
EASTBOUND MAINLINE**

**DETERIORATED PAINT ON SIGN STRUCTURE MONOTUBE STRUCTURE No. 87S944  
(TYPICAL THROUGHOUT THE CORRIDOR)**

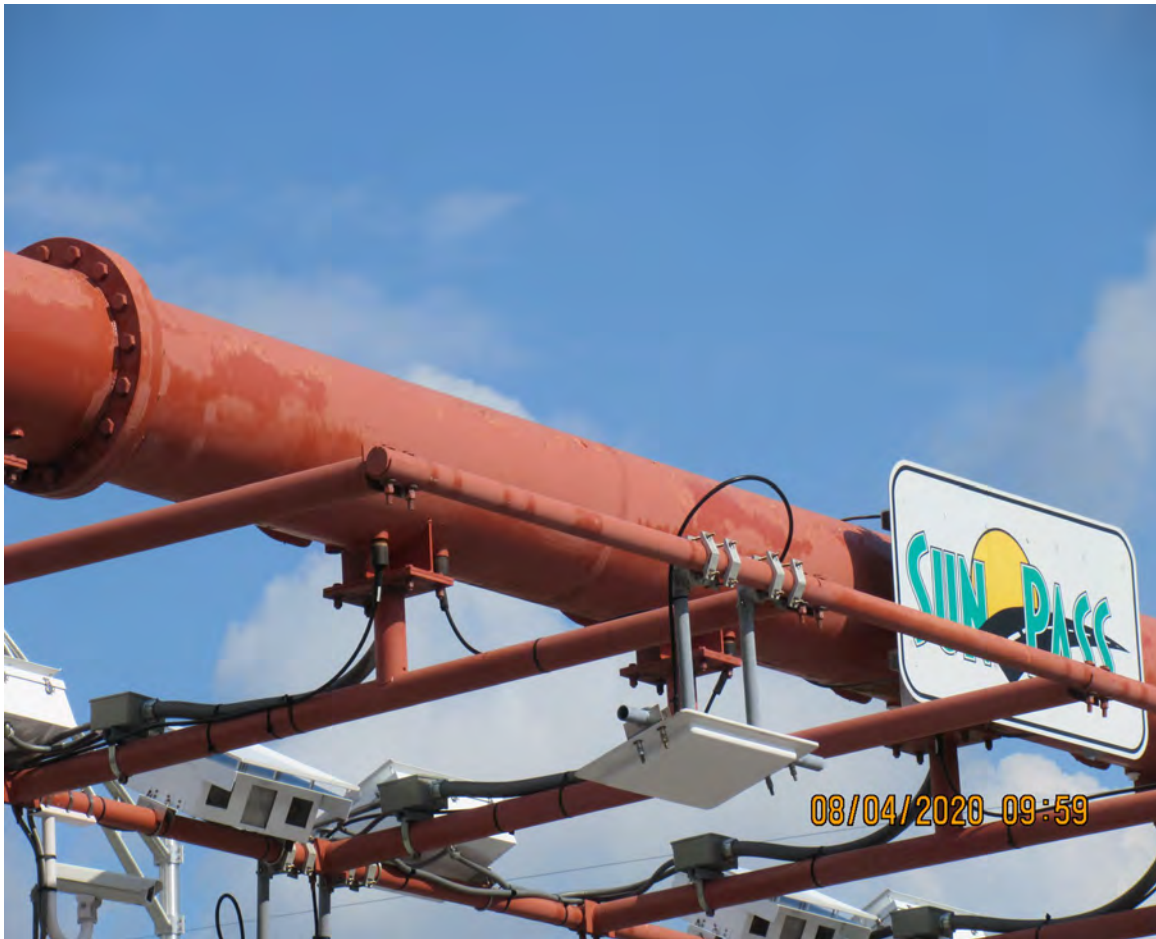
**ROADWAY INSPECTION  
LOCATION: MILE MARKER 2.17 MILES  
EASTBOUND MAINLINE**

**DETERIORATED PAINT ON ORT GANTRY MONOTUBE (STRUCTURE No. 87S935)**

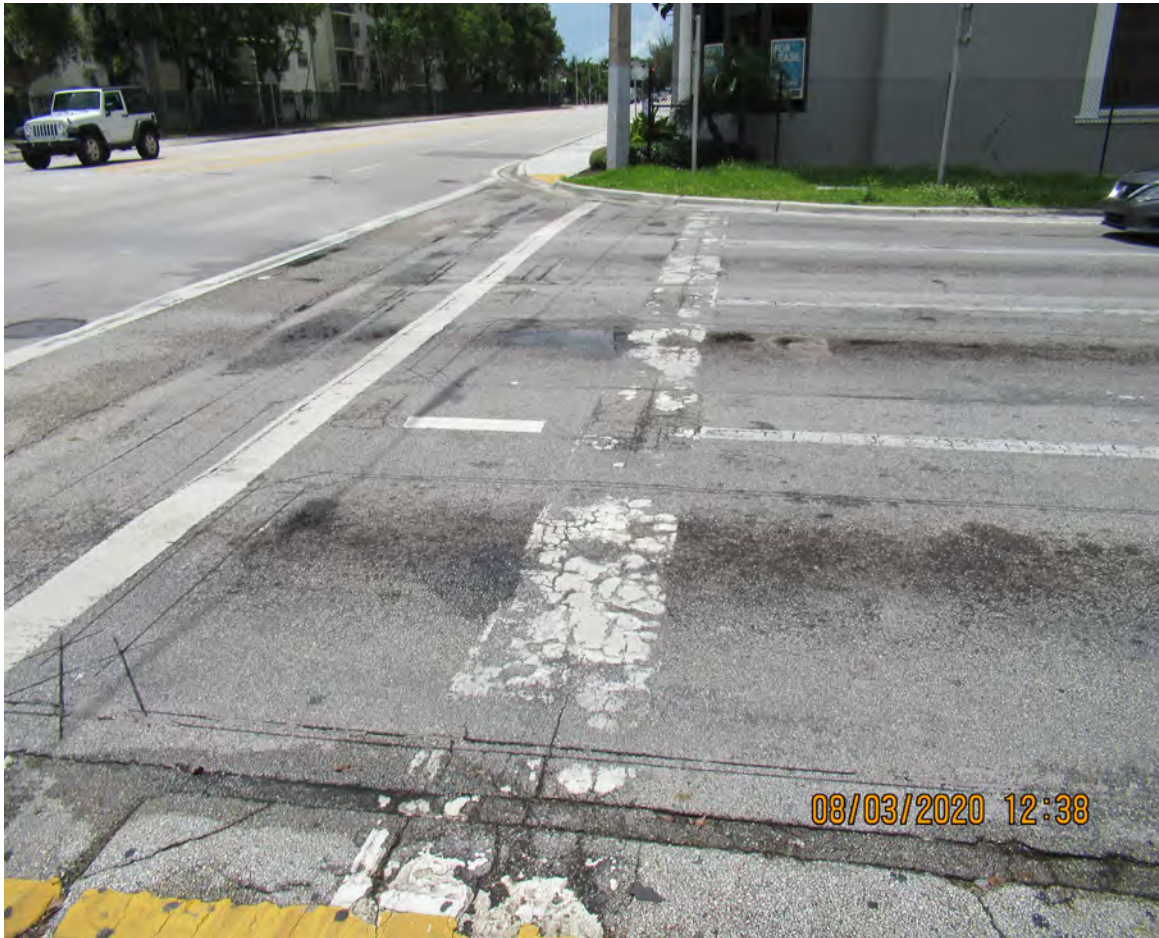
**ROADWAY INSPECTION  
LOCATION: MILE MARKER 2.80 MILES  
EASTBOUND OFF-RAMP TO SW 72<sup>ND</sup> AVENUE**

**DETERIORATED THERMOPLASTIC STOP BAR STRIPING**

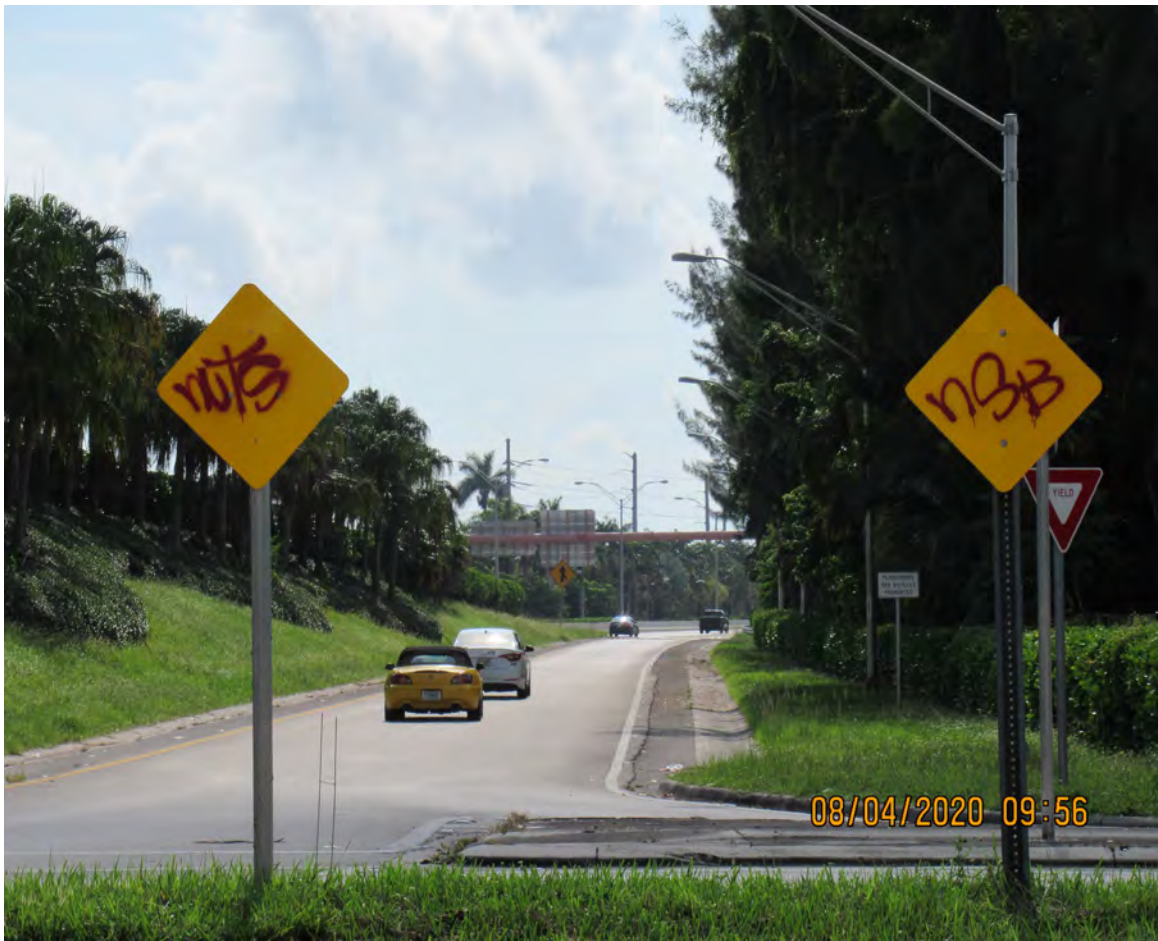
**ROADWAY INSPECTION  
LOCATION: MILE MARKER 1.30 MILES  
EASTBOUND OFF-RAMP TO SW 87<sup>th</sup> AVENUE**

**GRAFFITI ON MEDIAN REFLECTOR SIGNS**

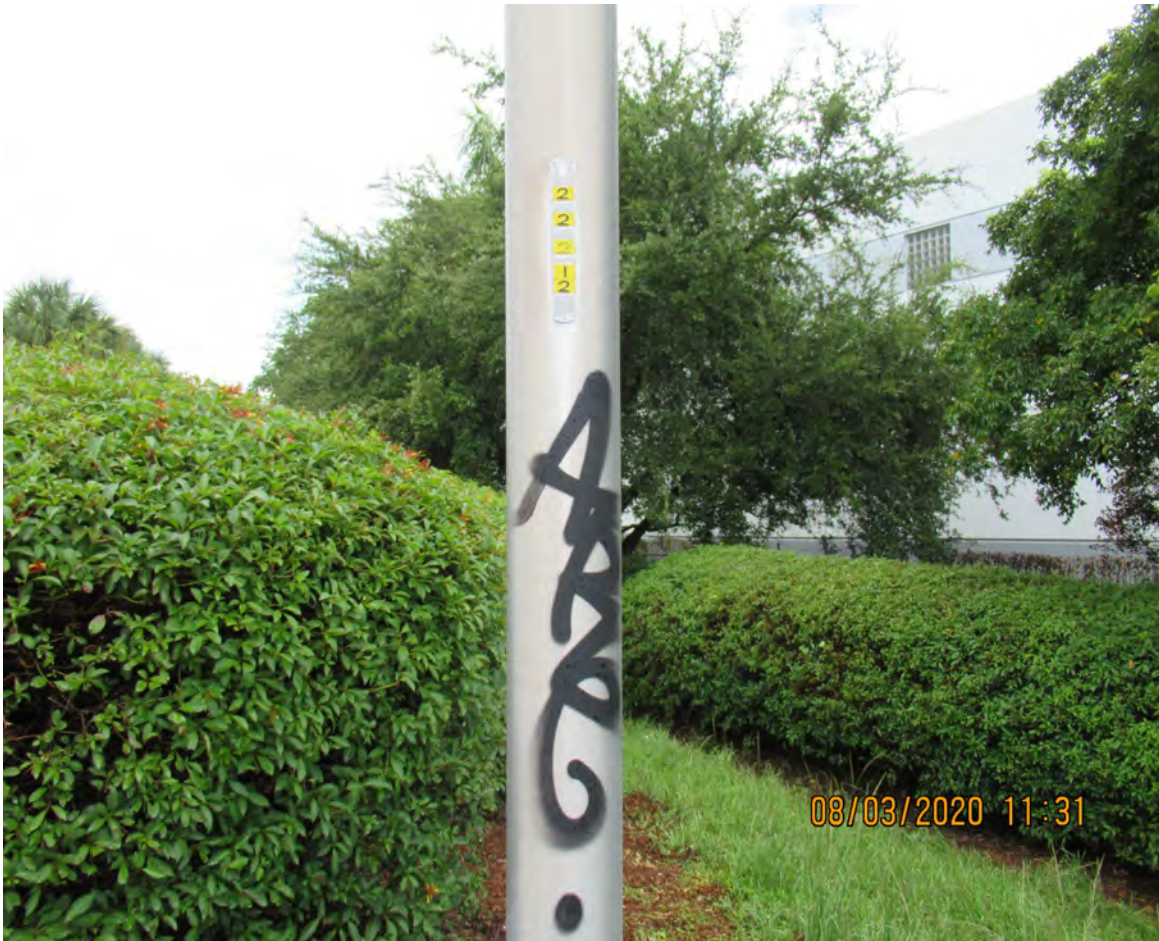
**ROADWAY INSPECTION  
LOCATION: MILE MARKER 2.88 MILES  
WESTBOUND MAINLINE (RIGHT SHOULDER)**

**GRAFFITI ON LIGHT POLE**

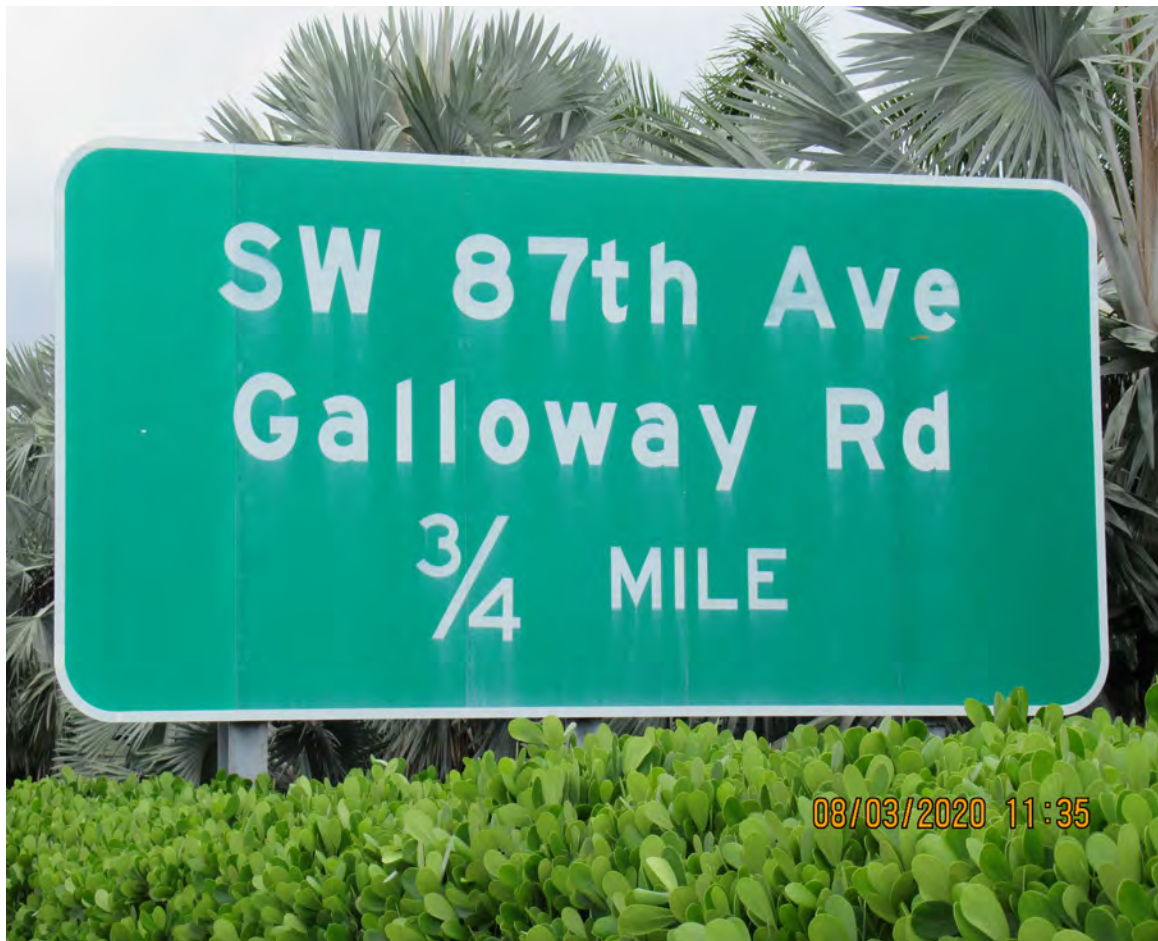
**ROADWAY INSPECTION  
LOCATION: MILE MARKER 2.20 MILES  
WESTBOUND MAINLINE**

**DETERIORATED REFLECTIVE SHEETING ON SIGN PANEL**

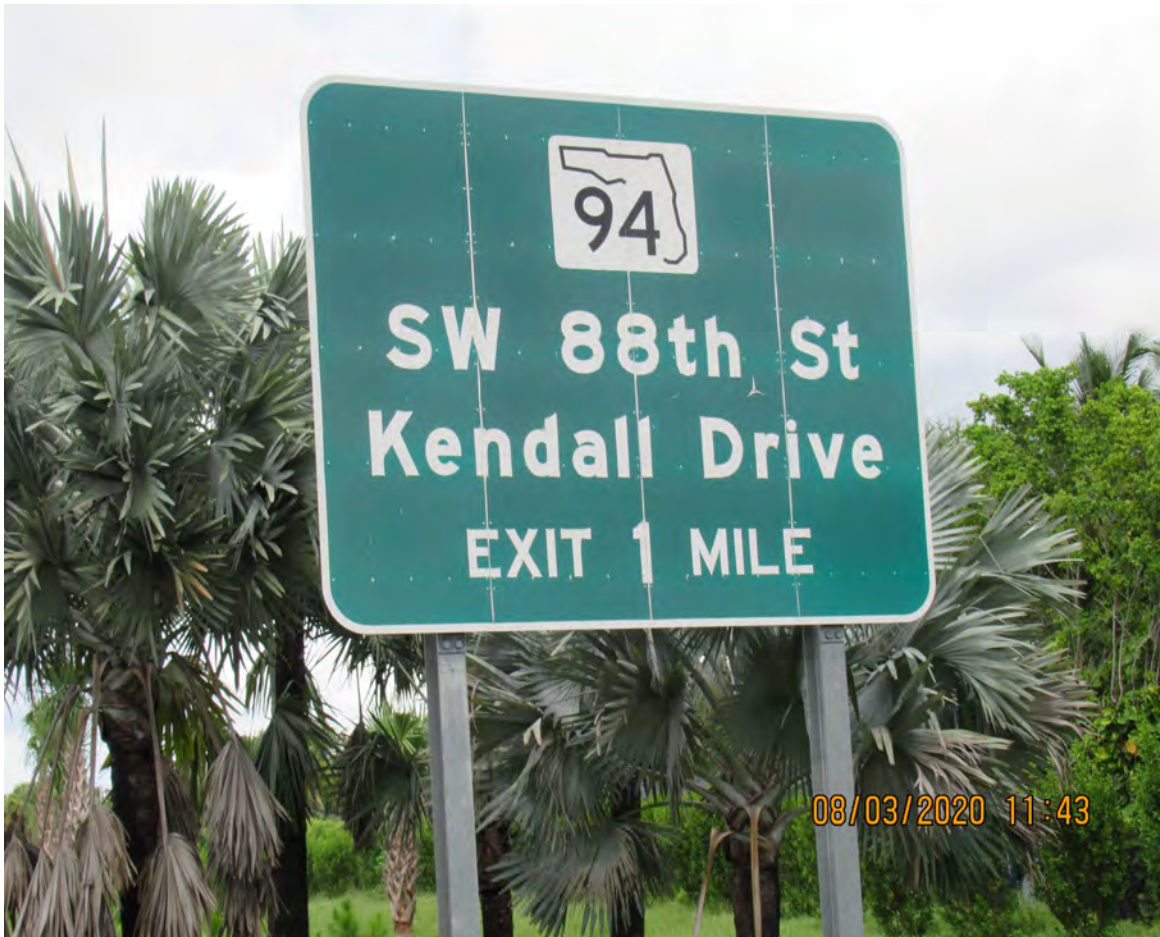
**ROADWAY INSPECTION  
LOCATION: MILE MARKER 1.14 MILES  
WESTBOUND MAINLINE**

**DETERIORATED REFLECTIVE SHEETING ON SIGN PANEL**
