# Annual Inspection Report 2020

# ANNUAL INSPECTION REPORT

As detailed in the following sections, EAC Consulting has found the MDX System to be in good working order and condition.

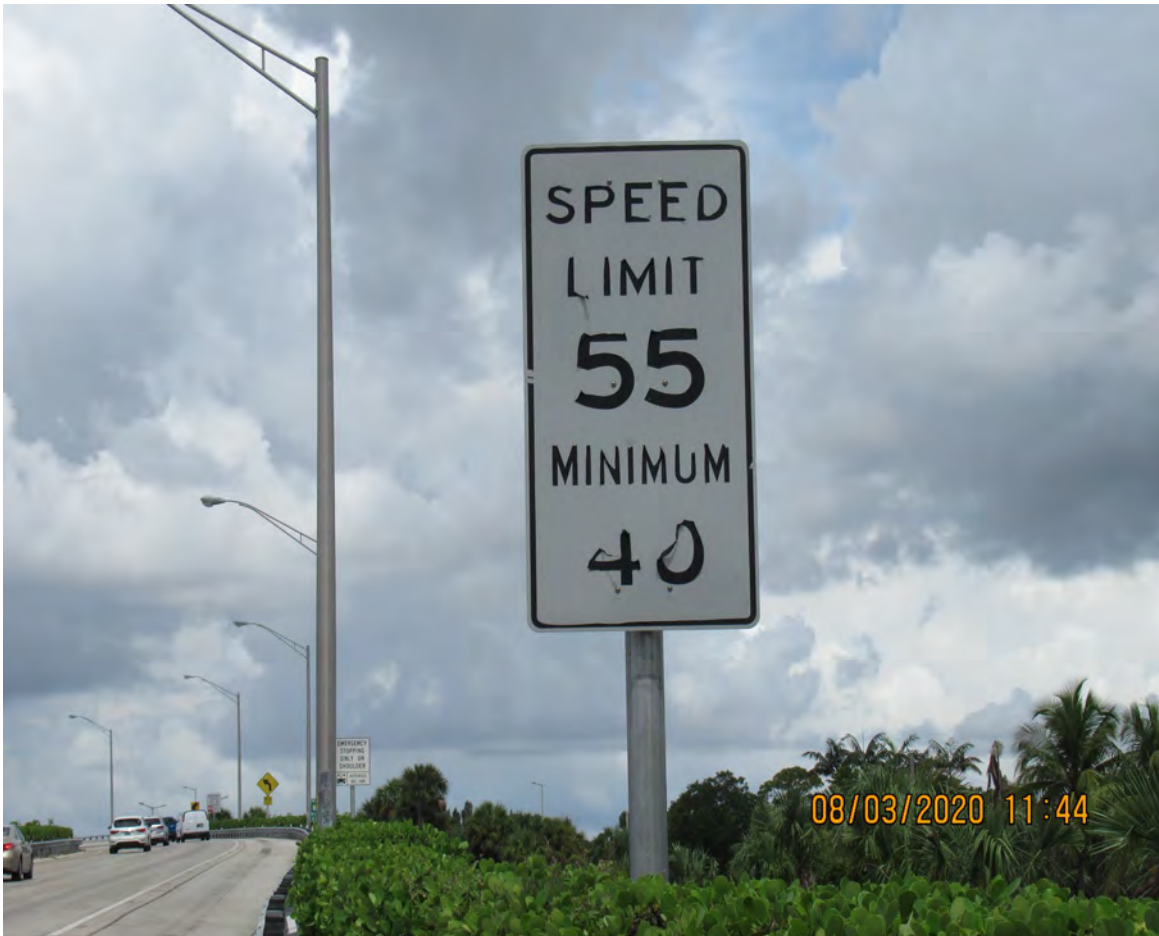
**ROADWAY INSPECTION  
LOCATION: MILE MARKER 0.06 MILES  
WESTBOUND MAINLINE**

**DETERIORATED REFLECTIVE SHEETING ON SIGN PANEL**

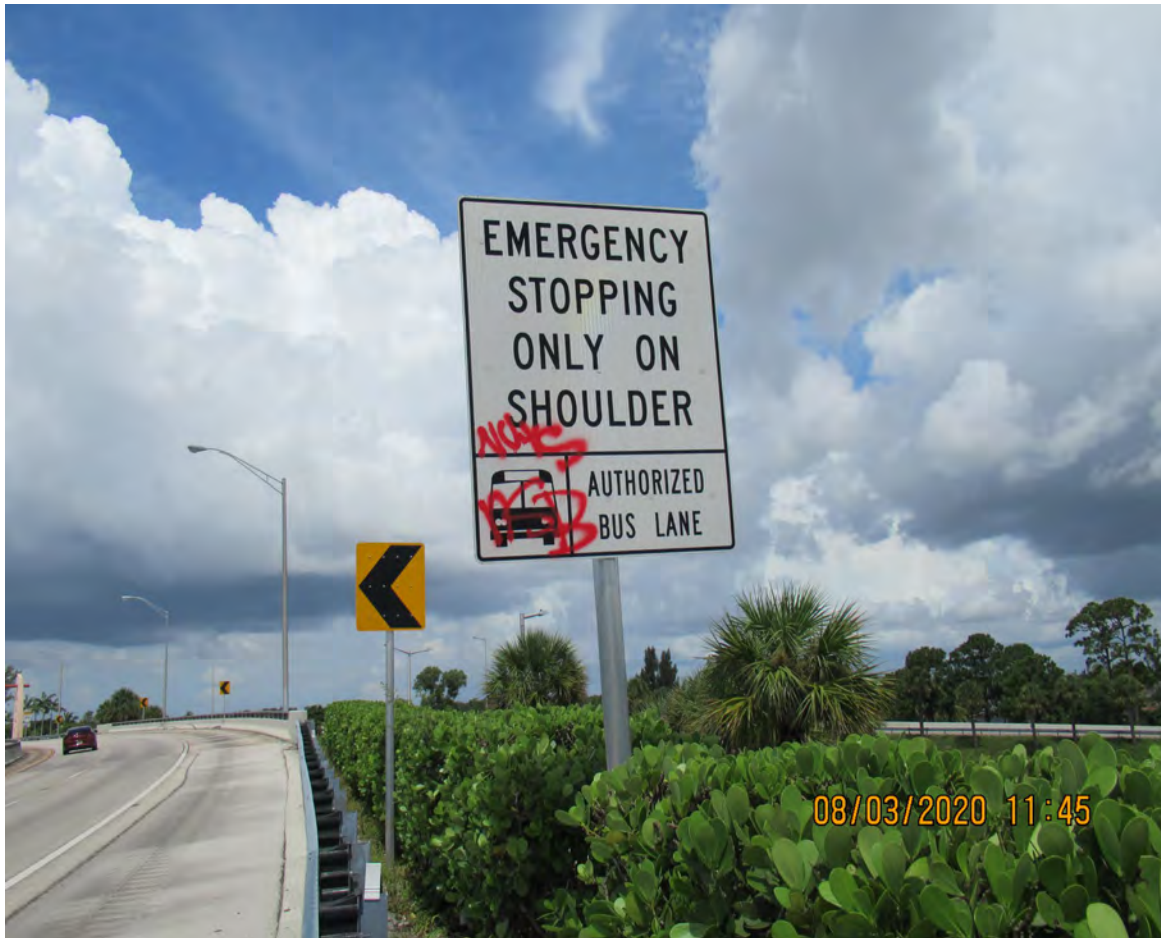
**ROADWAY INSPECTION  
LOCATION: MILE MARKER 0.75 MILES  
WESTBOUND MAINLINE**

**GRAFFITI ON SIGN PANEL**

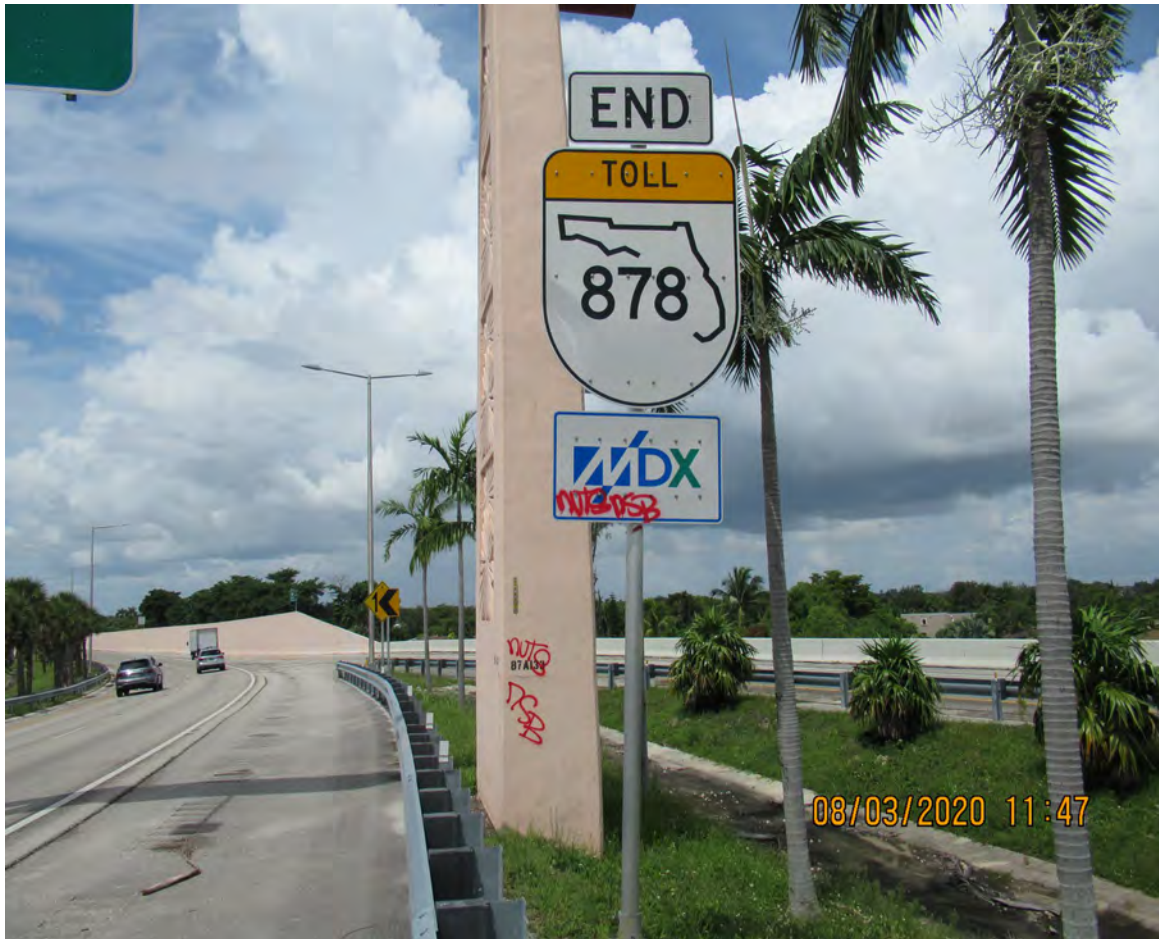
ROADWAY INSPECTION  
LOCATION: MILE MARKER 0.65 MILES  
WESTBOUND MAINLINE

**GRAFFITI ON SIGN PANEL AND STRUCTURE UPRIGHT**

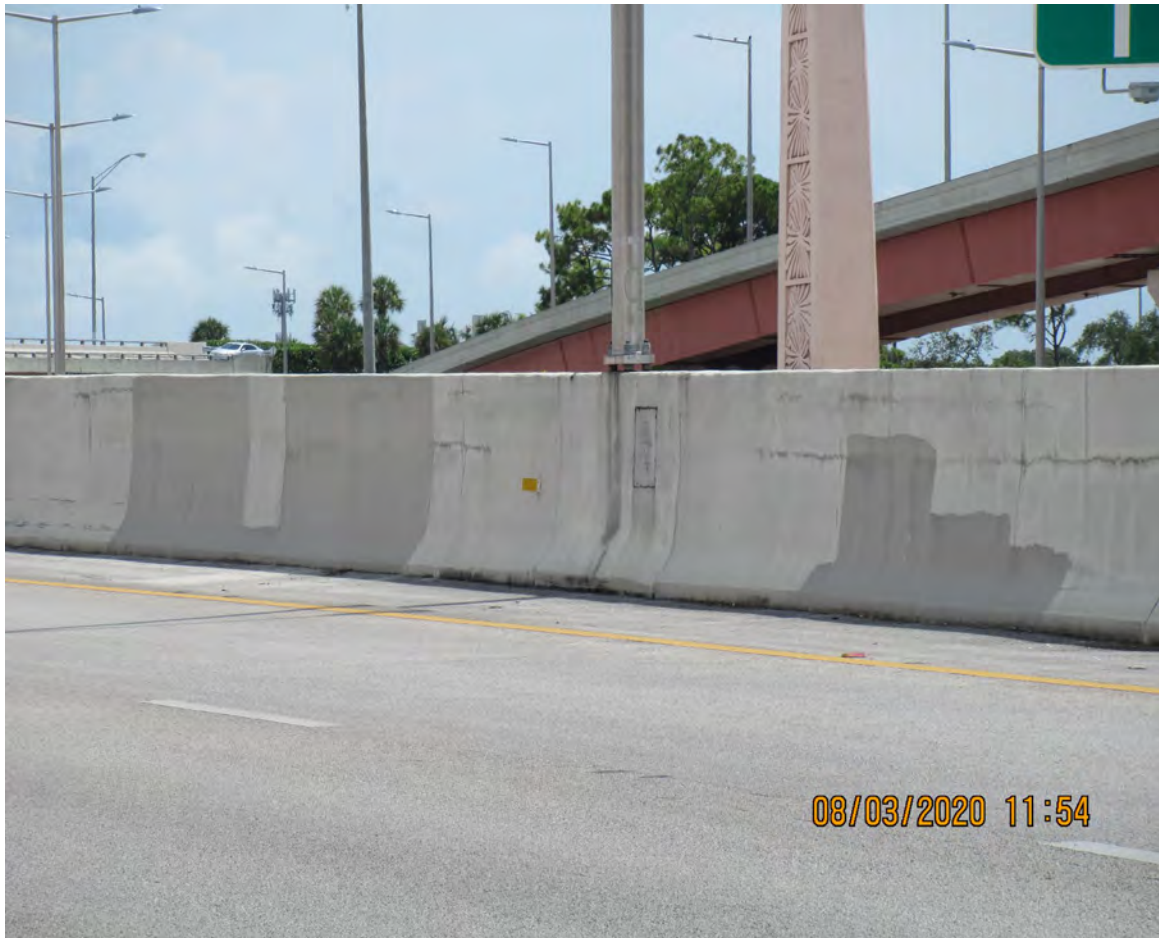
**ROADWAY INSPECTION  
LOCATION: MILE MARKER 0.04 MILES  
WESTBOUND MAINLINE**

**DETERIORATED CLASS V COATING ON BARRIER WALL  
(TYPICAL THROUGHOUT THE CORRIDOR)**

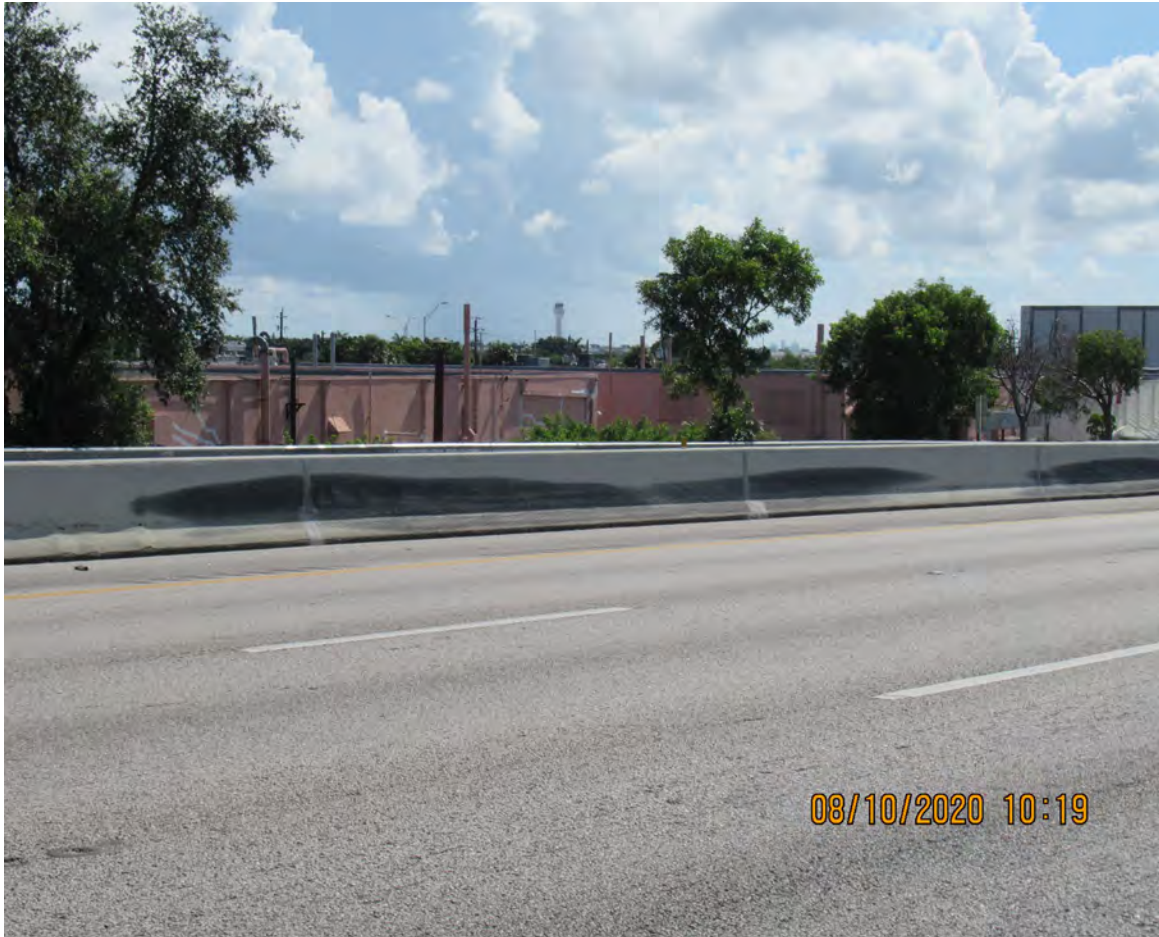
**ROADWAY INSPECTION  
LOCATION: MILE MARKER 1.60 MILES  
EASTBOUND MAINLINE**

**SCUFF MARKS ON MEDIAN BARRIER WALL  
(TYPICAL THROUGHOUT THE CORRIDOR)**

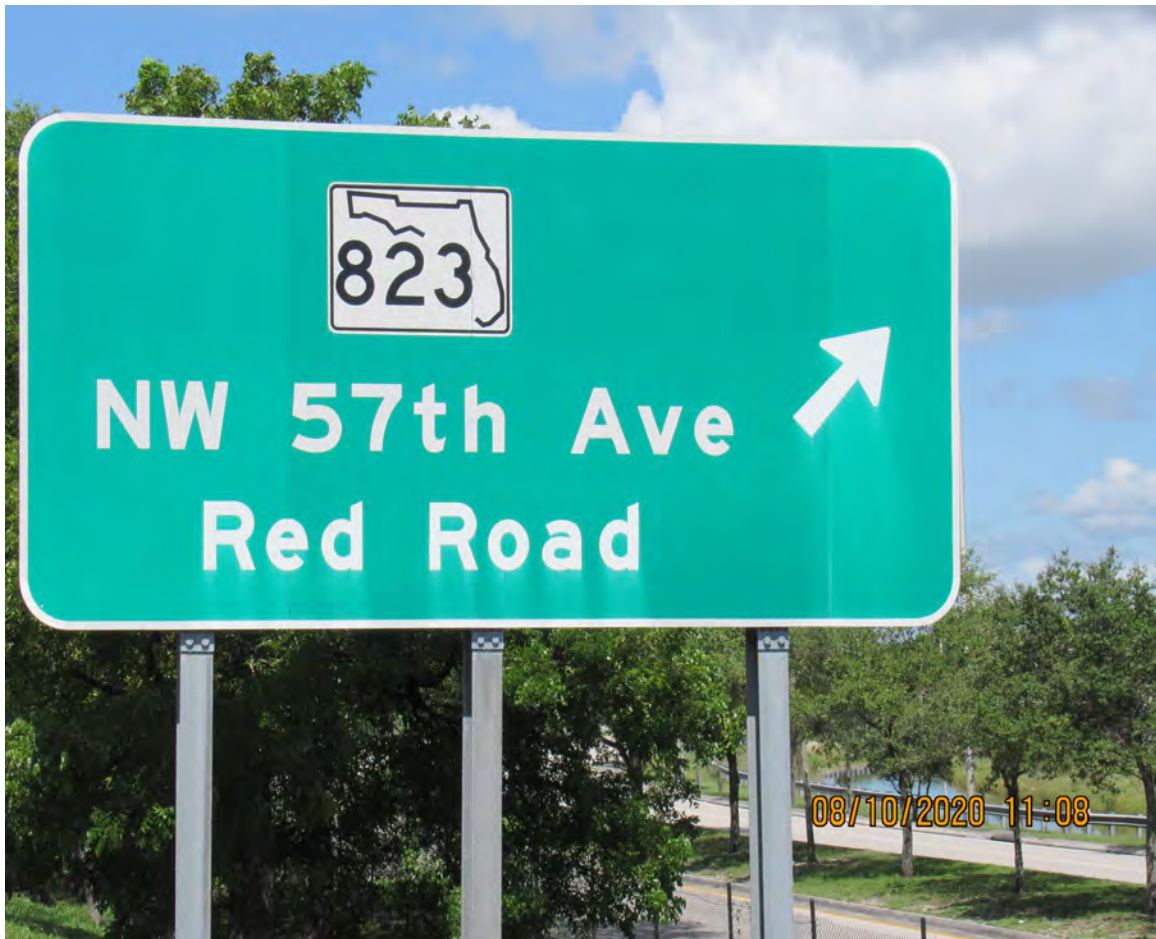
**ROADWAY INSPECTION  
LOCATION: MILE MARKER 2.42 MILES  
WESTBOUND MAINLINE (RIGHT SHOULDER)**

**DETERIORATED REFLECTIVE SHEETING ON SIGN PANEL**

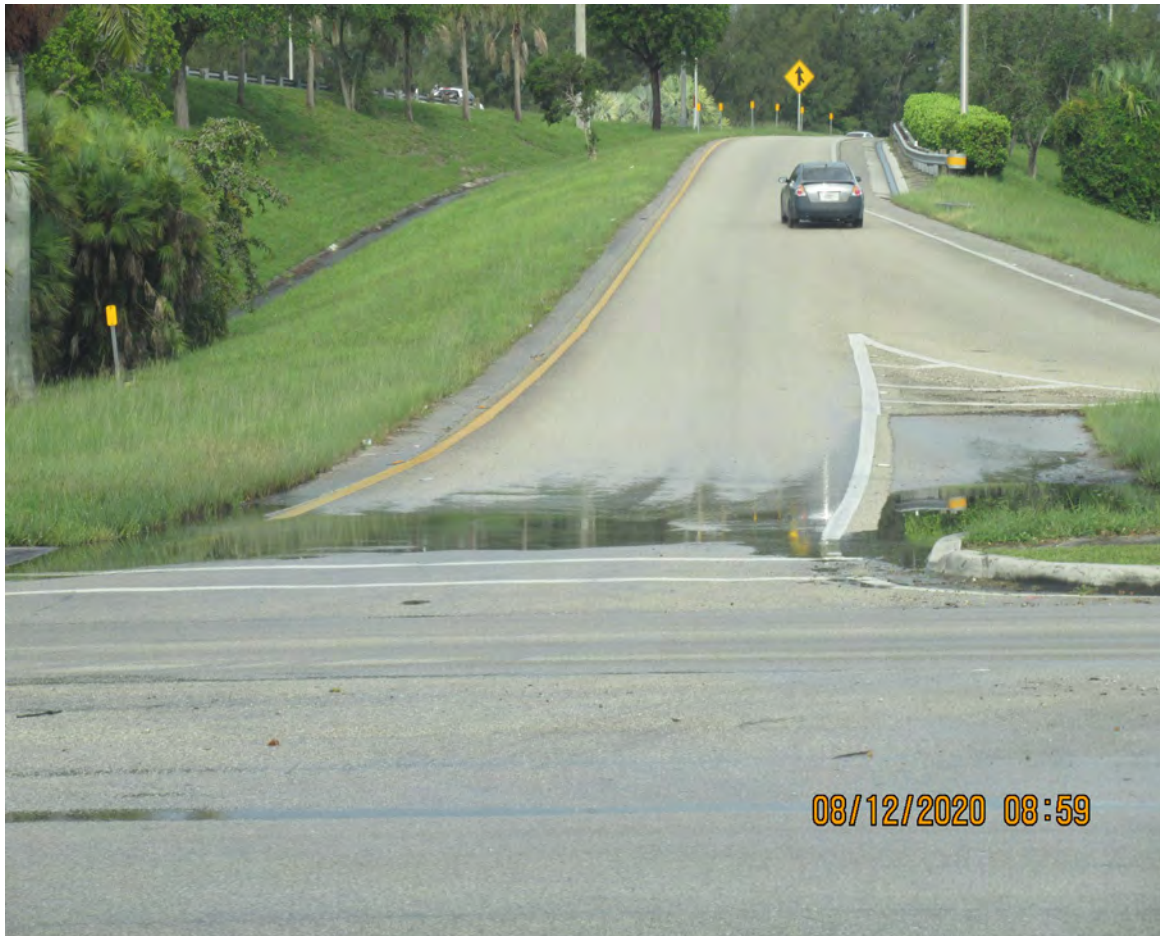
**ROADWAY INSPECTION  
LOCATION: MILE MARKER 4.10 MILES  
WESTBOUND ON-RAMP FROM NW 37<sup>th</sup> AVENUE**

**PONDING WATER ON RAMP ENTRANCE**

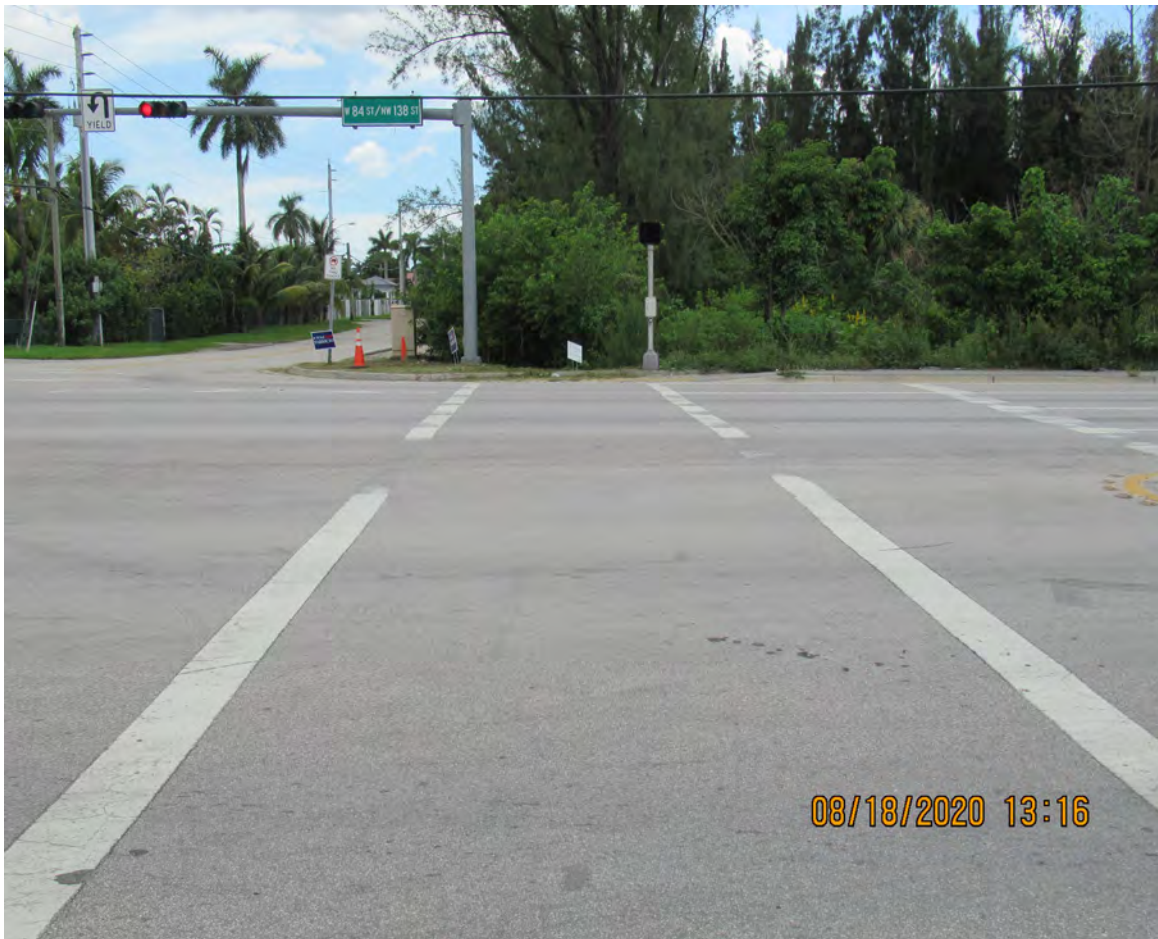
**ROADWAY INSPECTION  
LOCATION: NW 102<sup>ND</sup> AVENUE  
WESTBOUND NW 138<sup>th</sup> STREET**

**DETERIORATED PEDESTRIAN CROSSWALK (TYPICAL AT VARIOUS LOCATIONS)**

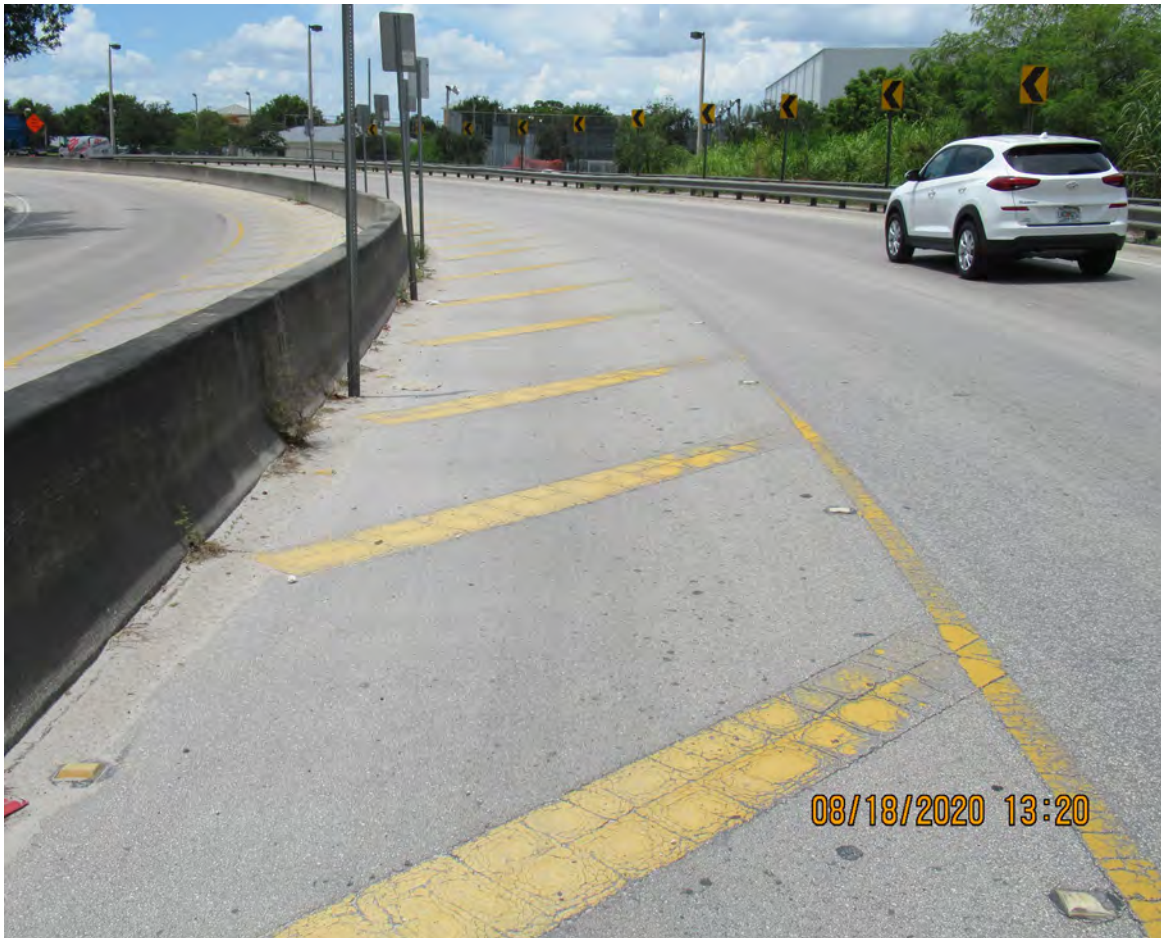
**ROADWAY INSPECTION  
LOCATION: 1,380 FT WEST OF NW 107<sup>th</sup> AVENUE  
WESTBOUND NW 138<sup>th</sup> STREET  
(LEFT SHOULDER & MAINLINE)**

**DETERIORATED WHITE SKIPS, EDGE LINES AND CHEVRONS**

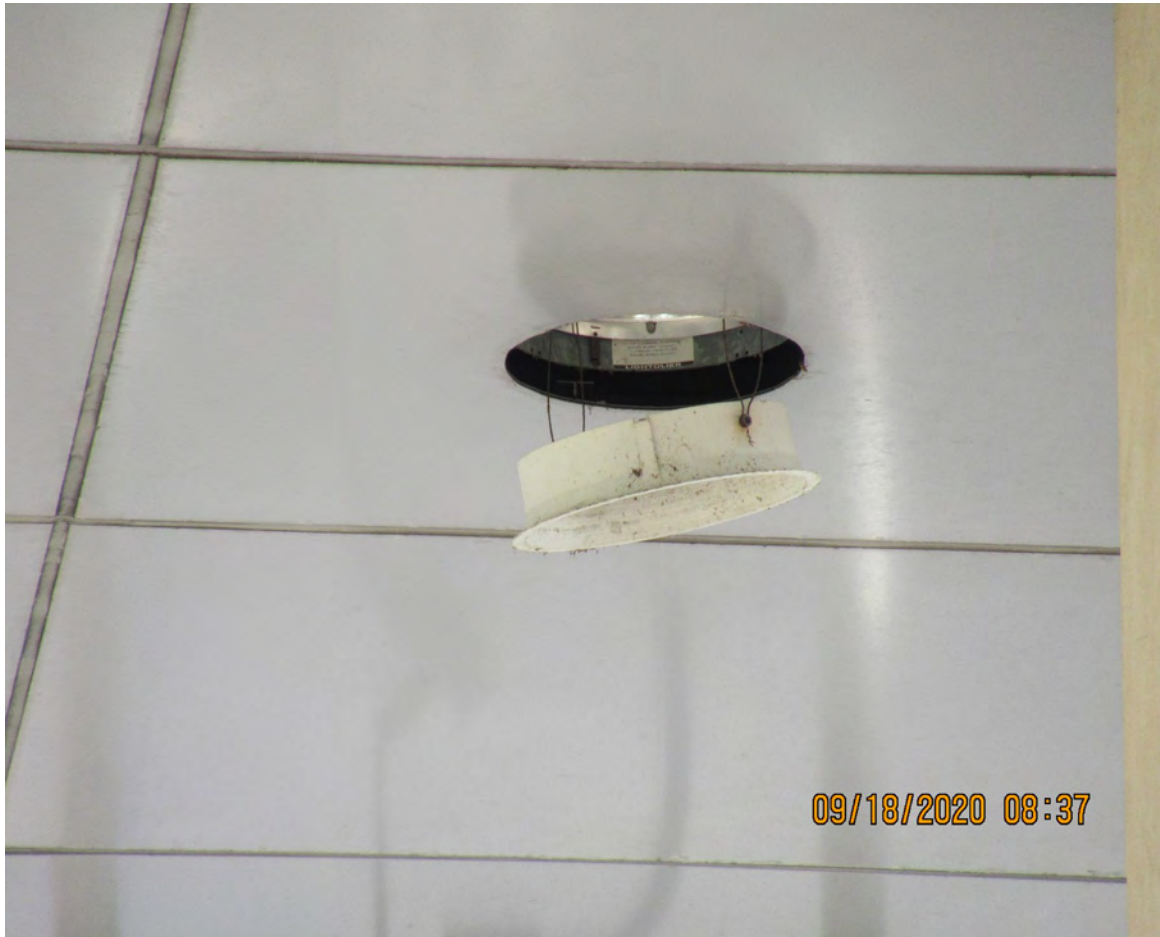
**ARCHITECTURAL INSPECTION  
LOCATION: SR-836 / NW 97<sup>th</sup> AVENUE EASTBOUND  
TOLL PLAZA**

**DETACHED CANOPY LIGHTING RECESSED BAFFLE TRIM**
