Annual Inspection Report 2021

General Engineering Consultant to the
Miami-Dade County Expressway Authority

ANNUAL INSPECTION REPORT 2021

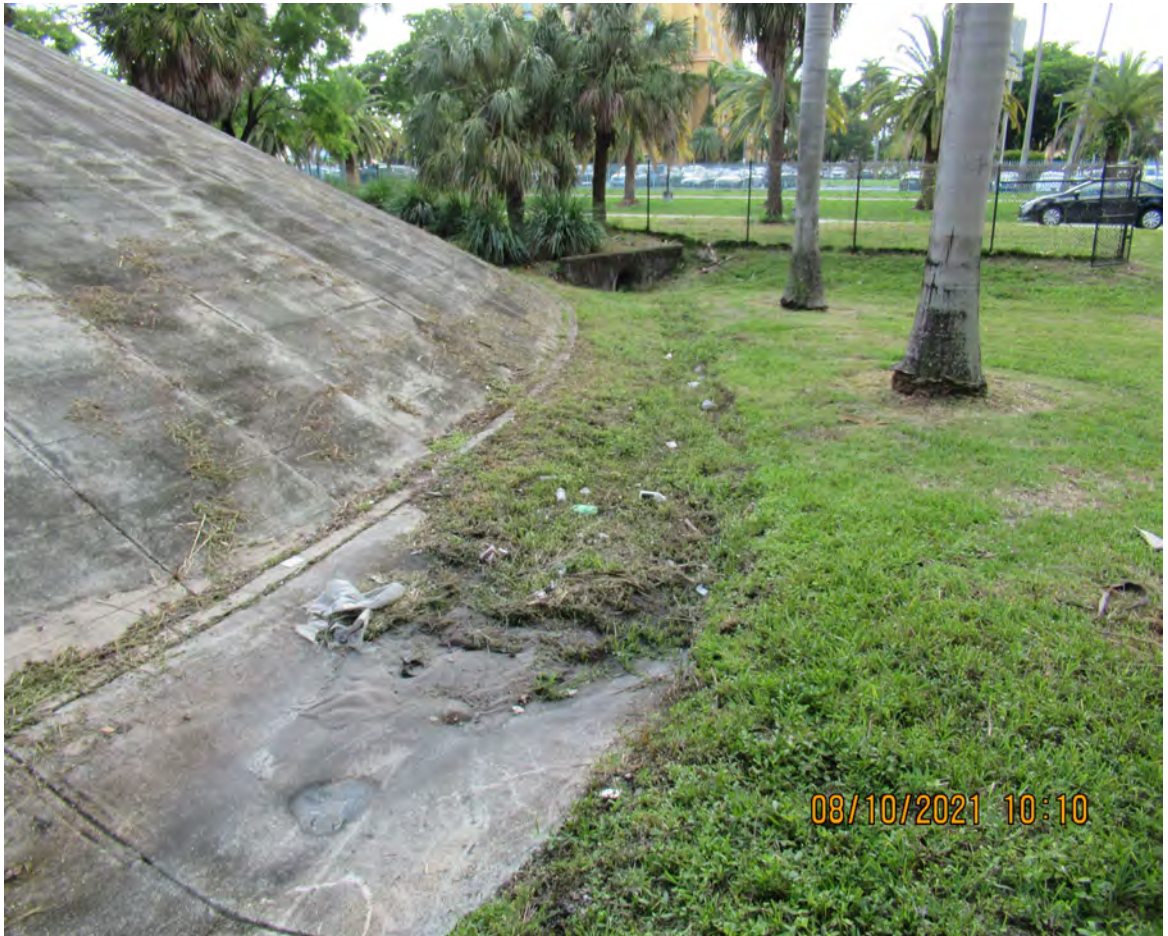
**ROADWAY INSPECTION
LOCATION: MILE MARKER 0.94 MILES
EASTBOUND ON-RAMP FROM LE JEUNE RD.
(RIGHT SHOULDER)**

**SEDIMENTATION AND OVERGROWN VEGETATION OBSTRUCTING
THE DRAINAGE FLUME**

ITEM NOTED TO BE ADDRESSED BY MDX MAINTENANCE

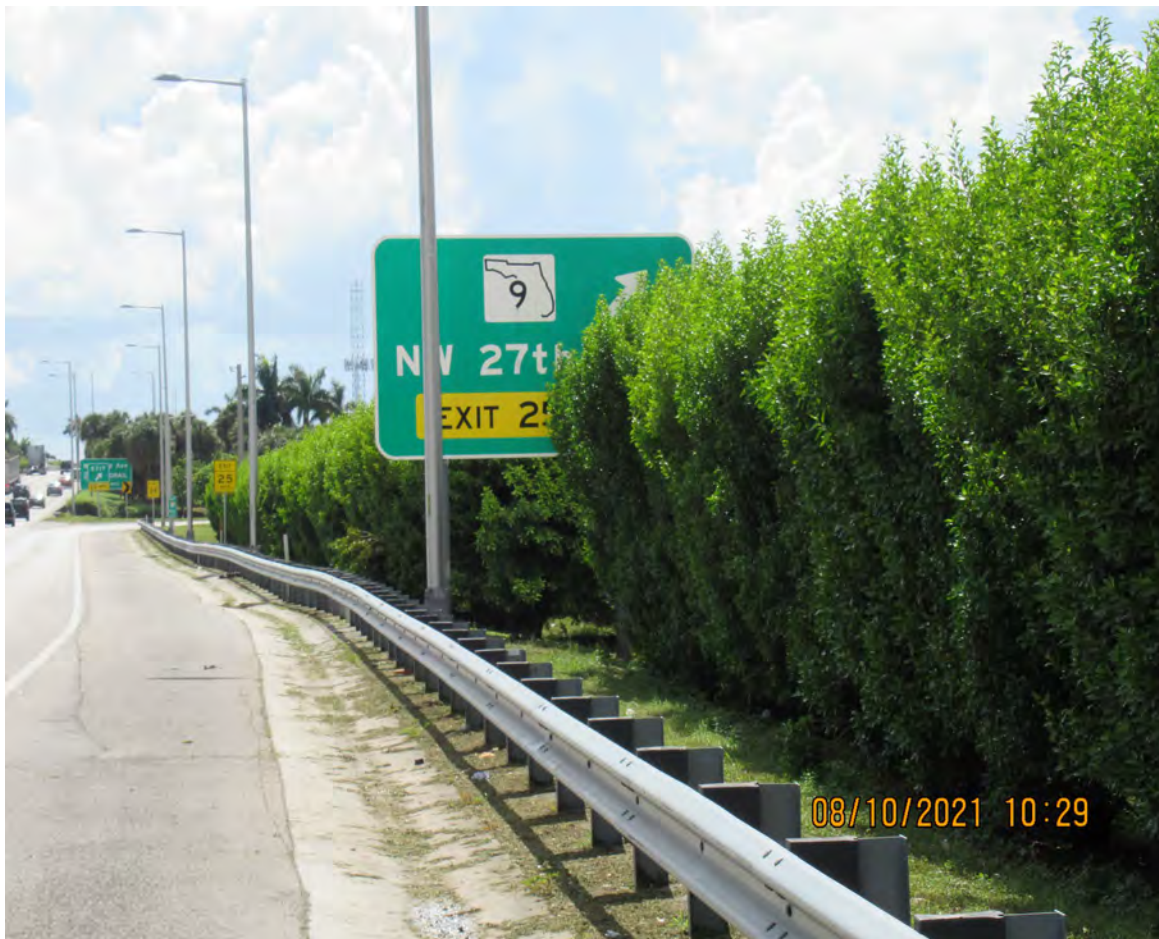
**ROADWAY INSPECTION
LOCATION: MILE MARKER 2.20 MILES
EASTBOUND MAINLINE**

OVERGROWN VEGETATION PARTIALLY OBSTRUCTING SIGN

ITEM NOTED TO BE ADDRESSED BY MDX MAINTENANCE

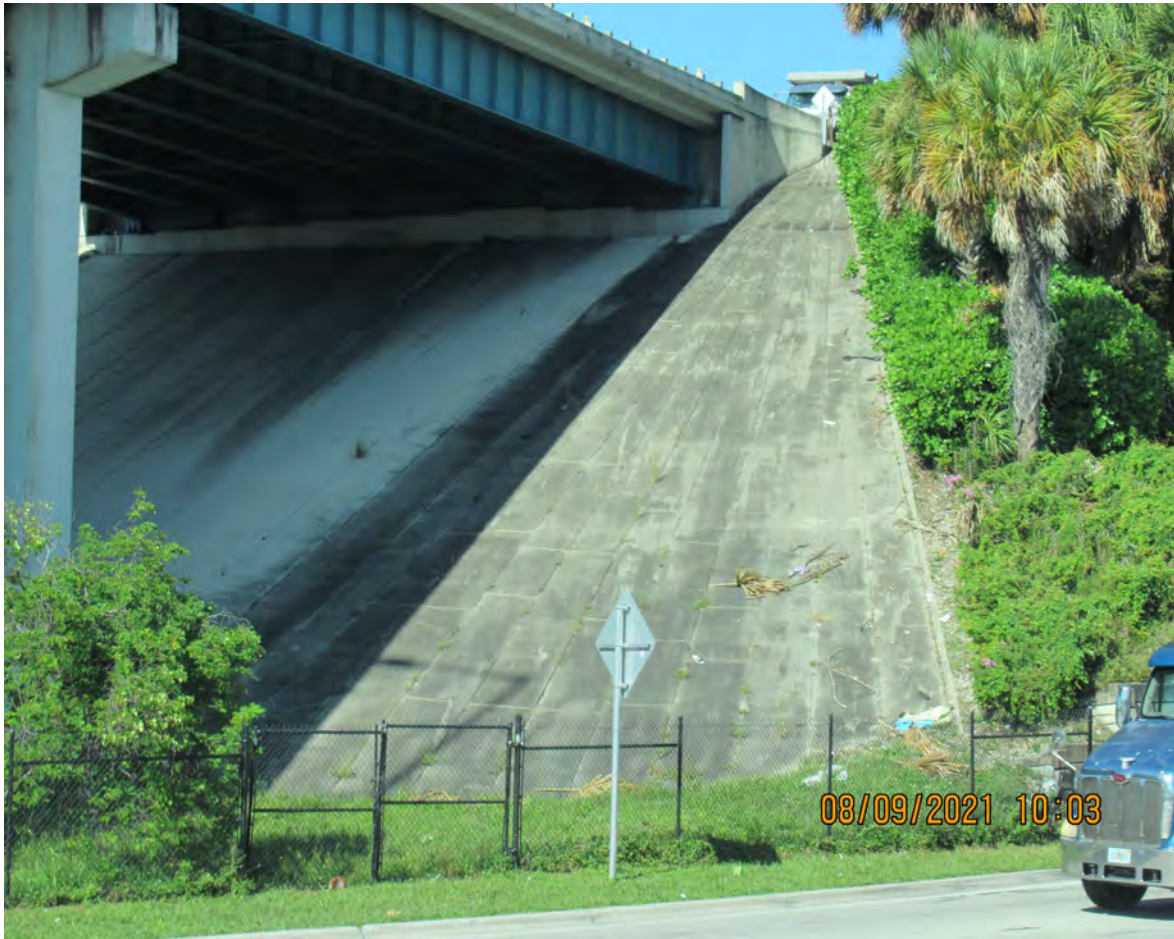
**ROADWAY INSPECTION
LOCATION: MILE MARKER 1.12 MILES
EASTBOUND MAINLINE**

**DETERIORATED CLASS V COATING ON SLOPE (BRIDGE # 870238)
(TYPICAL THROUGHOUT THE CORRIDOR)**

ITEM NOTED TO BE ADDRESSED BY MDX WORK PROGRAM No. 30037

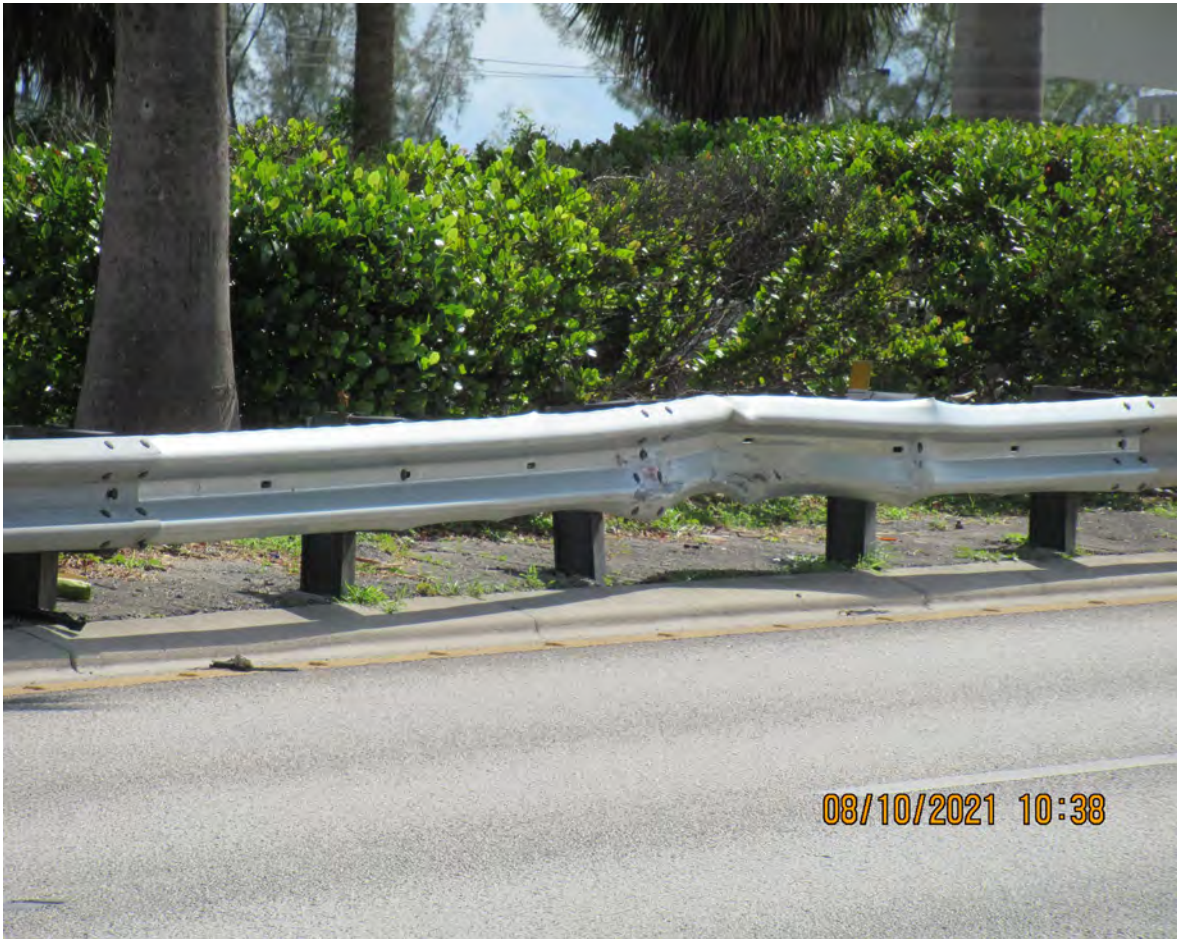
**ROADWAY INSPECTION
LOCATION: MILE MARKER 2.40 MILES
EASTBOUND MAINLINE**

DAMAGED GUARDRAIL

ITEM NOTED TO BE ADDRESSED BY MDX MAINTENANCE

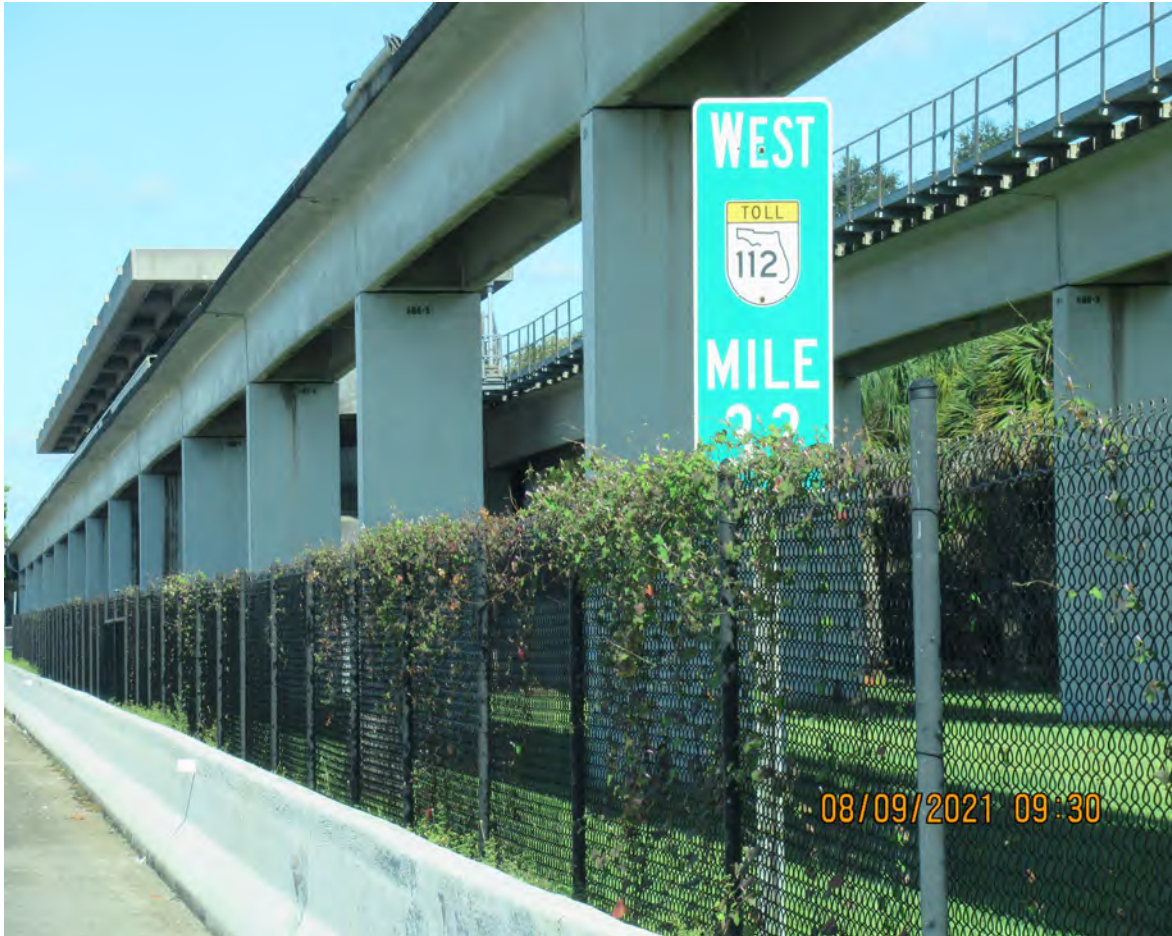
**ROADWAY INSPECTION
LOCATION: MILE MARKER 3.30 MILES
WESTBOUND MAINLINE**

VEGETATION ON FENCE

ITEM NOTED TO BE ADDRESSED BY MDX MAINTENANCE

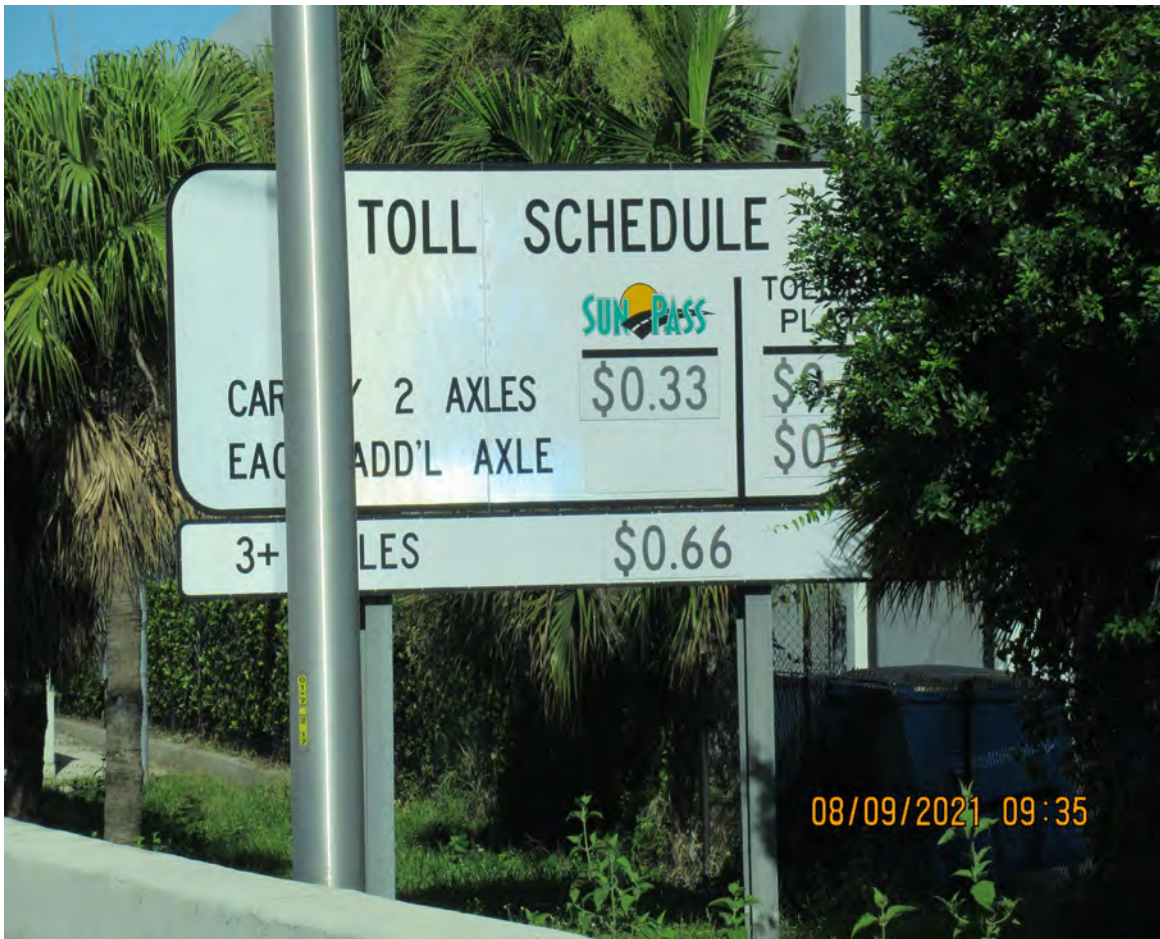
ROADWAY INSPECTION
LOCATION: MILE MARKER 1.80 MILES
WESTBOUND MAINLINE

OVERGROWN VEGETATION OBSTRUCTING TOLLING RATES SIGN

ITEM NOTED TO BE ADDRESSED BY MDX MAINTENANCE

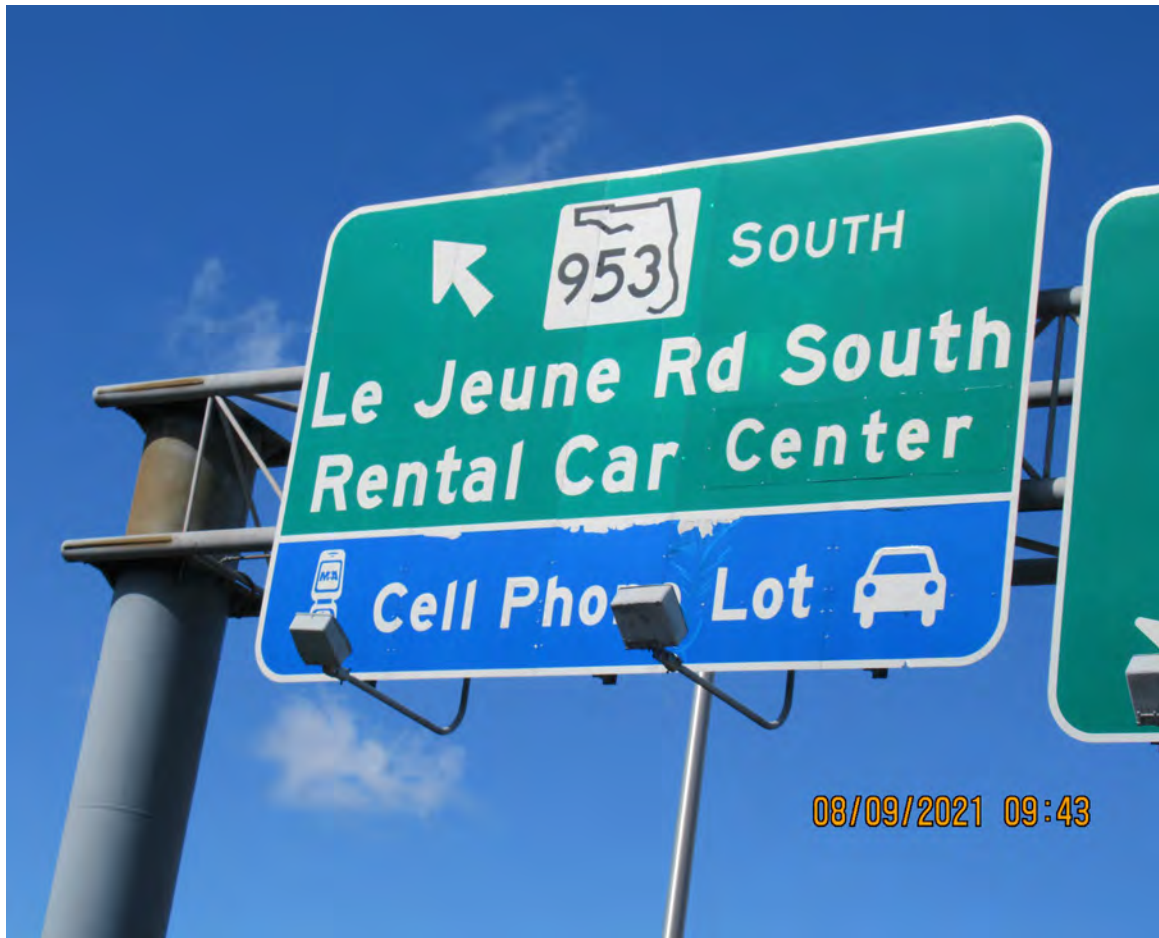
**ROADWAY INSPECTION
LOCATION: MILE MARKER 0.92 MILES
WESTBOUND OFF-RAMP TO LE JEUNE RD.**

DETERIORATED REFLECTIVE SHEETING (STRUCTURE 87S415)

ITEM NOTED TO BE ADDRESSED BY MDX MAINTENANCE

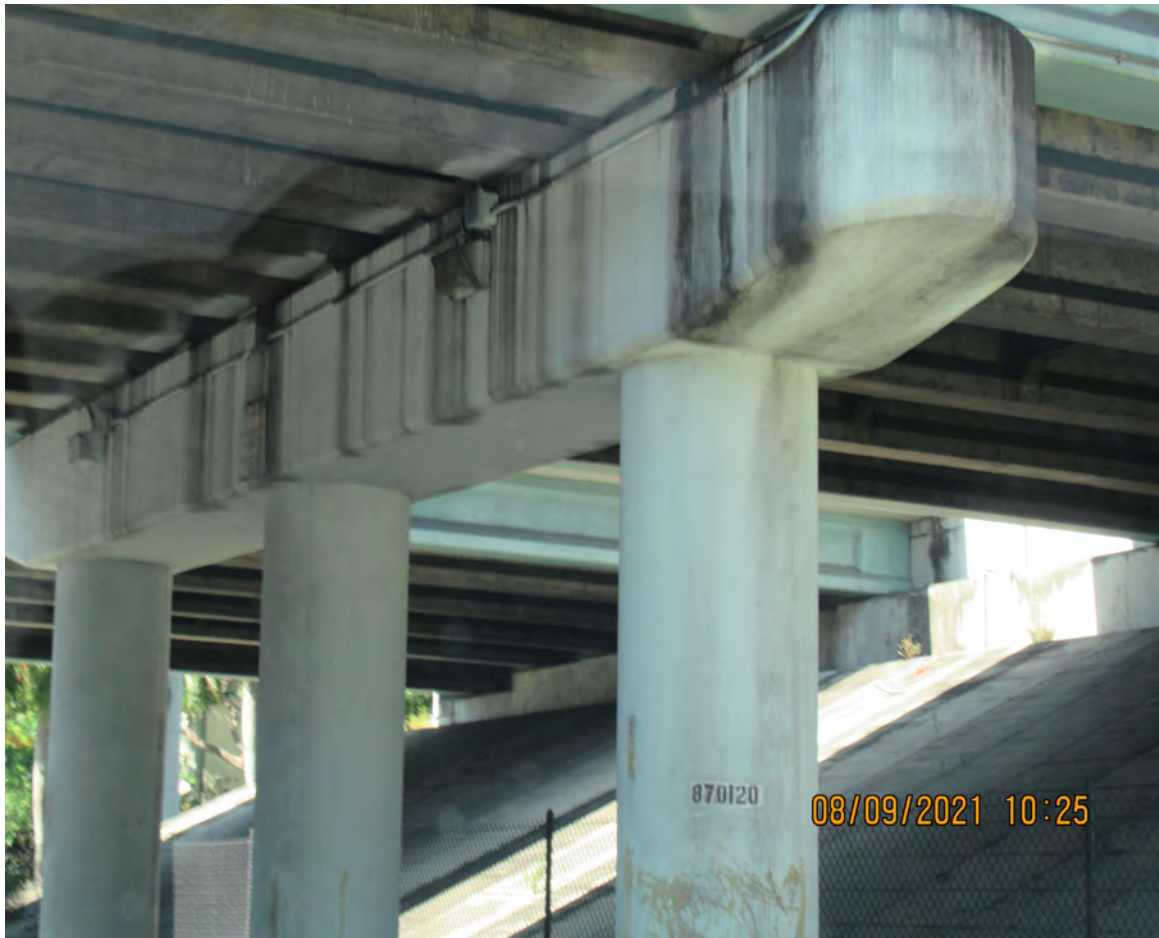
**ROADWAY INSPECTION
LOCATION: MILE MARKER 2.92 MILES
WESTBOUND MAINLINE**

**LEAKING BRIDGE JOINTS AND DETERIORATED CLASS V COATING ON BRIDGE
COLUMN'S, PIER CAPS AND BEAMS (TYPICAL THROUGHOUT THE CORRIDOR)**

ITEM NOTED TO BE ADDRESSED BY MDX WORK PROGRAM No. 30029 & 30037

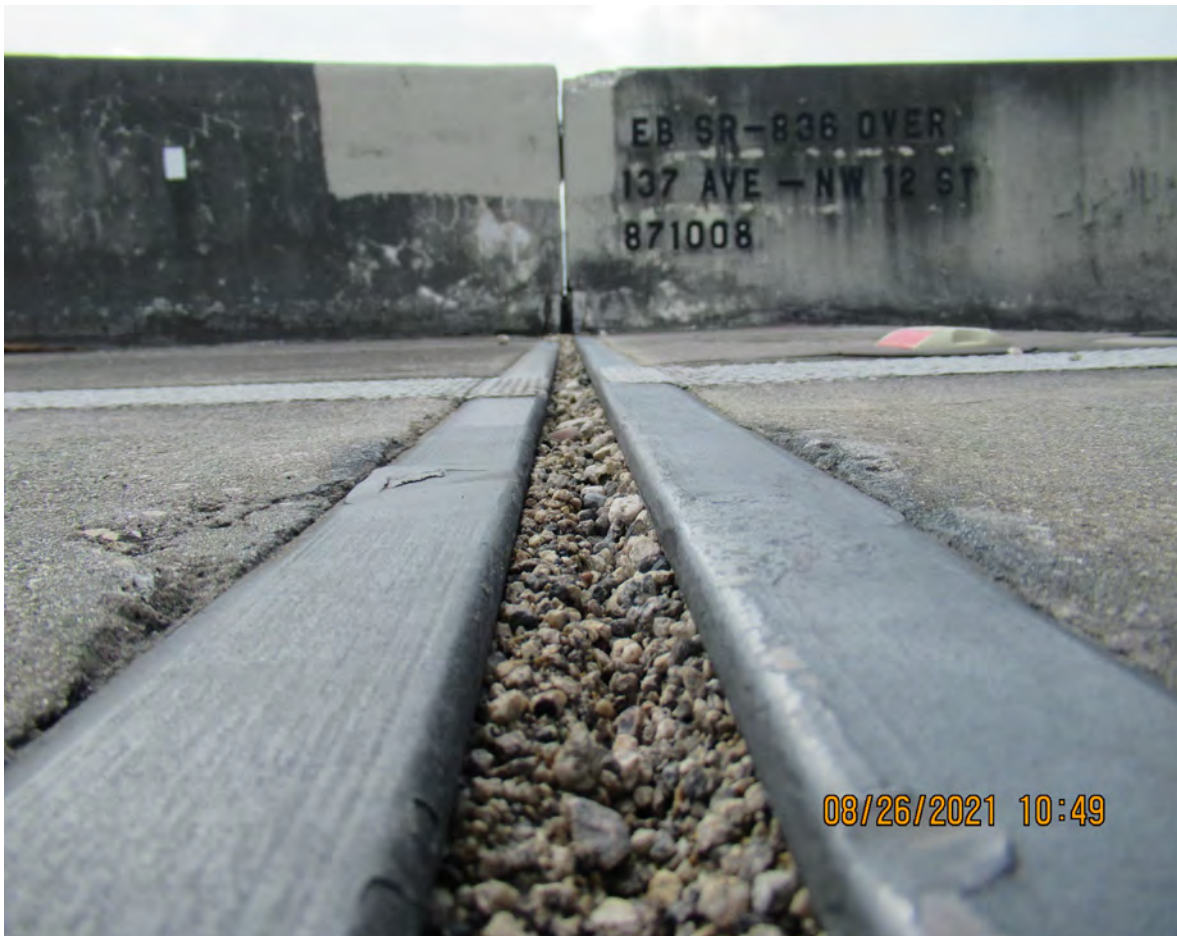
**ROADWAY INSPECTION
LOCATION: MILE MARKER 0.45 MILES
EASTBOUND MAINLINE**

**DEBRIS ON BRIDGE EXPANSION JOINT (BRIDGE No. 871008)
(TYPICAL THROUGHOUT)**

ITEM NOTED TO BE ADDRESSED BY MDX MAINTENANCE

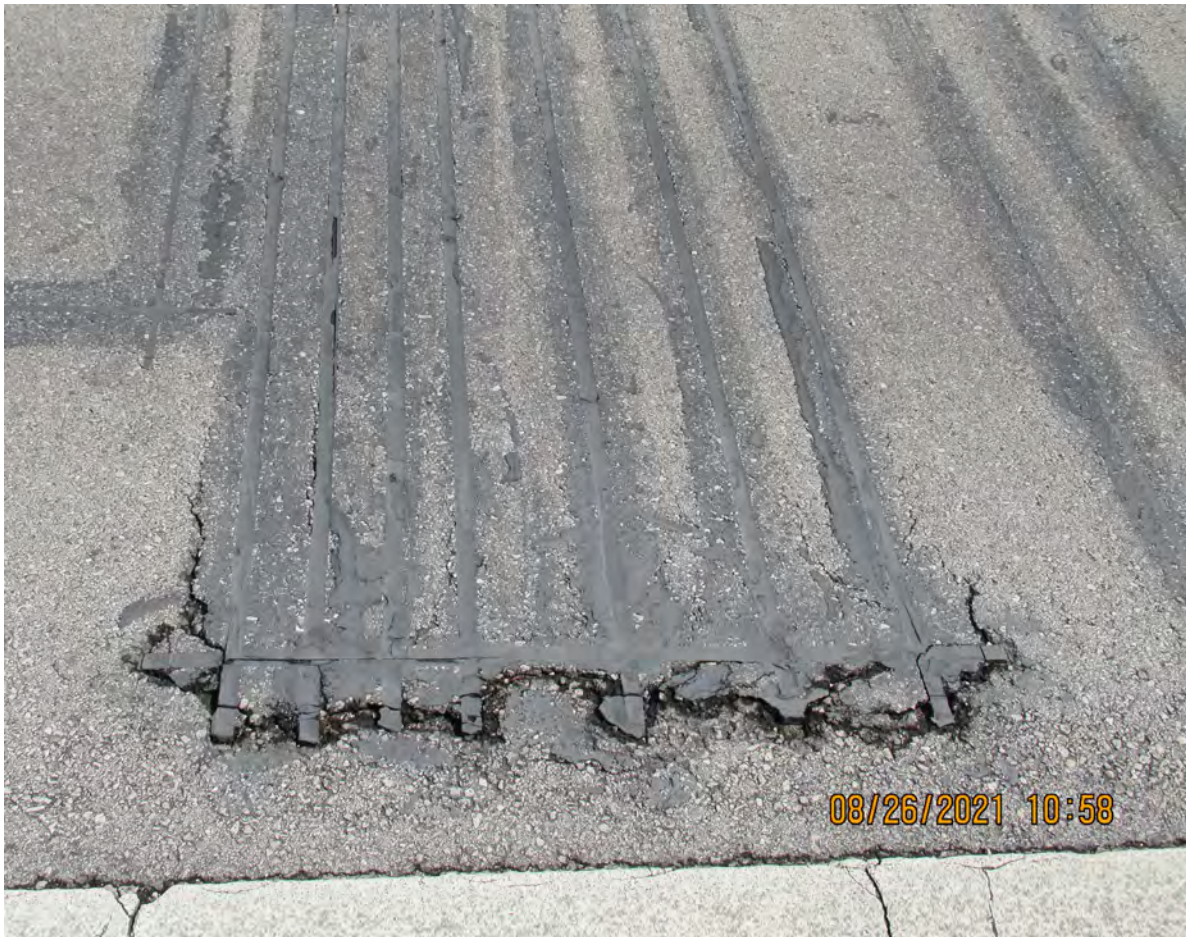
**ROADWAY INSPECTION
LOCATION: MILE MARKER 0.85 MILES
EASTBOUND MAINLINE**

DETERIORATED SEALANT ON ORT LOOP DETECTORS

ITEM NOTED TO BE ADDRESSED BY MDX ITS

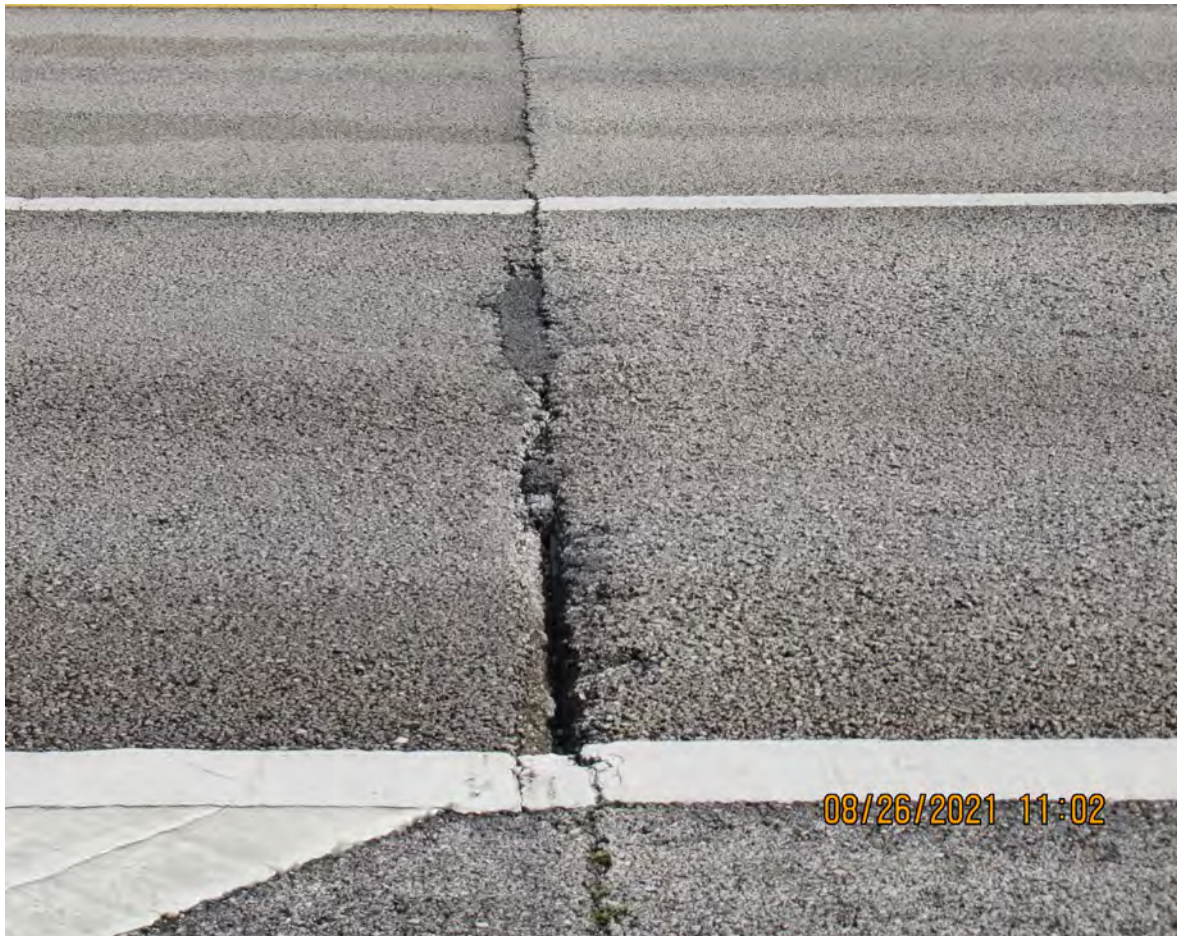
**ROADWAY INSPECTION
LOCATION: MILE MARKER 1.50 MILES
EASTBOUND MAINLINE**

**TRANSVERSE CRACK ON PAVEMENT AT APPROACH SLAB
(BRIDGE No. 871002)**

ITEM NOTED TO BE ADDRESSED BY MDX MAINTENANCE

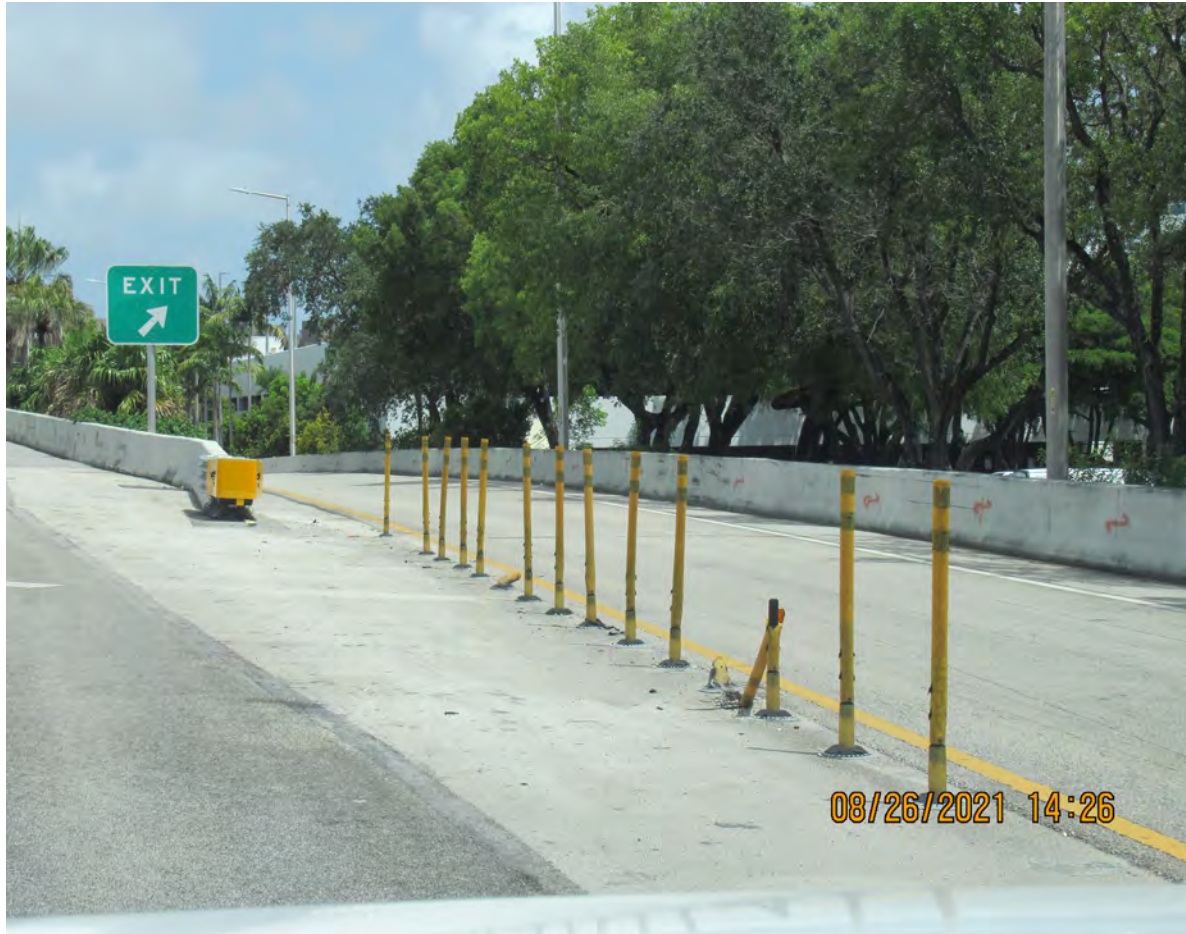
**ROADWAY INSPECTION
LOCATION: MILE MARKER 8.50
EASTBOUND MAILINE OFF-RAMP TO NW 57th AVENUE**

DAMAGED DELINIATORS

ITEM NOTED TO BE ADDRESSED BY MDX MAINTENANCE

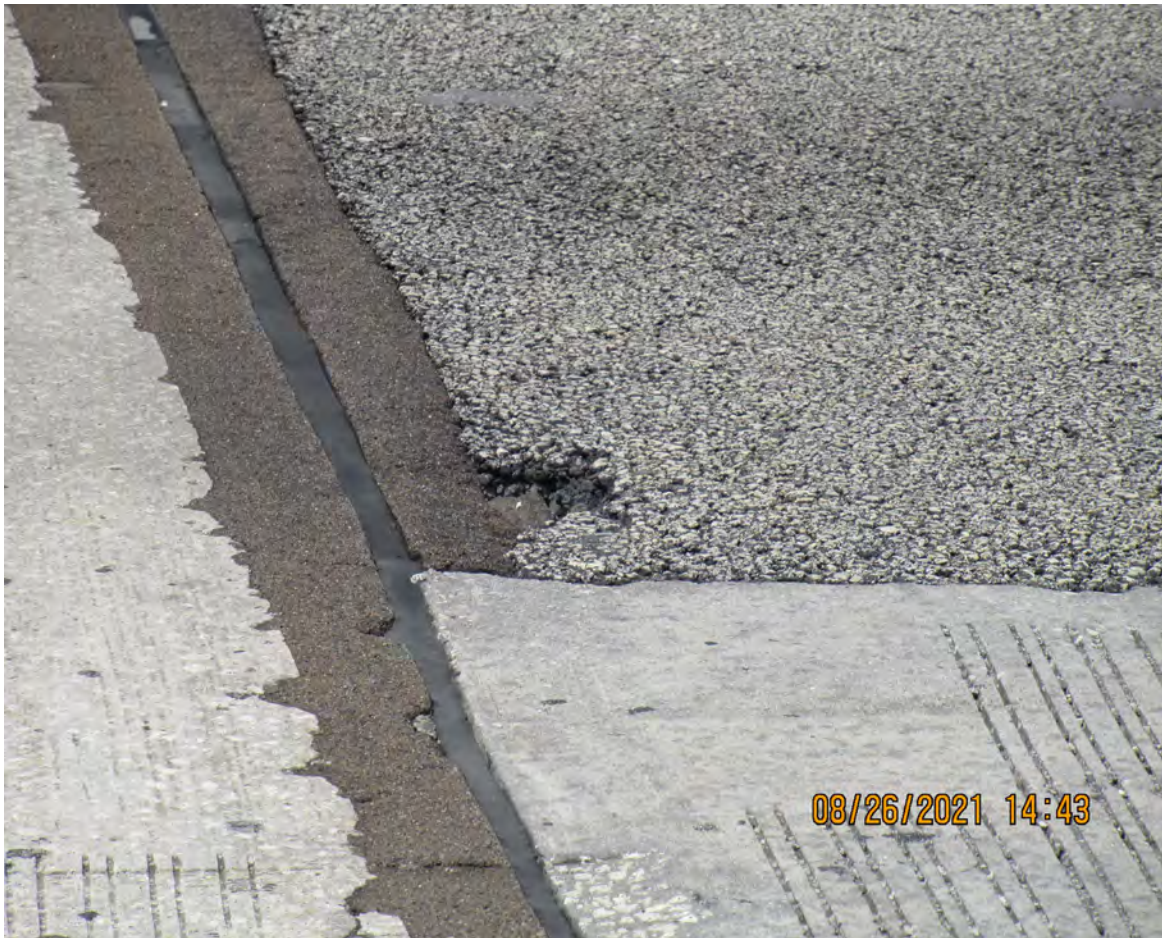
**ROADWAY INSPECTION
LOCATION: MILE MARKER 10.8
EASTBOUND MAILINE (LANE R-4)**

SPALLS ADJACENT TO JOINT HEADER (BRIDGE # 870292)

ITEM NOTED TO BE ADDRESSED BY MDX MAINTENANCE

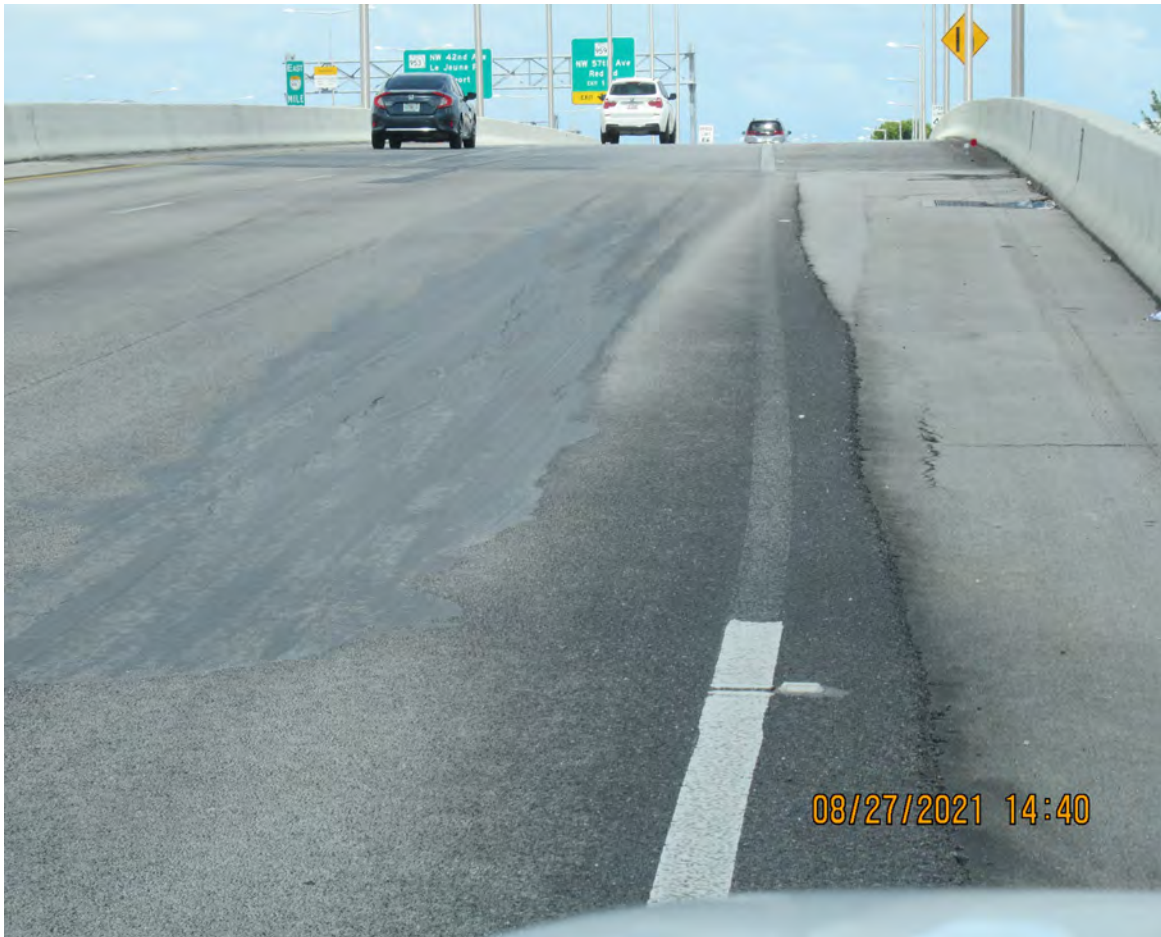
**ROADWAY INSPECTION
LOCATION: MILE MARKER 7.30
EASTBOUND ON-RAMP FROM NW 72nd AVENUE**

DETERIORATED WHITE EDGELINE STRIPING

ITEM NOTED TO BE ADDRESSED BY MDX MAINTENANCE

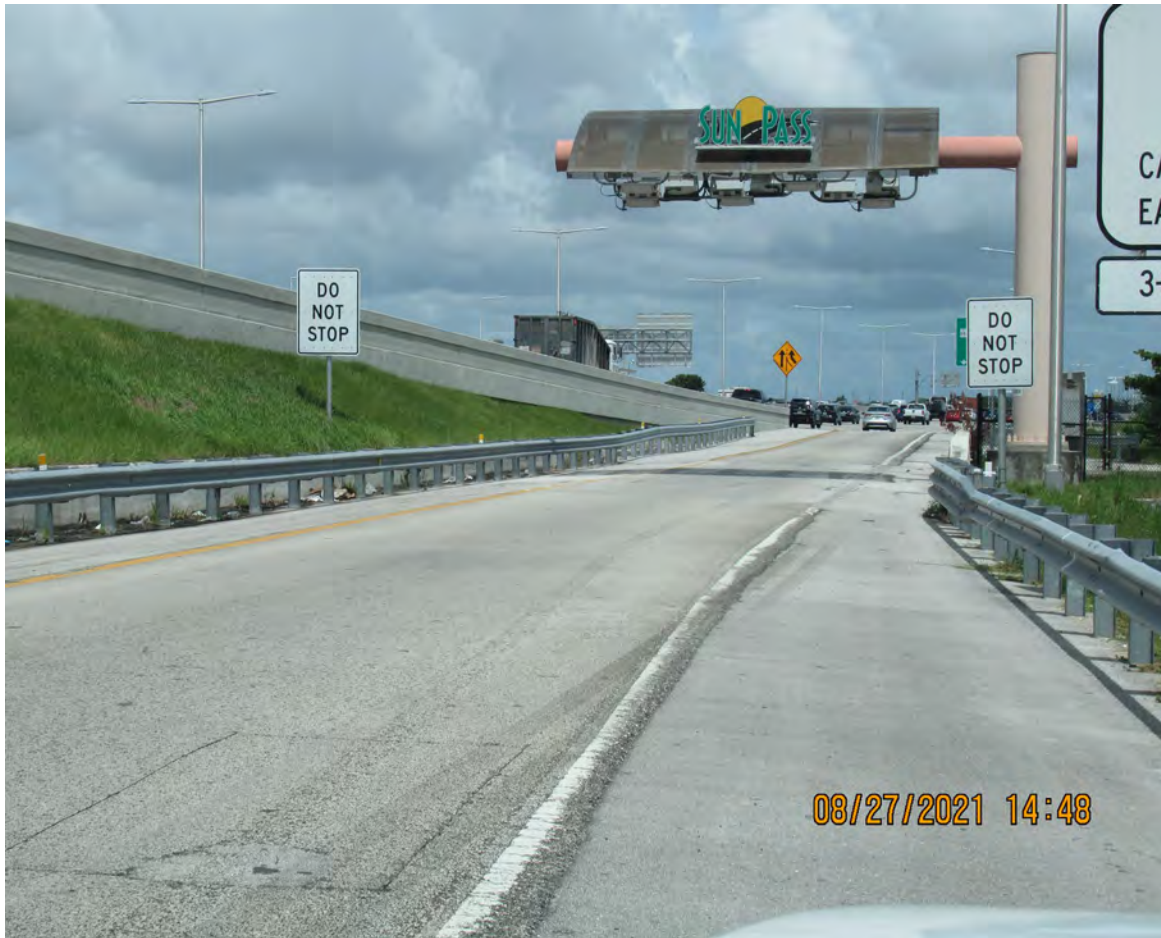
**ROADWAY INSPECTION
LOCATION: MILE MARKER 8.88
EASTBOUND ON-RAMP FROM NW 57th AVENUE**

DETERIORATED WHITE EDGELINE STRIPING

ITEM NOTED TO BE ADDRESSED BY MDX MAINTENANCE

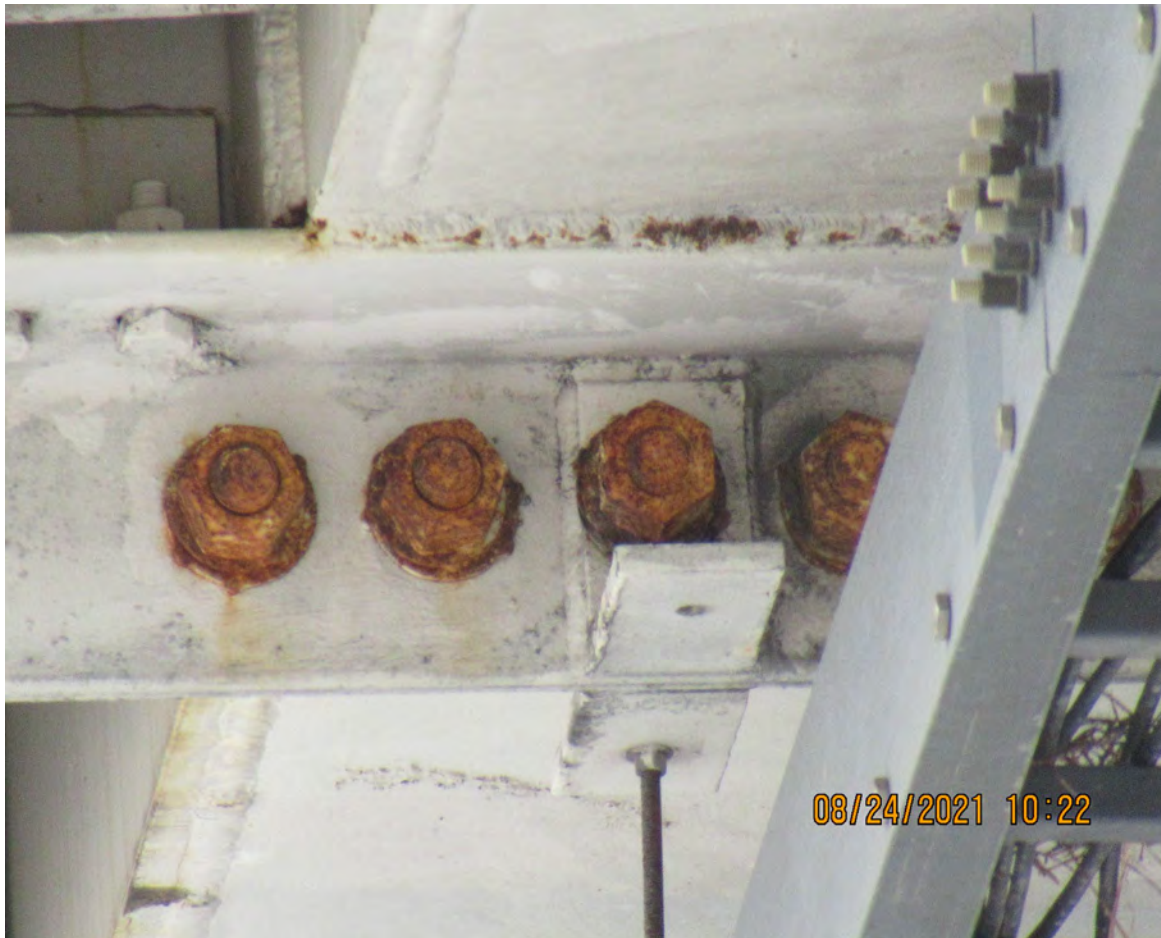
**ROADWAY INSPECTION
LOCATION: MILE MARKER 12.6 MILES
WESTBOUND MAINLINE**

CORROSION ON ORT GANTRY BOLTS (STRUCTURE # 87A253)

ITEM NOTED TO BE ADDRESSED BY MDX MAINTENANCE

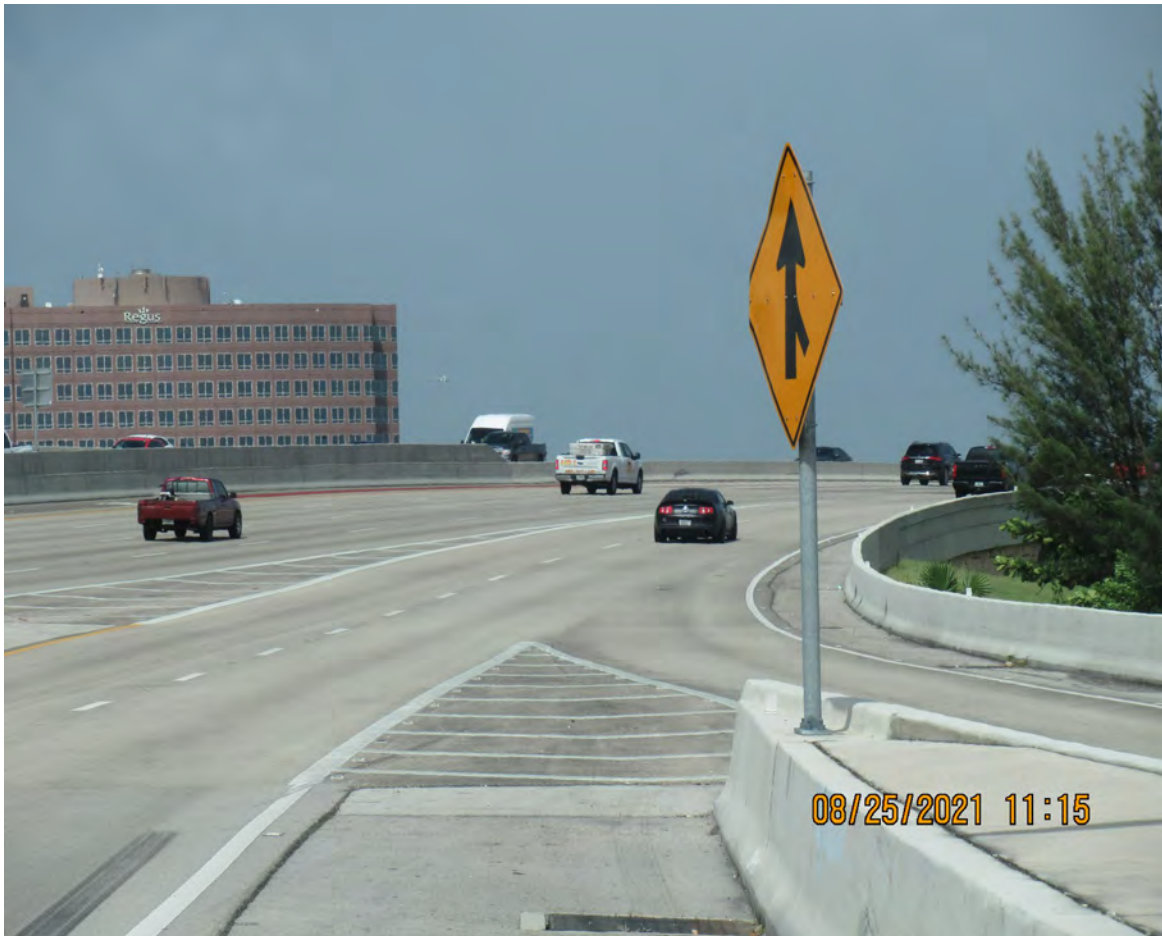
**ROADWAY INSPECTION
LOCATION: MILE MARKER 9.80 MILES
WESTBOUND ON-RAMP FROM NW 42nd AVENUE**

TWISTED MERGE SIGN WITH DAMAGED LEFT CORNER

ITEM NOTED TO BE ADDRESSED BY MDX MAINTENANCE

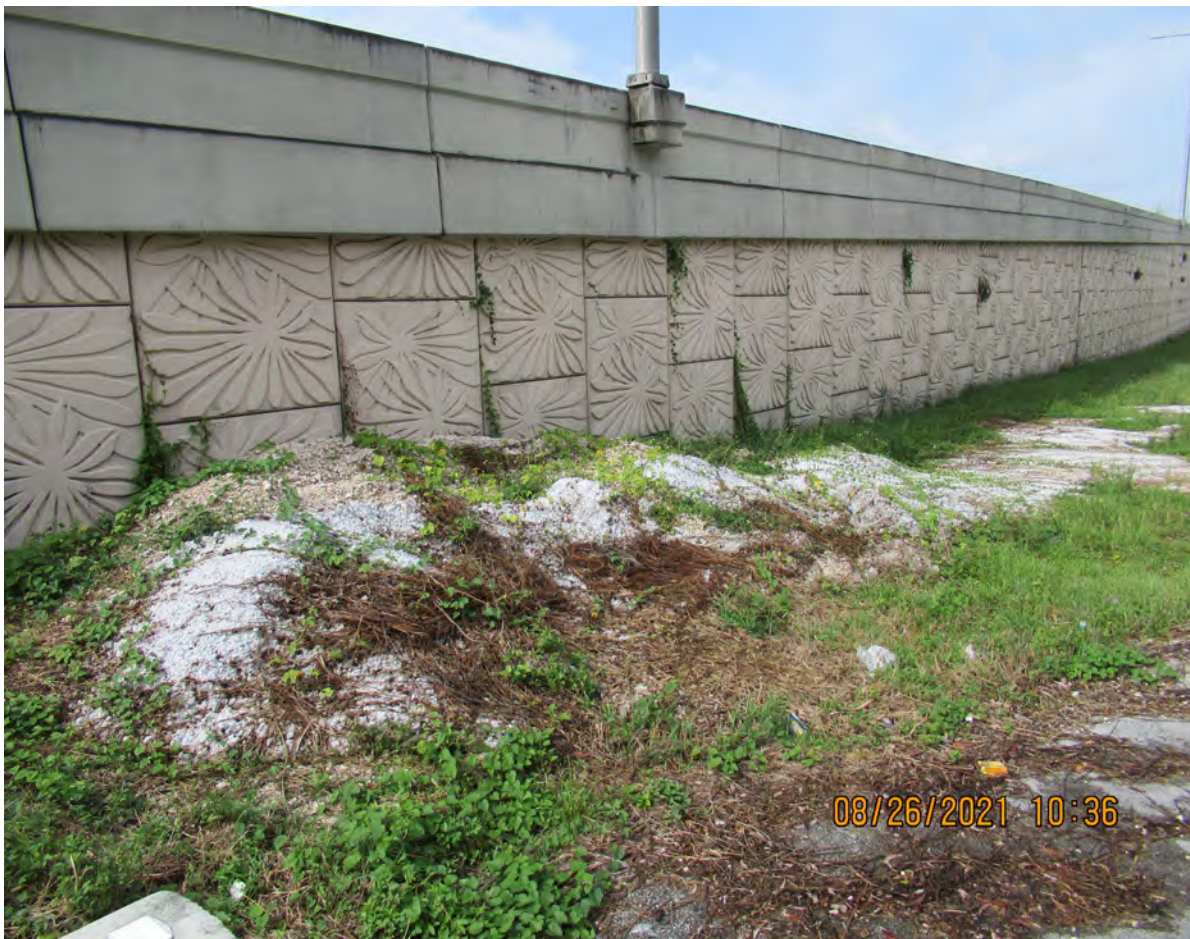
**ROADWAY INSPECTION
LOCATION: MILE MARKER 3.10 MILES
WESTBOUND ON-RAMP FROM NW 107th AVENUE TO
SR 836 WESTBOUND**

SPILLED CONCRETE FROM TURNPIKE CONSTRUCTION

ITEM NOTED TO BE ADDRESSED BY MDX MAINTENANCE

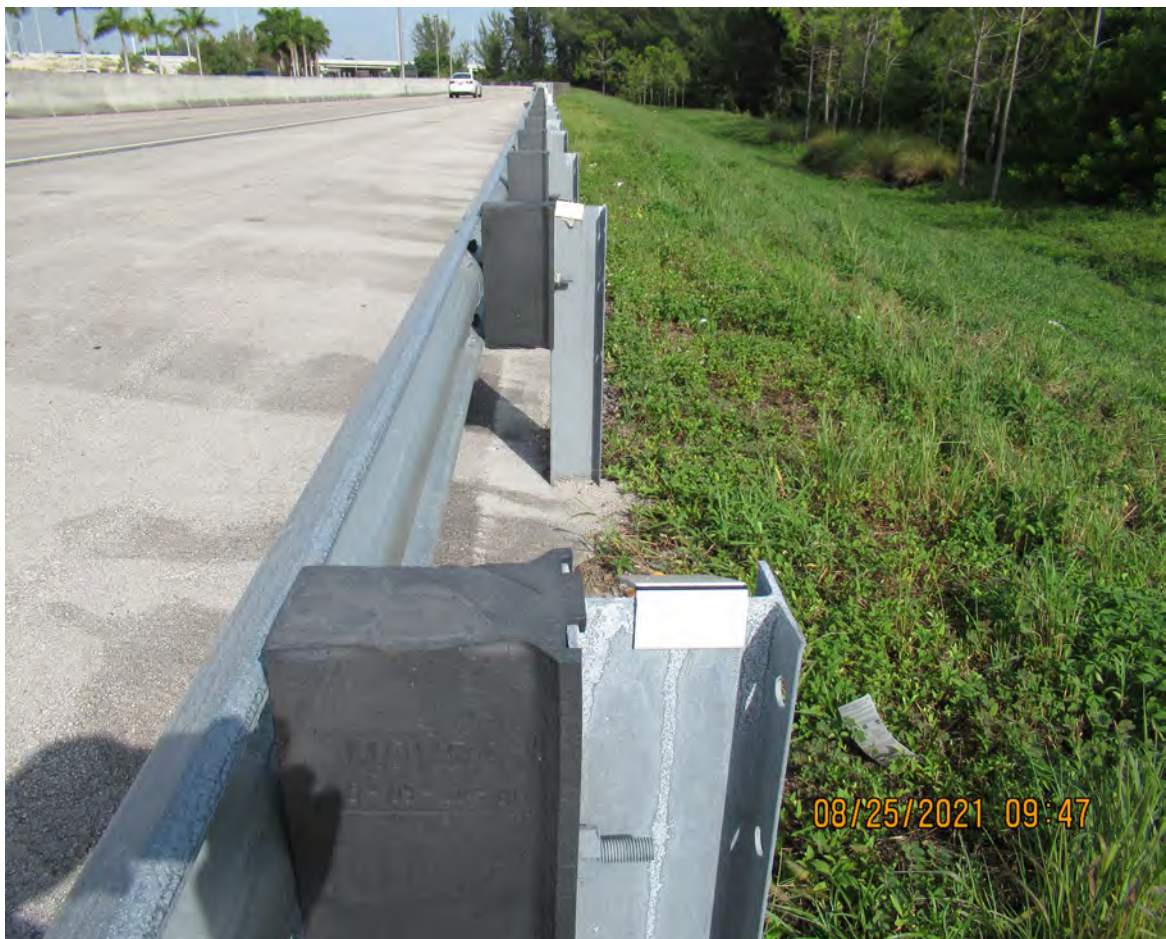
**ROADWAY INSPECTION
LOCATION: MILE MARKER 2.85 MILES
WESTBOUND MAINLINE**

DAMAGED GUARDRAIL REFLECTORS (TYPICAL THROUGHOUT THE CORRIDOR)

ITEM NOTED TO BE ADDRESSED BY MDX MAINTENANCE

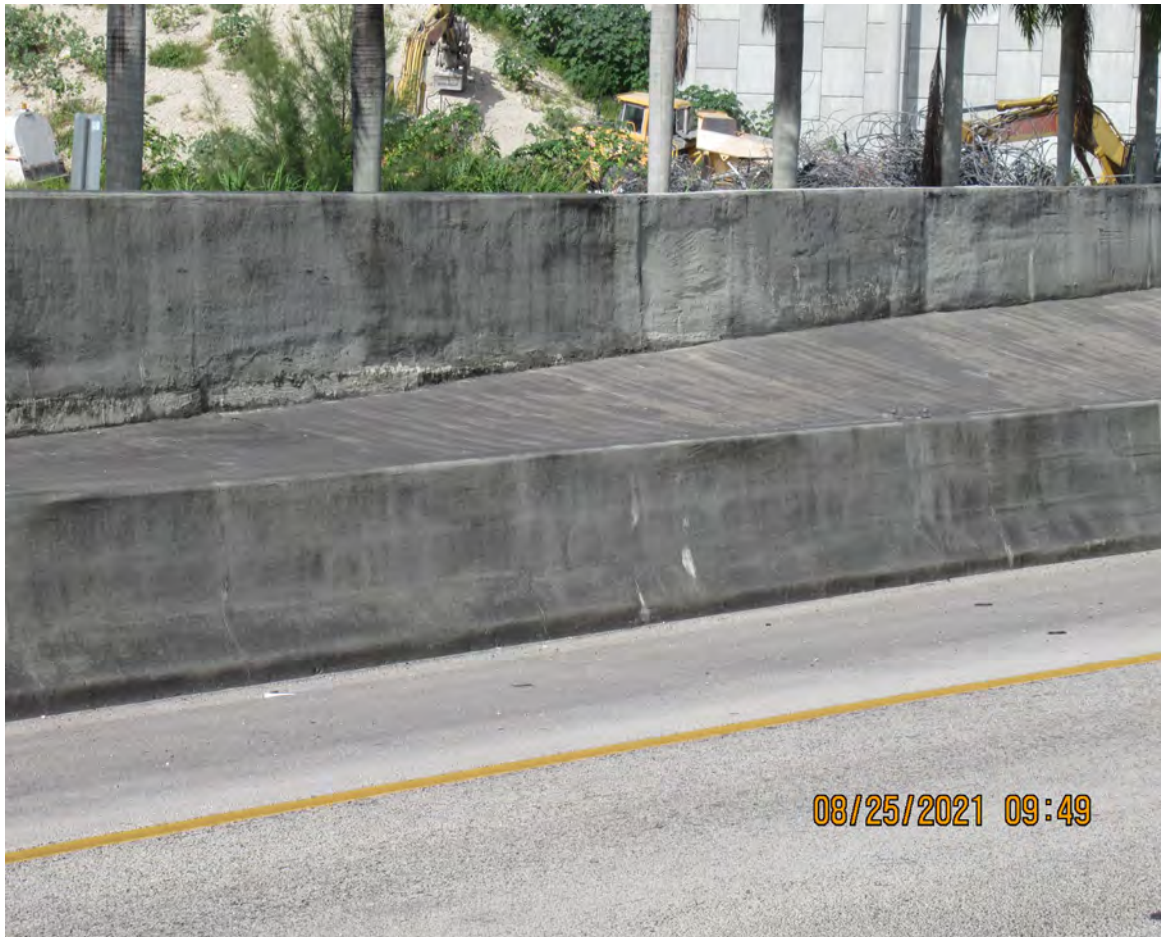
**ROADWAY INSPECTION
LOCATION: MILE MARKER 2.60 MILES
WESTBOUND MAINLINE**

**DETERIORATED CLASS V COATING ON BARRIER WALL AND TRAFFIC
SEPARATOR
(TYPICAL FROM NW 107th AVENUE WEST TO NW 137th AVENUE)**
