Annual Inspection Report 2021

General Engineering Consultant to the
Miami-Dade County Expressway Authority

ANNUAL INSPECTION REPORT 2021

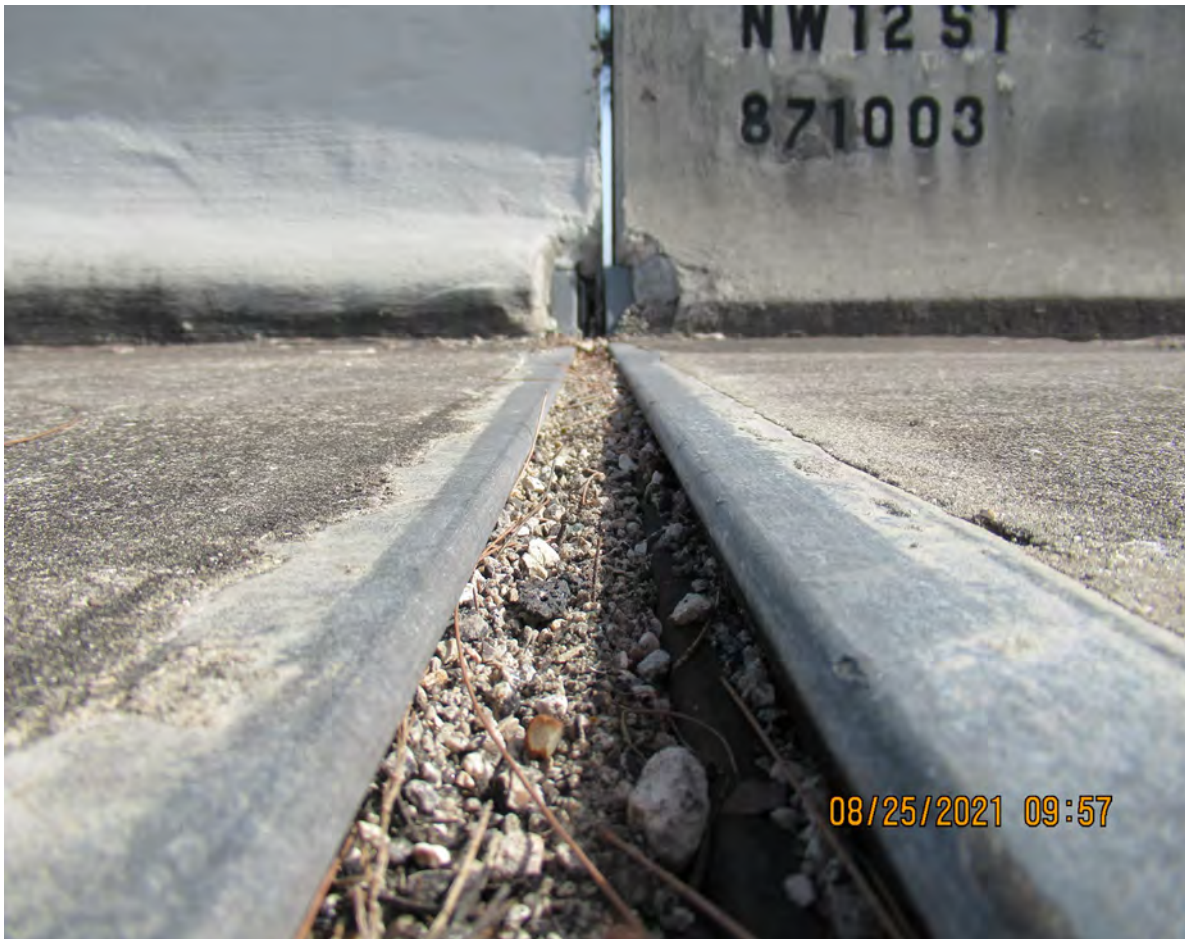
**ROADWAY INSPECTION
LOCATION: MILE MARKER 2.20 MILES
WESTBOUND MAINLINE**

**SEDIMENT AND DEBRIS ACCUMULATED ON BRIDGE
EXPANSION JOINTS (BRIDGE No. 871003)
(TYPICAL THROUGHOUT THE CORRIDOR)**

ITEM NOTED TO BE ADDRESSED BY MDX MAINTENANCE

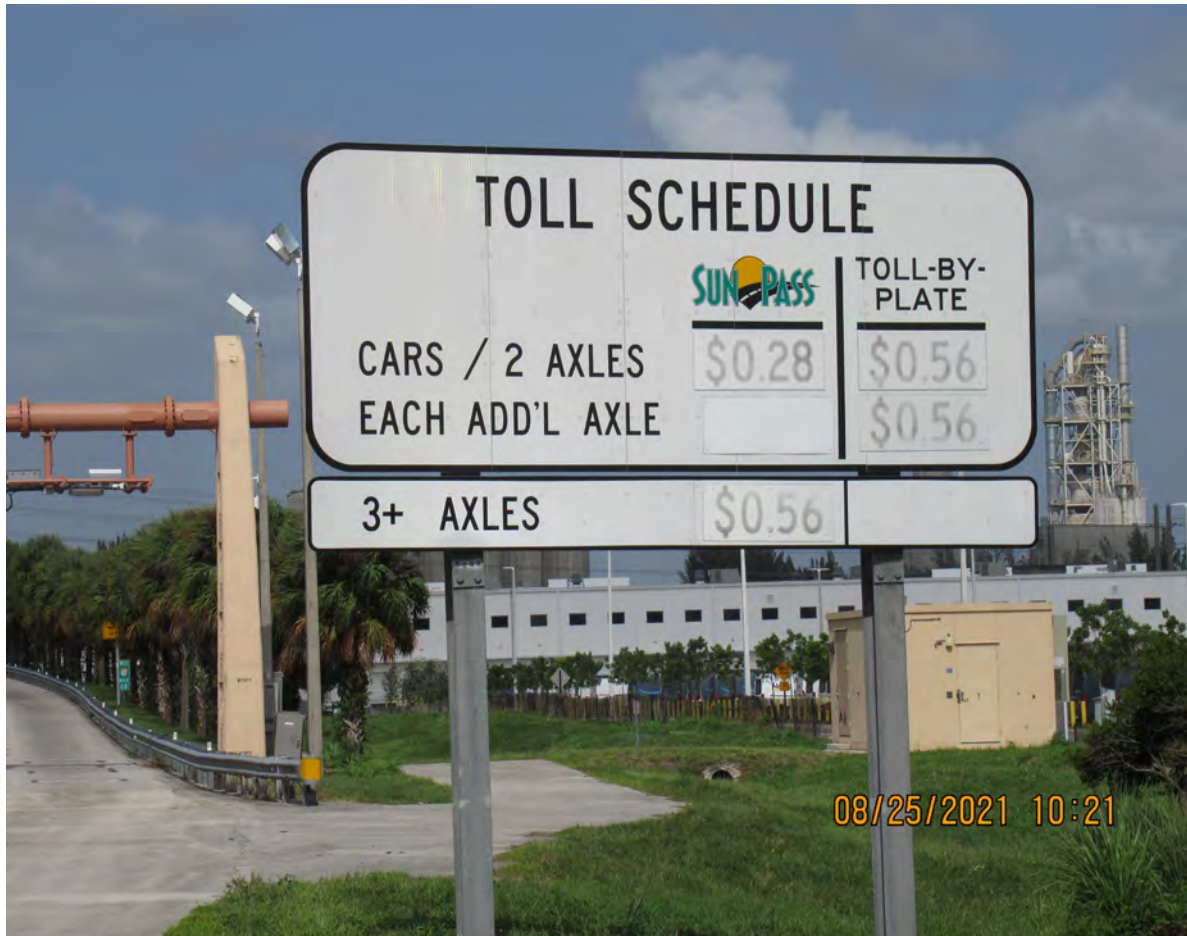
**ROADWAY INSPECTION
LOCATION: MILE MARKER 0.88 MILES
WESTBOUND MAINLINE**

**DETERIORATED TOLL RATES SIGN OVERLAYS
(TYPICAL THROUGHOUT THE CORRIDOR)**

ITEM NOTED TO BE ADDRESSED BY MDX MAINTENANCE

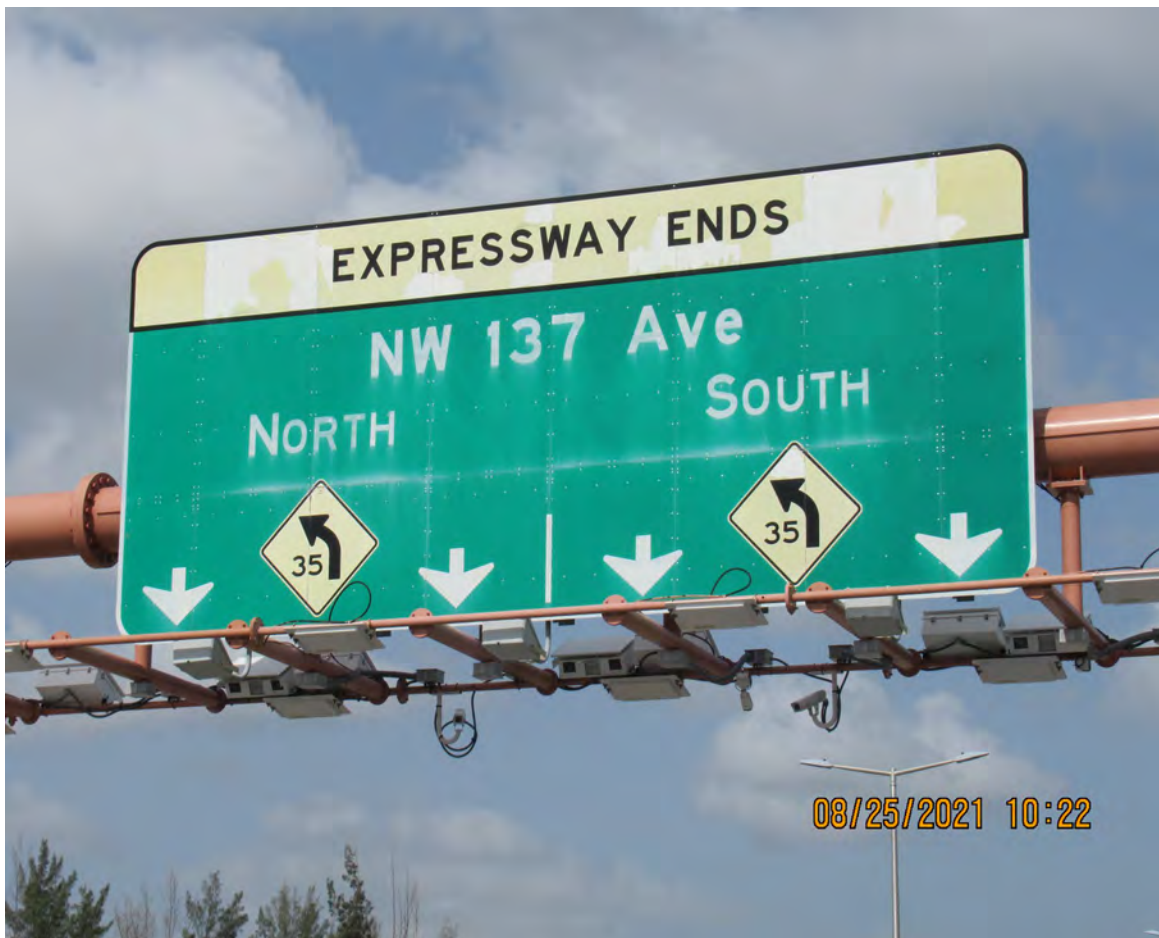
**ROADWAY INSPECTION
LOCATION: MILE MARKER 0.88 MILES
WESTBOUND MAINLINE**

DETERIORATED REFLECTIVE SHEETING ON SIGN PANEL

ITEM NOTED TO BE ADDRESSED BY MDX MAINTENANCE

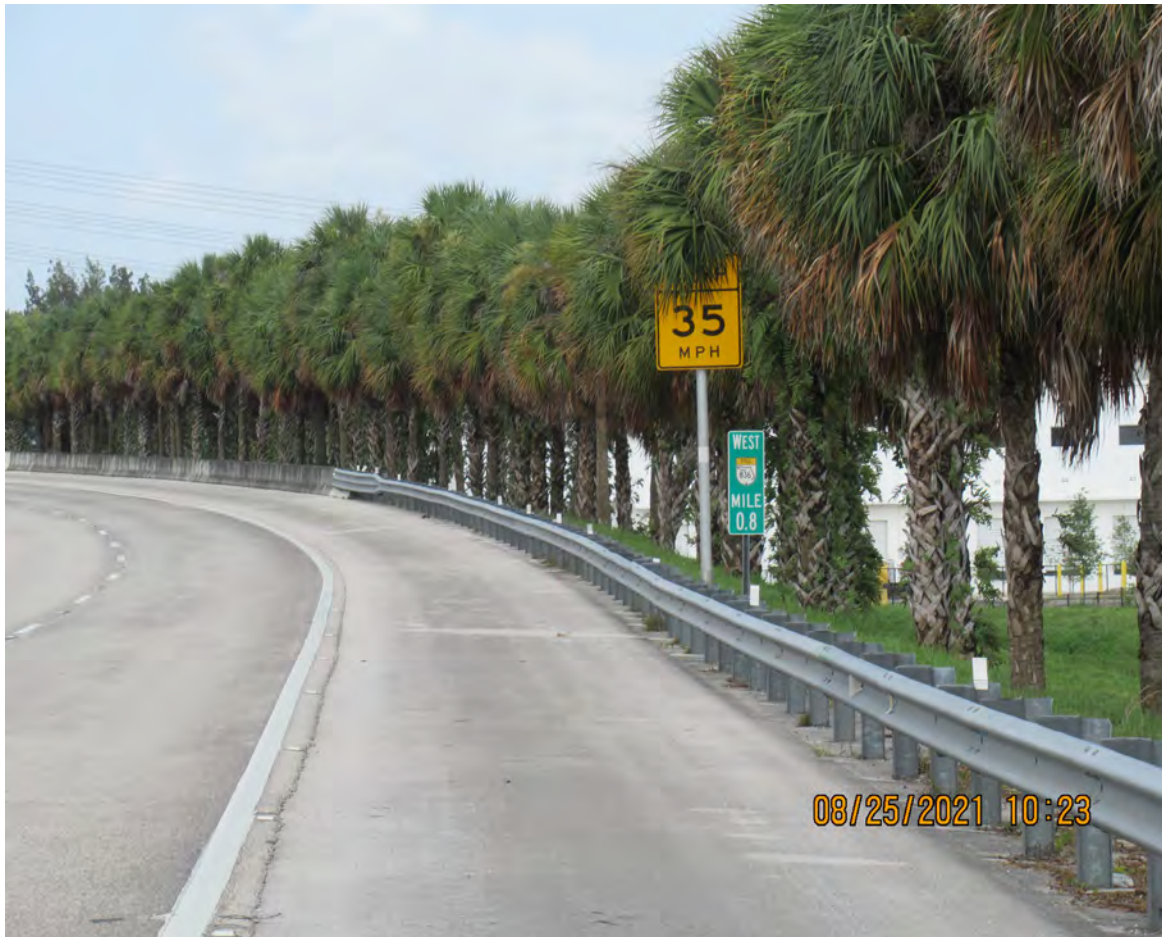
**ROADWAY INSPECTION
LOCATION: MILE MARKER 0.80 MILES
WESTBOUND MAINLINE**

OVERGROWN VEGETATION OBSTRUCTING SPEED LIMIT SIGN

ITEM NOTED TO BE ADDRESSED BY MDX MAINTENANCE

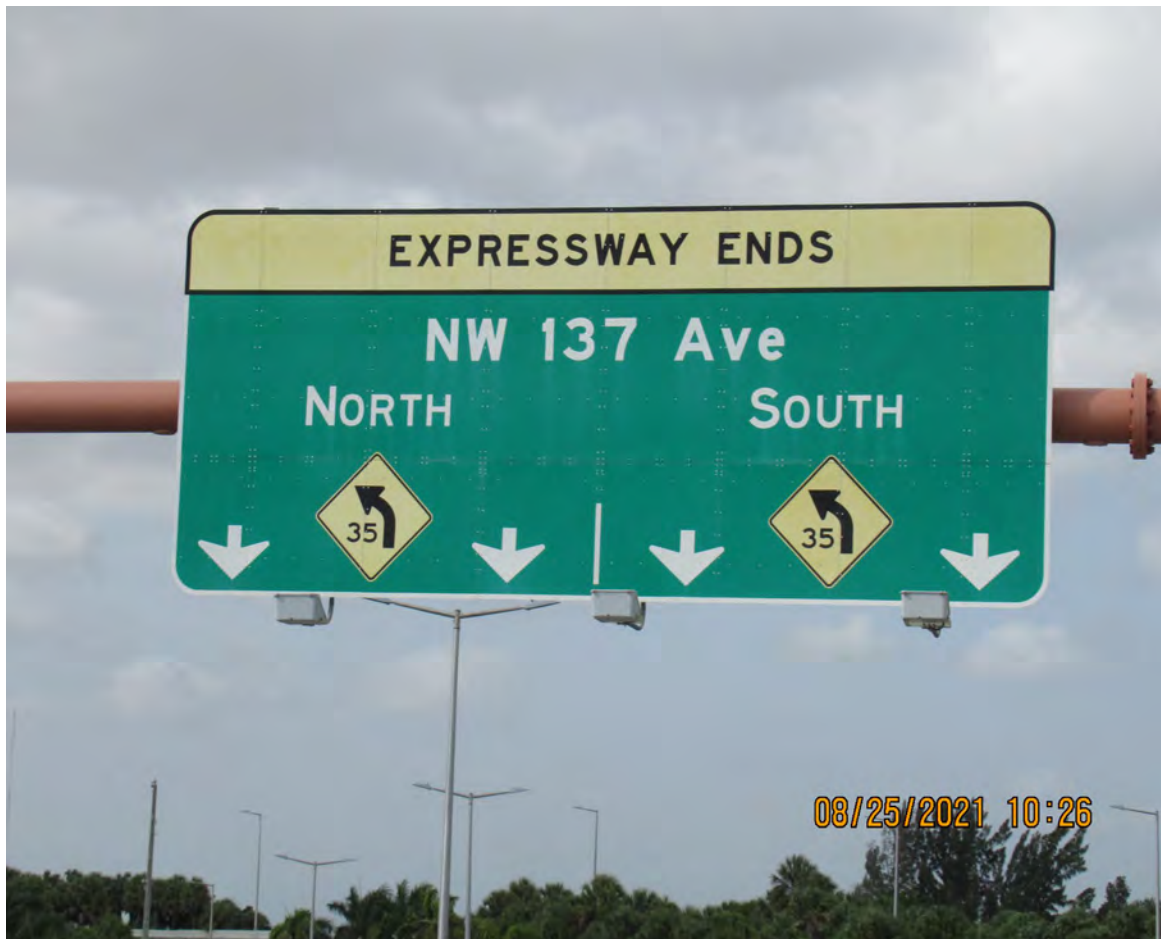
**ROADWAY INSPECTION
LOCATION: MILE MARKER 0.46 MILES
WESTBOUND MAINLINE**

DETERIORATED REFLECTIVE SHEETING

ITEM NOTED TO BE ADDRESSED BY MDX MAINTENANCE

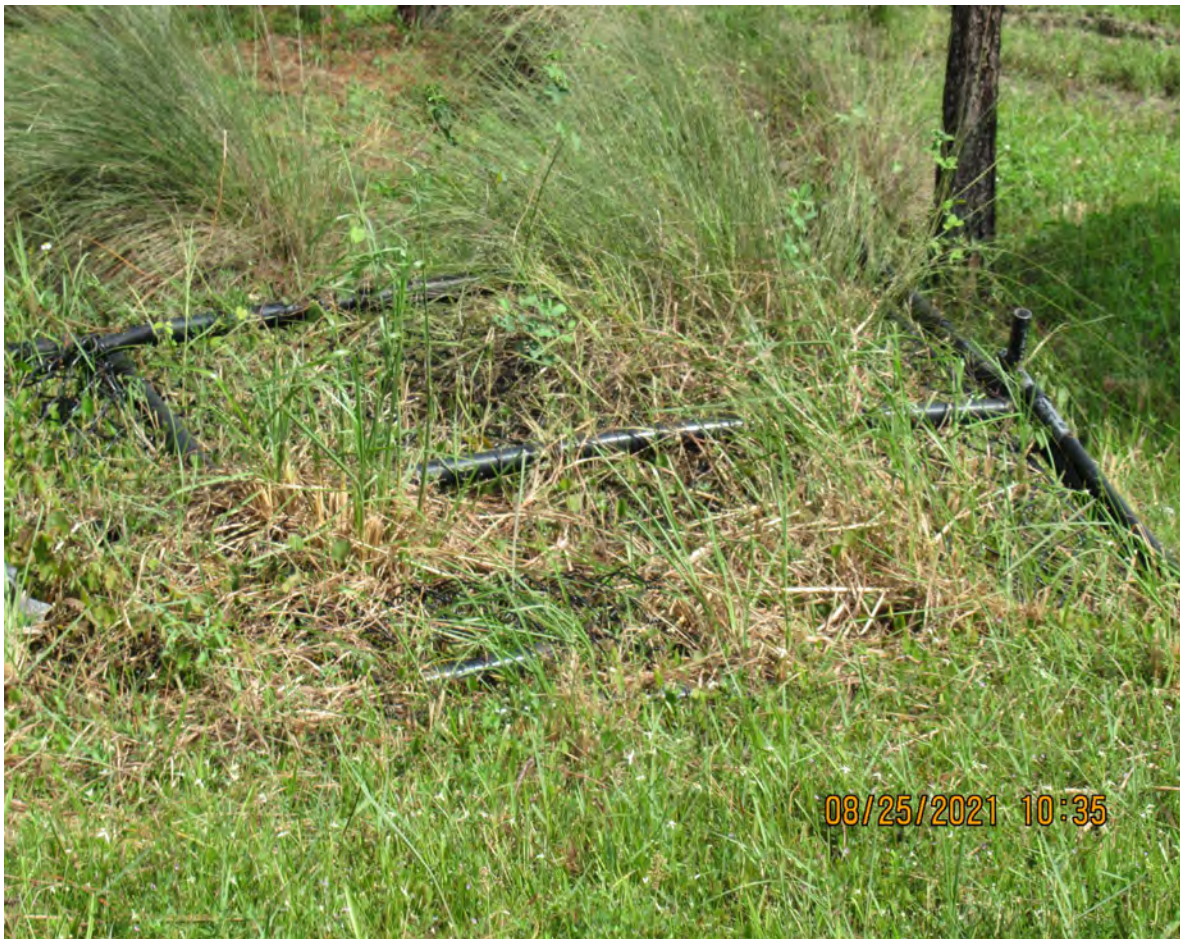
**ROADWAY INSPECTION
LOCATION: MILE MARKER 0.08 MILES
WESTBOUND OFF-RAMP TO SOUTHBOUND
NW 137th AVENUE (RIGHT SLOPE)**

DAMAGED / ABANDONED GATE

ITEM NOTED TO BE ADDRESSED BY MDX MAINTENANCE

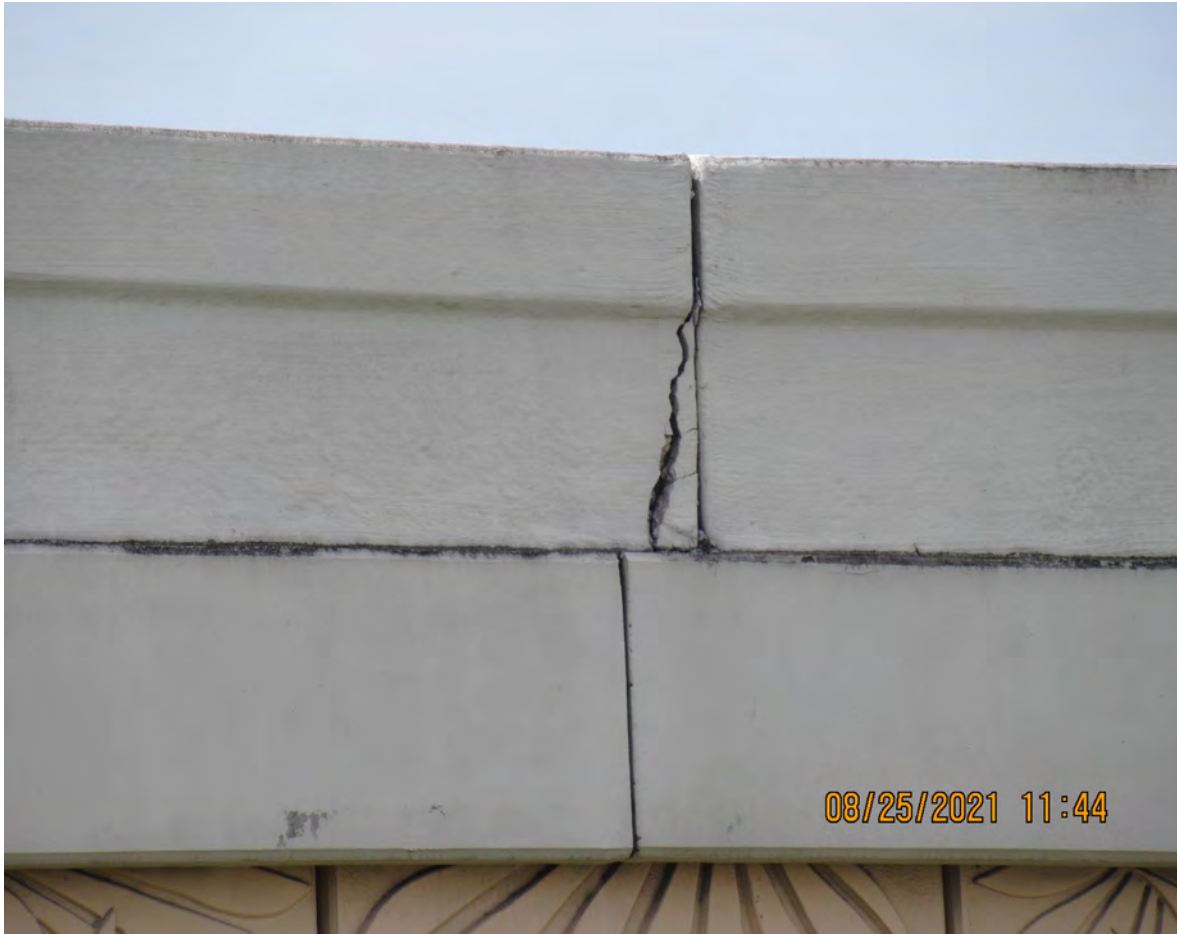
**ROADWAY INSPECTION
LOCATION: MILE MARKER 6.80 MILES
WESTBOUND CD-RAMP TO NW 82nd AVENUE**

CRACKED BARRIER WALL

ITEM NOTED TO BE ADDRESSED BY MDX MAINTENANCE

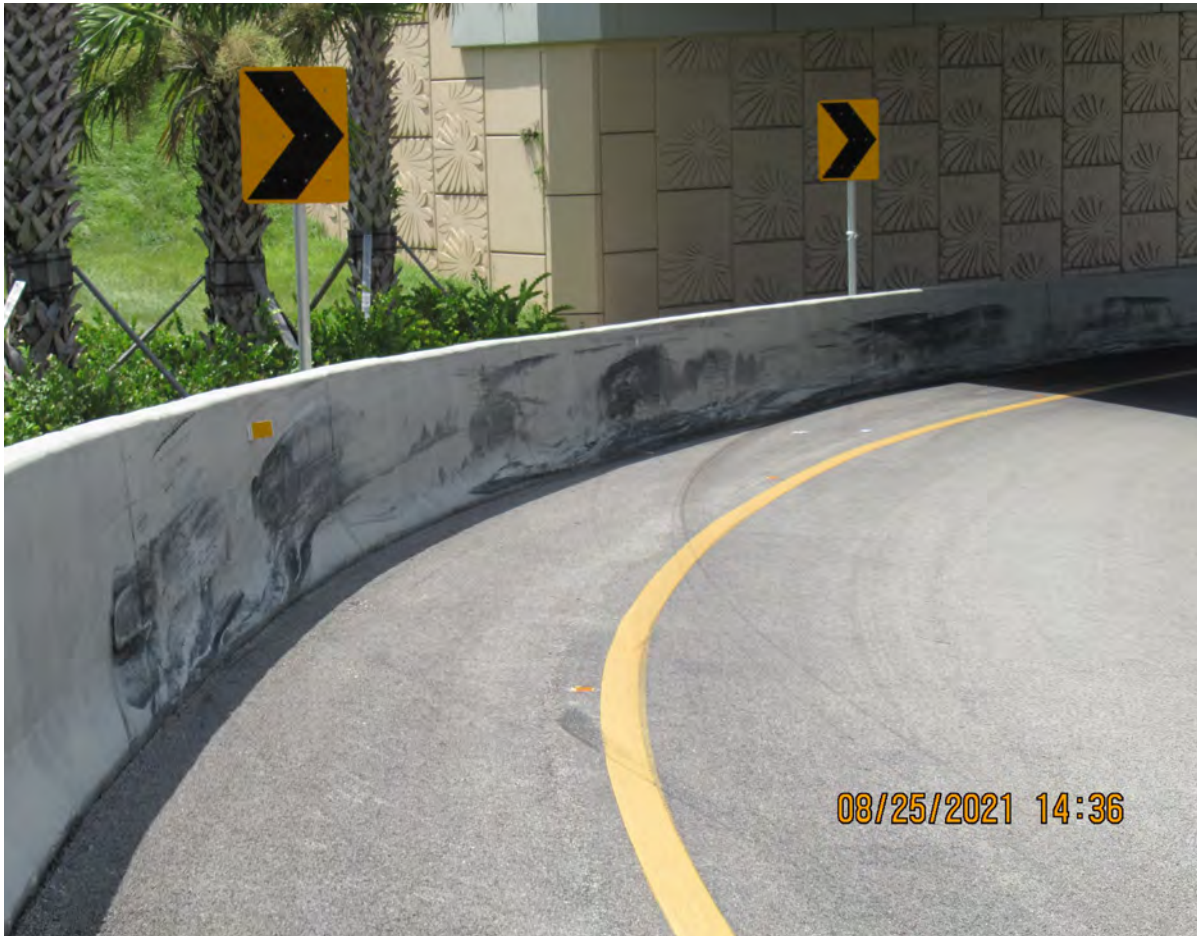
**ROADWAY INSPECTION
LOCATION: MILE MARKER 5.52 MILES
WESTBOUND OFF-RAMP TO SOUTHBOUND
NW 87th AVENUE**

SCUFF MARKS ON BARRIER WALL

ITEM NOTED TO BE ADDRESSED BY MDX MAINTENANCE

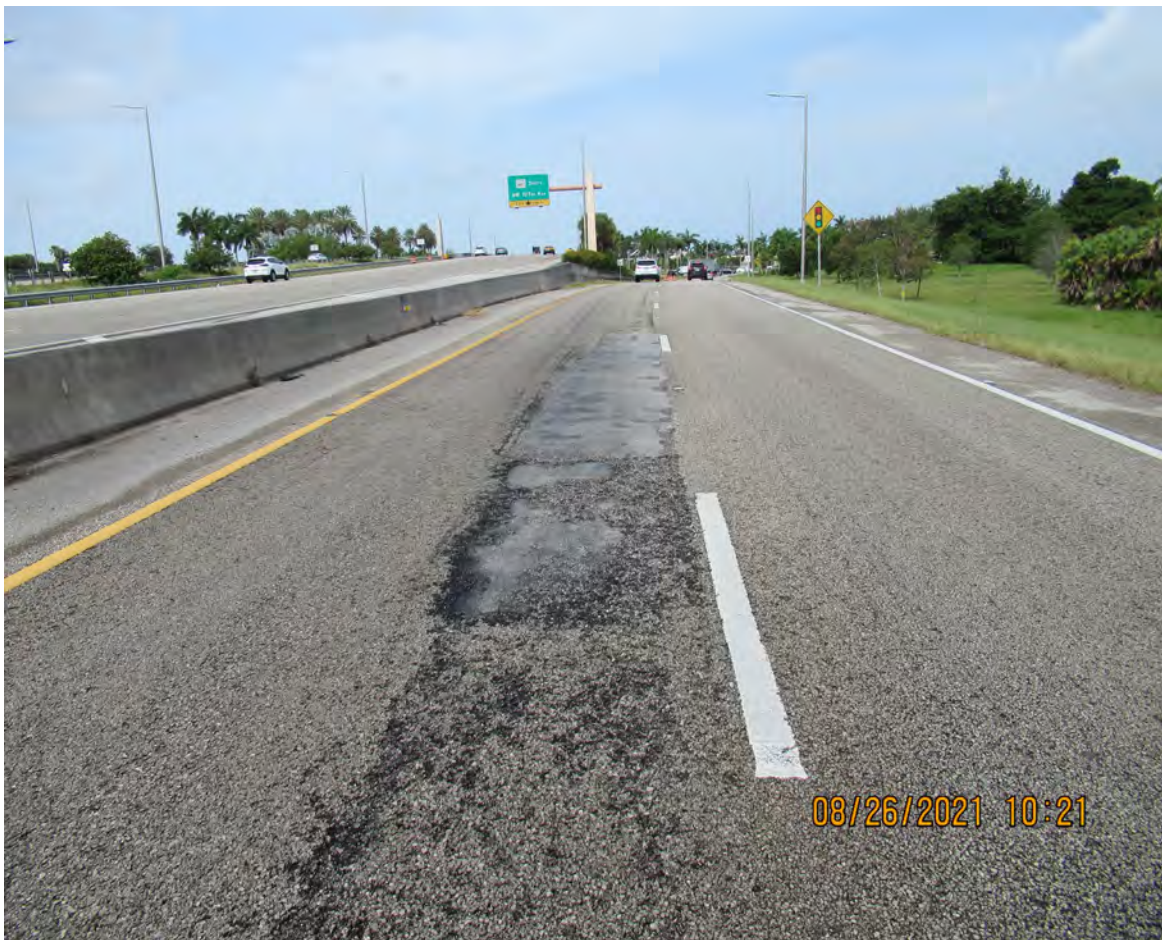
**ROADWAY INSPECTION
LOCATION: MILE MARKER 3.80 MILES
WESTBOUND OFF-RAMP TO NORTHBOUND
NW 107th AVENUE**

DETERIORATED PAVEMENT

ITEM NOTED TO BE ADDRESSED BY MDX MAINTENANCE

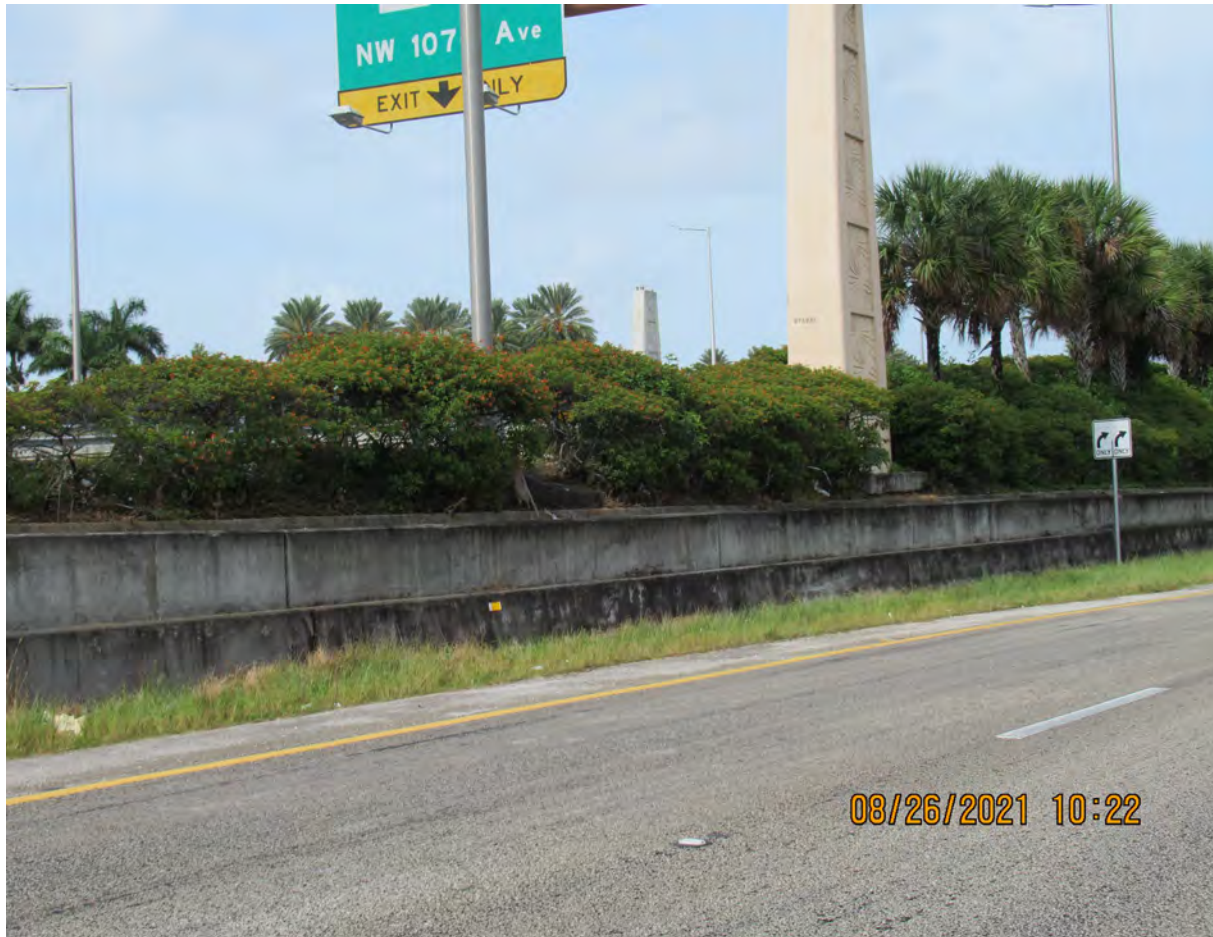
**ROADWAY INSPECTION
LOCATION: MILE MARKER 3.70 MILES
WESTBOUND OFF-RAMP TO NORTHBOUND
NW 107th AVENUE**

DETERIORATED CLASS V COATING OM RETAINING WALL

ITEM NOTED TO BE ADDRESSED BY MDX WORK PROGRAM No. 30037

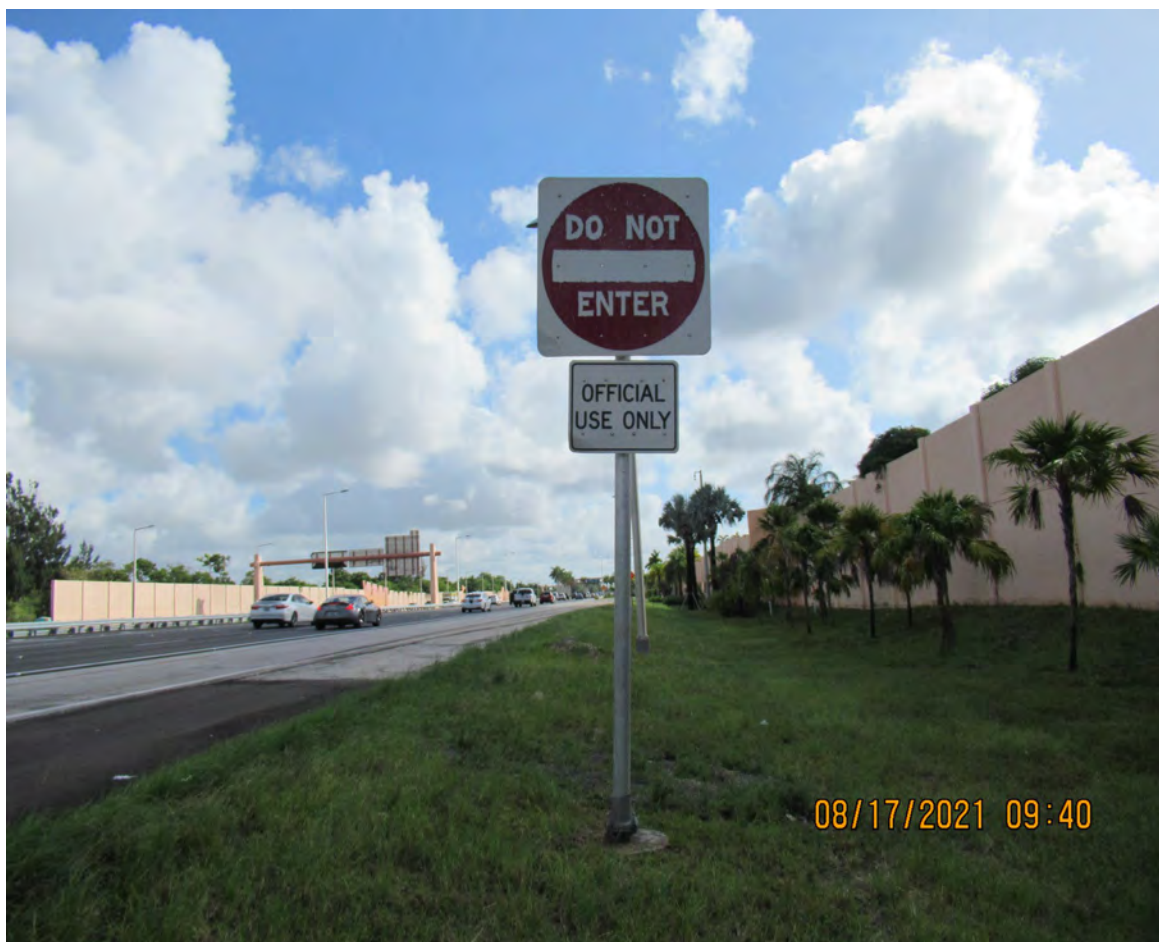
**ROADWAY INSPECTION
LOCATION: MILE MARKER 1.00 MILES
NORTHBOUND MAINLINE**

**DETERIORATED REFLECTIVE SHEETING ON DO NOT ENTER SIGN
(TYPICAL OF TWO SIGNS)**

ITEM NOTED TO BE ADDRESSED BY MDX MAINTENANCE

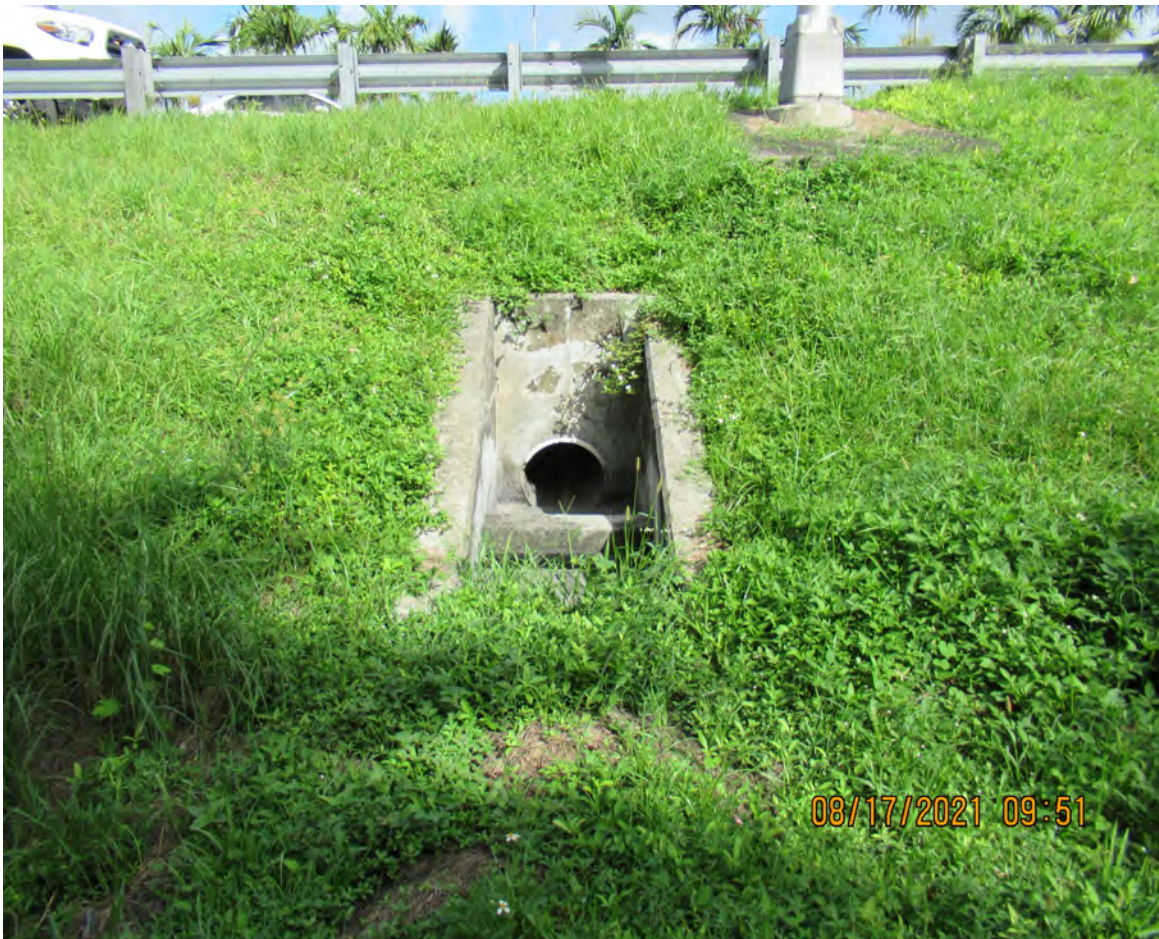
**ROADWAY INSPECTION
LOCATION: MILE MARKER 1.40 MILES
NORTHBOUND MAINLINE**

**SEDIMENT ABOVE END WALL INVERT ELEVATION
(TYPICAL THROUGHOUT THE CORRIDOR)**

ITEM NOTED TO BE ADDRESSED BY MDX MAINTENANCE

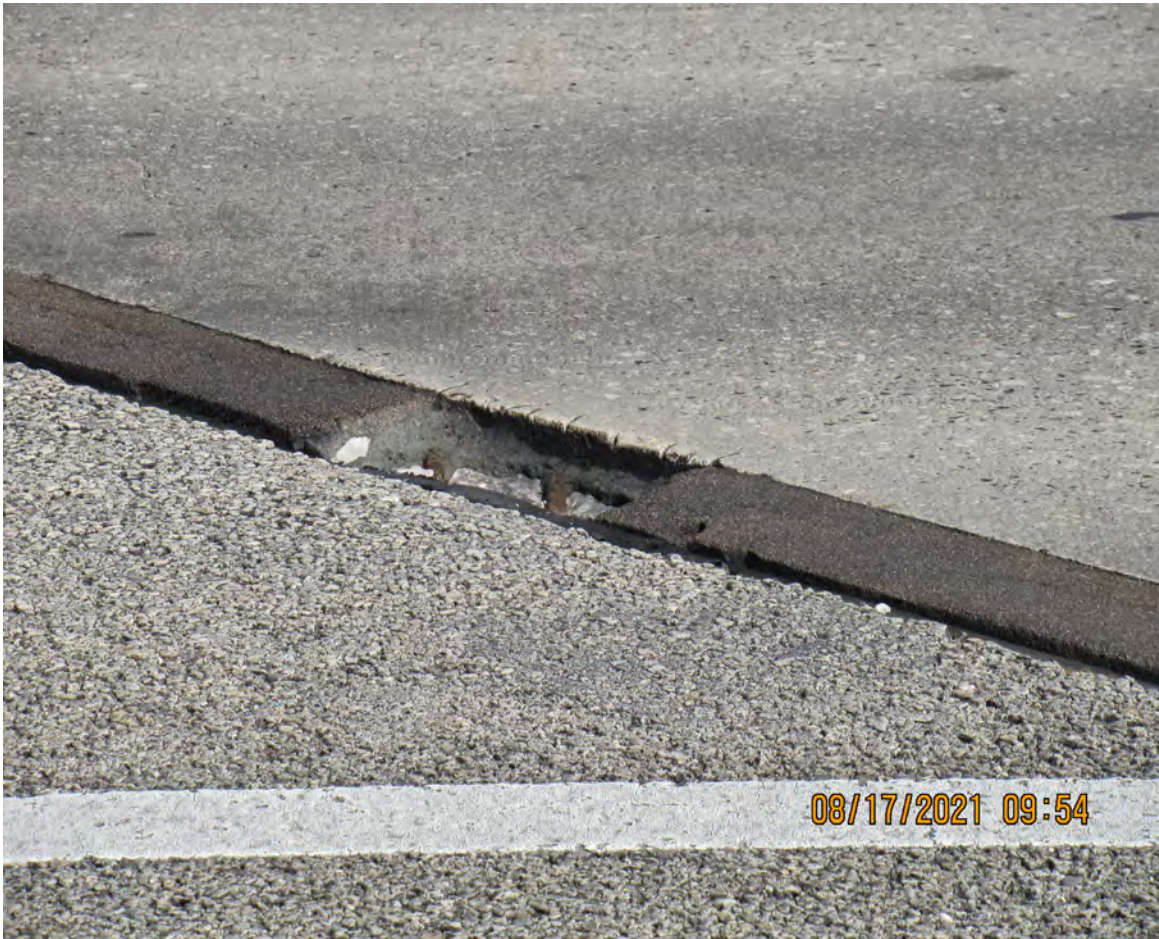
**ROADWAY INSPECTION
LOCATION: MILE MARKER 1.65 MILES
NORTHBOUND MAINLINE**

**DETERIORATED POLYMER NOSING BRIDGE JOINT (BRIDGE # 870462)
(TYPICAL AT VARIOUS LOCATIONS THROUGHOUT THE CORRIDOR)**

ITEM NOTED TO BE ADDRESSED BY MDX WORK PROGRAM No. 30029

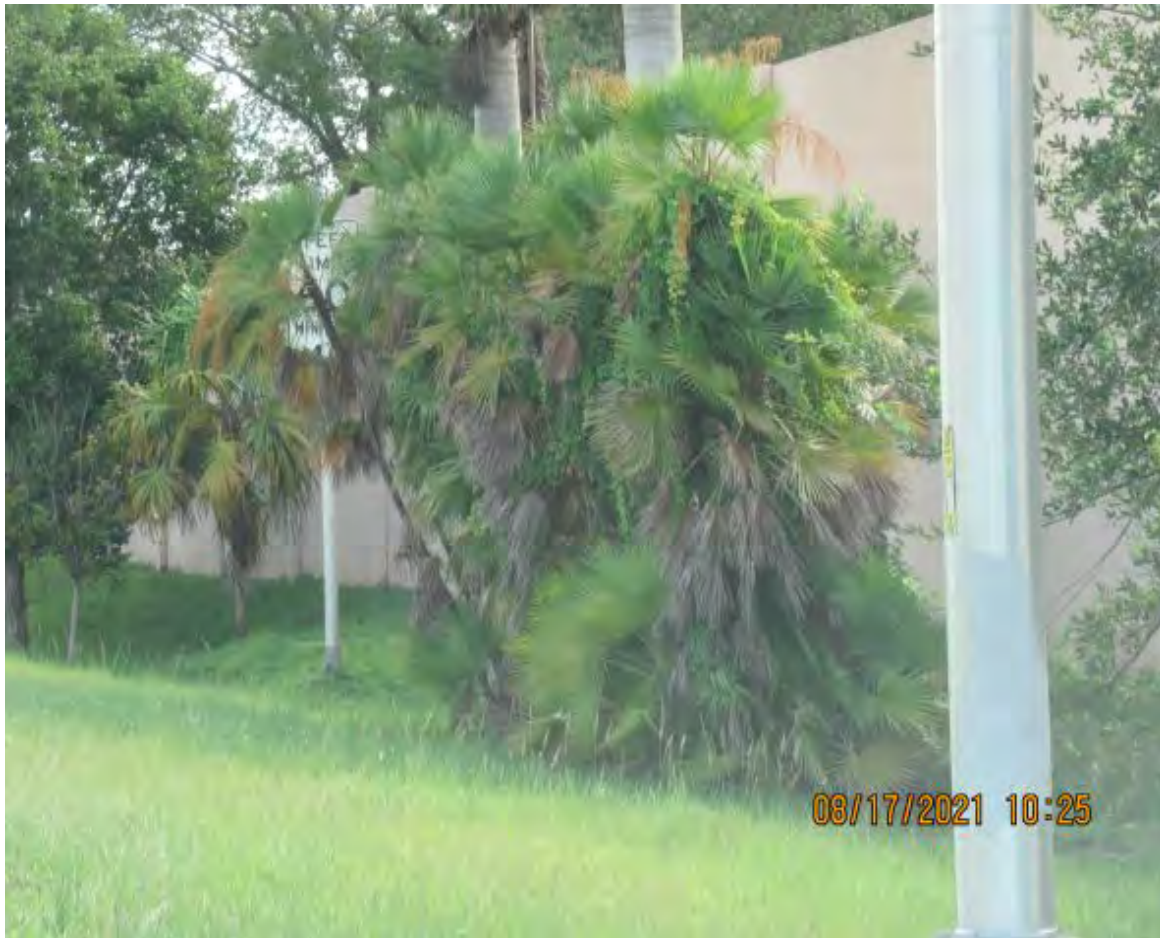
**ROADWAY INSPECTION
LOCATION: MILE MARKER 3.08 MILES
NORTHBOUND MAINLINE**

VEGETATION OBSTRUCTING SPEED LIMIT SIGN

ITEM NOTED TO BE ADDRESSED BY MDX MAINTENANCE

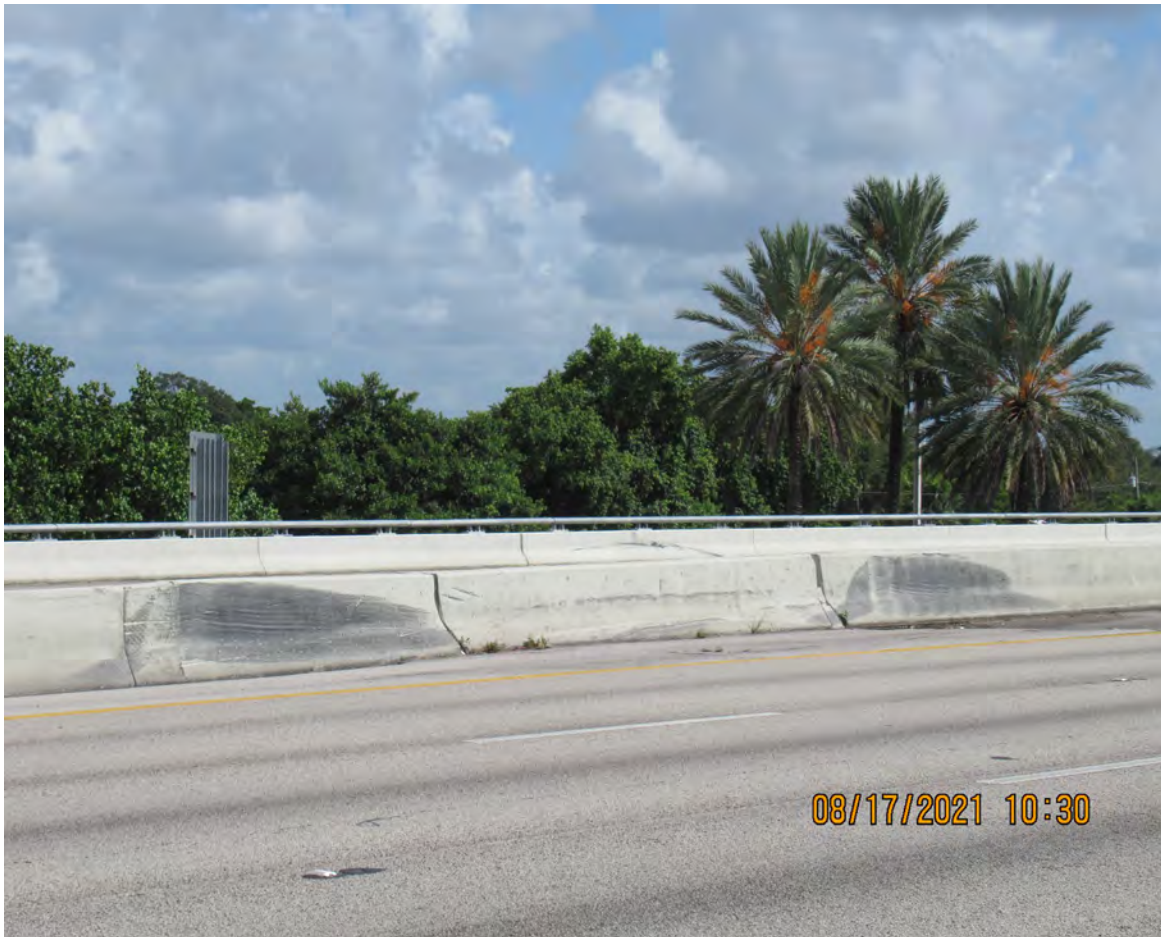
**ROADWAY INSPECTION
LOCATION: MILE MARKER 3.68 MILES
NORTHBOUND MAINLINE**

**TIRE SCUFF MARKS ON BARRIER WALL
(TYPICAL THROUGHOUT THE CORRIDOR)**

ITEM NOTED TO BE ADDRESSED BY MDX MAINTENANCE

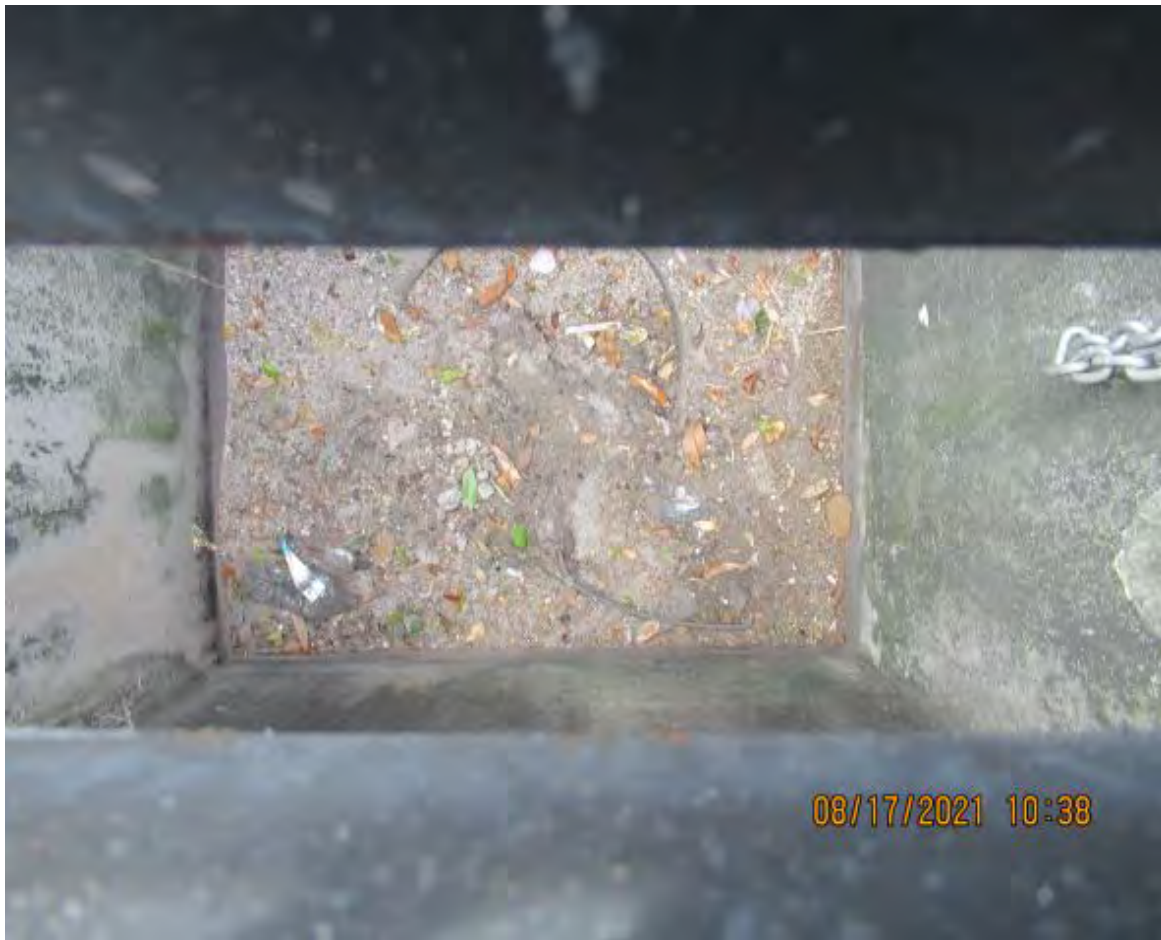
**ROADWAY INSPECTION
LOCATION: MILE MARKER 4.00 MILES
NORTHBOUND MAINLINE**

**SILTED DRAINAGE STRUCTURE
(TYPICAL THROUGHOUT THE CORRIDOR)**

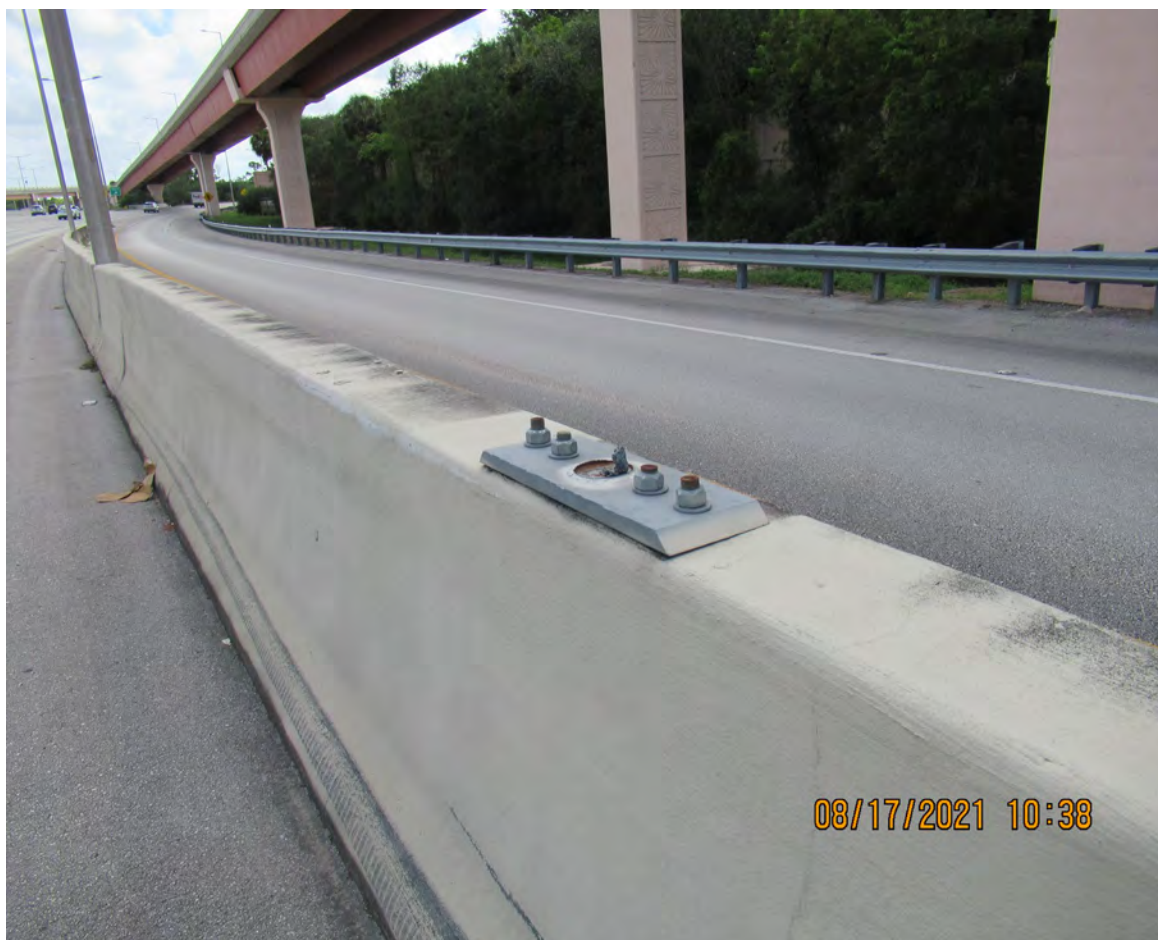
**ROADWAY INSPECTION
LOCATION: MILE MARKER 4.20 MILES
NORTHBOUND MAINLINE**

MISSING MILE MARKER SIGN (MILE POST 4.2)

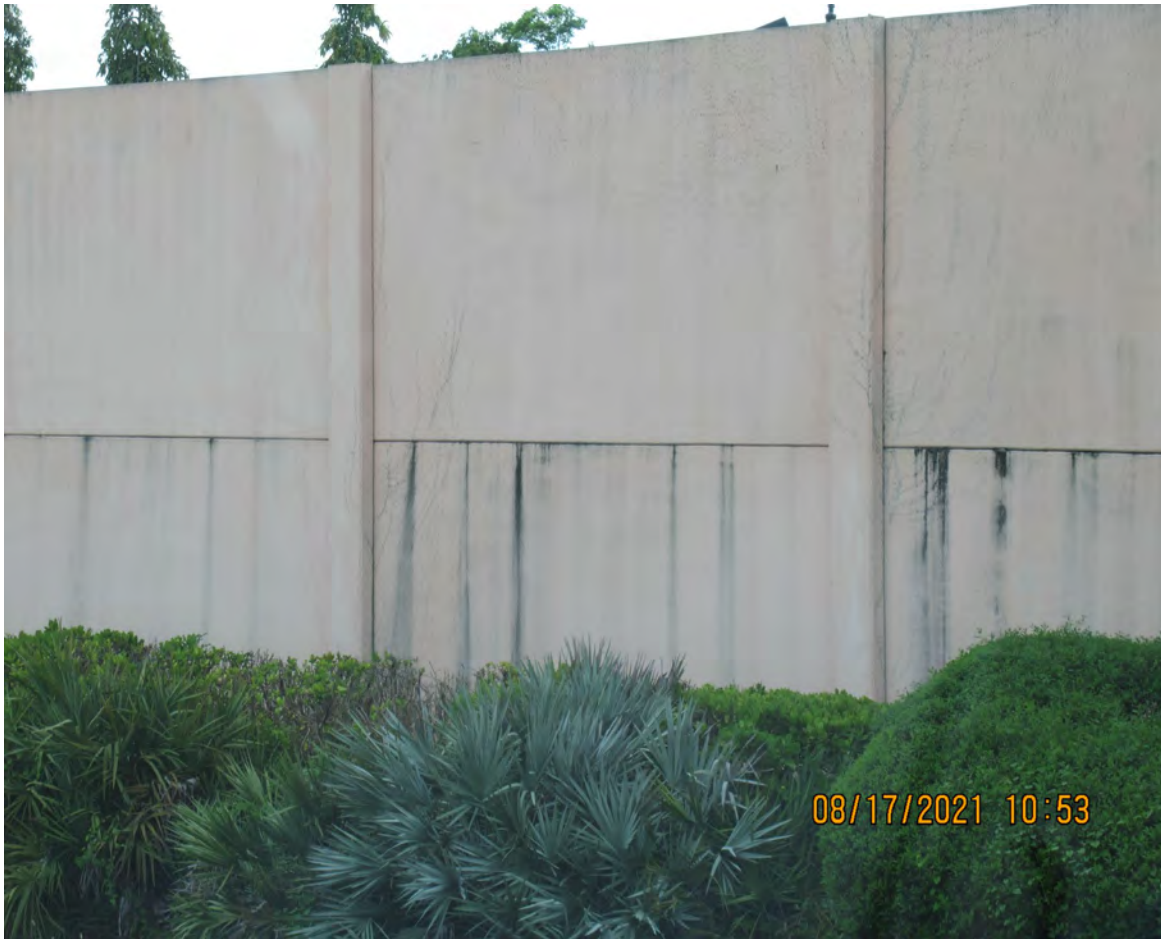
**ROADWAY INSPECTION
LOCATION: MILE MARKER 4.60 MILES
NORTHBOUND MAINLINE**

**DETERIORATED CLASS V COATING ON SOUND WALL
(TYPICAL THROUGHOUT THE CORRIDOR)**

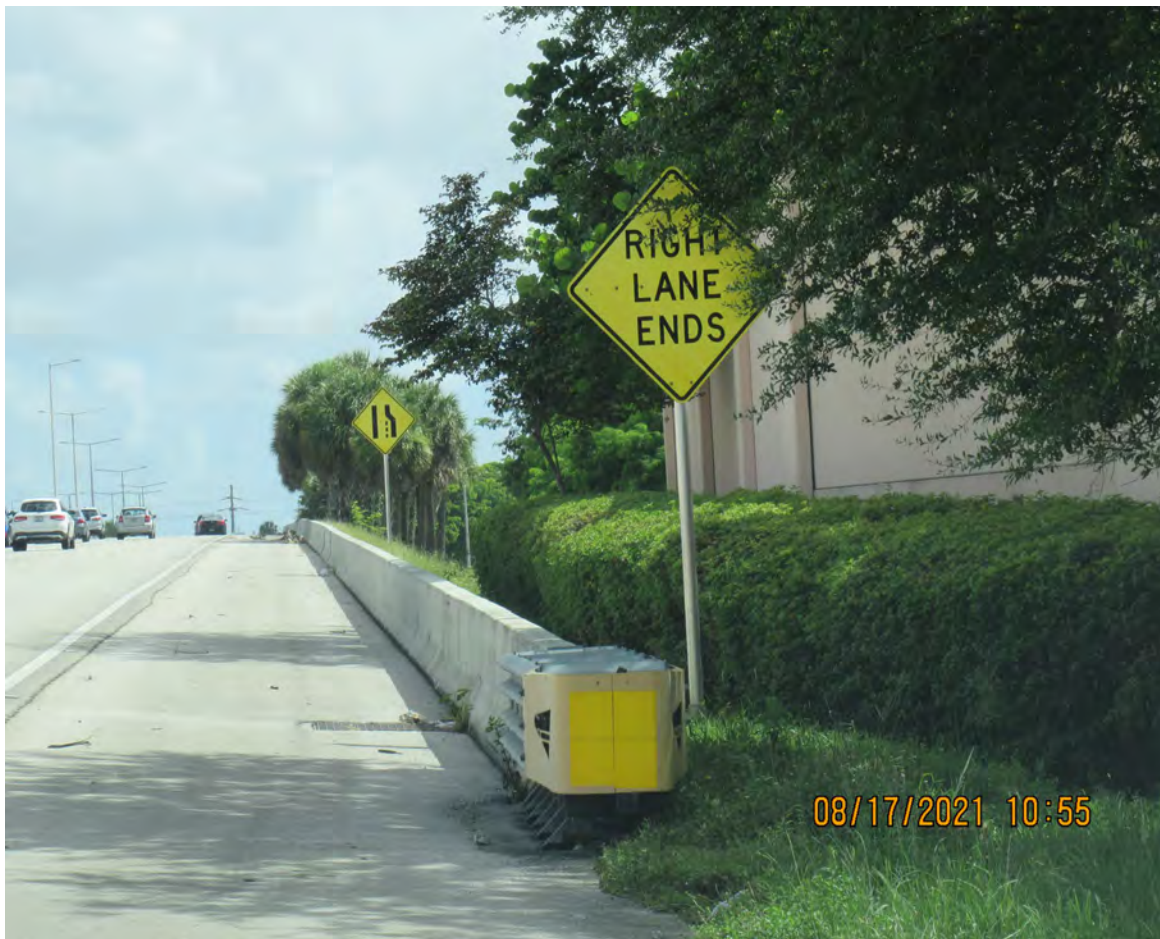
**ROADWAY INSPECTION
LOCATION: MILE MARKER 4.72 MILES
NORTHBOUND ON-RAMP FROM KENDALL DR.**

OVERGROWN VEGETATION OBSTRUCTING SIGN

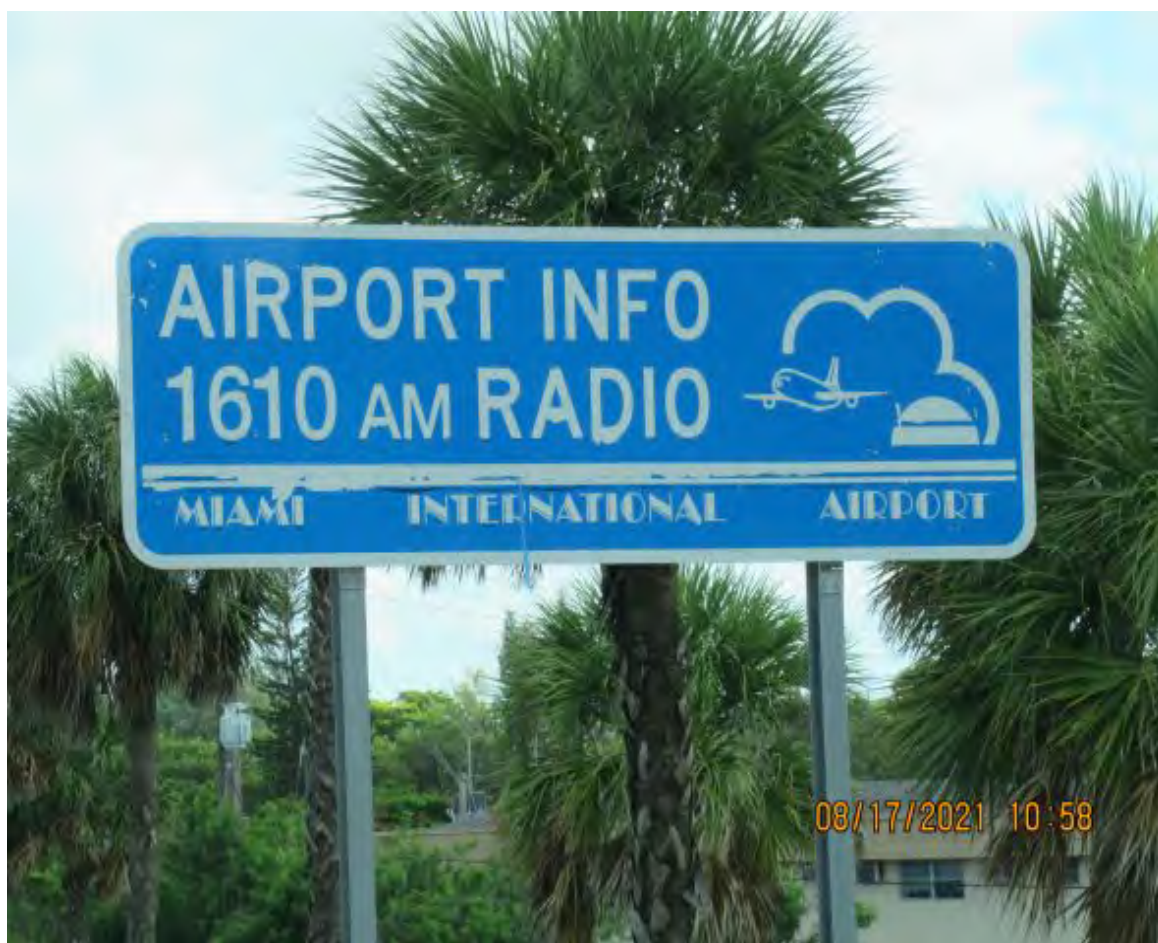
**ROADWAY INSPECTION
LOCATION: MILE MARKER 5.04 MILES
NORTHBOUND ON-RAMP FROM KENDALL DR.**

DETERIORATED REFLECTIVE SHEETING
