Annual Inspection Report 2021

General Engineering Consultant to the
Miami-Dade County Expressway Authority

ANNUAL INSPECTION REPORT 2021

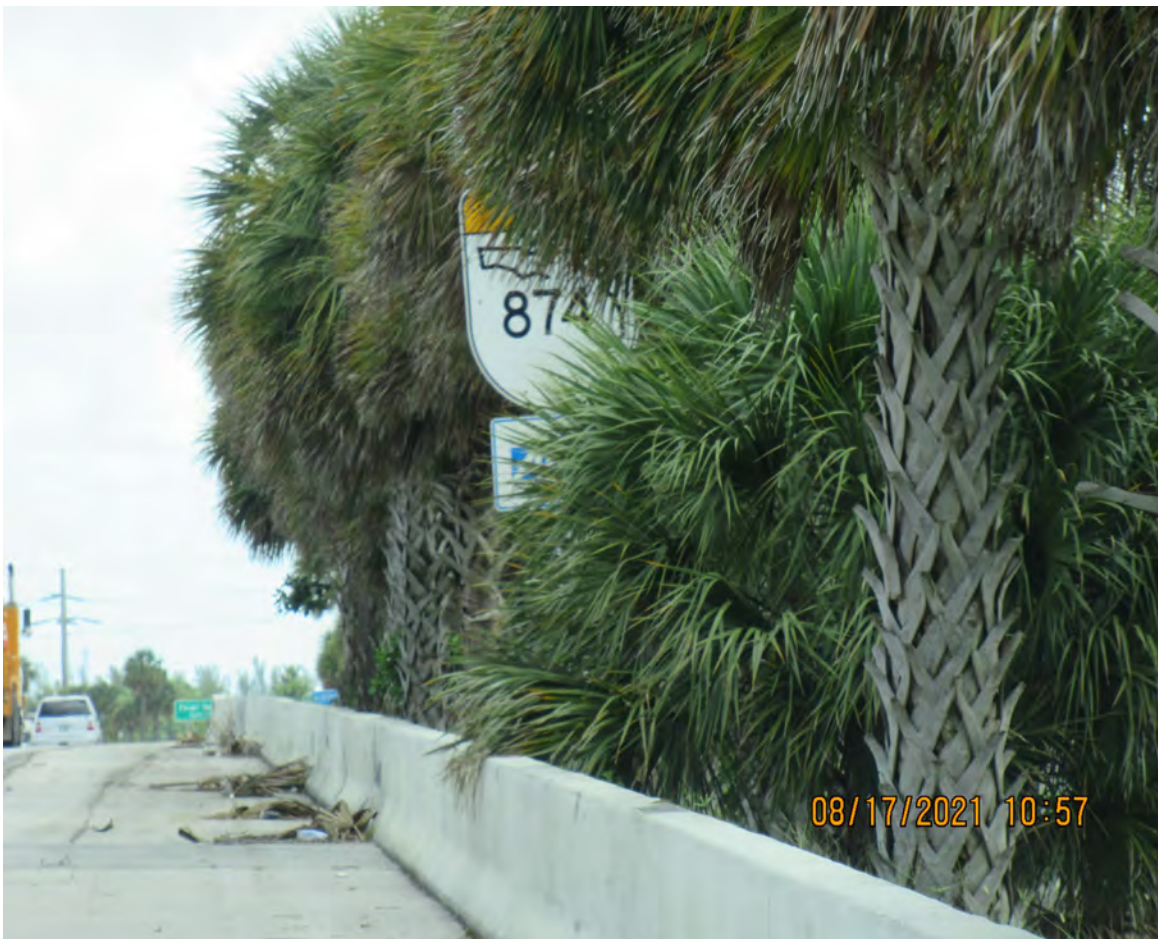
**ROADWAY INSPECTION
LOCATION: MILE MARKER 5.0 MILES
NORTHBOUND MAINLINE**

OVERGROWN VEGETATION OBSTRUCTING SIGN

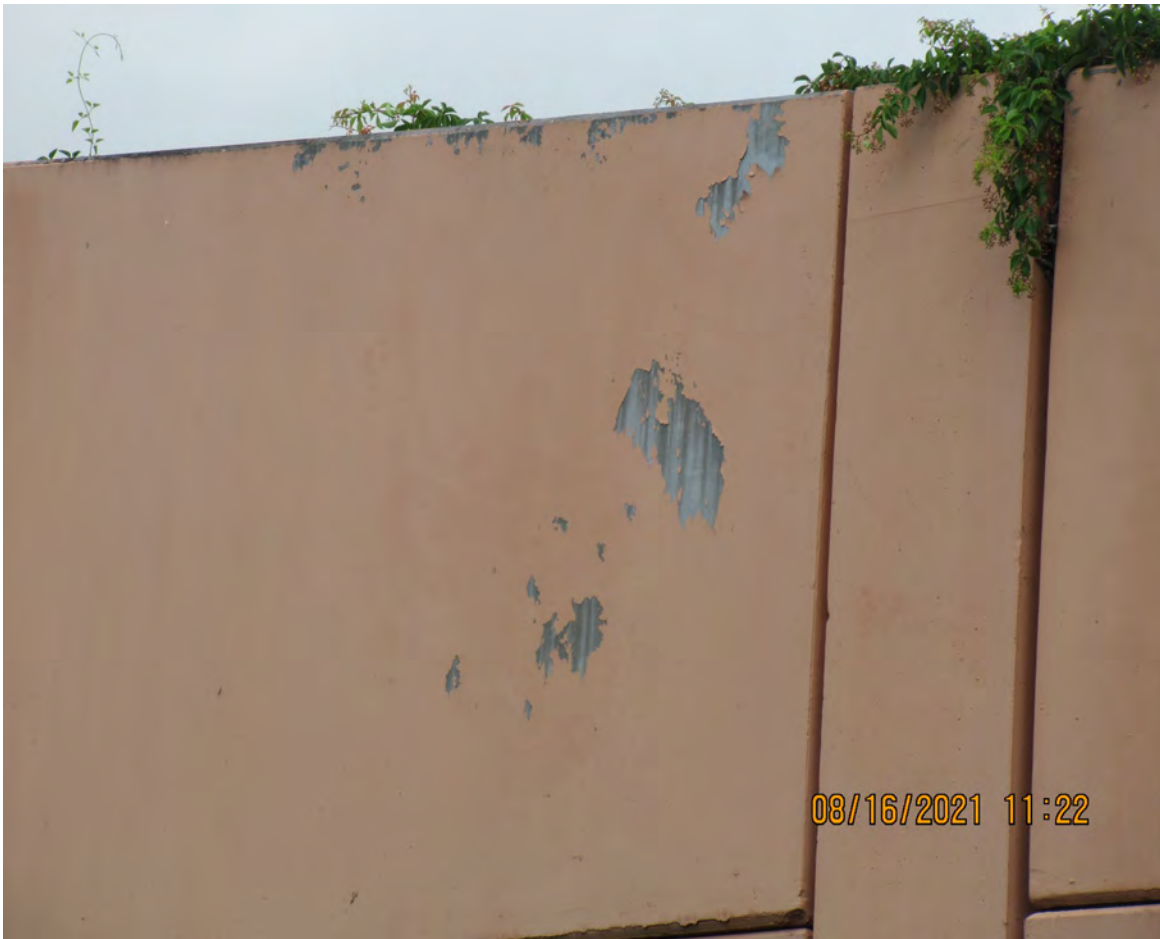
**ROADWAY INSPECTION
LOCATION: MILE MARKER 2.80 MILES
SOUTHBOUND MAINLINE**

**DETERIORATED CLASS V COATING ON SOUND WALLS
(TYPICAL THROUGHOUT THE CORRIDOR)**

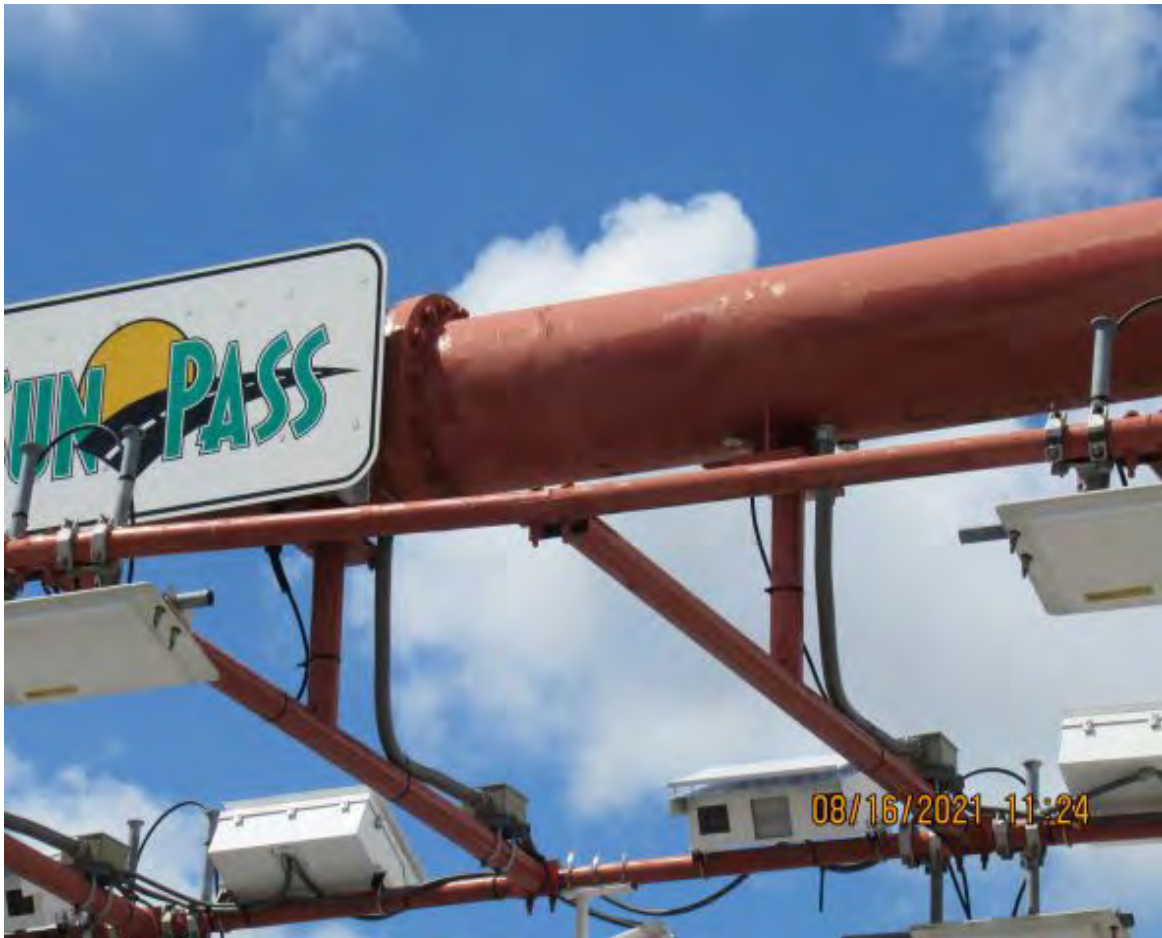
**ROADWAY INSPECTION
LOCATION: MILE MARKER 2.45 MILES
SOUTHBOUND MAINLINE**

**DETERIORATED PAINT ON ORT STRUCTURE
UPRIGHTS AND MONOTUBE (STRUCTURE # 87S937)**

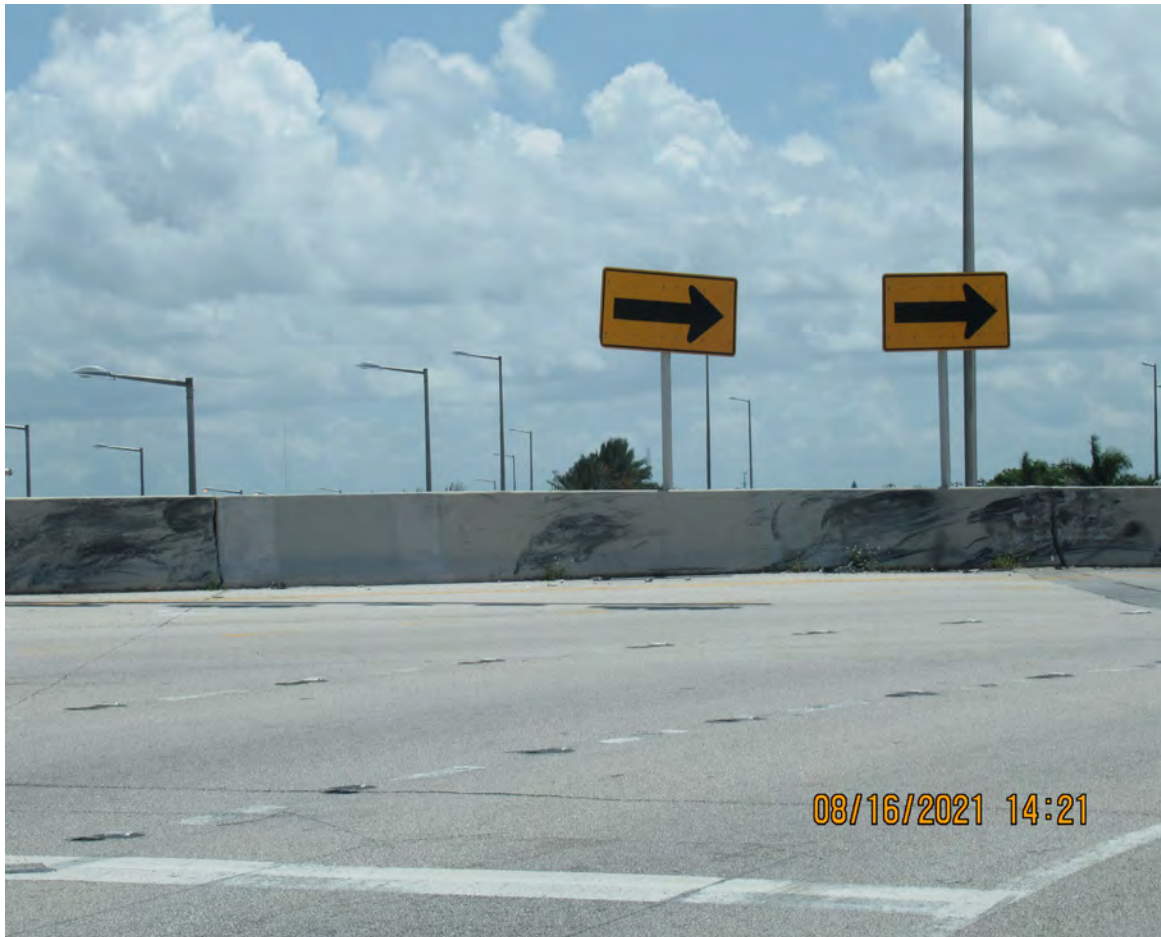
**ROADWAY INSPECTION
LOCATION: MILE MARKER 2.40 MILES
SOUTHBOUND OFF-RAMP TO KILLIAN PKWY. WEST**

MISSING SINGLE POST ARROW SIGN

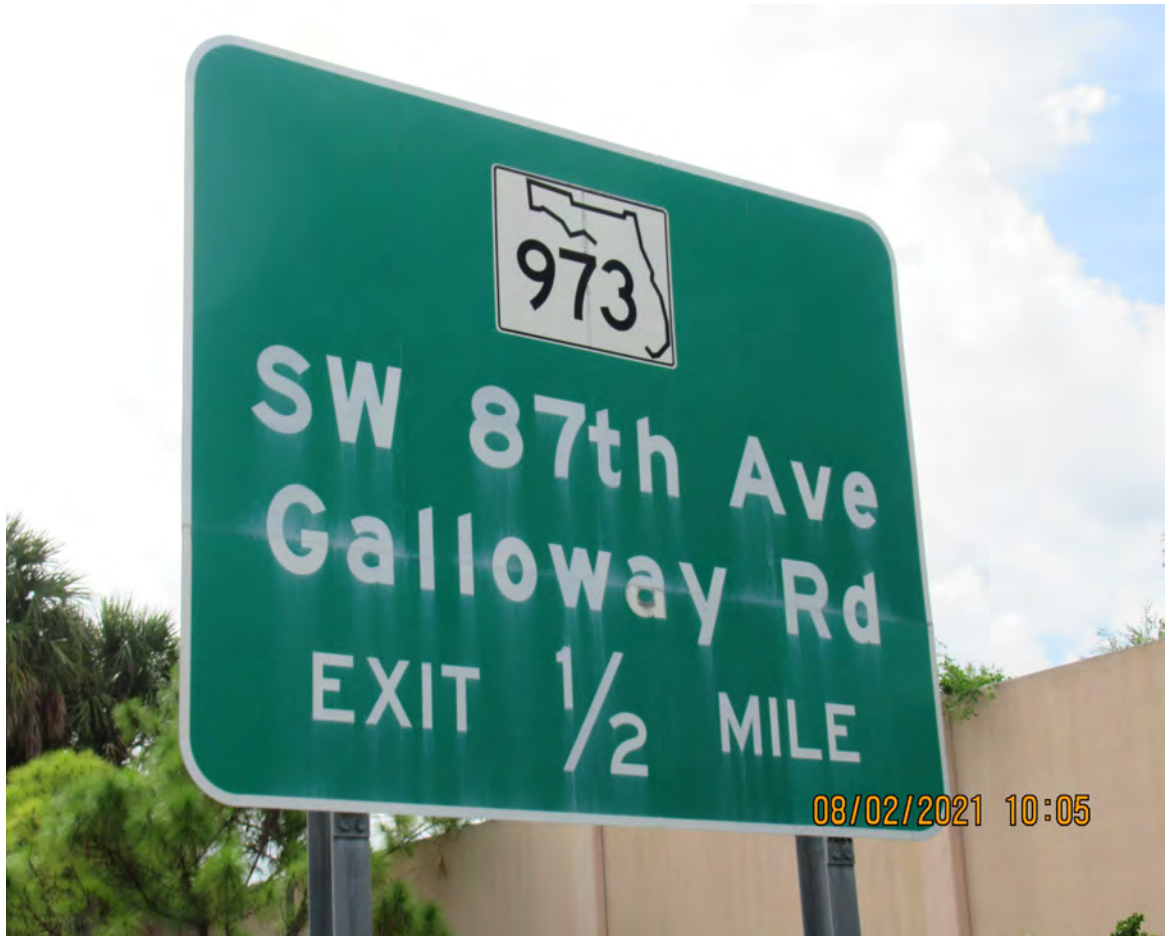
**ROADWAY INSPECTION
LOCATION: MILE MARKER 0.65 MILES
EASTBOUND MAINLINE**

DETERIORATED REFLECTIVE SHEETING ON SIGN PANEL

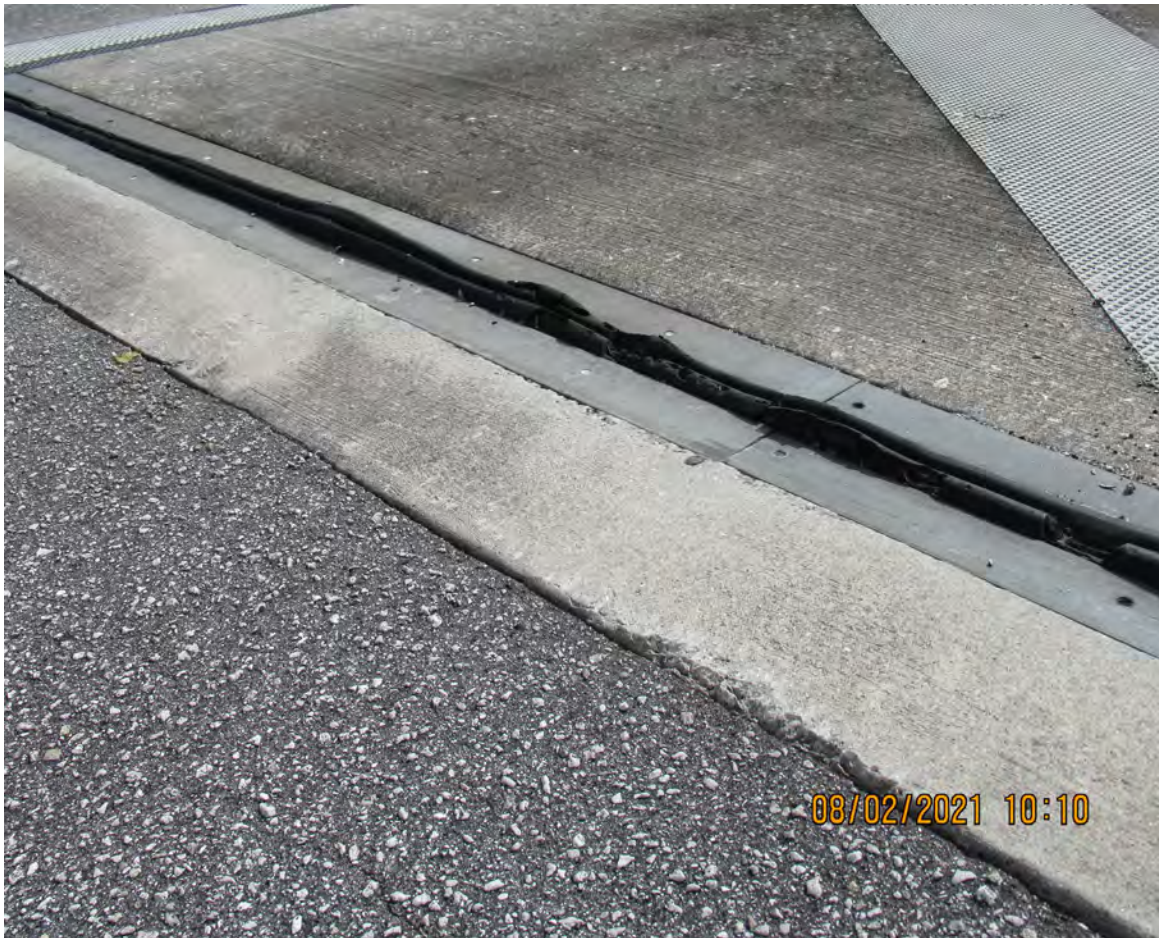
**ROADWAY INSPECTION
LOCATION: MILE MARKER 1.03 MILES
EASTBOUND MAINLINE**

**DETERIORATED EXPANSION JOINTS (BRIDGE #870557)
TYPICAL THROUGHOUT THE CORRIDOR**

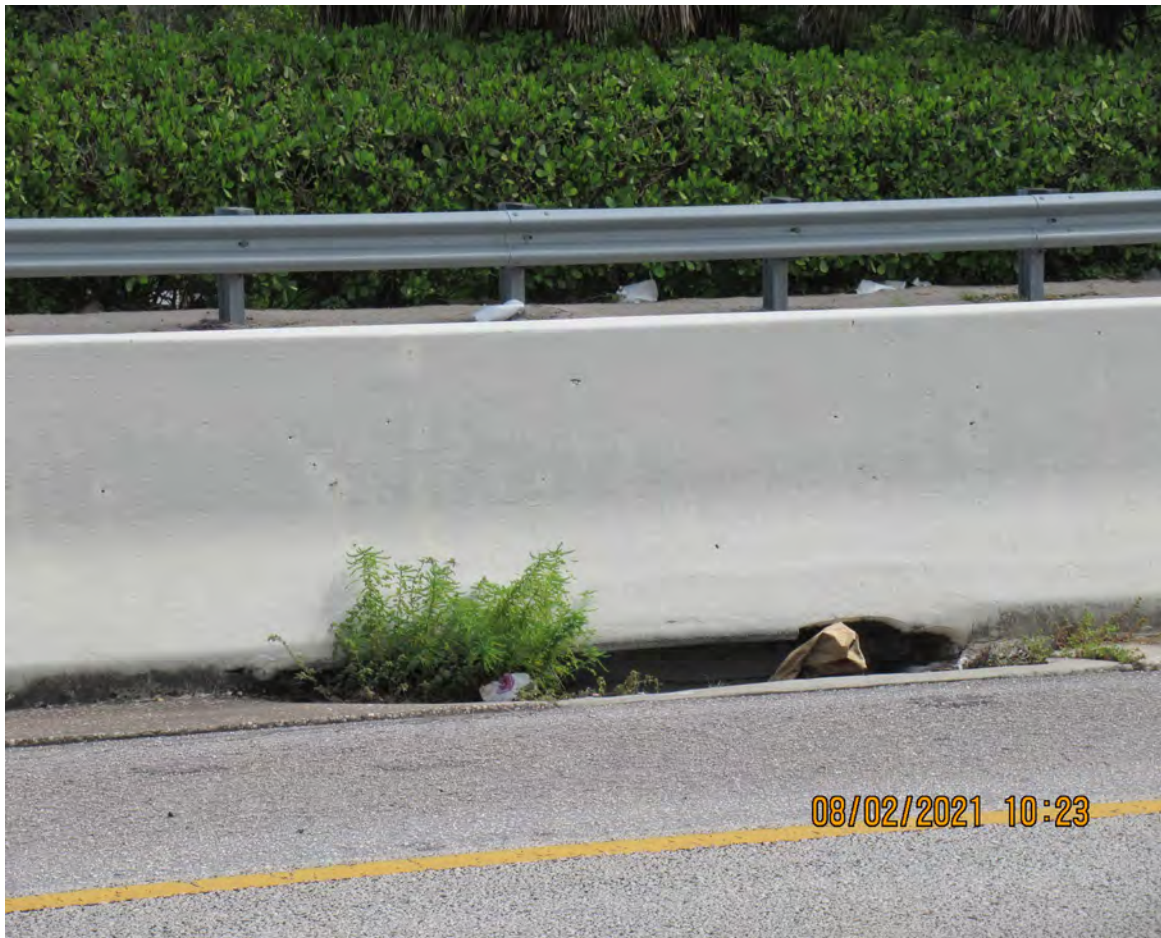
**ROADWAY INSPECTION
LOCATION: MILE MARKER 2.4 MILES
EASTBOUND MAINLINE (LEFT SHOULDER)**

**SILTED INLET
(TYPICAL THROUGHOUT THE CORRIDOR)**

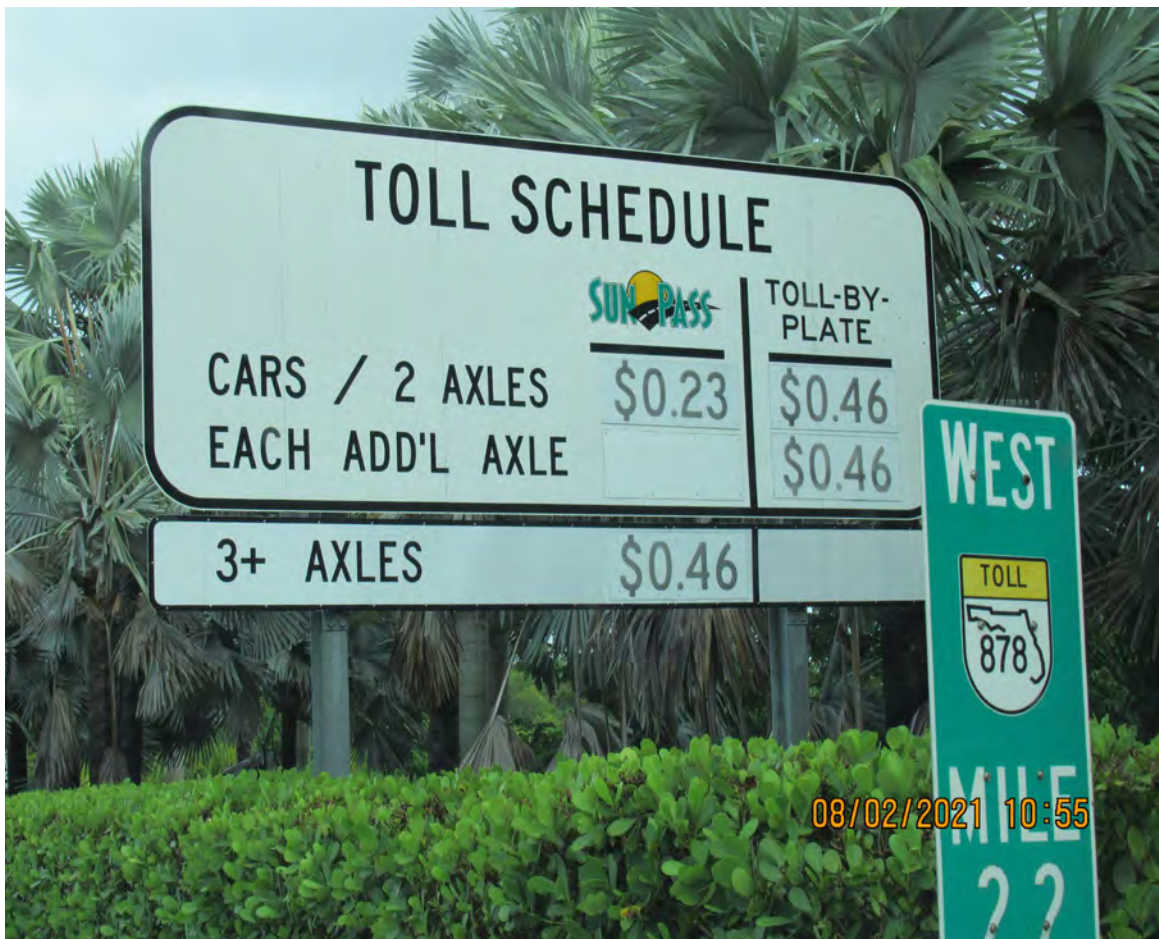
ROADWAY INSPECTION
LOCATION: MILE MARKER 2.20 MILES
WESTBOUND MAINLINE

**DETERIORATED REFLECTIVE SHEETING ON TOLL RATES
(TYPICAL THROUGHOUT THE CORRIDOR)**

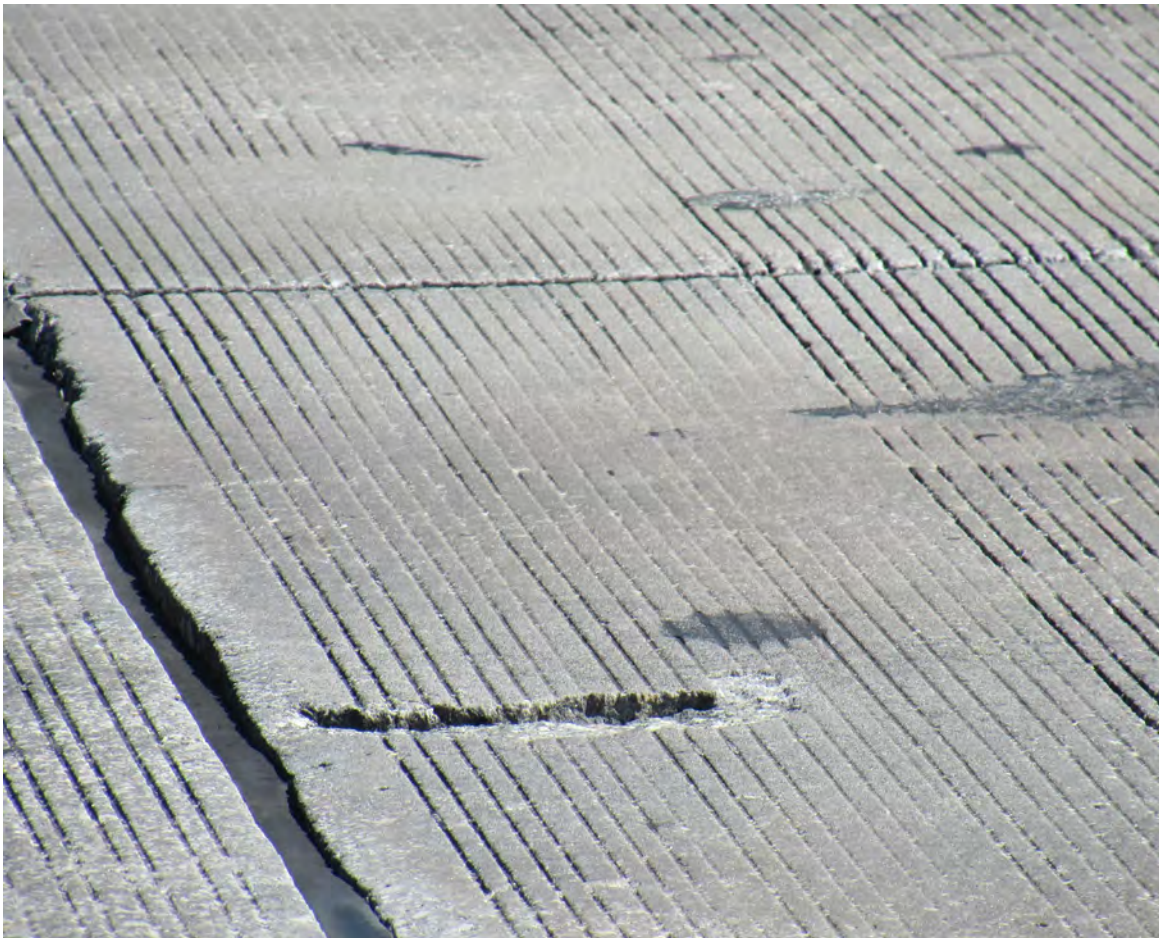
**ROADWAY INSPECTION
LOCATION: MILE MARKER 2.04 MILES
EASTBOUND MAINLINE**

SPALLS ON APPROACH SLAB (BRIDGE # 870721)

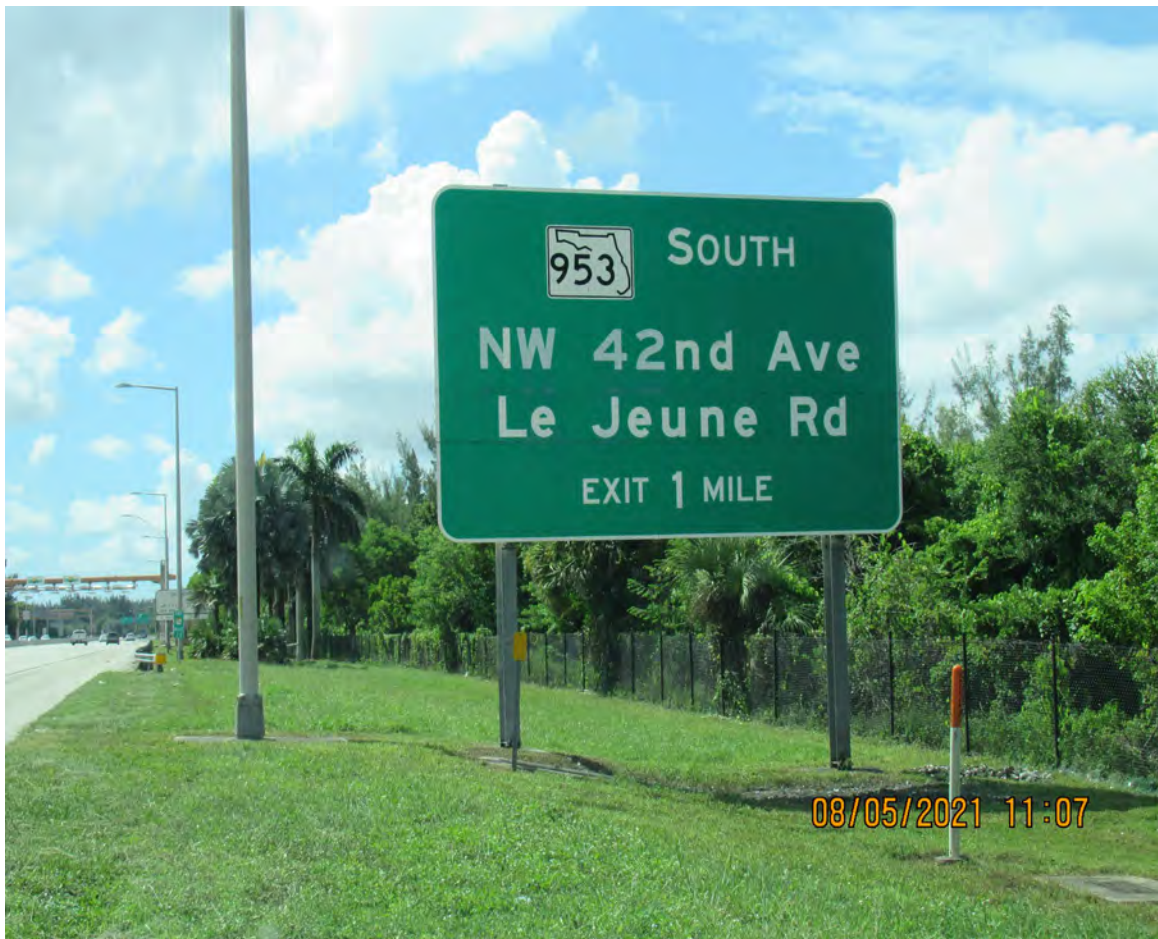
**ROADWAY INSPECTION
LOCATION: MILE MARKER 2.80 MILES
EASTBOUND MAINLINE**

DETERIORATED REFLECTIVE SHEETING ON SIGN PANEL

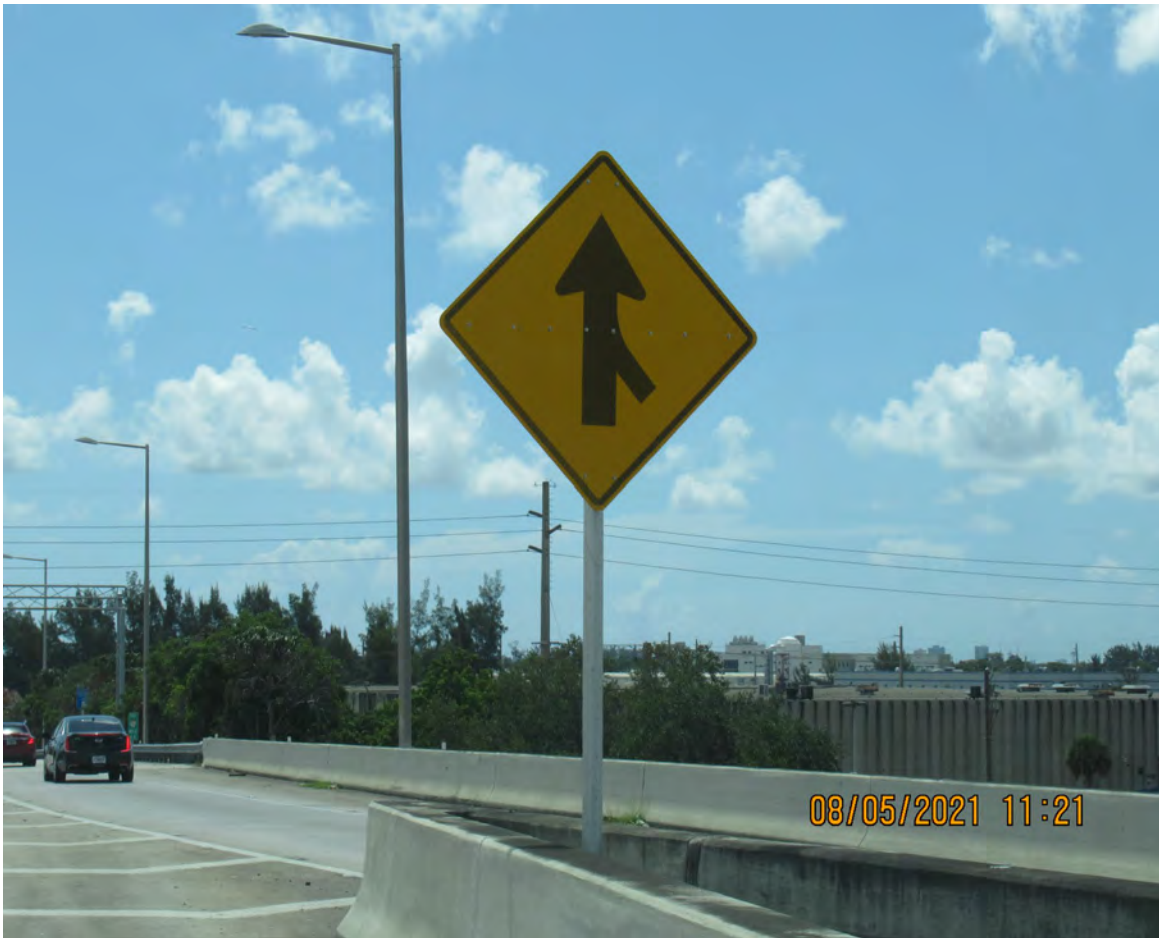
**ROADWAY INSPECTION
LOCATION: MILE MARKER 4.30 MILES
EASTBOUND MAINLINE**

DETERIORATED REFLECTIVE SHEETING

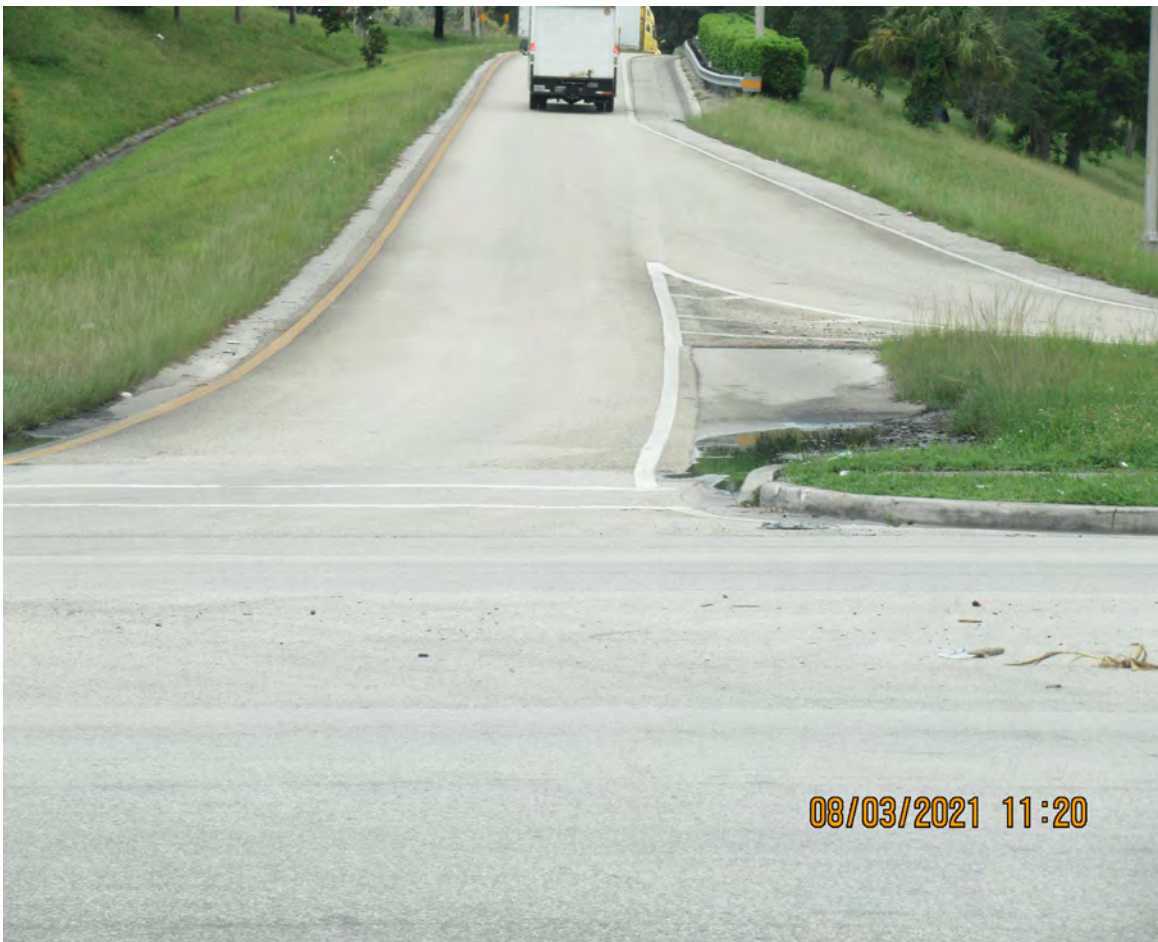
**ROADWAY INSPECTION
LOCATION: MILE MARKER 4.10 MILES
WESTBOUND ON-RAMP FROM NW 37th AVENUE**

PONDING WATER ON RAMP ENTRANCE

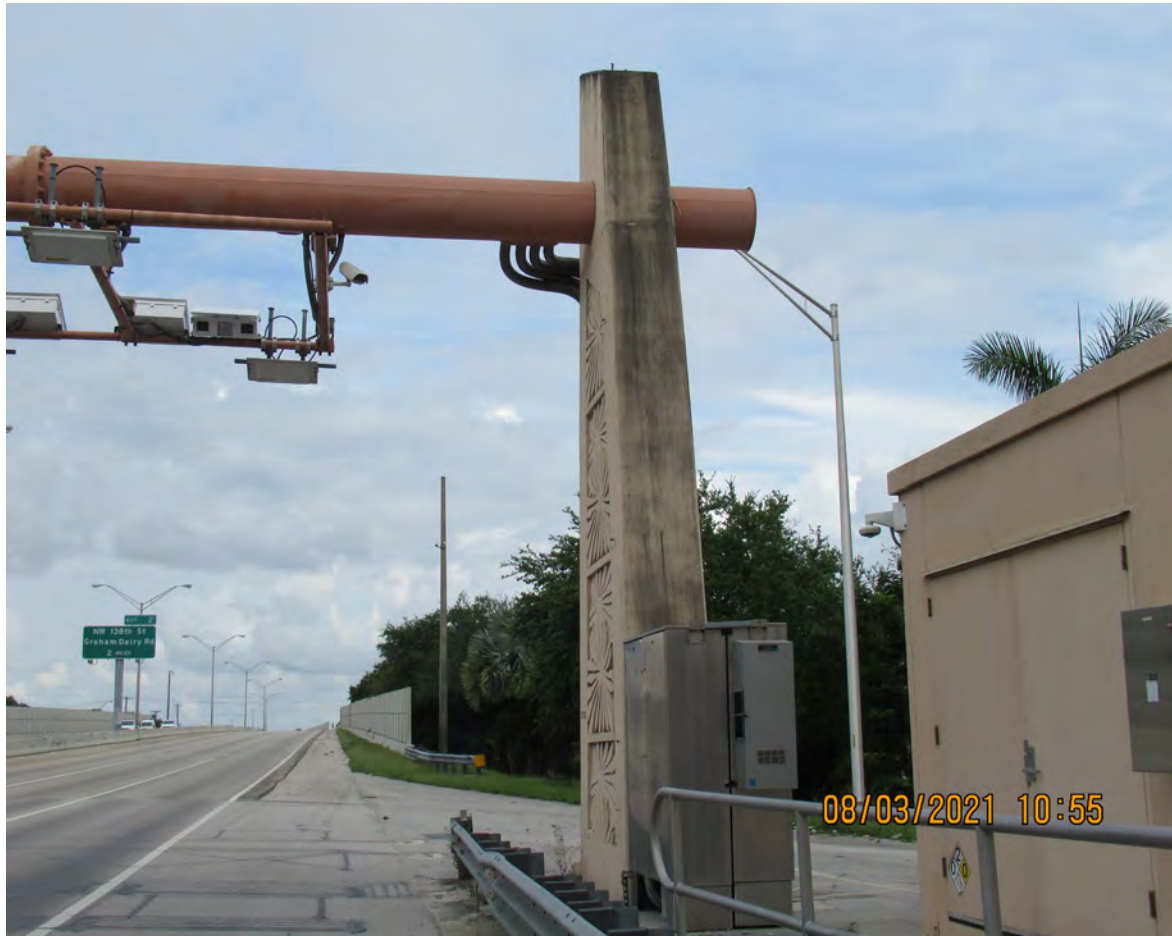
**ROADWAY INSPECTION
LOCATION: MILE MARKER 2.23 MILES
WESTBOUND MAINLINE**

**DETERIORATED PAINT ON STRUCTURE UPRIGHT AND MONOTUBE
(STRUCTURE # 87S933)**

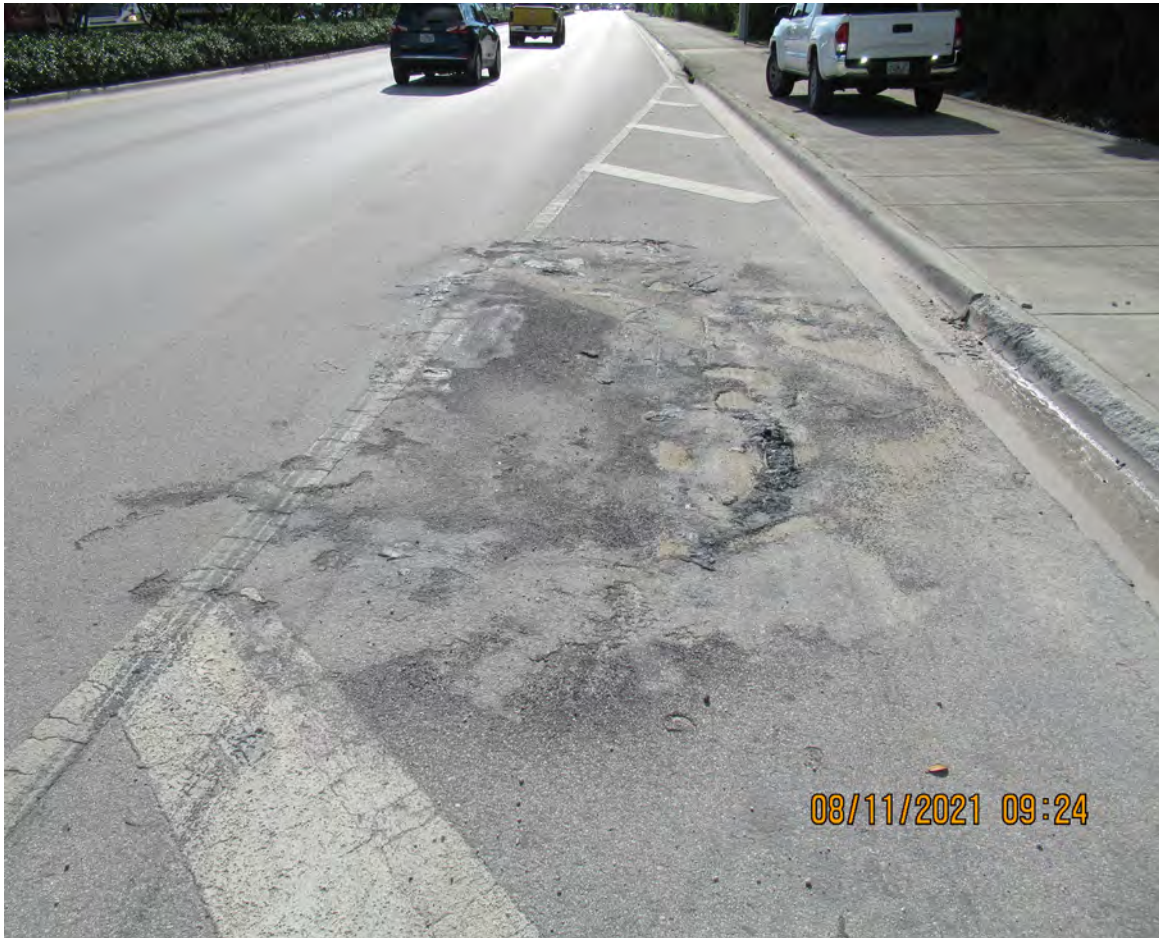
**ROADWAY INSPECTION
LOCATION: EASTBOUND NW 138TH ST
1,500' EAST OF NW 102ND AVENUE**

BURNED PAVEMENT, CHEVRON STRIPING AND DAMAGED CURB & GUTTER

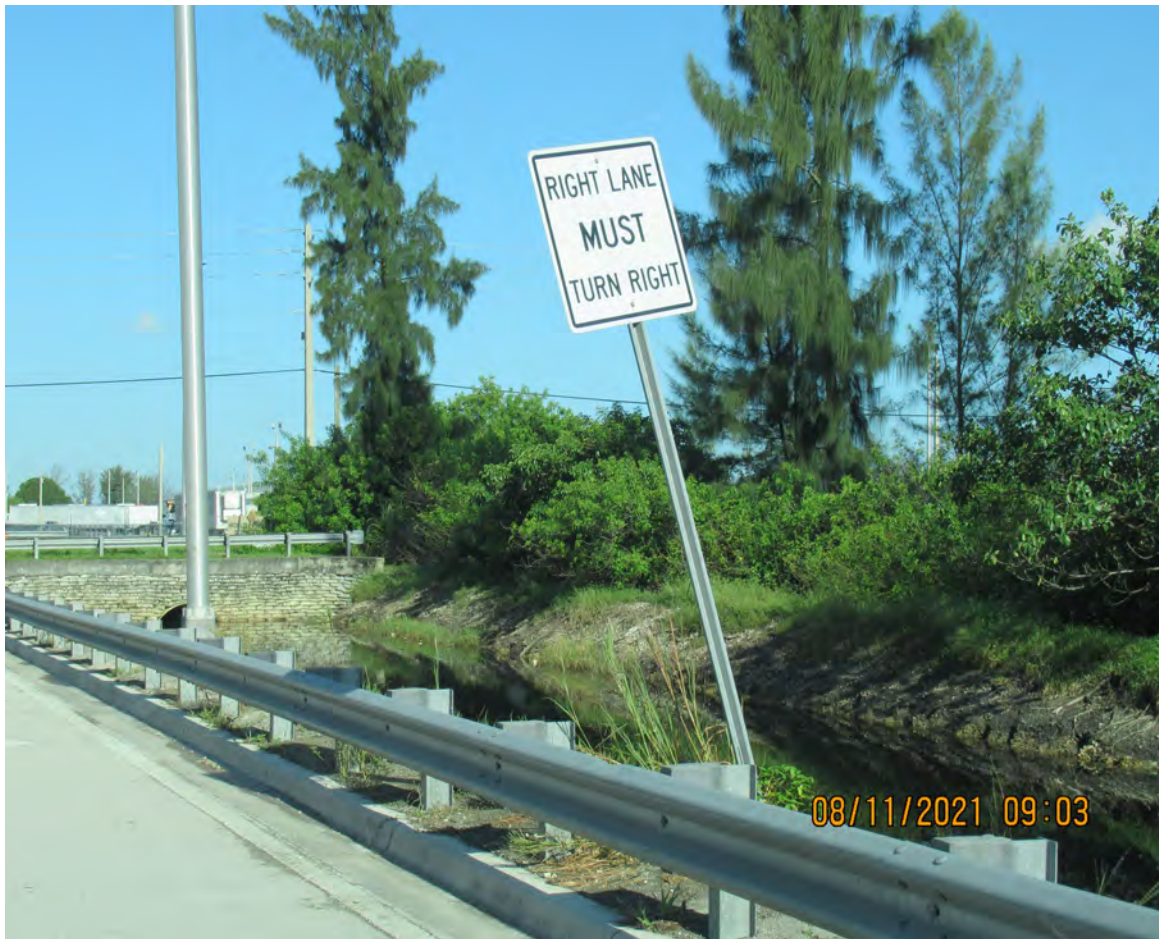
**ROADWAY INSPECTION
LOCATION: 275FT EAST OF NW 97th AVENUE
WESTBOUND NW 138th STREET**

LEANING SIGN

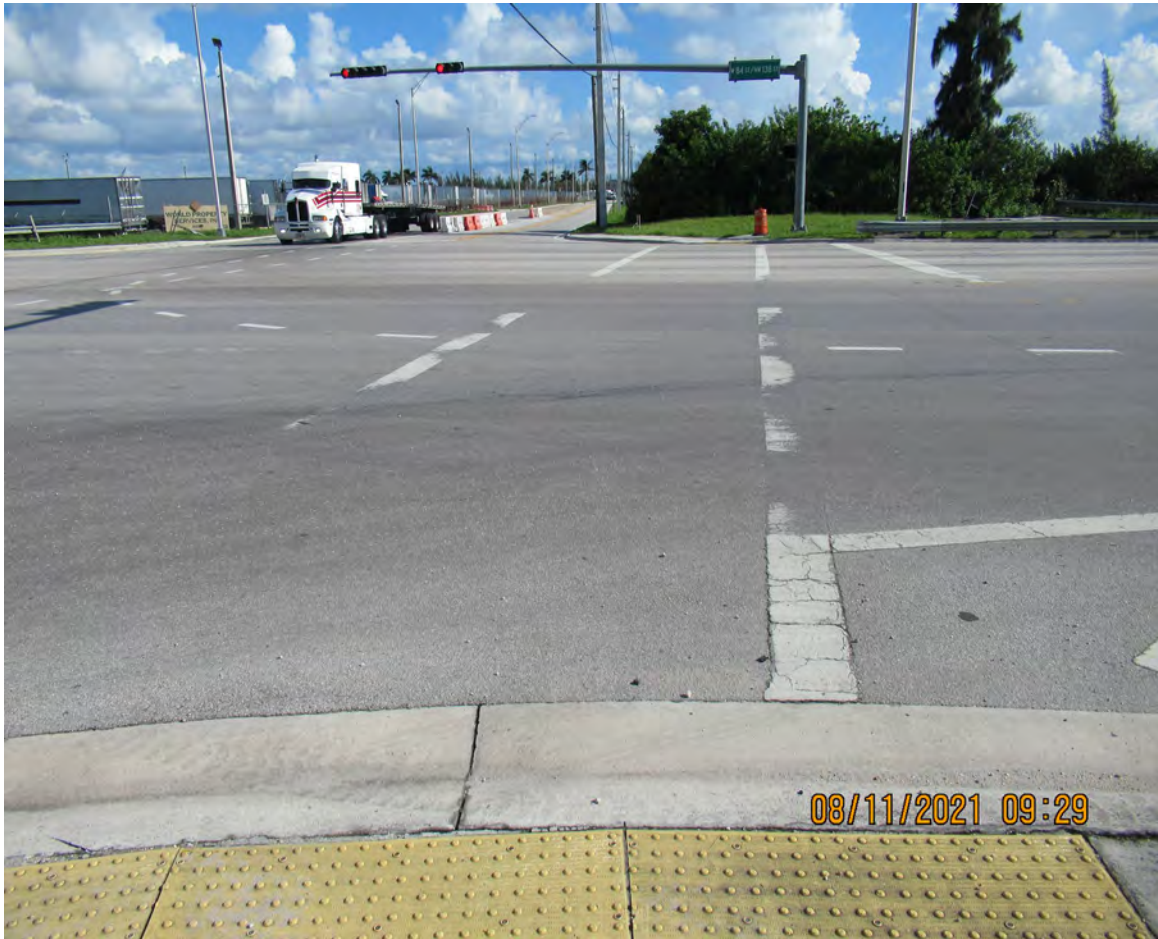
**ROADWAY INSPECTION
LOCATION: NW 102ND AVENUE
WESTBOUND NW 138th STREET**

**DETERIORATED STRIPING ON PEDESTRIAN CROSSWALK
(TYPICAL AT VARIOUS LOCATIONS)**

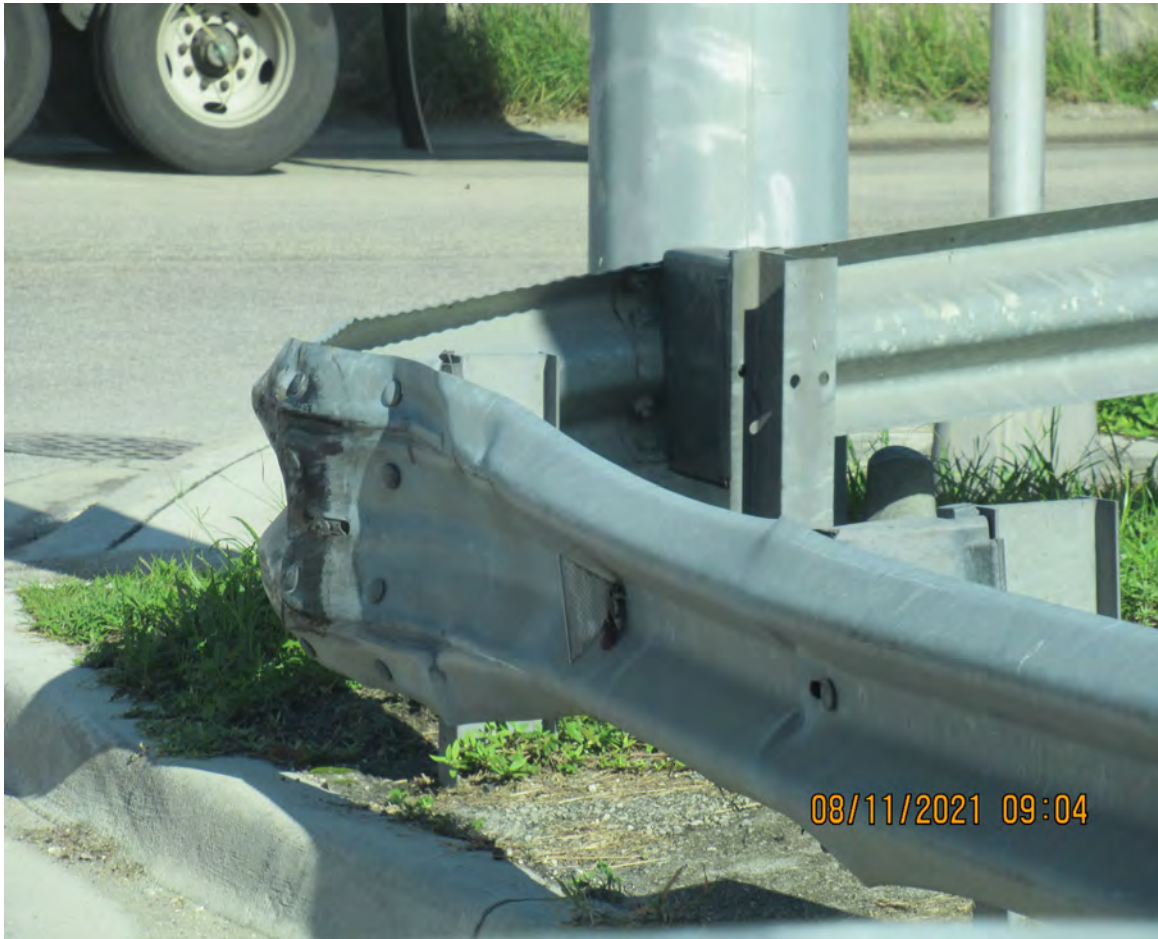
**ROADWAY INSPECTION
LOCATION: WESTBOUND NW 138th STREET & NW 107th
AVENUE (NE CORNER)**

DAMAGED GUARDRAIL

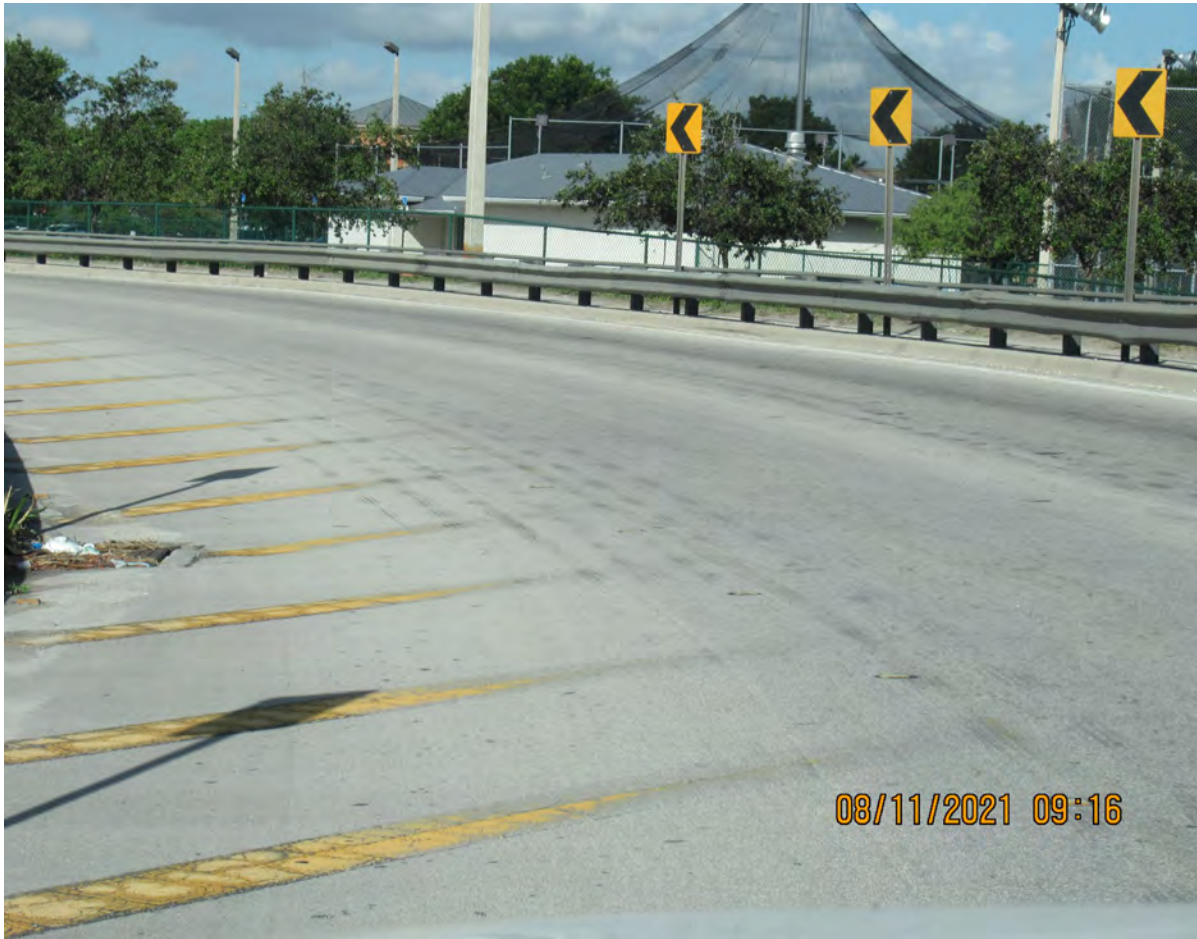
**ROADWAY INSPECTION
LOCATION: WESTBOUND NW 138th STREET BEFORE
OKEECHOBEE RD.**

DETERIORATED CHEVRONS, YELLOW EDGE LINE & WHITE SKIPS

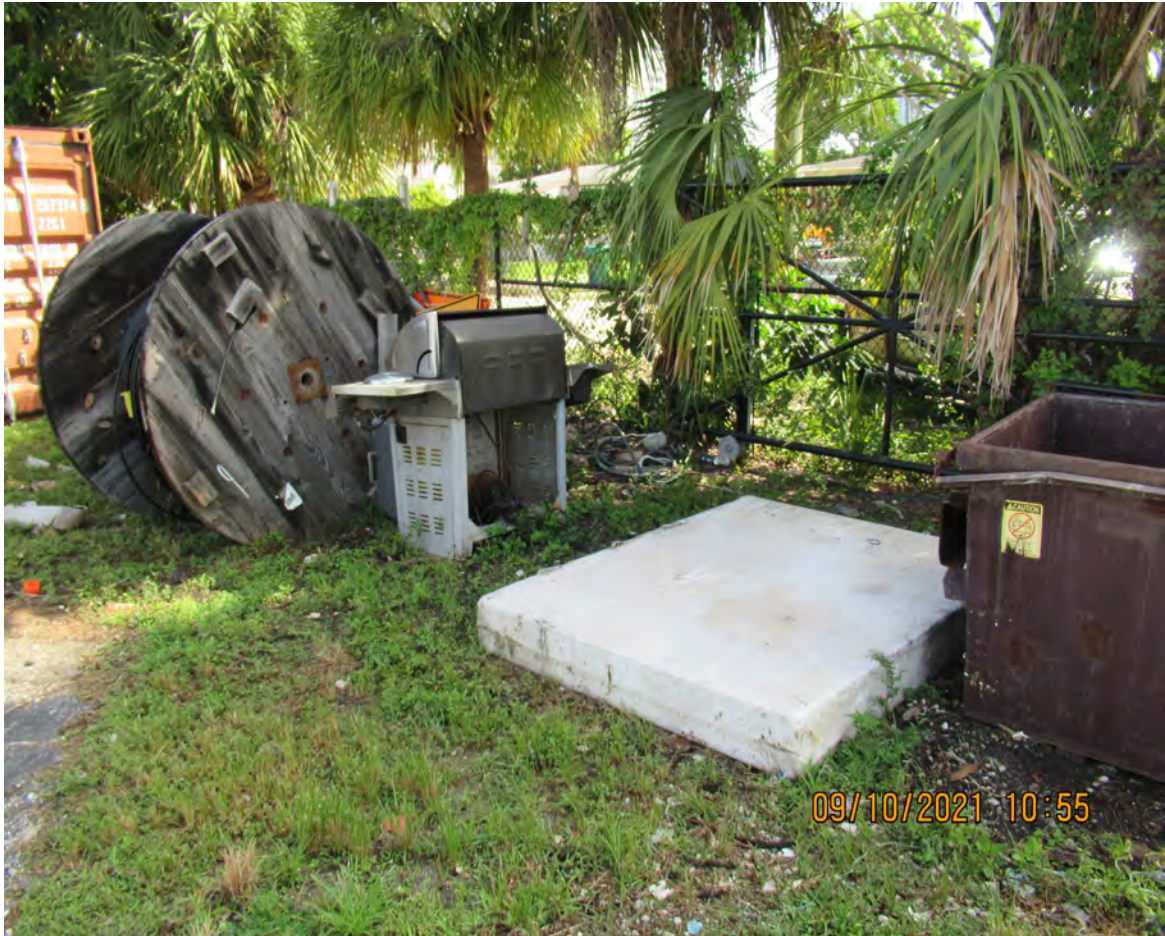
**ARCHITECTURAL INSPECTION
LOCATION: SR-836 MAIN ADMINISTRATION BUILDING
(NORTH ELEVATION)**

ACCUMULATED TRASH

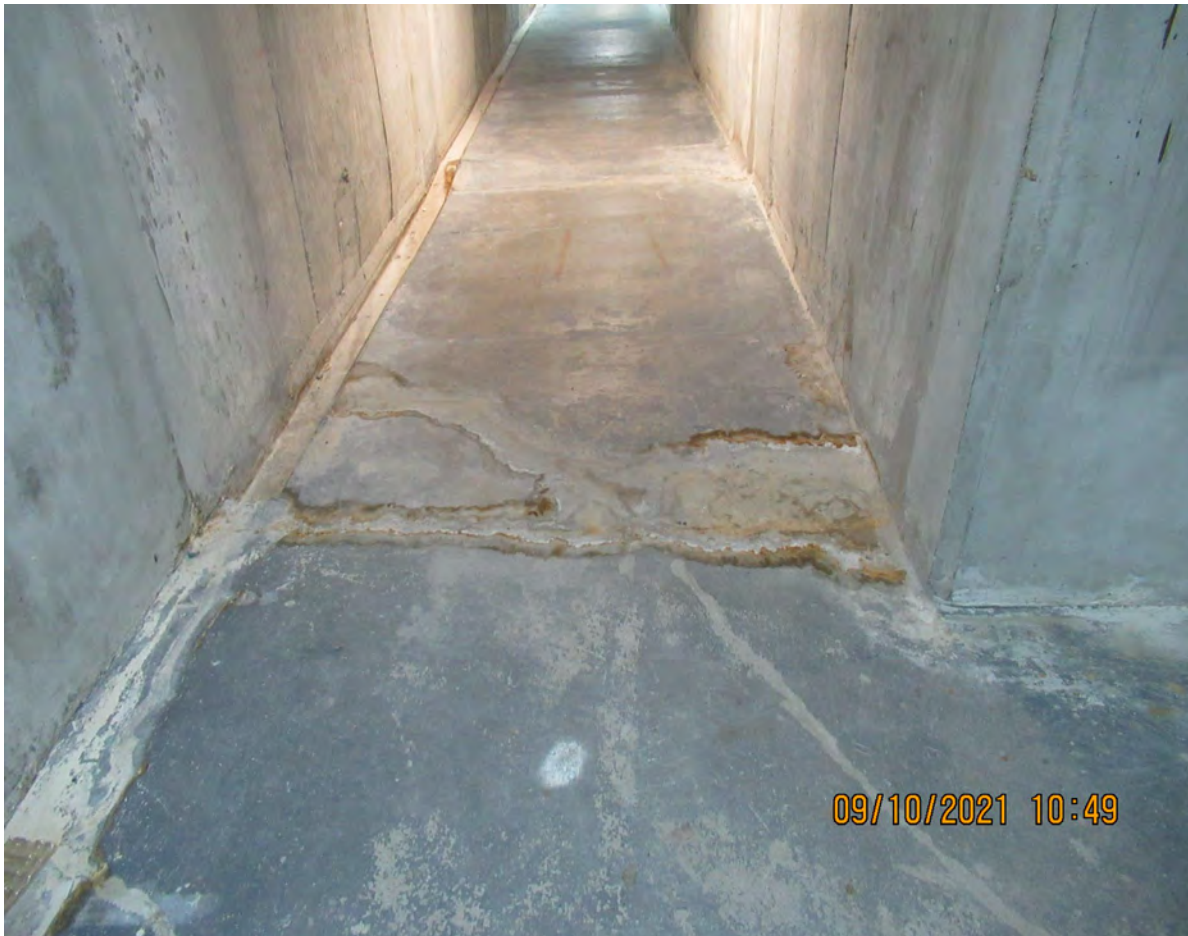
**ARCHITECTURAL INSPECTION
LOCATION: SR-836 MAIN ADMINISTRATION BUILDING
(TUNNEL)**

WATER INTRUSION STAINS ON TUNNEL FLOOR
