Annual Inspection Report 2021

General Engineering Consultant to the
Miami-Dade County Expressway Authority

ANNUAL INSPECTION REPORT 2021

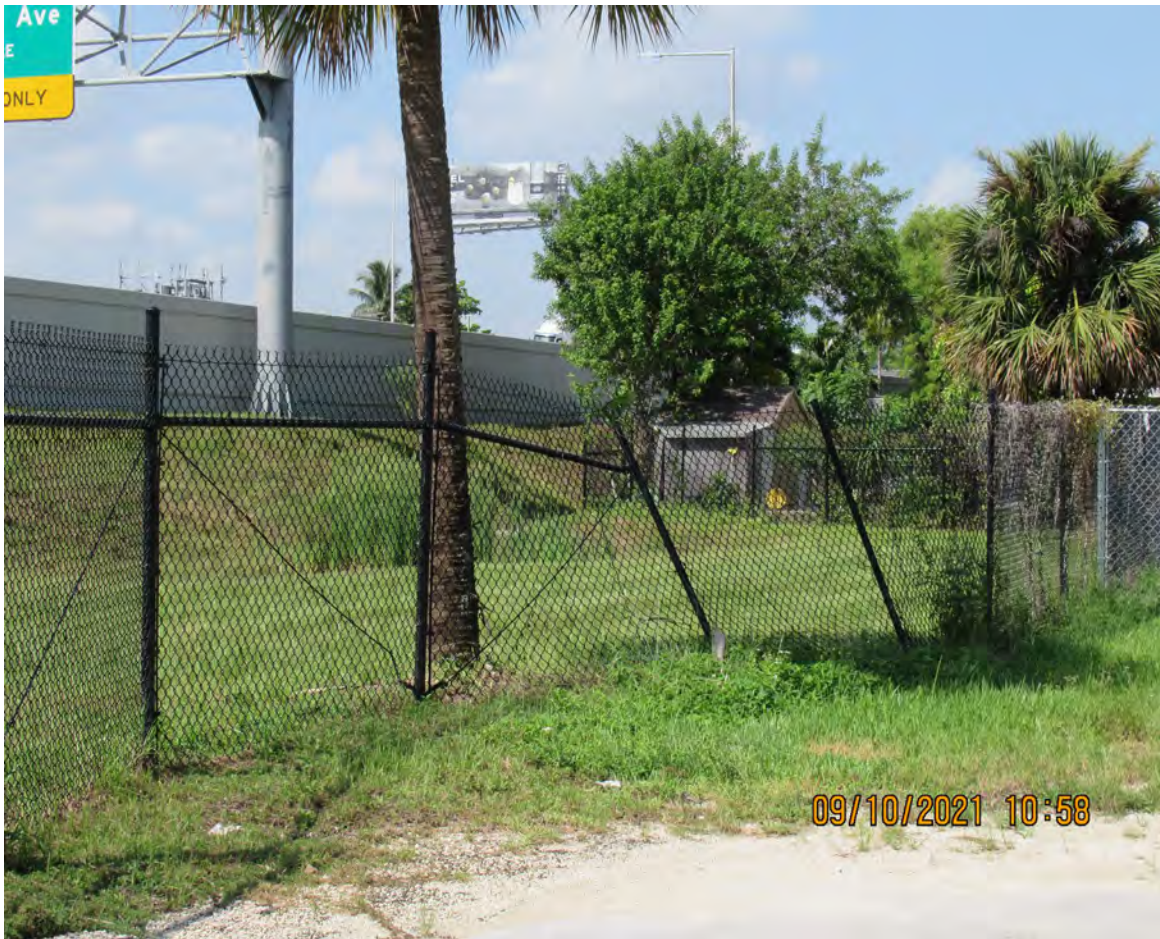
**ARCHITECTURAL INSPECTION
LOCATION: SR-836 MAIN ADMINISTRATION BUILDING
(WEST ELEVATION)**

DAMAGED FENCE POSTS

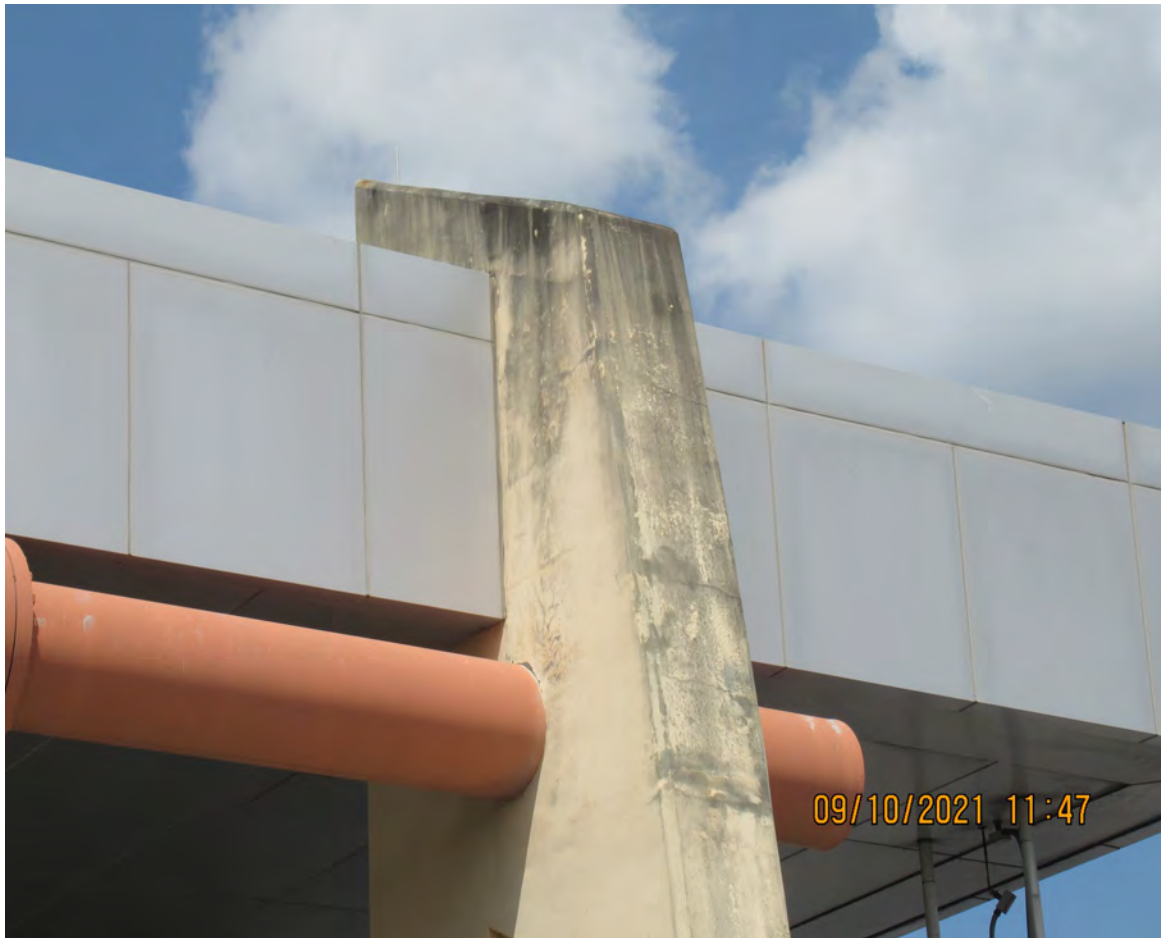
**ARCHITECTURAL INSPECTION
LOCATION: SR-836 / NW 97th AVENUE EASTBOUND
TOLL PLAZA CANOPY**

DETERIORATED CLASS 5 COATING ON TOLL CANOPY COLUMNS

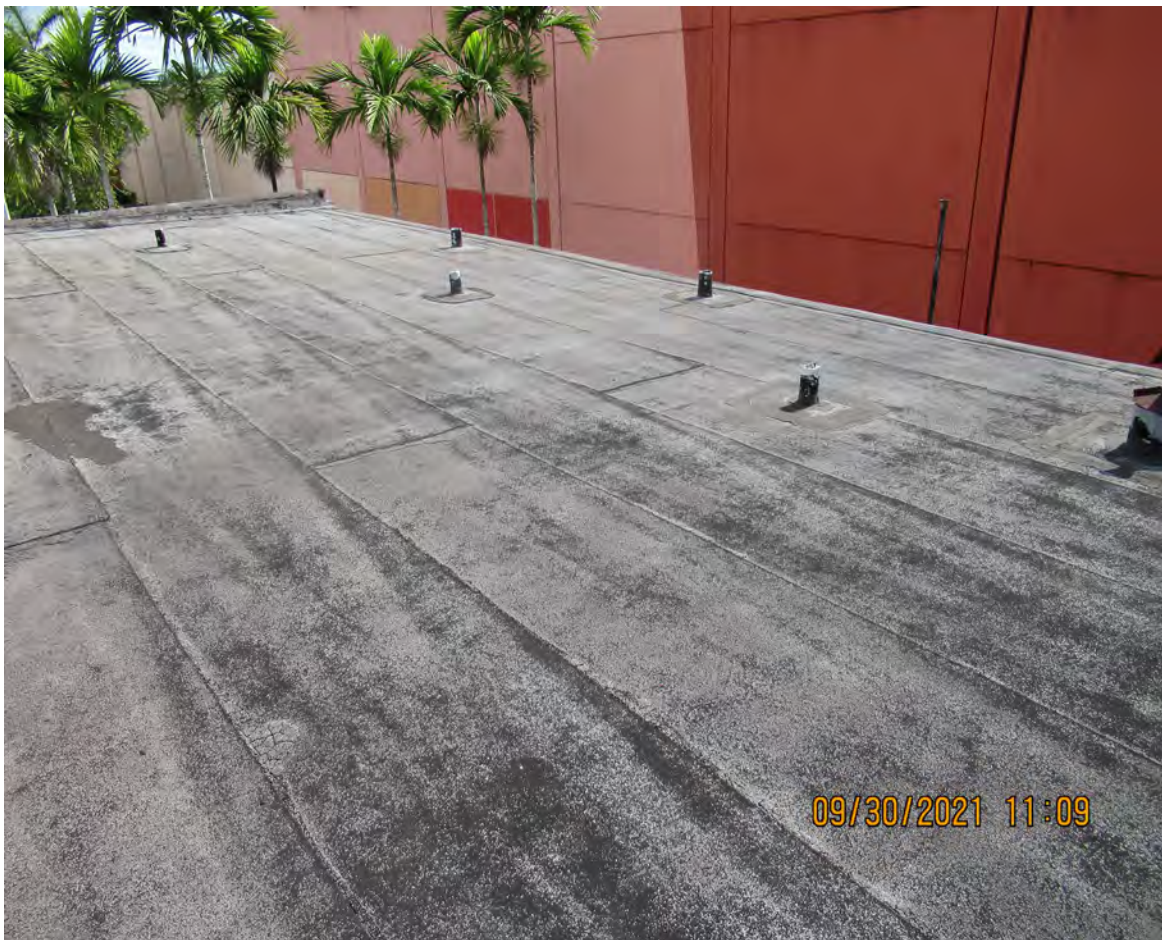
**ARCHITECTURAL INSPECTION
LOCATION: ADMINISTRATION BUILDING**

BLISTERING ON ROOF MEMBRANE / WATER INTRUSION ON INTERIOR ROOMS

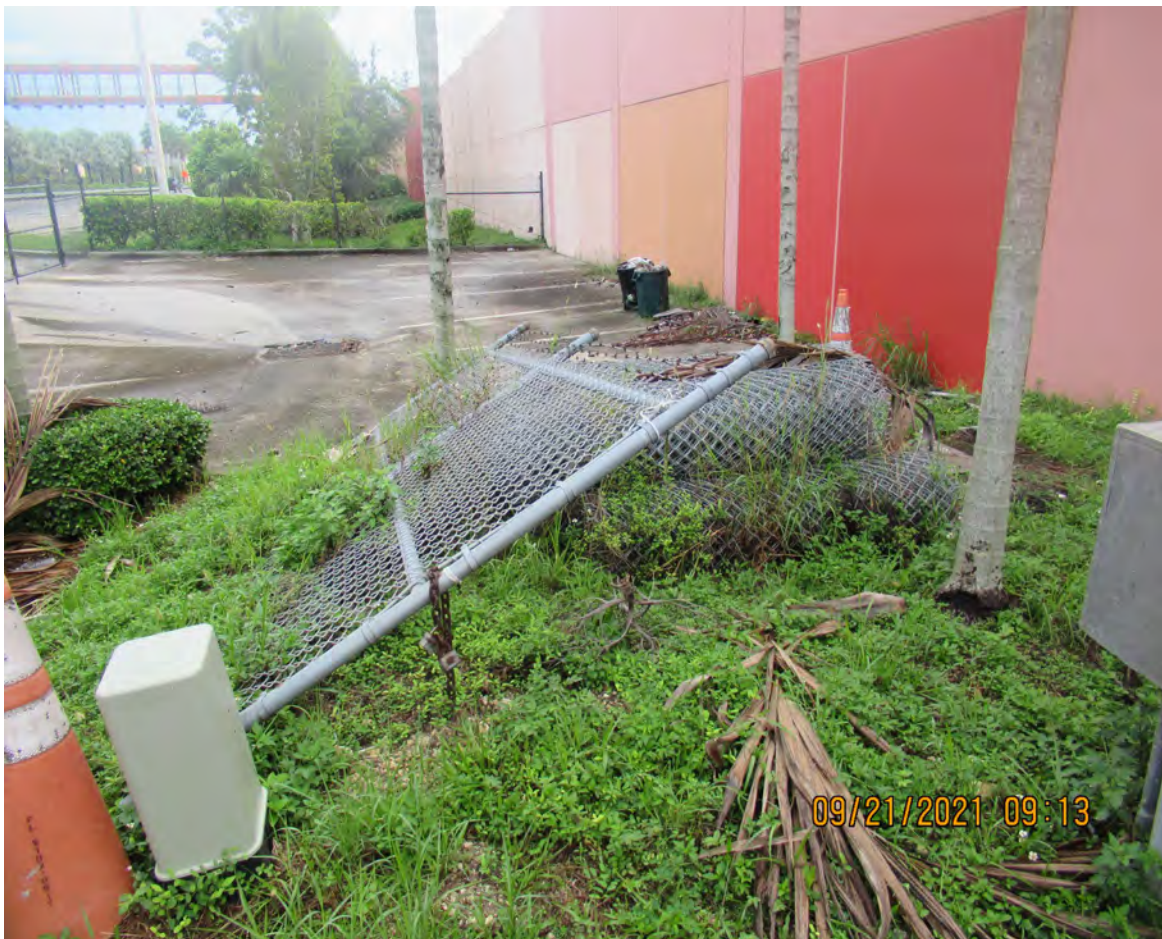
**ARCHITECTURAL INSPECTION
LOCATION: ADMINISTRATION BUILDING
(EAST ELEVATION)**

ABANDONED FENCE FABRIC AND GATE

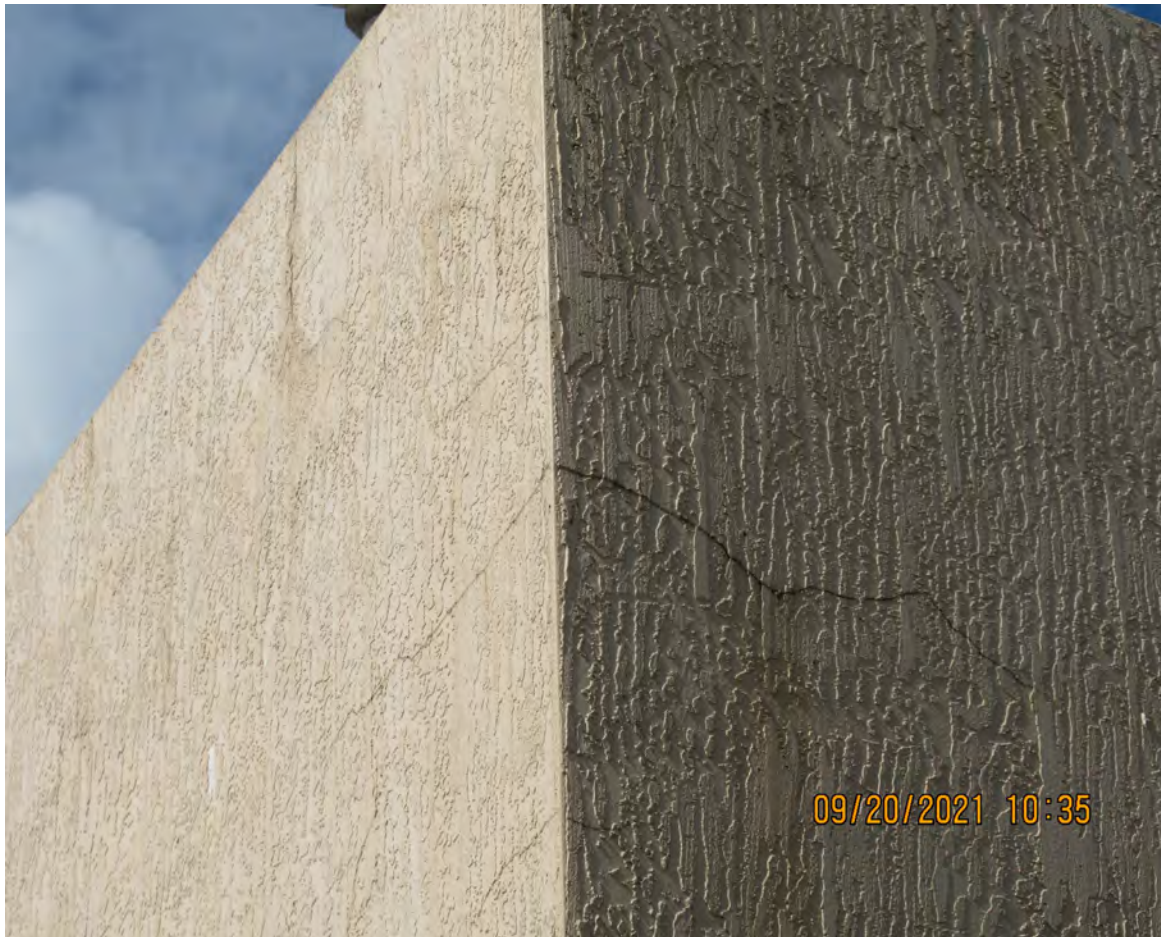
**ARCHITECTURAL INSPECTION
LOCATION: ADMINISTRATION BUILDING
(EAST ELEVATION)**

CRACKS ON STUCCO

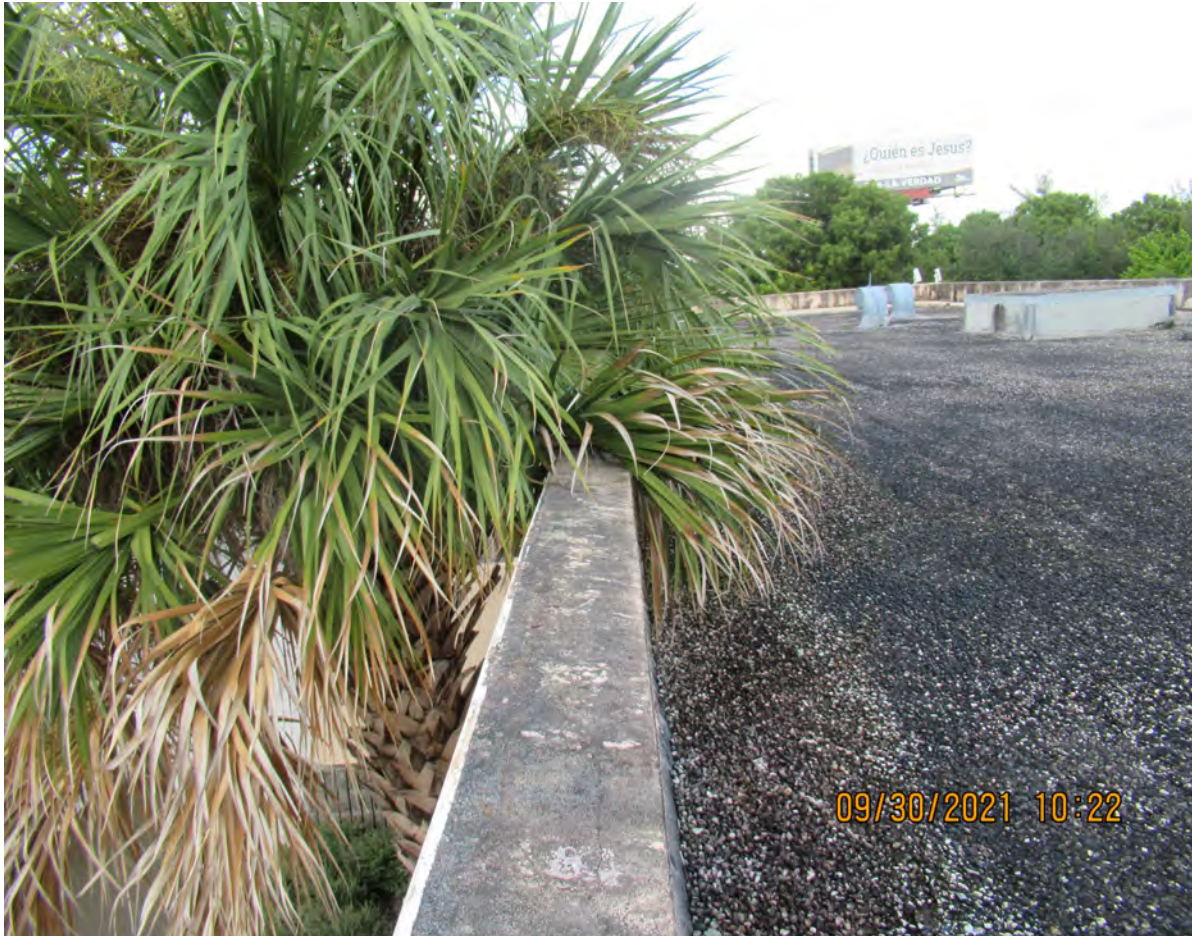
**ARCHITECTURAL INSPECTION
LOCATION: ADMINISTRATION BUILDING**

OVERGROWN VEGETATION ON PARAPET WALL

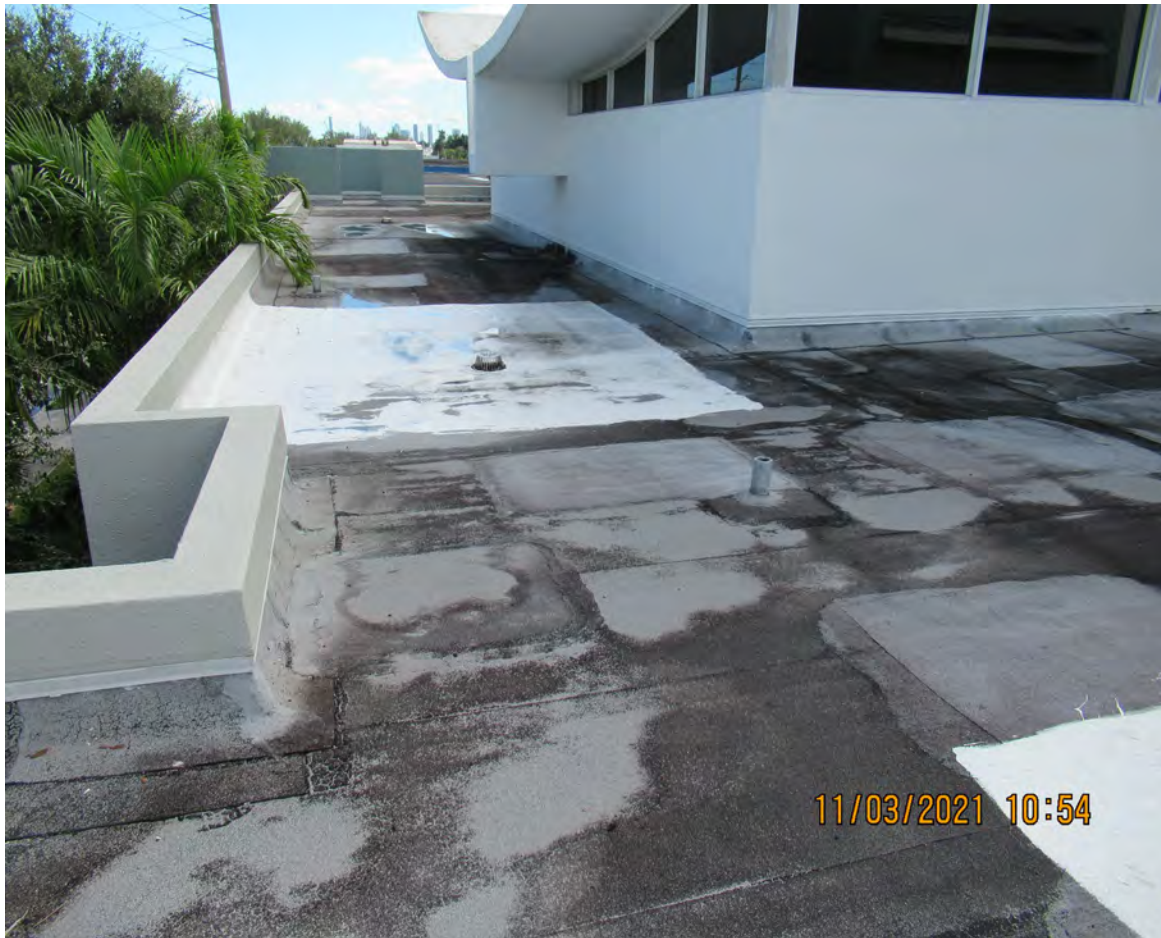
**ARCHITECTURAL INSPECTION
LOCATION: BLDG. 2**

ISOLATED REPAIRS ON ROOF MEMBRANE
