ANNUAL INSPECTION REPORT 2022

ANNUAL INSPECTION REPORT

In 1996, the Miami-Dade County Expressway Authority (MDX) acquired operational and financial control of five expressways in Miami-Dade County from the Florida Department of Transportation (FDOT). This group of expressways, toll facilities and the MDX headquarters facility, all as described below, are hereinafter referred to as the “MDX System”. In accordance with the Trust Indenture requirements, MDX retained EAC Consulting, Inc. (EAC), as the General Engineering Consultant to perform, among other duties assigned by the Authority, the yearly inspection of the MDX System. This report represents the annual inspection results for Fiscal Year (FY) 2022.

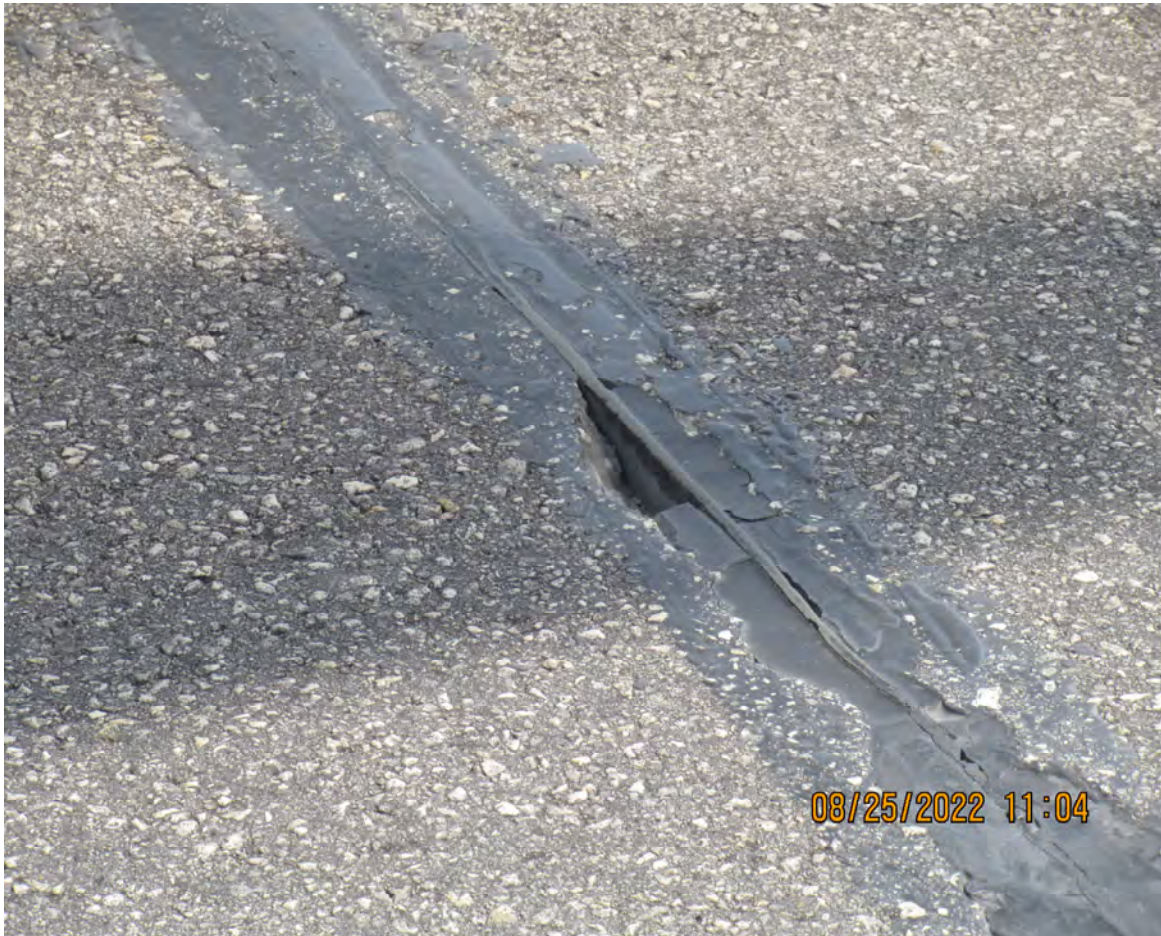
**ROADWAY INSPECTION
LOCATION: MILE MARKER 1.6 MILES
EASTBOUND MAINLINE**

DETERIORATED SEALANT AT ORT GANTRY LOOP DETECTORS

ITEMS NOTED TO BE ADDRESSED BY MDX ITS

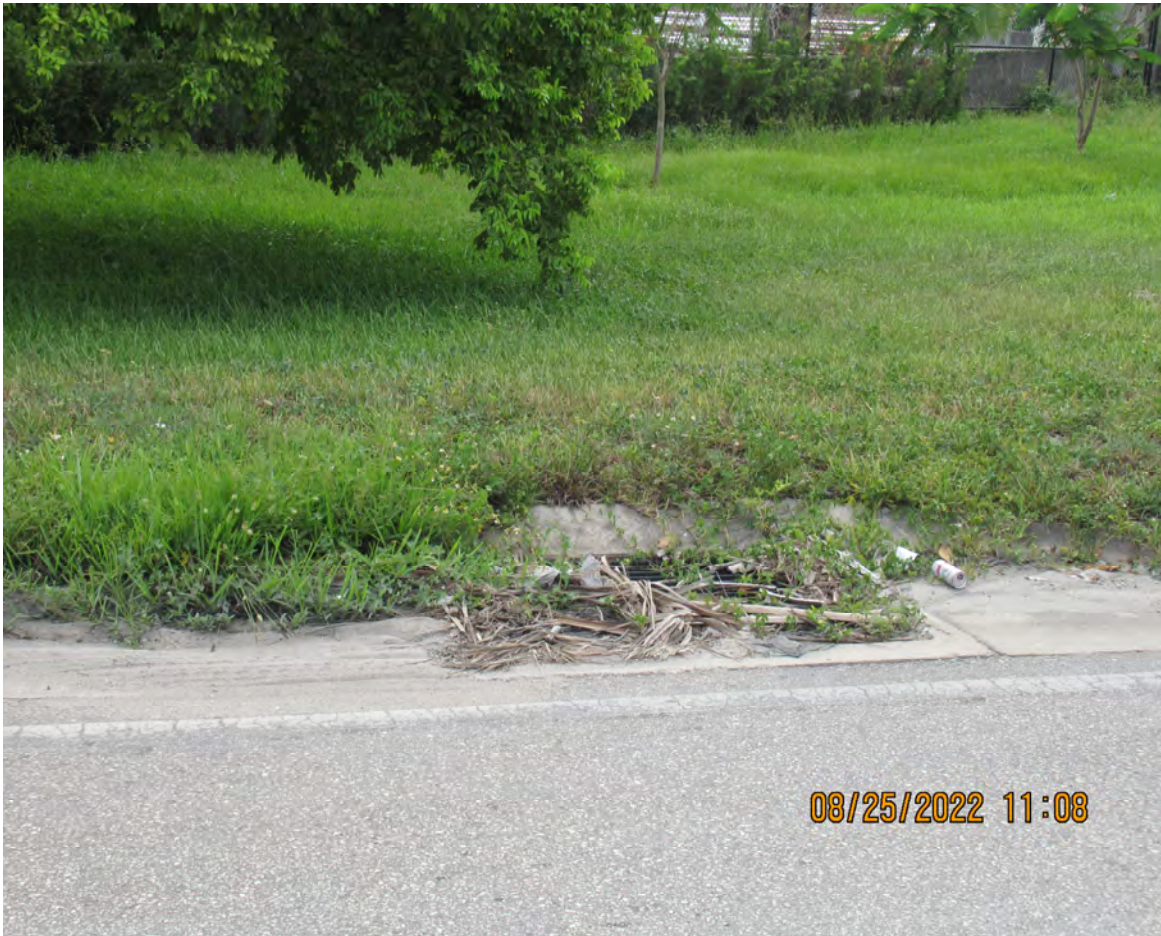
**ROADWAY INSPECTION
LOCATION: MILE MARKER 2.3 MILES
EASTBOUND ON-RAMP FROM NW 27TH AVENUE**

SILTED DRAINAGE STRUCTURE

ITEMS NOTED TO BE ADDRESSED BY MDX MAINTENANCE

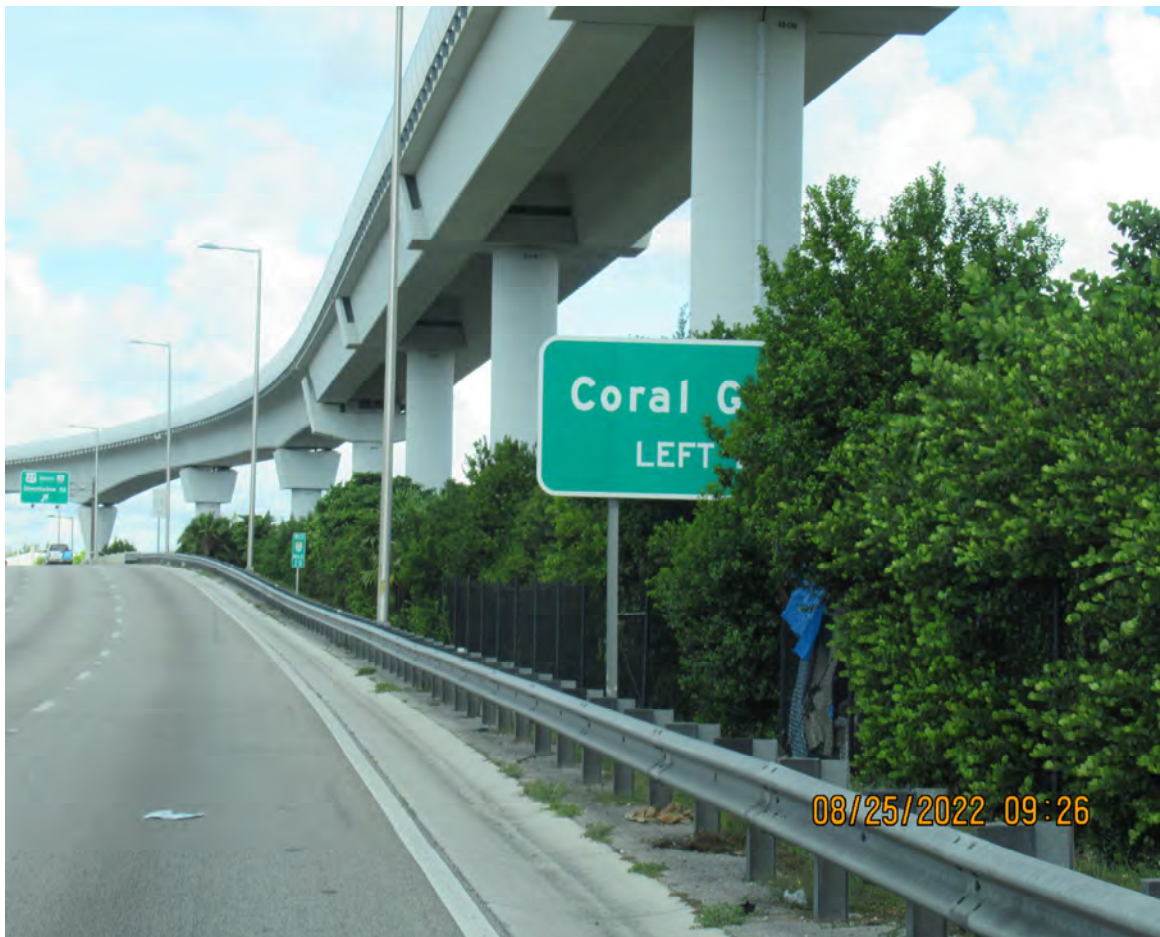
**ROADWAY INSPECTION
LOCATION: MILE MARKER MP 2.1 MILES
WESTBOUND MAINLINE**

OVERGROWN VEGETATION OBSTRUCTING SIGN

ITEM NOTED TO BE ADDRESSED BY MDX MAINTENANCE

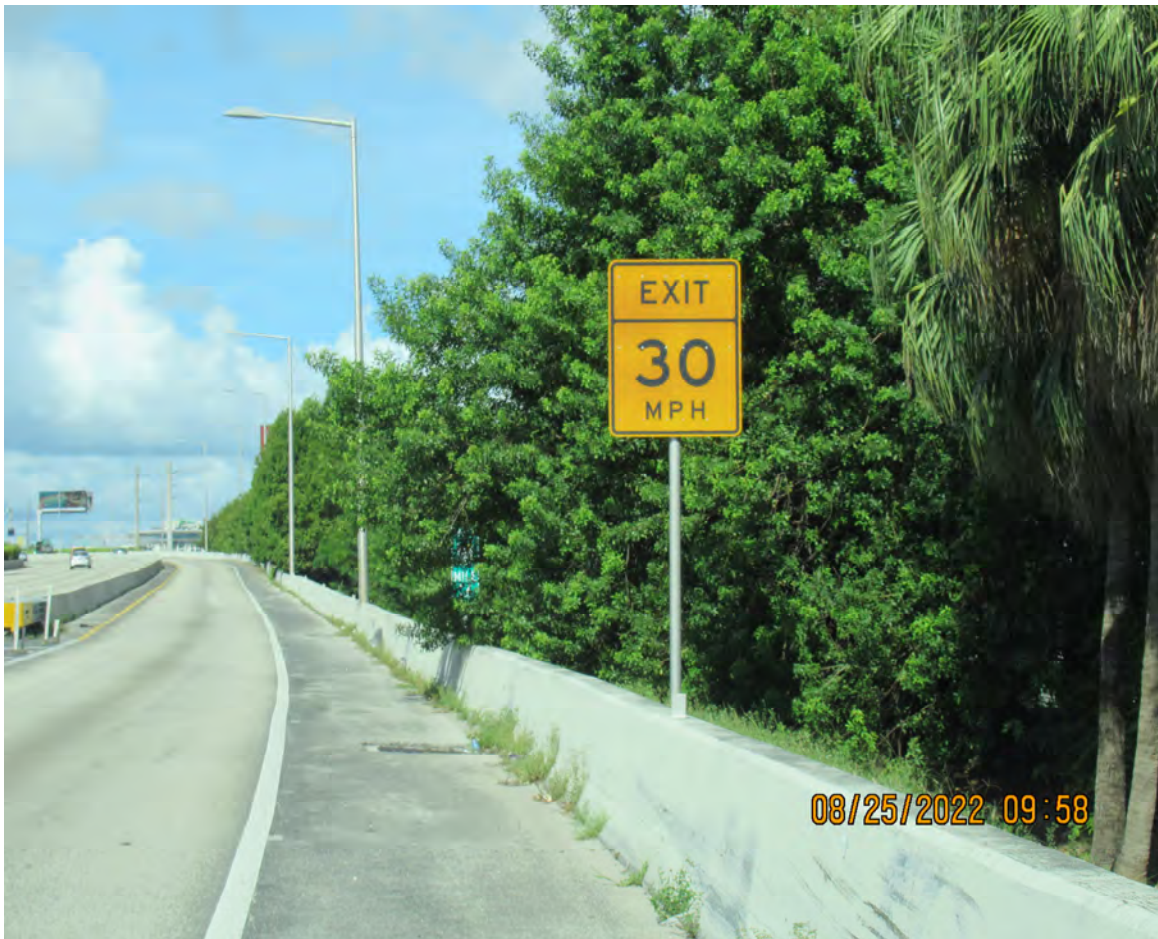
**ROADWAY INSPECTION
LOCATION: MILE MARKER MP 1.6 MILES
WESTBOUND RAMP TO OKEECHOBEE RD.**

**DETERIORATED REFLECTIVE SHIELD ON SPEED LIMIT SIGN / MILE MARKER SIGN
OBSTRUCTED BY OVERGROWN VEGETATION**

ITEM NOTED TO BE ADDRESSED BY MDX MAINTENANCE

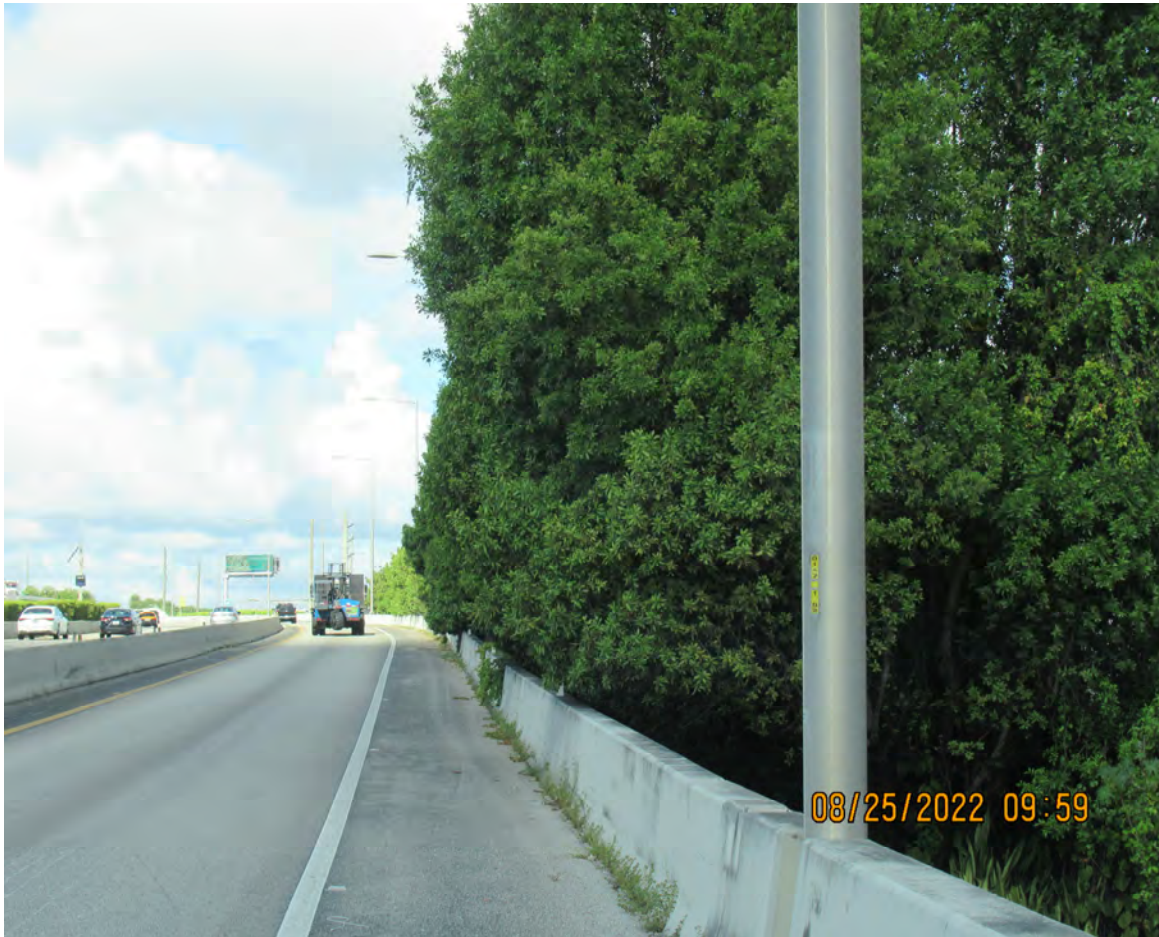
**ROADWAY INSPECTION
LOCATION: MILE MARKER MP 1.6 TO MP 1.4 MILES
WESTBOUND RAMP TO OKEECHOBEE RD.**

**OVERGROWN TREES ENCHROACHING OVER THE BARRIER WALL / OVERGROWN
VEGETATION AT THE BOTTOM OF THE BARRIER WALL**

ITEM NOTED TO BE ADDRESSED BY MDX MAINTENANCE

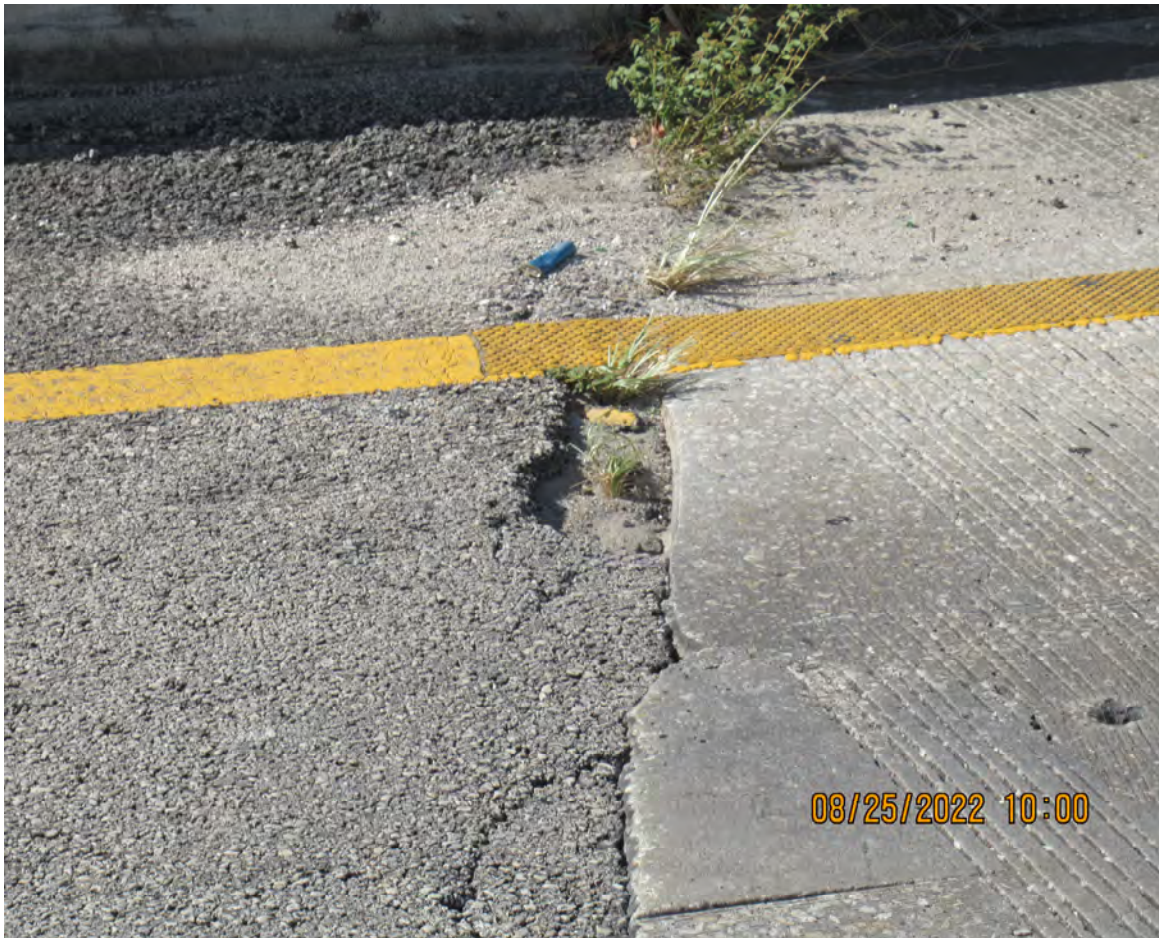
**ROADWAY INSPECTION
LOCATION: MILE MARKER MP 1.4 MILES
WESTBOUND RAMP TO OKEECHOBEE RD.**

**DETERIORATED ASPHALT PAVEMENT AT BENT #2
(BRIDGE # 870122)**

ITEM NOTED TO BE ADDRESSED BY MDX MAINTENANCE

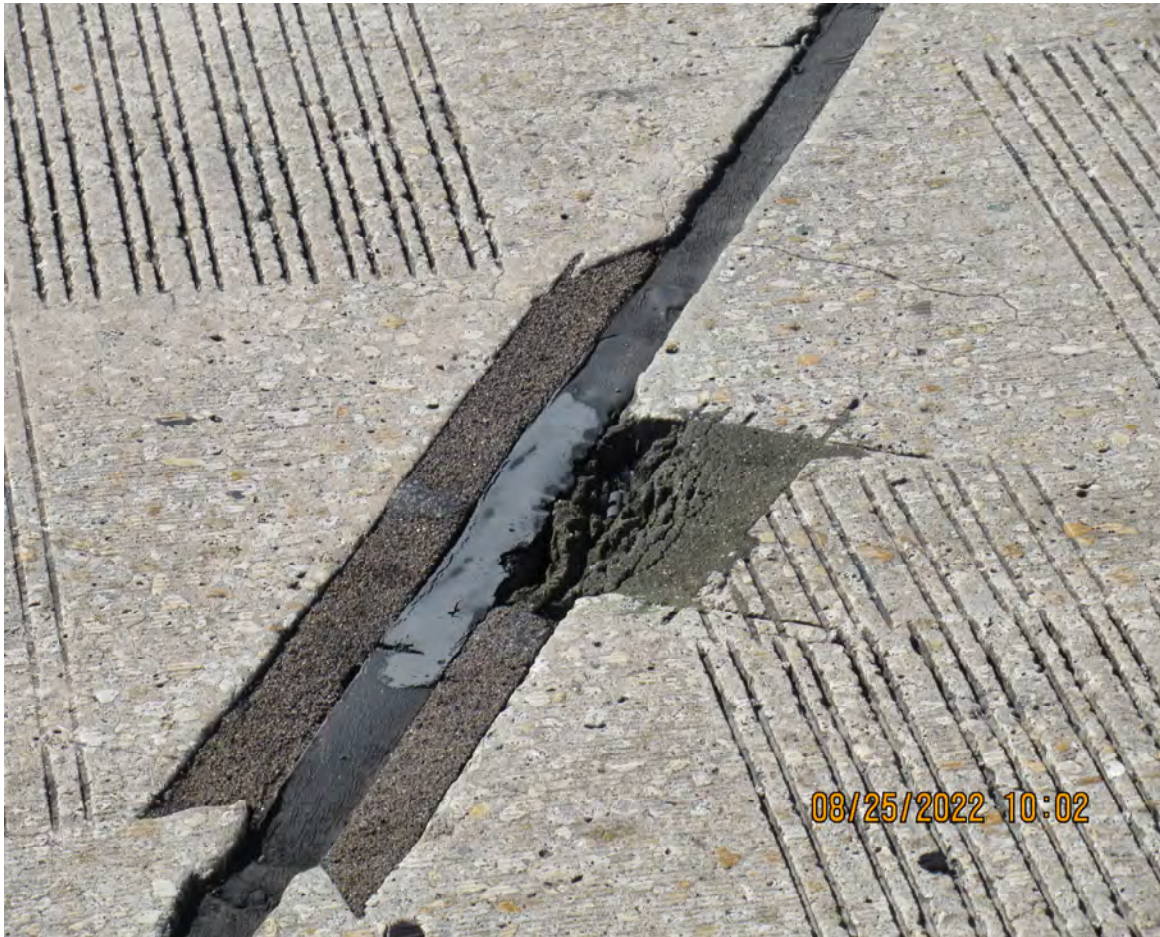
**ROADWAY INSPECTION
LOCATION: MILE MARKER MP 1.3 MILES
WESTBOUND RAMP TO OKEECHOBEE RD.**

**DETERIORATED JOINT REPAIR
(BRIDGE # 870026)**

ITEM NOTED TO BE ADDRESSED BY MDX MAINTENANCE

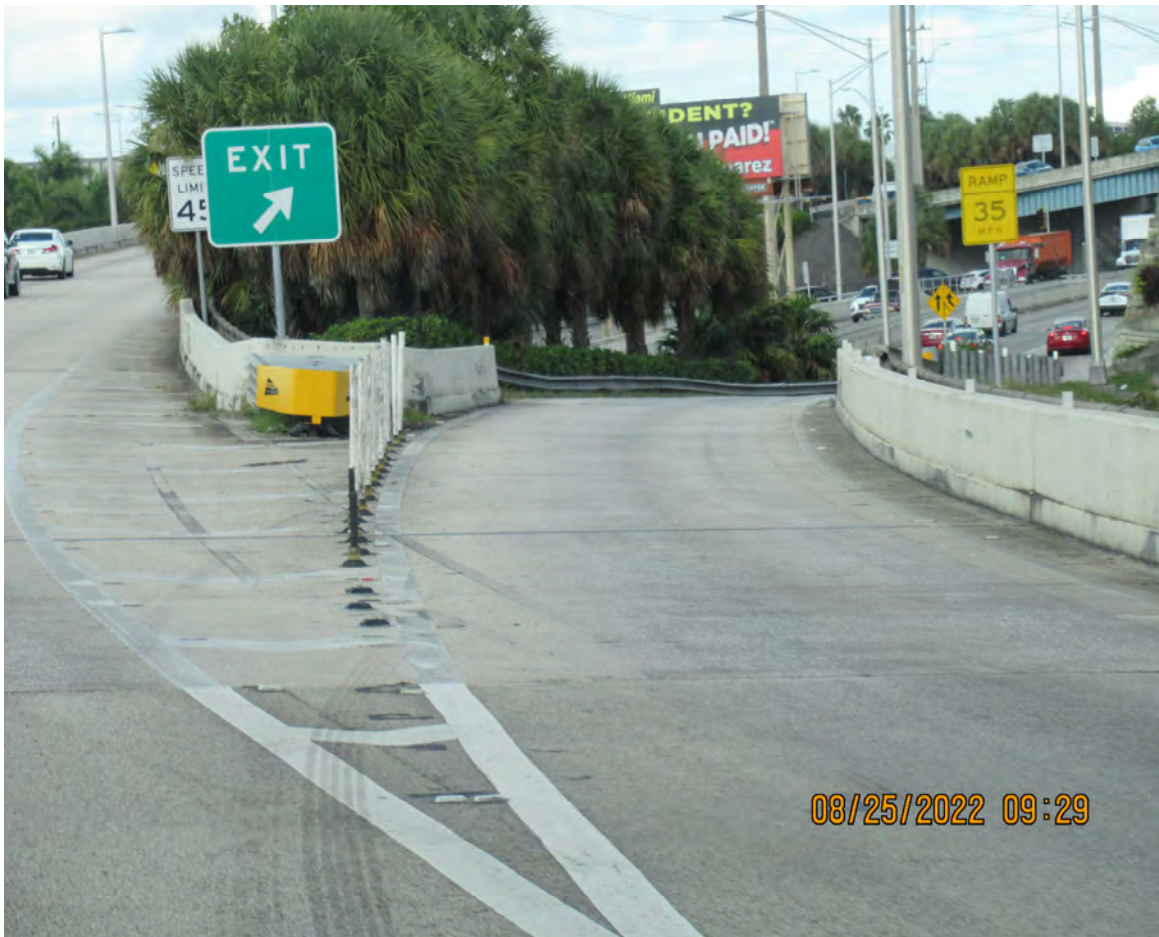
**ROADWAY INSPECTION
LOCATION: MILE MARKER MP 1.2 MILES
WESTBOUND OFF-RAMP TO NW 36th St.**

MISSING DELINEATORS

ITEM NOTED TO BE ADDRESSED BY MDX MAINTENANCE

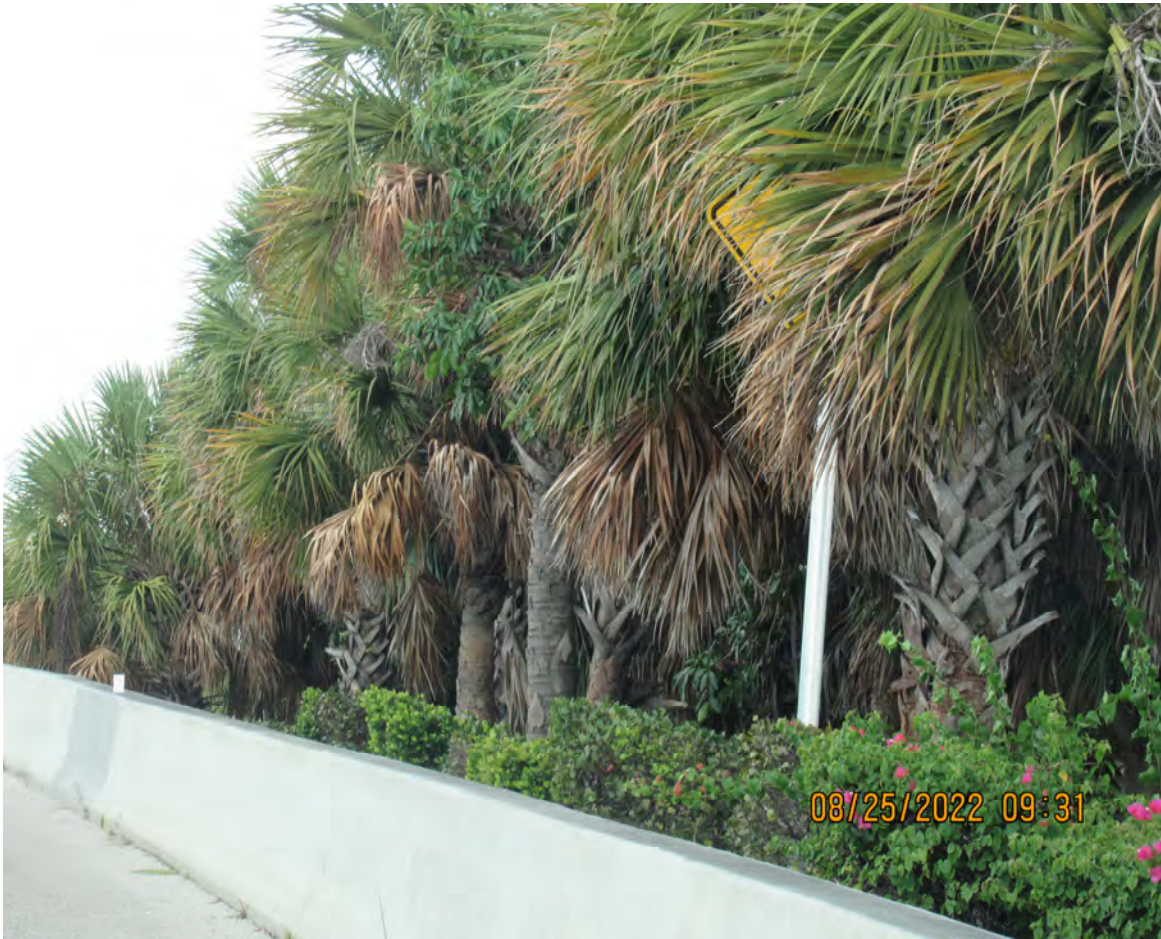
**ROADWAY INSPECTION
LOCATION: MILE MARKER MP 0.9 MILES
WESTBOUND OFF-RAMP TO NW 42ND AVENUE**

OVERGROWN VEGETATION OBSTRUCTING SPEED LIMIT SIGN

ITEM NOTED TO BE ADDRESSED BY MDX MAINTENANCE

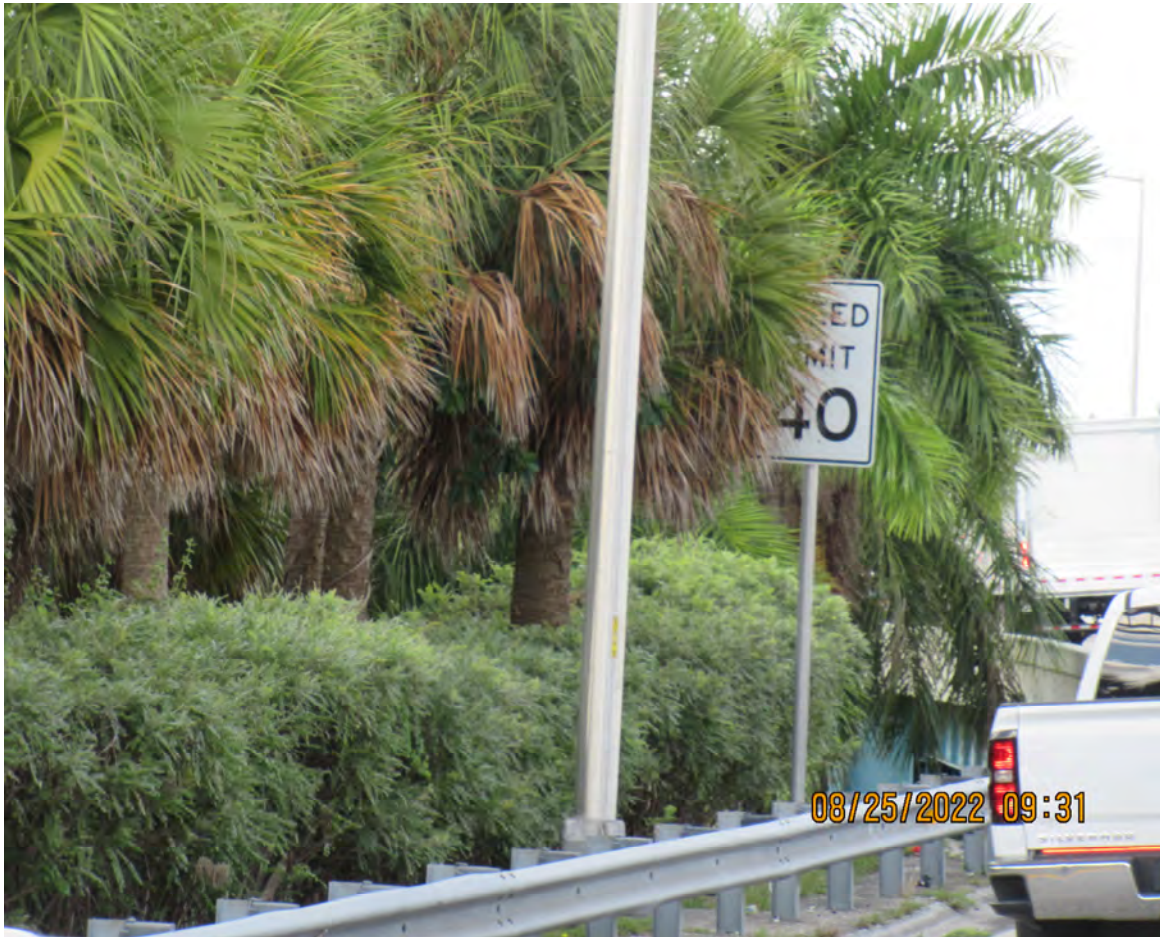
**ROADWAY INSPECTION
LOCATION: MILE MARKER MP 0.9 MILES
WESTBOUND OFF-RAMP TO NW 42ND AVENUE**

OVERGROWN VEGETATION OBSTRUCTING SPEED LIMIT SIGN

ITEM NOTED TO BE ADDRESSED BY MDX MAINTENANCE

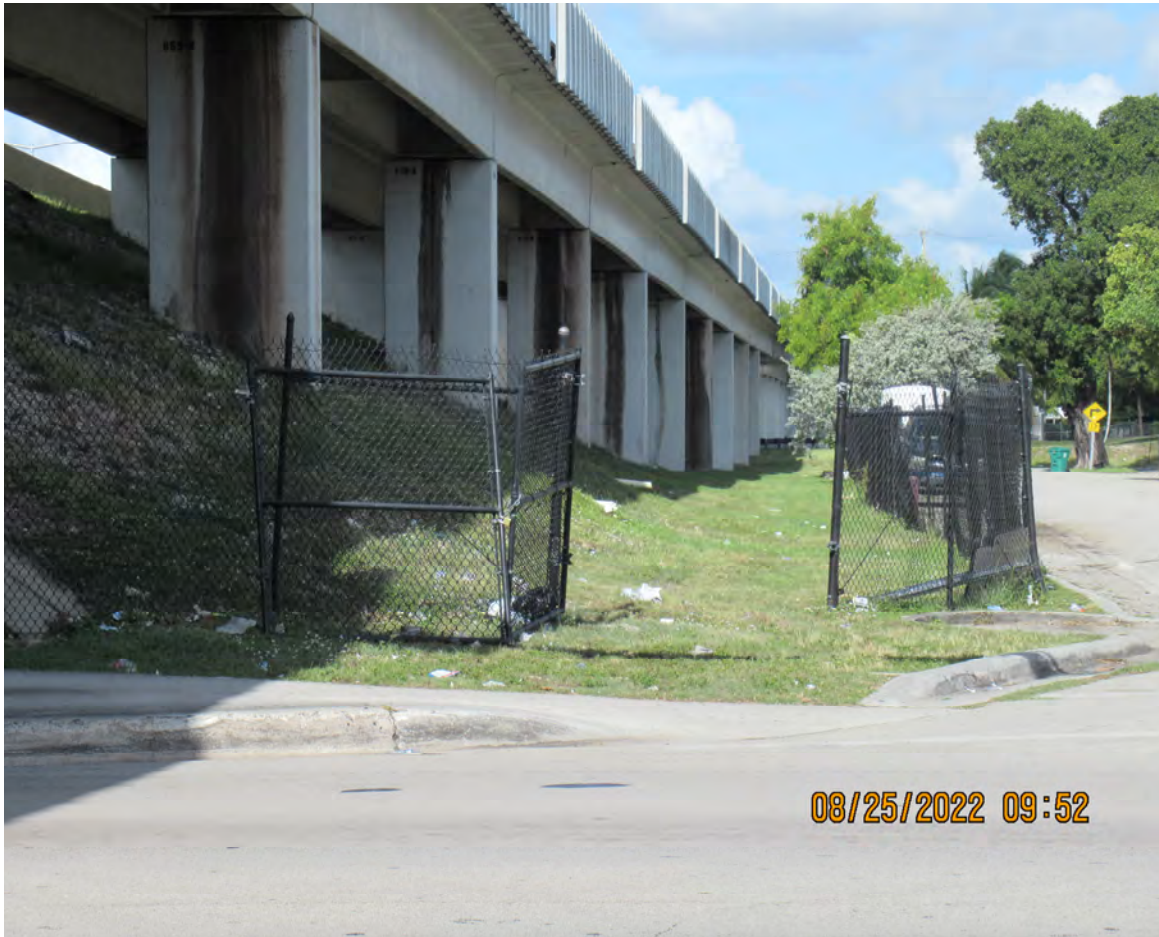
**ROADWAY INSPECTION
LOCATION: MILE MARKER MP 3.4 MILES
WESTBOUND MAINLINE NW 17TH AVENUE**

DAMAGED GATE

ITEM NOTED TO BE ADDRESSED BY MDX MAINTENANCE

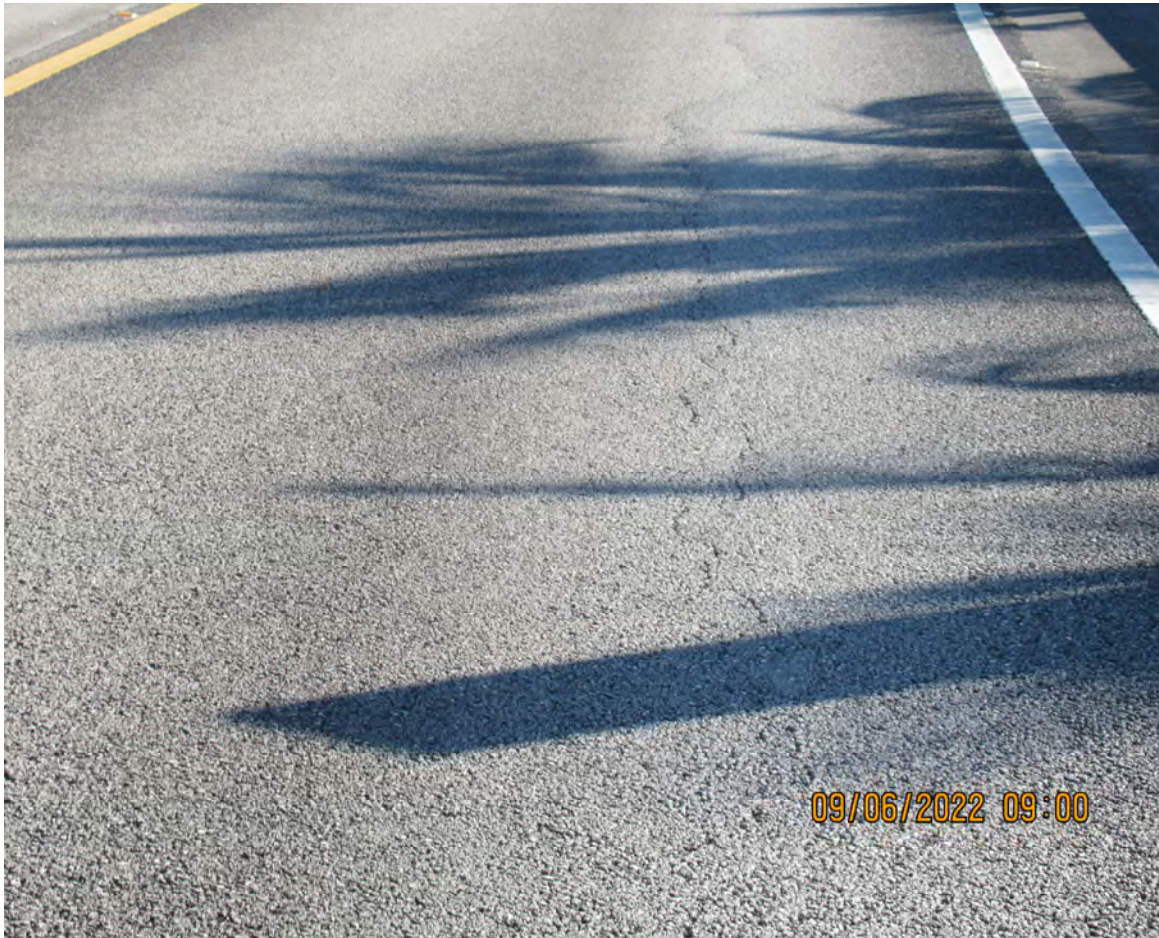
**ROADWAY INSPECTION
LOCATION: MILE MARKER 0.4 MILES
EASTBOUND ON-RAMP FROM NW 137th AVENUE SOUTH**

LONGITUDINAL CRACK ON PAVEMENT

ITEM NOTED TO BE ADDRESSED BY MDX MAINTENANCE

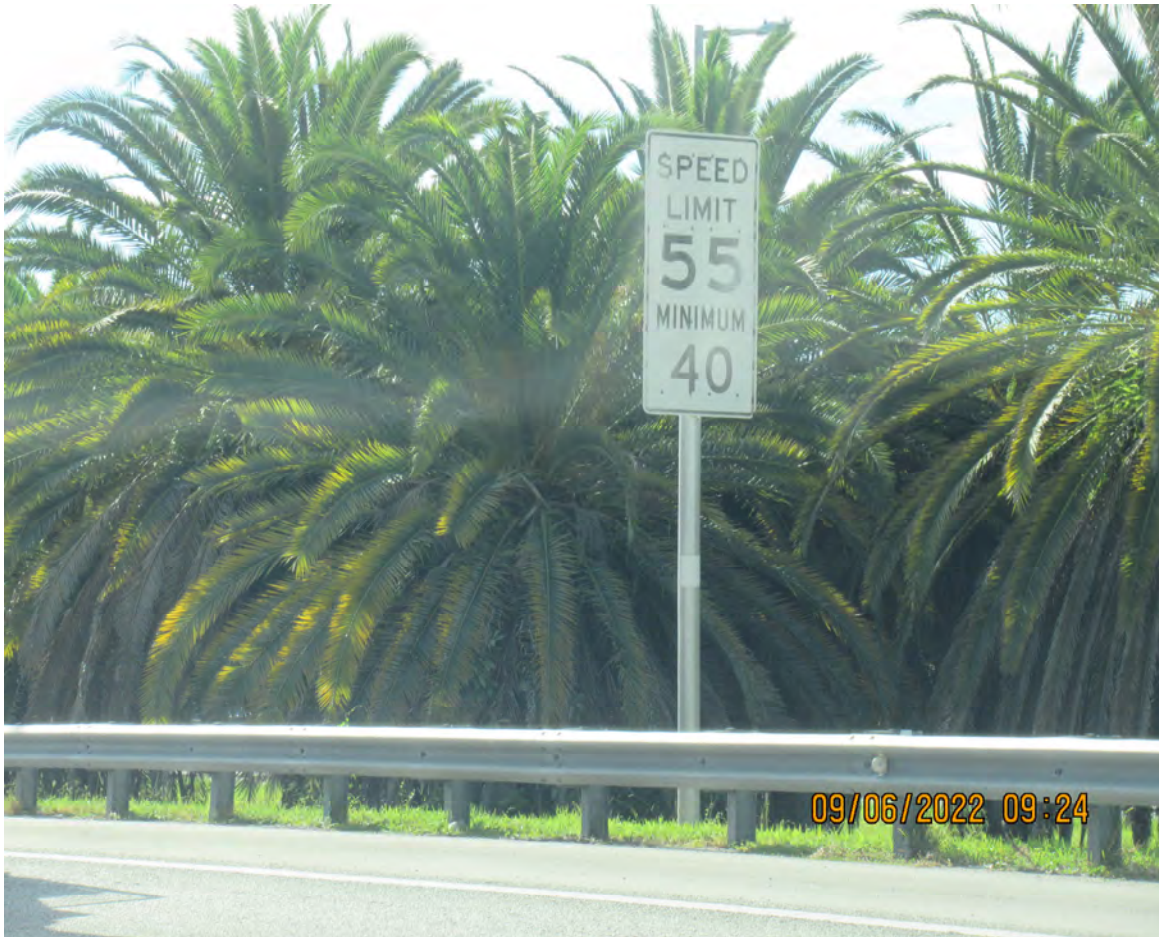
**ROADWAY INSPECTION
LOCATION: MILE MARKER 3.15
EASTBOUND MAINLINE**

DETERIORATED REFLECTIVE SHEETING ON SPEED LIMIT SIGN

ITEM NOTED TO BE ADDRESSED BY MDX MAINTENANCE

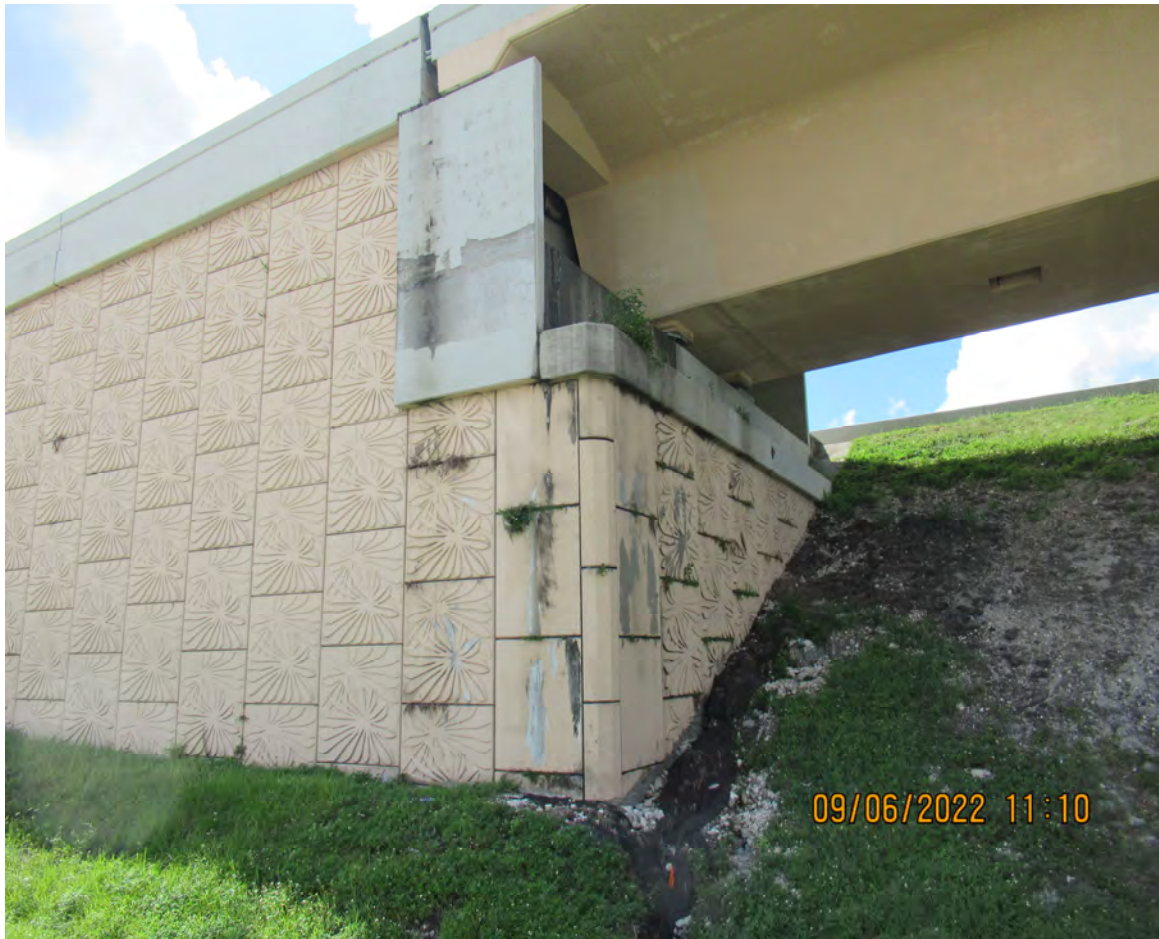
**ROADWAY INSPECTION
LOCATION: MILE MARKER 6.85 MILES
EASTBOUND MAINLINE (RIGHT SHOULDER)**

**DETERIORATED CLASS V COATING AT BENT 12
(BRIDGE # 871050)**

ITEM NOTED TO BE ADDRESSED BY MDX MAINTENANCE

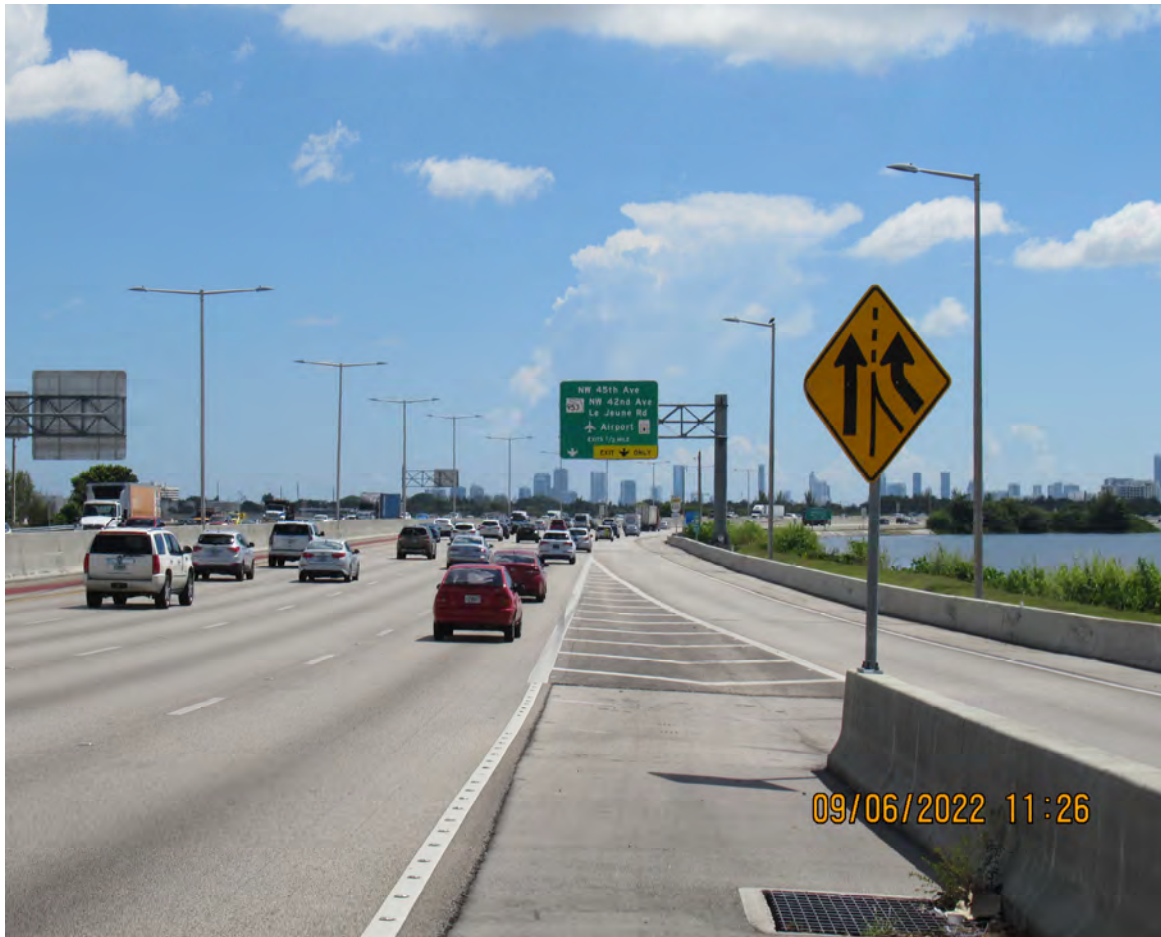
**ROADWAY INSPECTION
LOCATION: MILE MARKER 8.90
EASTBOUND MAINLINE**

TWISTED MERGE SIGN

ITEM NOTED TO BE ADDRESSED BY MDX MAINTENANCE

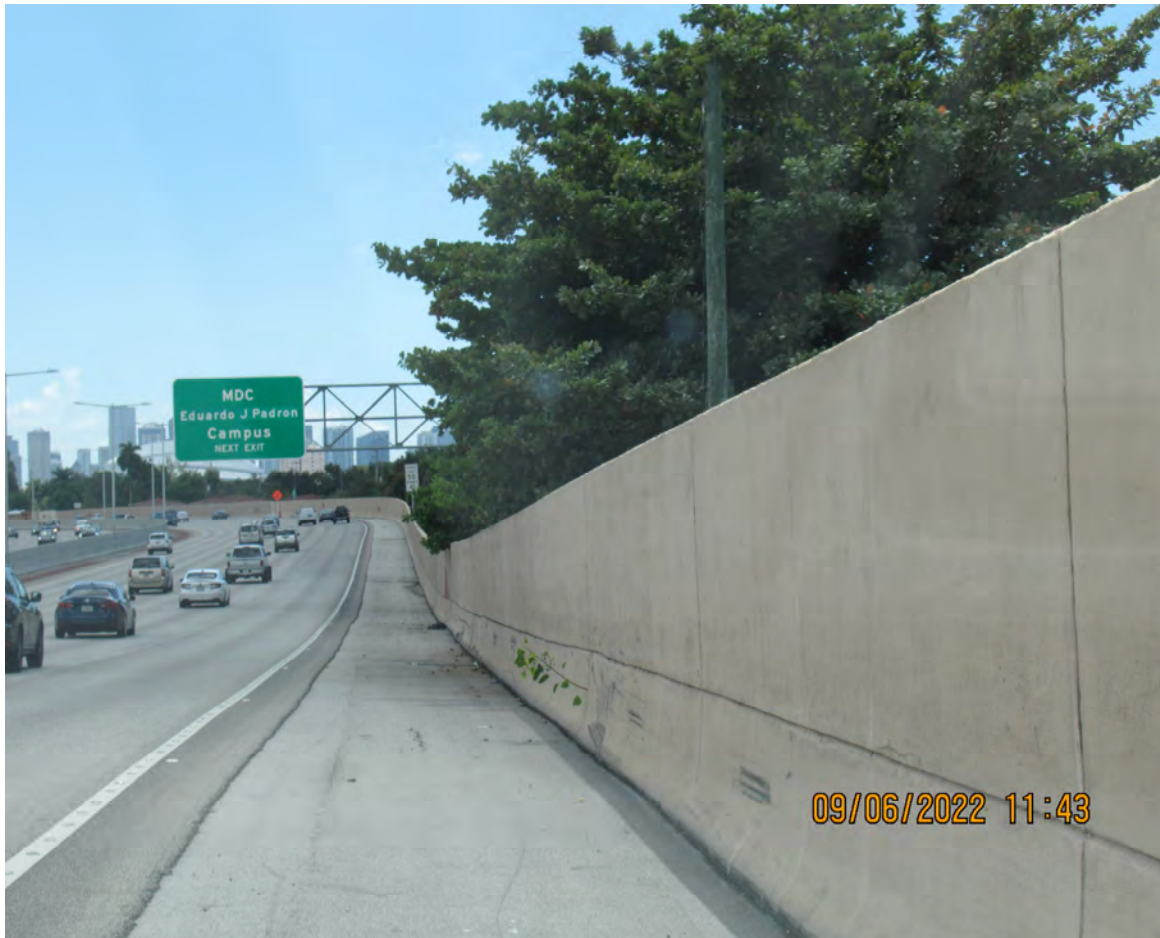
**ROADWAY INSPECTION
LOCATION: MILE MARKER 11.2
EASTBOUND MAINLINE**

OVERGROWN VEGETATION

ITEM NOTED TO BE ADDRESSED BY MDX MAINTENANCE

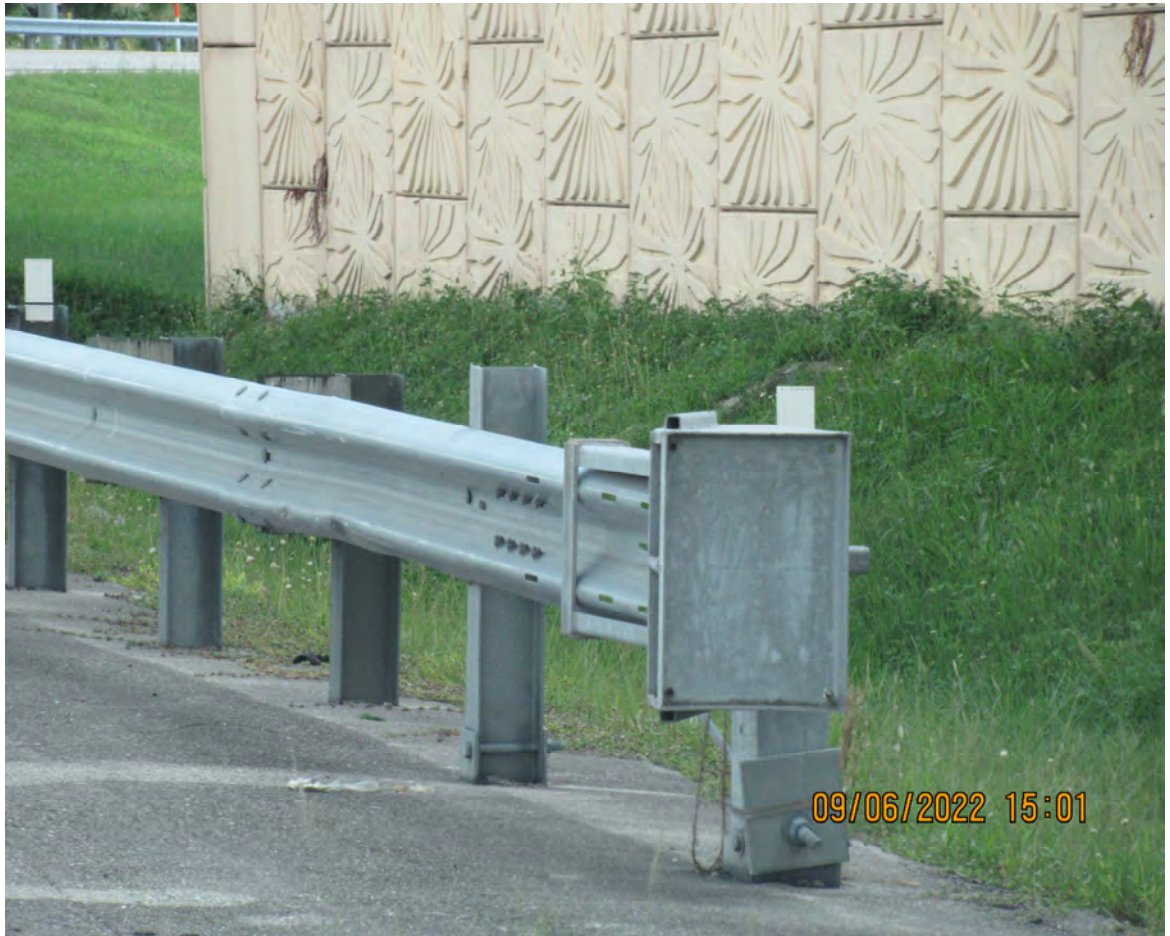
**ROADWAY INSPECTION
LOCATION: MILE MARKER 6.5
EASTBOUND CD FROM NW 87th AVENUE
(RIGHT SHOULDER)**

MISSING REFLECTIVE SHEETING ON END-TREATMENT

ITEM NOTED TO BE ADDRESSED BY MDX MAINTENANCE

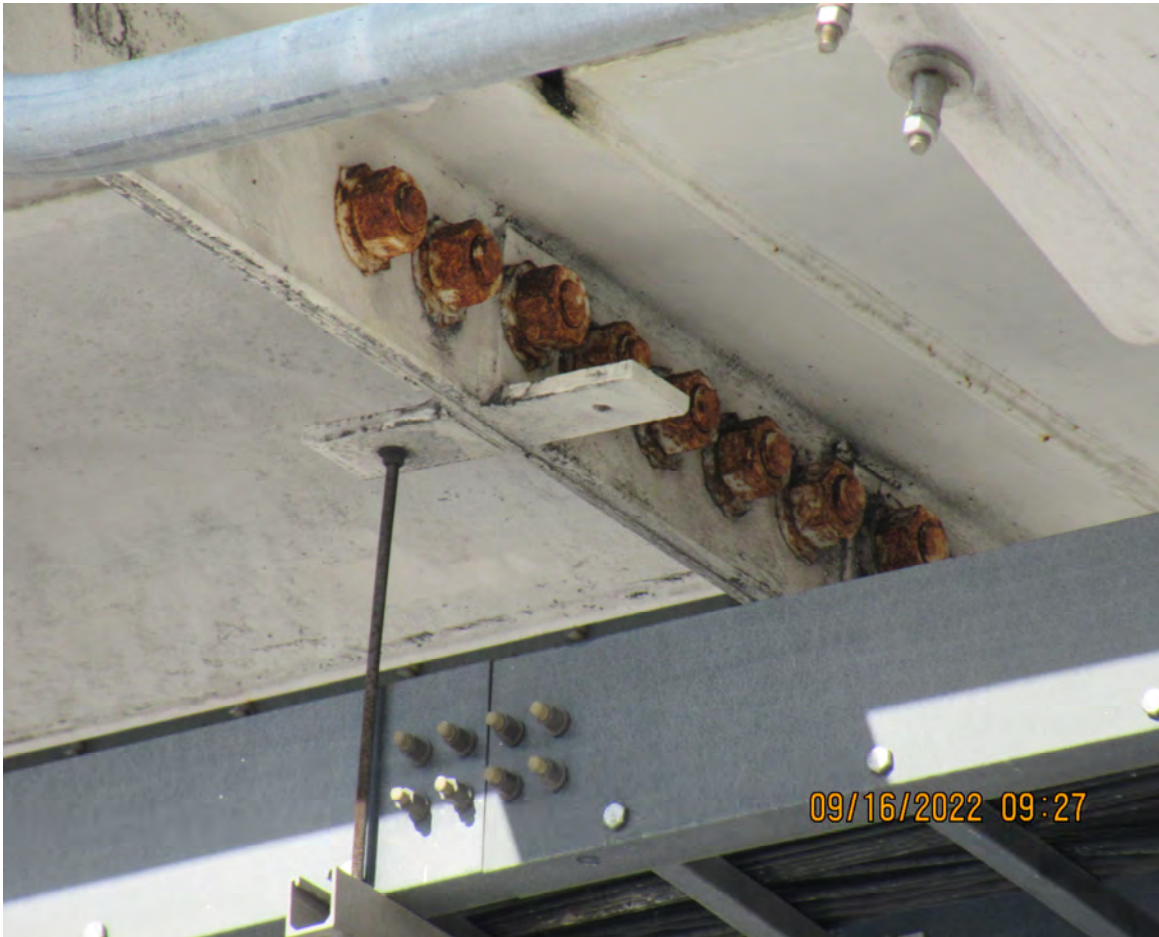
**ROADWAY INSPECTION
LOCATION: MILE MARKER 12.6 MILES
WESTBOUND MAINLINE**

CORROSION ON ORT GANTRY BOLTS (STRUCTURE # 87A253)

ITEM NOTED TO BE ADDRESSED BY MDX MAINTENANCE

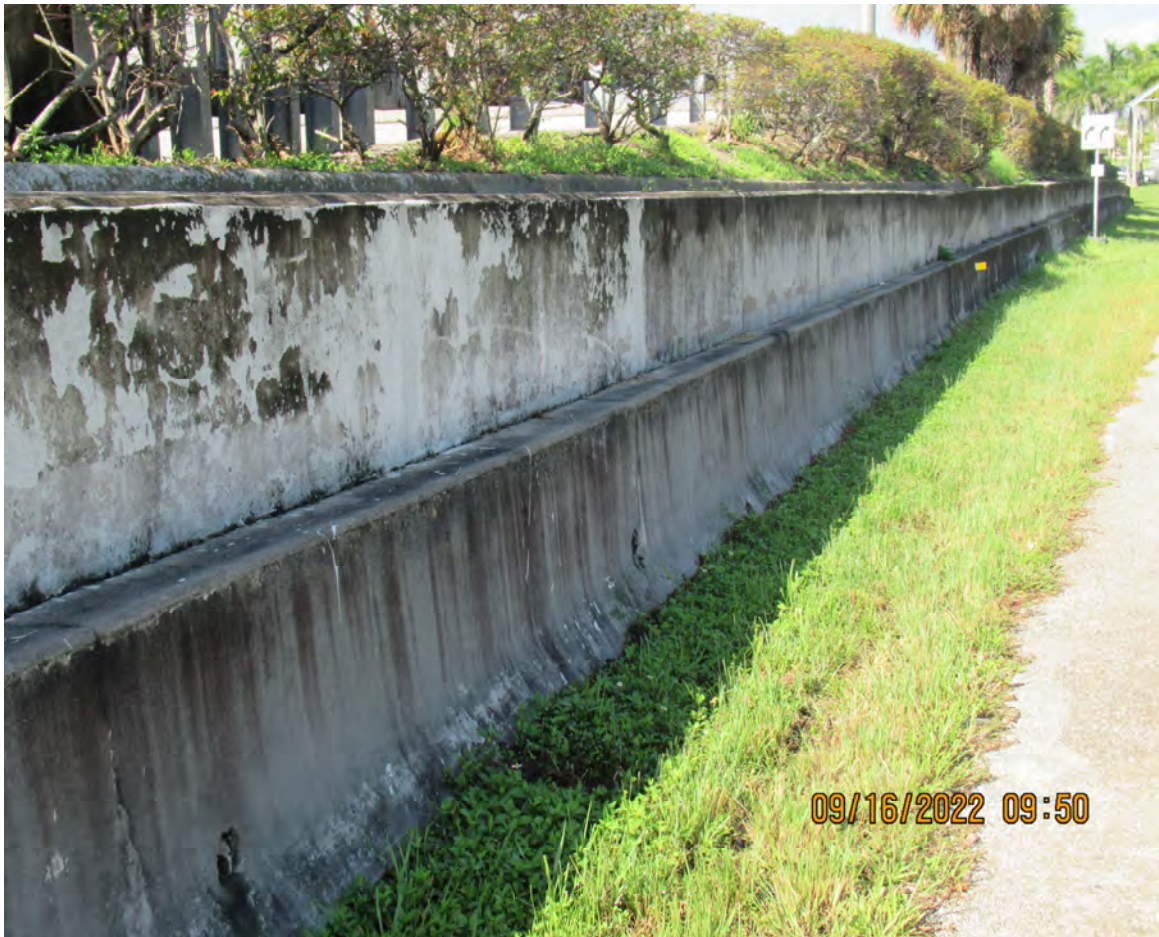
**ROADWAY INSPECTION
LOCATION: MILE MARKER 3.70 MILES
WESTBOUND OFF-RAMP TO NORTHBOUND
NW 107th AVENUE**

DETERIORATED CLASS V COATING ON RETAINING WALL

ITEM NOTED TO BE ADDRESSED BY MDX WORK PROGRAM NO. 30037

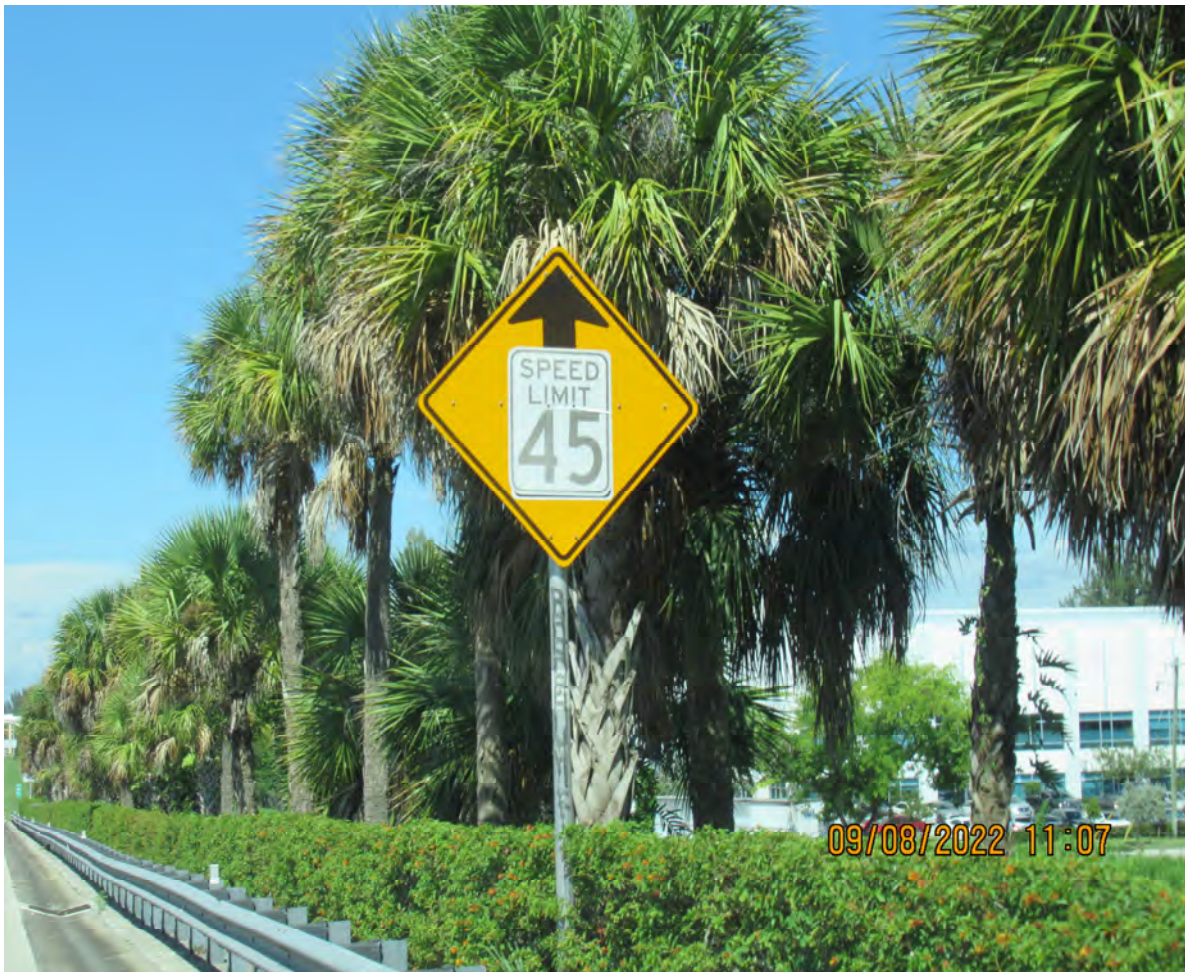
**ROADWAY INSPECTION
LOCATION: MILE MARKER 1.2 MILES
WESTBOUND MAINLINE**

DETERIORATED REFLECTIVE SHEETING ON SPEED LIMIT SIGN

ITEM NOTED TO BE ADDRESSED BY MDX MAINTENANCE
