ANNUAL INSPECTION REPORT 2022

ANNUAL INSPECTION REPORT

In 1996, the Miami-Dade County Expressway Authority (MDX) acquired operational and financial control of five expressways in Miami-Dade County from the Florida Department of Transportation (FDOT). This group of expressways, toll facilities and the MDX headquarters facility, all as described below, are hereinafter referred to as the “MDX System”. In accordance with the Trust Indenture requirements, MDX retained EAC Consulting, Inc. (EAC), as the General Engineering Consultant to perform, among other duties assigned by the Authority, the yearly inspection of the MDX System. This report represents the annual inspection results for Fiscal Year (FY) 2022.

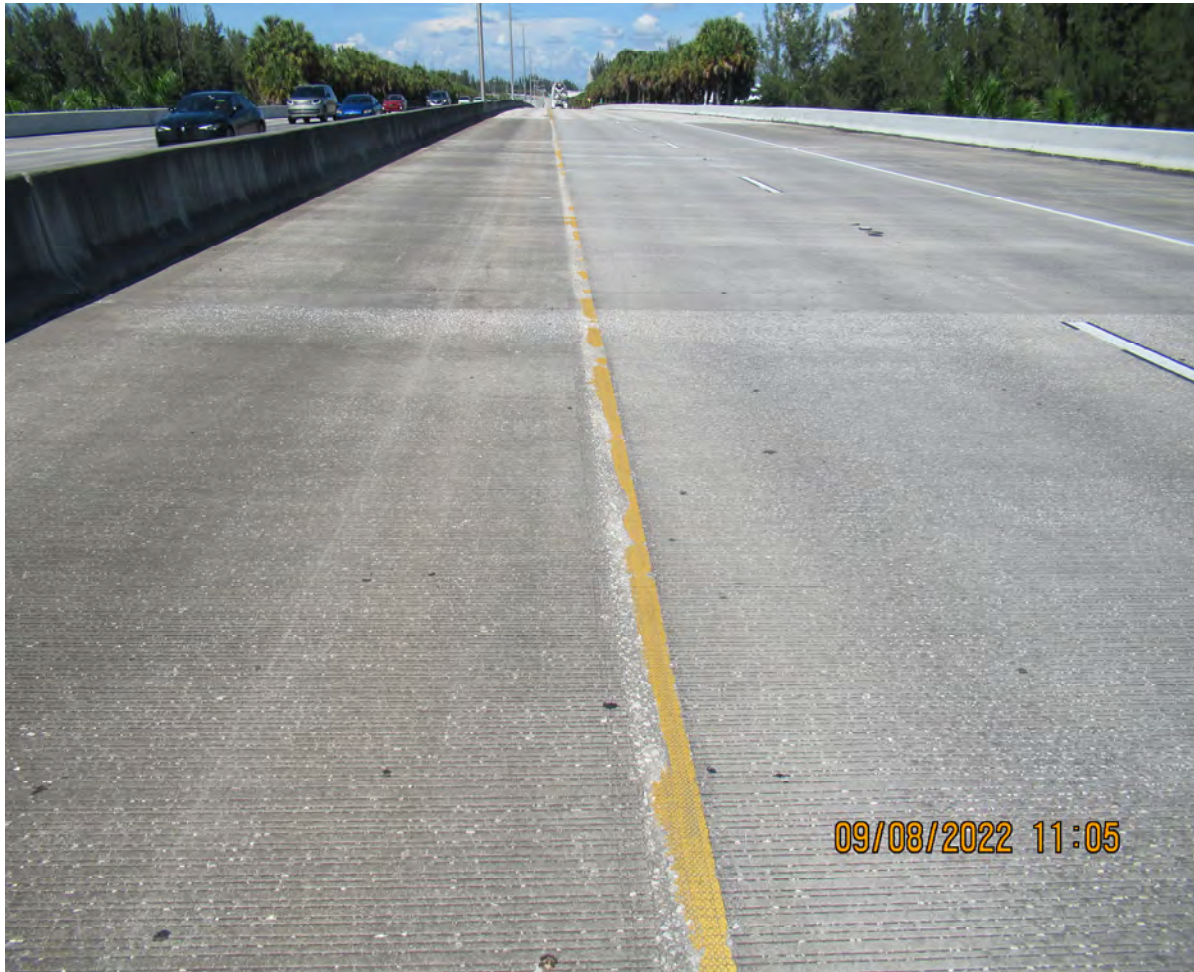
**ROADWAY INSPECTION
LOCATION: MILE MARKER 1.54 MILES
WESTBOUND MAINLINE**

DETERIORATED EDGE LINE STRIPING (BRIDGE # 871002)

ITEM NOTED TO BE ADDRESSED BY MDX MAINTENANCE

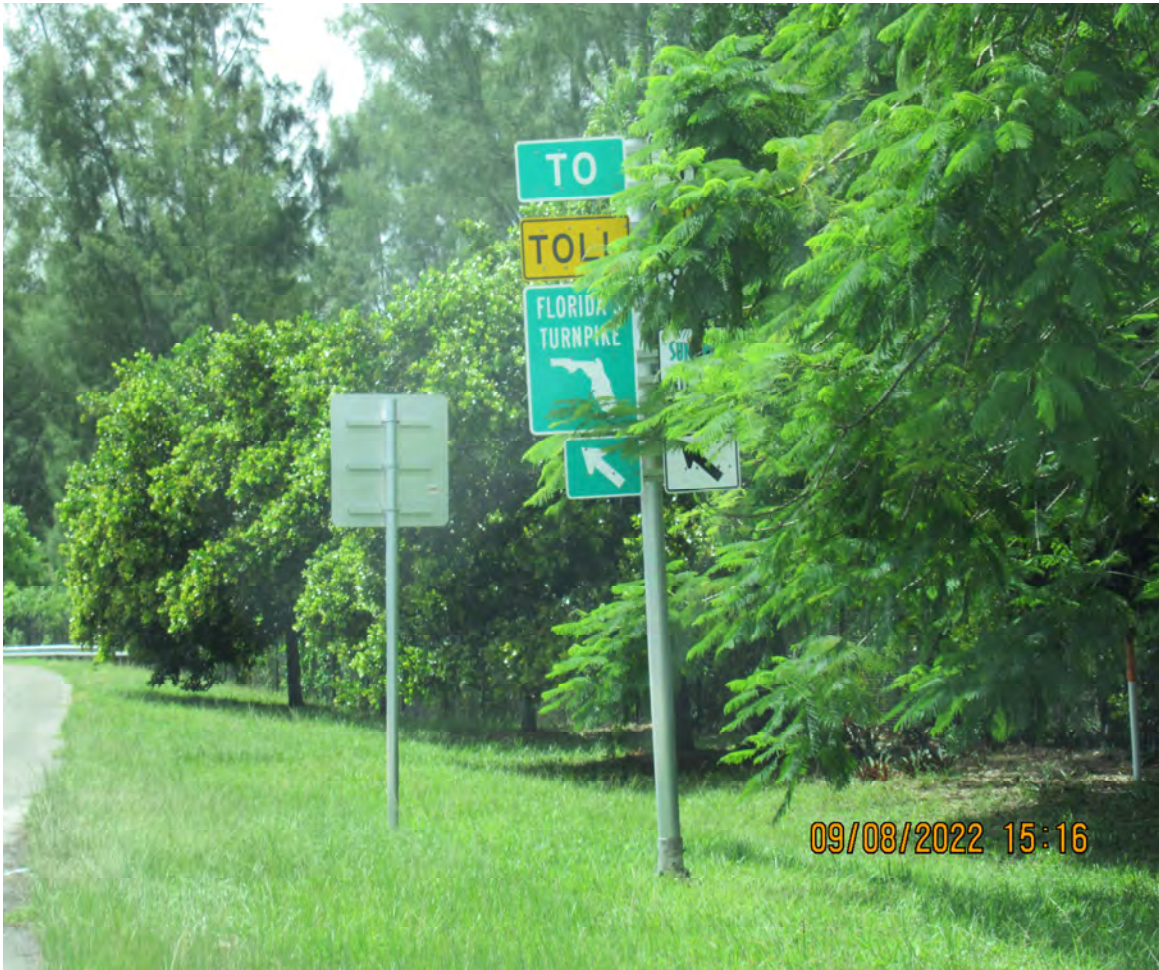
**ROADWAY INSPECTION
LOCATION: MILE MARKER 3.6 MILES
WESTBOUND ON-RAMP FROM NW 107th AVENUE**

OVERGROWN VEGETATION OBSTRUCTING SIGN

ITEM NOTED TO BE ADDRESSED BY MDX MAINTENANCE

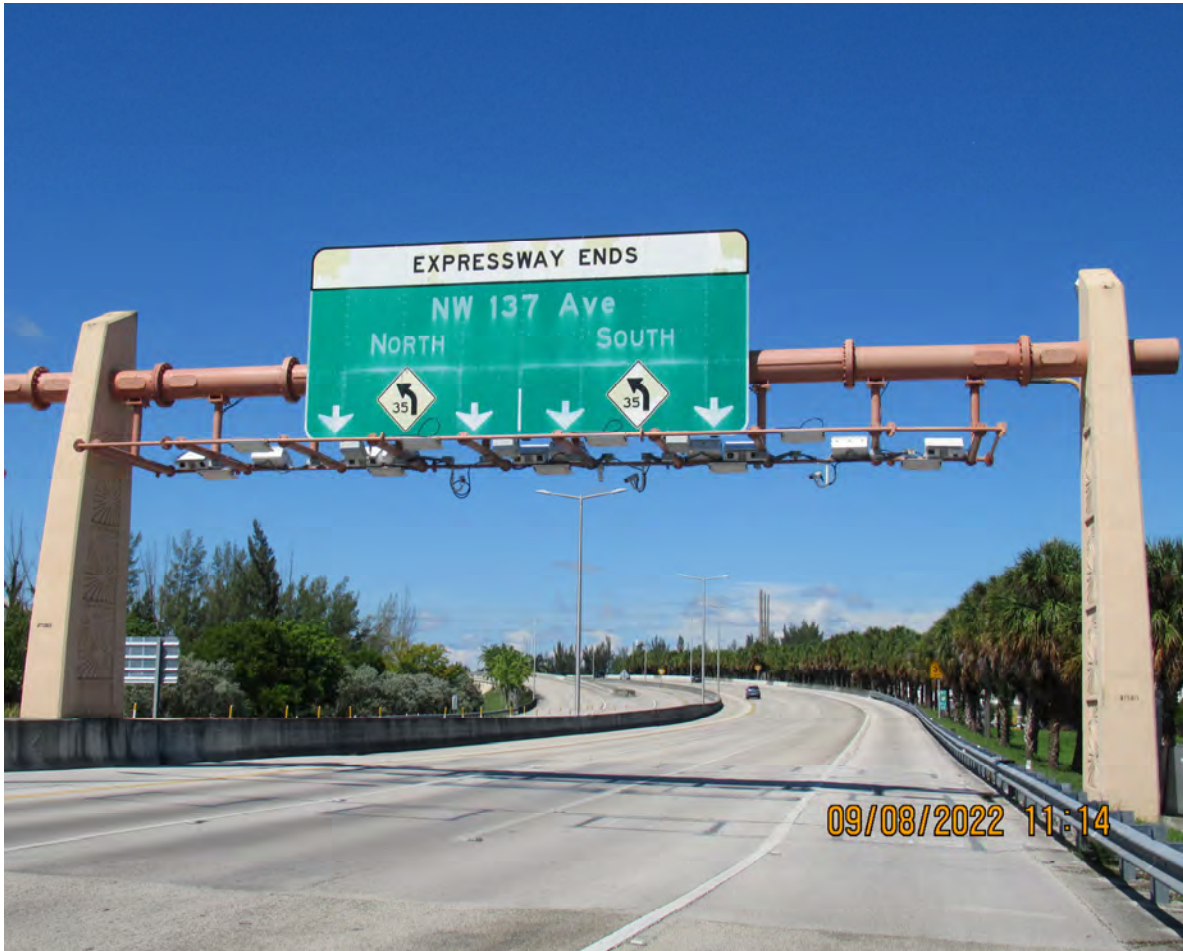
**ROADWAY INSPECTION
LOCATION: MILE MARKER 0.88 MILES
WESTBOUND MAINLINE**

DETERIORATED REFLECTIVE SHEETING ON SIGN PANEL

ITEM NOTED TO BE ADDRESSED BY MDX WORK PROGRAM 30058

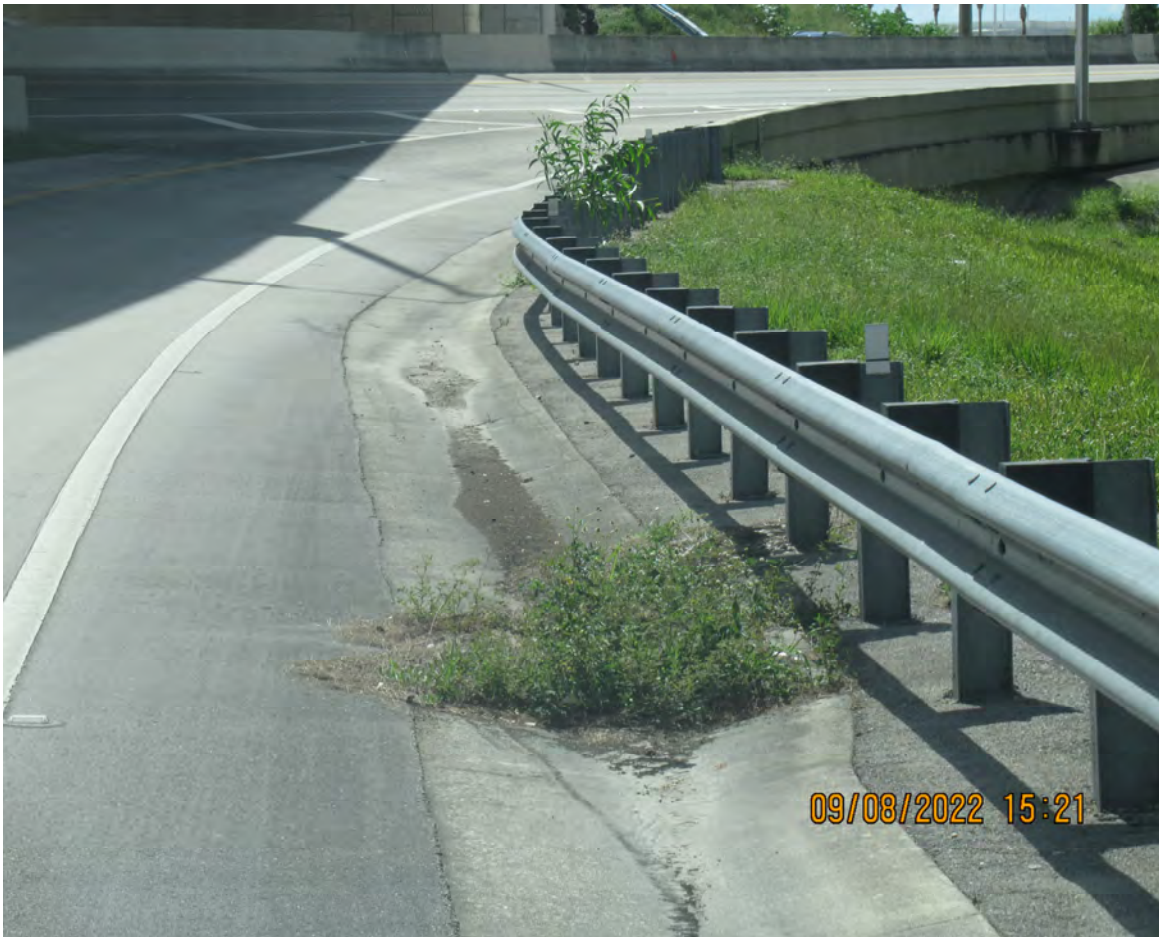
**ROADWAY INSPECTION
LOCATION: MILE MARKER 3.0 MILES
WESTBOUND MAINLINE**

**OVERGROWN VEGETATION AND DEBRIS OBSTRUCTING
DRAINAGE STRUCTURE**

ITEM NOTED TO BE ADDRESSED BY MDX MAINTENANCE

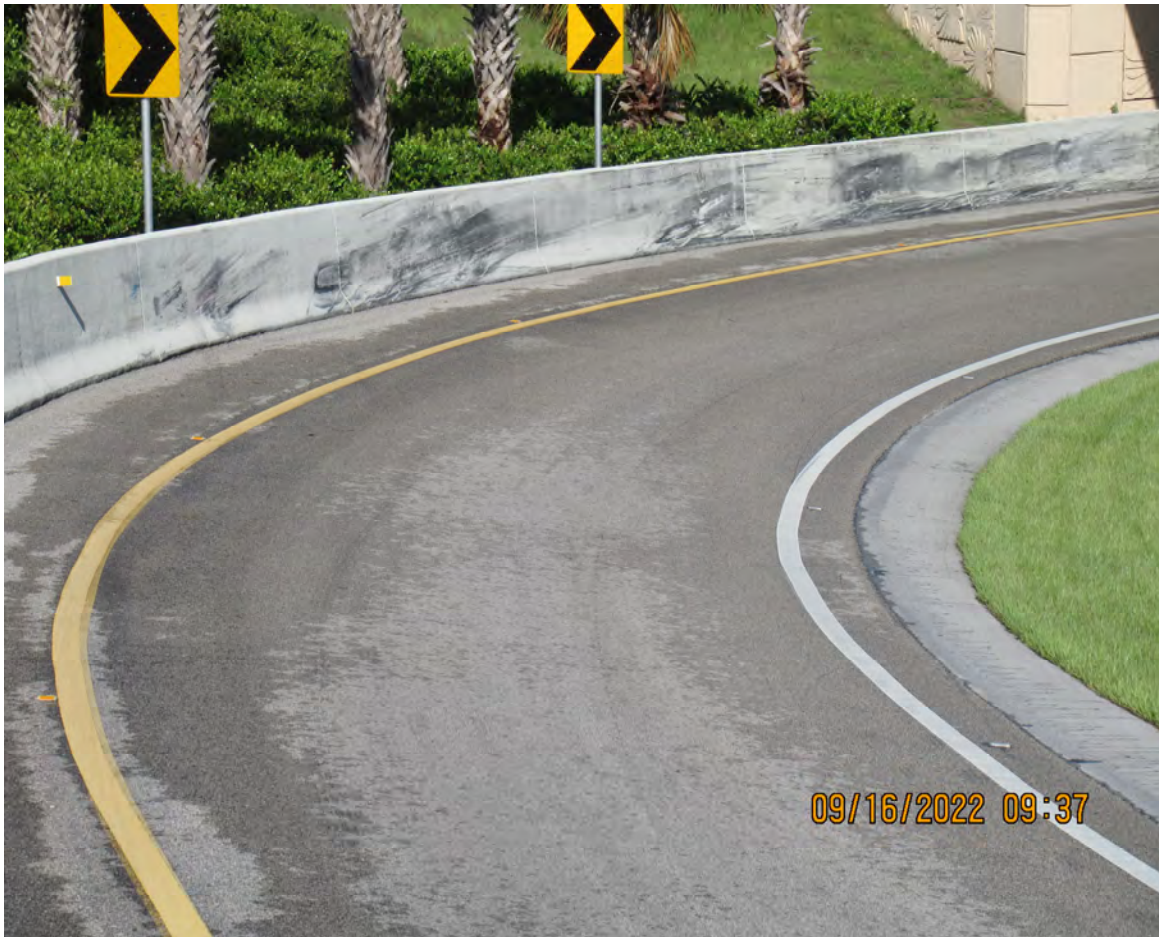
**ROADWAY INSPECTION
LOCATION: MILE MARKER 5.52 MILES
WESTBOUND OFF-RAMP TO SOUTHBOUND
NW 87th AVENUE**

SCUFF MARKS ON BARRIER WALL

ITEM NOTED TO BE ADDRESSED BY MDX MAINTENANCE

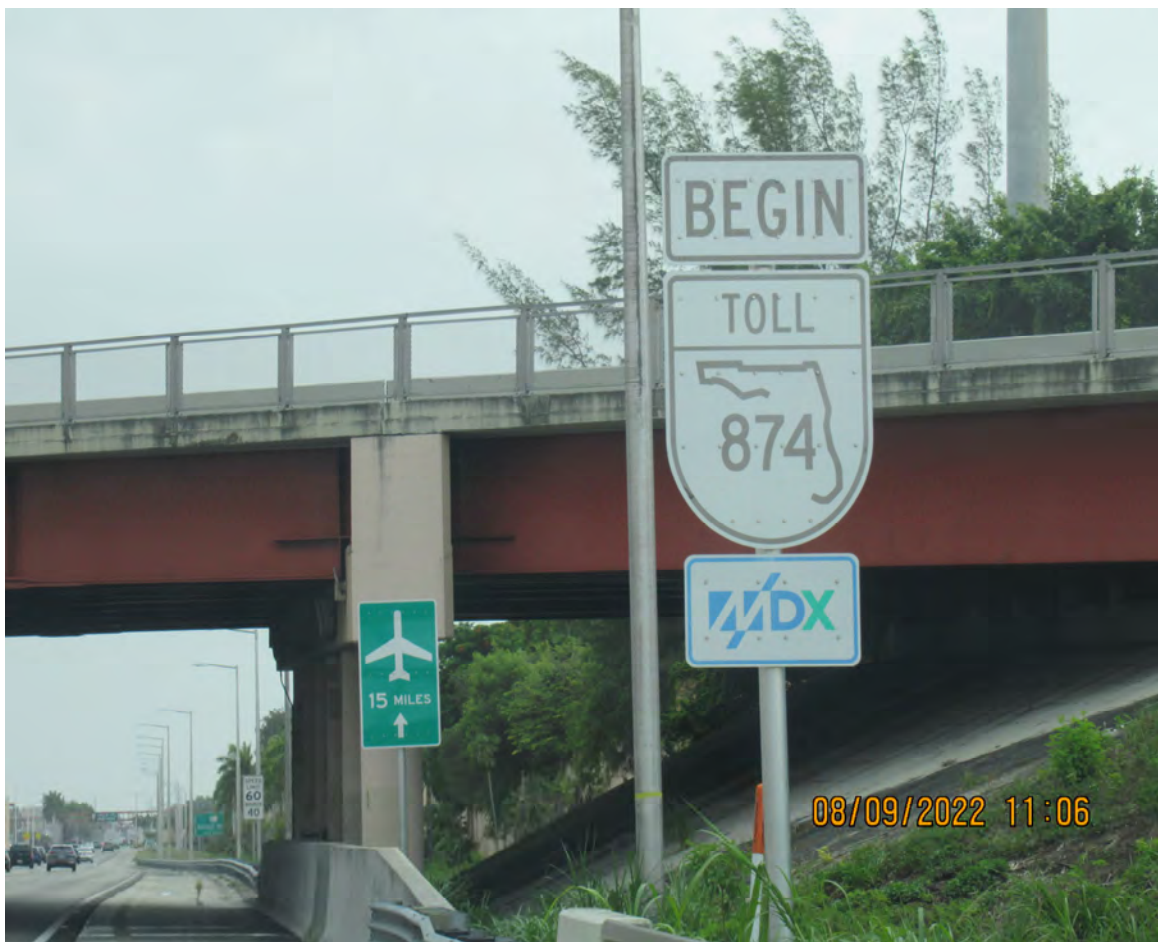
**ROADWAY INSPECTION
LOCATION: MILE MARKER 0.0 MILES
NORTHBOUND MAINLINE**

DETERIORATED REFLECTIVE SHEETING

ITEM NOTED TO BE ADDRESSED BY MDX MAINTENANCE

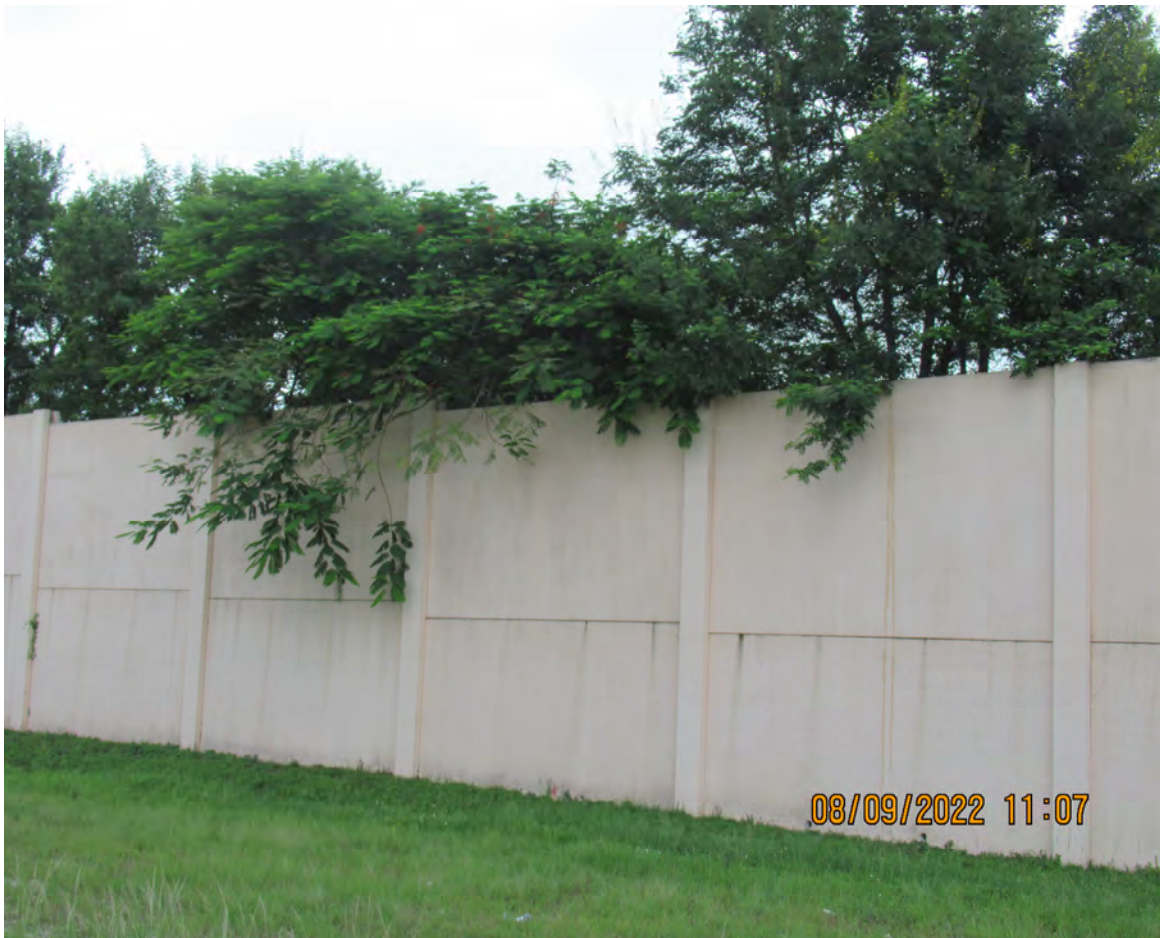
**ROADWAY INSPECTION
LOCATION: MILE MARKER 0.8 MILES
NORTHBOUND MAINLINE**

**OVERGROWN VEGETATION ON SOUND WALL
(TYPICAL THROUGHOUT THE CORRIDOR)**

ITEM NOTED TO BE ADDRESSED BY MDX MAINTENANCE

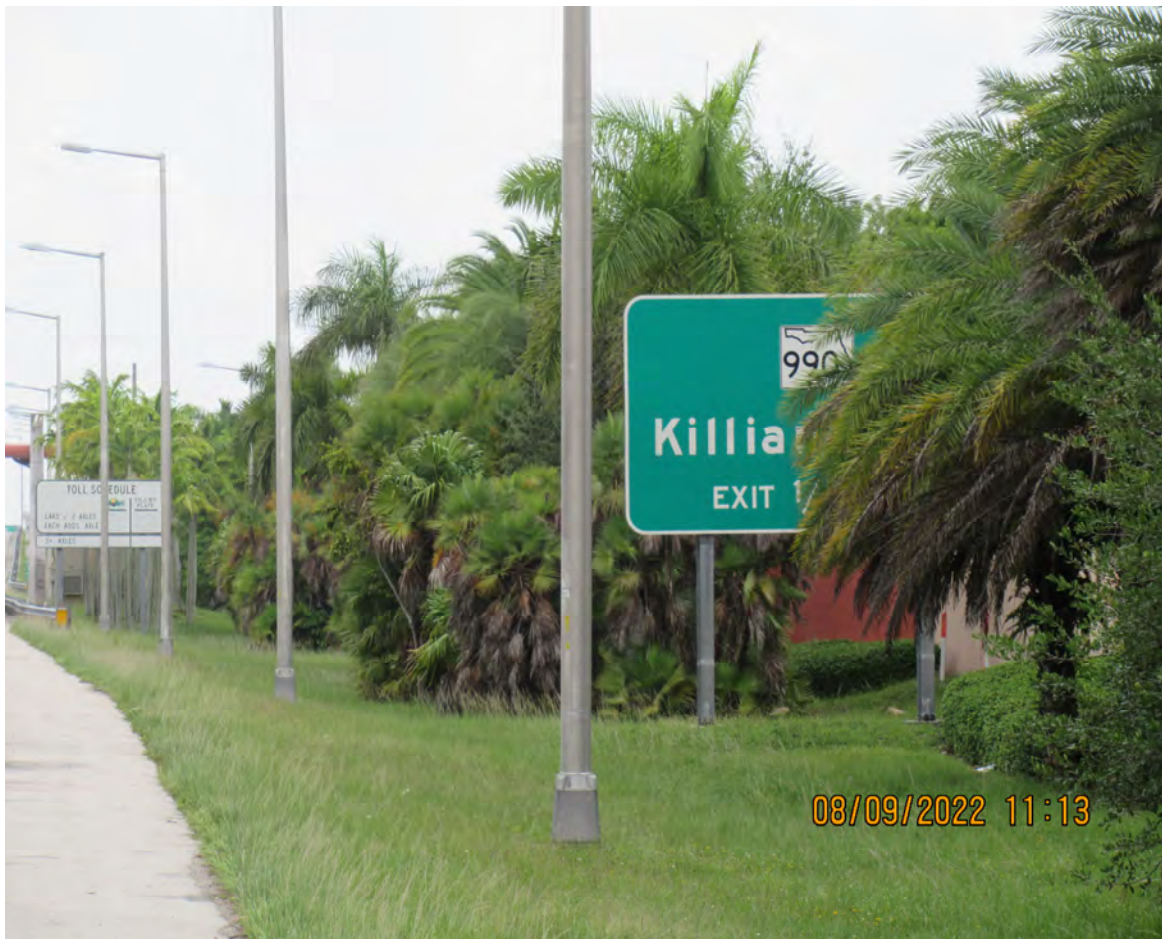
**ROADWAY INSPECTION
LOCATION: MILE MARKER 1.2 MILES
NORTHBOUND MAINLINE**

OVERGROWN VEGETATION OBSTRUCTING SIGN

ITEM NOTED TO BE ADDRESSED BY MDX MAINTENANCE

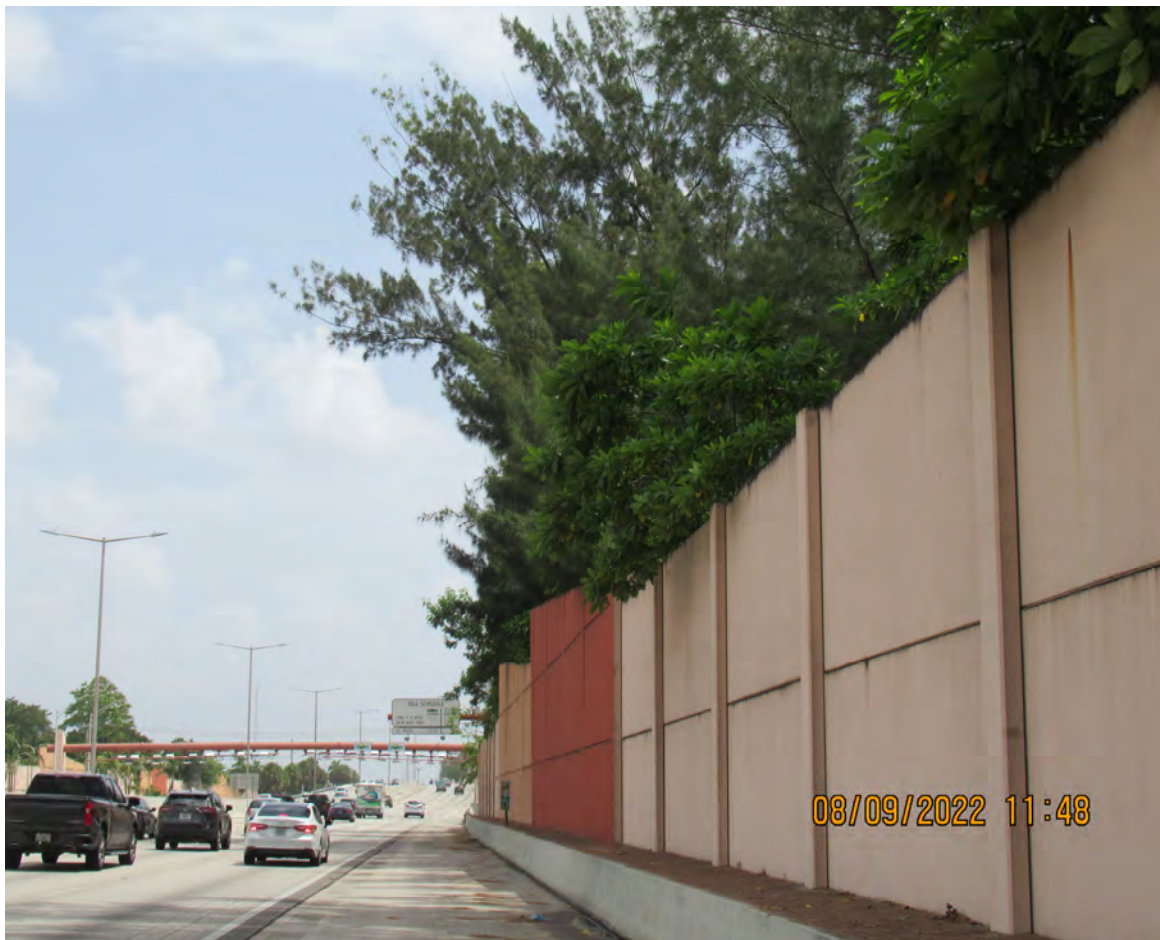
**ROADWAY INSPECTION
LOCATION: MILE MARKER 6.0 MILES
NORTHBOUND MAINLINE**

OVERGROWN VEGETATION

ITEM NOTED TO BE ADDRESSED BY MDX MAINTENANCE

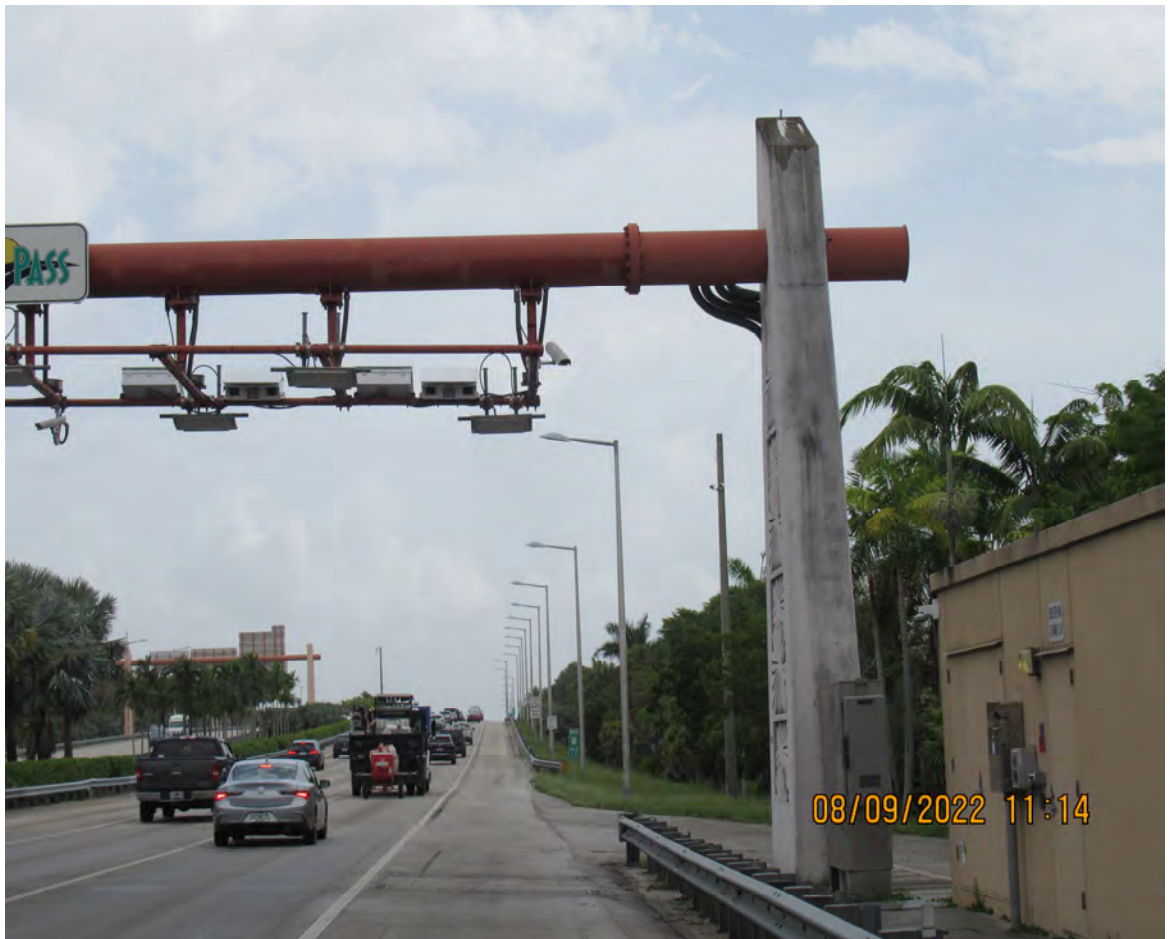
**ROADWAY INSPECTION
LOCATION: MILE MARKER 1.4 MILES
NORTHBOUND MAINLINE**

**DETERIORATED CLASS V COATING ON STRUCTURE UPWRIGHT
(TYPICAL THROUGHOUT THE CORRIDOR)**

ITEM NOTED TO BE ADDRESSED BY MDX WORK PROGRAM NO. 30043

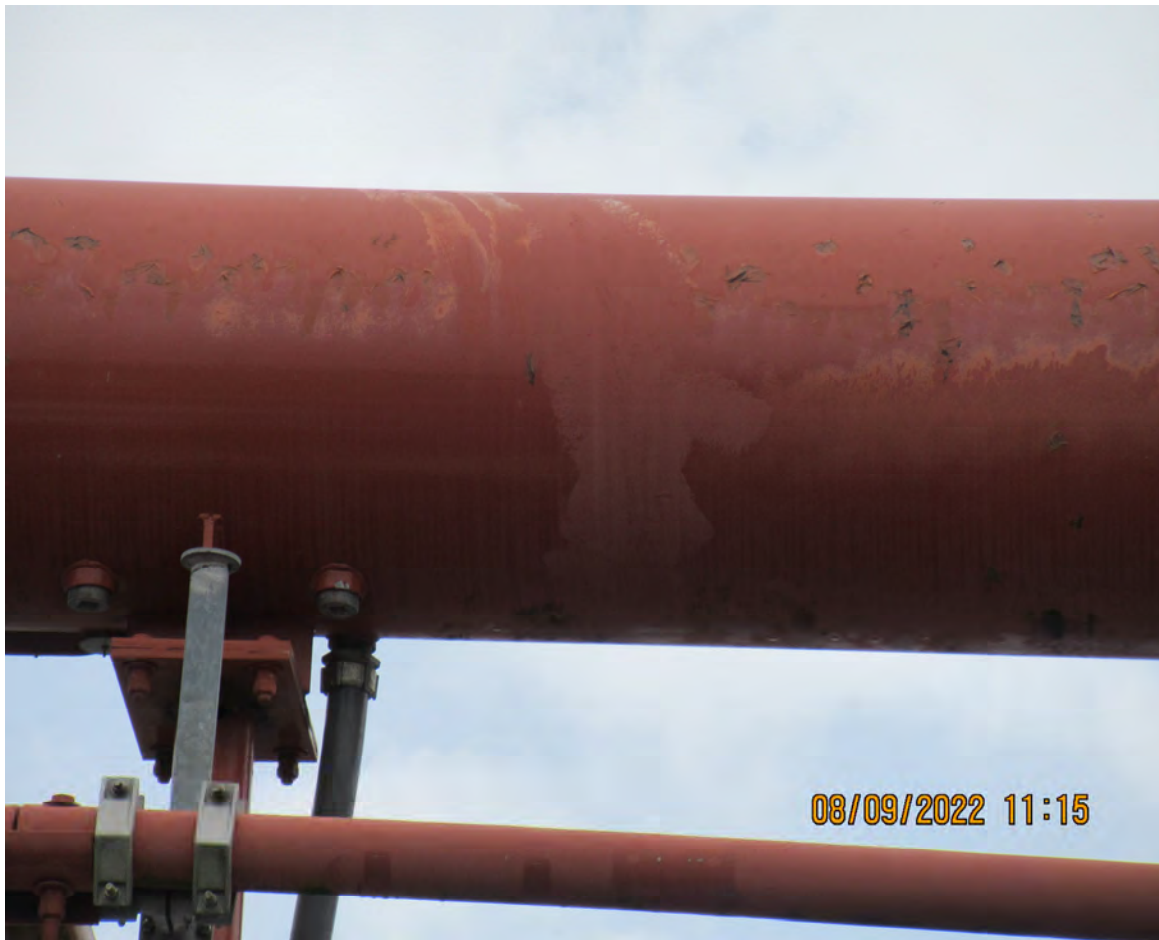
**ROADWAY INSPECTION
LOCATION: MILE MARKER 1.4 MILES
NORTHBOUND MAINLINE**

**DETERIORATED PAINT ON ORT GANTRY MONOTUBE
(STRUCTURE # 87S937)**

ITEM NOTED TO BE ADDRESSED BY MDX WORK PROGRAM NO. 30043

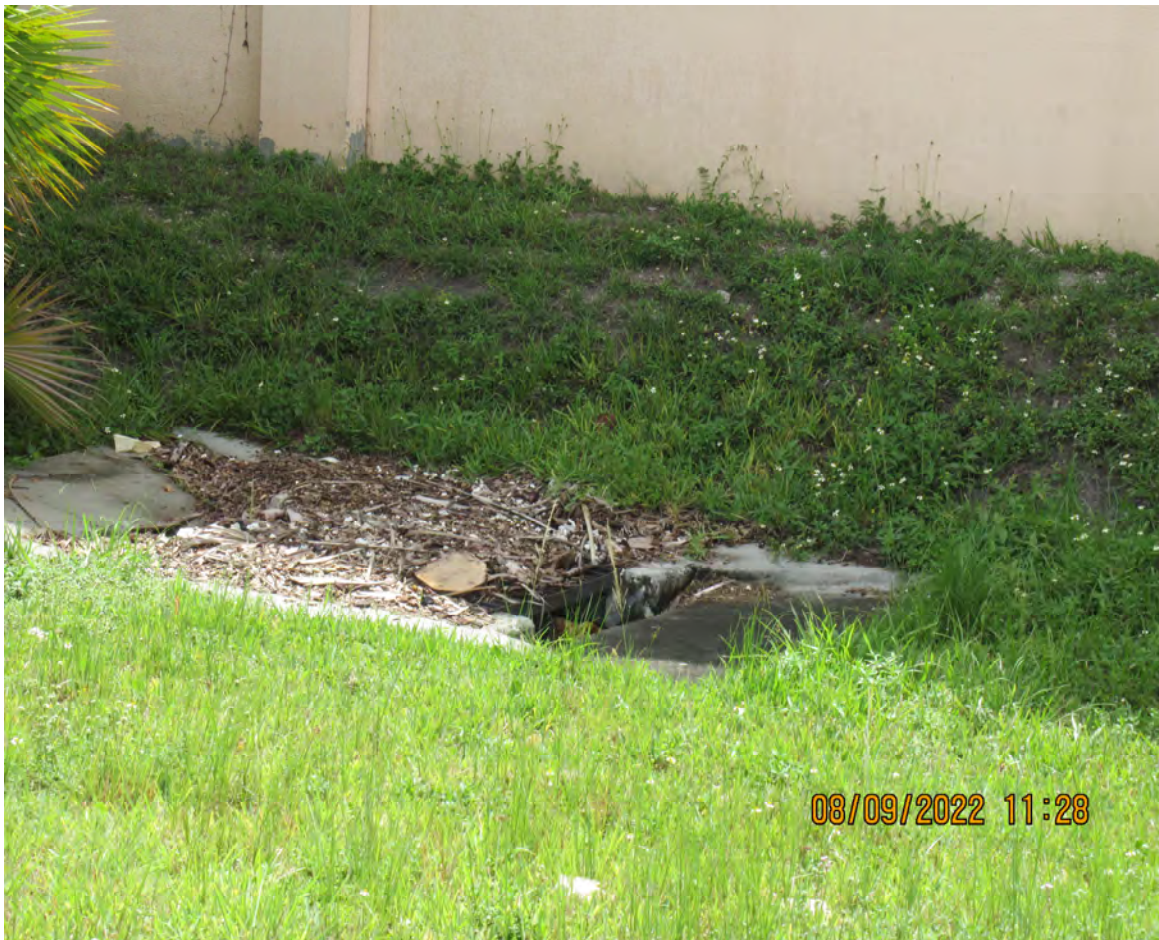
**ROADWAY INSPECTION
LOCATION: MILE MARKER 3.0 MILES
NORTHBOUND MAINLINE**

DEBRIS ON DRAINAGE STRUCTURE GRATE

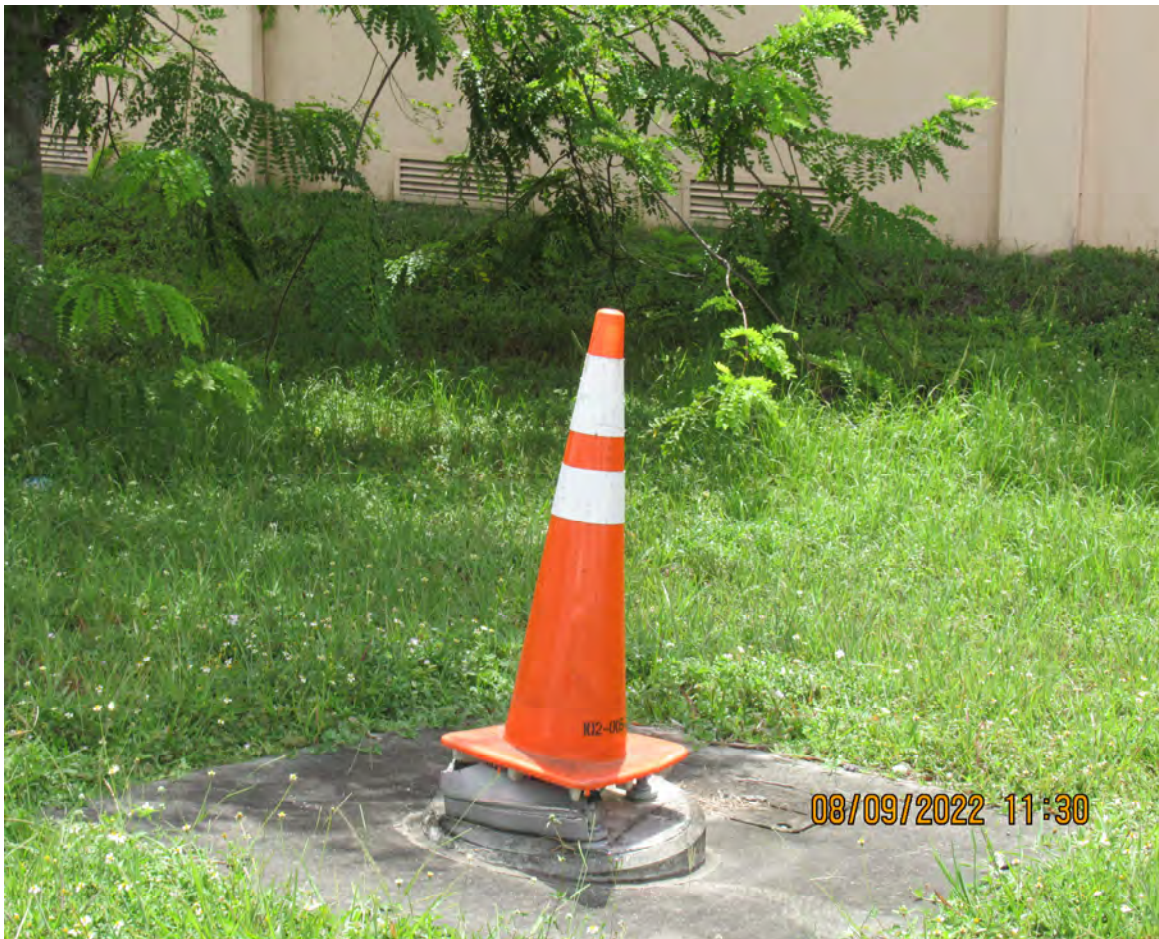
**ROADWAY INSPECTION
LOCATION: MILE MARKER 3.2 MILES
NORTHBOUND MAINLINE**

MISSING LIGHT POLE DUE TO VEHICULAR ACCIDENT

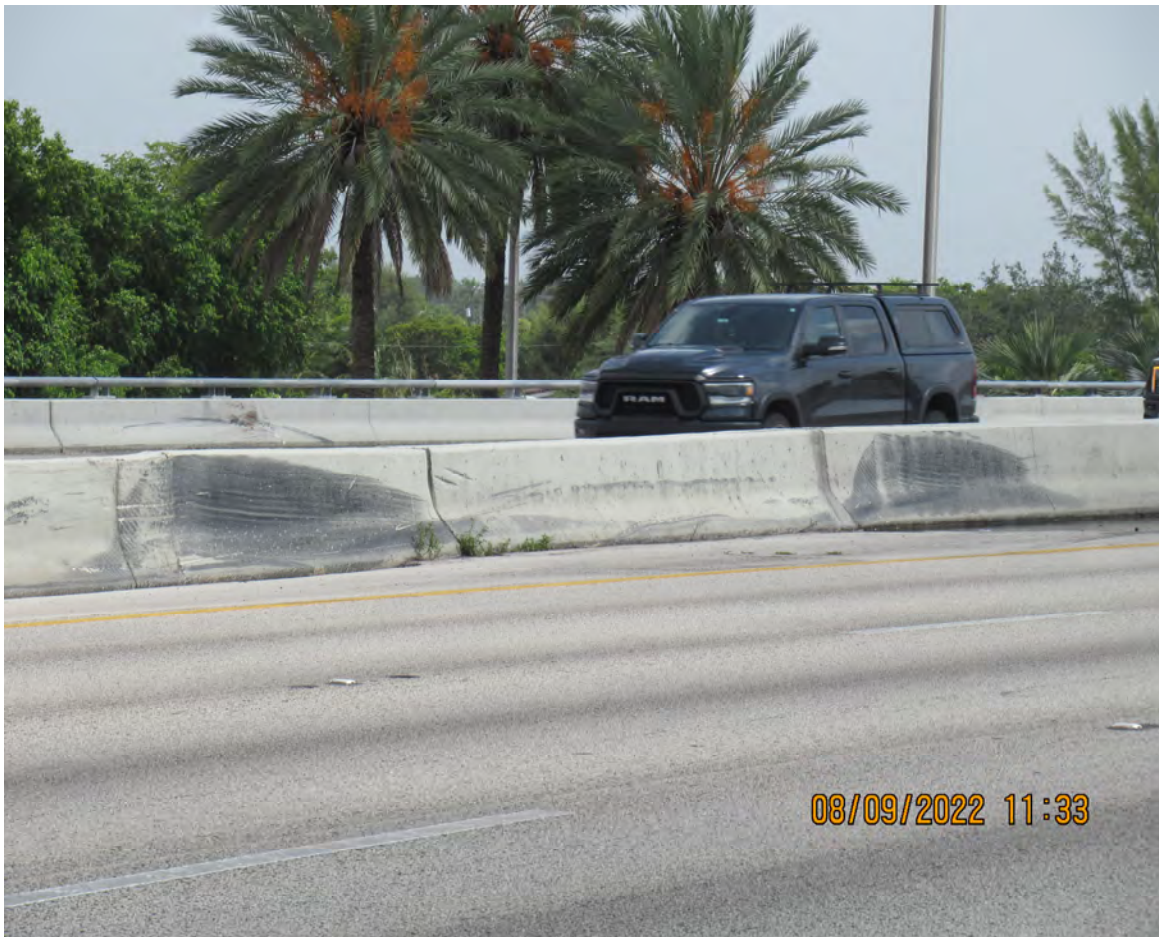
**ROADWAY INSPECTION
LOCATION: MILE MARKER 3.6 MILES
NORTHBOUND MAINLINE**

SCUFF MARKS ON BARRIER WALL

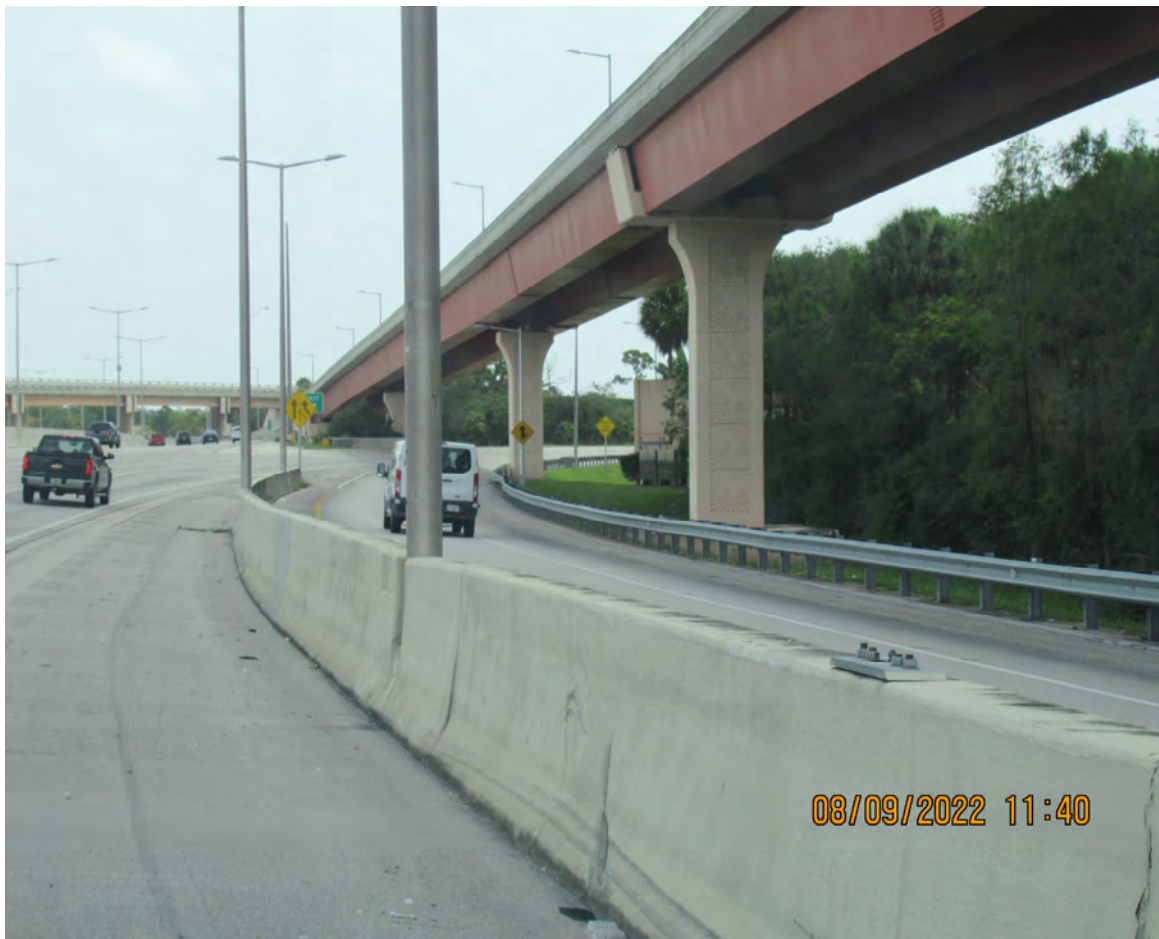
**ROADWAY INSPECTION
LOCATION: MILE MARKER 4.2 MILES
NORTHBOUND MAINLINE**

MISSING MILE MARKER 4.2

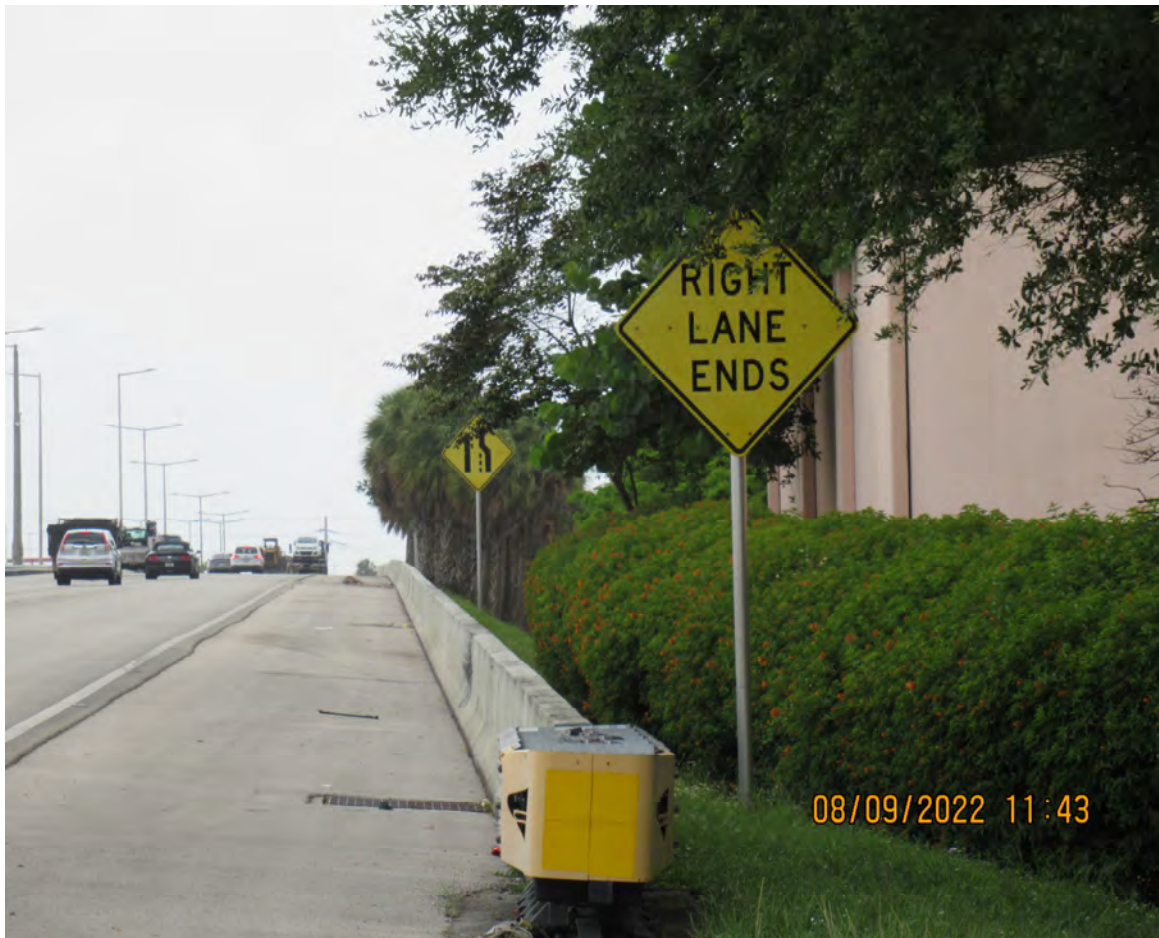
ROADWAY INSPECTION
LOCATION: MILE MARKER 4.74 MILES
NORTHBOUND MAINLINE

OVERGROWN VEGETATION OBSTRUCTING SIGN

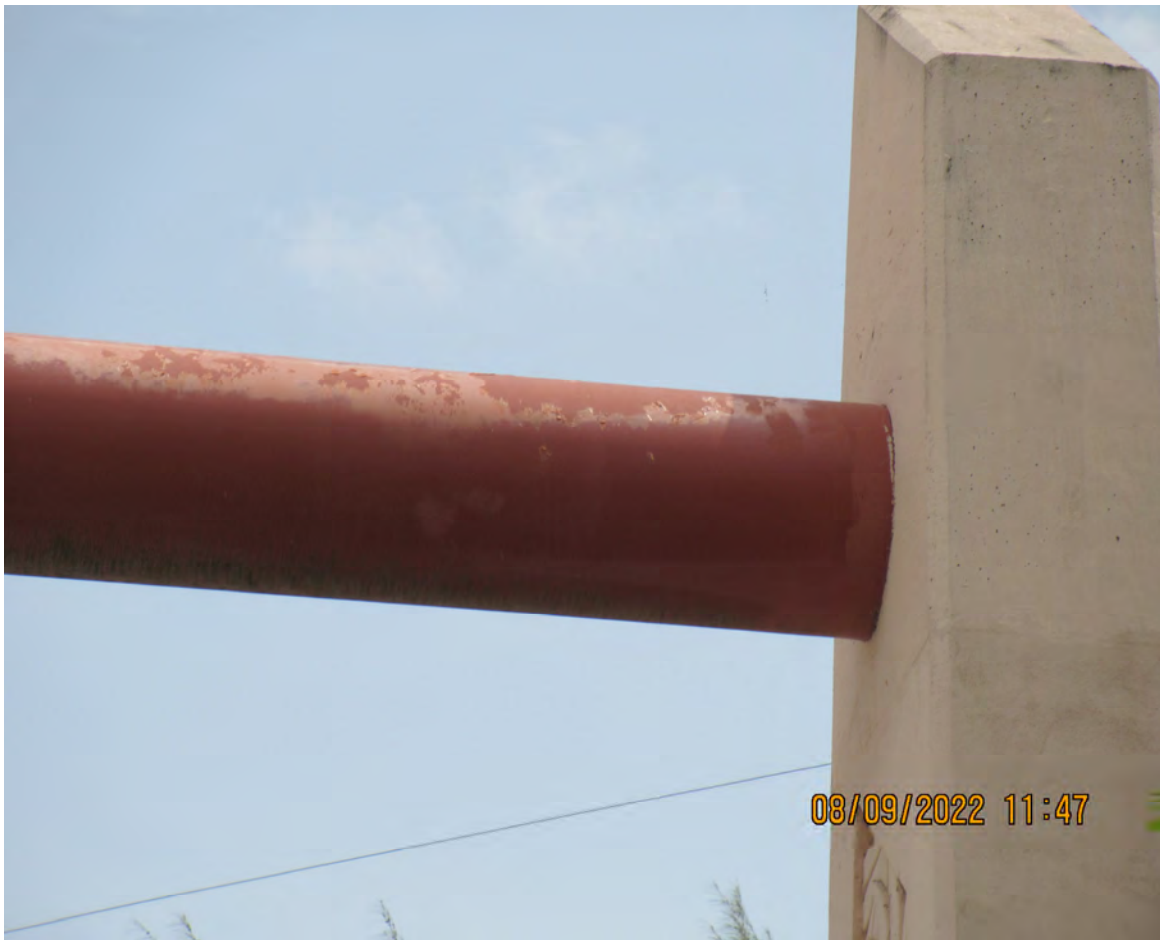
**ROADWAY INSPECTION
LOCATION: MILE MARKER 5.8 MILES
NORTHBOUND MAINLINE**

DETERIORATED PAINT ON MONOTUBE (STRUCTURE # 87A134)

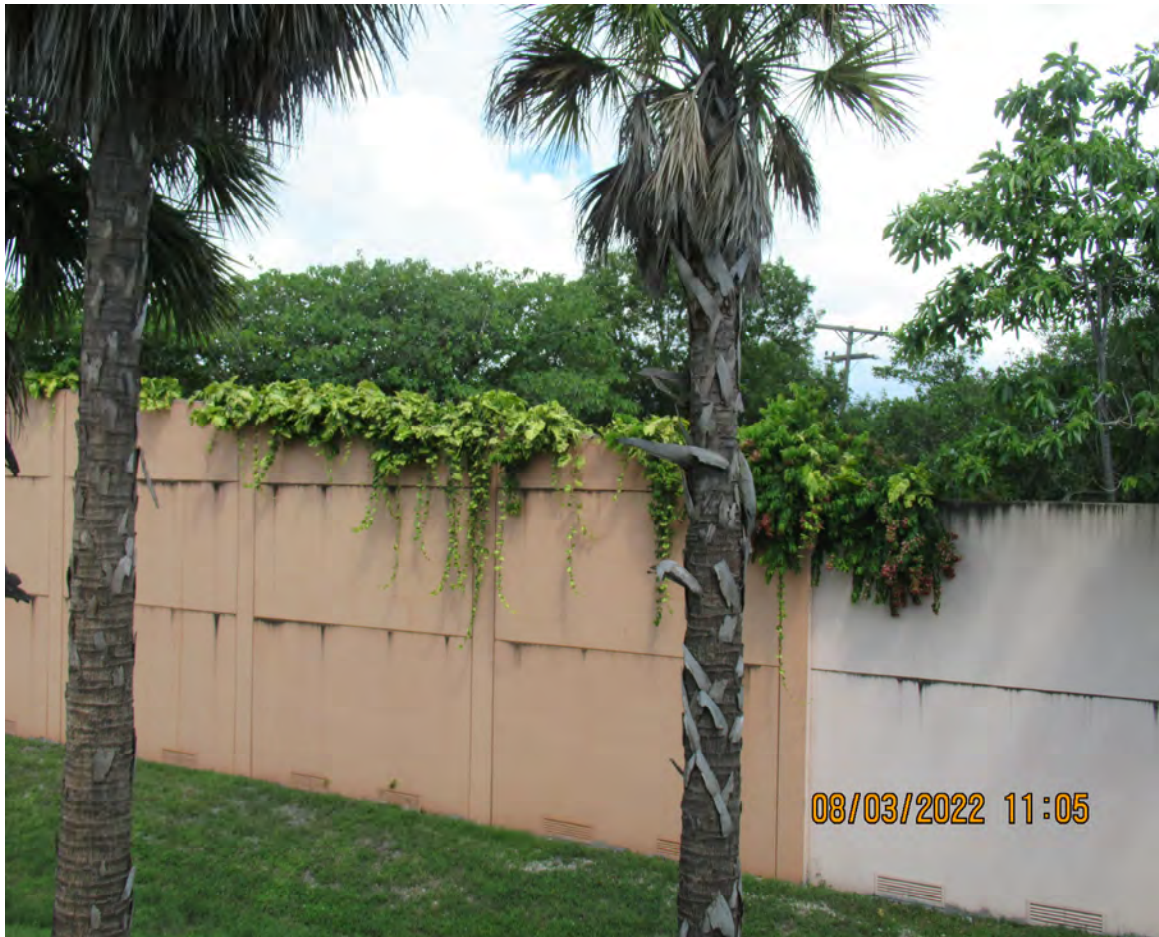
**ROADWAY INSPECTION
LOCATION: MILE MARKER 6.2 MILES
SOUTHBOUND MAINLINE**

**OVERGROWN VEGETATION ON SOUND WALL
(TYPICAL AT VARIOUS LOCATIONS)**

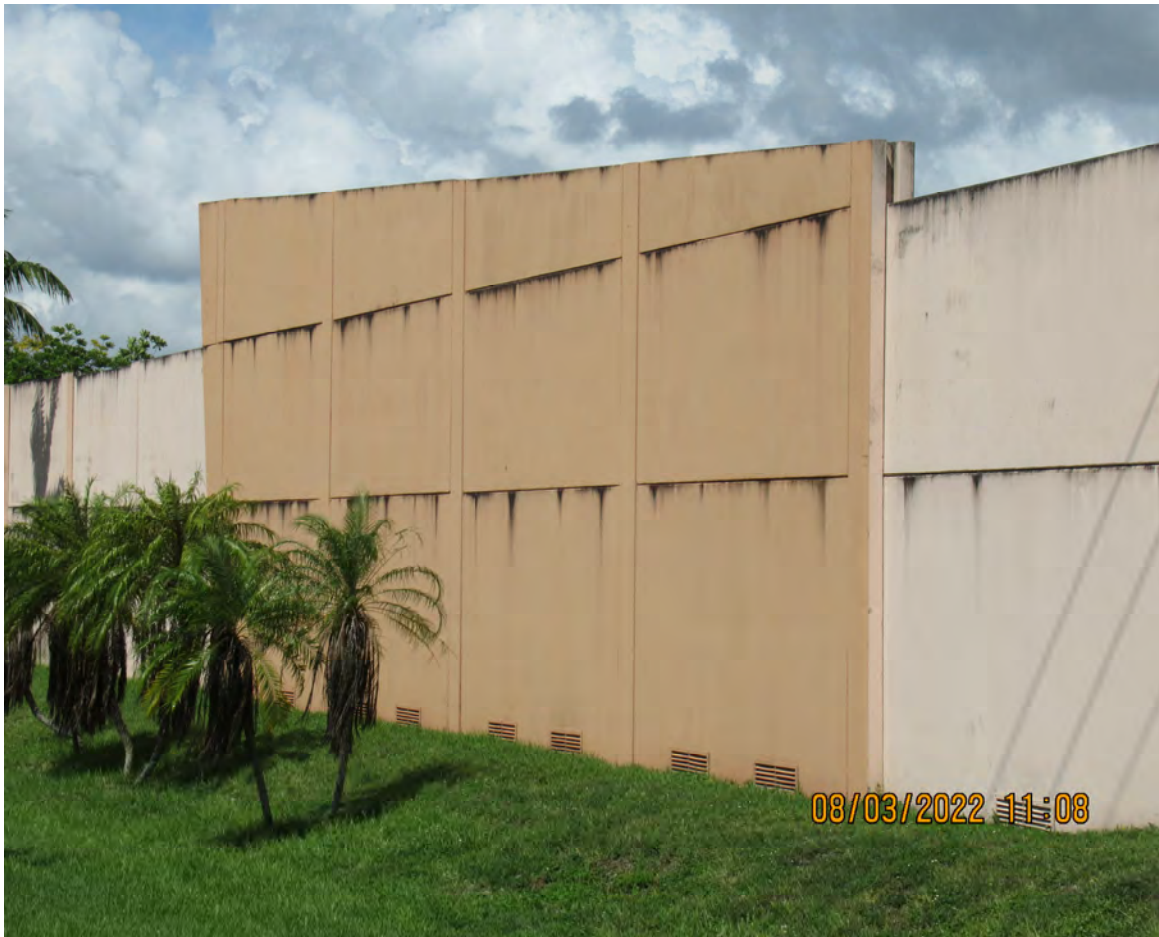
**ROADWAY INSPECTION
LOCATION: MILE MARKER 6.0 MILES
SOUTHBOUND MAINLINE**

**DETERIORATED CLASS V COATING ON SOUND WALL
(TYPICAL AT VARIOUS LOCATIONS)**

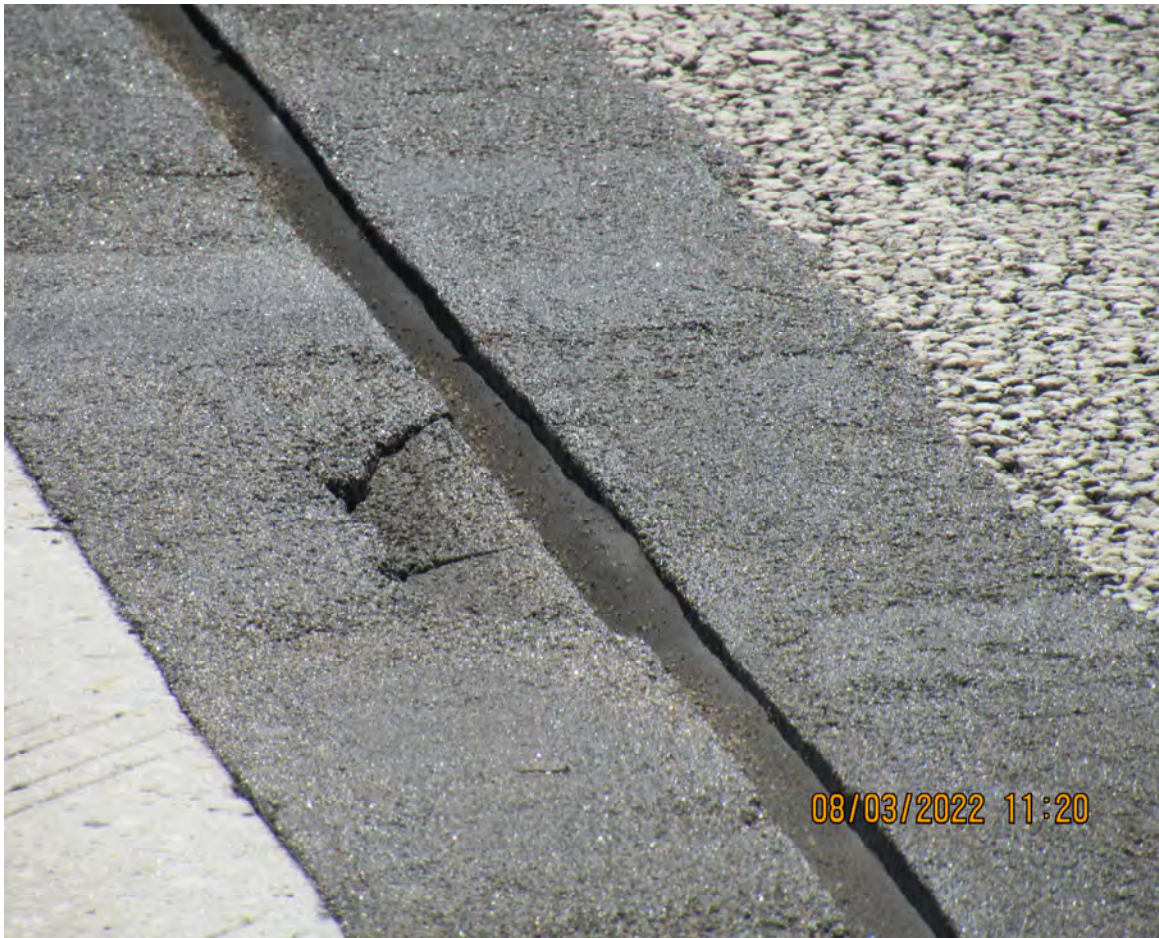
**ROADWAY INSPECTION
LOCATION: MILE MARKER 5.0 MILES
SOUTHBOUND MAINLINE**

**DETERIORATED POLYMER NOSING JOINT HEADER BENT 1
(BRIDGE # 870522)**
