ANNUAL INSPECTION REPORT 2022

ANNUAL INSPECTION REPORT

In 1996, the Miami-Dade County Expressway Authority (MDX) acquired operational and financial control of five expressways in Miami-Dade County from the Florida Department of Transportation (FDOT). This group of expressways, toll facilities and the MDX headquarters facility, all as described below, are hereinafter referred to as the “MDX System”. In accordance with the Trust Indenture requirements, MDX retained EAC Consulting, Inc. (EAC), as the General Engineering Consultant to perform, among other duties assigned by the Authority, the yearly inspection of the MDX System. This report represents the annual inspection results for Fiscal Year (FY) 2022.

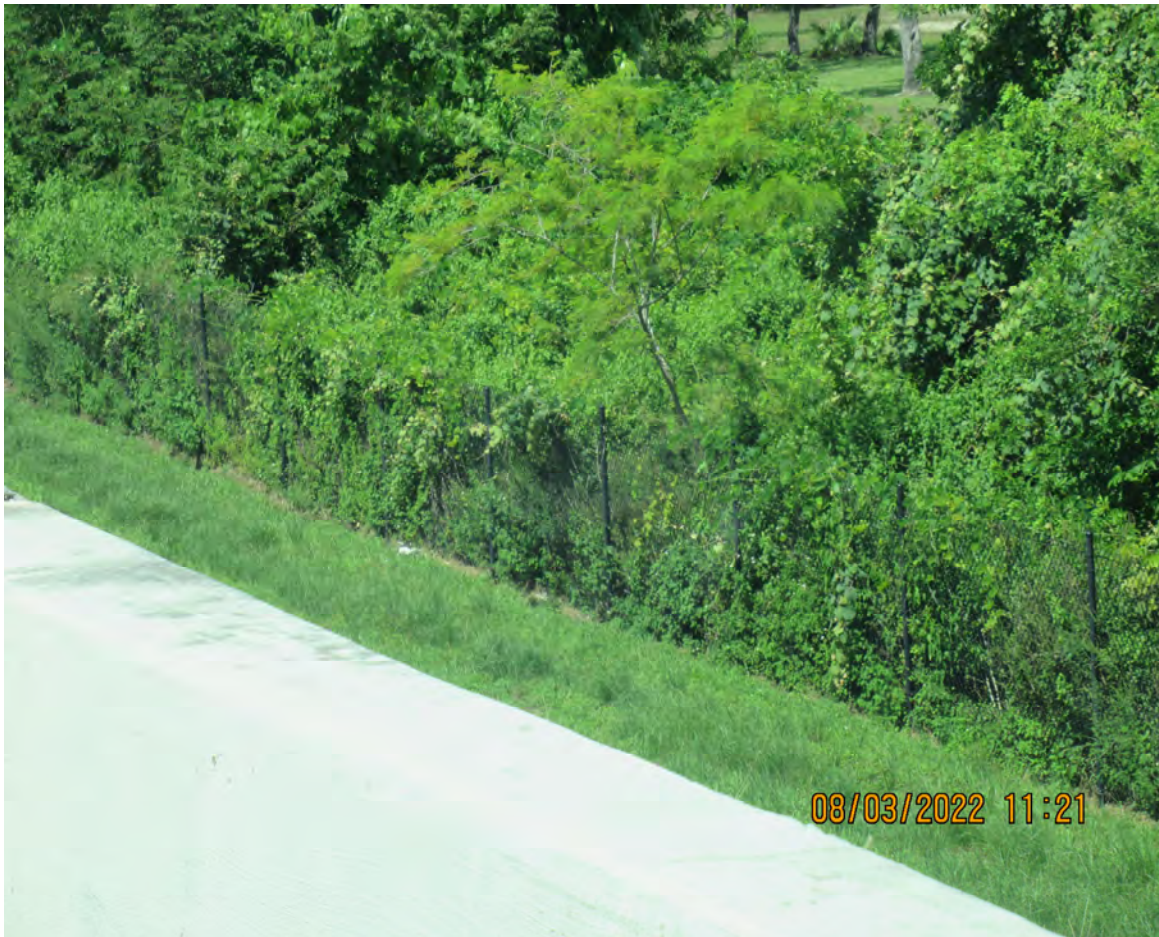
**ROADWAY INSPECTION
LOCATION: MILE MARKER 5.0 TO MILE MARKER 4.7 MILES
SOUTHBOUND MAINLINE**

OVERGROWN VEGETATION ON FENCE

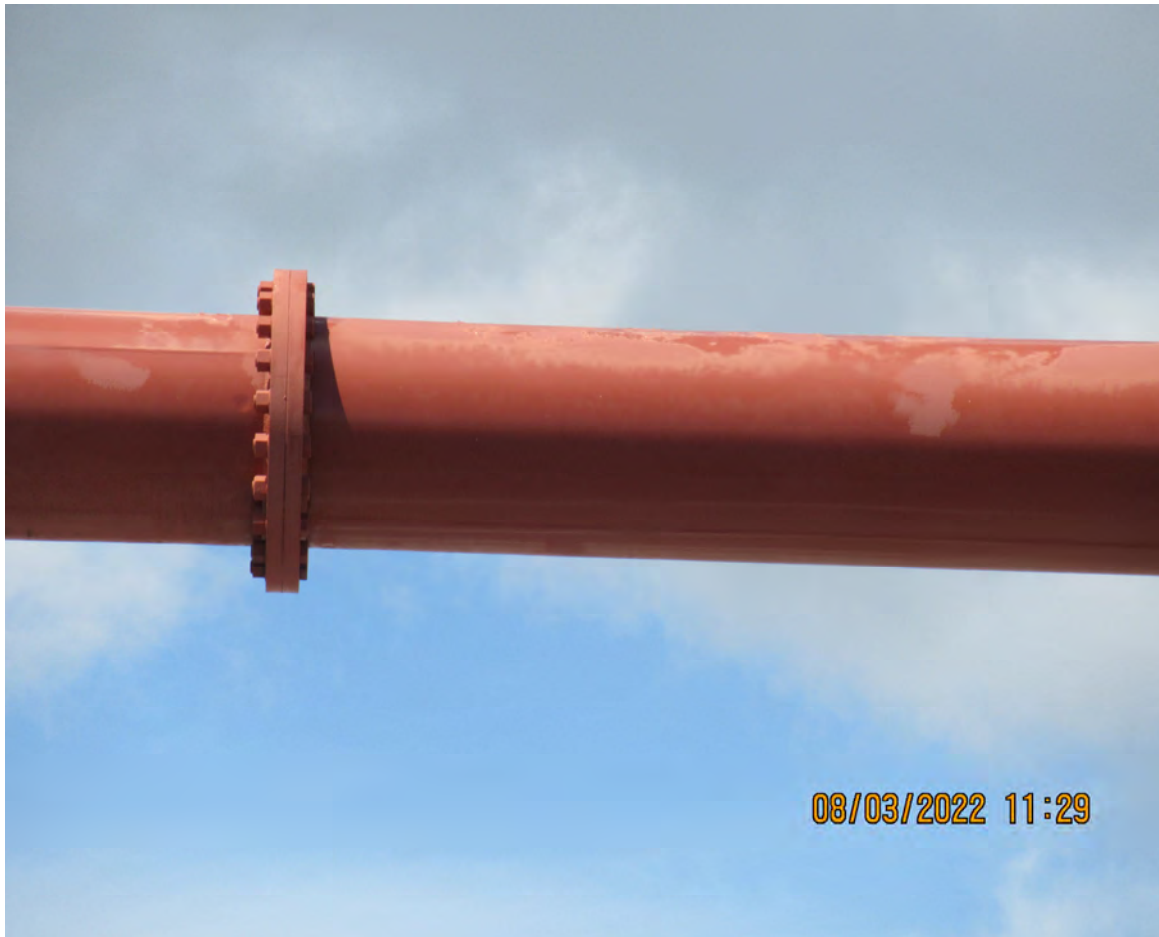
**ROADWAY INSPECTION
LOCATION: MILE MARKER 3.94 MILES
SOUTHBOUND MAINLINE**

DETERIORATED PAINT ON MONOTUBE (STRUCTURE # 87A130)

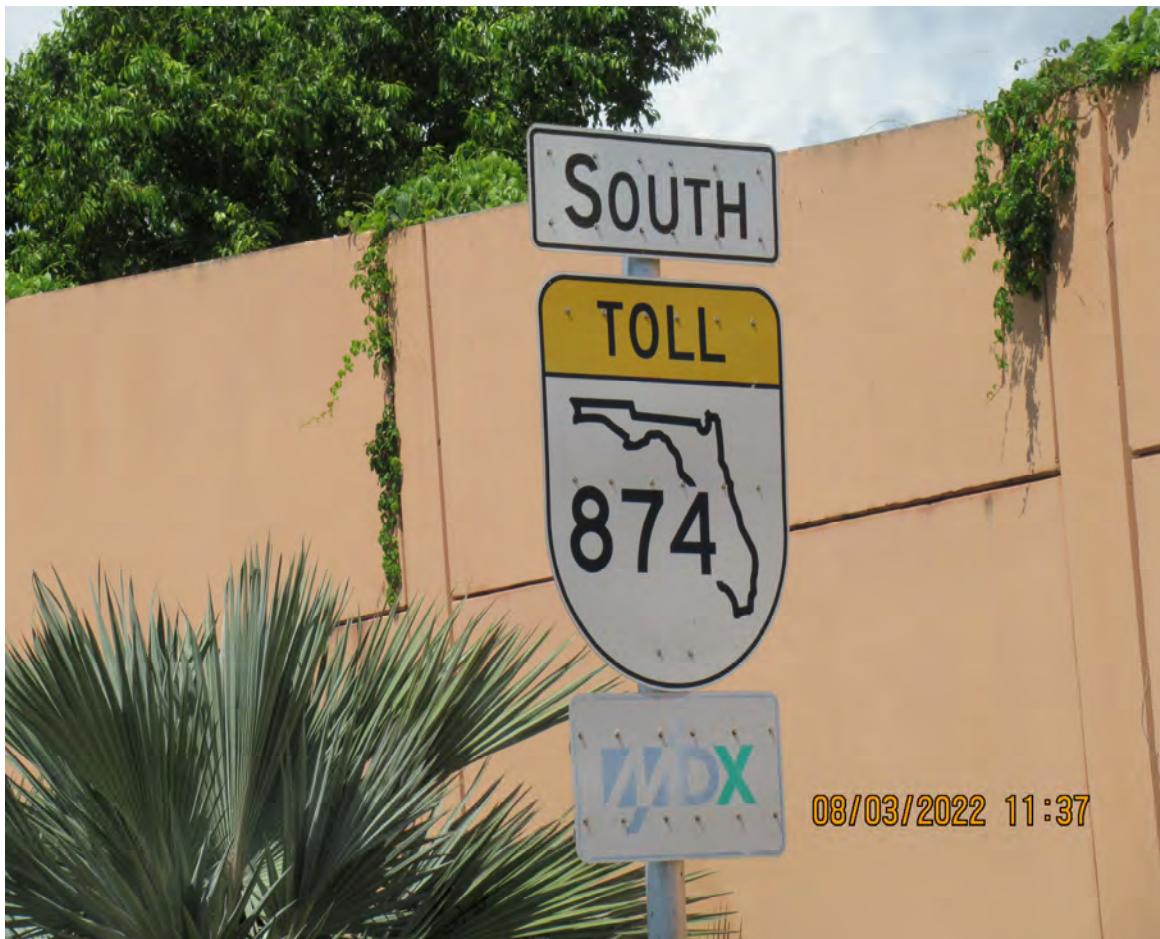
**ROADWAY INSPECTION
LOCATION: MILE MARKER 3.16 MILES
SOUTHBOUND MAINLINE**

DETERIORATED REFLECTIVE SHEETING ON MDX SIGN

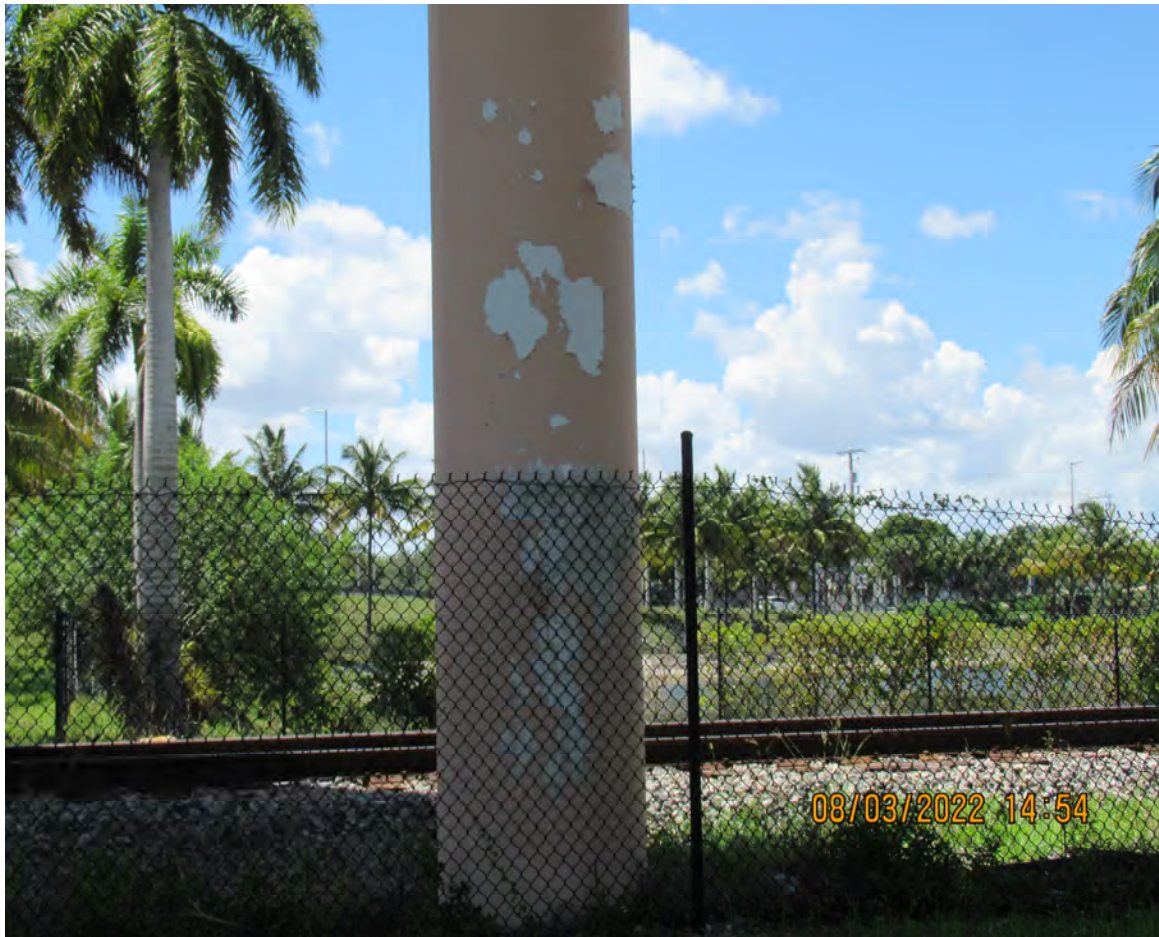
**ROADWAY INSPECTION
LOCATION: MILE MARKER 2.1 MILES
SOUTHBOUND MAINLINE**

DETERIORATED CLASS V COATING ON BRIDGE COLUMNS

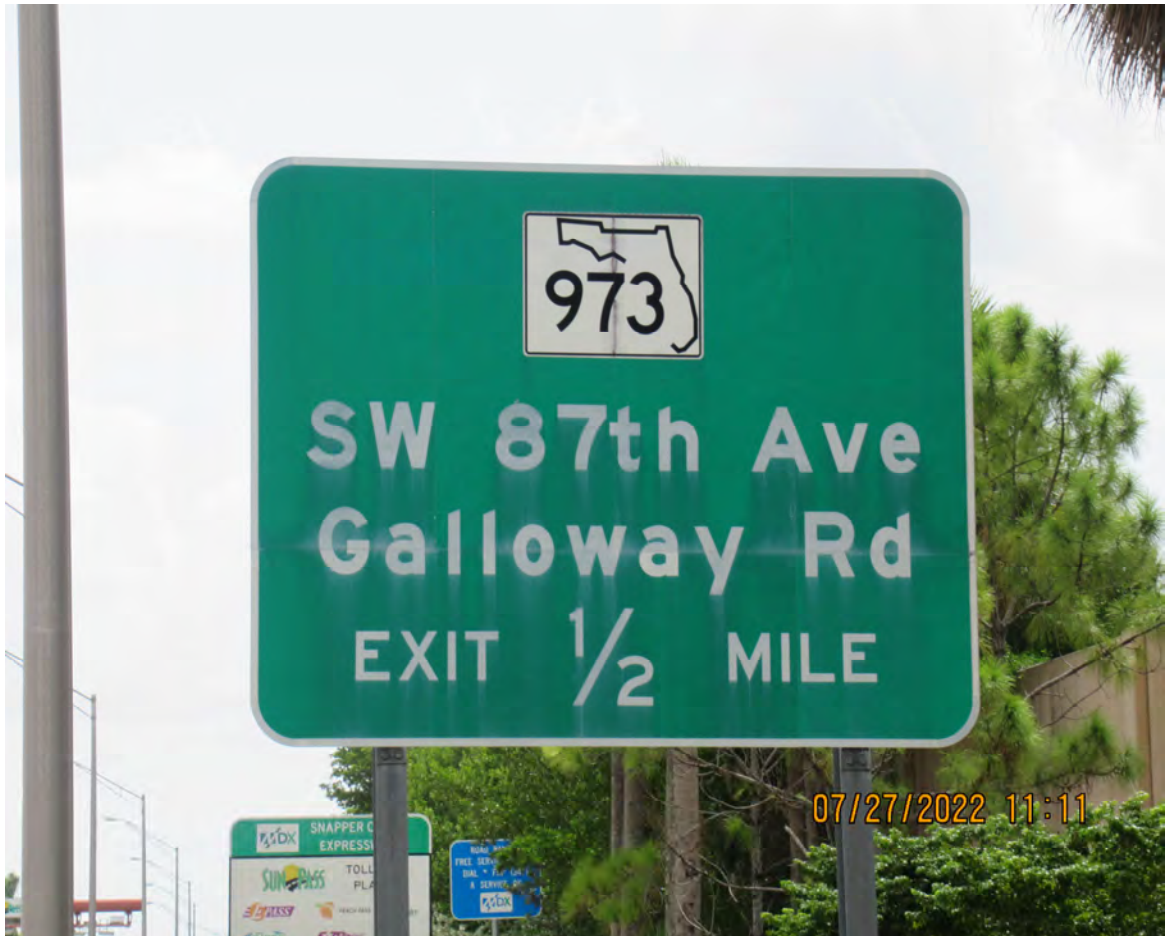
**ROADWAY INSPECTION
LOCATION: MILE MARKER 0.65 MILES
EASTBOUND MAINLINE**

DETERIORATED REFLECTIVE SHEETING

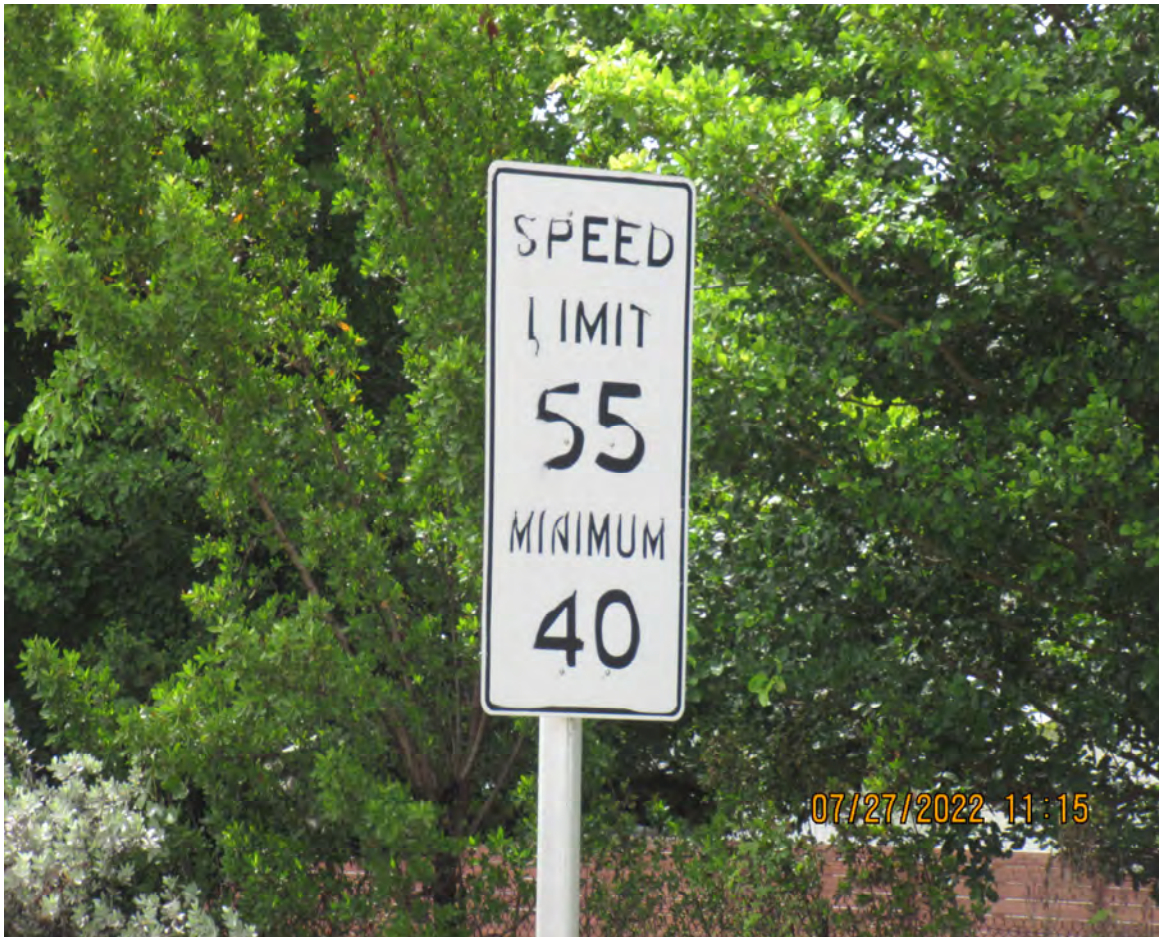
**ROADWAY INSPECTION
LOCATION: MILE MARKER 1.0 MILES
EASTBOUND MAINLINE**

DETERIORATED REFLECTIVE SHEETING

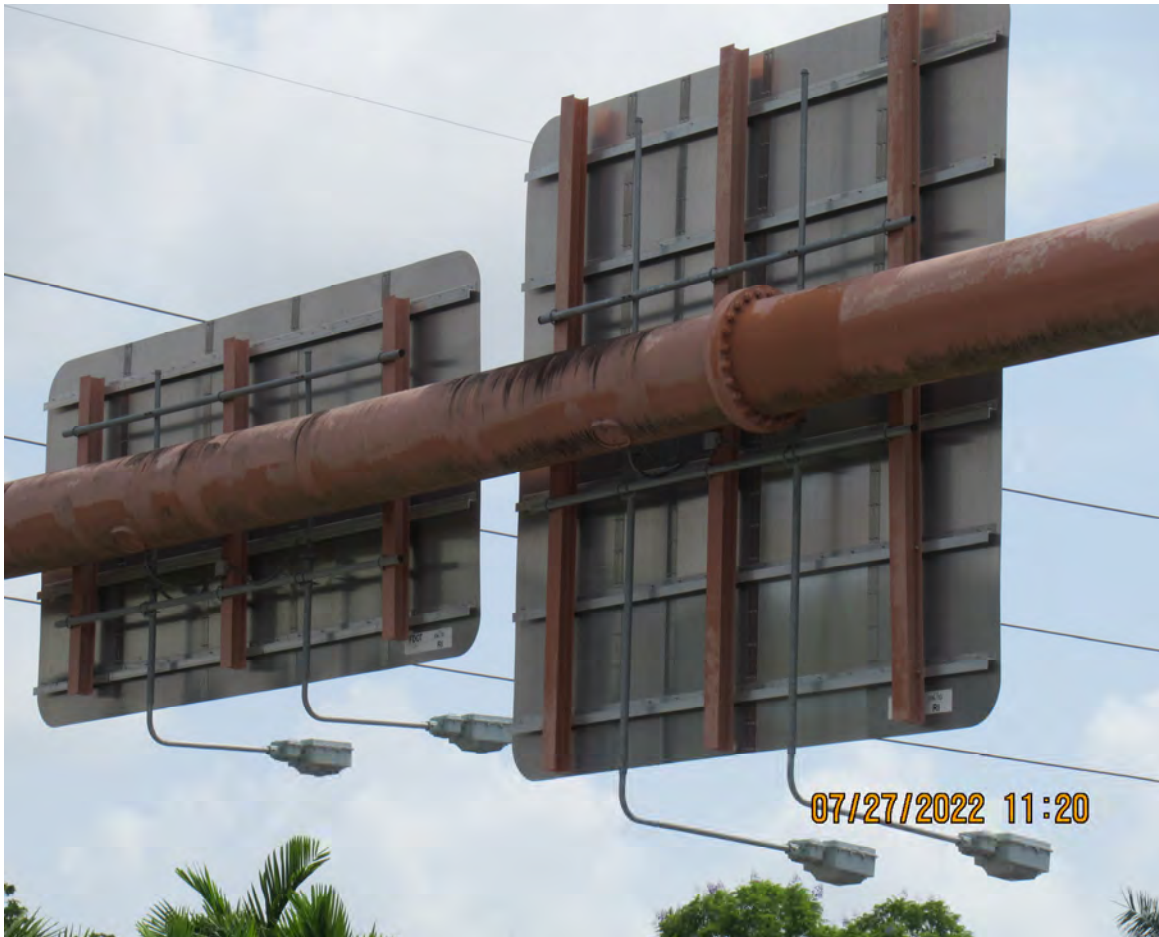
**ROADWAY INSPECTION
LOCATION: MILE MARKER 1.51 MILES
EASTBOUND MAINLINE**

DETERIORATED PAINT ON MONOTUBE

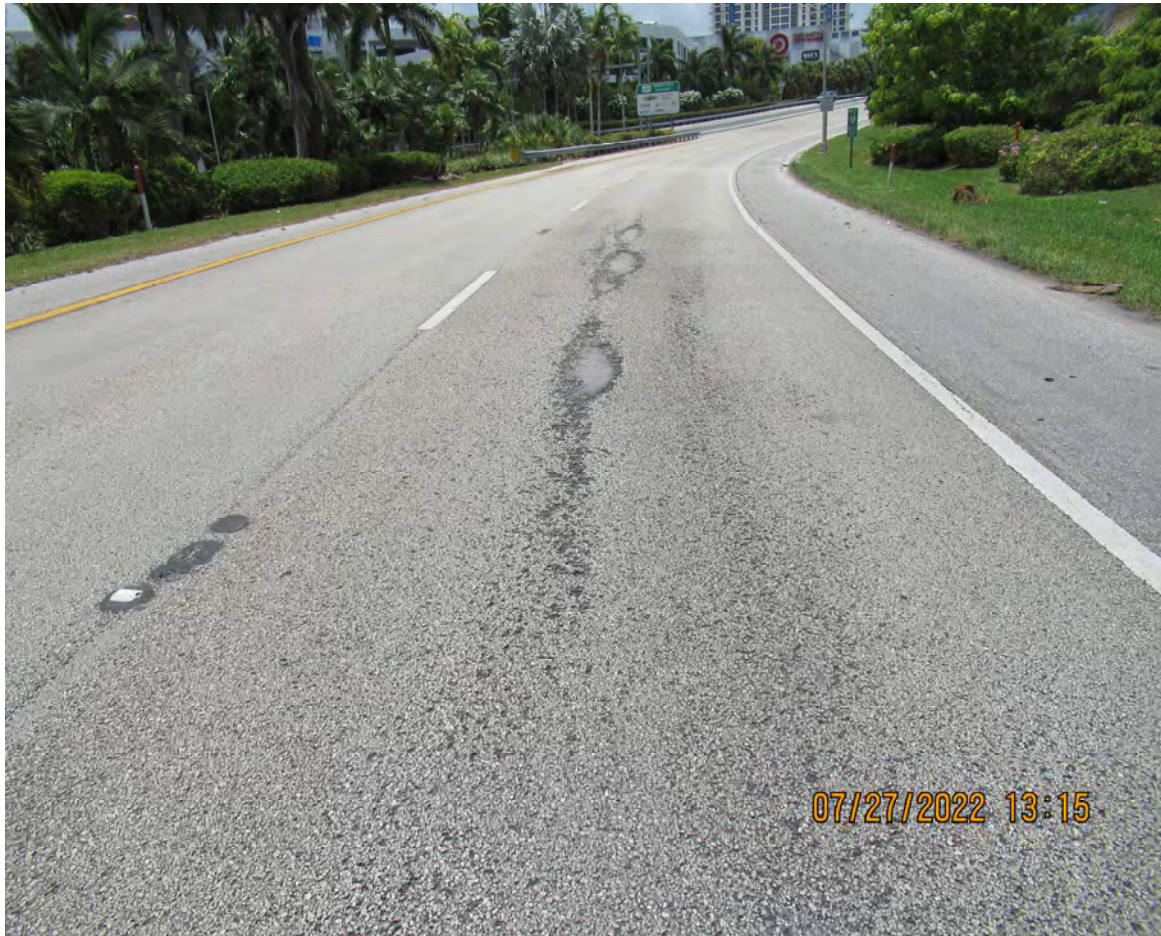
**ROADWAY INSPECTION
LOCATION: MILE MARKER 3.2 MILES
WESTBOUND MAINLINE**

DETERIORATED ASPHALT PAVEMENT

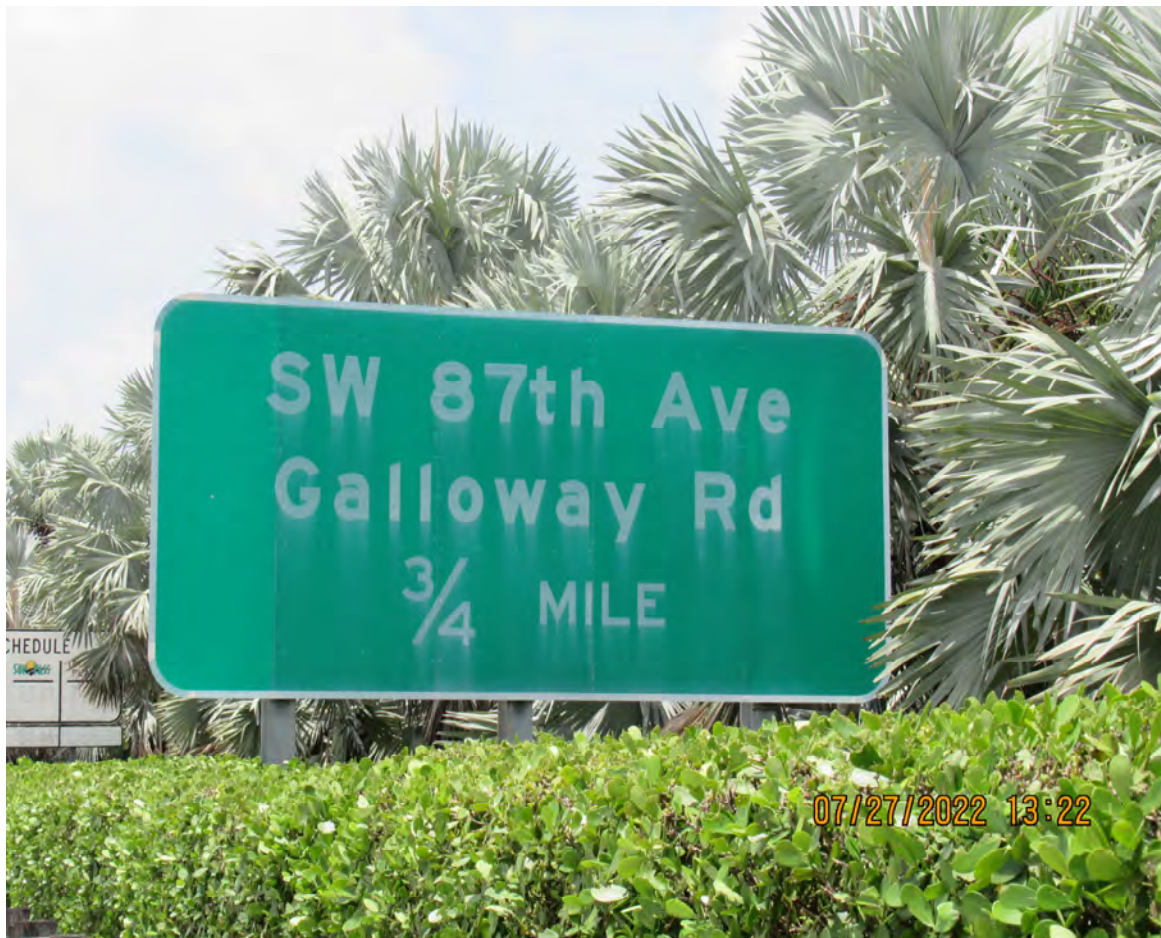
**ROADWAY INSPECTION
LOCATION: MILE MARKER 2.2 MILES
WESTBOUND MAINLINE**

DETERIORATED REFLECTIVE SHEETING

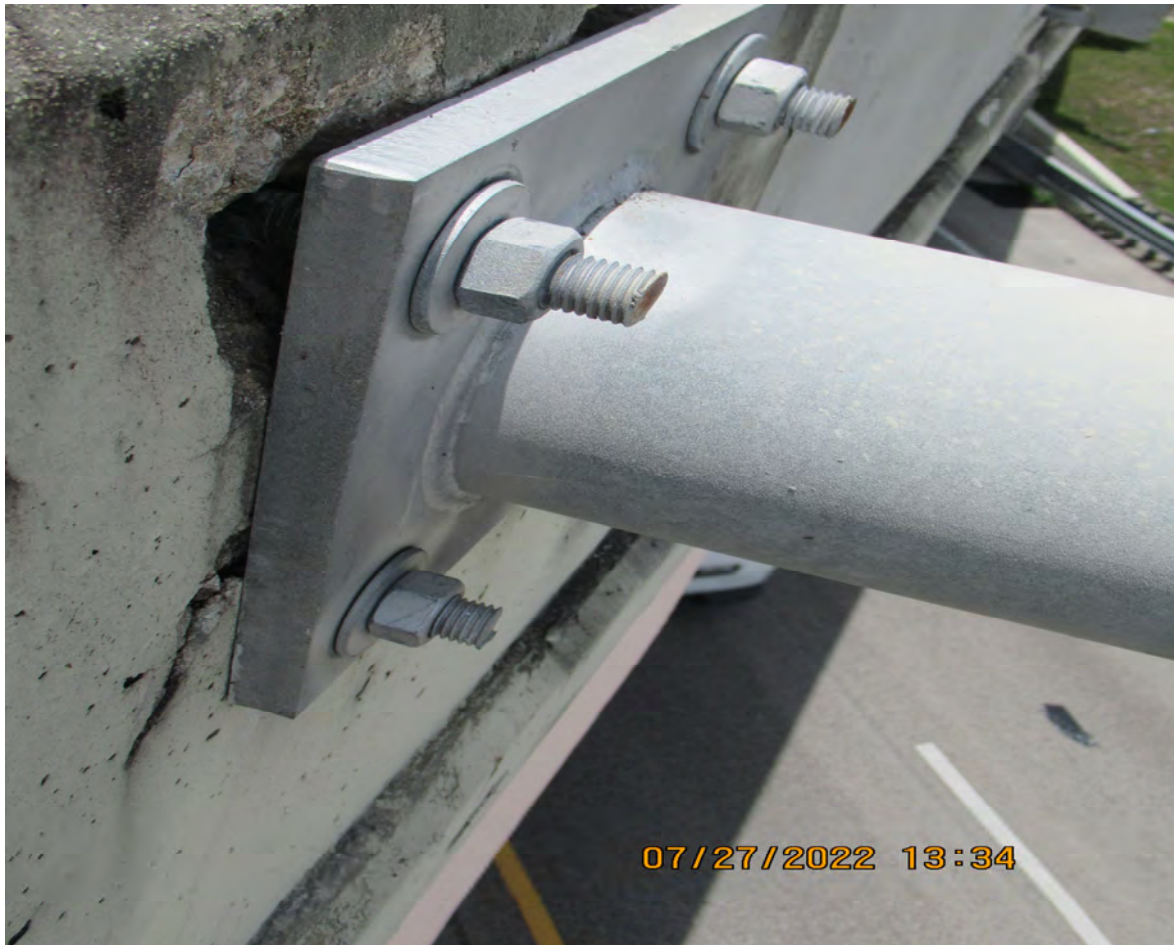
**ROADWAY INSPECTION
LOCATION: MILE MARKER 0.7 MILES
WESTBOUND MAINLINE**

SPALL ON BACKSIDE OF TRAFFIC RAILING

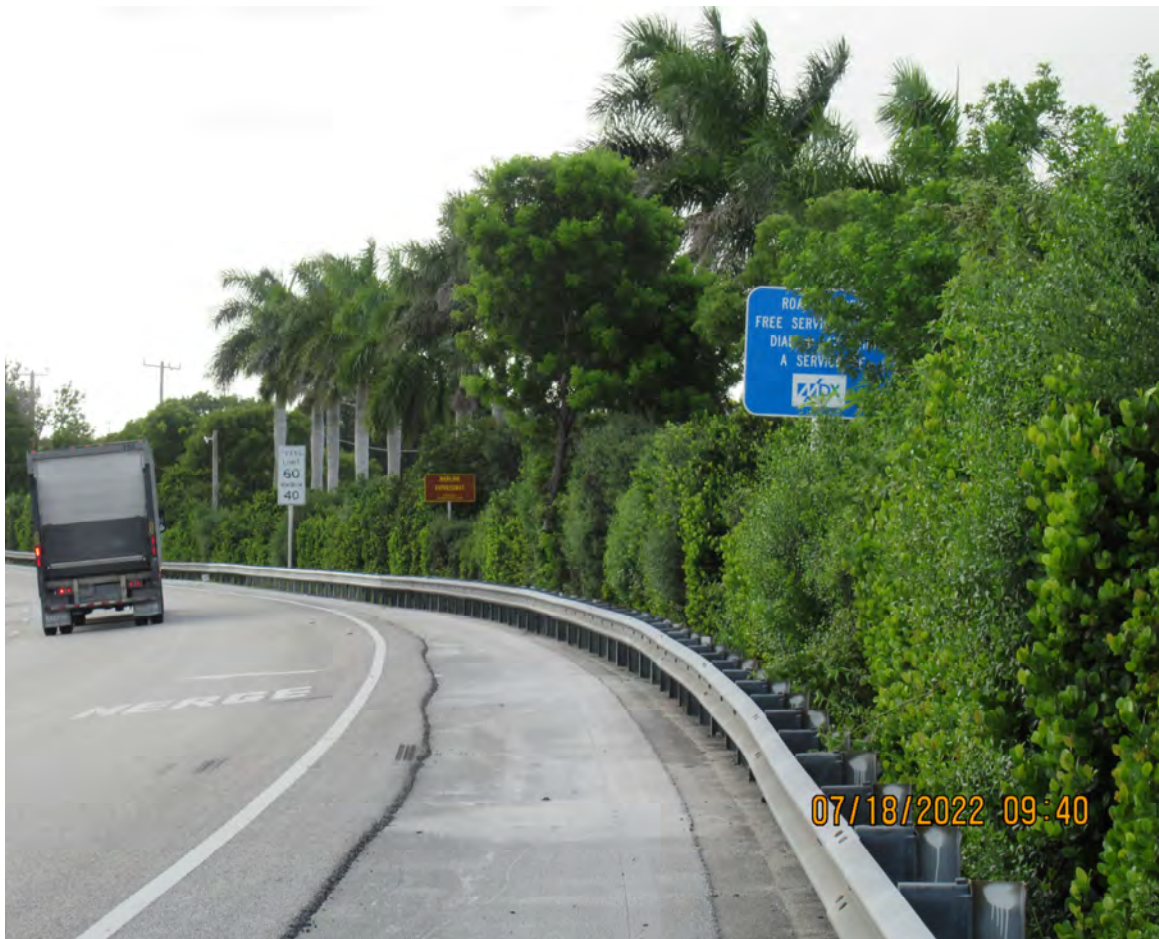
**ROADWAY INSPECTION
LOCATION: MILE MARKER 0.38
EASTBOUND MAINLINE (RIGHT SHOULDER)**

OVERGROWN VEGETATION OBSTRUCTING SIGN

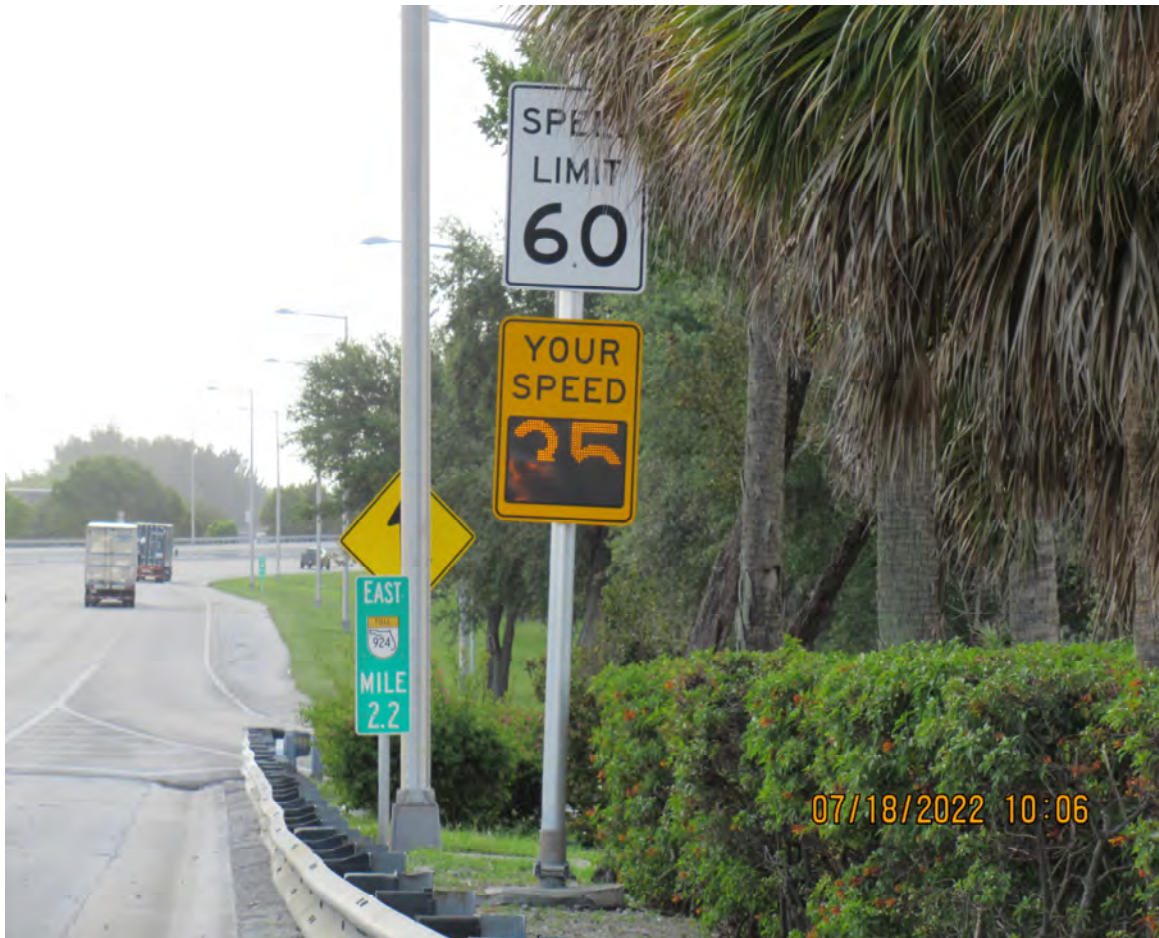
**ROADWAY INSPECTION
LOCATION: MILE MARKER 2.20 MILES
EASTBOUND MAINLINE**

MALFUNCTIONING SPEED LIMIT SIGNS

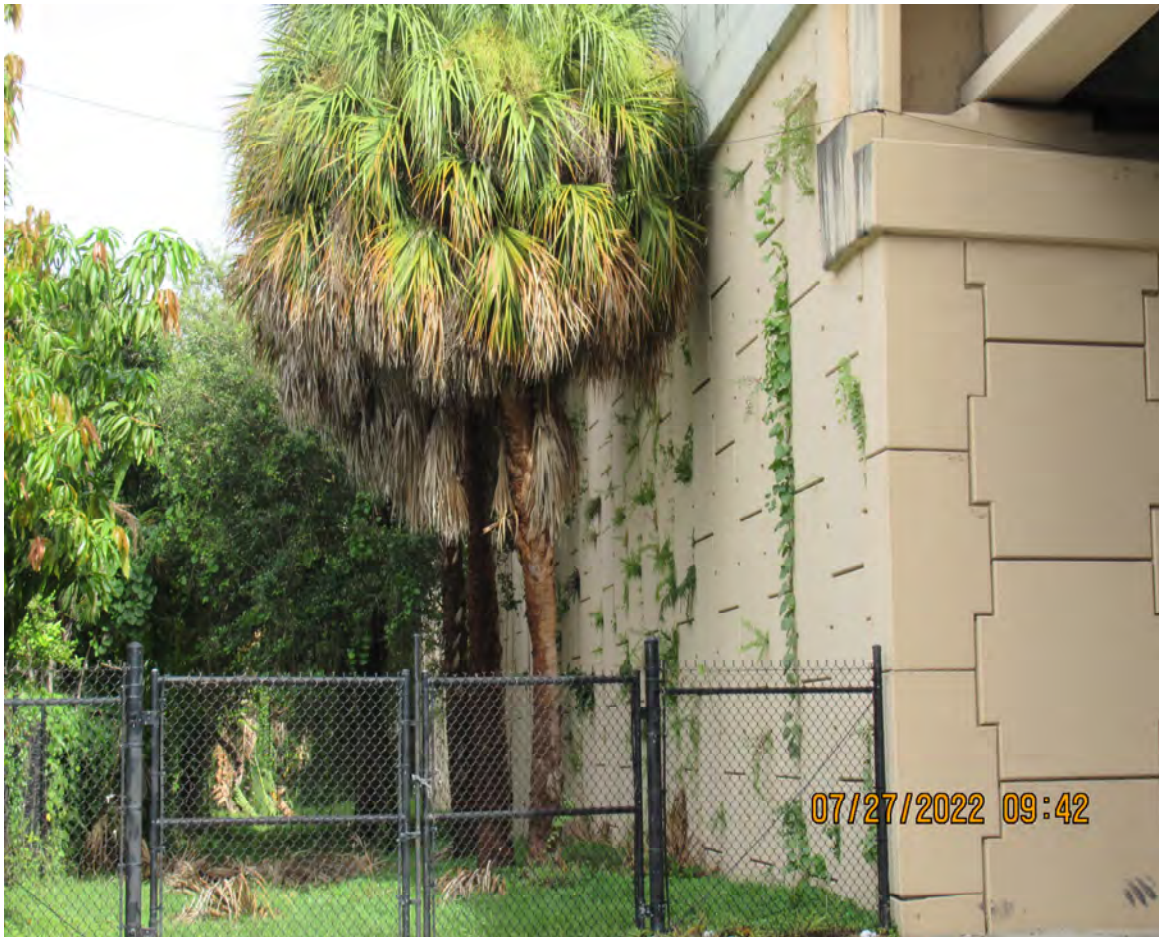
**ROADWAY INSPECTION
LOCATION: MILE MARKER 1.48
EASTBOUND MAINLINE AT WEST 8th AVENUE**

OVERGROWN VEGETATION ON MSE WALL

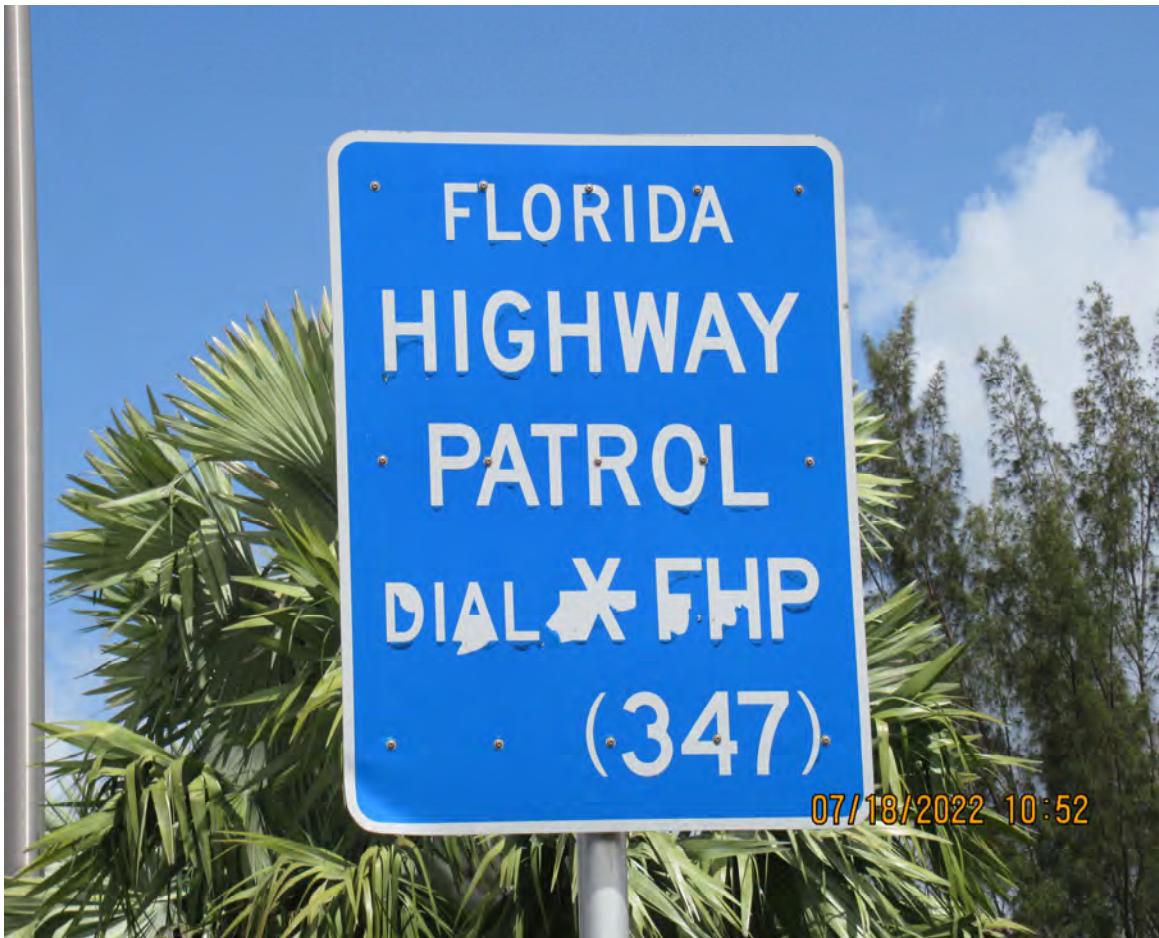
**ROADWAY INSPECTION
LOCATION: MILE MARKER 3.80 MILES
WESTBOUND MAINLINE**

DETERIORATED REFLECTIVE SHEETING ON SIGN

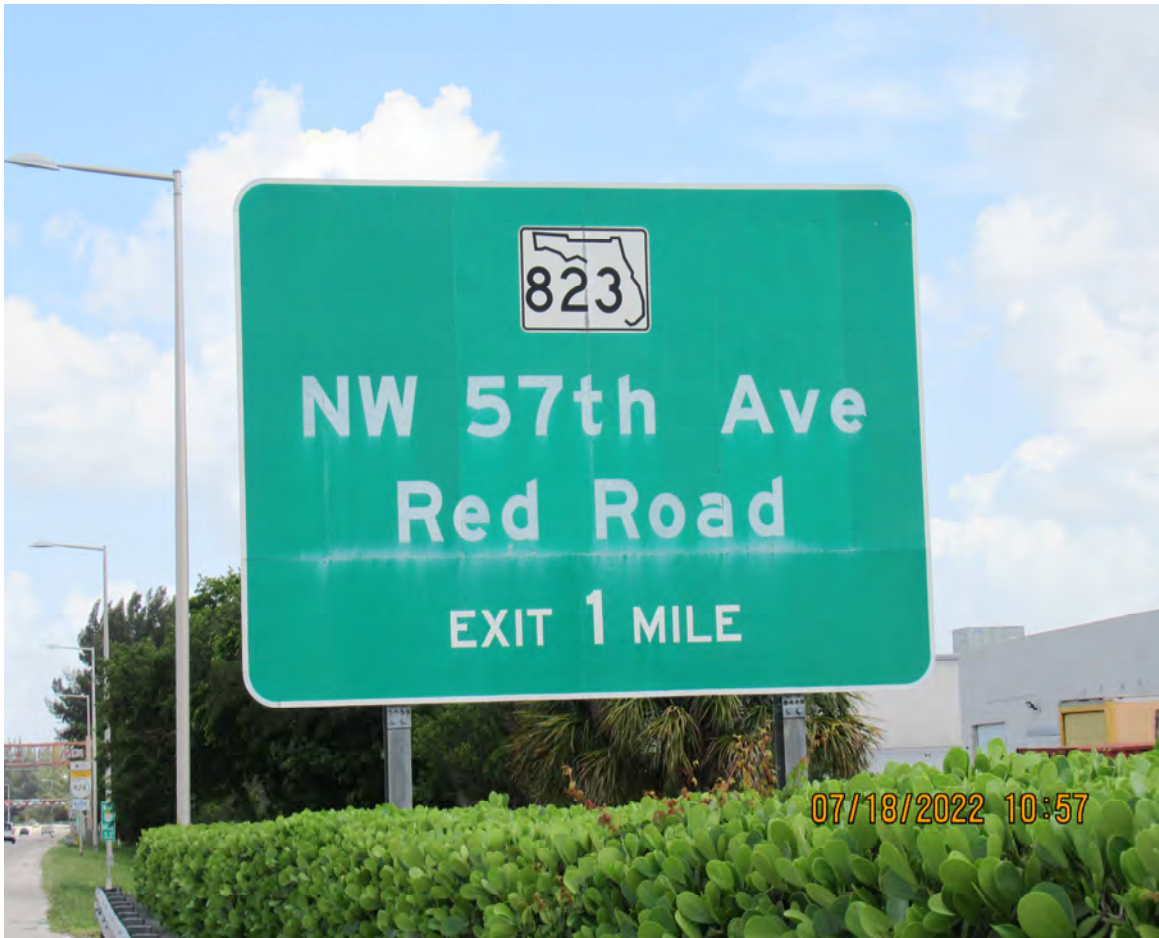
**ROADWAY INSPECTION
LOCATION: MILE MARKER 3.20 MILES
WESTBOUND MAINLINE**

DETERIORATED REFLECTIVE SHEETING ON SIGN

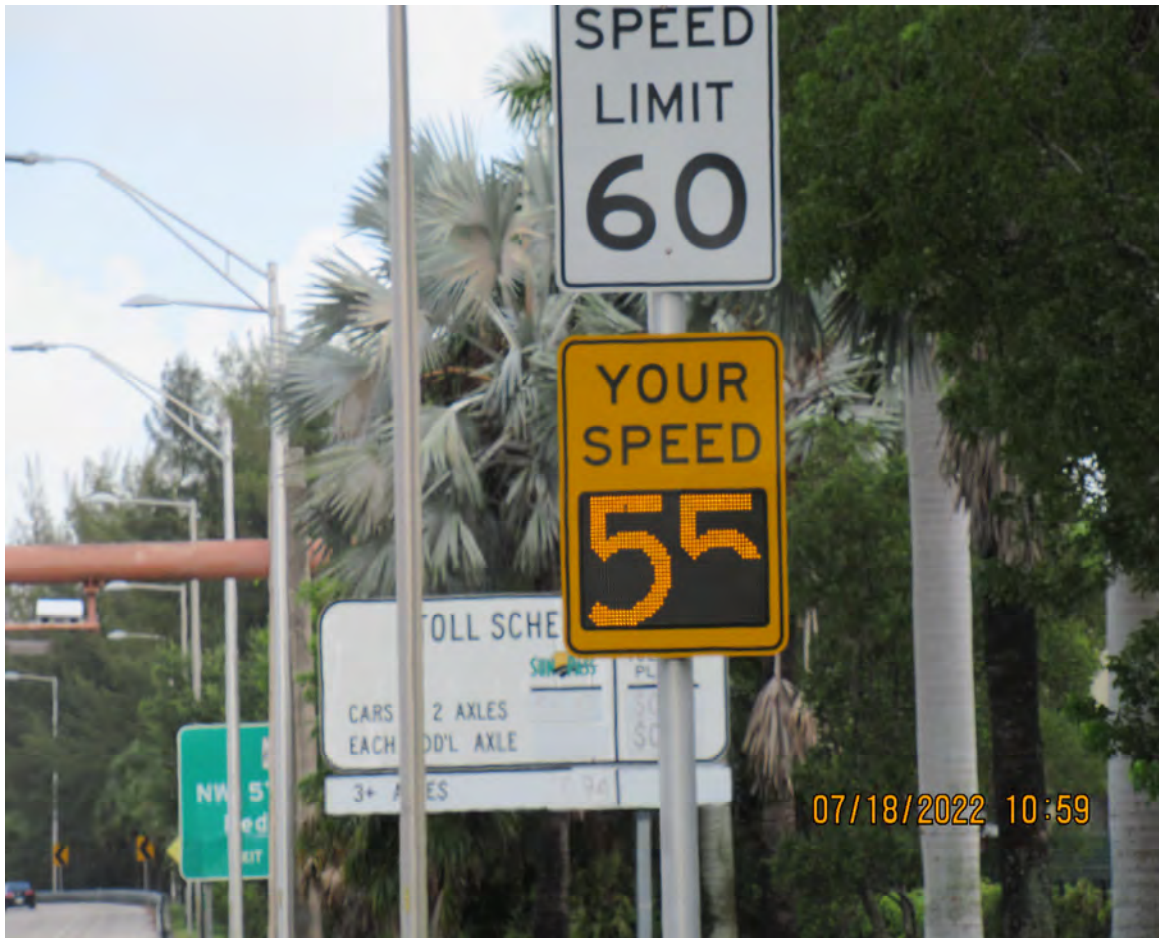
**ROADWAY INSPECTION
LOCATION: MILE MARKER 3.04 MILES
WESTBOUND MAINLINE (RIGHT SHOULDER)**

MALFUNCTIONING SPEED LIMIT SIGN

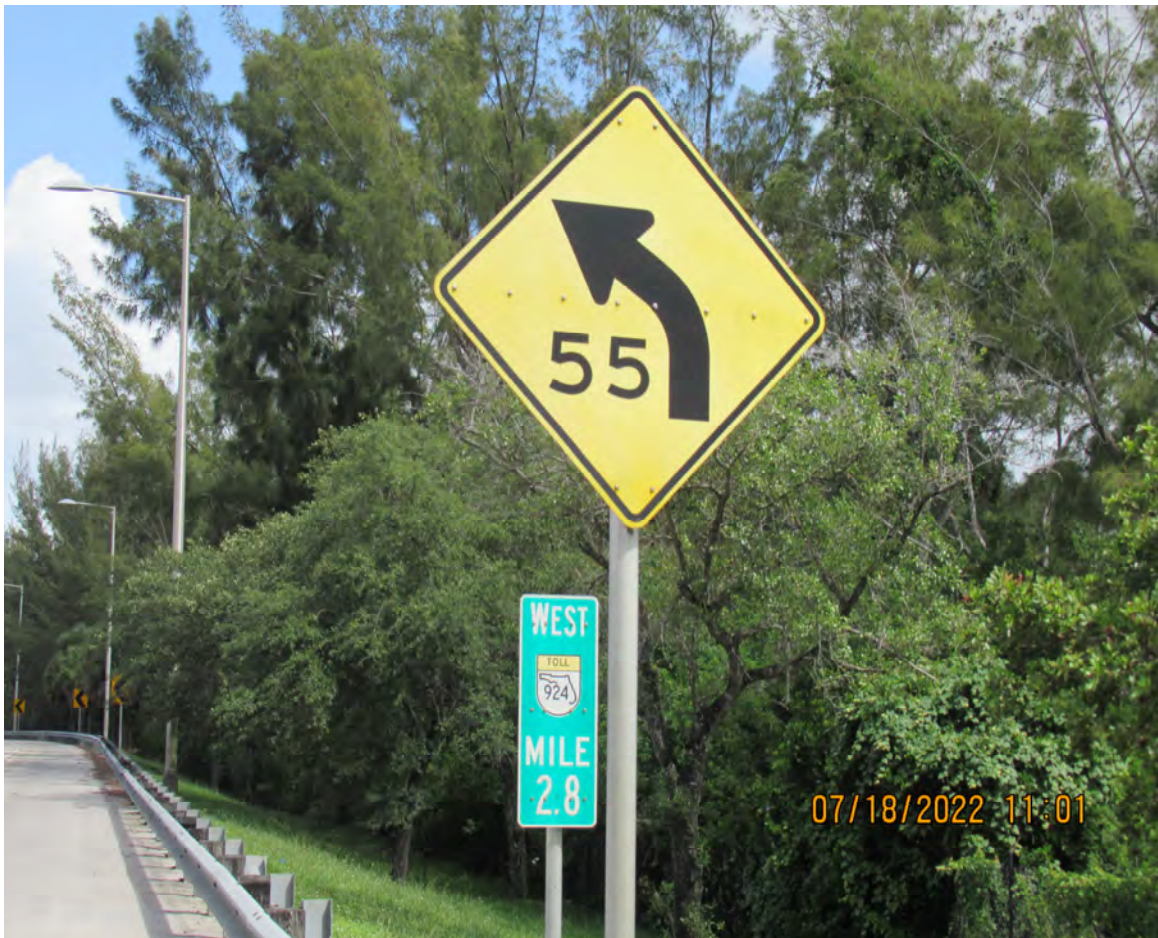
**ROADWAY INSPECTION
LOCATION: MILE MARKER 2.80 MILES
WESTBOUND MAINLINE**

DETERIORATED REFLECTIVE SHEETING

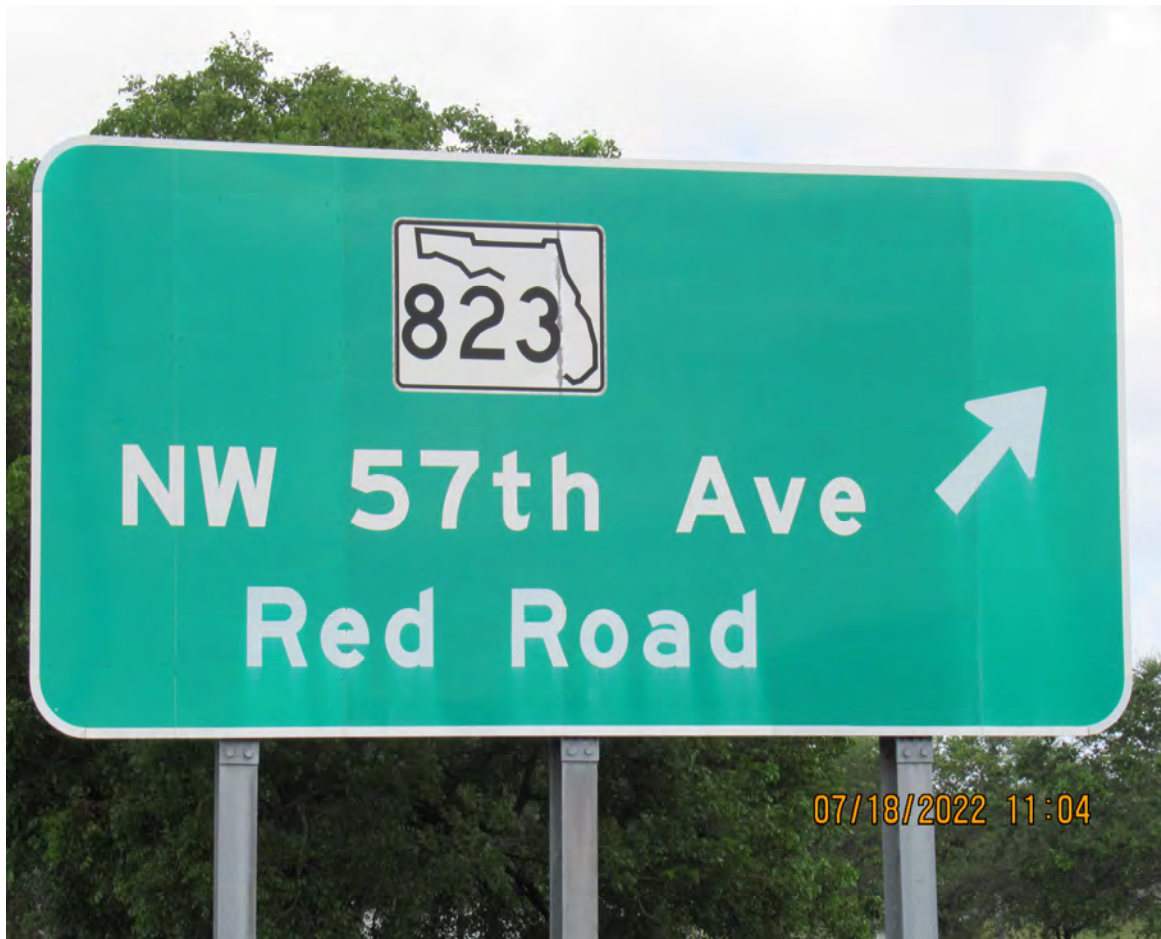
**ROADWAY INSPECTION
LOCATION: MILE MARKER 2.42 MILES
WESTBOUND MAINLINE**

DETERIORATED REFLECTIVE SHEETING

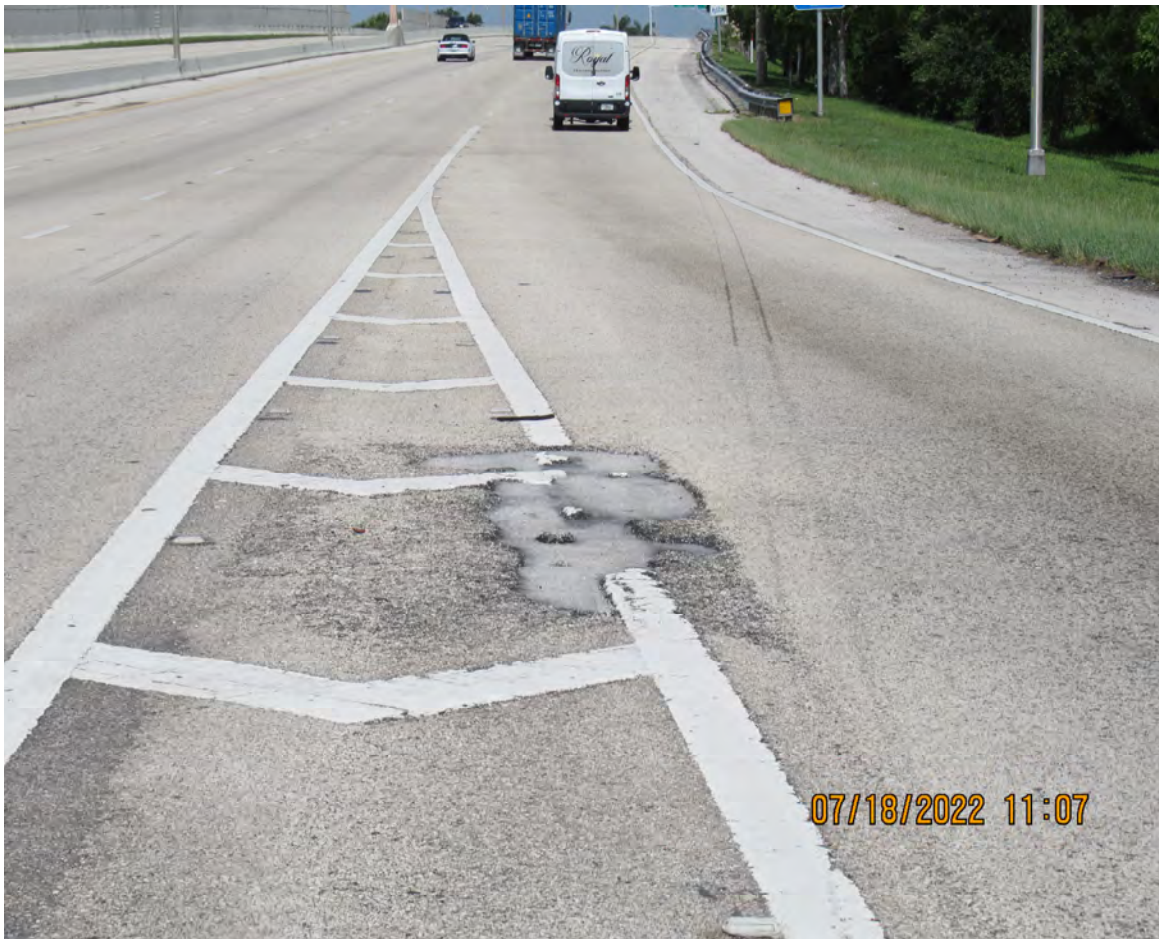
**ROADWAY INSPECTION
LOCATION: MILE MARKER 1.80 MILES
WESTBOUND MAINLINE (RIGHT SHOULDER)**

DETERIORATED PAVEMENT

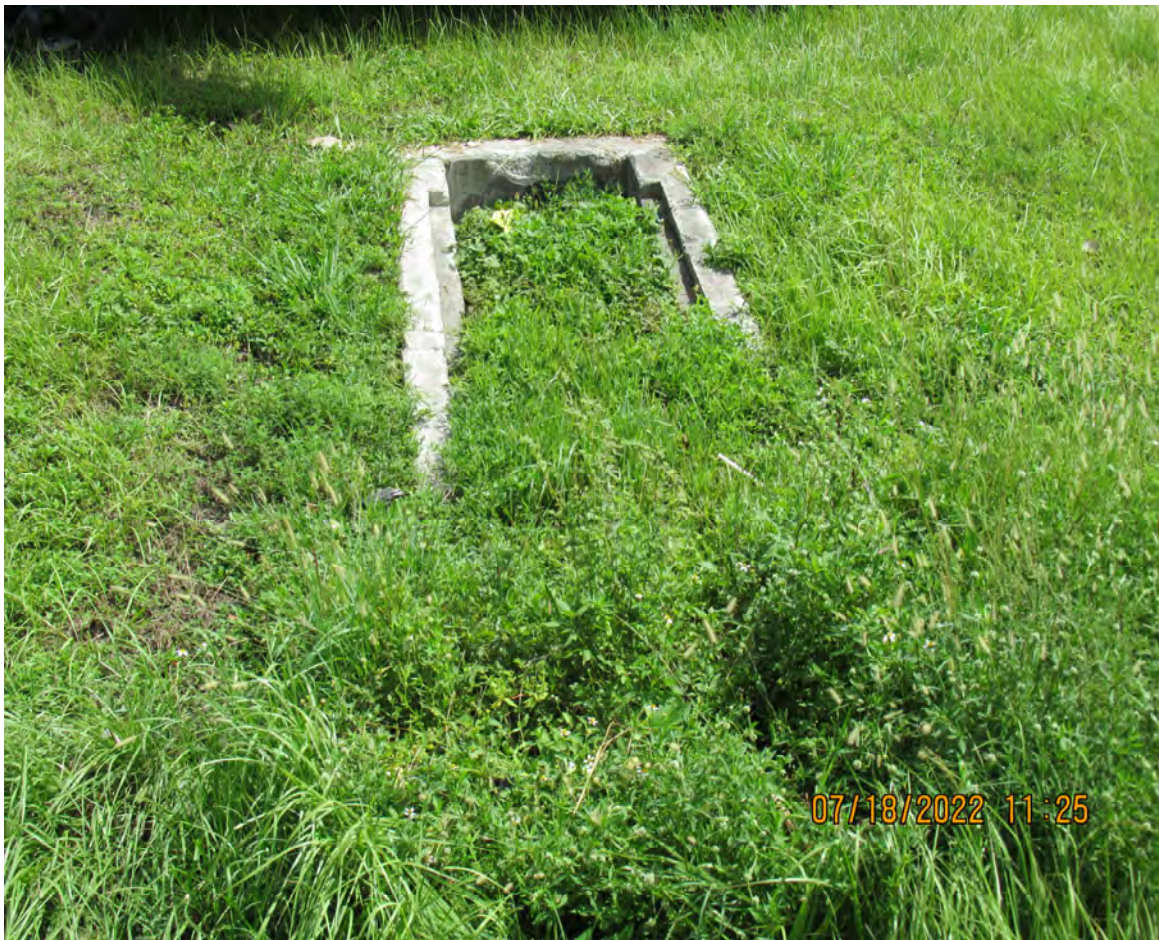
**ROADWAY INSPECTION
LOCATION: MILE MARKER 0.01 MILES
WESTBOUND MAINLINE (MEDIAN)**

**SILTED END WALL
(TYPICAL TROUGHOUT THE CORRIDOR)**
