ANNUAL INSPECTION REPORT 2022

ANNUAL INSPECTION REPORT

In 1996, the Miami-Dade County Expressway Authority (MDX) acquired operational and financial control of five expressways in Miami-Dade County from the Florida Department of Transportation (FDOT). This group of expressways, toll facilities and the MDX headquarters facility, all as described below, are hereinafter referred to as the “MDX System”. In accordance with the Trust Indenture requirements, MDX retained EAC Consulting, Inc. (EAC), as the General Engineering Consultant to perform, among other duties assigned by the Authority, the yearly inspection of the MDX System. This report represents the annual inspection results for Fiscal Year (FY) 2022.

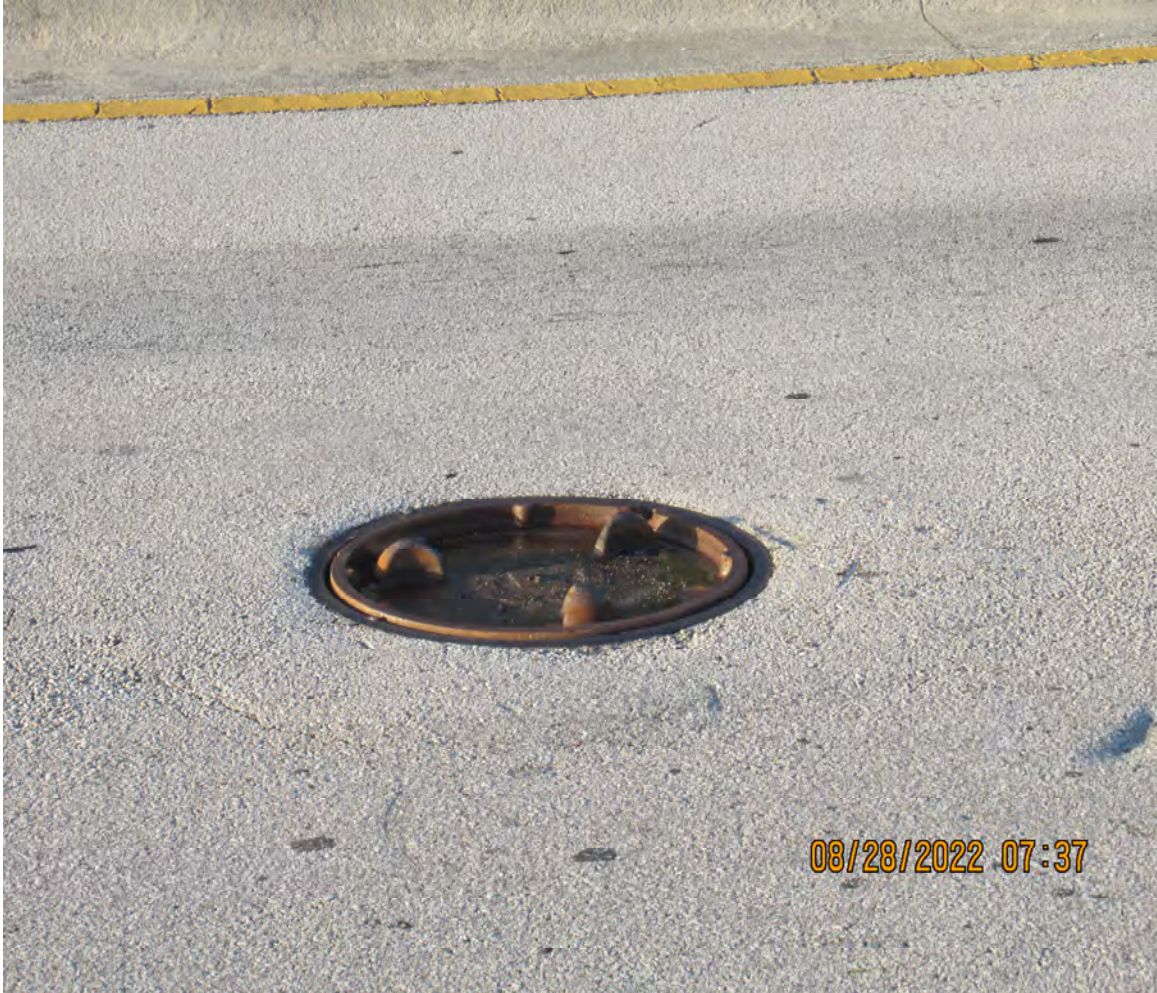
**ROADWAY INSPECTION
LOCATION: 275FT WEST OF NW 97th AVENUE
WESTBOUND NW 138th STREET**

FLIPPED MANHOLE COVER

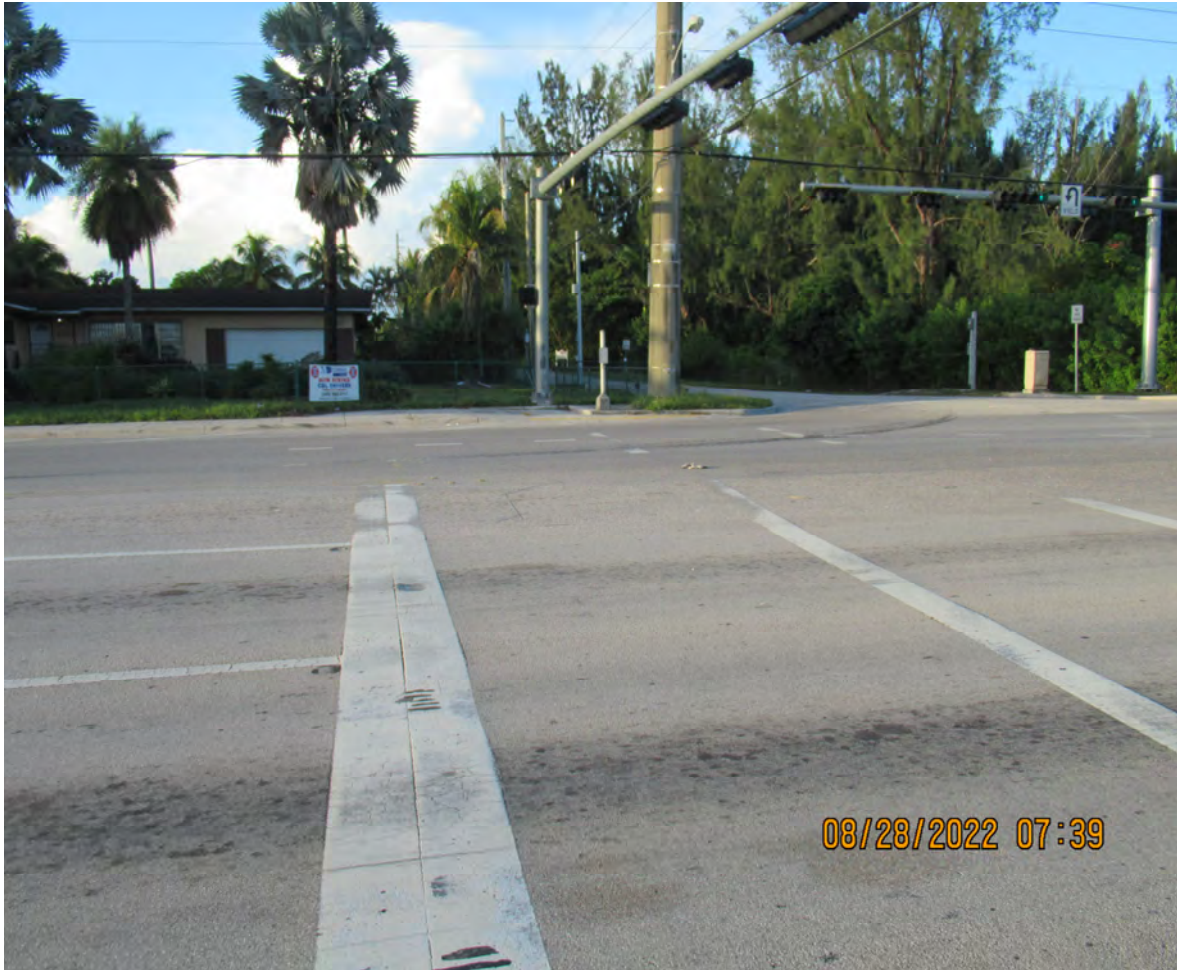
**ROADWAY INSPECTION
LOCATION: NW 102ND AVENUE
WESTBOUND NW 138th STREET**

DETERIORATED STOP BAR AND STRIPING ON PEDESTRIAN CROSSWALK

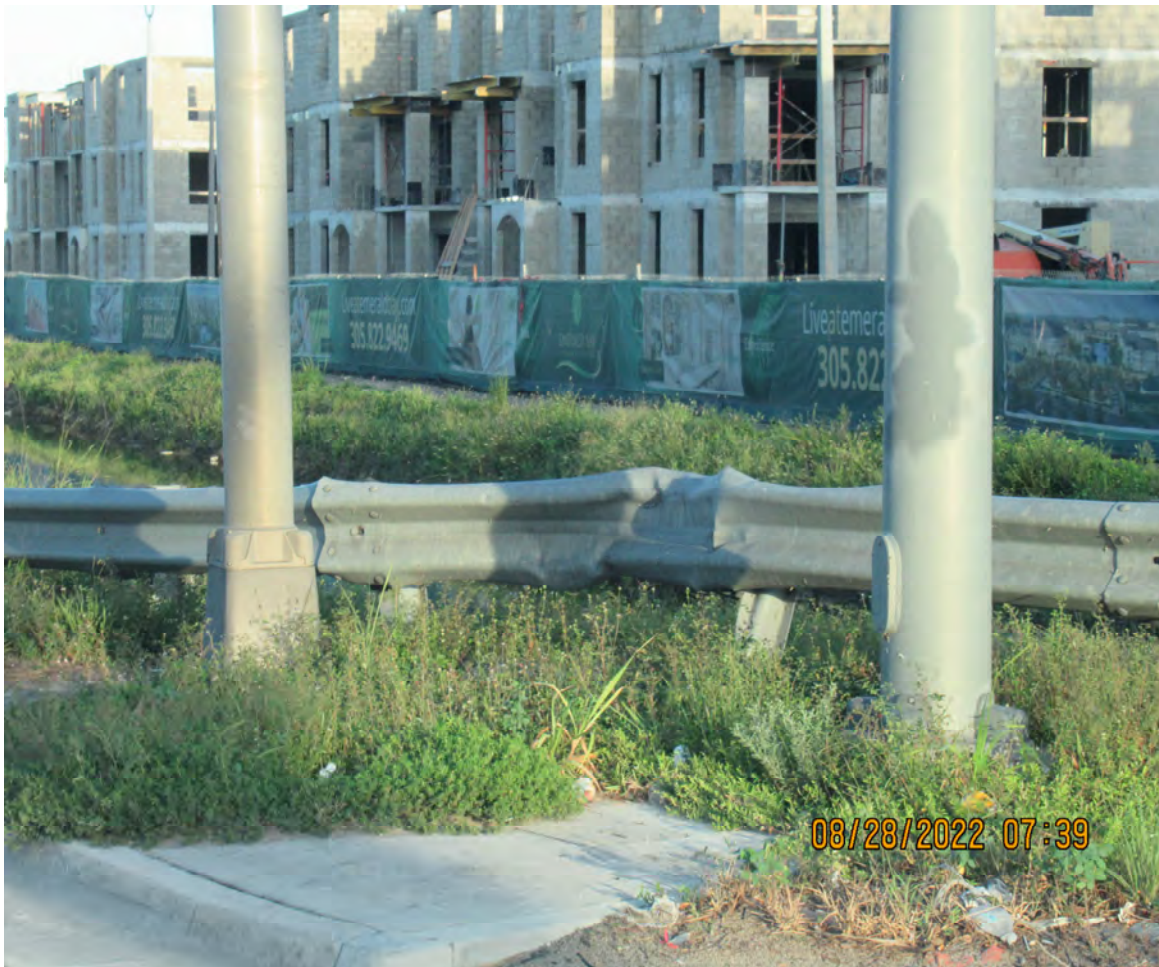
**ROADWAY INSPECTION
LOCATION: NW 102ND AVENUE
WESTBOUND NW 138th STREET**

DAMAGED GUARDRAIL

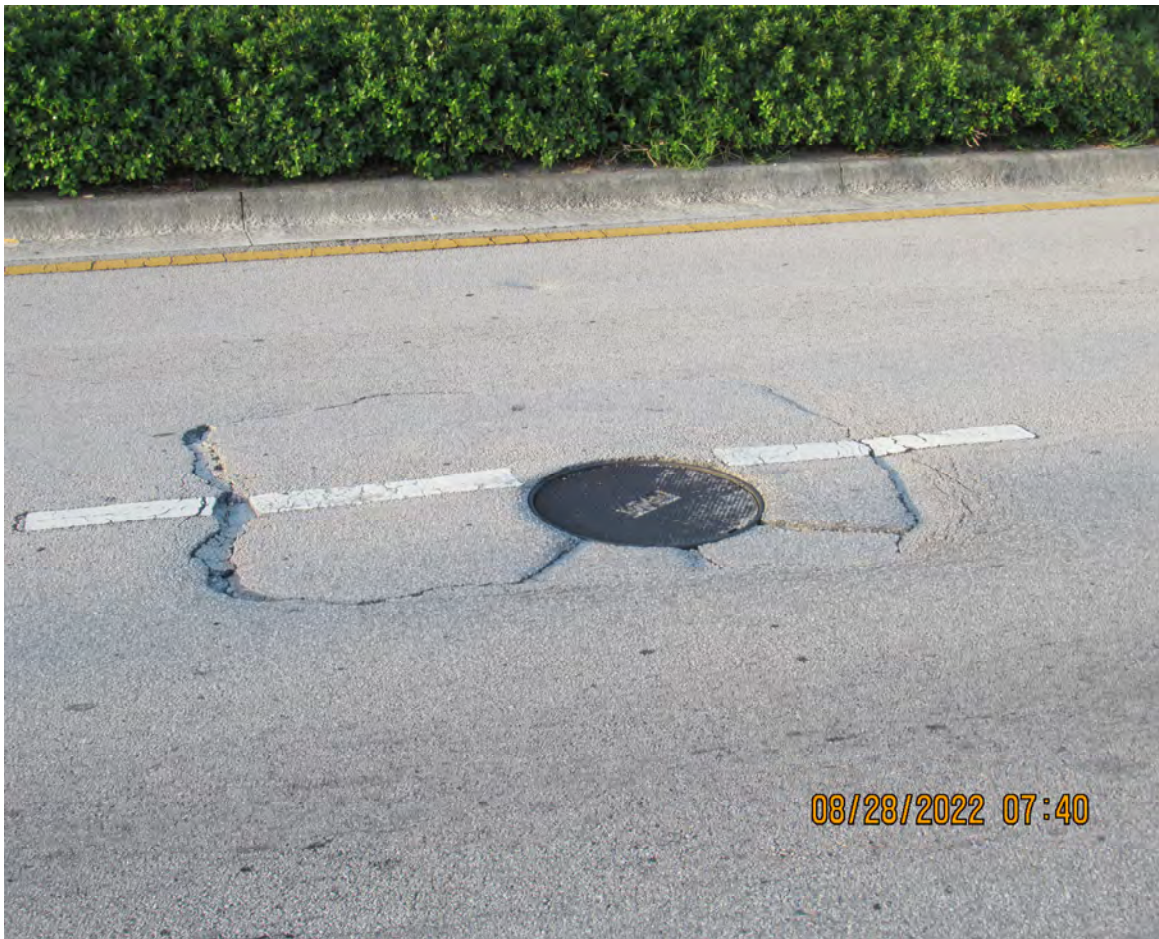
**ROADWAY INSPECTION
LOCATION: WESTBOUND NW 138th STREET & NW 102ND
AVENUE (APPROXIMATELY 600' FT TO THE WEST)**

DAMAGED PAVEMENT ADJACENT TO MANHOLE

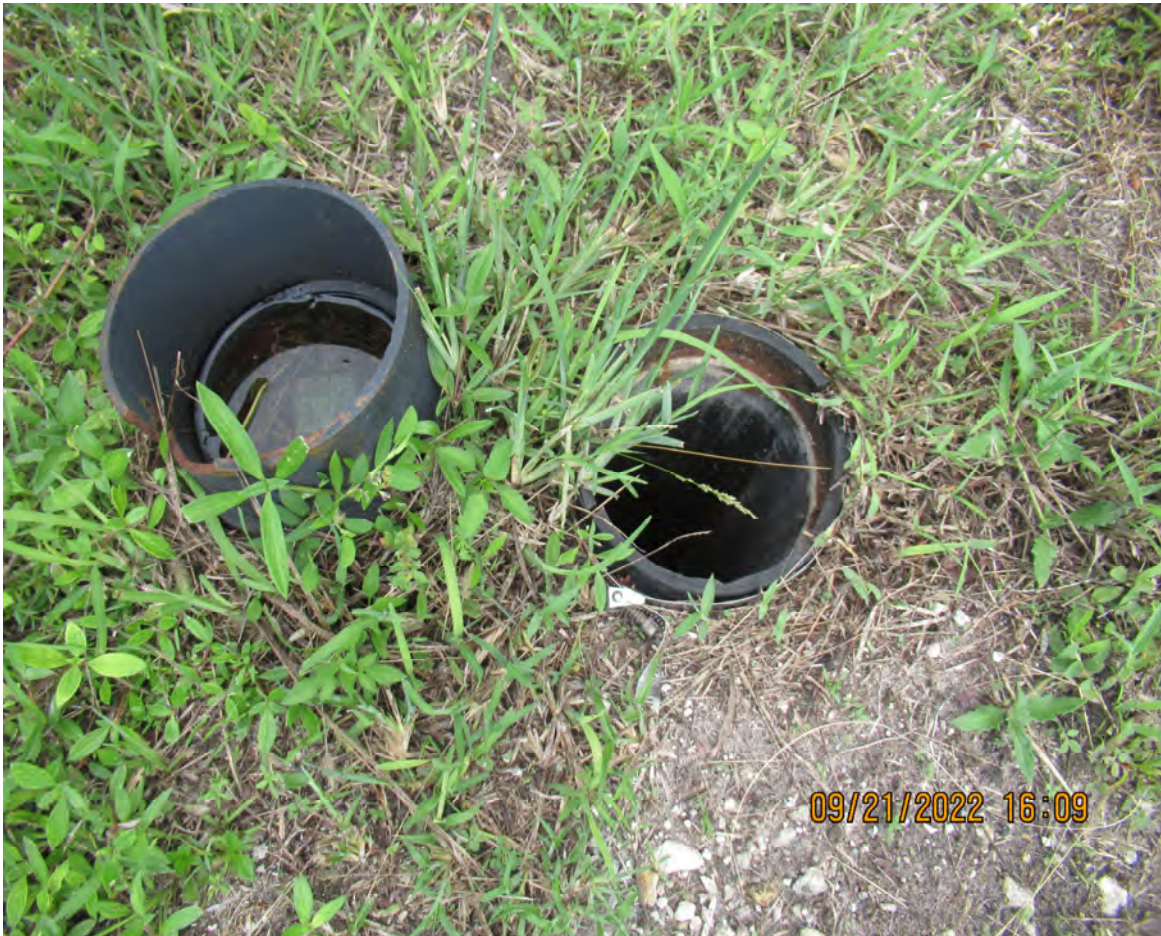
**ARCHITECTURAL INSPECTION
LOCATION: SR-836 / NW 97th AVENUE EASTBOUND
ADMINISTRATION BUILDING
(SOUTHSIDE OF DUMPSTER ENCLOSURE)**

DETACHED SANITARY SEWER CLEANOUT CAP

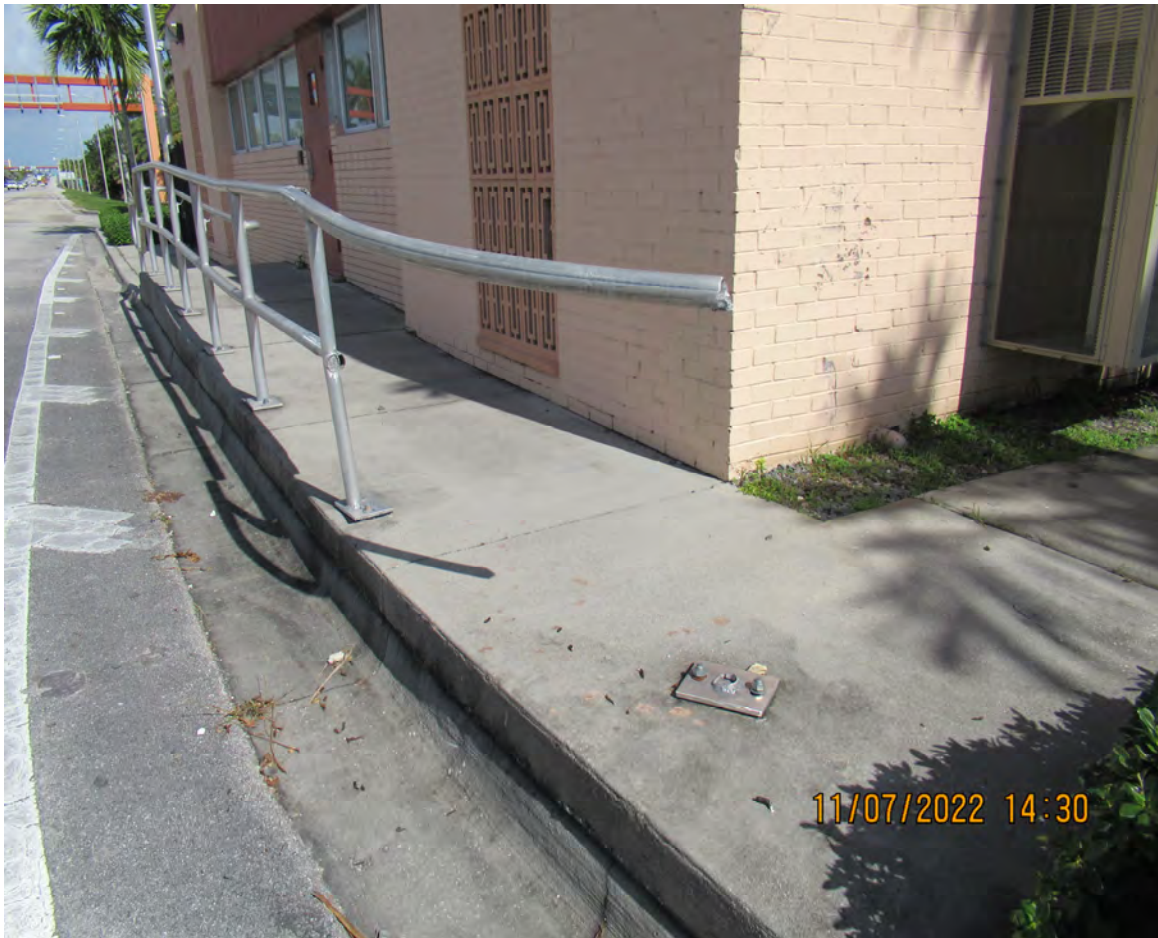
**ARCHITECTURAL INSPECTION
LOCATION: ADMINISTRATION BUILDING
(EAST ELEVATION)**

DAMAGED PEDESTRIAN RAILING

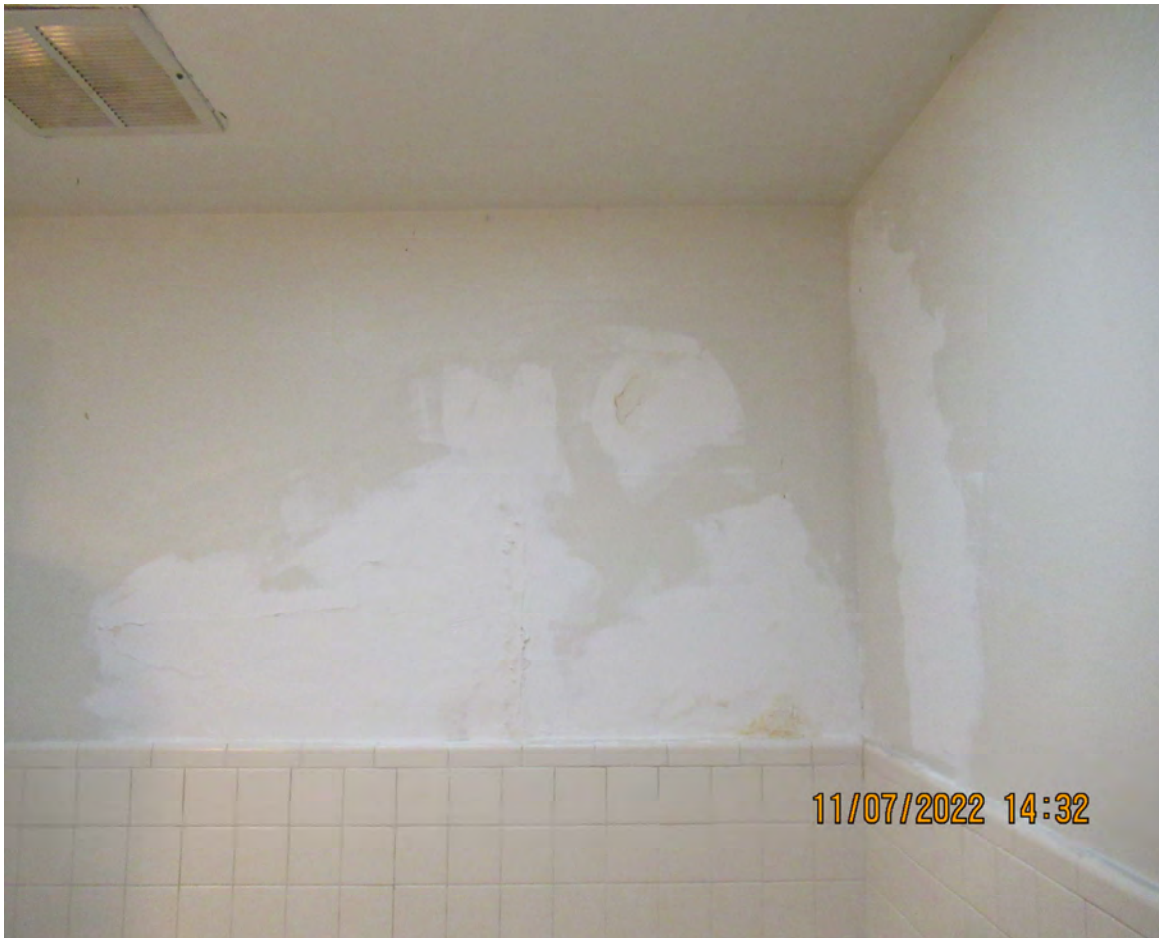
**ARCHITECTURAL INSPECTION
LOCATION: ADMINISTRATION BUILDING BATHROOM**

UNFINISHED DRYWALL REPAIRS IN BATHROOM WALLS

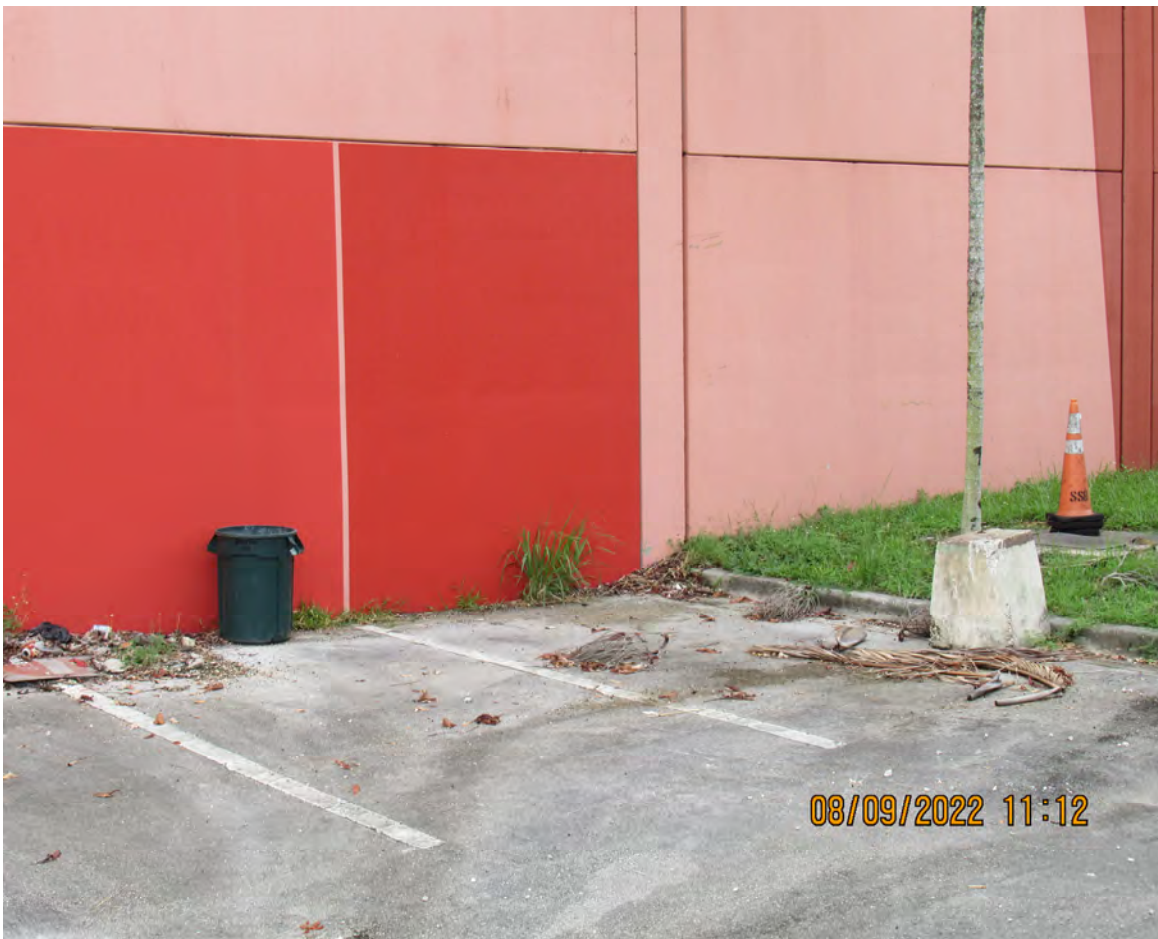
**ARCHITECTURAL INSPECTION
LOCATION: ADMINISTRATION BUILDING**

TRASH AND DEBRIS ON NORTH PARKING AREA

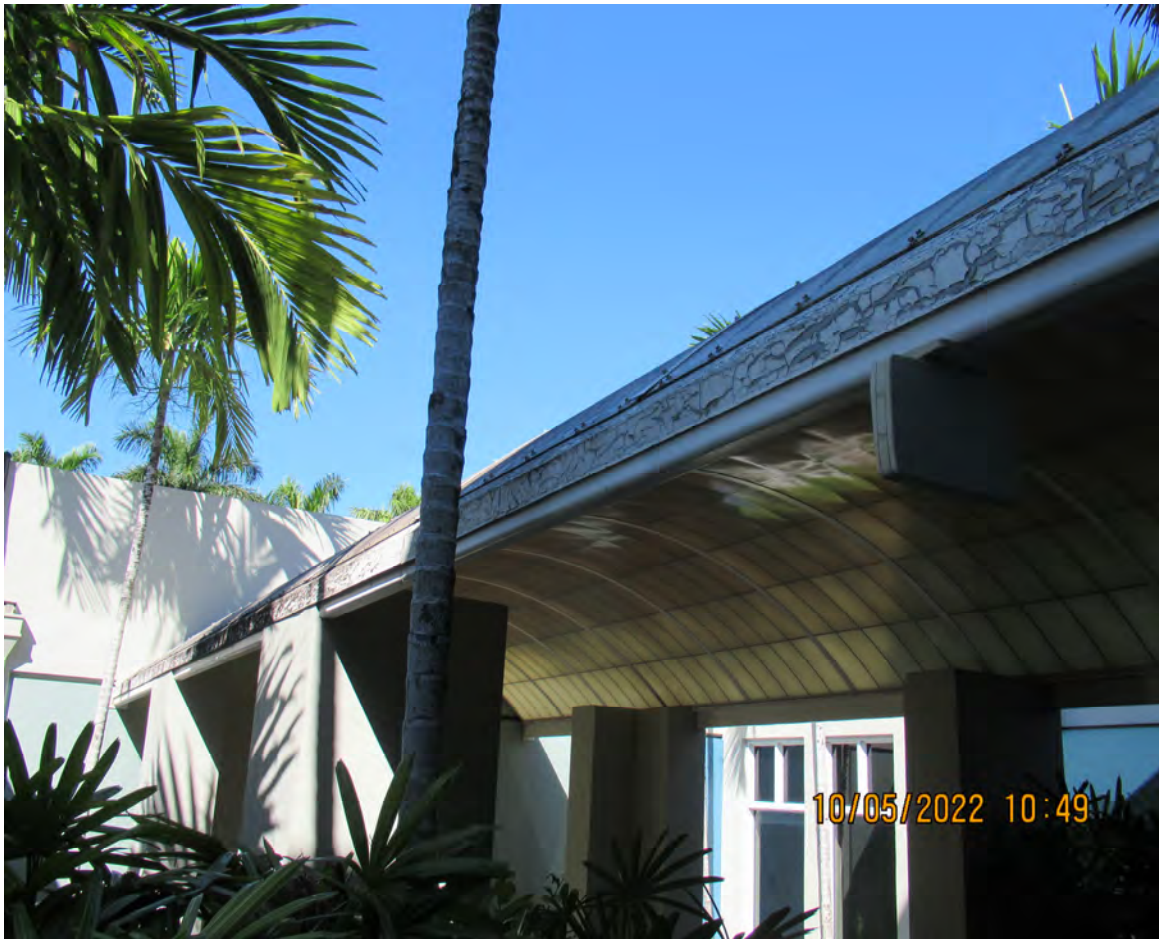
**ARCHITECTURAL INSPECTION
LOCATION: COURTYARD**

DETERIORATED PAINT ON CANOPY FRAME

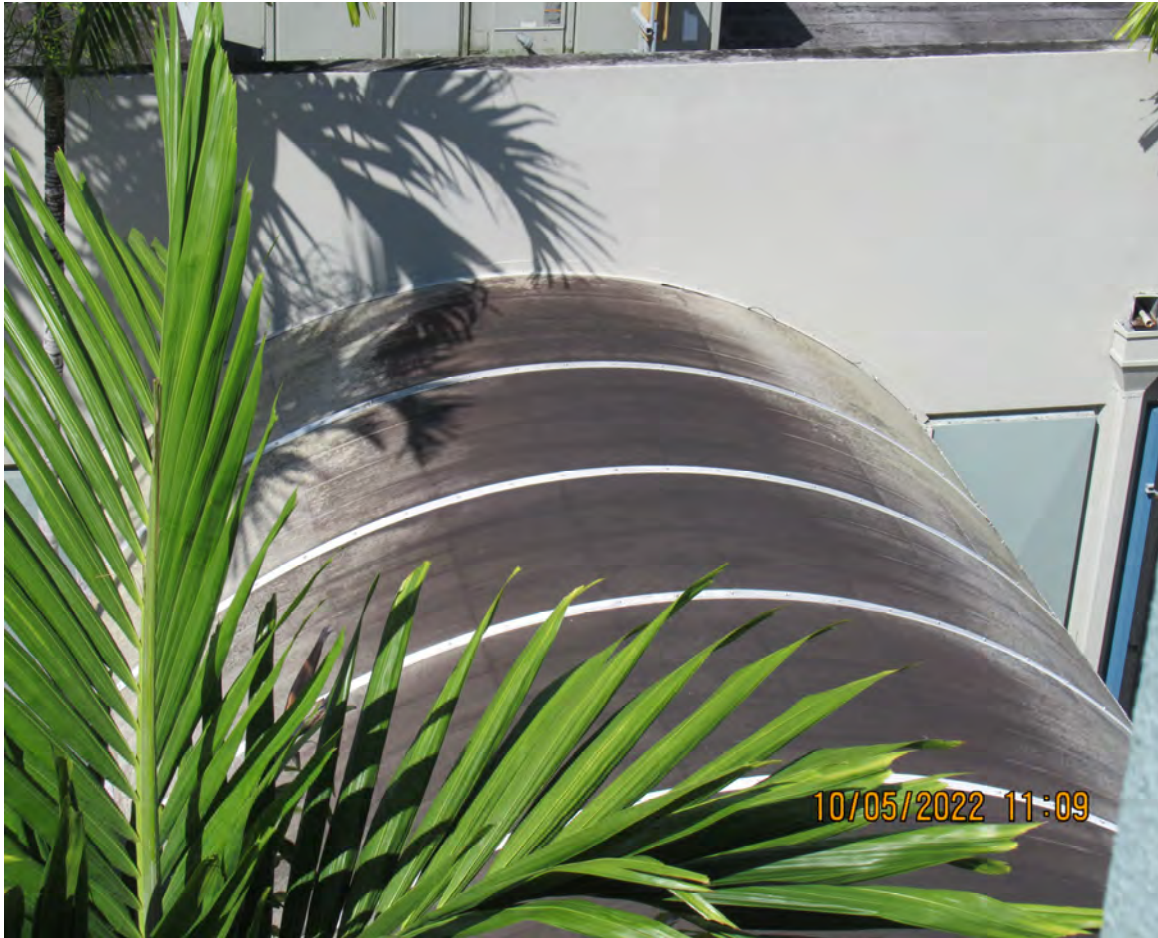
**ARCHITECTURAL INSPECTION
LOCATION: COURTYARD**

CANOPY ROOF REQUIRES CLEANING
