# ANNUAL INSPECTION REPORT 2023

## ANNUAL INSPECTION REPORT

In July 1, 2023, the Greater Miami Expressway Agency (GMX) acquired operational and financial control of five expressways in Miami-Dade County. This group of expressways, toll facilities, acquisition parcels and the GMX headquarters facility, all as described below, are hereinafter referred to as one of the "GMX System". In accordance with the Trust Indenture requirements, GMX retained EAC Consulting, Inc. (EAC), as the General Engineering Consultant to perform, among other duties assigned by the Agency, the yearly inspection of the GMX System. This report represents the annual inspection results for Fiscal Year (FY) 2023.

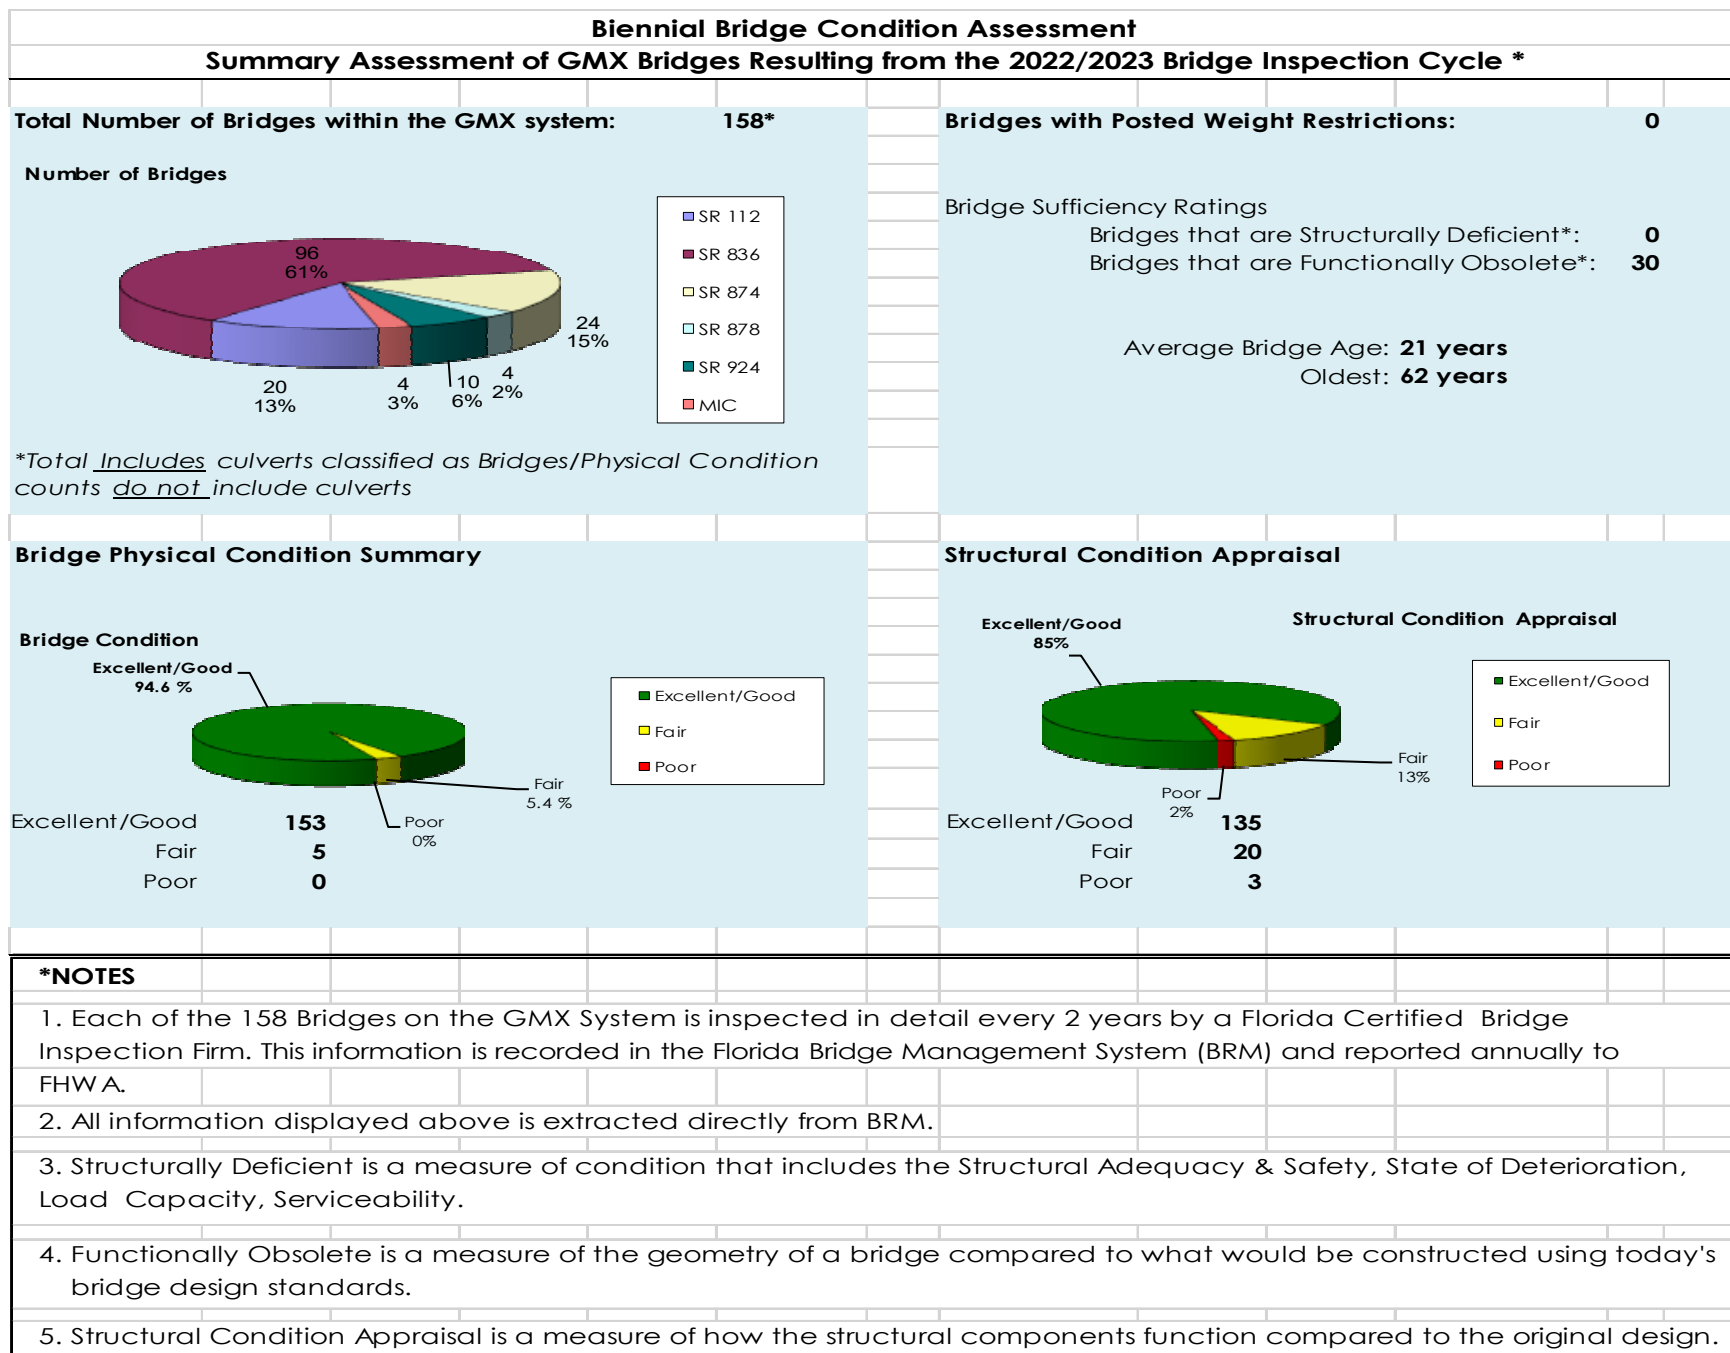
With regards to bridges, extensive and detailed inspections are performed on a biennial basis for GMX through the Inspections & Reporting Services Contracts for GMX Structures by Tran-Systems Corporation Consultants & Marlin Engineering, Inc. Inspections are required to be performed biennially by a Florida certified bridge inspection/engineering firm. GMX has chosen to group these inspections into two-year cycles for the purposes of tracking and programming. Structural repairs are currently performed under the Systemwide Structures Maintenance Contract awarded to P&P Contracting, Inc. GMX reported to the Florida Transportation Commission that 85% of its bridges were rated as good or better according to FDOT Structural Condition Appraisal rating criteria and no bridges have posted weight restrictions for FY 2023. Refer to **Figure 1** for a summary of the Biennial Bridge Condition Assessment.

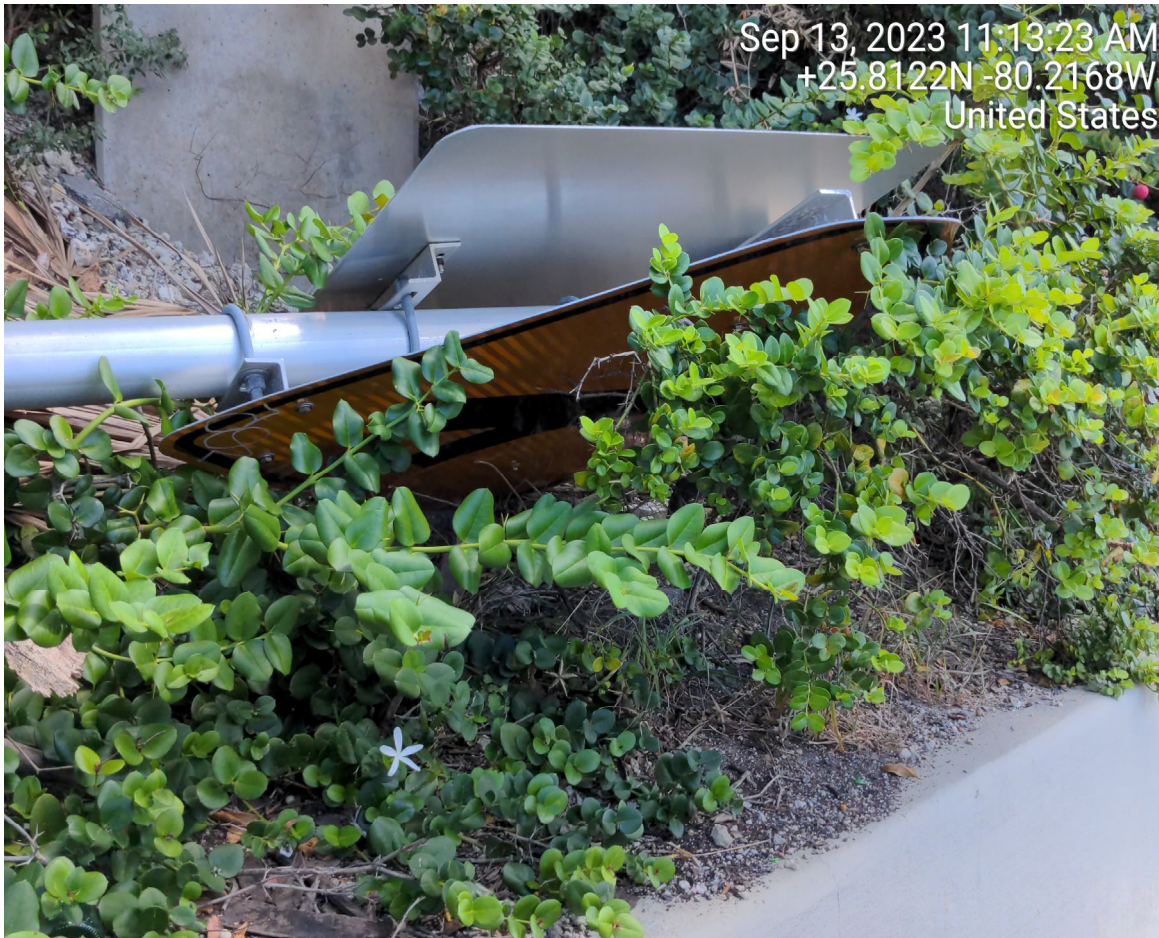
**ROADWAY INSPECTION  
LOCATION: MILE MARKER 3.91 MILES  
EASTBOUND OFF-RAMP TO NW 12<sup>TH</sup> AVENUE**

**KNOCKED DOWN PEDESTRIAN CROSSWALK SIGN**

**ITEMS NOTED TO BE ADDRESSED BY GMX MAINTENANCE ITB-23-17**

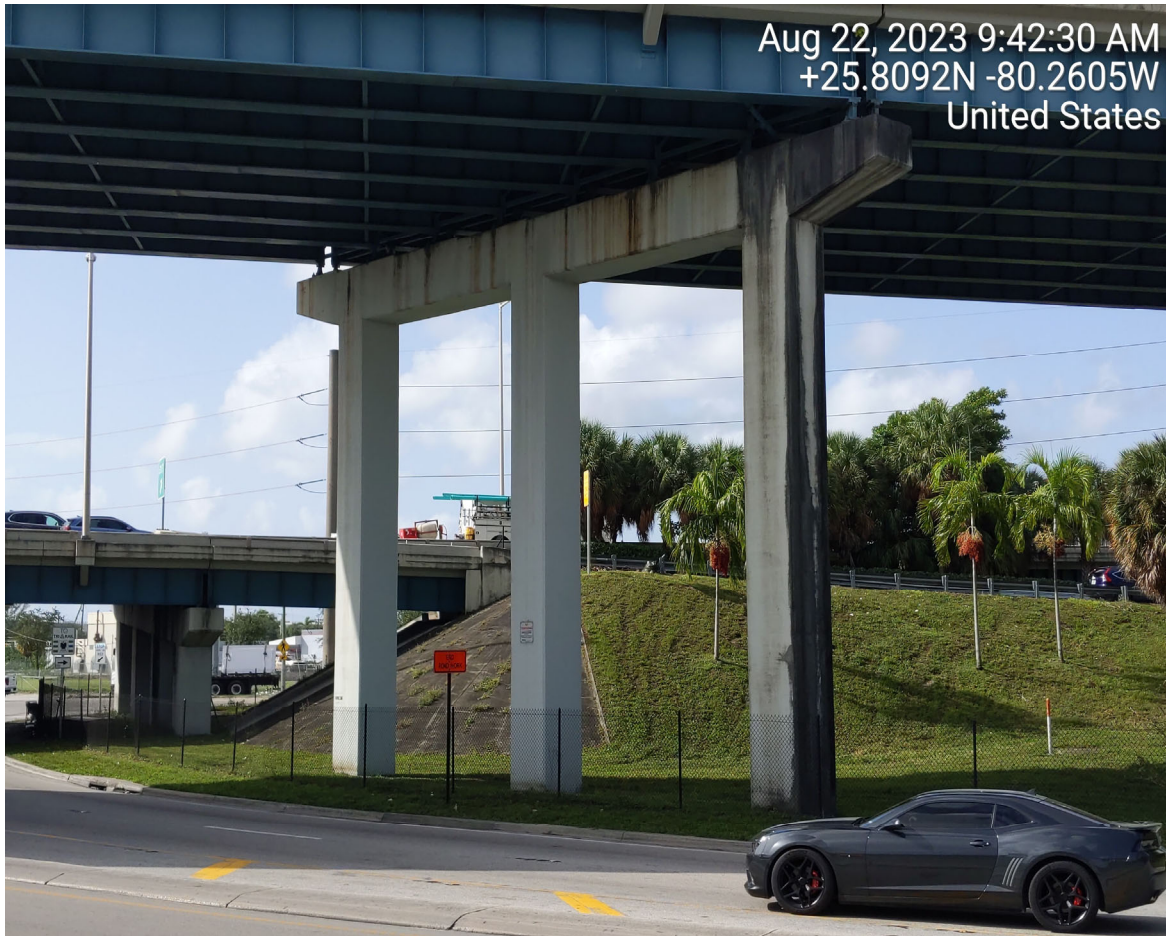
**ROADWAY INSPECTION  
LOCATION: MILE MARKER MP 1.2 MILES  
EASTBOUND MAINLINE.**

**DETERIORATED CLASS V COATING ON BRIDGE NO. 870238**

**ITEM NOTED TO BE ADDRESSED BY GMX WORK PROGRAM 30037**

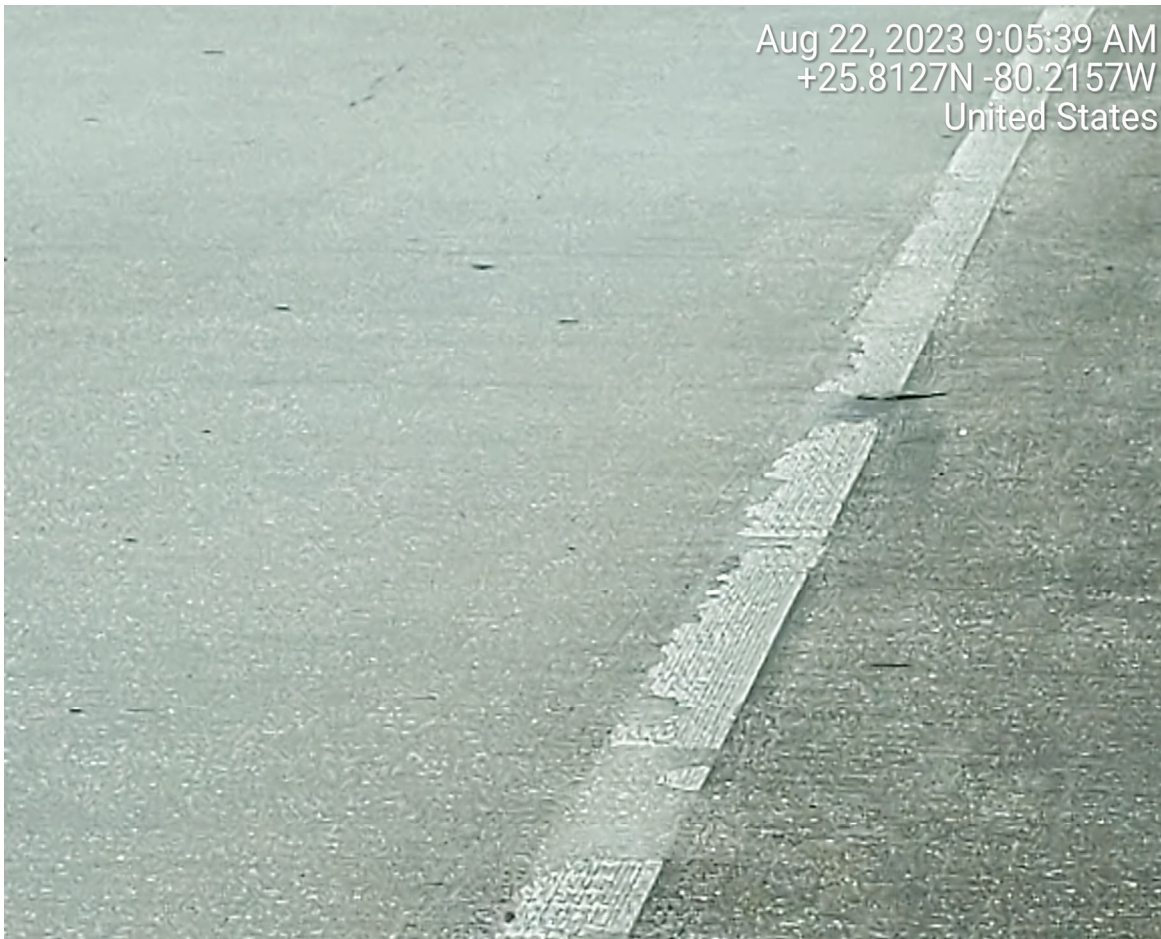
**ROADWAY INSPECTION  
LOCATION: MILE MARKER MP 3.95 MILES  
WESTBOUND MAINLINE**

**DETERIORATED STRIPING ON (BRIDGE # 870022)**

**ITEM NOTED TO BE ADDRESSED BY GMX WORK PROGRAM 30033**

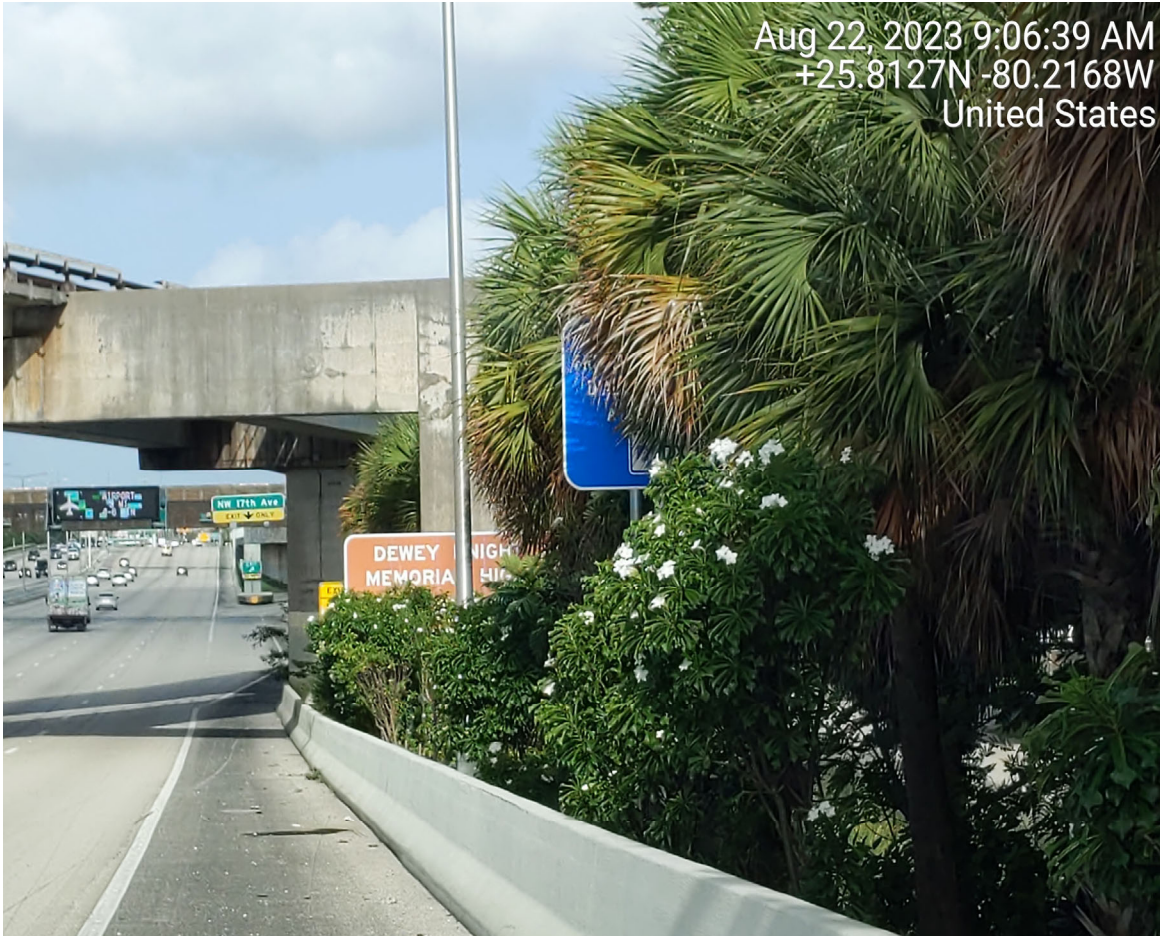
**ROADWAY INSPECTION  
LOCATION: MILE MARKER MP 3.88 MILES  
WESTBOUND MAINLINE**

**OVERGROWN VEGETATION OBSTRUCTING SIGN**

**ITEM NOTED TO BE ADDRESSED BY GMX MAINTENANCE RFP 23-01**

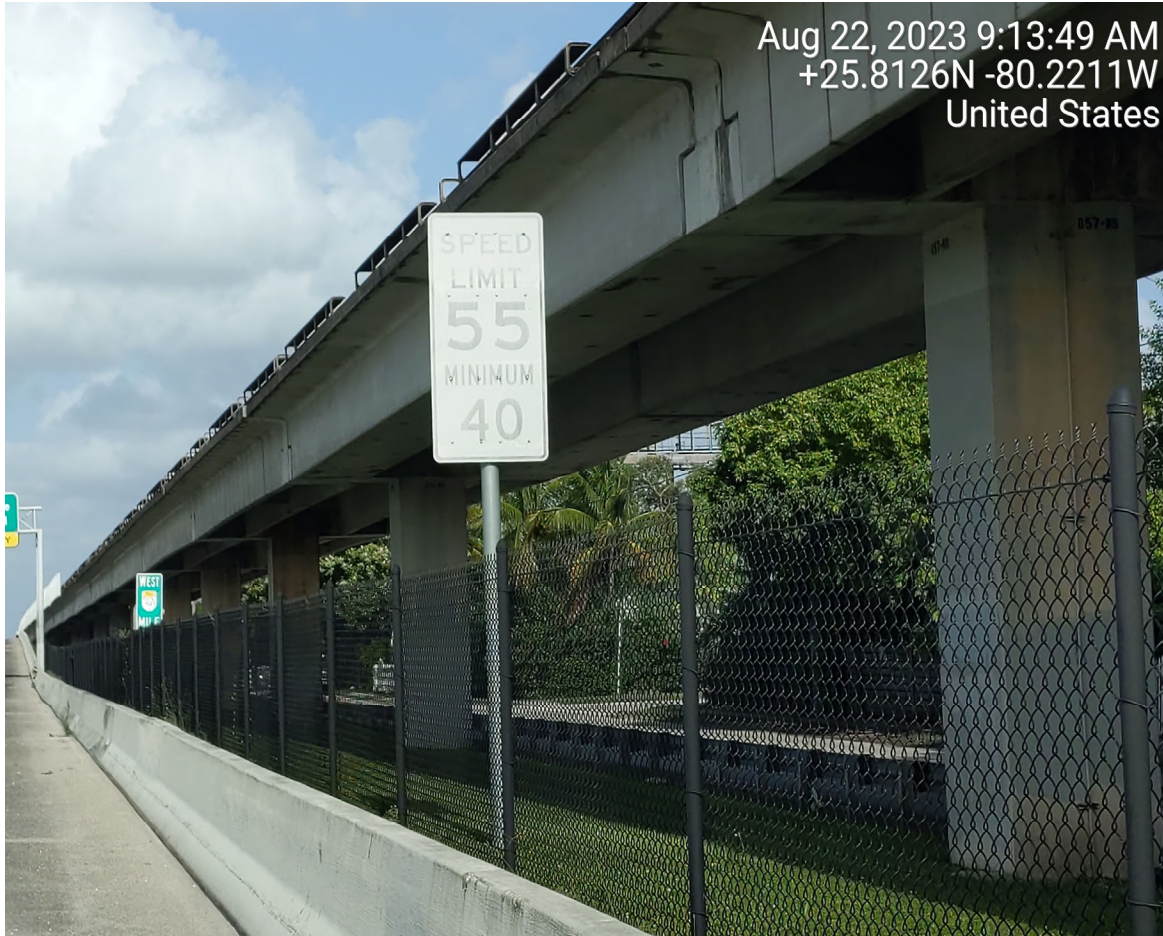
**ROADWAY INSPECTION  
LOCATION: MILE MARKER MP 3.6 MILES  
WESTBOUND MAINLINE**

**DETERIORATED REFLECTIVE SHEETING ON SPEED LIMIT SIGN**

**ITEM NOTED TO BE ADDRESSED BY GMX MAINTENANCE ITB 23-17**

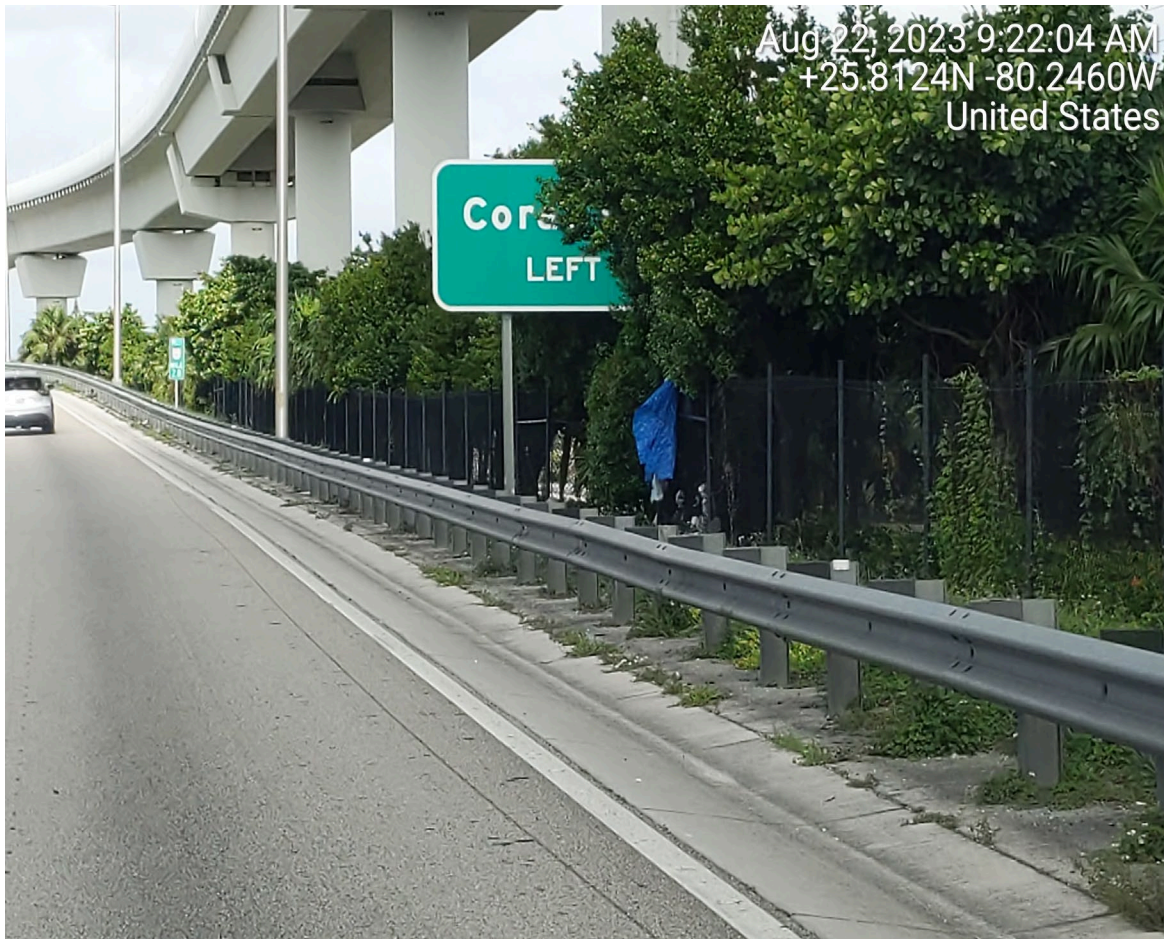
**ROADWAY INSPECTION  
LOCATION: MILE MARKER MP 2.1 MILES  
WESTBOUND MAINLINE**

**OVERGROWN VEGETATION OBSTRUCTING SIGN**

**ITEM NOTED TO BE ADDRESSED BY GMX MAINTENANCE RFP 23-01**

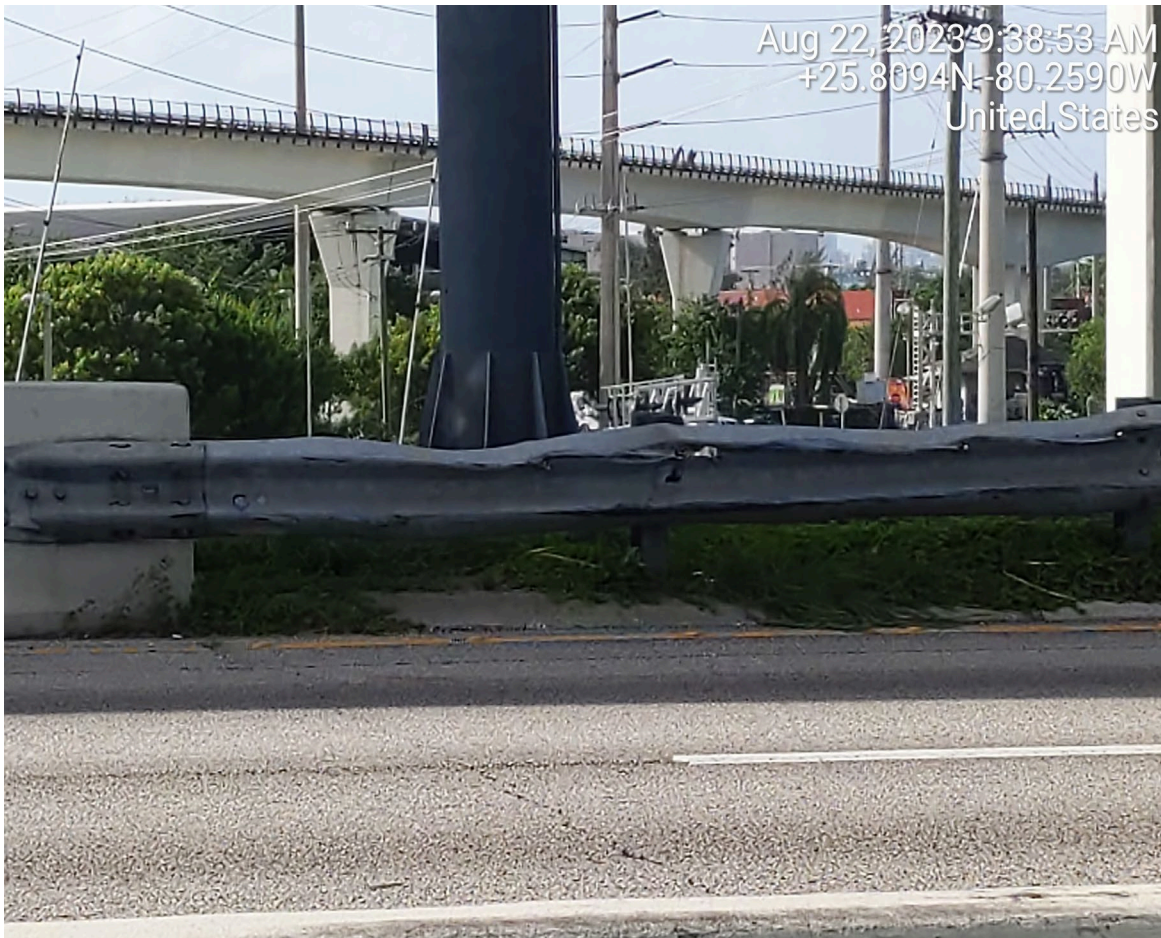
**ROADWAY INSPECTION  
LOCATION: MILE MARKER MP 1.3 MILES  
WESTBOUND MAINLINE LEFT SHOULDER.**

**DAMAGED GUARDRAIL**

**ITEM NOTED TO BE ADDRESSED BY GMX MAINTENANCE ITB-23-02**

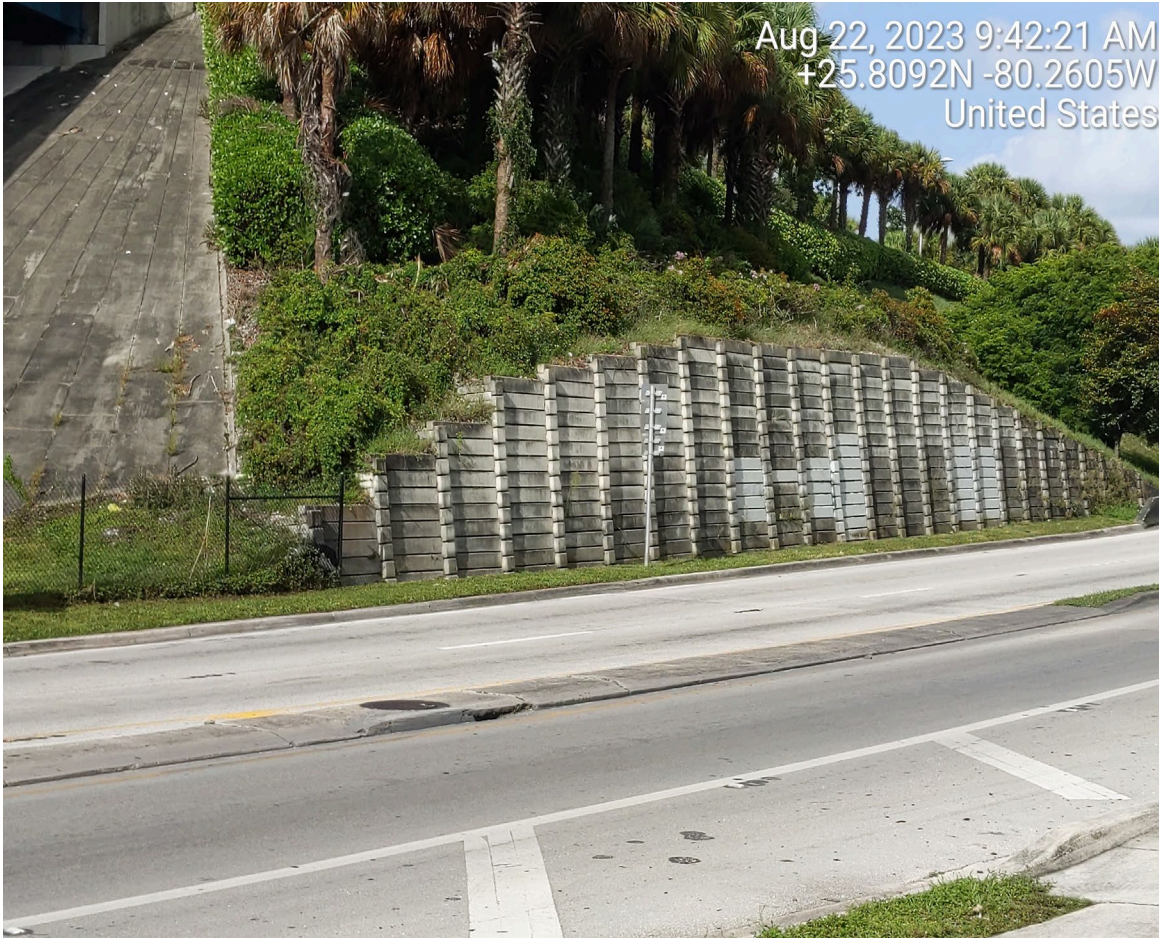
**ROADWAY INSPECTION  
LOCATION: MILE MARKER MP 1.1 MILES  
EASTBOUND OKEECHOBEE RD.**

**DETERIORATED CLASS V COATING ON RETAINING WALL**

**ITEM NOTED TO BE ADDRESSED BY GMX WORK PROGRAM 30037**

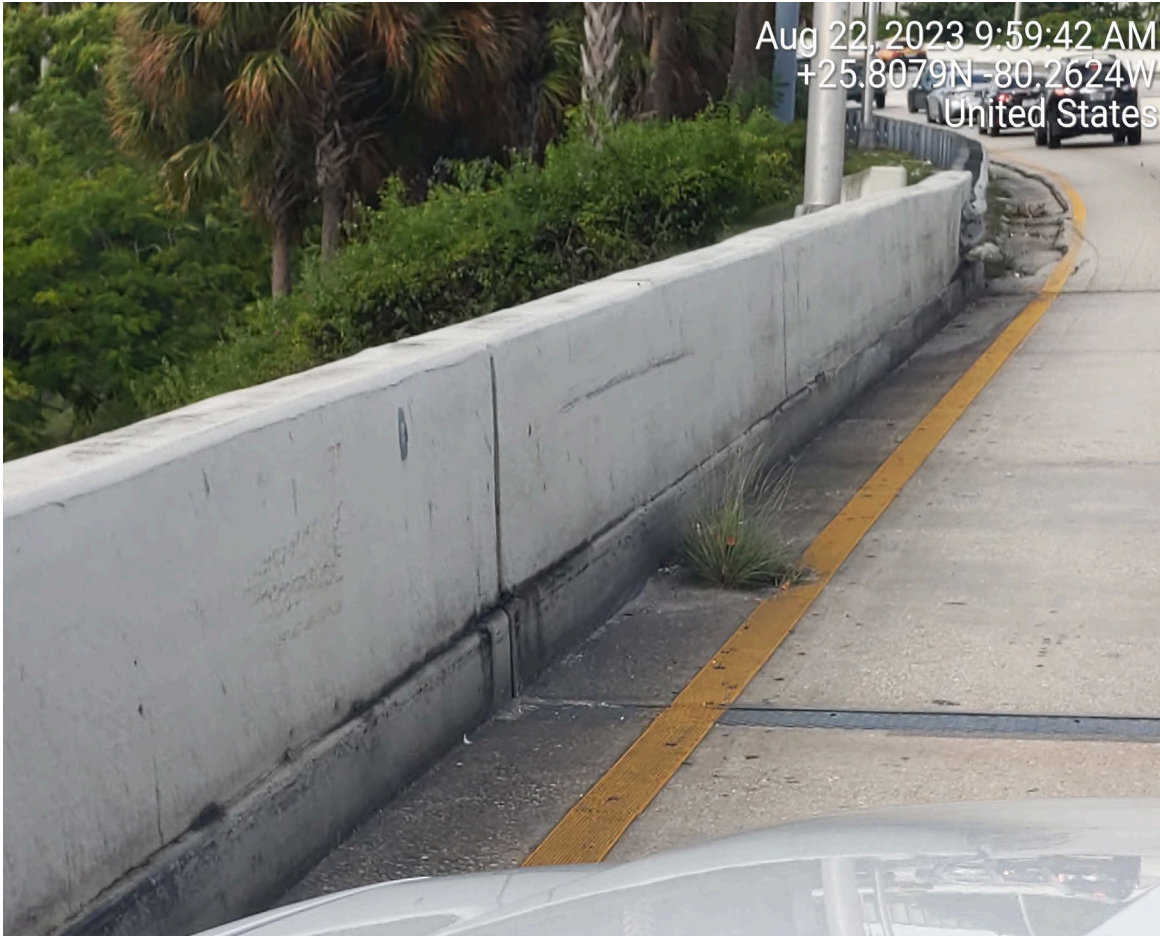
**ROADWAY INSPECTION  
LOCATION: MILE MARKER MP 1.0 MILES  
WESTBOUND OFF-RAMP TO NW 42<sup>ND</sup> AVENUE**

**SILTED BRIDGE DECK DRAINAGE INLET**

**ITEM NOTED TO BE ADDRESSED BY GMX MAINTENANCE ITB-22-09**

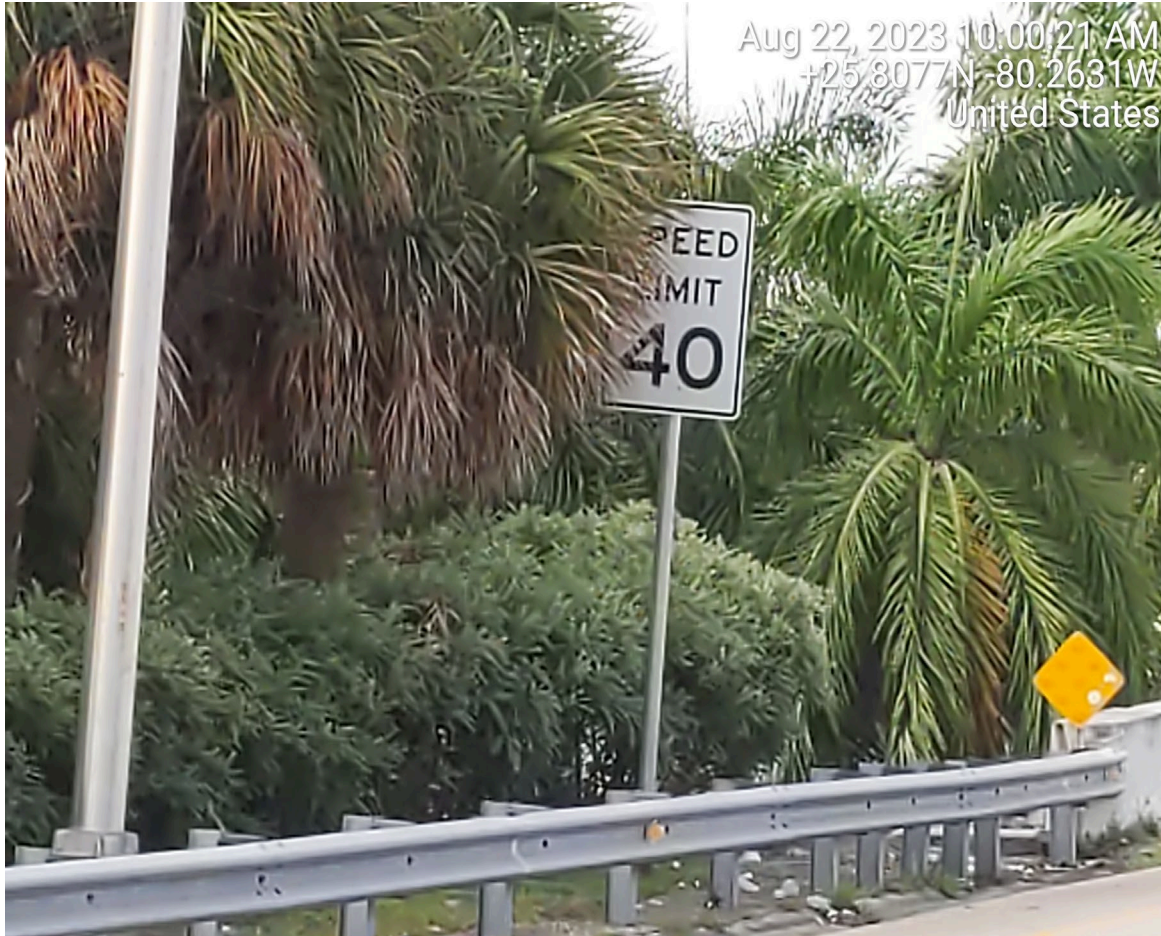
**ROADWAY INSPECTION  
LOCATION: MILE MARKER MP 0.9 MILES  
WESTBOUND OFF-RAMP TO NW 42<sup>ND</sup> AVENUE**

**OVERGROWN VEGETATION OBSTRUCTING SPEED LIMIT SIGN**

**ITEM NOTED TO BE ADDRESSED BY GMX MAINTENANCE RFP 23-01**

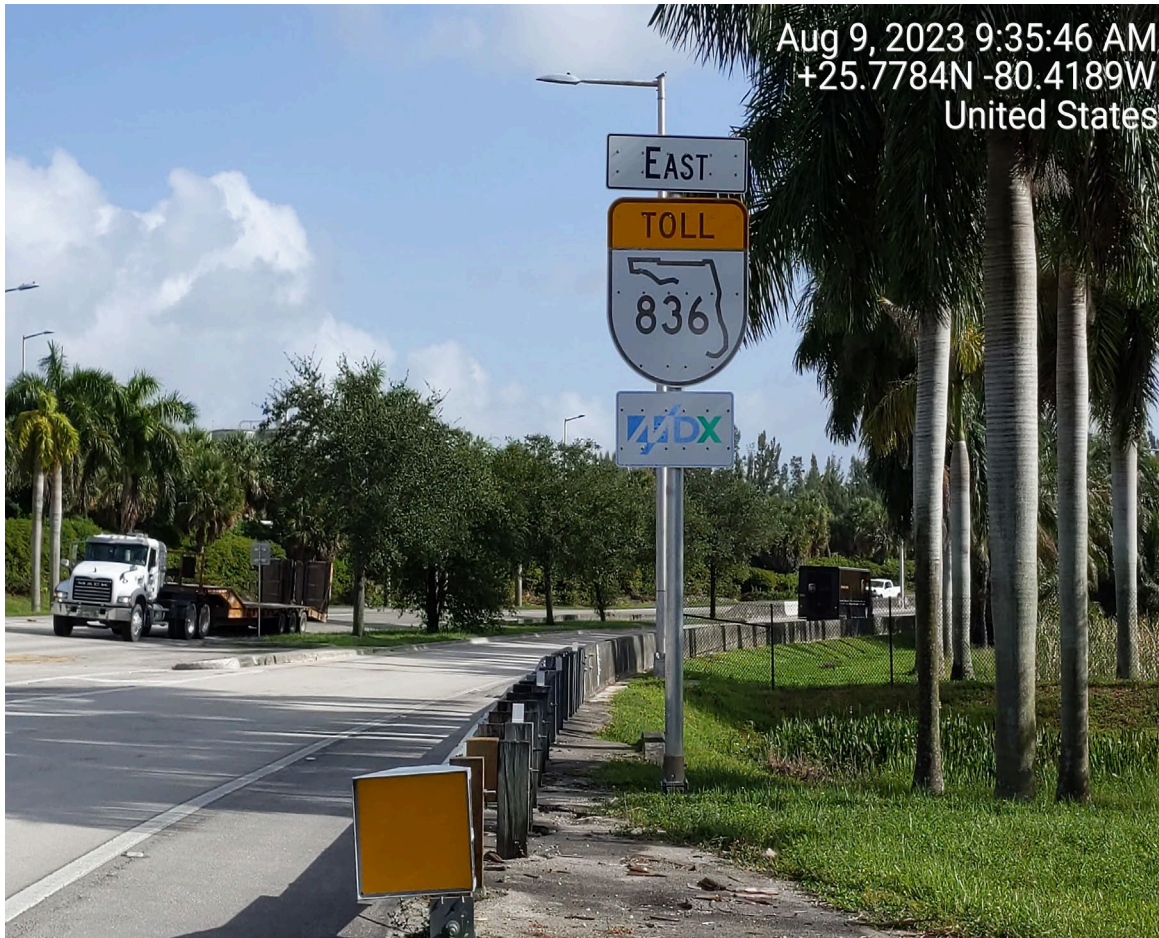
**ROADWAY INSPECTION  
LOCATION: MILE MARKER 0.2 MILES  
EASTBOUND ON-RAMP FROM NW 137<sup>th</sup> AVENUE**

**DETERIORATED REFLECTIVE SHEETING**

**ITEM NOTED TO BE ADDRESSED BY GMX MAINTENANCE ITB-23-17**

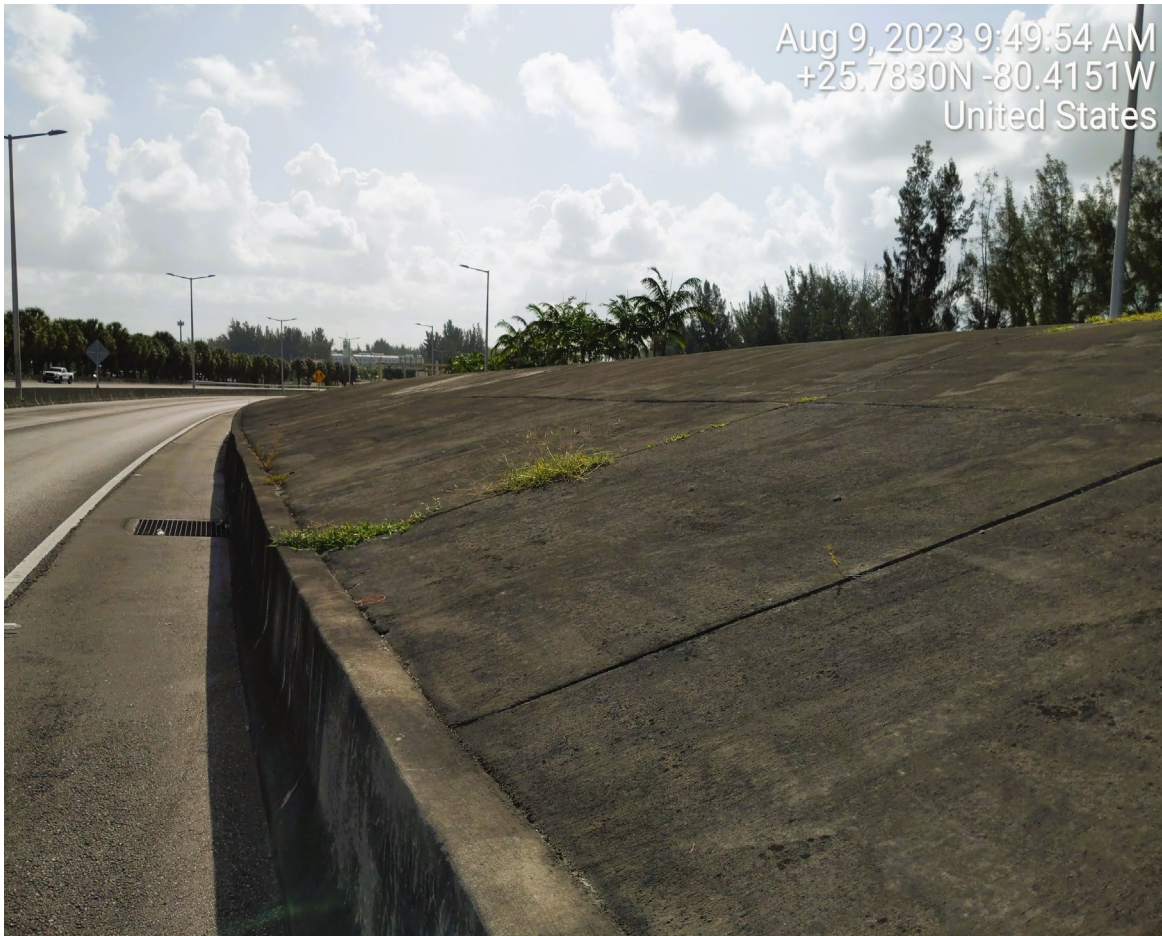
**ROADWAY INSPECTION  
LOCATION: MILE MARKER 0.65 MILES  
EASTBOUND MAINLINE (RIGHT SHOULDER)**

**DETERIORATED CLASS V COATING ON CONCRETE MEDIAN**

**ITEM NOTED TO BE ADDRESSED BY GMX WORK PROGRAM NO. 30037**

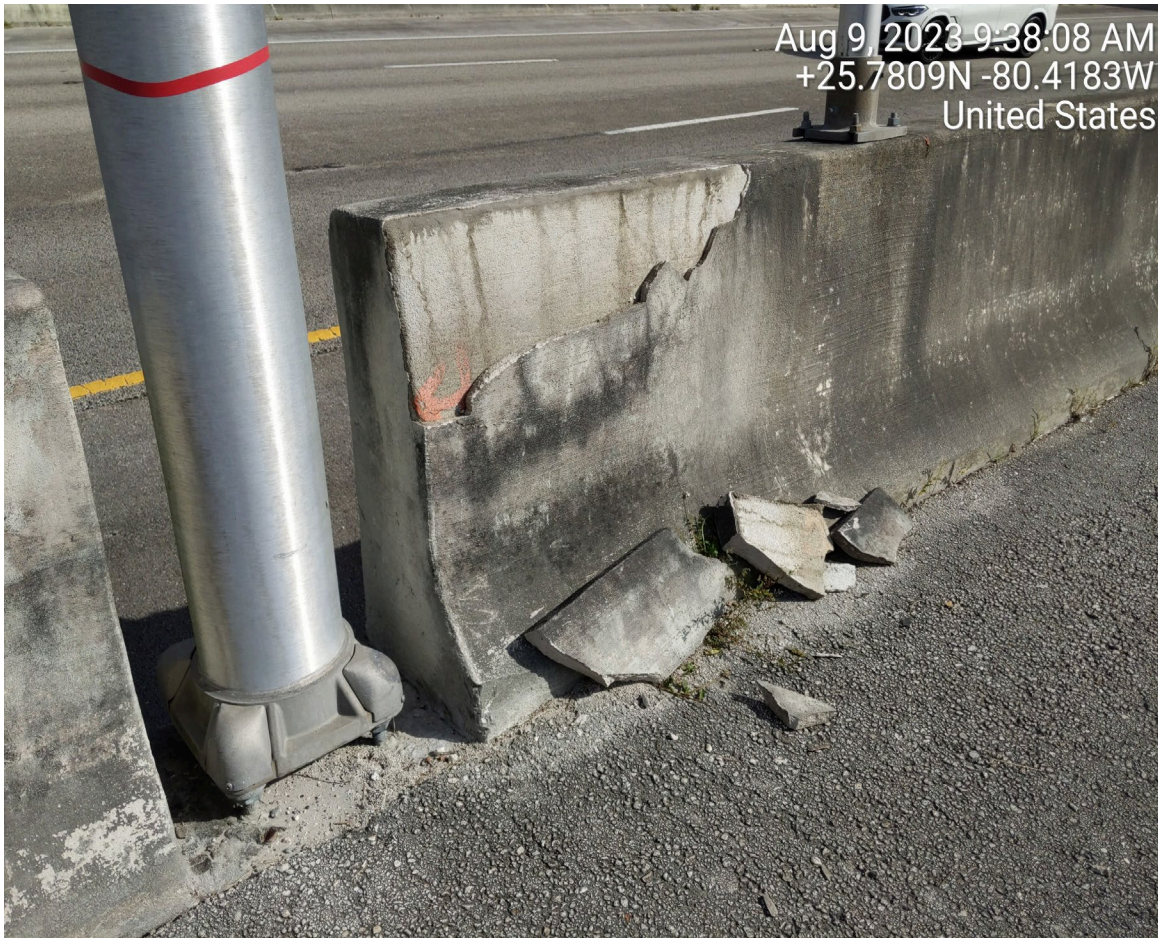
**ROADWAY INSPECTION  
LOCATION: MILE MARKER 0.4 MILES  
EASTBOUND ON-RAMP LEFT SHOULDER.**

**SPALL ON BARRIER WALL**

**ITEM NOTED TO BE ADDRESSED BY GMX MAINTENANCE ITB 22-07**

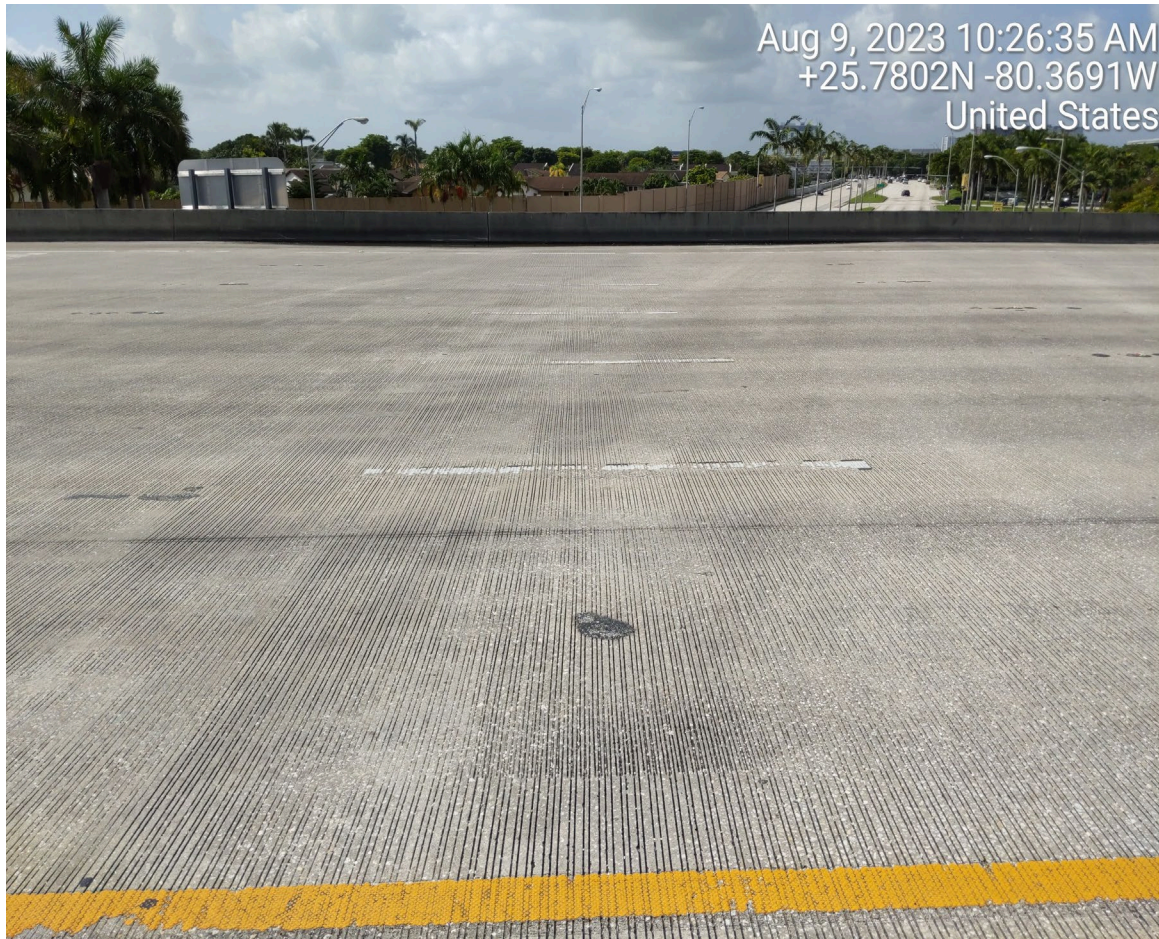
**ROADWAY INSPECTION  
LOCATION: MILE MARKER 3.6 MILES  
MAINLINE**

**DETERIORATED STRIPING  
BRIDGE No. 871010**

**ITEM NOTED TO BE ADDRESSED BY GMX MAINTENANCE ITB 23-17**

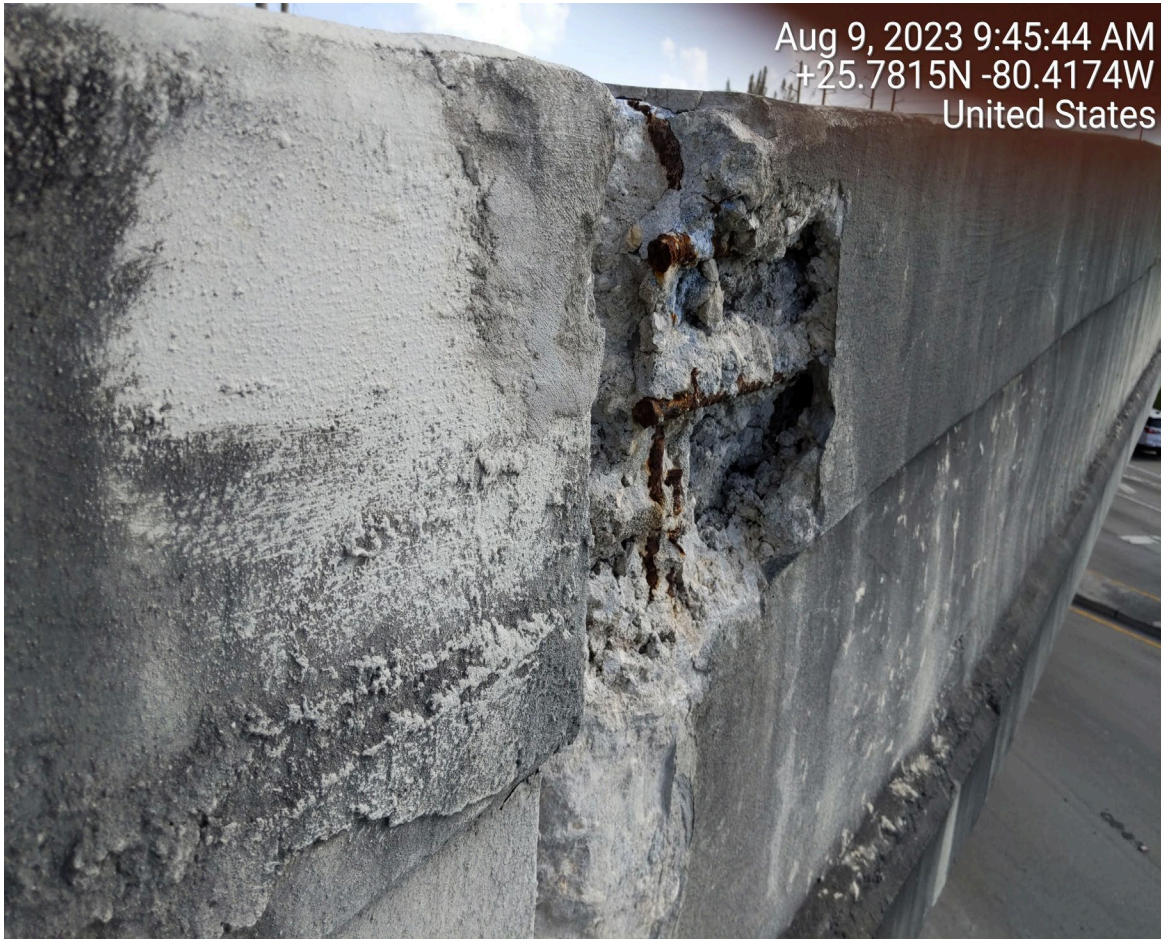
**ROADWAY INSPECTION  
LOCATION: MILE MARKER 12.2  
EASTBOUND MAILINE (RIGHT SHOULDER)**

**SPALL ON EXTERIOR FACE OF TRAFFIC RAILING AT ABUTMENT 1  
BRIDGE NO. 870966**

**ITEM NOTED TO BE ADDRESSED BY GMX MAINTENANCE ITB 22-07**

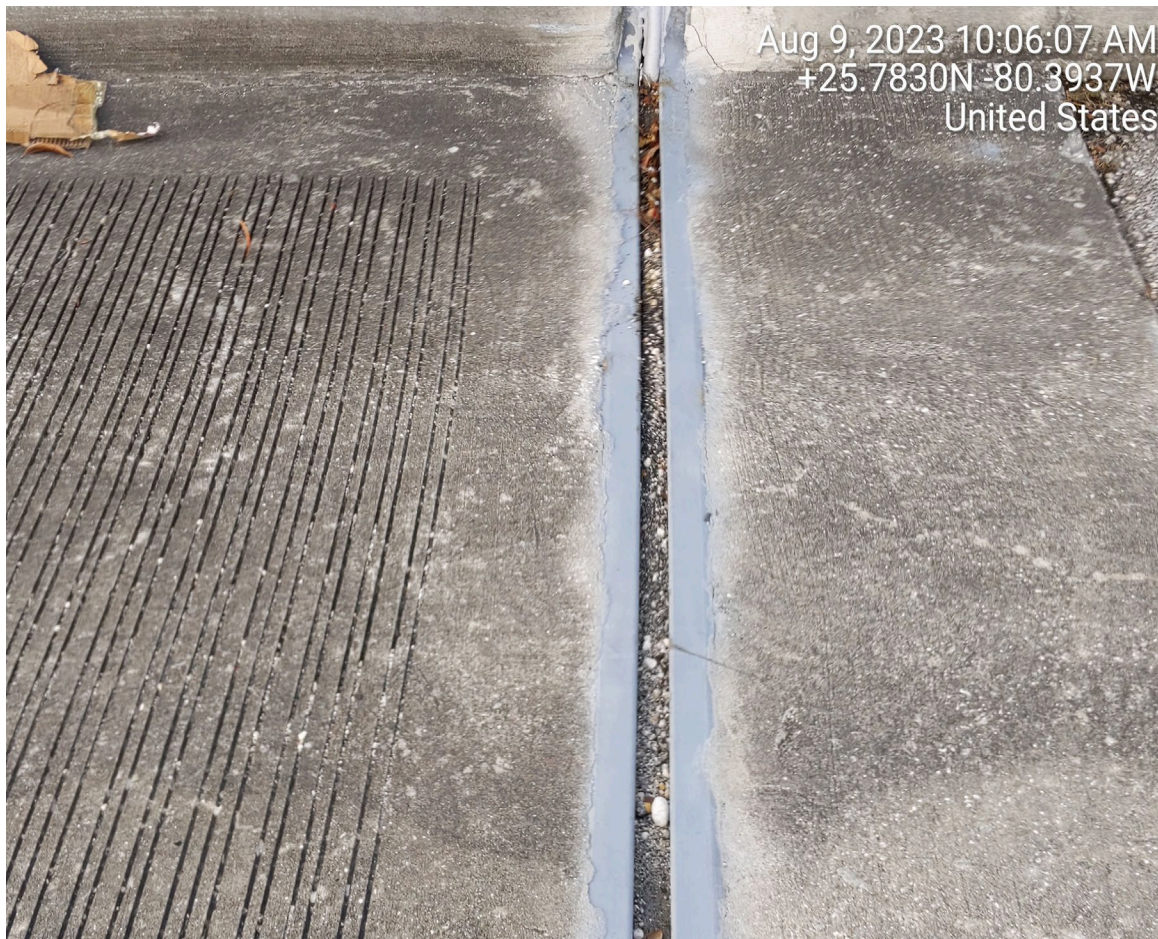
**ROADWAY INSPECTION  
LOCATION: MILE MARKER 12.2  
EASTBOUND MAINLINE**

**DEBRIS ON BRIDGE EXPANSION JOINTS BRIDGE NO. 870966**

**ITEM NOTED TO BE ADDRESSED BY GMX MAINTENANCE ITB 22-07**

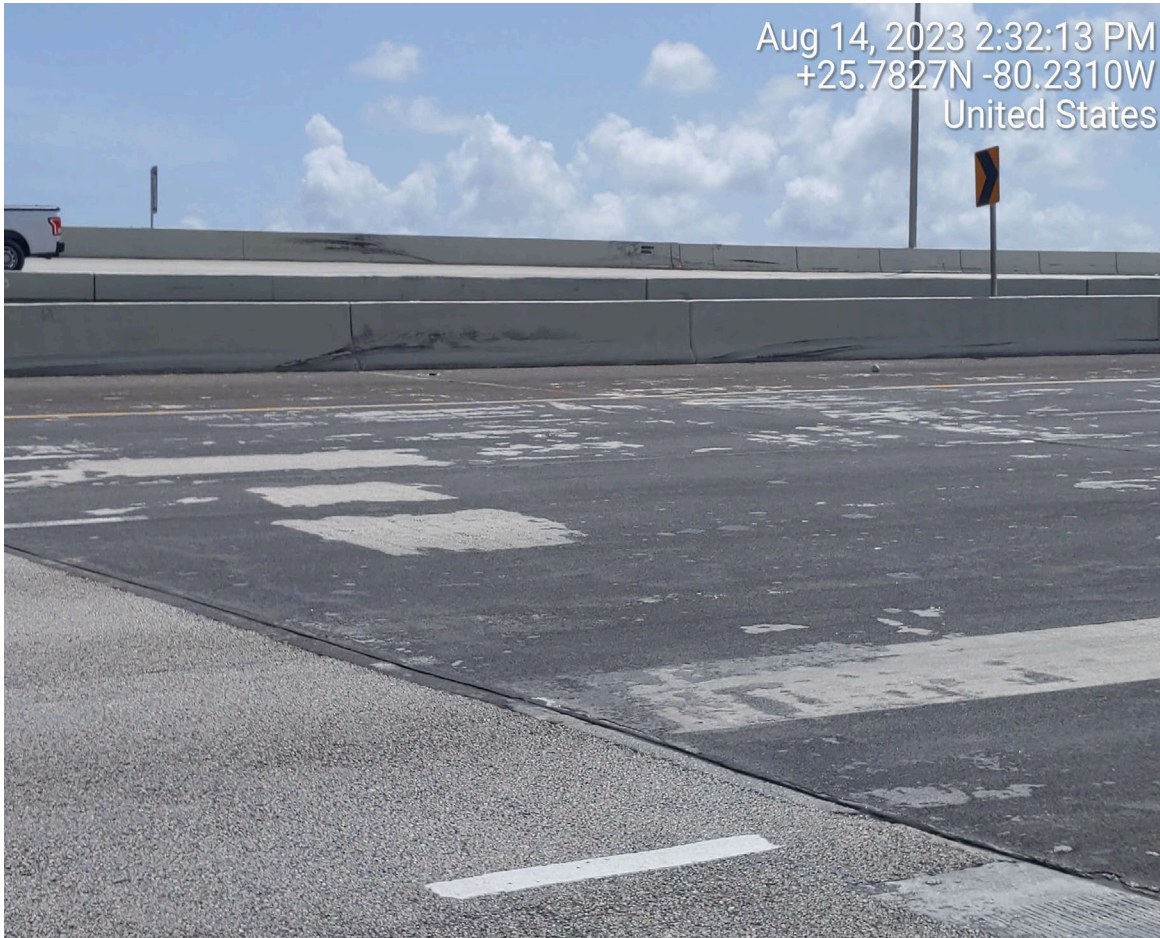
**ROADWAY INSPECTION  
LOCATION: MILE MARKER 12.1 MILES  
WESTBOUND MAINLINE**

**DETERIORATED DECK OVERLAY (BRIDGE # 870145)**

**ITEM NOTED TO BE ADDRESSED BY WORK PROGRAM NO 30044**

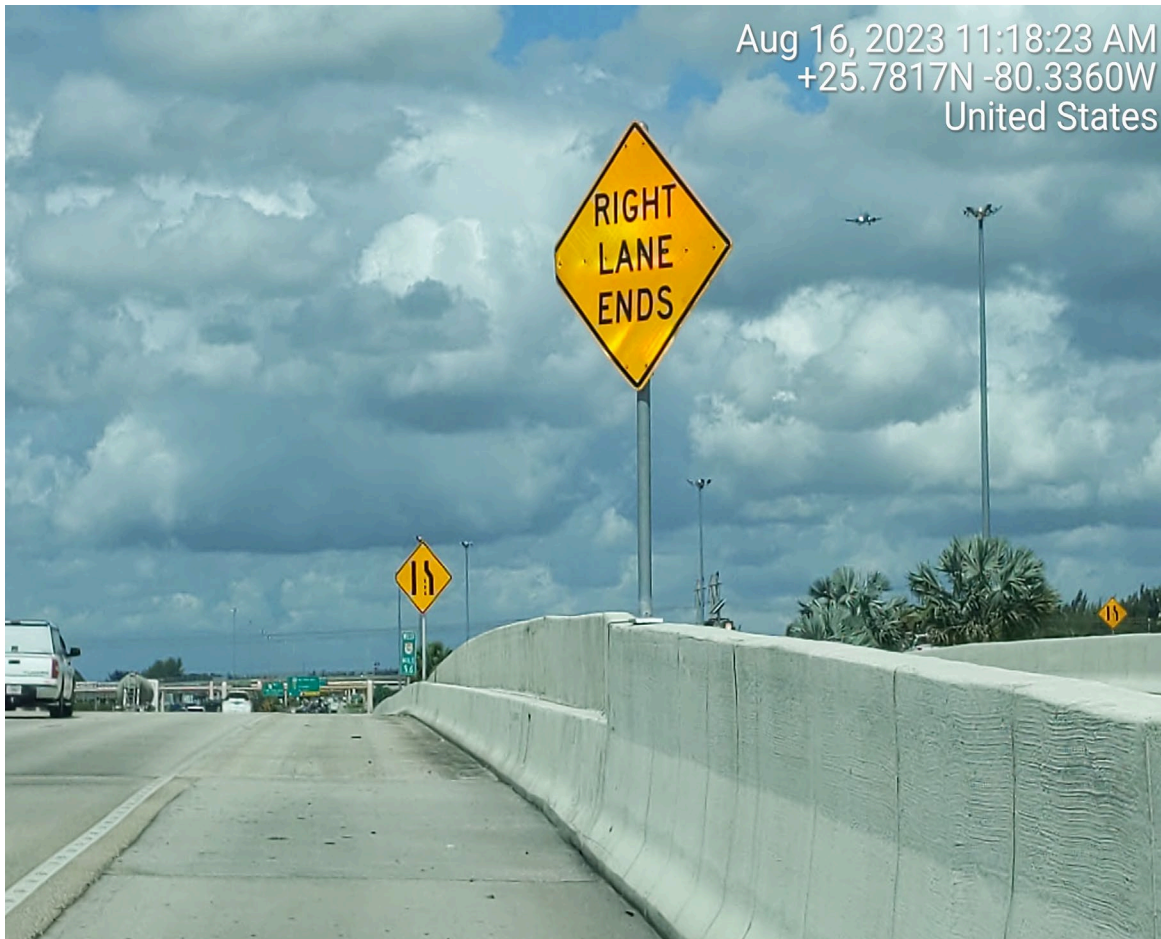
**ROADWAY INSPECTION  
LOCATION: MILE MARKER 5.7 MILES  
WESTBOUND MAINLINE**

**TWISTED SIGN PANEL**

**ITEM NOTED TO BE ADDRESSED BY GMX MAINTENANCE ITB-23-17**
