# ANNUAL INSPECTION REPORT 2023

## ANNUAL INSPECTION REPORT

In July 1, 2023, the Greater Miami Expressway Agency (GMX) acquired operational and financial control of five expressways in Miami-Dade County. This group of expressways, toll facilities, acquisition parcels and the GMX headquarters facility, all as described below, are hereinafter referred to as one of the "GMX System". In accordance with the Trust Indenture requirements, GMX retained EAC Consulting, Inc. (EAC), as the General Engineering Consultant to perform, among other duties assigned by the Agency, the yearly inspection of the GMX System. This report represents the annual inspection results for Fiscal Year (FY) 2023.

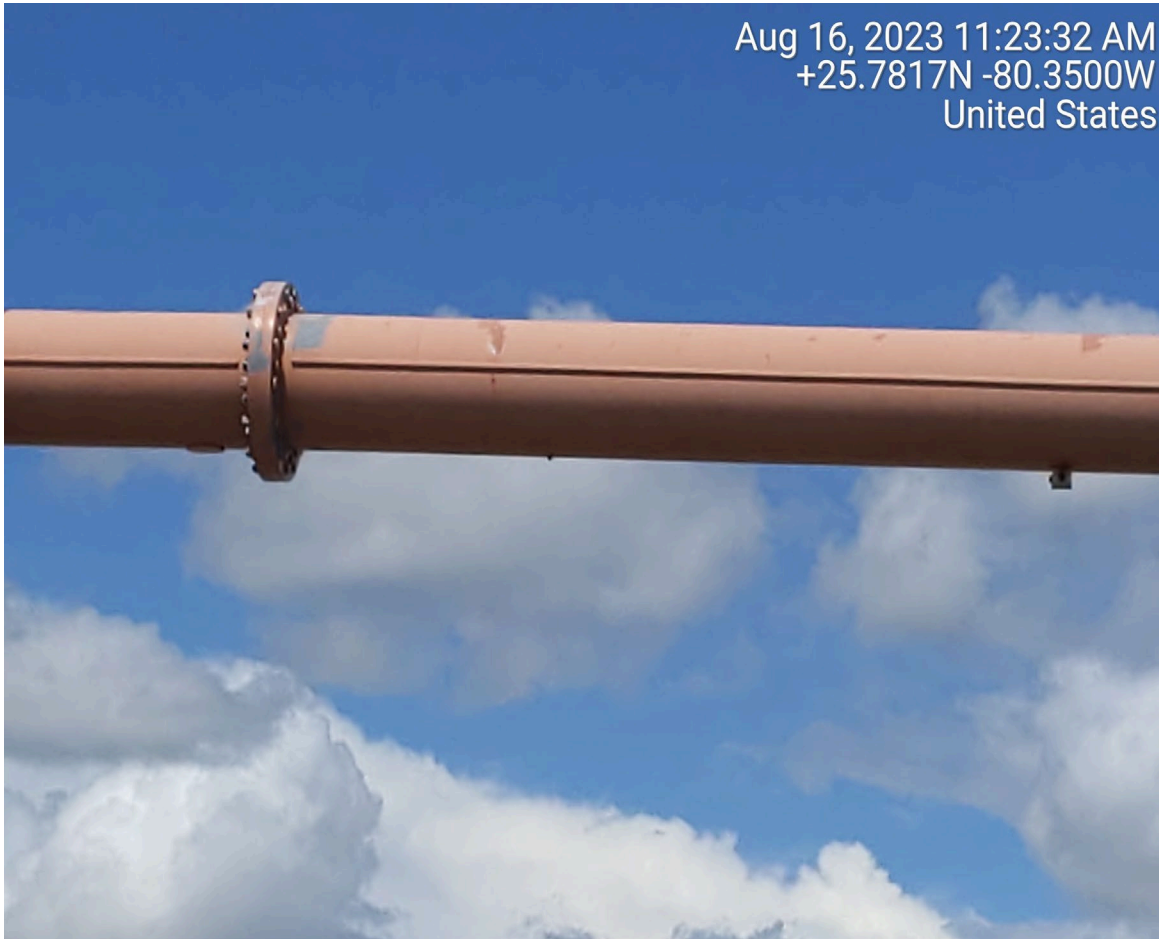
**ROADWAY INSPECTION  
LOCATION: MILE MARKER 4.8 MILES  
WESTBOUND MAINLINE**

**DETERIORATED PAINT ON MONOTUBE (STRUCTURE #875829)**

**ITEM NOTED TO BE ADDRESSED BY GMX PROJECT NO. 30047**

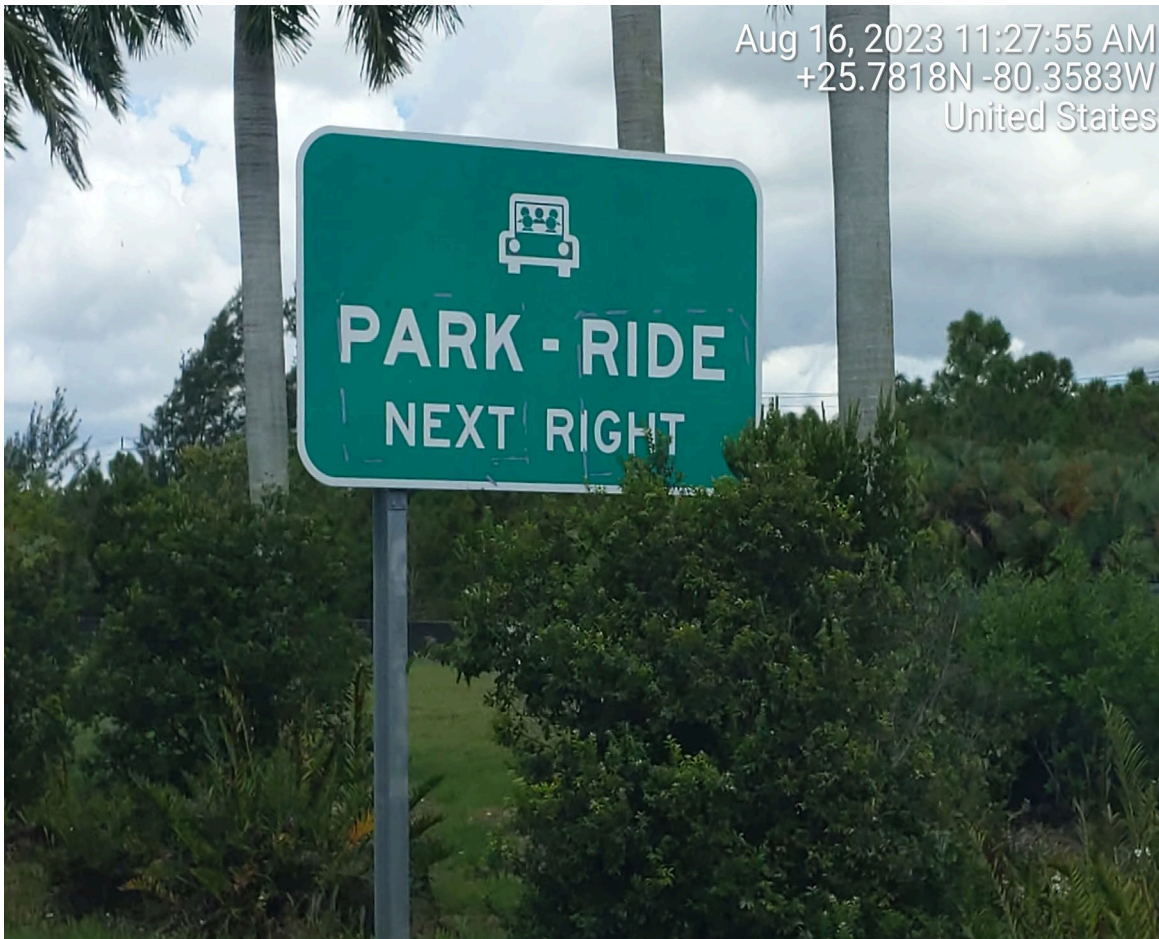
**ROADWAY INSPECTION  
LOCATION: MILE MARKER 4.2 MILES  
WESTBOUND MAINLINE**

**OVERGROWN VEGETATION OBSTRUCTING SIGN**

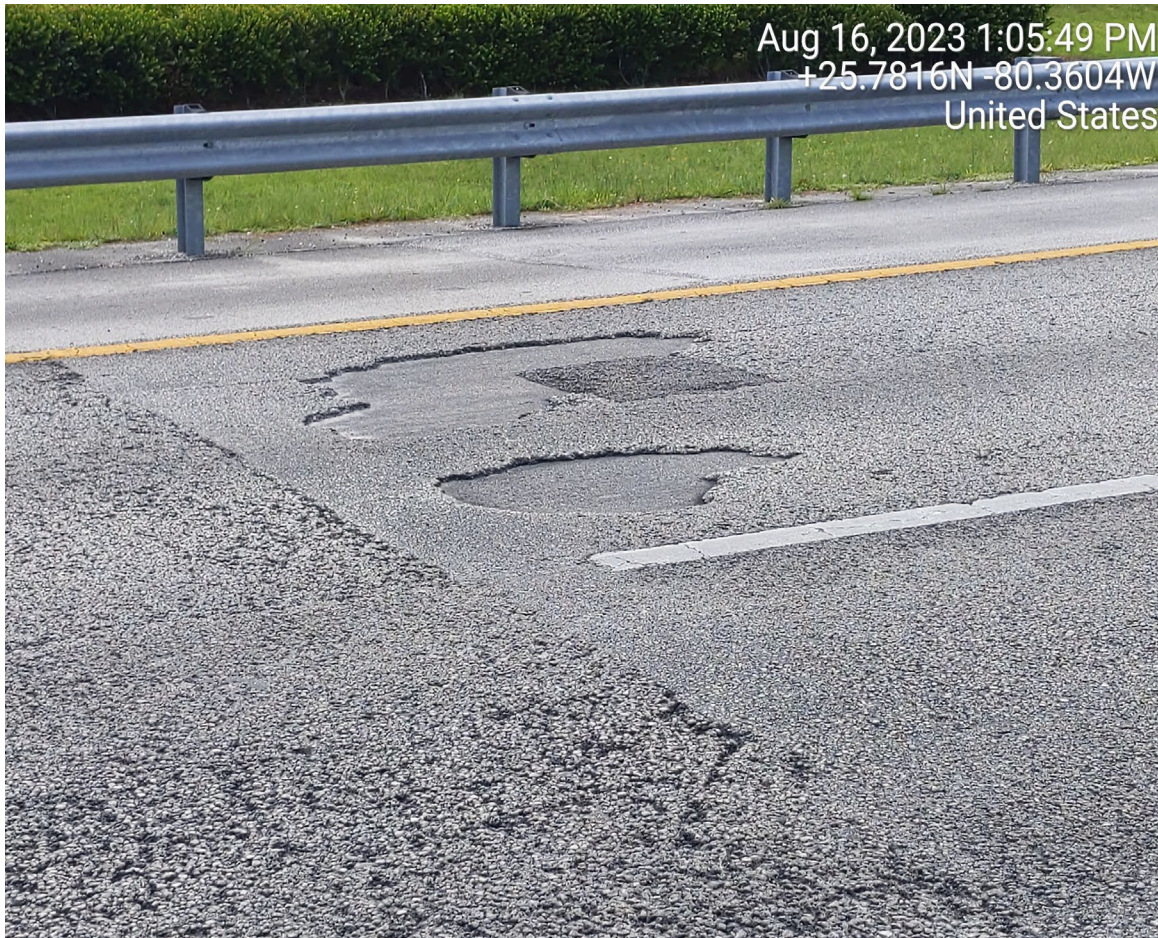
**ROADWAY INSPECTION  
LOCATION: MILE MARKER 4.20 MILES  
WESTBOUND MAINLINE (INSIDE LANE)**

**DETERIORATED ASPHALT**

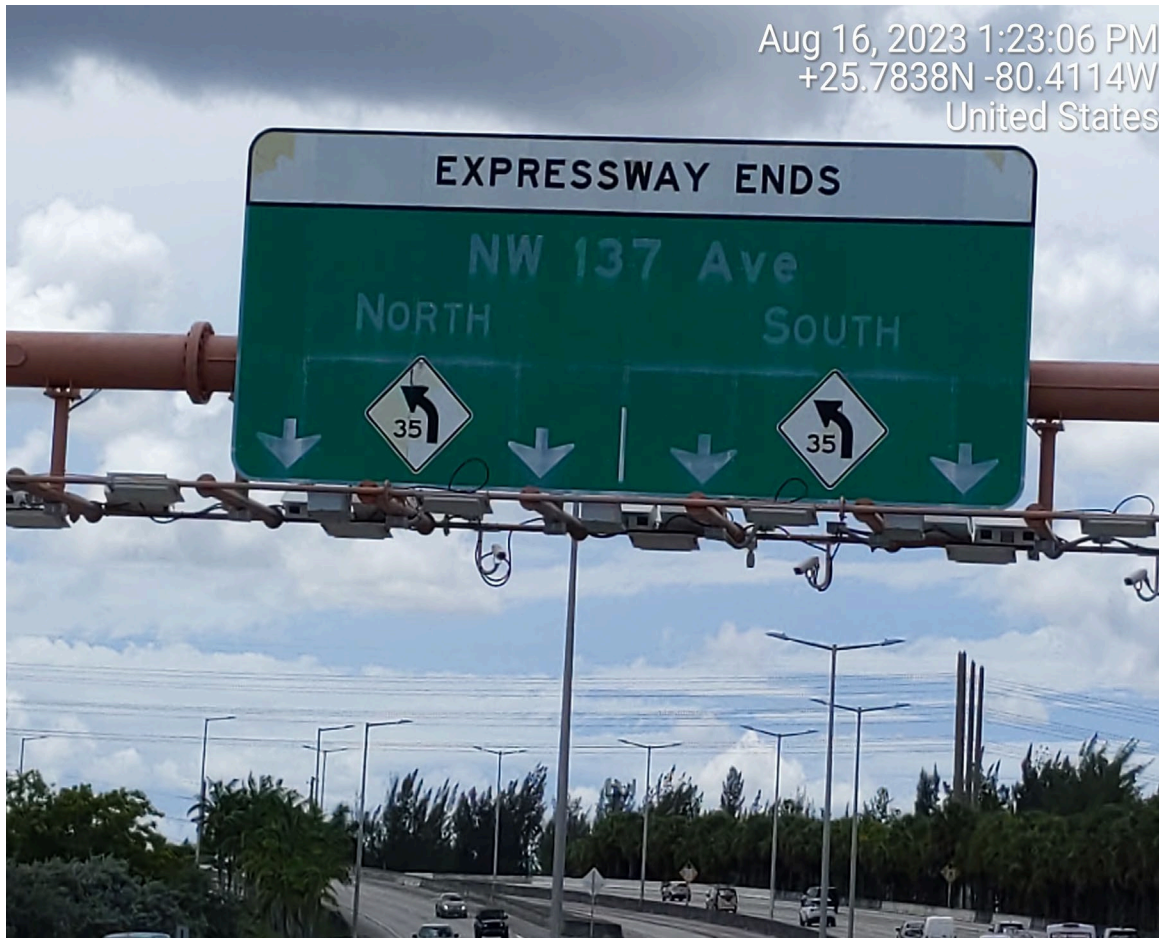
**ROADWAY INSPECTION  
LOCATION: MILE MARKER 0.8 MILES  
WESTBOUND MAINLINE**

**DETERIORATED REFLECTIVE SHEETING ON SIGN PANEL**

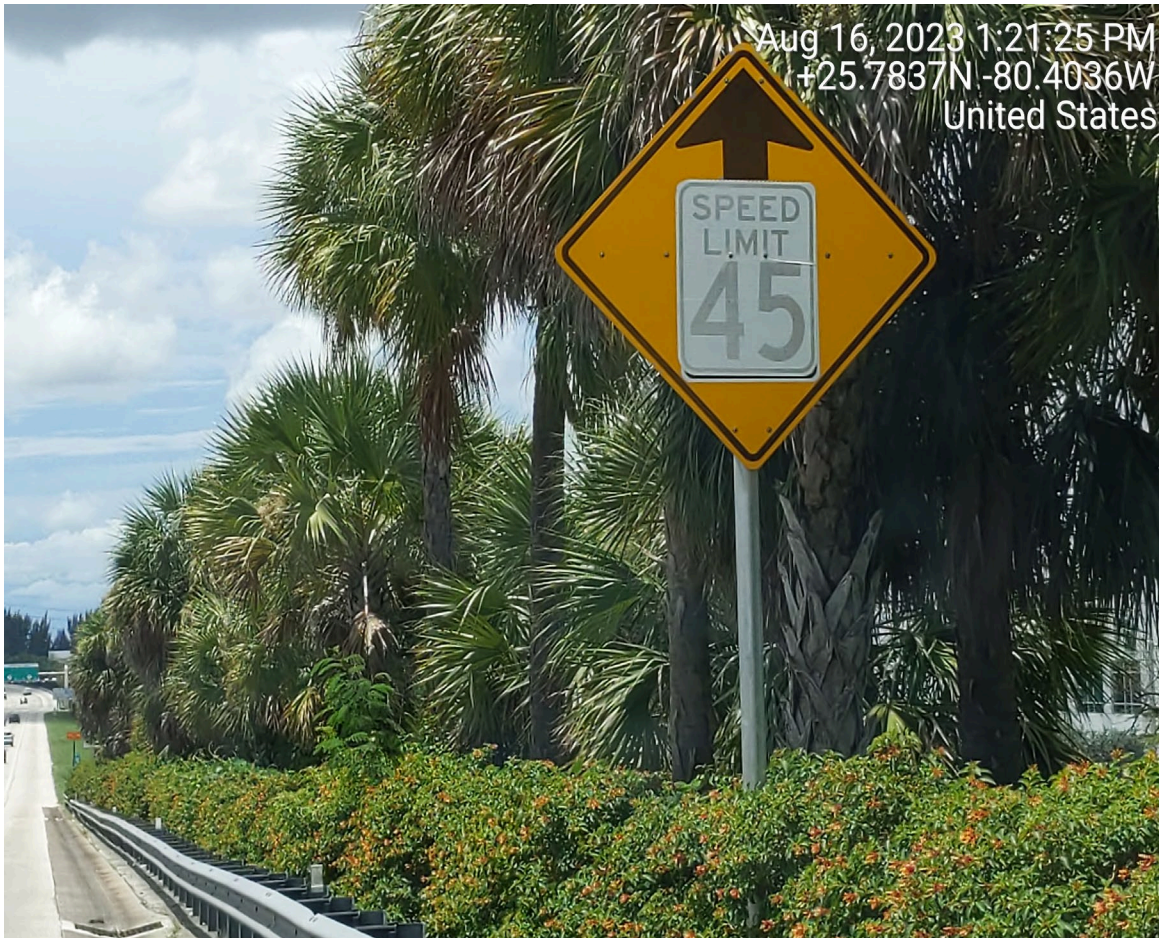
**ROADWAY INSPECTION  
LOCATION: MILE MARKER 1.2 MILES  
WESTBOUND MAINLINE**

**DETERIORATED REFLECTIVE SHEETING ON SPEED LIMIT SIGN**

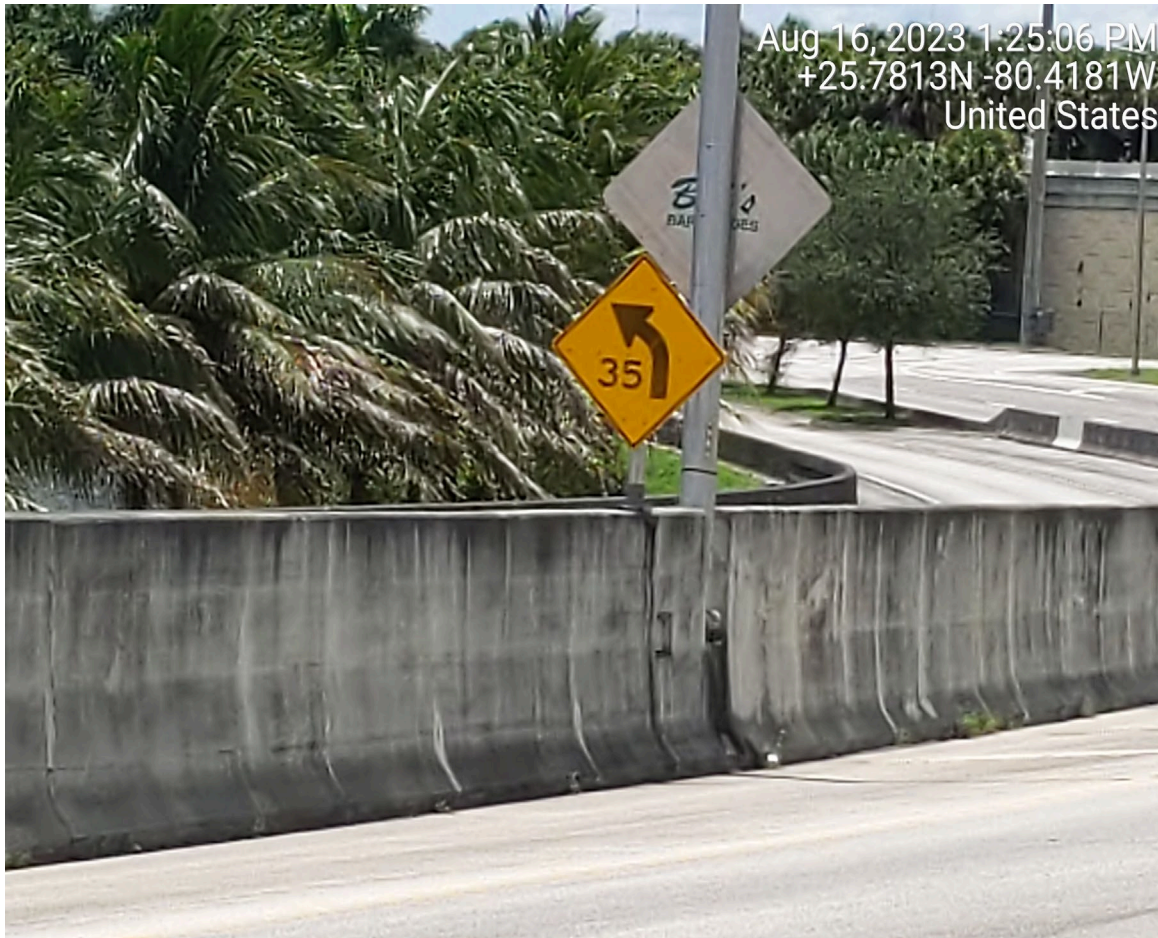
**ROADWAY INSPECTION  
LOCATION: MILE MARKER 0.4 MILES  
WESTBOUND MAINLINE**

**DETERIORATED CLASS V COATING ON BARRIER WALL & DETERIORATED  
REFLECTIVE SHEETING**

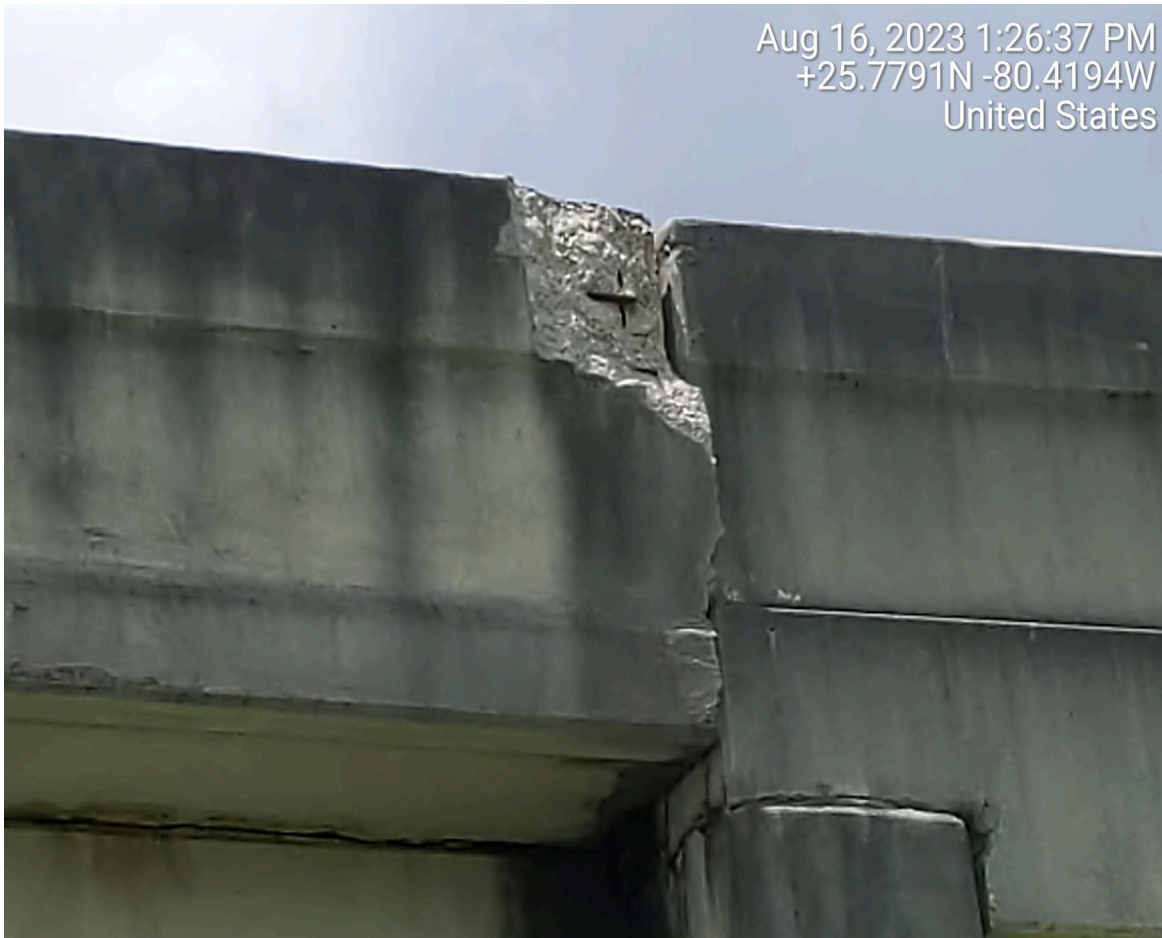
**ROADWAY INSPECTION  
LOCATION: MILE MARKER 2.20 MILES  
WESTBOUND MAINLINE**

**SPALL ON BRIDGE RAILING BRIDGE NO. 871006**

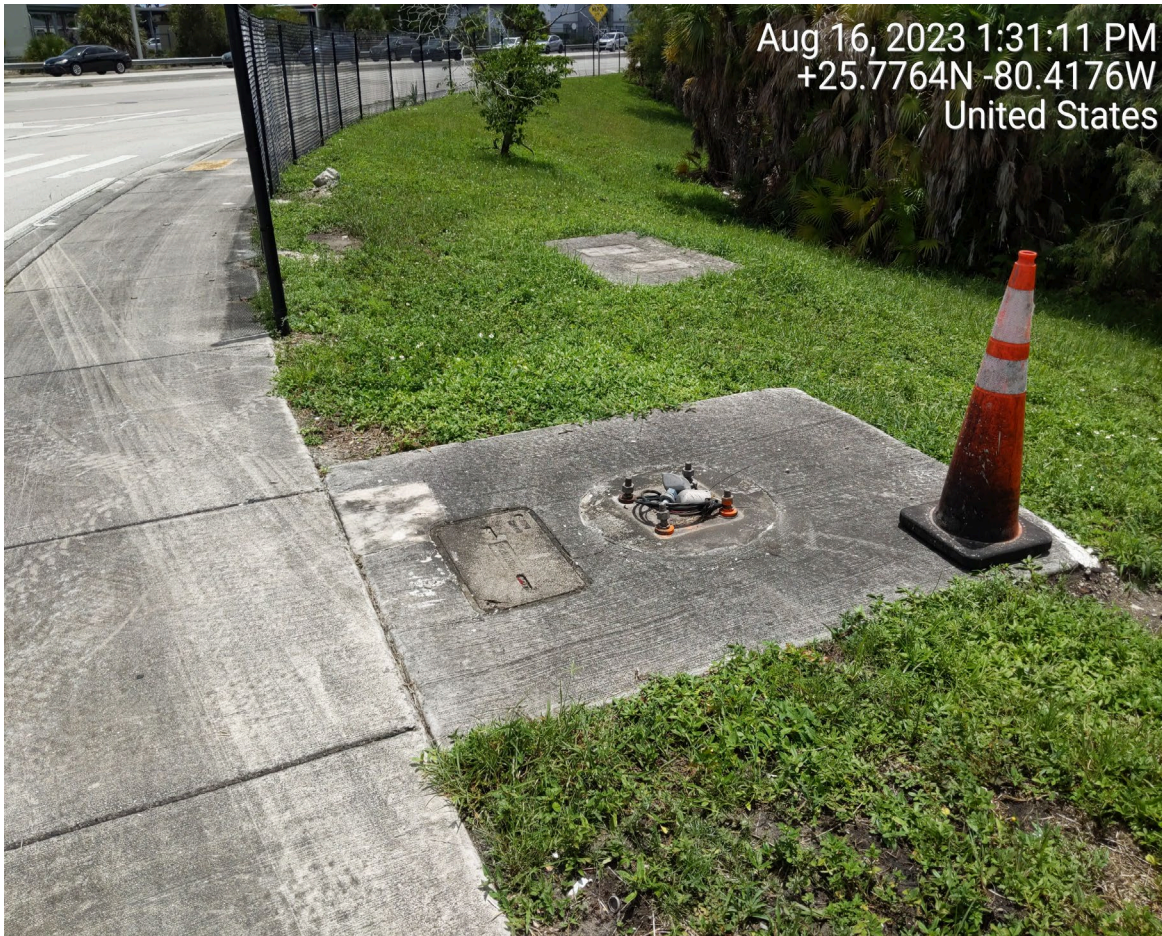
**ROADWAY INSPECTION  
LOCATION: MILE MARKER 1.54 MILES  
WESTBOUND OFF-RAMP TO NW 137<sup>TH</sup> AVE**

**MISSING LIGHT POLE**

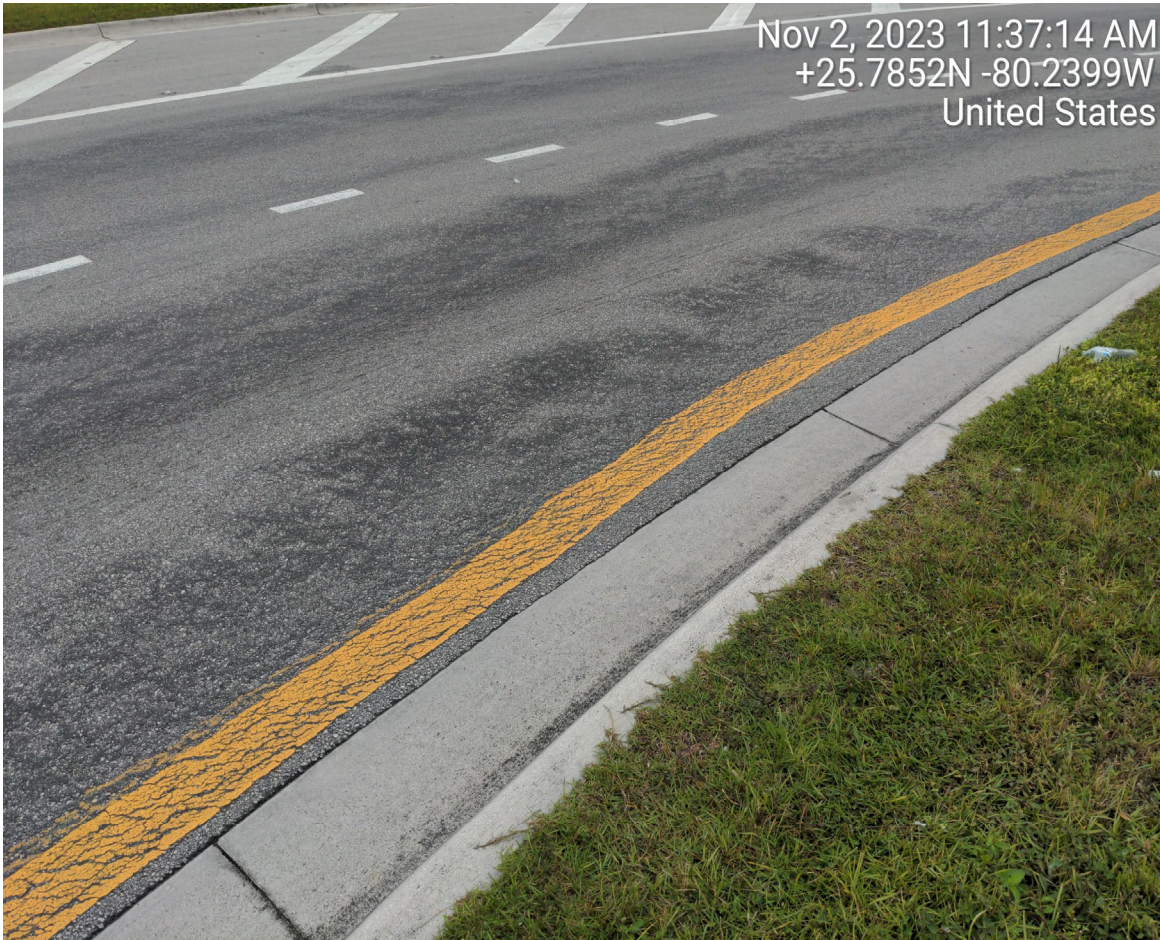
**ROADWAY INSPECTION  
LOCATION: MILE MARKER 1.54 MILES  
WESTBOUND OFF-RAMP TO NW 137<sup>TH</sup> AVE**

**DAMAGED PAVEMENT DUE TO SETTLEMENT**

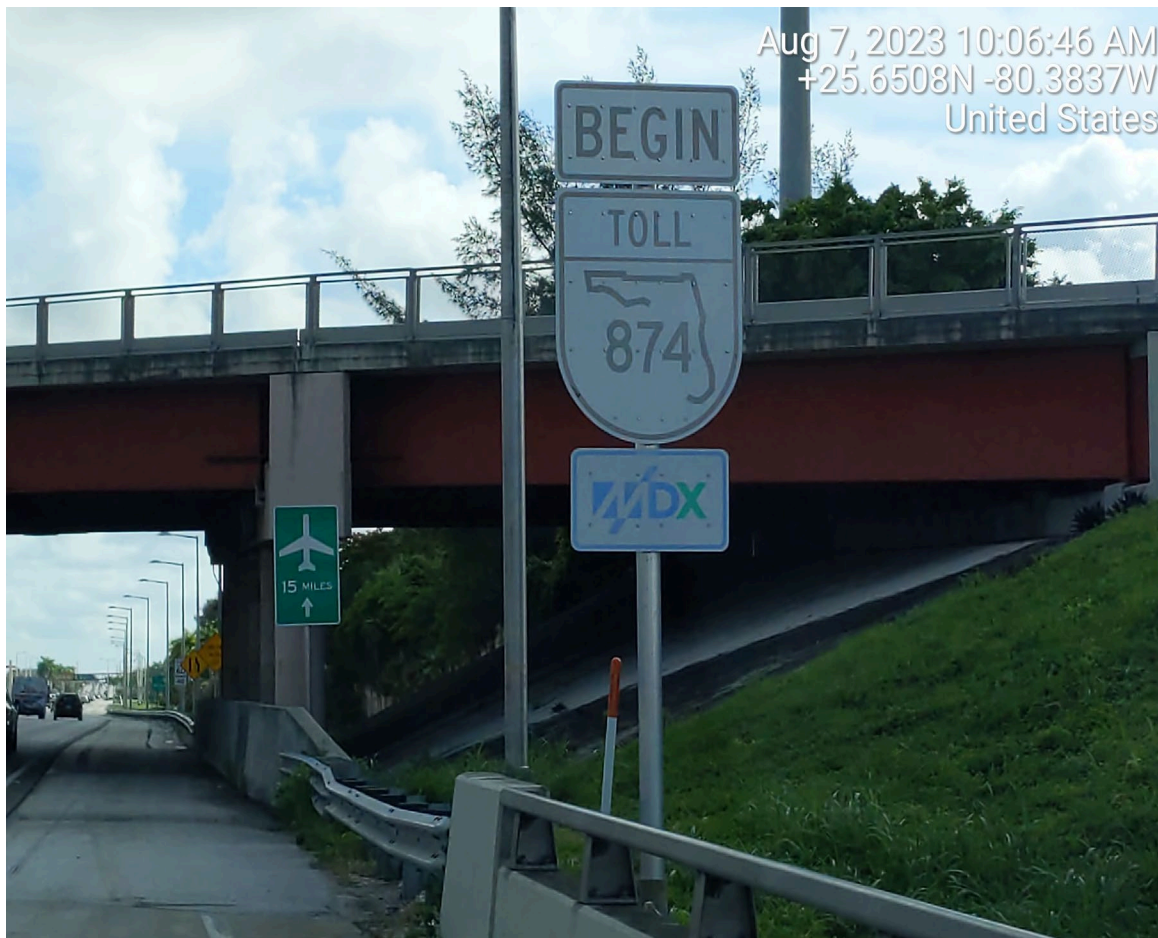
**ROADWAY INSPECTION  
LOCATION: MILE MARKER 0.0 MILES  
NORTHBOUND MAINLINE**

**DETERIORATED REFLECTIVE SHEETING**

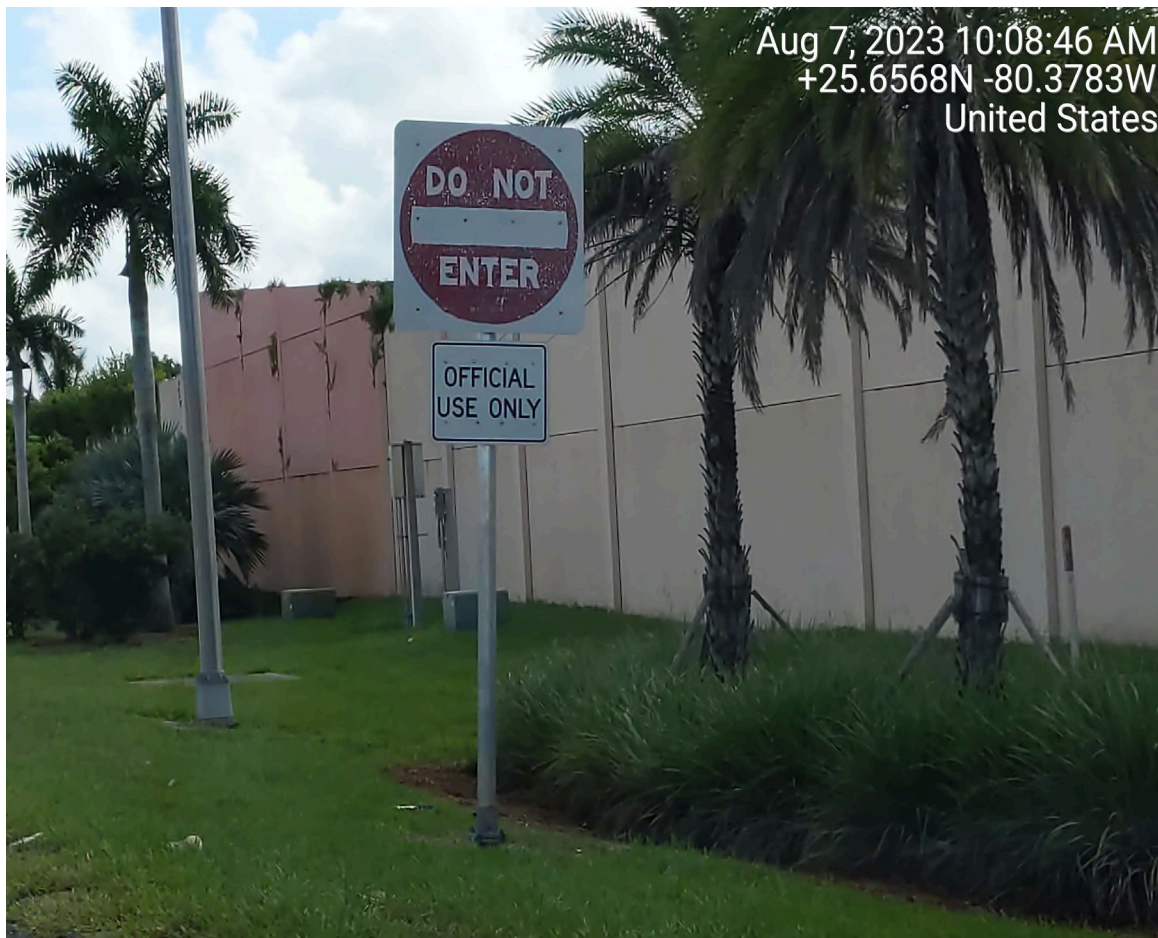
**ROADWAY INSPECTION  
LOCATION: MILE MARKER 1.0 MILES  
NORTHBOUND MAINLINE**

**DETERIORATED REFLECTIVE SHEETING**

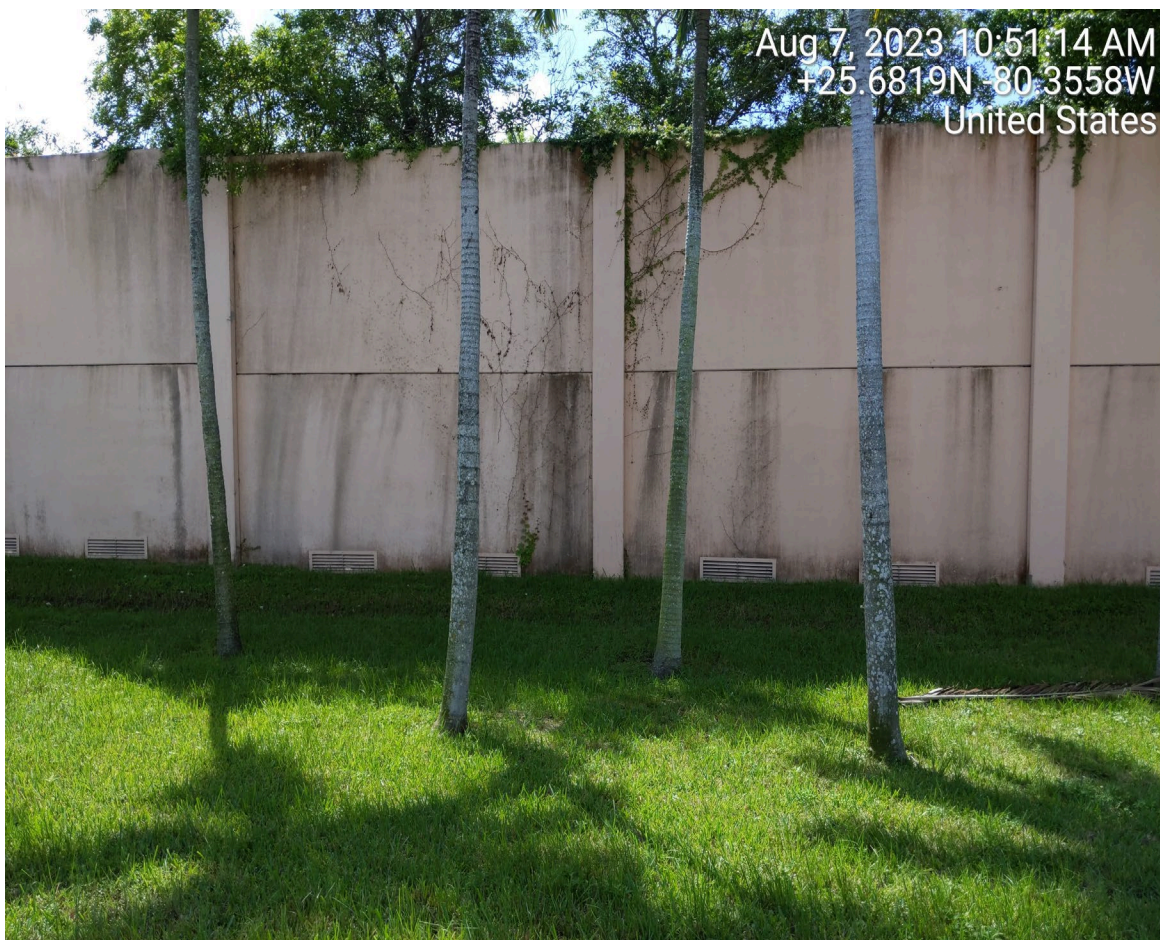
**ROADWAY INSPECTION  
LOCATION: MILE MARKER 3.2 MILES  
NORTHBOUND MAINLINE**

**DETERIORATED CLASS V COATING  
ON SOUND WALL**

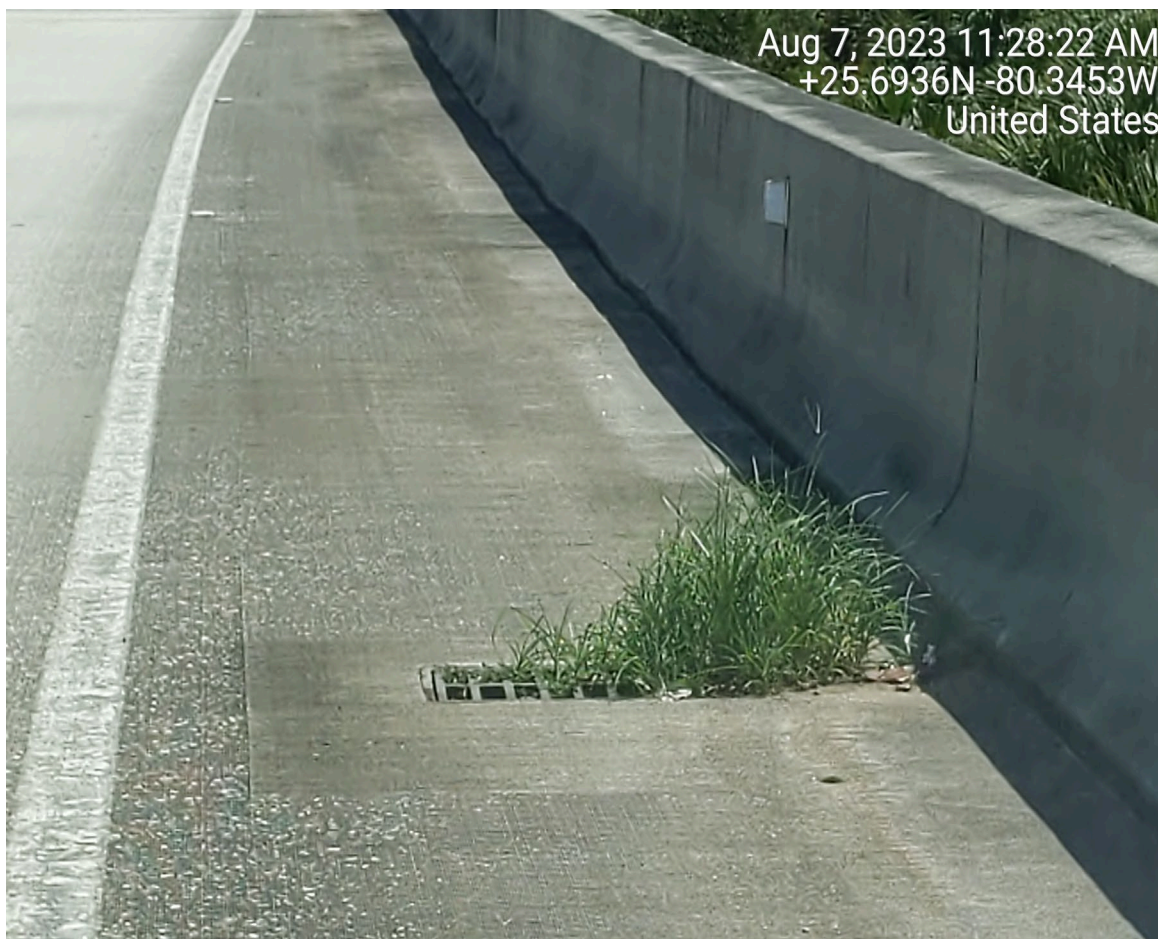
**ROADWAY INSPECTION  
LOCATION: MILE MARKER 4.0 MILES  
NORTHBOUND ON-RAMP FROM KENDALL DRIVE**

**SILTED DECK DRAINS (TYPICAL AT VARIOUS LOCATIONS)**

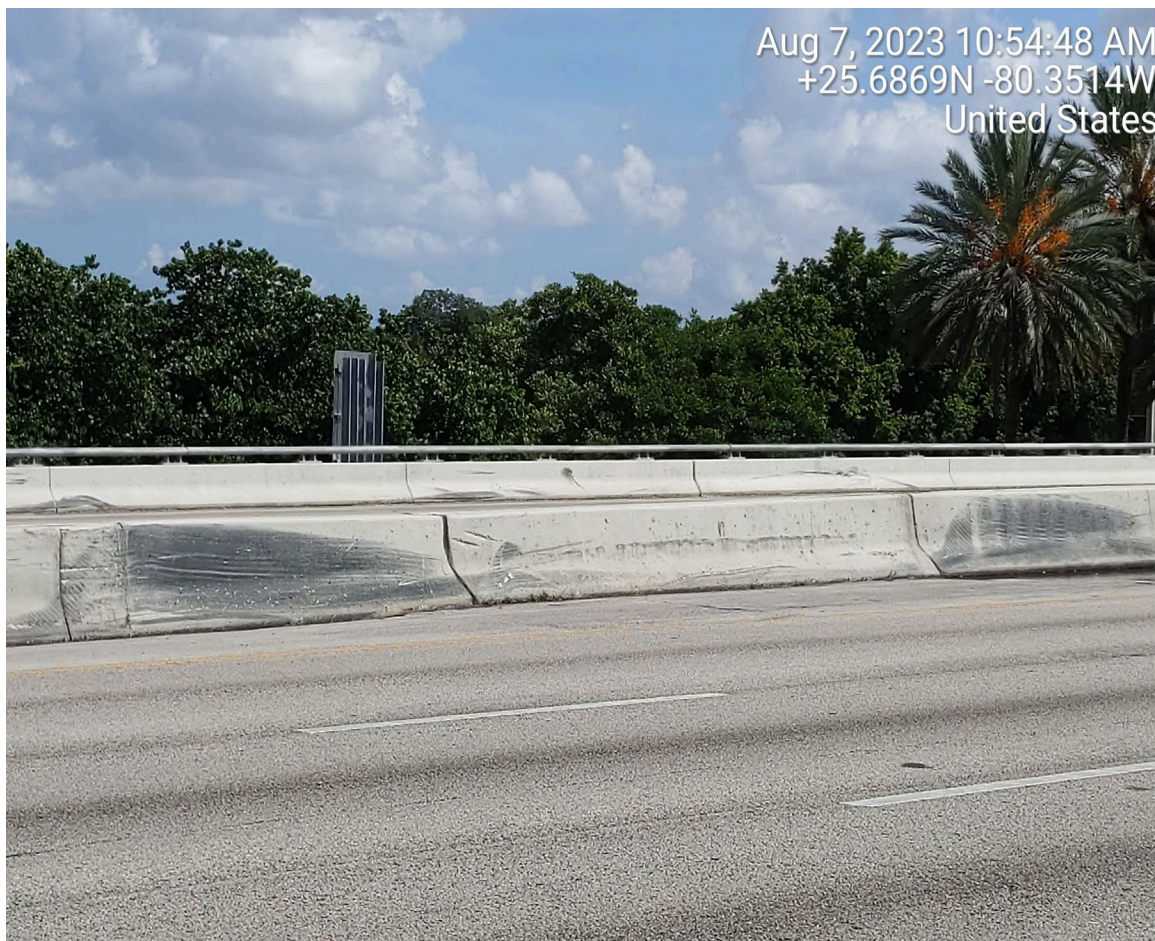
**ROADWAY INSPECTION  
LOCATION: MILE MARKER 3.6 MILES  
NORTHBOUND MAINLINE**

**SCUFF MARKS ON BARRIER WALL**

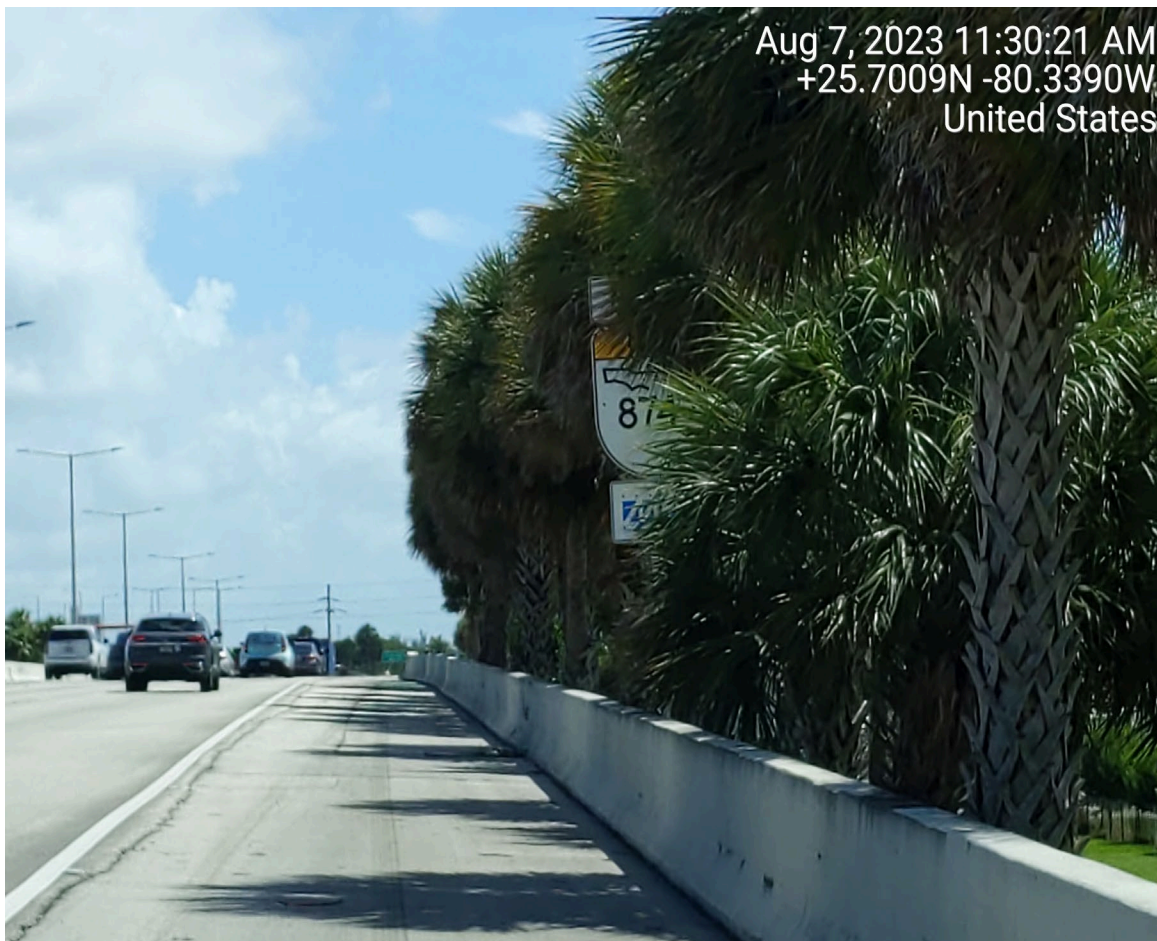
**ROADWAY INSPECTION  
LOCATION: MILE MARKER 4.6 MILES  
NORTHBOUND MAINLINE**

**OVERGROWN VEGETATION OBSTRUCTING SIGN**

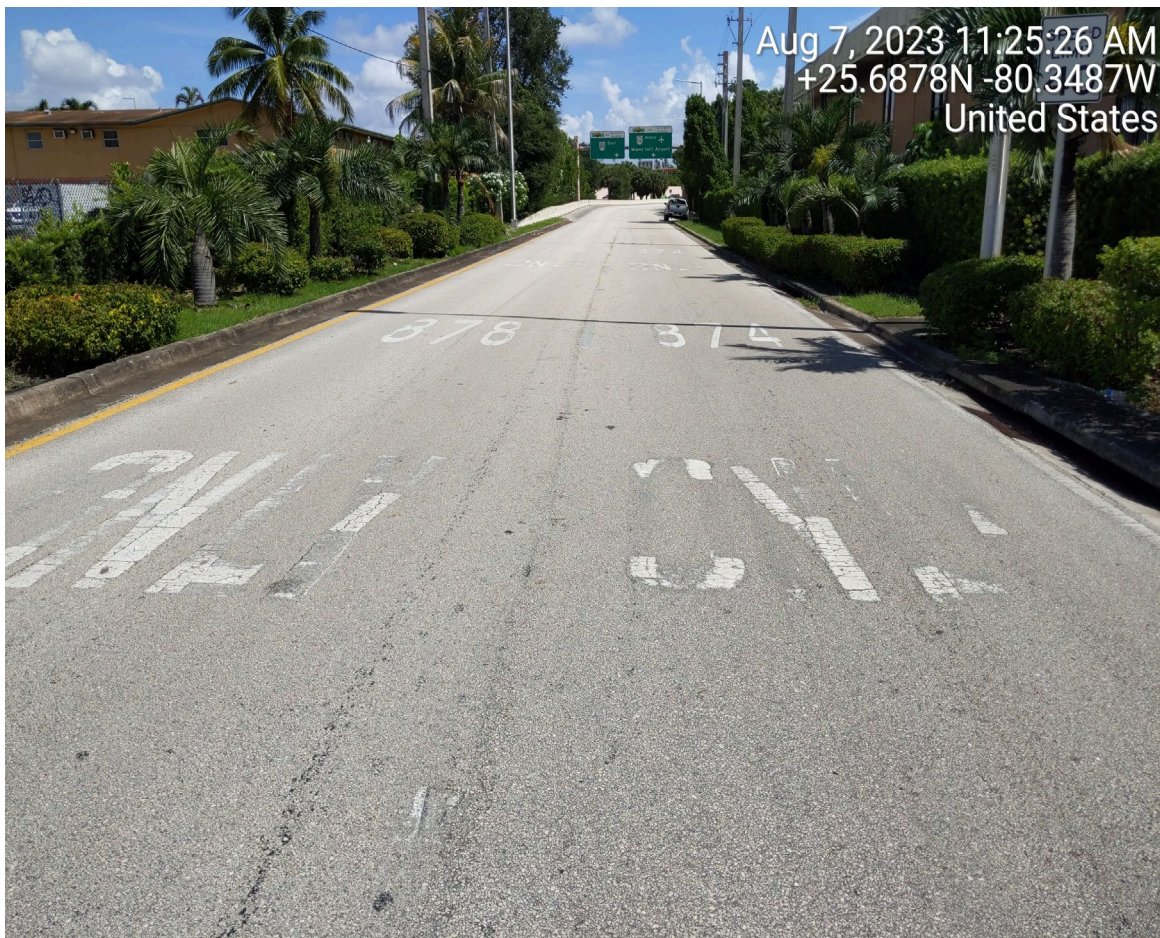
**ROADWAY INSPECTION  
LOCATION: MILE MARKER 3.9 MILES  
NORTHBOUND MAINLINE**

**DETERIORATED STRIPING / PAVEMENT MESSAGE**

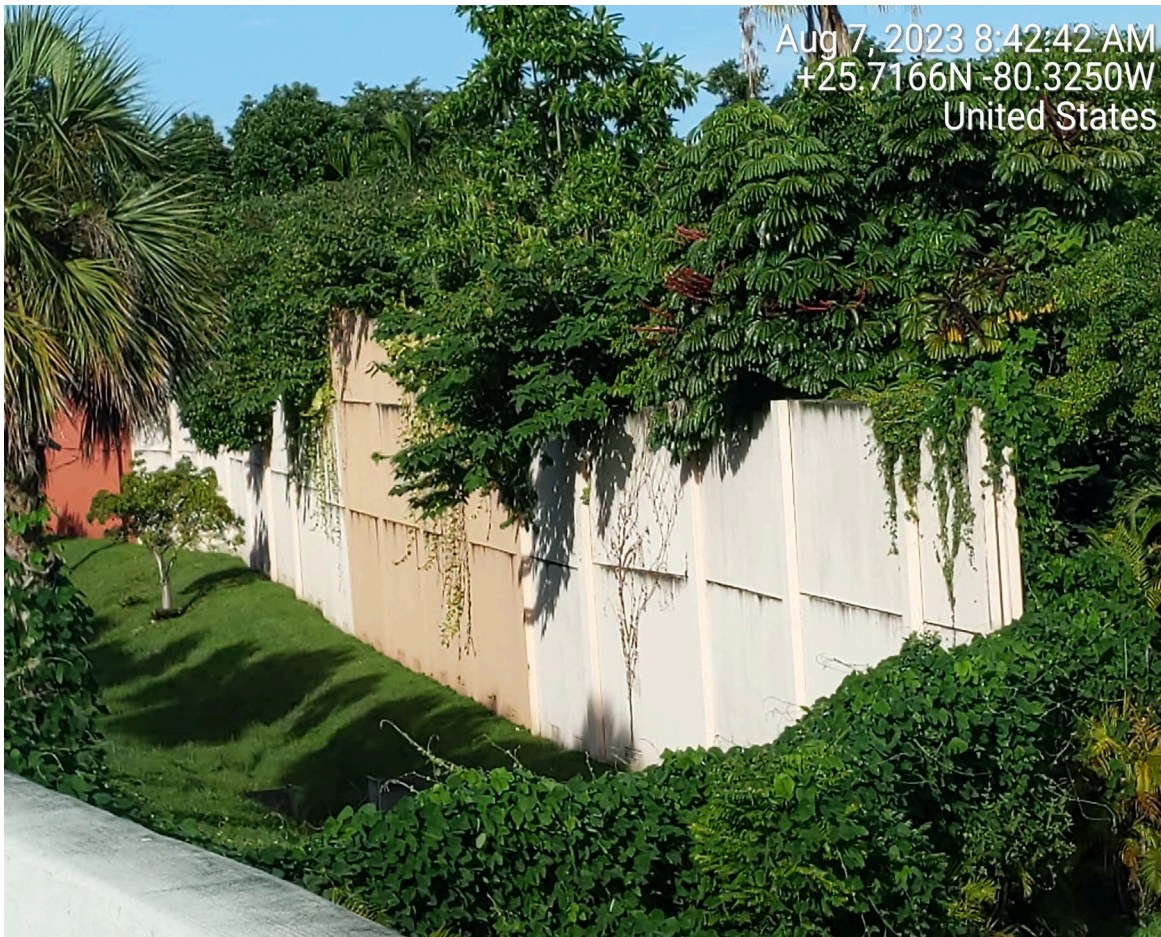
**ROADWAY INSPECTION  
LOCATION: MILE MARKER 6.2 MILES  
SOUTHBOUND MAINLINE**

**OVERGROWN VEGETATION ON SOUND WALL  
(TYPICAL AT VARIOUS LOCATIONS)**

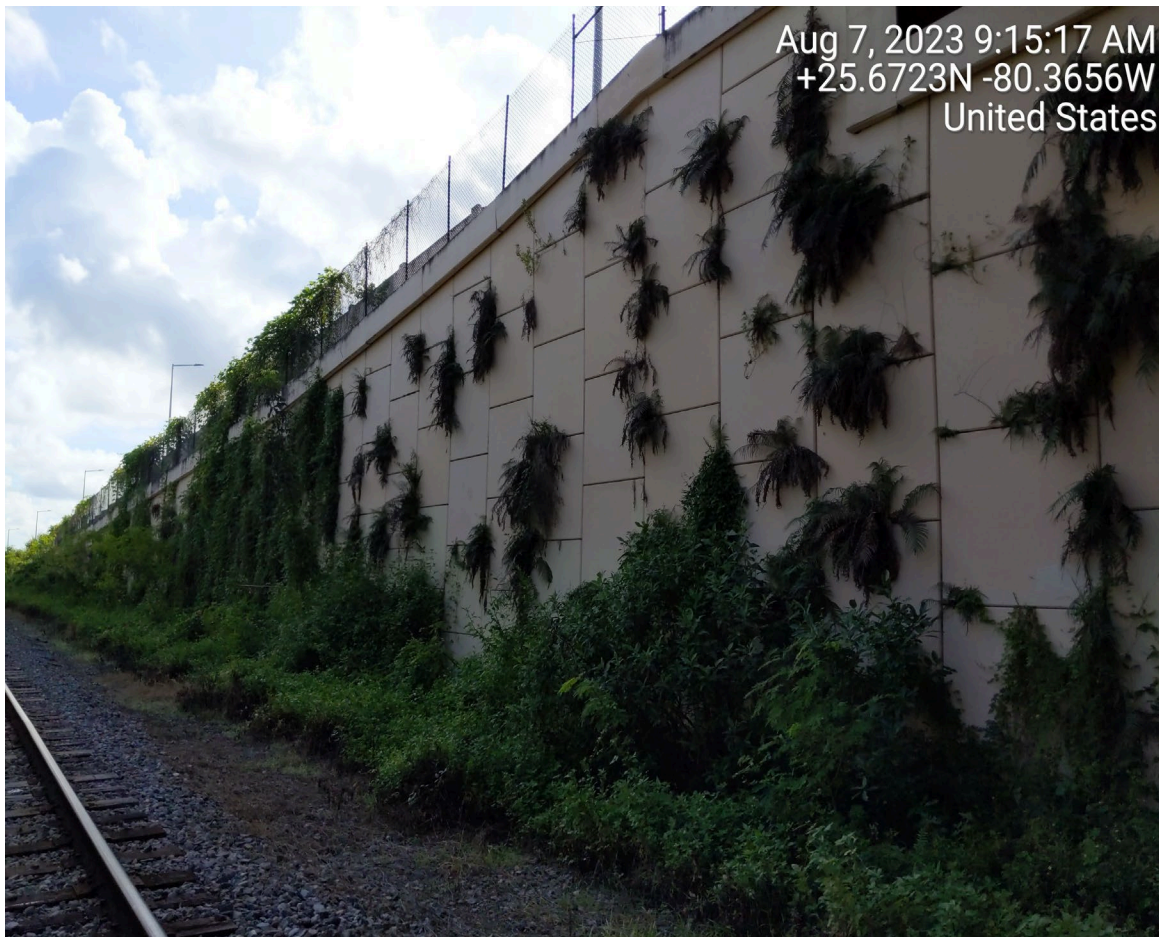
**ROADWAY INSPECTION  
LOCATION: MILE MARKER 2.3 MILES  
SOUTHBOUND OFF RAMP TO KILLIAN PKWY. WEST.**

**OVERGROWN VEGETATION ON MSE WALL**

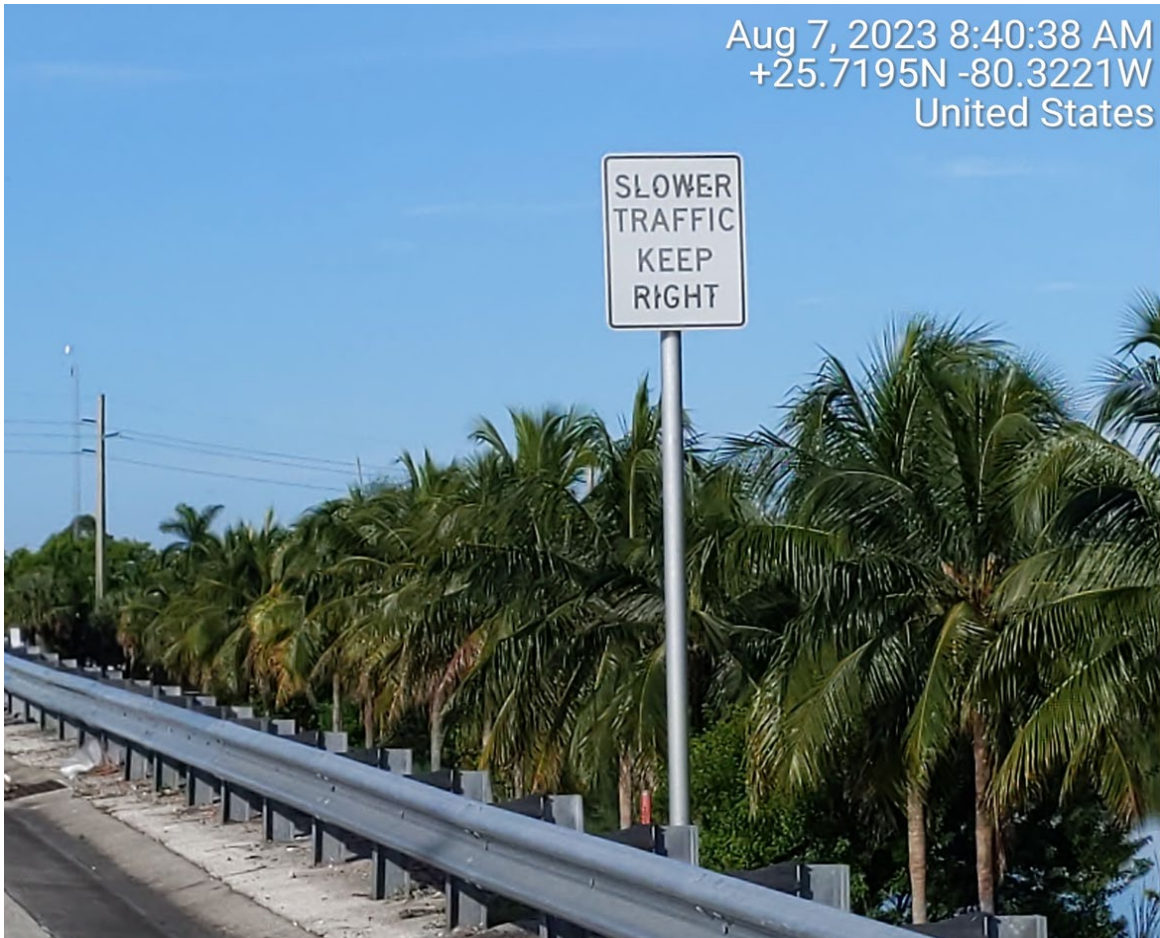
**ROADWAY INSPECTION  
LOCATION: MILE MARKER 6.6 MILES  
SOUTHBOUND MAINLINE.**

**DETERIORATED REFLECTIVE SHEETING**

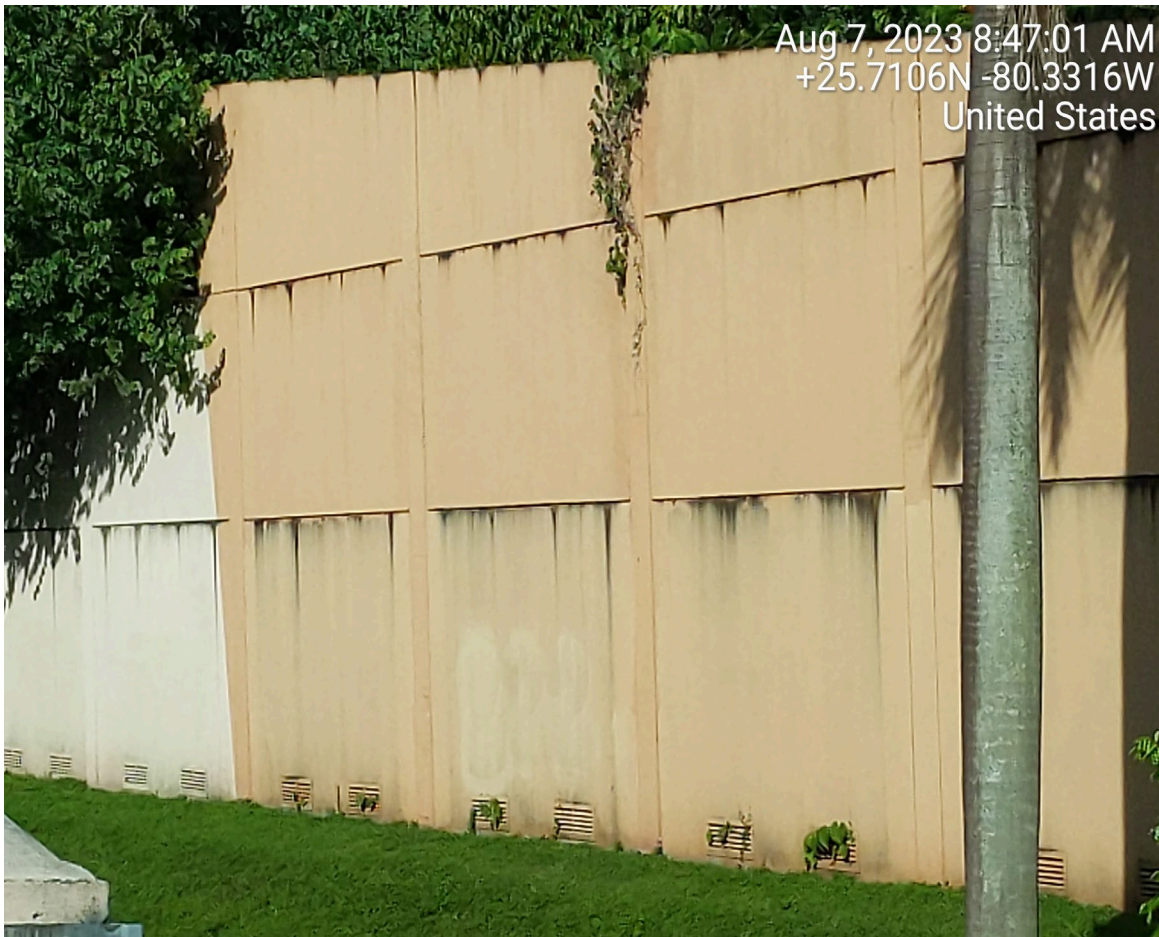
**ROADWAY INSPECTION  
LOCATION: MILE MARKER 6.0 MILES  
SOUTHBOUND MAINLINE**

**DETERIORATED CLASS V COATING ON SOUND WALL  
(TYPICAL AT VARIOUS LOCATIONS)**
