# ANNUAL INSPECTION REPORT 2023

## ANNUAL INSPECTION REPORT

In July 1, 2023, the Greater Miami Expressway Agency (GMX) acquired operational and financial control of five expressways in Miami-Dade County. This group of expressways, toll facilities, acquisition parcels and the GMX headquarters facility, all as described below, are hereinafter referred to as one of the "GMX System". In accordance with the Trust Indenture requirements, GMX retained EAC Consulting, Inc. (EAC), as the General Engineering Consultant to perform, among other duties assigned by the Agency, the yearly inspection of the GMX System. This report represents the annual inspection results for Fiscal Year (FY) 2023.

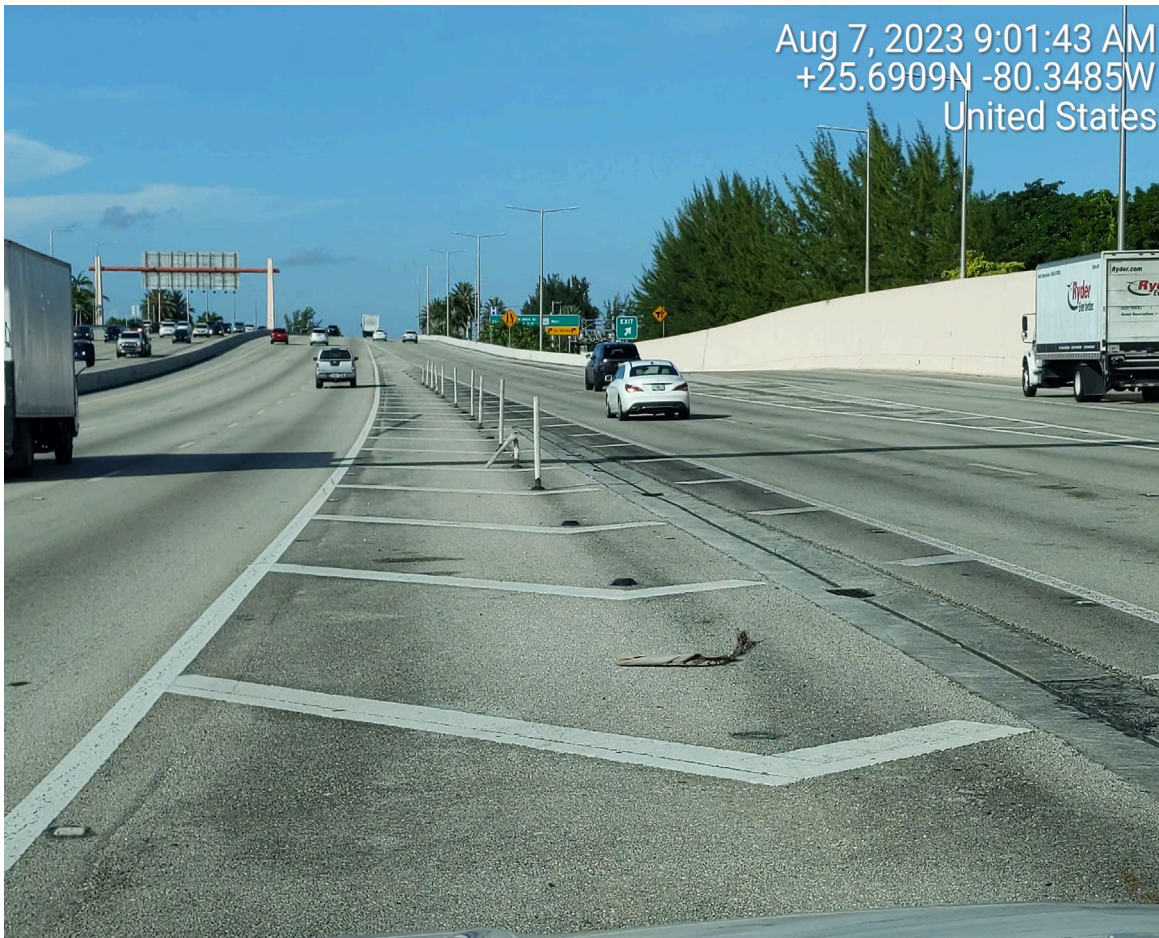
**ROADWAY INSPECTION  
LOCATION: MILE MARKER 4.0 MILES  
SOUTHBOUND MAINLINE**

**MISSING DELINIATORS**

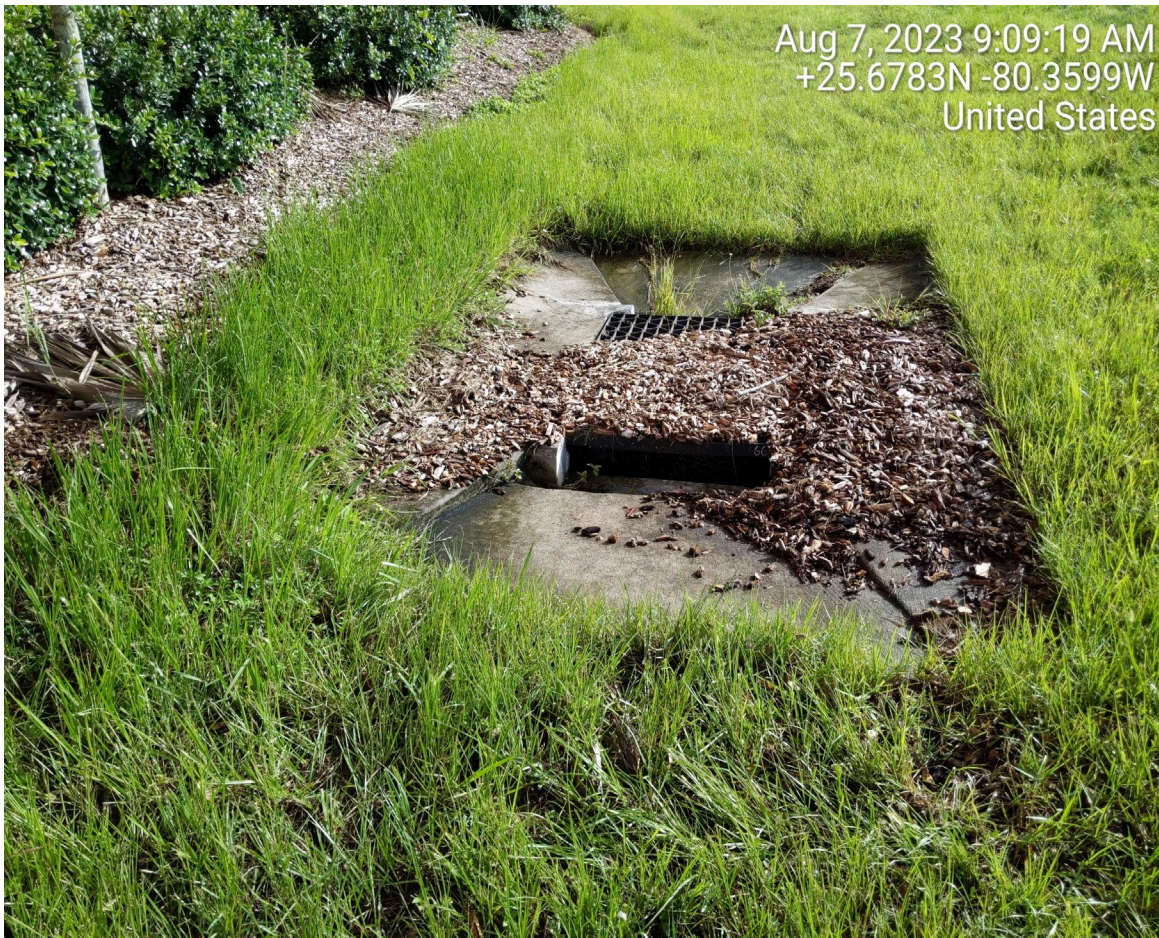
**ROADWAY INSPECTION  
LOCATION: MILE MARKER 3.2 MILES  
SOUTHBOUND MAINLINE**

**MULCH OBSTRUCTING STORM DRAIN**

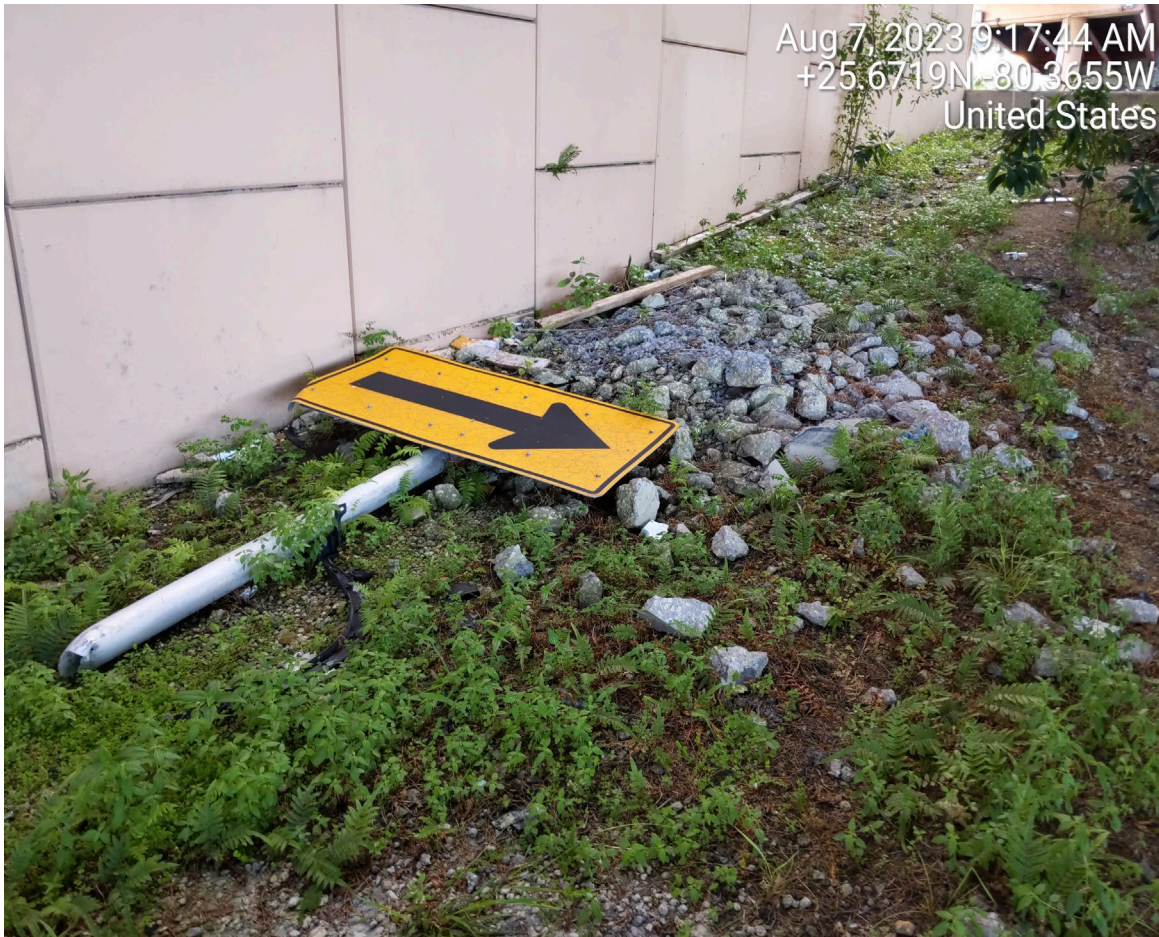
**ROADWAY INSPECTION  
LOCATION: MILE MARKER 3.1 MILES  
SOUTHBOUND MAINLINE**

**ABANDONED DAMAGED SIGN / CONCRETE DEBRIS**

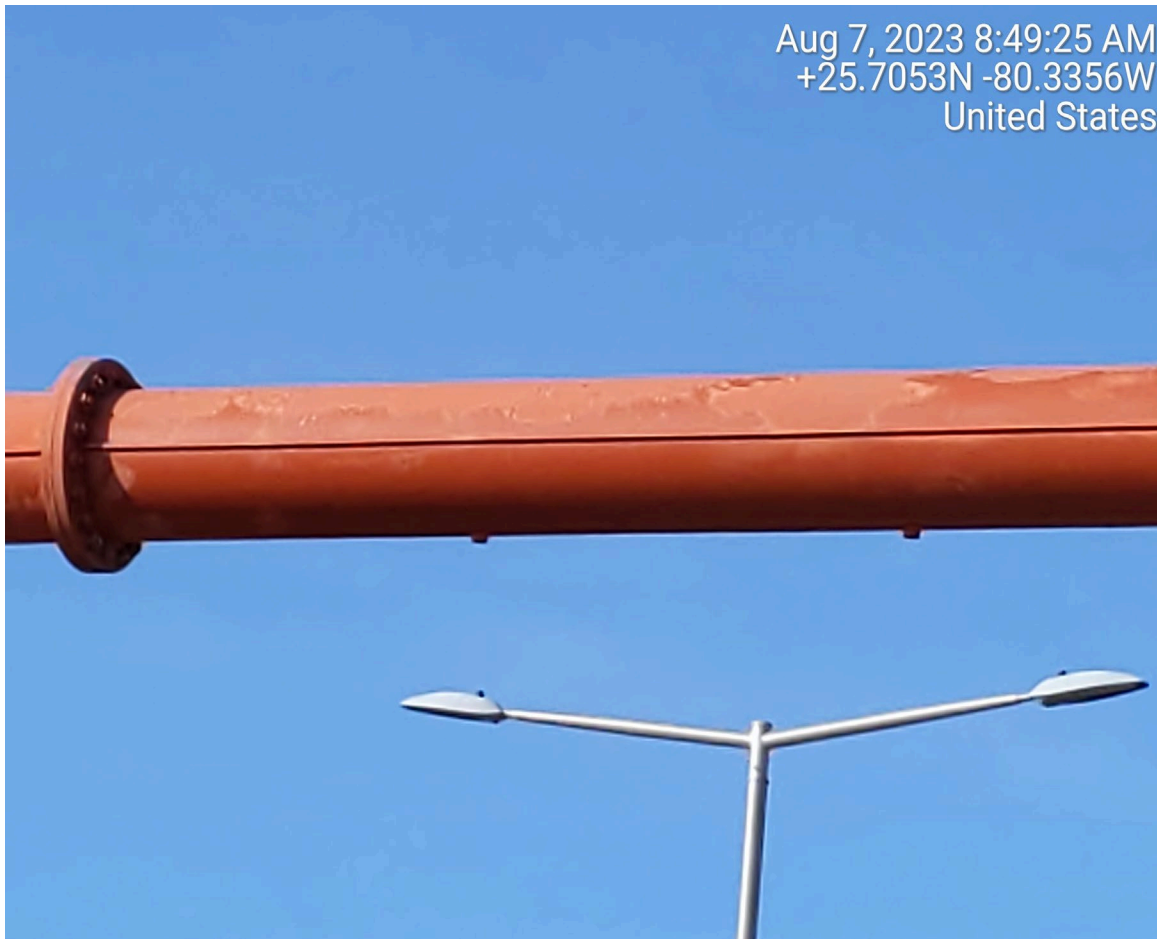
**ROADWAY INSPECTION  
LOCATION: MILE MARKER 5.2 MILES  
SOUTHBOUND MAINLINE**

**DETERIORATED PAINT ON MONOTUBE (STRUCTURE # 87A131)**

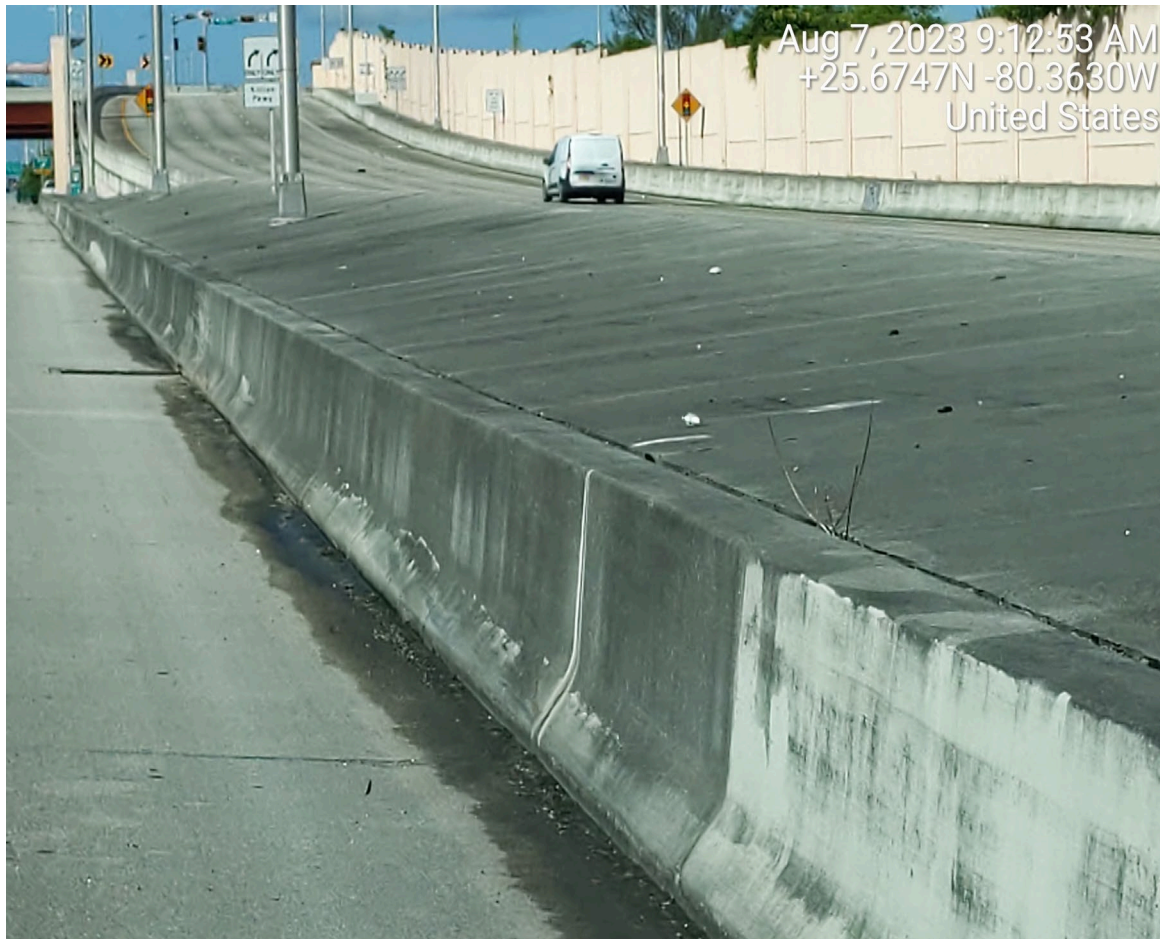
**ROADWAY INSPECTION  
LOCATION: MILE MARKERS 2.32 TO 2.42 MILES  
SOUTHBOUND MAINLINE**

**DETERIORATED CLASS V COATING ON TRAFFIC SEPARATOR AND  
BARRIER WALL**

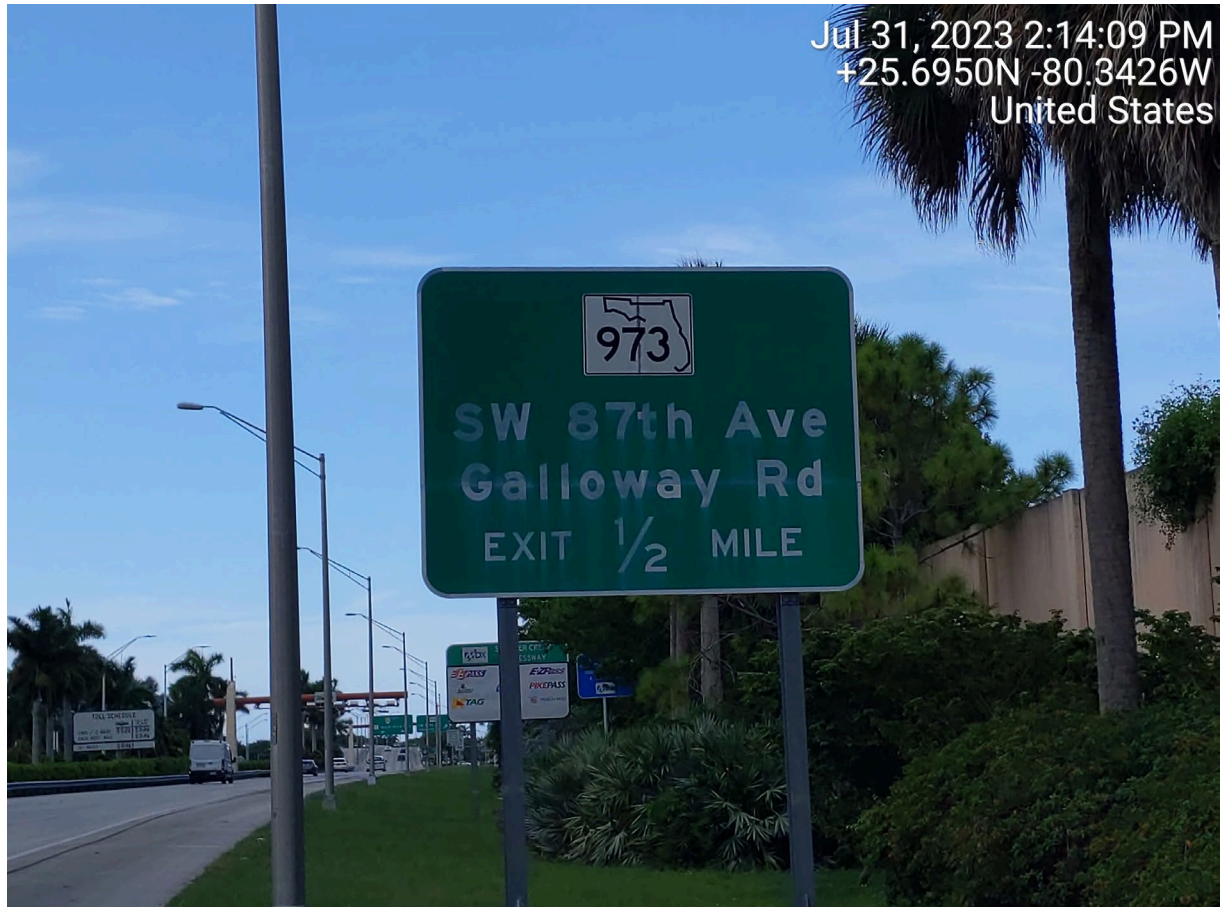
**ROADWAY INSPECTION  
LOCATION: MILE MARKER 0.65 MILES  
EASTBOUND MAINLINE**

**DETERIORATED REFLECTIVE SHEETING**

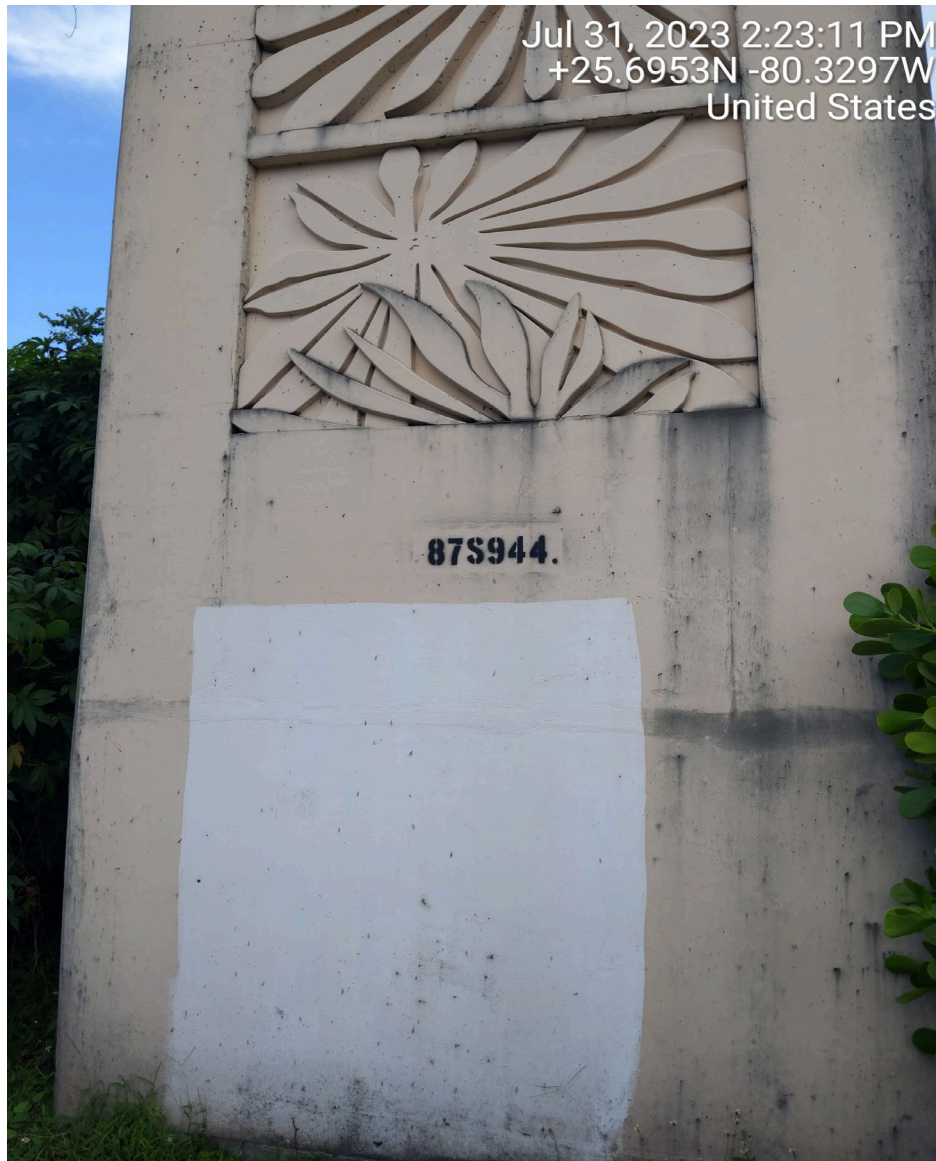
**ROADWAY INSPECTION  
LOCATION: MILE MARKER 1.4 MILES  
EASTBOUND MAINLINE**

**DETERIORATED CLASS V COATING ON STRUCTURE UPRIGHT**

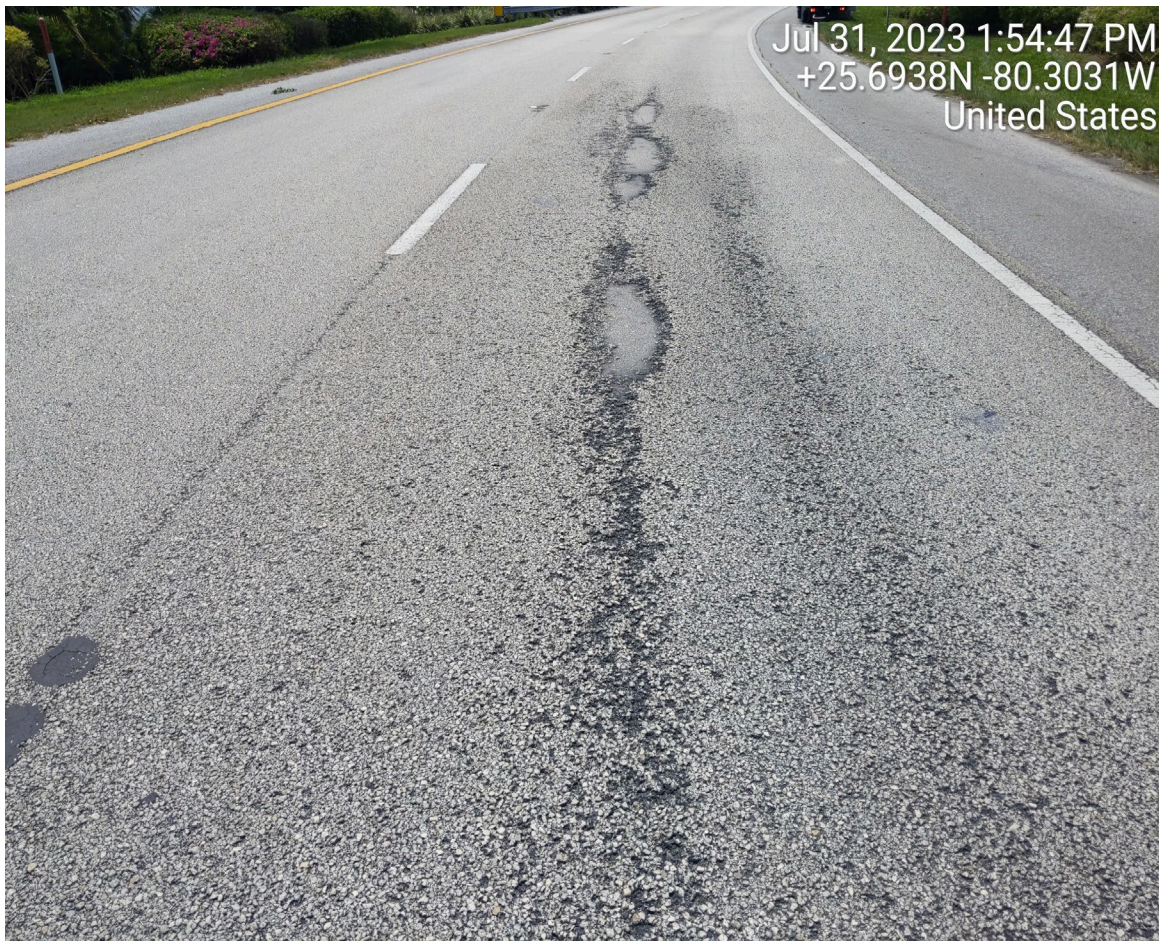
**ROADWAY INSPECTION  
LOCATION: MILE MARKER 3.2 MILES  
WESTBOUND MAINLINE**

**DETERIORATED PAVEMENT**

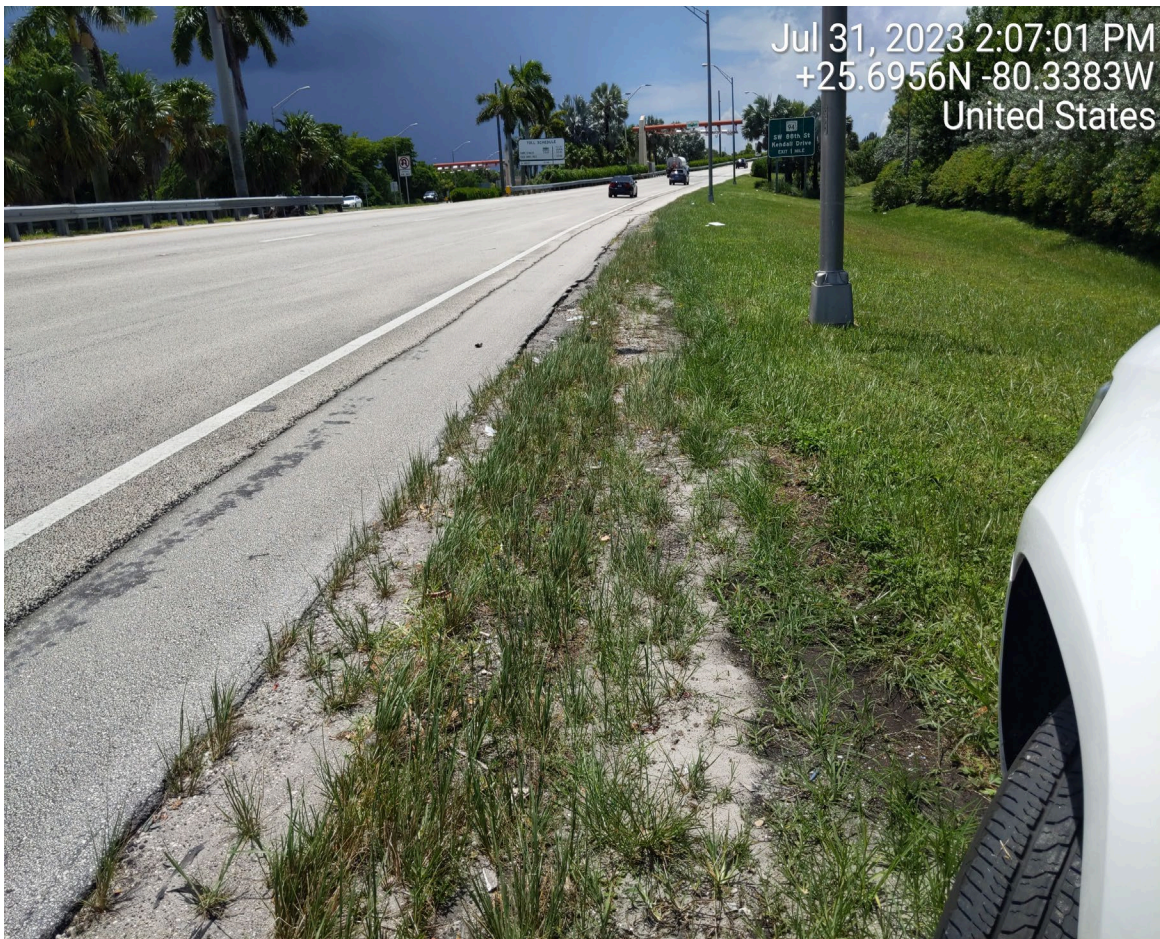
**ROADWAY INSPECTION  
LOCATION: MILE MARKER 1.0 MILES  
WESTBOUND MAINLINE**

**MISSING TURF & SHOULDER DROP OFF**

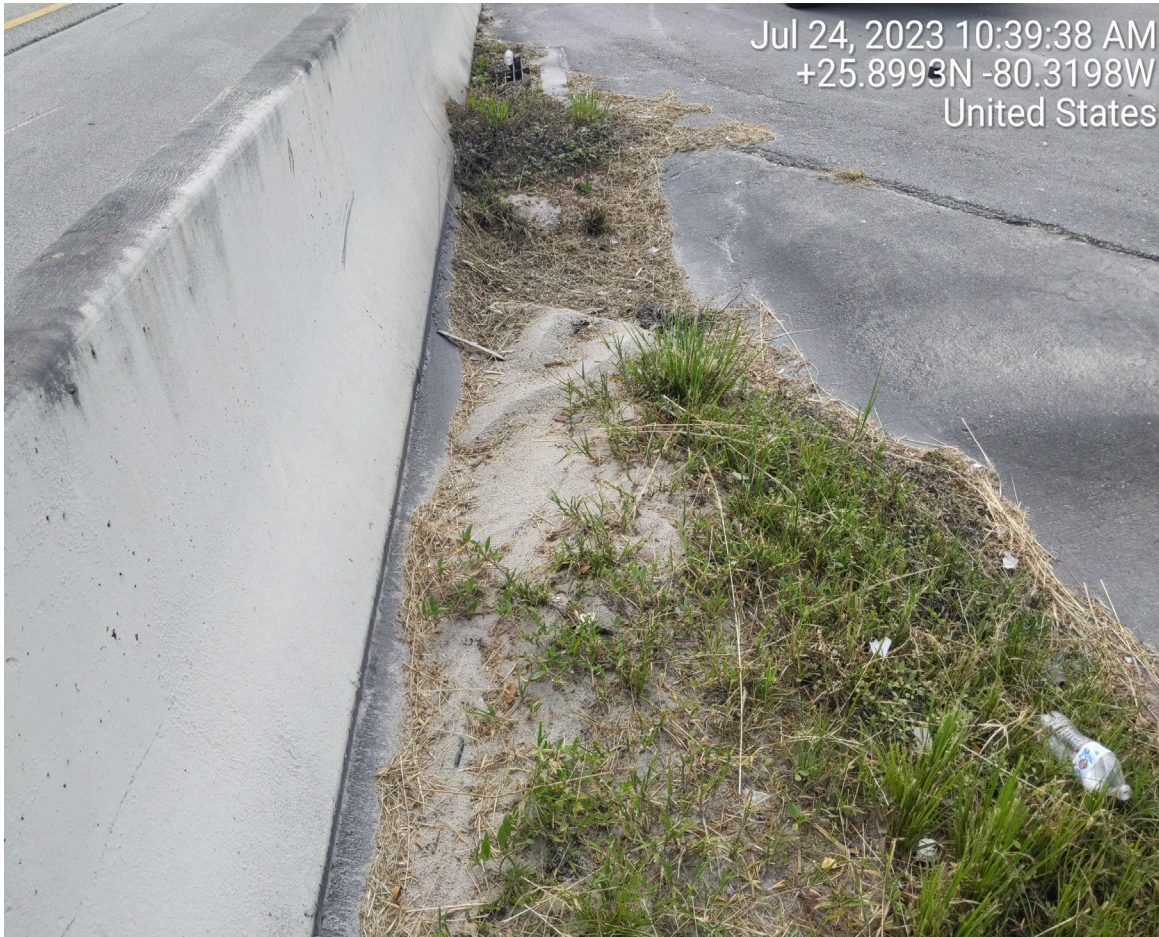
**ROADWAY INSPECTION  
LOCATION: MILE MARKER 0.26  
EASTBOUND MAINLINE (LEFT SHOULDER)**

**SEDIMENT OBSTRUCTING FLOW ON CONCRETE PLUME**

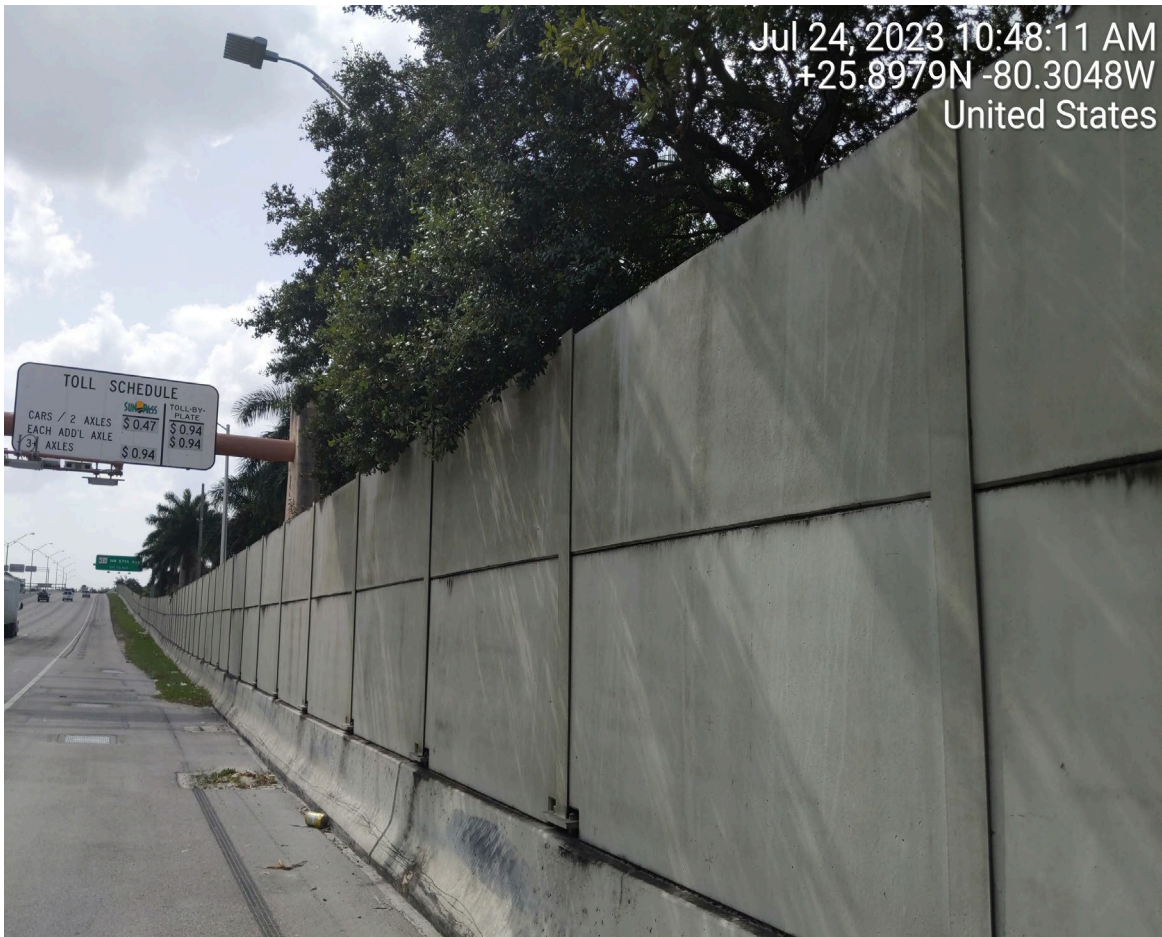
**ROADWAY INSPECTION  
LOCATION: MILE MARKER 1.20 MILES  
EASTBOUND MAINLINE**

**OVERGROWN VEGETATION ON SOUND WALL**

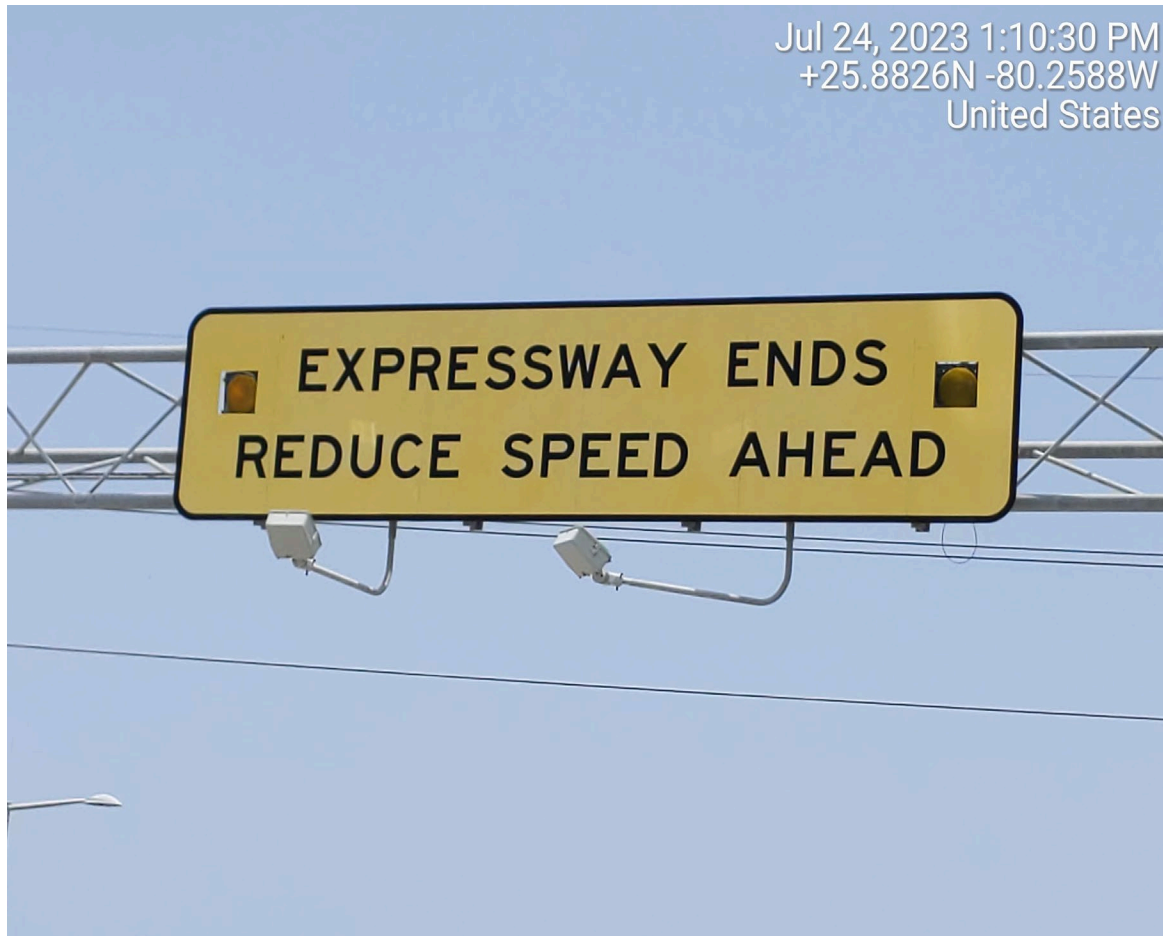
**ROADWAY INSPECTION  
LOCATION: MILE MARKER 4.4 MILES  
EASTBOUND MAINLINE**

**TEWISTED LUMINAIRE (STRUCTURE # 87S528)**

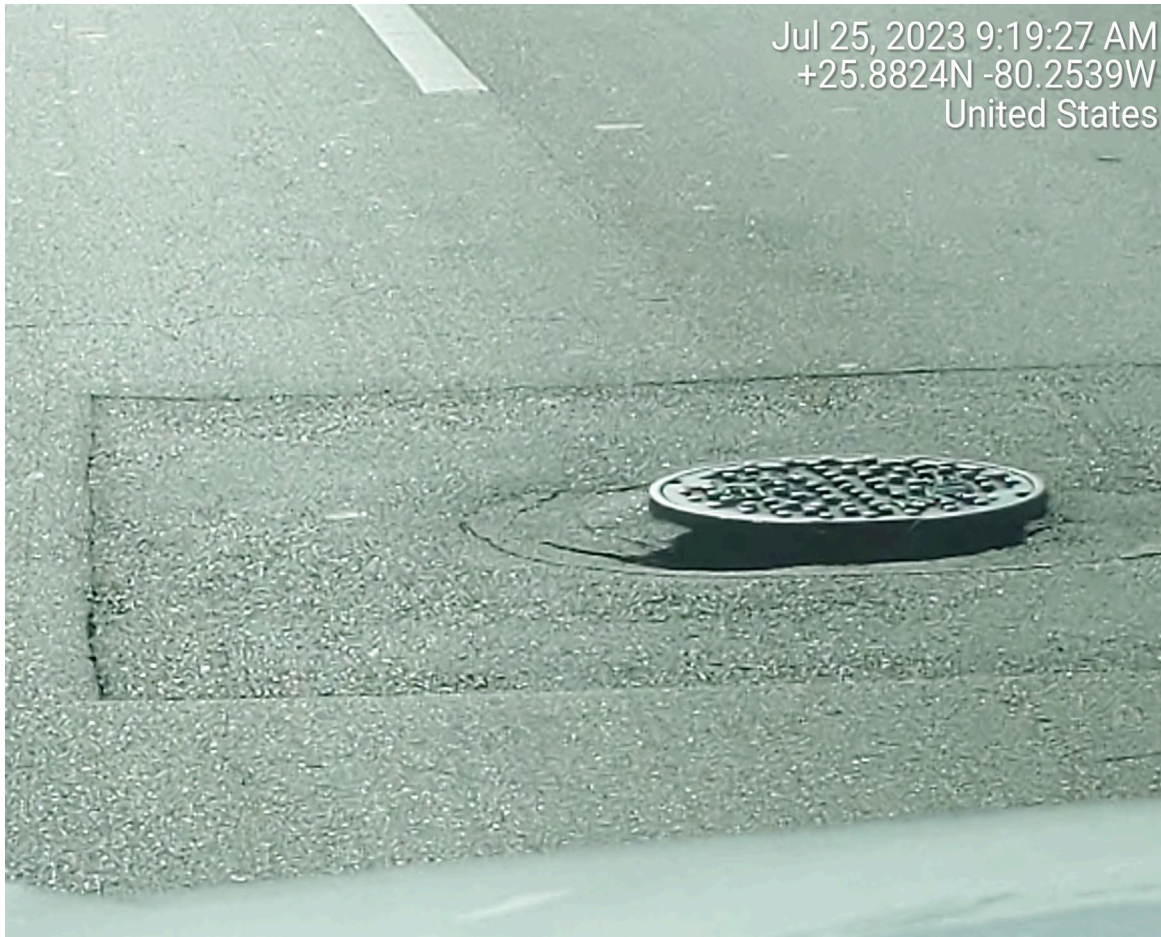
**ROADWAY INSPECTION  
LOCATION: MILE MARKER 4.66 MILES  
EASTBOUND MAINLINE (OUTSIDE LANE)**

**DAMAGED MANHOLE AND DETERIORATED PAVEMENT**

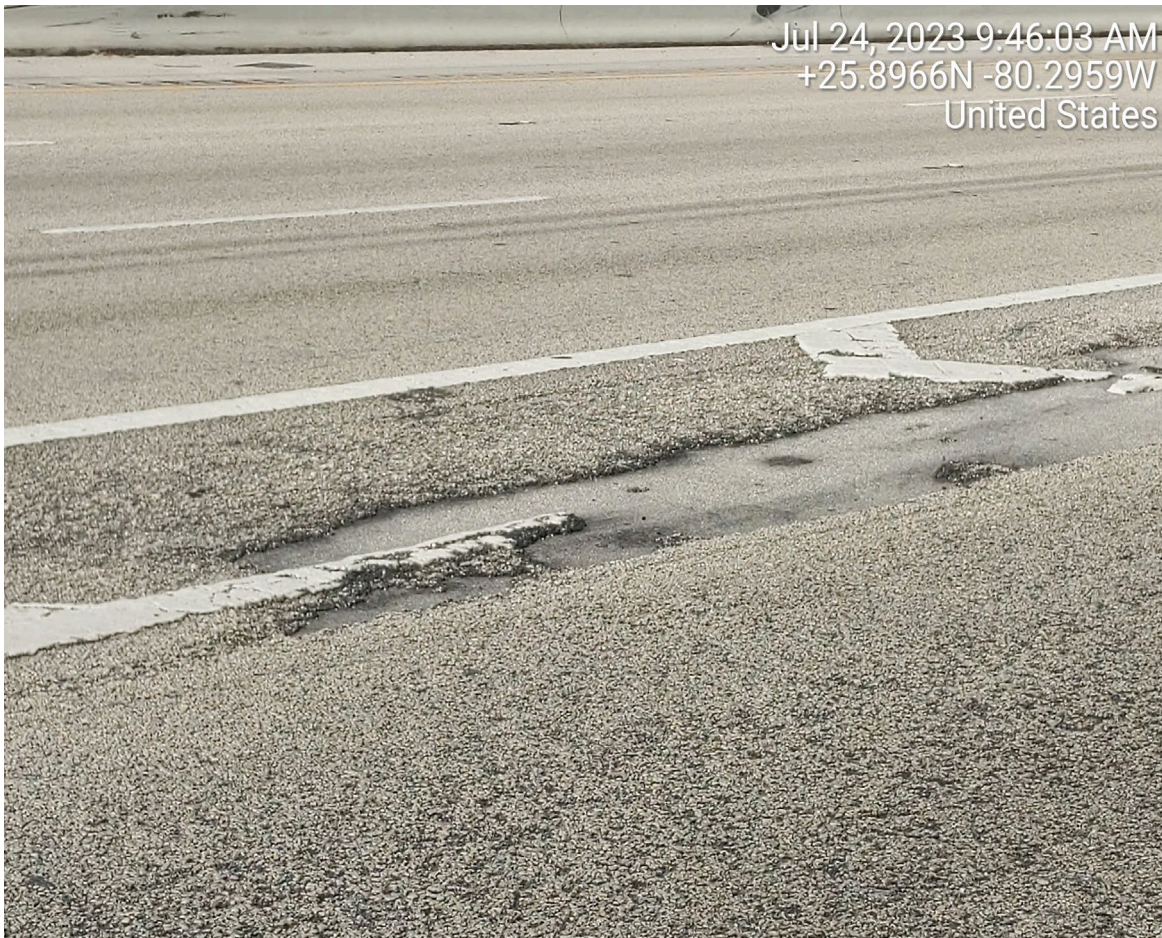
**ROADWAY INSPECTION  
LOCATION: MILE MARKER 1.8 MILES  
WESTBOUND MAINLINE**

**DETERIORATED ASPHALT PAVEMENT**

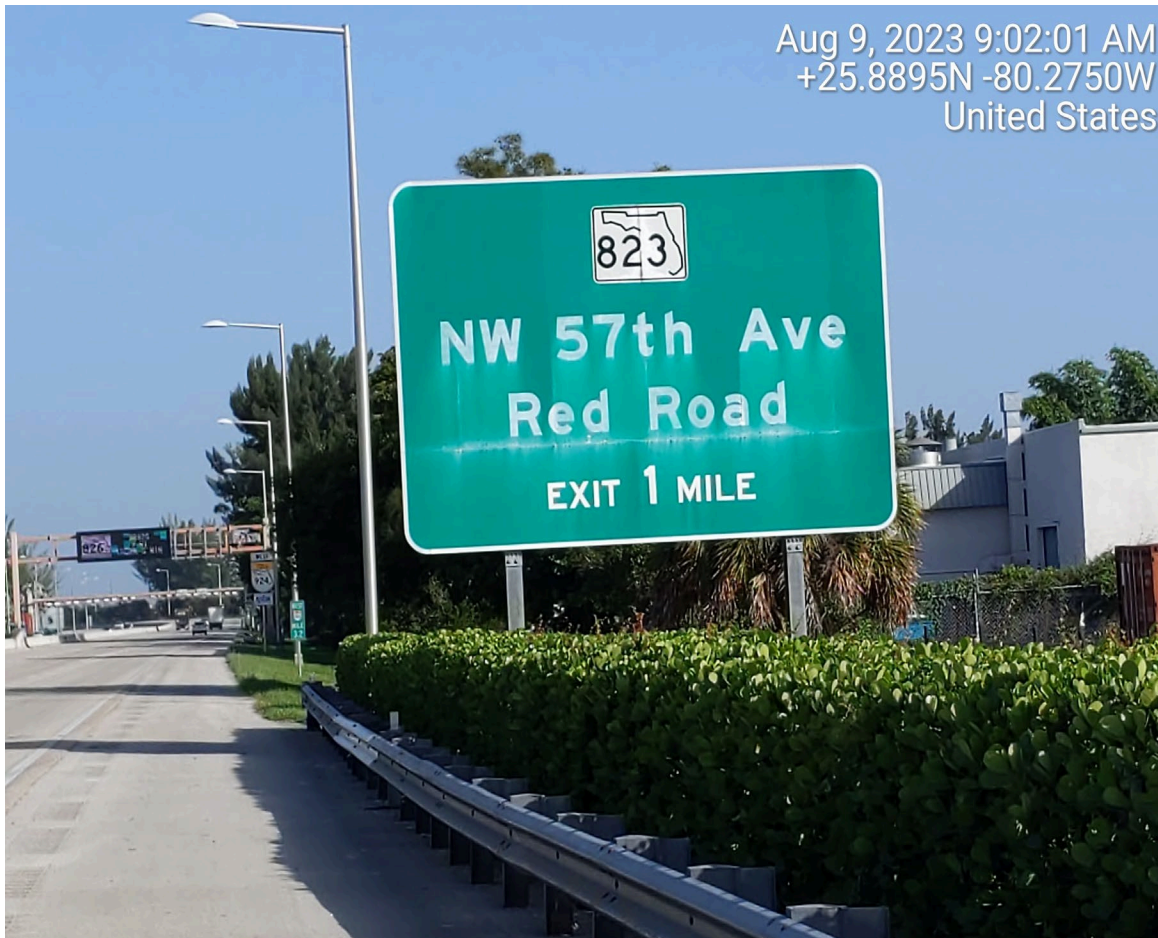
**ROADWAY INSPECTION  
LOCATION: MILE MARKER 3.02 MILES  
WESTBOUND MAINLINE**

**DETERIORATED REFLECTIVE SHEETING**

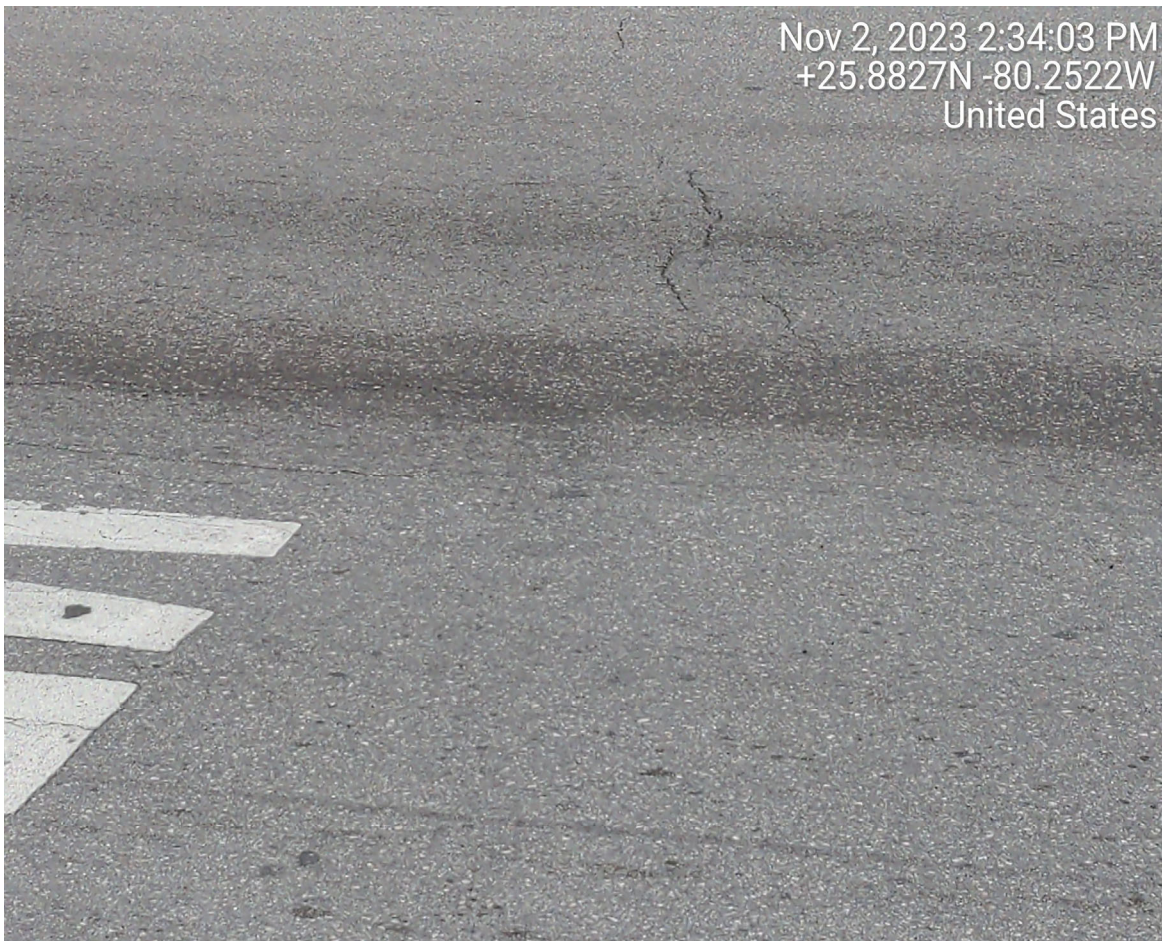
**ROADWAY INSPECTION  
LOCATION: MILE MARKER 4.8 MILES  
WESTBOUND MAINLINE**

**PAVEMENT SETTLEMENT AT PIPE CROSSING**

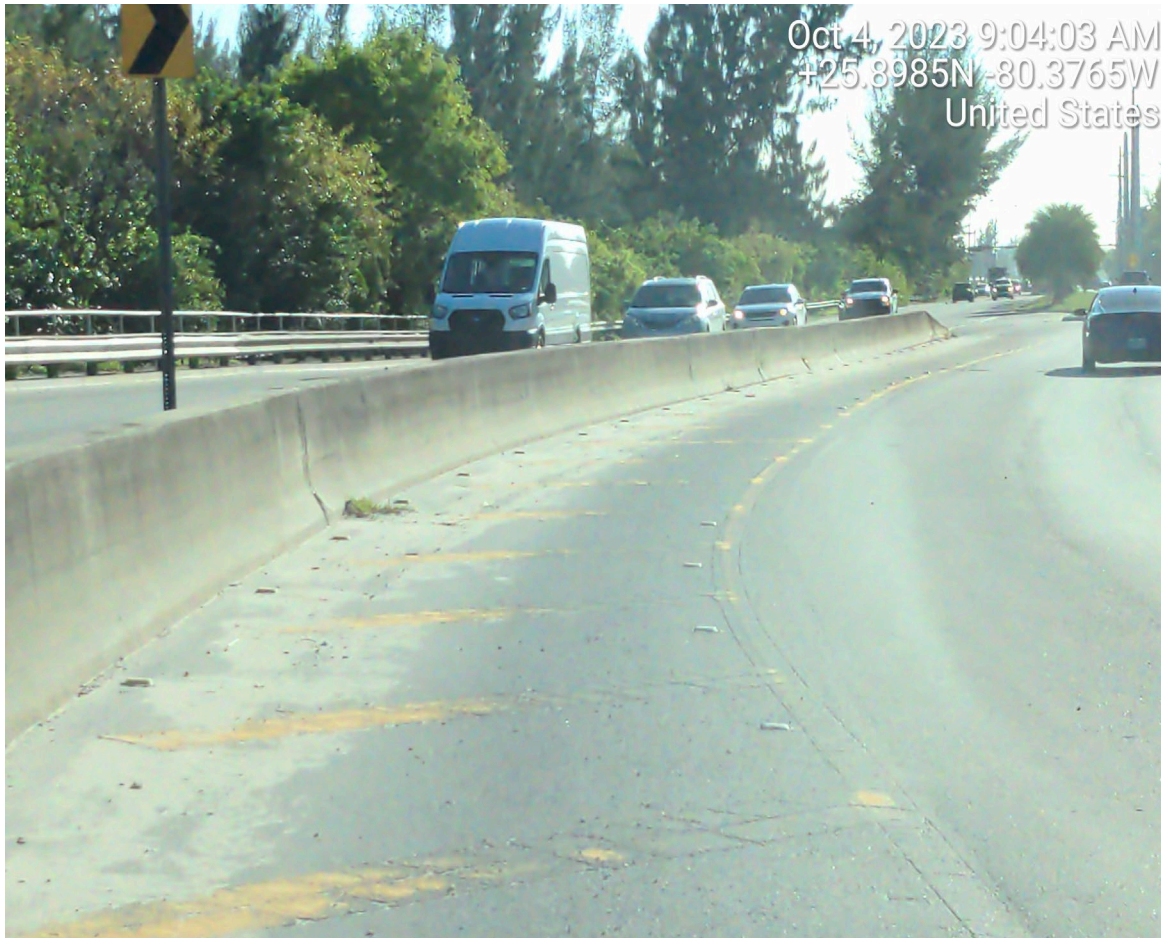
**ROADWAY INSPECTION  
LOCATION: EASTBOUND NW 138<sup>TH</sup> STREET  
800 FEET NORTH OF FRONTAGE ROAD**

**DETERIORATED STRIPING**

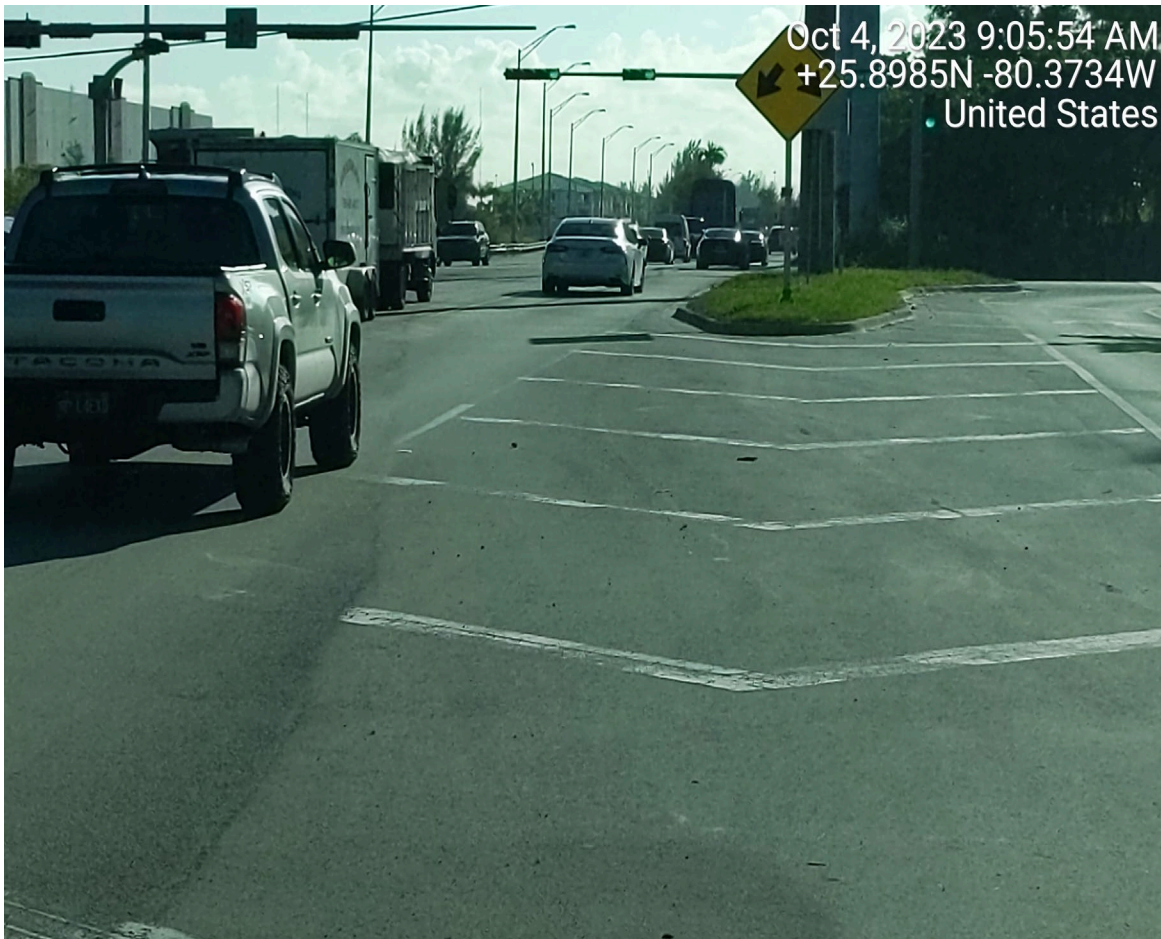
**ROADWAY INSPECTION  
LOCATION: EASTBOUND NW 138<sup>TH</sup> ST  
AT NW 107<sup>TH</sup> AVENUE.**

**DETERIORATED STRIPING ON MAINLINE AND GORE**

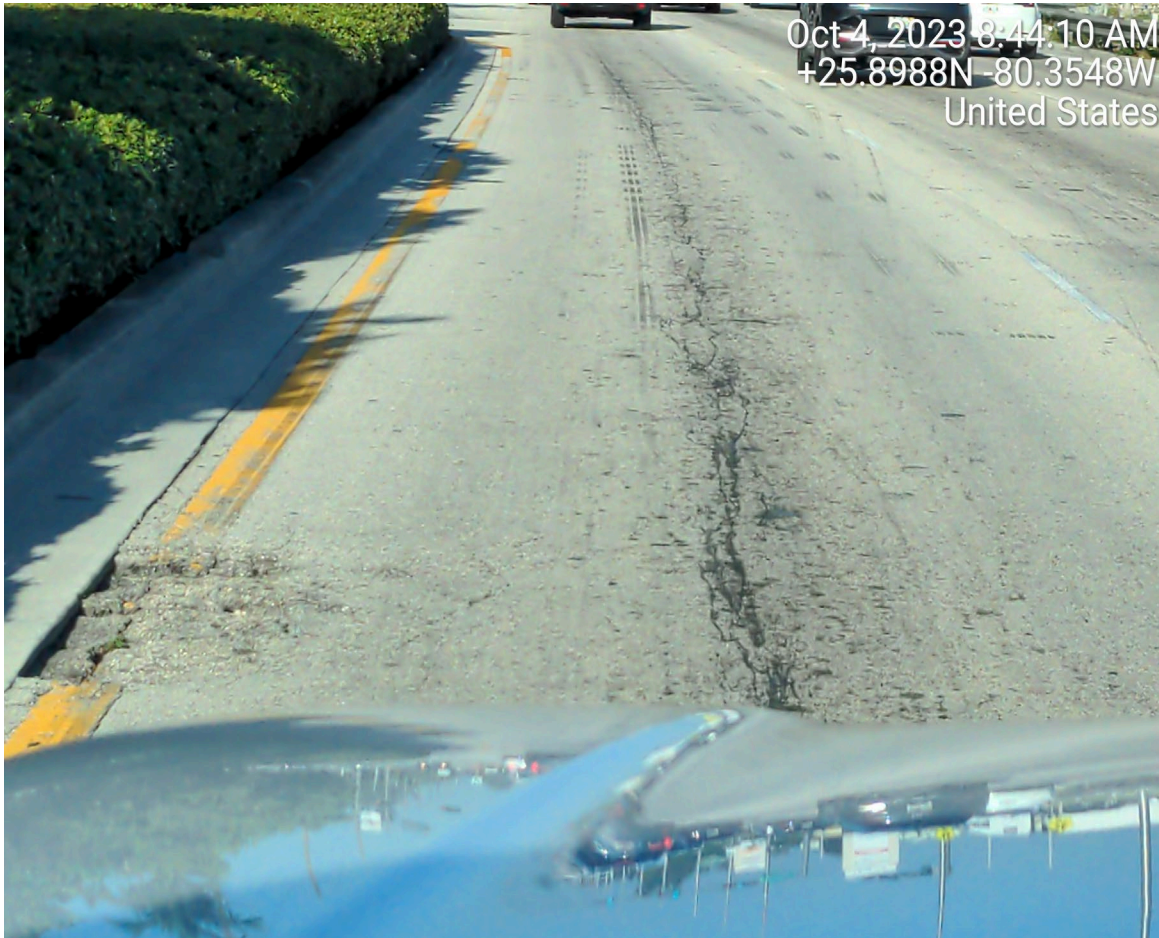
**ROADWAY INSPECTION  
LOCATION: WESTBOUND NW 138<sup>th</sup> STREET  
300 FT EAST OF NW 97<sup>th</sup> AVENUE**

**POTHOLE ON INSIDE LANE AND DETERIORATED STRIPING**

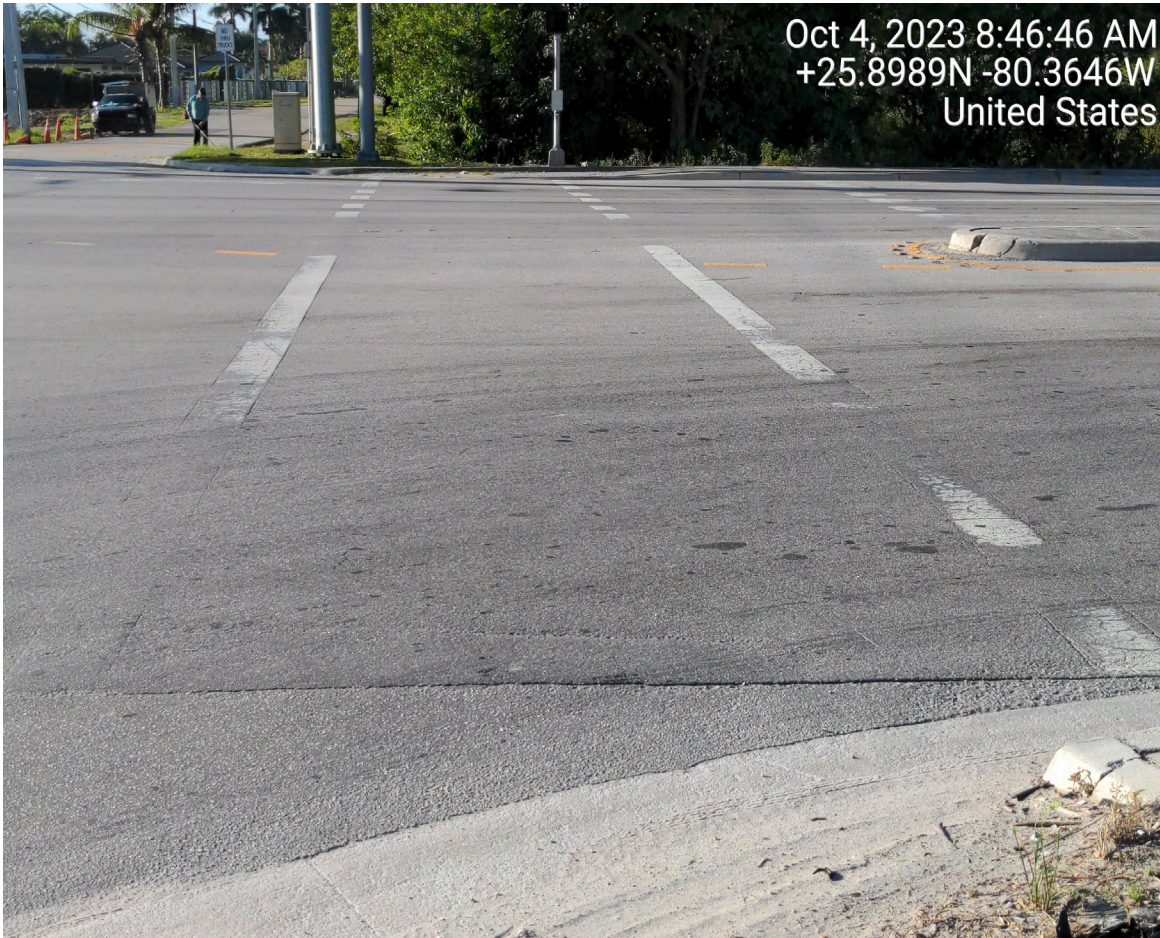
**ROADWAY INSPECTION  
LOCATION: WESTBOUND NW 138<sup>th</sup> STREET  
AT NW 97<sup>TH</sup> AVENUE.**

**DETERIORATED STOP BAR AND PEDESTRIAN CROSSWALK STRIPING  
(TYPICAL AT VARIOUS LOCATIONS)**
