# ANNUAL INSPECTION REPORT 2023

## ANNUAL INSPECTION REPORT

In July 1, 2023, the Greater Miami Expressway Agency (GMX) acquired operational and financial control of five expressways in Miami-Dade County. This group of expressways, toll facilities, acquisition parcels and the GMX headquarters facility, all as described below, are hereinafter referred to as one of the "GMX System". In accordance with the Trust Indenture requirements, GMX retained EAC Consulting, Inc. (EAC), as the General Engineering Consultant to perform, among other duties assigned by the Agency, the yearly inspection of the GMX System. This report represents the annual inspection results for Fiscal Year (FY) 2023.

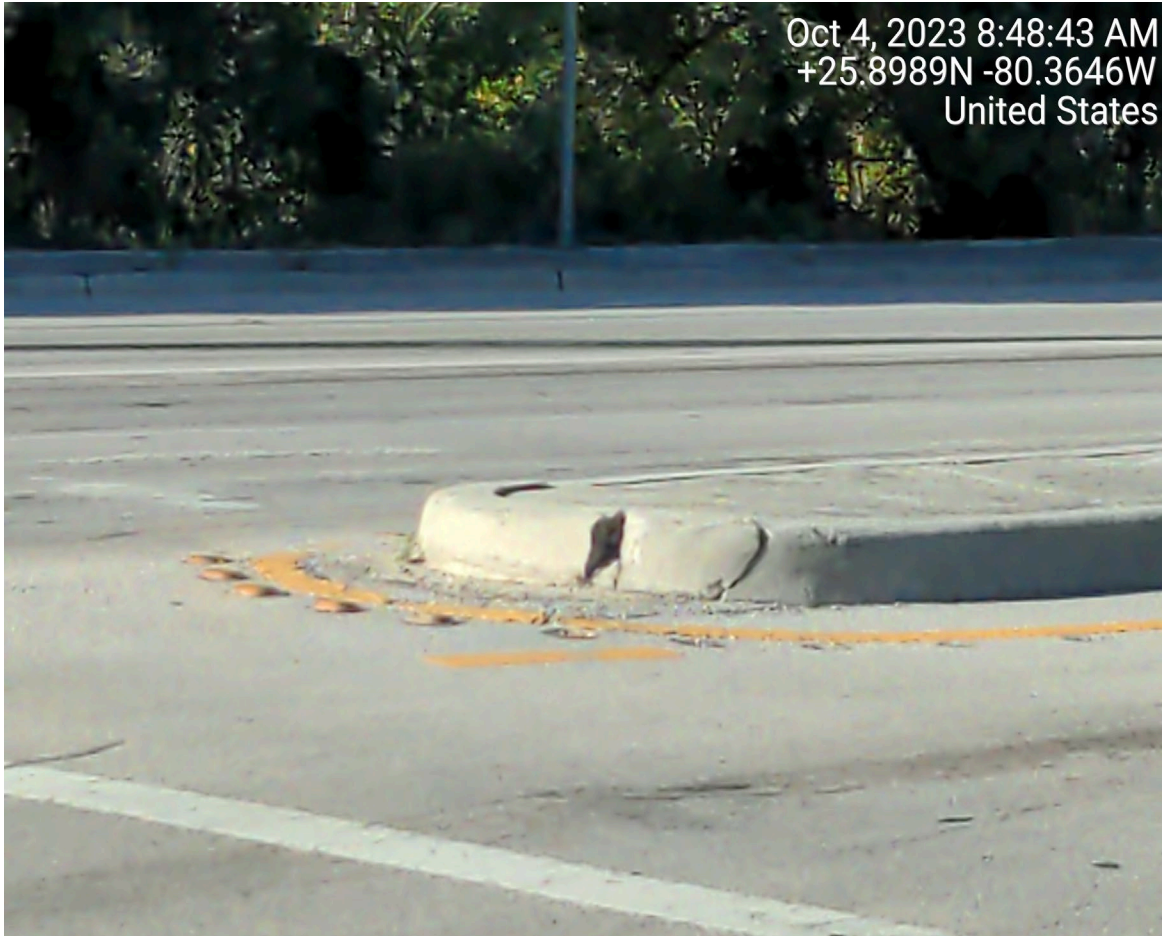
**ROADWAY INSPECTION  
LOCATION: WESTBOUND NW 138<sup>th</sup> STREET  
NW 102<sup>ND</sup> AVENUE**

**DAMAGED TRAFFIC SEPATATOR**

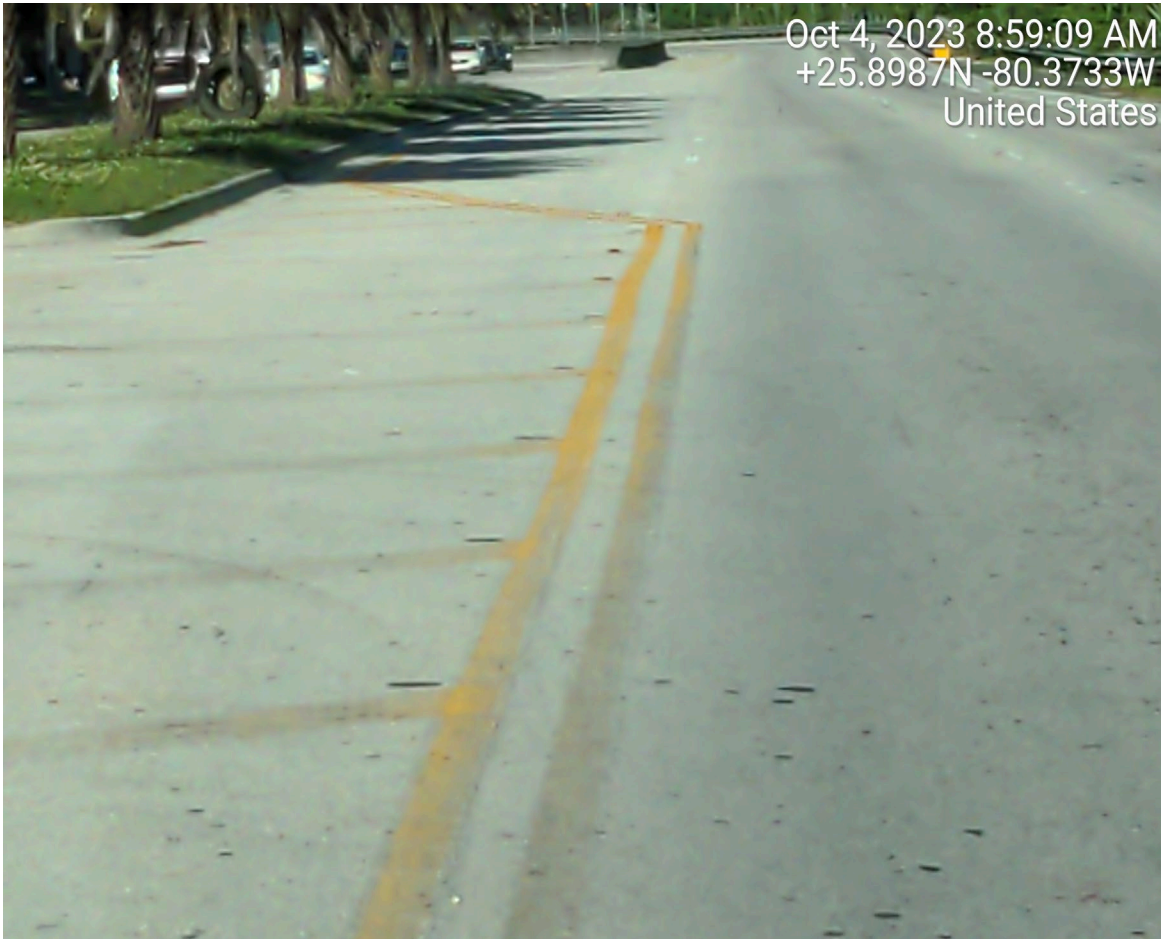
**ROADWAY INSPECTION  
LOCATION: WESTBOUND NW 138<sup>th</sup> STREET  
150 FEET WEST OF NW 107<sup>TH</sup> AVENUE.**

**DETERIORATED STRIPING IN GORE AREA**

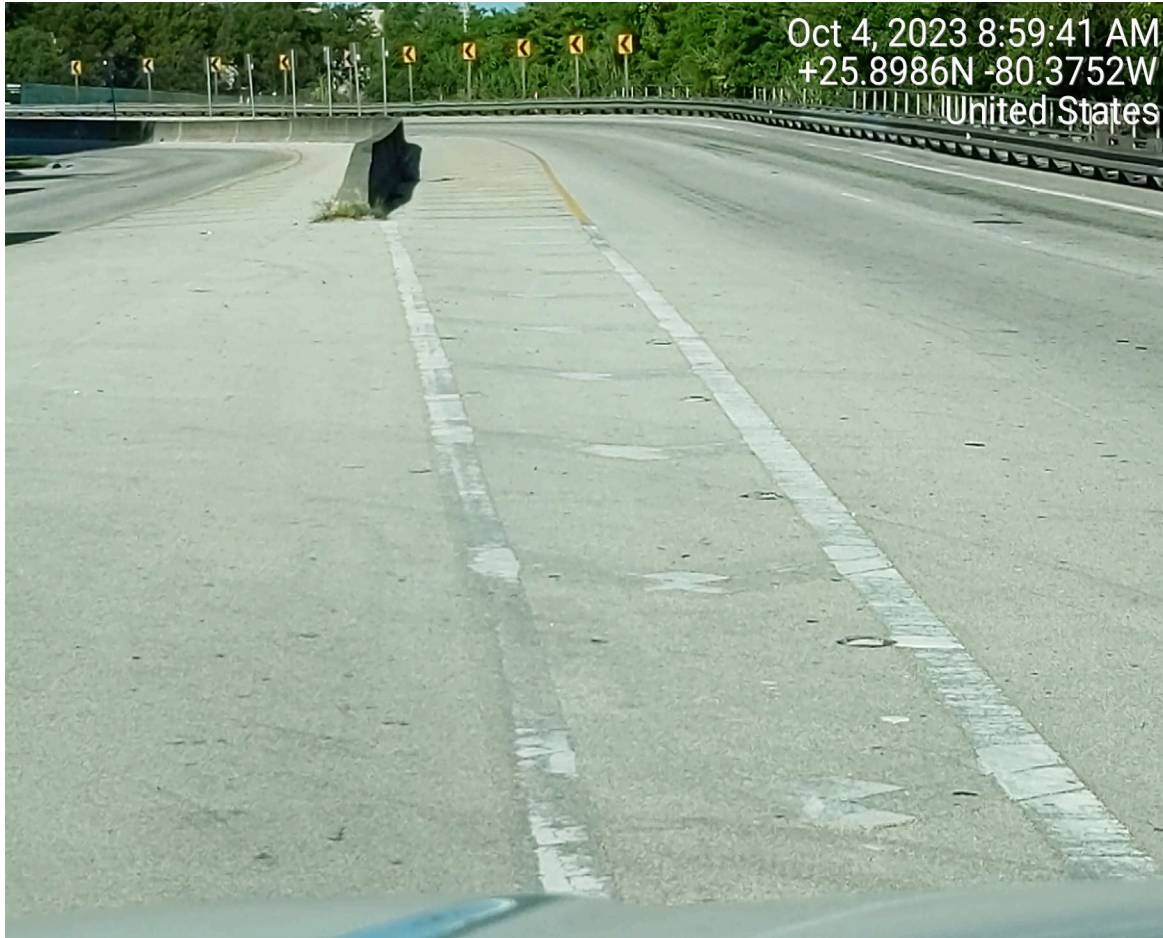
**ROADWAY INSPECTION  
LOCATION: WESTBOUND NW 138<sup>th</sup> STREET & NW 107<sup>th</sup>  
AVENUE 225 FEET WEST OF 107<sup>TH</sup> AVENUE.**

**DETERIORATED STRIPING IN GORE AREA**

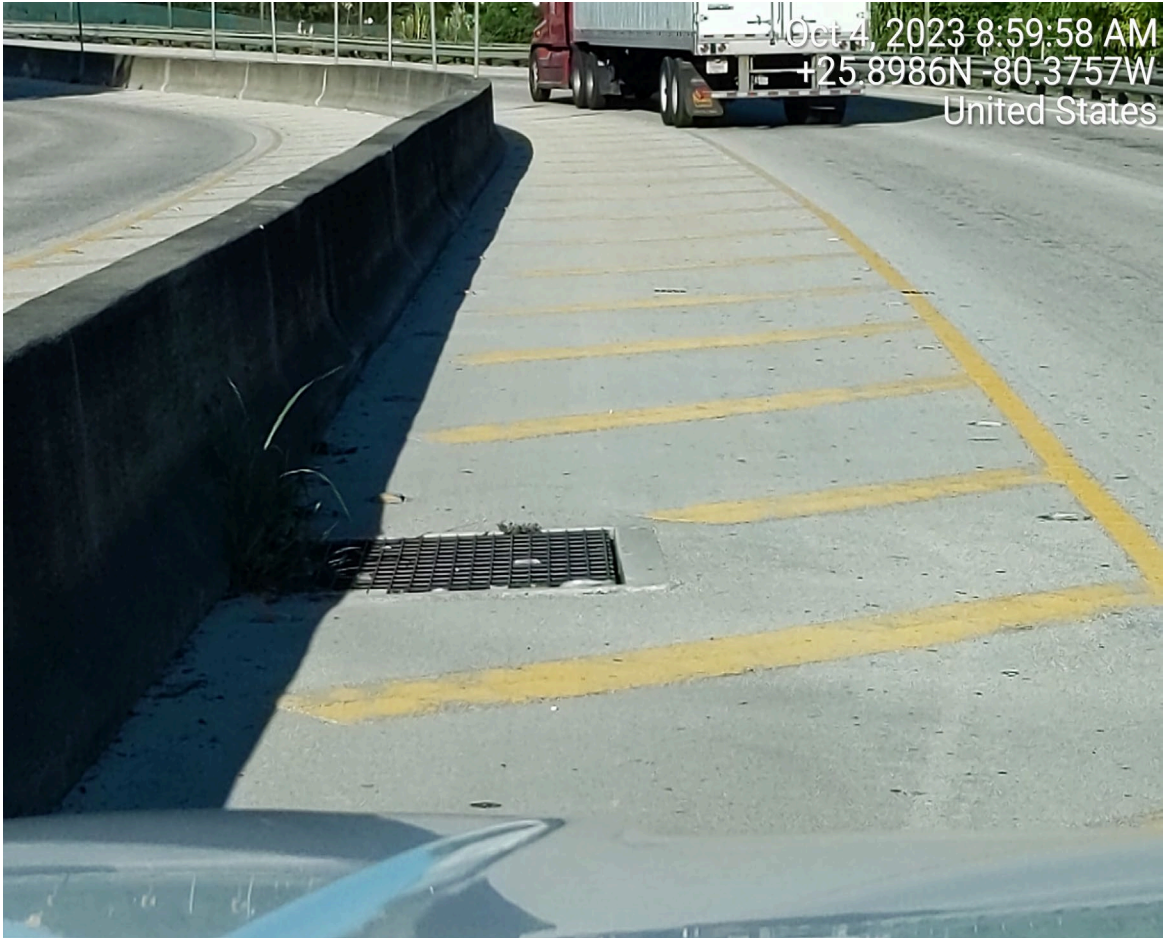
**ROADWAY INSPECTION  
LOCATION: WESTBOUND NW 107<sup>th</sup> AVENUE  
300 FEET WEST OF NW 107<sup>TH</sup> AVENUE.**

**SILTED DRAINAGE INLET (TYPICAL AT VARIOUS LOCATIONS)**

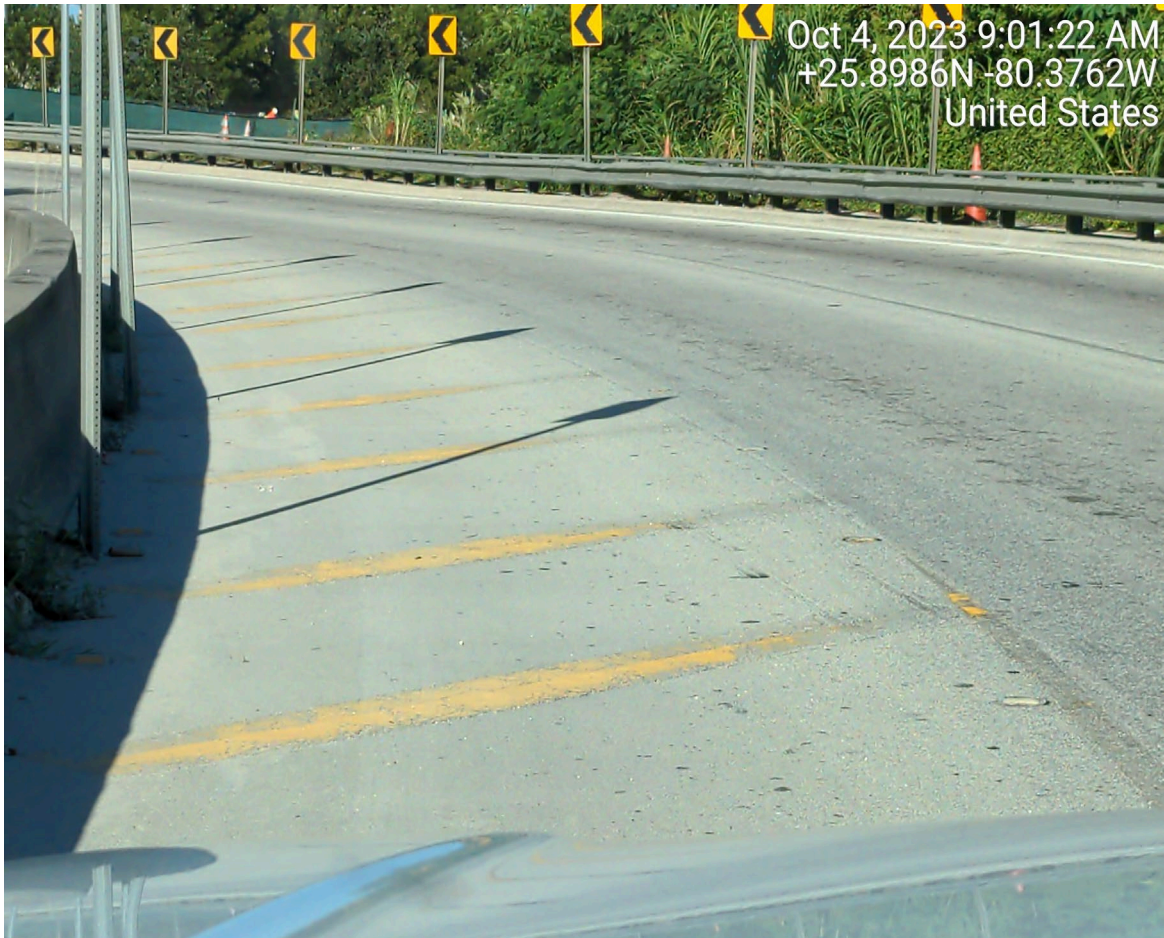
**ROADWAY INSPECTION  
LOCATION: WESTBOUND NW 138<sup>th</sup> STREET  
500 FEET NORTH OF FRONTAGE RD.**

**DETERIORATED STRIPING IN GORE AREA, EDGELINES & SKIIPS (TYPICAL AT  
VARIOUS LOCATIONS)**

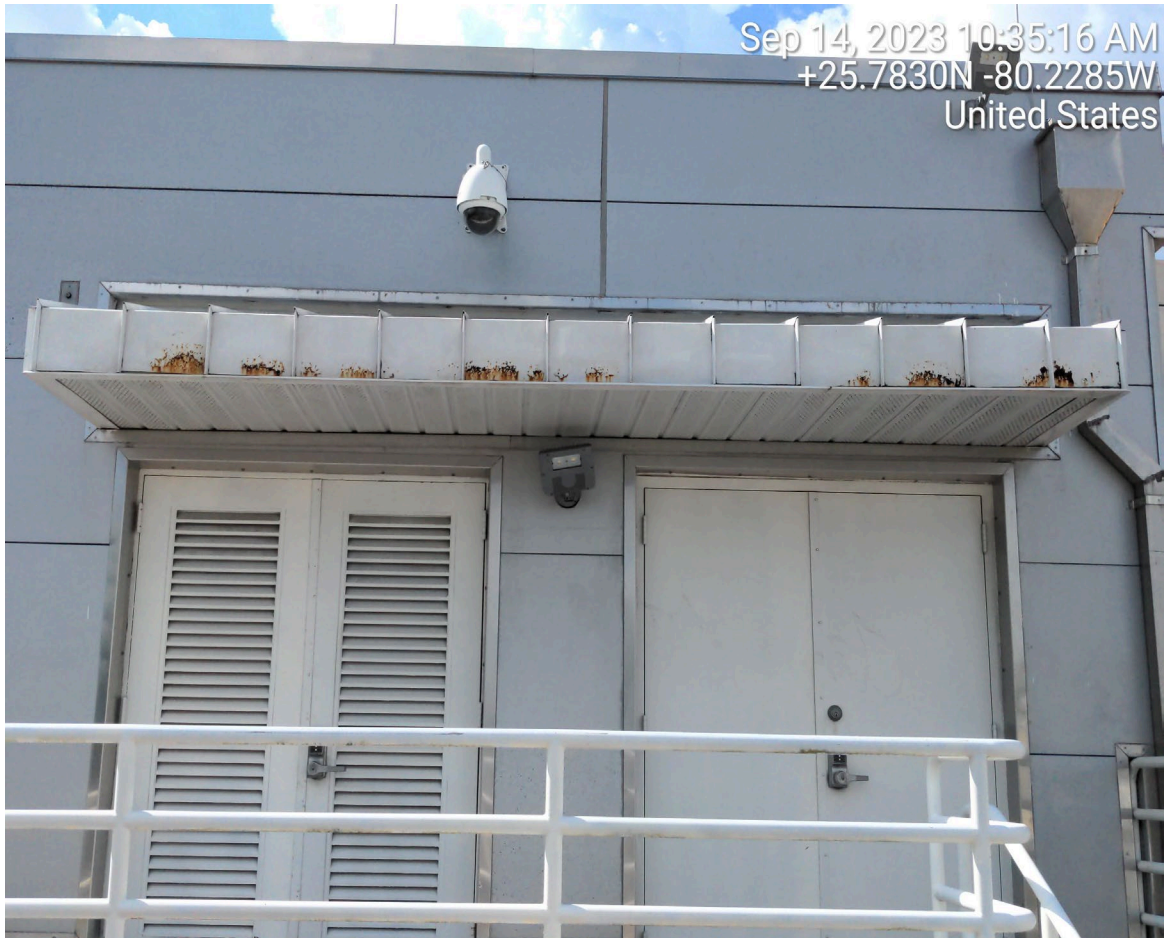
**ARCHITECTURAL INSPECTION  
LOCATION: SR-836 MAIN ADMINISTRATION BUILDING  
(MECHANICAL ROOM)**

**SURFACE CORROSION ON METAL AWNING**

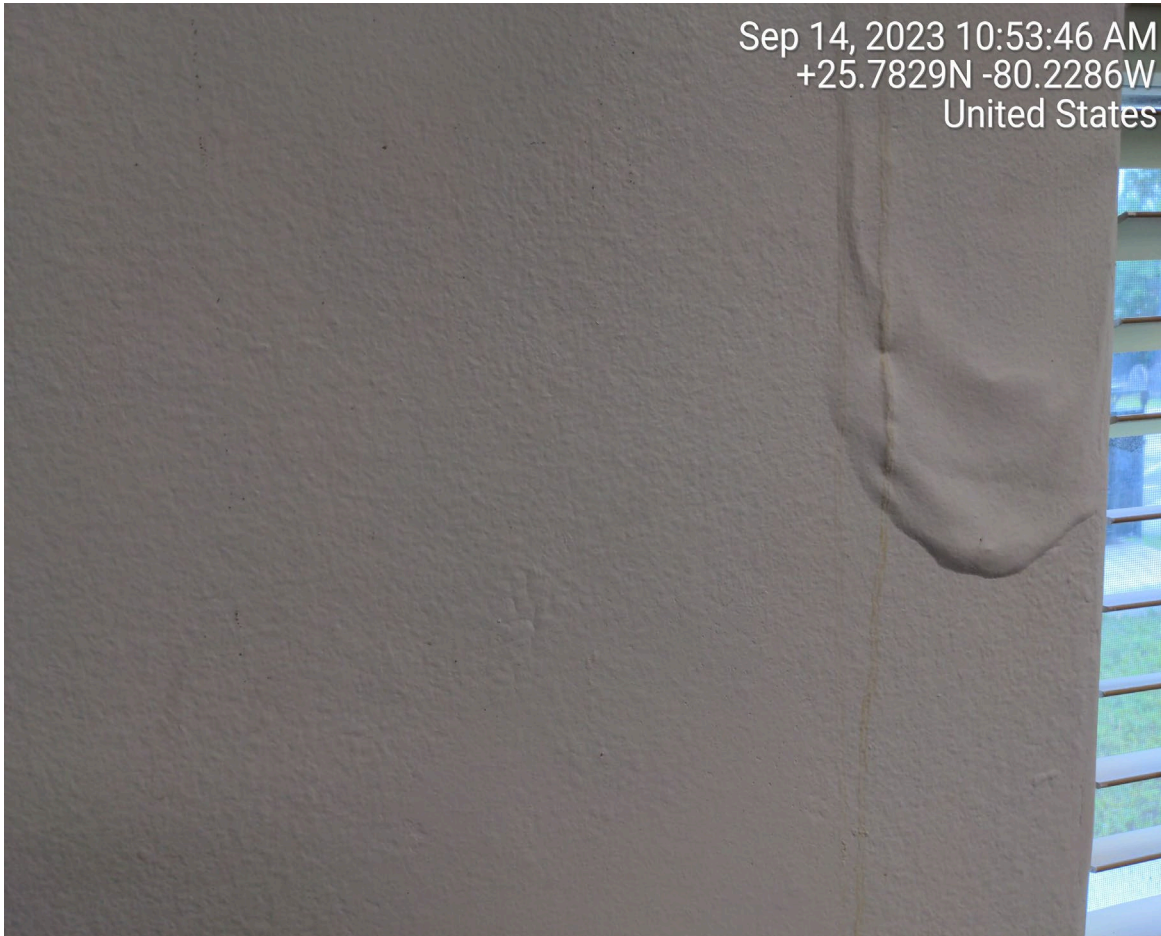
**ARCHITECTURAL INSPECTION  
LOCATION: SR-836 MAIN ADMINISTRATION BUILDING  
KITCHEN AREA**

**WATER FILTRATION**

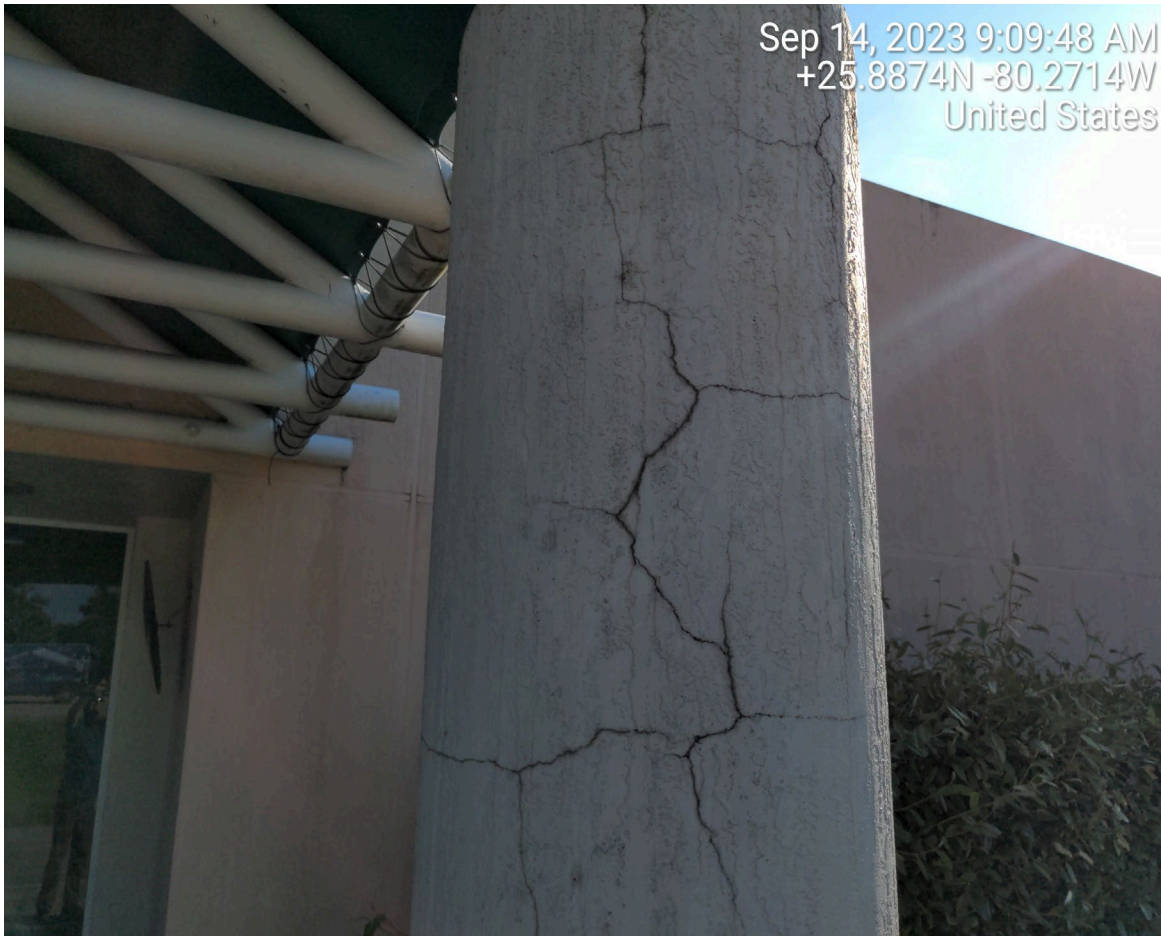
**ARCHITECTURAL INSPECTION  
LOCATION: ADMINISTRATION BUILDING**

**CRACKS ON COLUMN**

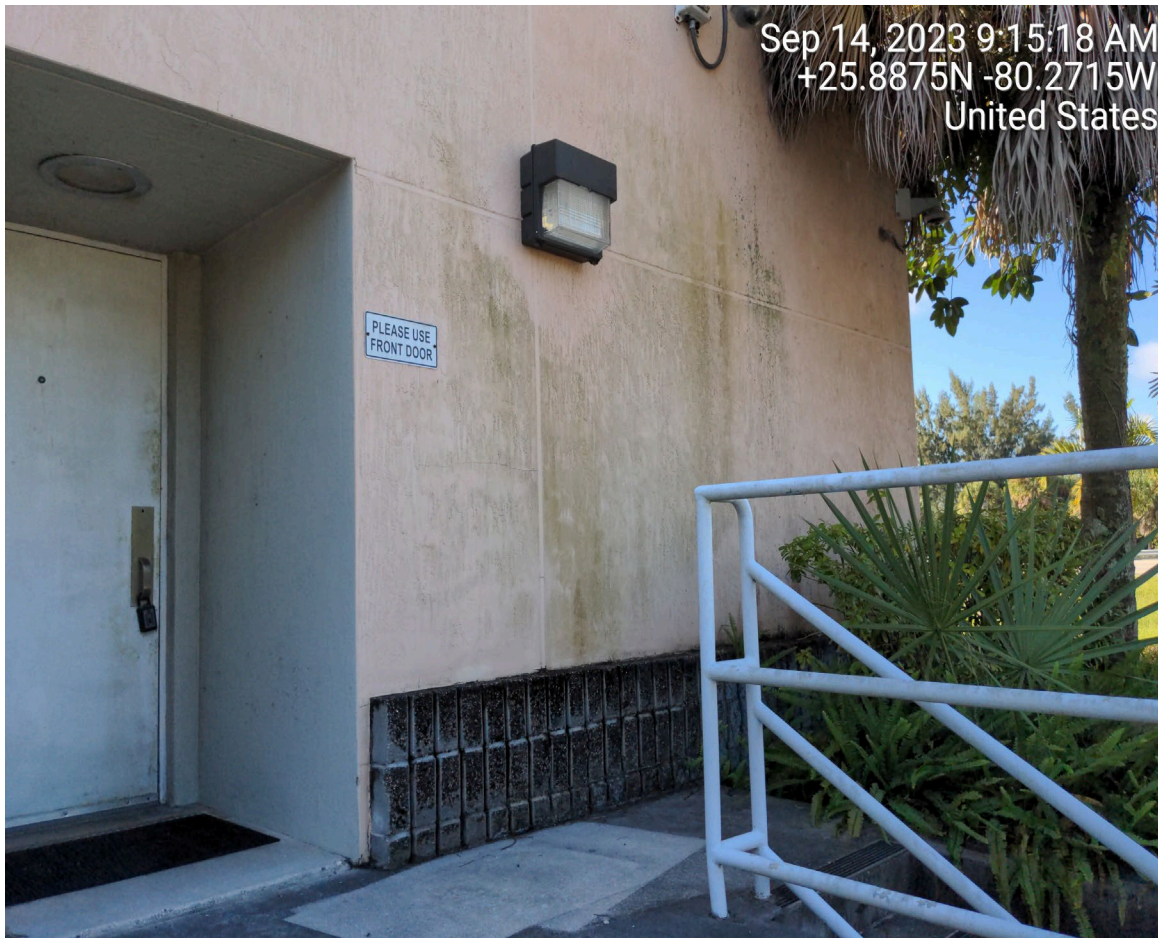
**ARCHITECTURAL INSPECTION  
LOCATION: ADMINISTRATION BUILDING**

**MOLD STAINS ON EXTERIOR WALLS**

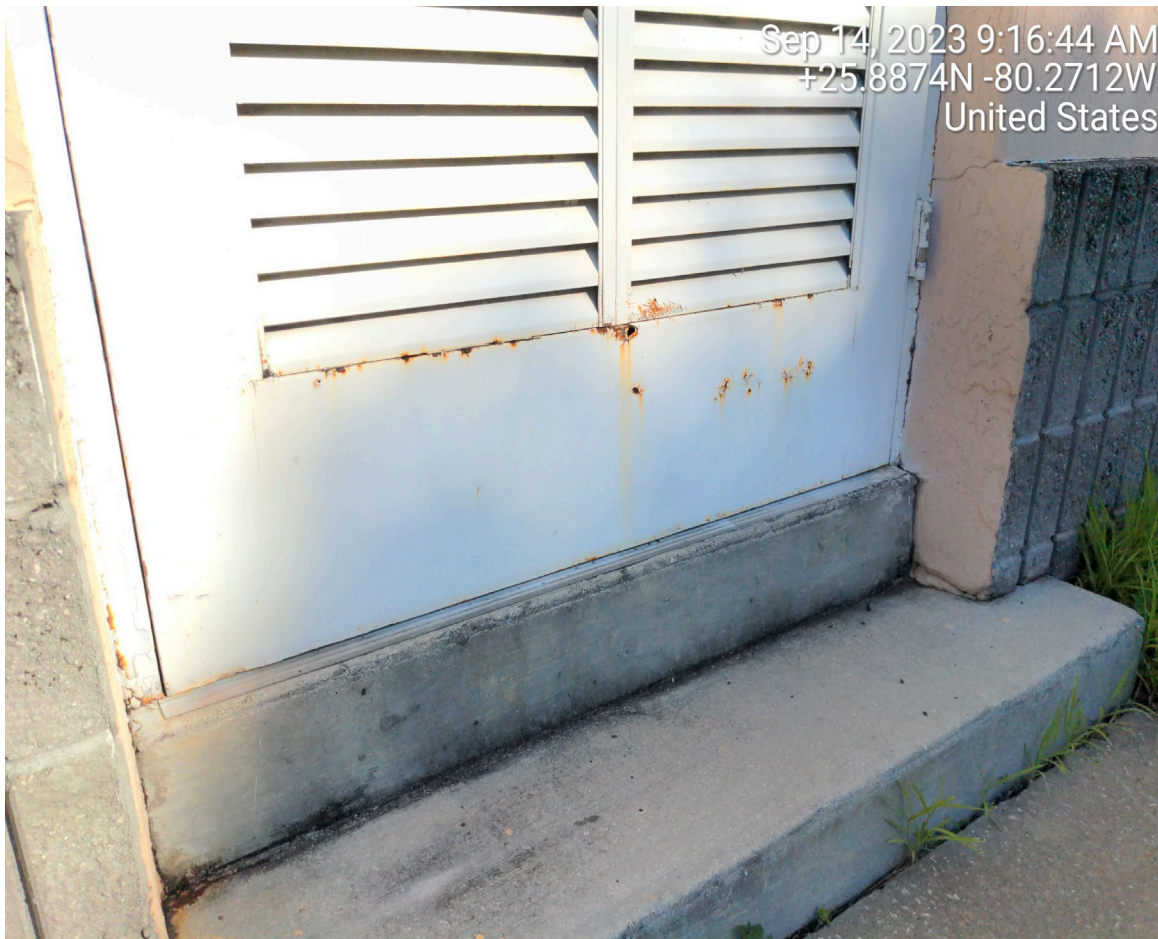
**ARCHITECTURAL INSPECTION  
LOCATION: ADMINISTRATION BUILDING  
MECHANICAL ROOM**

**SURFACE CORROSION ON METAL DOOR**
