# Annual Inspection Report 2020

# ANNUAL INSPECTION REPORT

As detailed in the following sections, EAC Consulting has found the MDX System to be in good working order and condition.

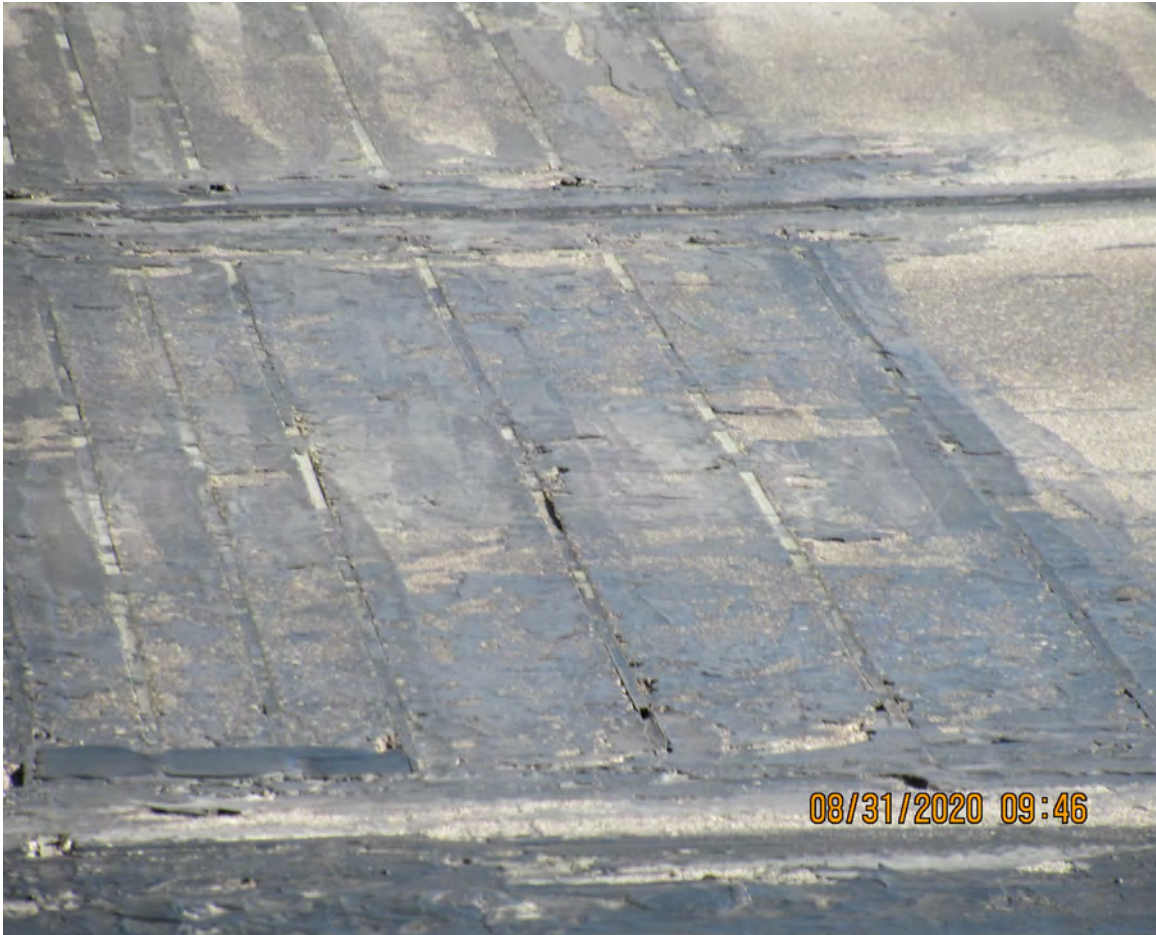
**PHOTO NO.: EB-007  
DATE: 8-31-2020**

**DETERIORATED TOLLS LOOP DETECTOR SEALANT**

**ITEMS NOTED TO BE ADDRESSED BY MDX TOLL SYSTEMS INTEGRATOR**

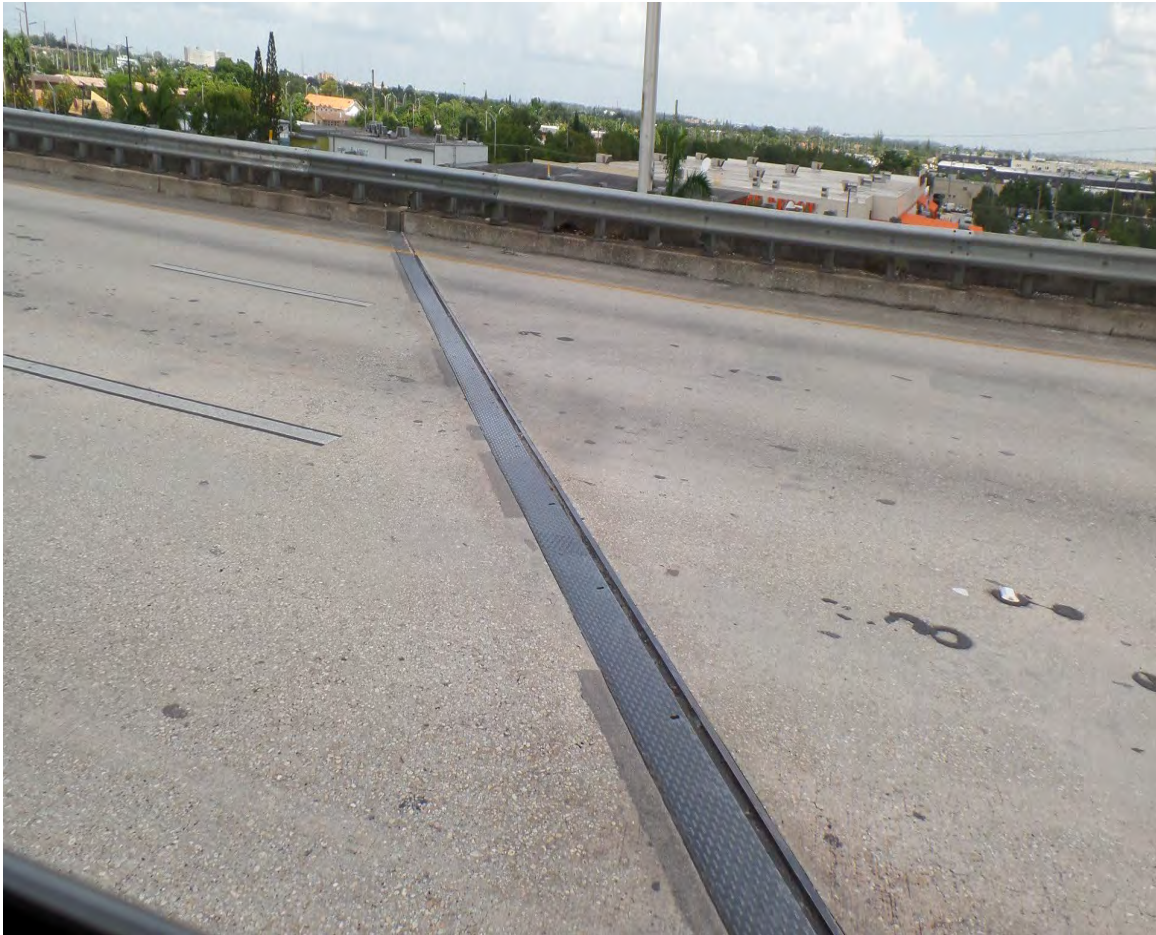
**PHOTO NO.: EB-008  
DATE: 8-31-2020**

**SLIDING PLATE EXPANSION JOINT BRIDGE # 870238  
(TYPICAL AT VARIOUS LOCATIONS)**

**ITEMS NOTED TO BE ADDRESSED BY MDX WORK PROGRAM No. 30029**

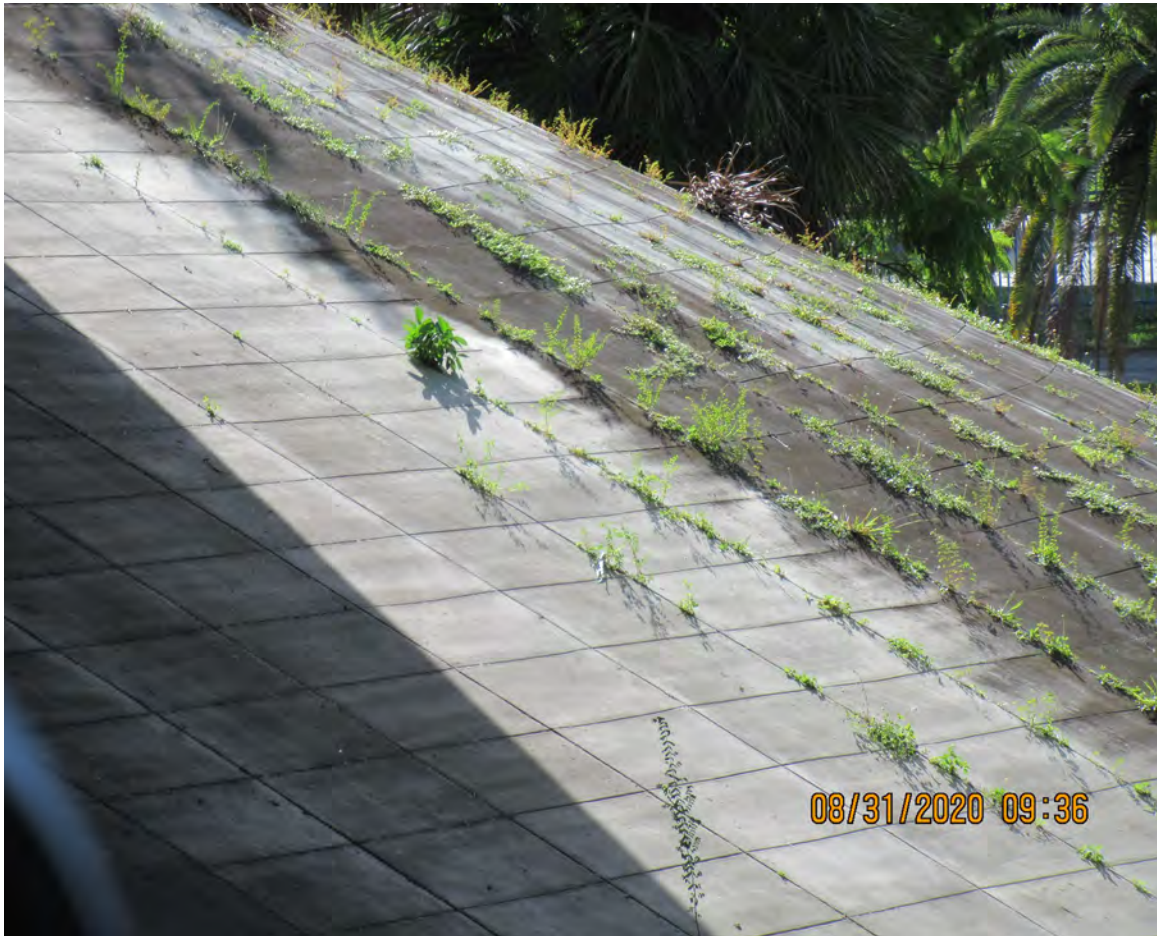
**PHOTO NO.: EB-011  
DATE: 8-31-2020**

**OVERGROWN VEGETATION ON BRIDGE SLOPE (BRIDGE # 870024)**

**ITEM NOTED TO BE ADDRESSED BY MDX EMERGENCY PUSH BOTTOM  
CONTRACTS**

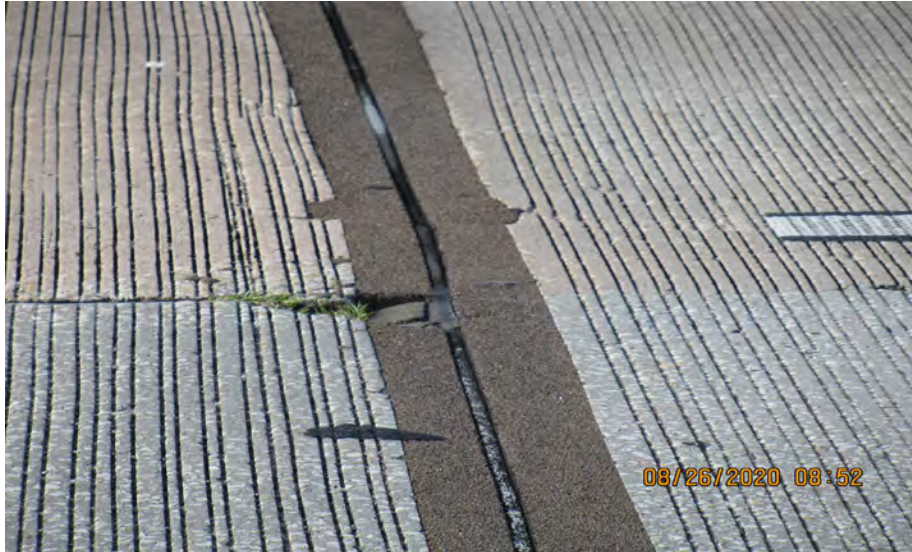
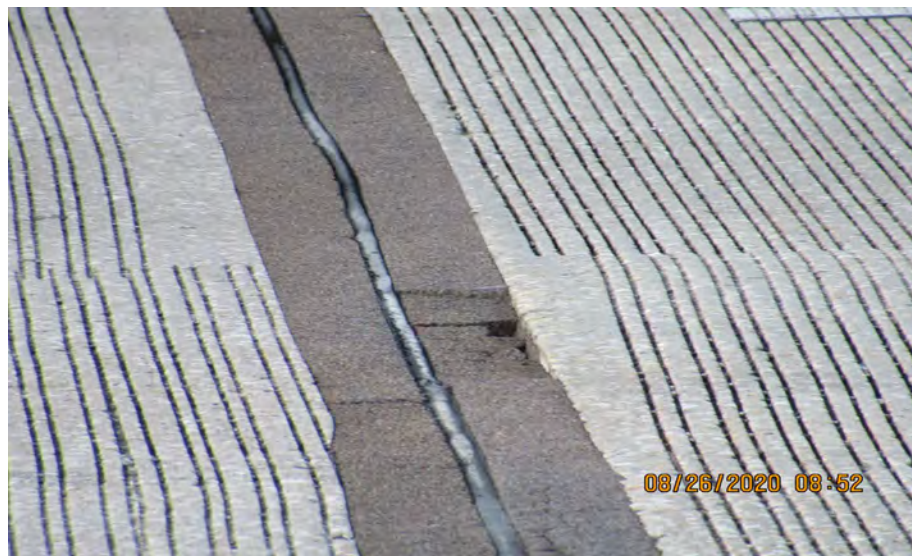
**PHOTO NO.: WB-001  
DATE: 8-26-2020**

**DETERIORATED POLYMER NOSING JOINT HEADER (BRIDGE # 870022)**

**ITEM NOTED TO BE ADDRESSED BY MDX WORK PROGRAM No. 30029**

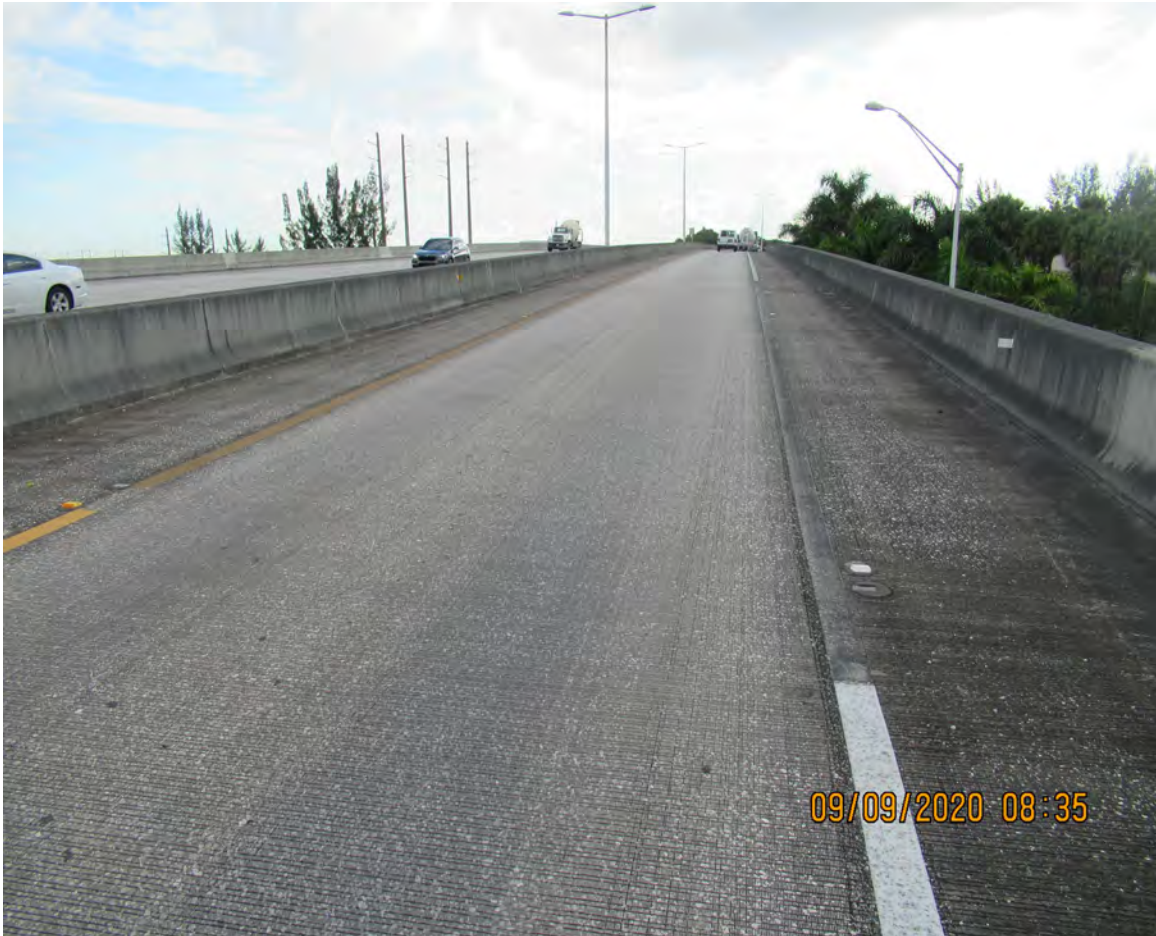
**PHOTO NO.: EB-001  
DATE: 09-09-2020**

**MISSING SECTION OF WHITE HIGH PERFORMANCE TAPE (BRIDGE No. 871008)**

**ITEM NOTED TO BE ADDRESSED BY MDX EMERGENCY PUSH BUTTON  
CONTRACTS**

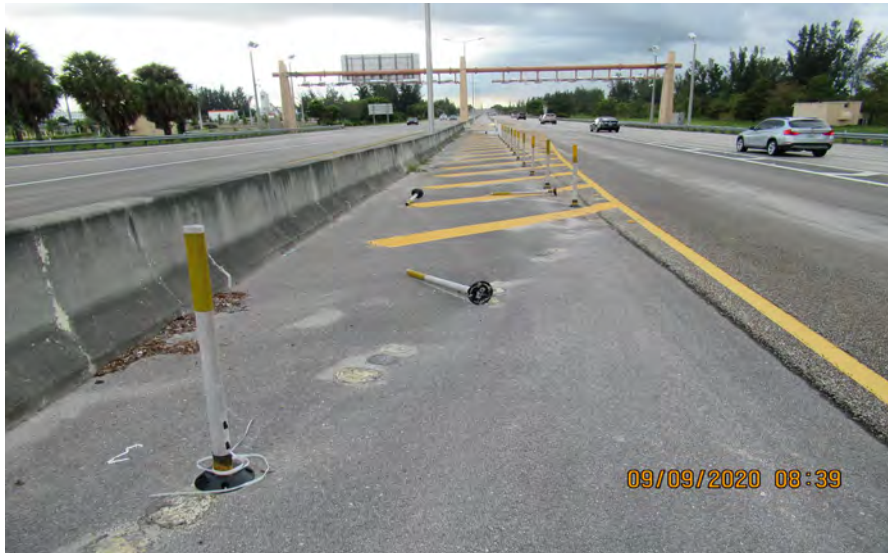
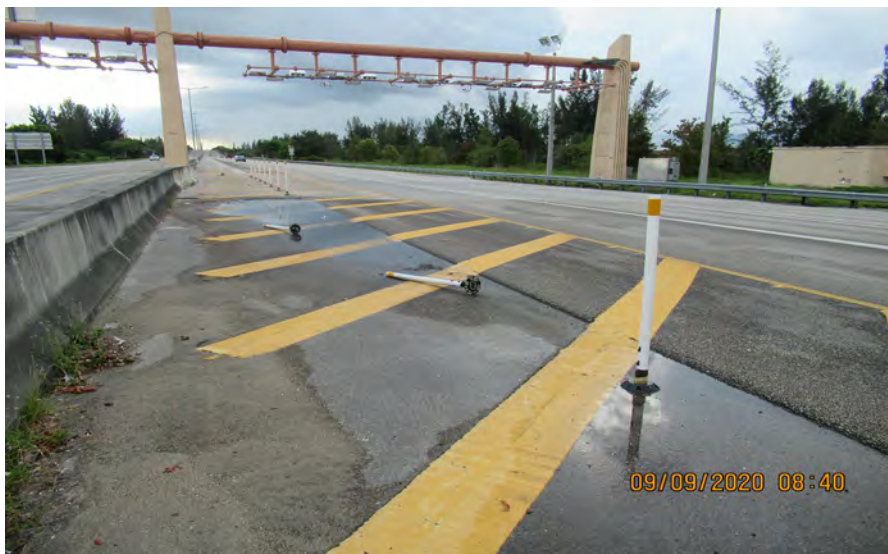
**PHOTO NO.: EB-003**  
**DATE: 09-09-2020**

### DAMAGED DELINEATORS

**ITEM NOTED TO BE ADDRESSED BY MDX EMERGENCY PUSH BUTTON  
CONTRACTS**

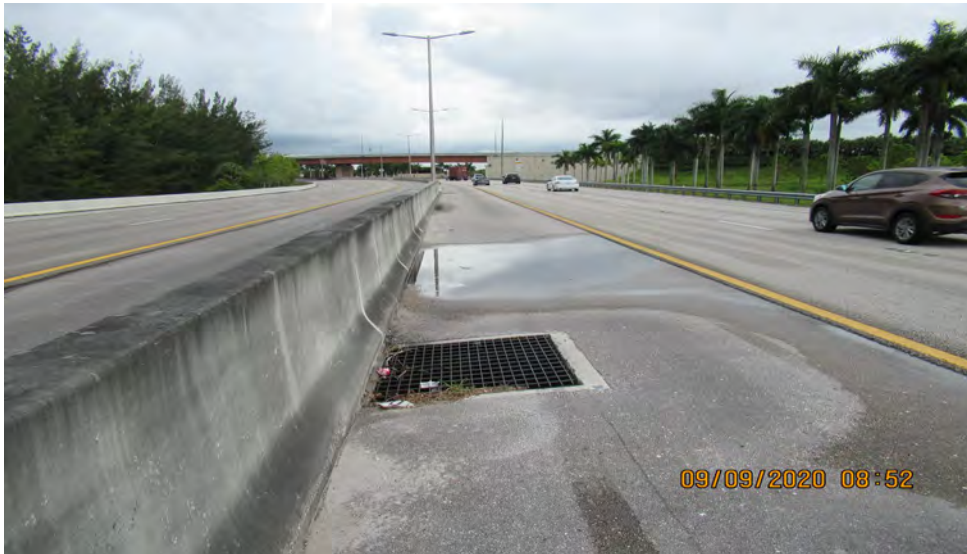
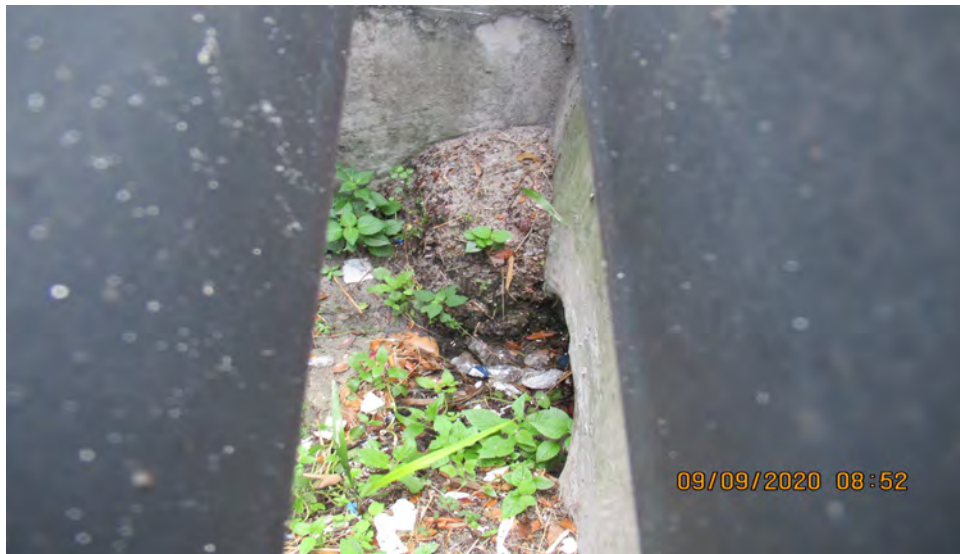
**PHOTO NO.: EB-006**  
**DATE: 09-09-2020**

**SILTED DRAINAGE INLET**

**ITEM NOTED TO BE ADDRESSED BY MDX EMERGENCY PUSH BUTTON  
CONTRACTS**

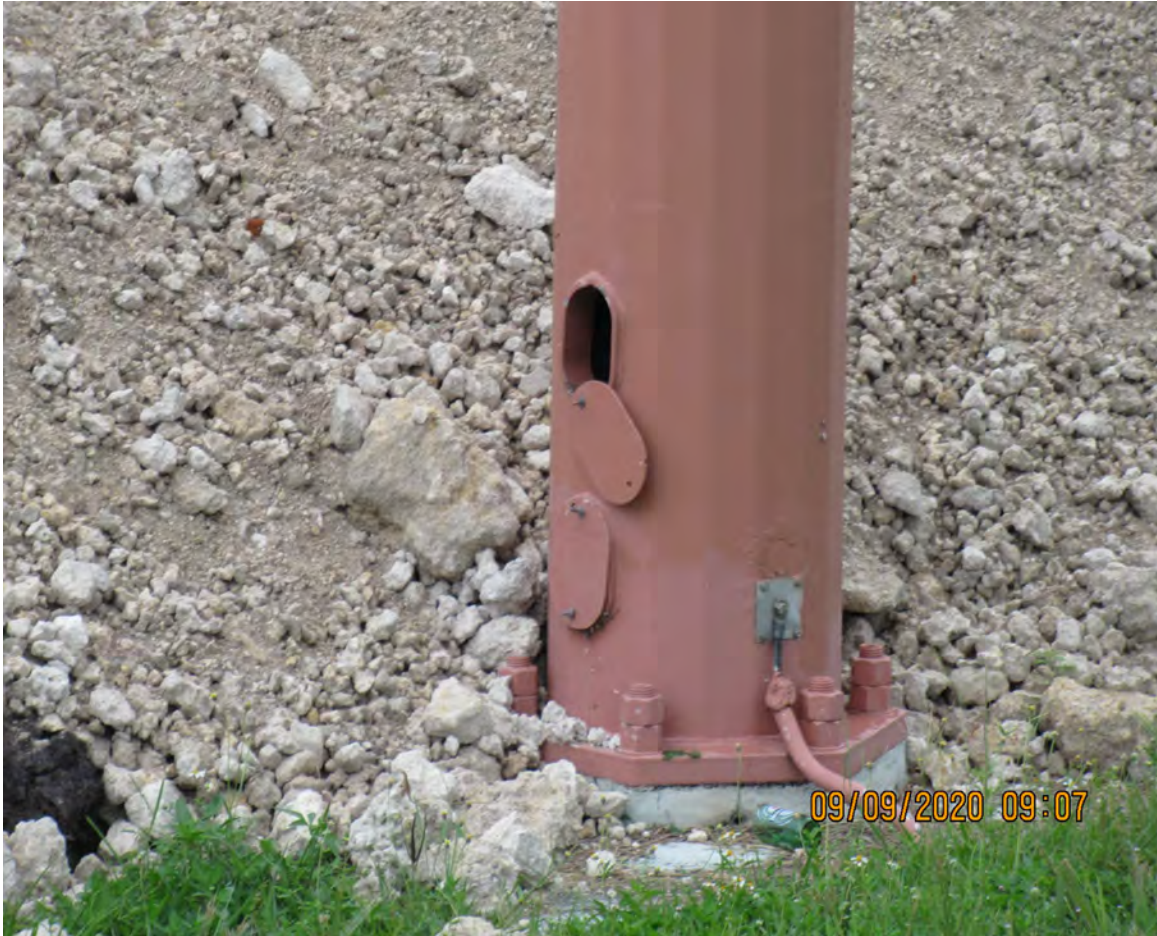
**PHOTO NO.: EB-007  
DATE: 09-09-2020**

**OPEN HANDHOLE ON HIGH-MAST POLE**

**ITEM NOTED TO BE ADDRESSED BY MDX EMERGENCY PUSH BUTTON  
CONTRACTS**

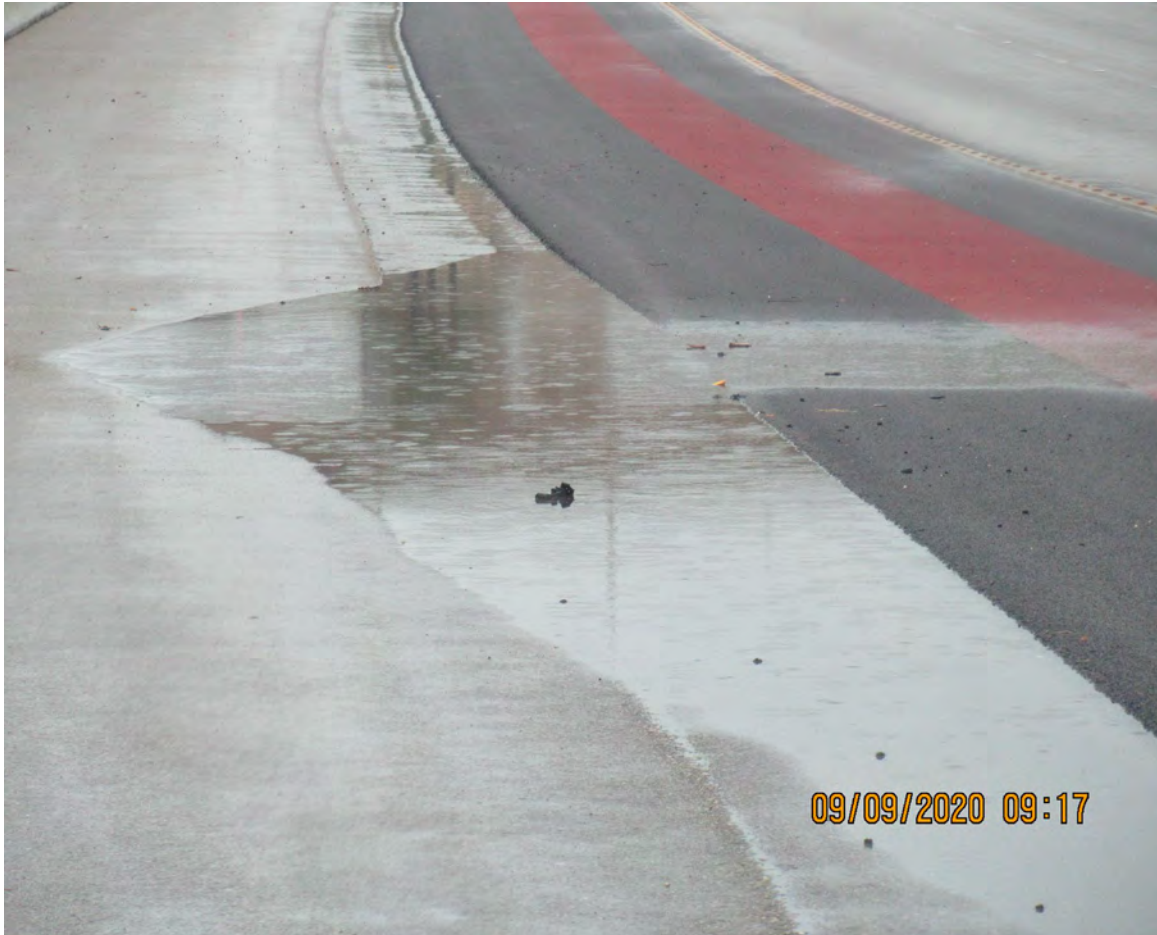
**PHOTO NO.: EB-008  
DATE: 09-09-2020**

**PONDING ON LEFT SHOULDER**

**ITEM NOTED TO BE ADDRESSED BY MDX MAINTENANCE**

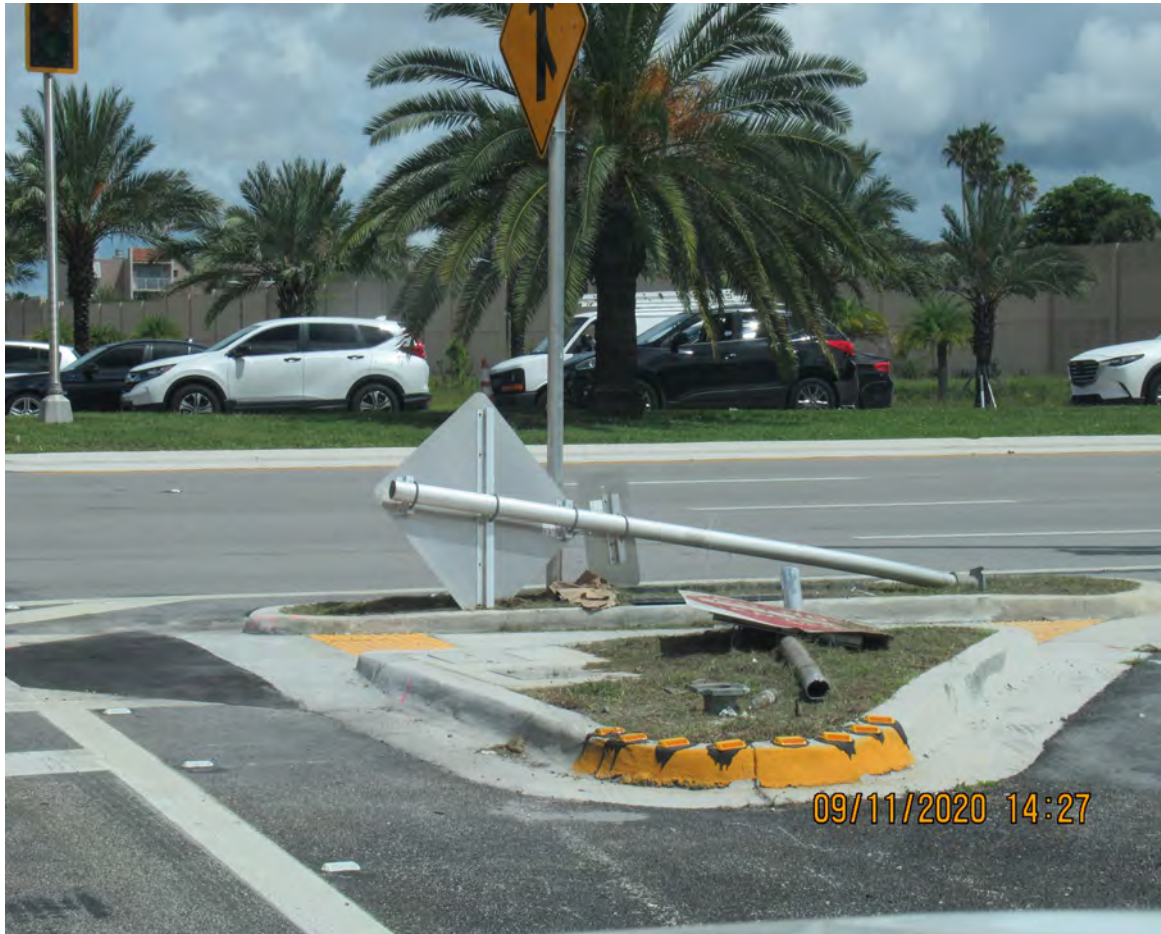
**PHOTO NO.: EB-009  
DATE: 09-11-2020**

**DOWN WARNING SIGNS DUE TO VEHICULAR ACCIDENT**

**ITEM NOTED TO BE ADDRESSED BY MDX EMERGENCY PUSH BUTTON  
CONTRACTS**

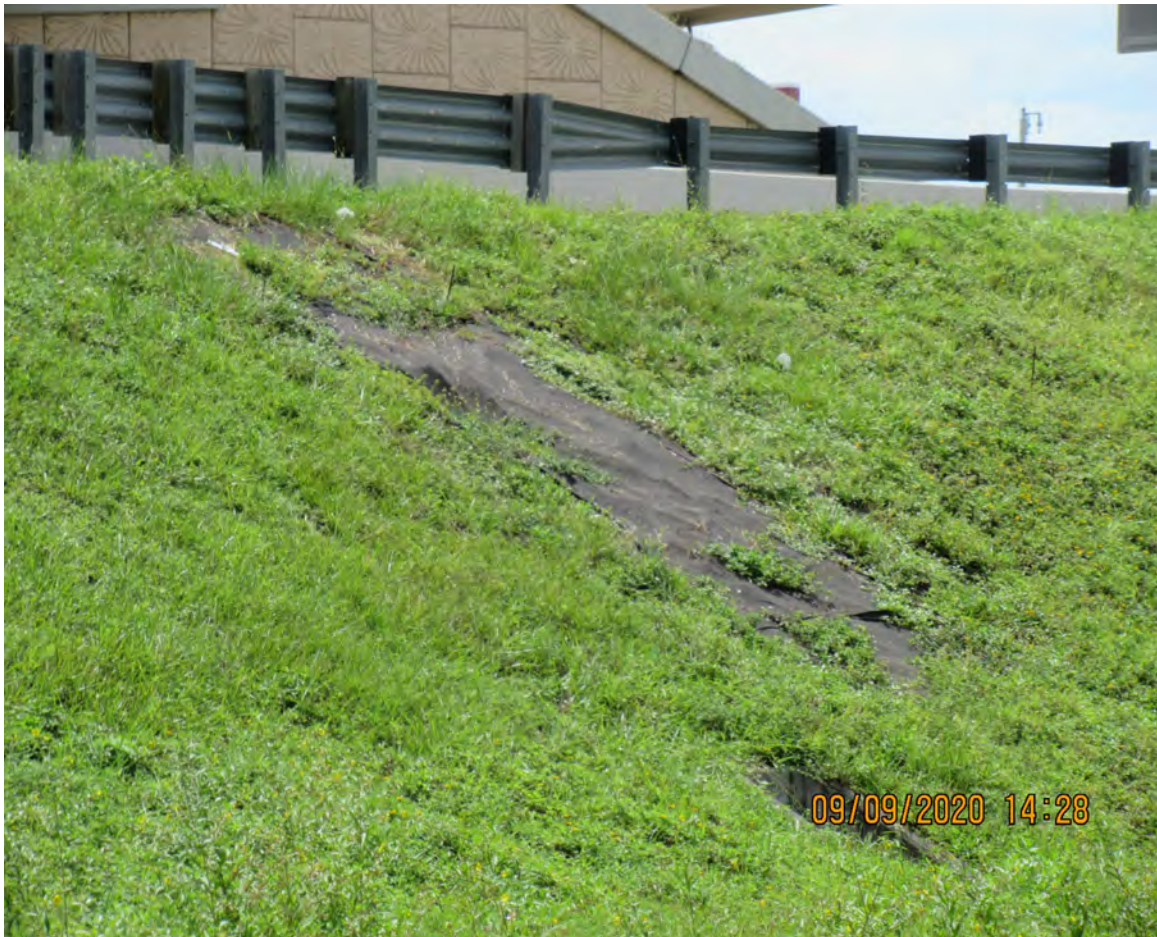
**PHOTO NO.: EB-013  
DATE: 09-09-2020**

**EROSION ON SLOPE (UNDERNEATH BRIDGE No. 871050 SPAN 11)**

**ITEM NOTED TO BE ADDRESSED BY 83608 WARRANTY**

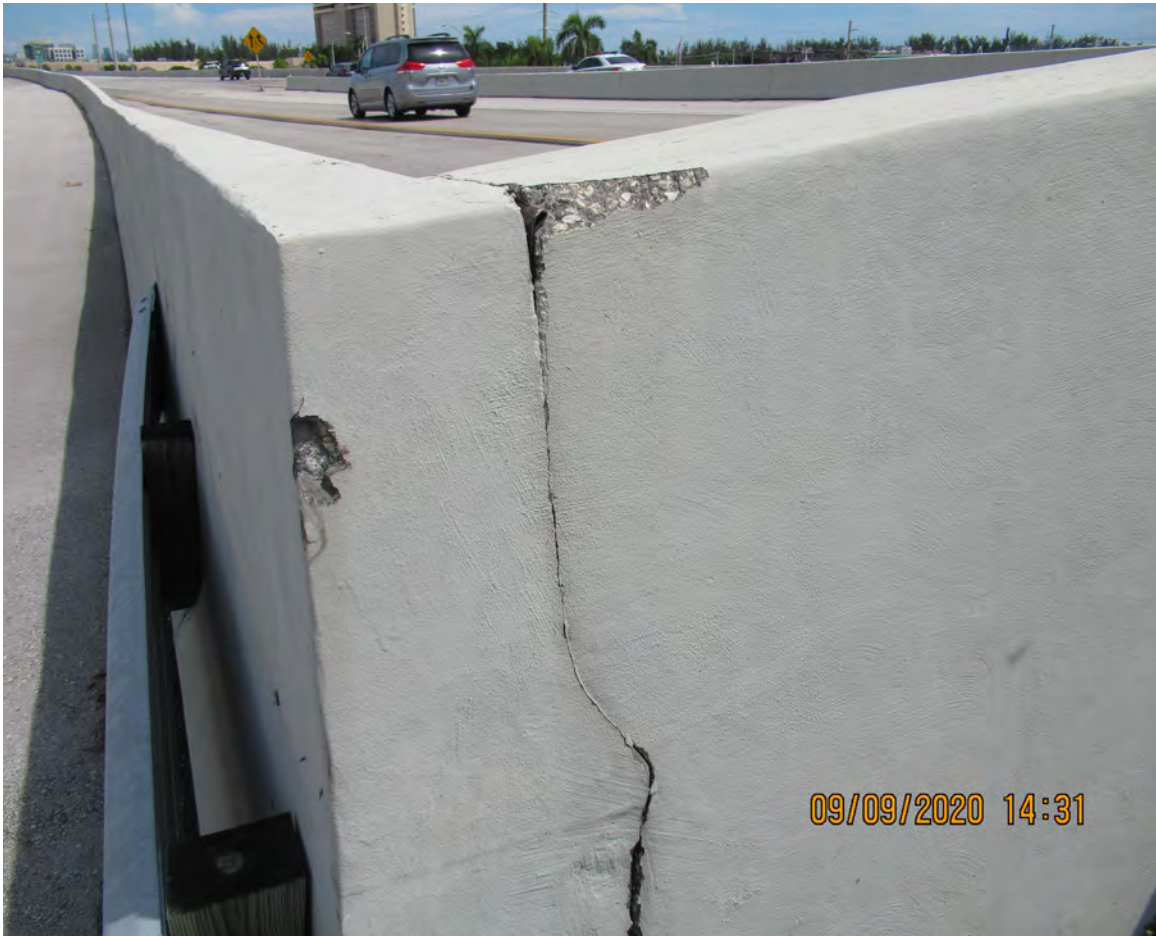
**PHOTO NO.: EB-014  
DATE: 09-09-2020**

**SPALLS ON BARRIER WALL**

**ITEM NOTED TO BE ADDRESSED BY 83608 WARRANTY**

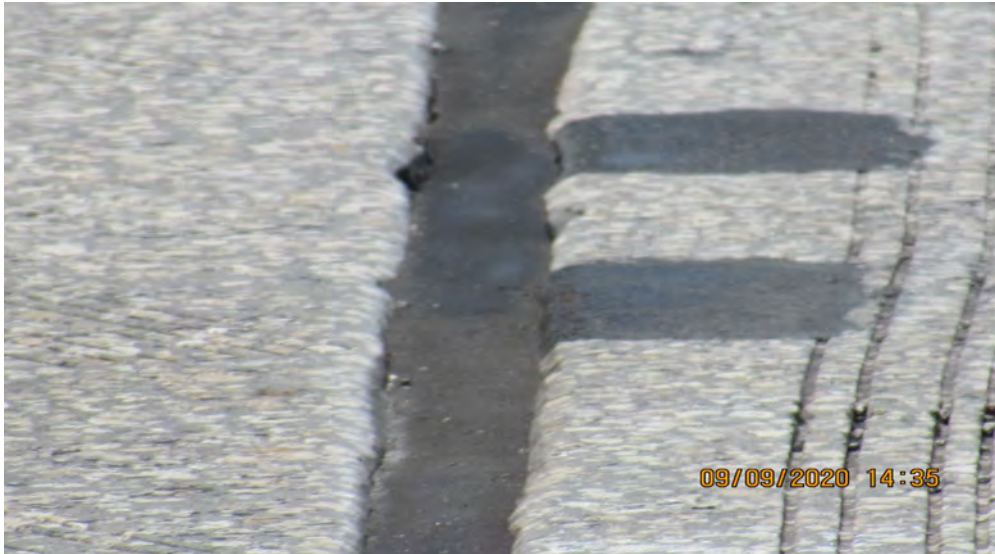
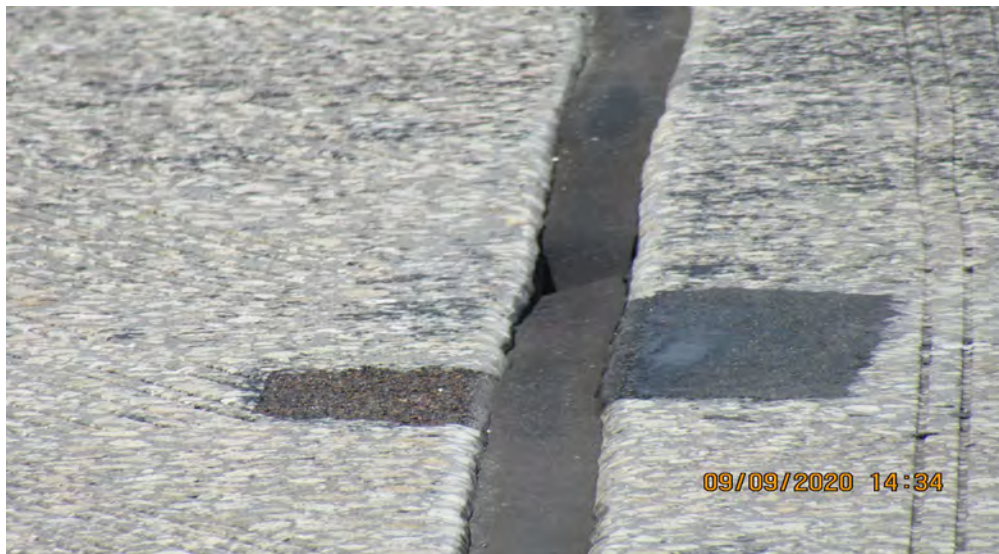
**PHOTO NO.: EB-016  
DATE: 09-09-2020**

**ROADWAY INSPECTION  
LOCATION: MILE MARKER 7.52  
EASTBOUND MAILINE**

**DETERIORATED JOINT SEALANT (BRIDGE No. 871075)**

**ITEM NOTED TO BE ADDRESSED BY 83608 WARRANTY**

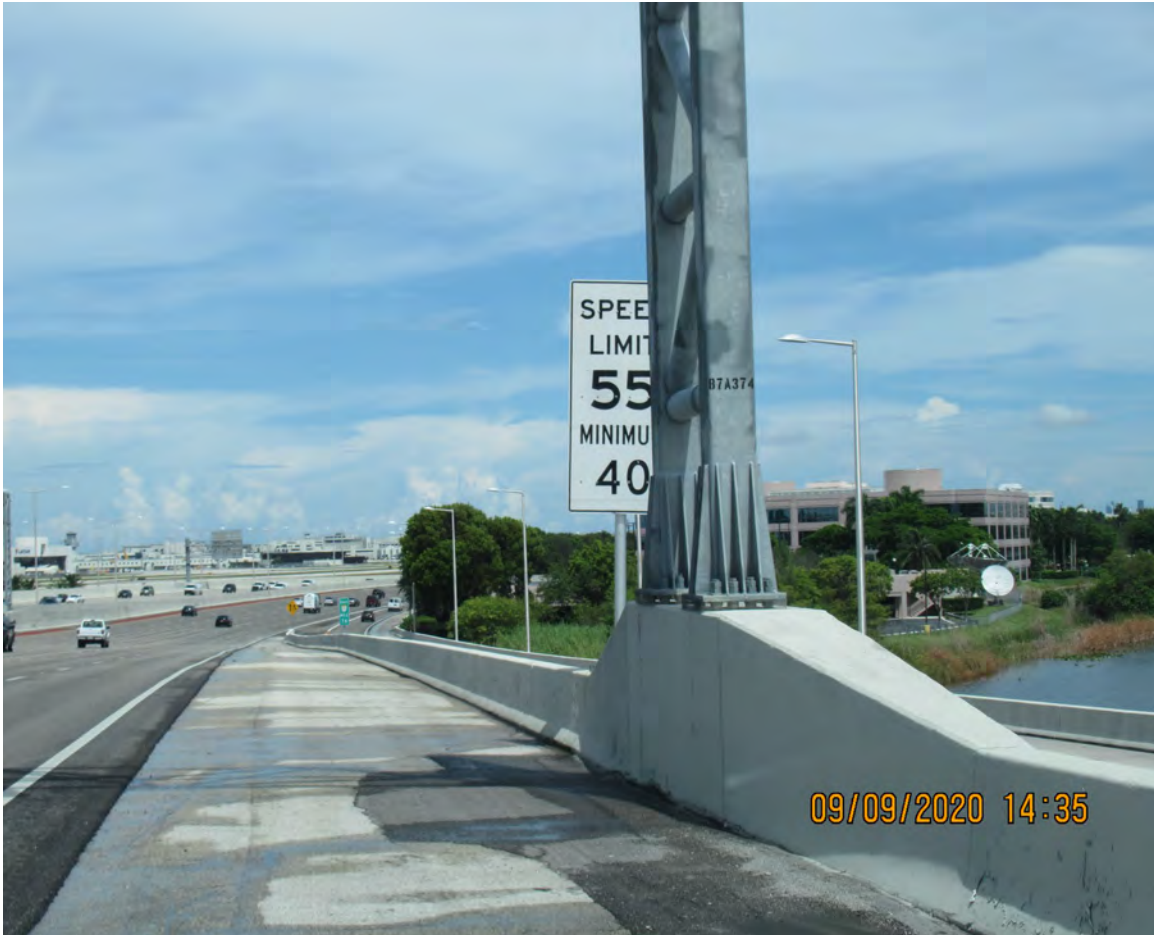
**PHOTO NO.: EB-017  
DATE: 09-09-2020**

**ROADWAY INSPECTION  
LOCATION: MILE MARKER 7.56  
EASTBOUND MAILINE (RIGHT SHOULDER)**

**SPEED LIMIT SIGN PARTIALLY OBSTRUCTED BY OVERHEAD SIGN STRUCTURE**

**ITEM NOTED TO BE ADDRESSED BY MDX MAINTENANCE**

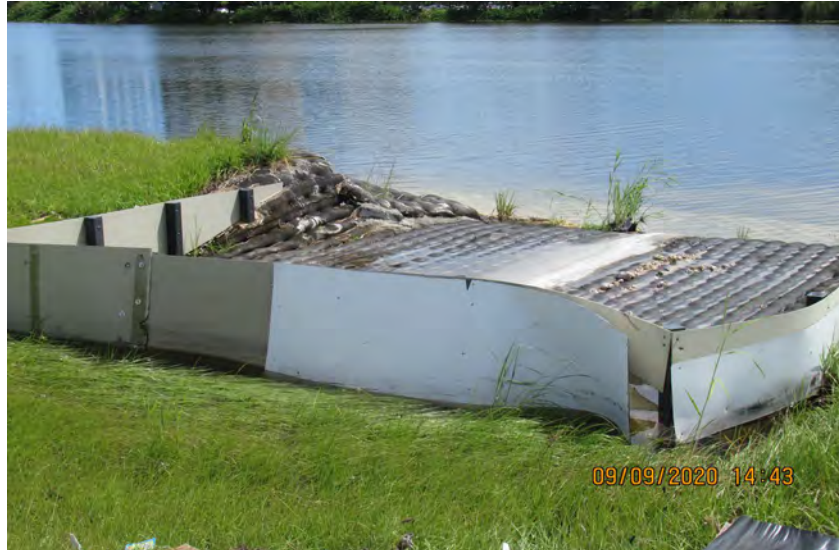
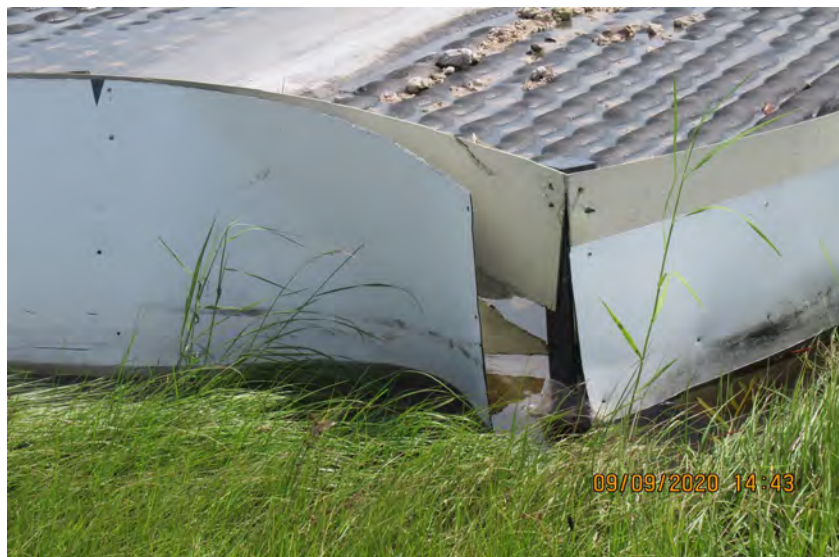
**PHOTO NO.: EB-020  
DATE: 09-09-2020**

**ROADWAY INSPECTION  
LOCATION: MILE MARKER 9.30  
EASTBOUND MAILINE (RIGHT SHOULDER)**

**FAILED REPAIR ON THE DRAINAGE SKIMMER**

**ITEM NOTED TO BE ADDRESSED BY MDX 83628 WARRANTY**

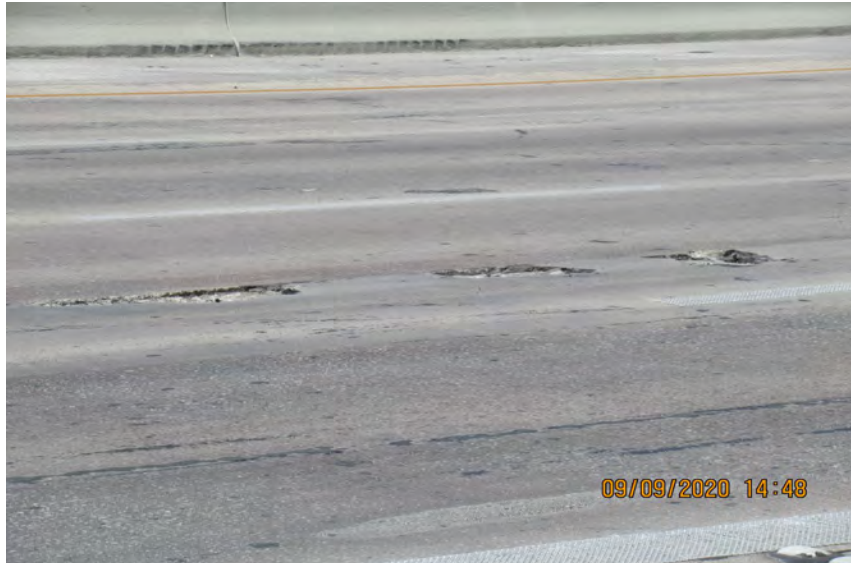
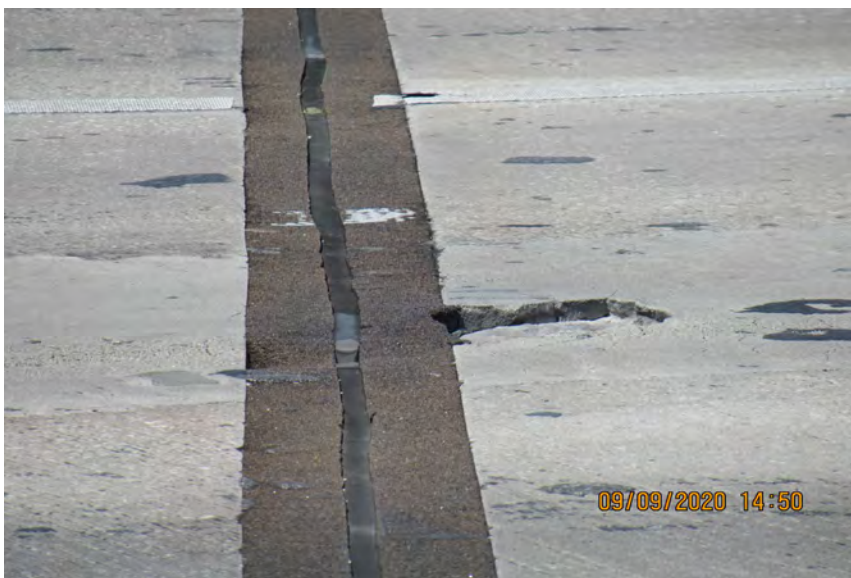
**PHOTO NO.: EB-021  
DATE: 09-09-2020**

**ROADWAY INSPECTION  
LOCATION: MILE MARKER 10.30  
EASTBOUND MAILINE (LANE R-3)**

**SPALLS ON BRIDGE DECK (BRIDGE # 870291)**

**ITEM NOTED TO BE ADDRESSED BY MDX EMERGENCY PUSH BUTTON  
CONTRACTS**

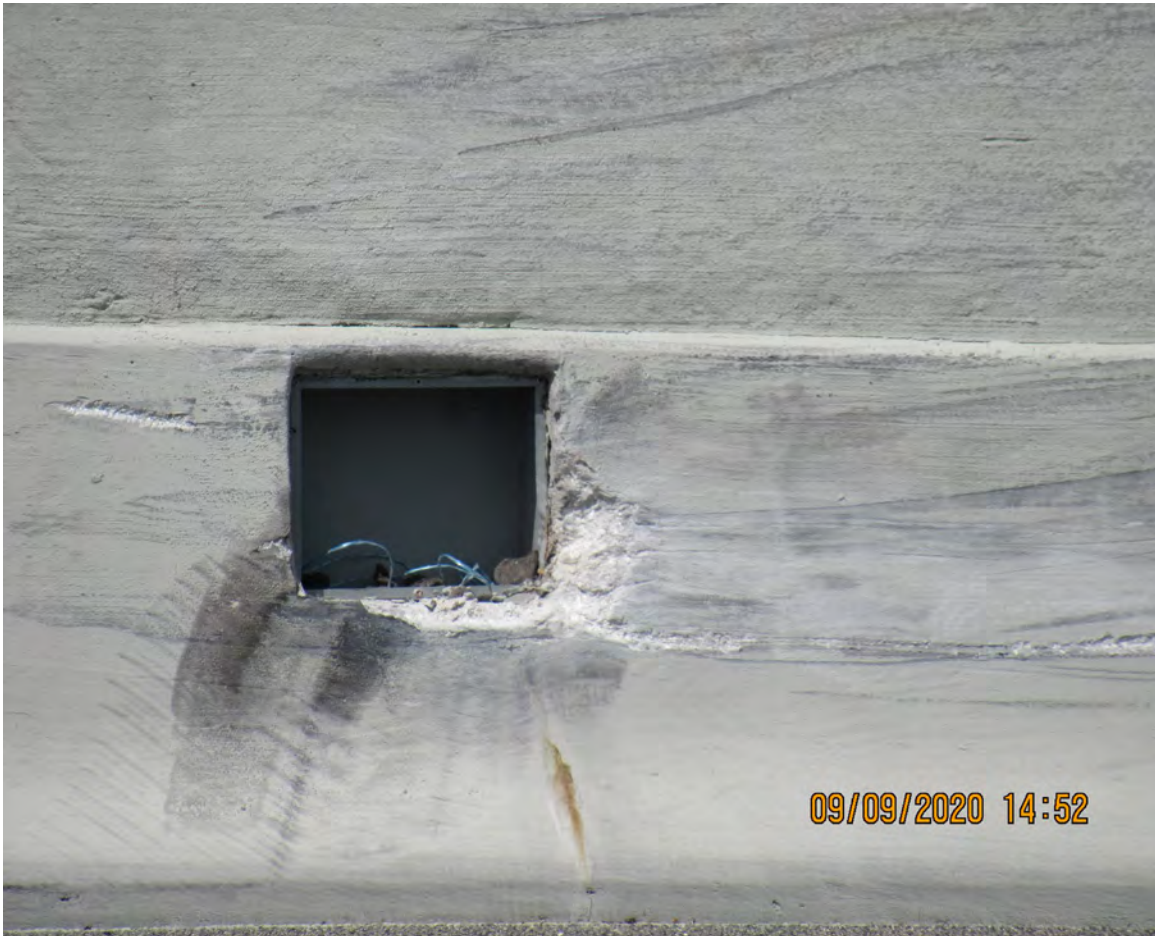
**PHOTO NO.: EB-022  
DATE: 09-09-2020**

**ROADWAY INSPECTION  
LOCATION: MILE MARKER 10.82  
EASTBOUND MAILINE (LEFT SHOULDER)**

**DAMAGED MEDIAN BARRIER WALL AND MISSING COVER ON PULL BOX**

**ITEM NOTED TO BE ADDRESSED BY MDX MAINTENANCE**

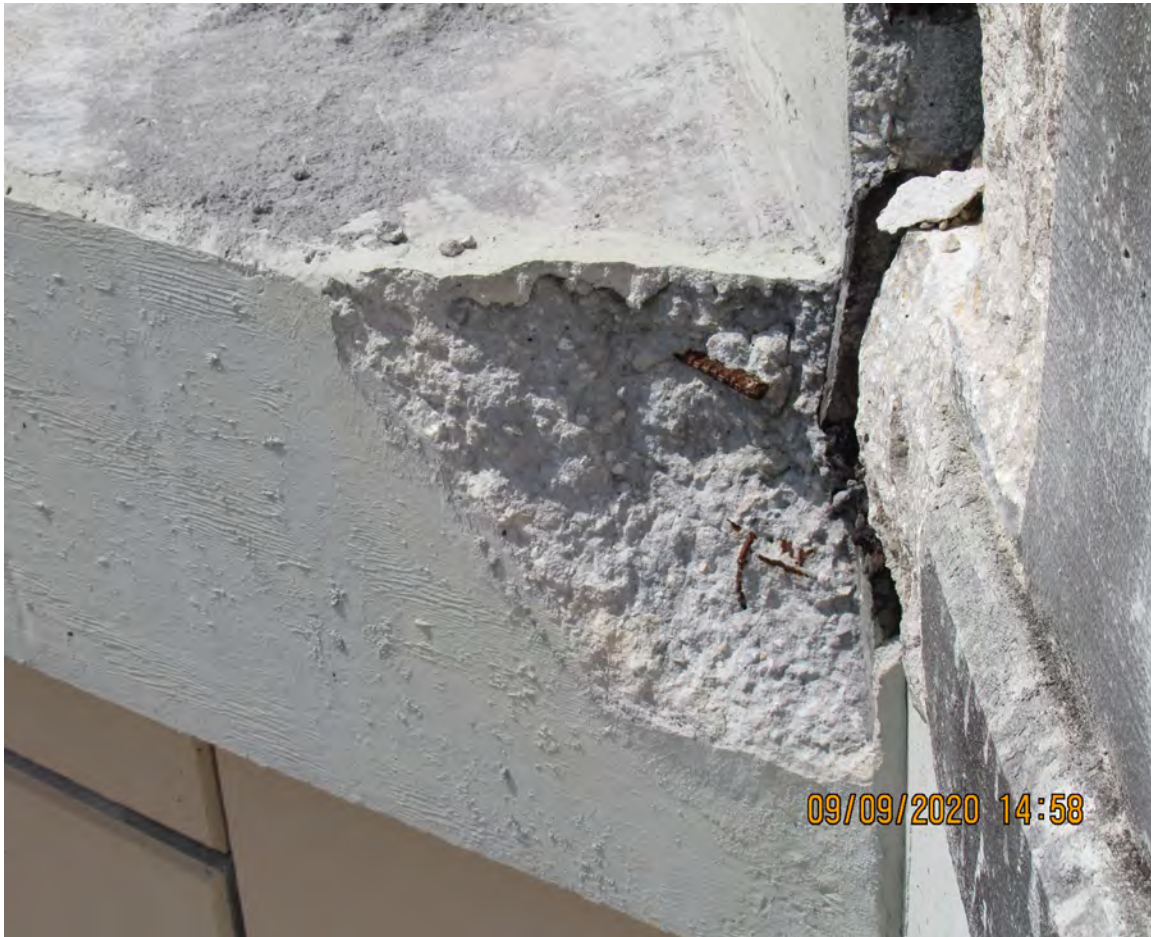
**PHOTO NO.: EB-023  
DATE: 09-09-2020**

**ROADWAY INSPECTION  
LOCATION: MILE MARKER 12.22  
EASTBOUND MAILINE (RIGHT SHOULDER)**

**SPALL ON ABUTMENT 1 (BRIDGE # 870966)**

**ITEM NOTED TO BE ADDRESSED BY MDX MAINTENANCE**

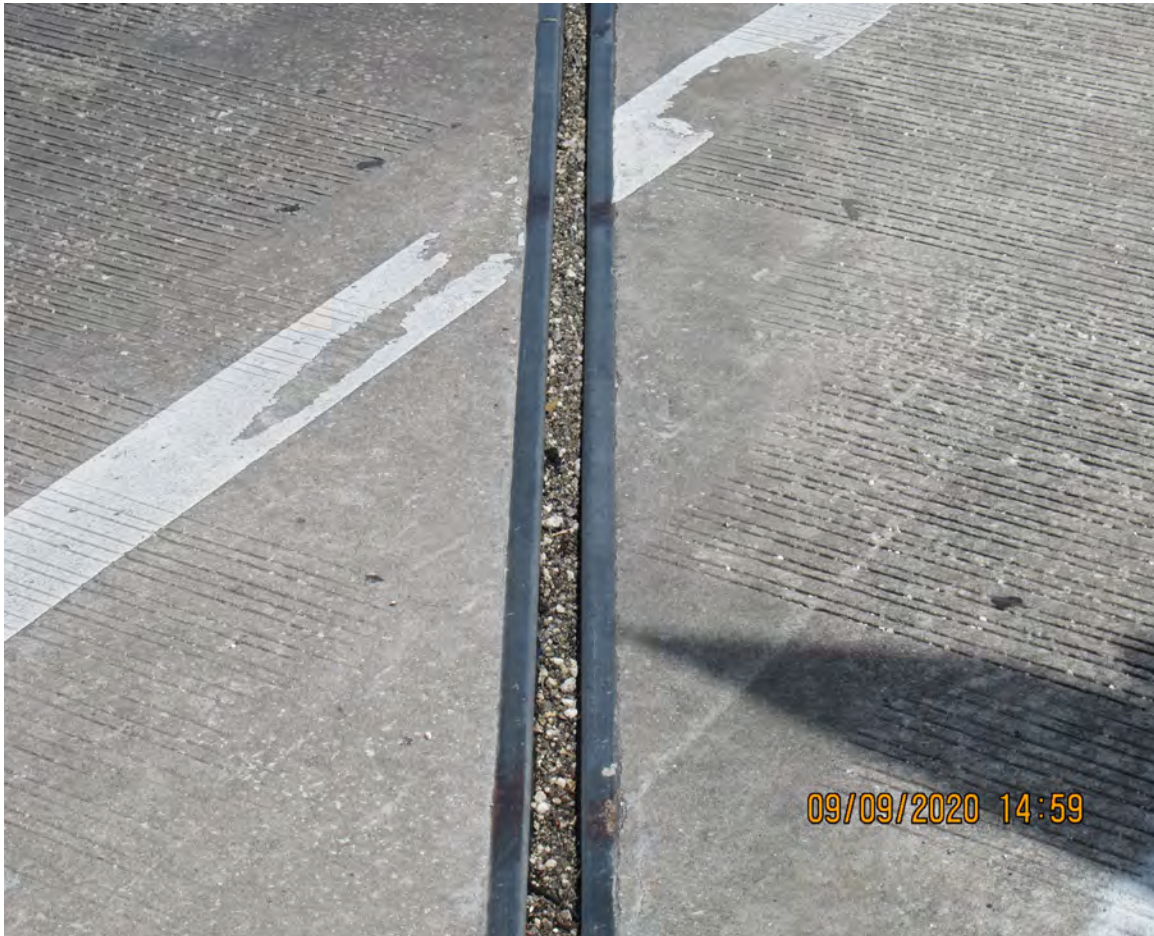
**PHOTO NO.: EB-024  
DATE: 09-09-2020**

**ROADWAY INSPECTION  
LOCATION: MILE MARKER 12.22  
EASTBOUND MAILINE**

**SEDIMENT AND DEBRIS ON BRIDGE EXPANSION JOINTS (BRIDGE # 870966)  
(TYPICAL THROUGHOUT)**

**ITEM NOTED TO BE ADDRESSED BY MDX EMERGENCY PUSH BUTTON  
CONTRACTS**

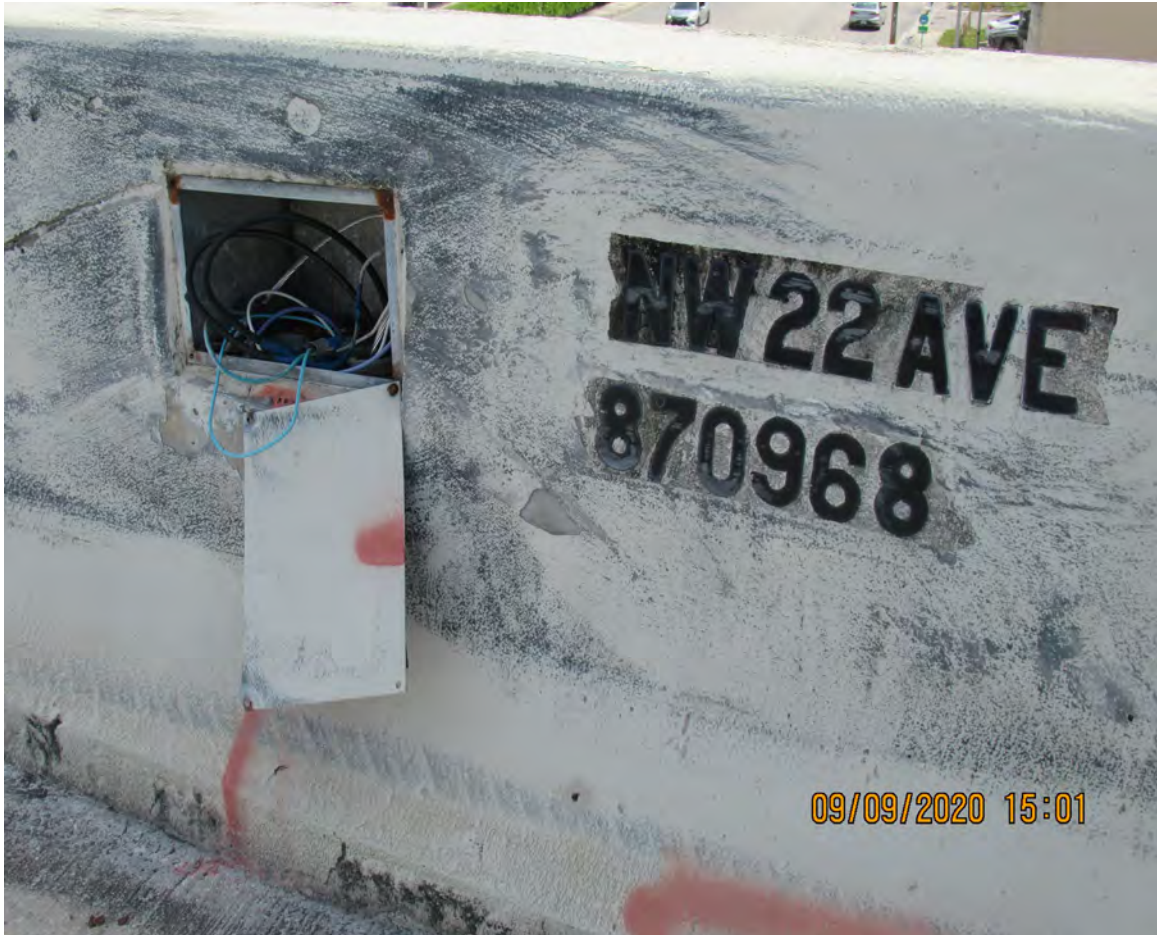
**PHOTO NO.: EB-025  
DATE: 09-09-2020**

**ROADWAY INSPECTION  
LOCATION: MILE MARKER 12.4  
EASTBOUND MAILINE (RIGHT SHOULDER)**

**DETACHED PULL BOX COVER (BRIDGE # 870968)**

**ITEM NOTED TO BE ADDRESSED BY MDX EMERGENCY PUSH BUTTON  
CONTRACTS**
