# Annual Inspection Report 2020

# ANNUAL INSPECTION REPORT

As detailed in the following sections, EAC Consulting has found the MDX System to be in good working order and condition.

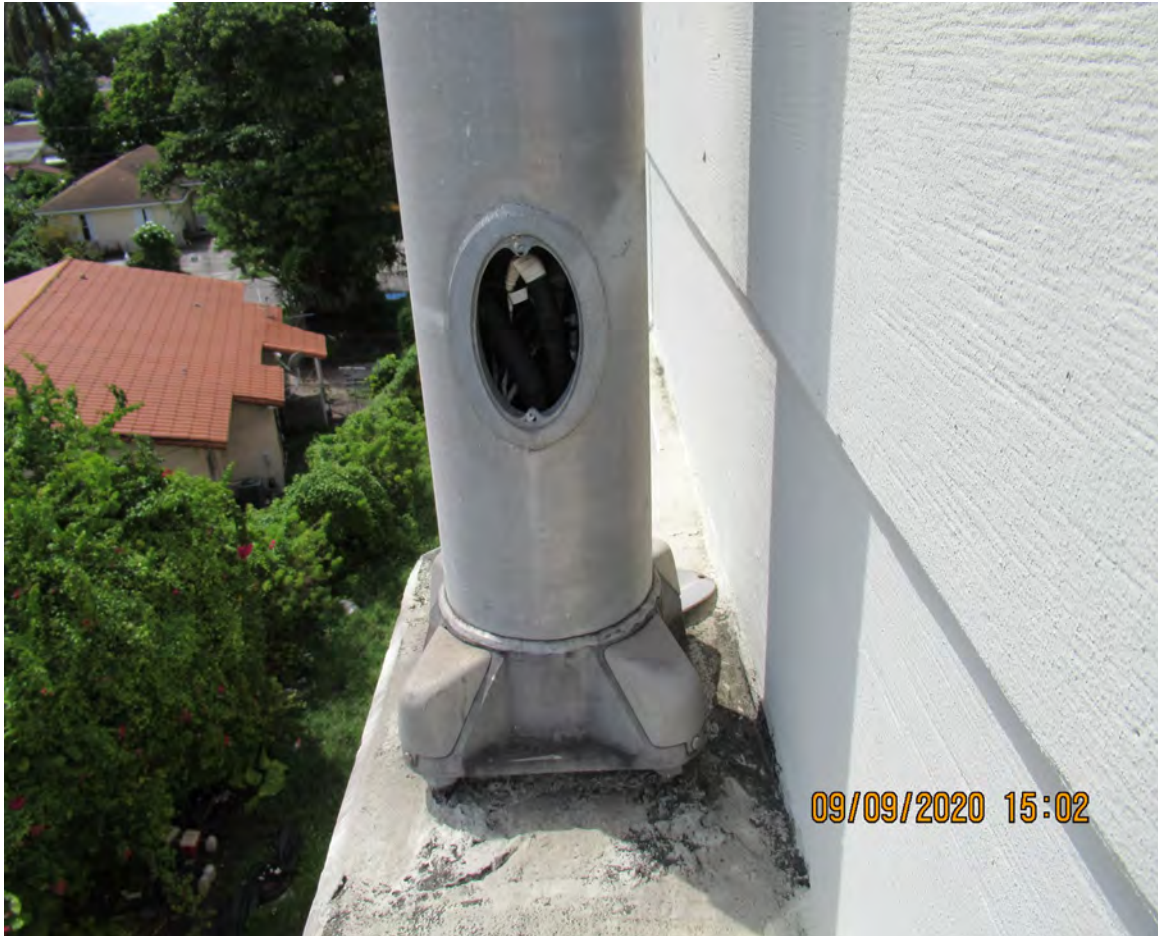
**PHOTO NO.: EB-026  
DATE: 09-09-2020**

**ROADWAY INSPECTION  
LOCATION: MILE MARKER 12.42  
EASTBOUND MAILINE (RIGHT SHOULDER)**

**MISSING HANDHOLE COVER (POLE ID # 11-9A-1-2)**

**ITEM NOTED TO BE ADDRESSED BY MDX EMERGENCY PUSH BUTTON  
CONTRACTS**

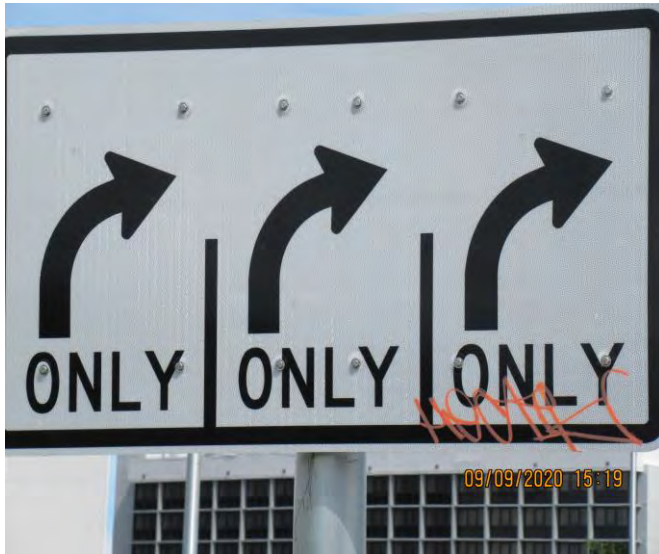
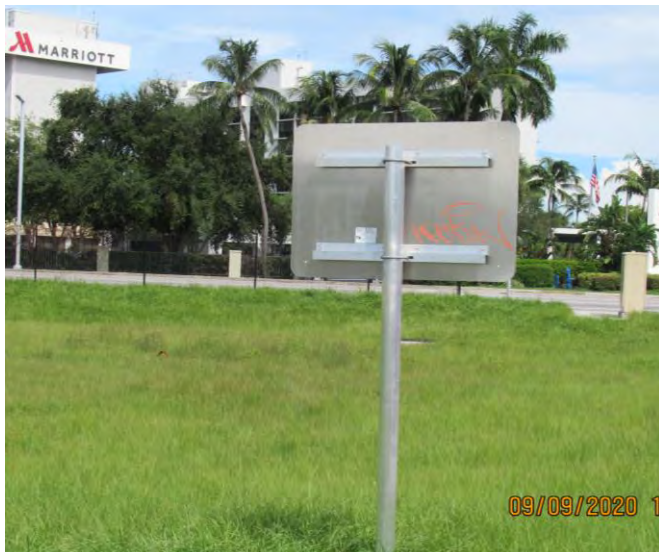
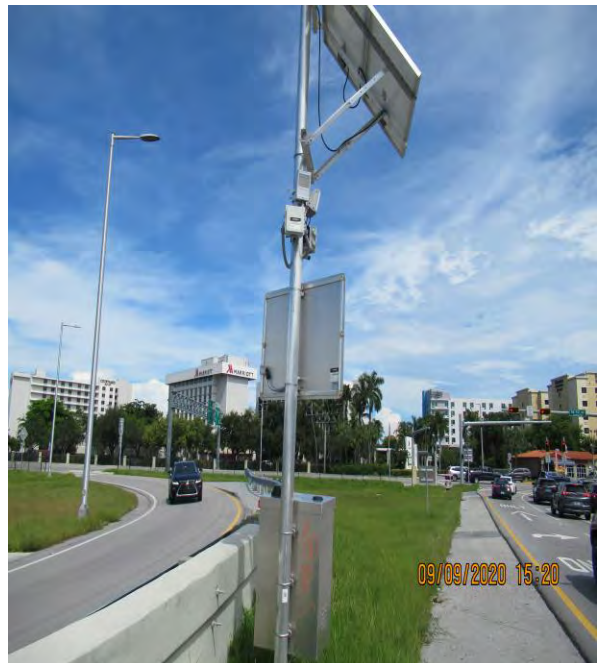
PHOTO NO.: EB-028  
DATE: 09-09-2020

ROADWAY INSPECTION  
LOCATION: MILE MARKER 10.26  
EASTBOUND OFF-RAMP TO NW 42<sup>nd</sup> AVENUE SOUTH  
(LEFT SHOULDER)

**GRAFITTI ON SIGN PANELS AND CONTROLER BOX**

**ITEM NOTED TO BE ADDRESSED BY MDX EMERGENCY PUSH BUTTON  
CONTRACTS**

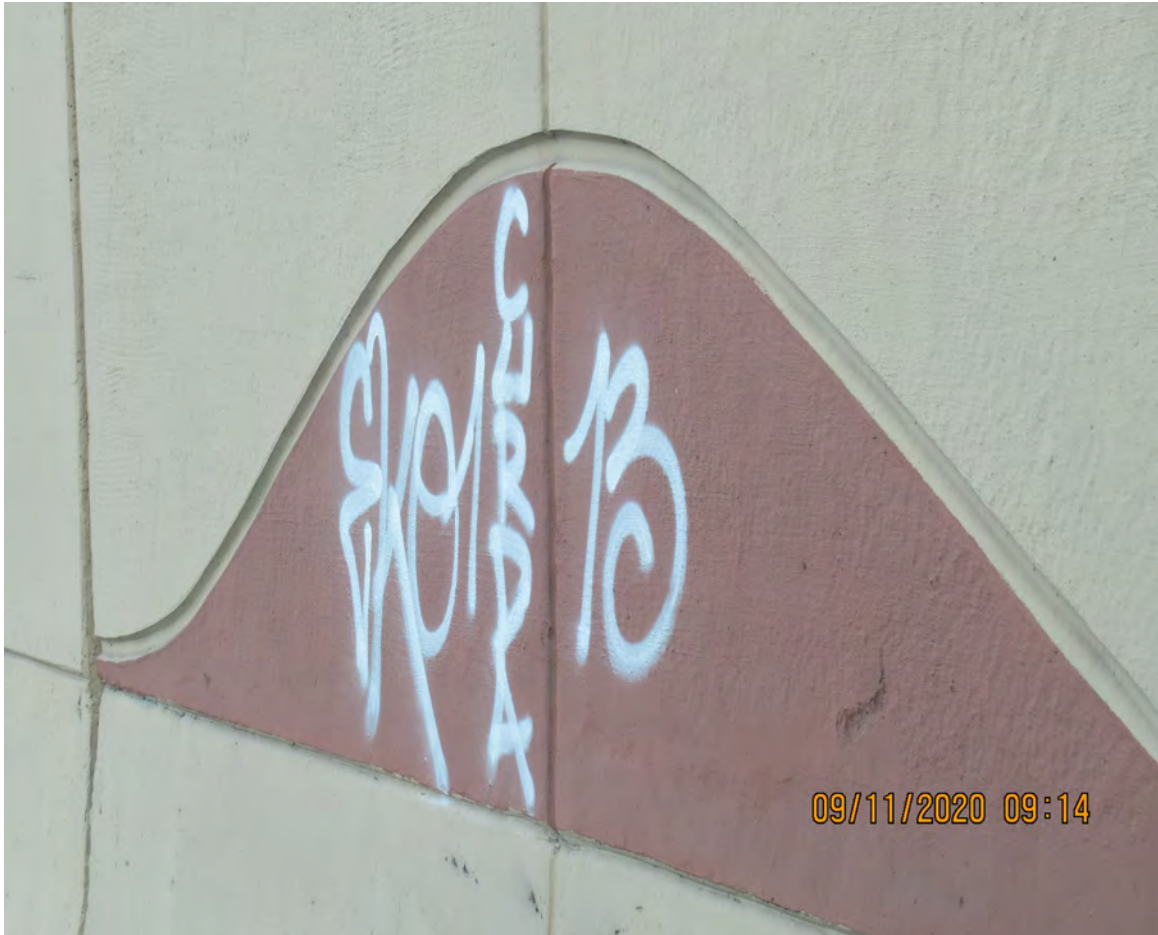
**PHOTO NO.: WB-003  
DATE: 09-11-2020**

**ROADWAY INSPECTION  
LOCATION: MILE MARKER 11.7 MILES  
WESTBOUND MAINLINE (RIGHT SHOULDER)**

**GRAFFITI ON SOUND WALL**

**ITEM NOTED TO BE ADDRESSED BY MDX EMERGENCY PUSH BUTTON  
CONTRACTS**

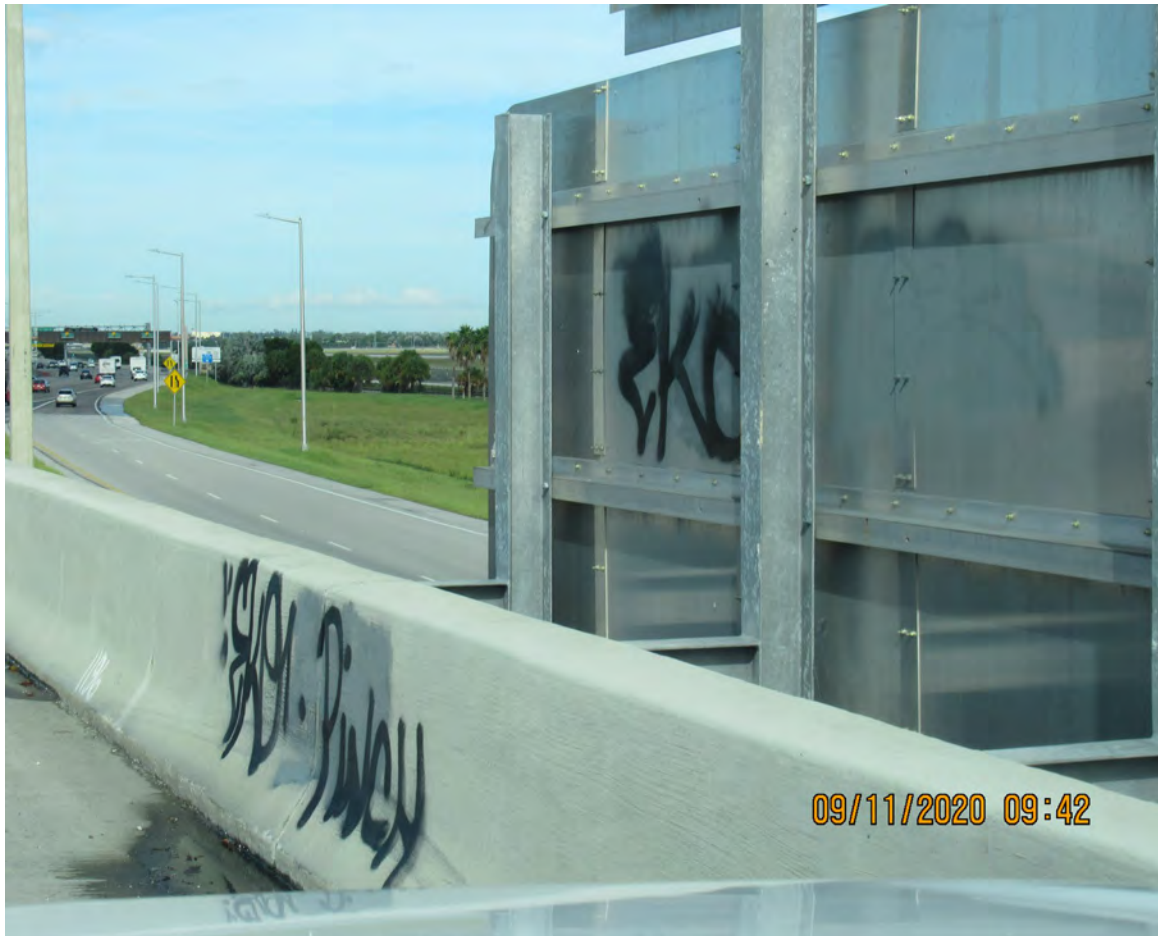
**PHOTO NO.: WB-007  
DATE: 09-11-2020**

**ROADWAY INSPECTION  
LOCATION: MILE MARKER 8.71 MILES  
WESTBOUND MAINLINE (RIGHT SHOULDER)**

**GRAFITTI ON THE BACK OF THE SIGN PANEL AND ON THE BARRIER WALL  
(END BENT 6)**

**ITEM NOTED TO BE ADDRESSED BY MDX EMERGENCY PUSH BUTTON  
CONTRACTS**

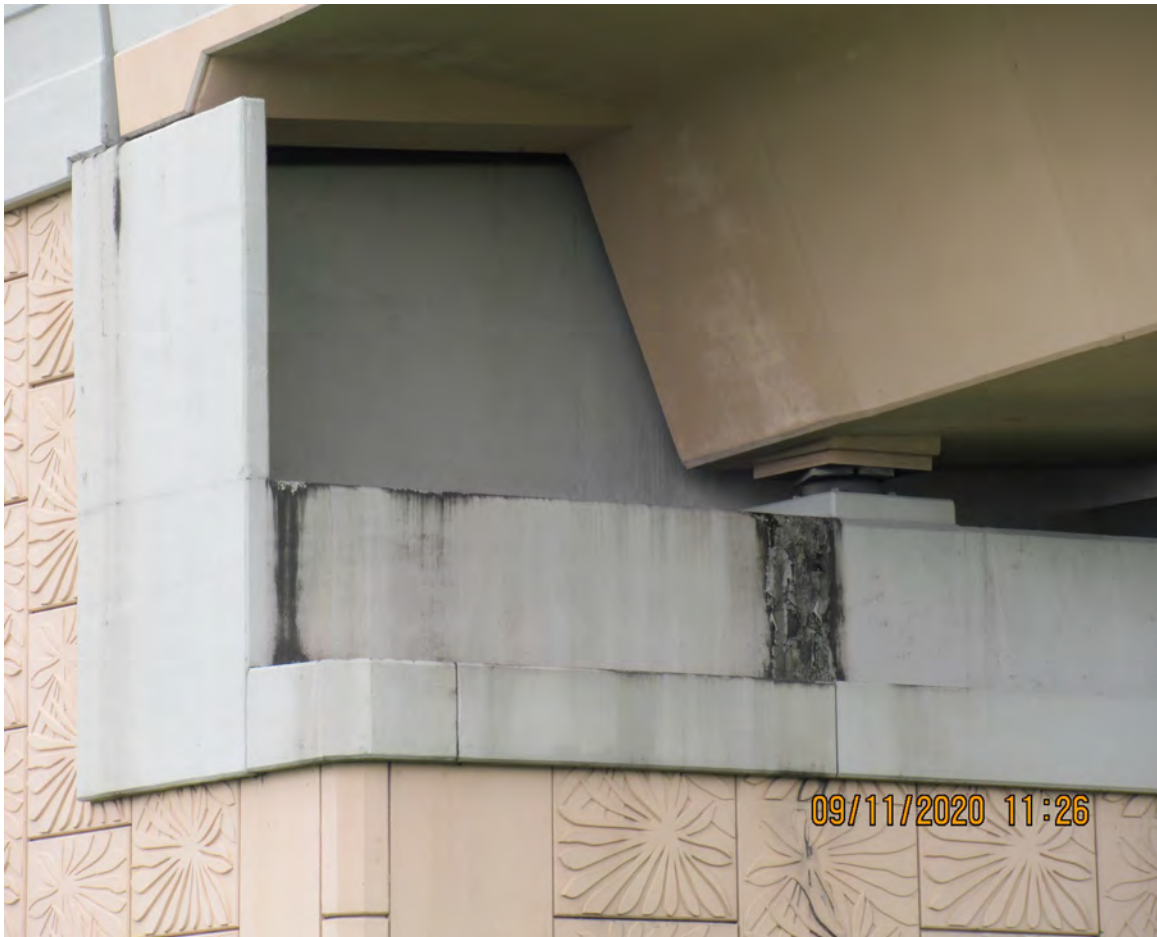
**PHOTO NO.: WB-011  
DATE: 09-11-2020**

**ROADWAY INSPECTION  
LOCATION: MILE MARKER 6.74 MILES  
SR 826 NORTHBOUND OFF-RAMP TO WESTBOUND SR 836**

**WATER STAINS FROM CLOGGED BRIDGE DRAINAGE (BRIDGE # 870078)**

**ITEM NOTED TO BE ADDRESSED BY MDX MAINTENANCE**

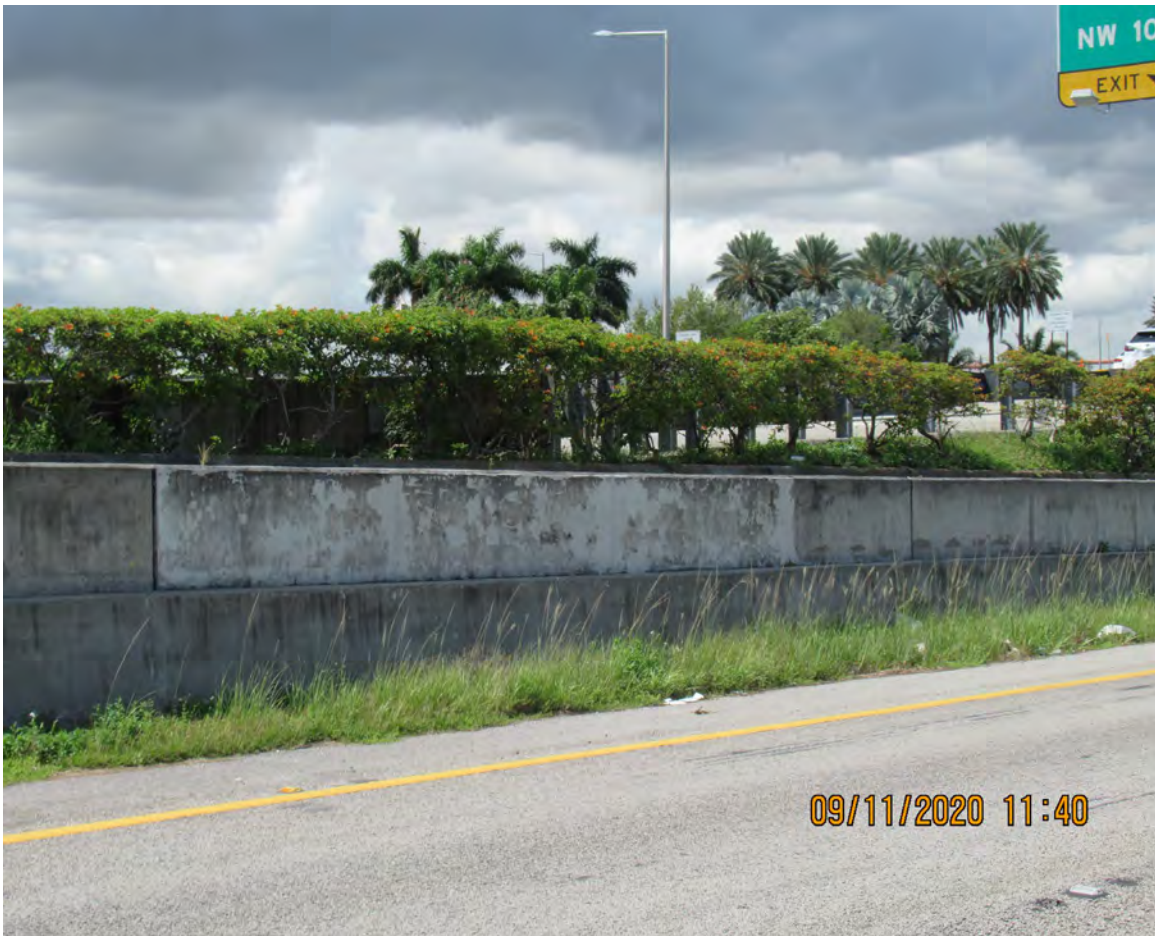
**PHOTO NO.: WB-013  
DATE: 09-11-2020**

**ROADWAY INSPECTION  
LOCATION: MILE MARKER 6.70 MILES  
WESTBOUND OFF-RAMP TO NW 107<sup>th</sup> AVENUE NORTH  
(LEFT SHOULDER)**

**DETERIORATED CLASS V COATING ON RETAINING WALL**

**ITEM NOTED TO BE ADDRESSED BY MDX WORK PROGRAM No. 30037**

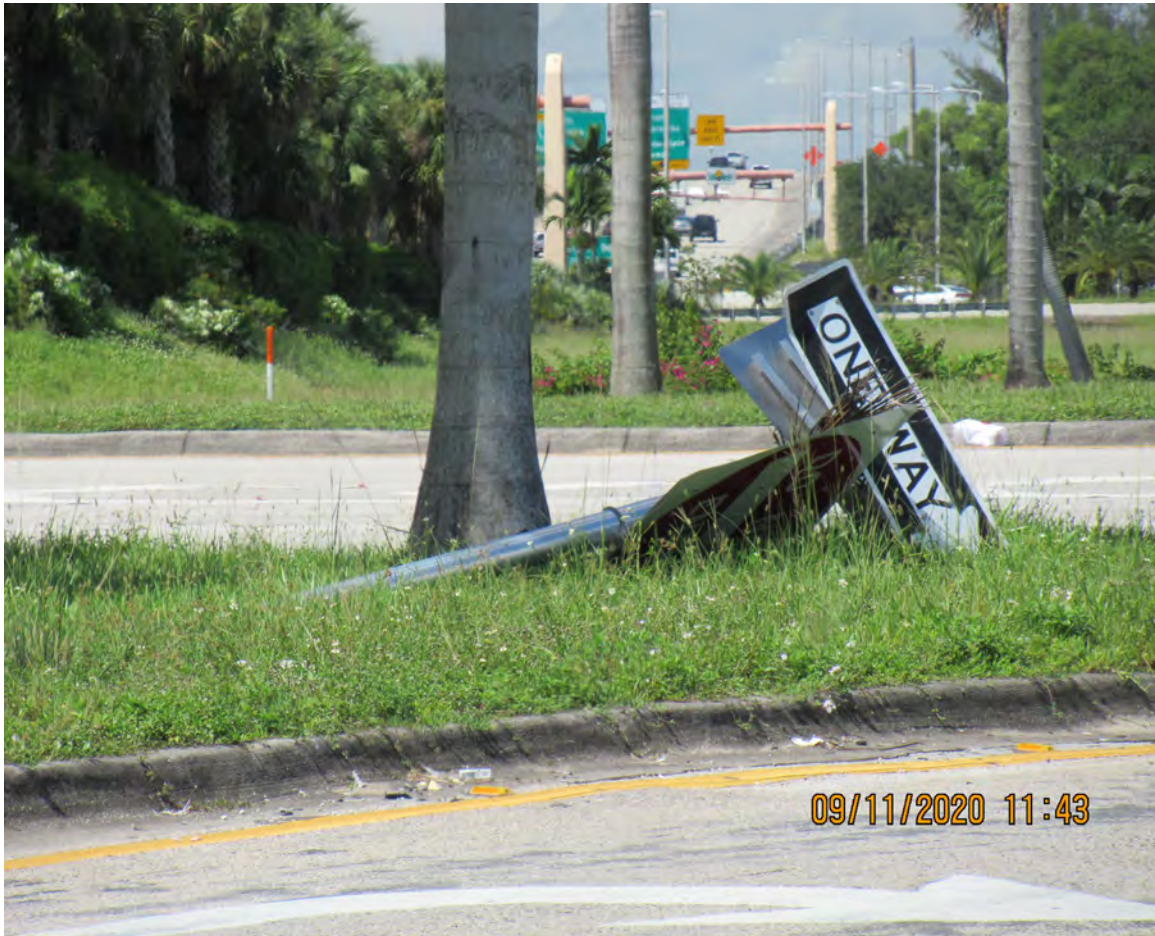
**PHOTO NO.: WB-014  
DATE: 09-11-2020**

**ROADWAY INSPECTION  
LOCATION: MILE MARKER 4.20 MILES  
WESTBOUND OFF-RAMP TO NW 107<sup>th</sup> AVENUE NORTH  
(LEFT SHOULDER)**

**DOWN SIGN DUE TO VEHICULAR ACCIDENT**

**ITEM NOTED TO BE ADDRESSED BY MDX EMERGENCY PUSH BUTTON  
CONTRACTS**

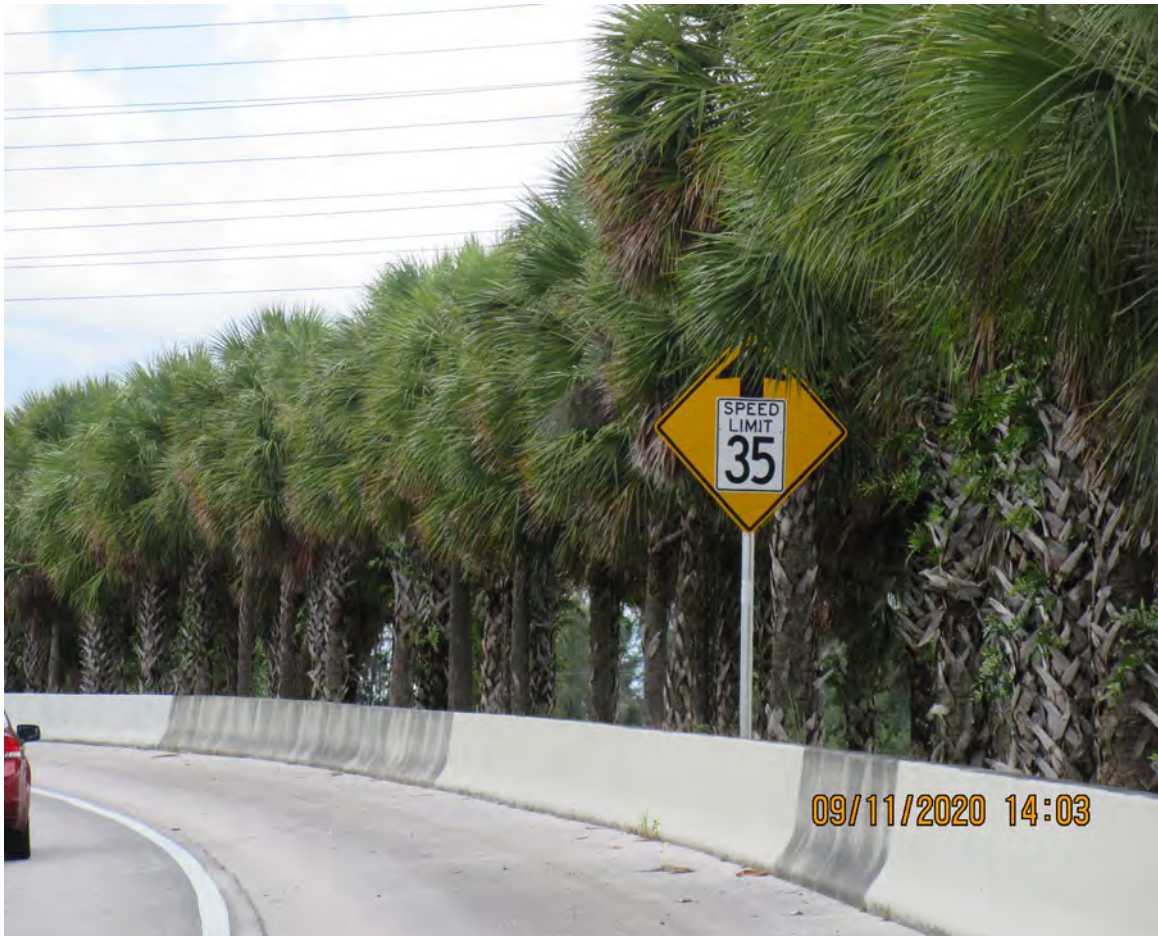
**PHOTO NO.: WB-020  
DATE: 09-11-2020**

**ROADWAY INSPECTION  
LOCATION: MILE MARKER 0.65 MILES  
WESTBOUND MAINLINE (RIGHT SHOULDER)**

**PALM FRONDS OBSTRUCTING SIGN**

**ITEM NOTED TO BE ADDRESSED BY MDX EMERGENCY PUSH BUTTON  
CONTRACTS**

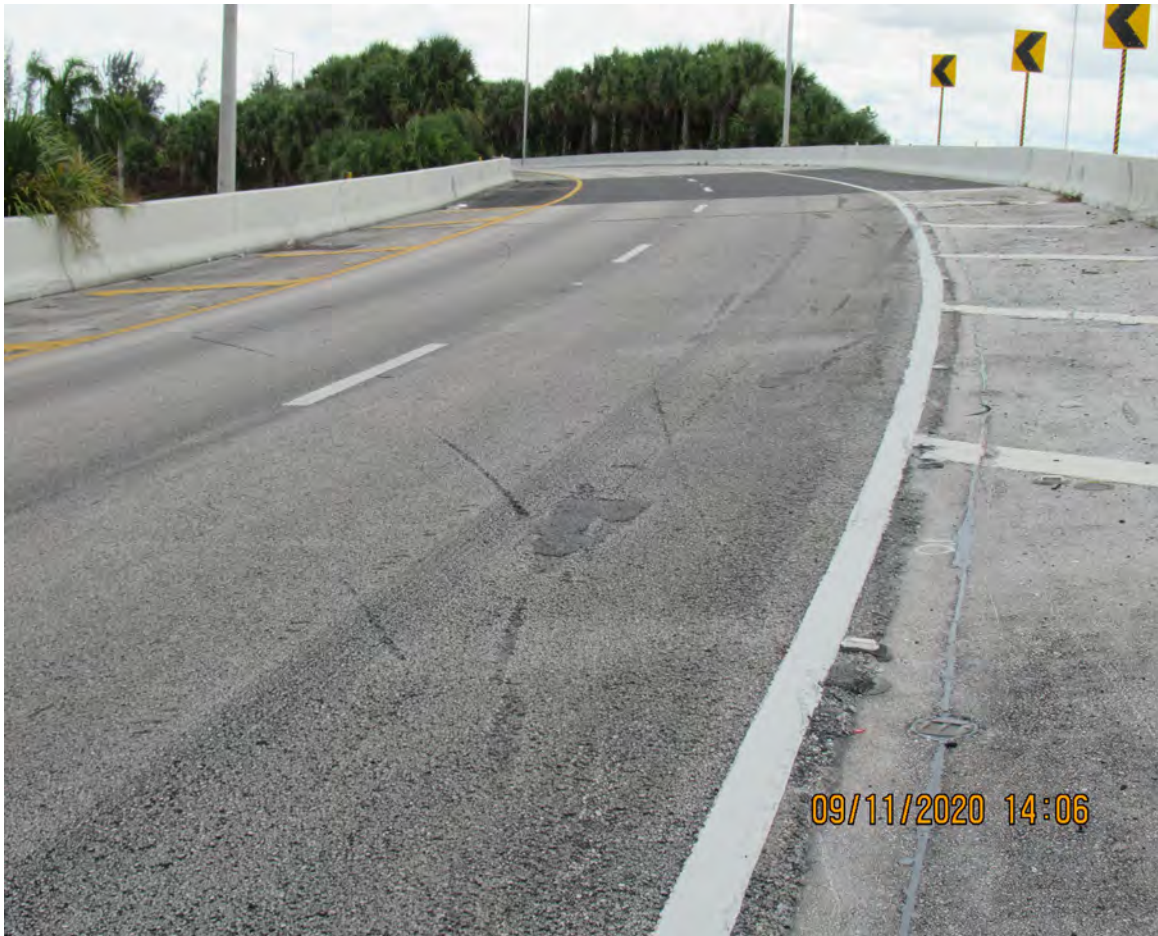
**PHOTO NO.: WB-022  
DATE: 09-11-2020**

**ROADWAY INSPECTION  
LOCATION: MILE MARKER 0.40 MILES  
WESTBOUND OFF-RAMP TO SOUTHBOUND  
NW 137<sup>th</sup> AVENUE**

**DETERIORATED FRICTION COURSE DUE TO NUMEROUS VEHICULAR ACCIDENTS**

**ITEM NOTED TO BE ADDRESSED BY MDX MAINTENANCE**

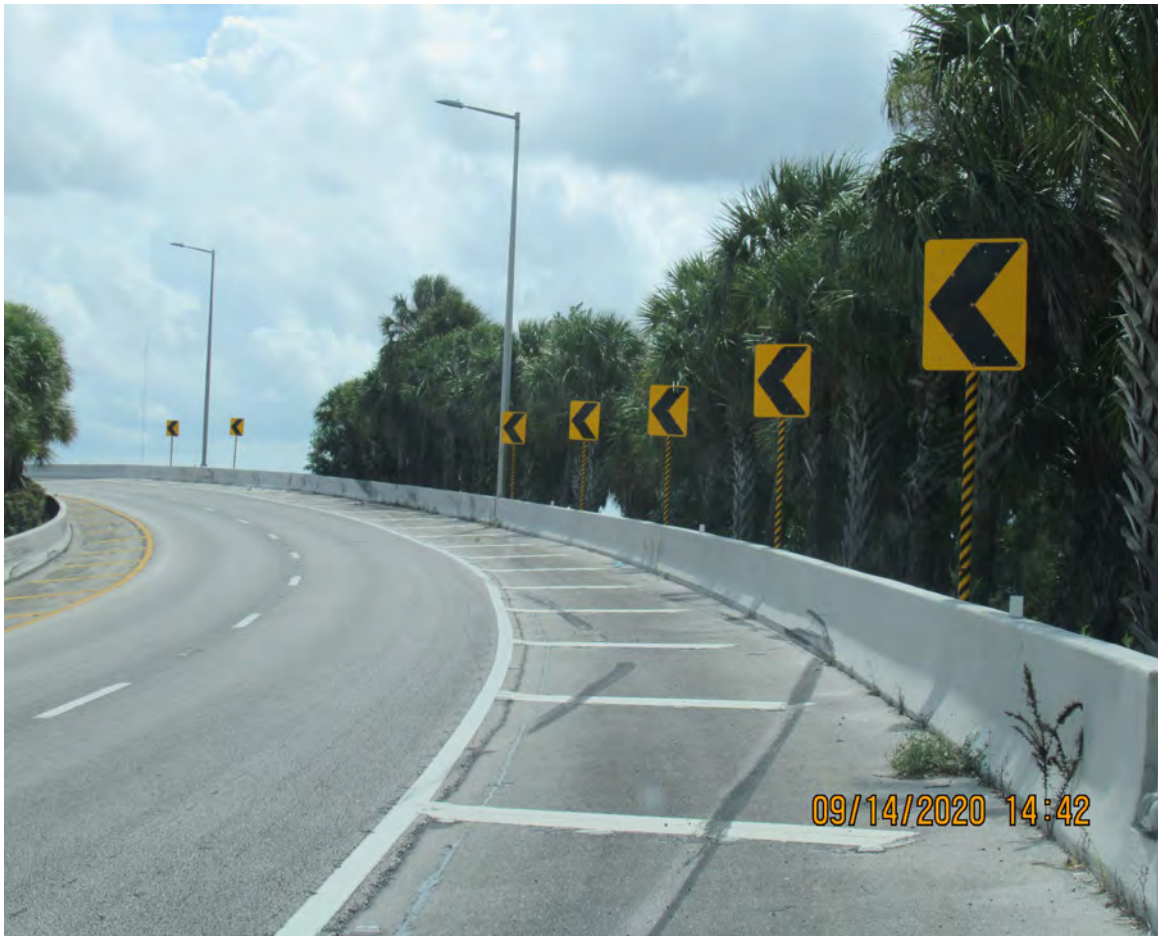
**PHOTO NO.: WB-023  
DATE: 09-14-2020**

**ROADWAY INSPECTION  
LOCATION: MILE MARKER 0.40 MILES  
WESTBOUND OFF-RAMP TO SOUTHBOUND  
NW 137<sup>th</sup> AVENUE**

**FIVE DAMAGED ILLUMINATED CHEVRONS DUE TO VEHICULAR ACCIDENTS**

**ITEM NOTED TO BE ADDRESSED BY MDX MAINTENANCE**

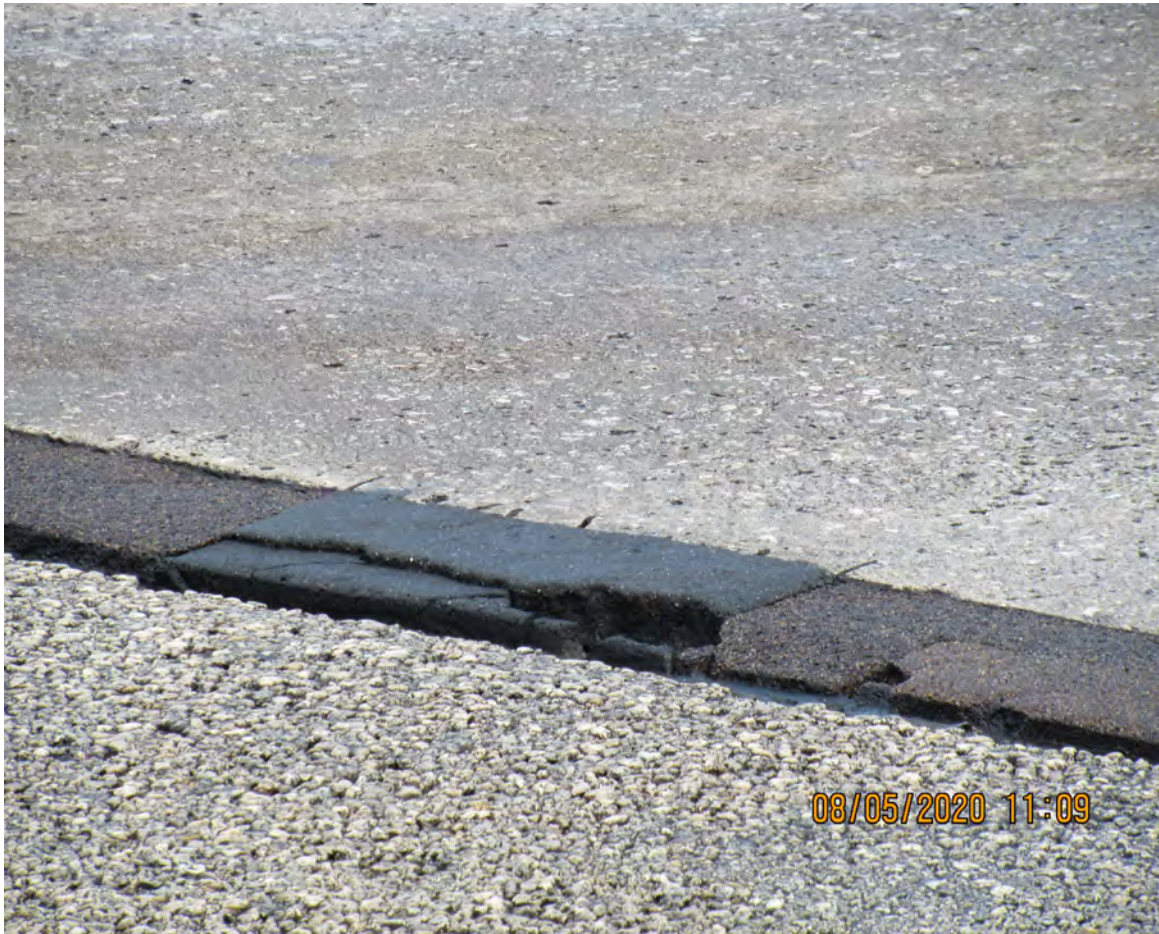
**PHOTO NO.: NB-001  
DATE: 08-05-2020**

**ROADWAY INSPECTION  
LOCATION: MILE MARKER 1.66 MILES  
NORTHBOUND MAINLINE**

**DETERIORATED POLYMER NOSING JOINT HEADER (BRIDGE # 870462)**

**ITEM NOTED TO BE ADDRESSED BY MDX WORK PROGRAM No. 30029**

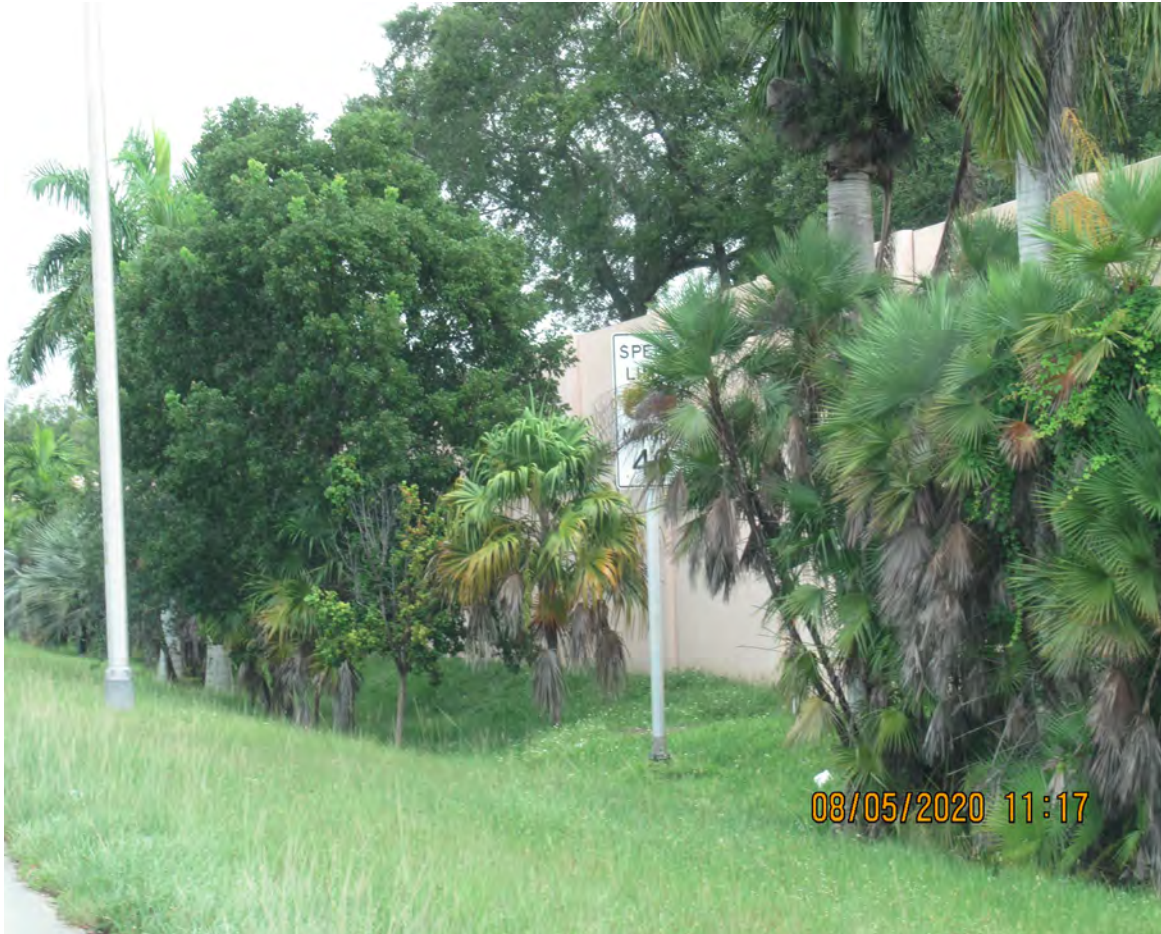
**PHOTO NO.: NB-002  
DATE: 08-05-2020**

**ROADWAY INSPECTION  
LOCATION: MILE MARKER 3.06 MILES  
NORTHBOUND MAINLINE (RIGHT SHOULDER)**

**OVERGROWN VEGETATION OBSTRUCTING SIGN**

**ITEM NOTED TO BE ADDRESSED BY MDX EMERGENCY PUSH BUTTON  
CONTRACTS**

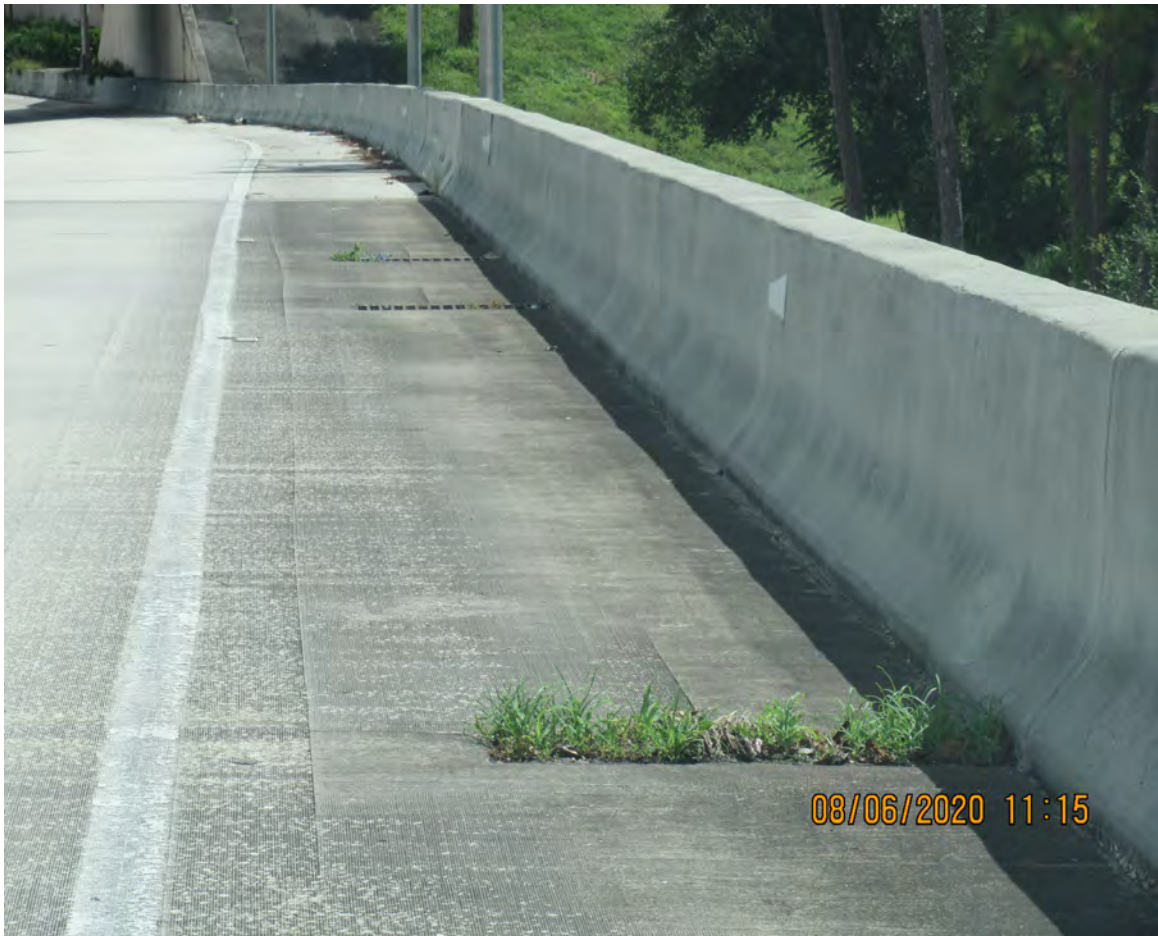
**PHOTO NO.: NB-005  
DATE: 08-06-2020**

**ROADWAY INSPECTION  
LOCATION: MILE MARKER 4.0 TO 4.4 MILES  
NORTHBOUND ON-RAMP FROM KENDALL DR.**

**SILTED DRAINAGE INLET BRIDGE # 871024  
(TYPICAL AT VARIOUS LOCATIONS)**

**ITEM NOTED TO BE ADDRESSED BY MDX MAINTENANCE**

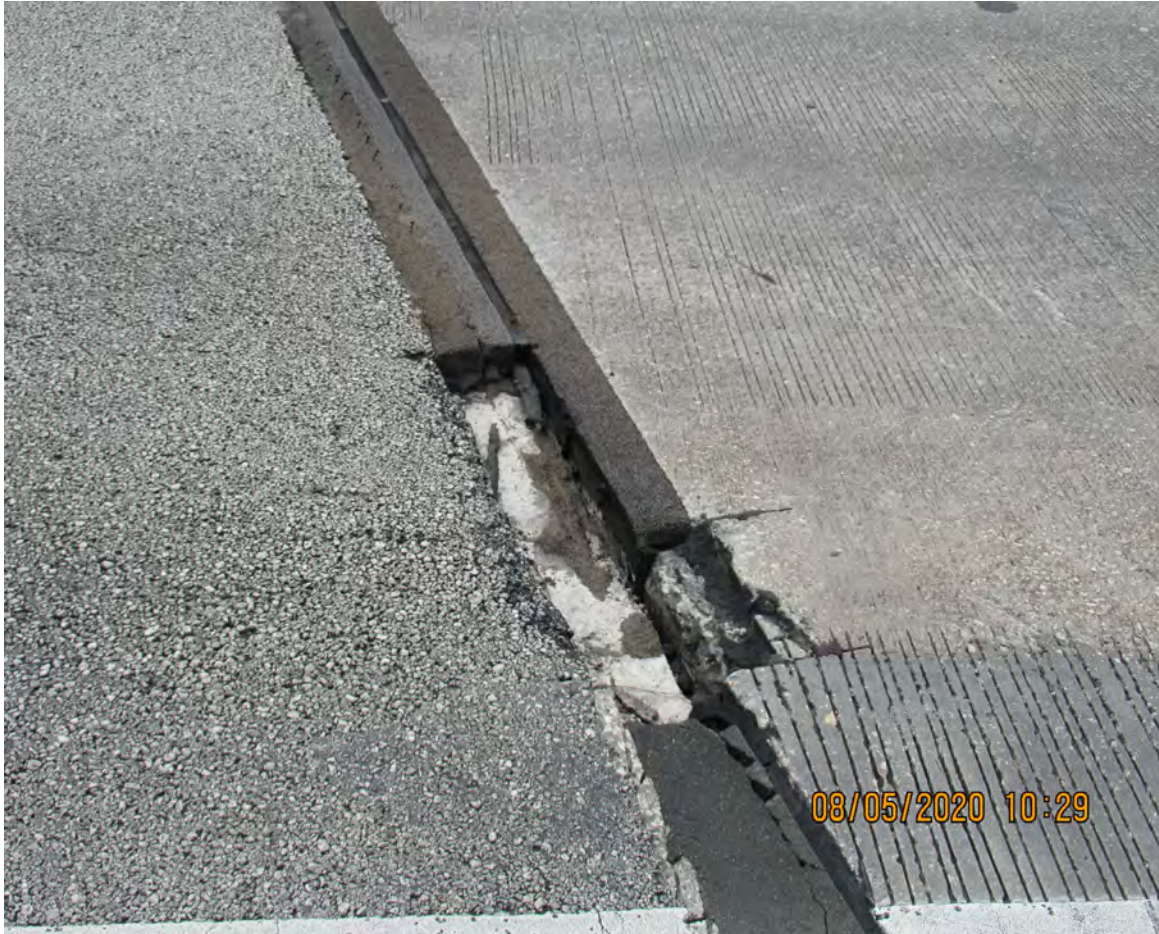
**PHOTO NO.: SB-002  
DATE: 08-05-2020**

**ROADWAY INSPECTION  
LOCATION: MILE MARKER 4.06 MILES  
SOUTHBOUND MAINLINE**

**DAMAGED POLYMER NOSING JOINT HEADER (BRIDGE # 870495)**

**ITEM NOTED TO BE ADDRESSED BY MDX EMERGENCY PUSH BUTTON  
CONTRACTS**

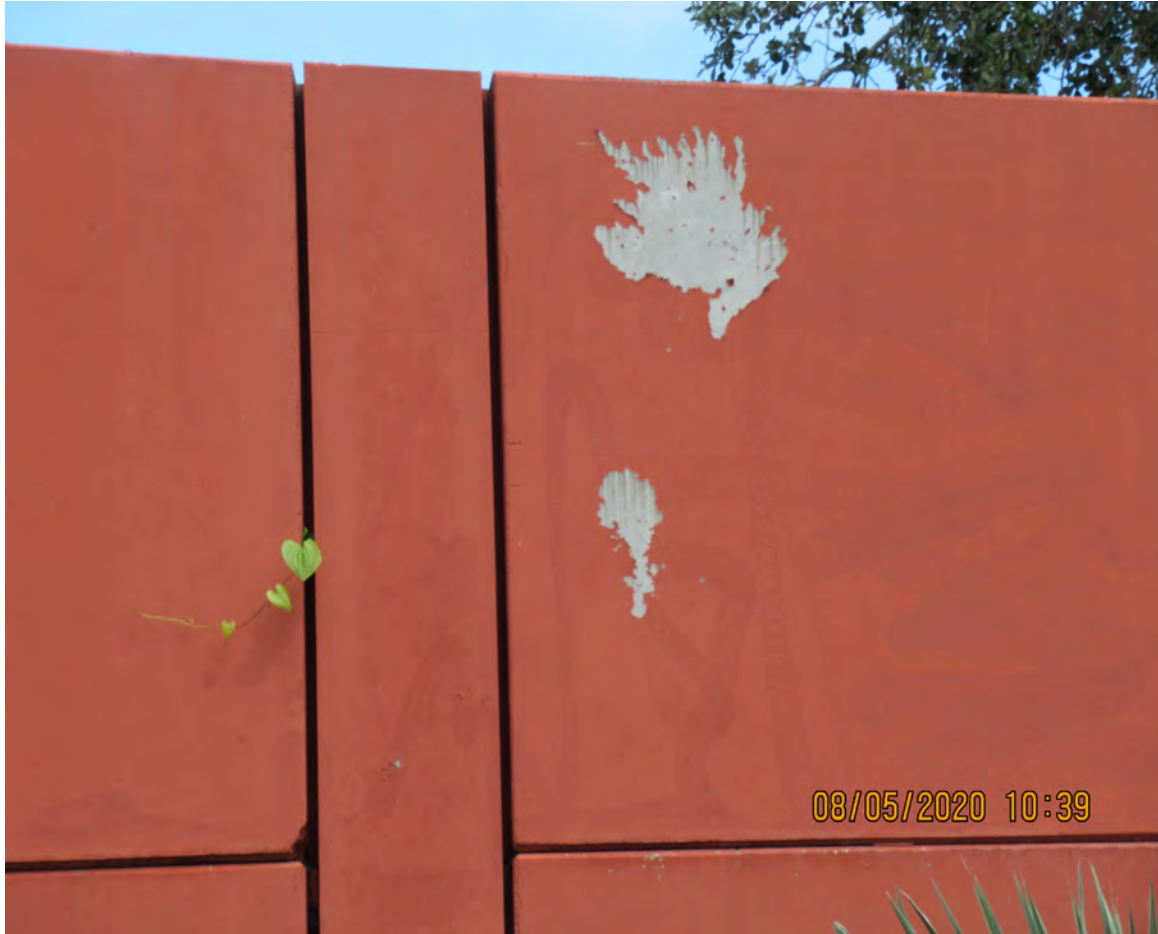
**PHOTO NO.: SB-003  
DATE: 08-05-2020**

**ROADWAY INSPECTION  
LOCATION: MILE MARKER 3.25 MILES  
SOUTHBOUND MAINLINE (RIGHT SHOULDER)**

**DETERIORATED CLASS V COATING ON SOUND WALLS  
(TYPICAL THROUGHOUT THE CORRIDOR)**

**ITEM NOTED TO BE ADDRESSED BY MDX WORK PROGRAM No. 30037**

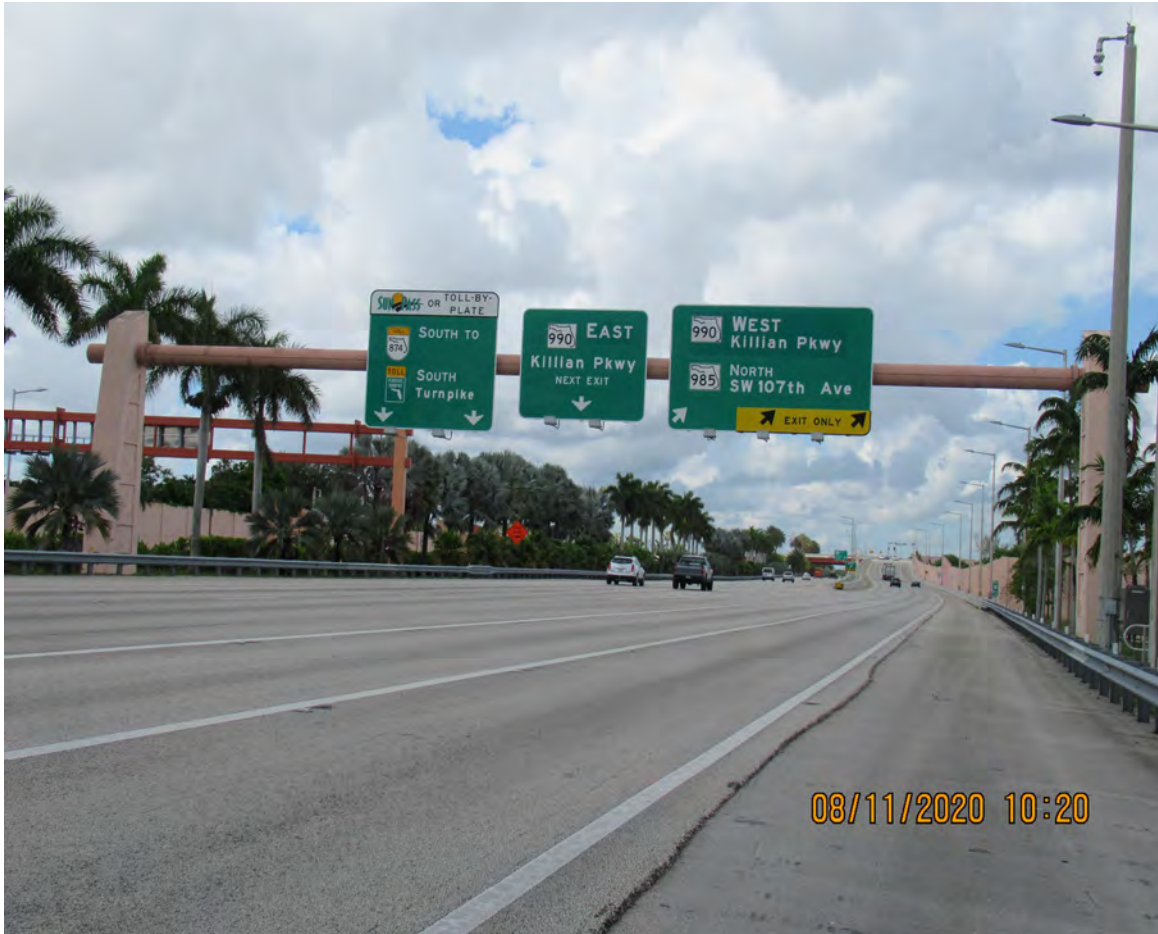
**PHOTO NO.: SB-005**  
**DATE: 08-11-2020**

**ROADWAY INSPECTION**  
**LOCATION: MILE MARKER 3.44 MILES**  
**SOUTHBOUND MAINLINE (RIGHT SHOULDER)**

**DETERIORATED PAINT ON SIGN STRUCTURE UPRIGHTS AND MONOTUBE  
(STRUCTURE #87A051)**

**ITEM NOTED TO BE ADDRESSED BY MDX WORK PROGRAM No. 30037 & 30047**

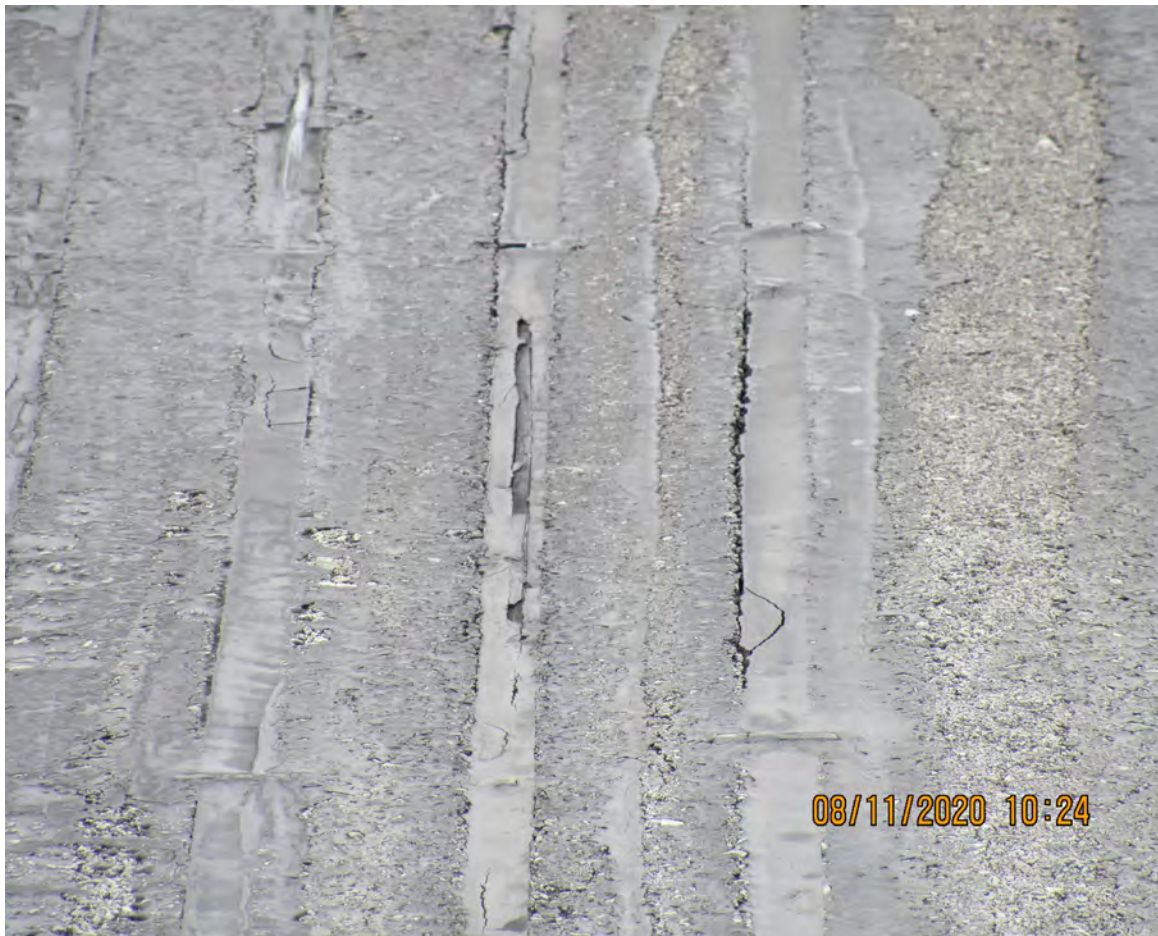
**PHOTO NO.: SB-006  
DATE: 08-11-2020**

**ROADWAY INSPECTION  
LOCATION: MILE MARKER 2.74 MILES  
SOUTHBOUND MAINLINE**

**DETERIORATED TOLLS LOOP DETECTOR SEALANT**

**ITEM NOTED TO BE ADDRESSED BY MDX TOLL SYSTEMS INTEGRATOR**

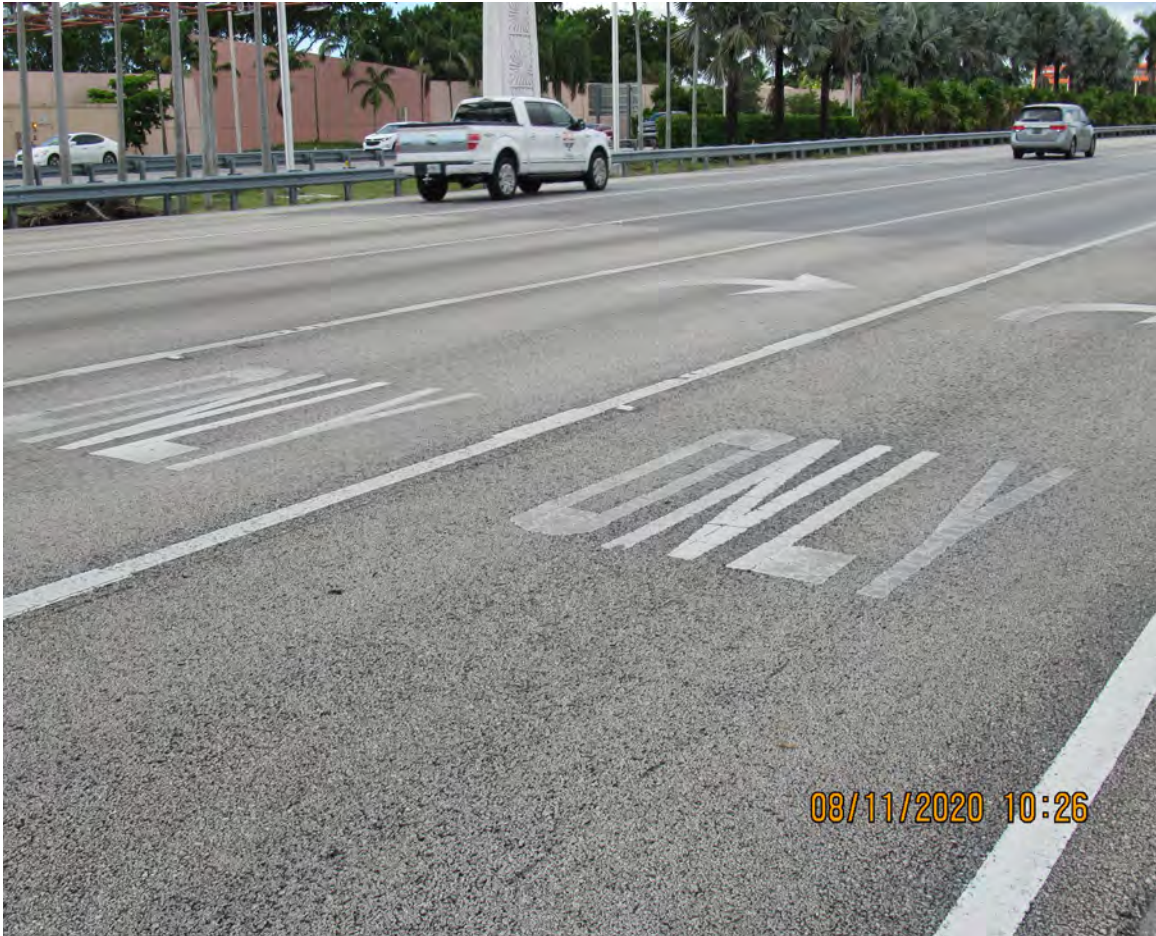
**PHOTO NO.: SB-007**  
**DATE: 08-11-2020**

**ROADWAY INSPECTION**  
**LOCATION: MILE MARKER 2.77 & 2.87 MILES**  
**SOUTHBOUND MAINLINE (LANES 3 & 4)**

**DETERIORATED THERMOPLASTIC PAVEMENT MESSAGE AND ARROWS**

**ITEM NOTED TO BE ADDRESSED BY MDX MAINTENANCE**

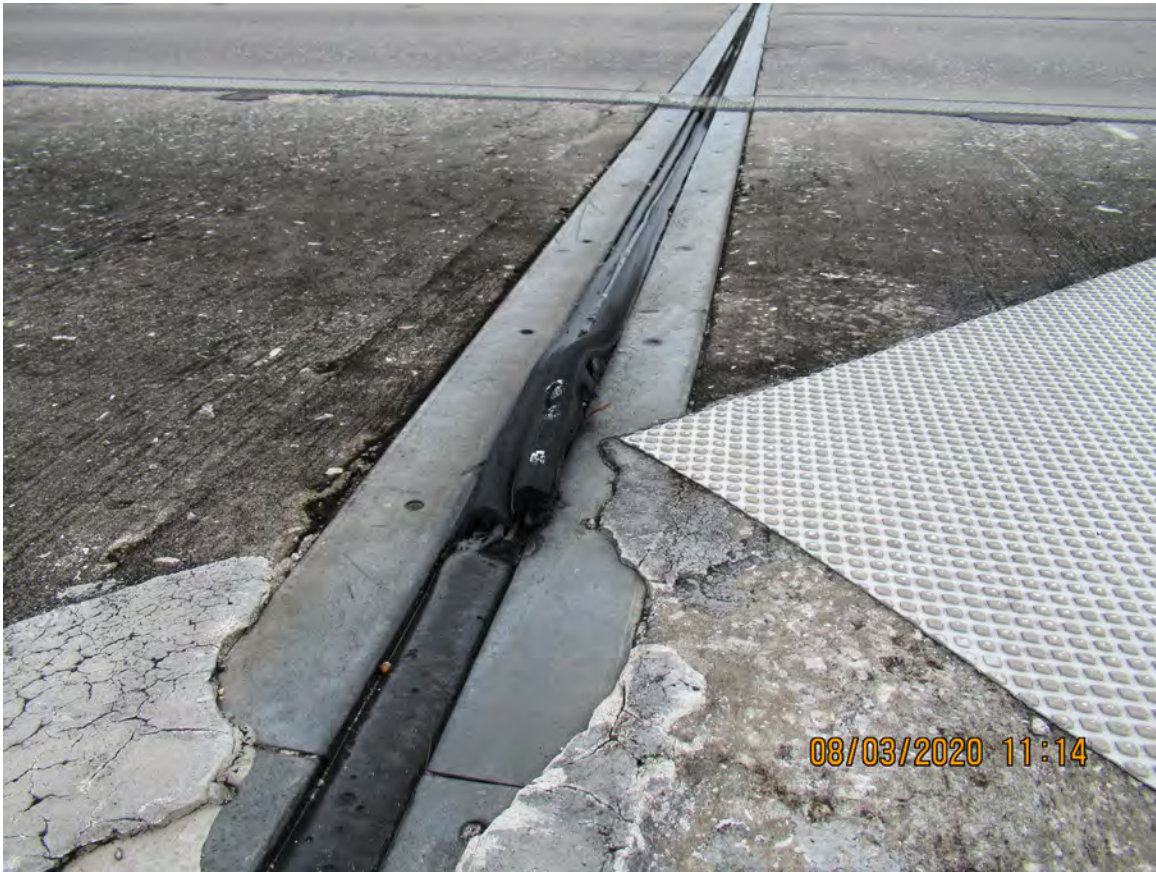
**PHOTO NO.: EB-002  
DATE: 08-03-2020**

**ROADWAY INSPECTION  
LOCATION: MILE MARKER 1.03 MILES  
EASTBOUND MAINLINE**

**DETERIORATED EXPANSION JOINTS (BRIDGE #870557)  
TYPICAL THROUGHOUT THE CORRIDOR**

**ITEM NOTED TO BE ADDRESSED BY MDX WORK PROGRAM No. 30029**

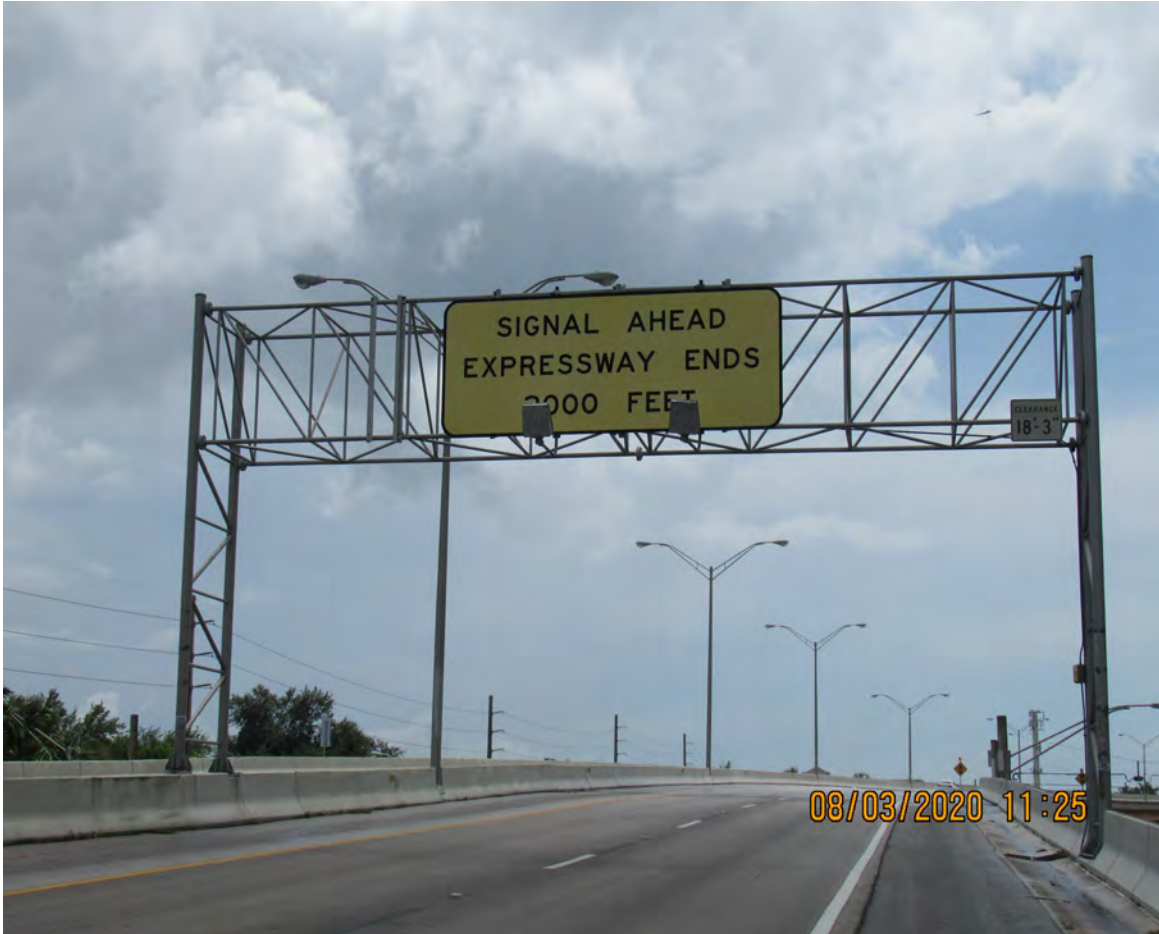
**PHOTO NO.: EB-006  
DATE: 08-03-2020**

**ROADWAY INSPECTION  
LOCATION: MILE MARKER 2.20 MILES  
EASTBOUND MAINLINE**

**DETERIORETED REFLECTIVE SHEETING ON SIGN PANEL  
(STRUCTURE # 87S115)**

**ITEM NOTED TO BE ADDRESSED BY MDX MAINTENANCE**
