# Annual Inspection Report 2020

# ANNUAL INSPECTION REPORT

As detailed in the following sections, EAC Consulting has found the MDX System to be in good working order and condition.

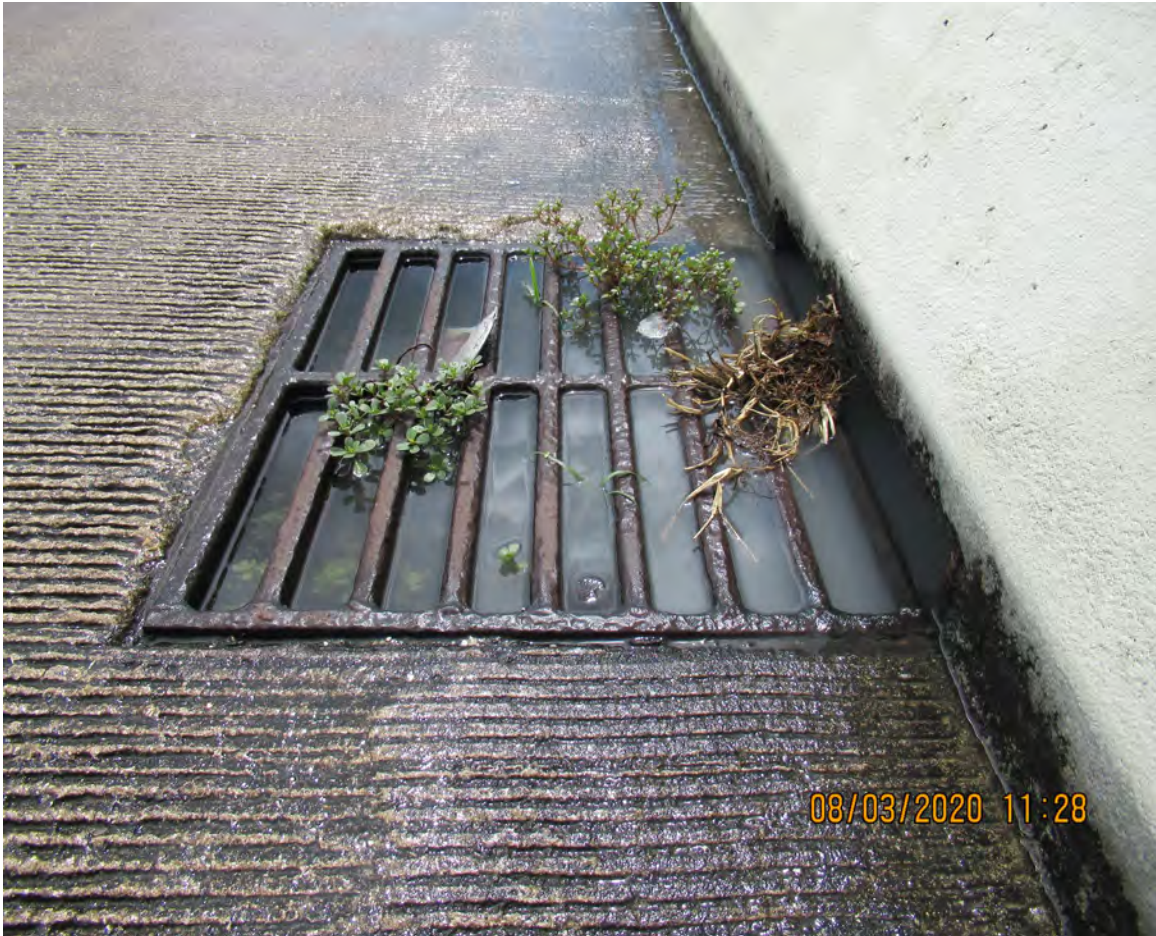
**PHOTO NO.: EB-007  
DATE: 08-03-2020**

**ROADWAY INSPECTION  
LOCATION: MILE MARKER 2.80 MILES  
EASTBOUND MAINLINE**

**SILTED BRIDGE DRAINAGE INLET BRIDGE #870559  
(TYPICAL AT VARIOUS LOCATIONS)**

**ITEM NOTED TO BE ADDRESSED BY MDX EMERGENCY PUSH BUTTON  
CONTRACTS**

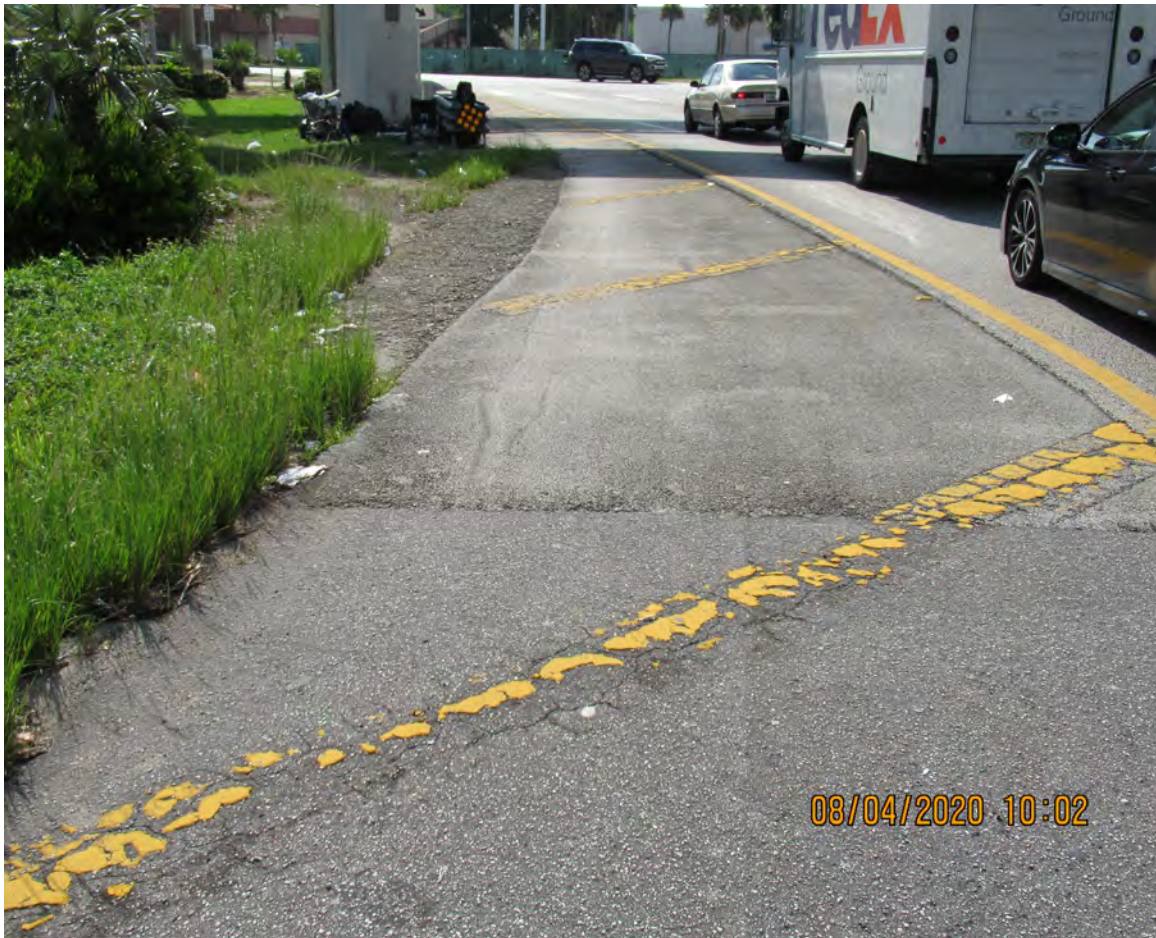
**PHOTO NO.: EB-008  
DATE: 08-04-2020**

**ROADWAY INSPECTION  
LOCATION: MILE MARKER 3.20 MILES  
EASTBOUND MAINLINE (LEFT SHOULDER)**

**DETERIORATED THERMOPLASTIC STRIPING IN GORE AREA**

**ITEM NOTED TO BE ADDRESSED BY MDX MAINTENANCE**

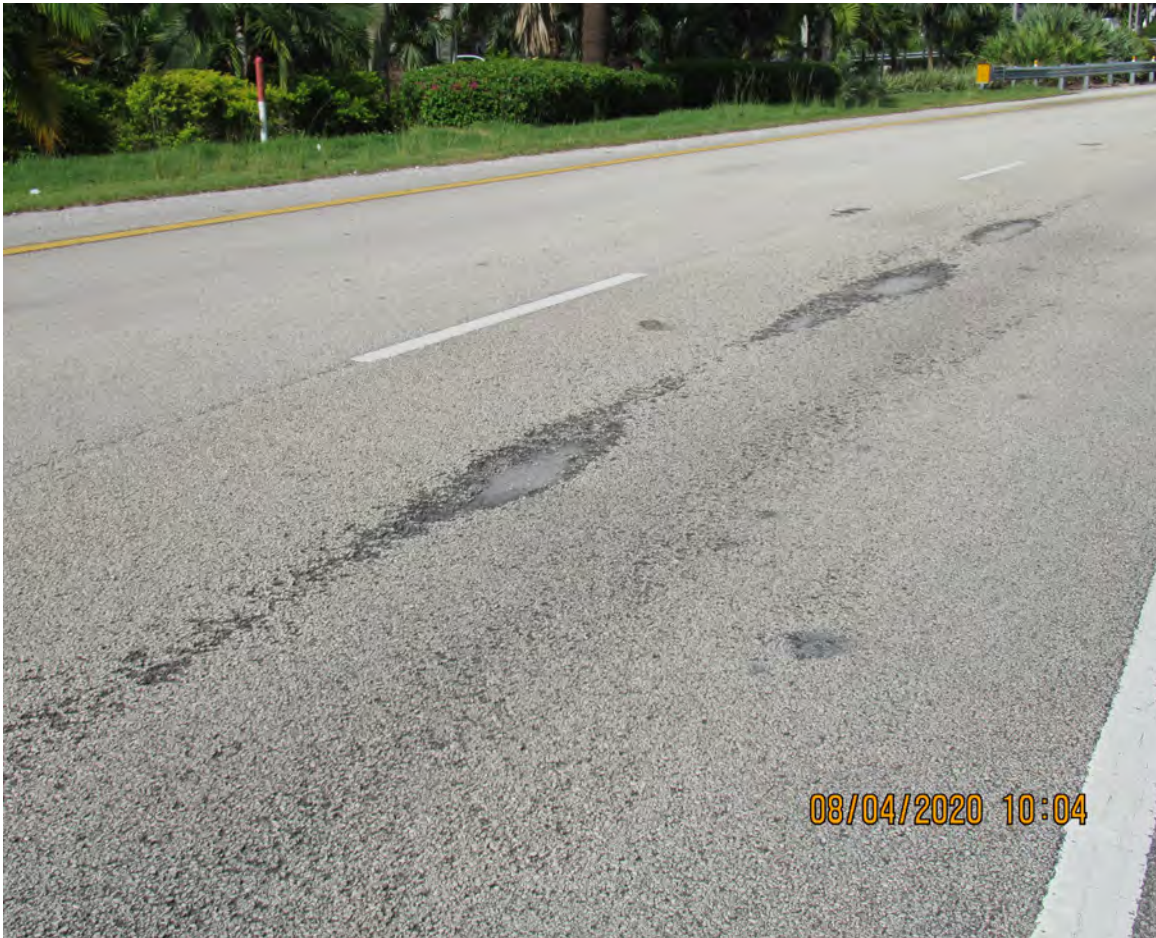
**PHOTO NO.: WB-001  
DATE: 08-04-2020**

**ROADWAY INSPECTION  
LOCATION: MILE MARKER 3.10 MILES  
WESTBOUND MAINLINE**

**DETERIORATED ASPHALT PAVEMENT**

**ITEM NOTED TO BE ADDRESSED BY MDX MAINTENANCE**

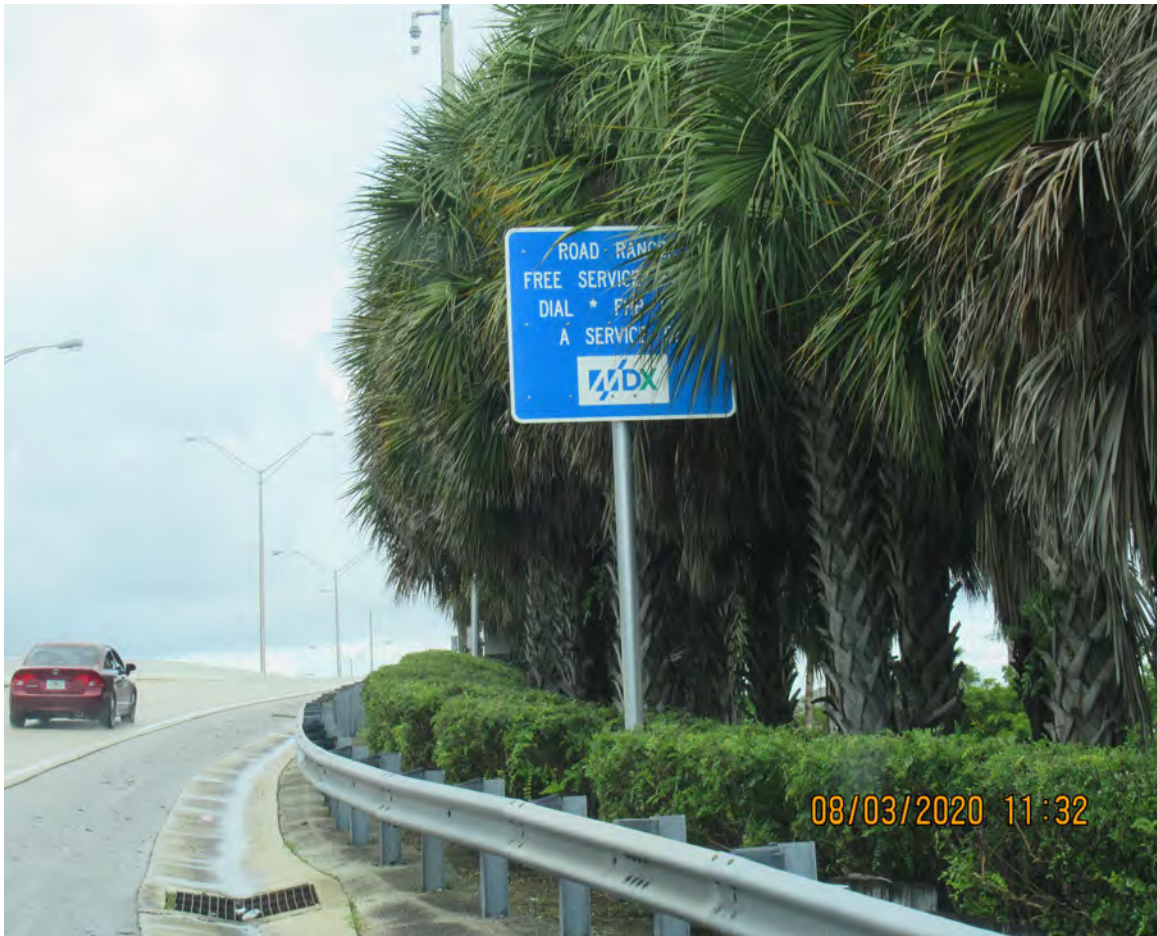
**PHOTO NO.: WB-003  
DATE: 08-03-2020**

**ROADWAY INSPECTION  
LOCATION: MILE MARKER 2.92 MILES  
WESTBOUND MAINLINE (RIGHT SHOULDER)**

**OVERGROWN VEGETATION OBSTRUCTING SIGN**

**ITEM NOTED TO BE ADDRESSED BY MDX EMERGENCY PUSH BUTTON  
CONTRACTS**

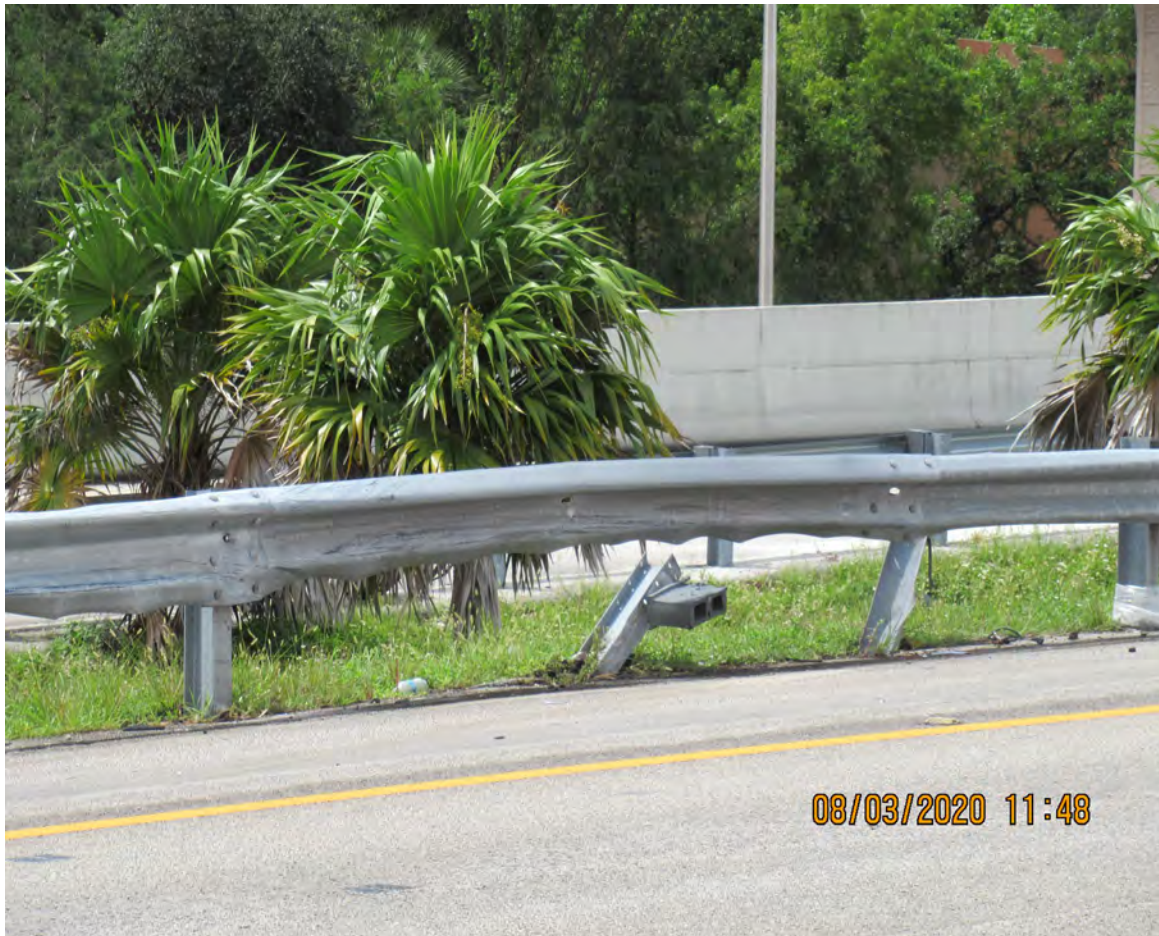
**PHOTO NO.: WB-010  
DATE: 08-03-2020**

**ROADWAY INSPECTION  
LOCATION: MILE MARKER 0.52 MILES  
WESTBOUND MAINLINE (LEFT SHOULDER)**

**DAMAGED GUARDRAIL & GUARDRAIL POST**

**ITEM NOTED TO BE ADDRESSED BY MDX EMERGENCY PUSH BUTTON  
CONTRACTS**

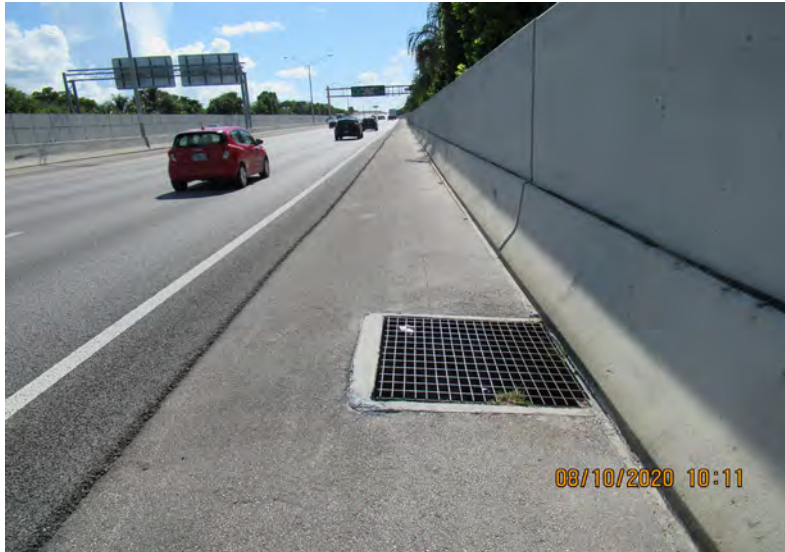
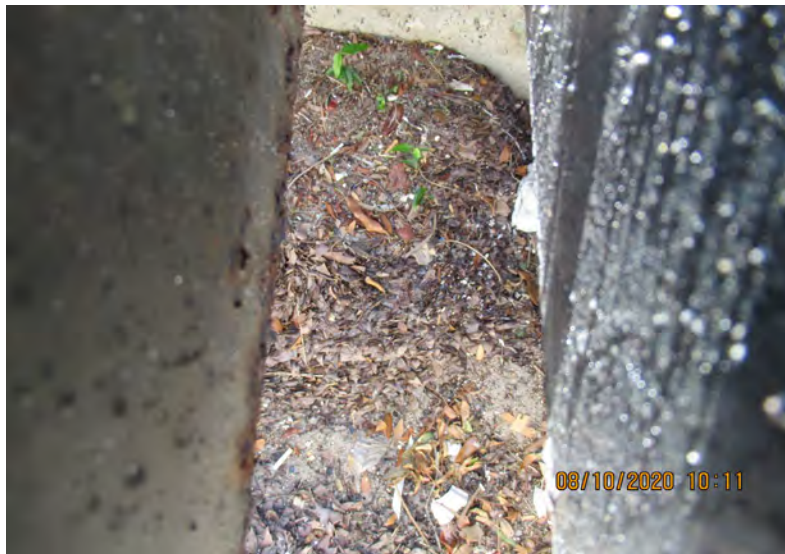
**PHOTO NO.: EB-001**  
**DATE: 08-10-2020**

**ROADWAY INSPECTION**  
**LOCATION: MILE MARKER 0.48**  
**EASTBOUND MAINLINE (RIGHT SHOULDER)**

**SILTED DRAINAGE STRUCTURE (TYPICAL THROUGHOUT THE CORRIDOR)**

**ITEM NOTED TO BE ADDRESSED BY MDX EMERGENCY PUSH BUTTON  
CONTRACTS**

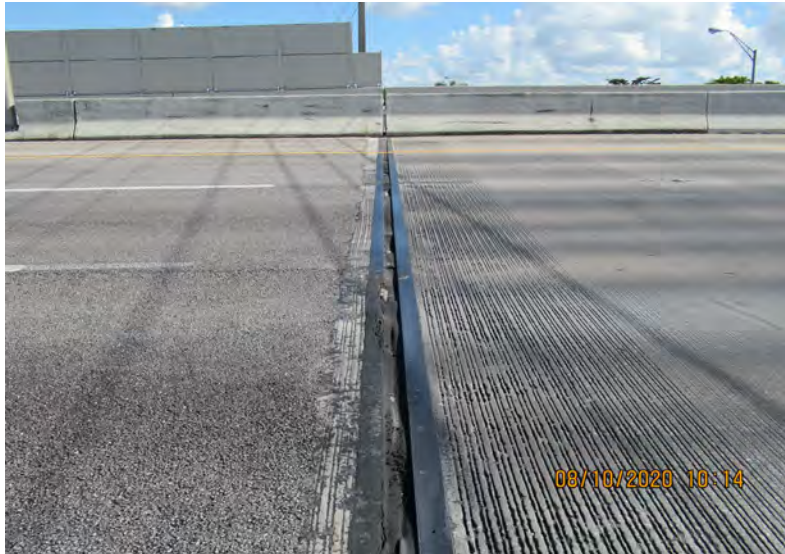
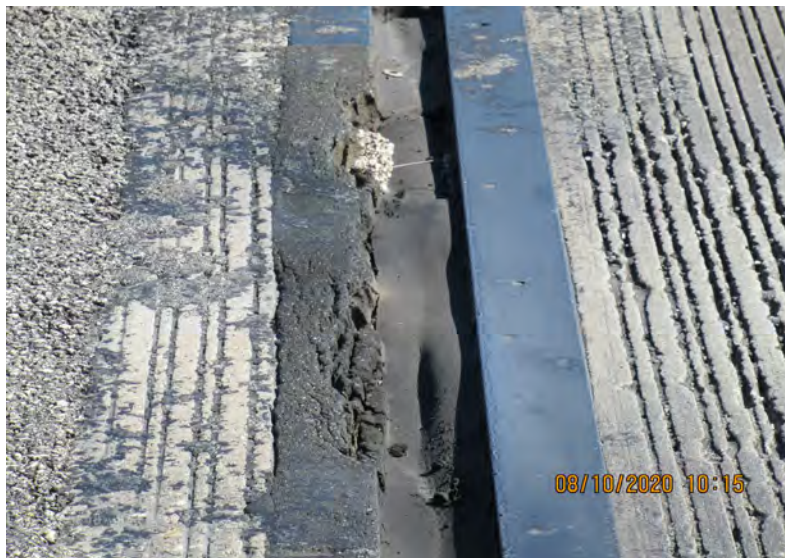
**PHOTO NO.: EB-002**  
**DATE: 08-10-2020**

**DETERIORATED EXPANSION JOINT (BRIDGE # 870708)**

**ITEM NOTED TO BE ADDRESSED BY MDX WORK PROGRAM No. 30029**

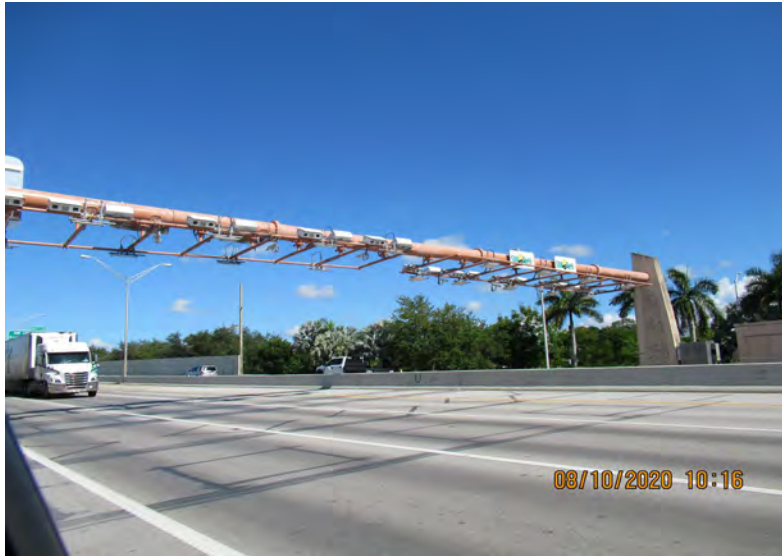
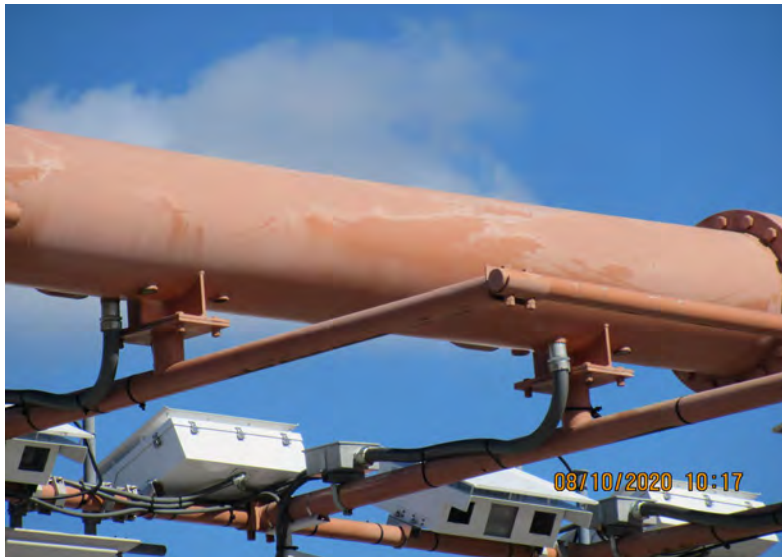
**PHOTO NO.: EB-003**  
**DATE: 08-10-2020**

**DETERIORATED CLASS V COATING ON STRUCTURE UPRIGHT AND PAINT ON  
MONOTUBE (STRUCTURE # 87S933)**

**ITEM NOTED TO BE ADDRESSED BY MDX WORK PROGRAM No. 30043**

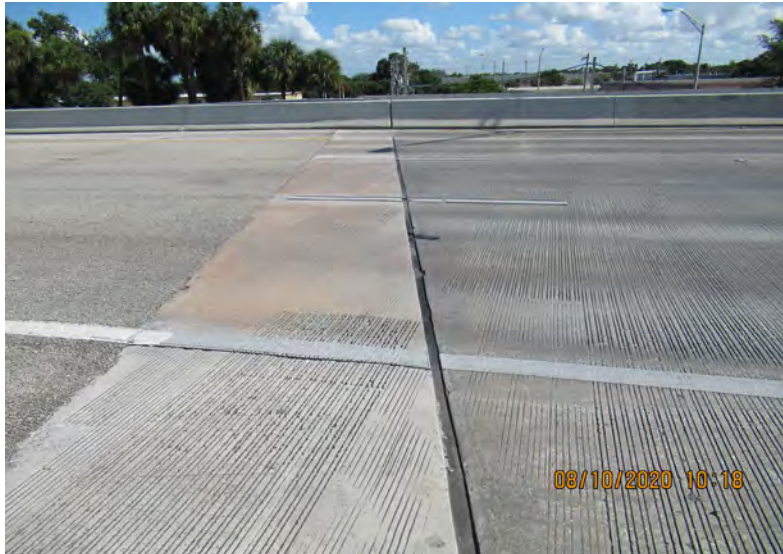
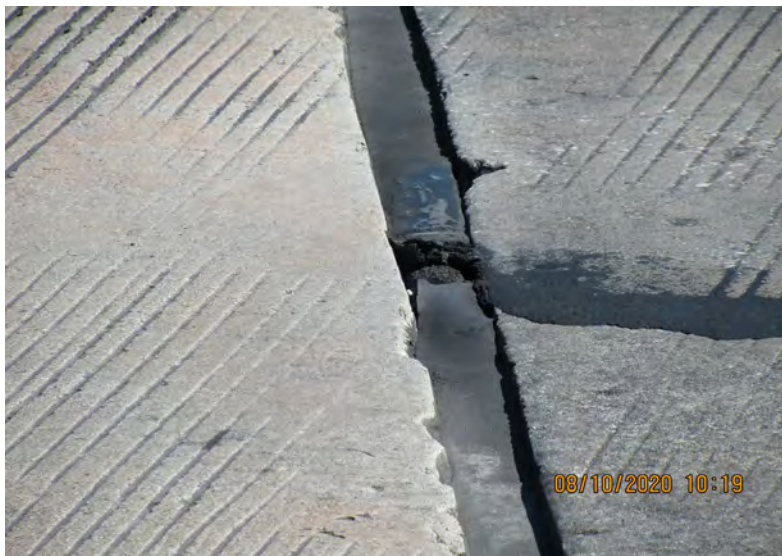
**PHOTO NO.: EB-004  
DATE: 08-10-2020**

**DETERIORATED EXPANSION JOINT SEALANT (BRIDGE # 870720)**

**ITEM NOTED TO BE ADDRESSED BY MDX WORK PROGRAM No. 30029**

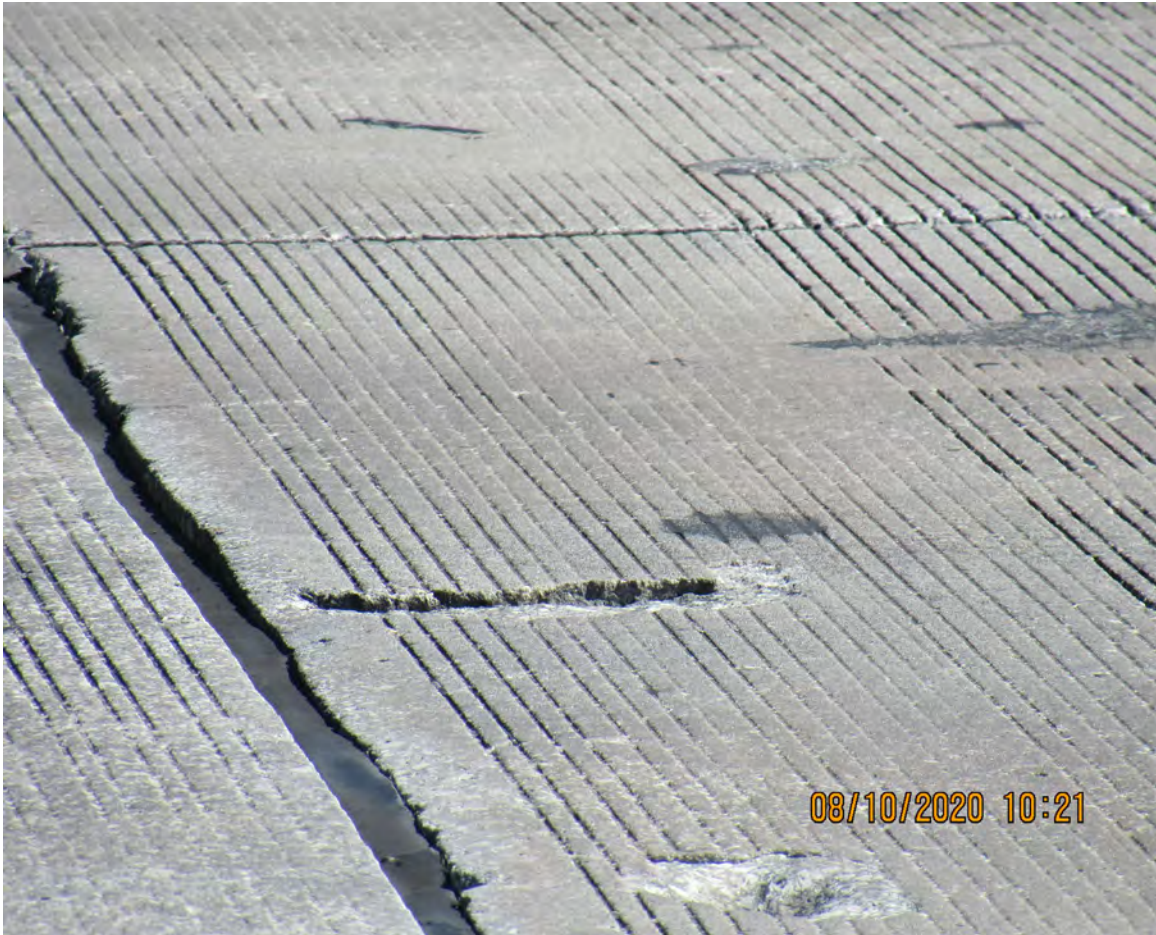
**PHOTO NO.: EB-006**  
**DATE: 08-10-2020**

**SPALLS ON APPROACH SLAB (BRIDGE # 870721)**

**ITEM NOTED TO BE ADDRESSED BY MDX MAINTENANCE**

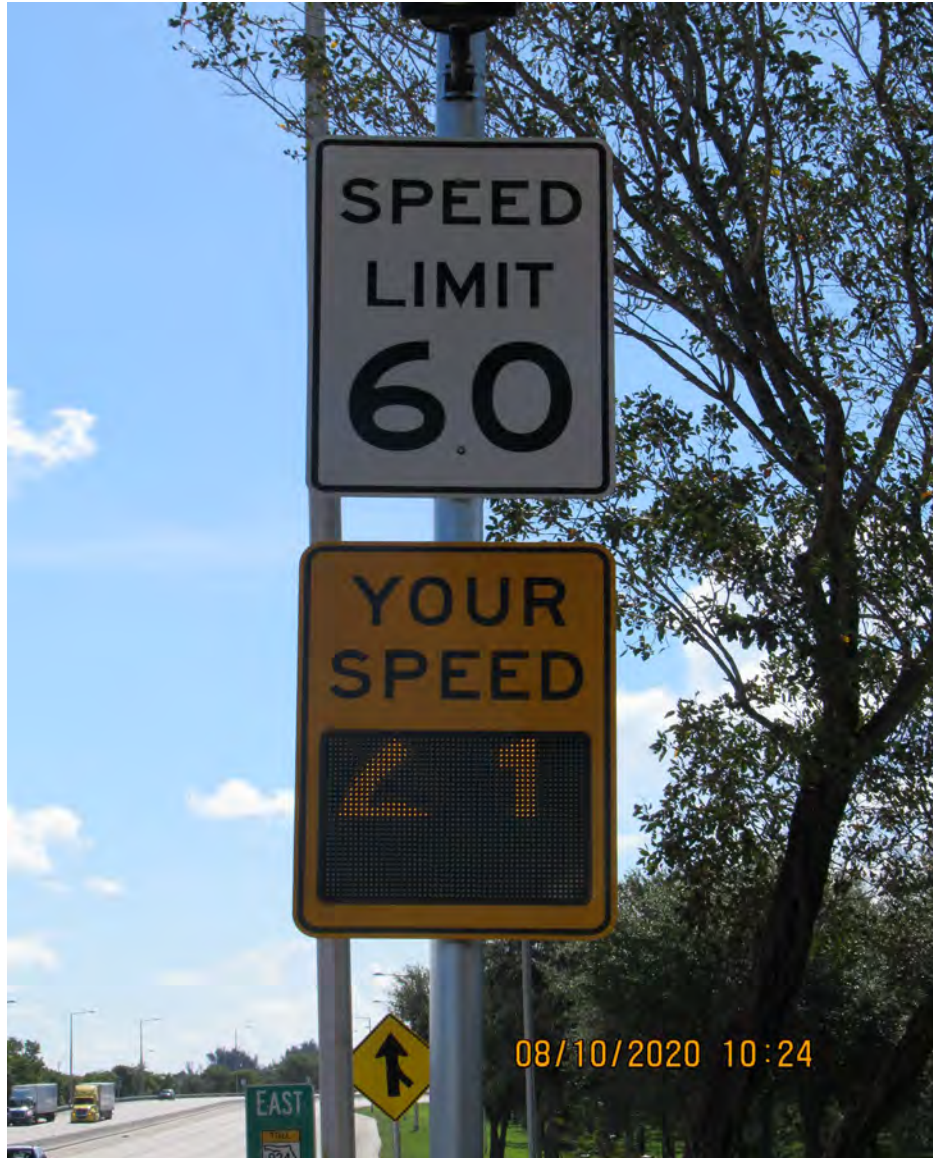
**PHOTO NO.: EB-007  
DATE: 08-10-2020**

**MALFUNCTIONING SPEED LIMIT SIGNS**

**ITEM NOTED TO BE ADDRESSED BY MDX MAINTENANCE**

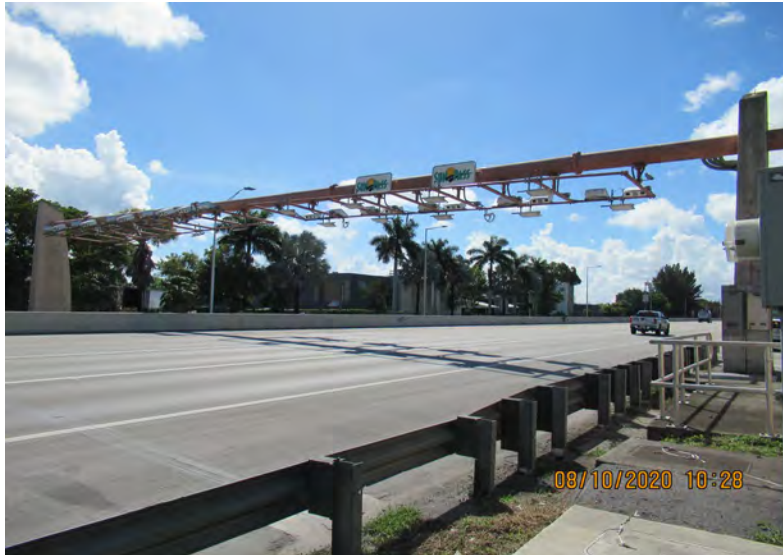
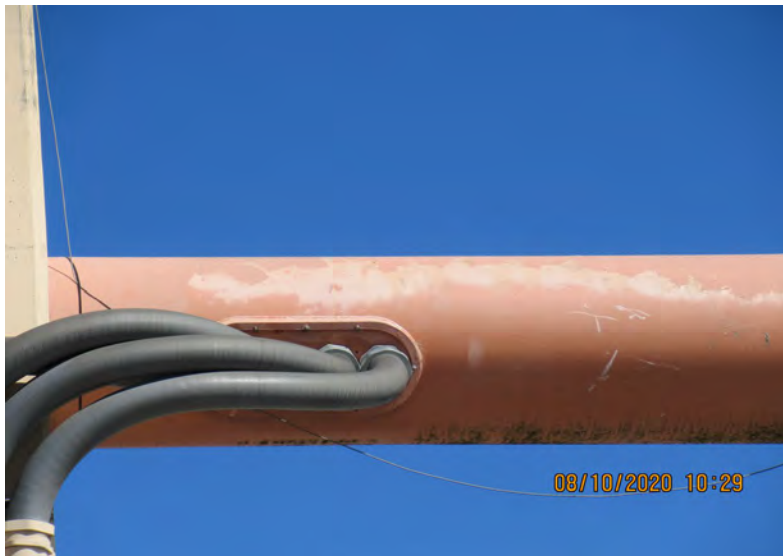
**PHOTO NO.: EB-008**  
**DATE: 08-10-2020**

**DETERIORATED CLASS V COATING ON STRUCTURE UPRIGHT AND PAINT ON  
MONOTUBE (STRUCTURE # 87S932)**

**ITEM NOTED TO BE ADDRESSED BY MDX WORK PROGRAM No. 30043**

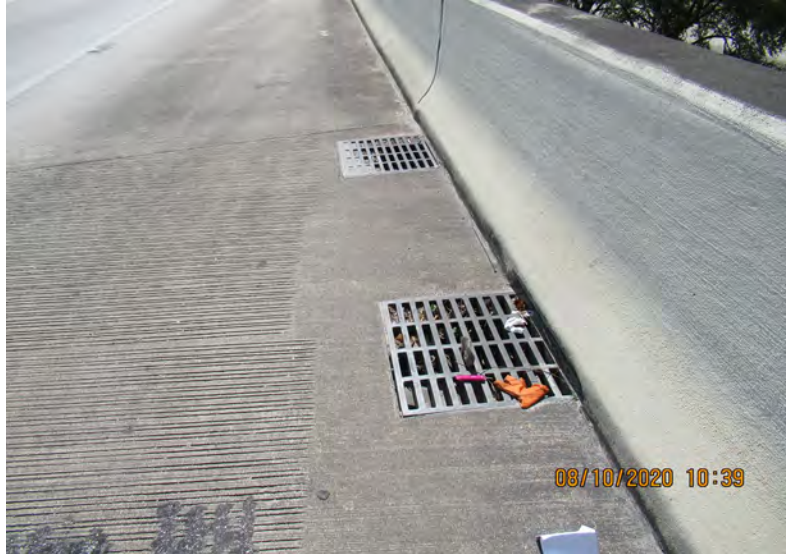
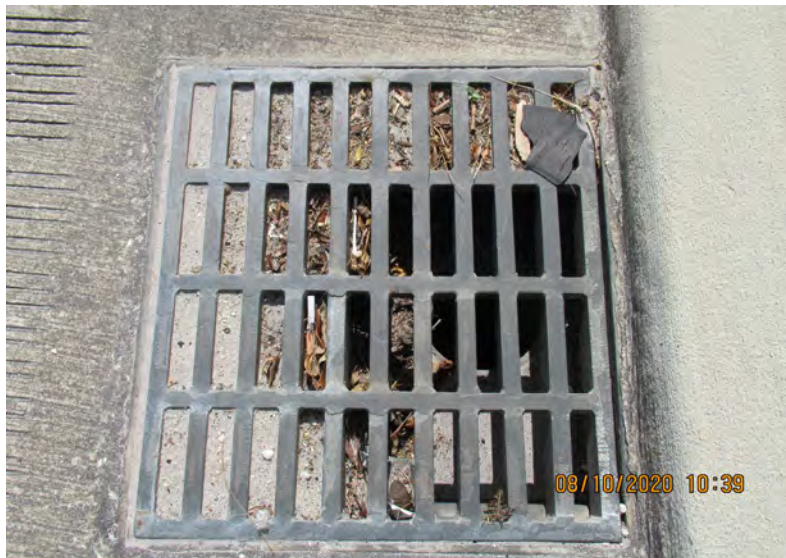
**PHOTO NO.: EB-009**  
**DATE: 08-10-2020**

**SILTED BRIDGE DRAINAGE INLET (BRIDGE # 870740)**

**ITEM NOTED TO BE ADDRESSED BY MDX EMERGENCY PUSH BUTTON  
CONTRACTS**

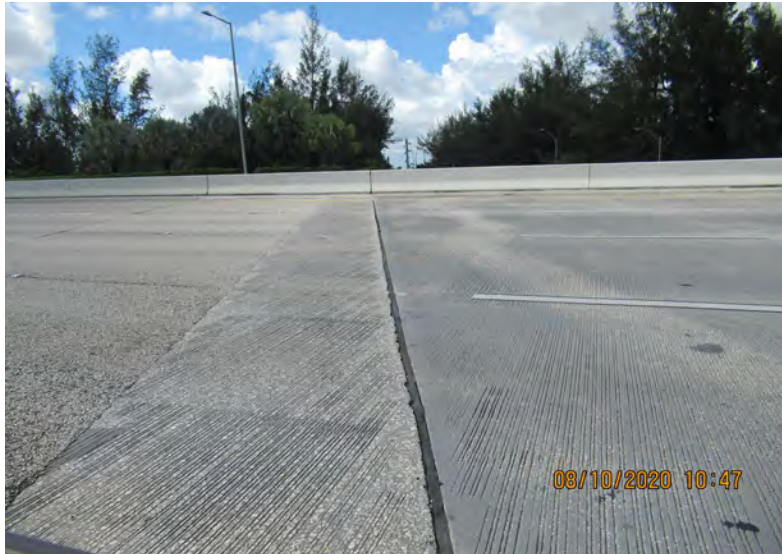
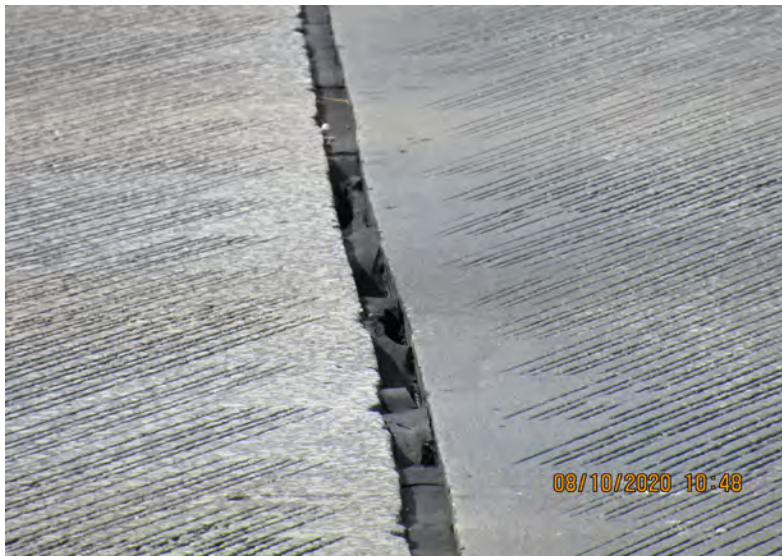
**PHOTO NO.: WB-001  
DATE: 08-10-2020**

**DETERIORATED JOINT SEALANT (BRIDGE # 870738)**

**ITEM NOTED TO BE ADDRESSED BY MDX WORK PROGRAM No. 30029**

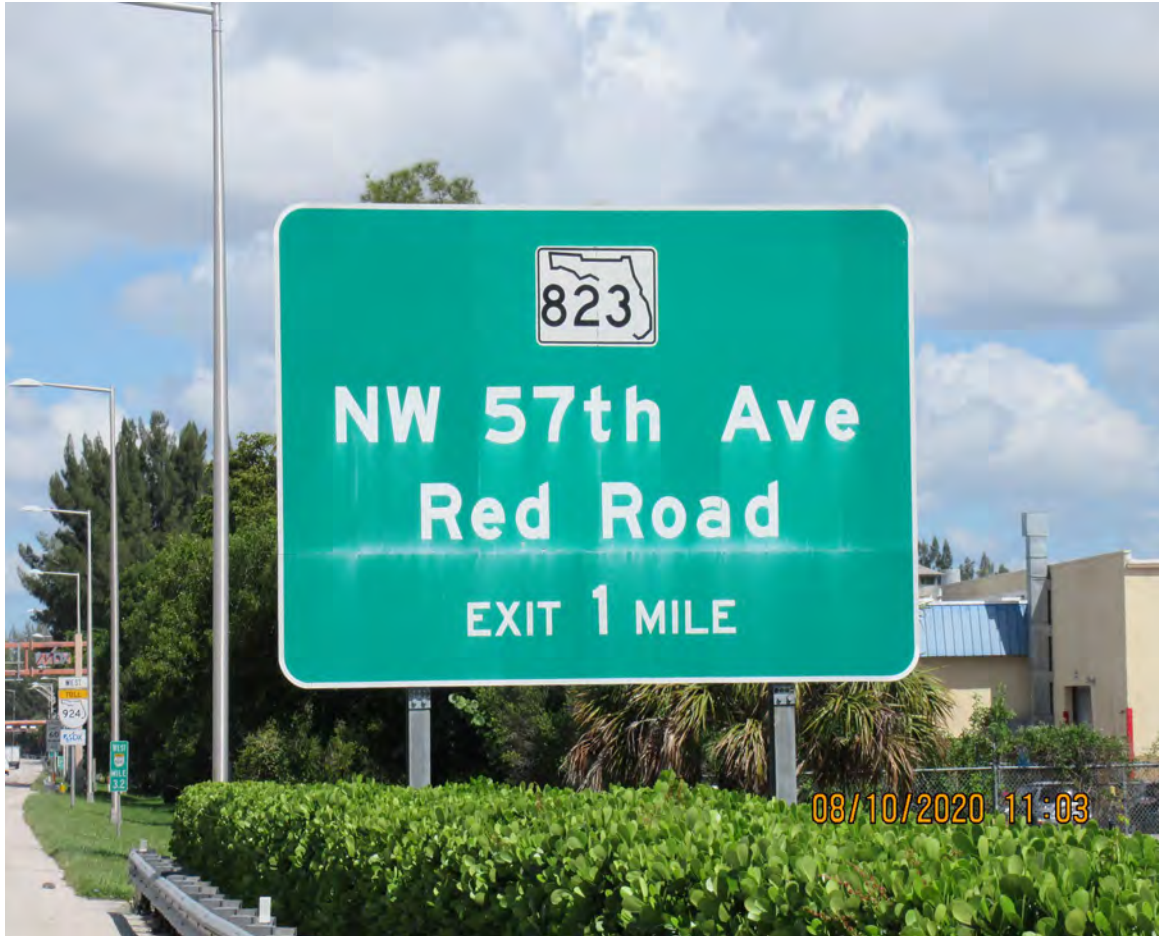
**PHOTO NO.: WB-002  
DATE: 08-10-2020**

**DETERIORATED REFLECTIVE SHEETING**

**ITEM NOTED TO BE ADDRESSED BY MDX MAINTENANCE**

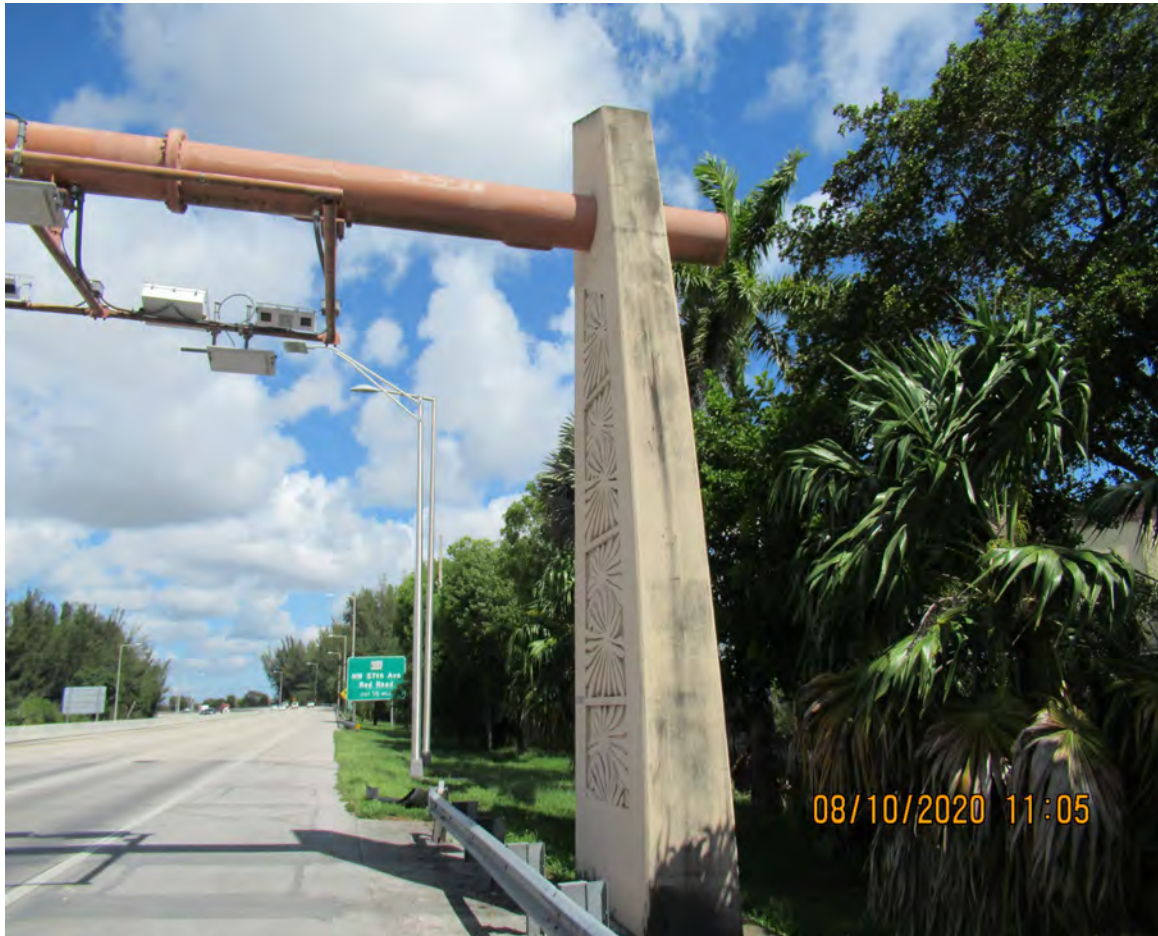
**PHOTO NO.: WB-003**  
**DATE: 08-10-2020**

**DETERIORATED PAINT ON STRUCTURE UPRIGHT AND MONOTUBE  
(STRUCTURE # 87S932)**

**ITEM NOTED TO BE ADDRESSED BY MDX WORK PROGRAM No. 30037 & 30043**

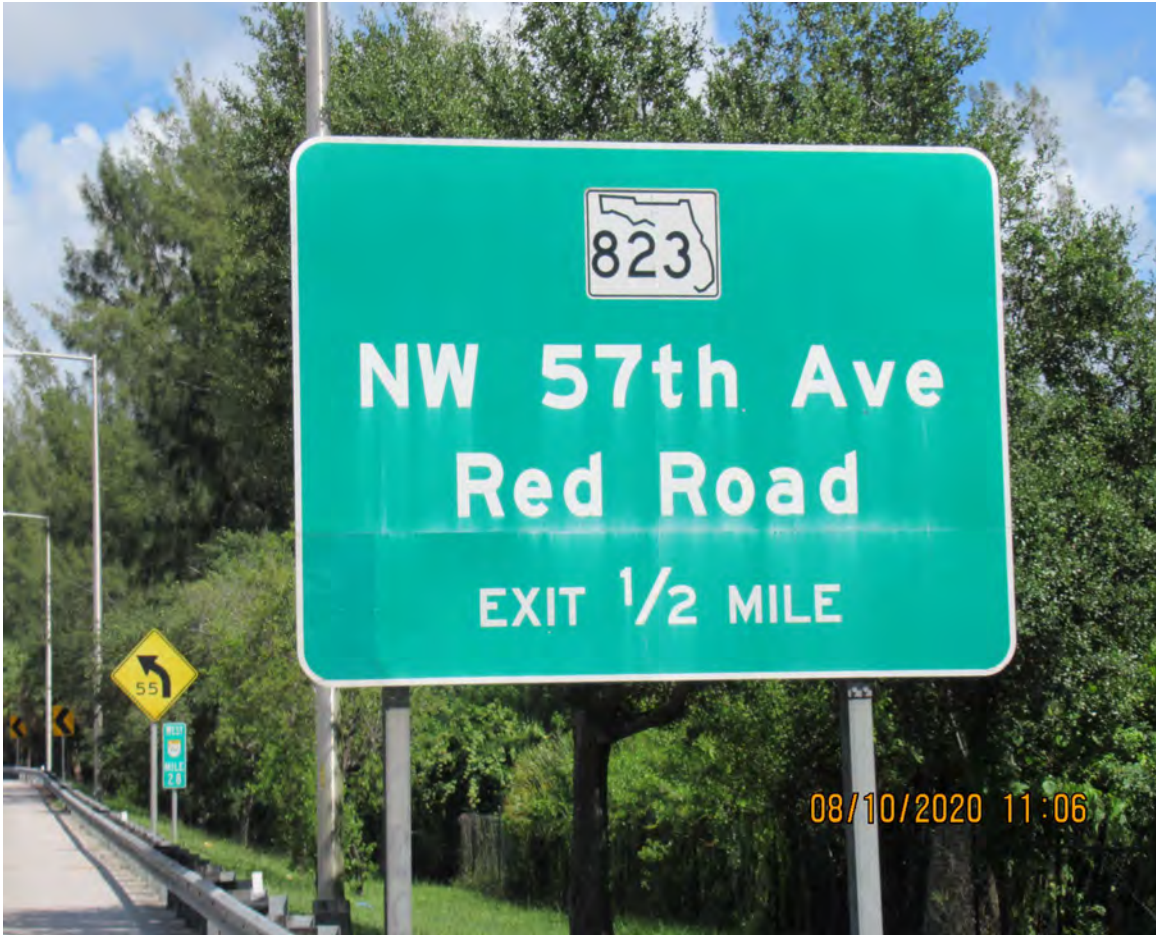
**PHOTO NO.: WB-004  
DATE: 08-10-2020**

**DETERIORATED REFLECTIVE SHEETING**

**ITEM NOTED TO BE ADDRESSED BY MDX MAINTENANCE**

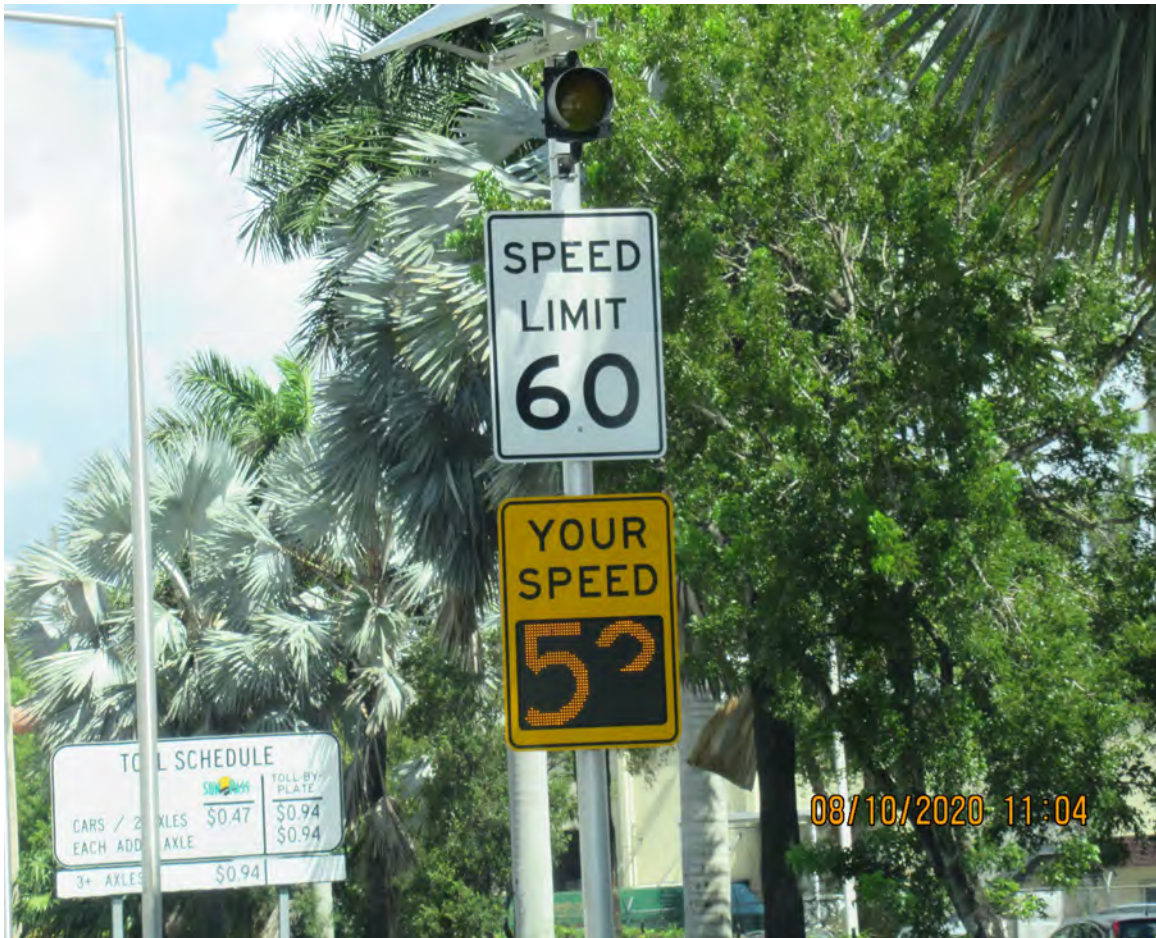
**PHOTO NO.: WB-005**  
**DATE: 08-10-2020**

**MALFUNCTIONING SPEED LIMIT SIGN**

**ITEM NOTED TO BE ADDRESSED BY MDX MAINTENANCE**

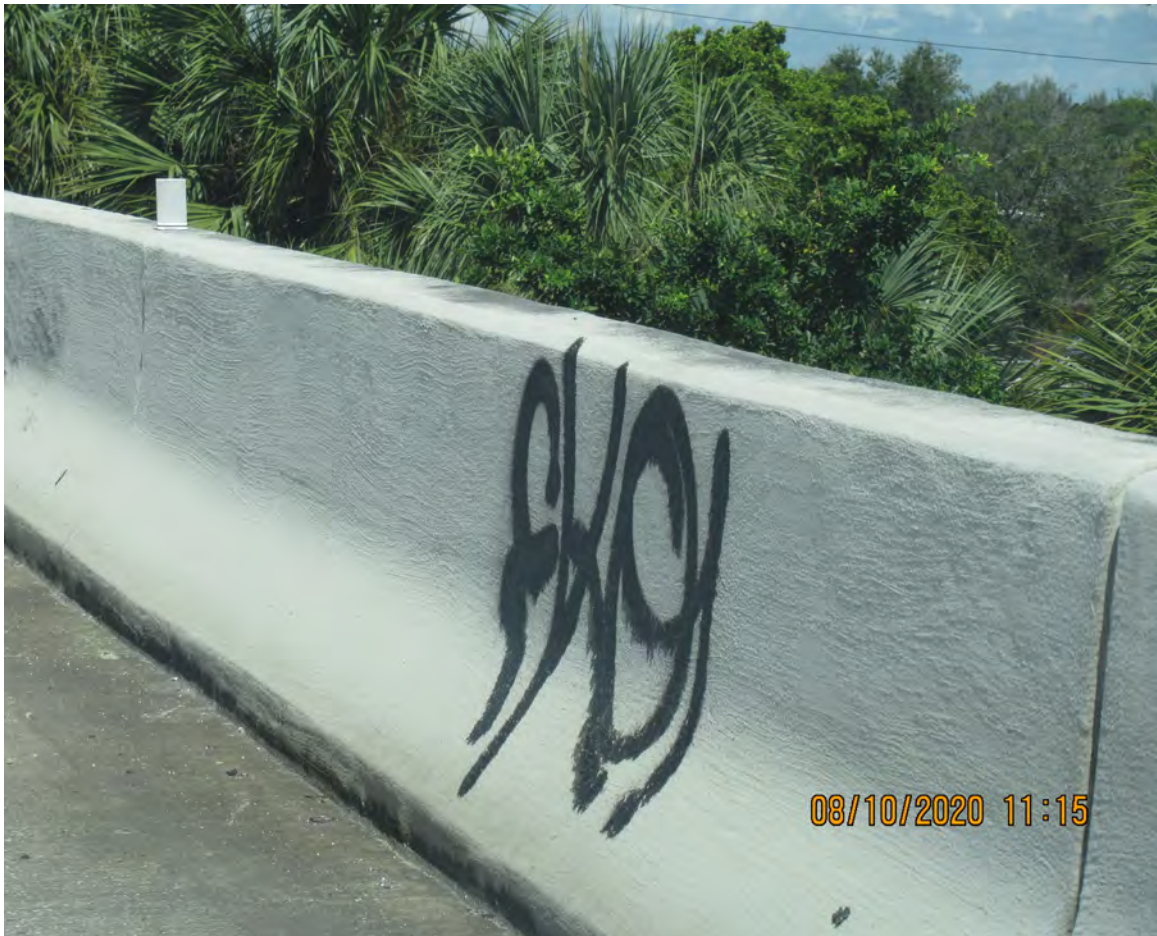
**PHOTO NO.: WB-007  
DATE: 08-10-2020**

**GRAFFITI ON BARRIER WALL (BRIDGE # 870708)**

**ITEM NOTED TO BE ADDRESSED BY MDX EMERGENCY PUSH BUTTON  
CONTRACTS**

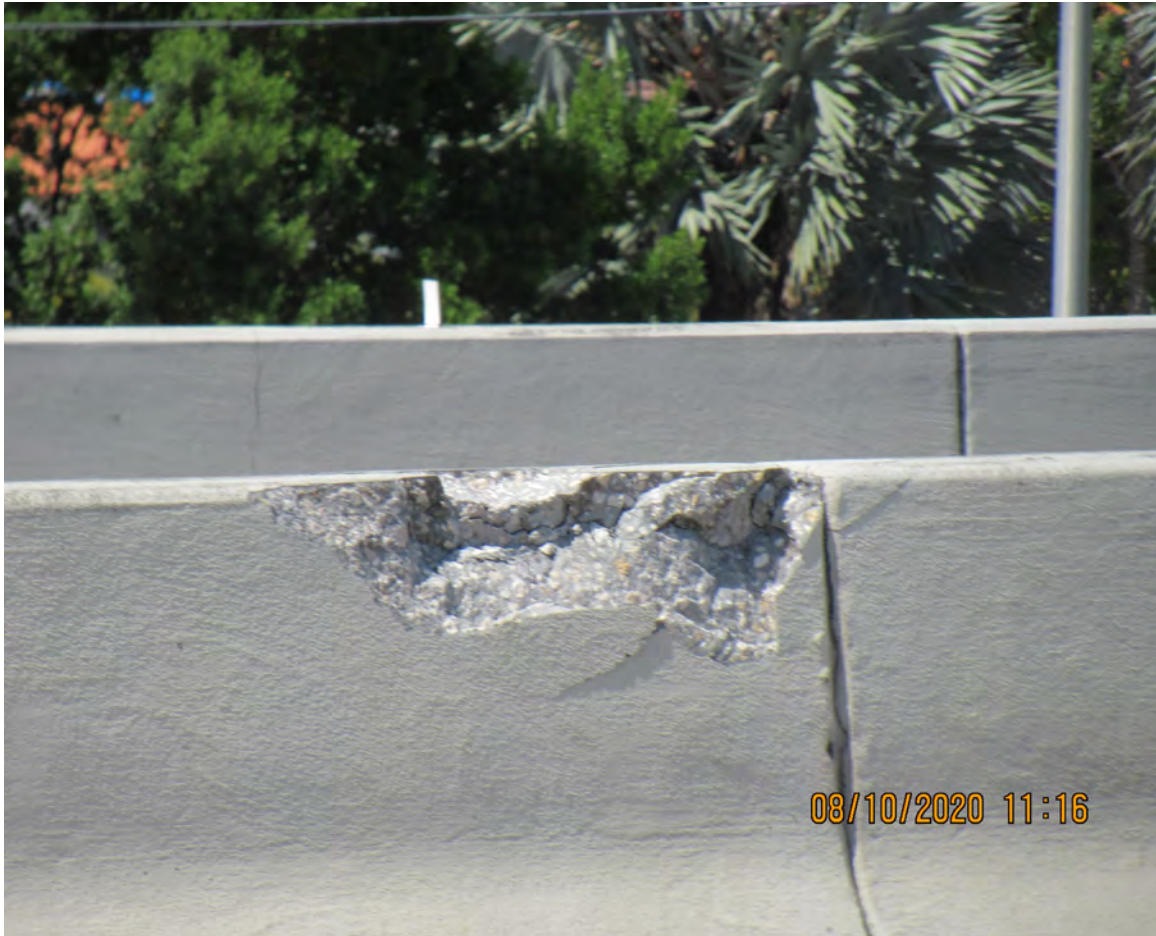
**PHOTO NO.: WB-008  
DATE: 08-10-2020**

**DAMAGED MEDIAN BARRIER WALL (BRIDGE # 870708)**

**ITEM NOTED TO BE ADDRESSED BY MDX MAINTENANCE**

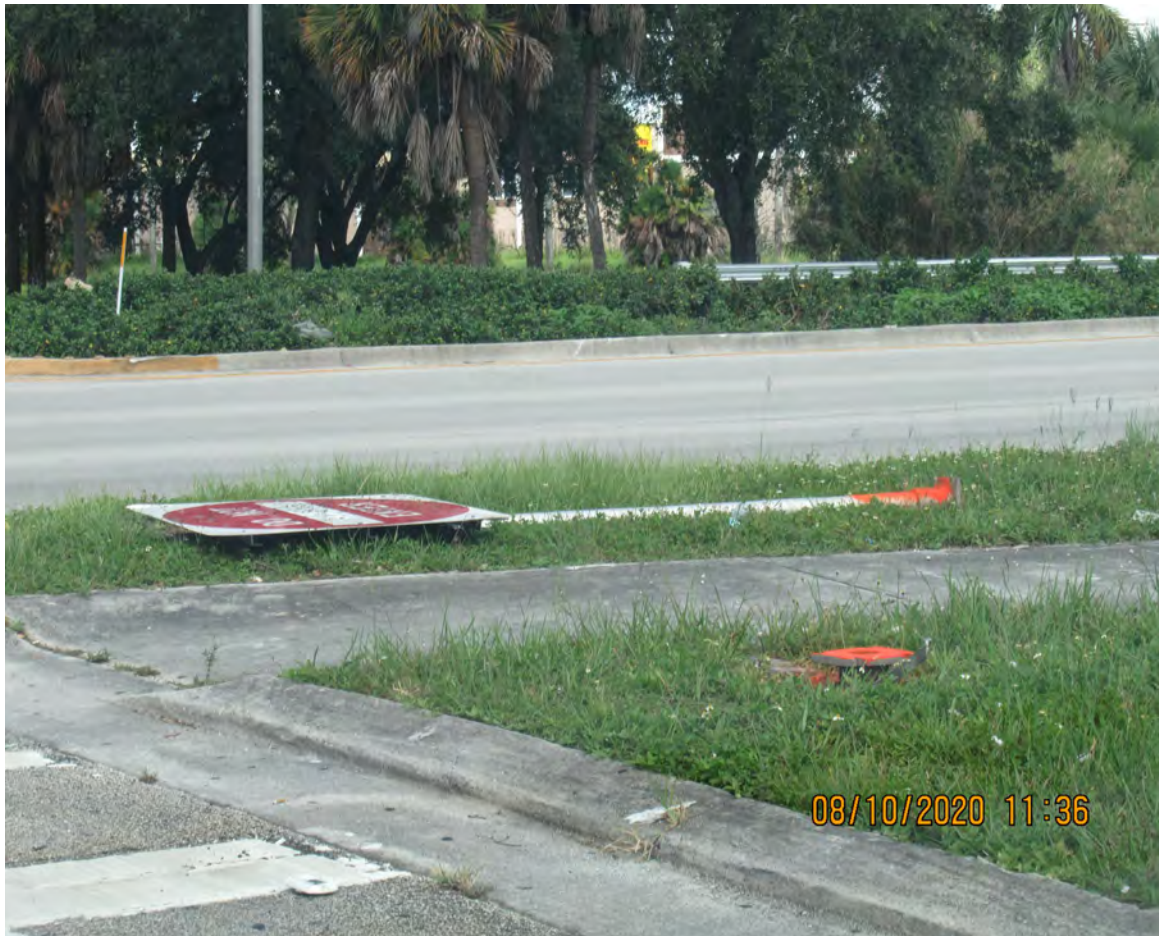
**PHOTO NO.: WB-009  
DATE: 08-10-2020**

**DOWN DO NOT ENTER SIGN**

**ITEM NOTED TO BE ADDRESSED BY MDX EMERGENCY PUSH BUTTON  
CONTRACTS**

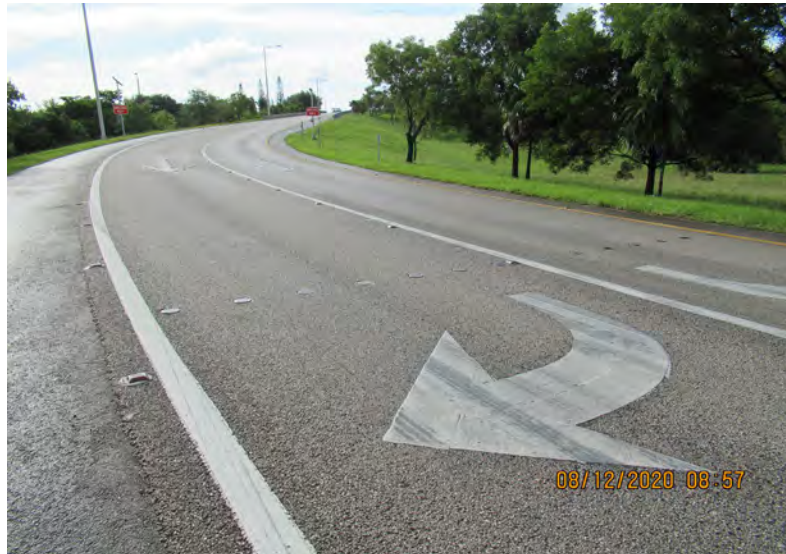
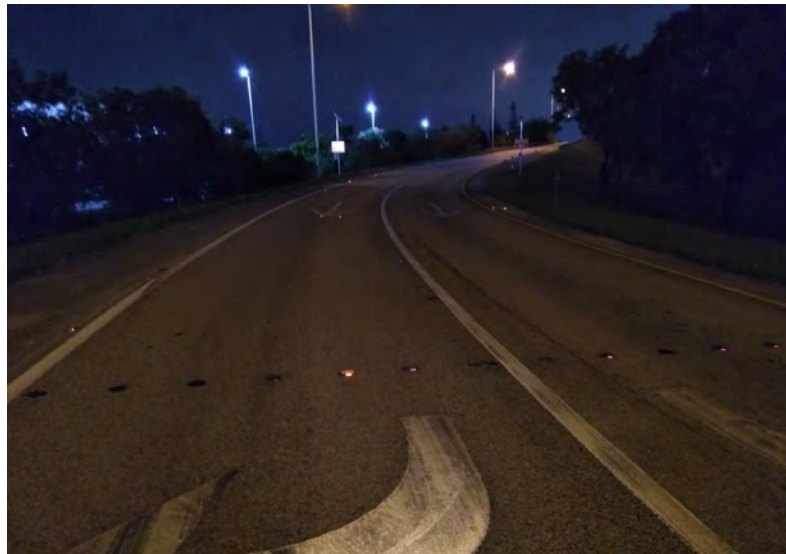
**PHOTO NO.: WB-010  
DATE: 08-12-2020**

**MALFUNCTIONING ILLUMINATED REFLECTIVE PAVEMENT MARKERS (RPM'S)**

**ITEM NOTED TO BE ADDRESSED BY MDX MAINTENANCE**
