# Annual Inspection Report 2020

# ANNUAL INSPECTION REPORT

As detailed in the following sections, EAC Consulting has found the MDX System to be in good working order and condition.

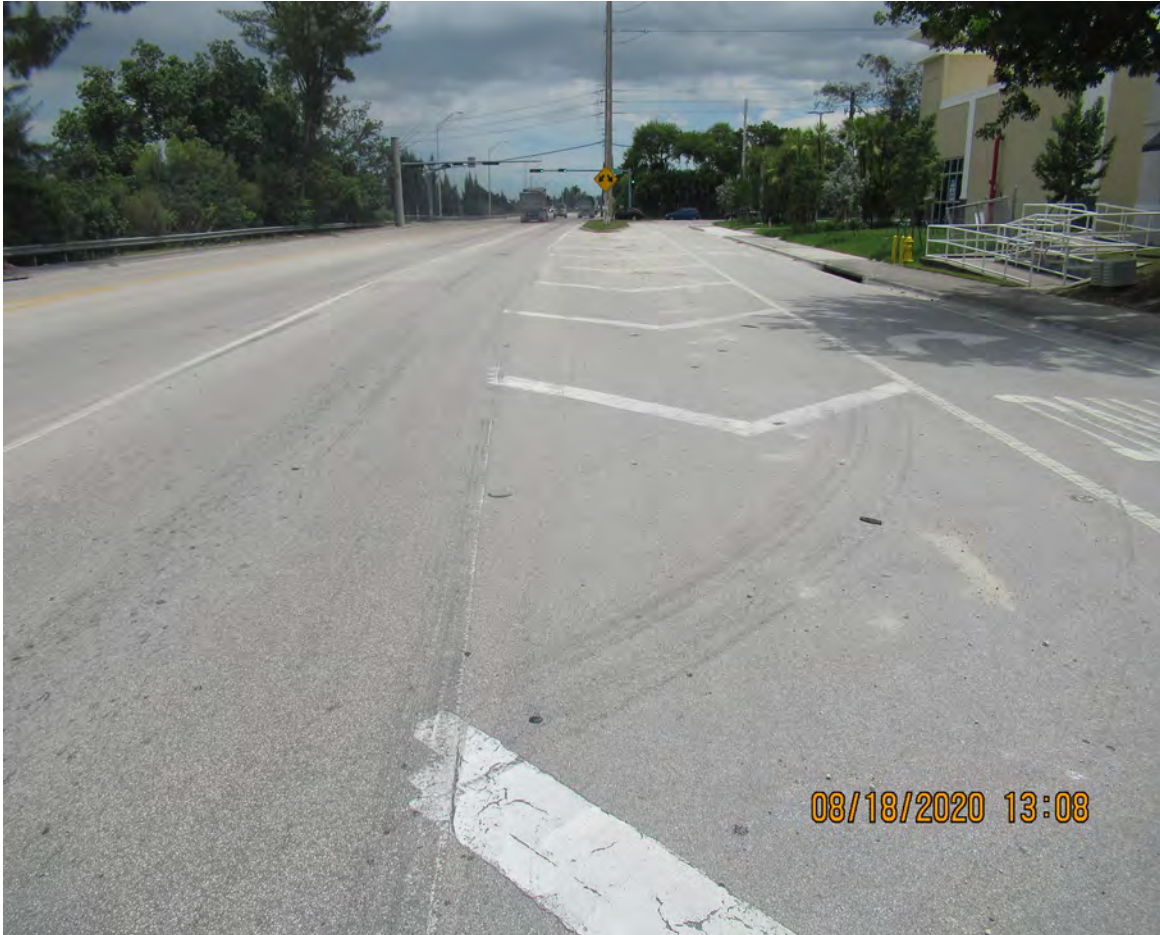
**PHOTO NO.: EB-001  
DATE: 8-18-2020**

**DETERIORATED STRIPING ON MAINLINE AND GORE**

**ITEM NOTED TO BE ADDRESSED BY MDX MAINTENANCE**

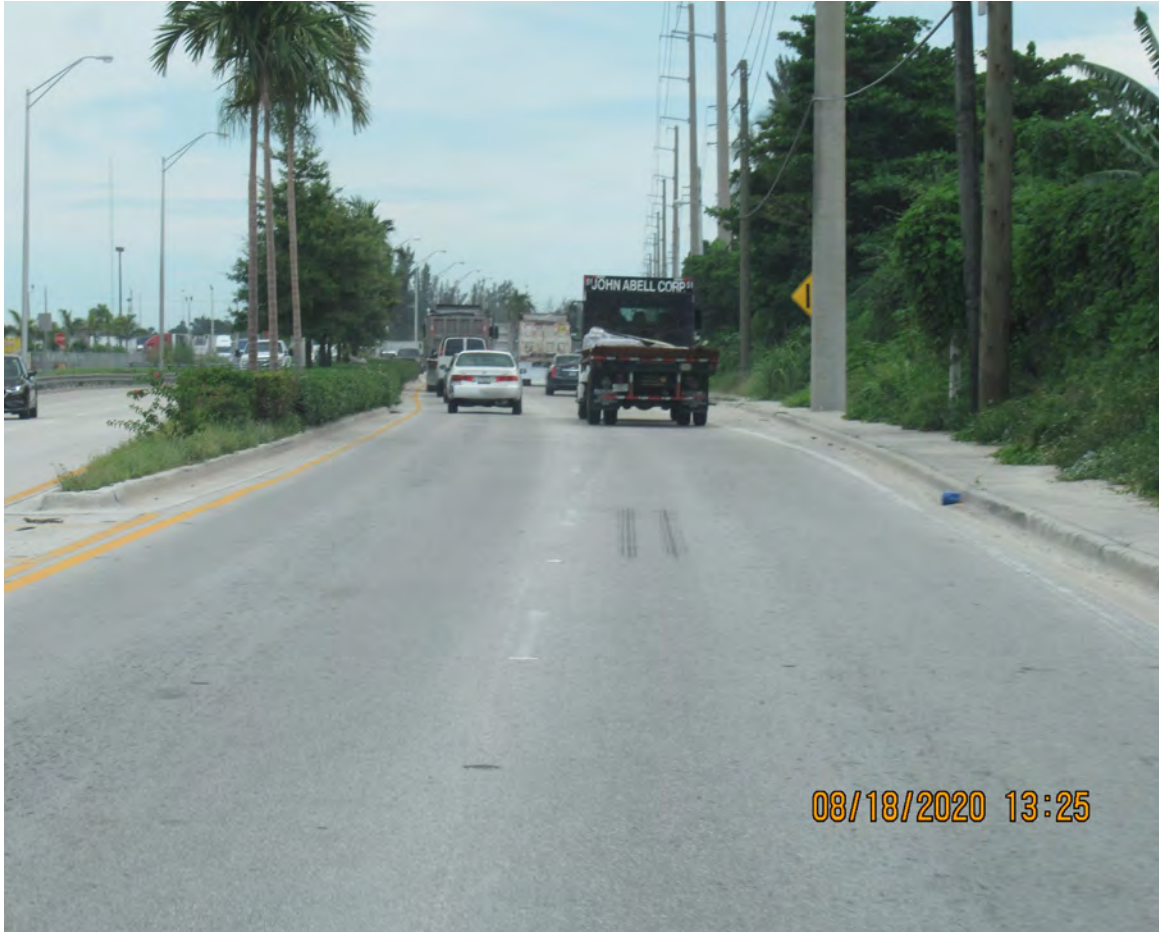
**PHOTO NO.: EB-002  
DATE: 8-18-2020**

**DETERIORATED STRIPING**

**ITEM NOTED TO BE ADDRESSED BY MDX MAINTENANCE**

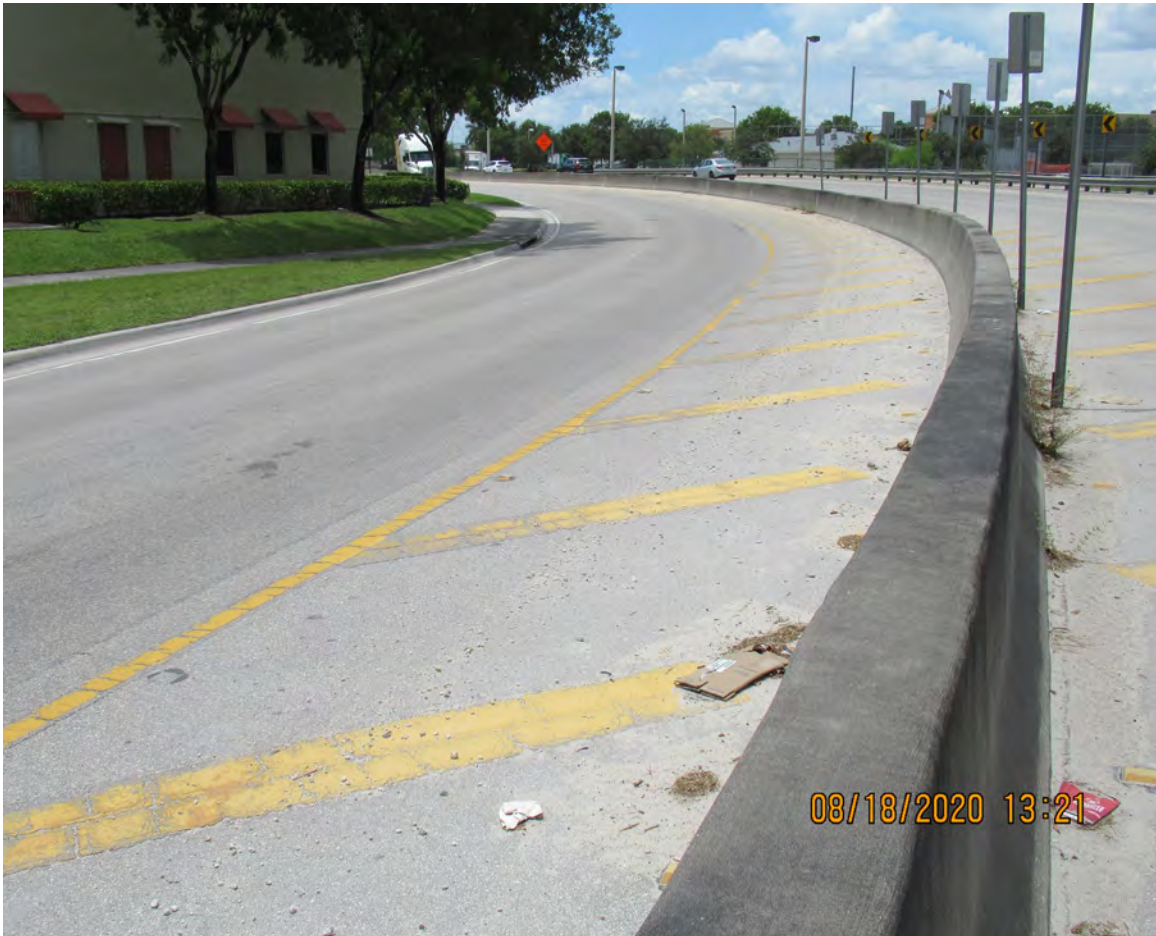
**PHOTO NO.: EB-003  
DATE: 8-18-2020**

**DETERIORATED WHITE SKIP AND EDGE LINE STRIPING**

**ITEM NOTED TO BE ADDRESSED BY MDX MAINTENANCE**

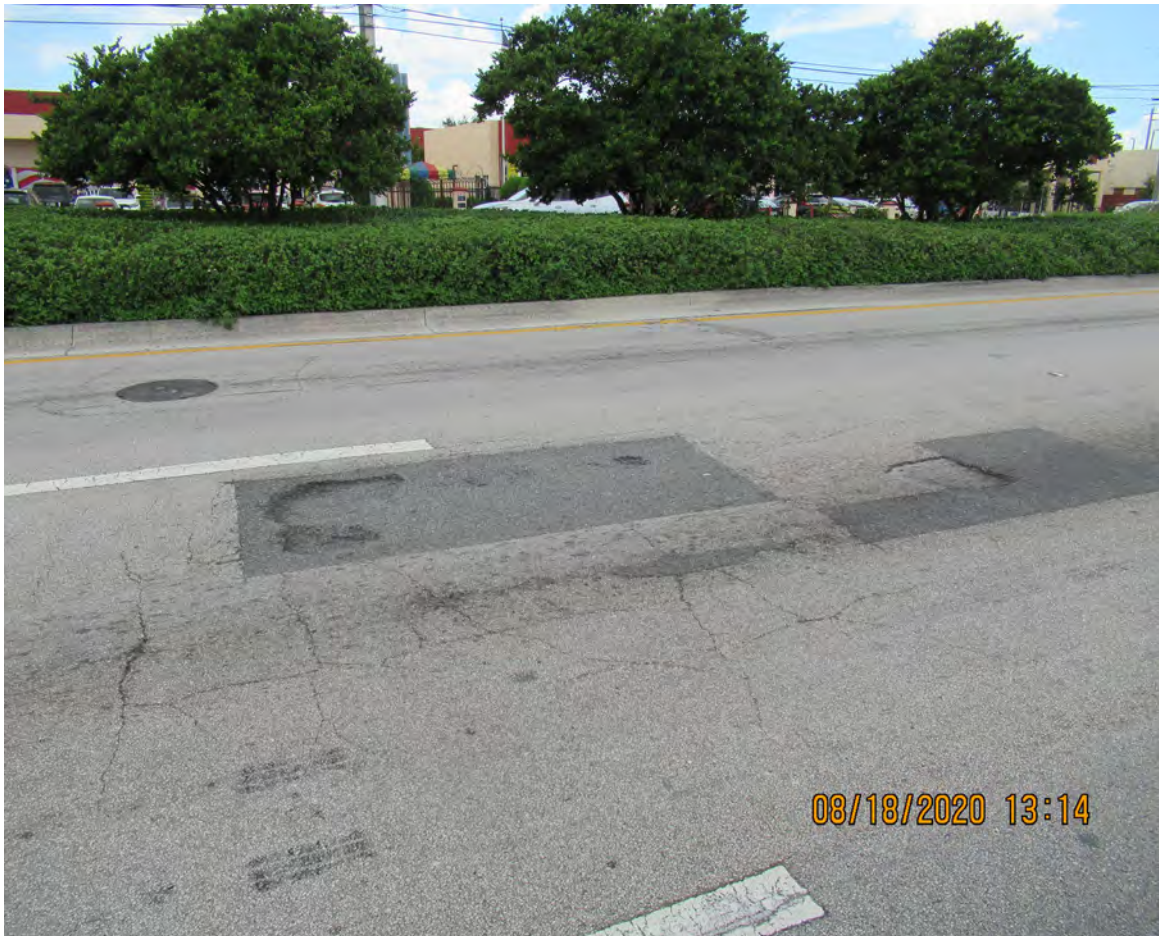
**PHOTO NO.: WB-001  
DATE: 8-18-2020**

**DETERIORATED ASPHALT PAVEMENT**

**ITEM NOTED TO BE ADDRESSED BY MDX MAINTENANCE**

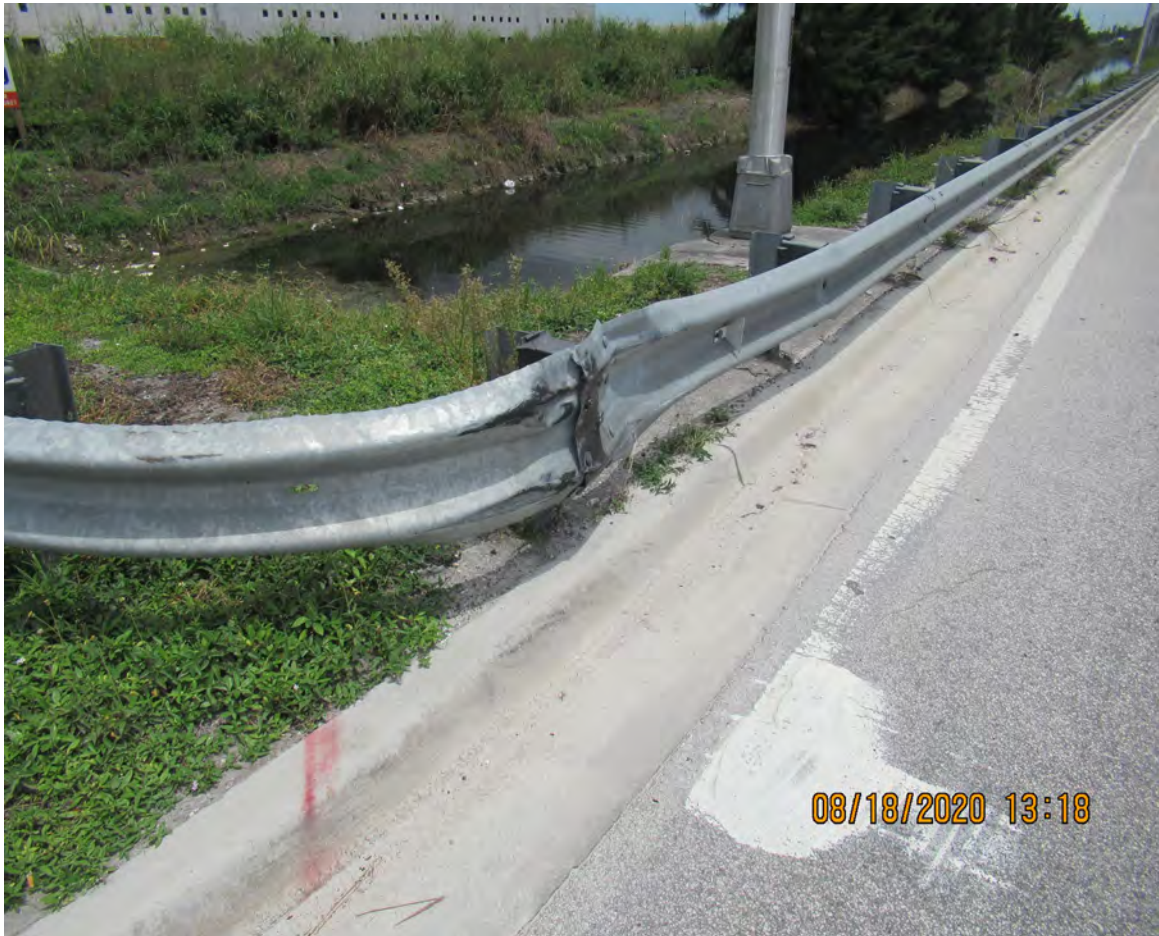
**PHOTO NO.: WB-003  
DATE: 8-18-2020**

**DAMAGED GUARDRAIL PANELS**

**ITEM NOTED TO BE ADDRESSED BY MDX EMERGENCY PUSH BUTTON  
CONTRACTS**

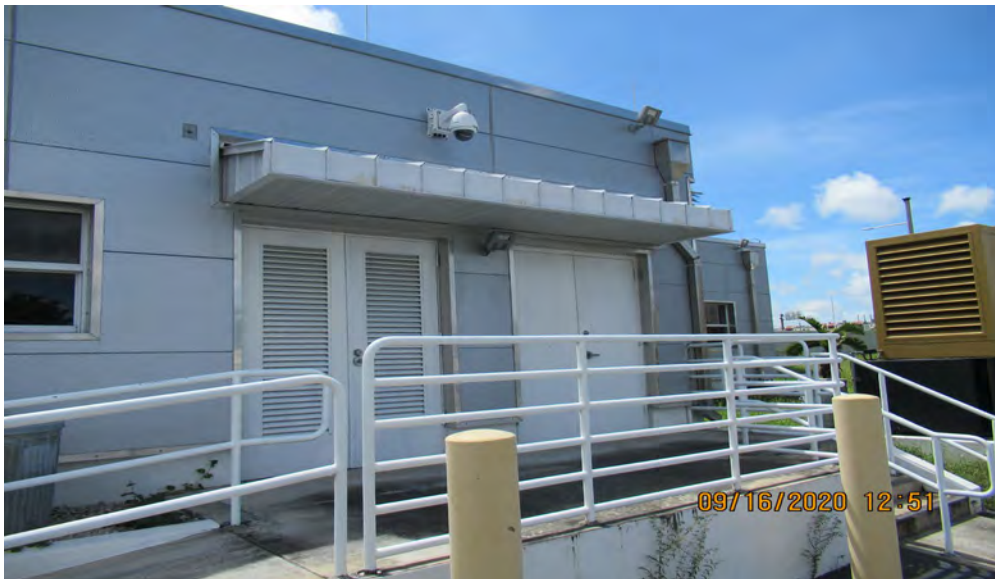
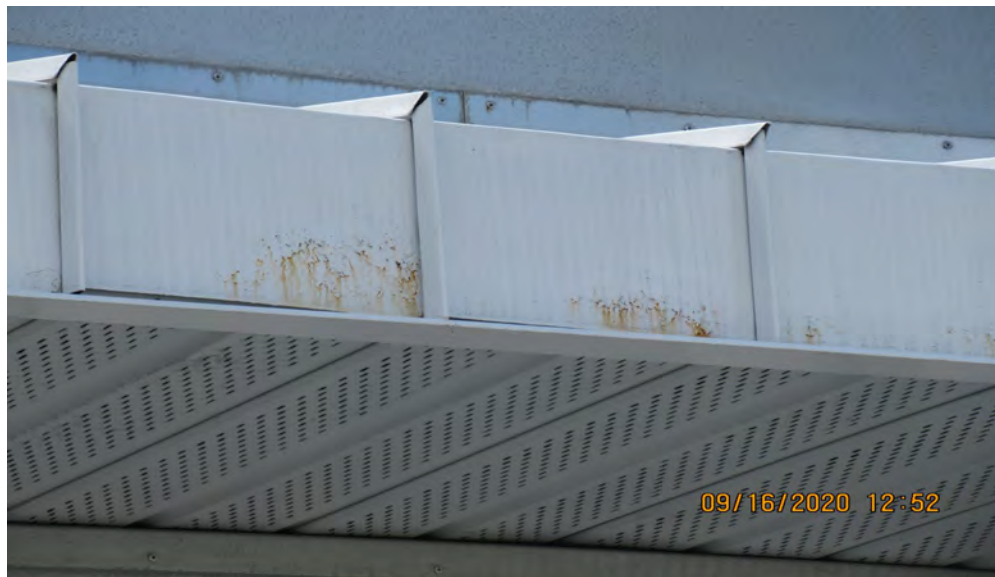
**PHOTO NO.: A-001**  
**DATE: 9-16-2020**

**CORROSION ON METAL AWNING**

**ITEM NOTED TO BE ADDRESSED BY MDX MAINTENANCE**

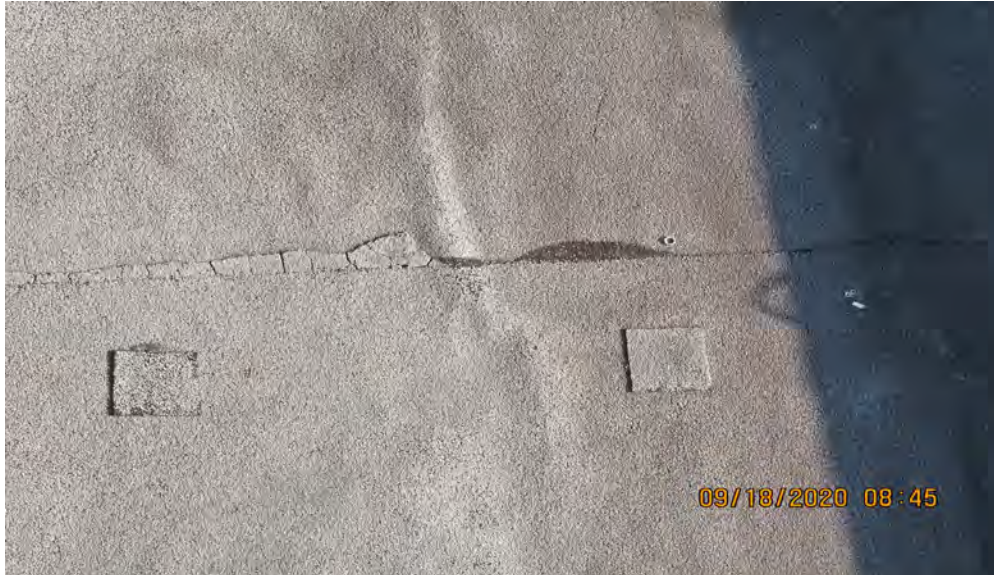
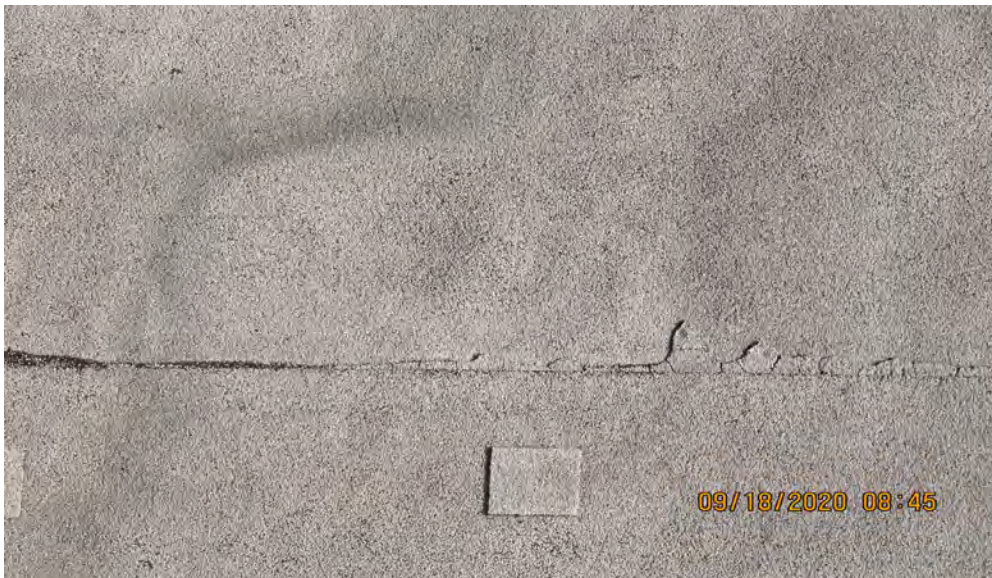
**PHOTO NO.: A-002  
DATE: 9-18-2020**

**BLISTERING ON ROOF MEMBRANE**

**ITEM NOTED TO BE ADDRESSED BY MDX MAINTENANCE**

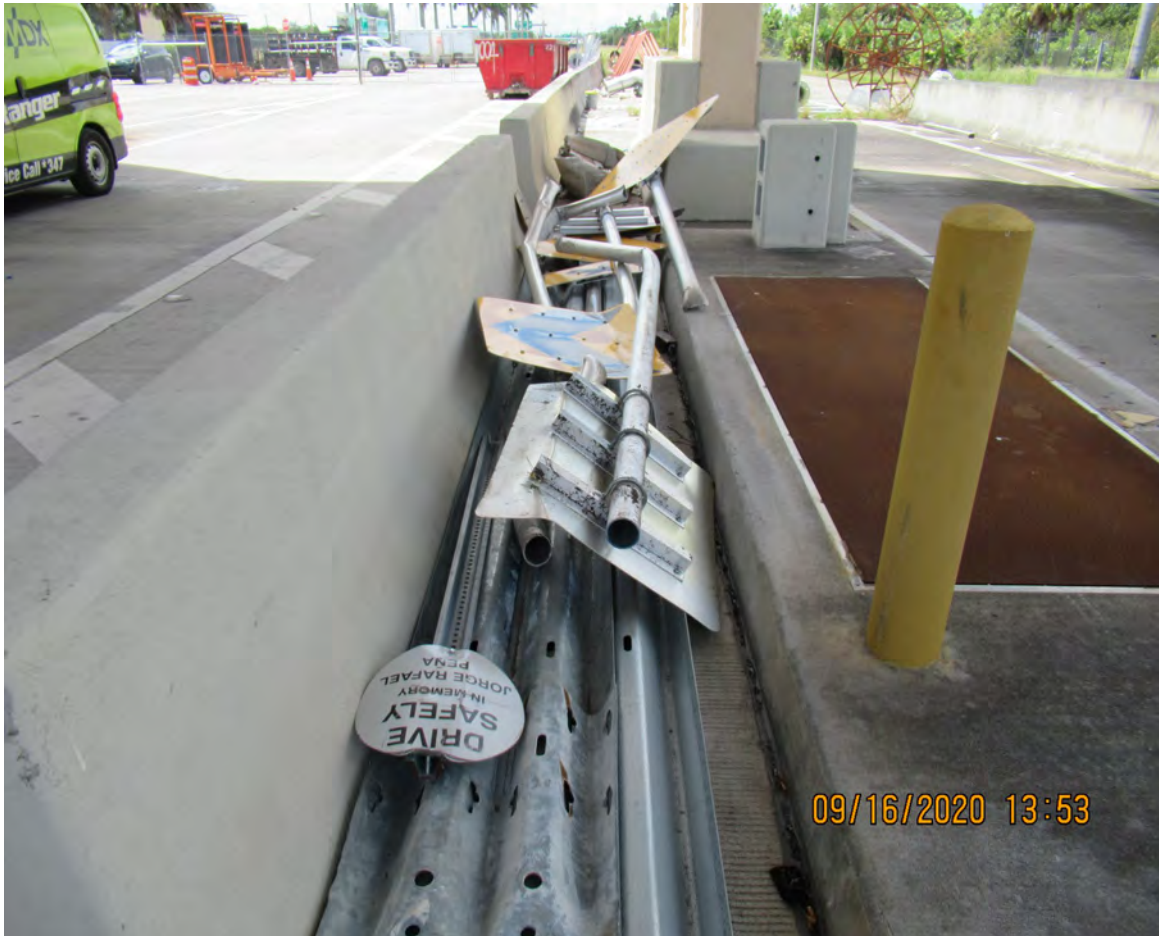
**PHOTO NO.: A-001**  
**DATE: 9-16-2020**

**STORED DAMAGED SIGNS AND GUARDRAIL PANELS**

**ITEM NOTED TO BE ADDRESSED BY MDX MAINTENANCE**

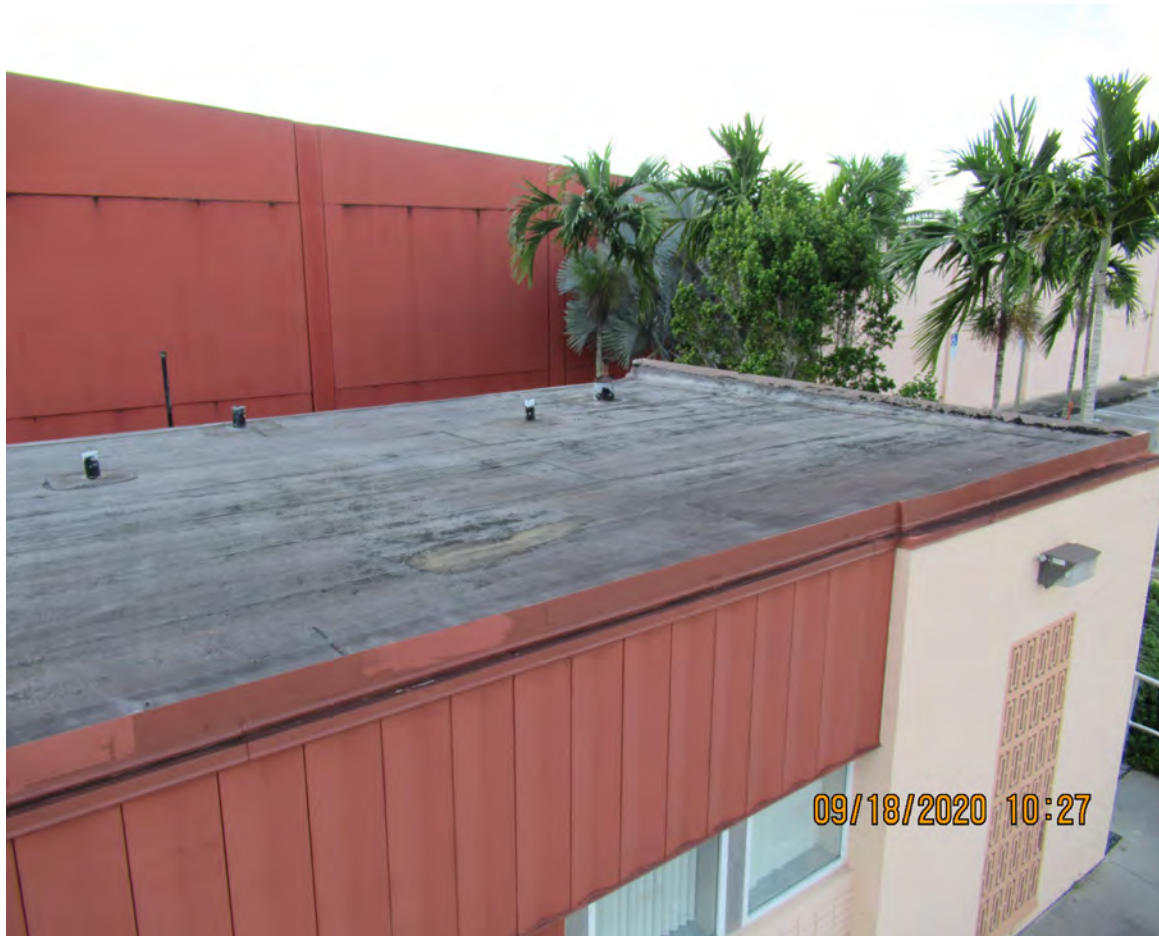
**PHOTO NO.: A-001  
DATE: 9-18-2020**

**BLISTERING ON ROOF MEMBRANE**

**ITEM NOTED TO BE ADDRESSED BY MDX MAINTENANCE**

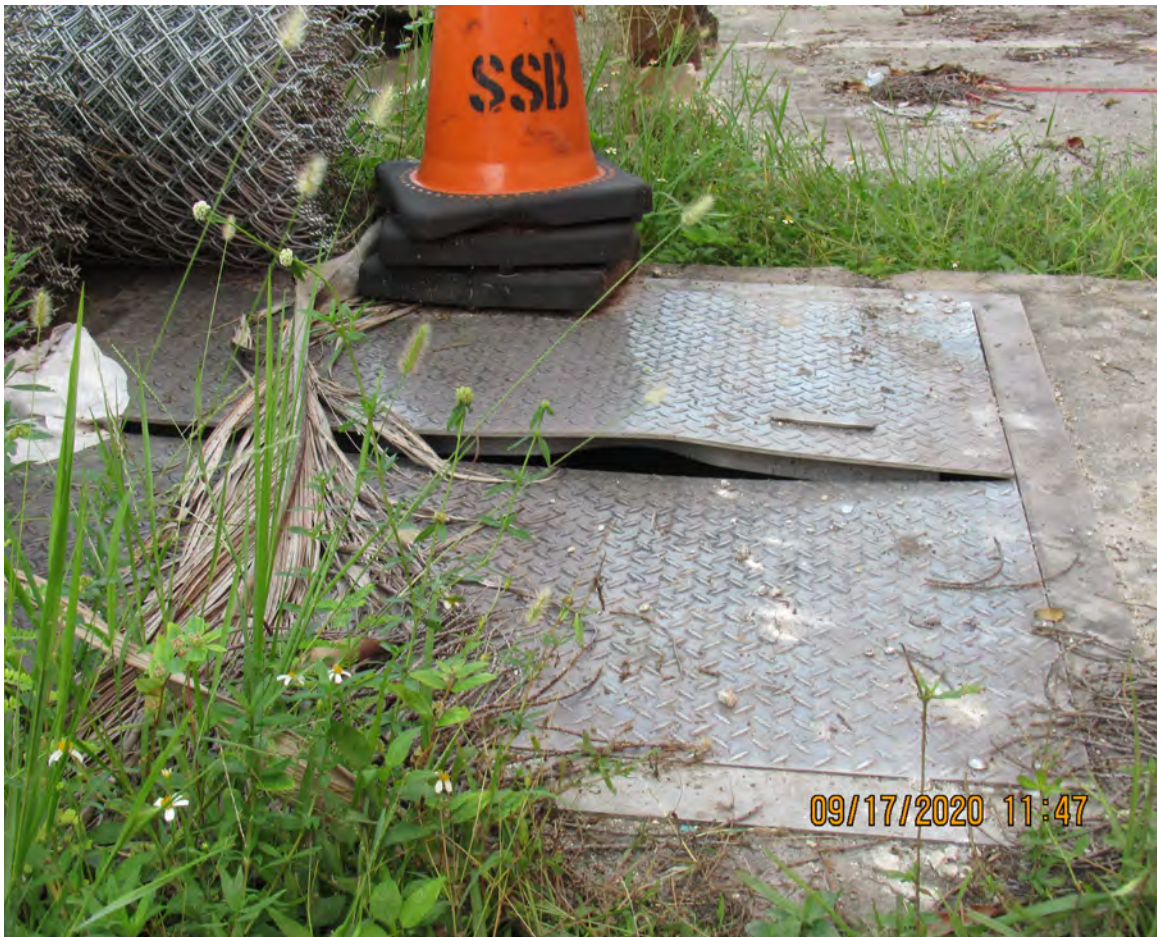
**PHOTO NO.: A-002  
DATE: 9-17-2020**

**DAMAGED SPLICE VAULT ACCESS PLATE**

**ITEM NOTED TO BE ADDRESSED BY MDX PROJECT No. 87410 CONSTRUCTION**

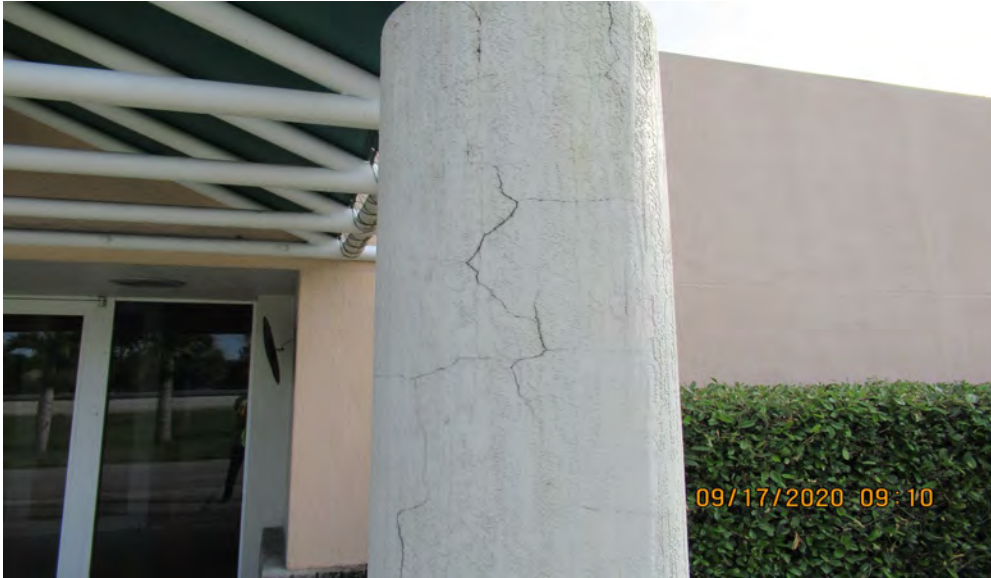
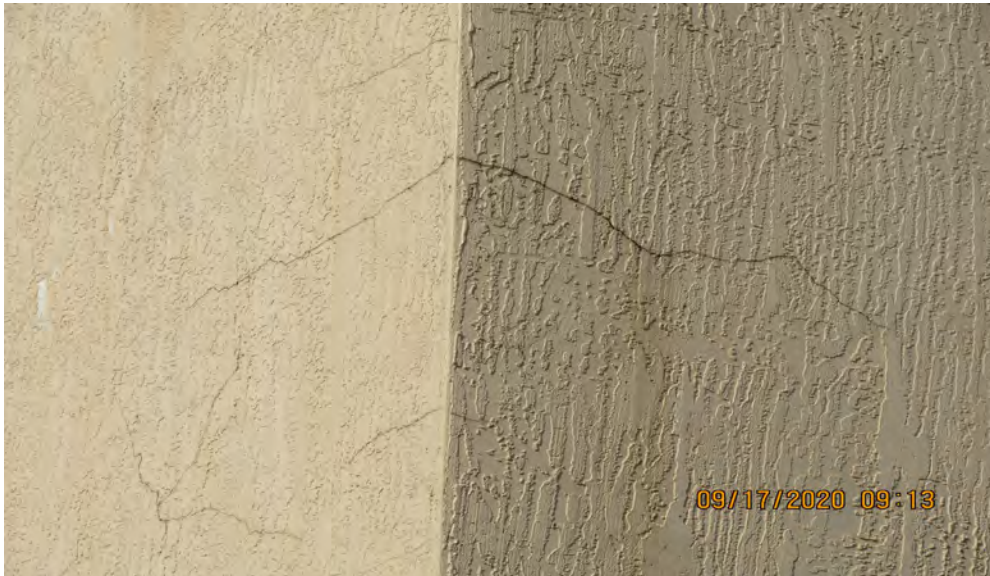
**PHOTO NO.: A-001  
DATE: 9-17-2020**

**CRACKS ON STUCCO**

**ITEM NOTED TO BE ADDRESSED BY MDX MAINTENANCE**

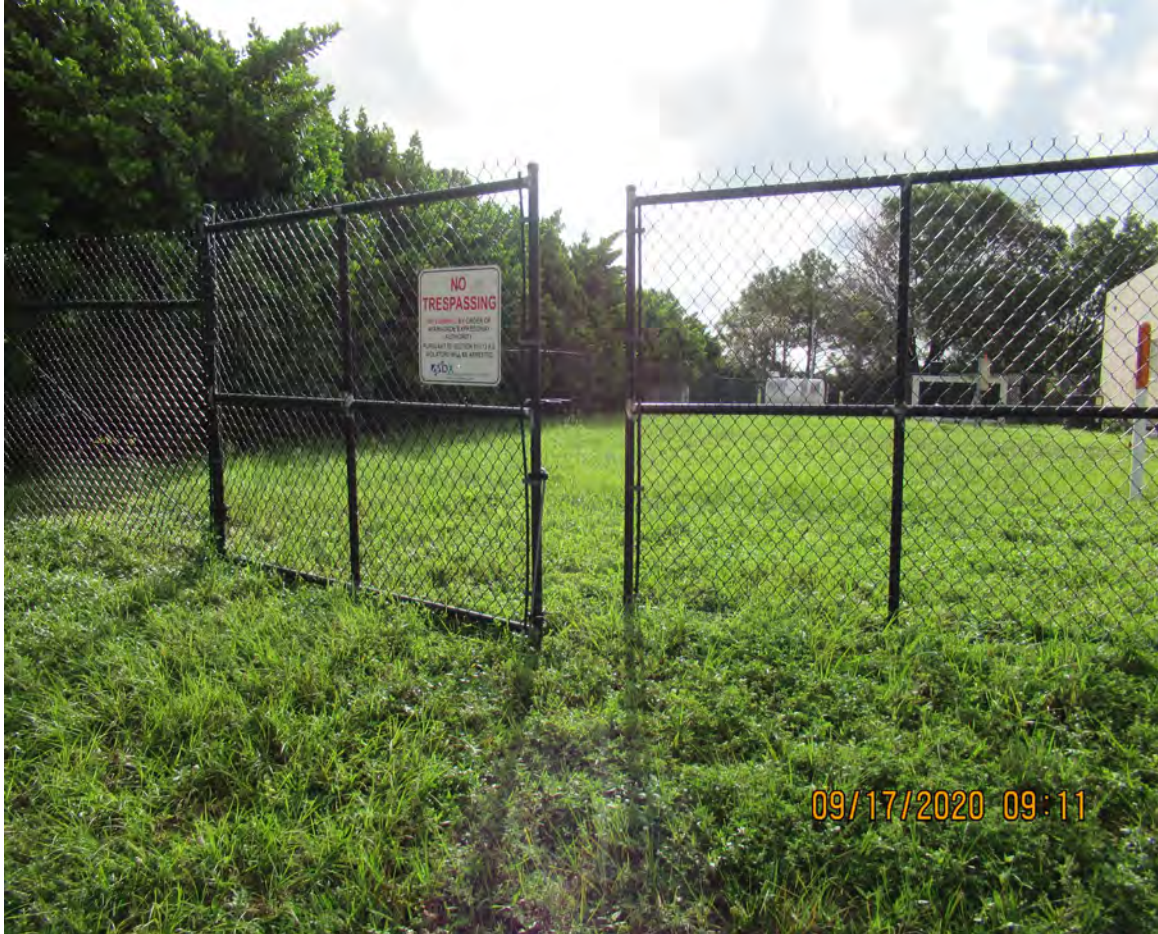
**PHOTO NO.: A-002  
DATE: 9-17-2020**

**MISSING LOCK ON GATE**

**ITEM NOTED TO BE ADDRESSED BY MDX MAINTENANCE**

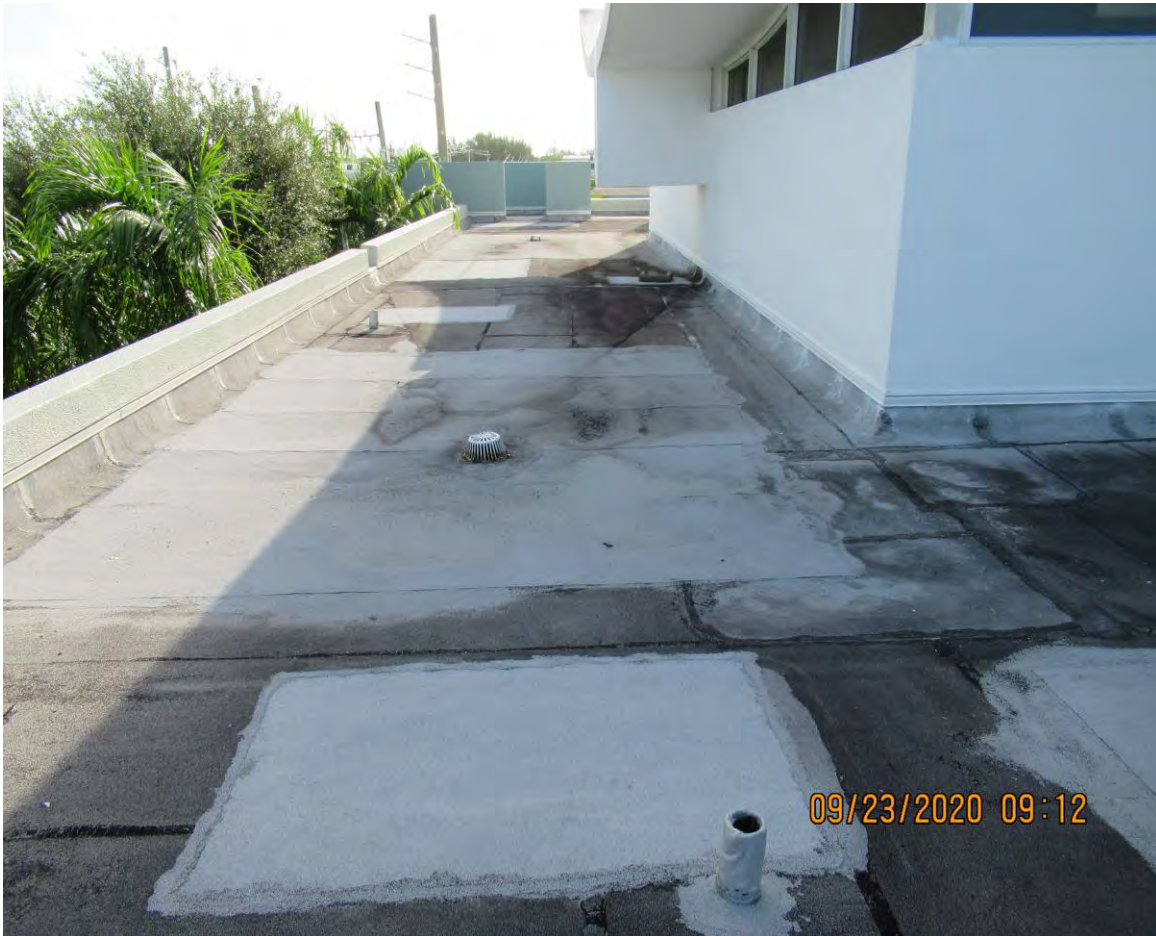
**PHOTO NO.: A-001  
DATE: 9-23-2020**

**ISOLATED REPAIRS ON ROOF MEMBRANE**

**ITEM NOTED TO BE ADDRESSED BY MDX WORK PROGRAM No. 30052**

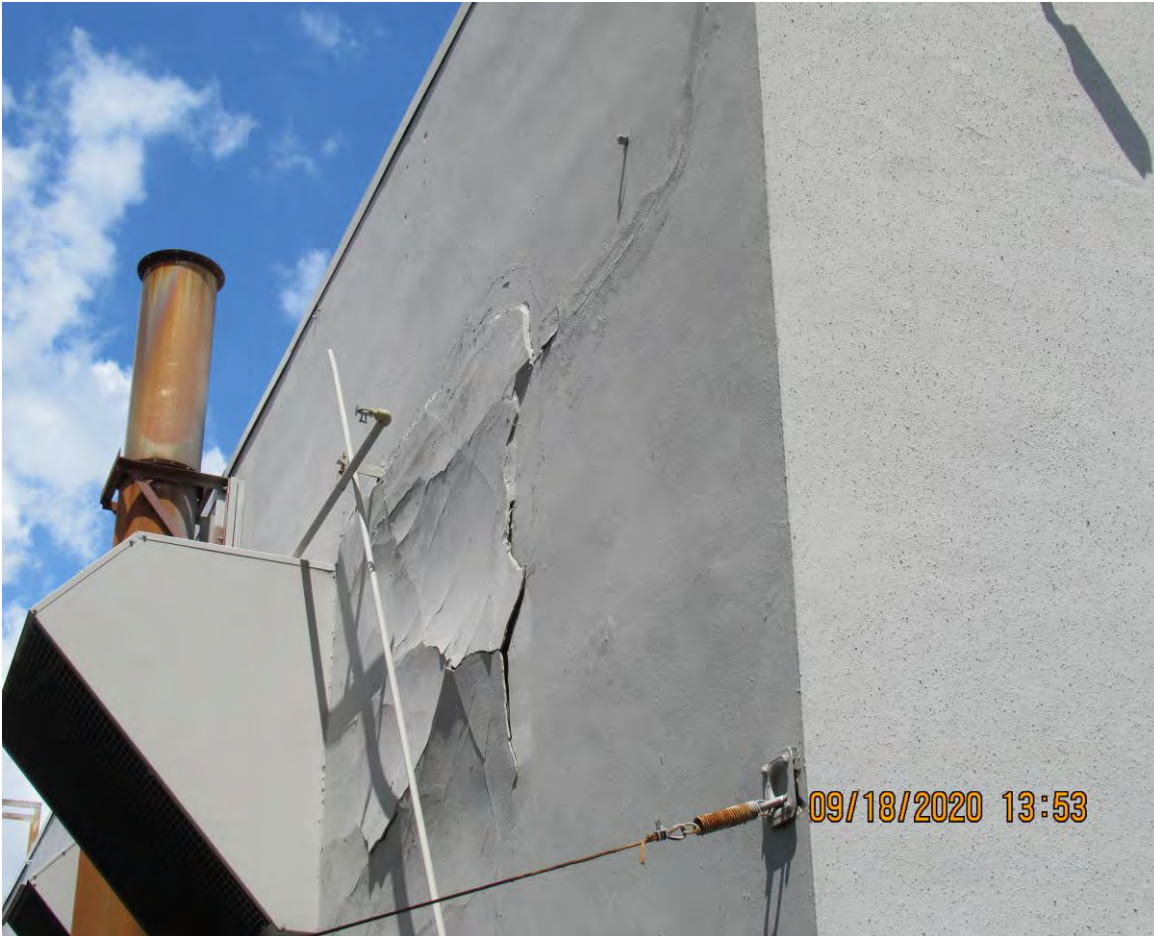
**PHOTO NO.: A-001  
DATE: 9-18-2020**

**DELAMINATION OF STUCCO (EAST ELEVATION)**

**ITEM NOTED TO BE ADDRESSED BY THE TENANT**
