Annual Inspection Report 2021

General Engineering Consultant to the
Miami-Dade County Expressway Authority

ANNUAL INSPECTION REPORT 2021

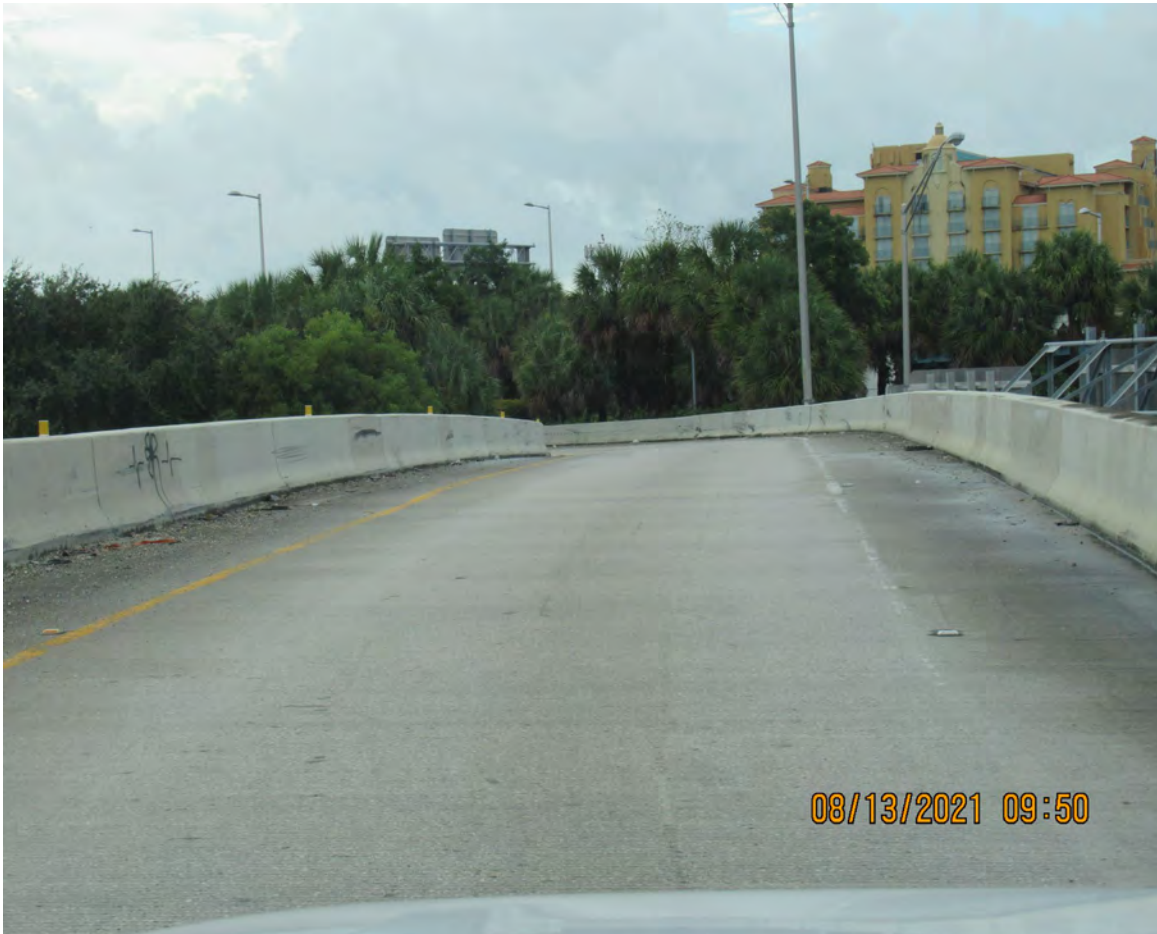
**PHOTO NO.: EB-001
DATE: 8-13-2021**

DETERIORATED STRIPING (BRIDGE No. 870962)

ITEMS NOTED TO BE ADDRESSED BY MDX MAINTENANCE

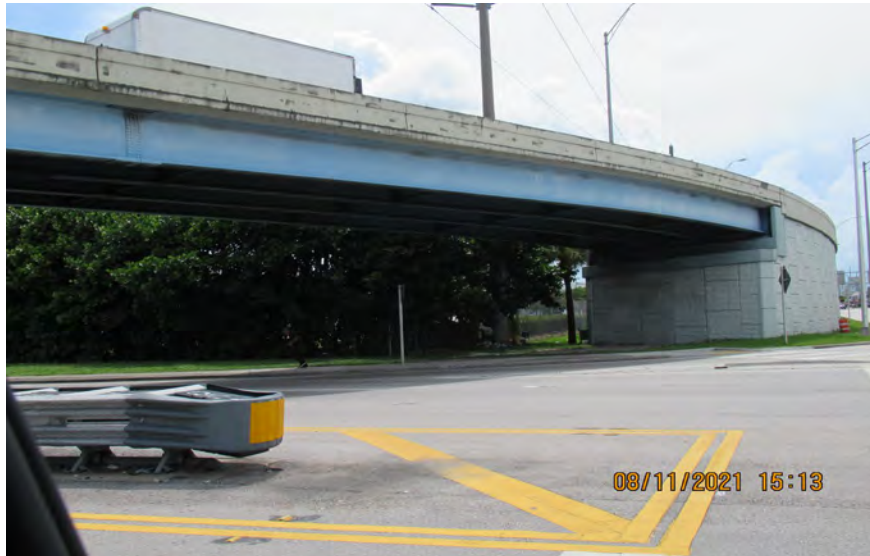
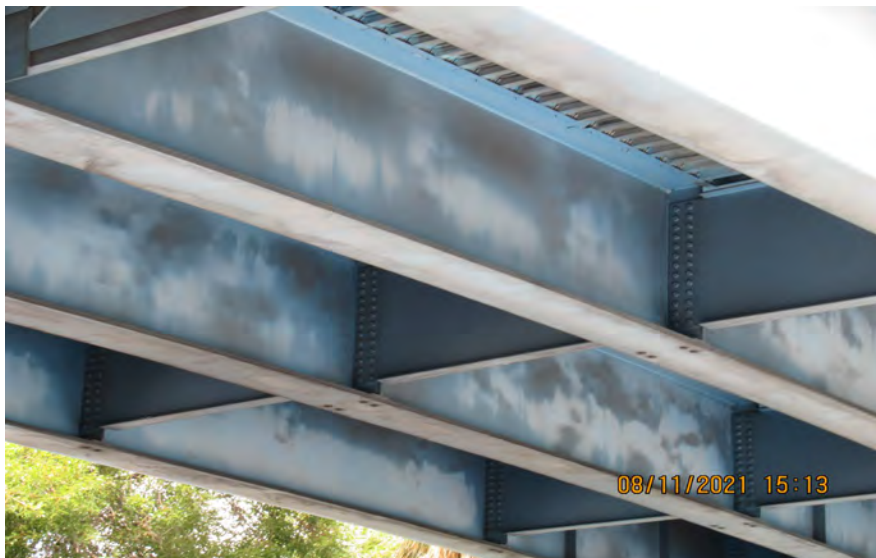
**PHOTO NO.: EB-002
DATE: 8-11-2021**

**DETERIORATED PAINT ON COLUMNS, PIER CAPS, TRAFFIC RAILING AND MSE
WALL (BRIDGE No. 870962)**

ITEMS NOTED TO BE ADDRESSED BY MDX PROJECT (TBD)

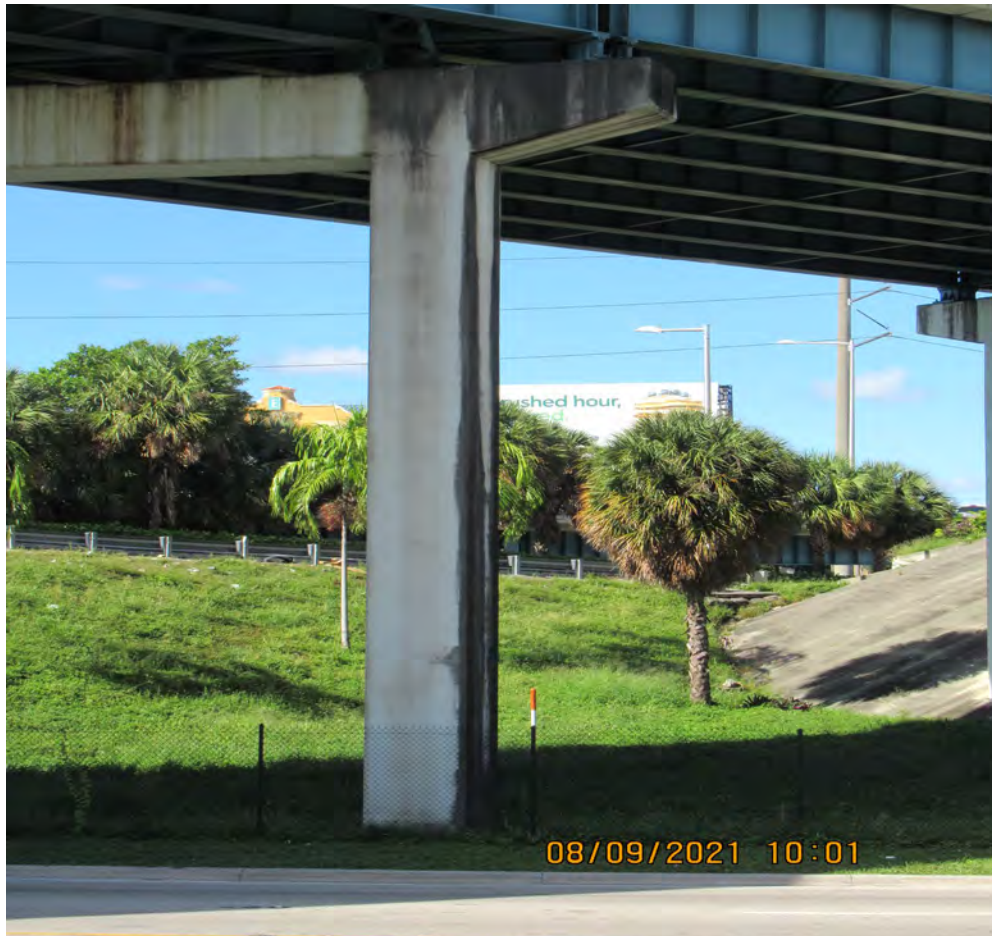
**PHOTO NO.: EB-004
DATE: 8-9-2021**

**STAINS ON PIER CAPS & COLUMNS DUE TO LEAKING SLIDING PLATE JOINTS
AND DETERIORATED CLASS V COATING (BRIDGE No. 870238)
TYPICAL AT VARIOUS LOCATIONS**

ITEMS NOTED TO BE ADDRESSED BY MDX WORK PROGRAM No. 30029 & 30037

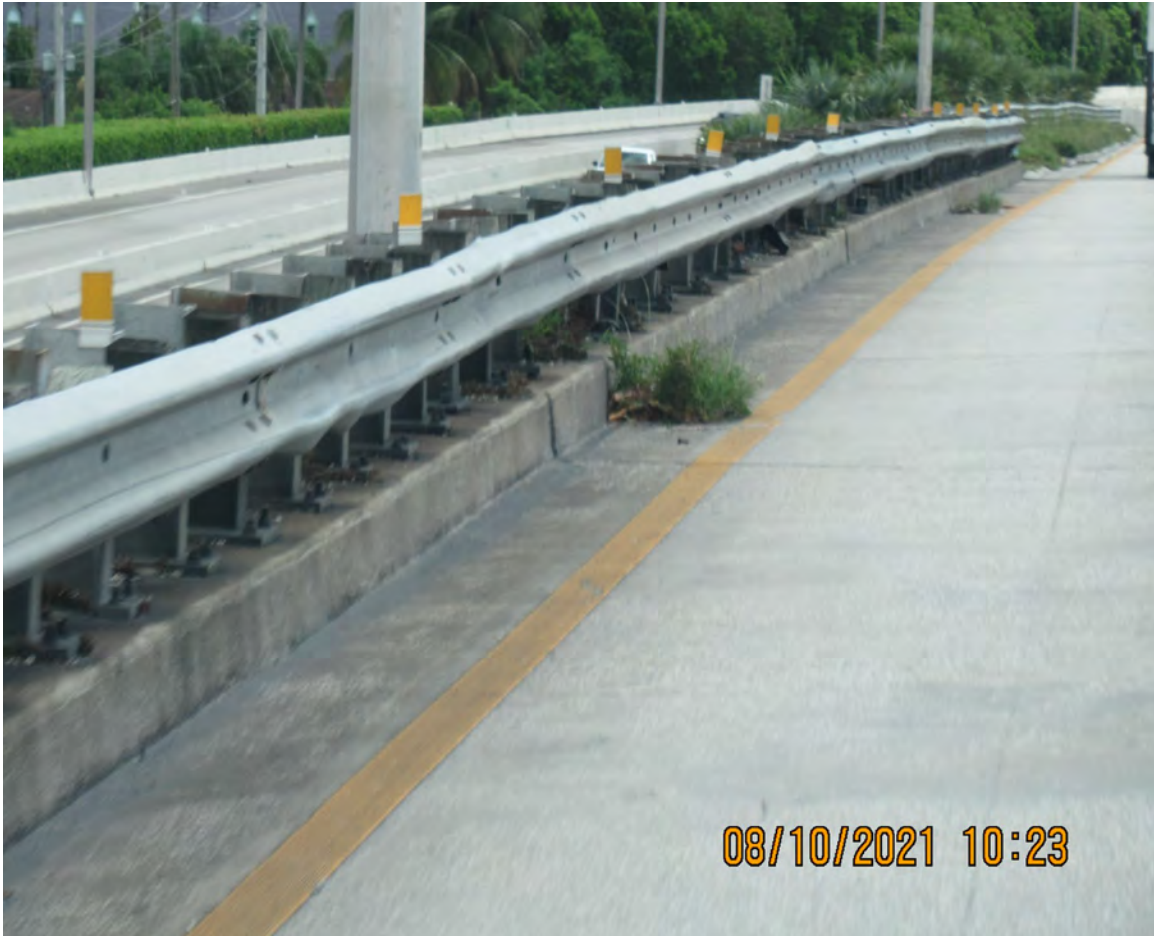
**PHOTO NO.: EB-006
DATE: 8-10-2021**

**SEDIMENTATION AND OVERGROWN VEGETATION ON BRIDGE DRAINAGE INLETS
(BRIDGE # 870238) (TYPICAL THROUGHOUT THE CORRIDOR)**

ITEM NOTED TO BE ADDRESSED BY MDX MAINTENANCE

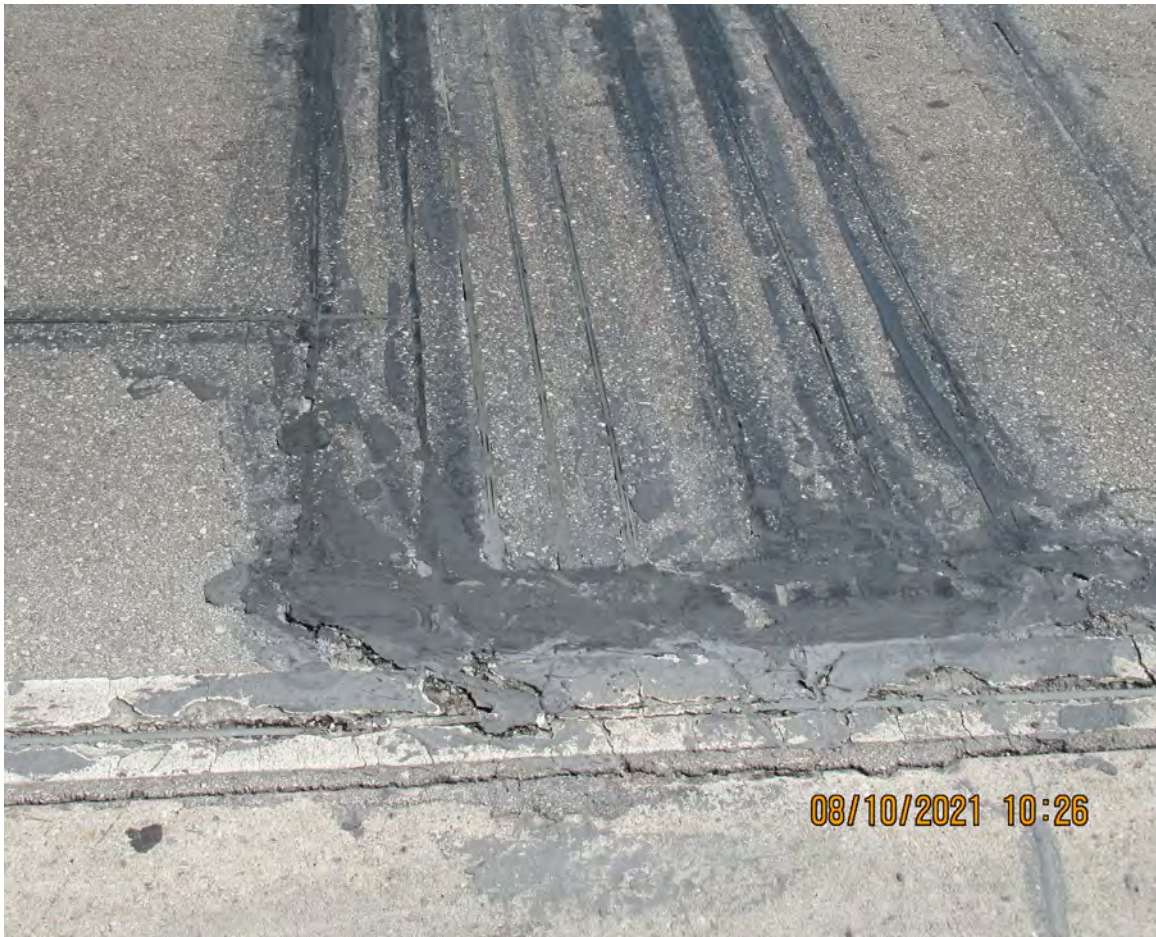
**PHOTO NO.: EB-007
DATE: 8-10-2021**

DETERIORATED TOLLS LOOP DETECTOR SEALANT

ITEMS NOTED TO BE ADDRESSED BY MDX TOLL SYSTEMS INTEGRATOR

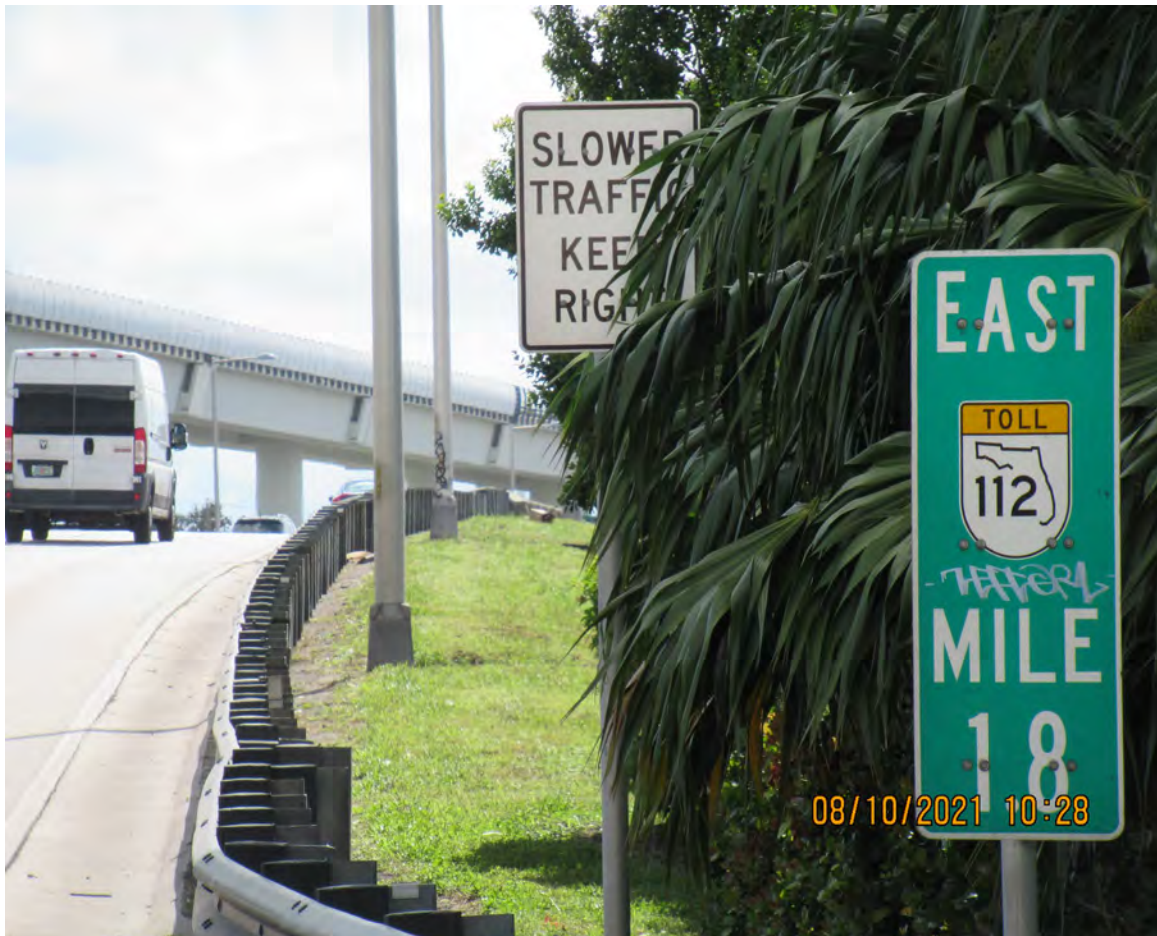
**PHOTO NO.: EB-008
DATE: 8-10-2021**

**OVERGROWN VEGETATION OBSTRUCTING SIGN &
GRAFITTI ON MILE MARKER SIGN**

ITEMS NOTED TO BE ADDRESSED BY MDX MAINTENANCE

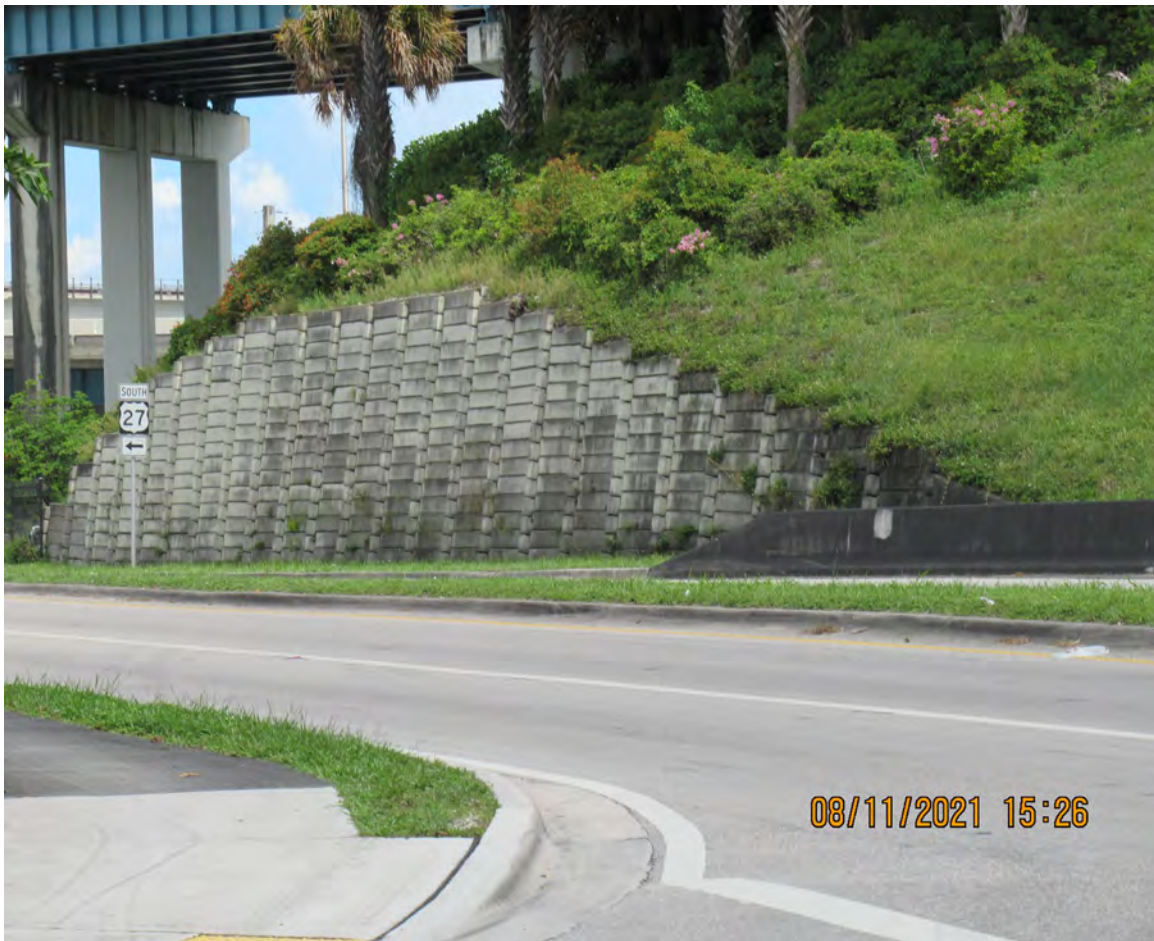
**PHOTO NO.: EB-010
DATE: 8-11-2021**

DETERIORATED CLASS V COATING ON RETAINING WALL

ITEMS NOTED TO BE ADDRESSED BY MDX WORK PROGRAM No. 30037

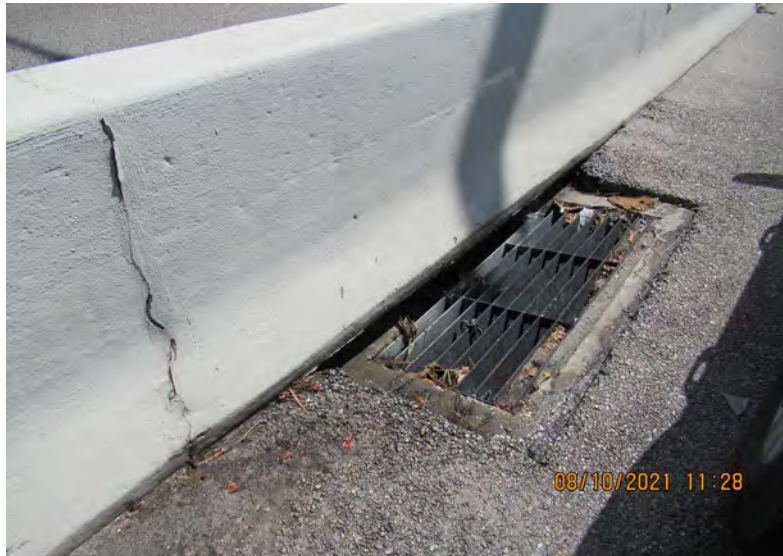
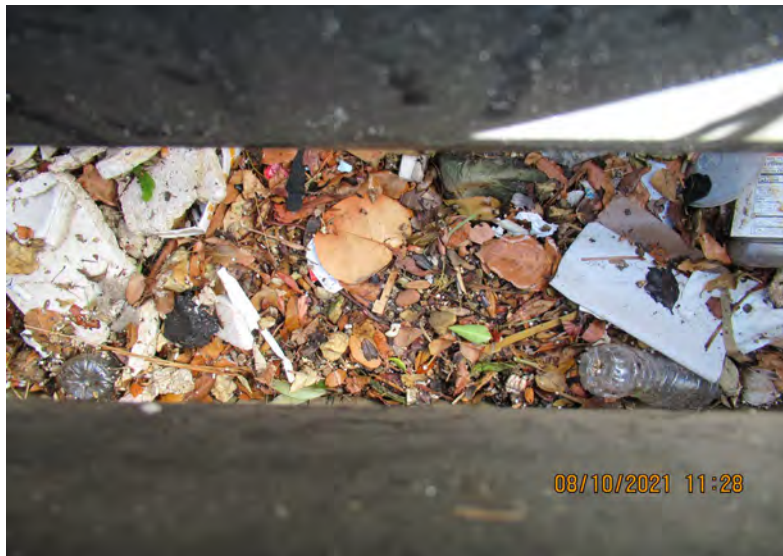
**PHOTO NO.: EB-013
DATE: 8-10-2021**

**SILTED DRAINAGE INLET
(TYPICAL THROUGHOUT THE CORRIDOR)**

ITEM NOTED TO BE ADDRESSED BY MDX MAINTENANCE

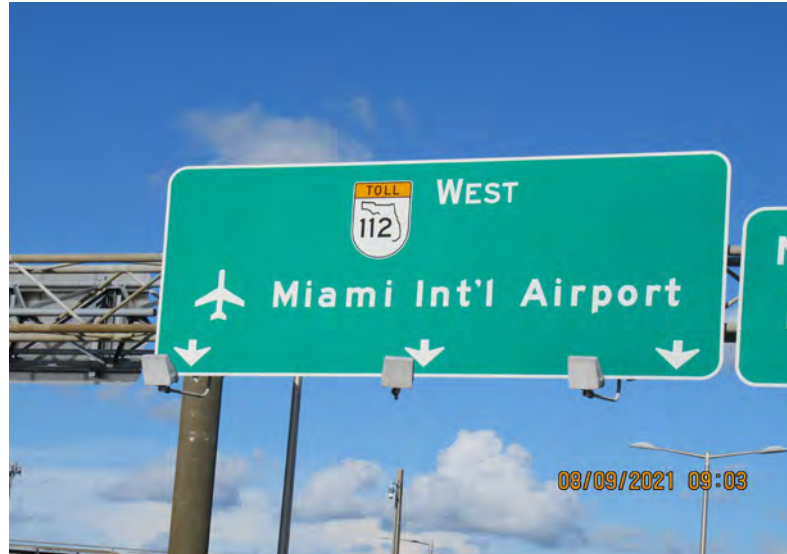
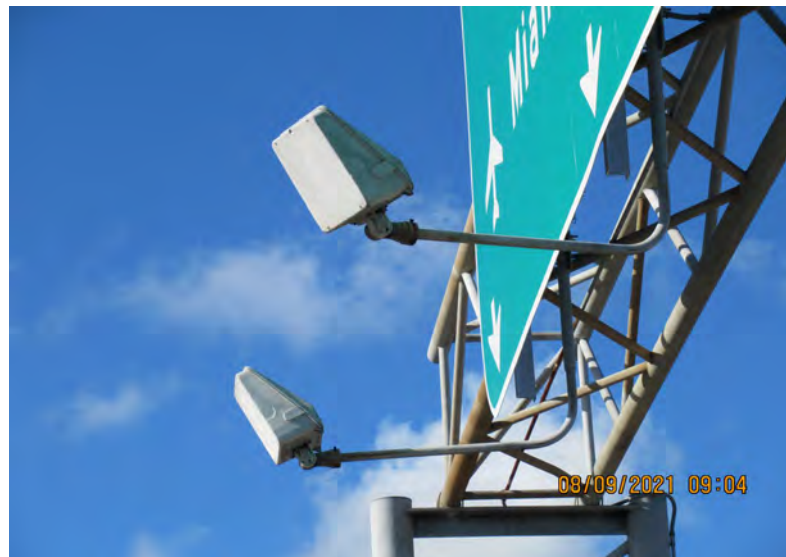
**PHOTO NO.: WB-001
DATE: 8-9-2021**

TWISTED LUMINAIRE (STRUCTURE # 87S422)

ITEM NOTED TO BE ADDRESSED BY MDX MAINTENANCE

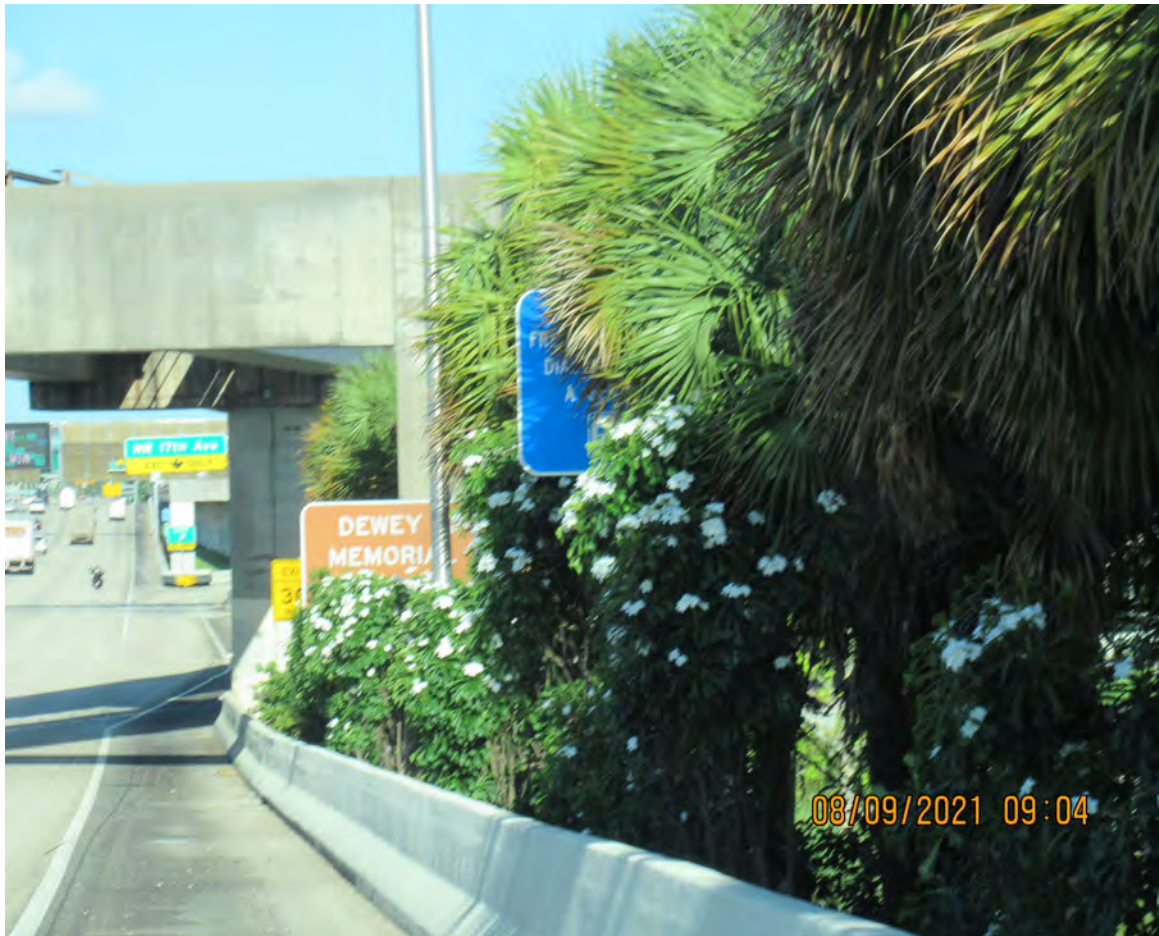
**PHOTO NO.: WB-002
DATE: 8-9-2021**

OVERGROWN VEGETATION OBSTRUCTING SIGN

ITEM NOTED TO BE ADDRESSED BY MDX MAINTENANCE

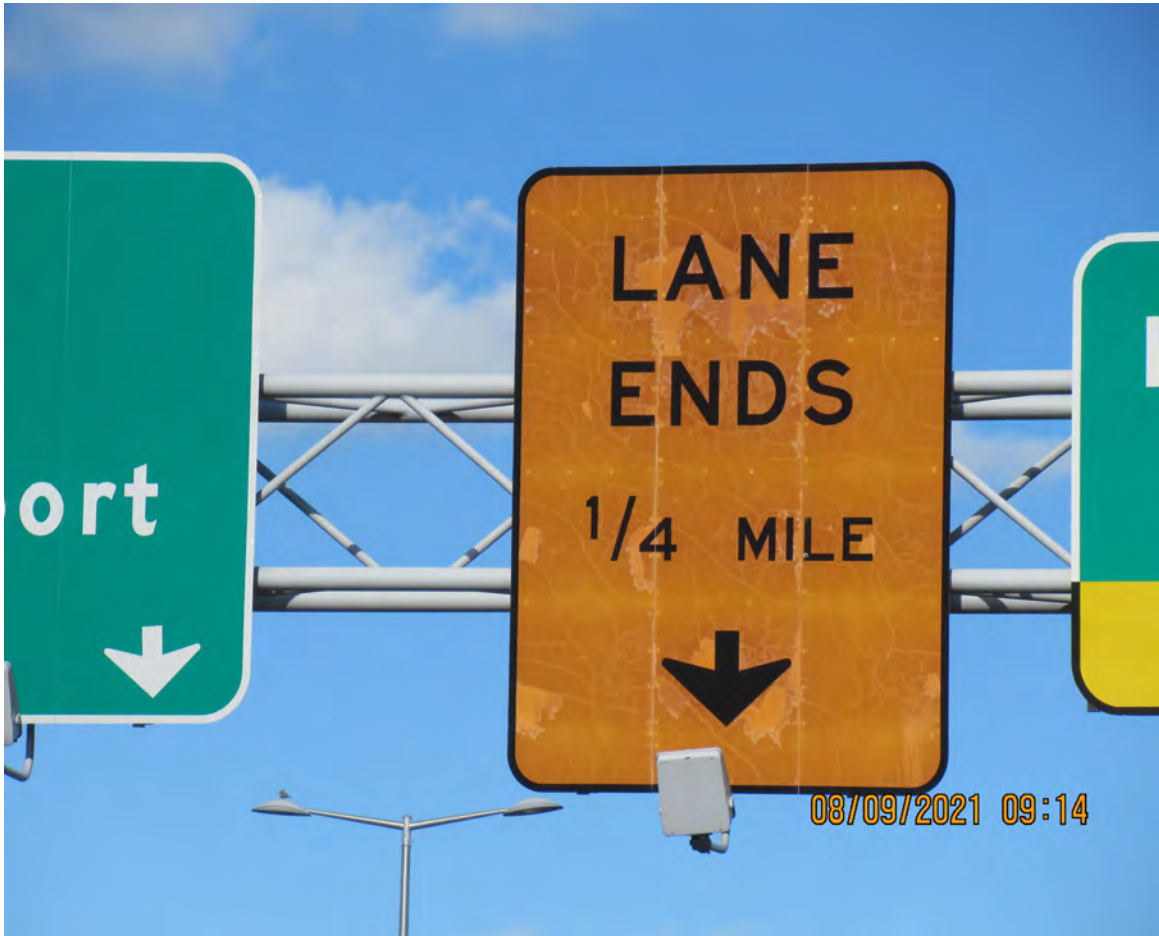
**PHOTO NO.: WB-003
DATE: 8-9-2021**

**DETERIORATED REFLECTIVE SHEETING ON
LANE ENDS 1/4 MILE SIGN PANEL**

ITEM NOTED TO BE ADDRESSED BY MDX MAINTENANCE

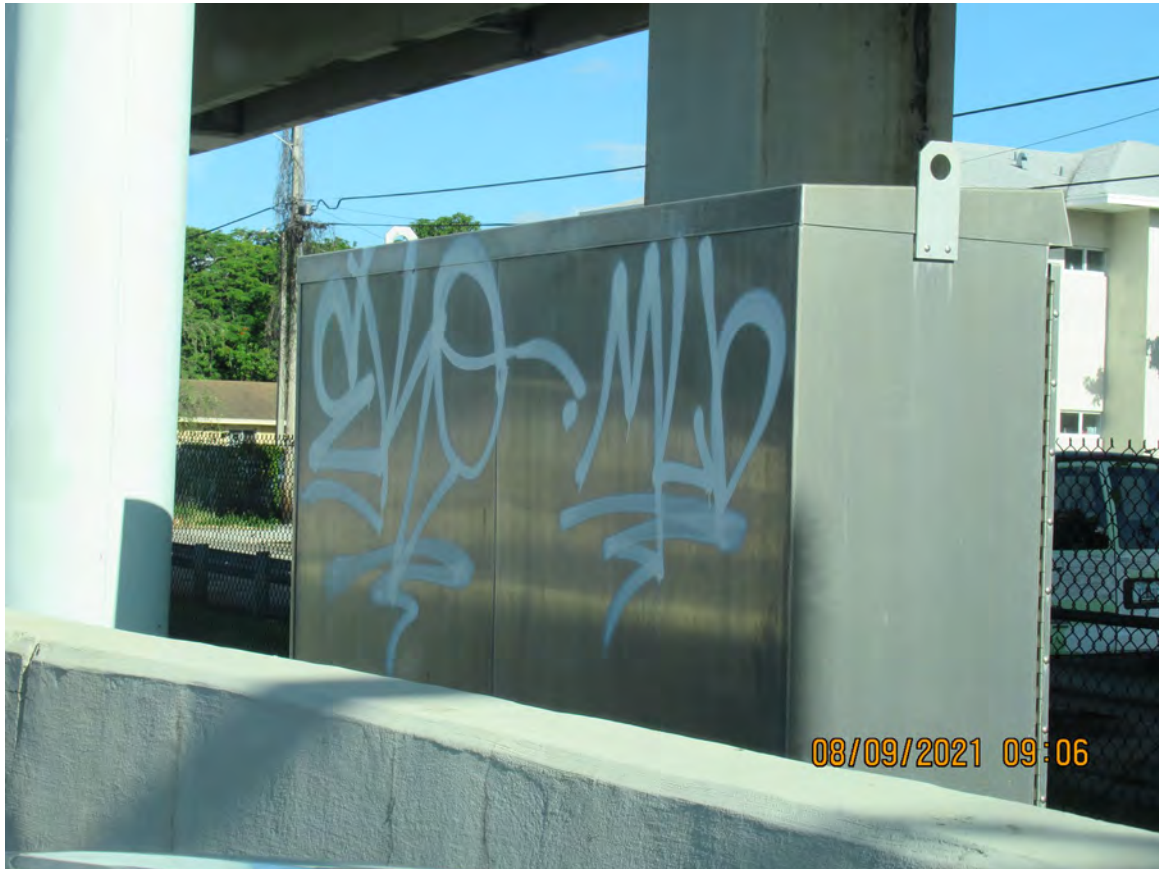
**PHOTO NO.: WB-004
DATE: 8-9-2021**

GRAFITTI ON ITS CABINET

ITEM NOTED TO BE ADDRESSED BY MDX MAINTENANCE

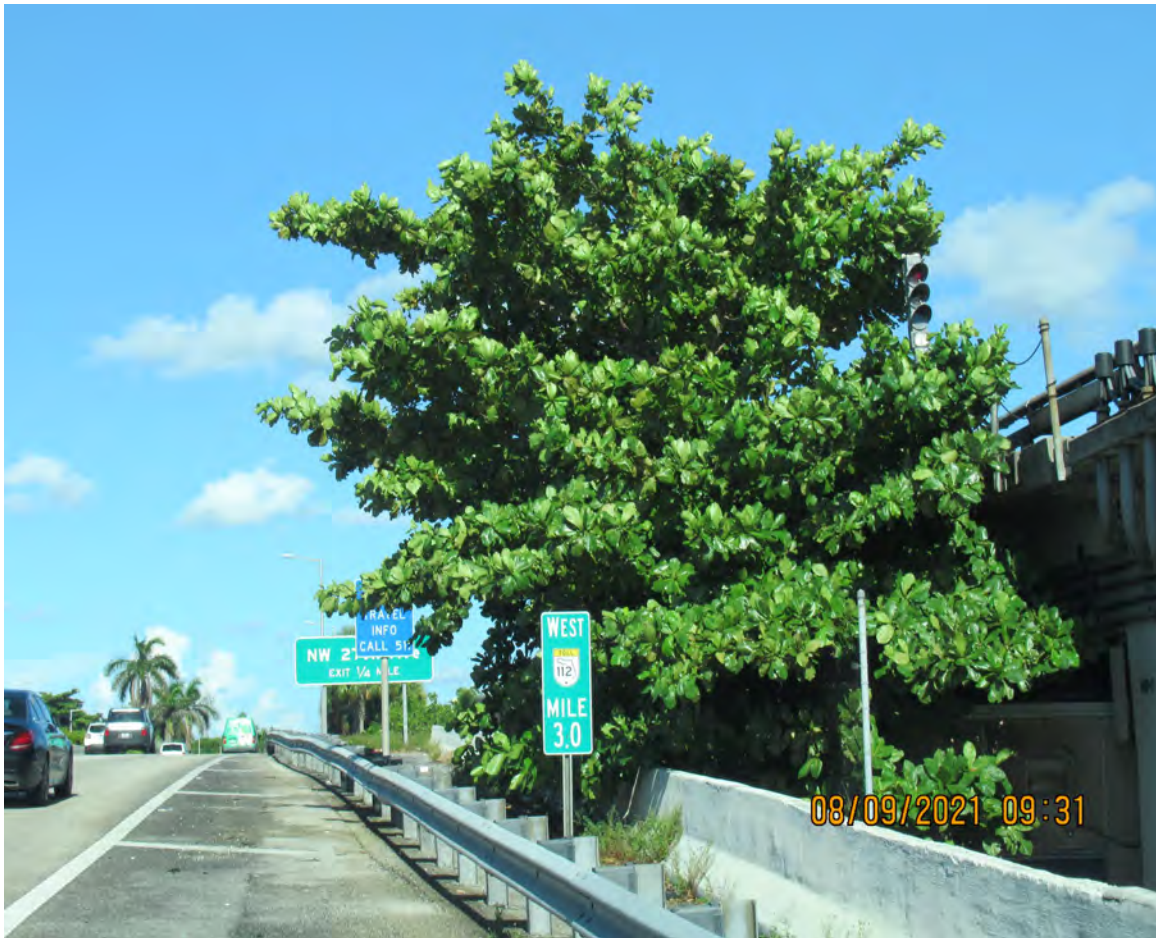
**PHOTO NO.: WB-006
DATE: 8-9-2021**

**OVERGROWN VEGETATION FROM METRO-RAIL ENCROACHING ON MDX
RIGHT-OF-WAY**

ITEM NOTED TO BE ADDRESSED BY MDX MAINTENANCE

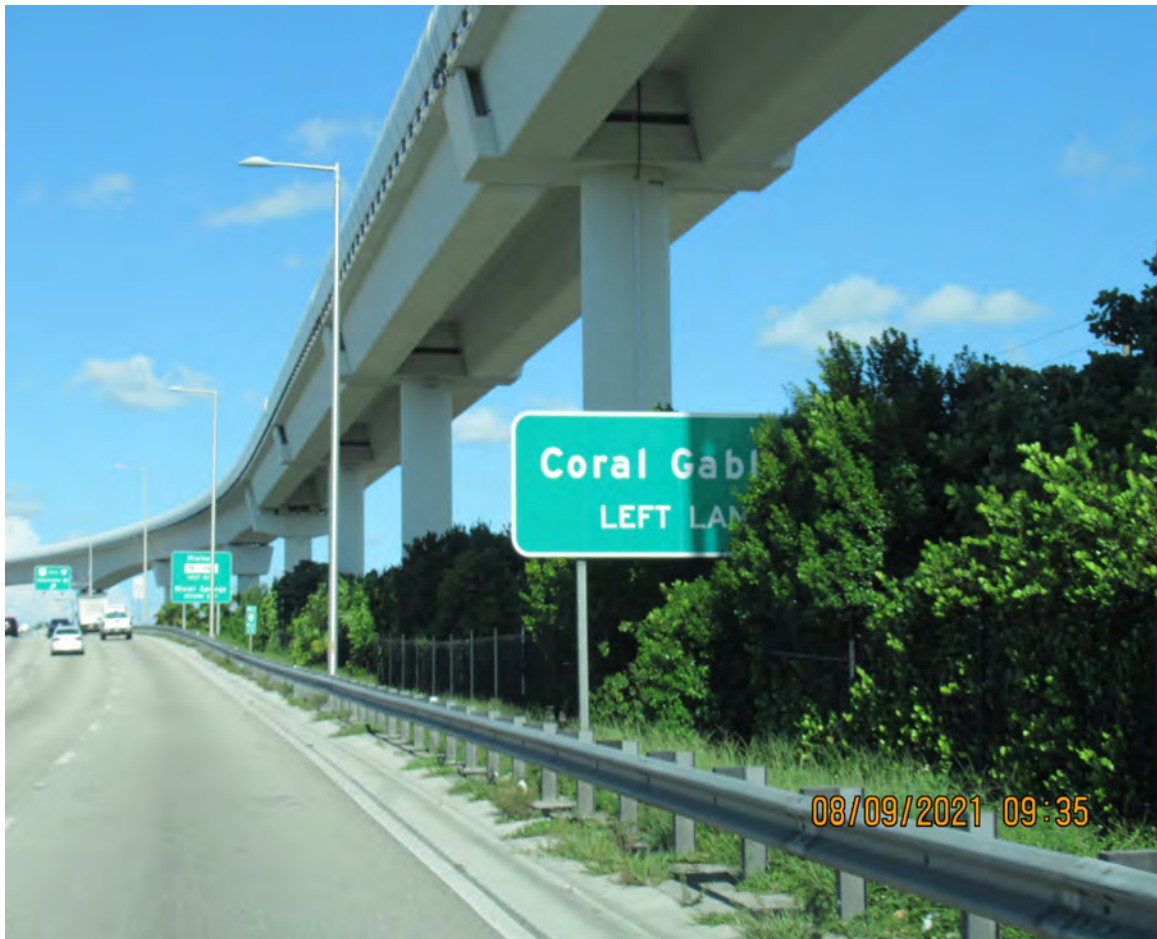
**PHOTO NO.: WB-007
DATE: 8-9-2021**

OVERGROWN VEGETATION OBSTRUCTING SIGN

ITEM NOTED TO BE ADDRESSED BY MDX MAINTENANCE

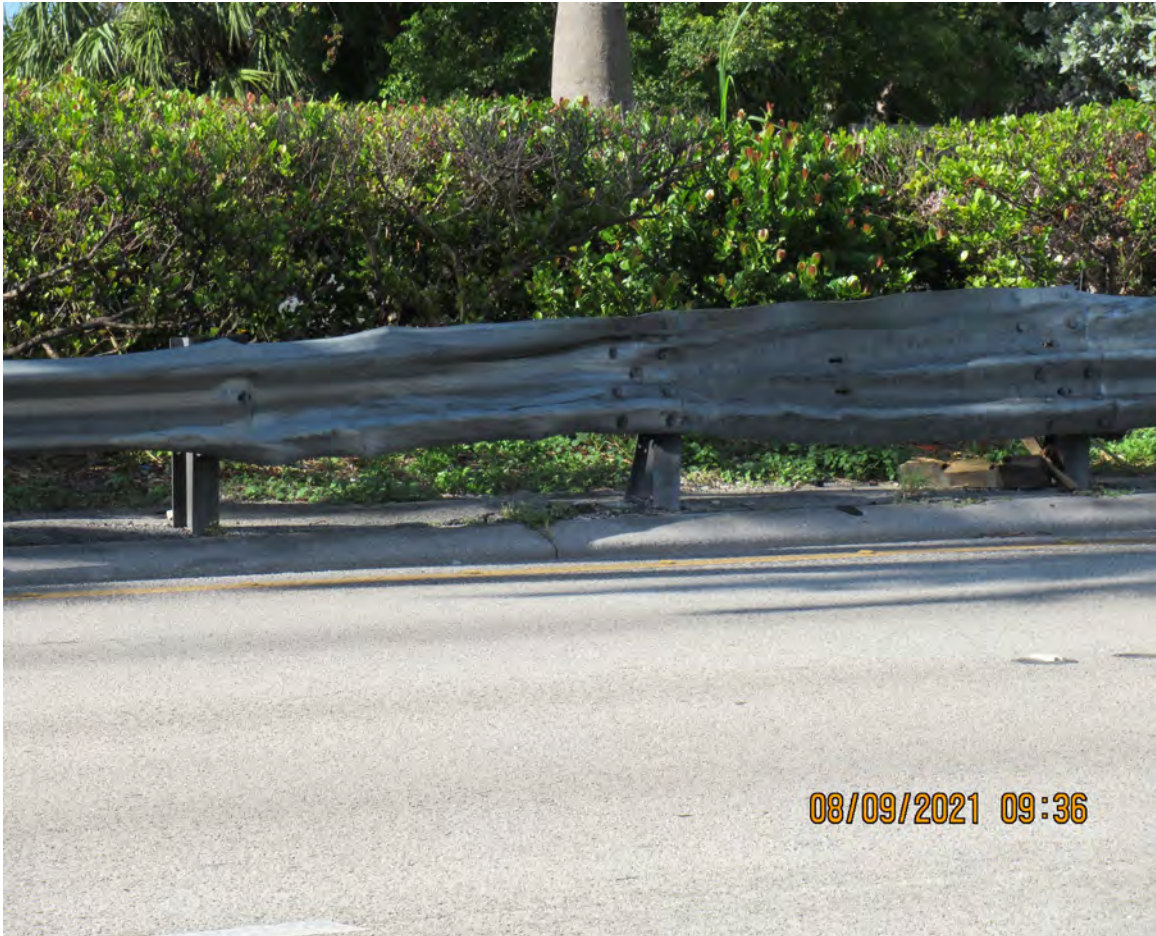
**PHOTO NO.: WB-009
DATE: 8-9-2021**

DAMAGED GUARDRAIL

ITEM NOTED TO BE ADDRESSED BY MDX MAINTENANCE

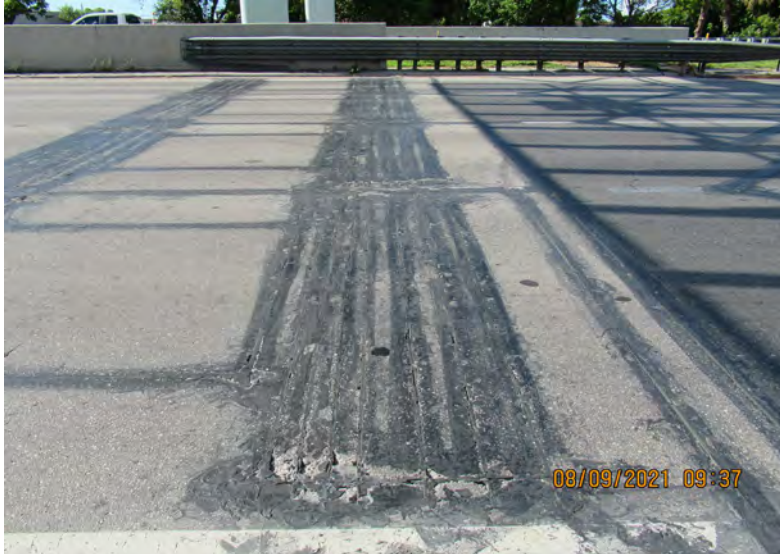
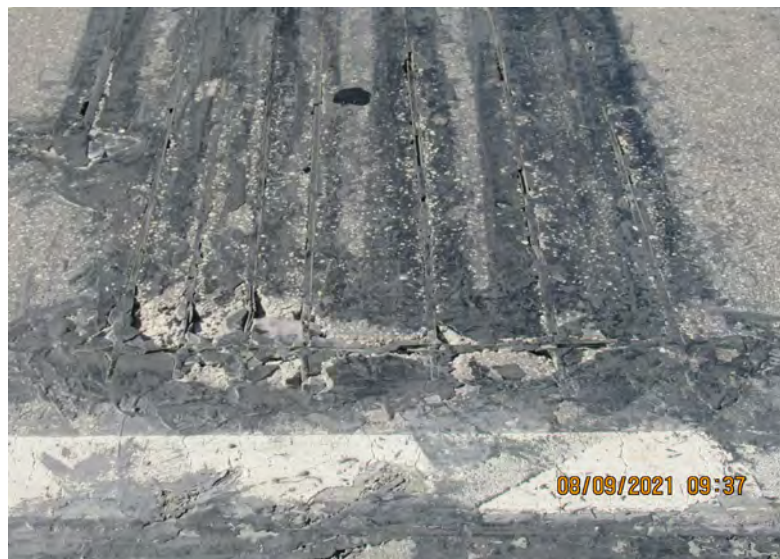
**PHOTO NO.: WB-010
DATE: 8-9-2021**

DETERIORATED LOOP DETECTOR SEALANT

ITEMS NOTED TO BE ADDRESSED BY MDX TOLL SYSTEMS INTEGRATOR

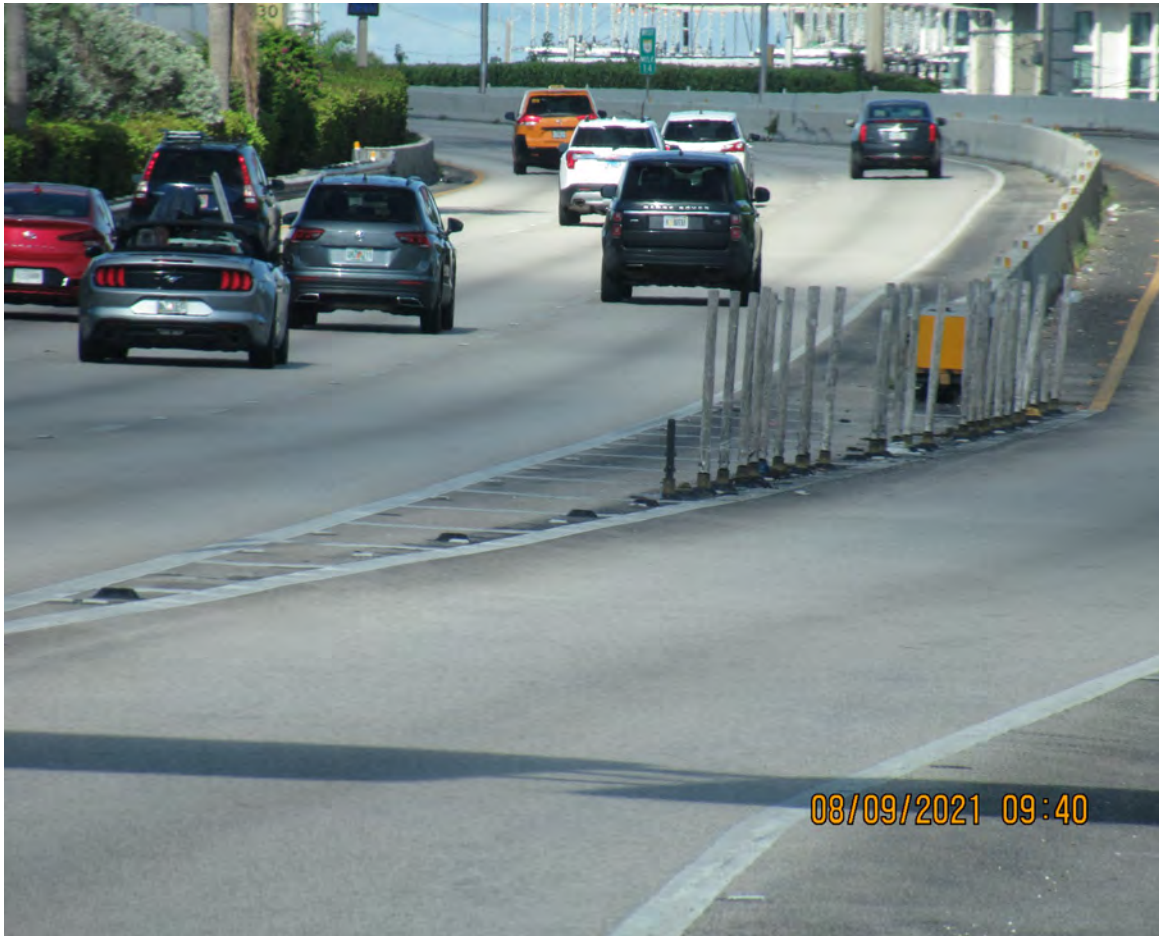
**PHOTO NO.: WB-011
DATE: 8-9-2021**

DAMAGED / MISSING DELINIATORS

ITEM NOTED TO BE ADDRESSED BY MDX MAINTENANCE

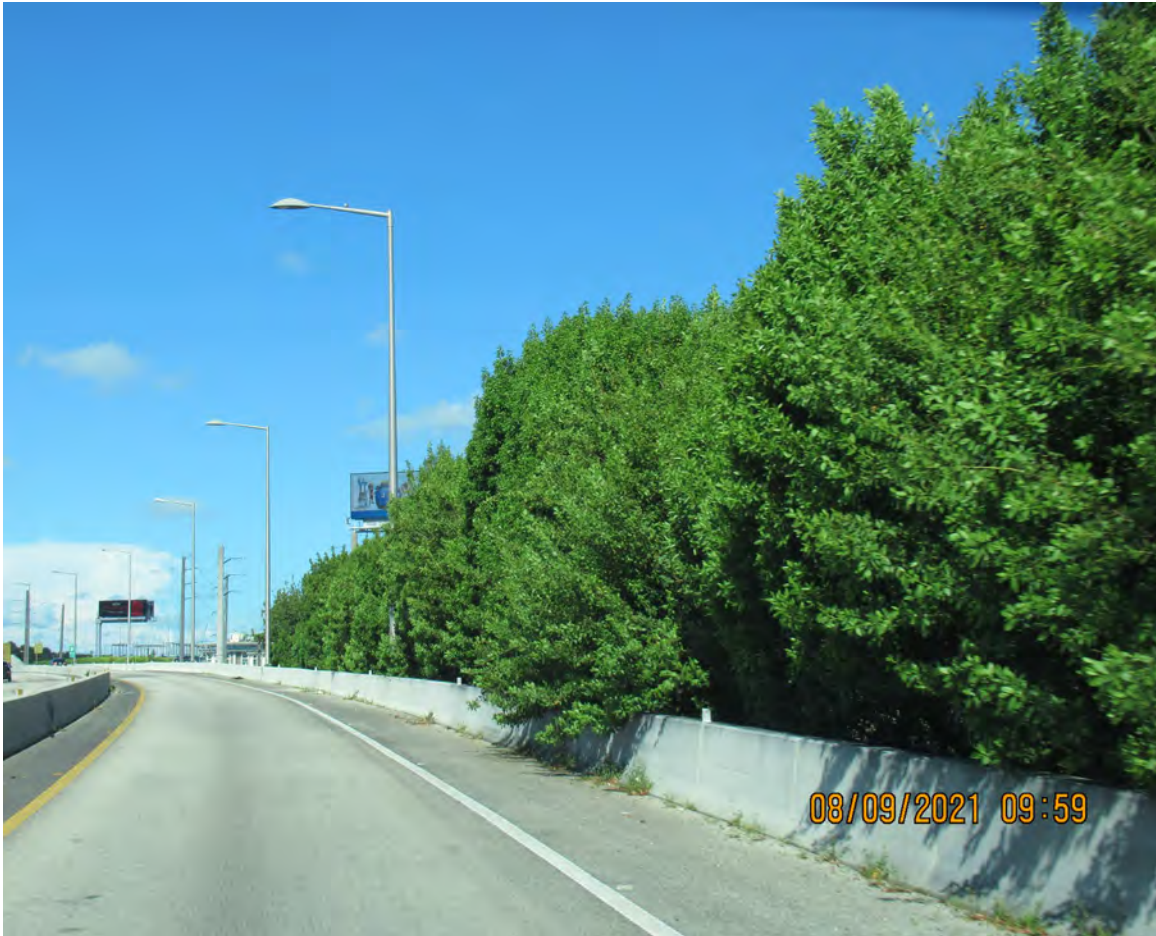
**PHOTO NO.: WB-012
DATE: 8-9-2021**

OVERGROWN VEGETATION

ITEM NOTED TO BE ADDRESSED BY MDX MAINTENANCE

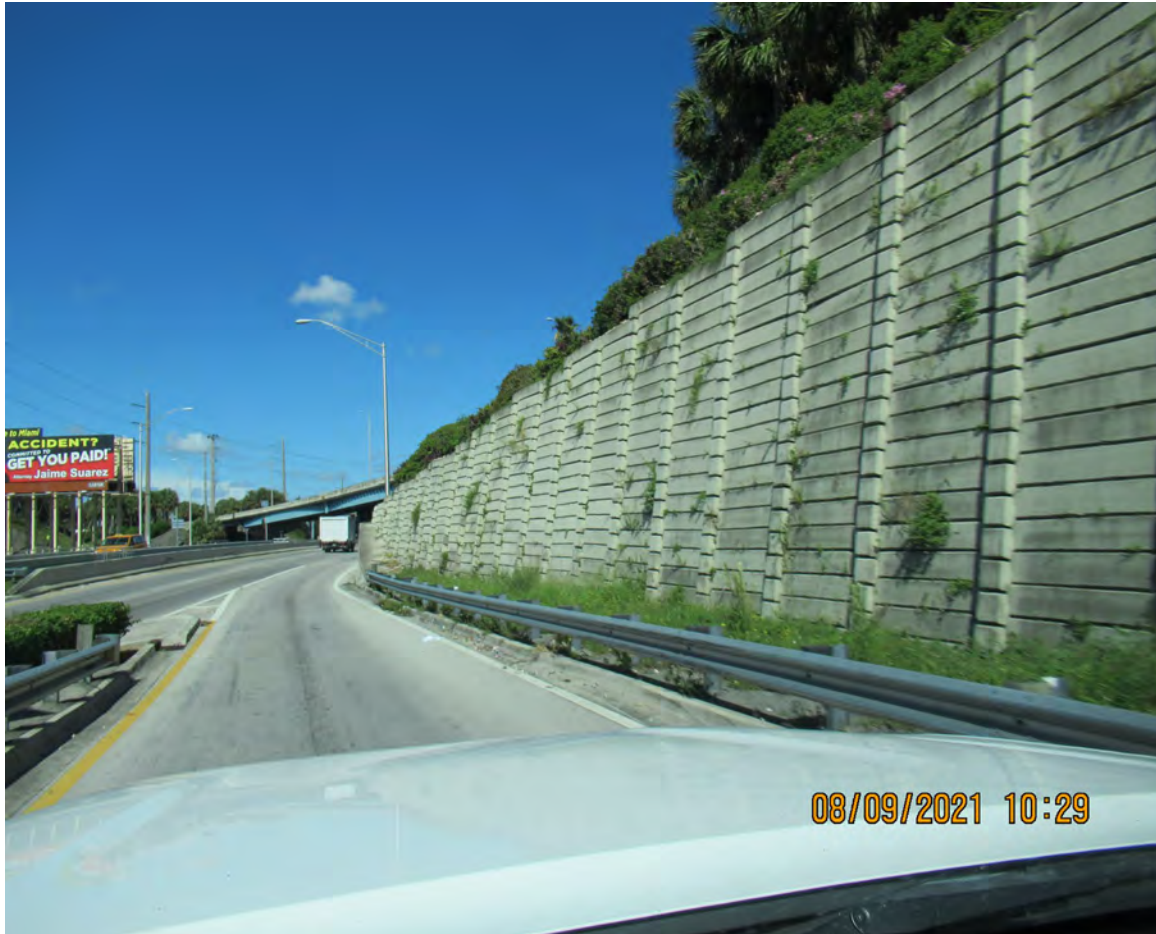
**PHOTO NO.: WB-013
DATE: 8-9-2021**

VEGETATION ON RETAINING WALL

ITEM NOTED TO BE ADDRESSED BY MDX MAINTENANCE

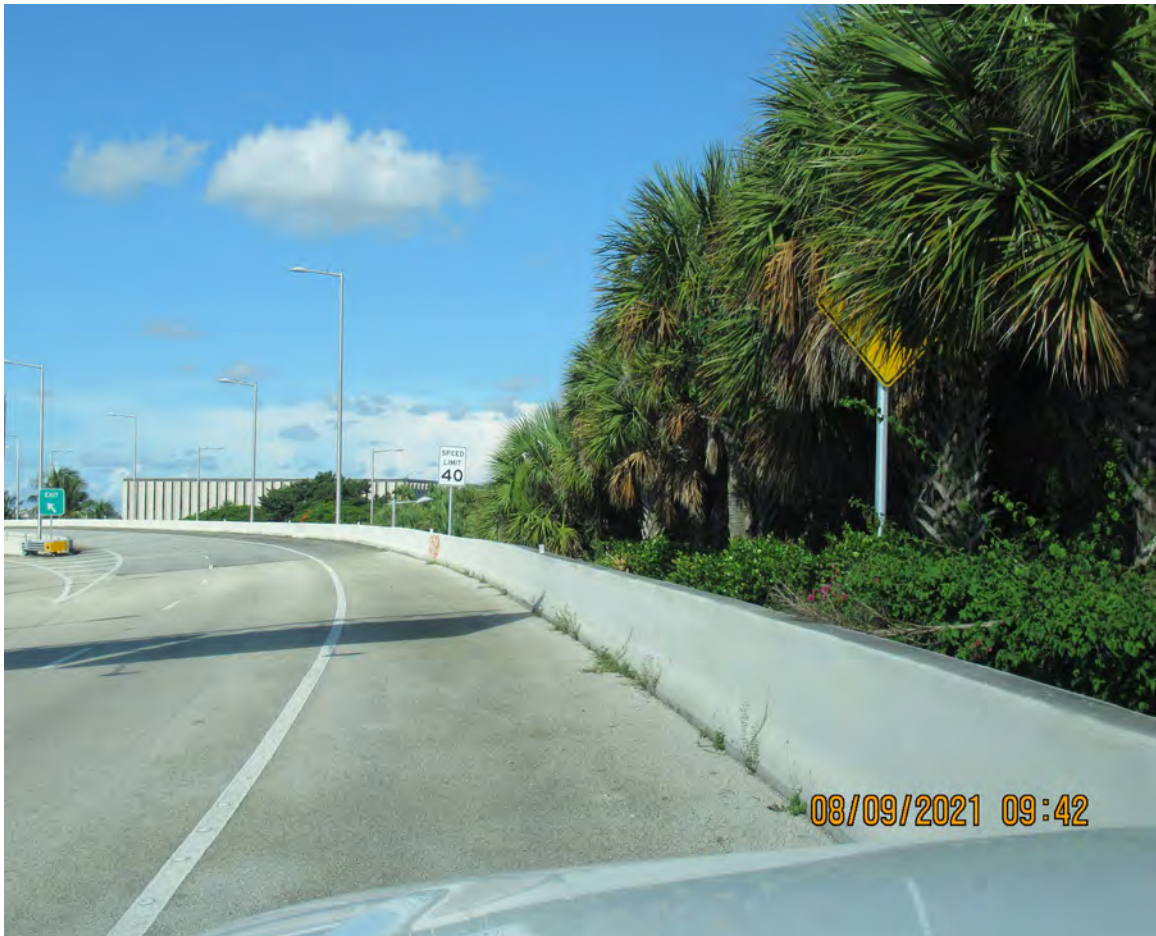
**PHOTO NO.: WB-015
DATE: 8-9-2021**

OVERGROWN VEGETATION OBSTRUCTING SIGN

ITEM NOTED TO BE ADDRESSED BY MDX MAINTENANCE

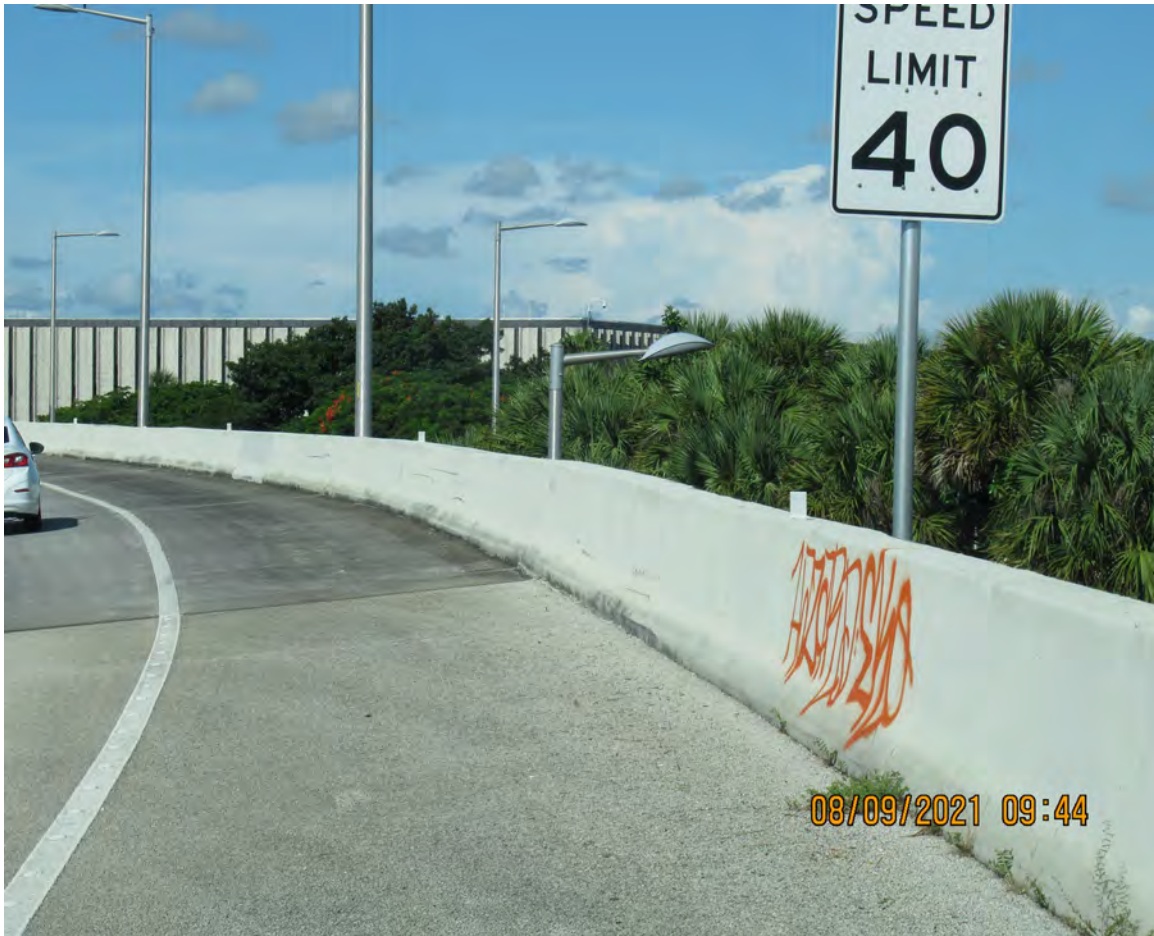
**PHOTO NO.: WB-016
DATE: 8-9-2021**

GRAFITTI ON BARRIER WALL

ITEM NOTED TO BE ADDRESSED BY MDX MAINTENANCE
