Annual Inspection Report 2021

General Engineering Consultant to the
Miami-Dade County Expressway Authority

ANNUAL INSPECTION REPORT 2021

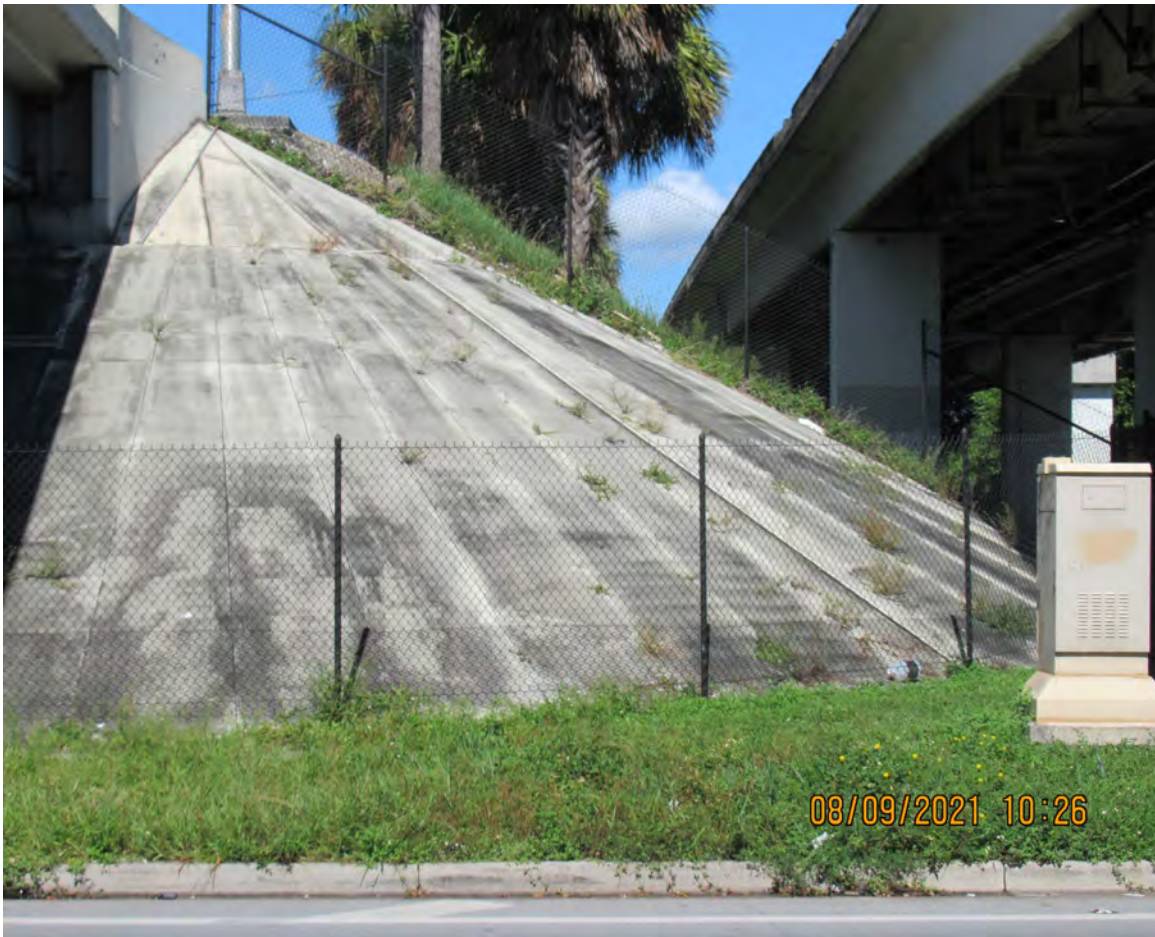
**PHOTO NO.: WB-017
DATE: 8-9-2021**

**DETERIORATED CLASS V COATING ON SLOPE
(TYPICAL THROUGHOUT THE CORRIDOR)**

ITEM NOTED TO BE ADDRESSED BY MDX WORK PROGRAM No. 30037

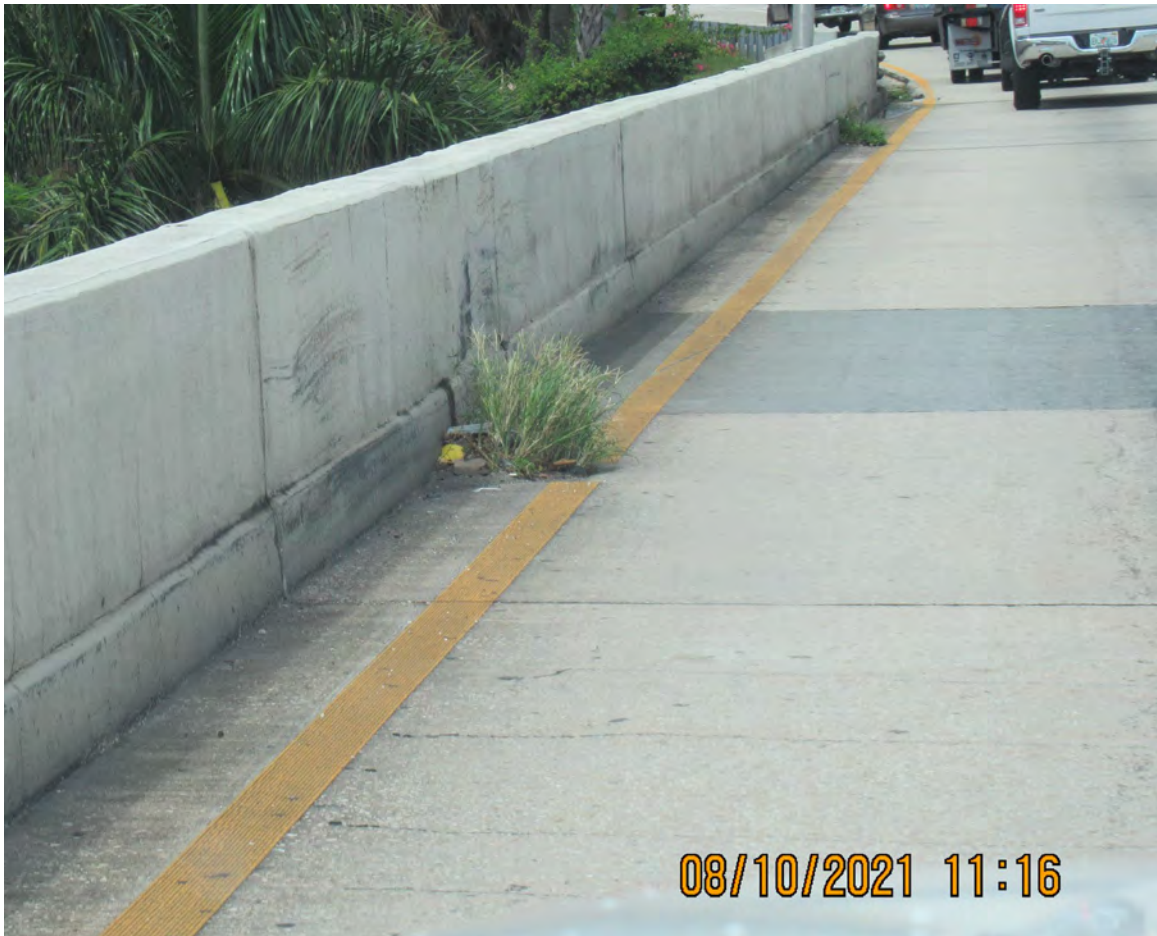
**PHOTO NO.: WB-019
DATE: 8-10-2021**

**SEDIMENTATION AND OVERGROWN VEGETATION ON BRIDGE DRAINAGE INLETS
(BRIDGE # 870237) (TYPICAL THROUGHOUT THE CORRIDOR)**

ITEM NOTED TO BE ADDRESSED BY MDX MAINTENANCE

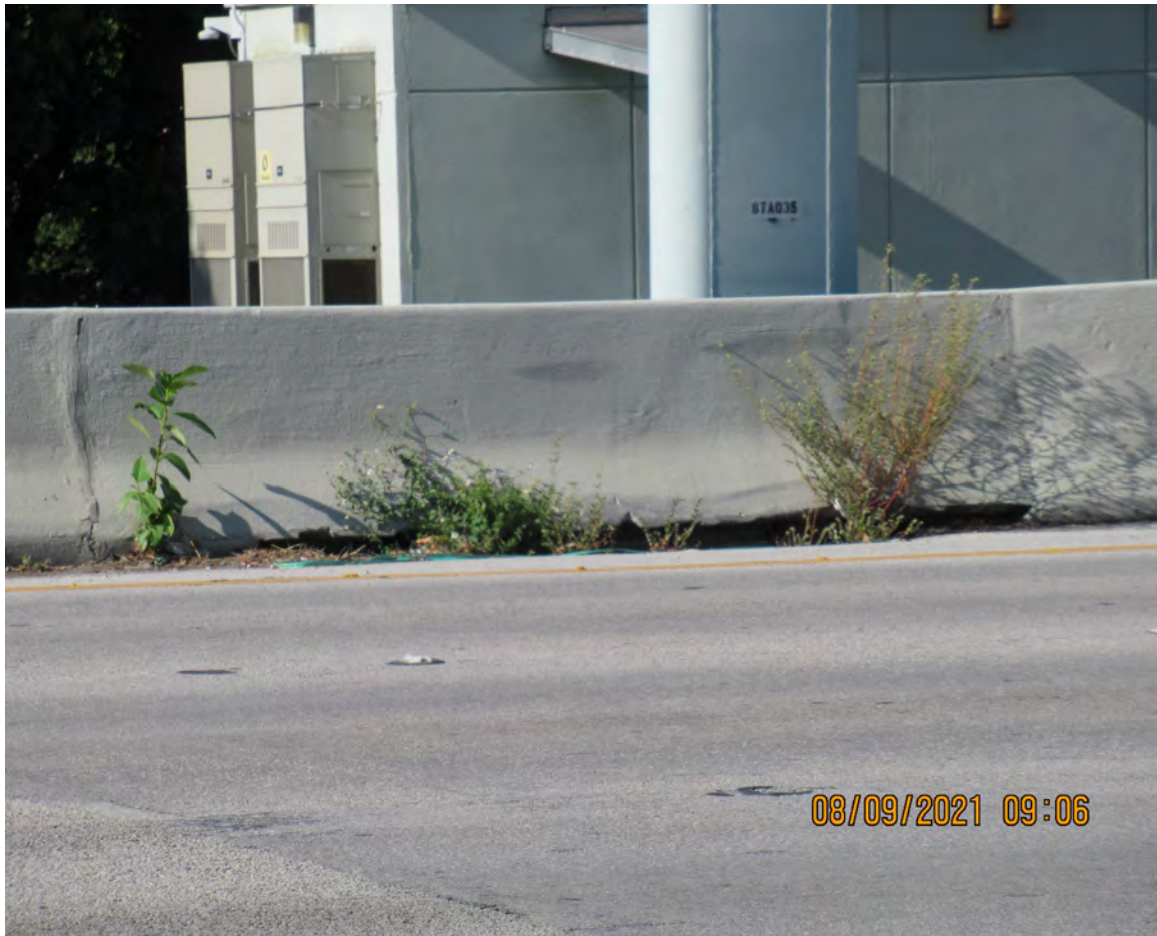
**PHOTO NO.: WB-020
DATE: 8-9-2021**

**SEDIMENTATION AND OVERGROWN VEGETATION ON DRAINAGE INLET
(TYPICAL THROUGHOUT THE CORRIDOR)**

ITEM NOTED TO BE ADDRESSED BY MDX MAINTENANCE

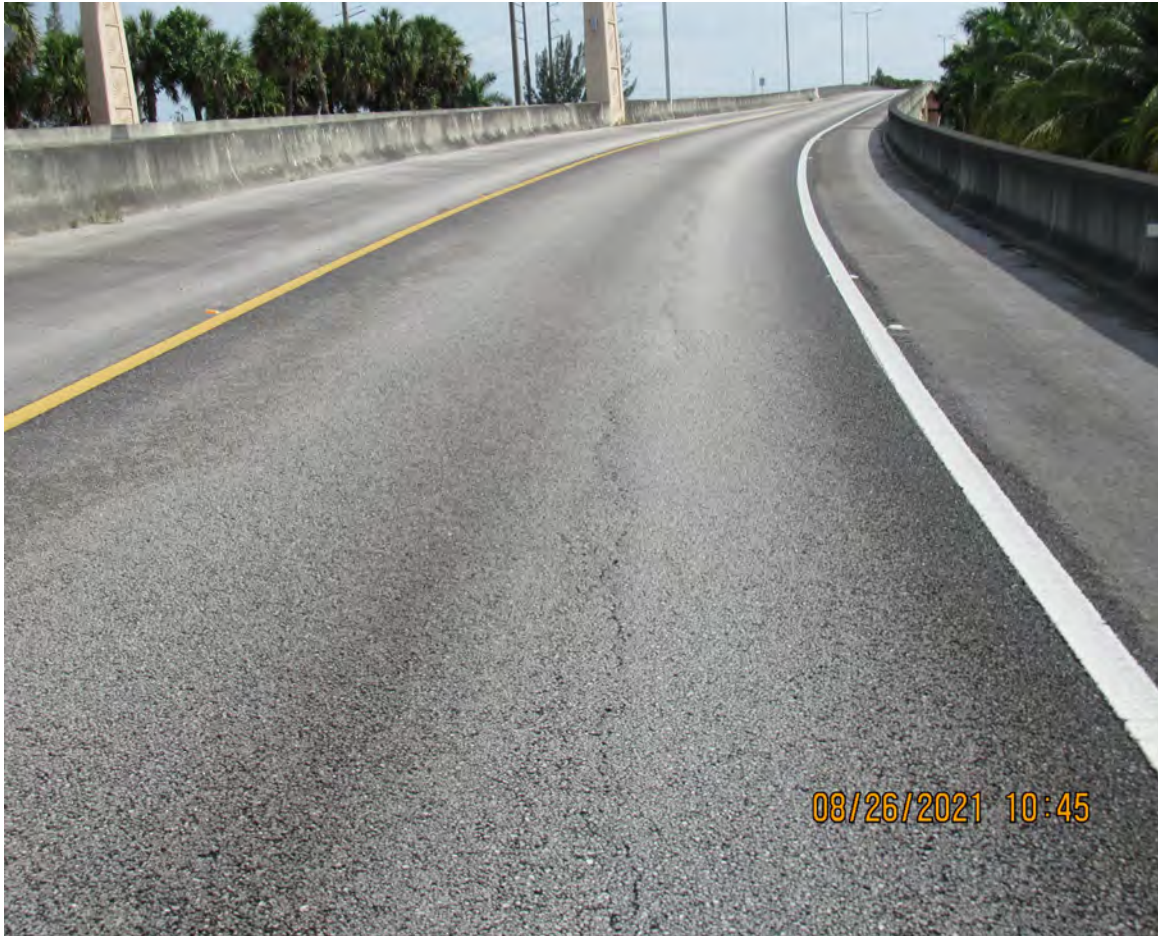
**PHOTO NO.: EB-001
DATE: 8-26-2021**

LONGITUDINAL CRACK ON PAVEMENT

ITEM NOTED TO BE ADDRESSED BY MDX MAINTENANCE

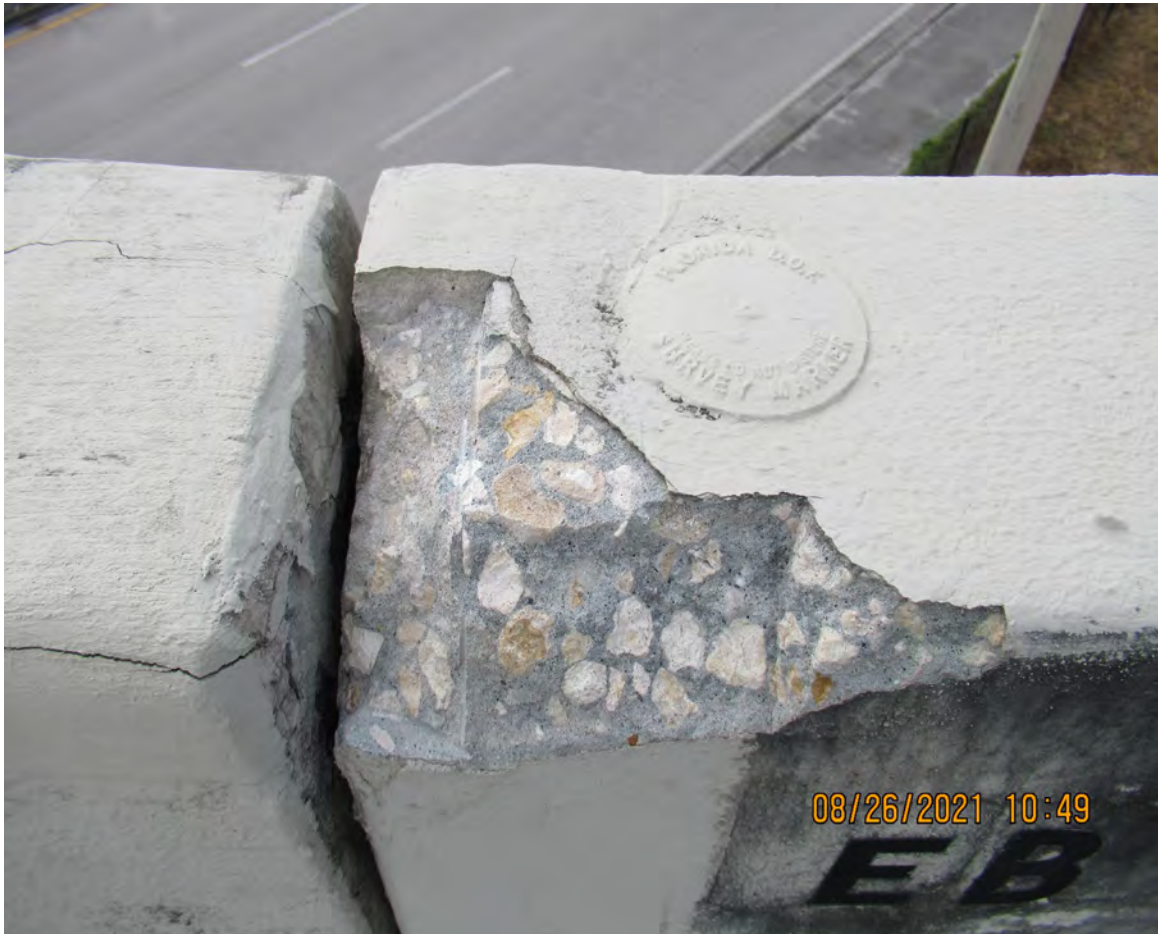
**PHOTO NO.: EB-003
DATE: 8-26-2021**

SPALL ON TRAFFIC RAILING (ABUTMENT 1, BRIDGE No. 871008)

ITEM NOTED TO BE ADDRESSED BY MDX MAINTENANCE

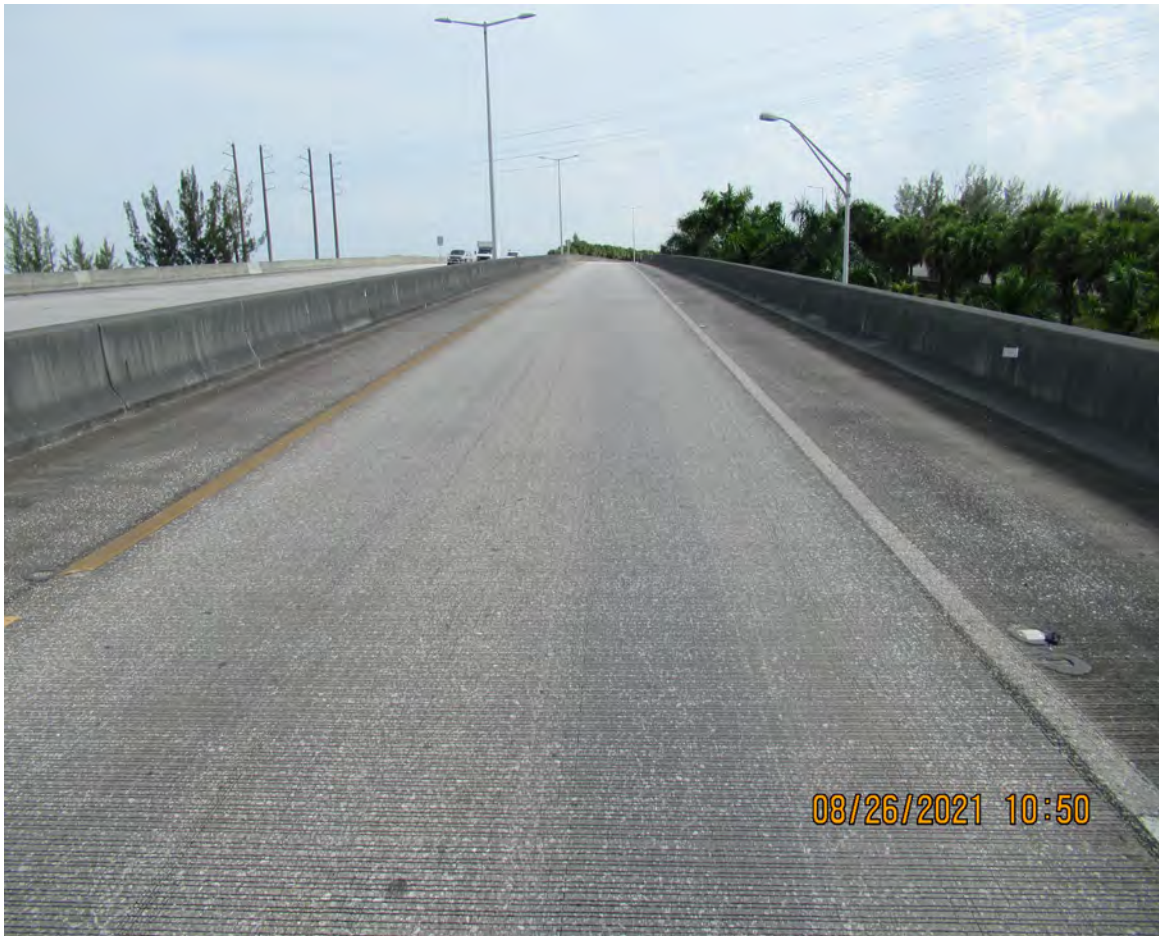
**PHOTO NO.: EB-004
DATE: 8-26-2021**

DETERIORATED STRIPING (BRIDGE No. 871008)

ITEM NOTED TO BE ADDRESSED BY MDX MAINTENANCE

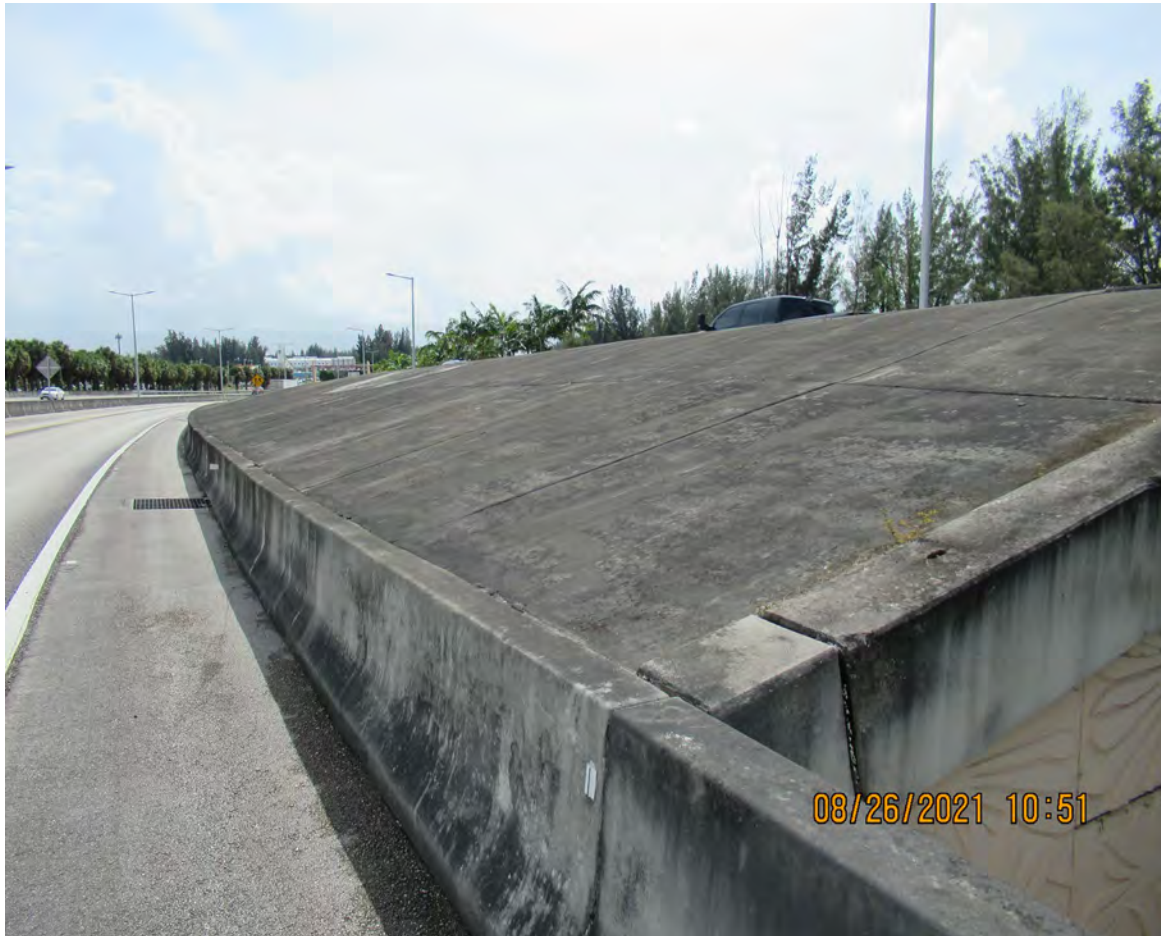
**PHOTO NO.: EB-005
DATE: 8-26-2021**

DETERIORATED CLASS V COATING ON CONCRETE MEDIAN

ITEM NOTED TO BE ADDRESSED BY MDX WORK PROGRAM No. 30037

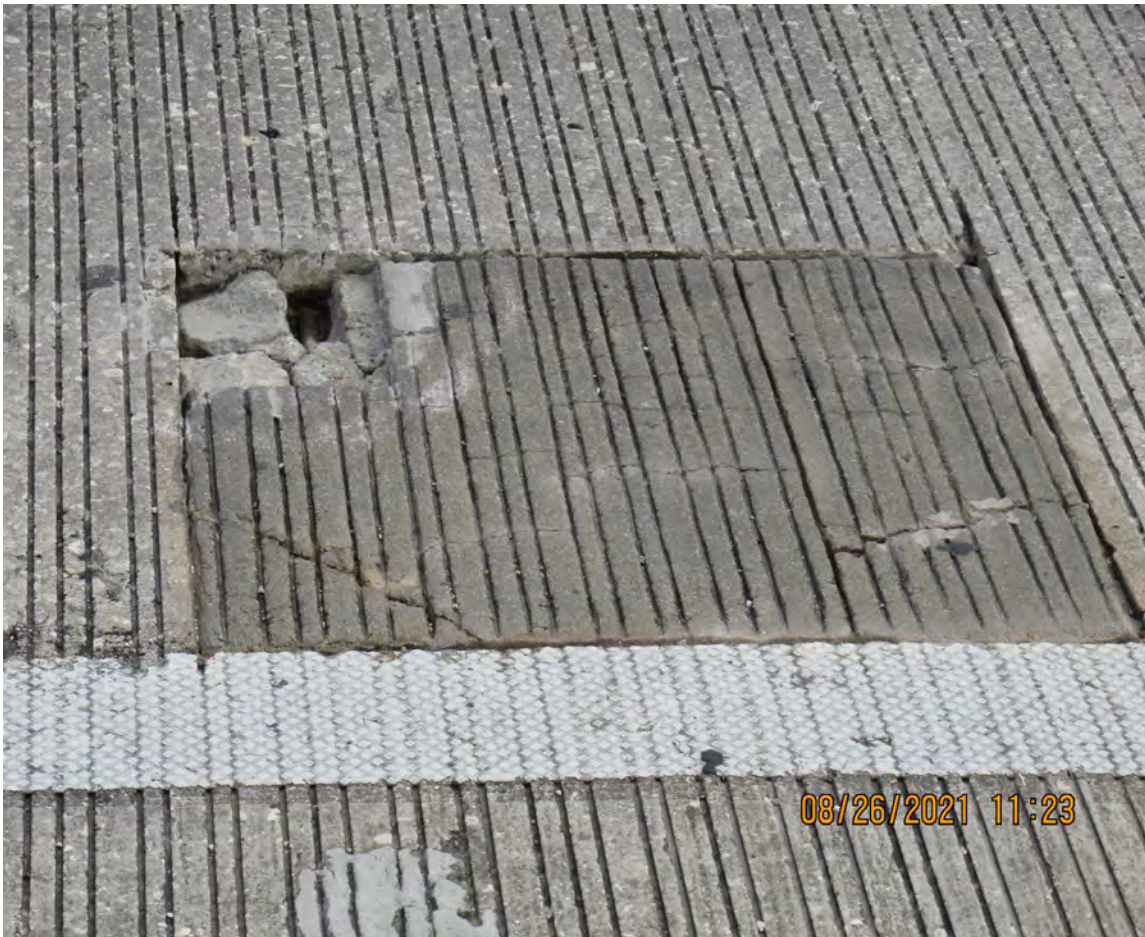
**PHOTO NO.: EB-007
DATE: 8-26-2021**

SPALL ON BRIDGE DECK (BRIDGE No. 871002)

ITEM NOTED TO BE ADDRESSED BY MDX MAINTENANCE

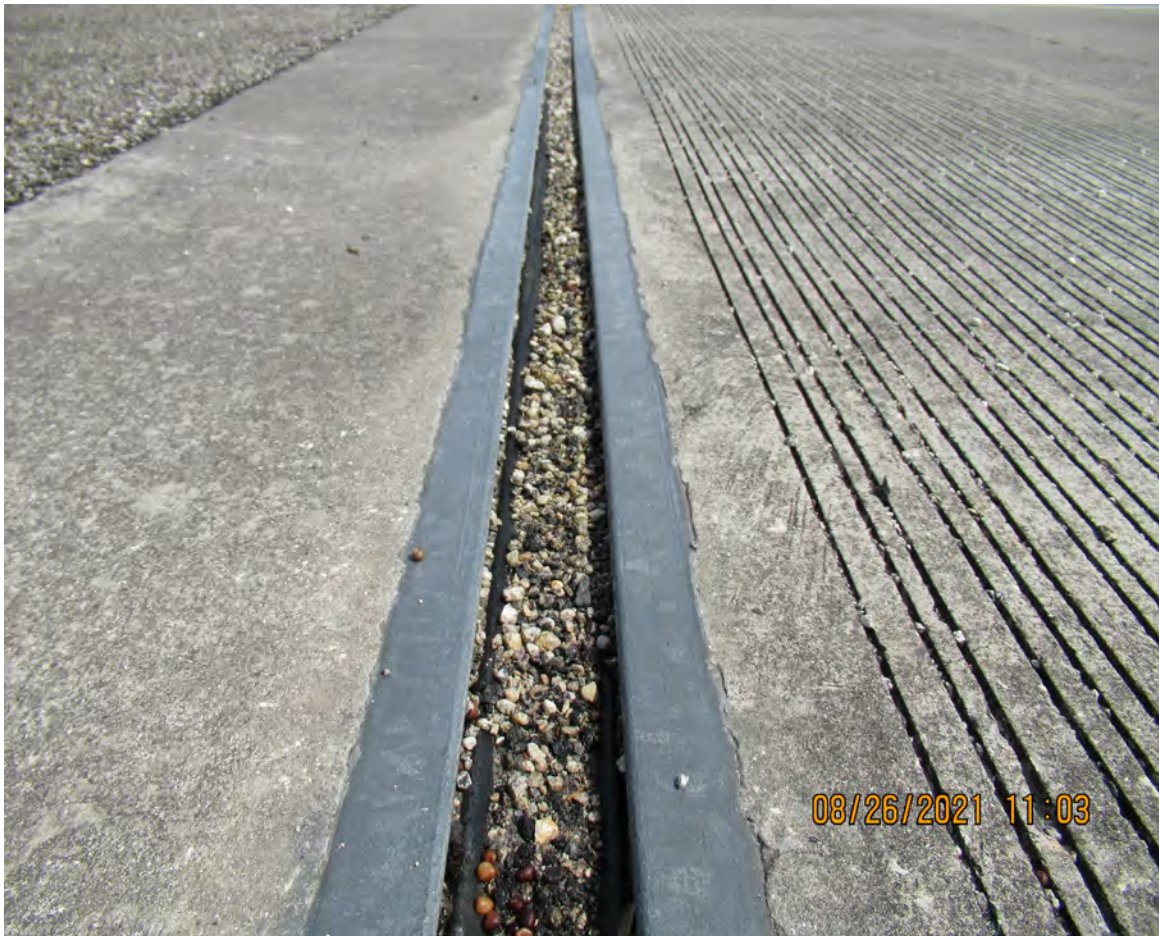
**PHOTO NO.: EB-009
DATE: 8-26-2021**

**DEBRIS ON BRIDGE EXPANSION JOINT (TYPICAL THROUGHOUT
(BRIDGE No. 871002)**

ITEM NOTED TO BE ADDRESSED BY MDX MAINTENANCE

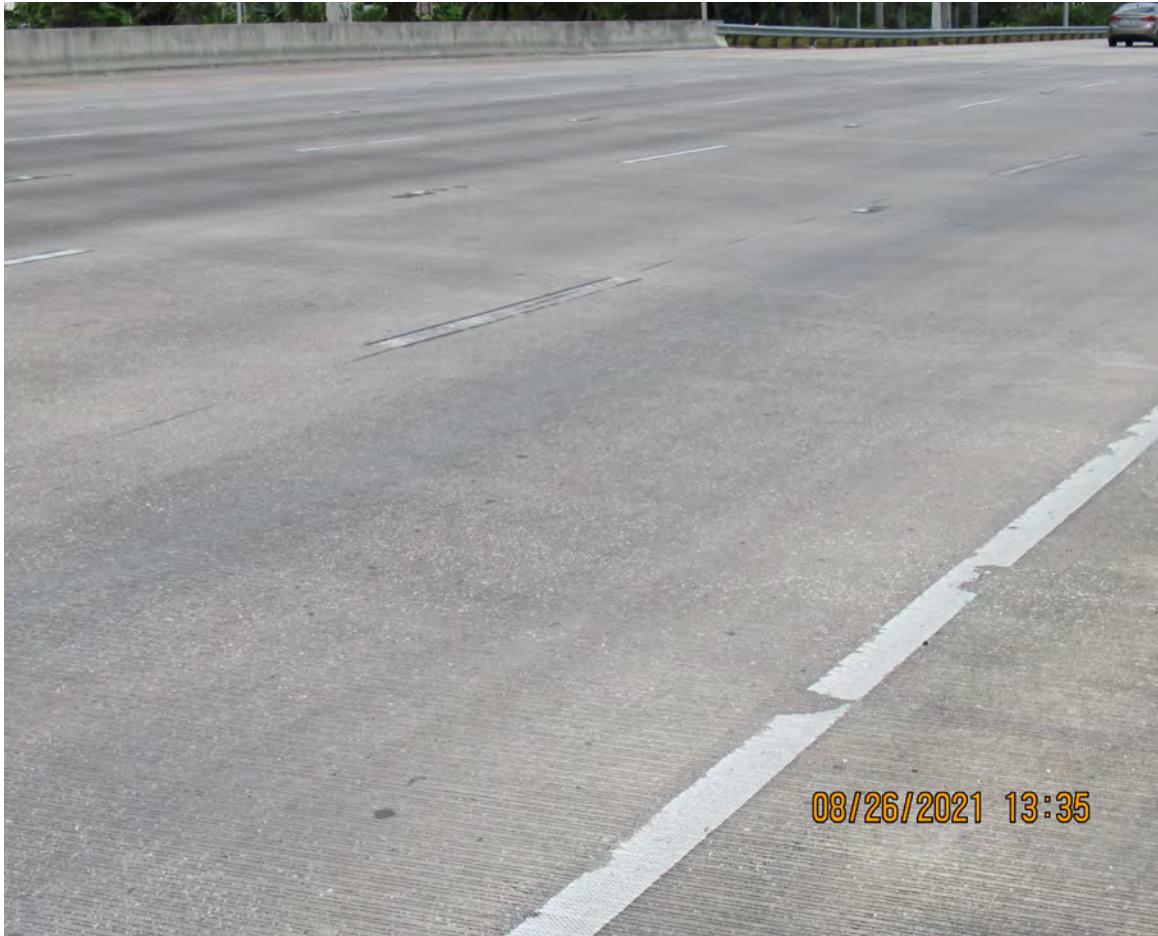
**PHOTO NO.: EB-010
DATE: 8-26-2021**

DETERIORATED STRIPING (BRIDGE No. 871010)

ITEM NOTED TO BE ADDRESSED BY MDX MAINTENANCE

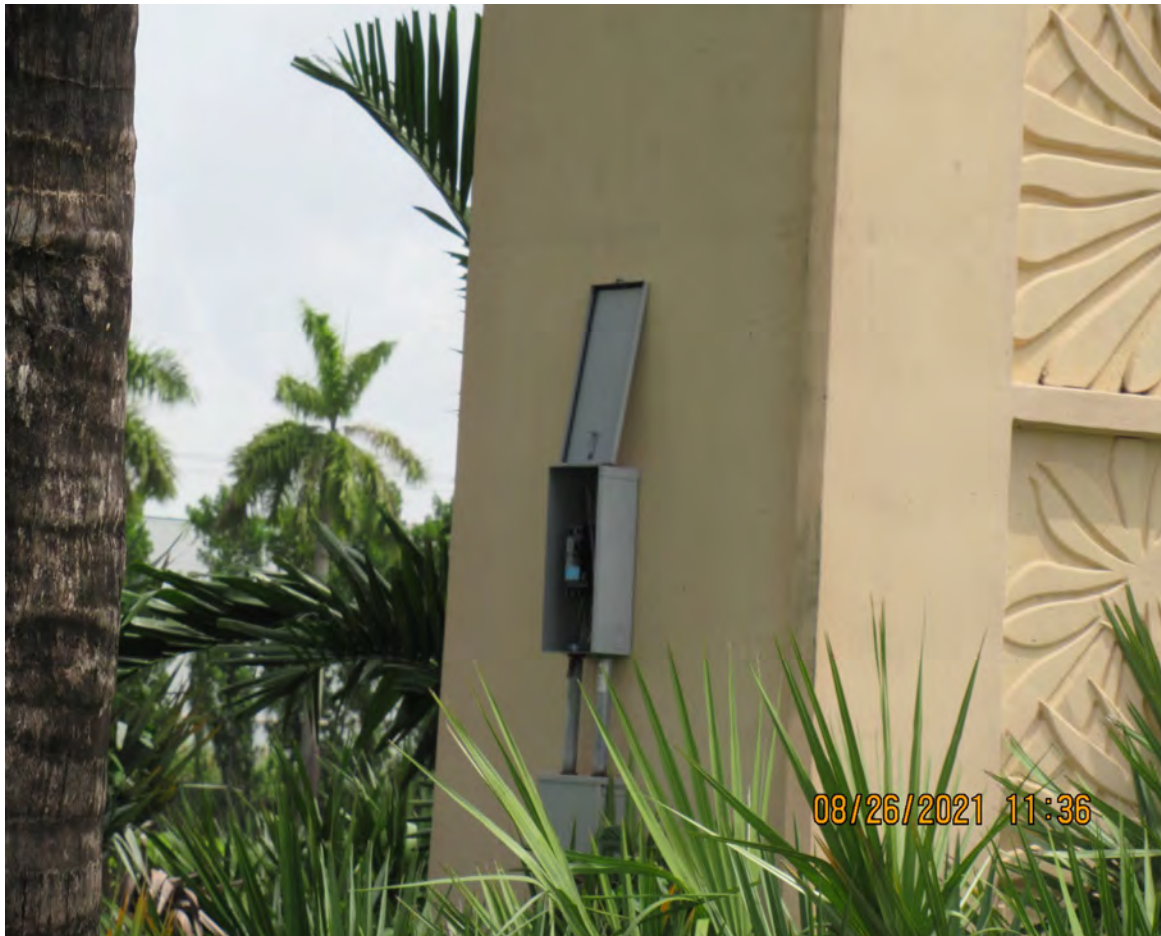
**PHOTO NO.: EB-011
DATE: 8-26-2021**

OPENED PULL BOX

ITEM NOTED TO BE ADDRESSED BY MDX MAINTENANCE

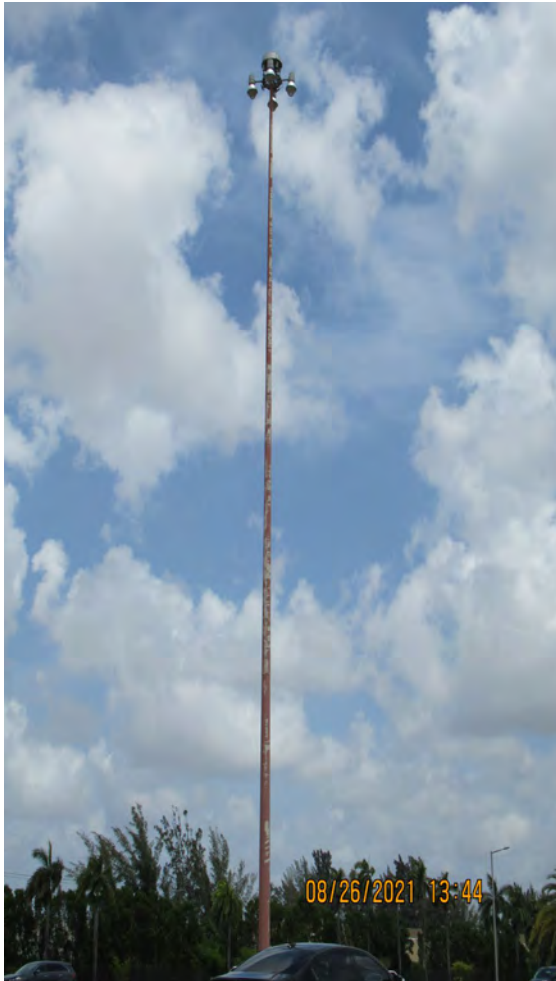
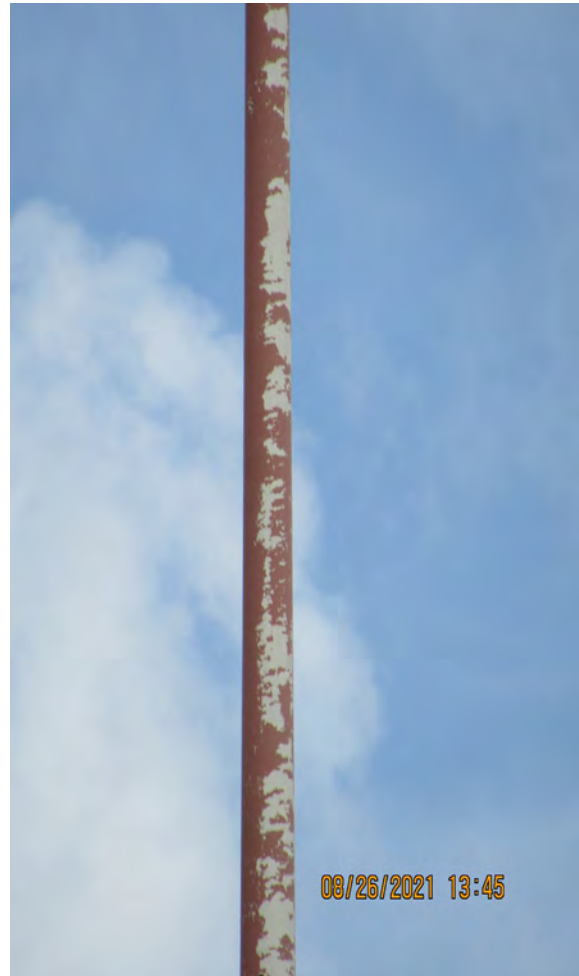
**PHOTO NO.: EB-012
DATE: 8-26-2021**

DETERIORATED PAINT ON HIGH MAST LIGHT POLE

ITEM NOTED TO BE ADDRESSED BY MDX MAINTENANCE

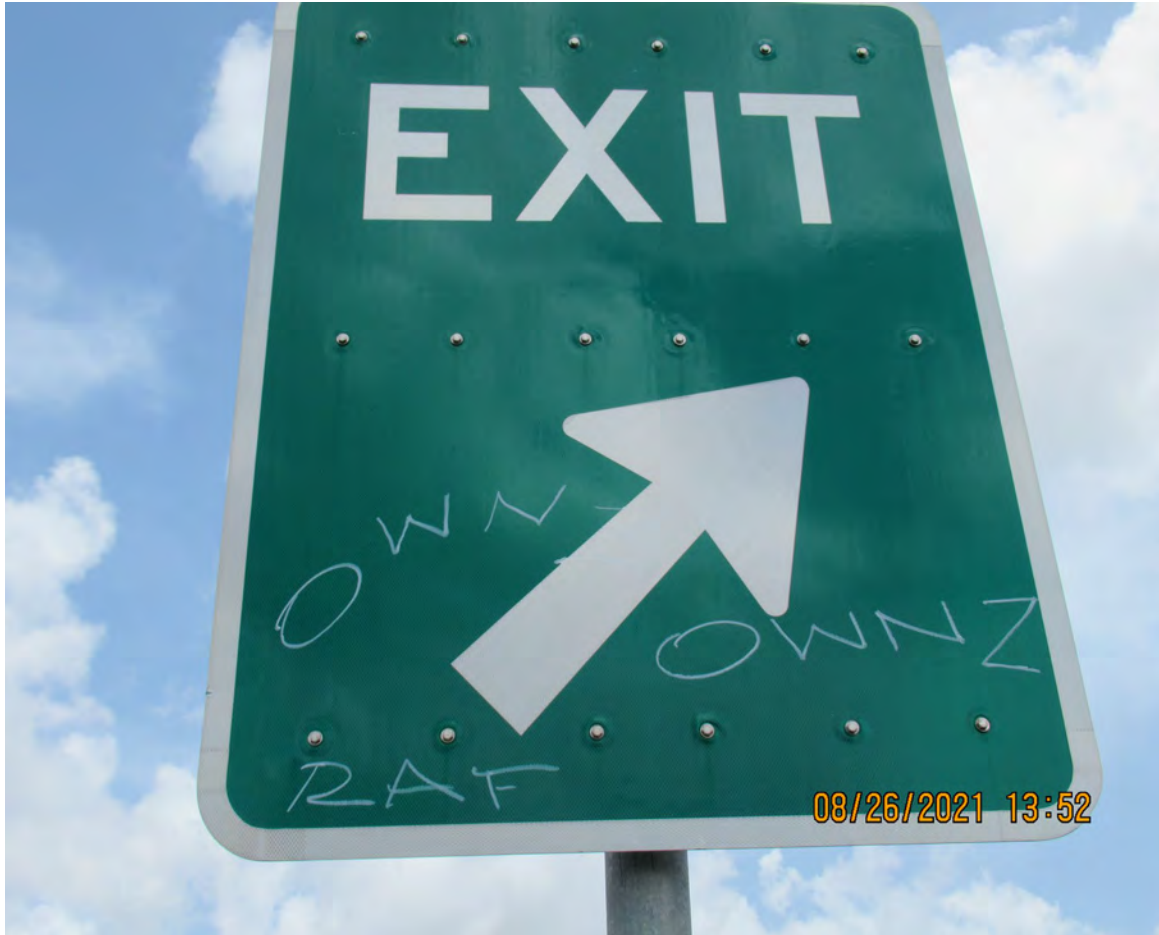
**PHOTO NO.: EB-013
DATE: 8-26-2021**

GRAFITTI ON SIGN PANEL

ITEM NOTED TO BE ADDRESSED BY MDX MAINTENANCE

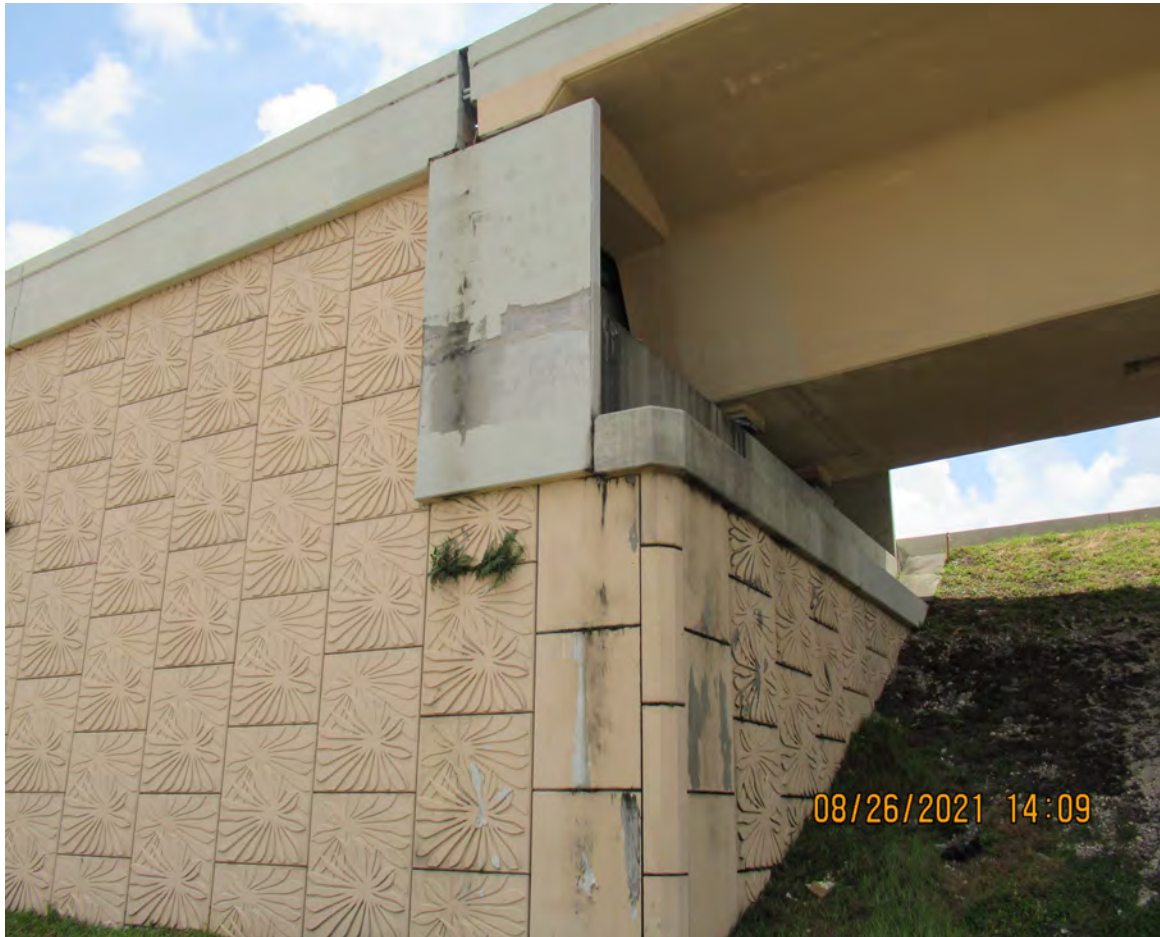
**PHOTO NO.: EB-014
DATE: 8-26-2021**

**DETERIORATED CLASS V COATING AT BENT 12
(BRIDGE # 871050)**

ITEM NOTED TO BE ADDRESSED BY MDX MAINTENANCE

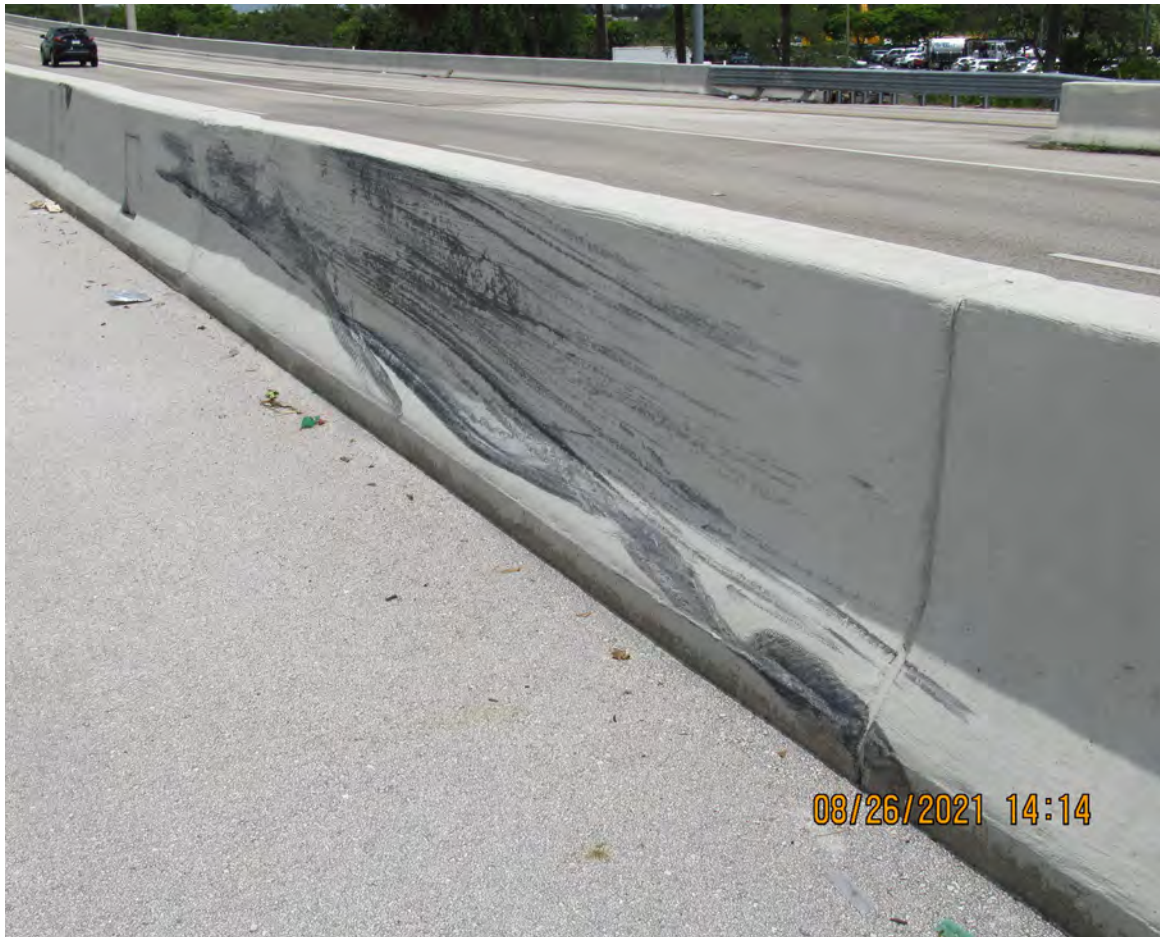
**PHOTO NO.: EB-015
DATE: 8-26-2021**

**SCUFF MARKS ON BARRIER WALL
(TYPICAL THROUGHOUT THE CORRIDOR)**

ITEM NOTED TO BE ADDRESSED BY MDX MAINTENANCE

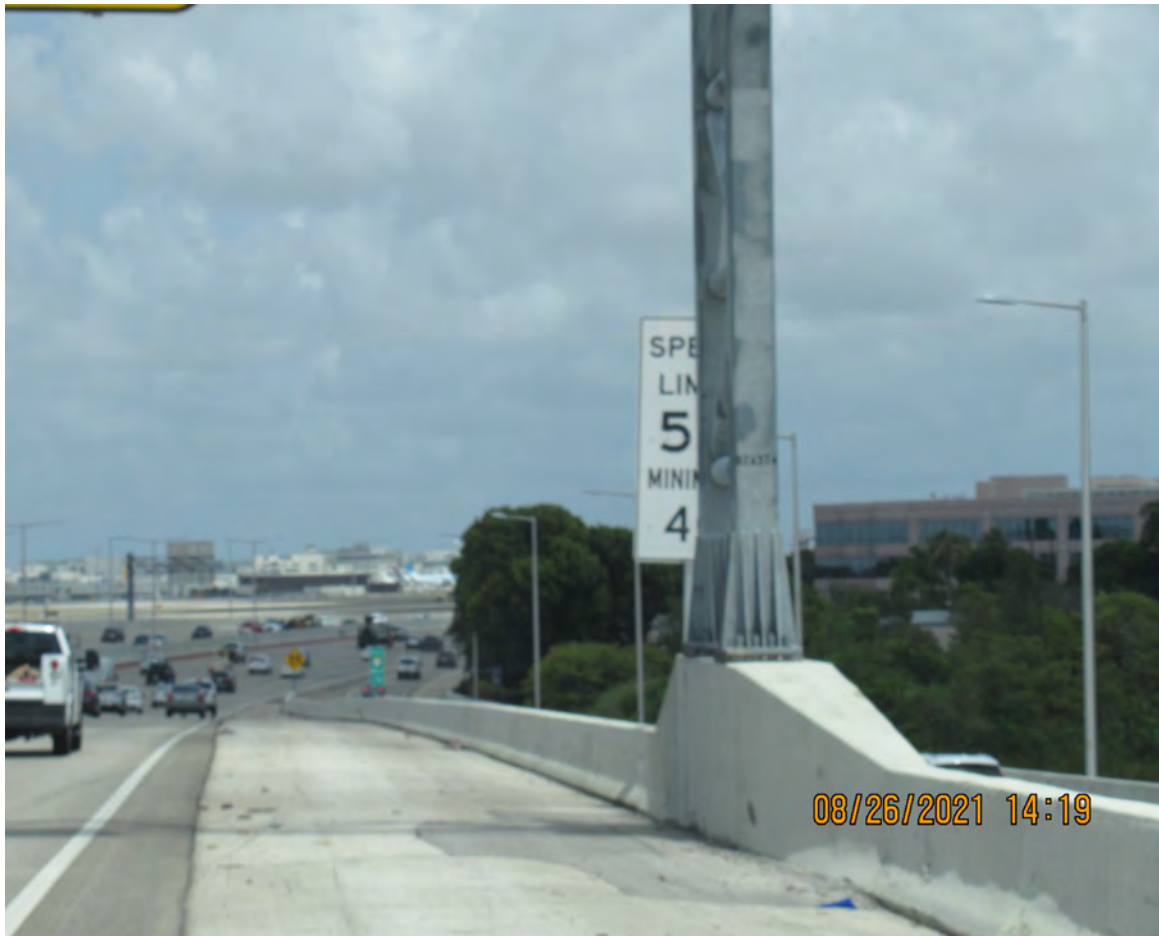
**PHOTO NO.: EB-016
DATE: 8-26-2021**

SPEED LIMIT SIGN PARTIALLY OBSTRUCTED BY OVERHEAD SIGN STRUCTURE

ITEM NOTED TO BE ADDRESSED BY MDX MAINTENANCE

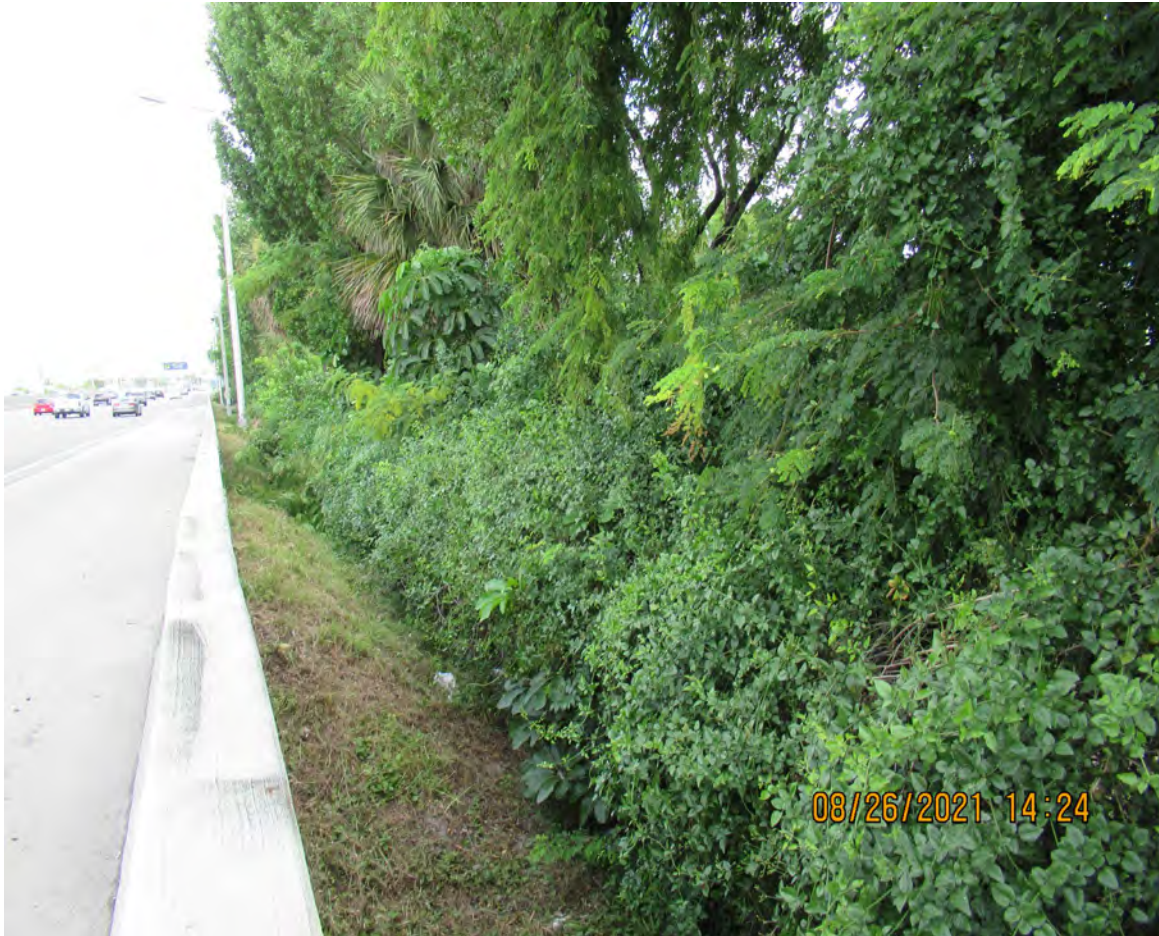
**PHOTO NO.: EB-017
DATE: 8-26-2021**

OVERGROWN VEGETATION ENCHROACHING ON MDX RIGHT-OF-WAY FENCE

ITEM NOTED TO BE ADDRESSED BY MDX MAINTENANCE

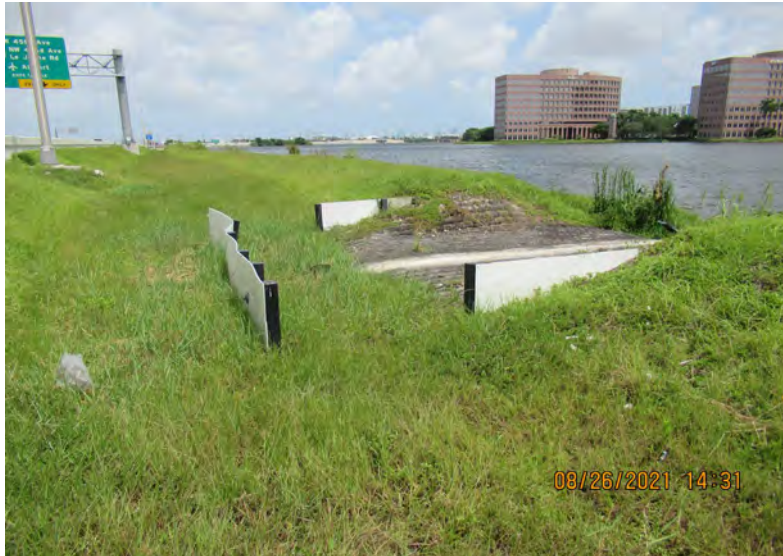
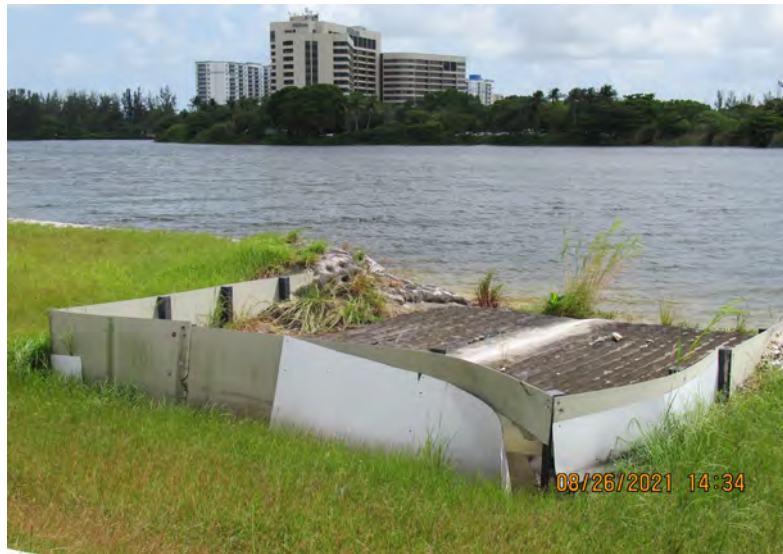
**PHOTO NO.: EB-019
DATE: 8-26-2021**

DAMAGED SKIMMER (TYPICAL AT VARIOUS LOCATIONS)

ITEM NOTED TO BE ADDRESSED BY MDX MAINTENANCE

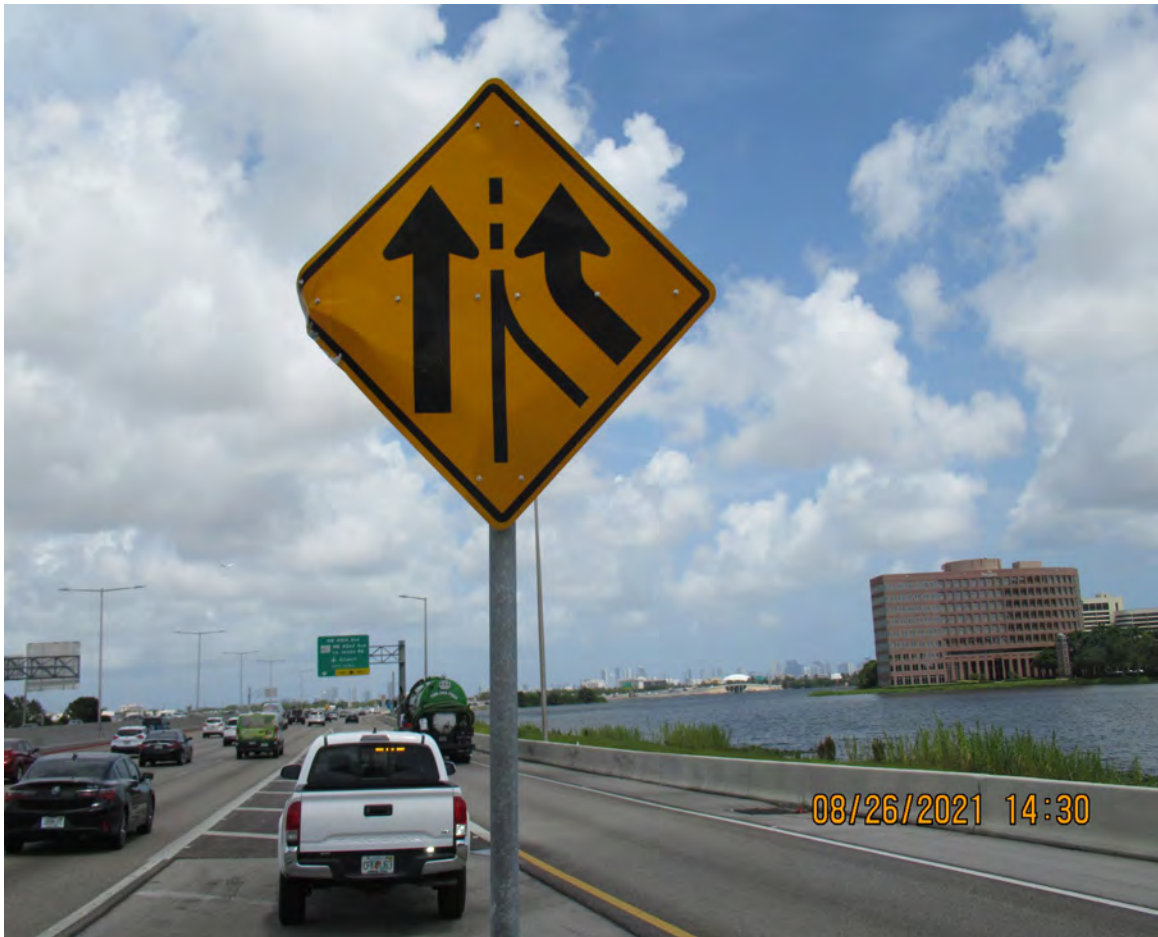
**PHOTO NO.: EB-020
DATE: 8-26-2021**

DAMAGED MERGE SIGN (TYPICAL AT VARIOUS LOCATIONS)

ITEM NOTED TO BE ADDRESSED BY MDX MAINTENANCE

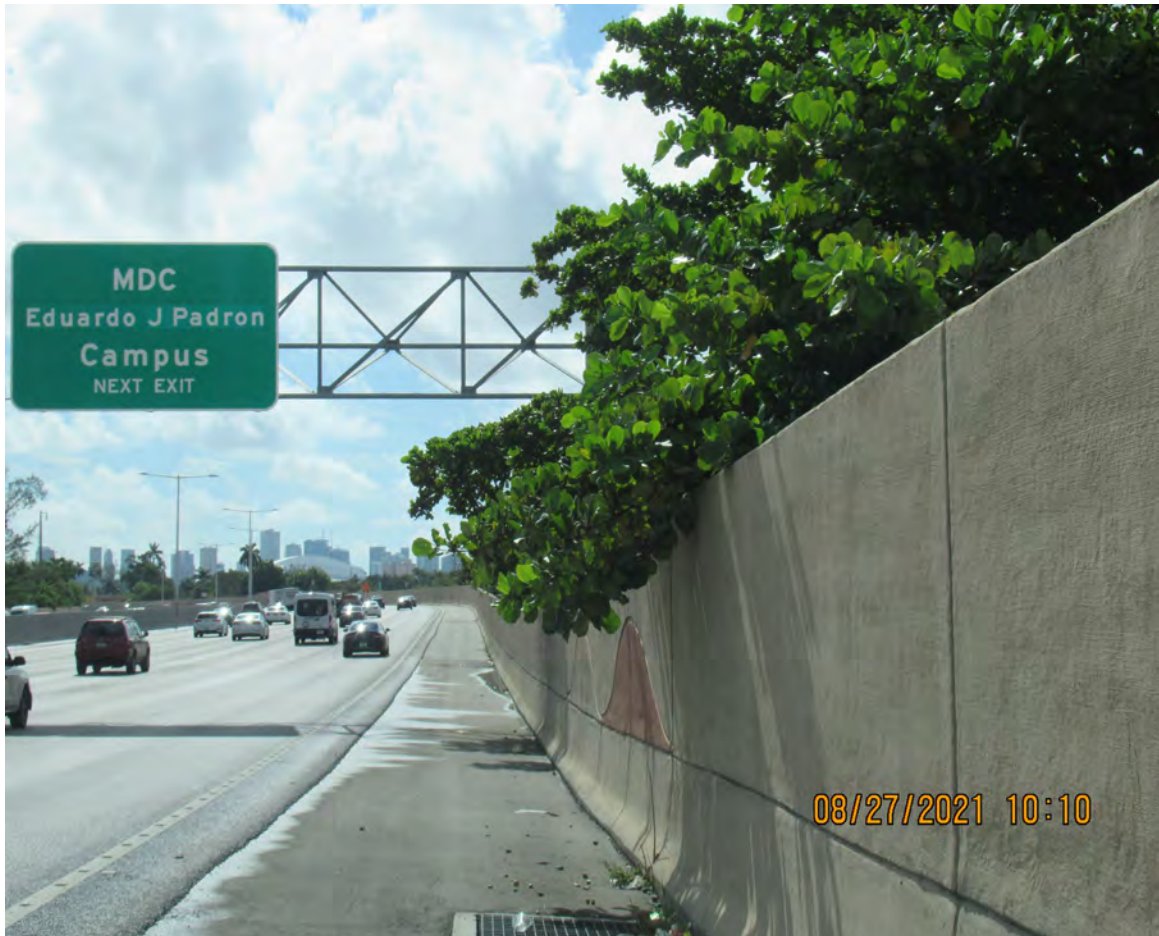
**PHOTO NO.: EB-022
DATE: 8-27-2021**

OVERGROWN VEGETATION

ITEM NOTED TO BE ADDRESSED BY MDX MAINTENANCE

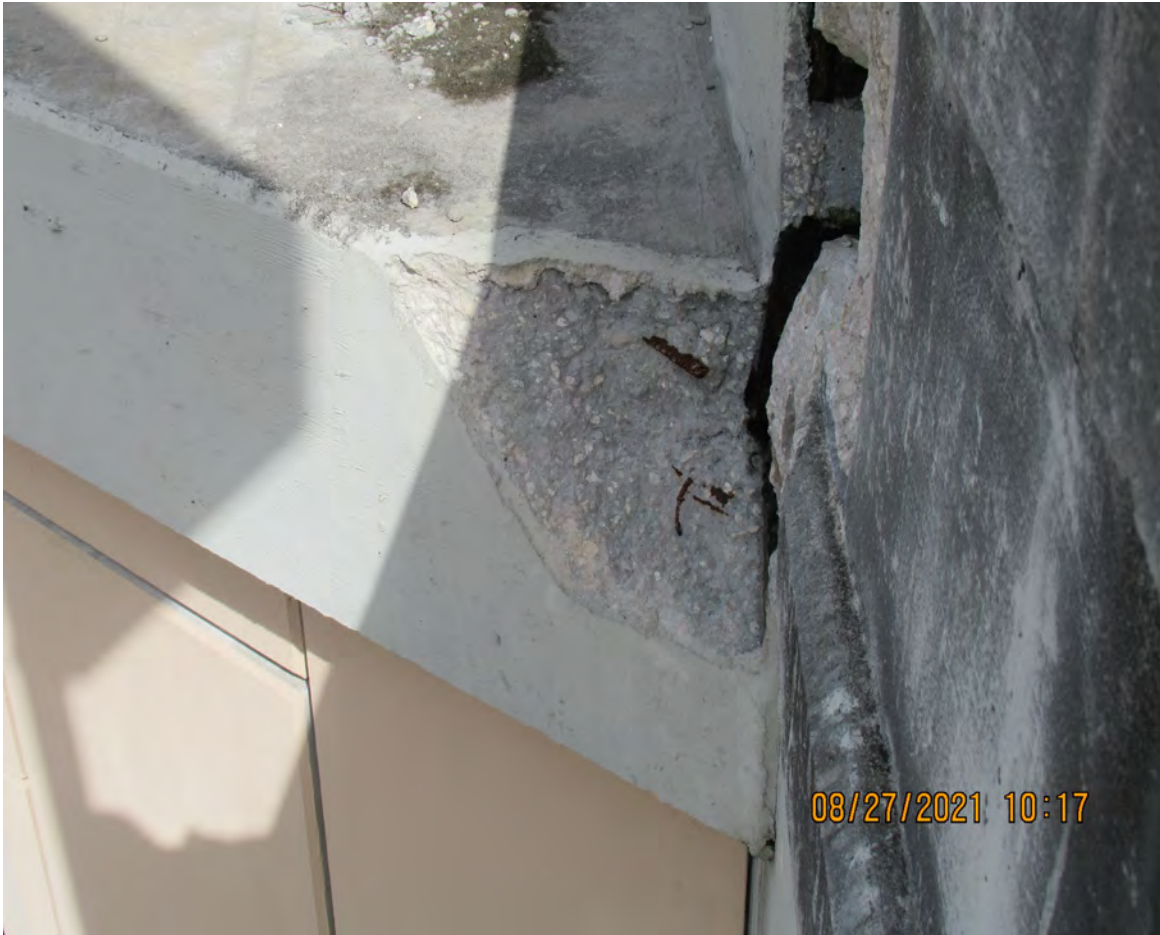
**PHOTO NO.: EB-023
DATE: 8-27-2021**

SPALL ON ABUTMENT 1 (BRIDGE # 870966)

ITEM NOTED TO BE ADDRESSED BY MDX MAINTENANCE
