Annual Inspection Report 2021

General Engineering Consultant to the
Miami-Dade County Expressway Authority

ANNUAL INSPECTION REPORT 2021

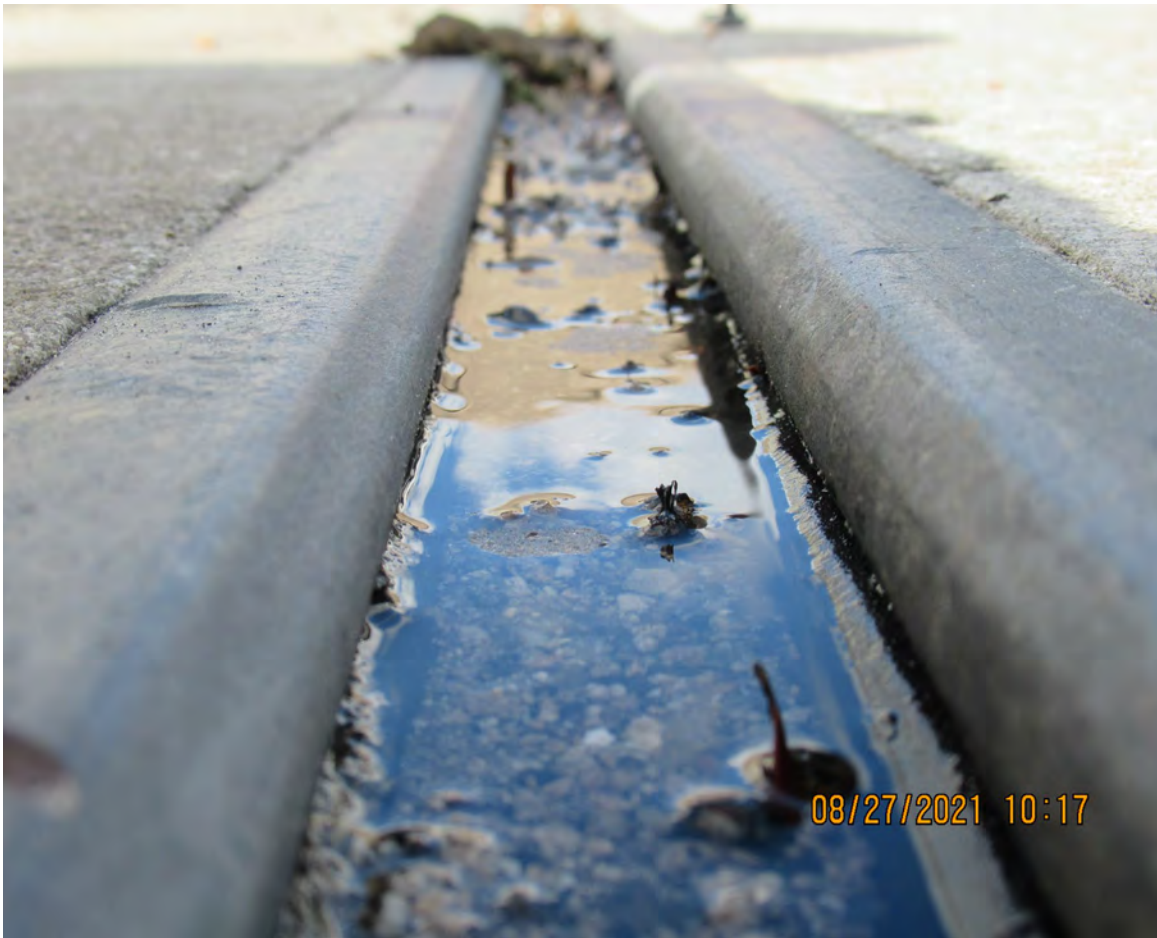
**PHOTO NO.: EB-024
DATE: 8-27-2021**

**SEDIMENT AND DEBRIS ON BRIDGE EXPANSION JOINTS (BRIDGE # 870966)
(TYPICAL THROUGHOUT)**

ITEM NOTED TO BE ADDRESSED BY MDX MAINTENANCE

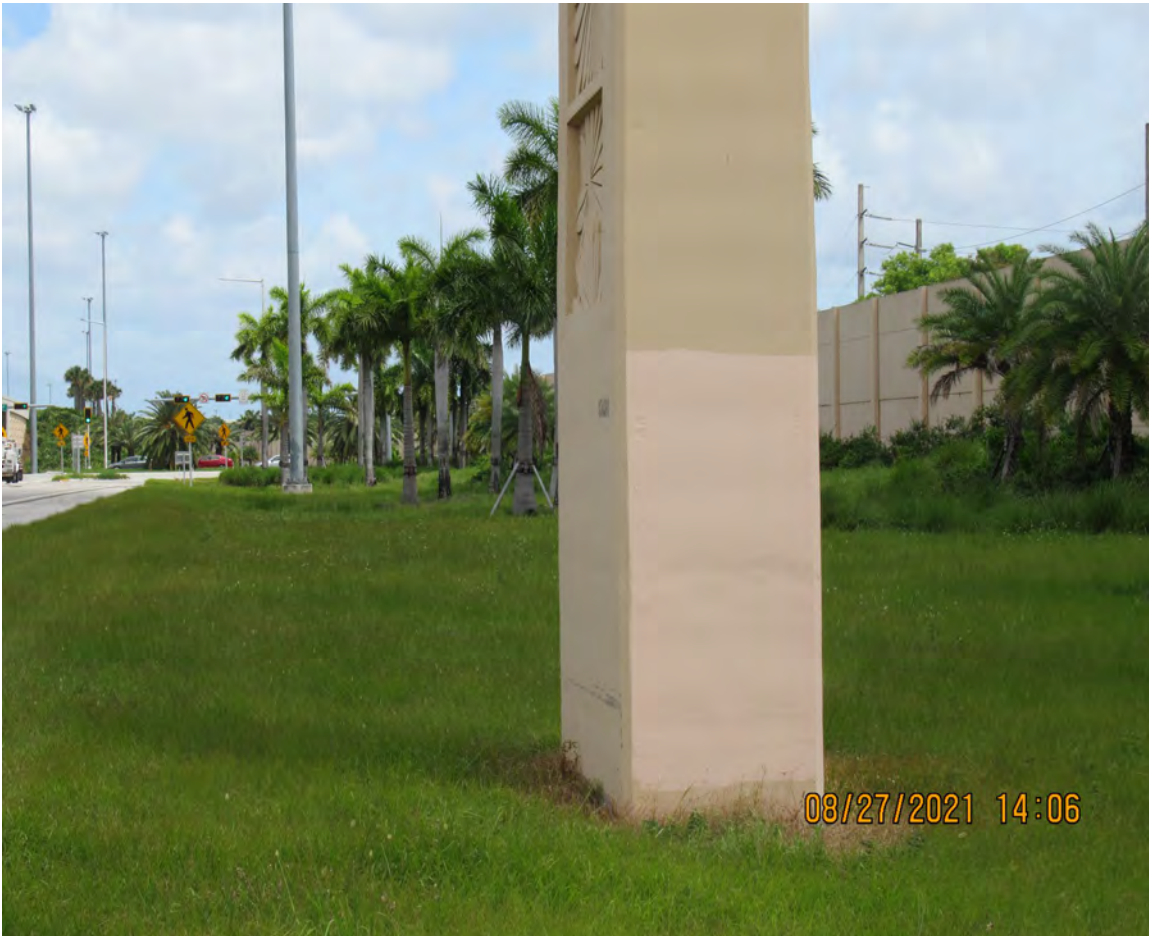
**PHOTO NO.: EB-025
DATE: 8-27-2021**

**IMPROPER COLOR APPLIED TO COVER UP GRAFITTI
(STRUCTURE # 87A364)**

ITEM NOTED TO BE ADDRESSED BY MDX MAINTENANCE

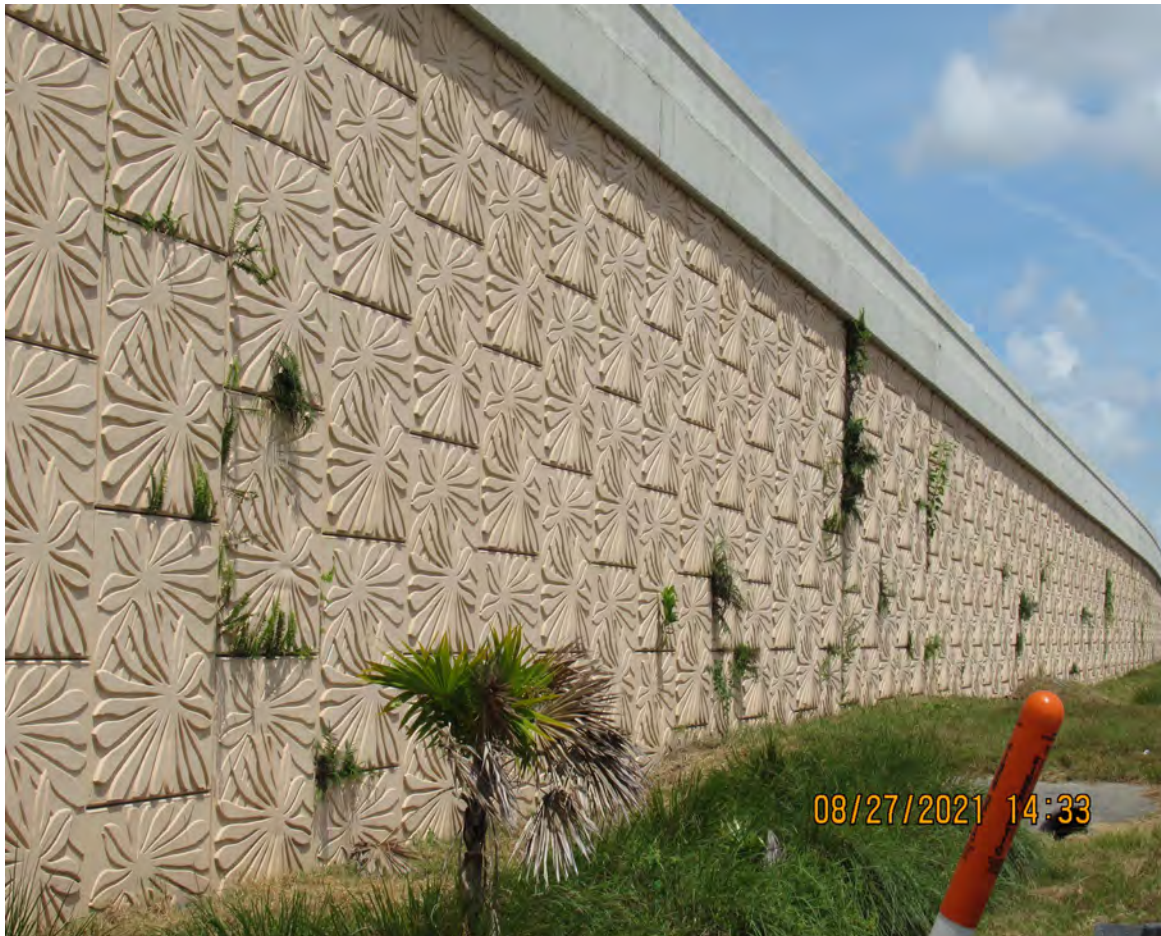
**PHOTO NO.: EB-026
DATE: 8-27-2021**

OVERGROWN VEGETATION ON MSE WALL

ITEM NOTED TO BE ADDRESSED BY MDX MAINTENANCE

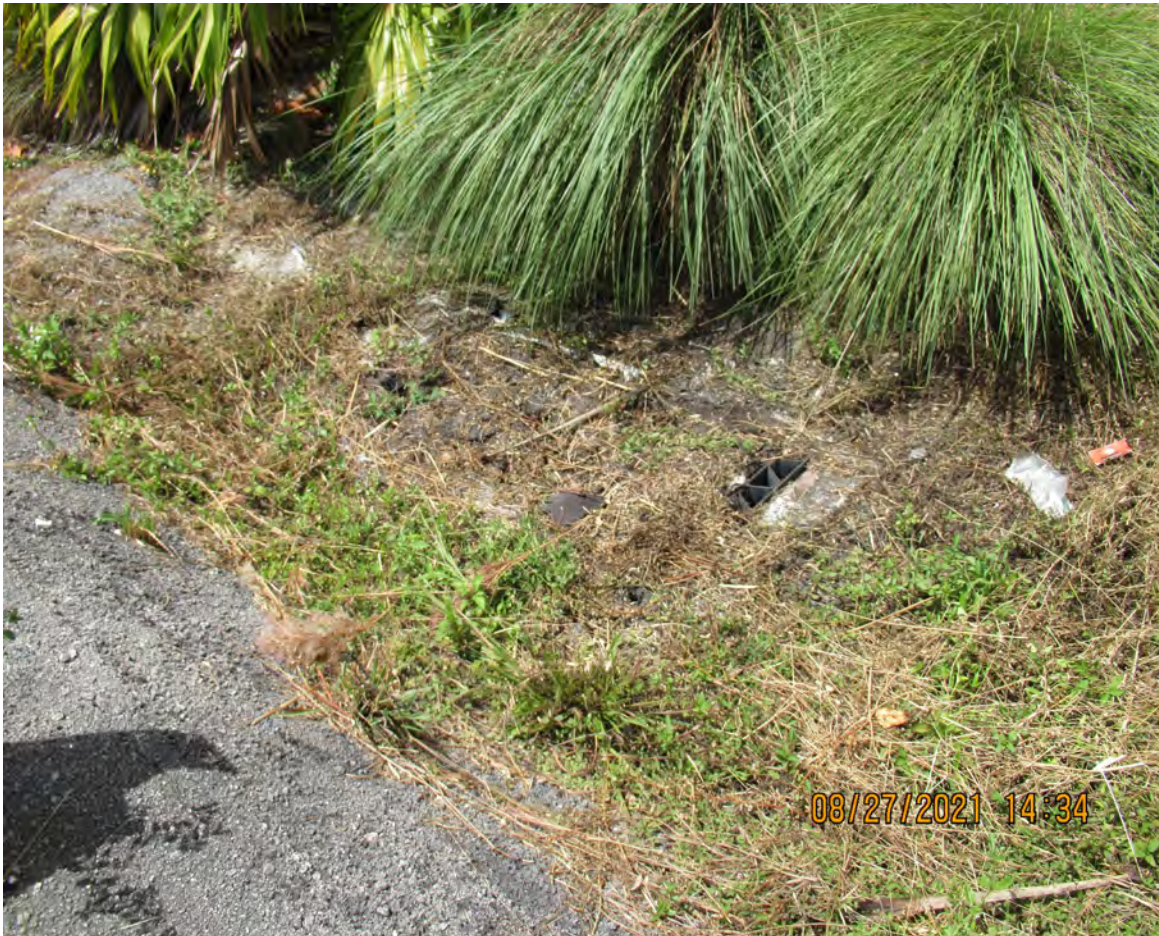
**PHOTO NO.: EB-027
DATE: 8-27-2021**

DRAINAGE INLET OBSTRUCTED WITH SEDIMENT, DEBRIS AND VEGETATION

ITEM NOTED TO BE ADDRESSED BY MDX MAINTENANCE

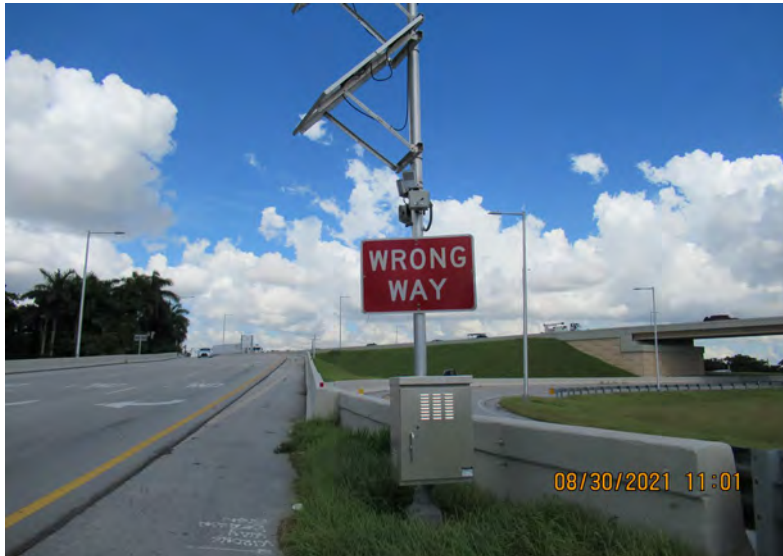
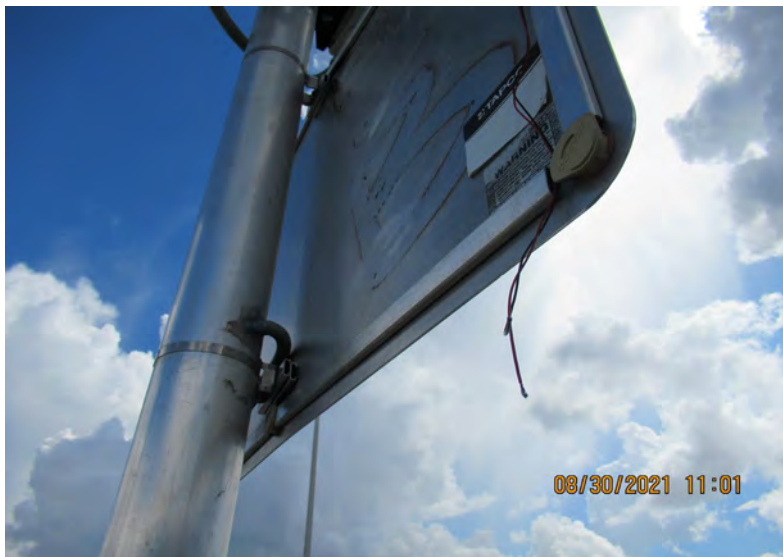
**PHOTO NO.: EB-030
DATE: 8-30-2021**

BROKEN WIRING ON WRONG WAY SIGN

ITEM NOTED TO BE ADDRESSED BY MDX MAINTENANCE

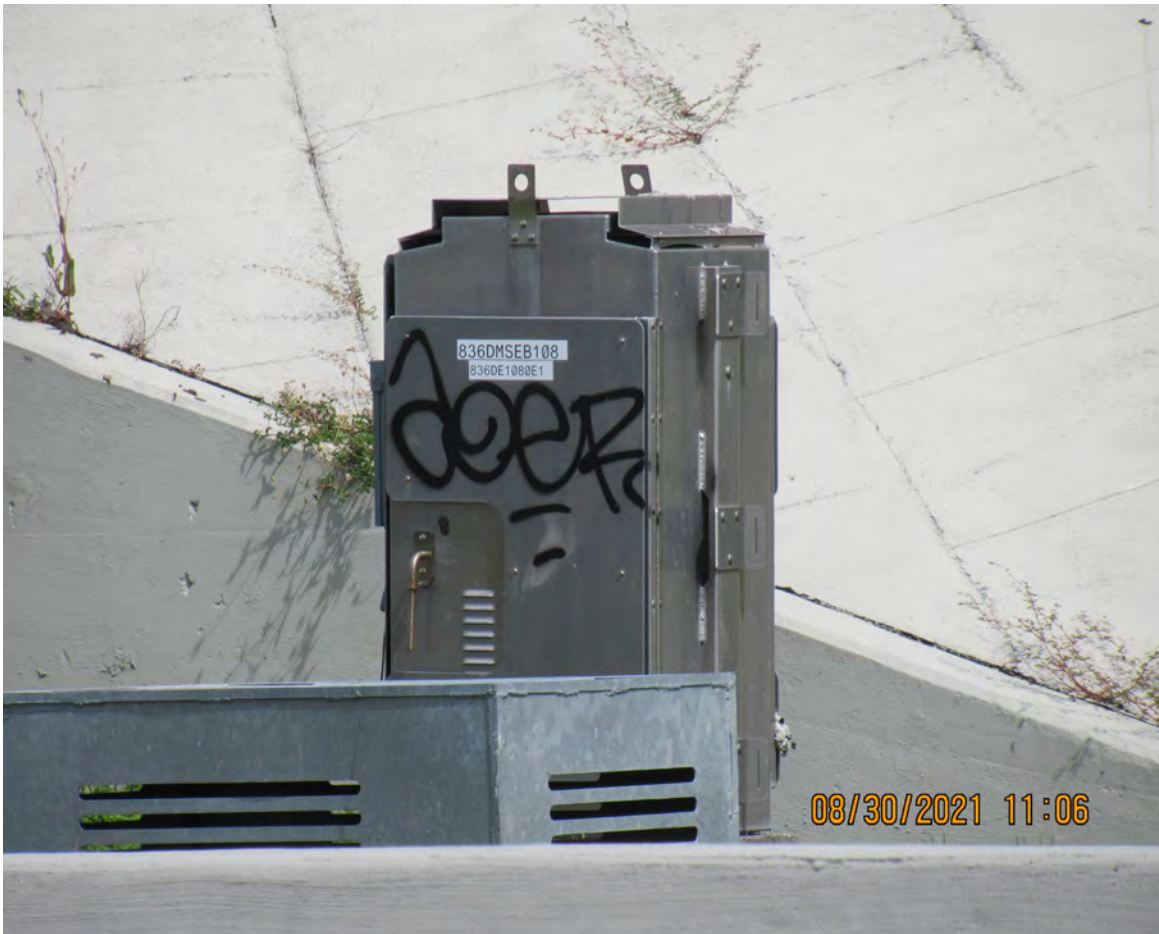
**PHOTO NO.: EB-031
DATE: 8-30-2021**

GRAFITTI ON CONTROL CABINET

ITEM NOTED TO BE ADDRESSED BY MDX MAINTENANCE

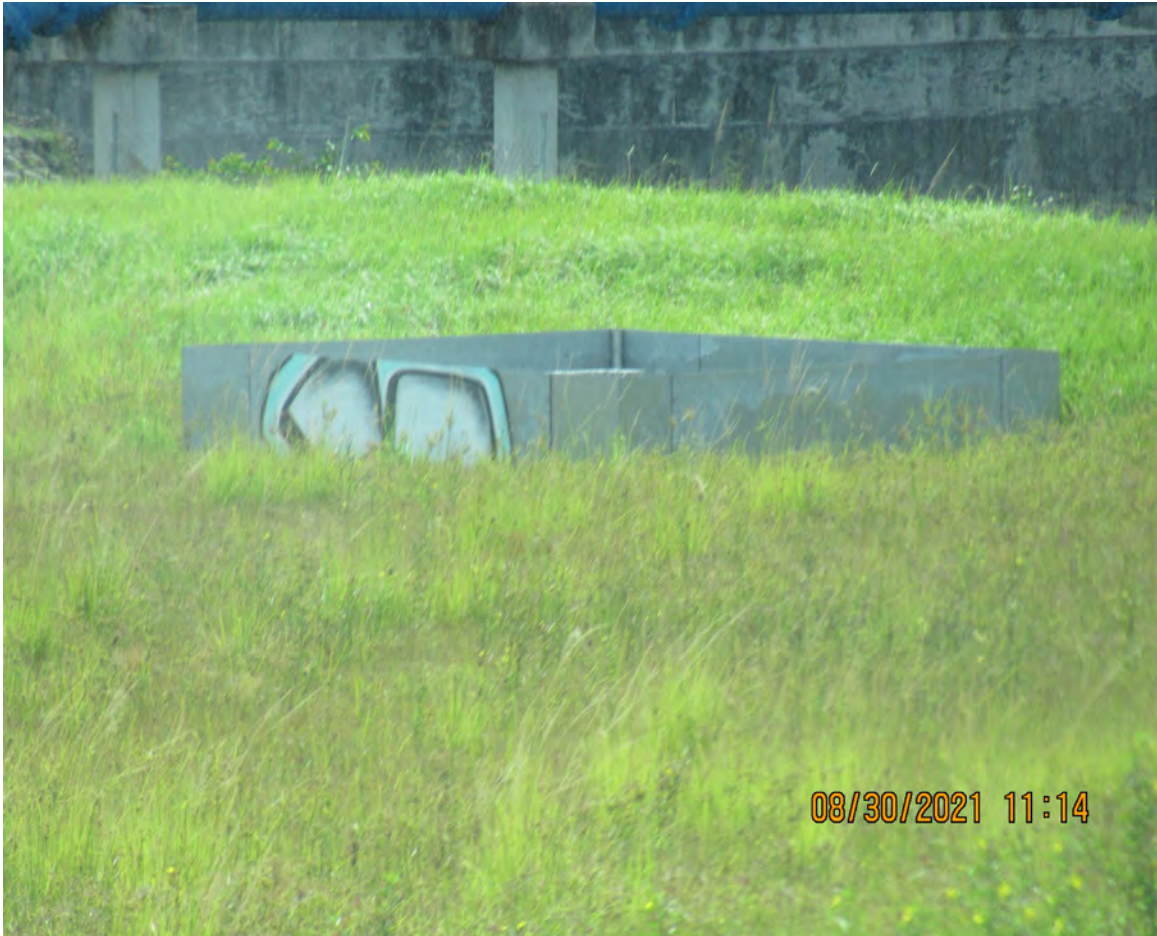
**PHOTO NO.: EB-032
DATE: 8-30-2021**

GRAFFITI SKIMMER

ITEM NOTED TO BE ADDRESSED BY MDX MAINTENANCE

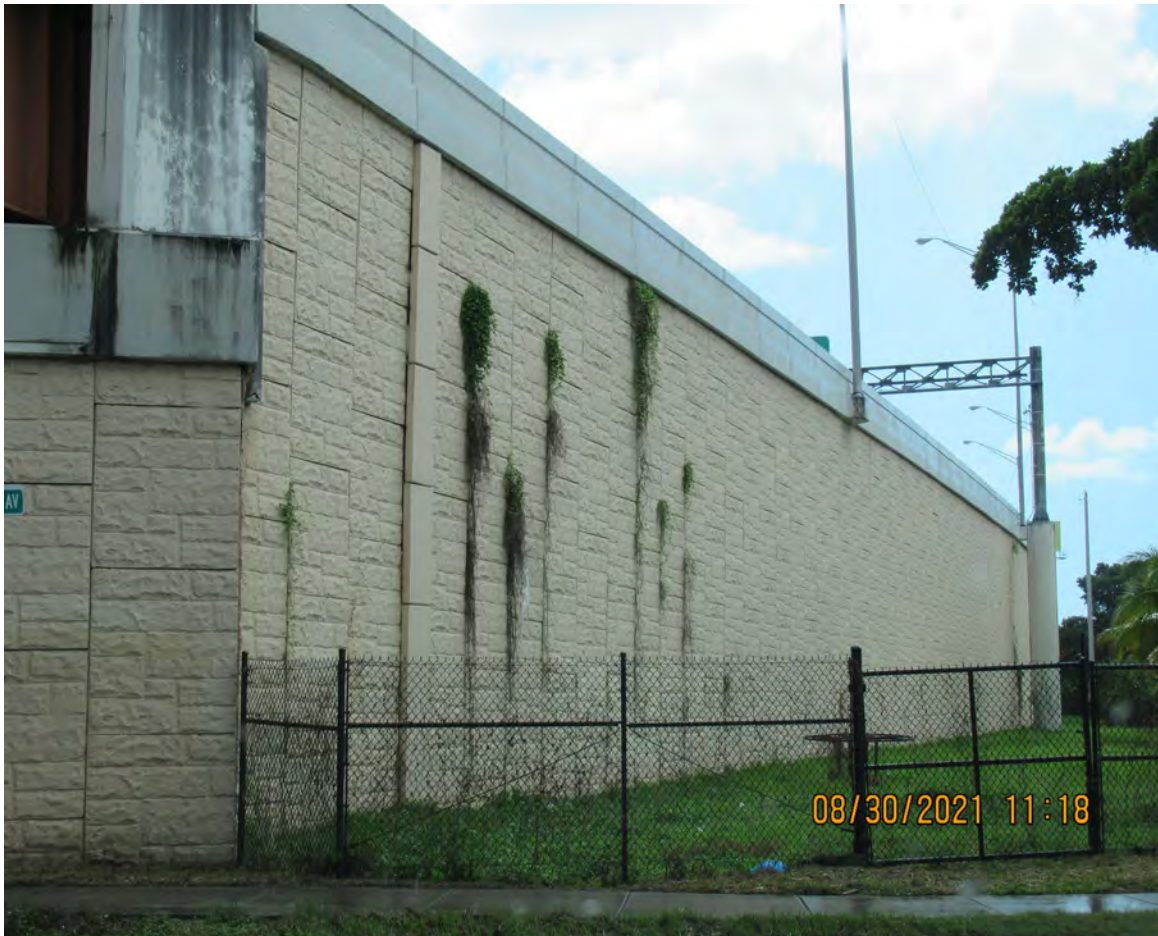
**PHOTO NO.: EB-033
DATE: 8-30-2021**

OVERGROWN VEGETATION ON MSE WALL

ITEM NOTED TO BE ADDRESSED BY MDX MAINTENANCE

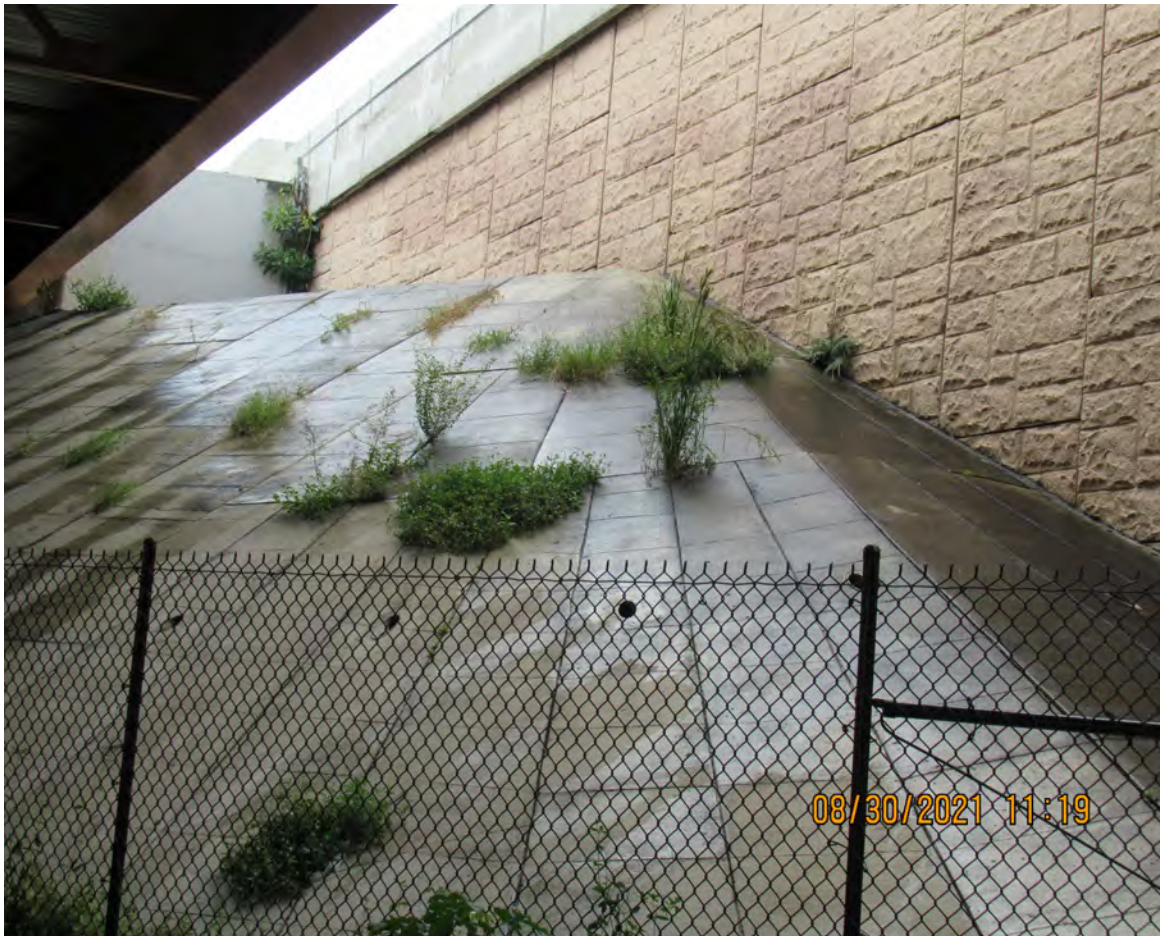
**PHOTO NO.: EB-034
DATE: 8-30-2021**

OVERGROWN VEGETATION ON SLOPE & ABUTMENT

ITEM NOTED TO BE ADDRESSED BY MDX MAINTENANCE

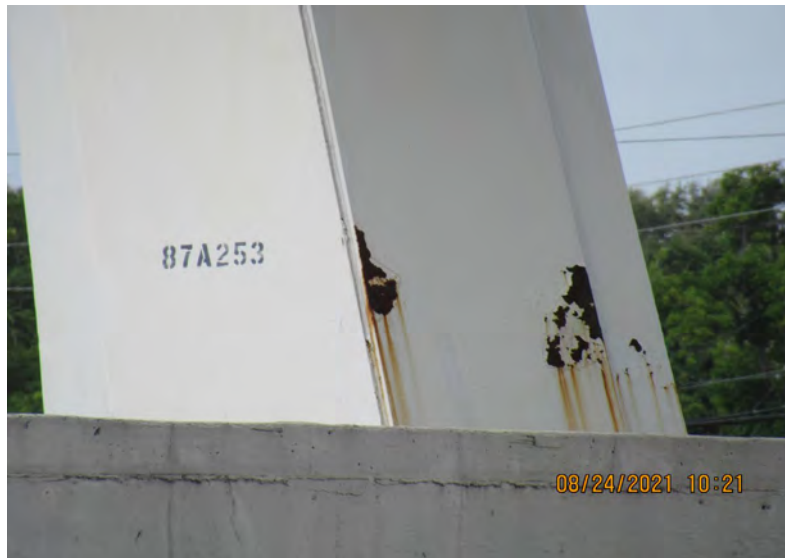
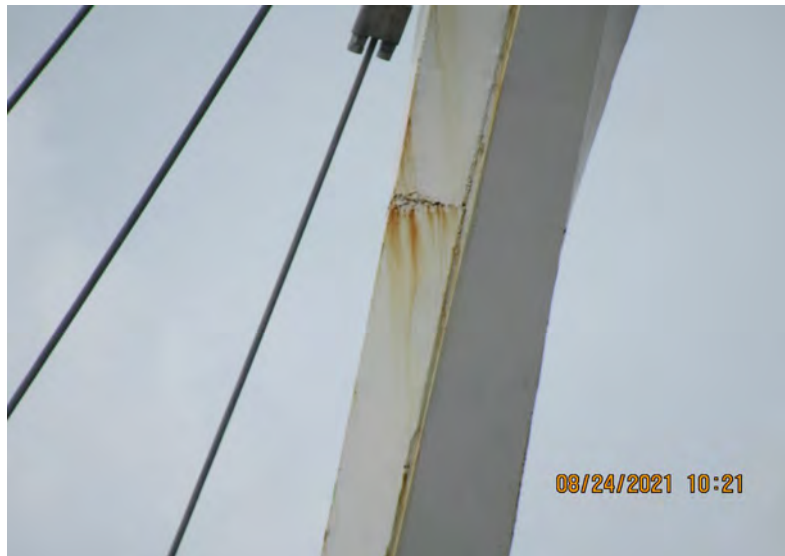
**PHOTO NO.: WB-001
DATE: 8-24-2021**

CORROSION ON PILONS (STRUCTURE # 87A253)

ITEM NOTED TO BE ADDRESSED BY MDX MAINTENANCE

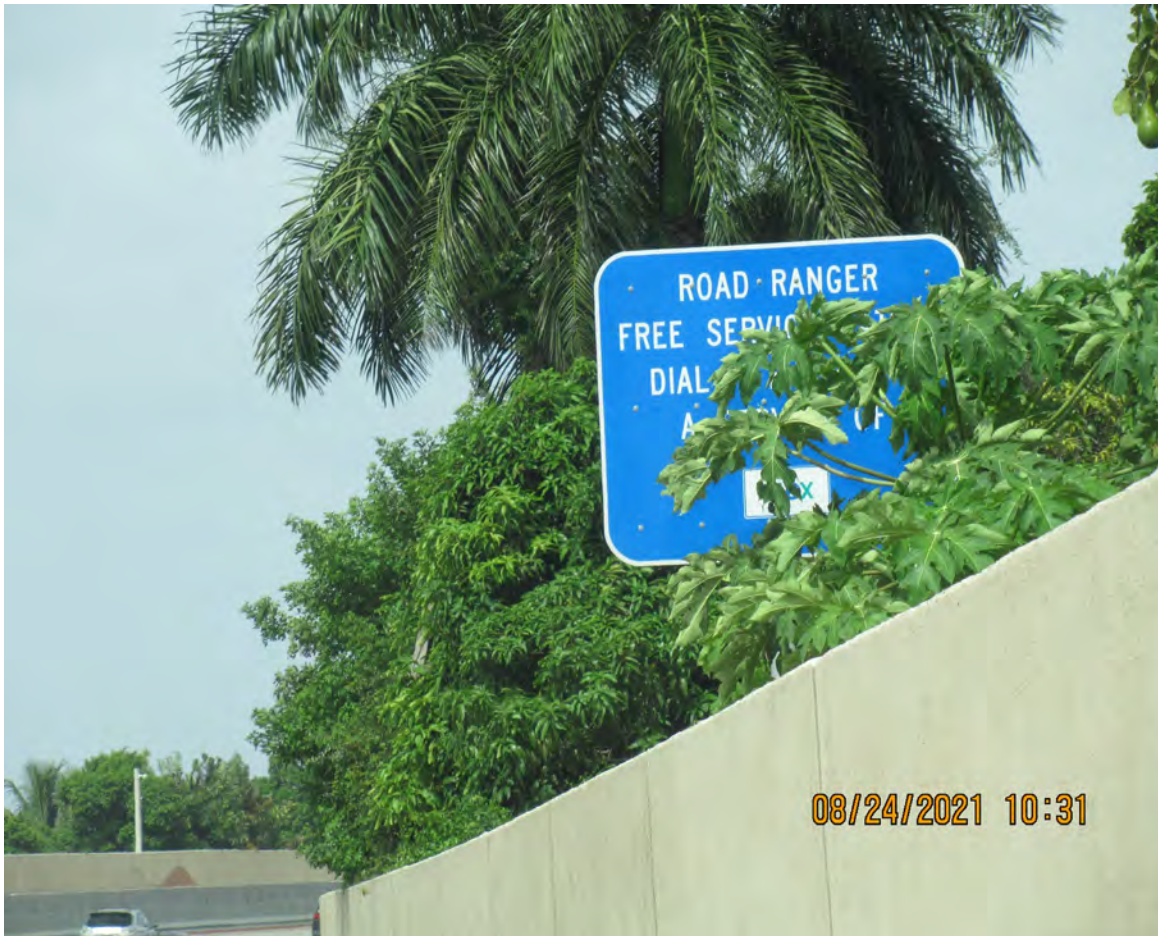
**PHOTO NO.: WB-003
DATE: 8-24-2021**

OVERGROWN VEGETATION OBSTRUCTING SIGN

ITEM NOTED TO BE ADDRESSED BY MDX MAINTENANCE

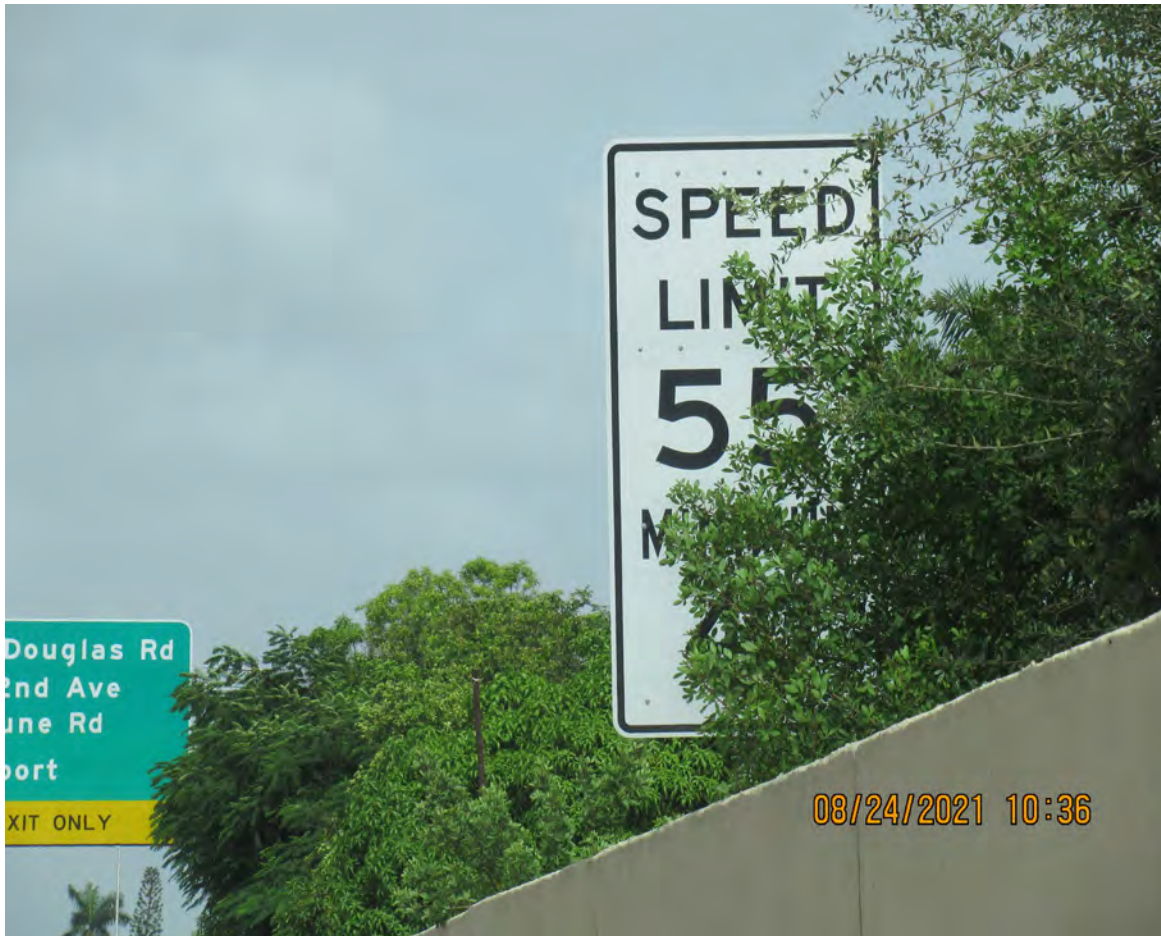
**PHOTO NO.: WB-004
DATE: 8-24-2021**

OVERGROWN VEGETATION OBSTRUCTING SIGN

ITEM NOTED TO BE ADDRESSED BY MDX MAINTENANCE

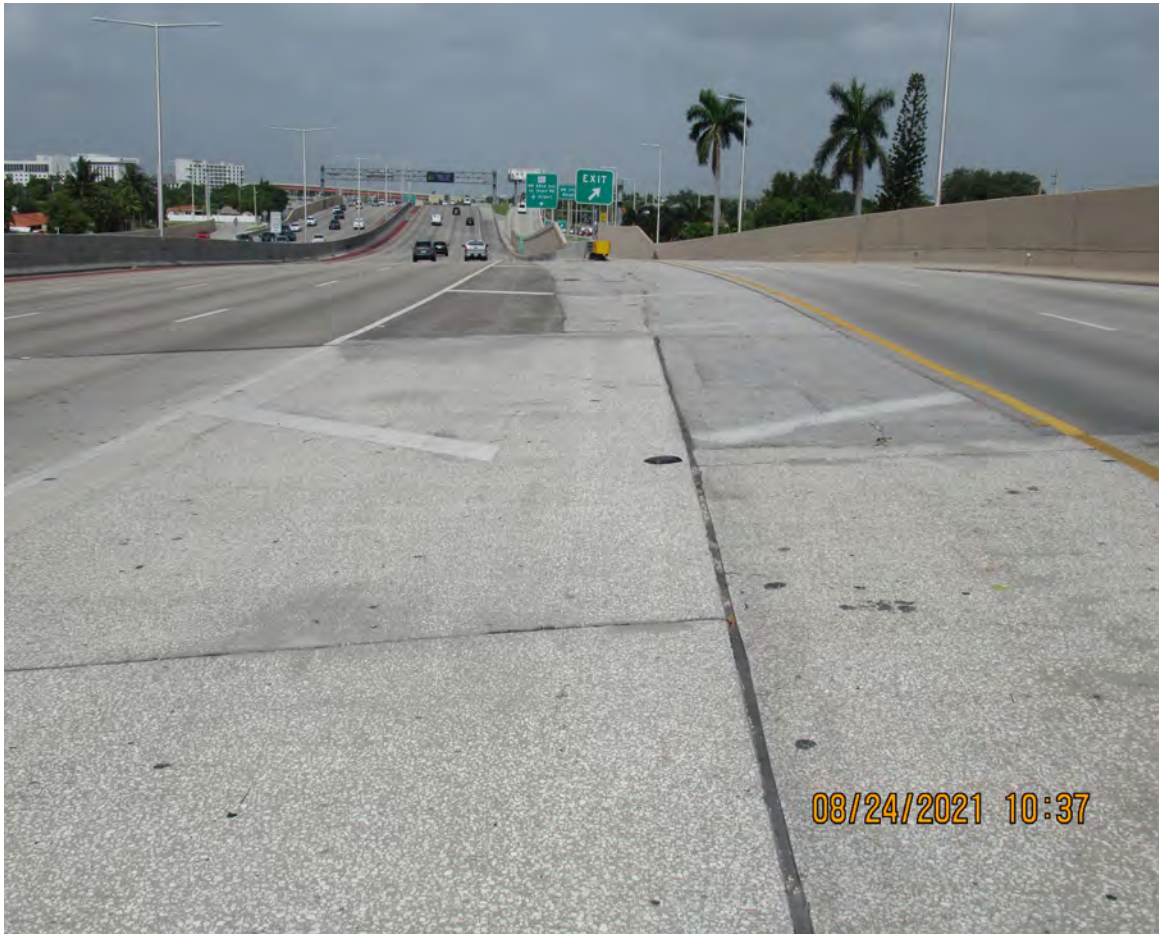
**PHOTO NO.: WB-005
DATE: 8-24-2021**

DETERIORATED CHEVRON STRIPING IN GORE AREA

ITEM NOTED TO BE ADDRESSED BY MDX MAINTENANCE

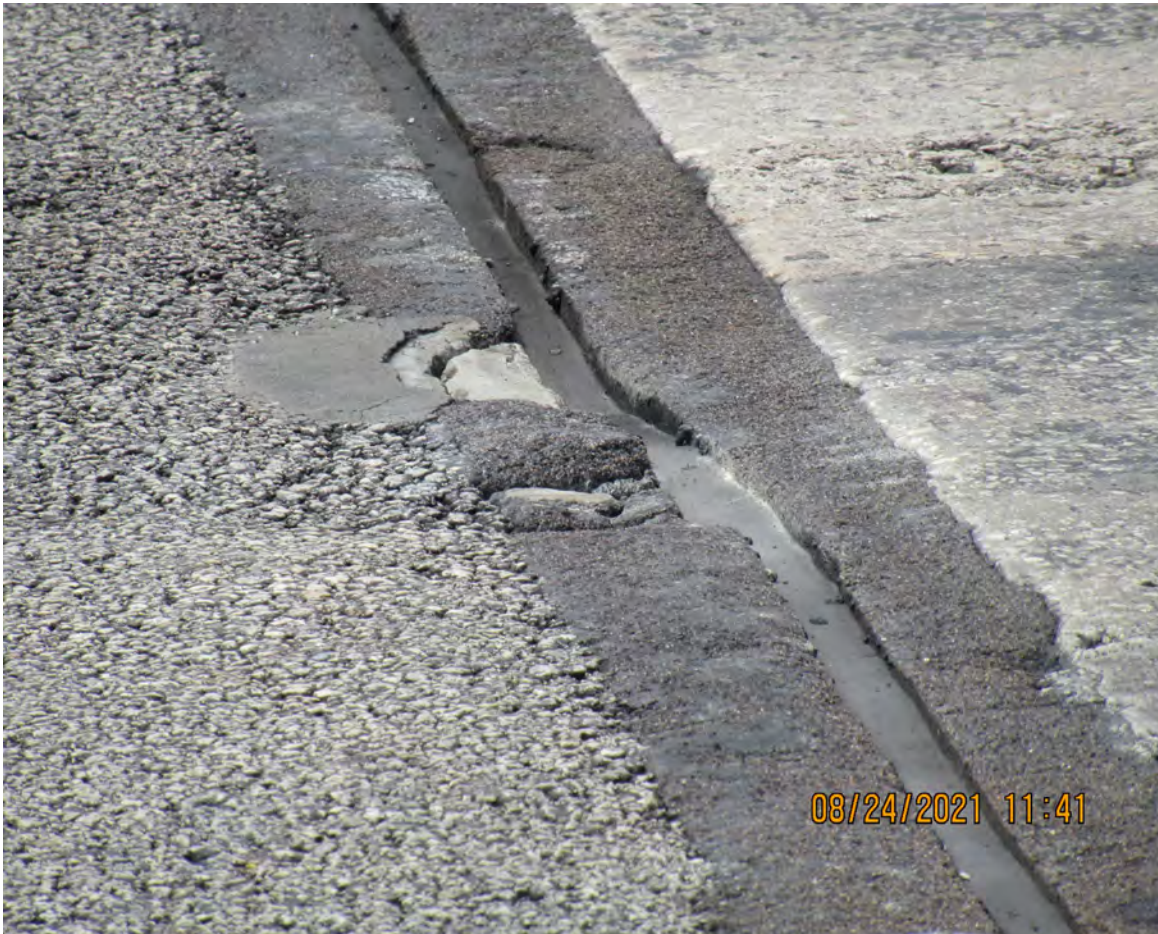
**PHOTO NO.: WB-006
DATE: 8-24-2021**

DAMAGED POLYMER NOSING JOINT HEADER (BRIDGE No. 870138)

ITEM NOTED TO BE ADDRESSED BY MDX WORK PROGRAM No. 30029

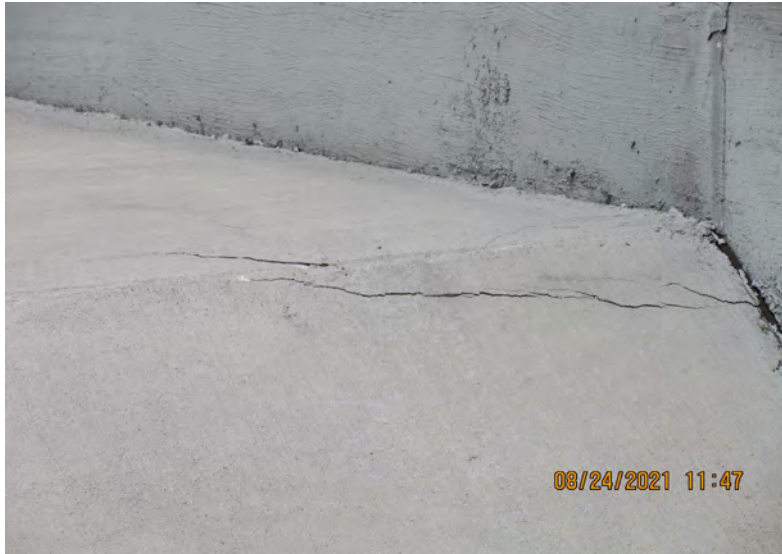
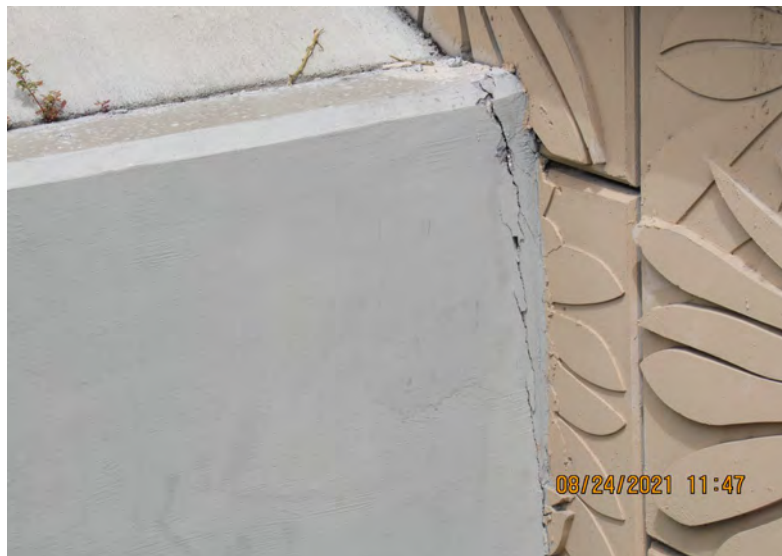
**PHOTO NO.: WB-007
DATE: 8-24-2021**

CRACKS ON ABUTMENT 1 (BRIDGE # 870137)

ITEM NOTED TO BE ADDRESSED BY MDX MAINTENANCE

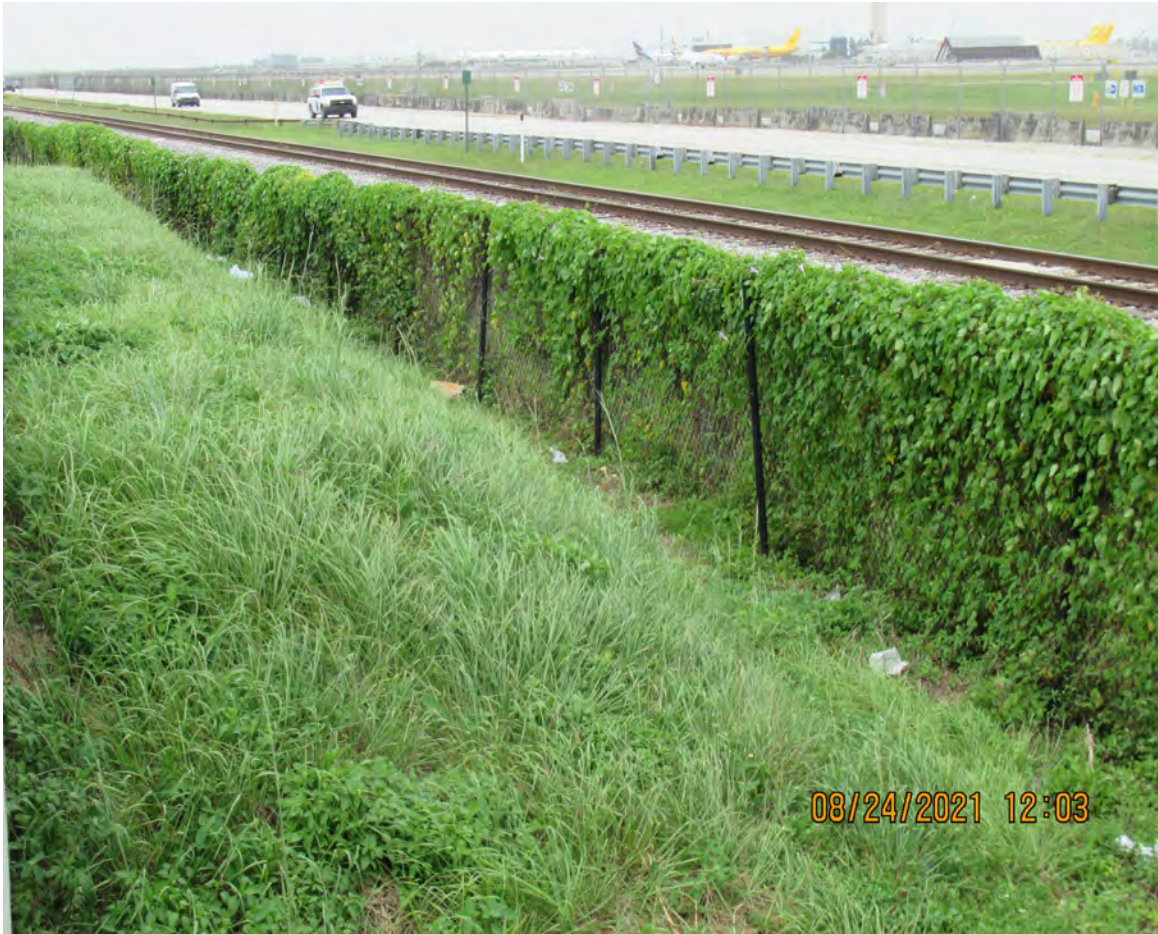
**PHOTO NO.: WB-009
DATE: 8-24-2021**

OVERGROWN VEGETATION ON FENCE

ITEM NOTED TO BE ADDRESSED BY MDX MAINTENANCE

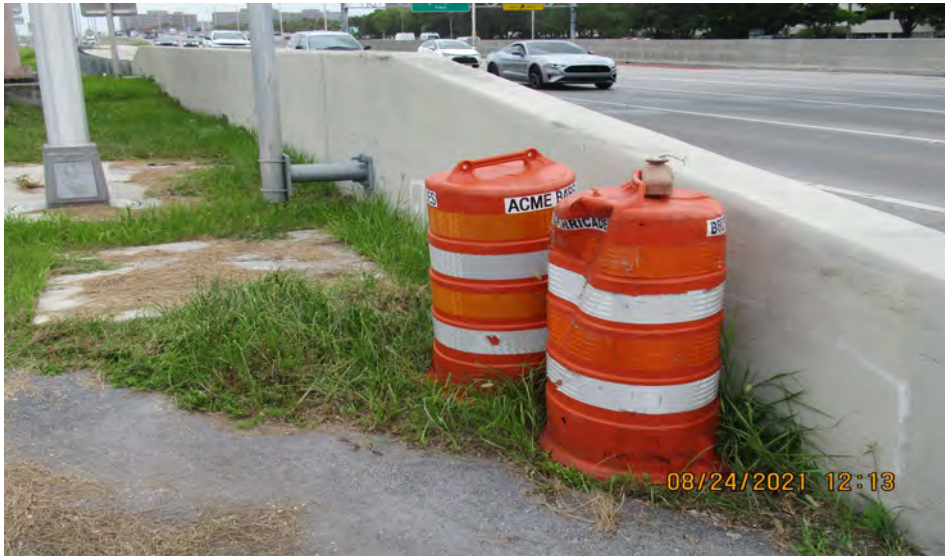
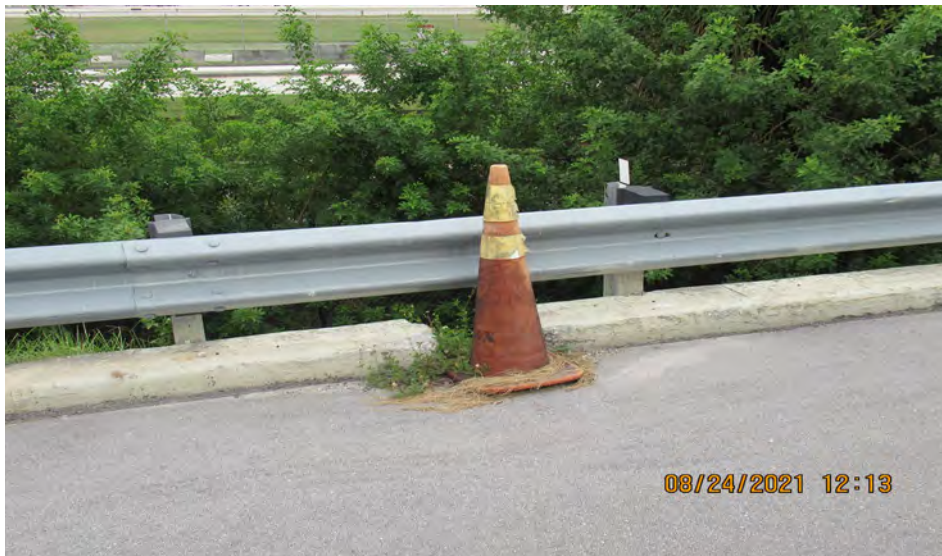
**PHOTO NO.: WB-011
DATE: 8-24-2021**

ABANDONED MOT DEVICES AT HUB PARKING AREA

ITEM NOTED TO BE ADDRESSED BY MDX MAINTENANCE

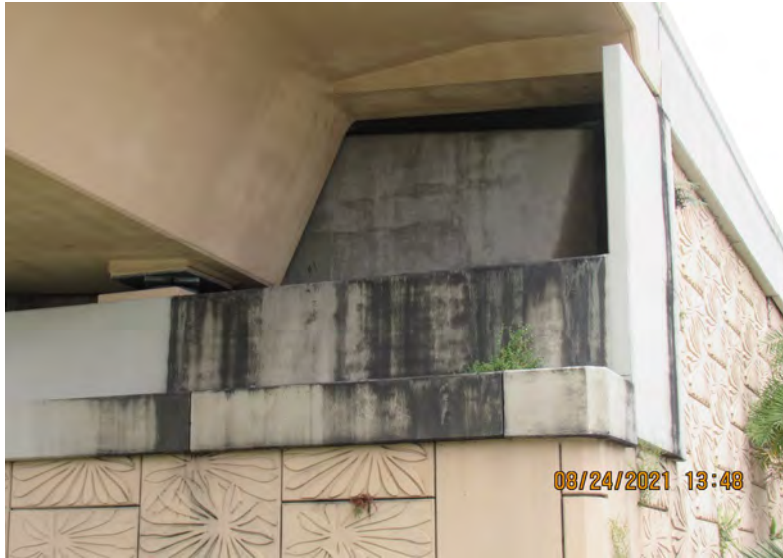
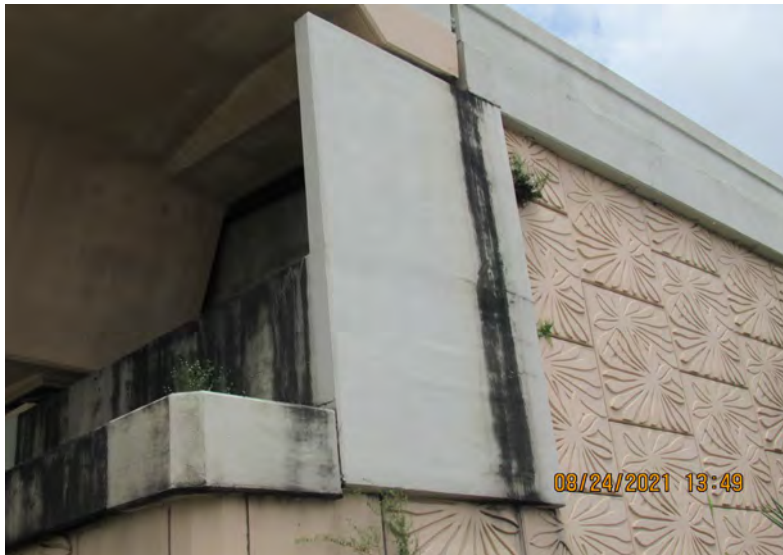
**PHOTO NO.: WB-012
DATE: 8-24-2021**

WATER STAINS FROM CLOGGED JOINT DRAINAGE (BRIDGE # 871046)

ITEM NOTED TO BE ADDRESSED BY MDX MAINTENANCE

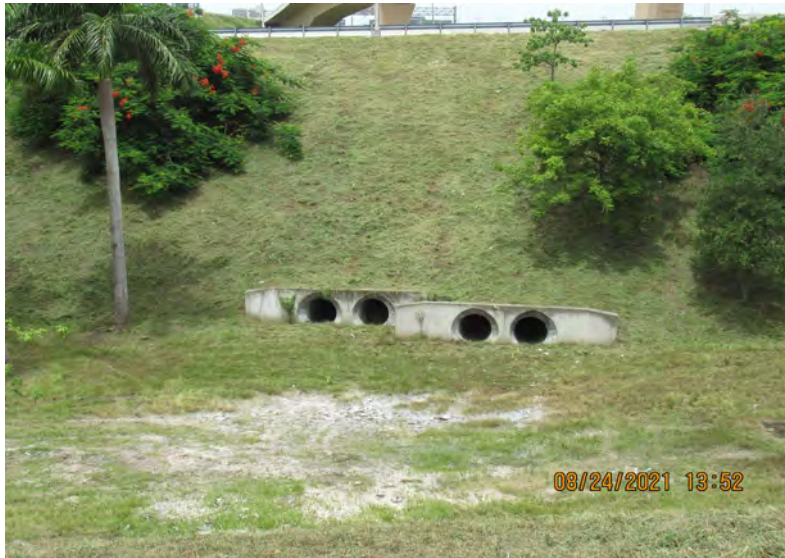
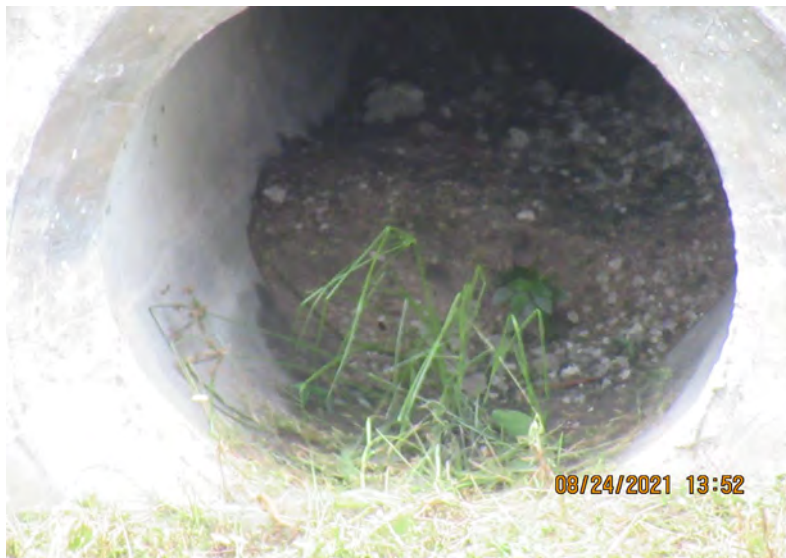
**PHOTO NO.: WB-013
DATE: 8-24-2021**

SEDIMENTATION INSIDE CROSS DRAINS

ITEM NOTED TO BE ADDRESSED BY MDX MAINTENANCE

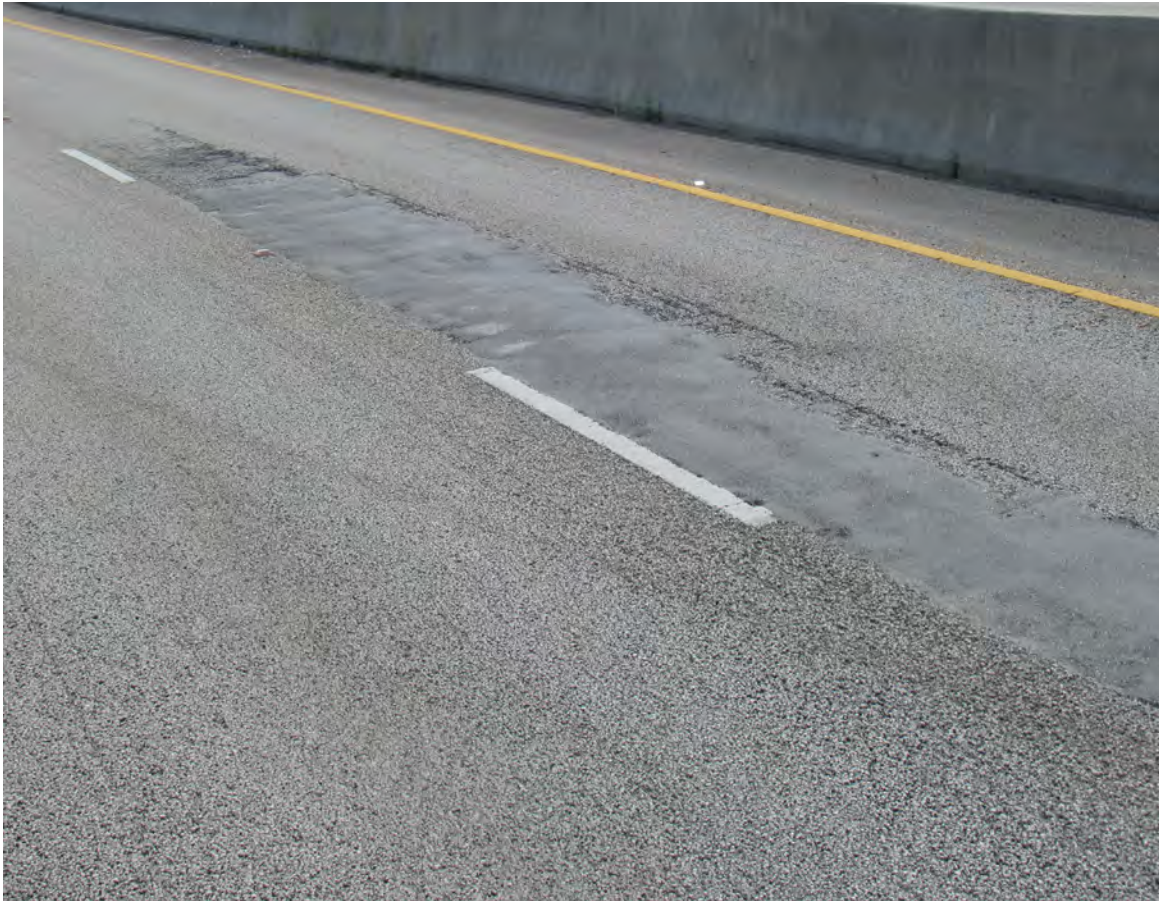
**PHOTO NO.: WB-014
DATE: 08-24-2021**

DETERIORATED ASPHALT REPAIR

ITEM NOTED TO BE ADDRESSED BY MDX MAINTENANCE

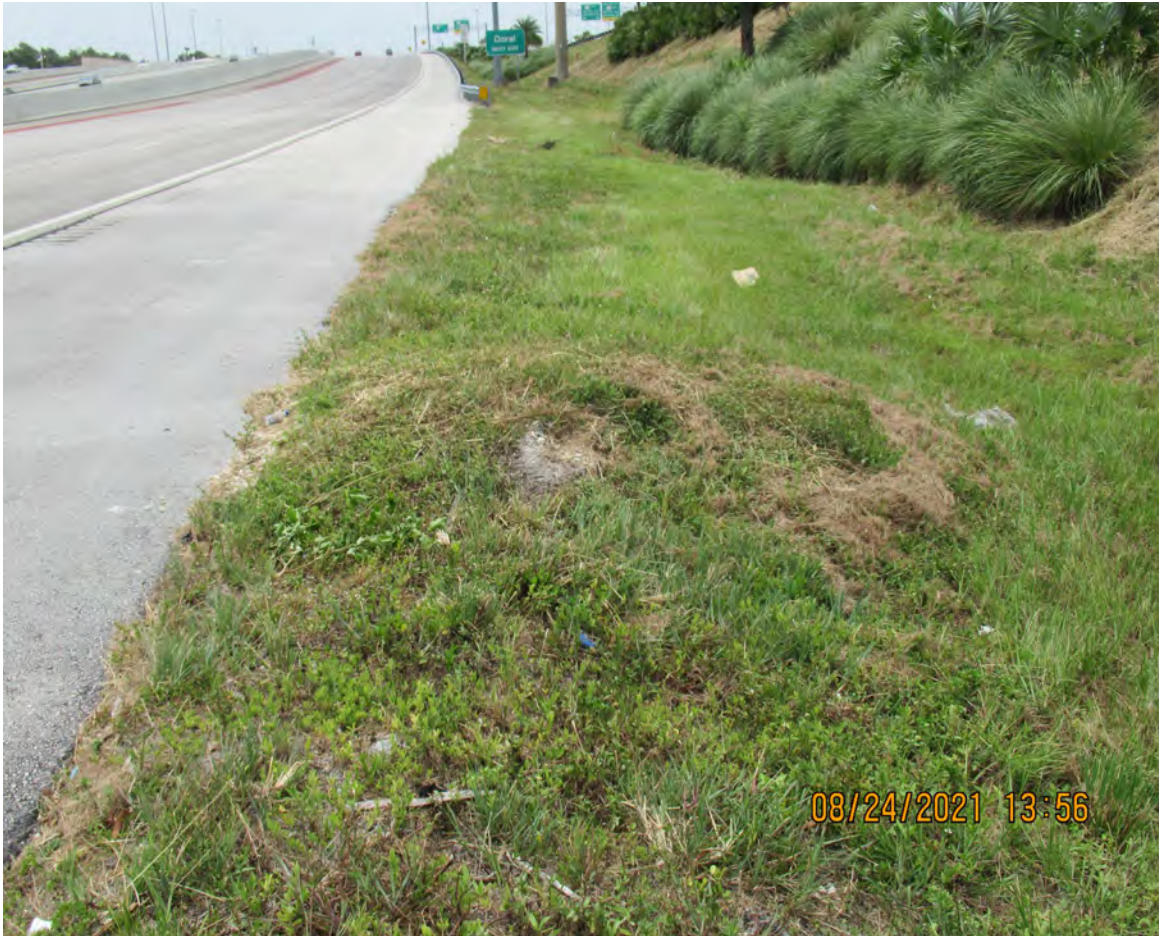
**PHOTO NO.: WB-015
DATE: 8-24-2021**

RAISED SHOULDER GRADE, DUE TO ILLEGAL DUMPING

ITEM NOTED TO BE ADDRESSED BY MDX MAINTENANCE
