Annual Inspection Report 2021

General Engineering Consultant to the
Miami-Dade County Expressway Authority

ANNUAL INSPECTION REPORT 2021

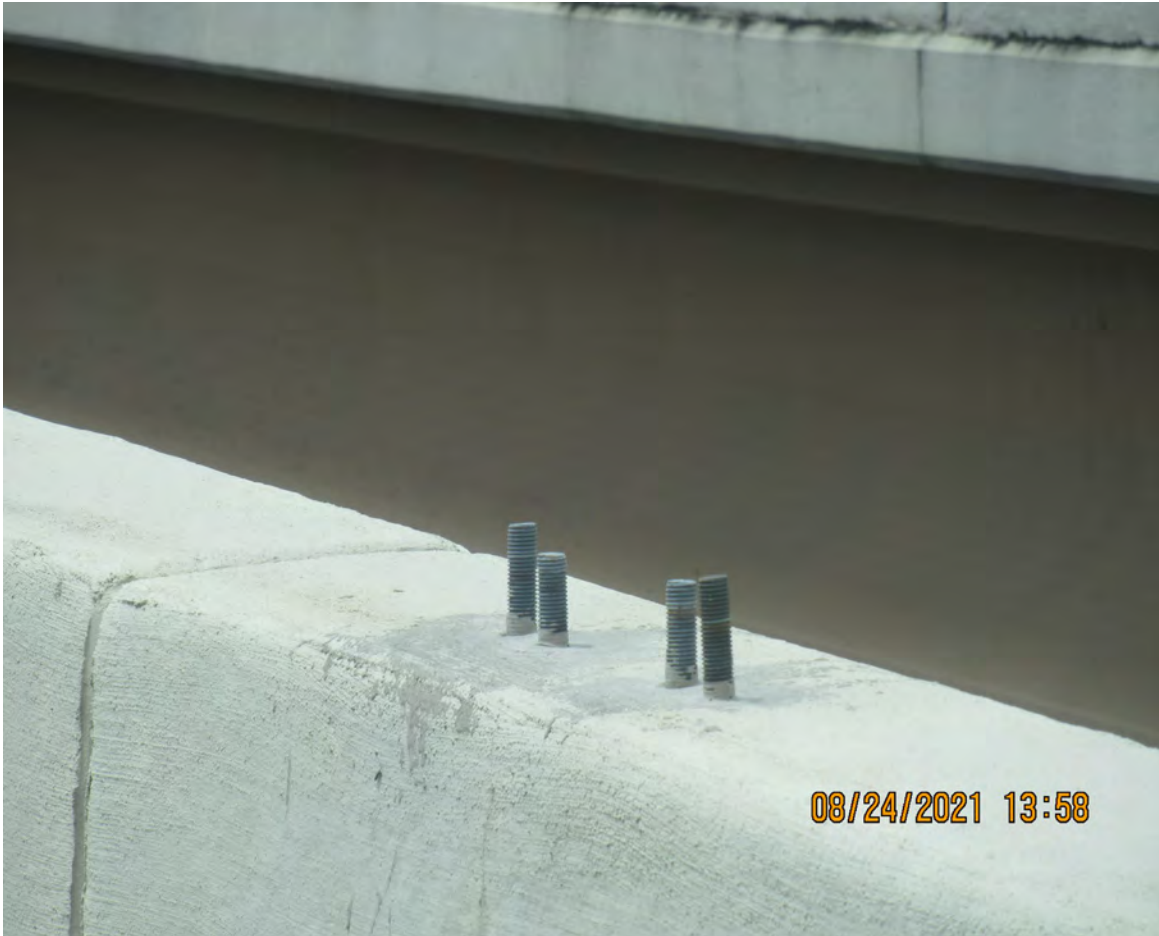
**PHOTO NO.: WB-016
DATE: 8-24-2021**

ANCHOR BOLTS FROM TEMPORARY CONSTRUCTION SIGN (BRIDGE # 871085)

ITEM NOTED TO BE ADDRESSED BY MDX MAINTENANCE

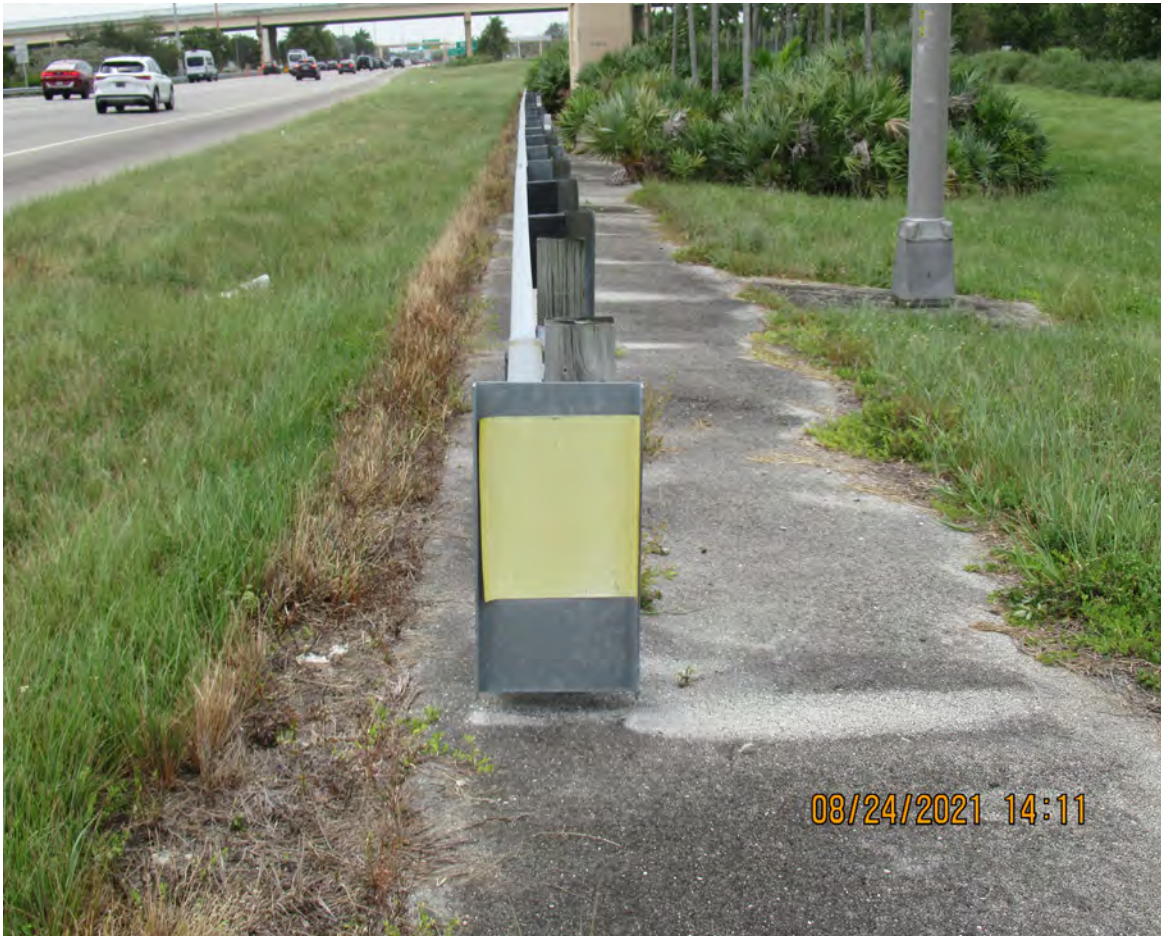
**PHOTO NO.: WB-017
DATE: 08-24-2021**

DETERIORATED REFLECTIVE SHEETING ON END-TREATMENT

ITEM NOTED TO BE ADDRESSED BY MDX MAINTENANCE

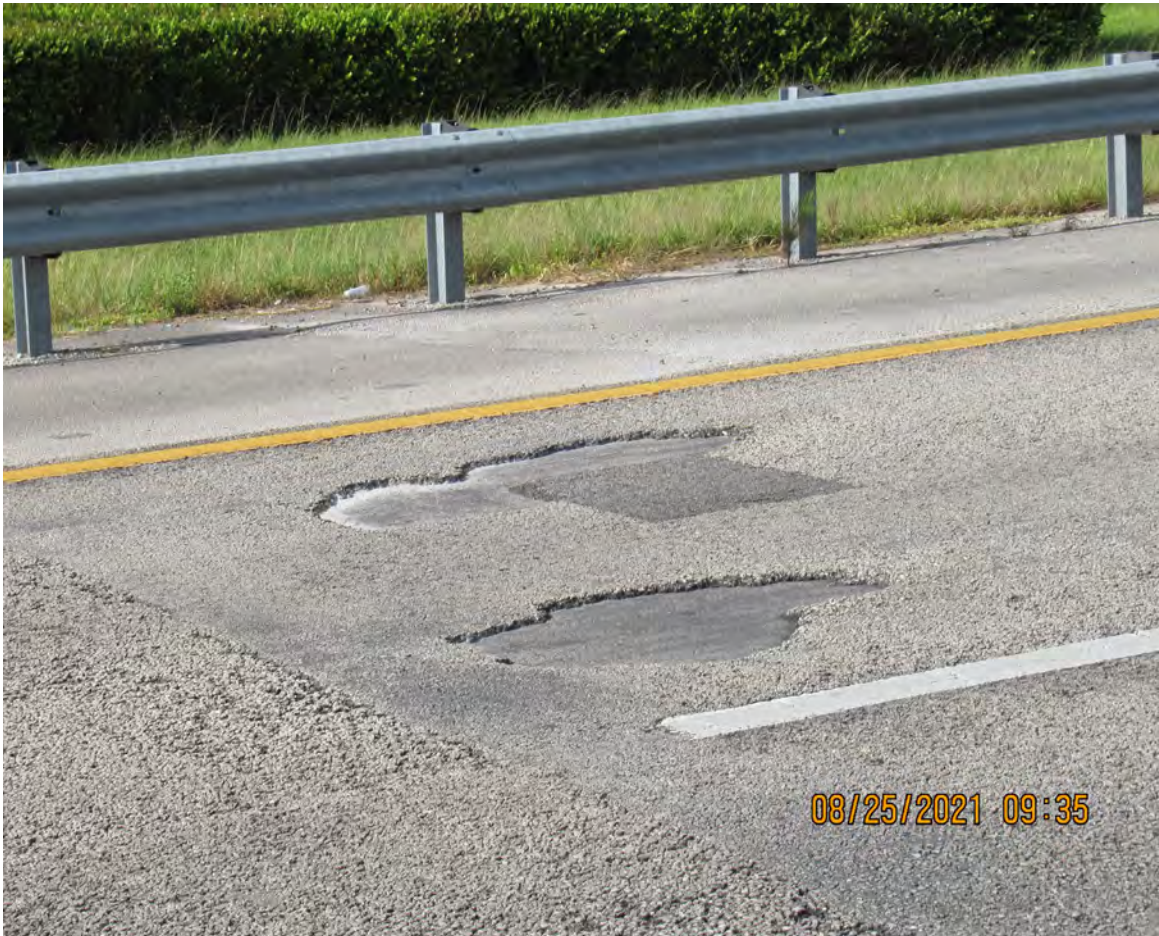
**PHOTO NO.: WB-018
DATE: 8-25-2021**

DAMAGED FRICTION COURSE PAVEMENT

ITEM NOTED TO BE ADDRESSED BY MDX MAINTENANCE

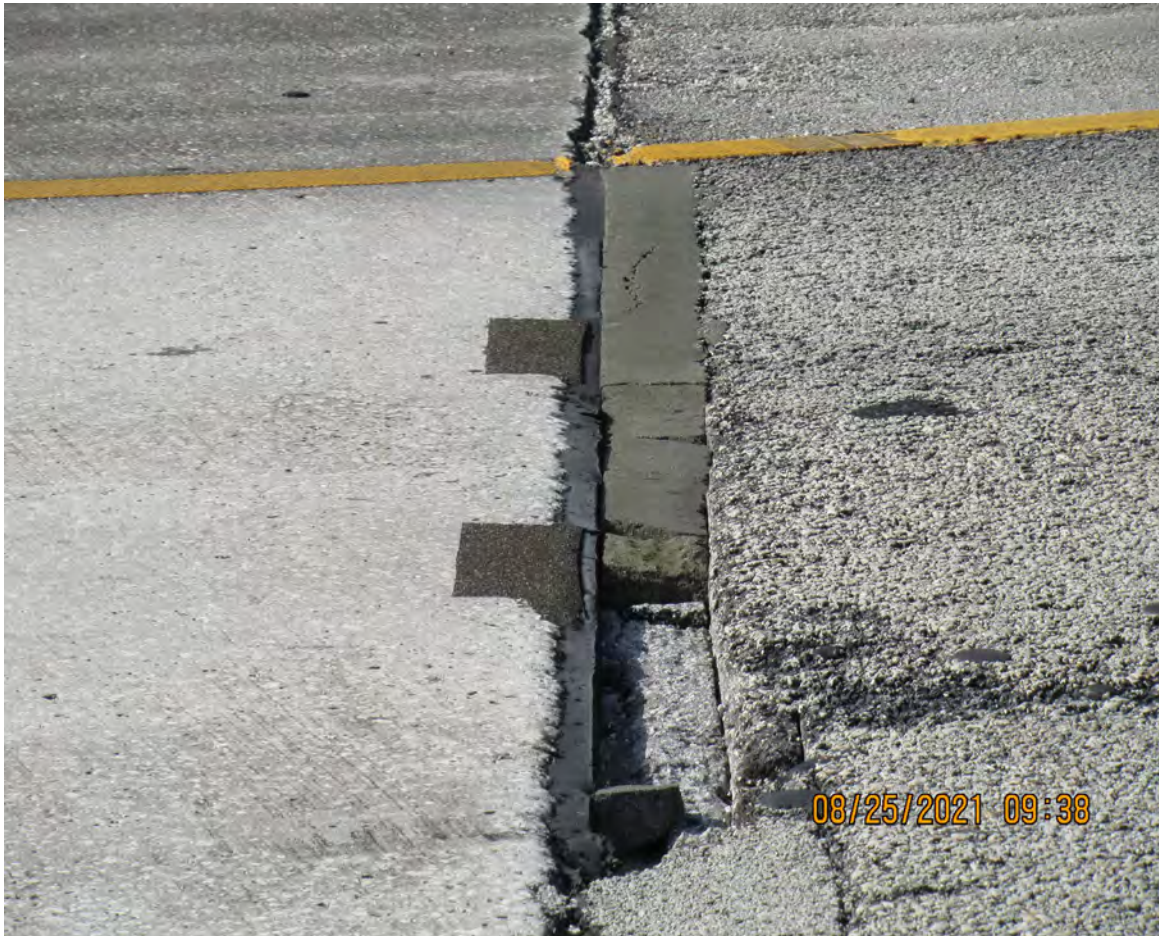
**PHOTO NO.: WB-019
DATE: 8-25-2021**

**DETERIORATED APPROACH SLAB PAVEMENT ON ABUTMENT # 1
(BRIDGE No. 870535)**

ITEM NOTED TO BE ADDRESSED BY MDX MAINTENANCE

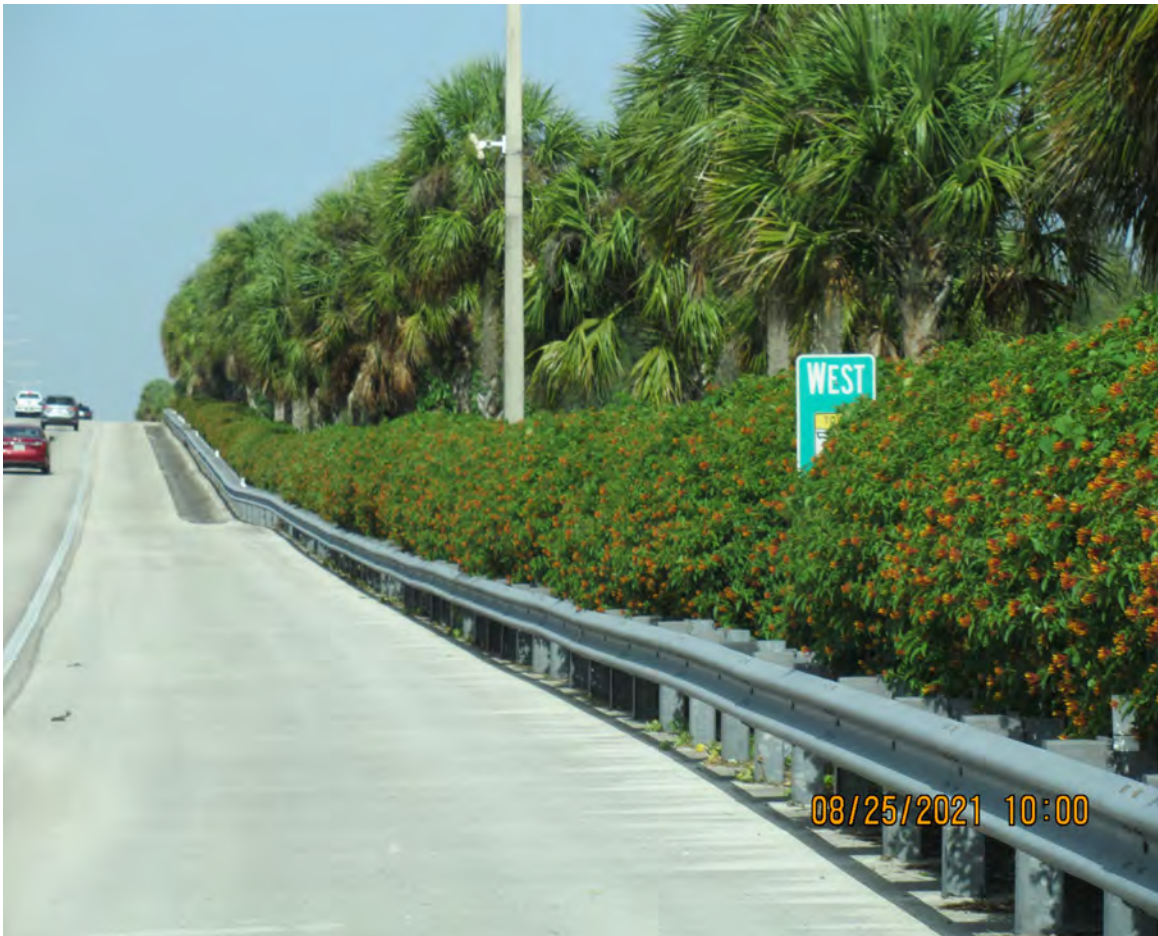
**PHOTO NO.: WB-023
DATE: 8-25-2021**

OVERGROWN VEGETATION OBSTRUCTING MILE MARKER SIGN

ITEM NOTED TO BE ADDRESSED BY MDX MAINTENANCE

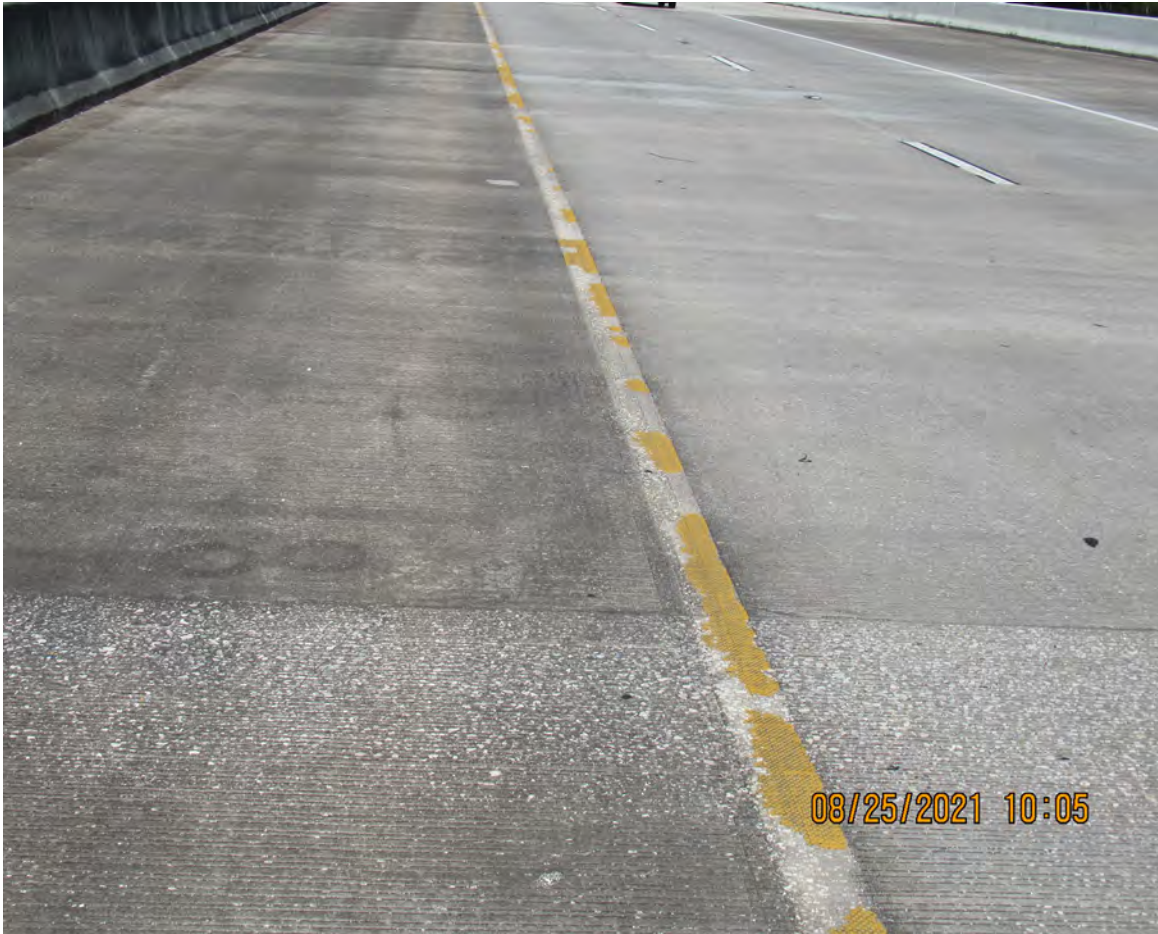
**PHOTO NO.: WB-024
DATE: 8-25-2021**

DETERIORATED EDGE LINE STRIPING (BRIDGE # 871002)

ITEM NOTED TO BE ADDRESSED BY MDX MAINTENANCE

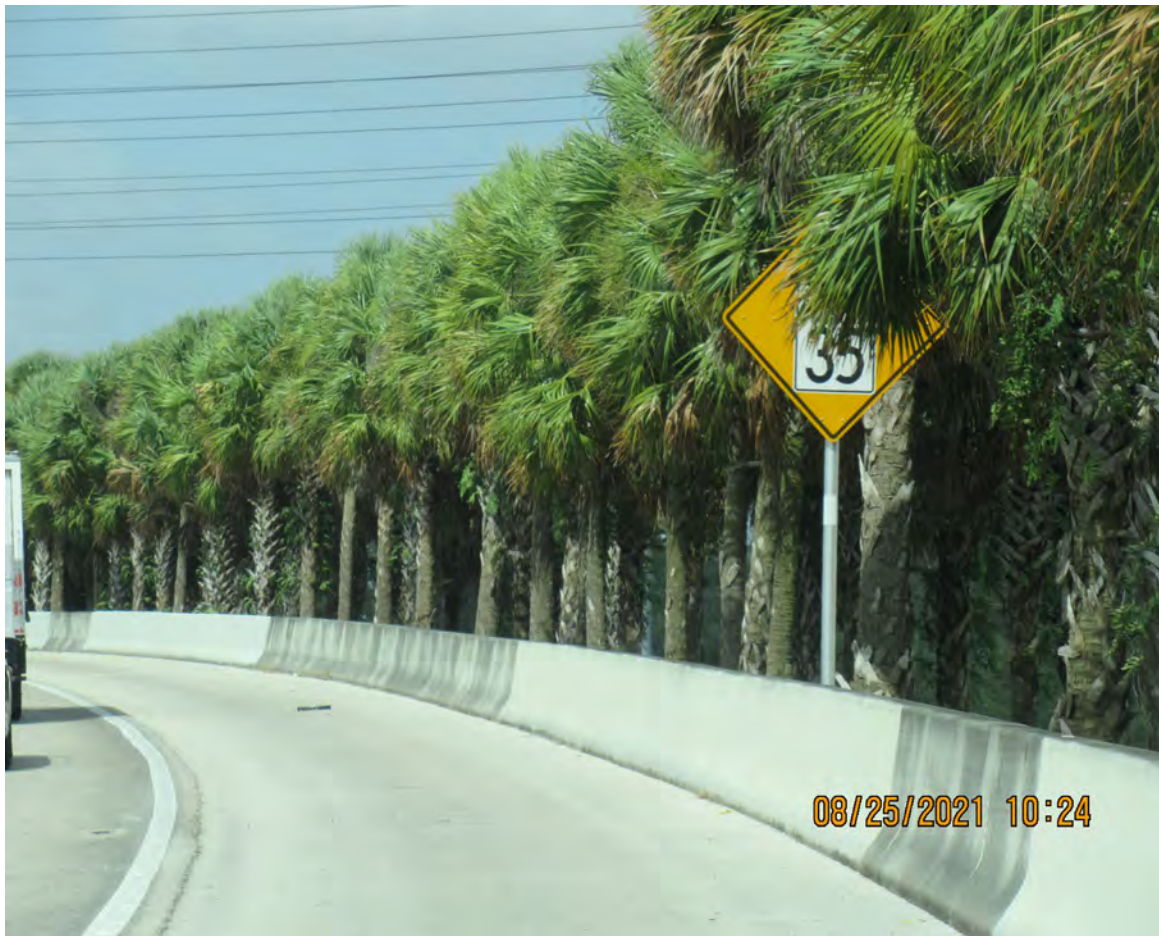
**PHOTO NO.: WB-028
DATE: 8-25-2021**

OVERGROWN VEGETATION OBSTRUCTING SPEED LIMIT SIGN

ITEM NOTED TO BE ADDRESSED BY MDX MAINTENANCE

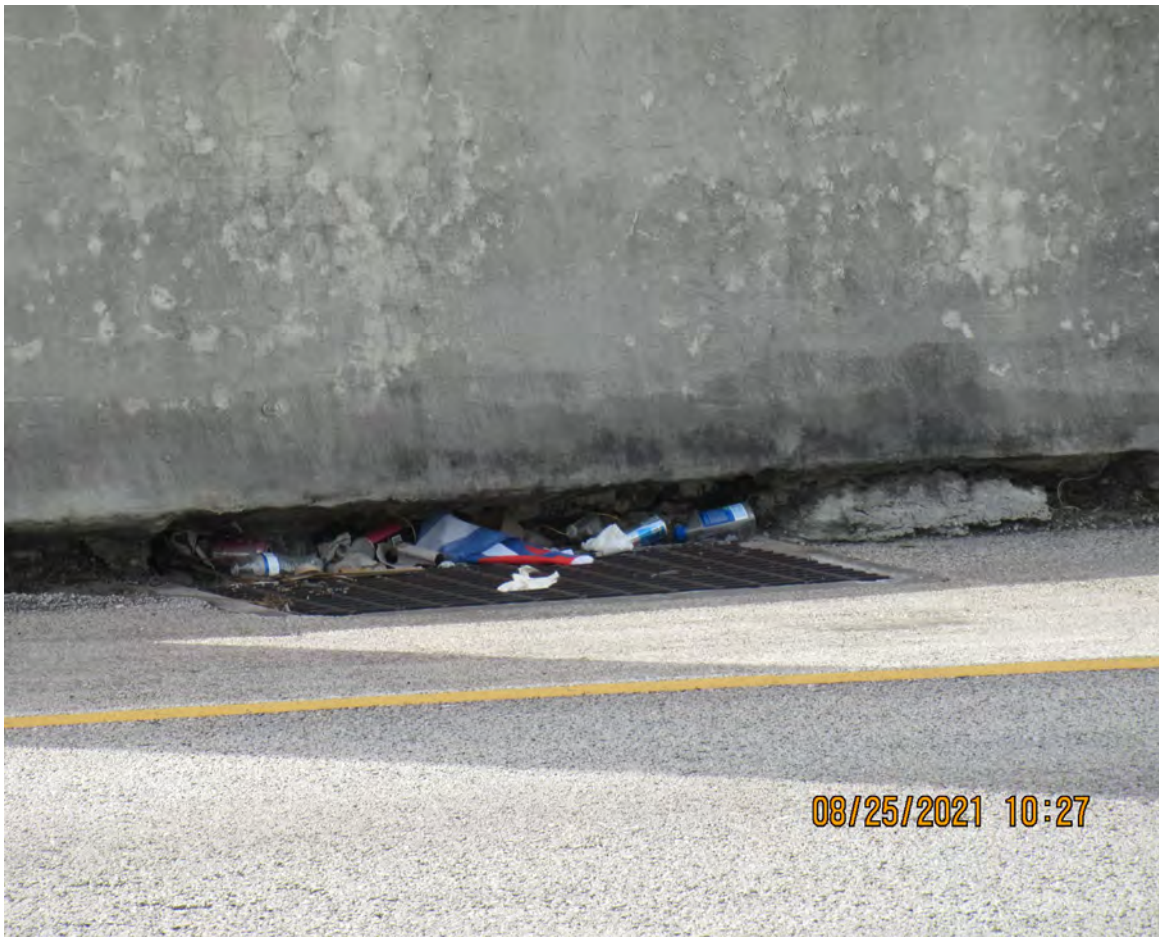
**PHOTO NO.: WB-030
DATE: 8-25-2021**

**TRASH AND DEBRIS ON DRAINAGE STRUCTURE
(TYPICAL AT VARIOUS LOCATIONS)**

ITEM NOTED TO BE ADDRESSED BY MDX MAINTENANCE

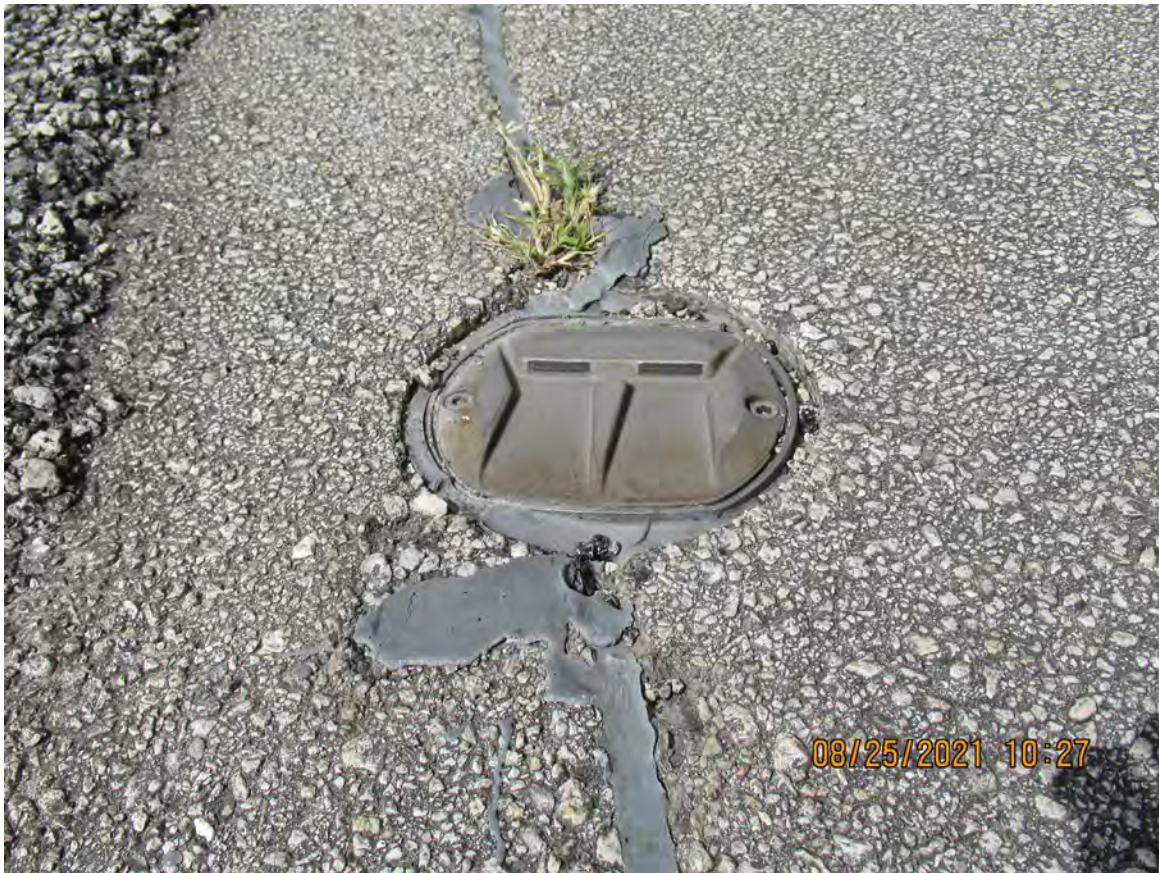
**PHOTO NO.: WB-031
DATE: 8-25-2021**

MALFUNCTIONING ILLUMINATED REFLECTIVE PAVEMENT MARKERS

ITEM NOTED TO BE ADDRESSED BY MDX MAINTENANCE

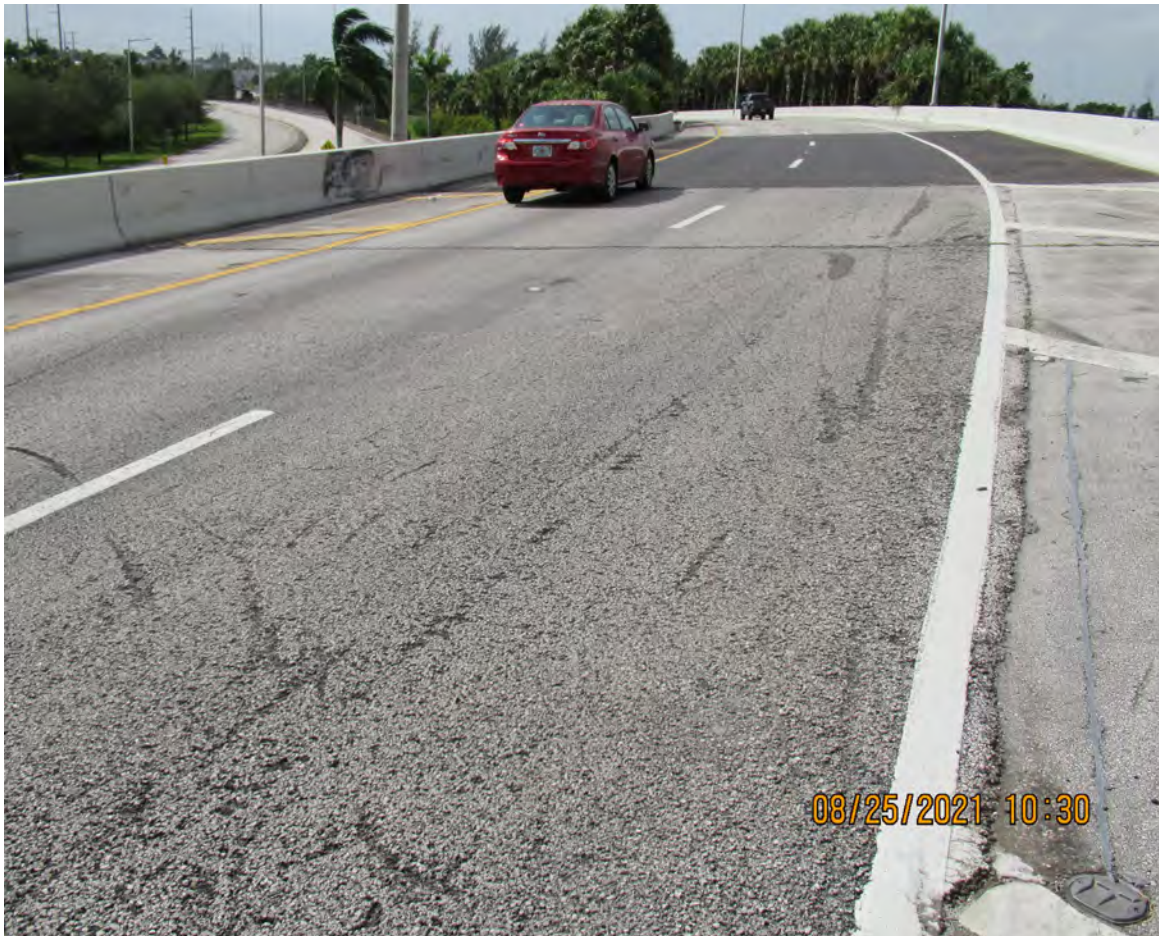
**PHOTO NO.: WB-032
DATE: 8-25-2021**

**DETERIORATED / DAMAGED FRICTION COURSE DUE TO NUMEROUS
ACCIDENTS**

ITEM NOTED TO BE ADDRESSED BY MDX MAINTENANCE

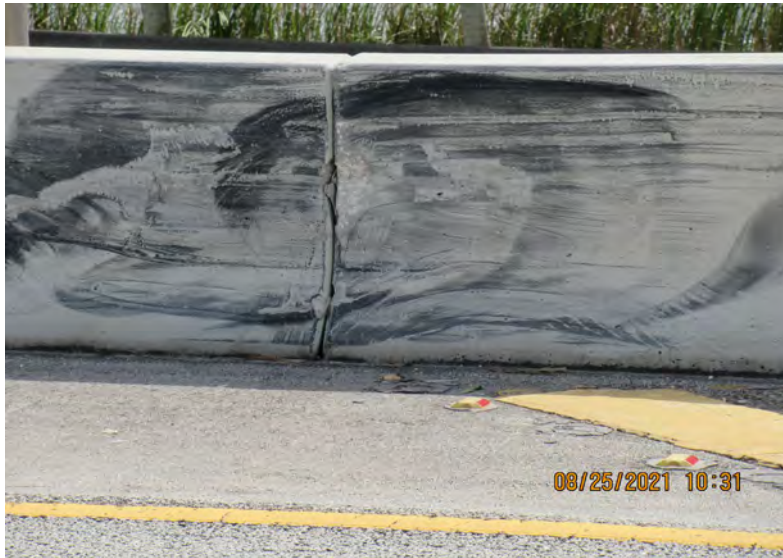
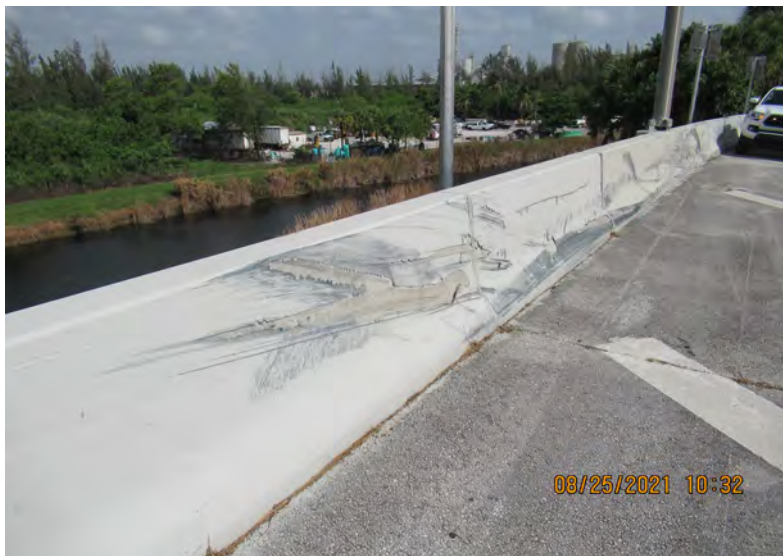
**PHOTO NO.: WB-033
DATE: 8-25-2021**

SCUFF MARKS / VEHICULAR IMPACT ON BARRIER WALL

ITEM NOTED TO BE ADDRESSED BY MDX MAINTENANCE

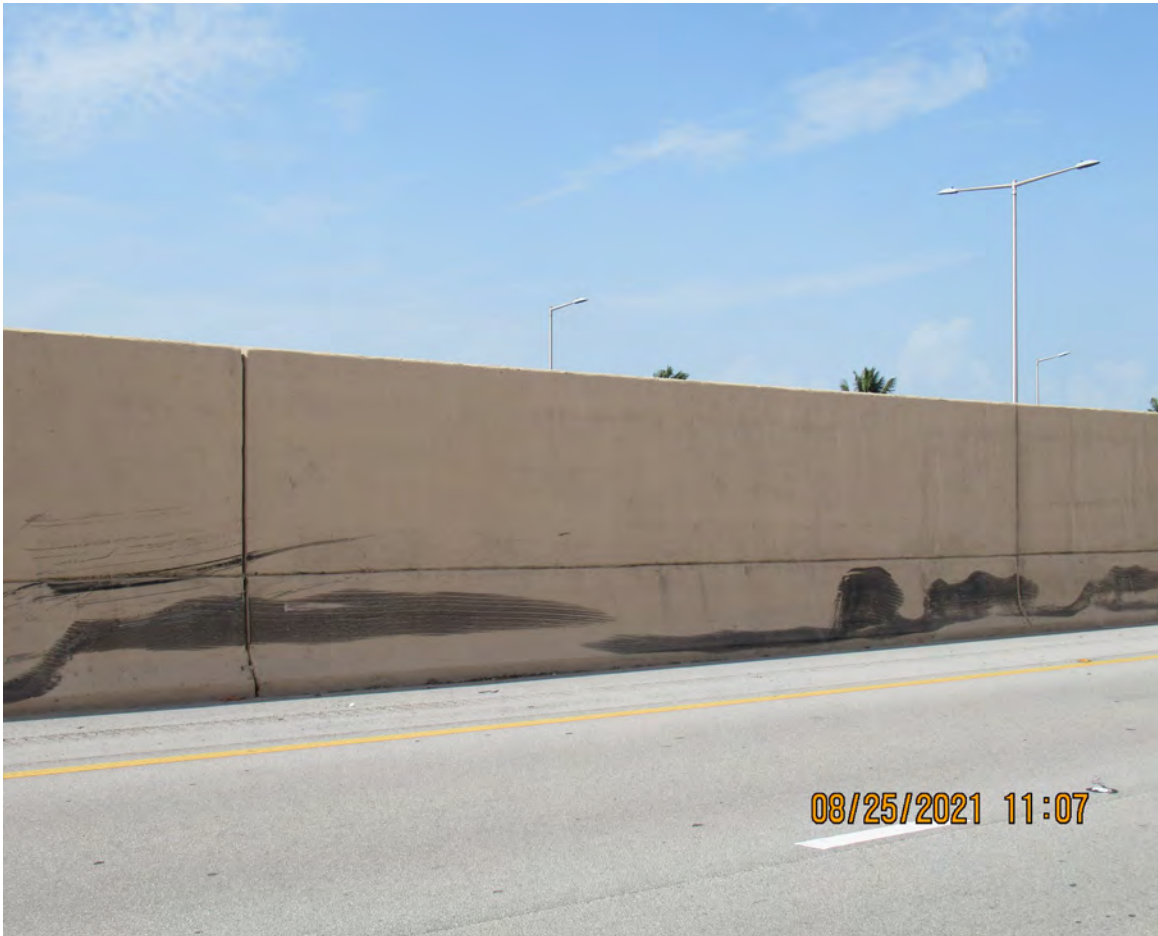
**PHOTO NO.: WB-035
DATE: 8-25-2021**

SCUFF MARKS ON BARRIER & SOUND WALL

ITEM NOTED TO BE ADDRESSED BY MDX MAINTENANCE

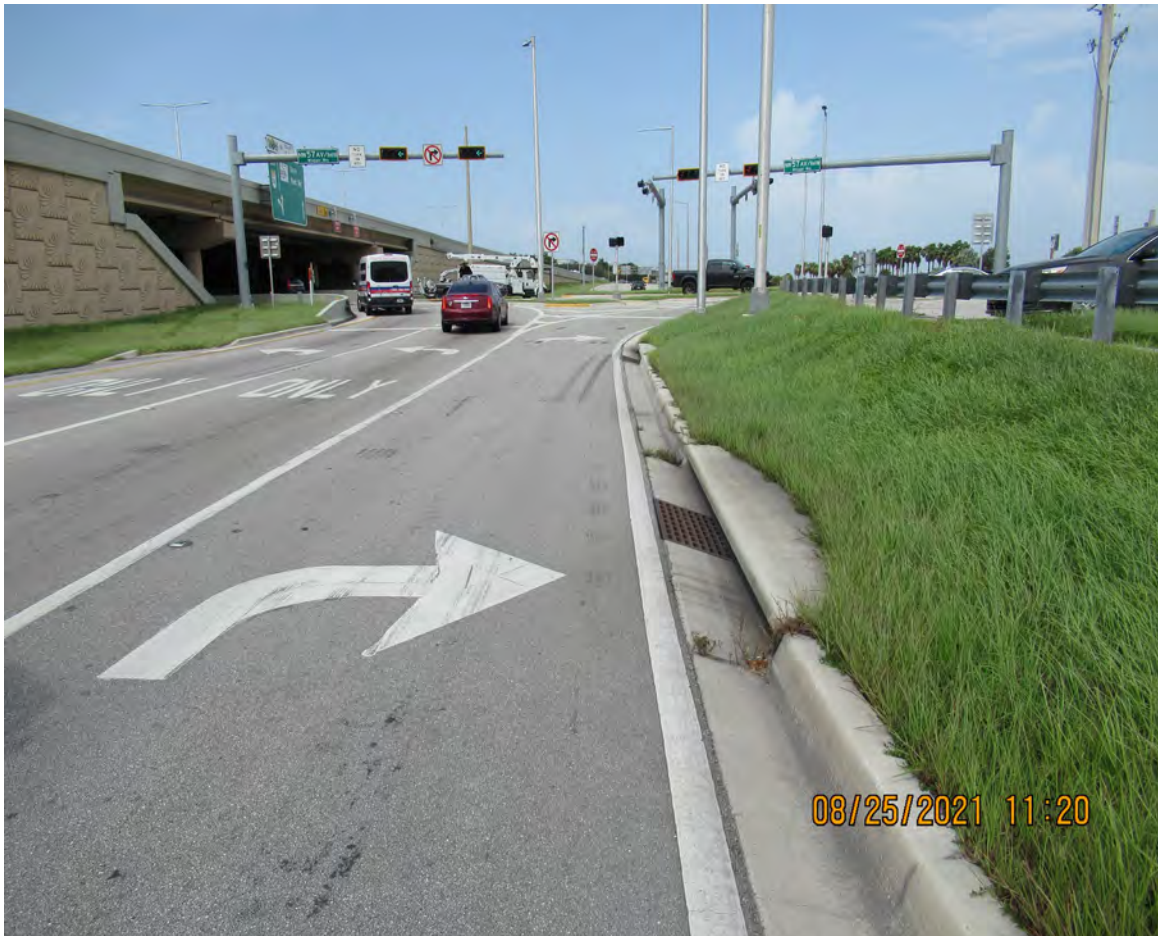
**PHOTO NO.: WB-036
DATE: 8-25-2021**

CLOGGED DRAINAGE STRUCTURE

ITEM NOTED TO BE ADDRESSED BY MDX MAINTENANCE

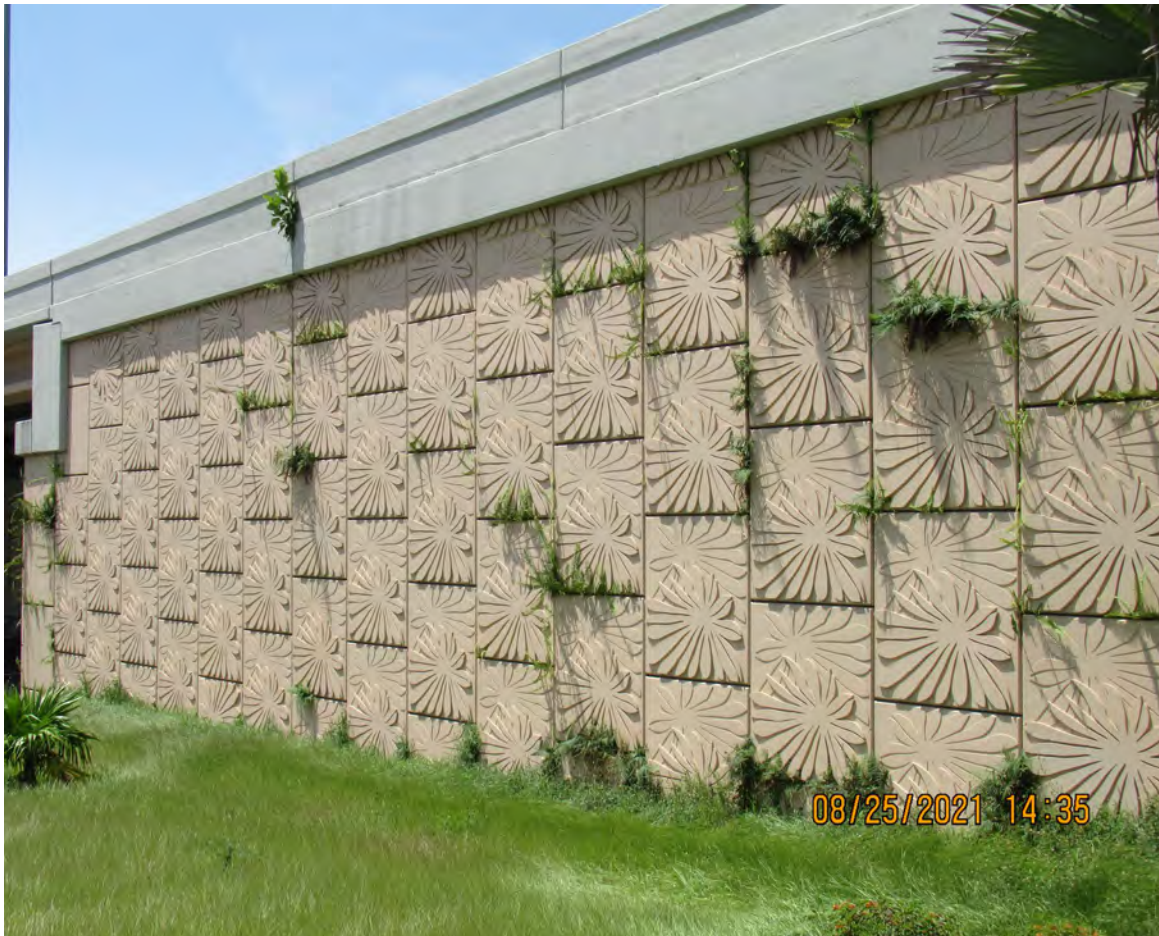
**PHOTO NO.: WB-038
DATE: 8-25-2021**

OVERGROWN VEGETATION ON MSE WALL

ITEM NOTED TO BE ADDRESSED BY MDX MAINTENANCE

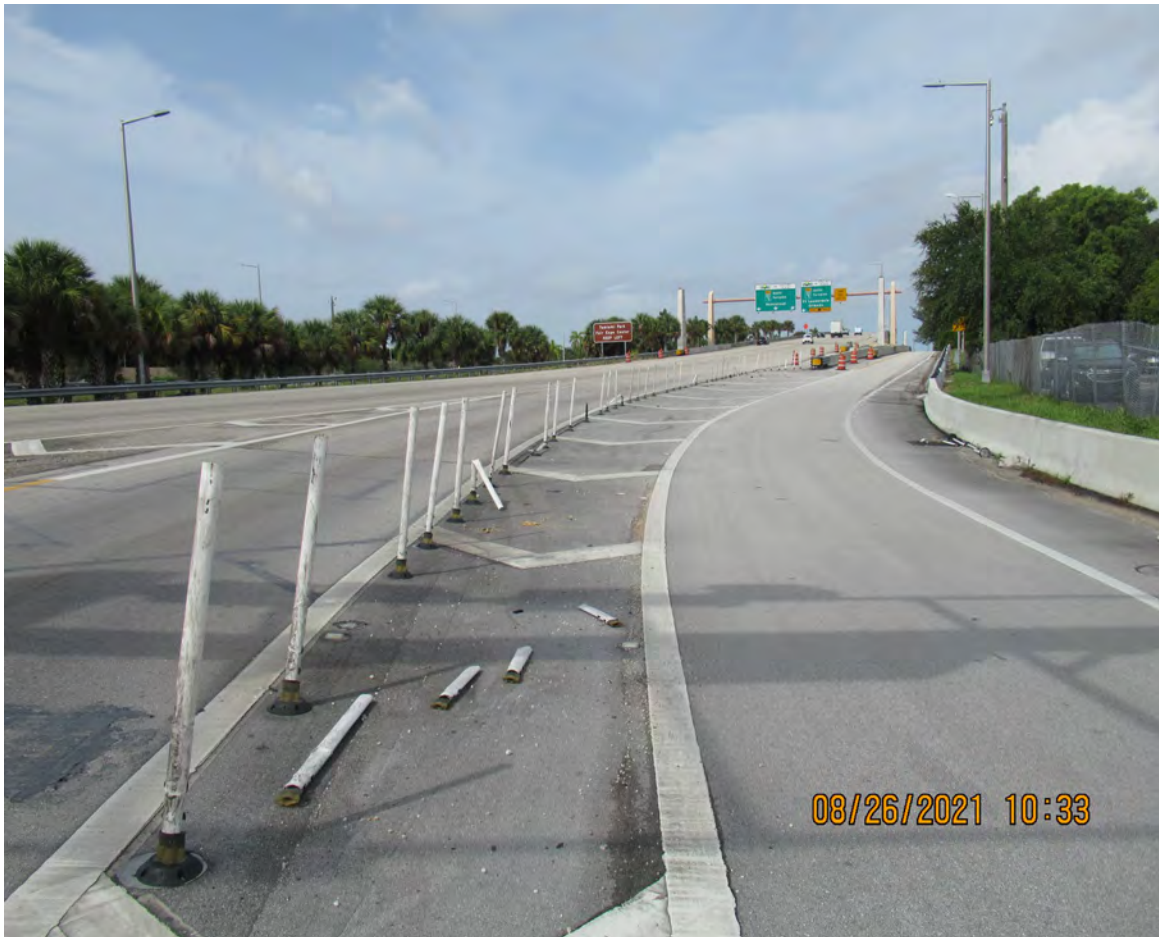
**PHOTO NO.: WB-042
DATE: 8-26-2021**

DAMAGED / MISSING DELINIATORS

ITEM NOTED TO BE ADDRESSED BY MDX MAINTENANCE

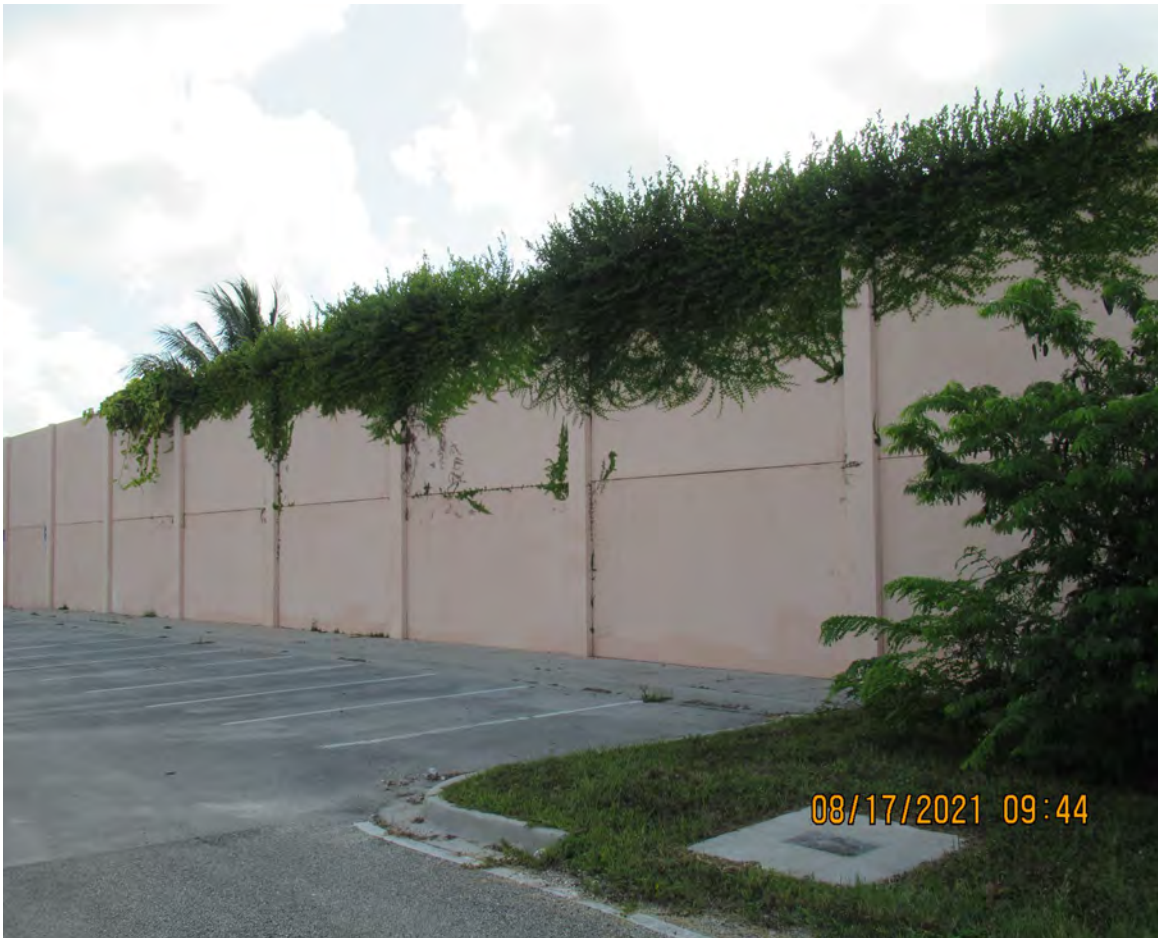
**PHOTO NO.: NB-002
DATE: 8-17-2021**

**OVERGROWN VEGETATION ON SOUND WALL
(TYPICAL AT VARIOUS LOCATIONS THROUGHOUT THE CORRIDOR)**

ITEM NOTED TO BE ADDRESSED BY MDX MAINTENANCE

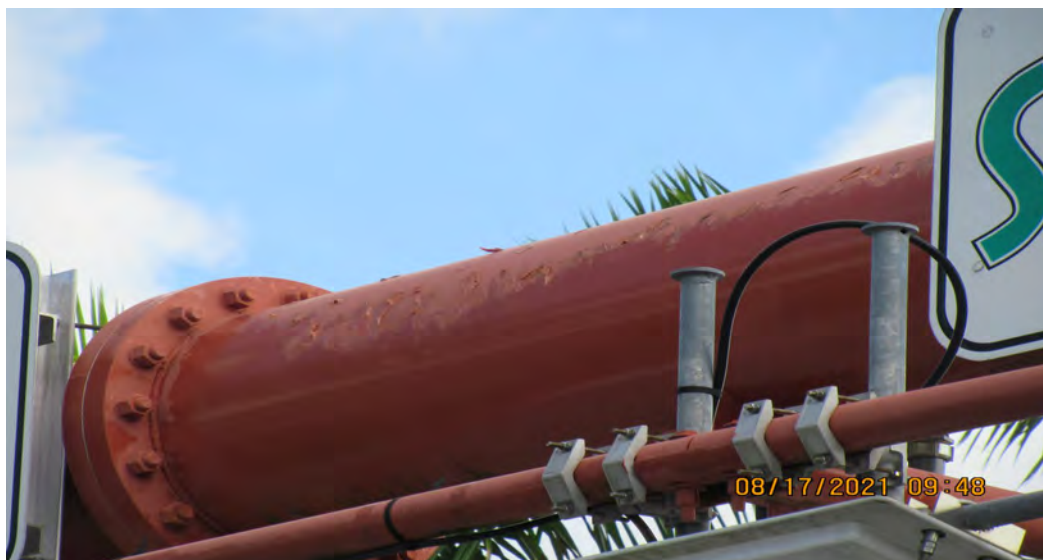
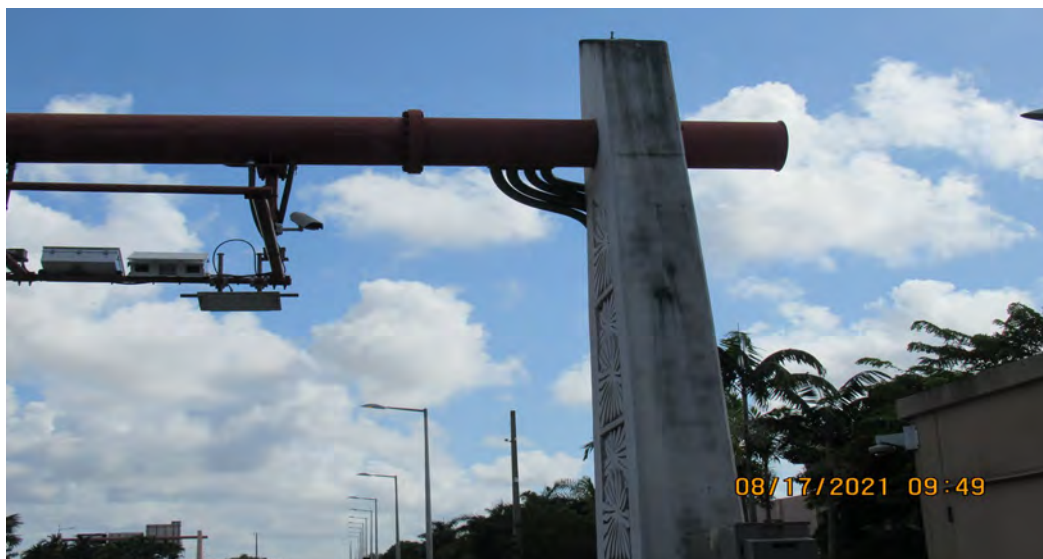
**PHOTO NO.: NB-003
DATE: 8-17-2021**

**DETERIORATED PAINT ON ORT MONOTUBE AND CLASS V COATING (STRUCTURE
87S937) (TYPICAL THROUGHOUT THE CORRIDOR)**

ITEM NOTED TO BE ADDRESSED BY MDX WORK PROGRAM No. 30037 & 30047

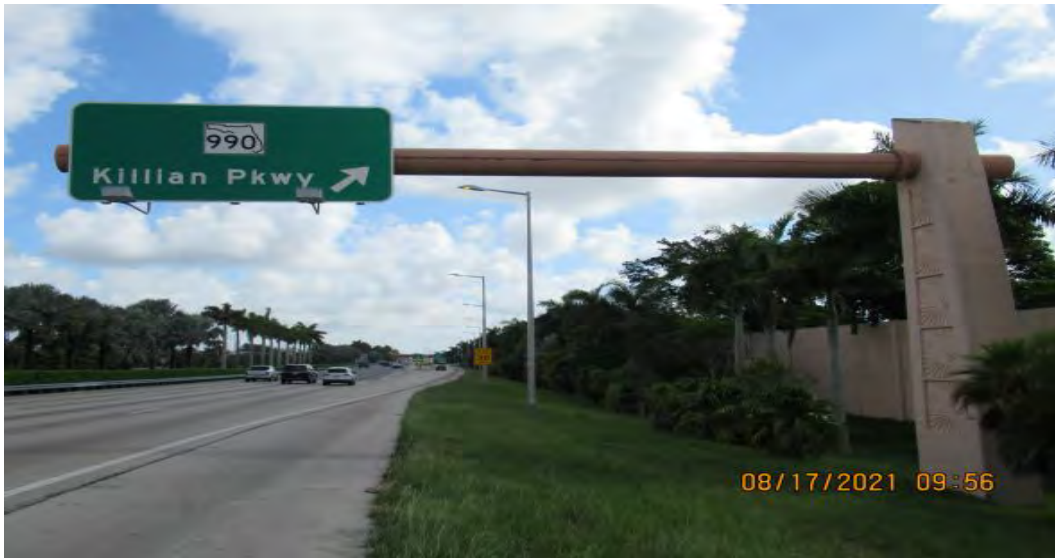
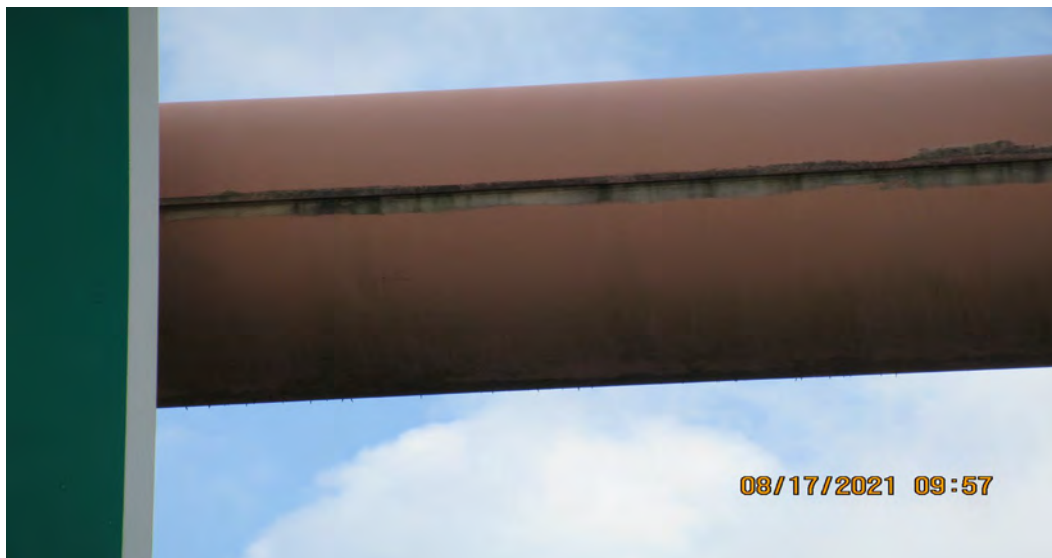
**PHOTO NO.: NB-006
DATE: 8-17-2021**

**DETERIORATED PAINT ON MONOTUBE (STRUCTURE # 87A048)
(TYPICAL THROUGHOUT THE CORRIDOR)**

ITEM NOTED TO BE ADDRESSED BY MDX WORK PROGRAM No. 30047

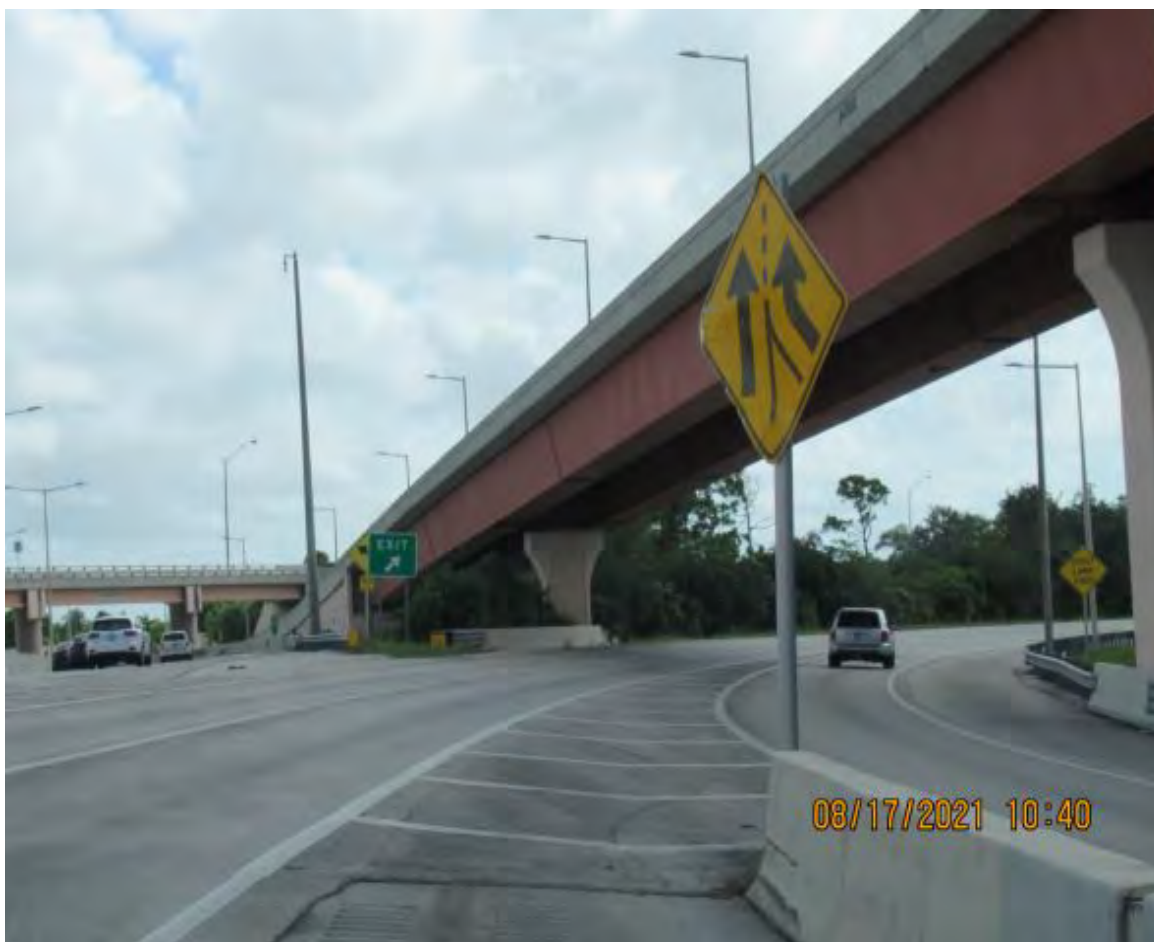
**PHOTO NO.: NB-011
DATE: 8-17-2021**

TWISTED / DAMAGED SIGN PANEL

ITEM NOTED TO BE ADDRESSED BY MDX MAINTENANCE

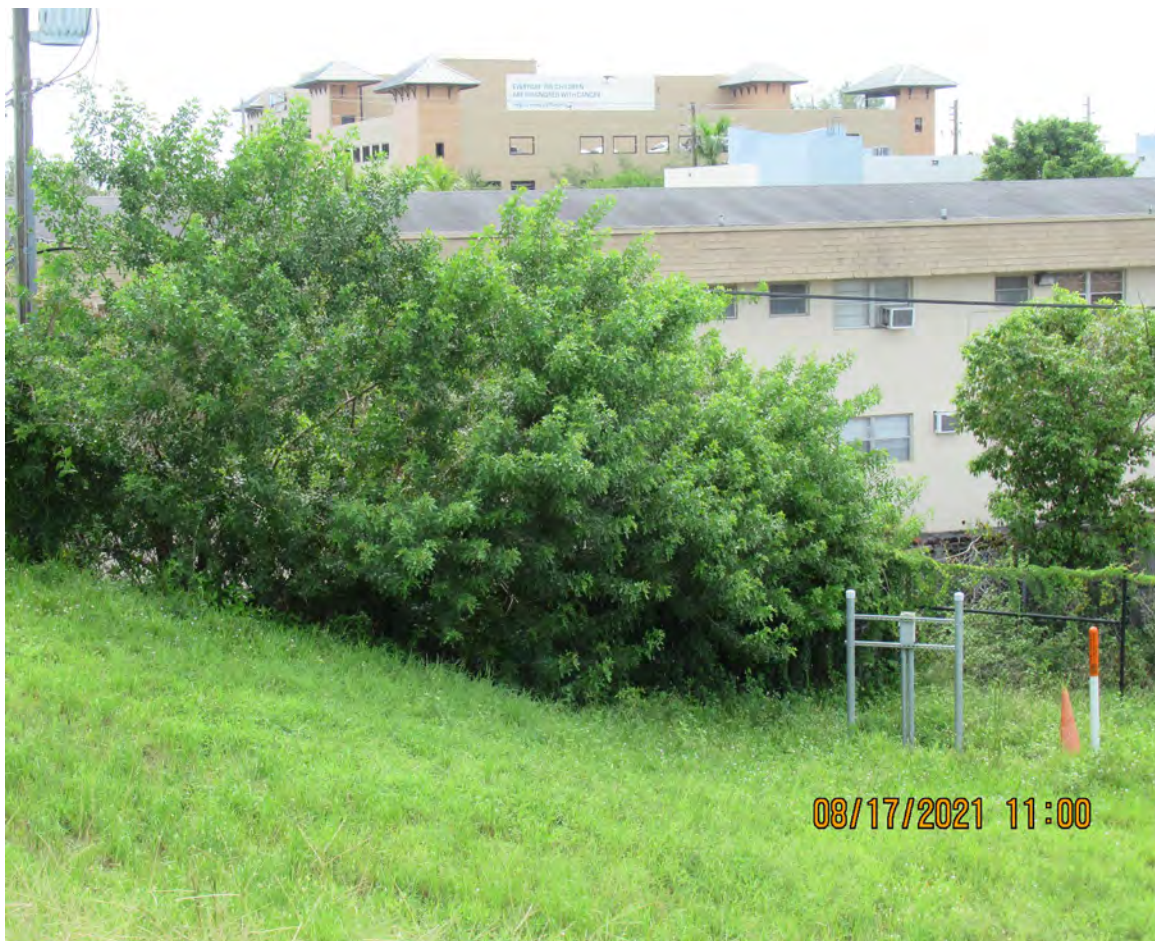
**PHOTO NO.: NB-015
DATE: 8-17-2021**

OVERGRWON VEGETATION ON FENCE

ITEM NOTED TO BE ADDRESSED BY MDX MAINTENANCE
