Annual Inspection Report 2021

General Engineering Consultant to the
Miami-Dade County Expressway Authority

ANNUAL INSPECTION REPORT 2021

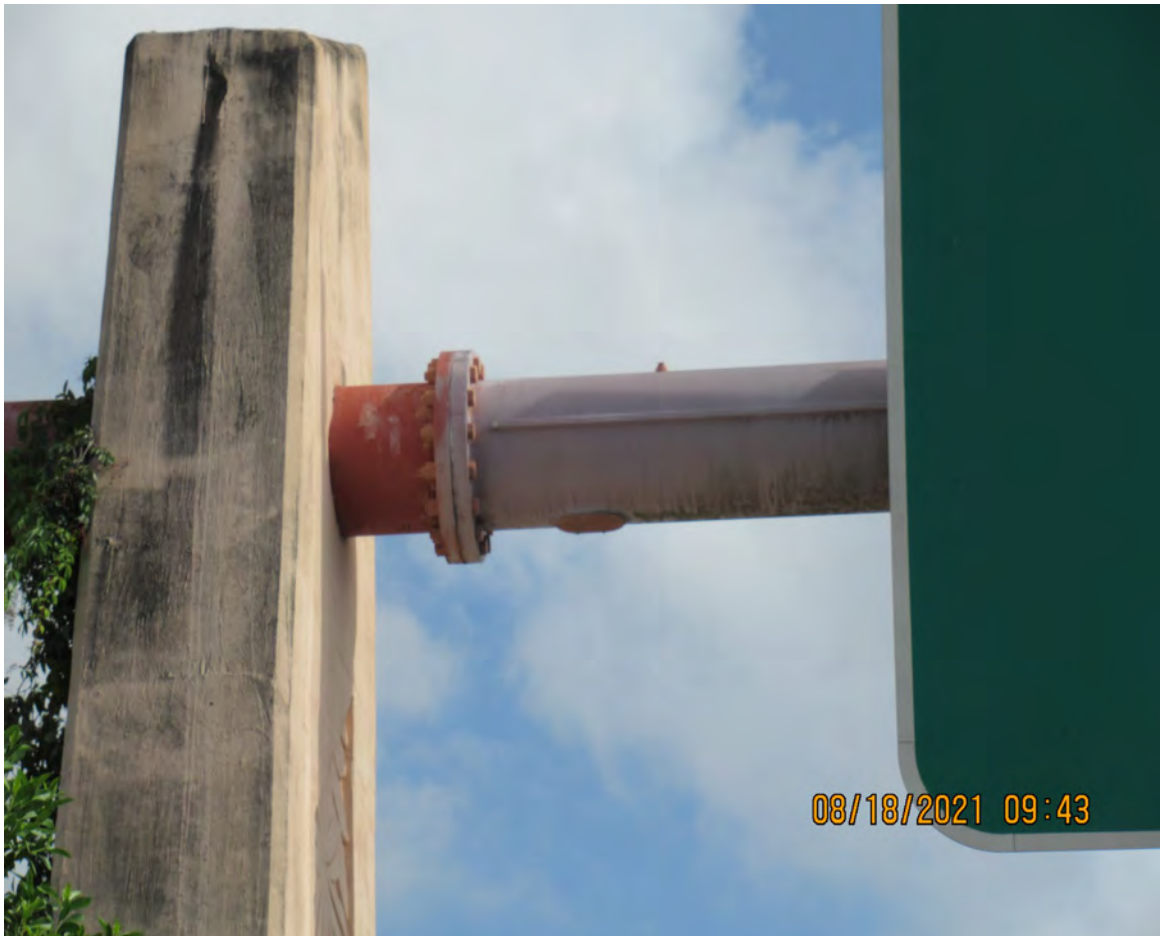
**PHOTO NO.: NB-016
DATE: 8-18-2021**

**DETERIORATED PAINT ON MONOTUBE AND CLASS V COATING ON STRUCTURE
UPRIGHTS (STRUCTURE # 87S897)**

ITEM NOTED TO BE ADDRESSED BY MDX MAINTENANCE

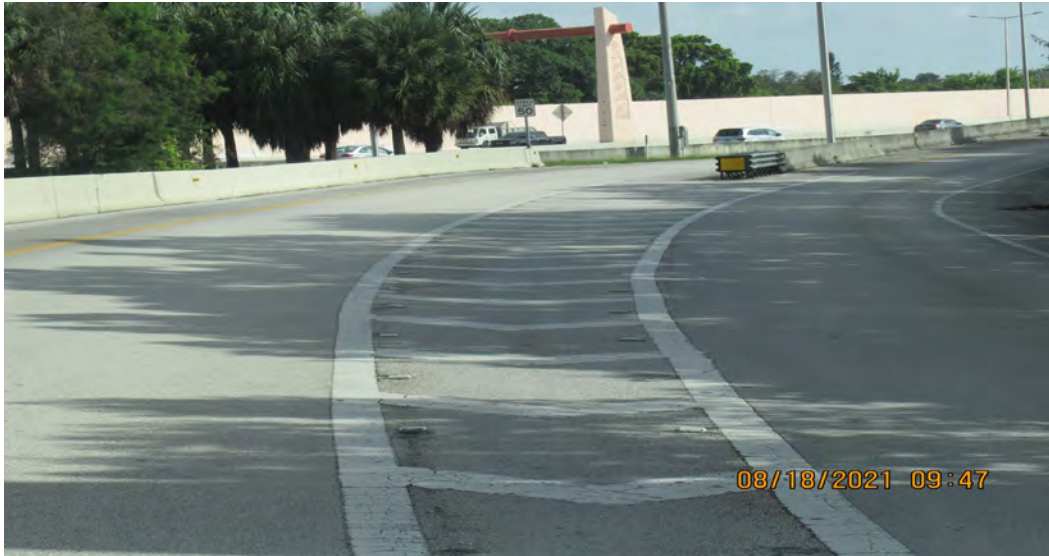
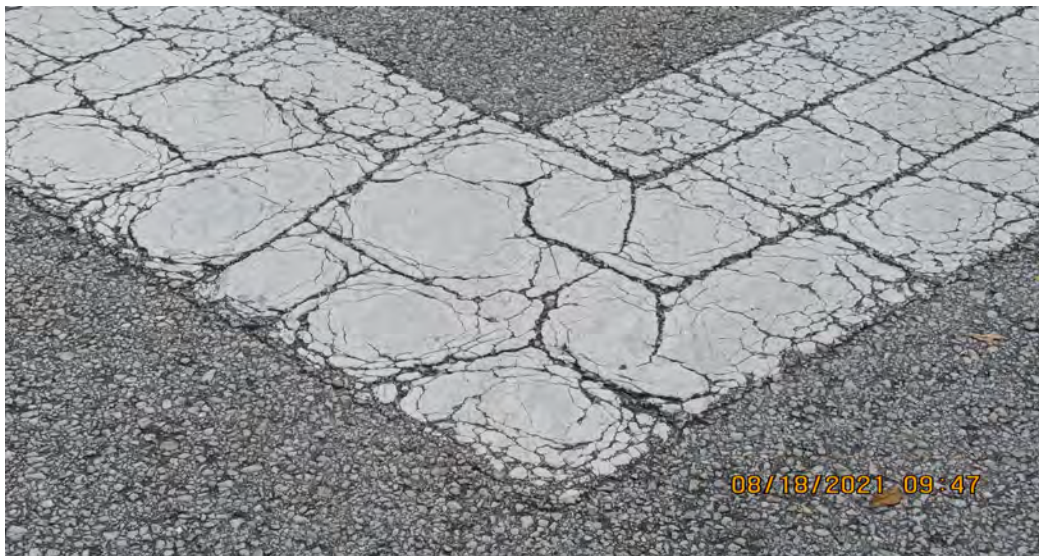
**PHOTO NO.: NB-017
DATE: 8-18-2021**

DETERIORATED THERMOPLASTIC STRIPING ON GORE AREA

ITEM NOTED TO BE ADDRESSED BY MDX MAINTENANCE

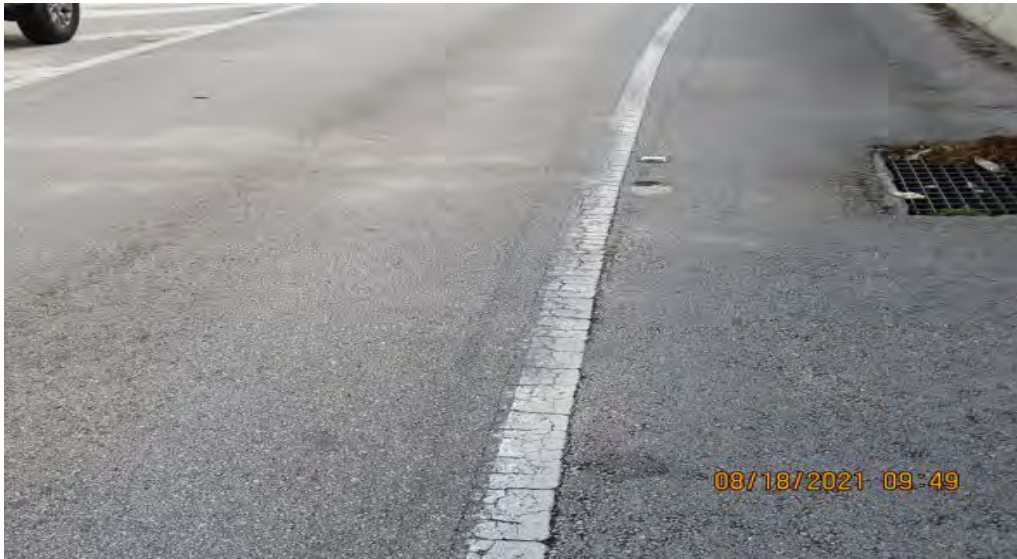
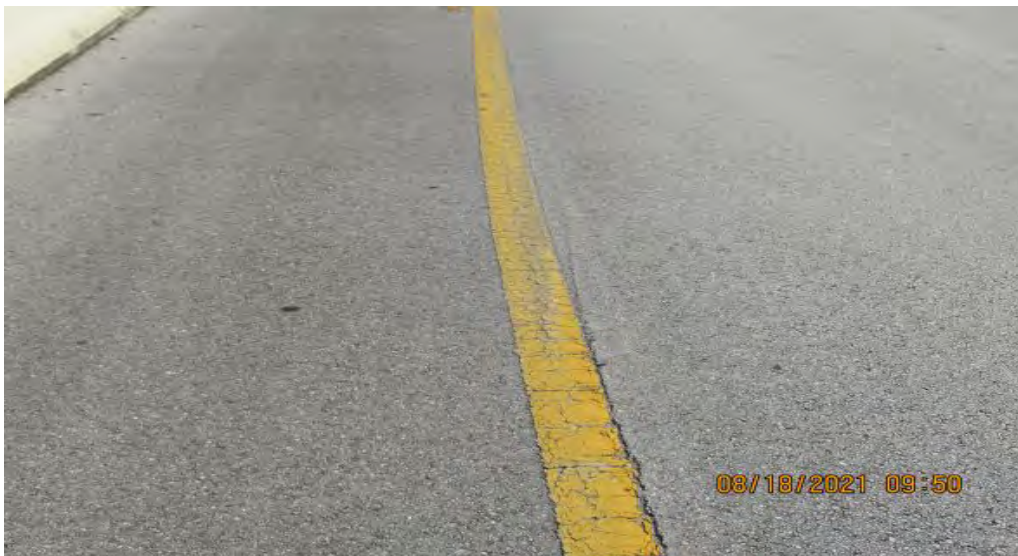
**PHOTO NO.: NB-018
DATE: 8-18-2021**

DETERIORATED THERMOPLASTIC STRIPING

ITEM NOTED TO BE ADDRESSED BY MDX MAINTENANCE

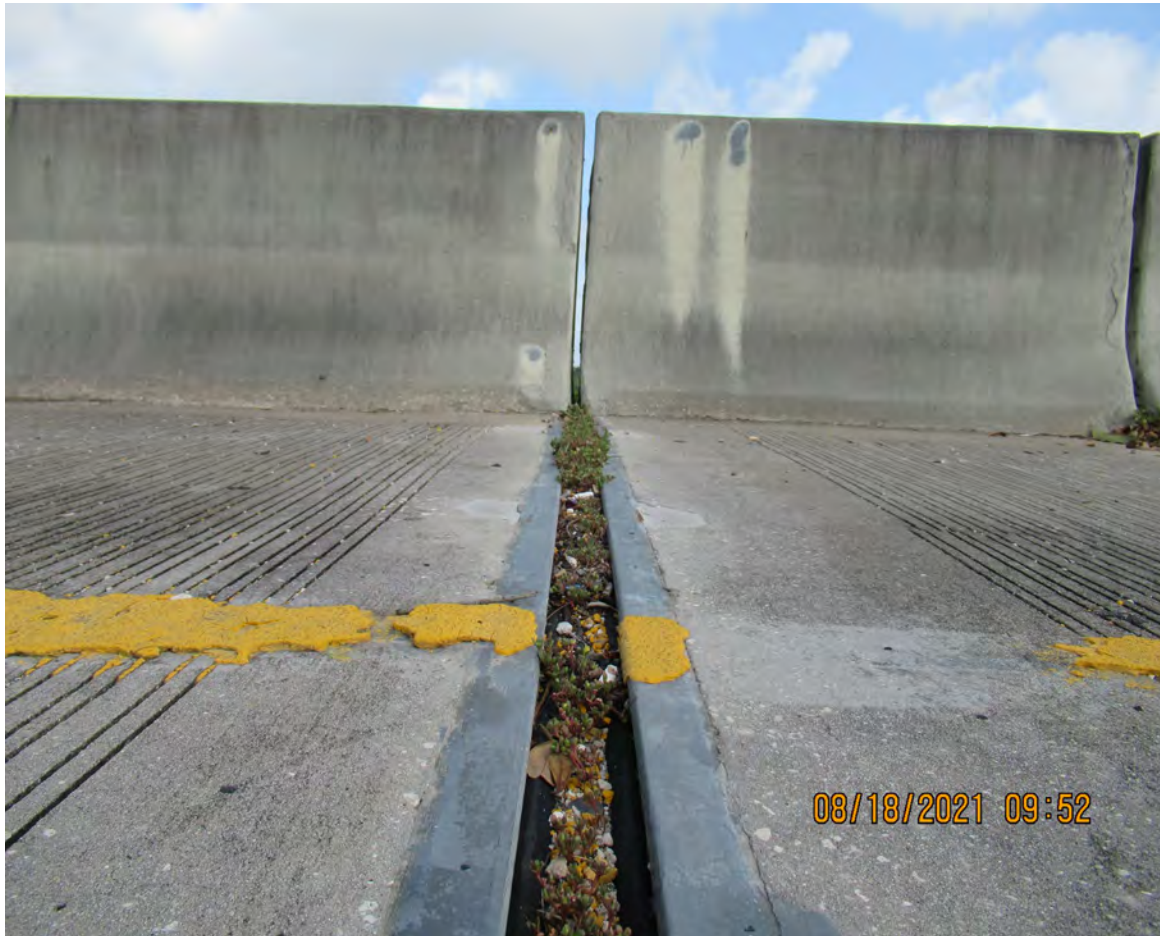
**PHOTO NO.: NB-019
DATE: 8-18-2021**

DEBRIS ON BRIDGE JOINT (BRIDGE # 871024)

ITEM NOTED TO BE ADDRESSED BY MDX MAINTENANCE

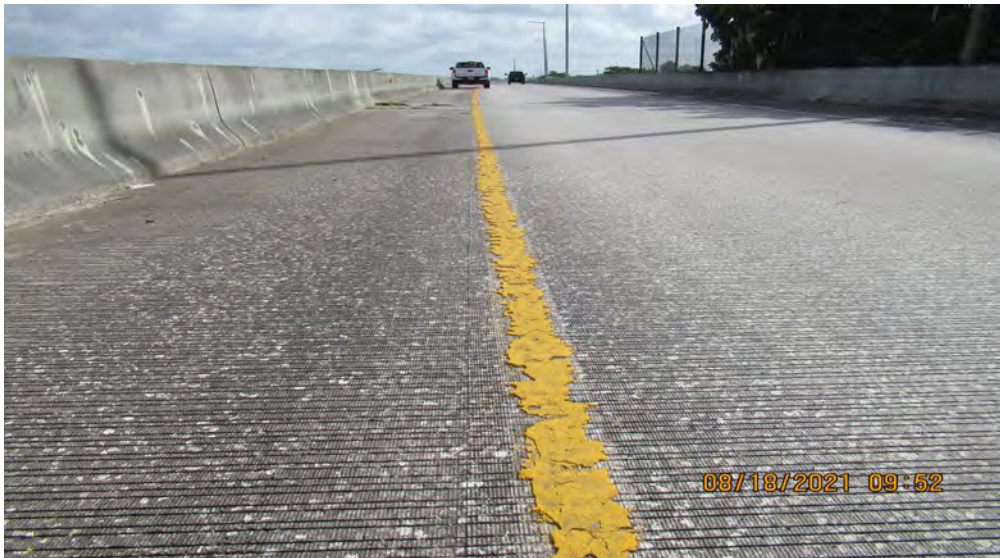
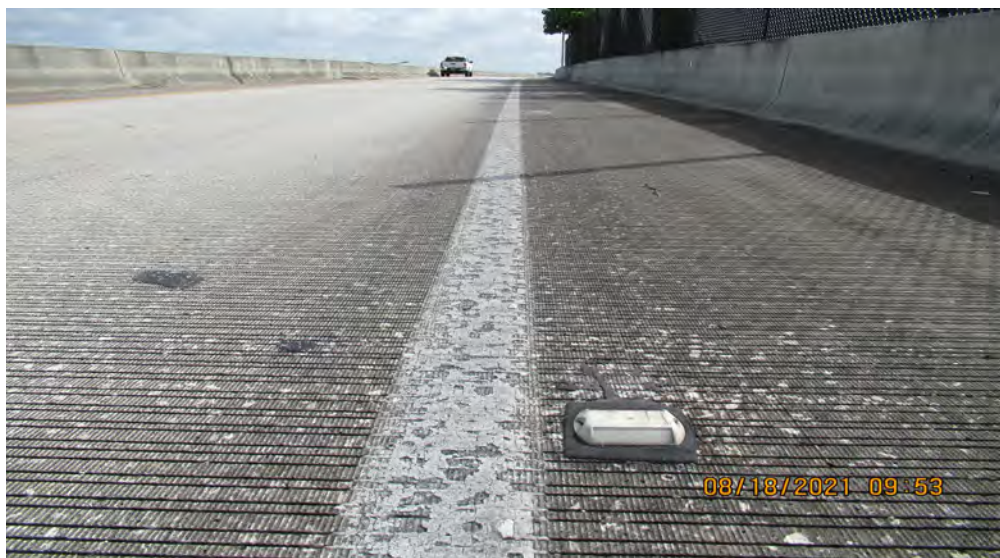
**PHOTO NO.: NB-020
DATE: 8-18-2021**

**DETERIORATED THERMOPLASTIC STRIPING ON
(BRIDGE # 871024)**

ITEM NOTED TO BE ADDRESSED BY MDX MAINTENANCE

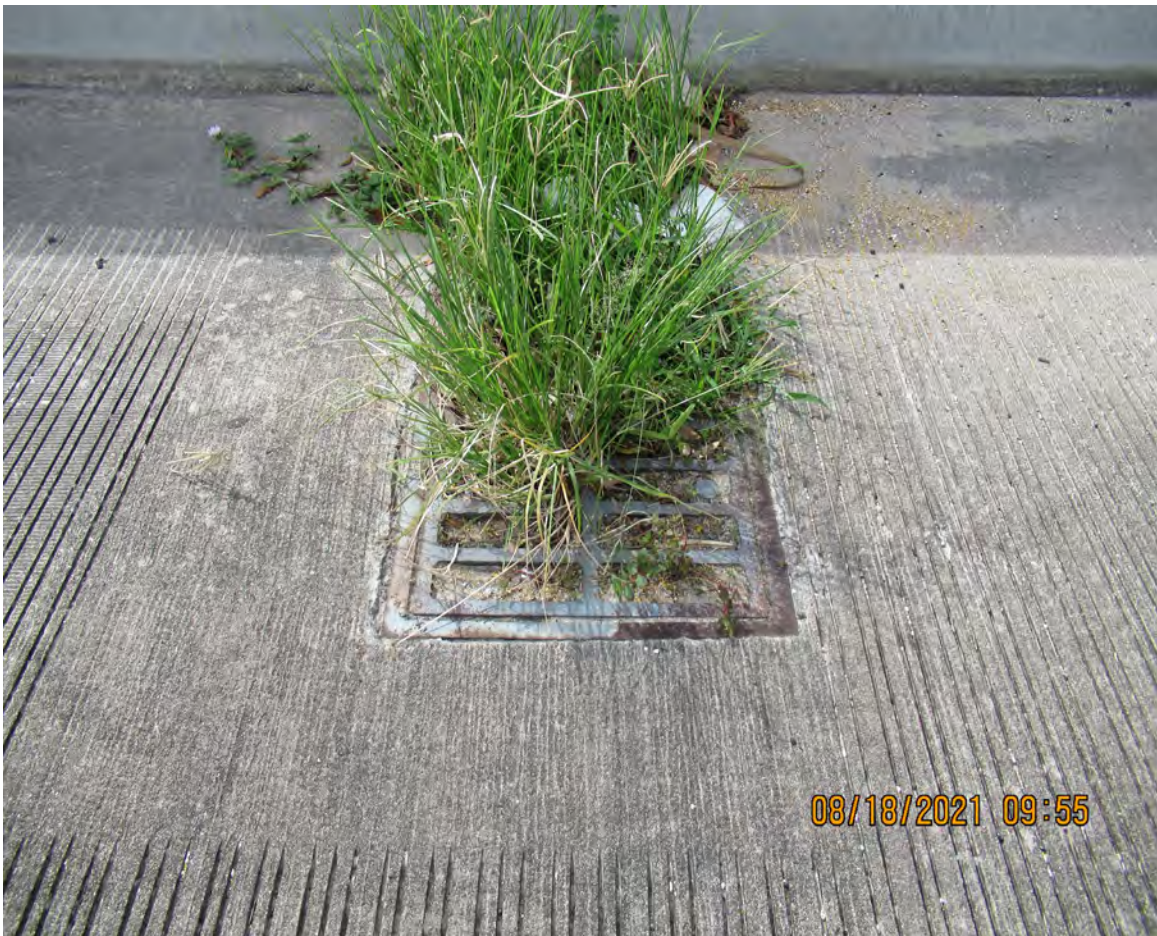
**PHOTO NO.: NB-021
DATE: 8-18-2021**

**SILTED BRIDGE DRAINAGE (BRIDGE # 871024)
(TYPICAL THROUGHOUT THE BRIDGE)**

ITEM NOTED TO BE ADDRESSED BY MDX MAINTENANCE

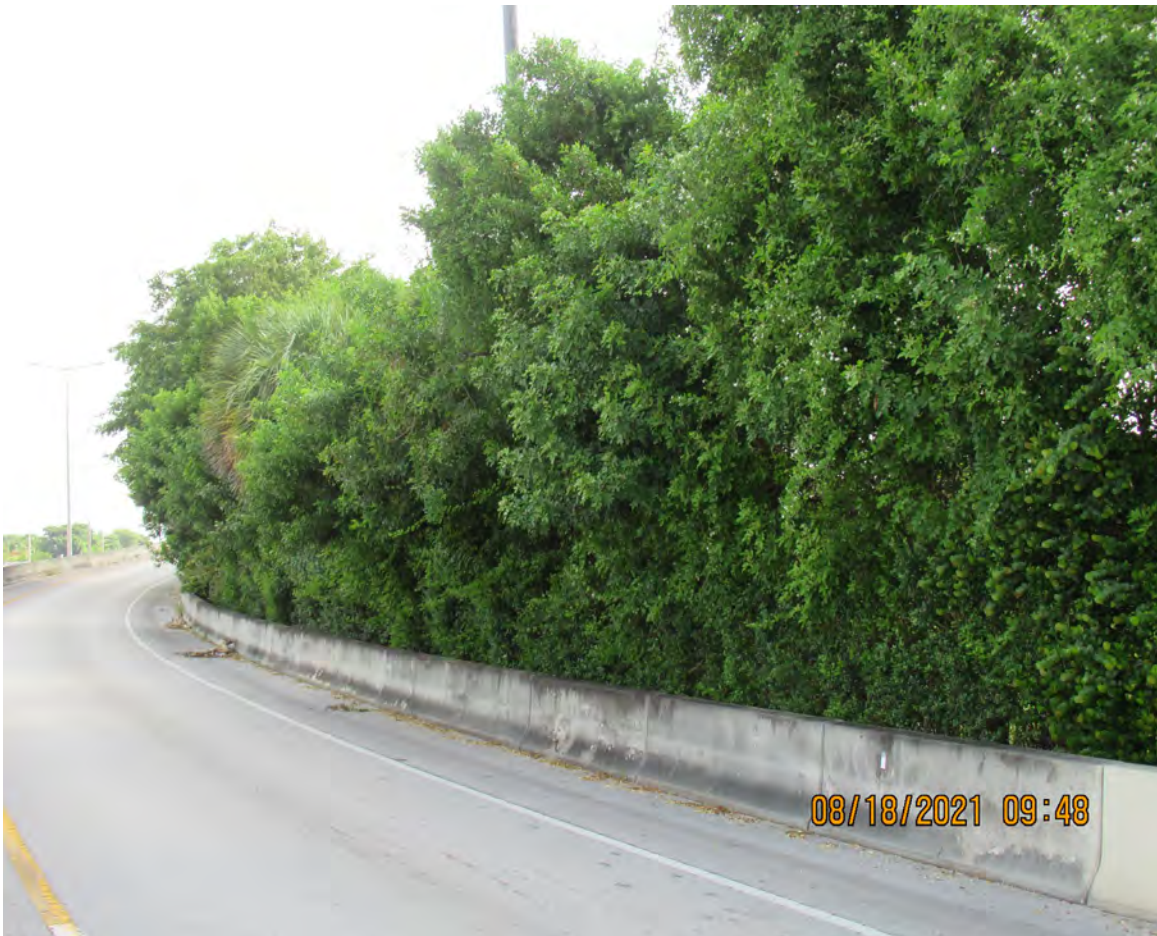
**PHOTO NO.: NB-022
DATE: 8-18-2021**

OVERGROWN VEGETATION ON SHOULDER

ITEM NOTED TO BE ADDRESSED BY MDX MAINTENANCE

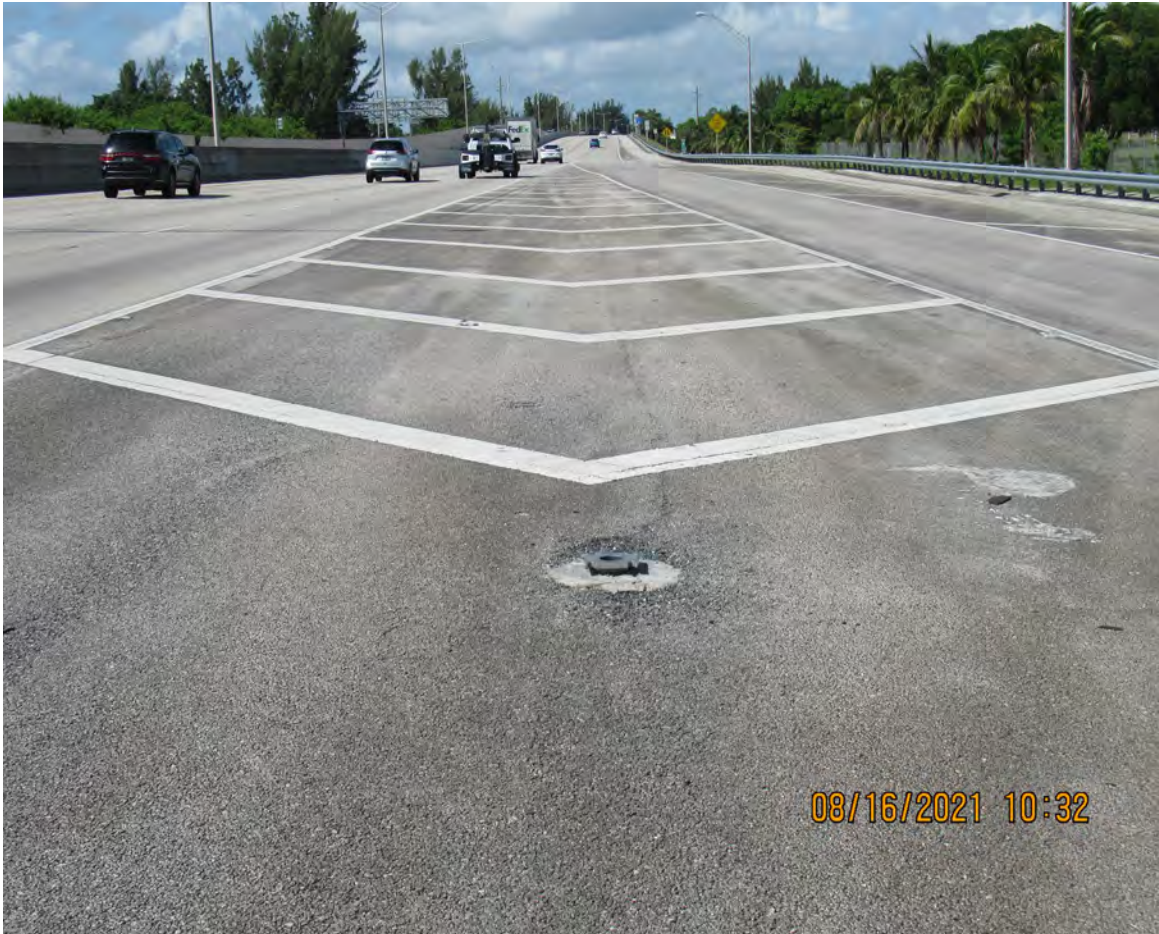
**PHOTO NO.: SB-001
DATE: 8-16-2021**

MISSING MERGE SIGN

ITEM NOTED TO BE ADDRESSED BY MDX MAINTENANCE

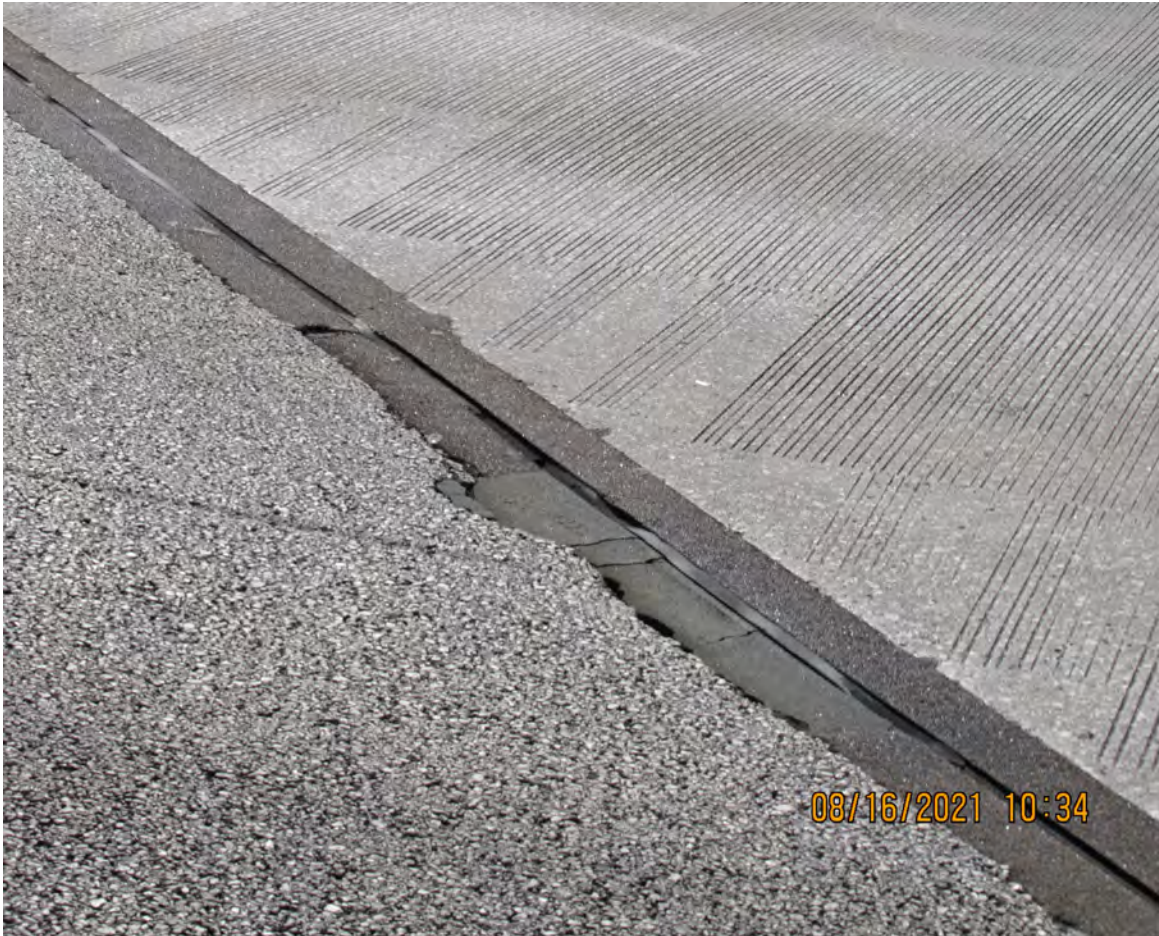
**PHOTO NO.: SB-002
DATE: 8-16-2021**

DETERIORATED POLYMER NOSING BRIDGE JOINT HEADER (BRIDGE # 870522)

ITEM NOTED TO BE ADDRESSED BY MDX WORK PROGRAM No. 30029

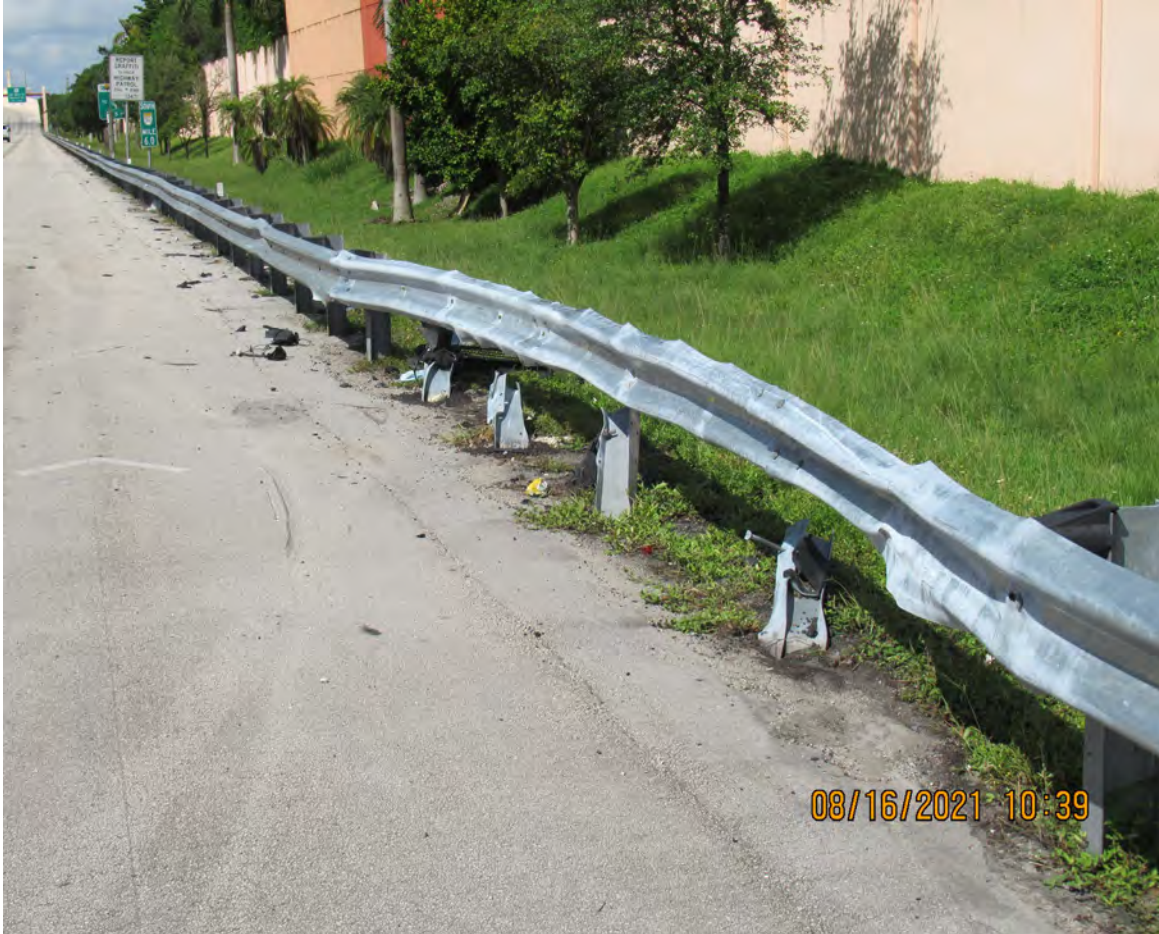
**PHOTO NO.: SB-003
DATE: 8-16-2021**

DAMAGED GUARDRAIL

ITEM NOTED TO BE ADDRESSED BY MDX MAINTENANCE

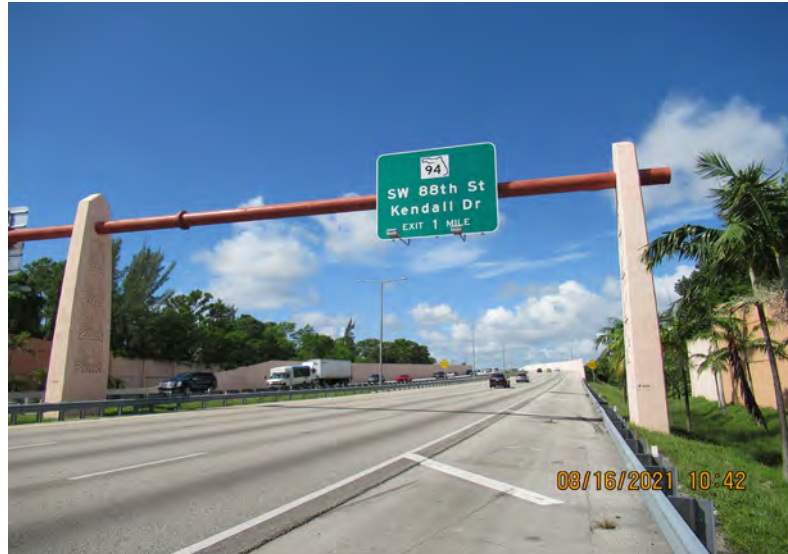
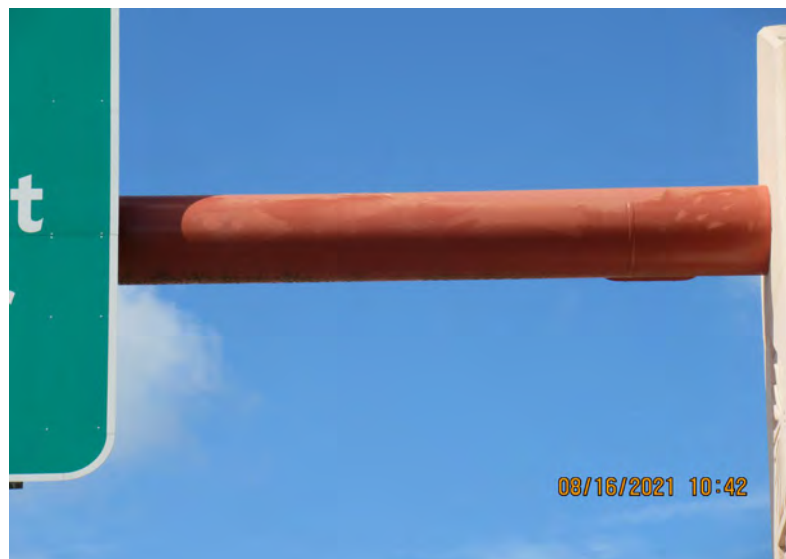
**PHOTO NO.: SB-004
DATE: 8-16-2021**

**DETERIORATED PAINT ON MONOTUBE (STRUCTURE# 87A134)
(TYPICAL THROUGHOUT THE CORRIDOR)**

ITEM NOTED TO BE ADDRESSED BY MDX WORK PROGRAM No. 30043

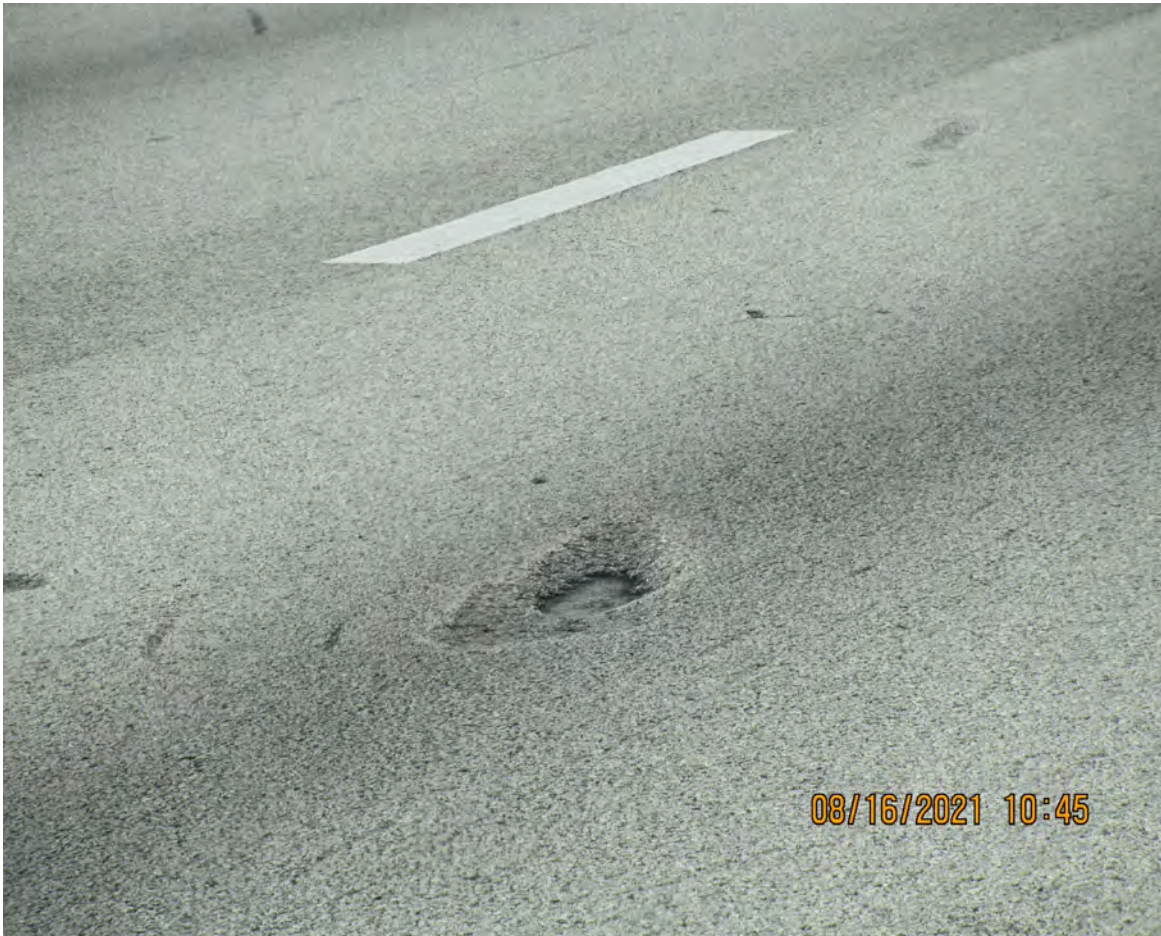
**PHOTO NO.: SB-005
DATE: 8-16-2021**

DAMAGED PAVEMENT

ITEM NOTED TO BE ADDRESSED BY MDX MAINTENANCE

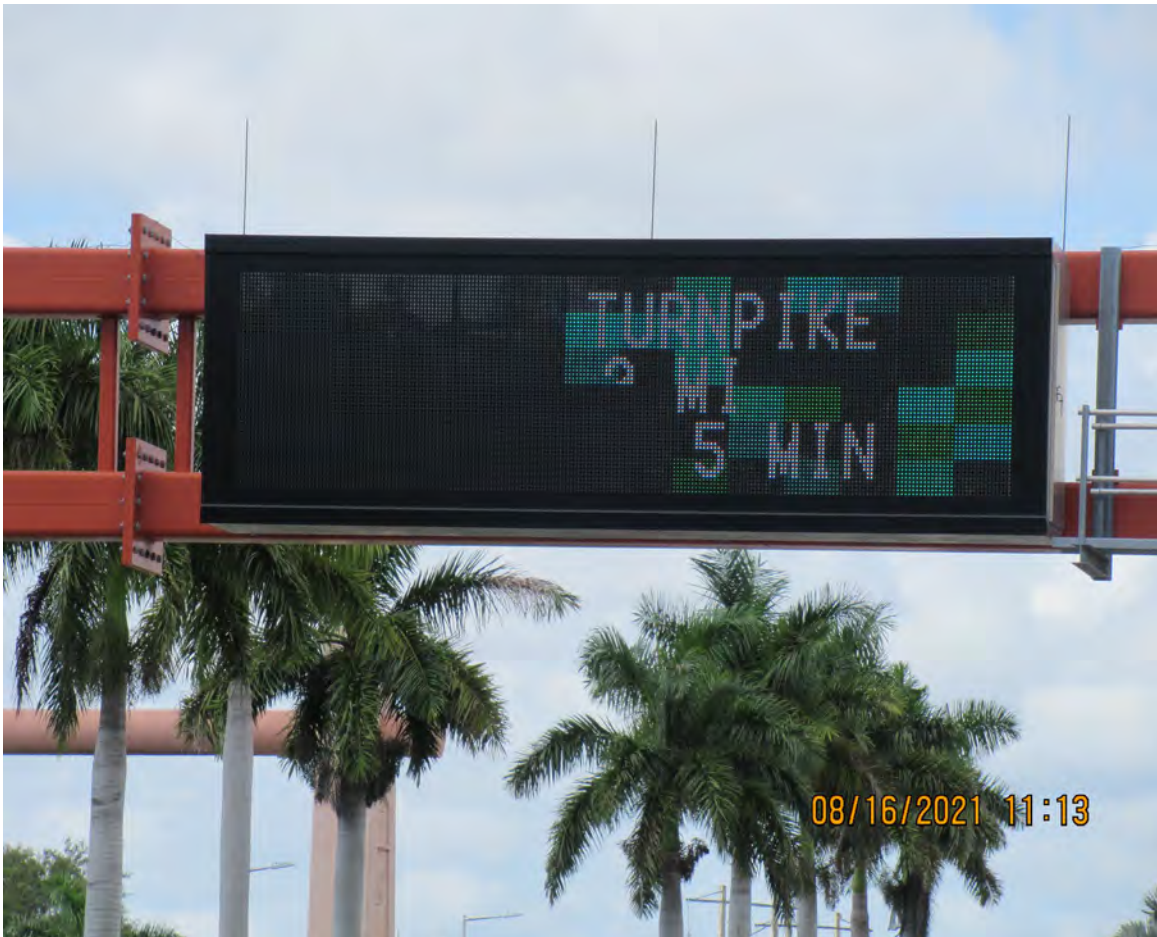
**PHOTO NO.: SB-006
DATE: 8-16-2021**

MALFUNCTIONING DMS SIGN (STRUCTURE # 87A327)

ITEM NOTED TO BE ADDRESSED BY MDX ITS

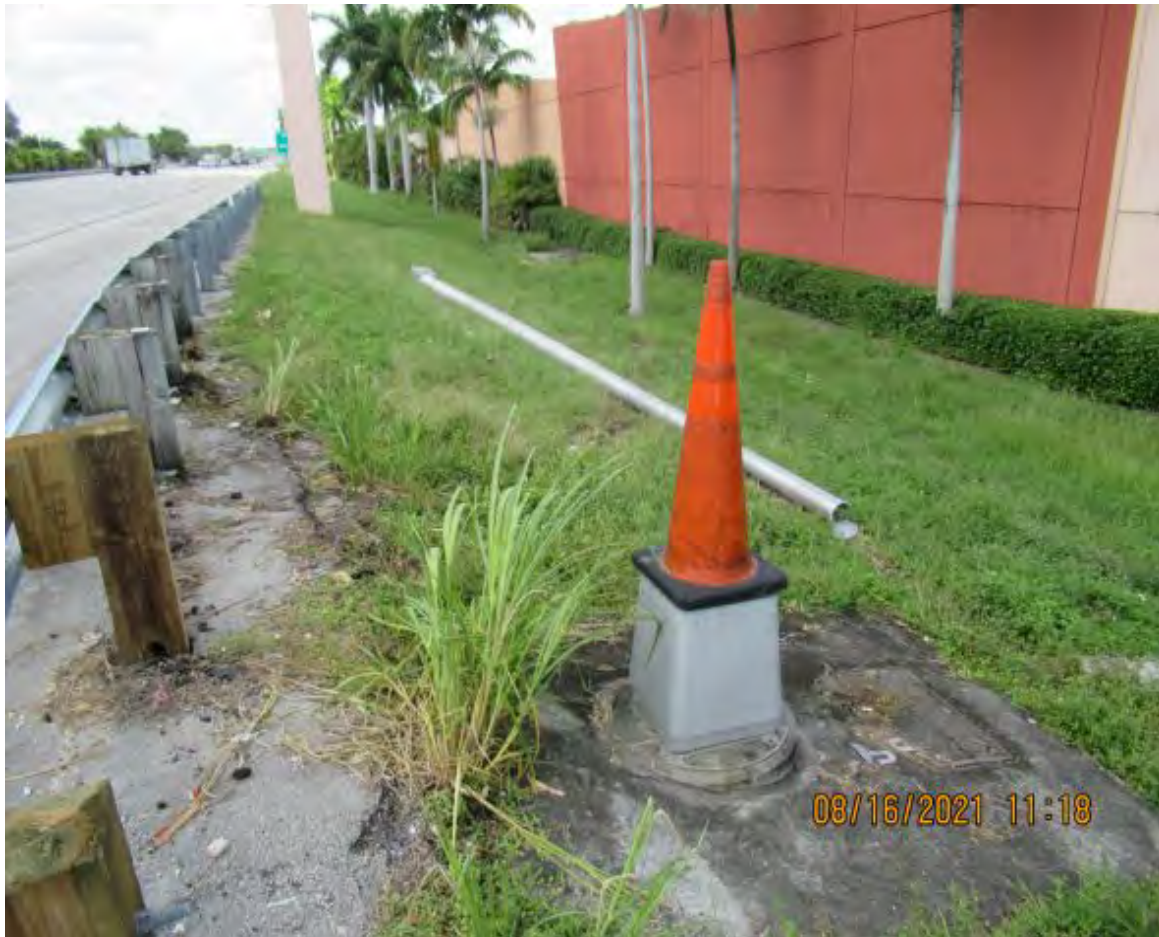
**PHOTO NO.: SB-007
DATE: 8-16-2021**

DAMAGED LIGHT POLE DUE TO VEHICULAR ACCIDENT (POLE # 02-74 16)

ITEM NOTED TO BE ADDRESSED BY MDX MAINTENANCE

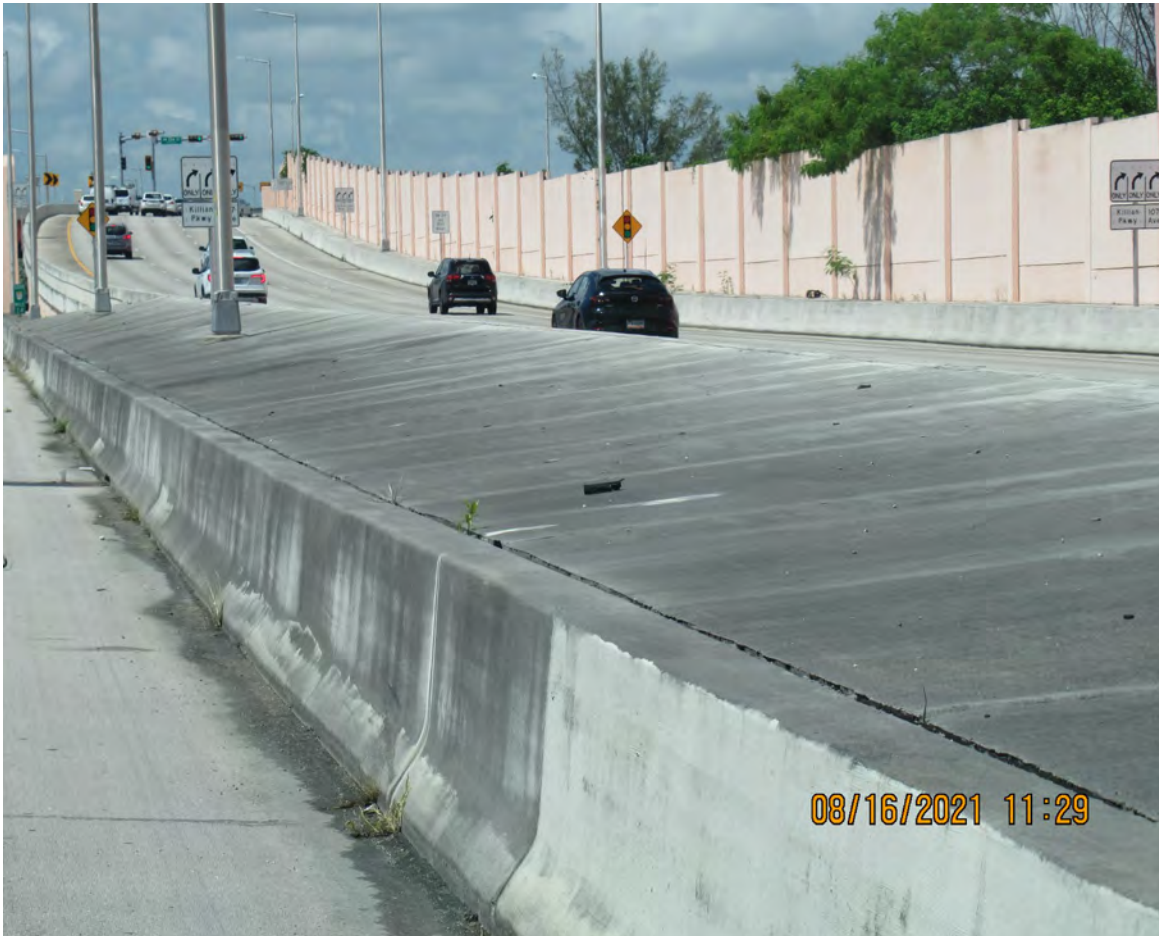
**PHOTO NO.: SB-010
DATE: 8-16-2021**

DETERIORATED CLASS V COATING ON CONCRETE MEDIAN

ITEM NOTED TO BE ADDRESSED BY MDX WORK PROGRAM NO. 30037

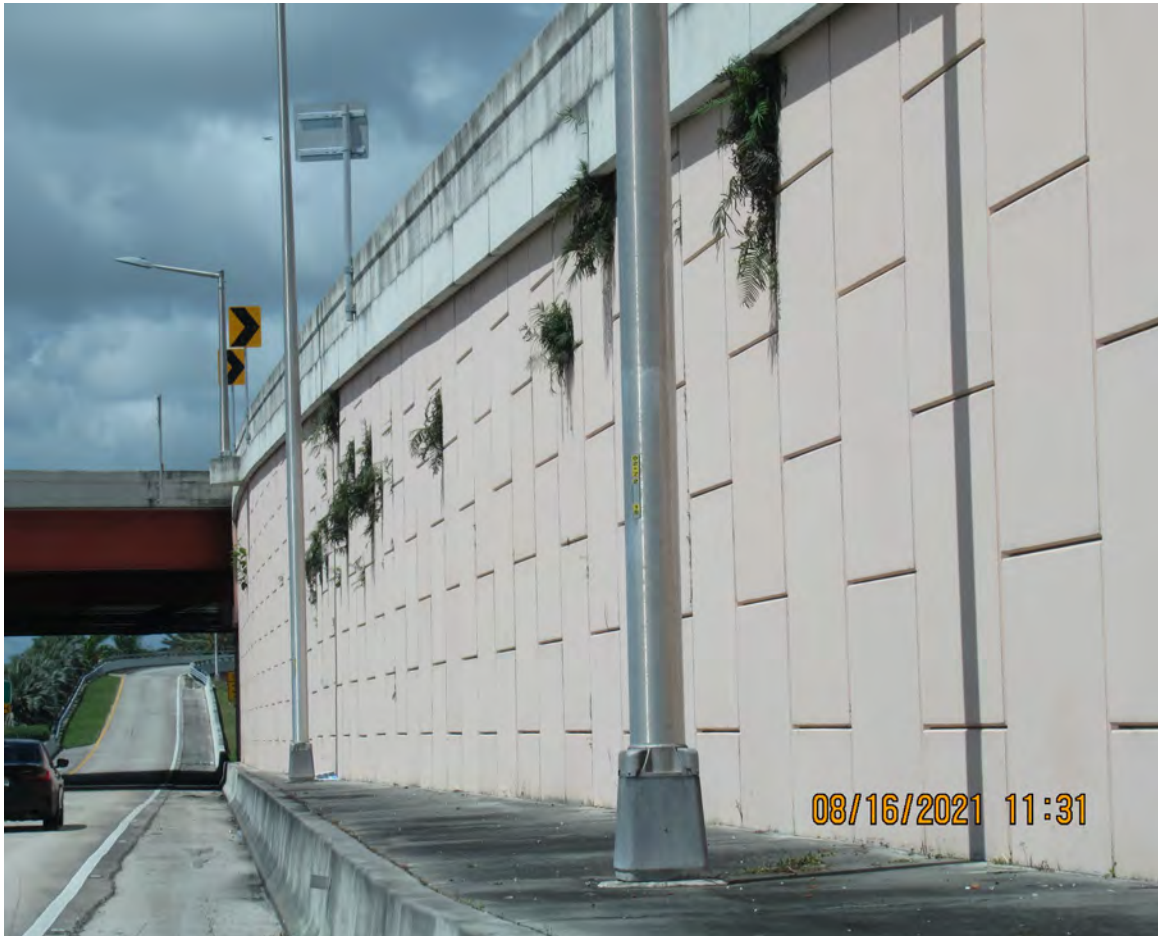
**PHOTO NO.:
SB-011 DATE:
8-16-2021**

OVERGROWN VEGETATION ON MSE WALL

ITEM NOTED TO BE ADDRESSED BY MDX MAINTENANCE

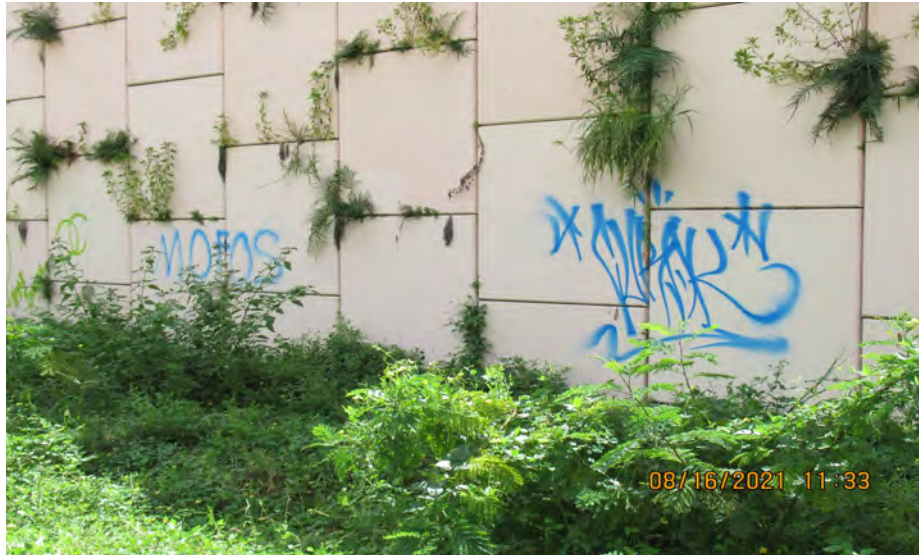
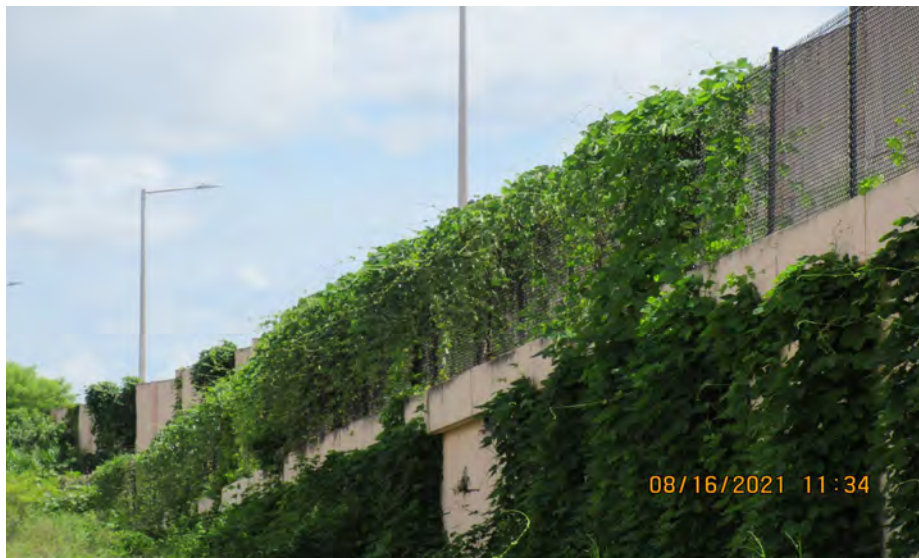
**PHOTO NO.:
SB-012 DATE:
8-16-2021**

OVERGROWN VEGETATION & GRAFFITI ON MSE WALL

ITEM NOTED TO BE ADDRESSED BY MDX MAINTENANCE

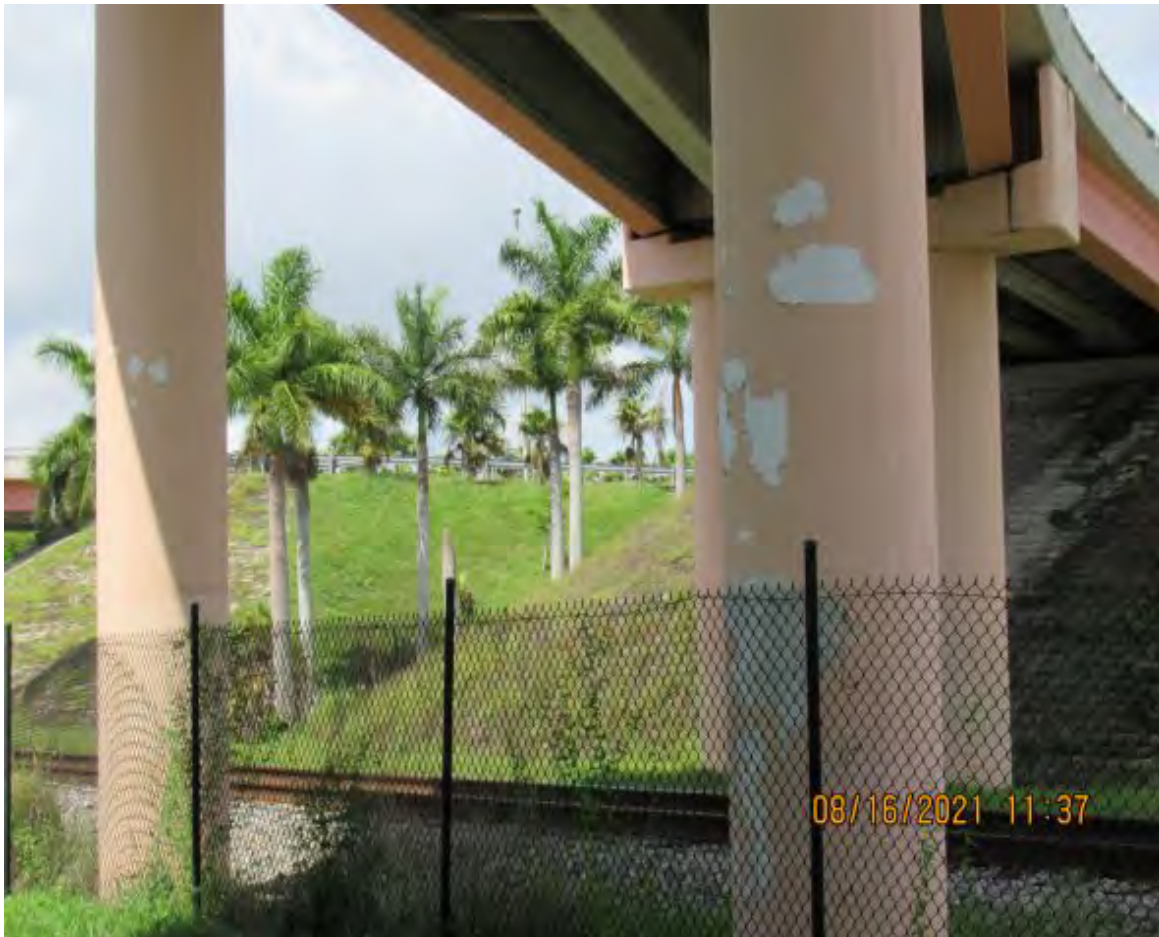
**PHOTO NO.: SB-013
DATE: 8-16-2021**

DETERIORATED CLASS V COATING ON BRIDGE COLUMNS (BRIDGE # 870543)

ITEM NOTED TO BE ADDRESSED BY MDX WORK PROGRAM No. 30037

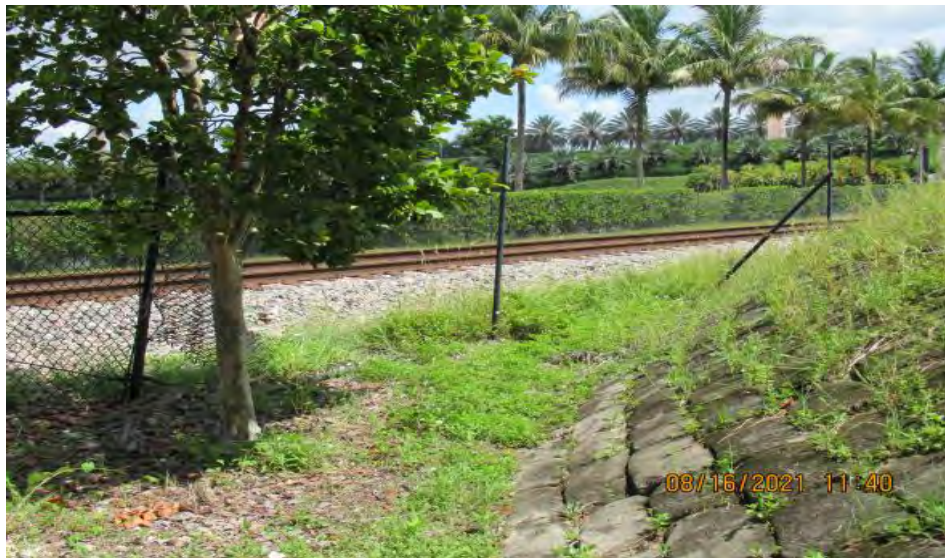
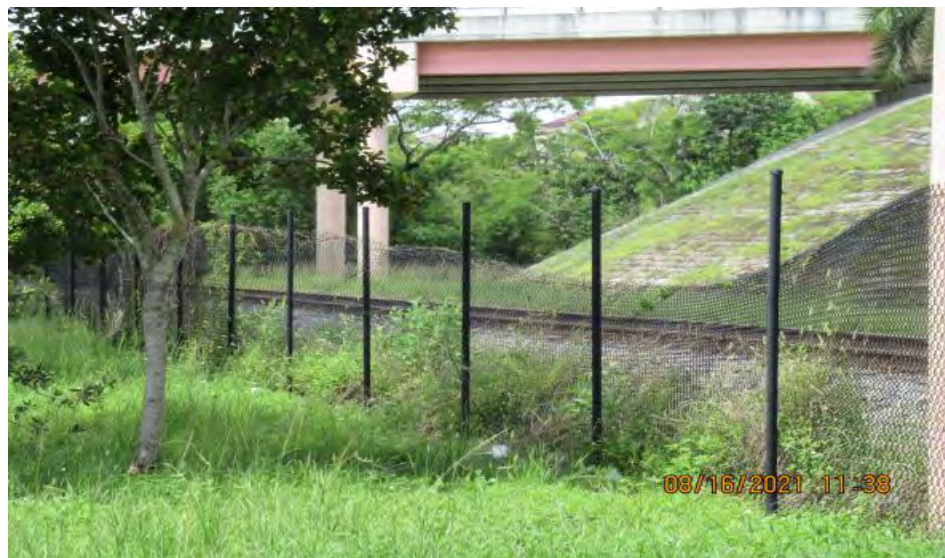
**PHOTO NO.: SB-014
DATE: 8-16-2021**

DAMAGED FENCE

ITEM NOTED TO BE ADDRESSED BY MDX MAINTENANCE

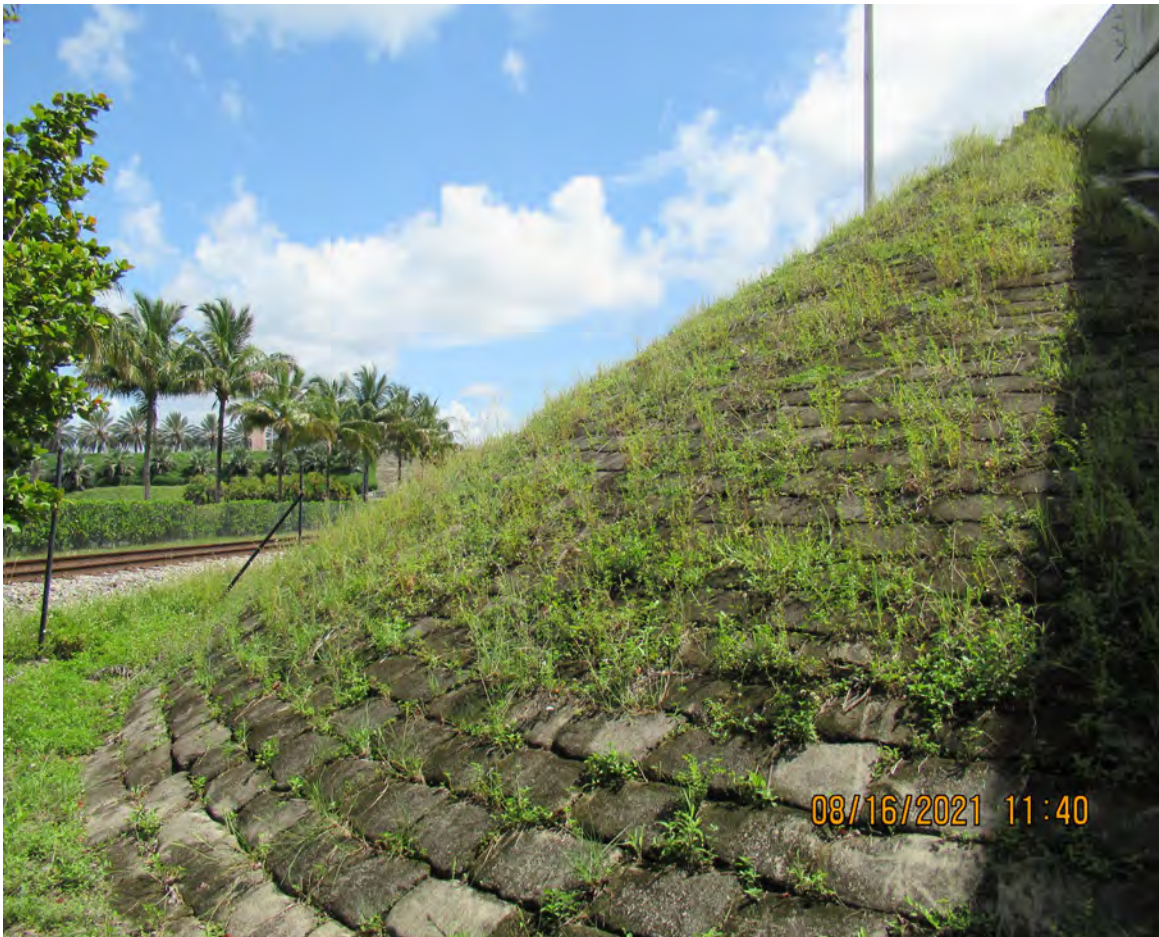
**PHOTO NO.: SB-015
DATE: 8-16-2021**

OVERGROWN VEGETATION ON BRIDGE SLOPE PAVEMENT

ITEM NOTED TO BE ADDRESSED BY MDX MAINTENANCE
