Annual Inspection Report 2021

General Engineering Consultant to the
Miami-Dade County Expressway Authority

ANNUAL INSPECTION REPORT 2021

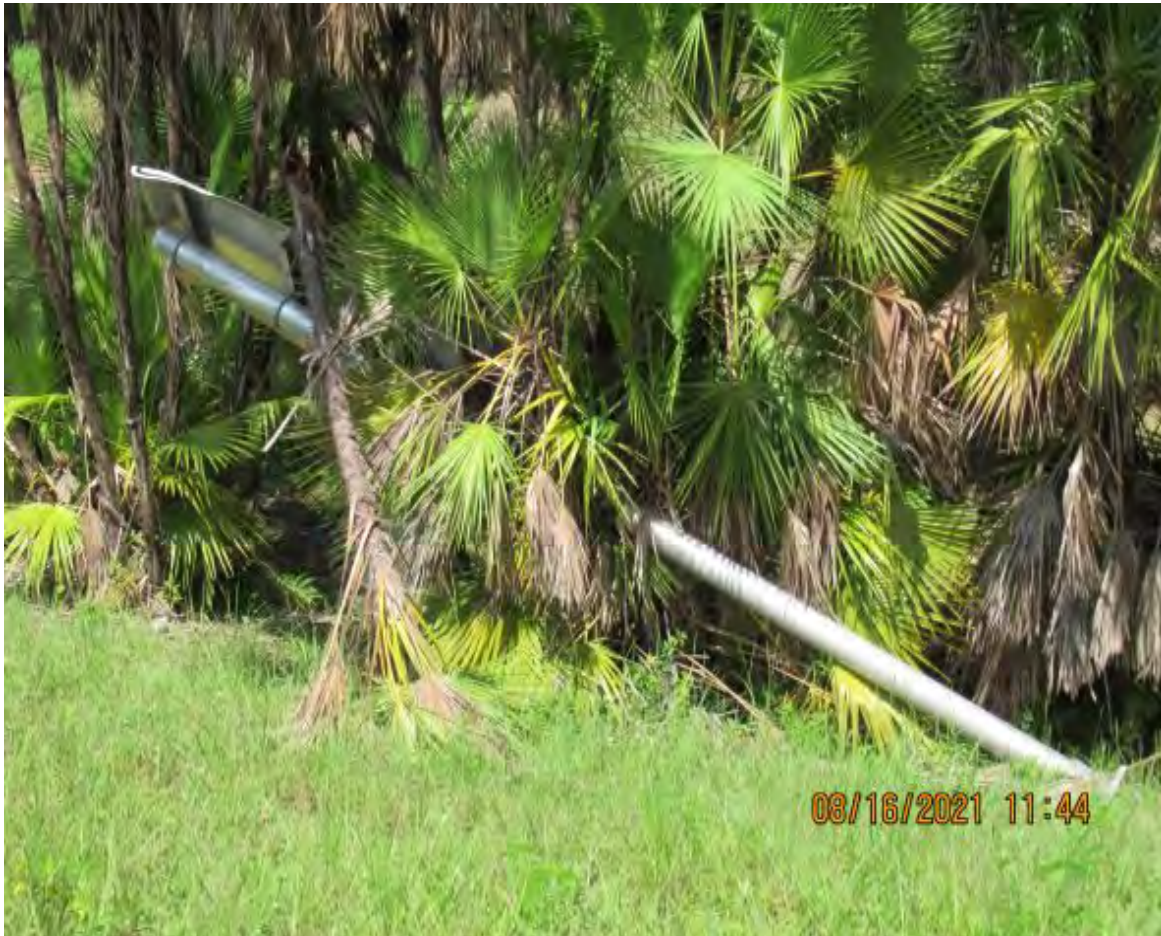
**PHOTO NO.: SB-016
DATE: 8-16-2021**

DAMAGED SINGLE POST SIGN DUE TO VEHICULAR ACCIDENT

ITEM NOTED TO BE ADDRESSED BY MDX MAINTENANCE

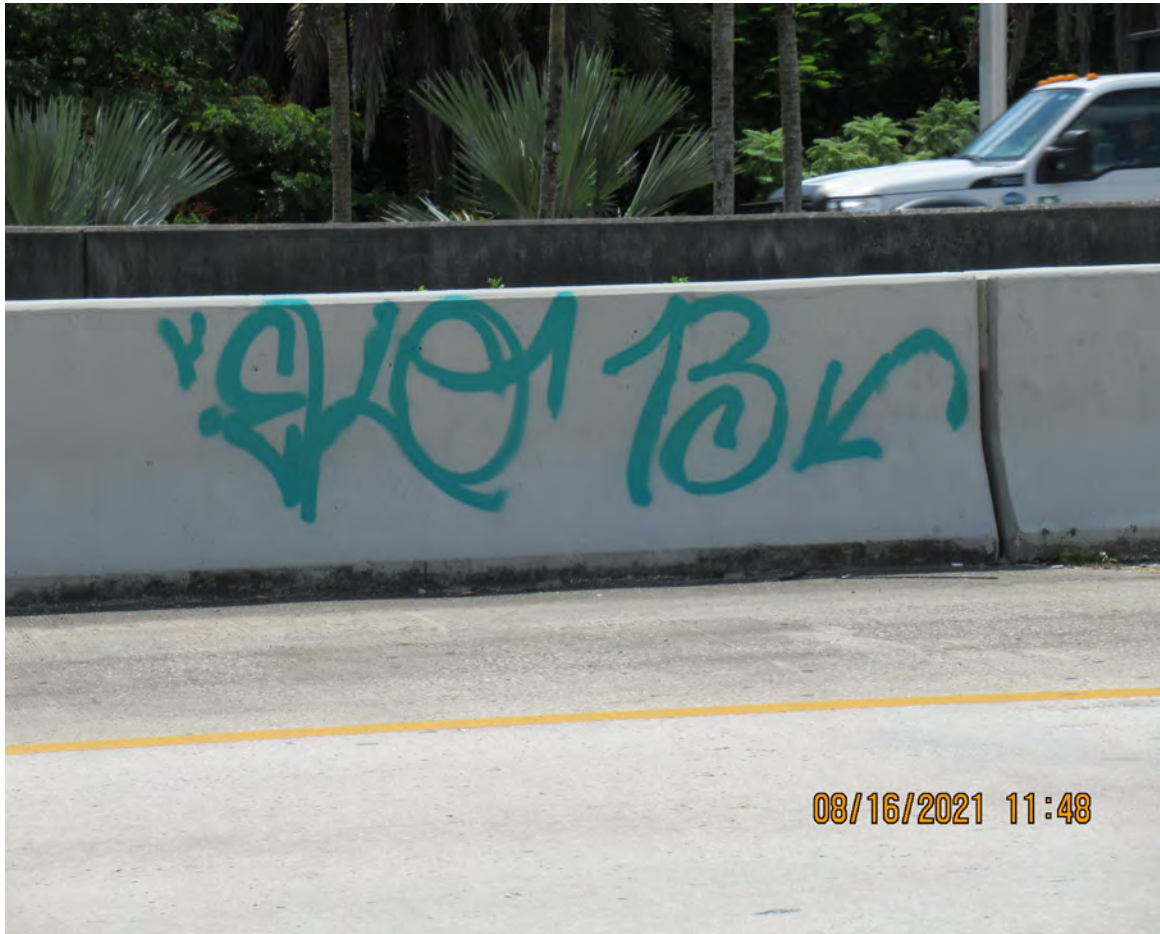
**PHOTO NO.: SB-017
DATE: 8-16-2021**

GRAFITTI ON BARRIER WALL

ITEM NOTED TO BE ADDRESSED BY MDX MAINTENANCE

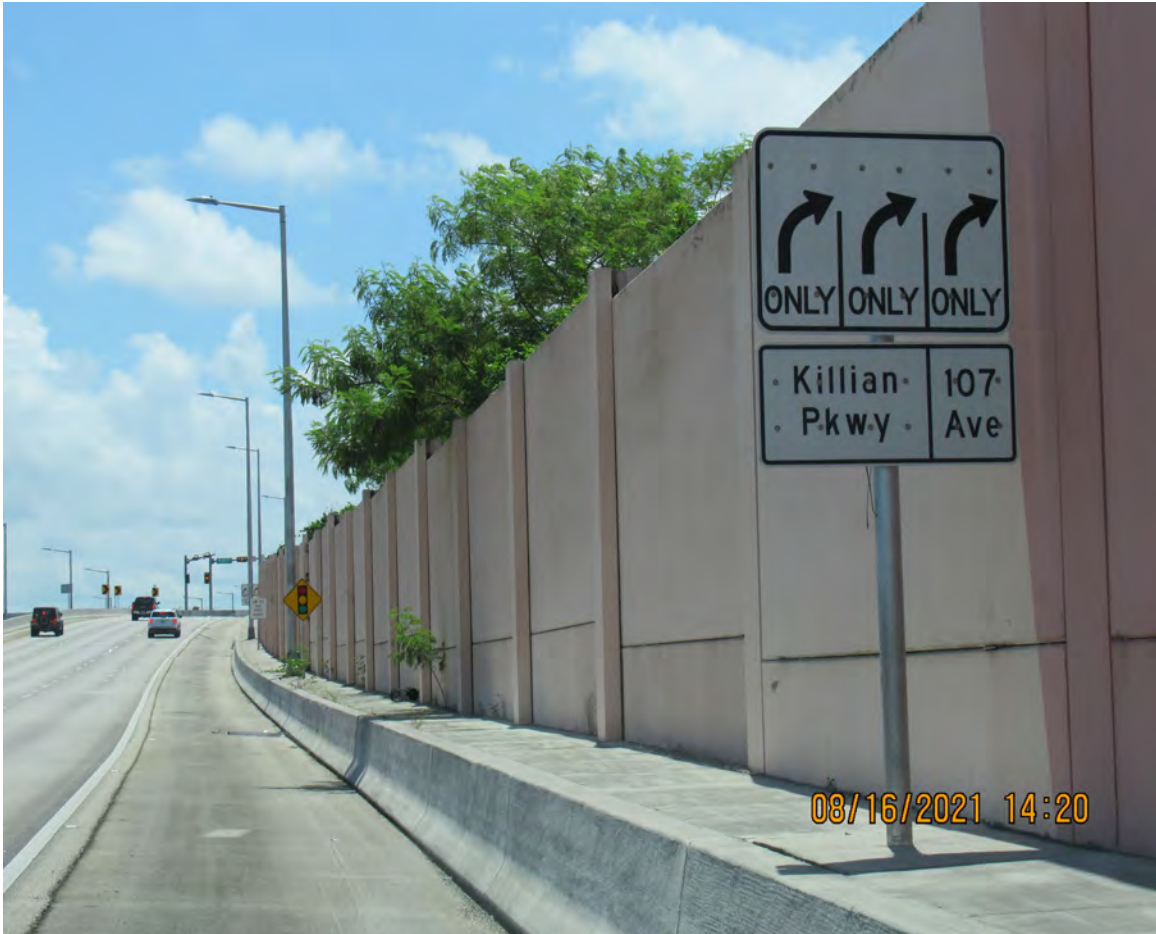
**PHOTO NO.: SB-018
DATE: 8-16-2021**

OVERGROWN VEGETATION OVER SOUND WALL

ITEM NOTED TO BE ADDRESSED BY MDX MAINTENANCE

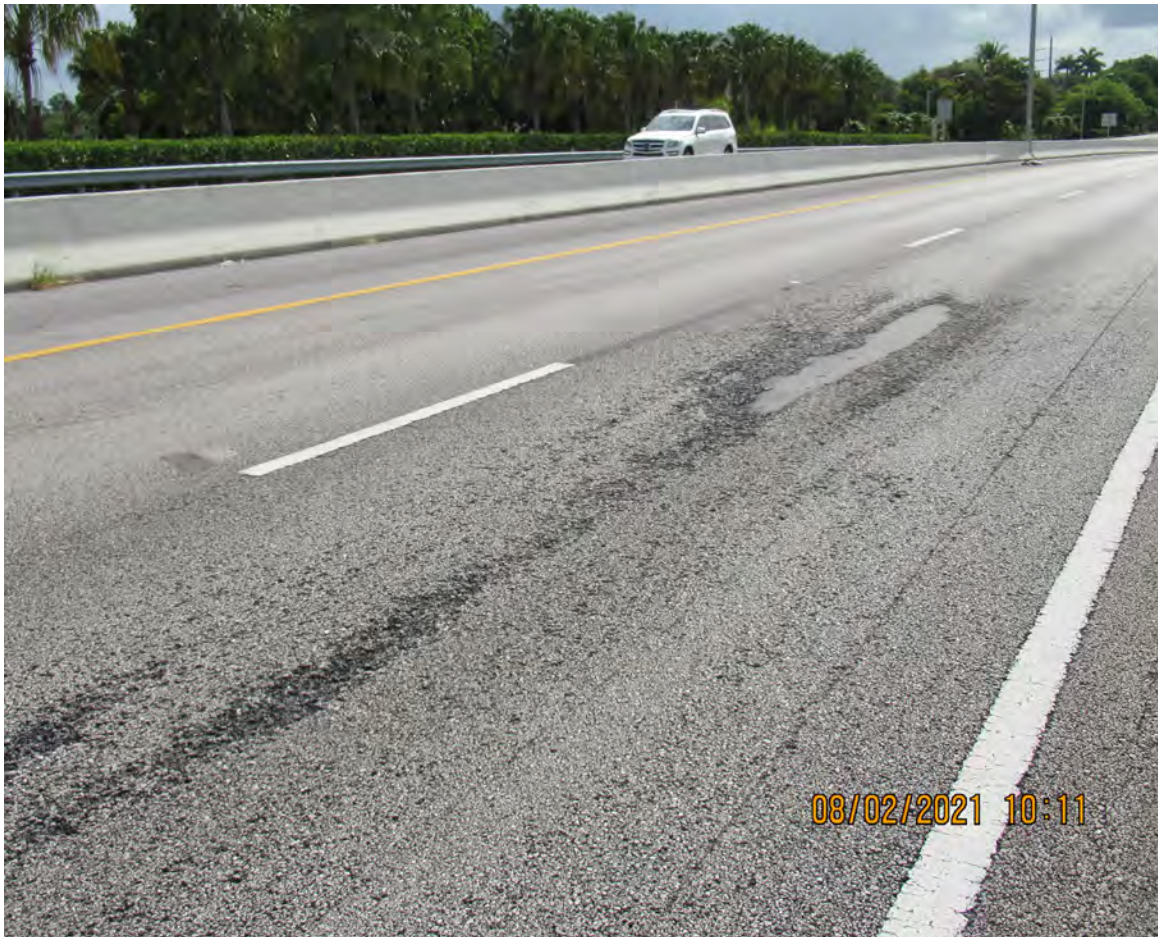
**PHOTO NO.: EB-003
DATE: 8-2-2021**

DETERIORATED ASPHALT PAVEMENT

ITEM NOTED TO BE ADDRESSED BY MDX MAINTENANCE

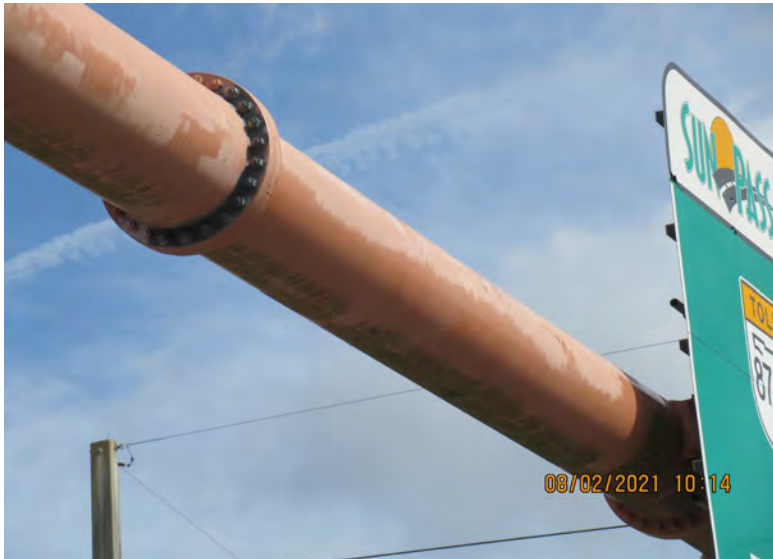
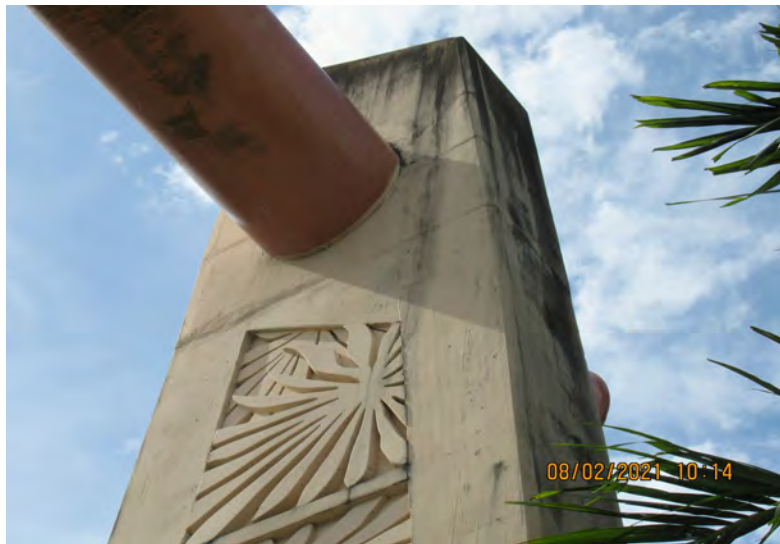
**PHOTO NO.: EB-004
DATE: 8-2-2021**

**DETERIORATED PAINT ON SIGN STRUCTURE MONOTUBE STRUCTURE AND
UPRIGHT STRUCTURE No. 87S944
(TYPICAL THROUGHOUT THE CORRIDOR)**

ITEM NOTED TO BE ADDRESSED BY MDX WORK PROGRAM 30047

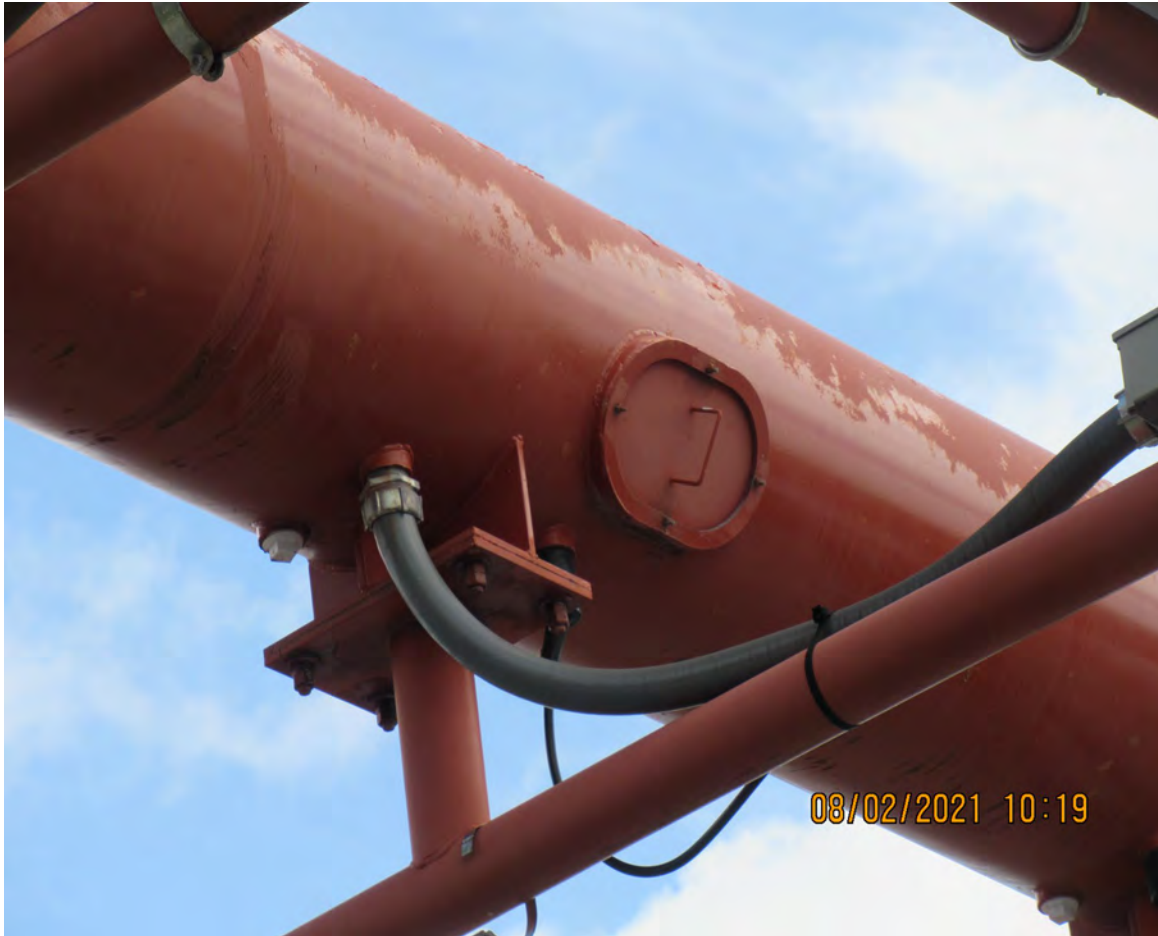
**PHOTO NO.: EB-005
DATE: 8-2-2021**

**DETERIORATED PAINT ON ORT GANTRY MONOTUBE (STRUCTURE No. 87S935)
(TYPICAL THROUGHOUT THE CORRIDOR)**

ITEM NOTED TO BE ADDRESSED BY MDX WORK PROGRAM No. 30043

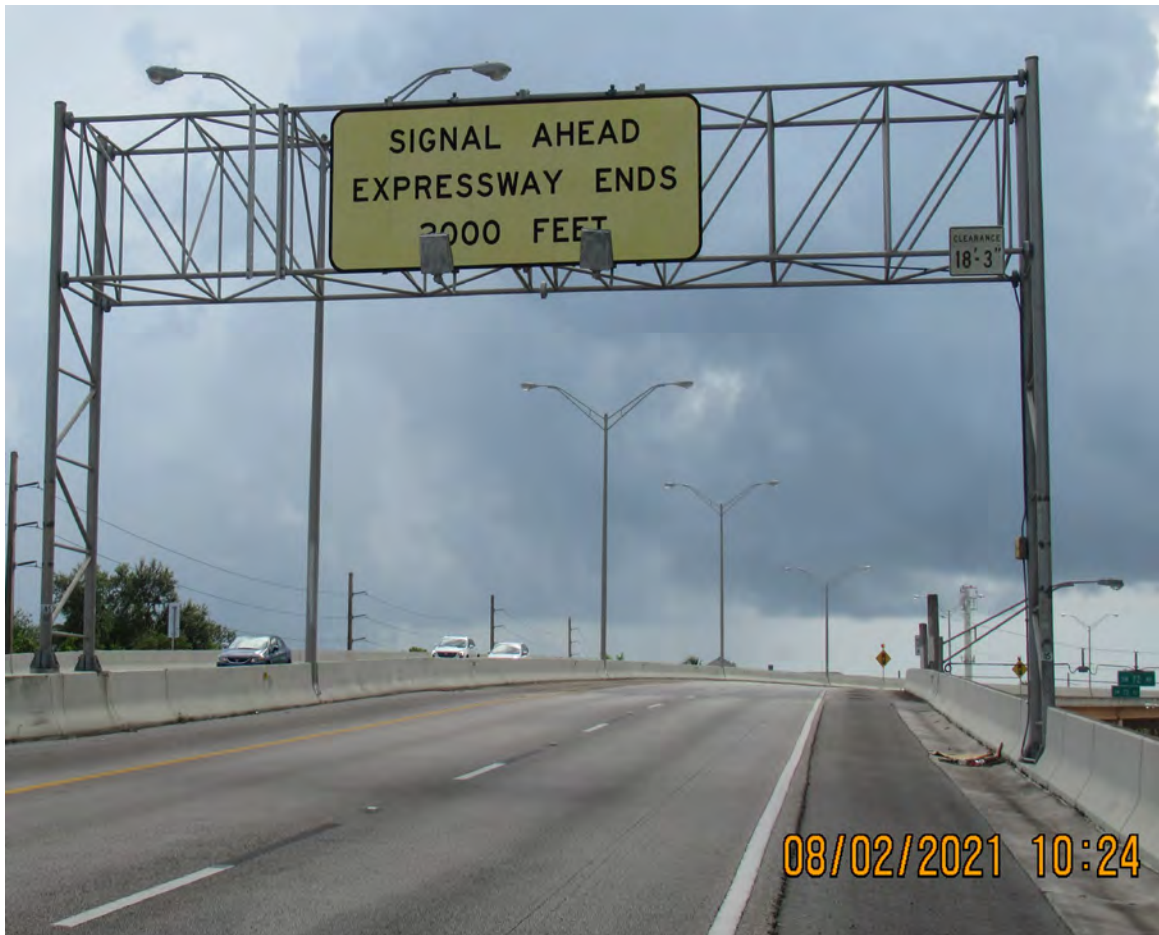
**PHOTO NO.:
EB-006 DATE:
8-2-2021**

**DETERIORATED REFLECTIVE SHEETING ON SIGN PANEL
(STRUCTURE # 87S115)**

ITEM NOTED TO BE ADDRESSED BY MDX MAINTENANCE

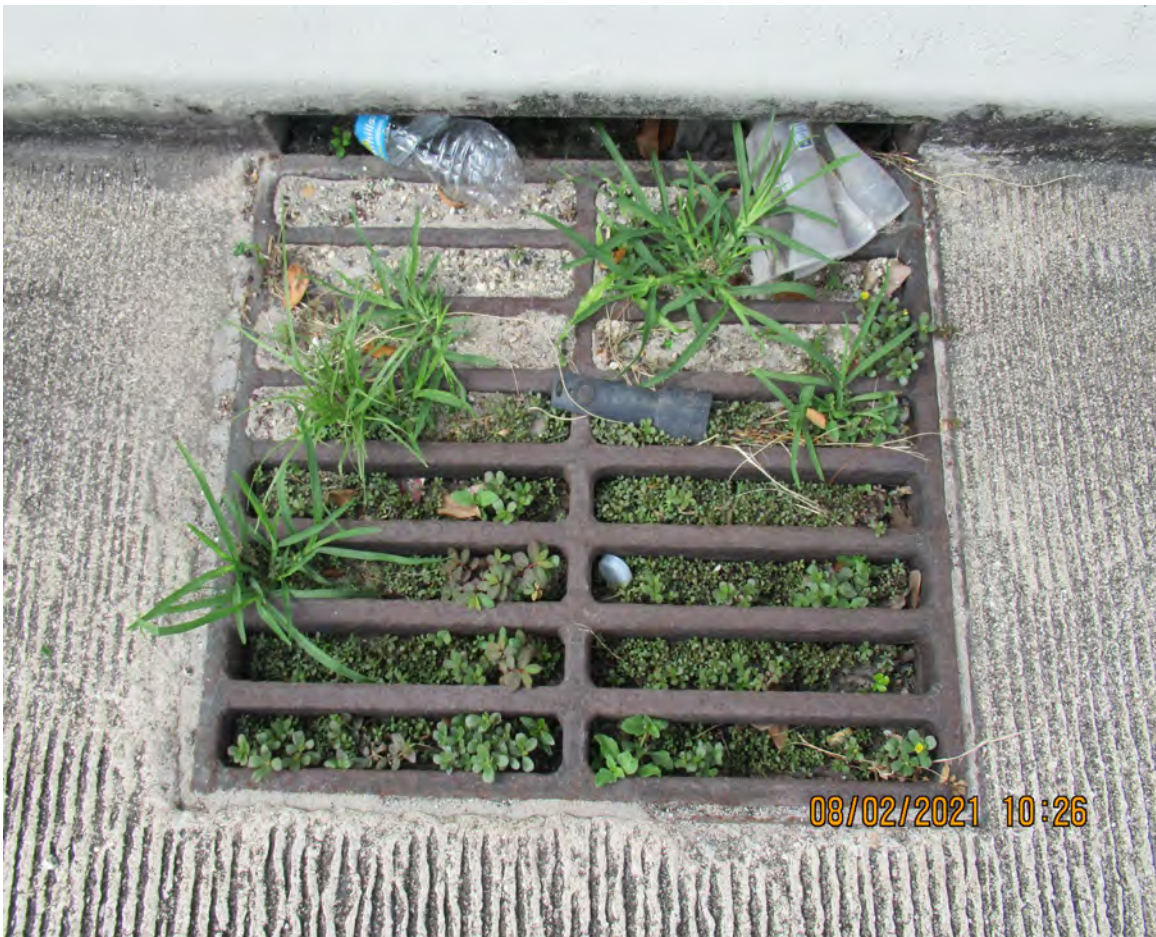
**PHOTO NO.: EB-007
DATE: 8-2-2021**

**SILTED BRIDGE DRAINAGE INLET BRIDGE #870559
(TYPICAL AT VARIOUS LOCATIONS)**

ITEM NOTED TO BE ADDRESSED BY MDX MAINTENANCE

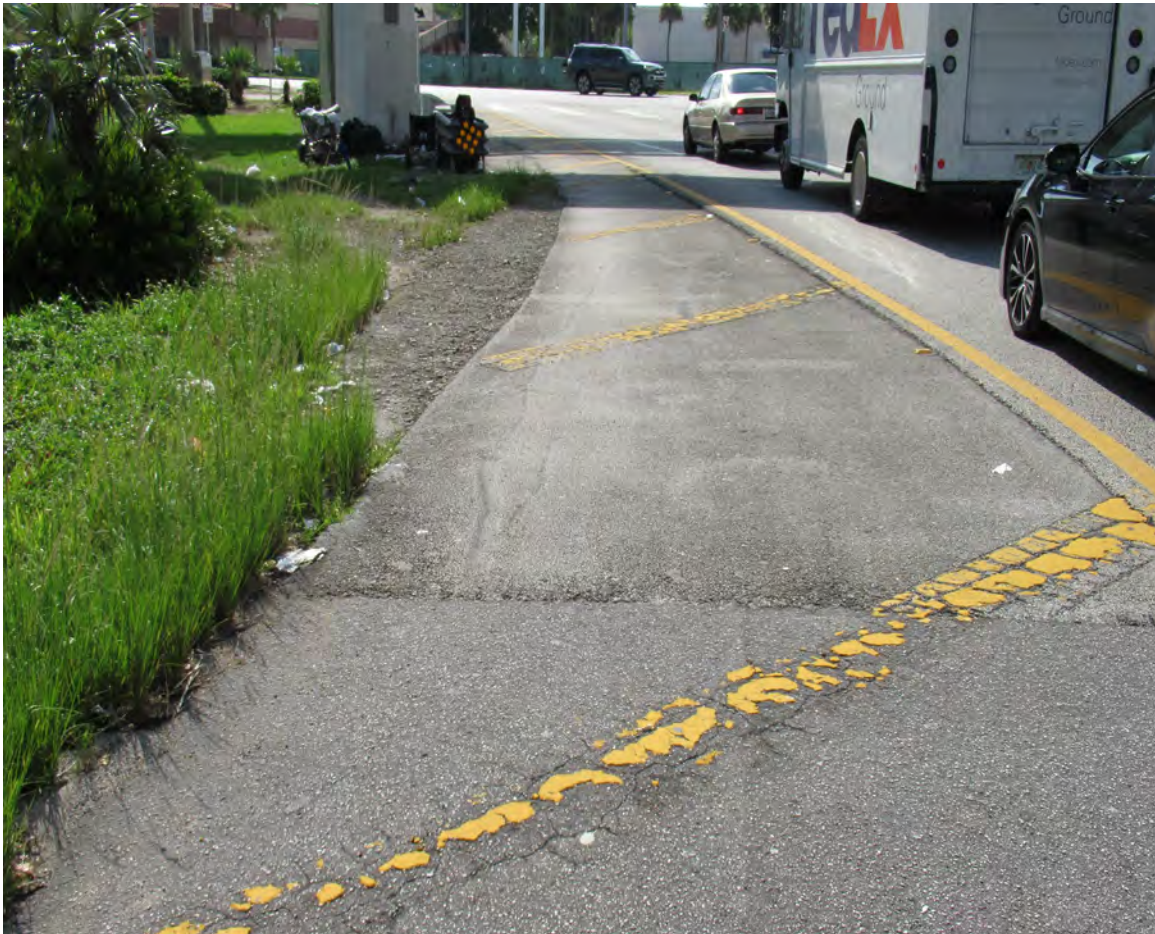
**PHOTO NO.: EB-008
DATE: 8-2-2021**

DETERIORATED THERMOPLASTIC STRIPING IN GORE AREA

ITEM NOTED TO BE ADDRESSED BY MDX MAINTENANCE

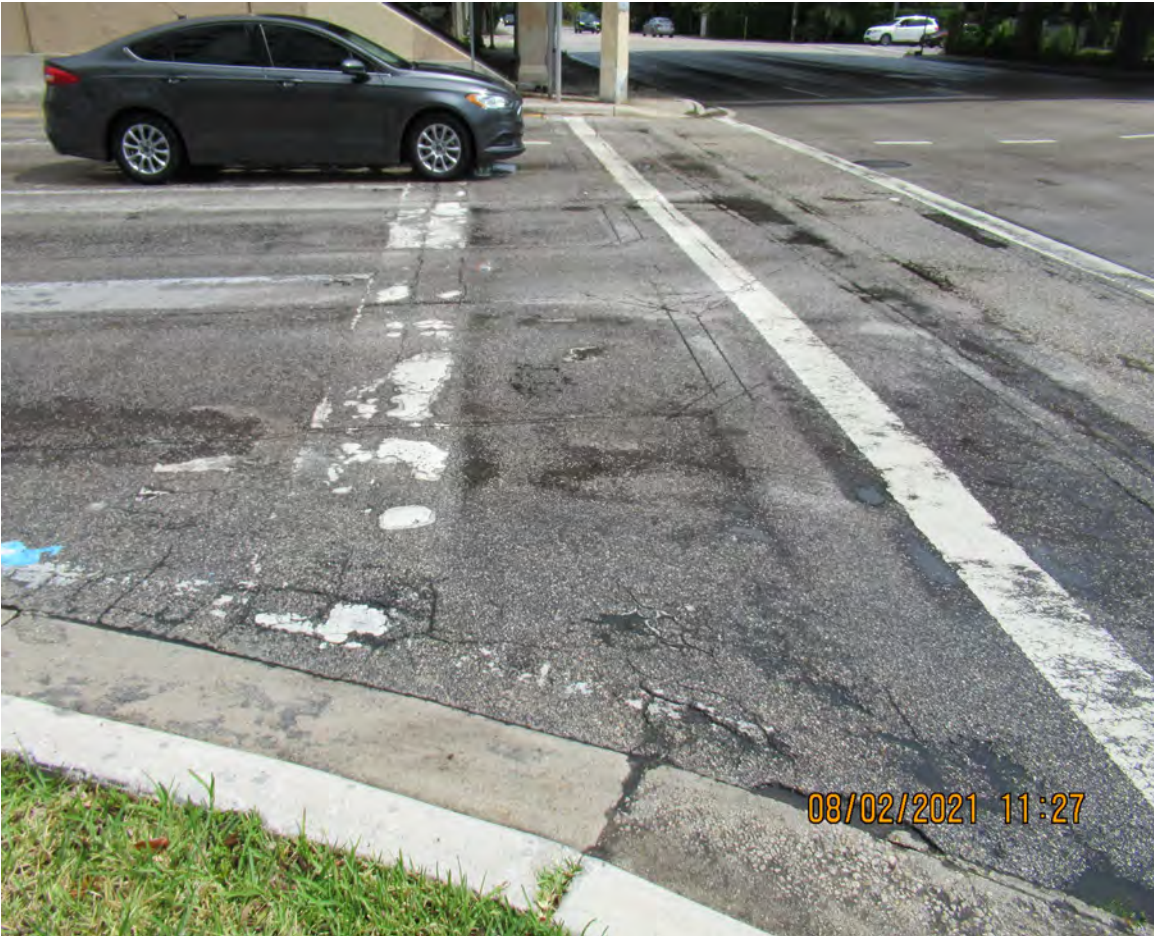
**PHOTO NO.: EB-009
DATE: 8-2-2021**

**DETERIORATED THERMOPLASTIC STOP BAR, PEDESTRIAN CROSSWALK AND
EDGE LINE STRIPING**

ITEM NOTED TO BE ADDRESSED BY MDX MAINTENANCE

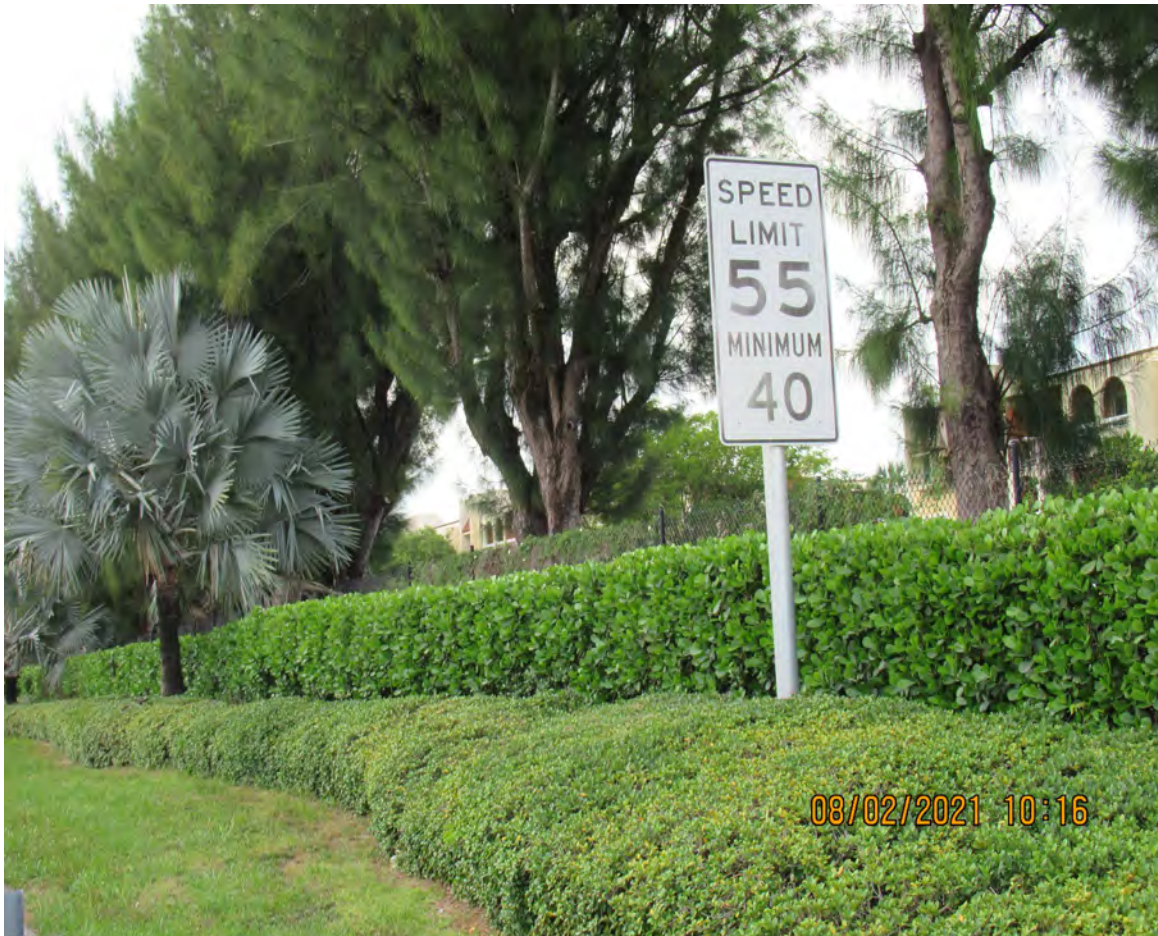
**PHOTO NO.: EB-010
DATE: 8-2-2021**

DETERIORATED REFLECTIVE SHEETING ON SPEED LIMIT SIGN

ITEM NOTED TO BE ADDRESSED BY MDX MAINTENANCE

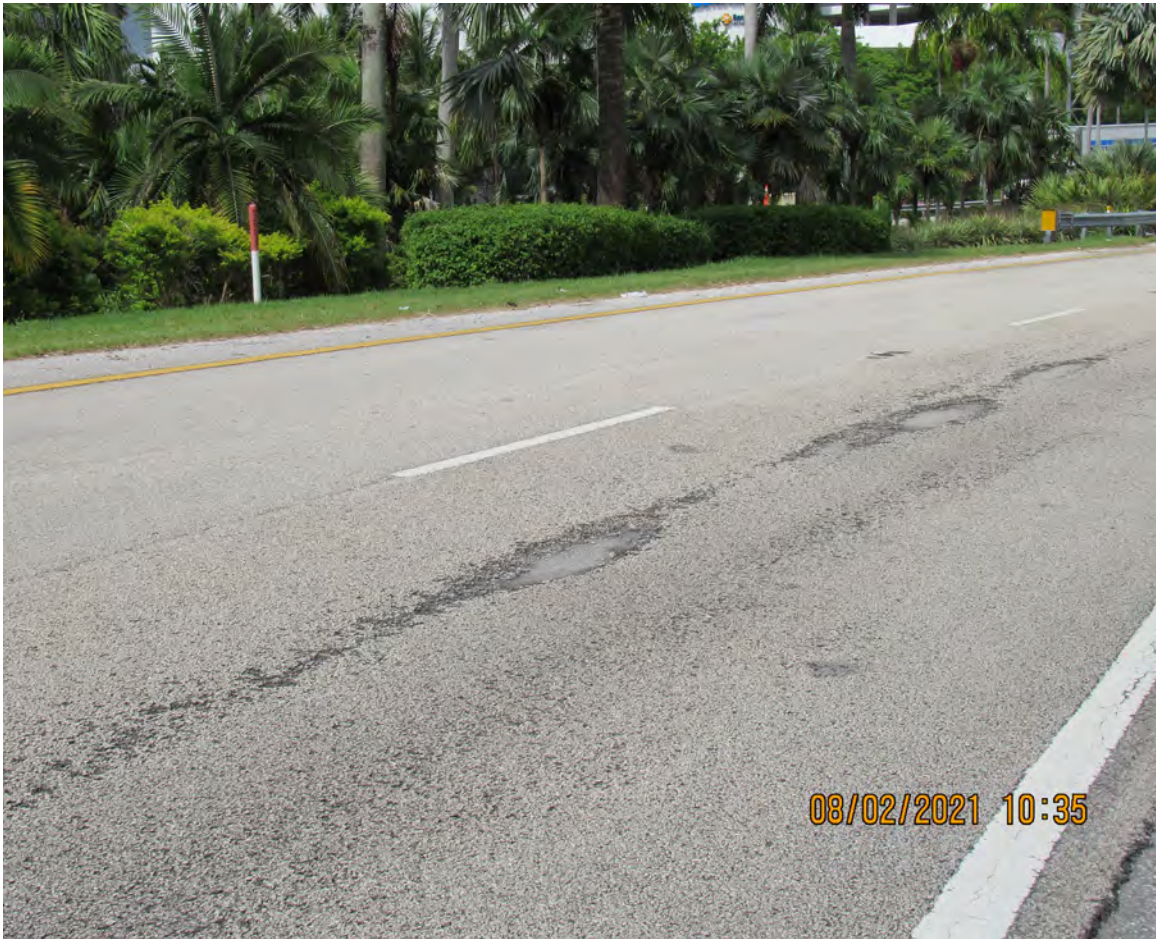
**PHOTO NO.: WB-001
DATE: 8-2-2021**

DETERIORATED ASPHALT PAVEMENT

ITEM NOTED TO BE ADDRESSED BY MDX MAINTENANCE

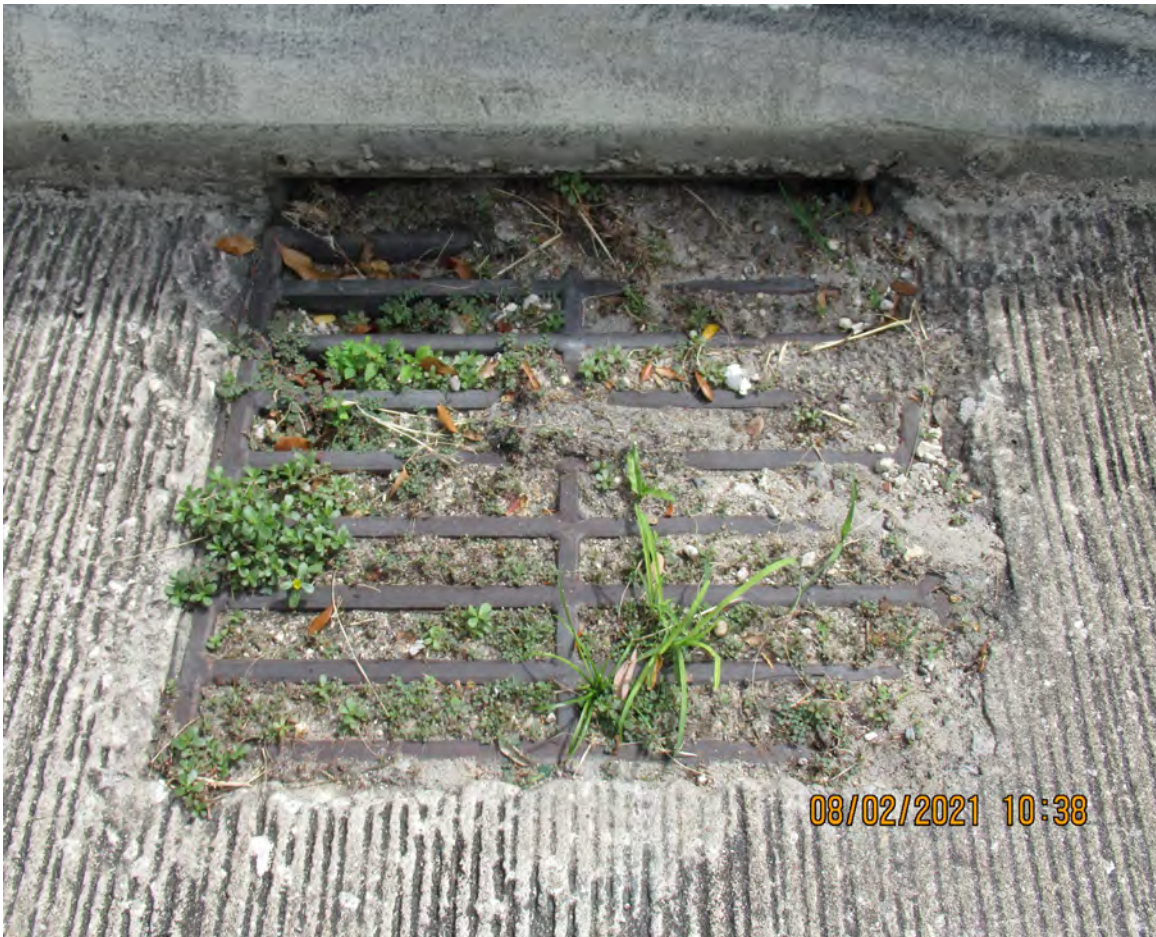
**SILTED BRIDGE DRAINAGE INLET BRIDGE #870559
(TYPICAL AT VARIOUS LOCATIONS)**

ITEM NOTED TO BE ADDRESSED BY MDX MAINTENANCE

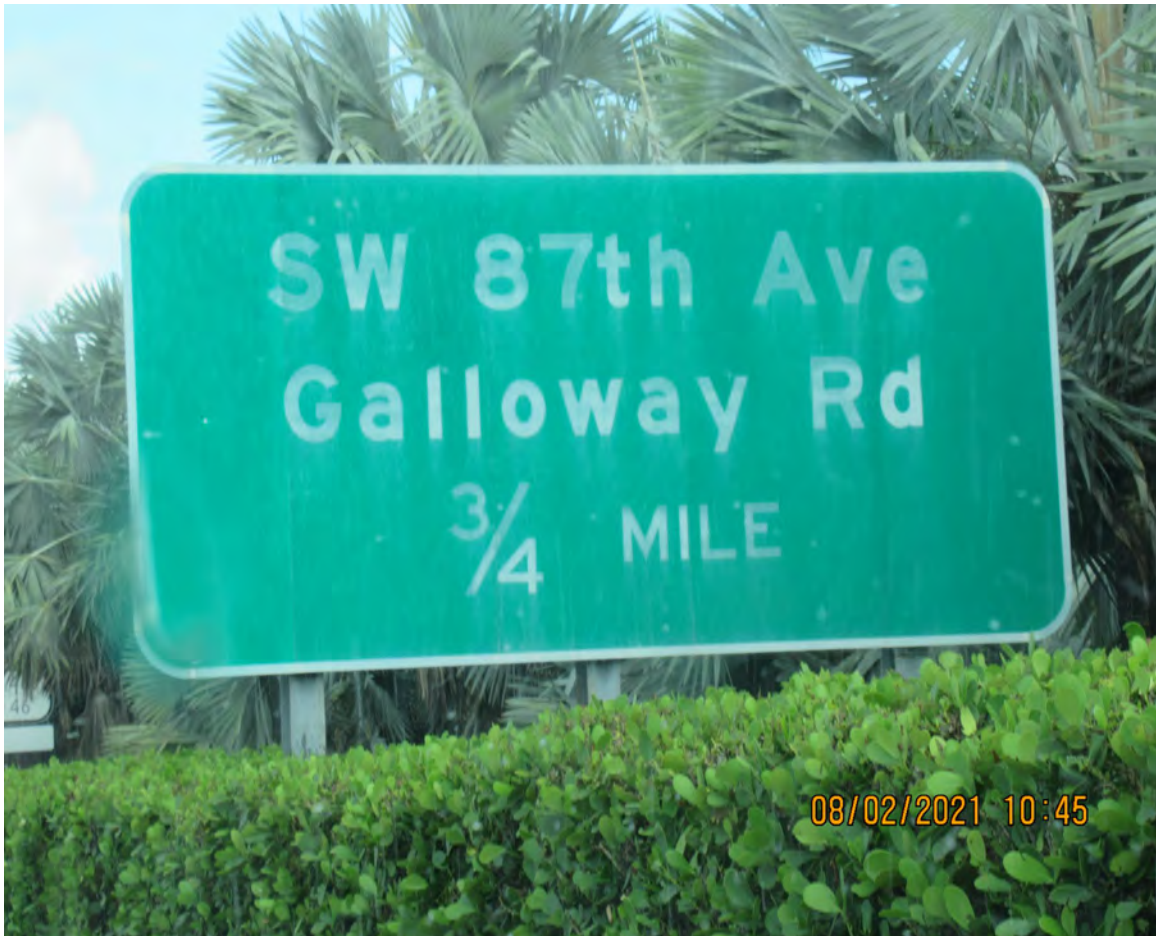
**PHOTO NO.: WB-003
DATE: 8-2-2021**

DETERIORATED REFLECTIVE SHEETING ON SIGN PANEL

ITEM NOTED TO BE ADDRESSED BY MDX MAINTENANCE

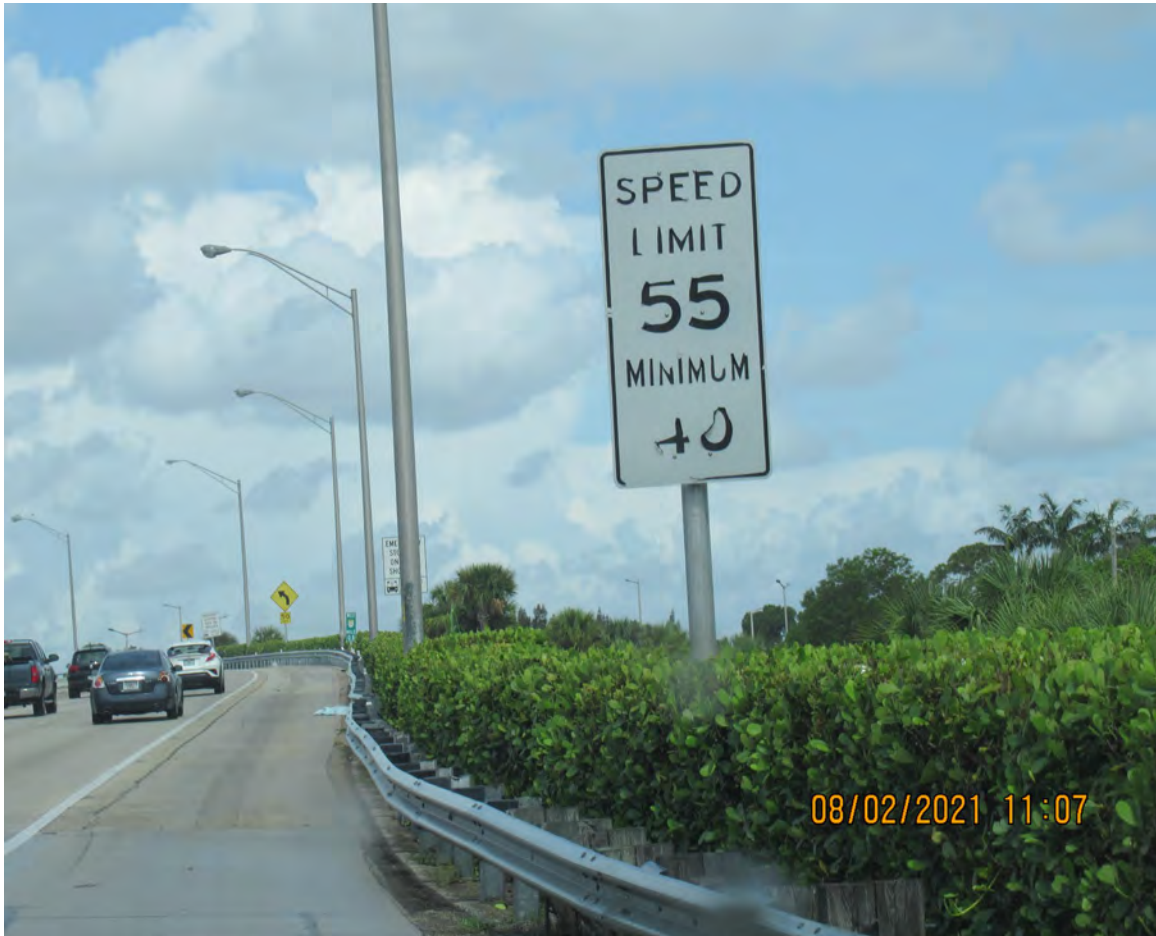
**PHOTO NO.: WB-005
DATE: 8-2-2021**

DETERIORATED REFLECTIVE SHEETING ON SIGN PANEL

ITEM NOTED TO BE ADDRESSED BY MDX MAINTENANCE

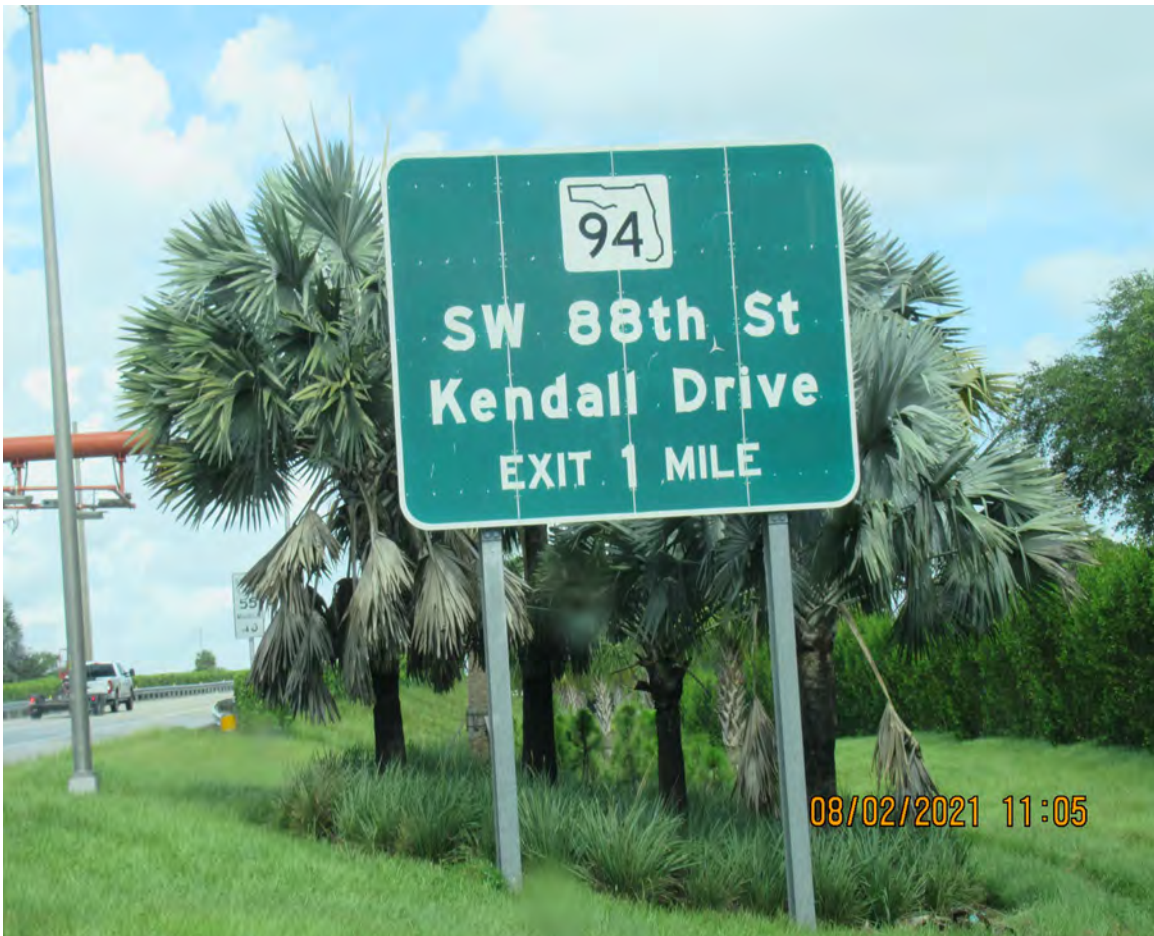
**PHOTO NO.: WB-006
DATE: 8-2-2021**

DETERIORATED REFLECTIVE SHEETING ON SIGN PANEL

ITEM NOTED TO BE ADDRESSED BY MDX MAINTENANCE

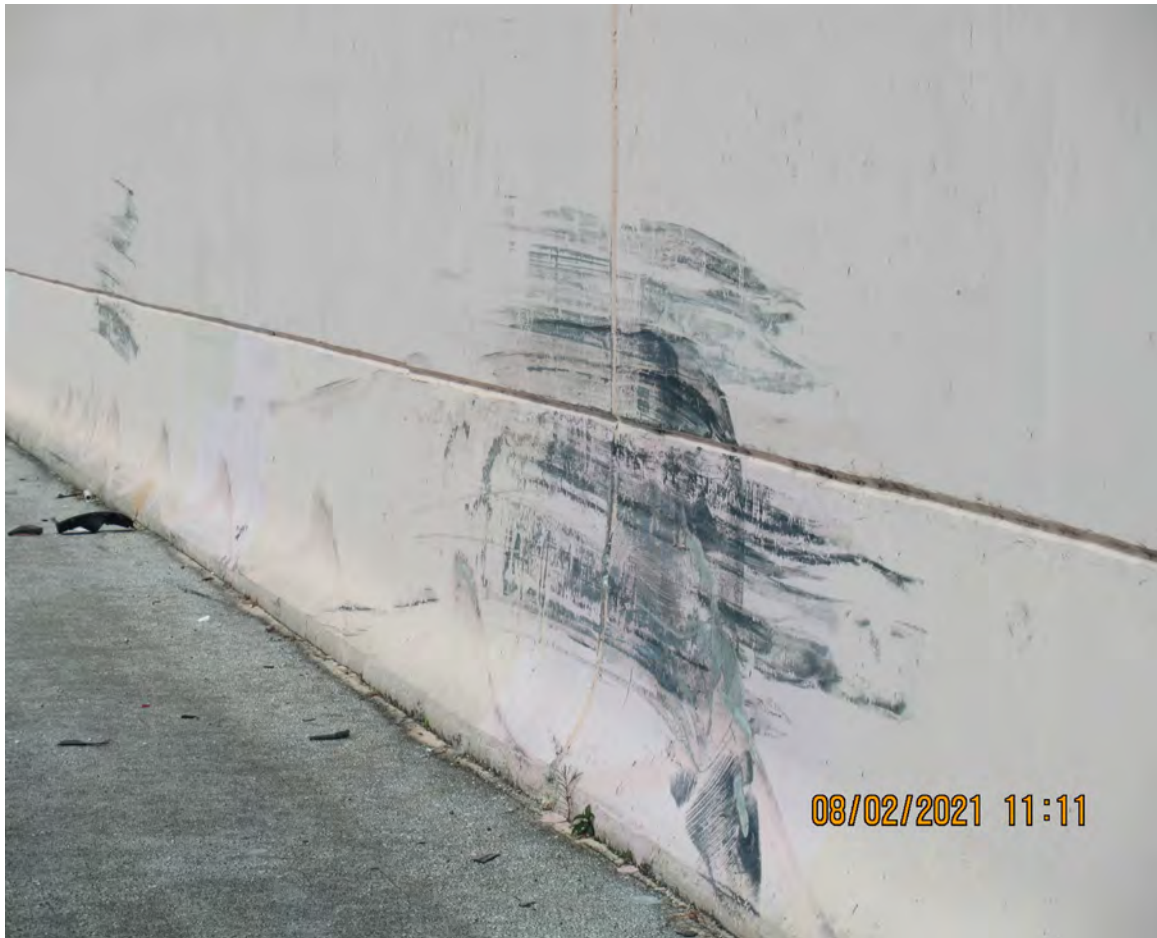
**PHOTO NO.: WB-007
DATE: 82-2021**

**DETERIORATED CLASS V COATING ON BARRIER WALL
(TYPICAL THROUGHOUT THE CORRIDOR)**

ITEM NOTED TO BE ADDRESSED BY MDX PROJECT No. 30037

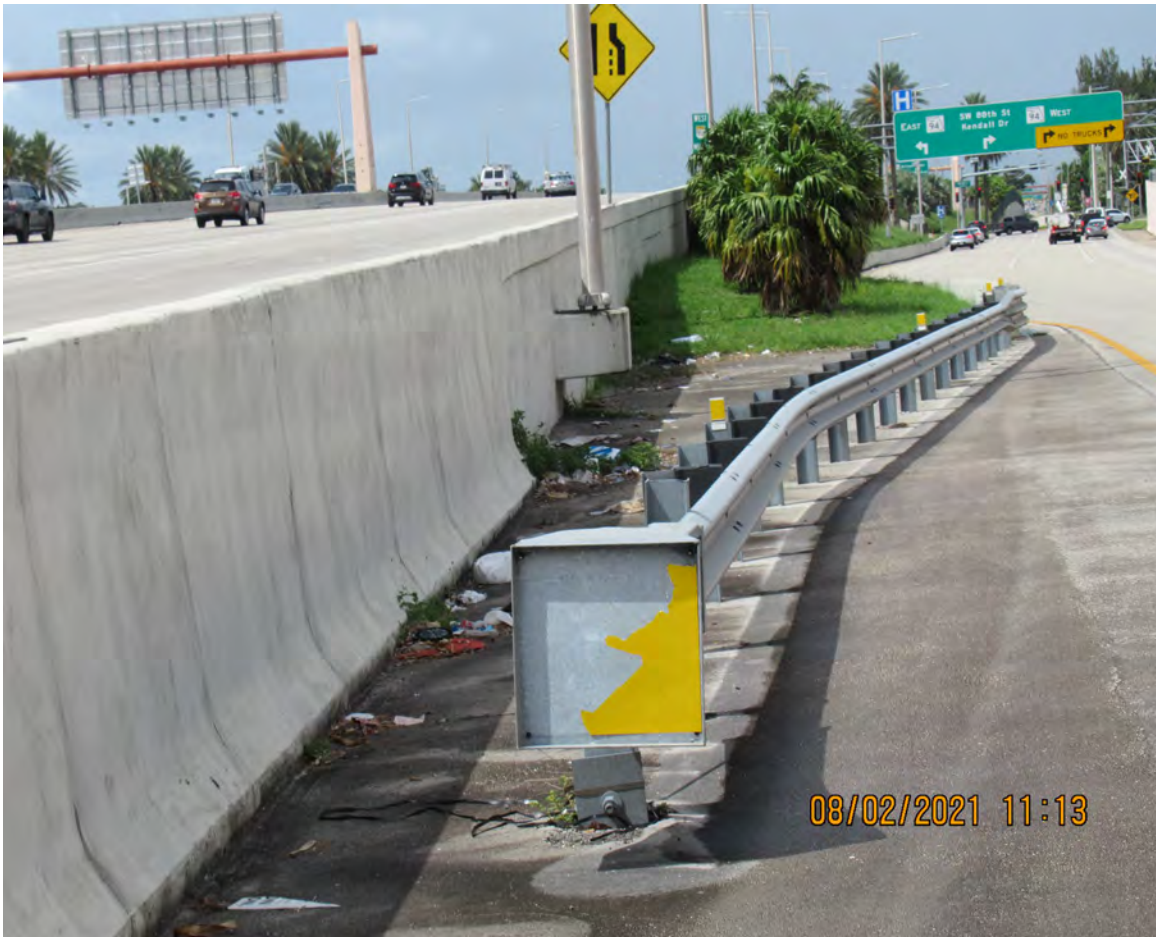
**PHOTO NO.: WB-008
DATE: 8-2-2021**

DETERIORATED REFLECTIVE SHEETING ON END-TREATMENT

ITEM NOTED TO BE ADDRESSED BY MDX MAINTENANCE

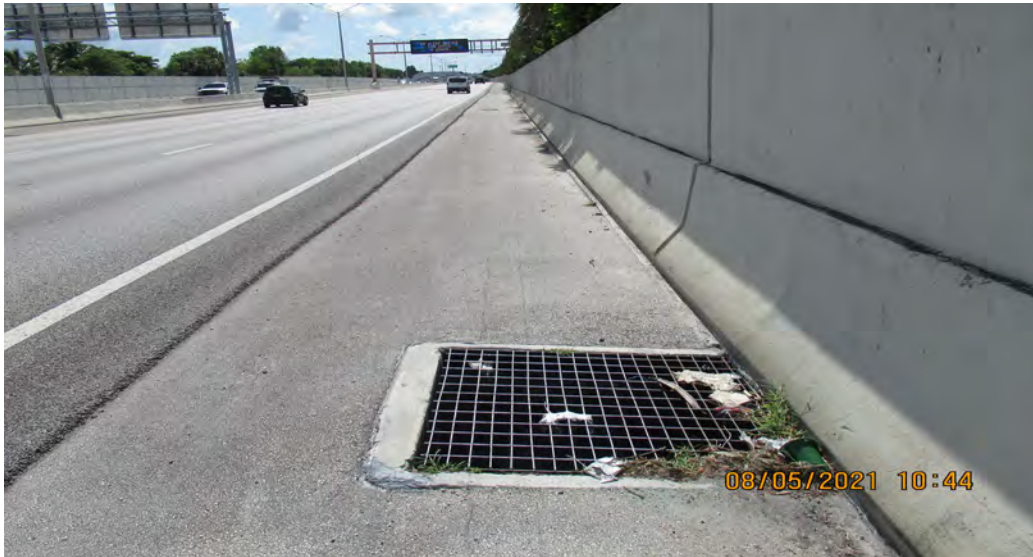
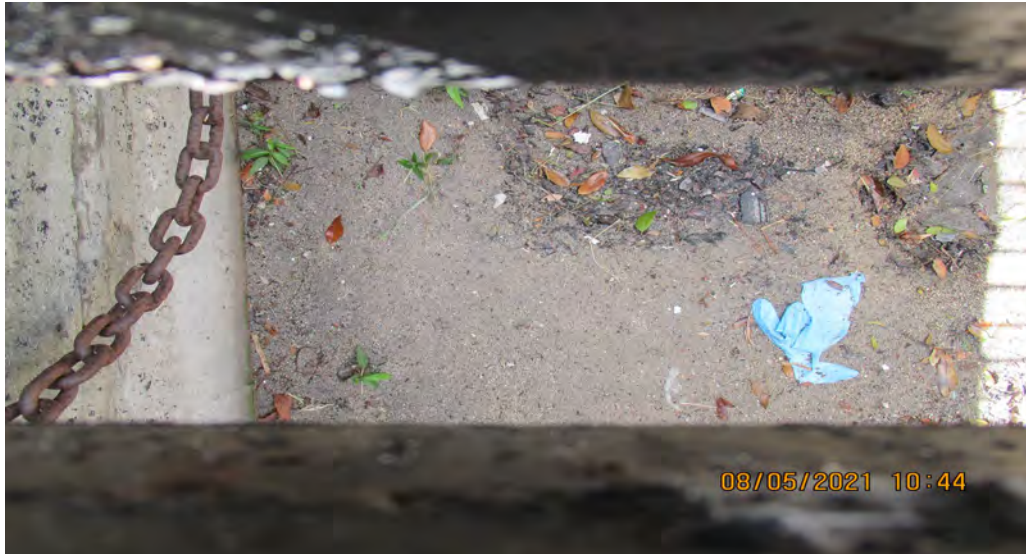
**PHOTO NO.: EB-001
DATE: 8-5-2021**

SILTED DRAINAGE STRUCTURE (TYPICAL THROUGHOUT THE CORRIDOR)

ITEM NOTED TO BE ADDRESSED BY MDX MAINTENANCE

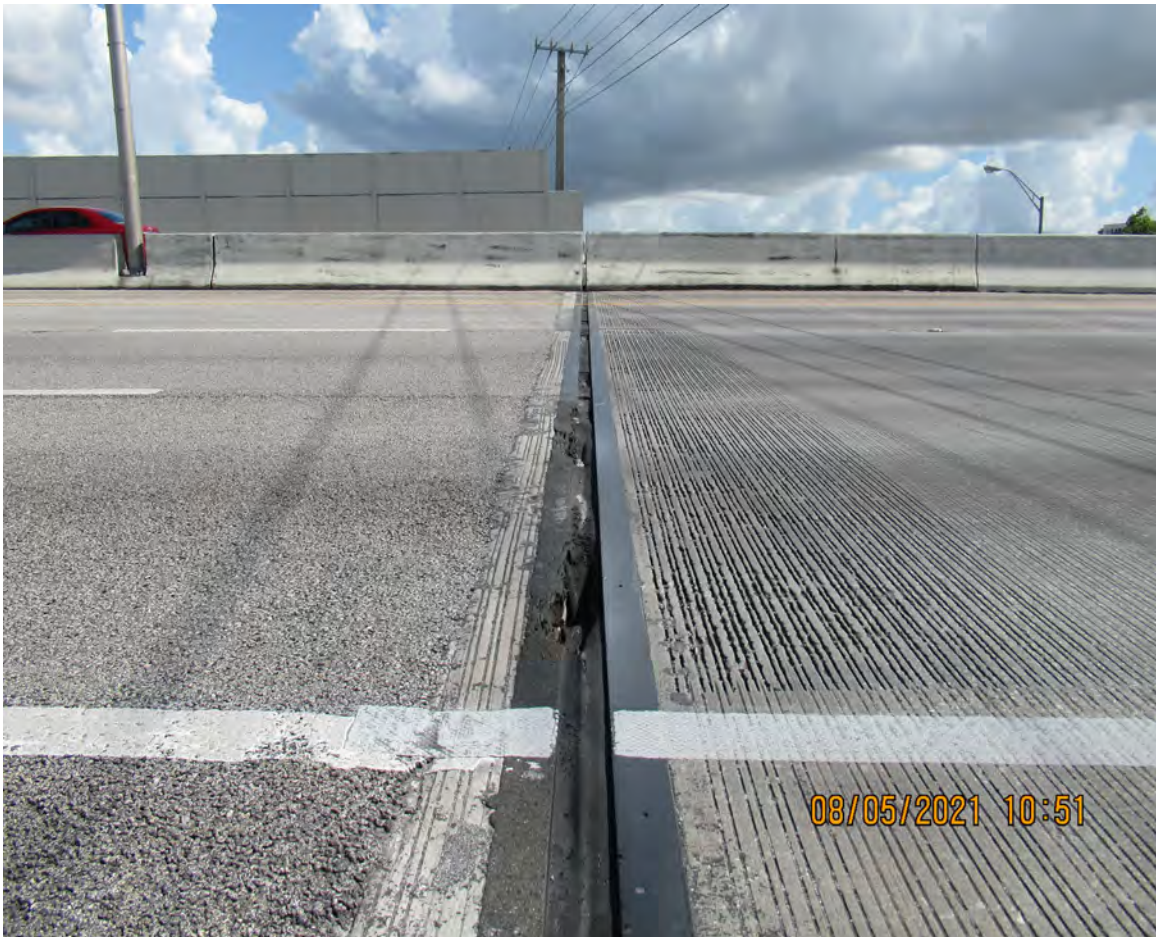
**PHOTO NO.: EB-002
DATE: 8-5-2021**

DETERIORATED EXPANSION JOINT (BRIDGE # 870708)

ITEM NOTED TO BE ADDRESSED BY MDX WORK PROGRAM No. 30029
