Annual Inspection Report 2021

General Engineering Consultant to the
Miami-Dade County Expressway Authority

ANNUAL INSPECTION REPORT 2021

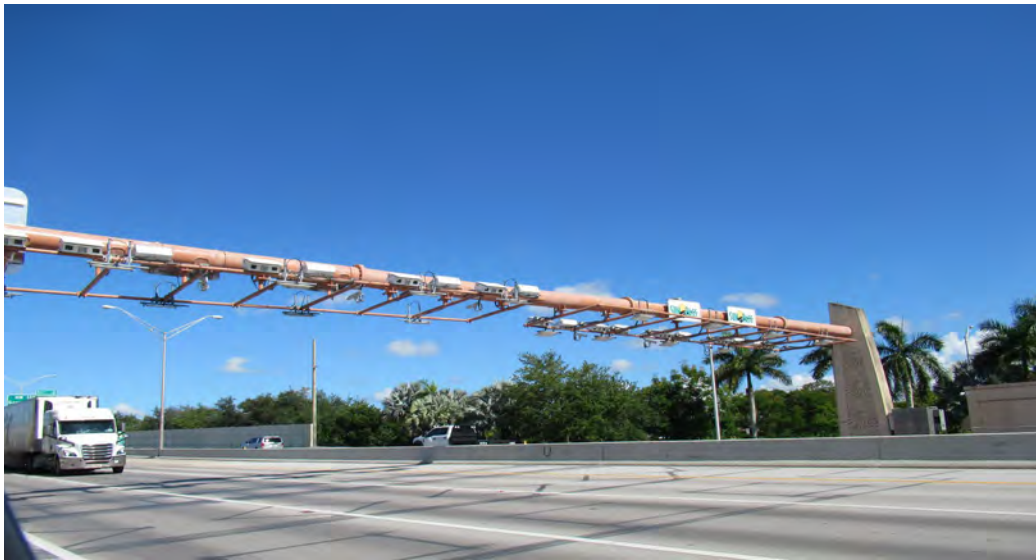
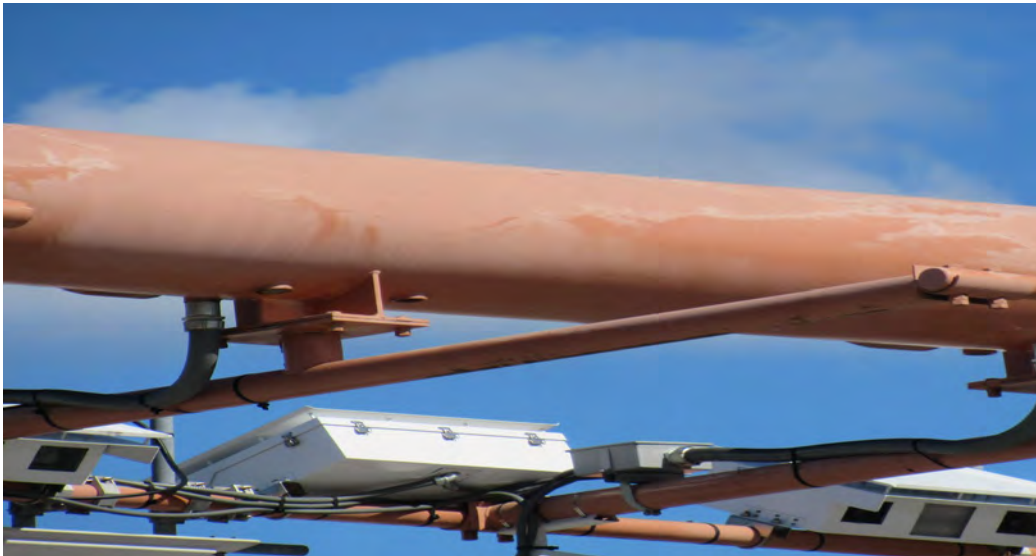
**PHOTO NO.: EB-003
DATE: 8-5-2021**

**DETERIORATED CLASS V COATING ON STRUCTURE UPRIGHT AND PAINT ON
MONOTUBE (STRUCTURE # 87S933)**

ITEM NOTED TO BE ADDRESSED BY MDX WORK PROGRAM No. 30043

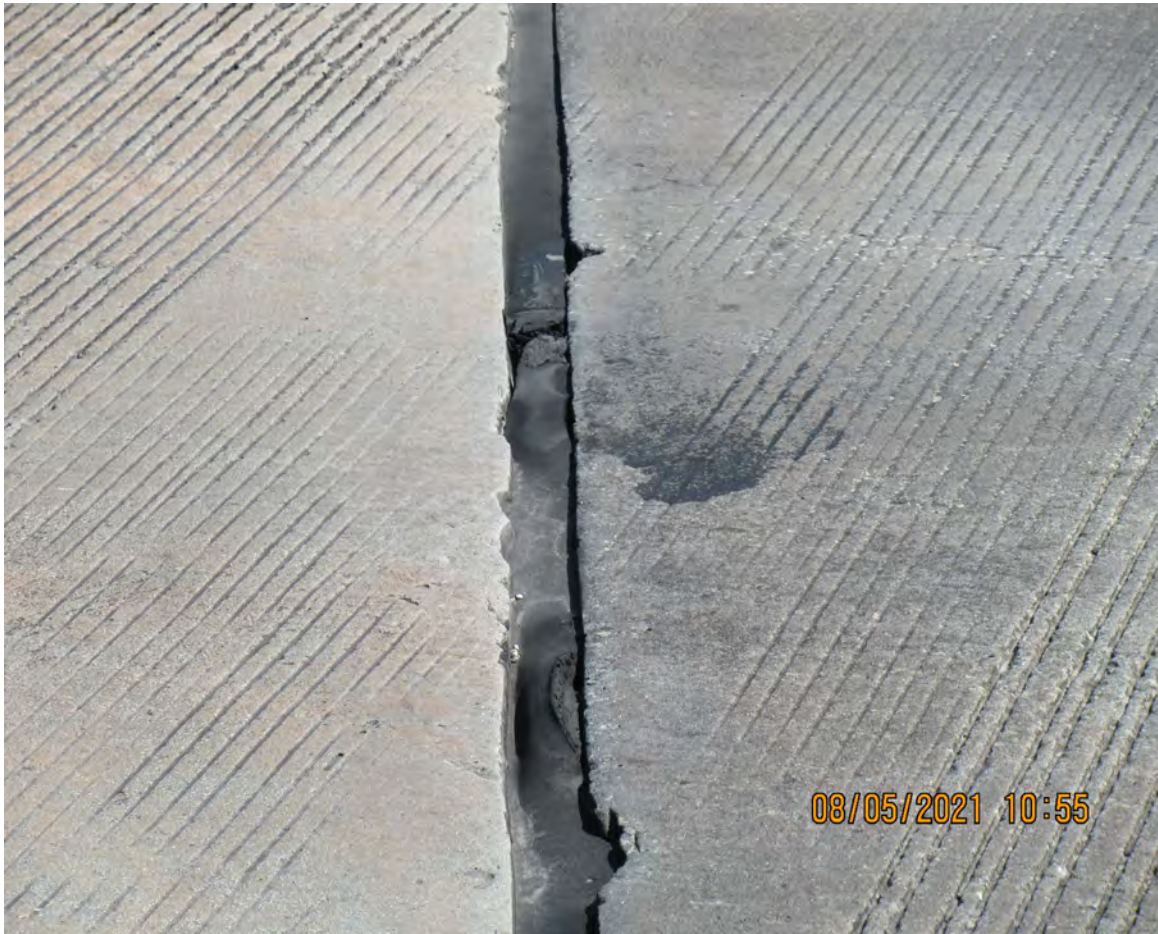
**PHOTO NO.: EB-004
DATE: 8-5-2021**

DETERIORATED EXPANSION JOINT SEALANT (BRIDGE # 870720)

ITEM NOTED TO BE ADDRESSED BY MDX WORK PROGRAM No. 30029

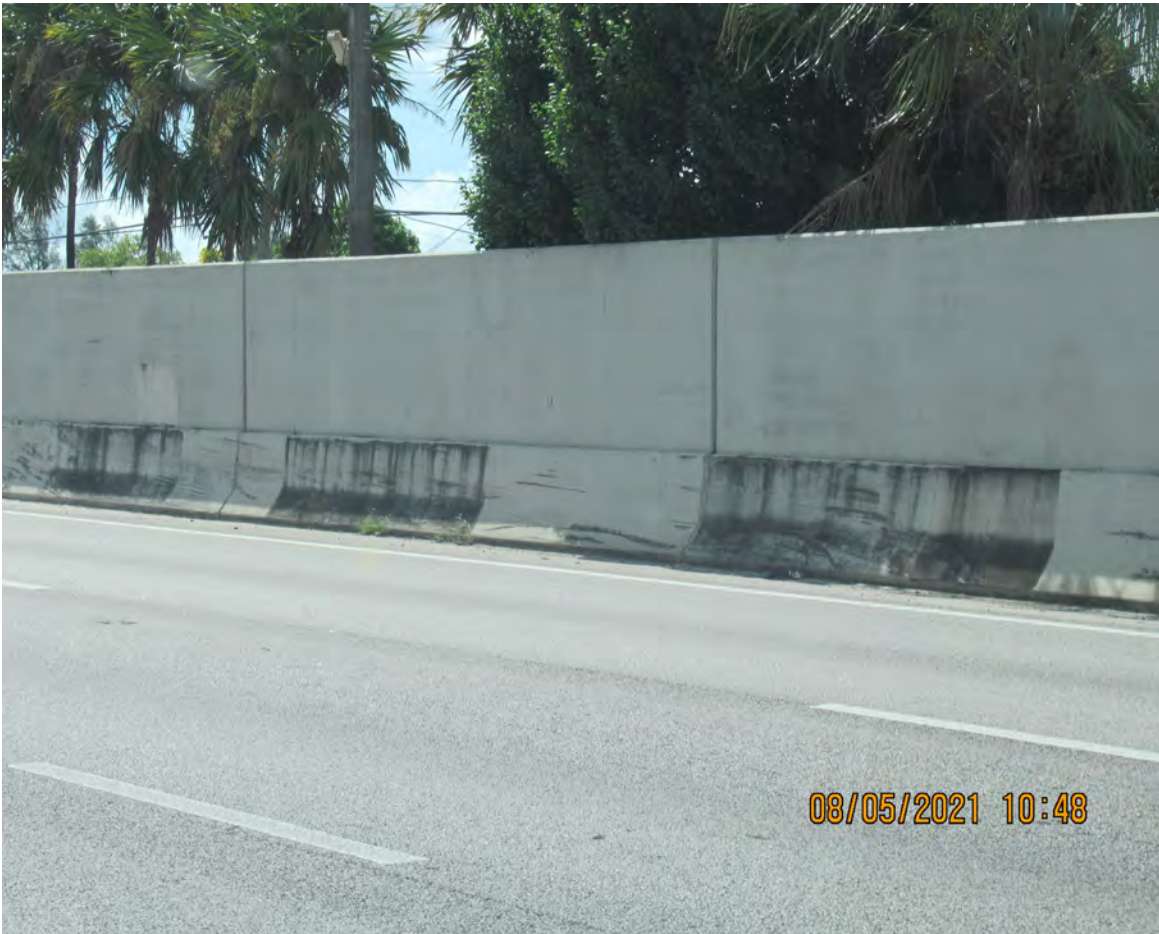
**PHOTO NO.: EB-005
DATE: 8-5-2021**

**DETERIORATED CLASS V COATING
(TYPICAL THROUGHOUT THE CORRIDOR)**

ITEM NOTED TO BE ADDRESSED BY MDX WORK PROGRAM No. 30037

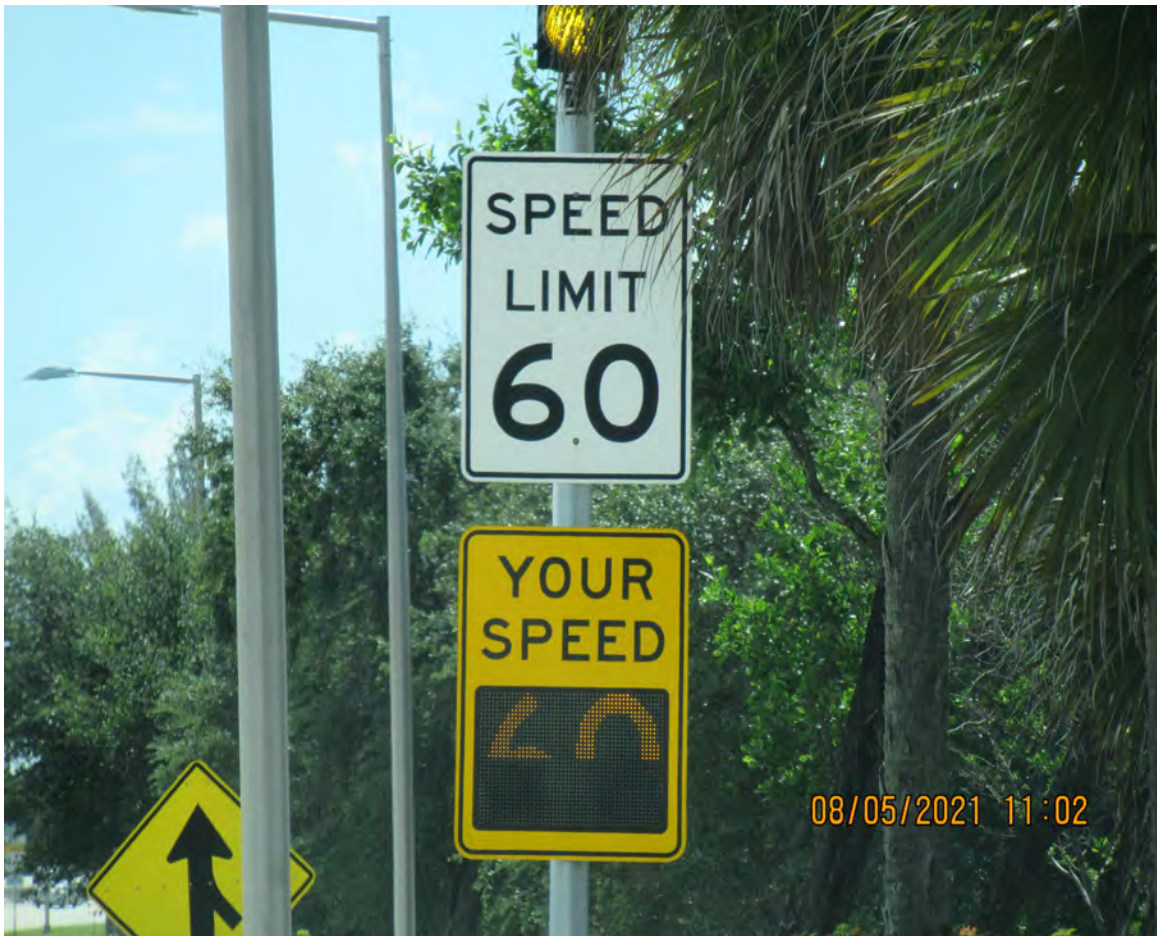
**PHOTO NO.: EB-007
DATE: 8-5-2021**

MALFUNCTIONING SPEED LIMIT SIGNS

ITEM NOTED TO BE ADDRESSED BY MDX MAINTENANCE

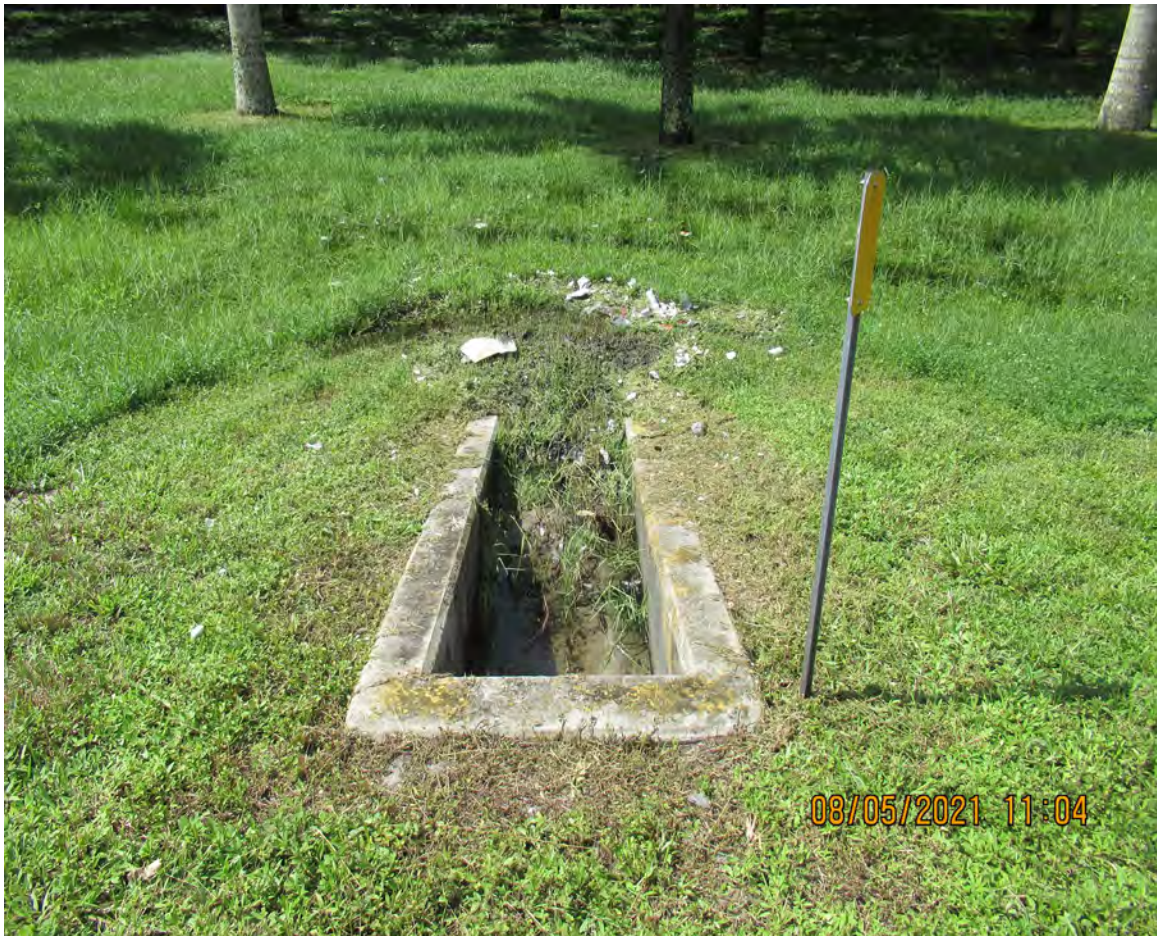
**PHOTO NO.: EB-008
DATE: 8-5-2021**

**SEDIMENT AND VEGETATION ON END WALL OBSTRUCTING WATER FLOW
(TYPICAL THROUGHOUT THE CORRIDOR)**

ITEM NOTED TO BE ADDRESSED BY MDX MAINTENANCE

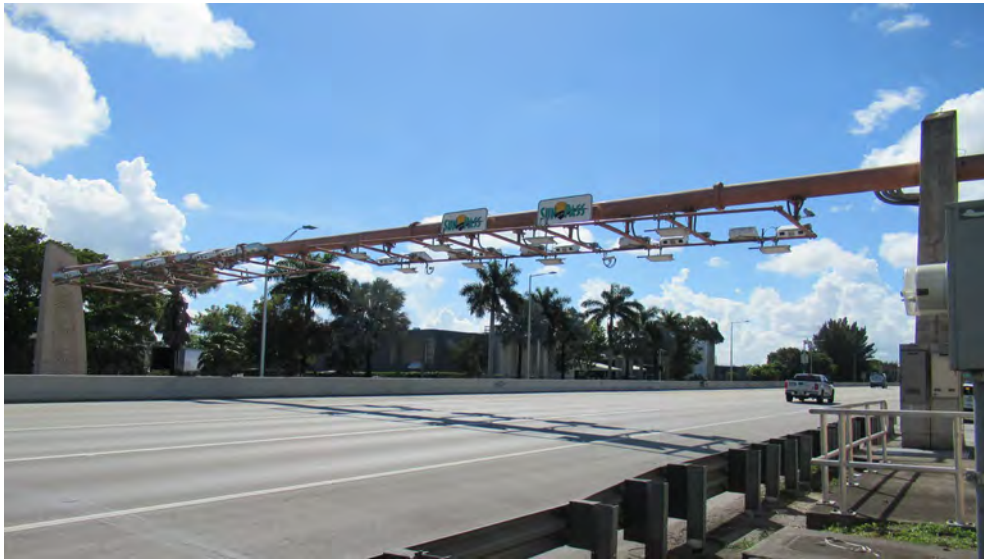
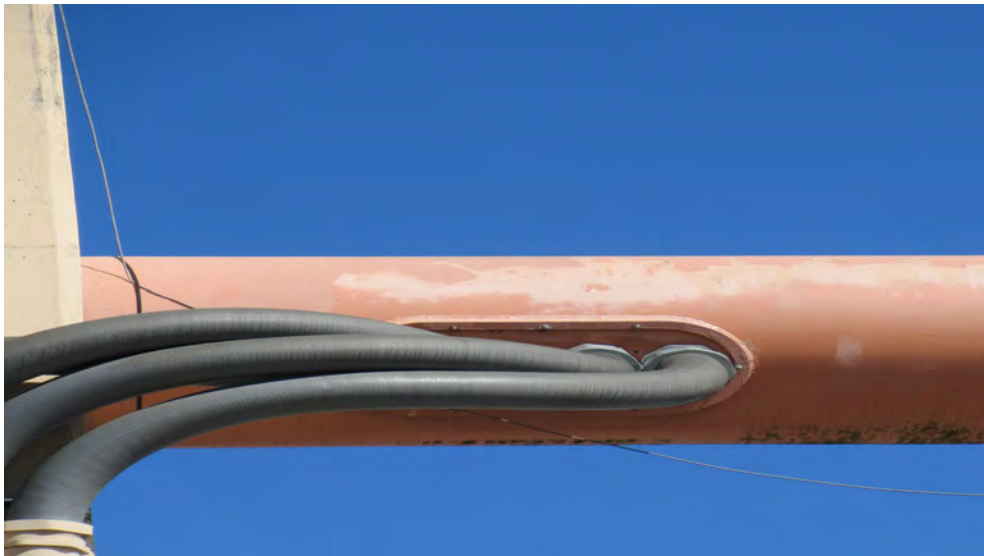
**PHOTO NO.: EB-009
DATE: 8-5-2021**

**DETERIORATED CLASS V COATING ON STRUCTURE UPRIGHT AND PAINT ON
MONOTUBE (STRUCTURE # 87S932)**

ITEM NOTED TO BE ADDRESSED BY MDX WORK PROGRAM No. 30043

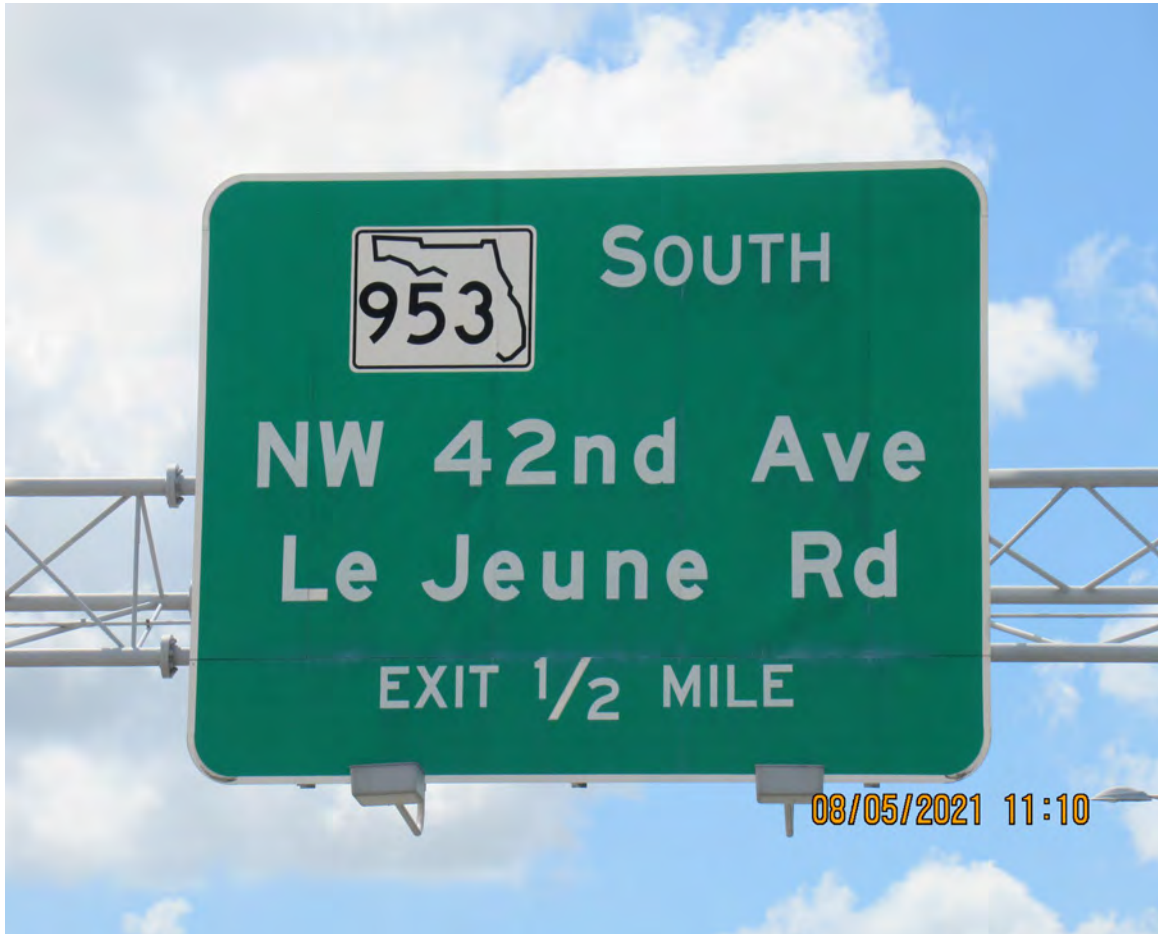
**PHOTO NO.: EB-011
DATE: 8-5-2021**

**DETERIORATED REFLECTIVE SHEETING ON SIGN PANEL
(STRUCTURE 87S524)**

ITEM NOTED TO BE ADDRESSED BY MDX MAINTENANCE

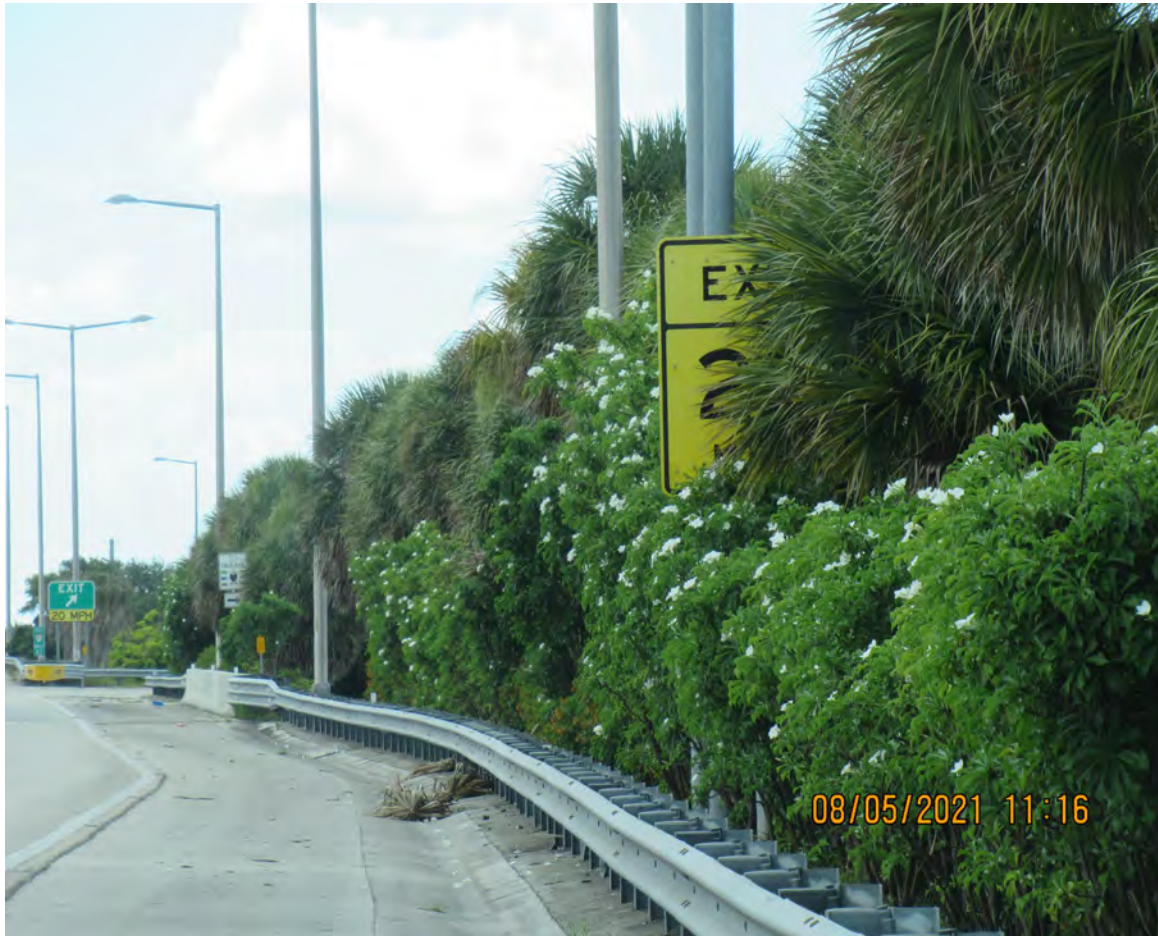
**PHOTO NO.: EB-012
DATE: 8-5-2021**

OVERGROWN VEGETATION OBSTRUCTING SPEED LIMIT SIGN

ITEM NOTED TO BE ADDRESSED BY MDX MAINTENANCE

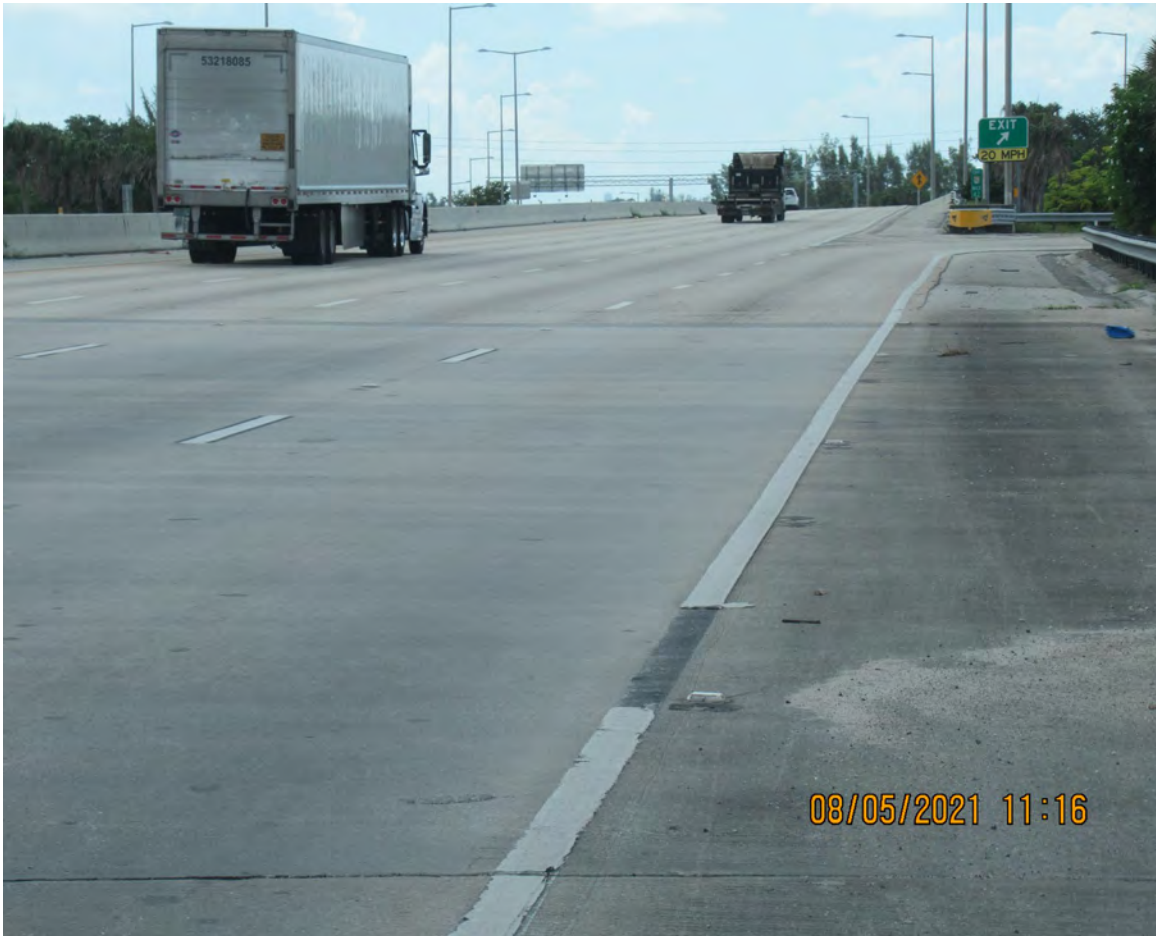
**PHOTO NO.: EB-013
DATE: 8-5-2021**

**MISSING WHITE EDGELINE HIGH PERFORMANCE TAPE
(BRIDGE # 870039)**

ITEM NOTED TO BE ADDRESSED BY MDX MAINTENANCE

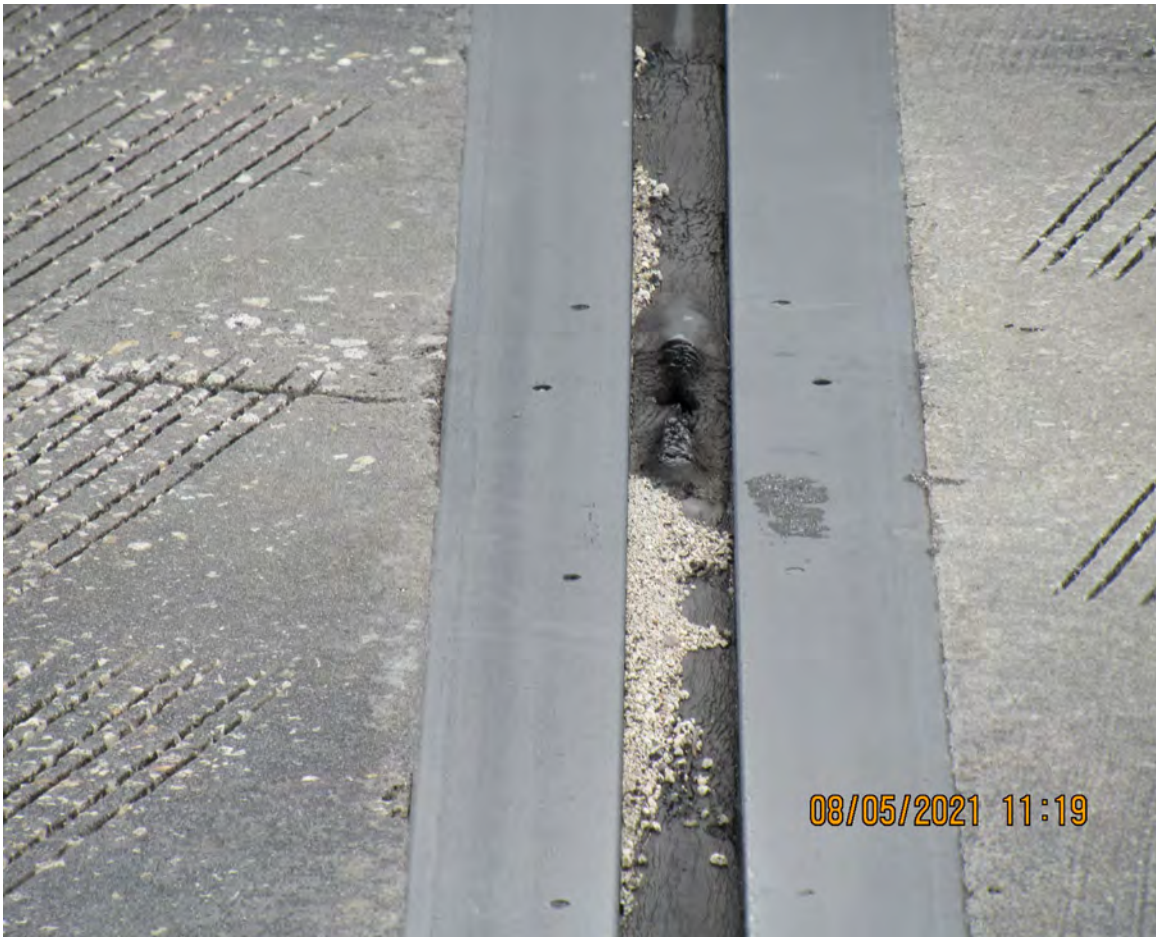
**PHOTO NO.: EB-014
DATE: 8-5-2021**

**DETERIORATED BRIDGE JOINT
(BRIDGE # 870740)**

ITEM NOTED TO BE ADDRESSED BY MDX WORK PROGRAM No. 30029

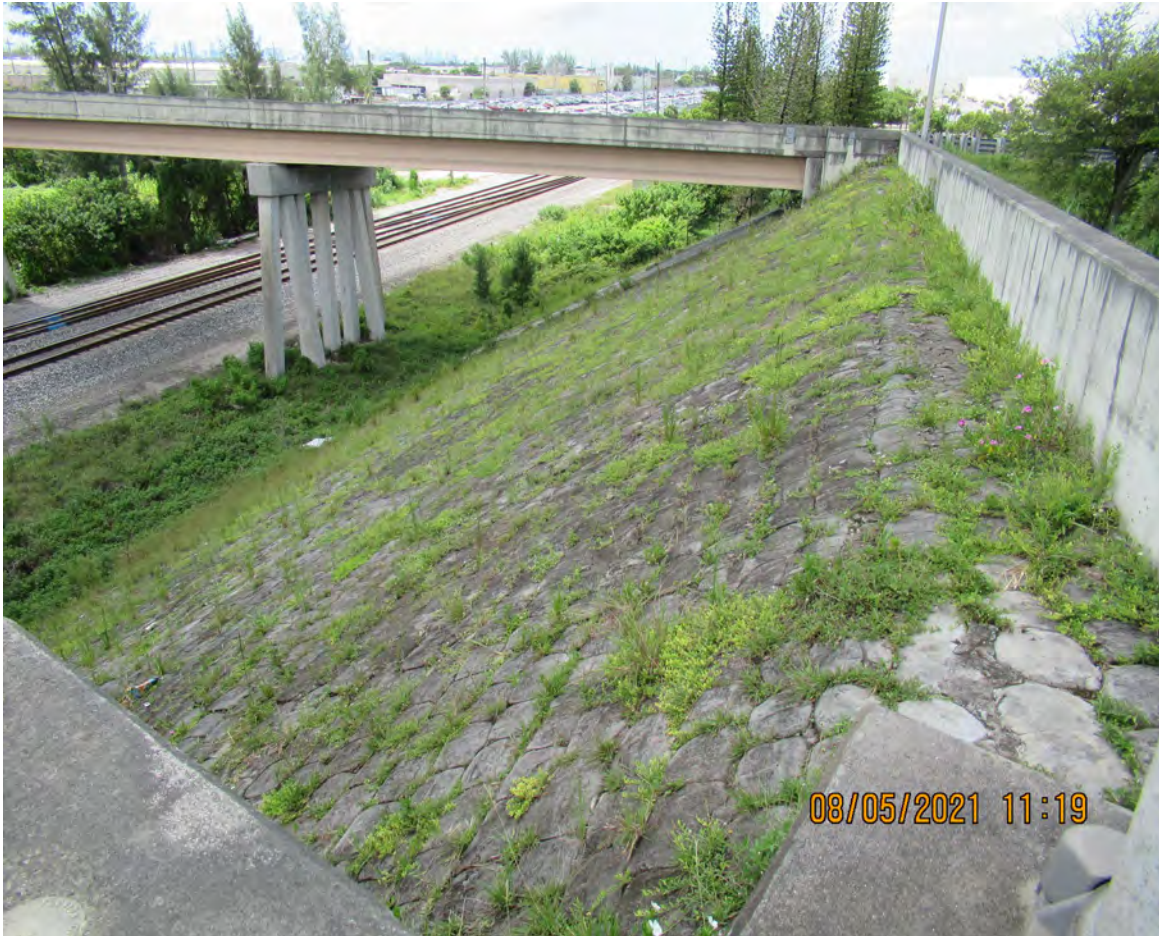
**PHOTO NO.: EB-015
DATE: 8-5-2021**

**OVERGROWN VEGETATION ON BRIDGE SLOPE
(BRIDGE # 870740)**

ITEM NOTED TO BE ADDRESSED BY MDX MAINTENANCE

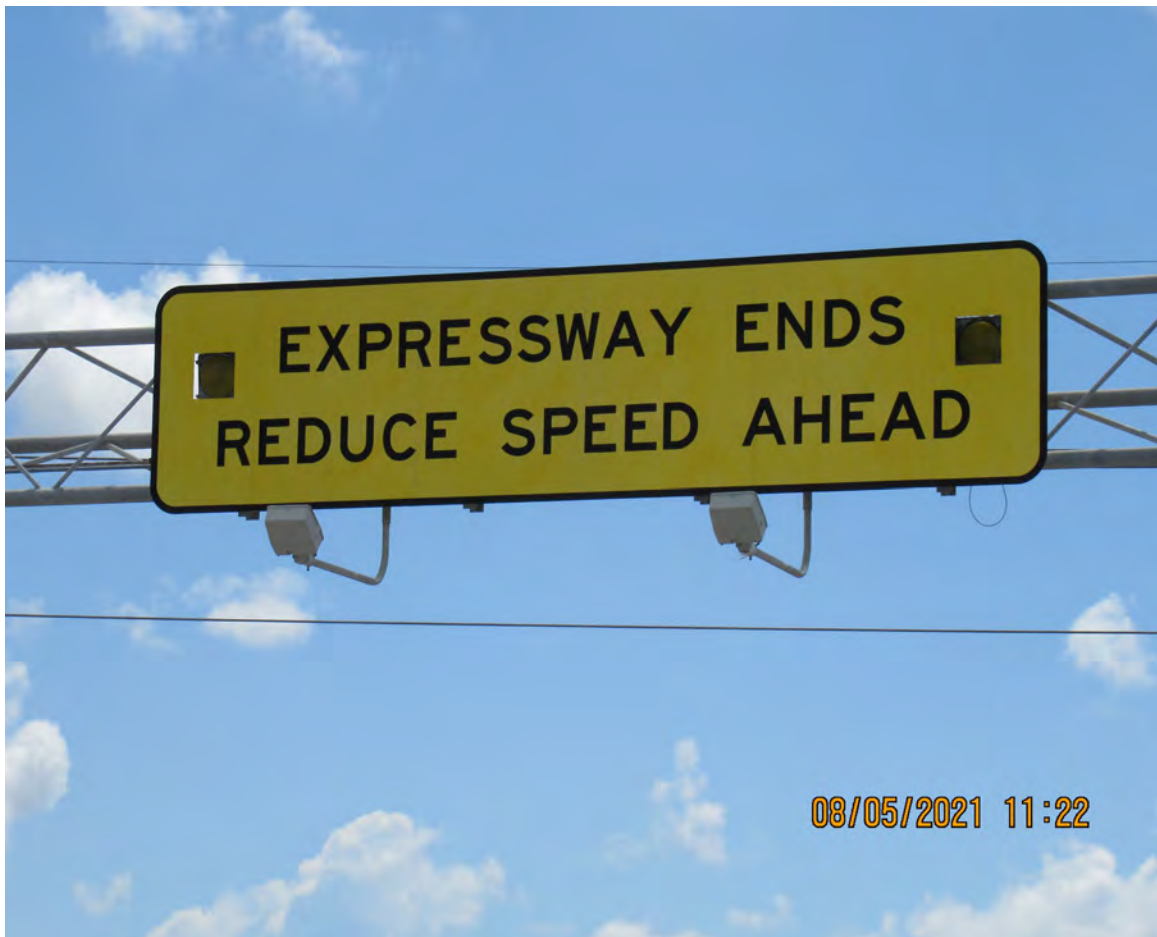
**PHOTO NO.: EB-017
DATE: 8-5-2021**

FLASHING AMBER LIGHTS AND LUMINAIRES NOT WORKING

ITEM NOTED TO BE ADDRESSED BY MDX MAINTENANCE

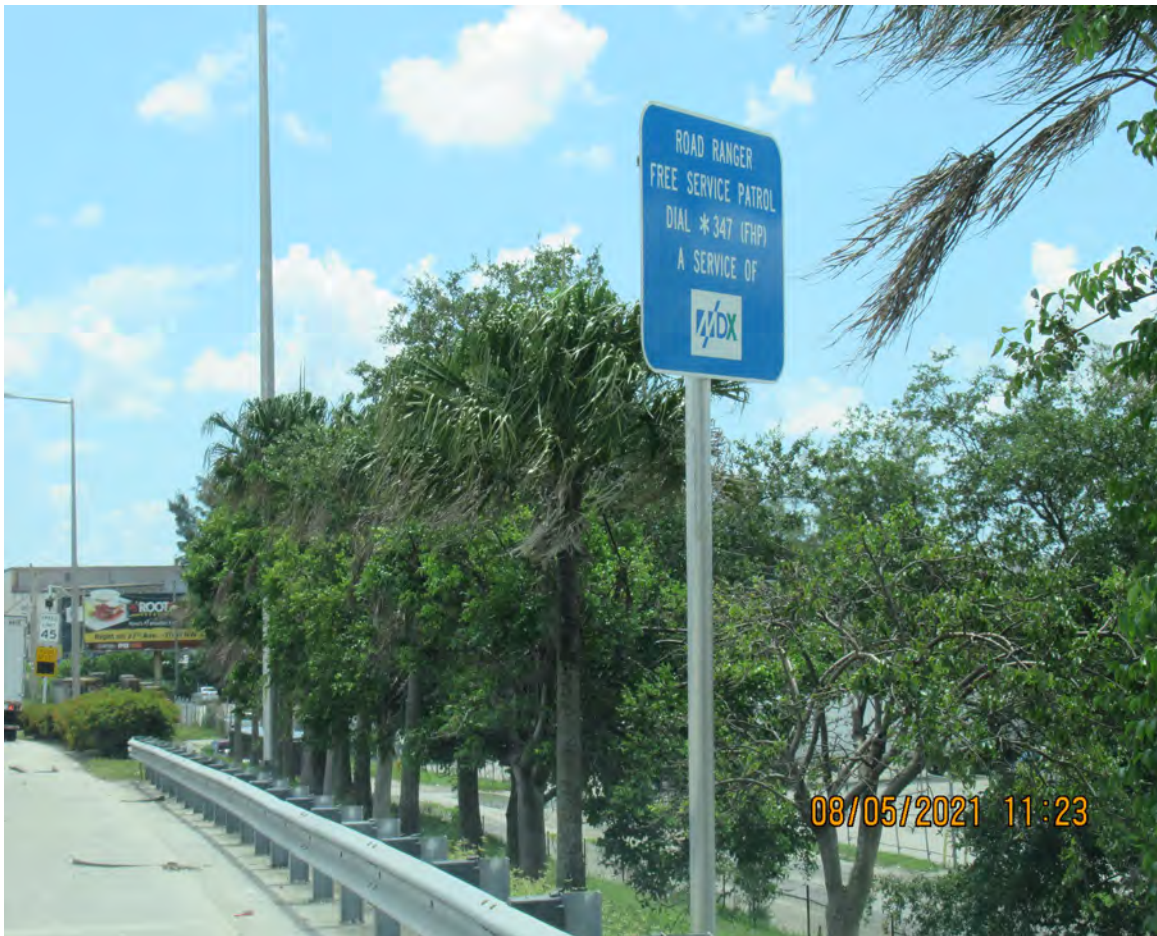
**PHOTO NO.: EB-018
DATE: 8-5-2021**

TWISTED SIGN PANEL

ITEM NOTED TO BE ADDRESSED BY MDX MAINTENANCE

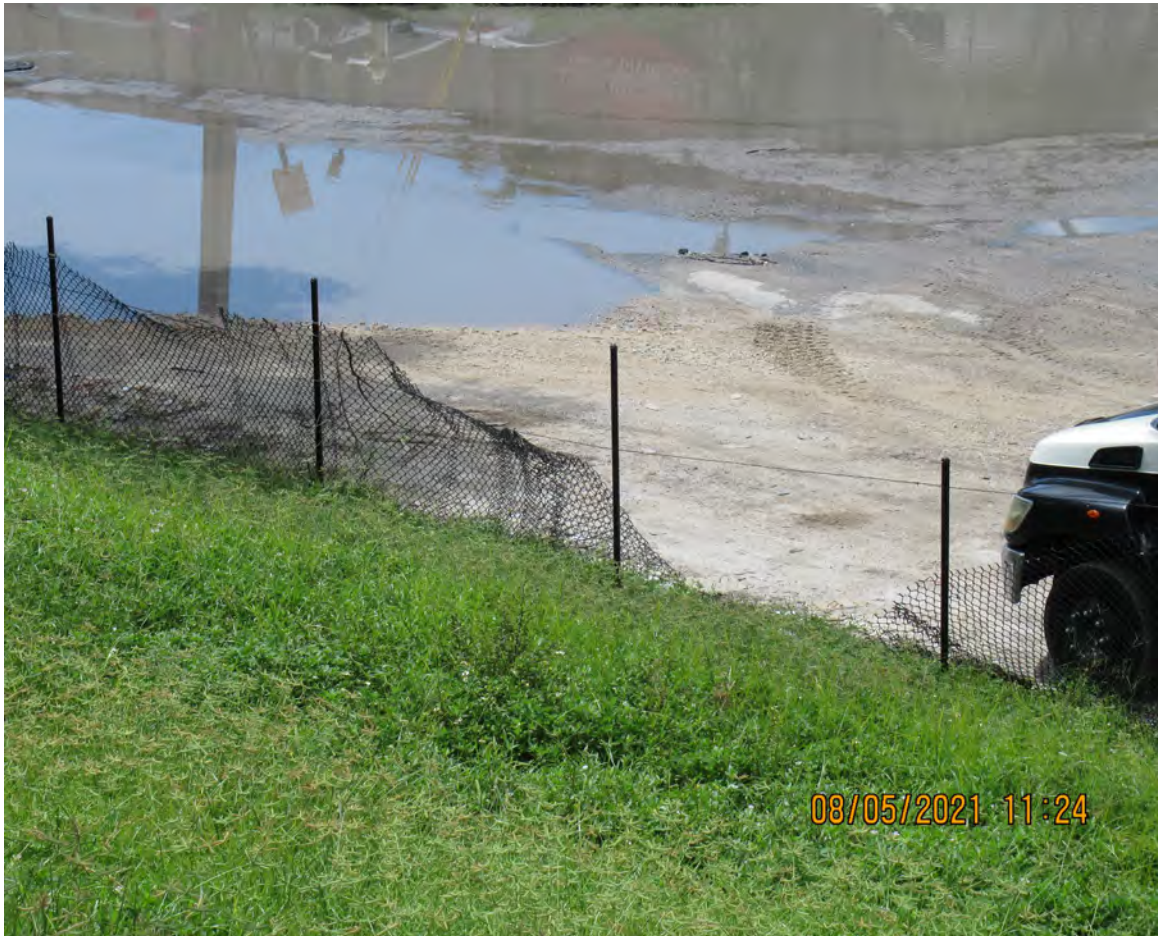
**PHOTO NO.: EB-019
DATE: 8-5-2021**

DAMAGED FENCE

ITEM NOTED TO BE ADDRESSED BY MDX MAINTENANCE

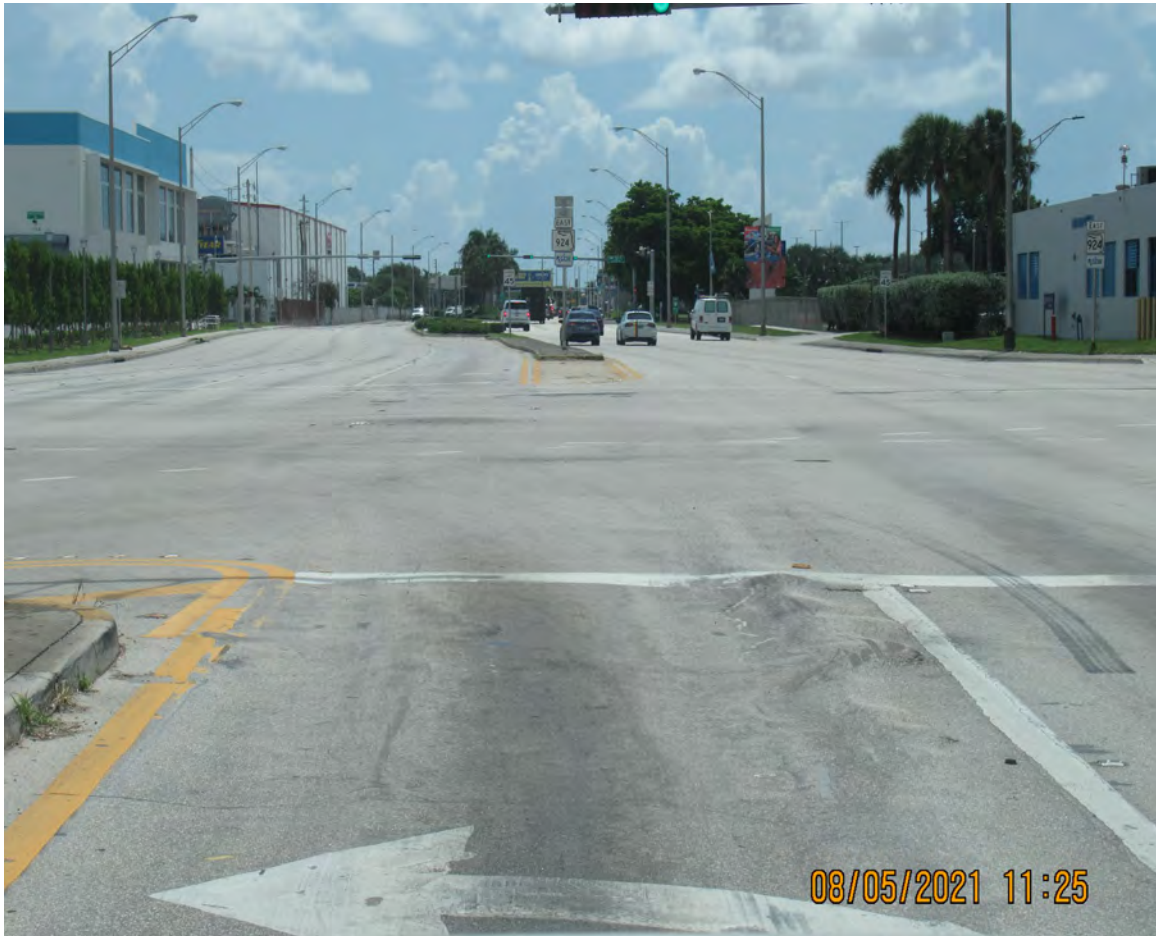
**PHOTO NO.: EB-020
DATE: 8-5-2021**

DAMAGED PAVEMENT (LEFT TURN AND CENTER LANES)

ITEM NOTED TO BE ADDRESSED BY MDX MAINTENANCE

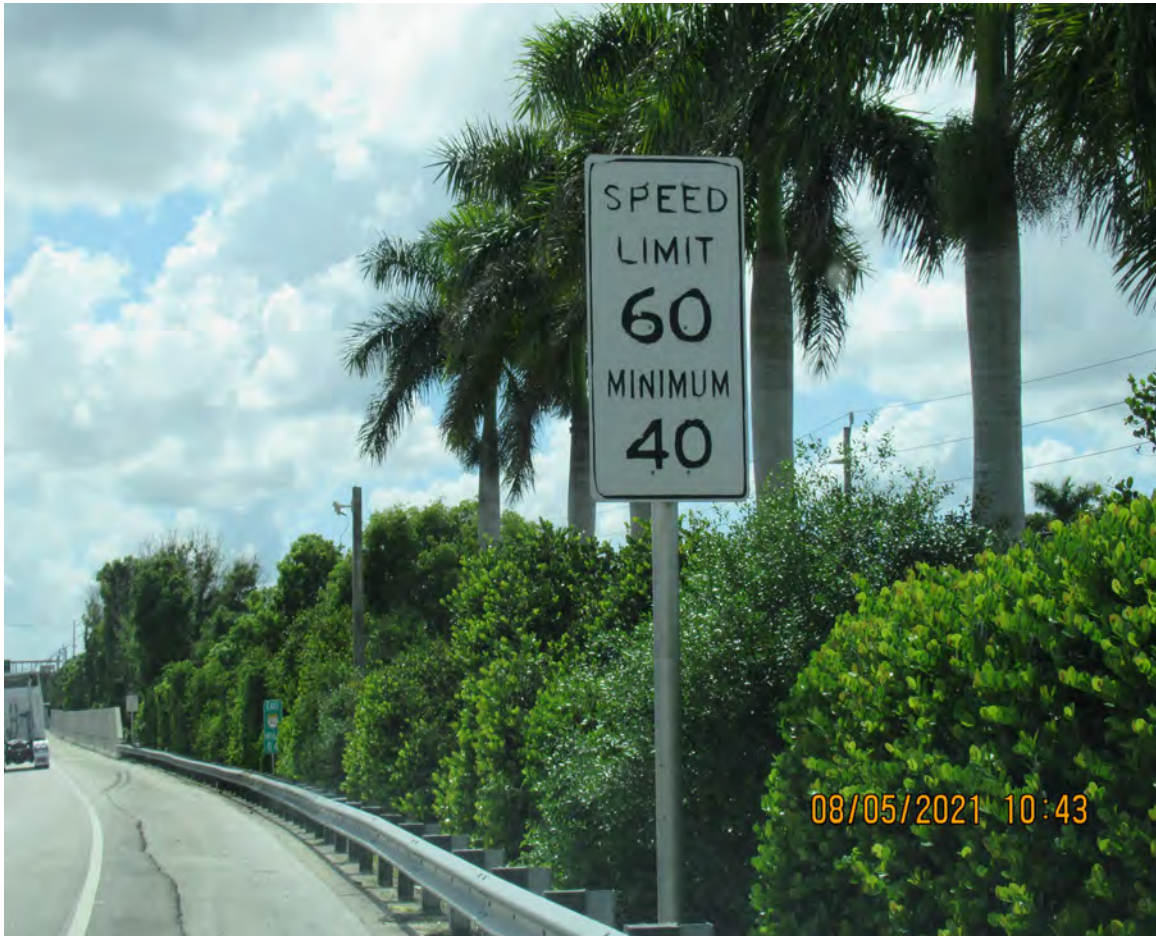
**PHOTO NO.: EB-021
DATE: 8-5-2021**

DETERIORATED REFLECTIVE SHEETING ON SPEED LIMIT SIGN

ITEM NOTED TO BE ADDRESSED BY MDX MAINTENANCE

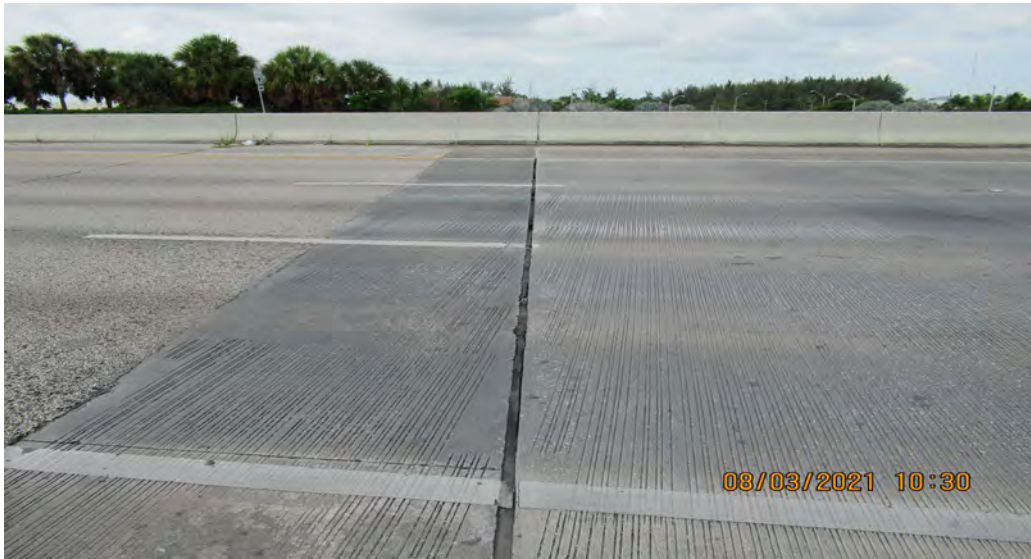
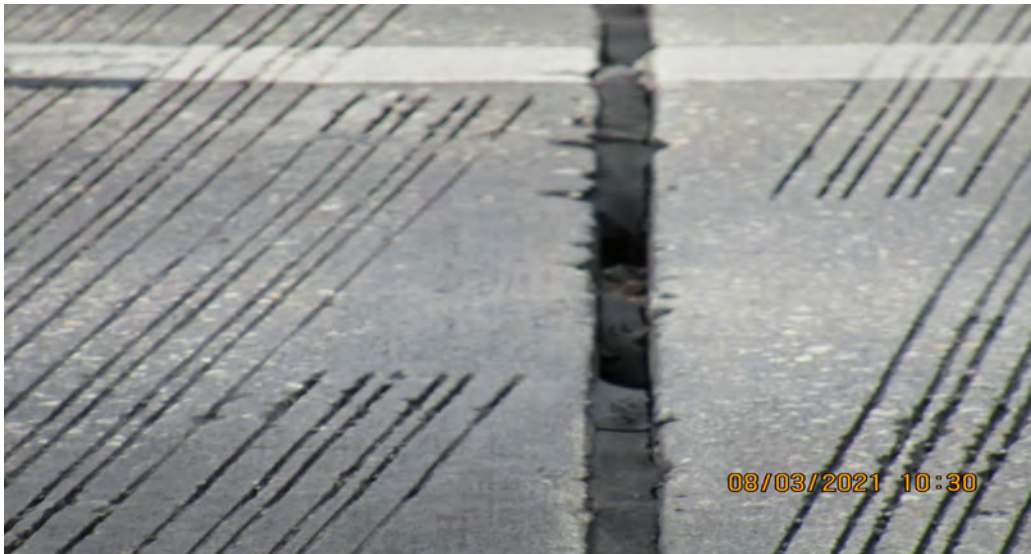
**PHOTO NO.: WB-001
DATE: 8-3-2021**

DETERIORATED JOINT SEALANT (BRIDGE # 870739)

ITEM NOTED TO BE ADDRESSED BY MDX WORK PROGRAM No. 30029

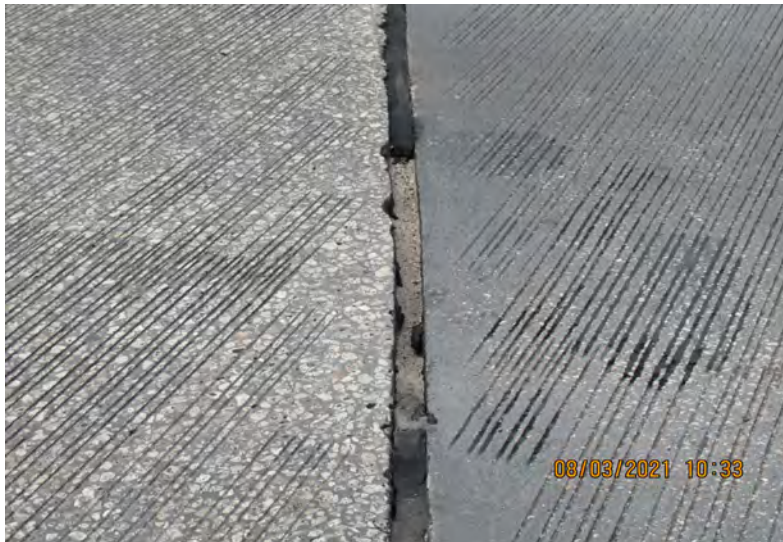
**PHOTO NO.: WB-002
DATE: 8-3-2021**

DETERIORATED JOINT SEALANT (BRIDGE # 870738)

ITEM NOTED TO BE ADDRESSED BY MDX WORK PROGRAM No. 30029

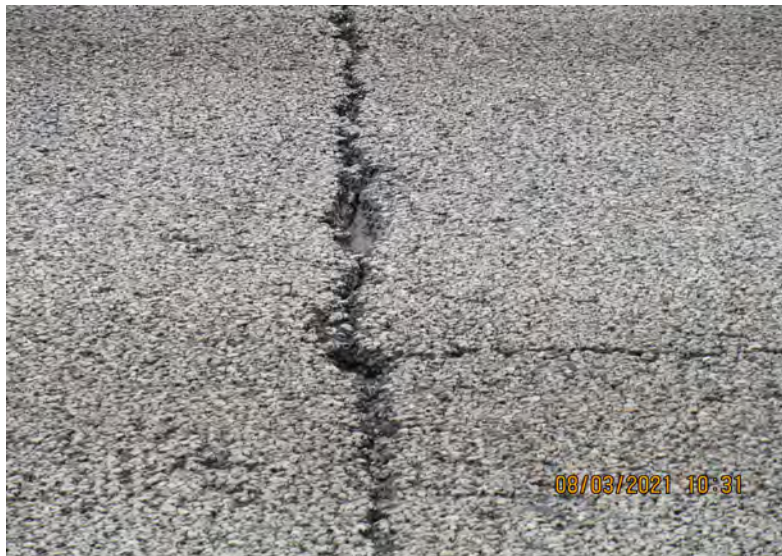
TRANSVERSE PAVEMENT CRACK AT APPROACH SLAB (BRIDGE # 870738)

ITEM NOTED TO BE ADDRESSED BY MDX MAINTENANCE

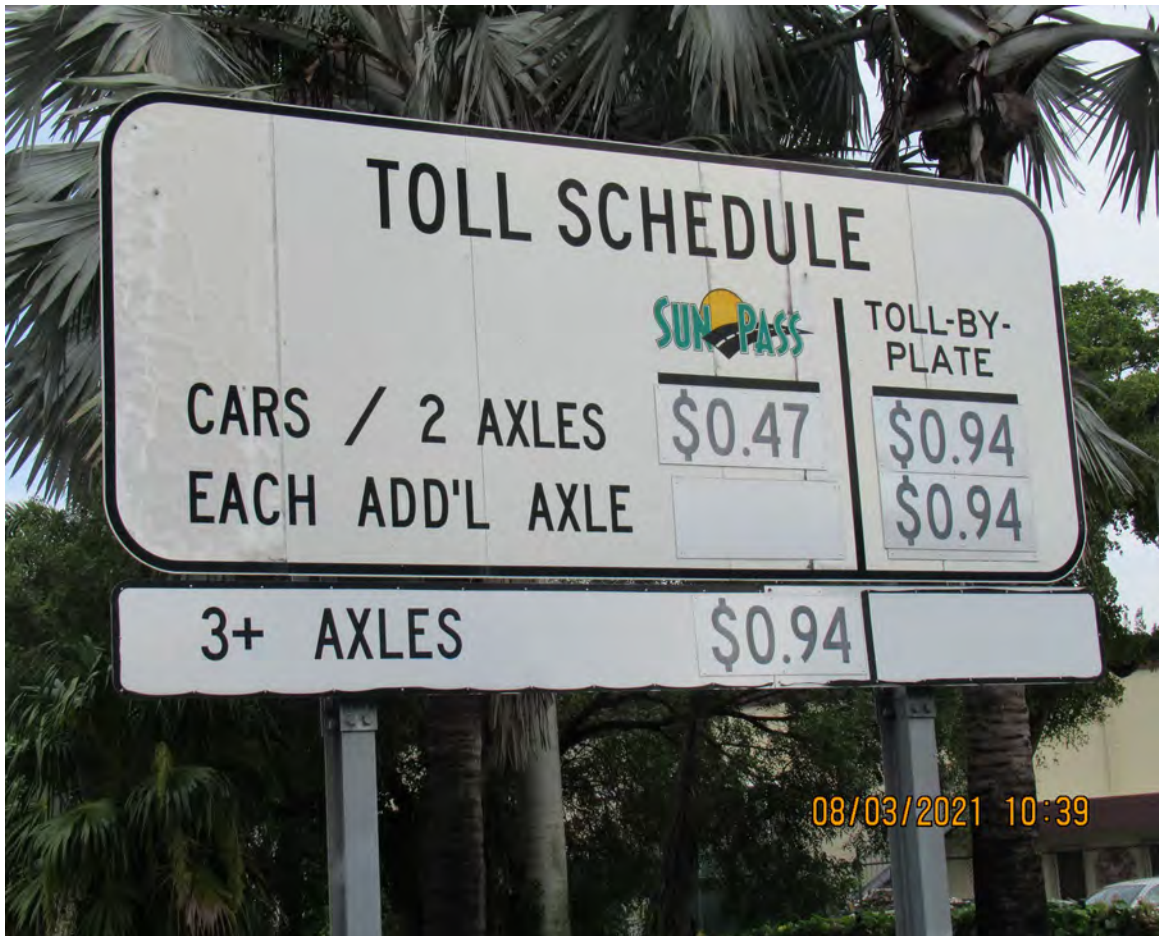
**PHOTO NO.: WB-003
DATE: 8-3-2021**

DETERIORATED REFLECTIVE SHEETING

ITEM NOTED TO BE ADDRESSED BY MDX MAINTENANCE

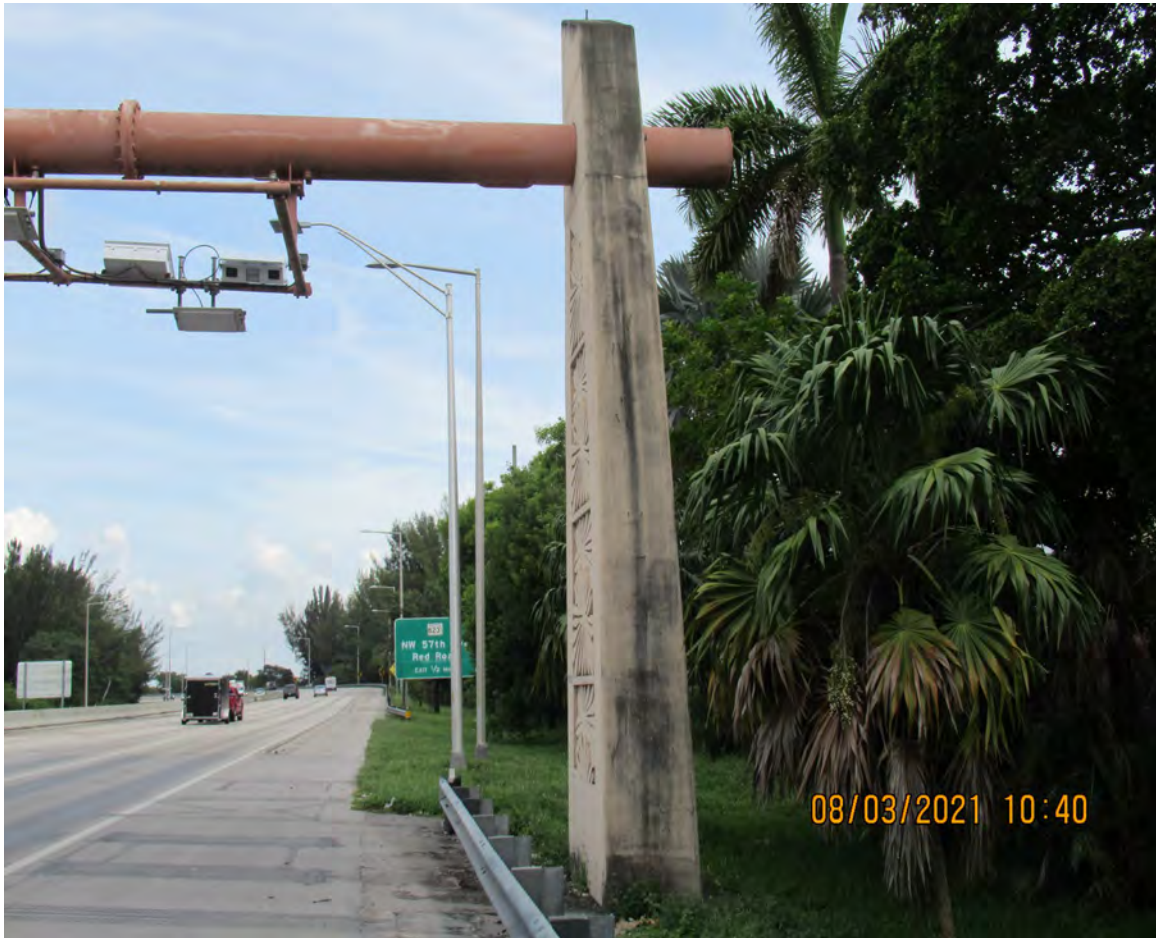
**PHOTO NO.: WB-004
DATE: 8-3-2021**

**DETERIORATED PAINT ON STRUCTURE UPRIGHT AND MONOTUBE
(STRUCTURE # 87S932)**

ITEM NOTED TO BE ADDRESSED BY MDX WORK PROGRAM No. 30037 & 30043
