Annual Inspection Report 2021

General Engineering Consultant to the
Miami-Dade County Expressway Authority

ANNUAL INSPECTION REPORT 2021

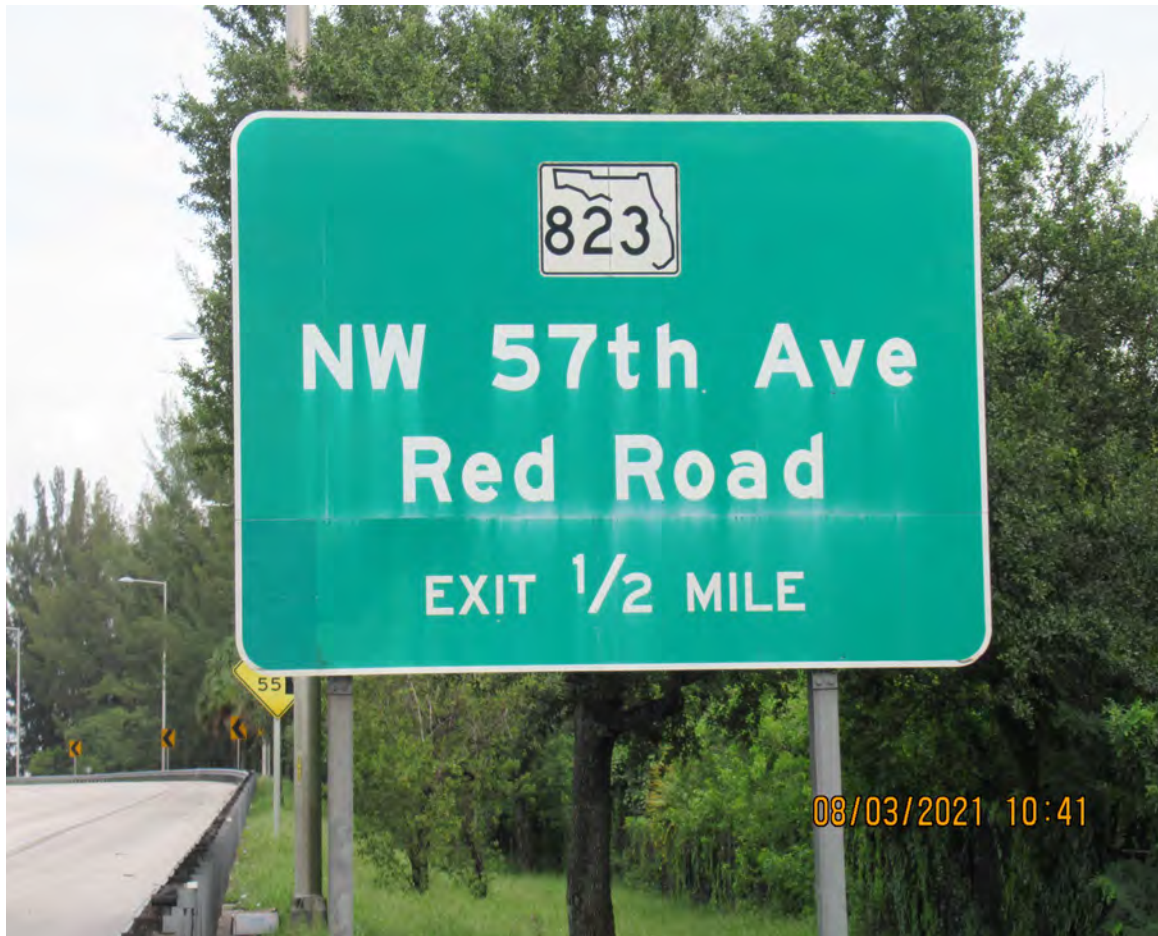
**PHOTO NO.: WB-005
DATE: 8-3-2021**

DETERIORATED REFLECTIVE SHEETING

ITEM NOTED TO BE ADDRESSED BY MDX MAINTENANCE

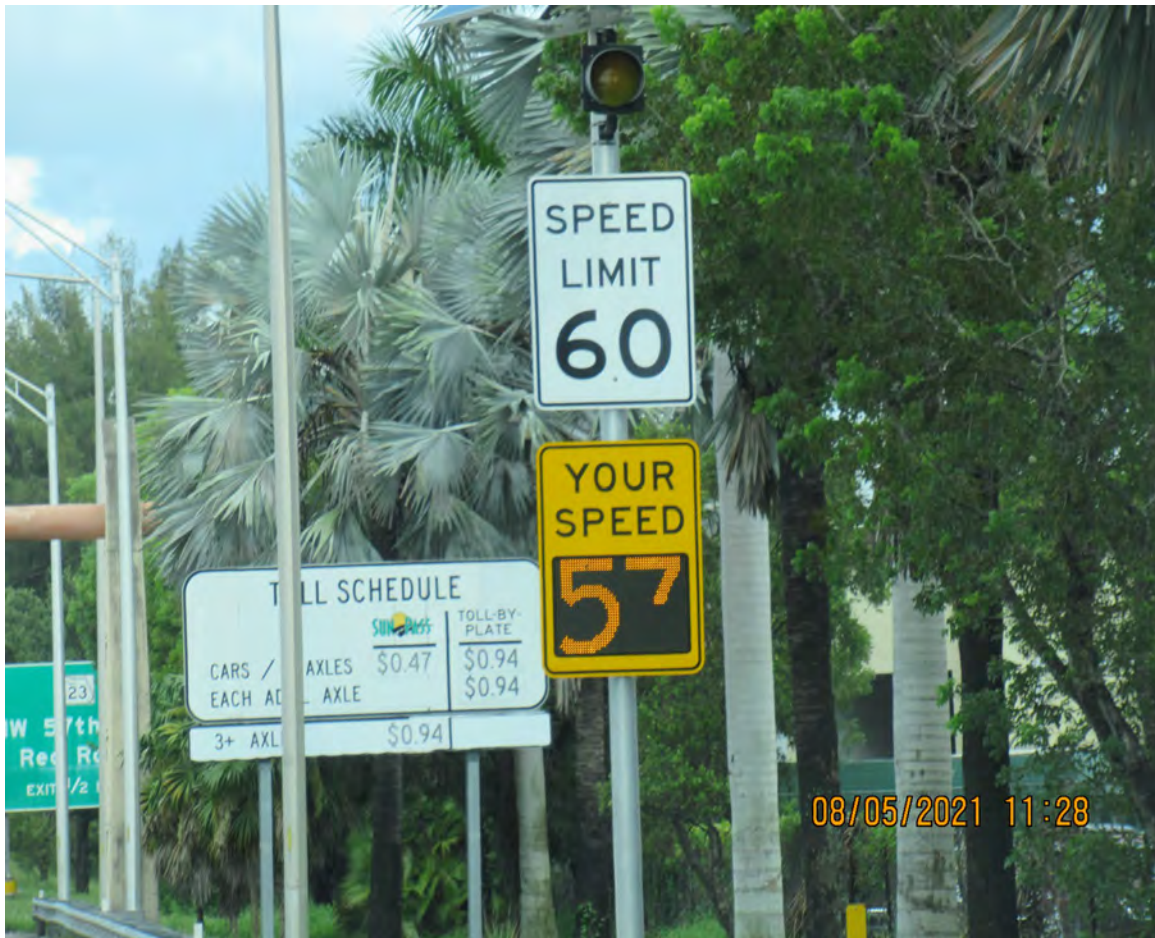
**PHOTO NO.: WB-006
DATE: 8-5-2021**

MALFUNCTIONING SPEED LIMIT SIGN

ITEM NOTED TO BE ADDRESSED BY MDX MAINTENANCE

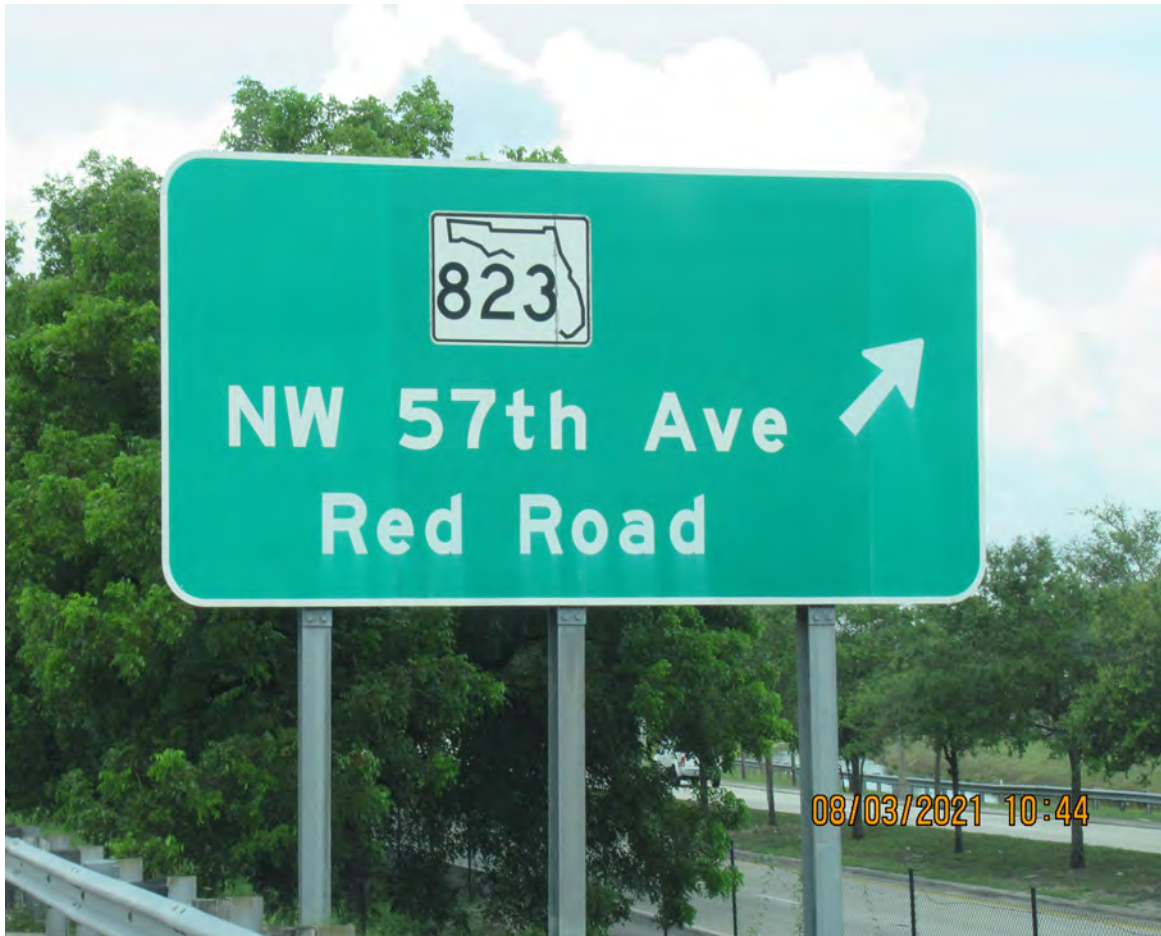
**PHOTO NO.: WB-007
DATE: 8-3-2021**

DETERIORATED REFLECTIVE SHEETING ON SIGN PANEL

ITEM NOTED TO BE ADDRESSED BY MDX MAINTENANCE

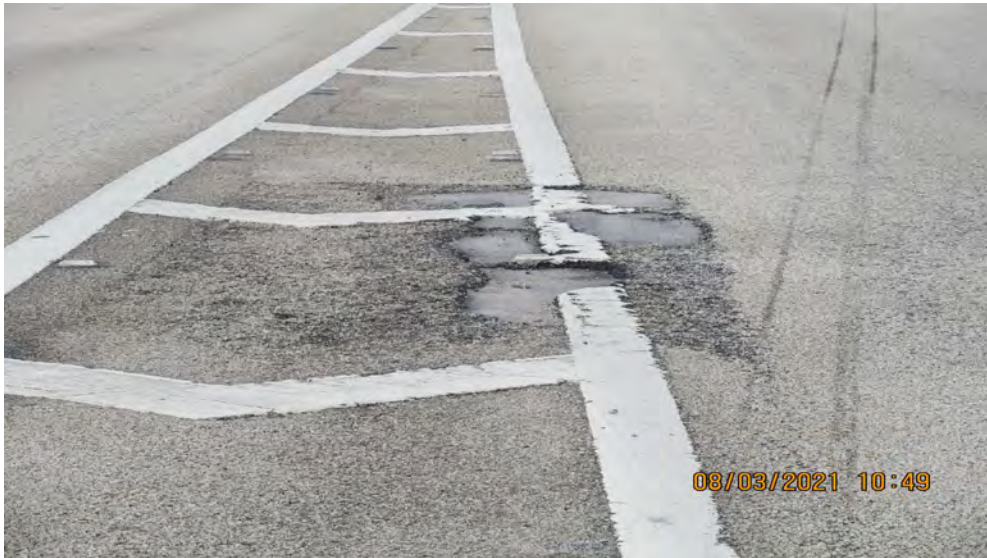
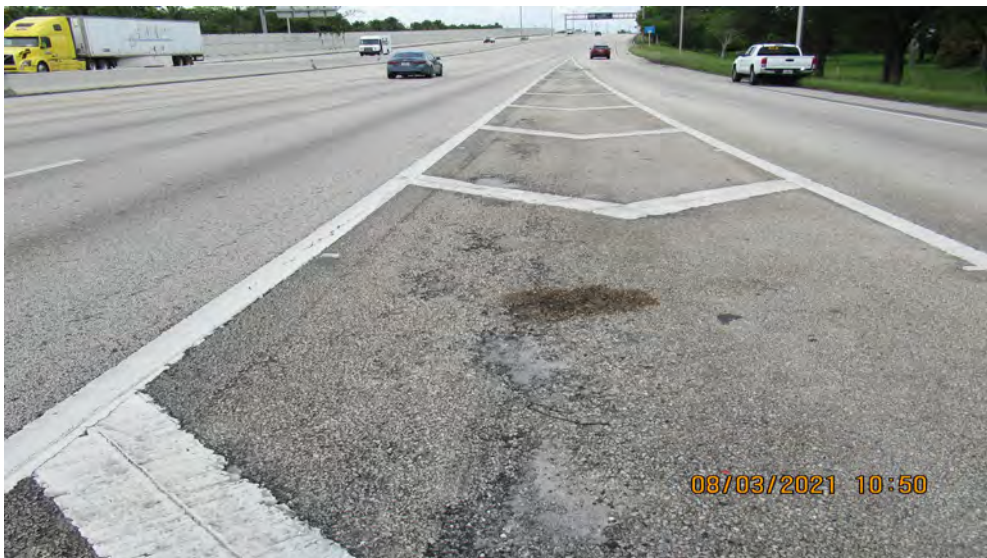
**PHOTO NO.: WB-008
DATE: 8-3-2021**

DETERIORATED PAVEMENT

ITEM NOTED TO BE ADDRESSED BY MDX MAINTENANCE

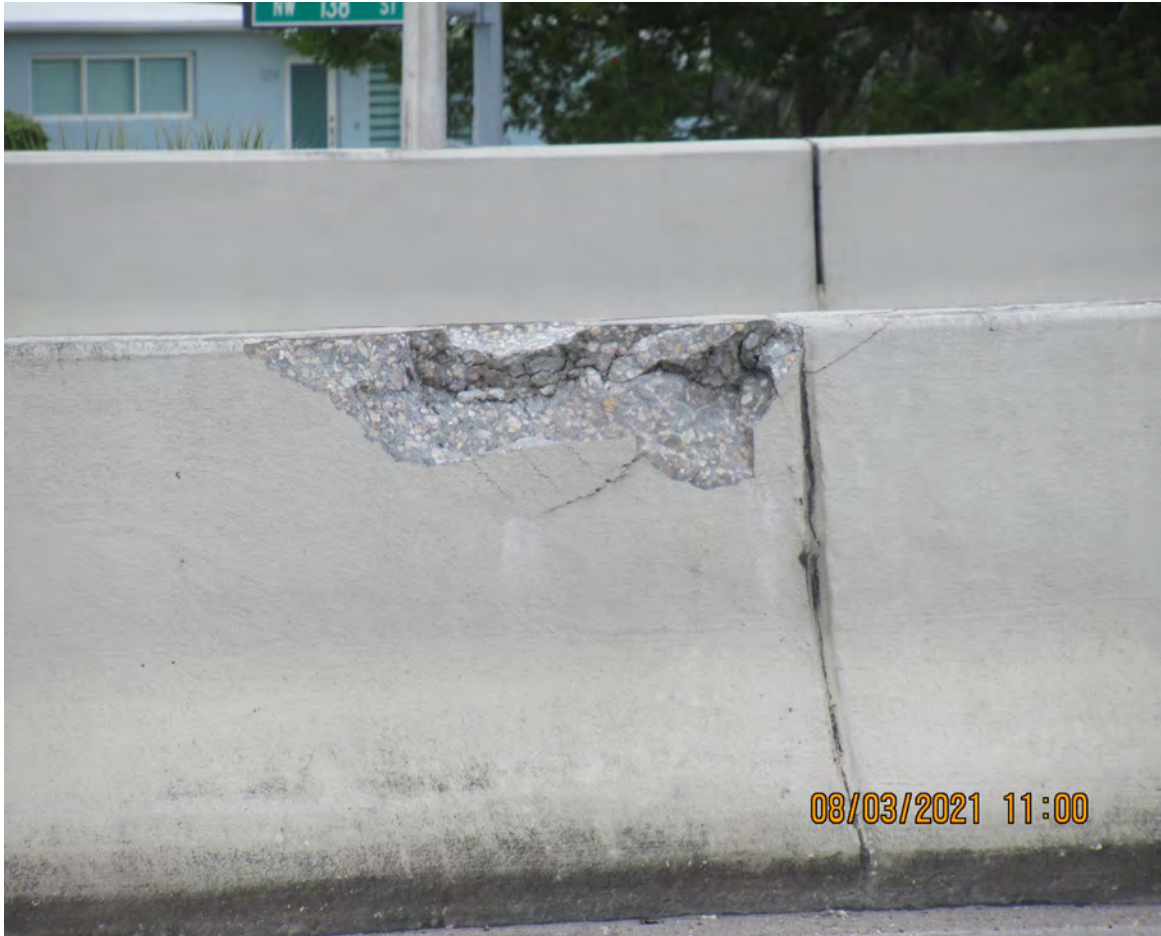
**PHOTO NO.: WB-009
DATE: 8-3-2021**

DAMAGED MEDIAN BARRIER WALL (BRIDGE # 870708)

ITEM NOTED TO BE ADDRESSED BY MDX MAINTENANCE

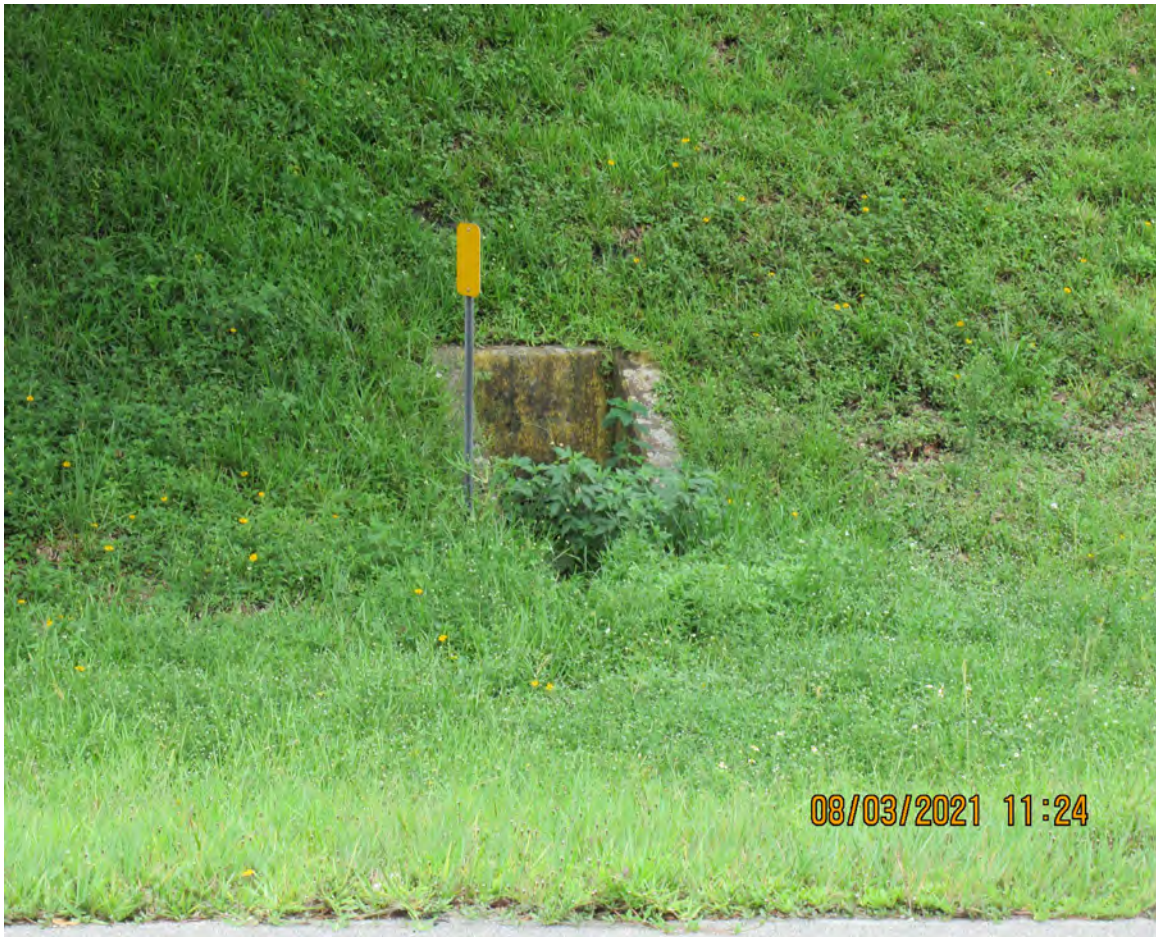
**PHOTO NO.: WB-010
DATE: 8-3-2021**

**OVERGROWN VEGETATION OBSTRUCTING DRAINAGE OUTFALL
(TYPICAL THROUGHOUT THE CORRIDOR)**

ITEM NOTED TO BE ADDRESSED BY MDX MAINTENANCE

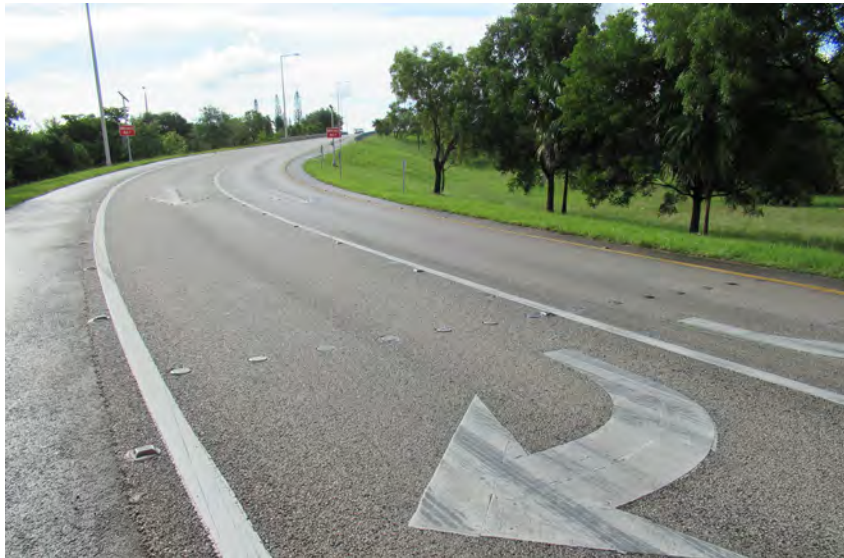
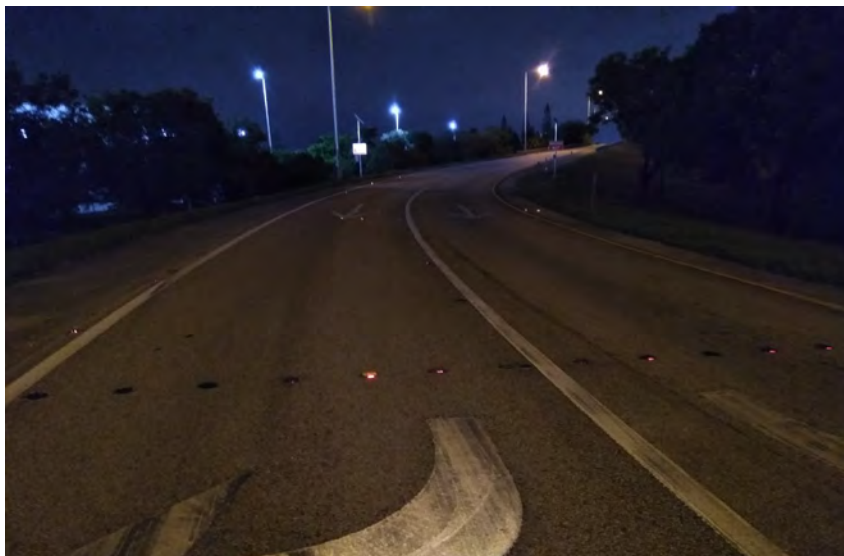
**PHOTO NO.: WB-011
DATE: 8-3-2021**

MALFUNCTIONING ILLUMINATED PAVEMENT MARKERS (RPM'S)

ITEM NOTED TO BE ADDRESSED BY MDX MAINTENANCE

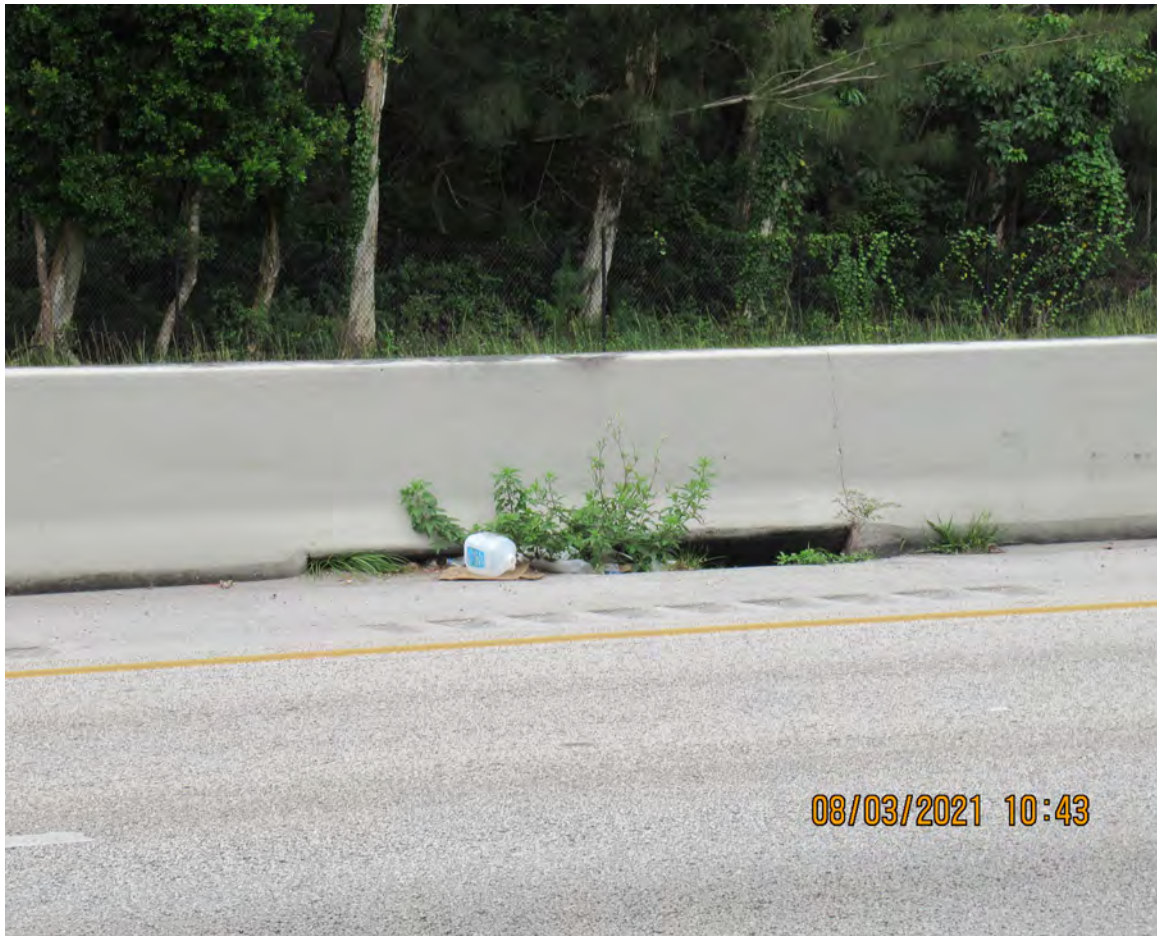
**PHOTO NO.: WB-013
DATE: 8-3-2021**

**SILTED DRAINAGE STRUCTURE
(TYPICAL TROUGHOUT THE CORRIDOR)**

ITEM NOTED TO BE ADDRESSED BY MDX MAINTENANCE

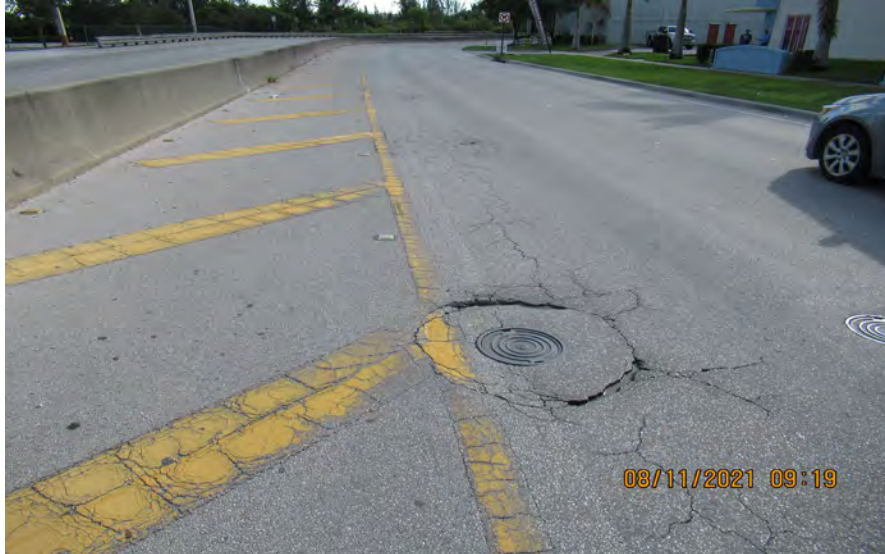
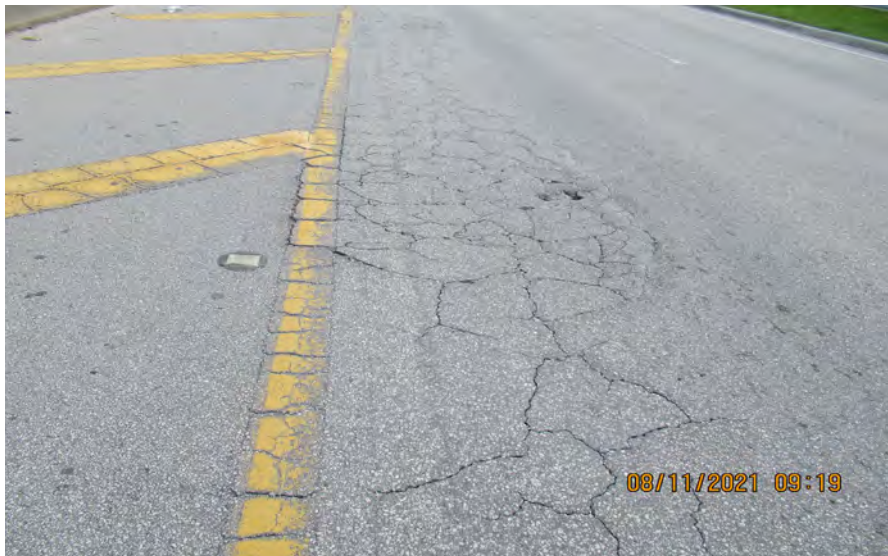
**PHOTO NO.: EB-001
DATE: 8-11-2021**

DETERIORATED PAVEMENT AND STRIPING

ITEM NOTED TO BE ADDRESSED BY MDX MAINTENANCE

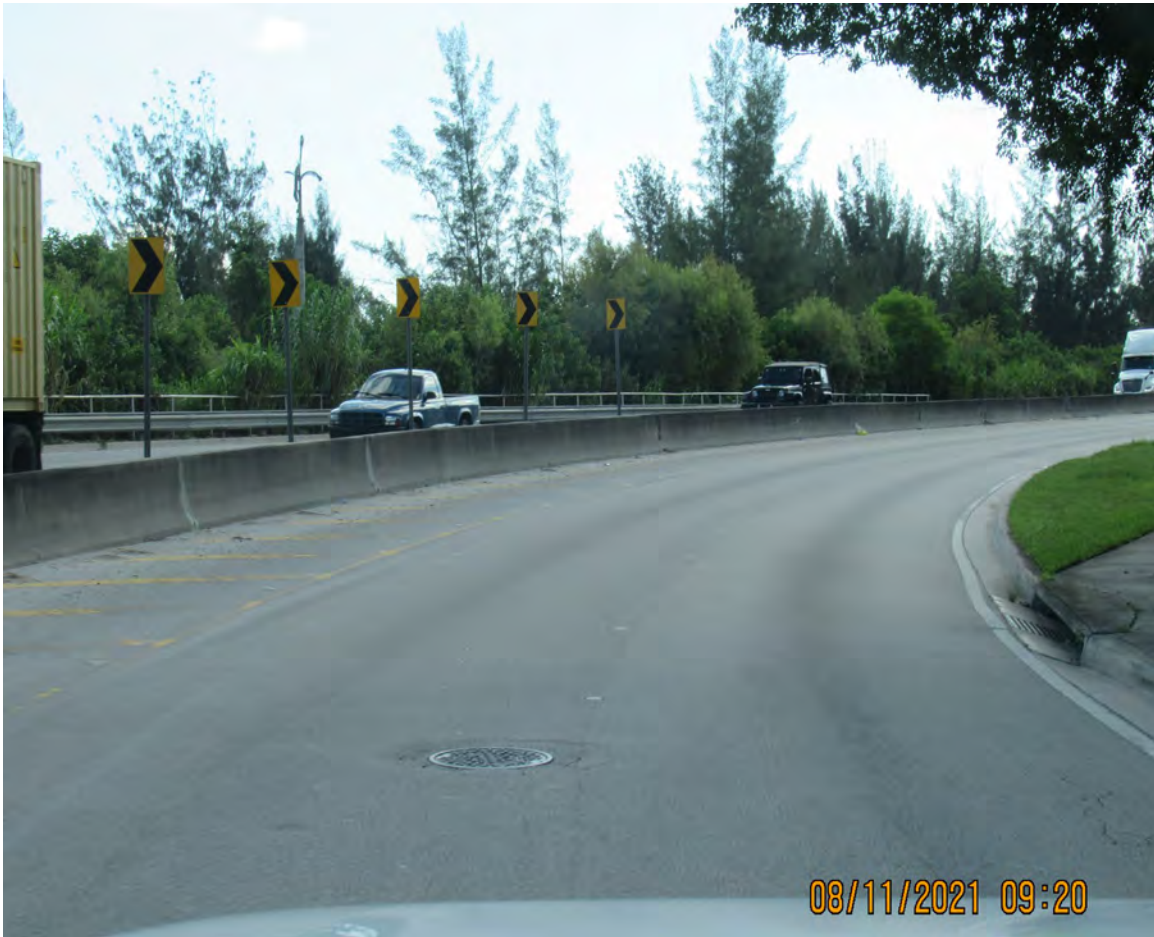
**PHOTO NO.: EB-002
DATE: 8-11-2021**

DETERIORATED WHITE SKIP AND EDGE LINE STRIPING

ITEM NOTED TO BE ADDRESSED BY MDX MAINTENANCE

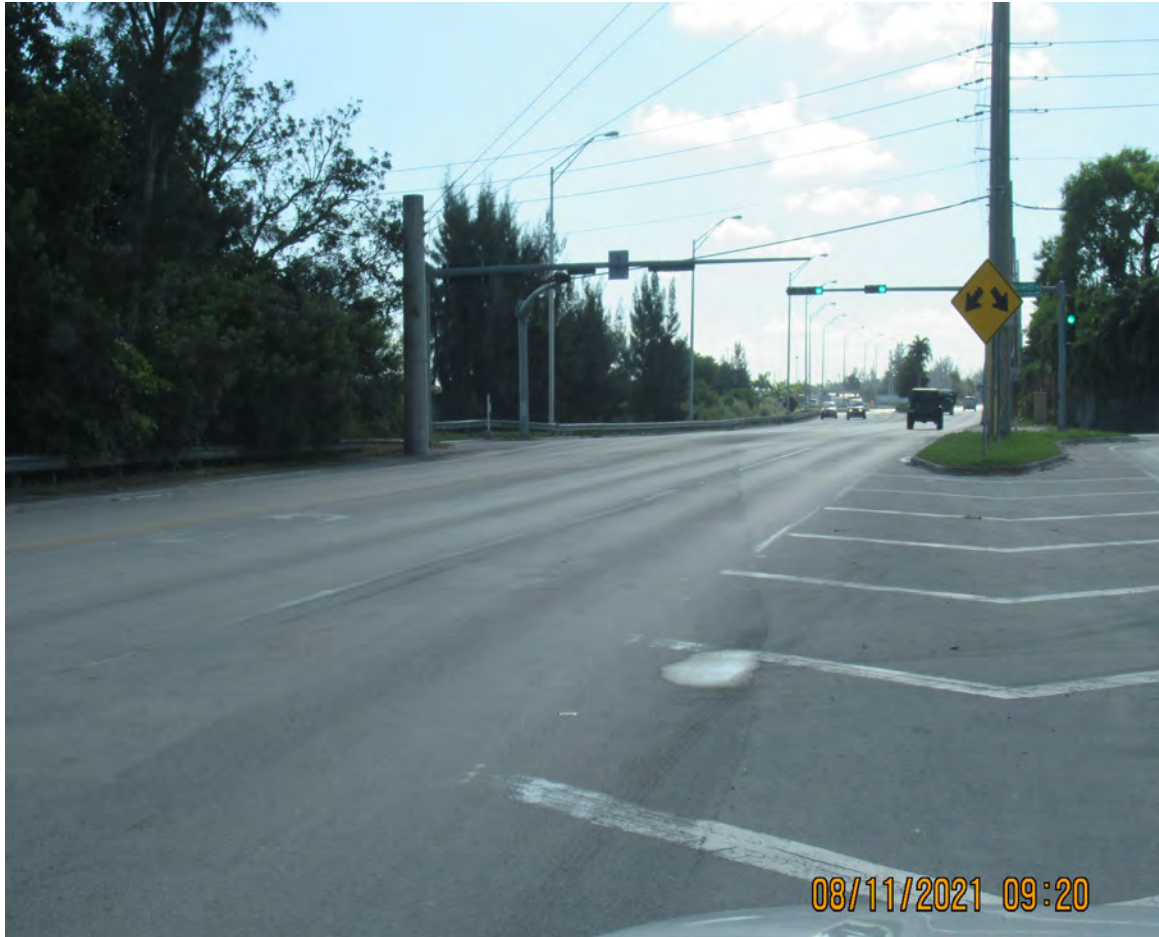
**PHOTO NO.: EB-003
DATE: 8-11-2021**

DETERIORATED STRIPING ON MAINLINE AND GORE

ITEM NOTED TO BE ADDRESSED BY MDX MAINTENANCE

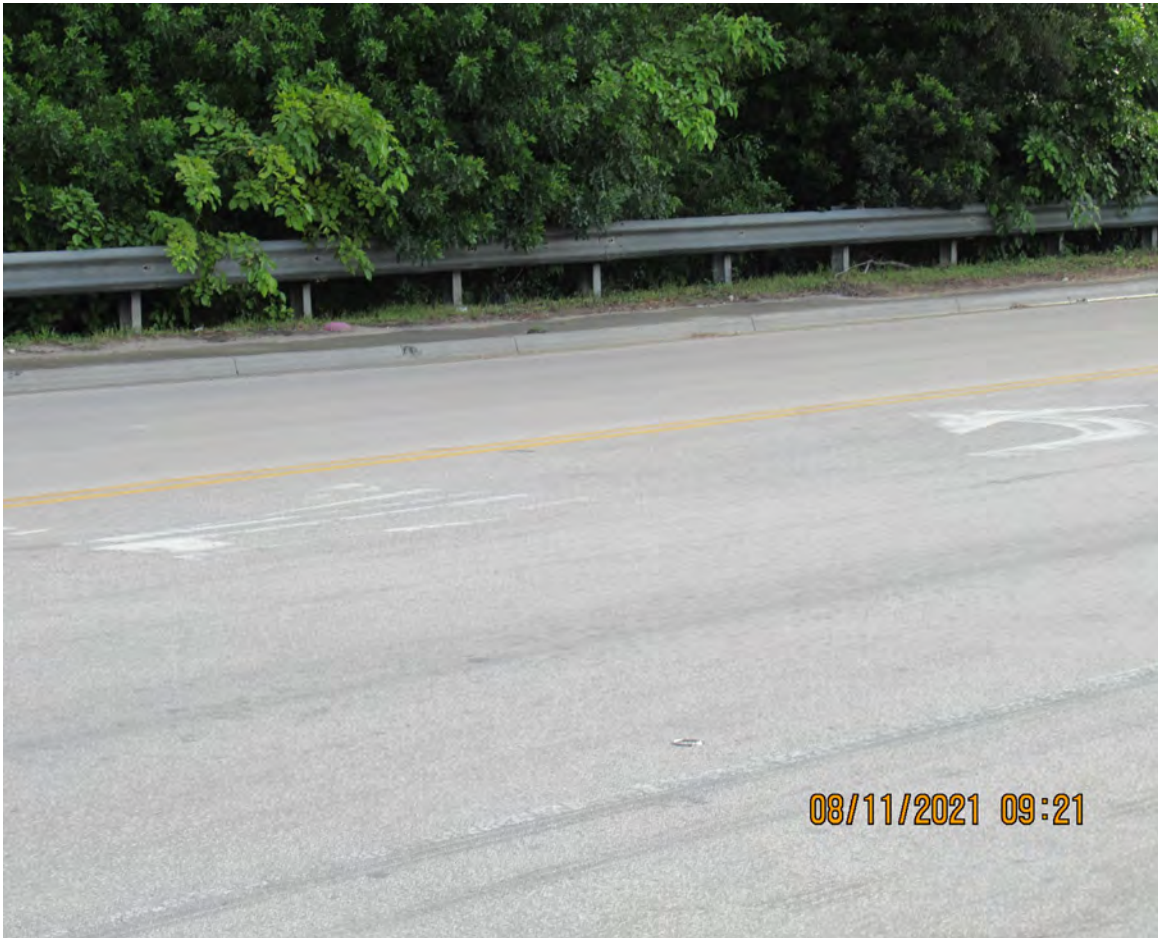
**PHOTO NO.: EB-004
DATE: 8-11-2021**

DETERIORATED PAVEMENT MESSAGE AND TURN ARROW

ITEM NOTED TO BE ADDRESSED BY MDX MAINTENANCE

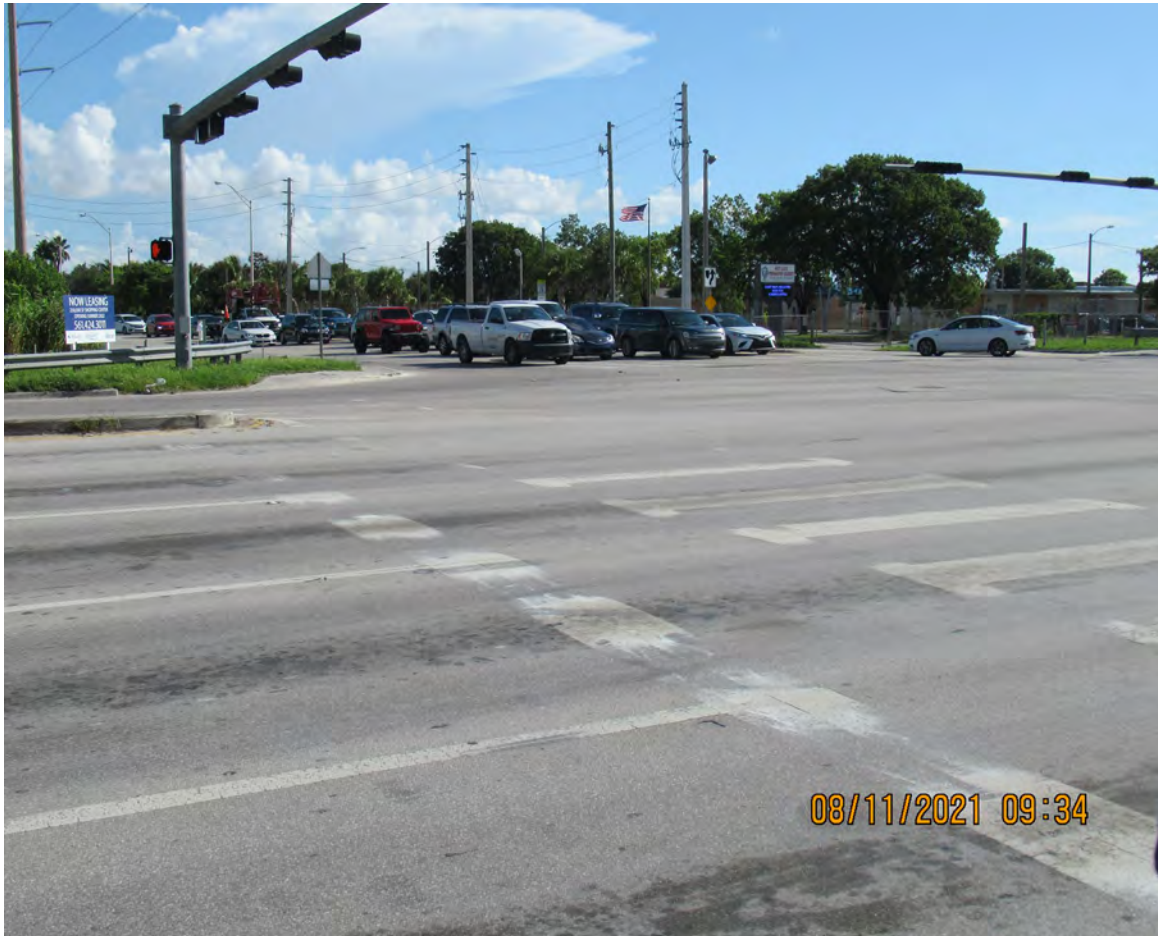
**PHOTO NO.: EB-006
DATE: 8-11-2021**

DETERIORATED STOP BAR, PEDESTRIAN CROSSWALK AND ROADWAY STRIPING

ITEM NOTED TO BE ADDRESSED BY MDX MAINTENANCE

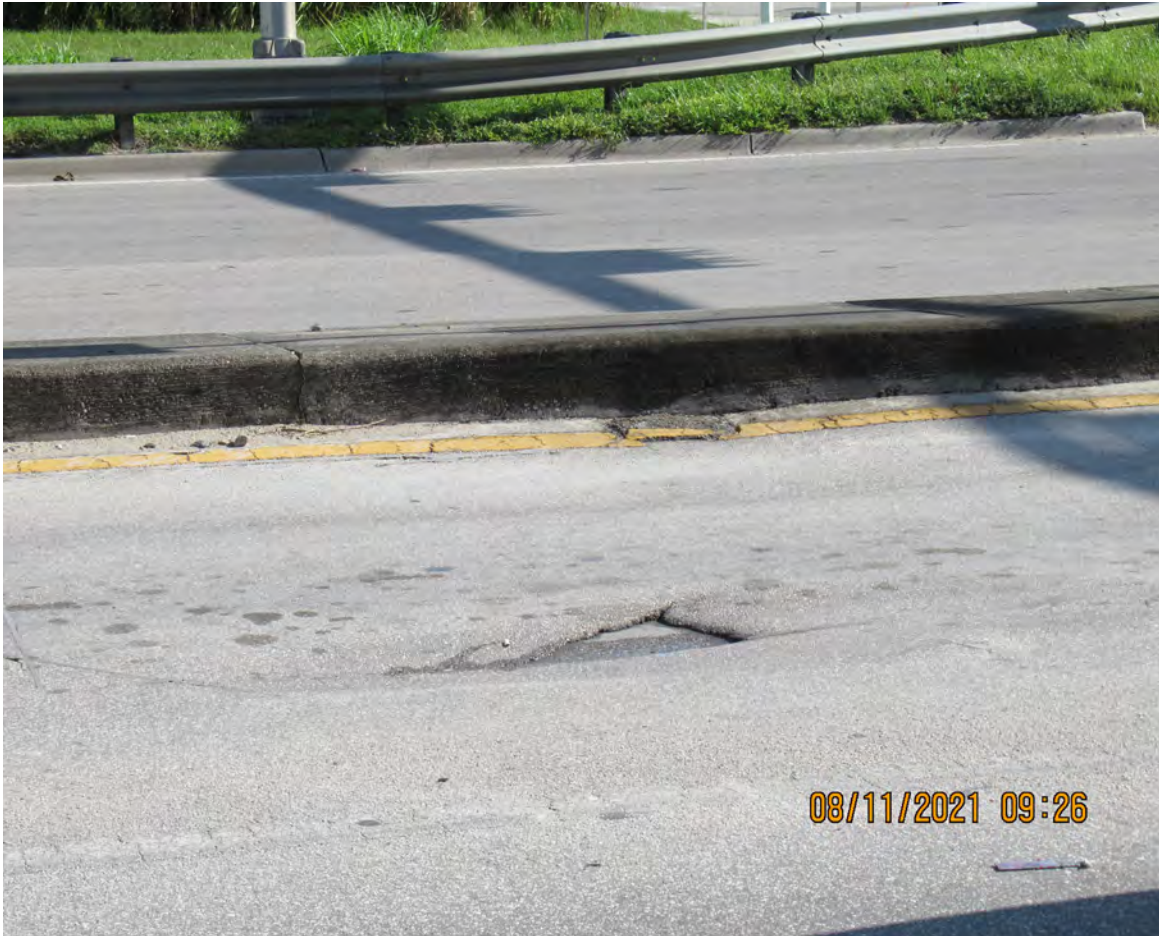
**PHOTO NO.: EB-007
DATE: 8-11-2021**

**ROADWAY INSPECTION
LOCATION: EASTBOUND NW 138TH ST
AT NW 97th AVENUE (LEFT TURN LANE)**

DETERIORATED PAVEMENT

ITEM NOTED TO BE ADDRESSED BY MDX MAINTENANCE

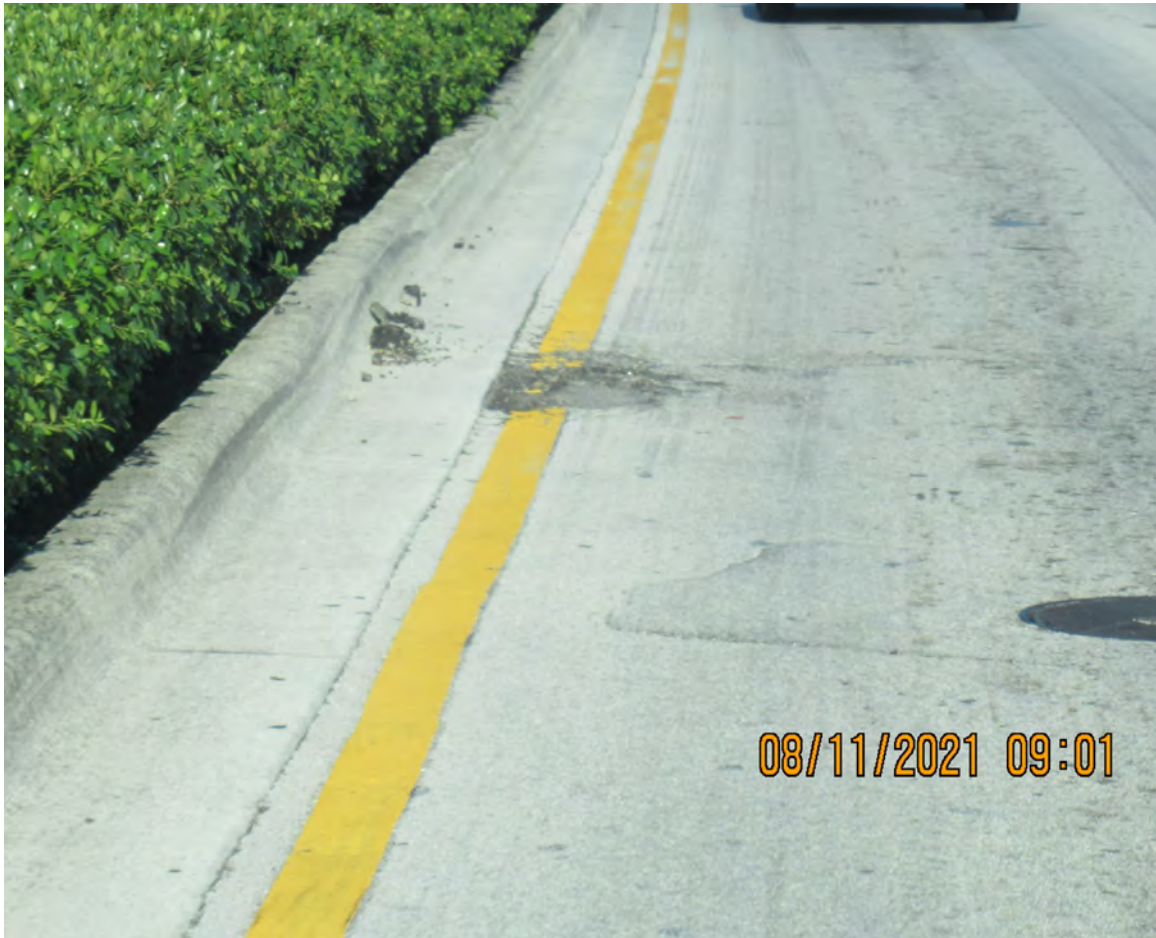
**PHOTO NO.: WB-001
DATE: 8-11-2021**

**ROADWAY INSPECTION
LOCATION: 300FT EAST OF NW 97th AVENUE
WESTBOUND NW 138th STREET**

DETERIORATED ASPHALT PAVEMENT AND STRIPING

ITEM NOTED TO BE ADDRESSED BY MDX MAINTENANCE

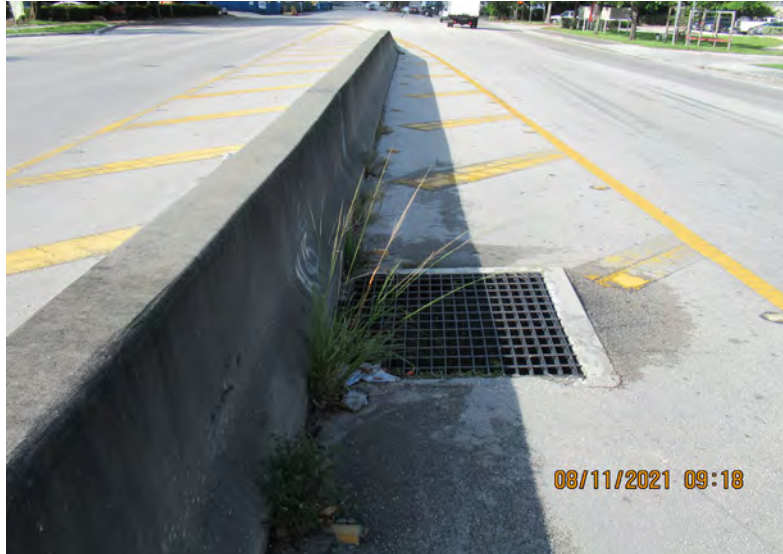
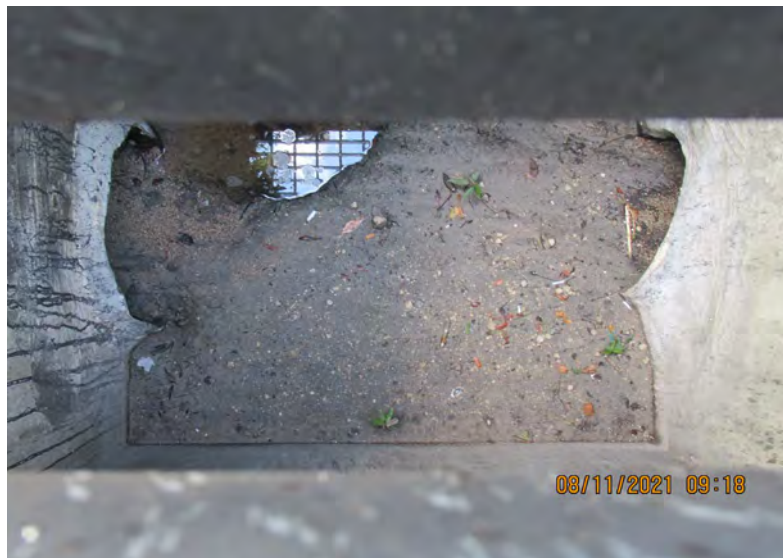
**PHOTO NO.: WB-006
DATE: 8-11-2021**

**ROADWAY INSPECTION
LOCATION: WESTBOUND NW 138th STREET BEFORE
OKEECHOBEE RD.**

SILTED DRAINAGE STRUCTURE (TYPICAL AT VARIOUS LOCATIONS)

ITEM NOTED TO BE ADDRESSED BY MDX MAINTENANCE

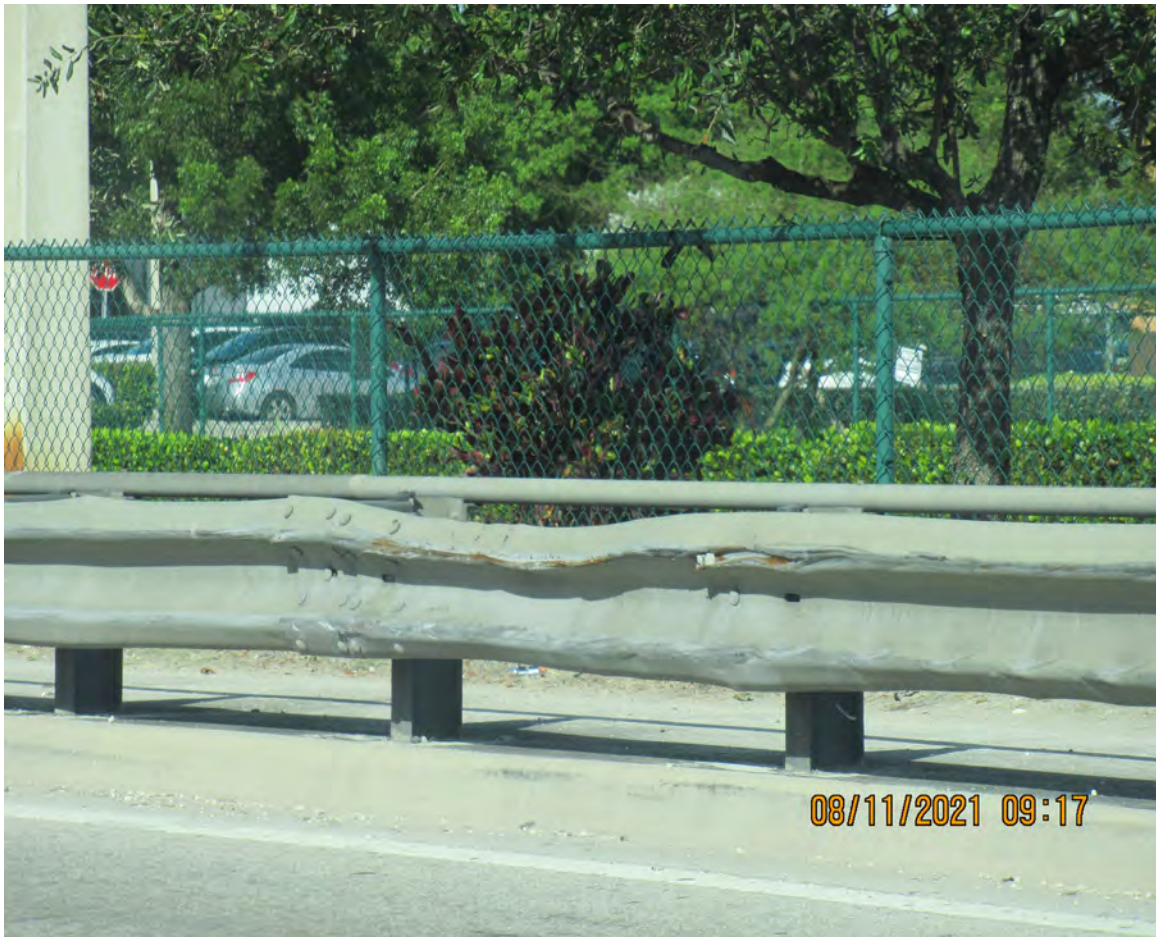
**PHOTO NO.: WB-007
DATE: 8-11-2021**

**ROADWAY INSPECTION
LOCATION: WESTBOUND NW 138th STREET BEFORE
OKEECHOBEE RD.**

DAMAGED GUARDRAIL

ITEM NOTED TO BE ADDRESSED BY MDX MAINTENANCE

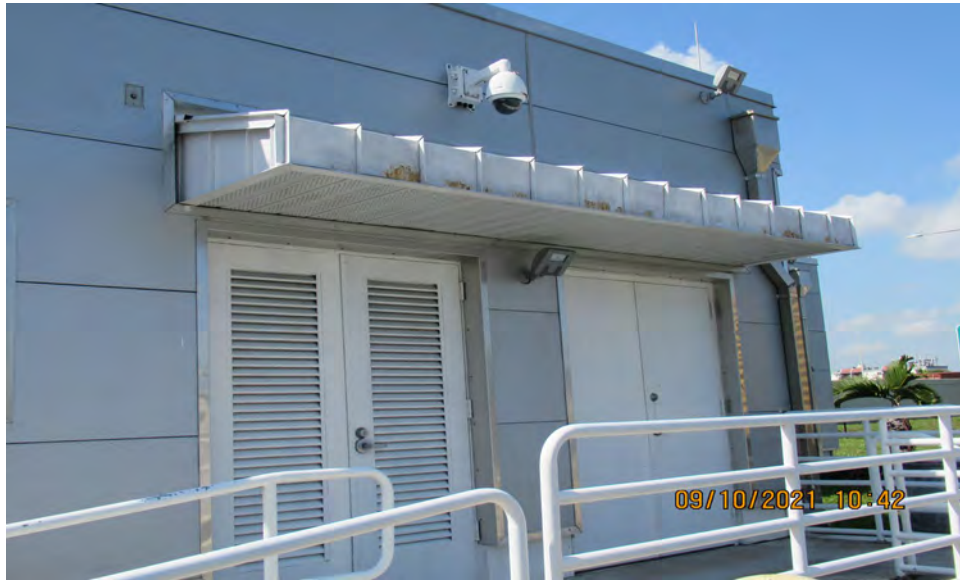
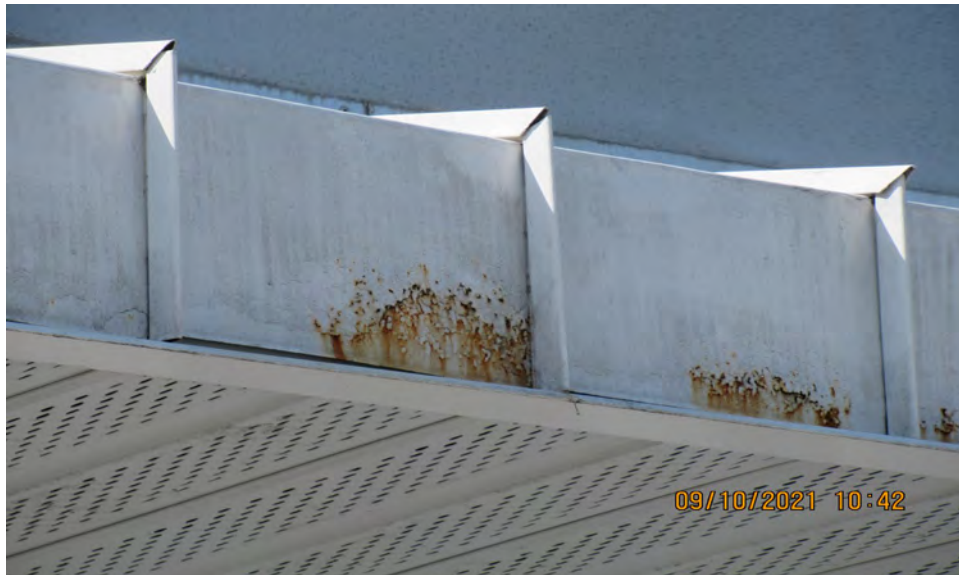
**PHOTO NO.: A-001
DATE: 9-10-2021**

**ARCHITECTURAL INSPECTION
LOCATION: SR-836 MAIN ADMINISTRATION BUILDING
(MECHANICAL ROOM)**

CORROSION ON METAL AWNING

ITEM NOTED TO BE ADDRESSED BY MDX MAINTENANCE

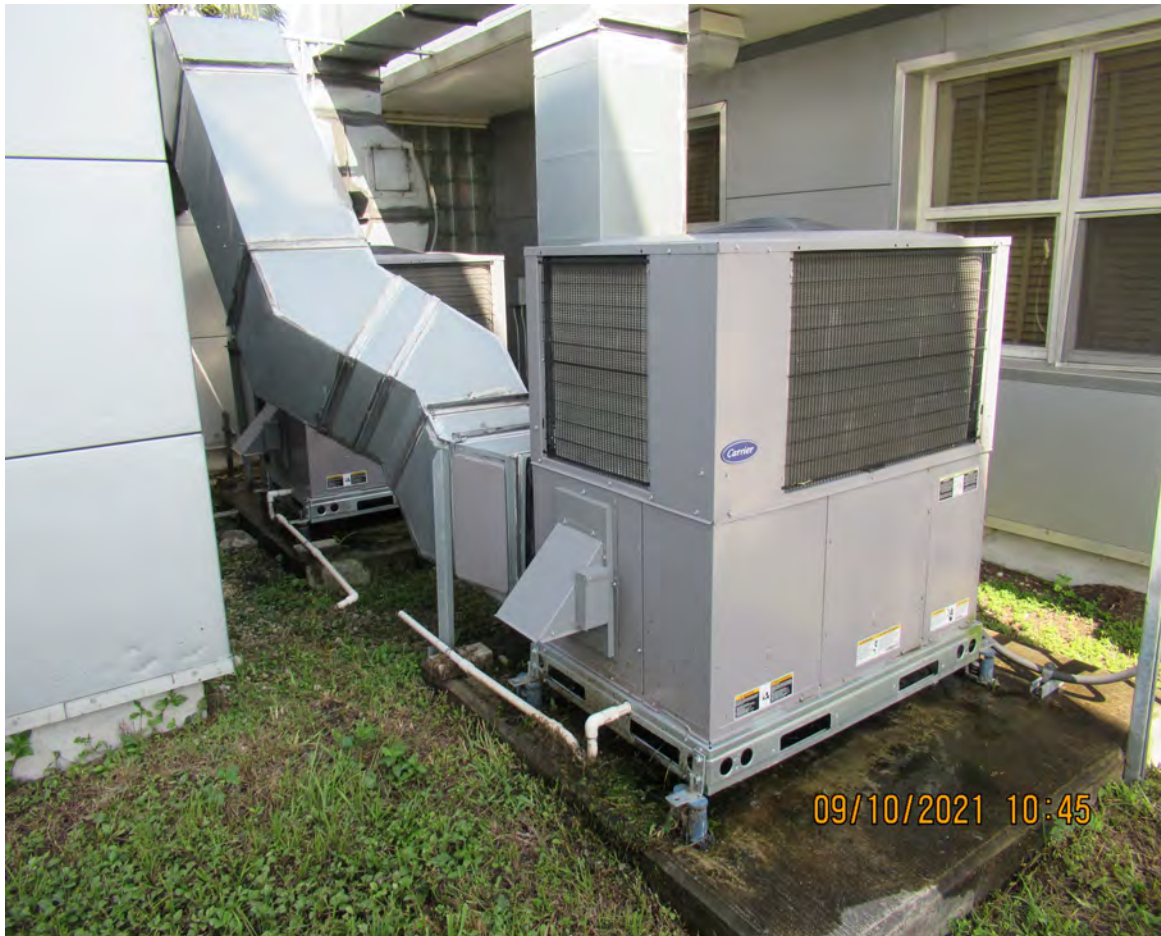
**PHOTO NO.: A-002
DATE: 9-10-2021**

**ARCHITECTURAL INSPECTION
LOCATION: SR-836 MAIN ADMINISTRATION BUILDING
(SOUTH ELEVATION)**

CLOGGED CONDENSATE DRAIN

ITEM NOTED TO BE ADDRESSED BY MDX MAINTENANCE

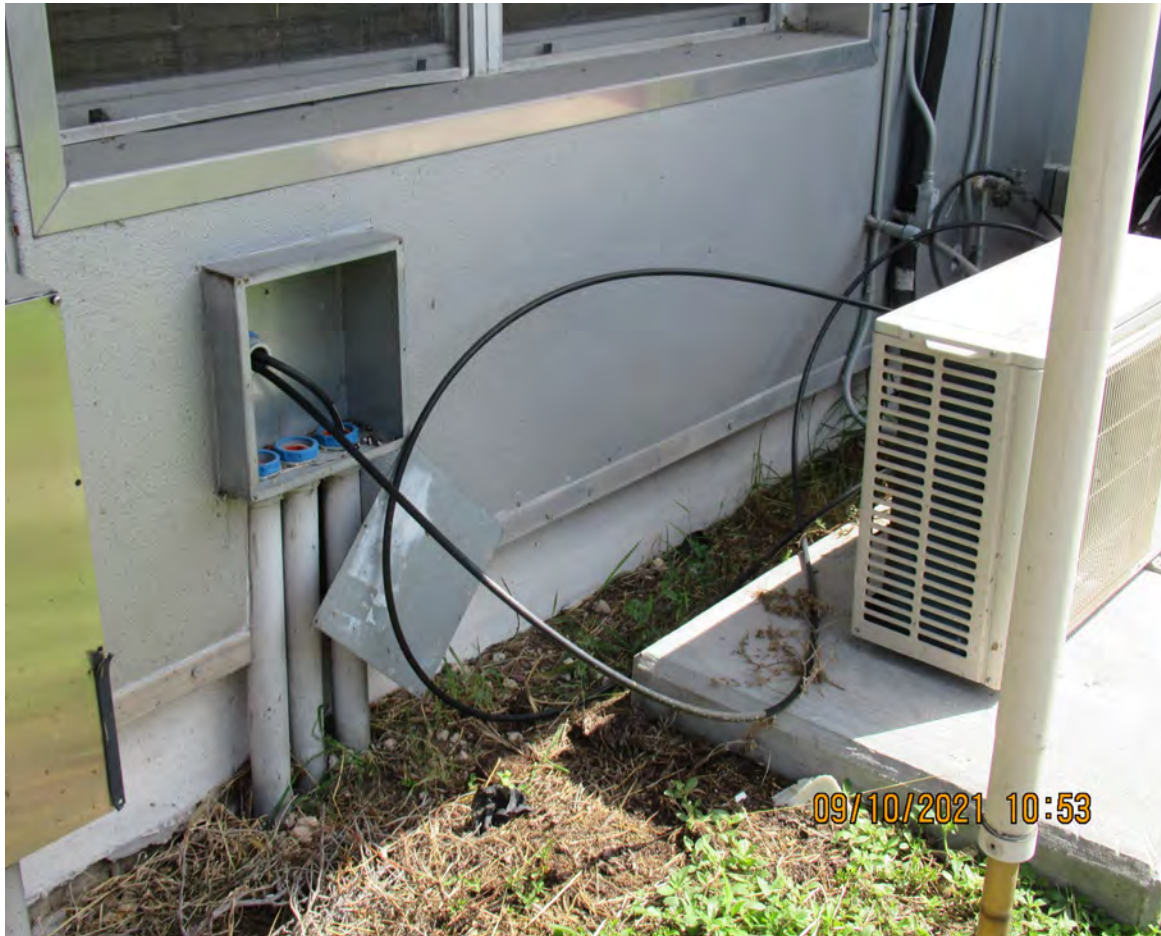
**PHOTO NO.: A-003
DATE: 9-10-2021**

**ARCHITECTURAL INSPECTION
LOCATION: SR-836 MAIN ADMINISTRATION BUILDING
(SOUTH ELEVATION)**

OPEN ITS PULL BOX

ITEM NOTED TO BE ADDRESSED BY MDX ITS

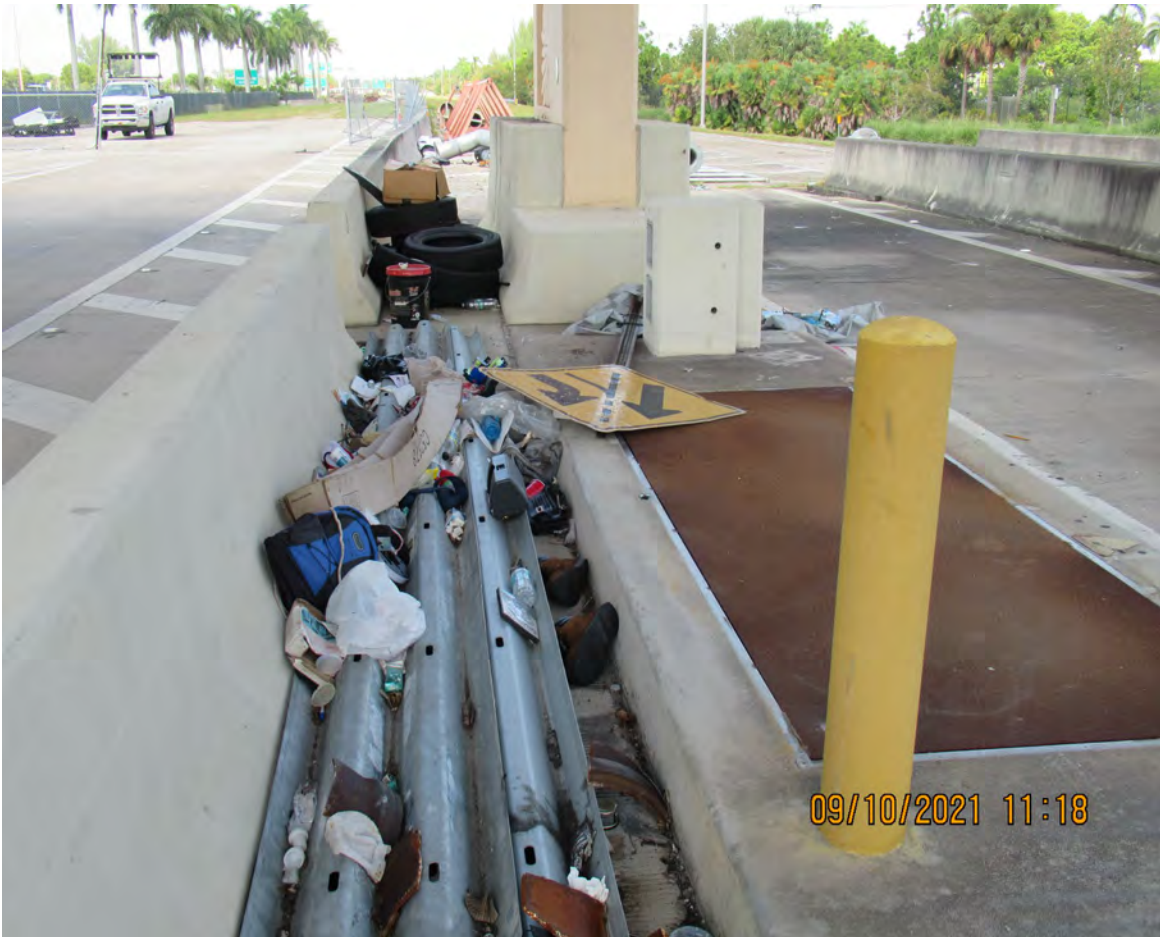
**PHOTO NO.: A-001
DATE: 9-10-2021**

**ARCHITECTURAL INSPECTION
LOCATION: SR-836 / NW 97th AVENUE WESTBOUND
TOLL PLAZA**

ROAD DEBRIS AND GUARD RAIL PANELS

ITEM NOTED TO BE ADDRESSED BY MDX MAINTENANCE
