Annual Inspection Report 2021

General Engineering Consultant to the
Miami-Dade County Expressway Authority

ANNUAL INSPECTION REPORT 2021

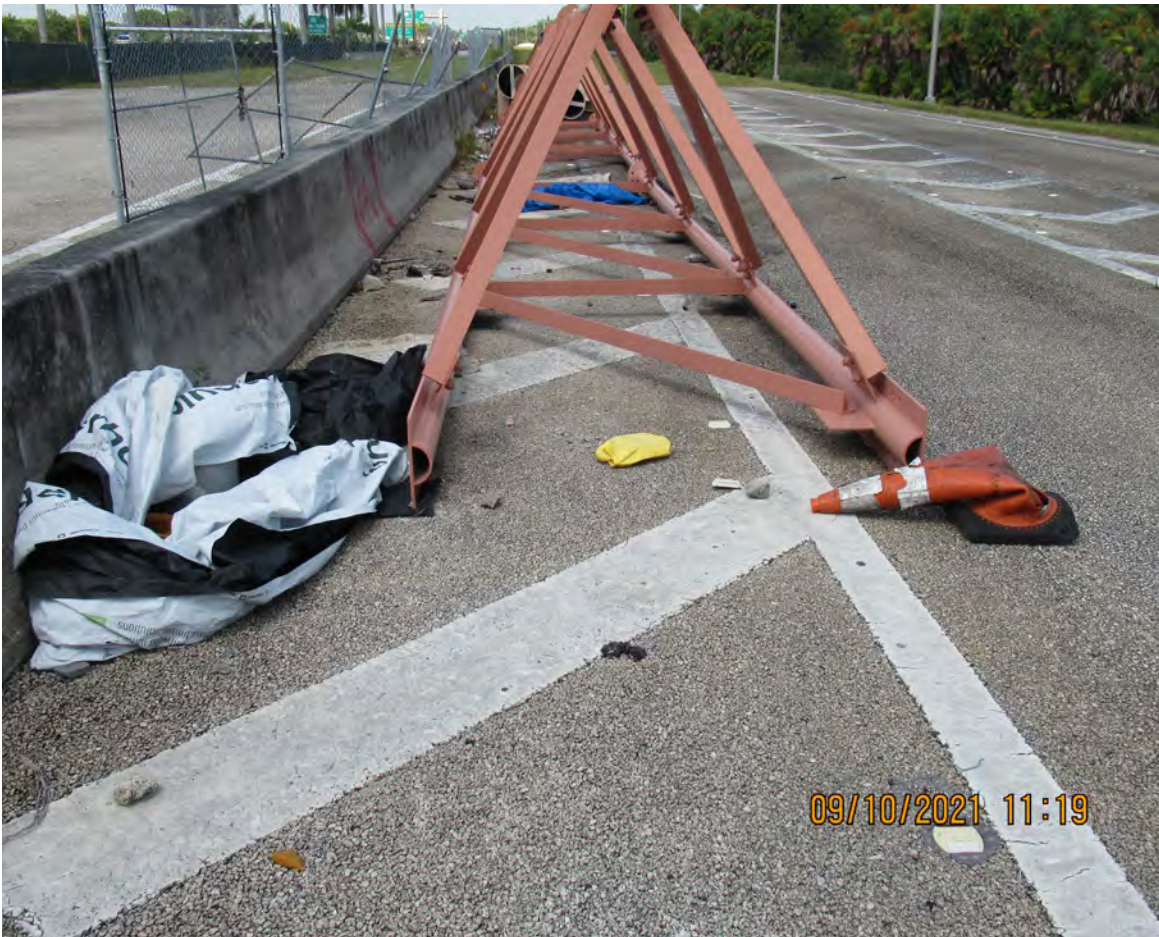
**PHOTO NO.: A-002
DATE: 9-10-2021**

**ARCHITECTURAL INSPECTION
LOCATION: SR-836 / NW 97th AVENUE WESTBOUND
TOLL PLAZA**

TRASH

ITEM NOTED TO BE ADDRESSED BY MDX MAINTENANCE

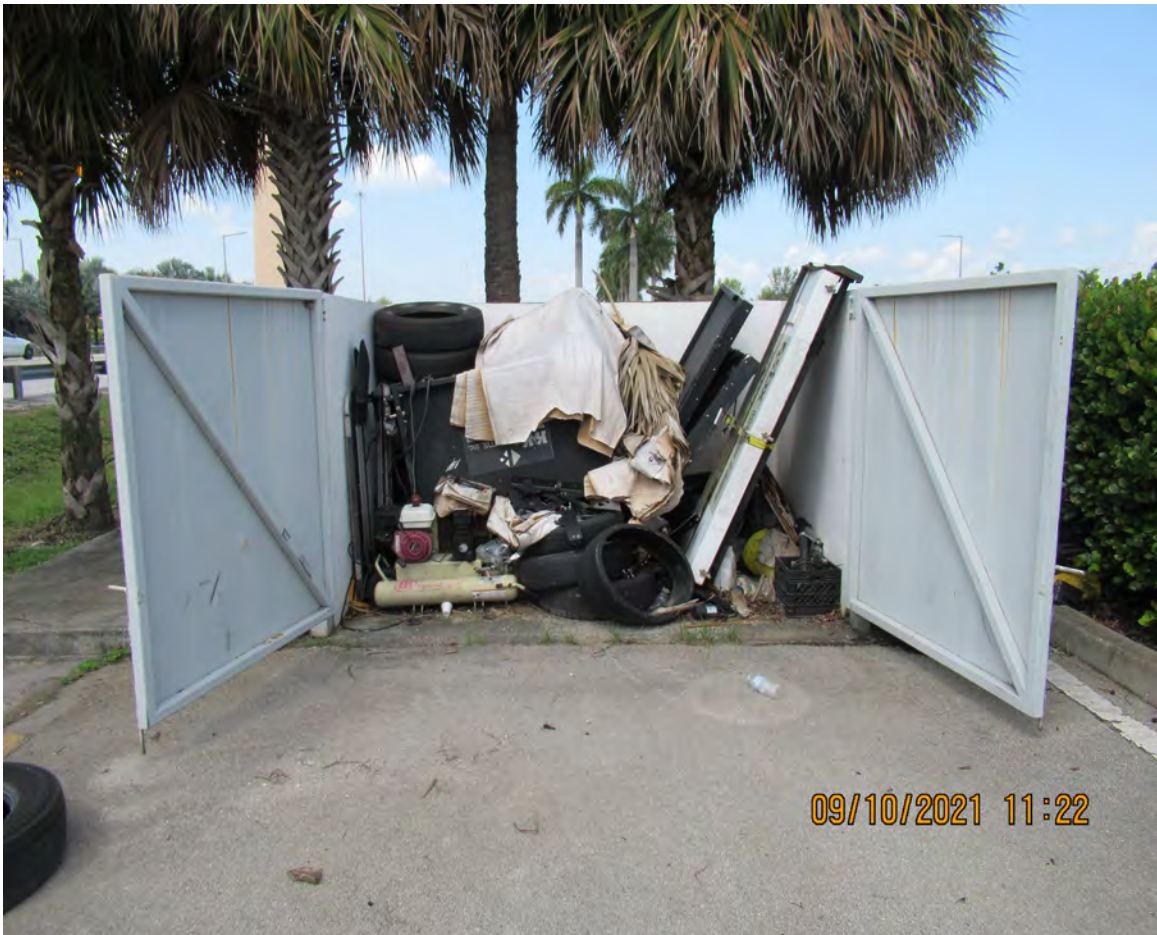
**PHOTO NO.: A-003
DATE: 9-10-2021**

**ARCHITECTURAL INSPECTION
LOCATION: SR-836 / NW 97th AVENUE WESTBOUND
ADMINISTRATION BUILDING DUMPSTER ENCLOSURE
(WEST ELEVATION)**

TRASH AND DEBRIS

ITEM NOTED TO BE ADDRESSED BY MDX MAINTENANCE

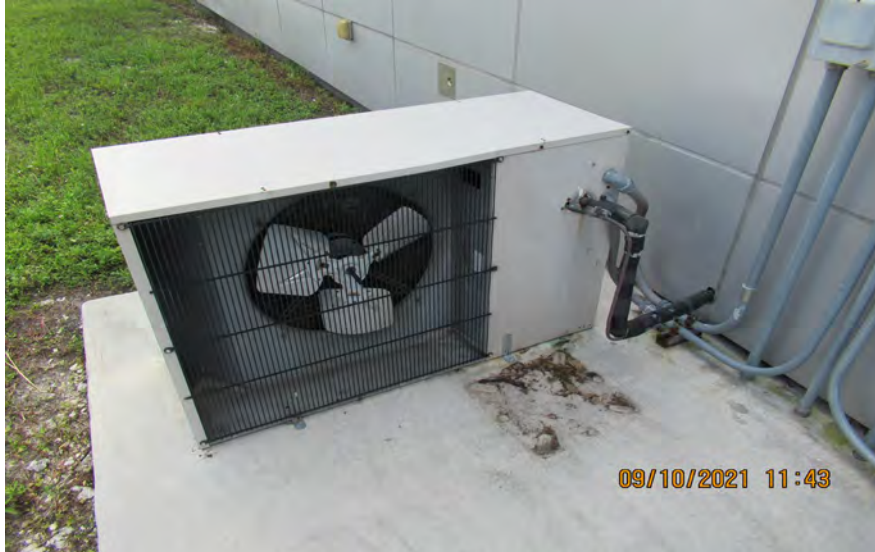
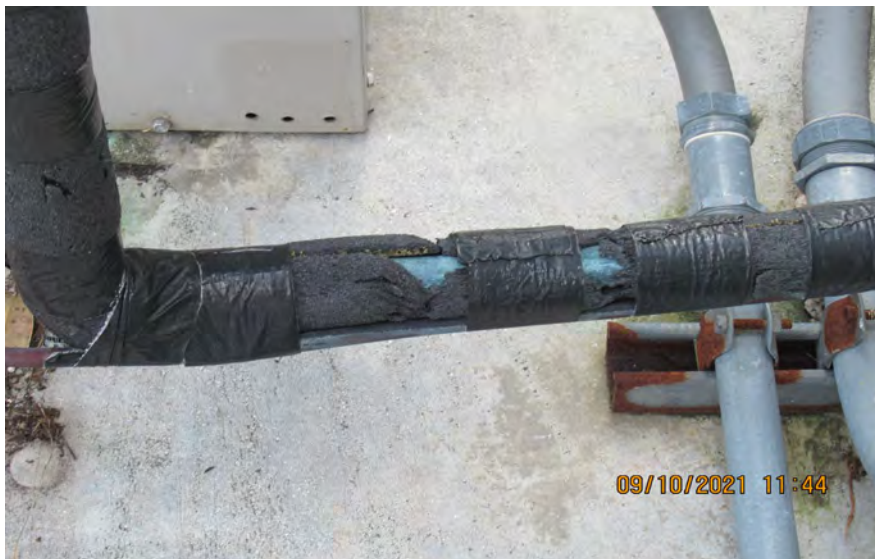
**PHOTO NO.: A-001
DATE: 9-10-2021**

**ARCHITECTURAL INSPECTION
LOCATION: SR-836 / NW 97th AVENUE EASTBOUND
ADMINISTRATION BUILDING (NORTH ELEVATION)**

DETERIORATED HVAC REFRIGERANT LINE INSULATION

ITEM NOTED TO BE ADDRESSED BY MDX MAINTENANCE

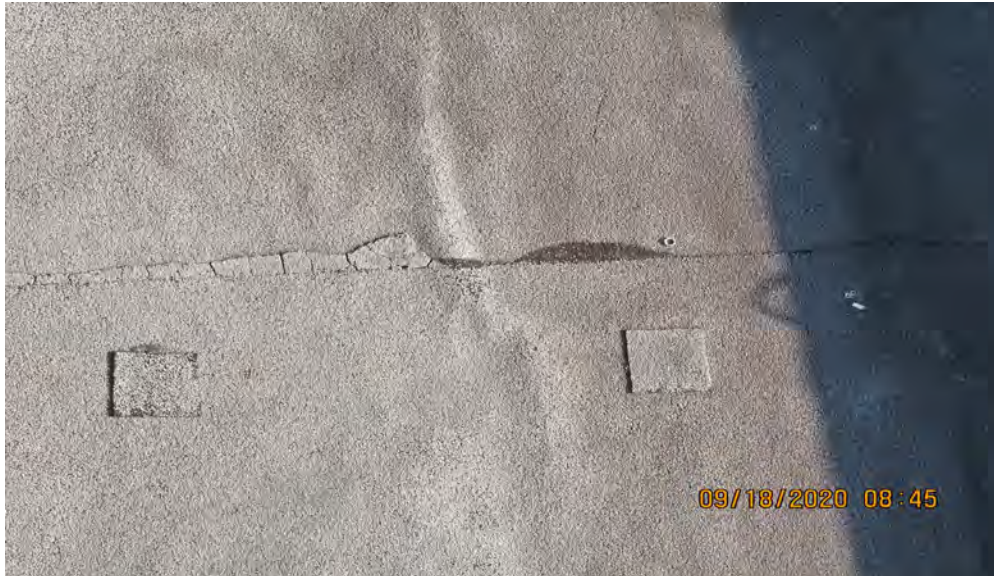
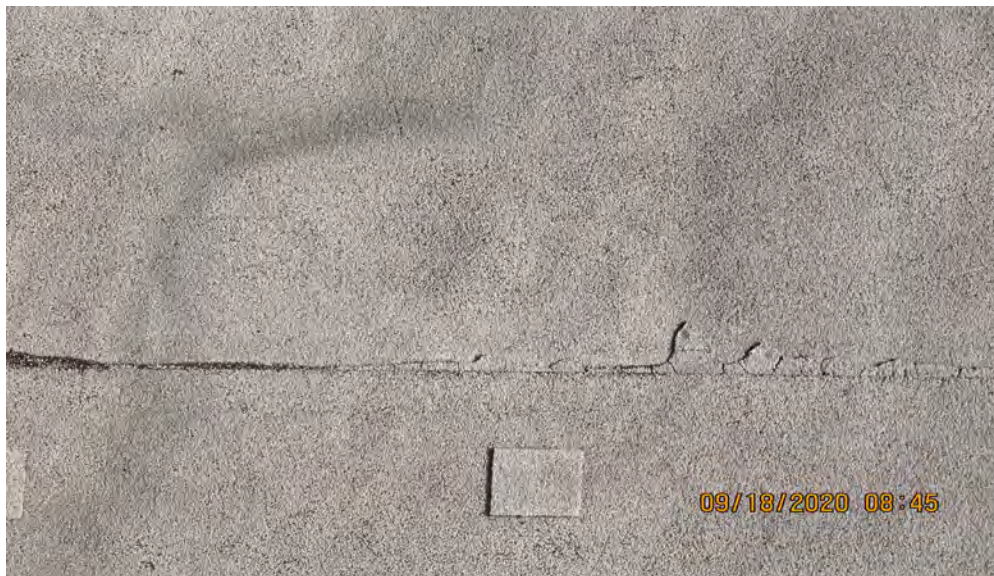
**PHOTO NO.: A-002
DATE: 9-30-2021**

**ARCHITECTURAL INSPECTION
LOCATION: SR-836 / NW 97th AVENUE EASTBOUND
ADMINISTRATION BUILDING**

BLISTERING ON ROOF MEMBRANE

ITEM NOTED TO BE ADDRESSED BY MDX MAINTENANCE

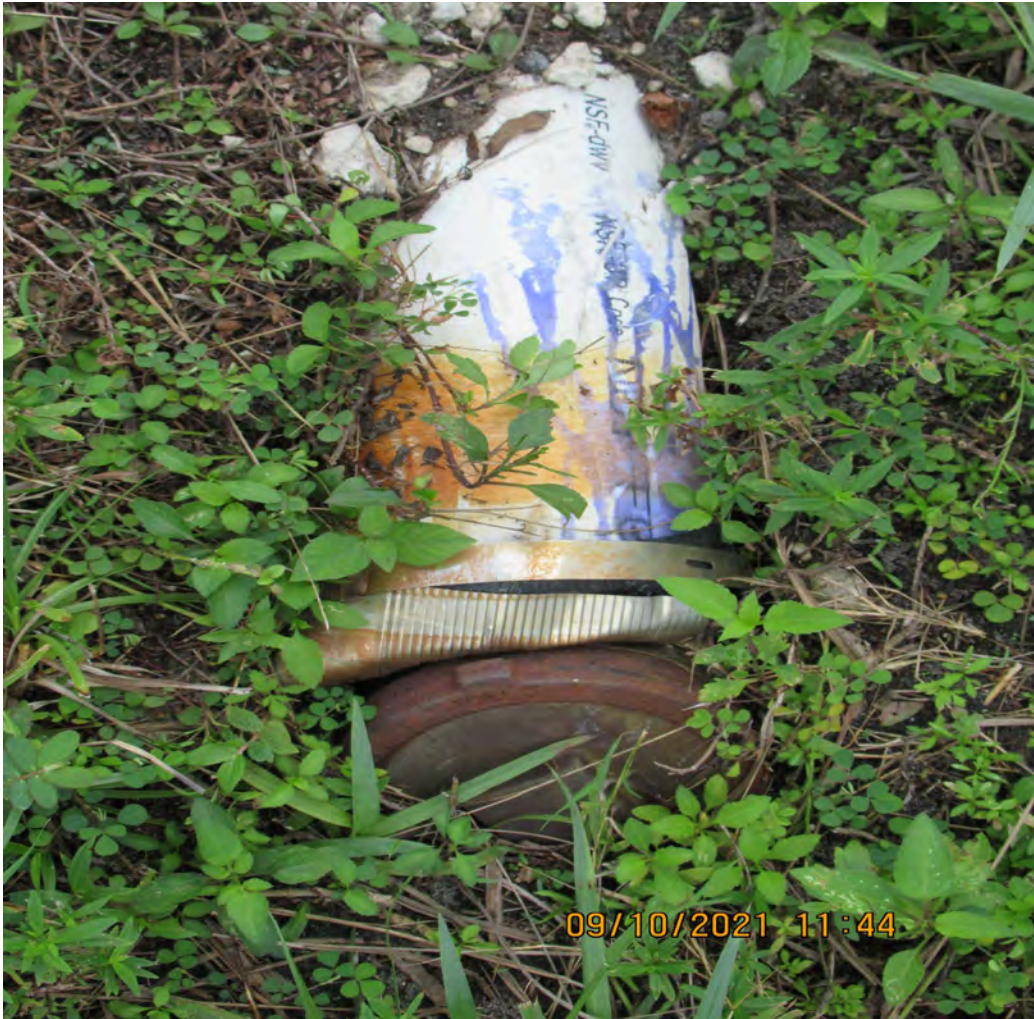
**PHOTO NO.: A-003
DATE: 9-10-2021**

**ARCHITECTURAL INSPECTION
LOCATION: SR-836 / NW 97th AVENUE EASTBOUND
ADMINISTRATION BUILDING (NORTH ELEVATION)**

IMPROPER SEWER CLEANOUT INSTALLATION

ITEM NOTED TO BE ADDRESSED BY MDX MAINTENANCE

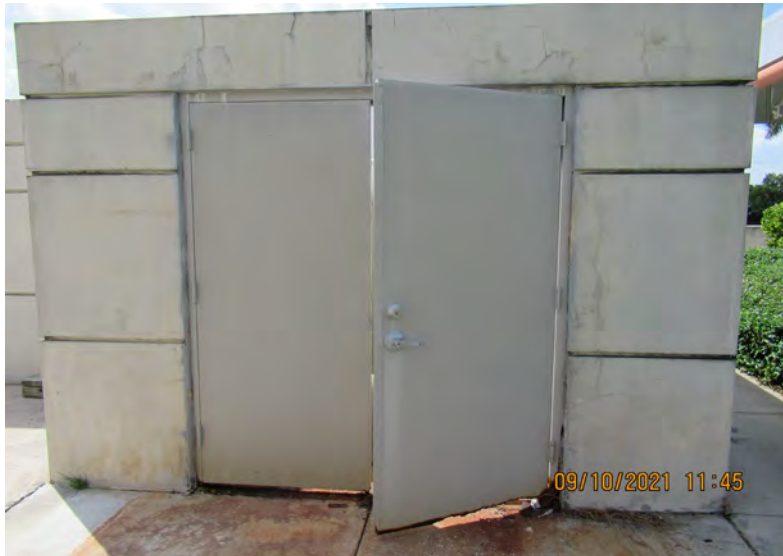
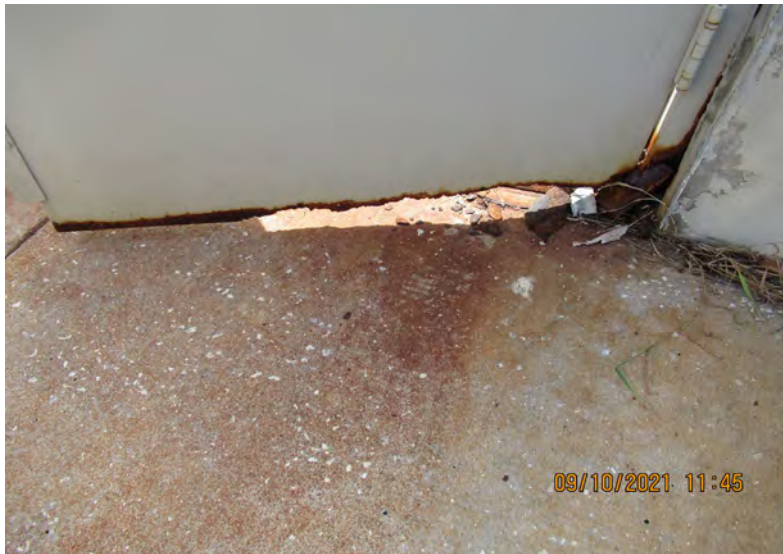
**PHOTO NO.: A-004
DATE: 9-10-2021**

**ARCHITECTURAL INSPECTION
LOCATION: SR-836 / NW 97th AVENUE EASTBOUND
ADMINISTRATION BUILDING (EAST ELEVATION)**

CORRODED STEEL DOORS AT WATER TREATMENT ENCLOSURE

ITEM NOTED TO BE ADDRESSED BY MDX MAINTENANCE

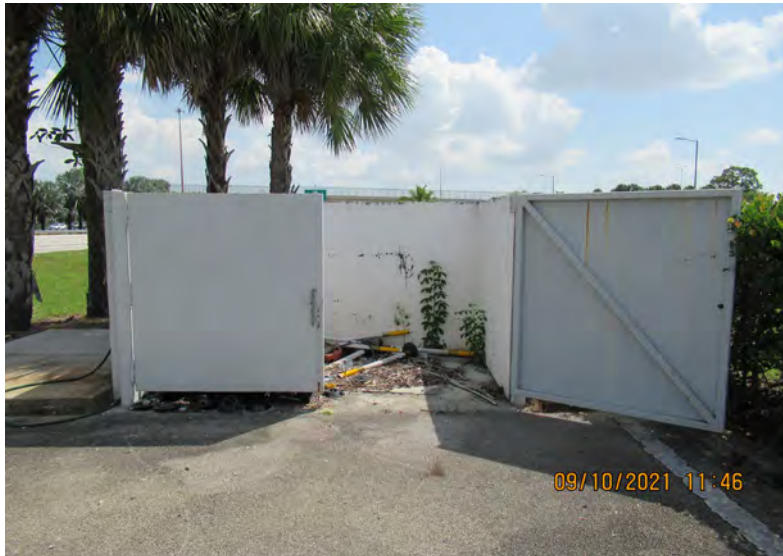
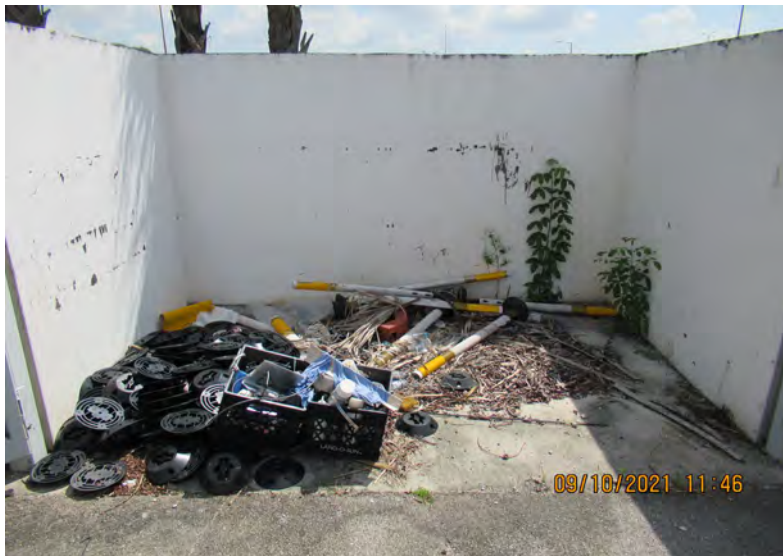
**PHOTO NO.: A-005
DATE: 9-10-2021**

**ARCHITECTURAL INSPECTION
LOCATION: SR-836 / NW 97th AVENUE EASTBOUND
ADMINISTRATION BUILDING (EAST ELEVATION)**

TRASH AND DEBRIS AT DUMPSTER ENCLOSURE

ITEM NOTED TO BE ADDRESSED BY MDX MAINTENANCE

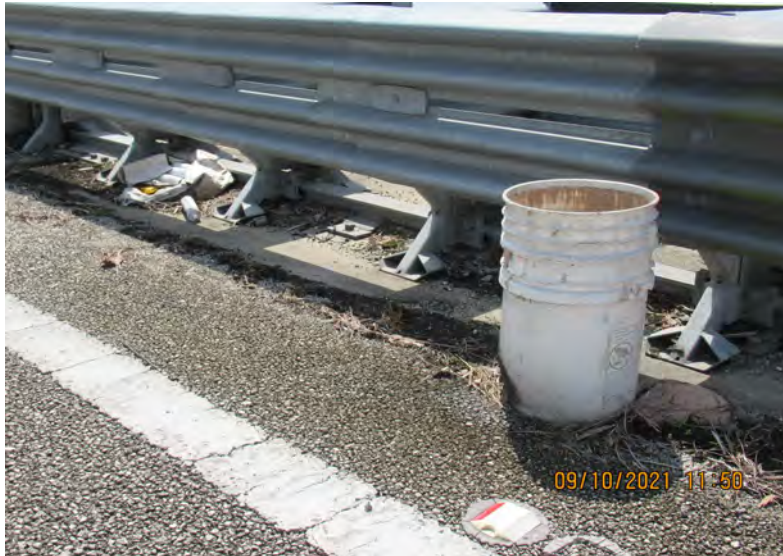
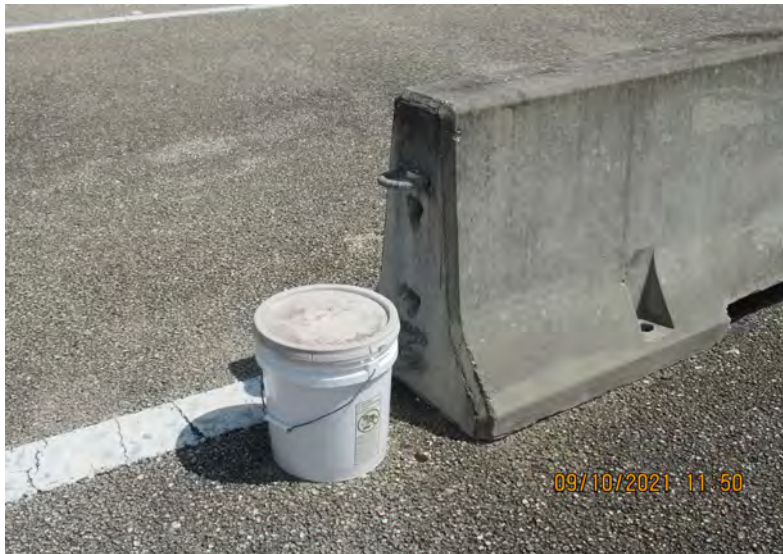
**PHOTO NO.: A-007
DATE: 9-10-2021**

**ARCHITECTURAL INSPECTION
LOCATION: SR-836 / NW 97th AVENUE EASTBOUND
TOLL PLAZA**

TRASH AND DEBRIS THROUGHOUT THE SITE

ITEM NOTED TO BE ADDRESSED BY MDX MAINTENANCE

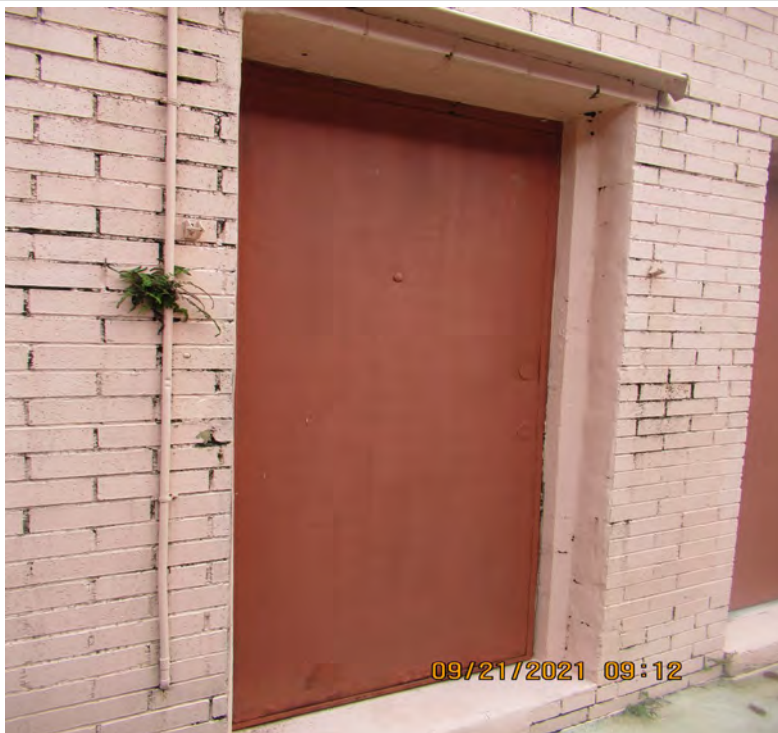
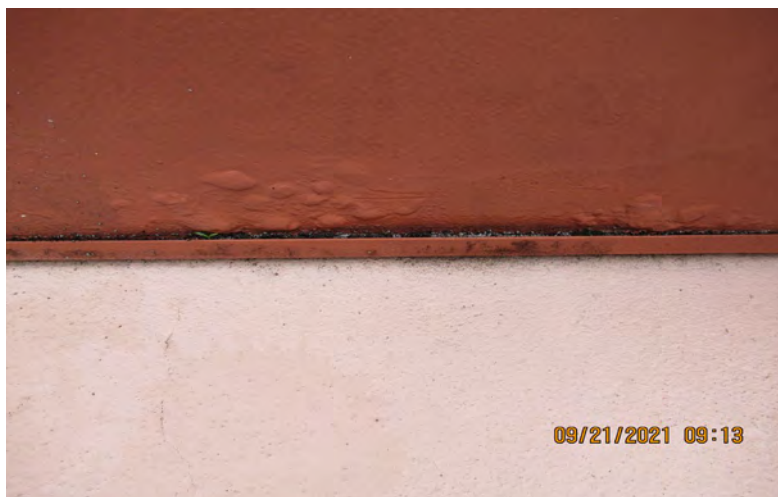
**PHOTO NO.: A-002
DATE: 9-21-2021**

**ARCHITECTURAL INSPECTION
LOCATION: ADMINISTRATION BUILDING
(EAST ELEVATION)**

CORRODED EXTERIOR STEEL DOOR

ITEM NOTED TO BE ADDRESSED BY MDX MAINTENANCE

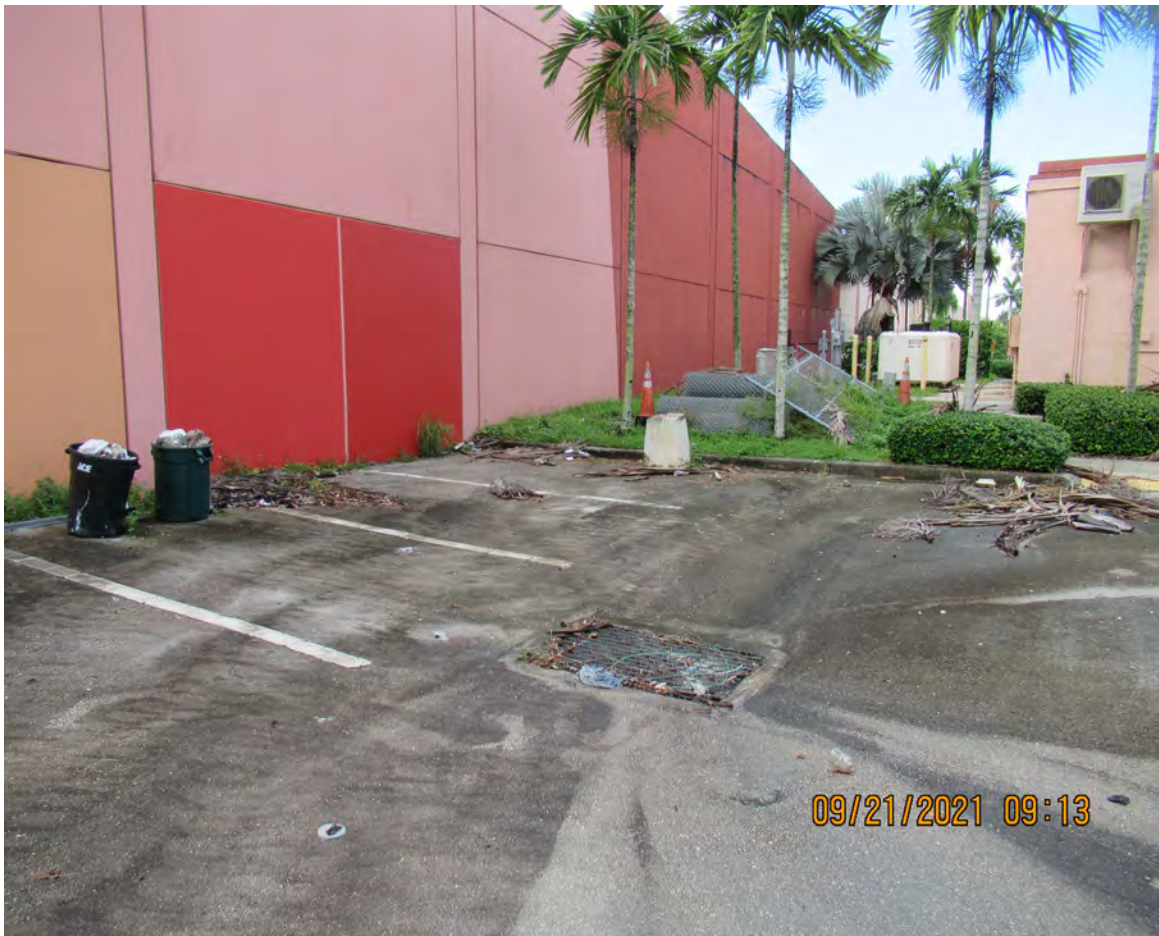
**PHOTO NO.: A-004
DATE: 9-21-2021**

**ARCHITECTURAL INSPECTION
LOCATION: ADMINISTRATION BUILDING
(EAST ELEVATION)**

TRASH AND DEBRIS THROUGHOUT THE SITE

ITEM NOTED TO BE ADDRESSED BY MDX MAINTENANCE

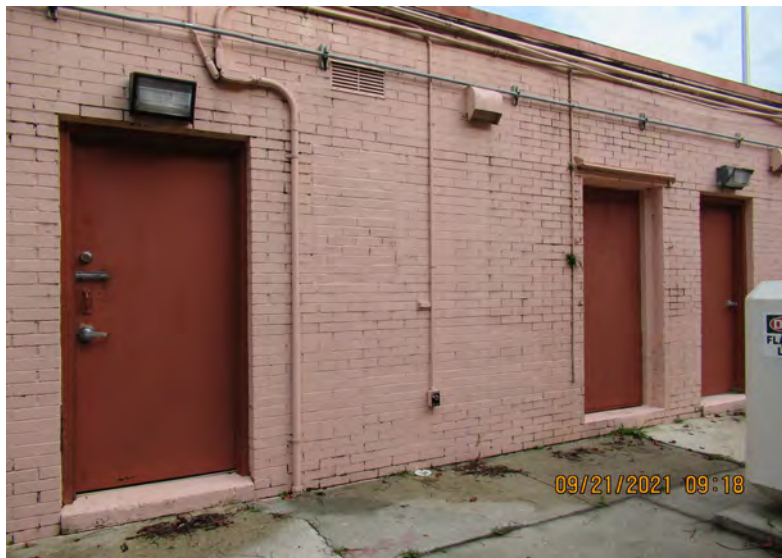
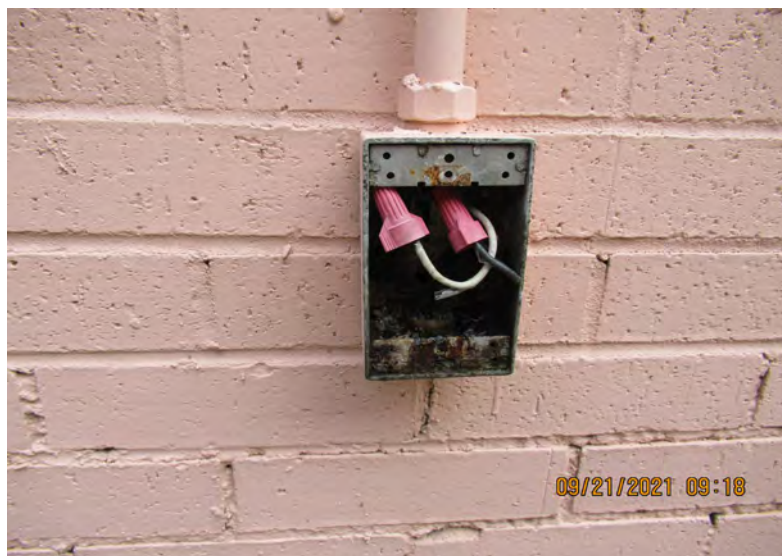
**PHOTO NO.: A-005
DATE: 9-21-2021**

**ARCHITECTURAL INSPECTION
LOCATION: ADMINISTRATION BUILDING
(EAST ELEVATION)**

ELECTRICAL BOX MISSING COVER

ITEM NOTED TO BE ADDRESSED BY MDX MAINTENANCE

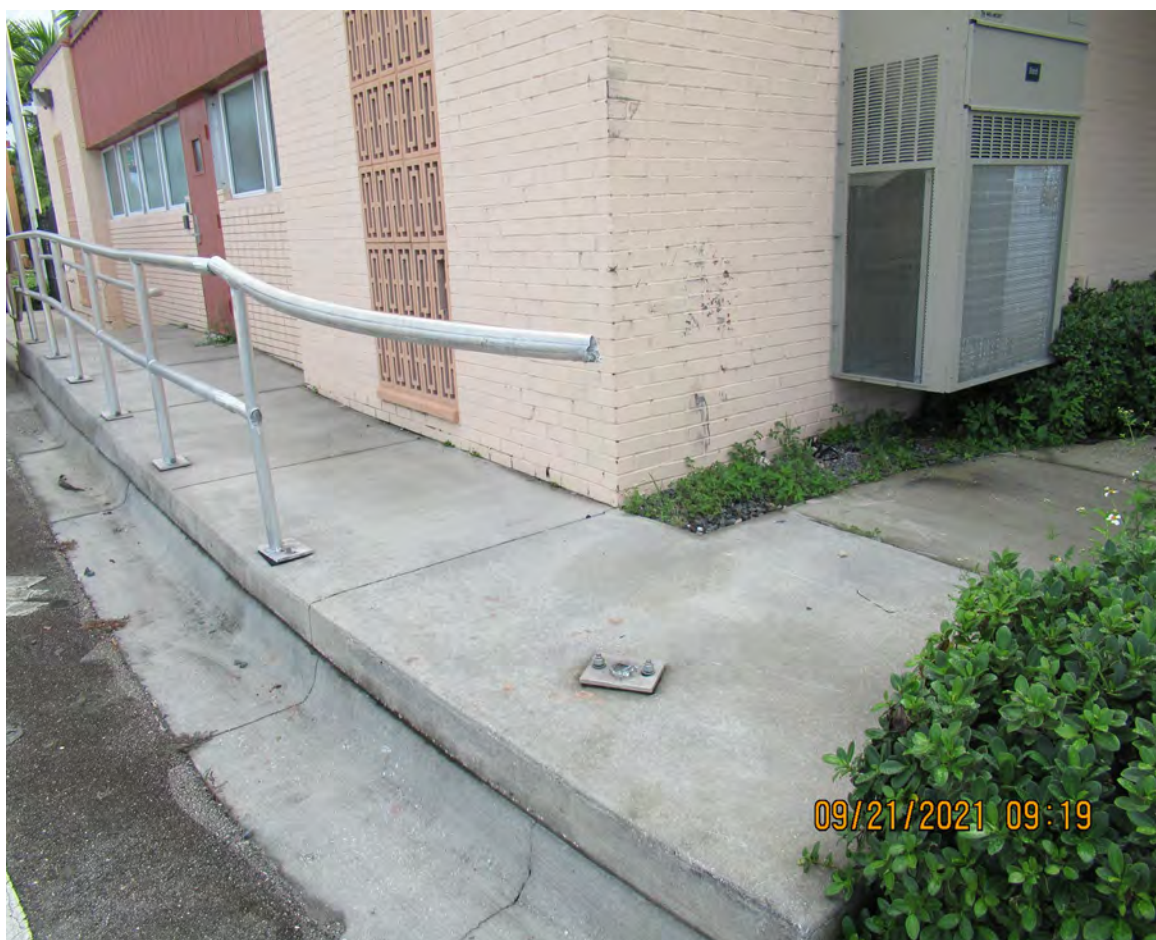
**PHOTO NO.: A-006
DATE: 9-21-2021**

**ARCHITECTURAL INSPECTION
LOCATION: ADMINISTRATION BUILDING
(WEST ELEVATION)**

UNREPAIRED DAMAGED PEDESTRIAN RAILING

ITEM NOTED TO BE ADDRESSED BY MDX MAINTENANCE

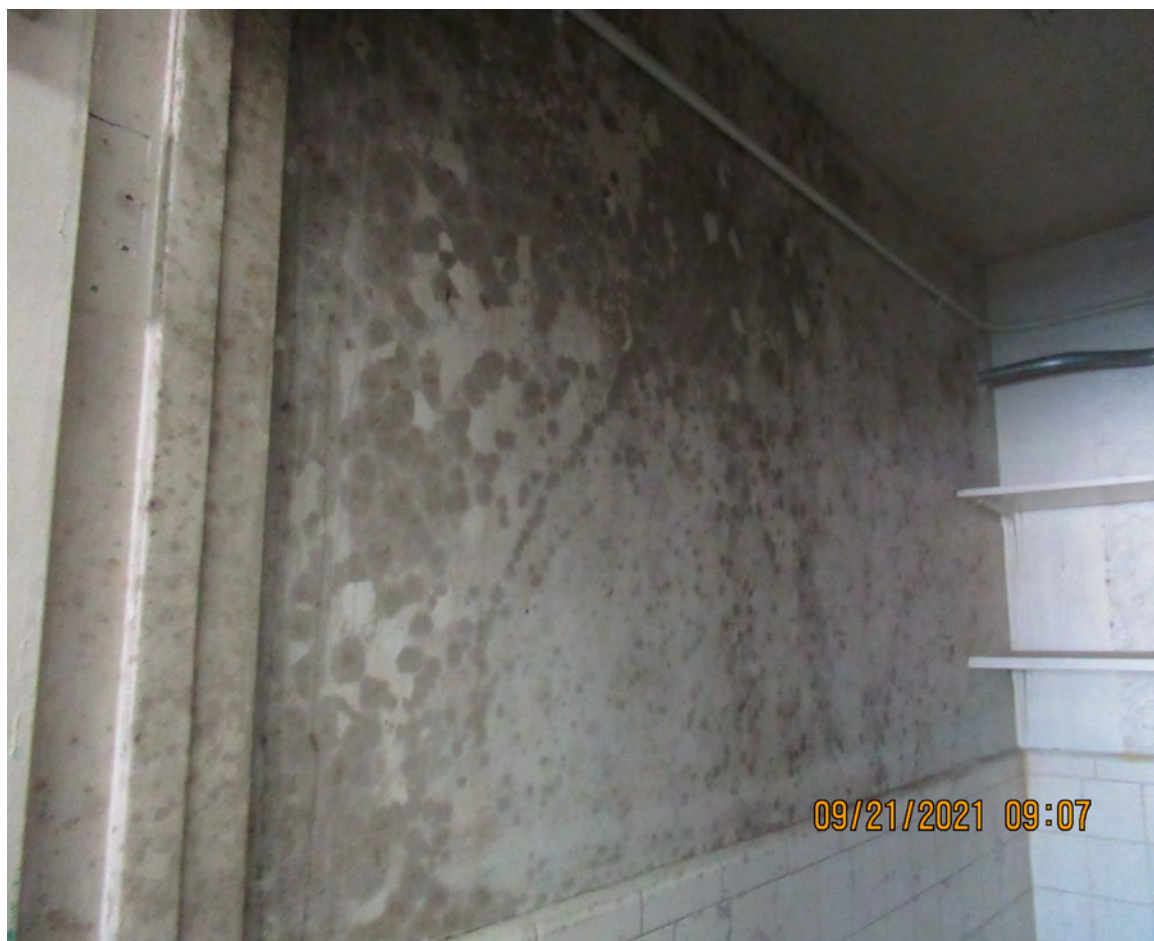
**PHOTO NO.: A-007
DATE: 9-21-2021**

**ARCHITECTURAL INSPECTION
LOCATION: ADMINISTRATION BUILDING**

MOLD ON INTERIOR WALLS DUE TO ROOF LEAK

ITEM NOTED TO BE ADDRESSED BY MDX MAINTENANCE

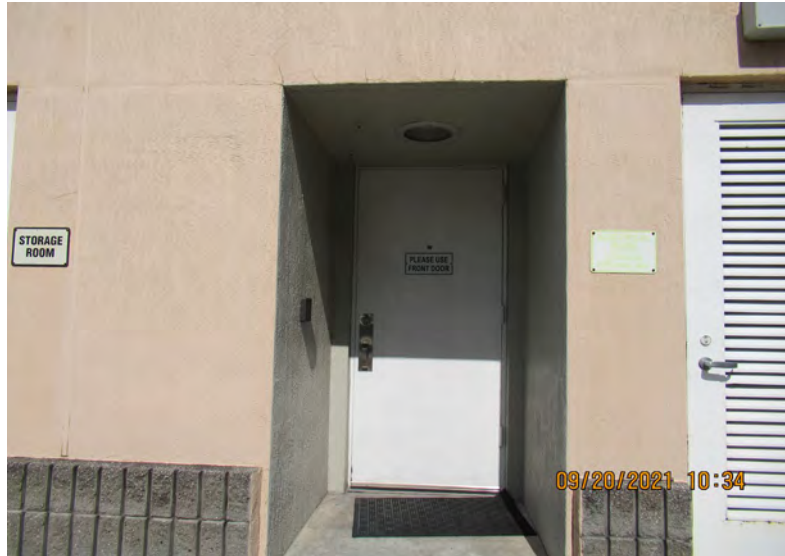
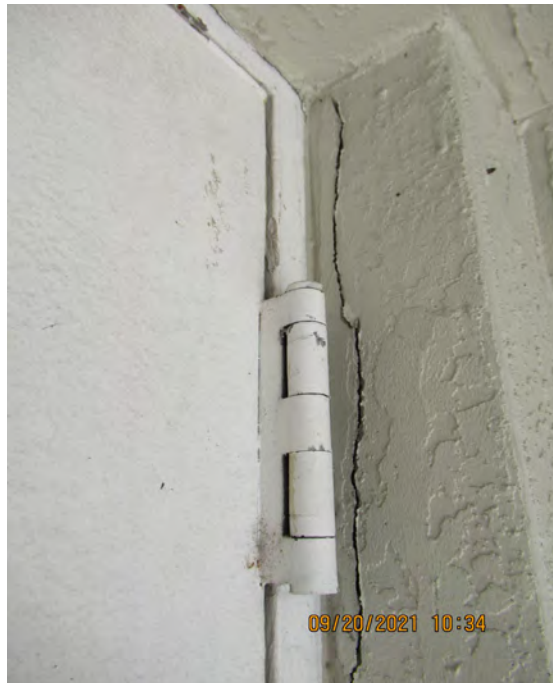
**PHOTO NO.: A-002
DATE: 9-20-2021**

**ARCHITECTURAL INSPECTION
LOCATION: ADMINISTRATION BUILDING
(EAST ELEVATION)**

CRACKS ON STUCCO ADJACENT TO EXTERIOR DOOR

ITEM NOTED TO BE ADDRESSED BY MDX MAINTENANCE

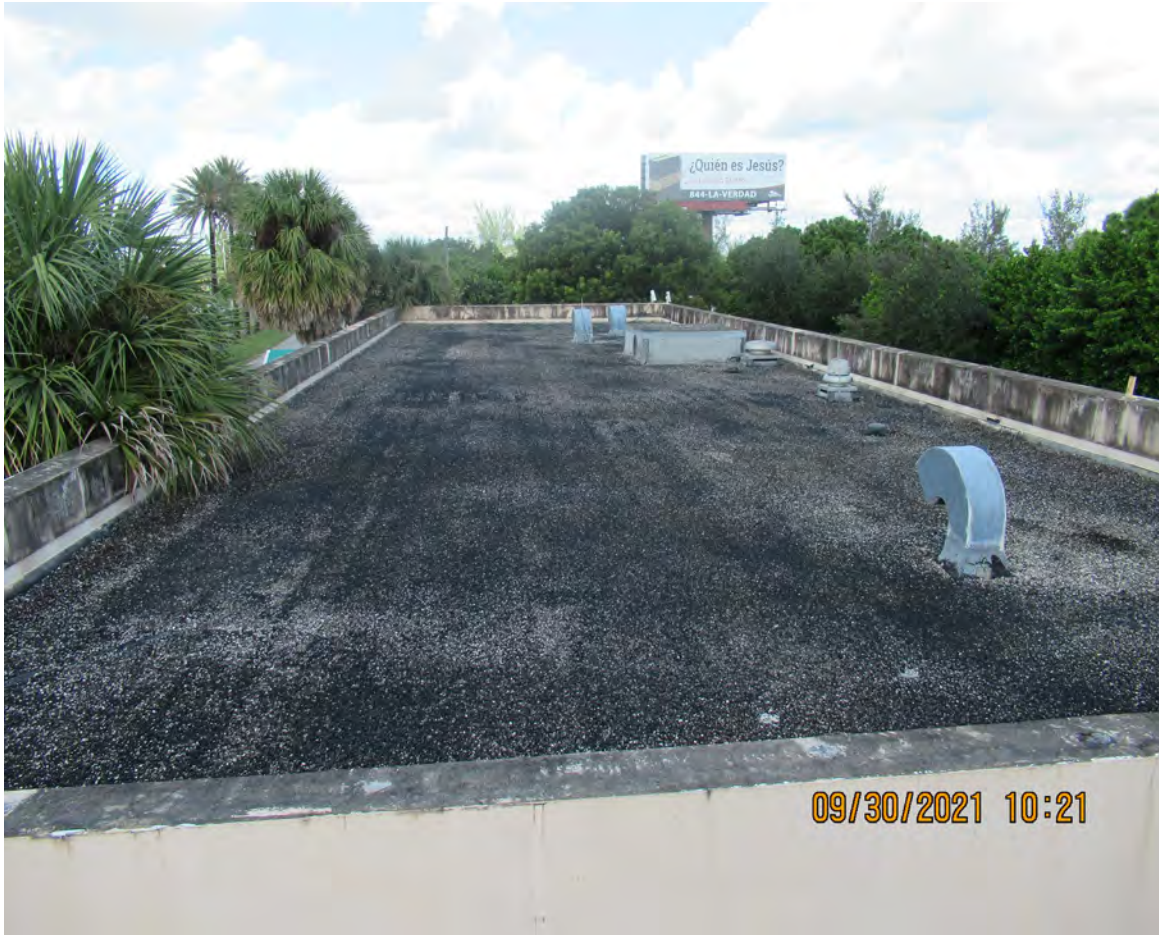
**PHOTO NO.: A-003
DATE: 9-30-2021**

**ARCHITECTURAL INSPECTION
LOCATION: ADMINISTRATION BUILDING
(EAST ELEVATION)**

AGING ROOF SYSTEM / WATER INTRUSION ON INTERIOR ROOM CEILING TILES

ITEM NOTED TO BE ADDRESSED BY MDX MAINTENANCE

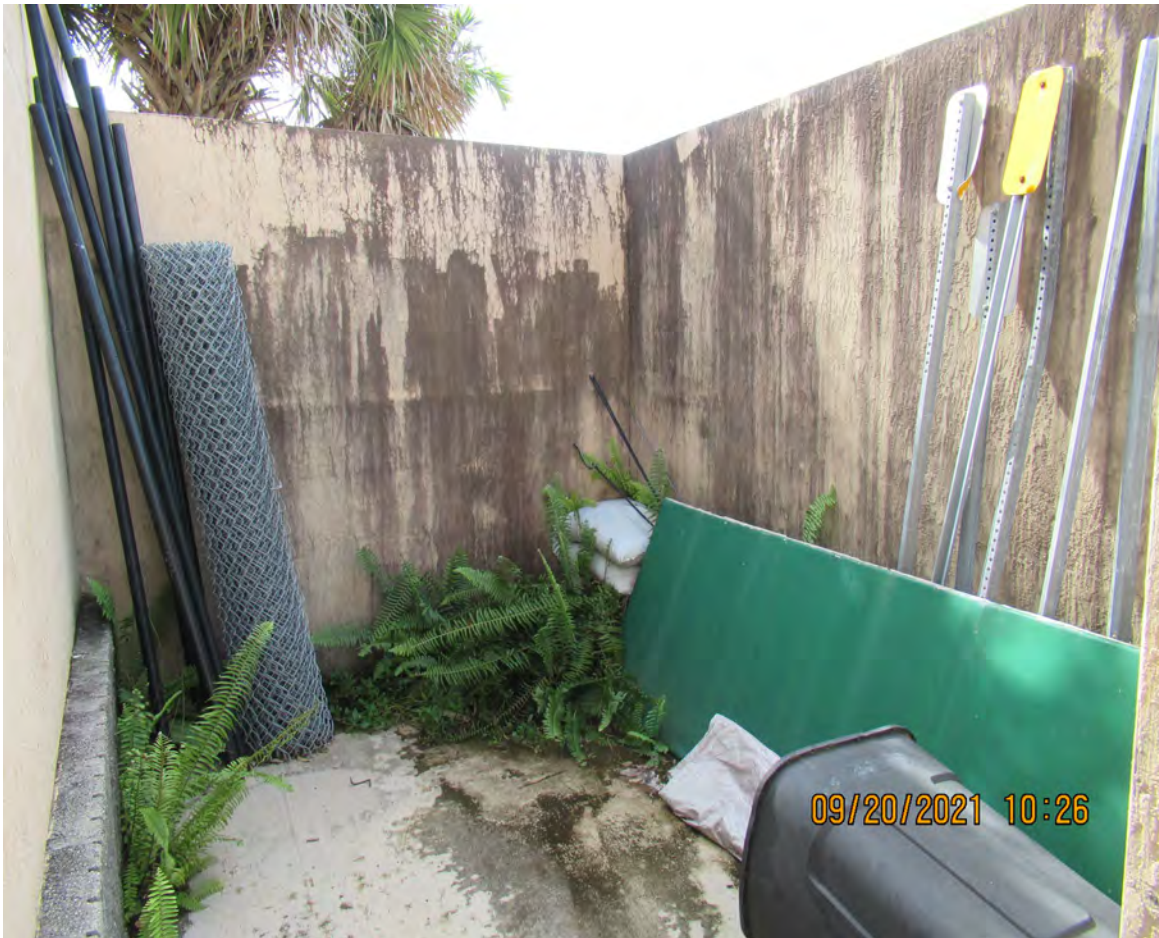
**PHOTO NO.: A-004
DATE: 9-20-2021**

**ARCHITECTURAL INSPECTION
LOCATION: ADMINISTRATION BUILDING
(SOUTH ELEVATION)**

DETERIORATED PAINT ON WALLS AND STORED MATERIALS

ITEM NOTED TO BE ADDRESSED BY MDX MAINTENANCE

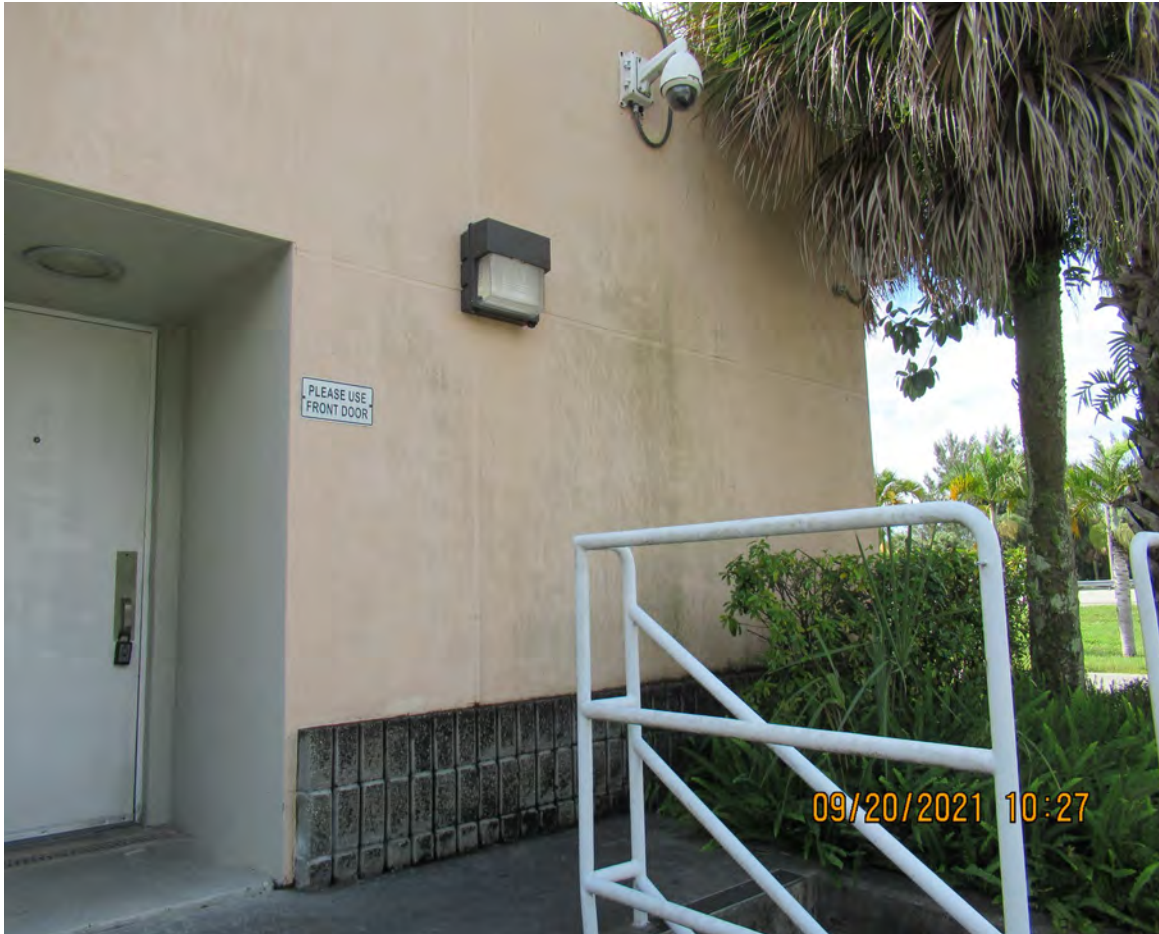
**PHOTO NO.: A-005
DATE: 9-20-2021**

**ARCHITECTURAL INSPECTION
LOCATION: ADMINISTRATION BUILDING
(WEST ELEVATION)**

MOLD ON EXTERIOR WALLS AND BRICK FACADE

ITEM NOTED TO BE ADDRESSED BY MDX MAINTENANCE

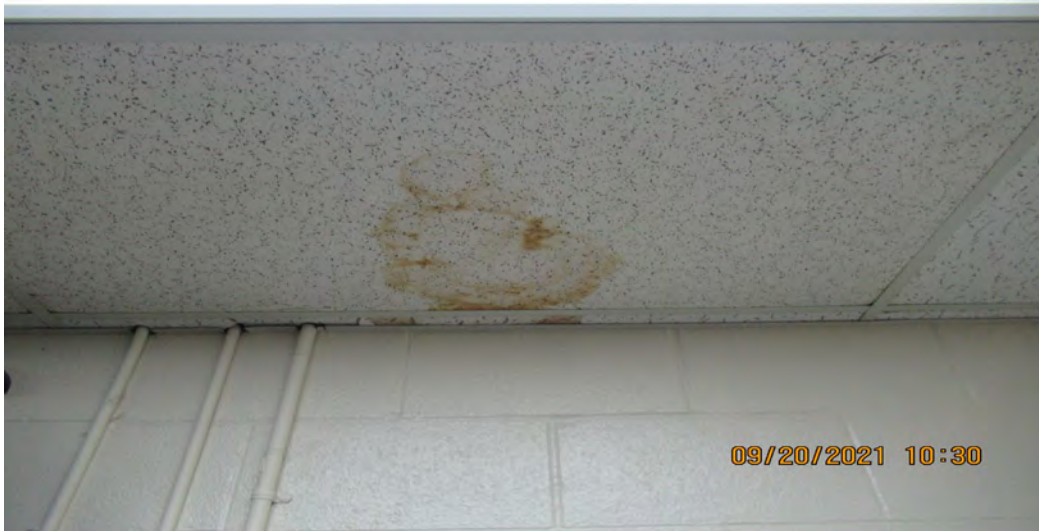
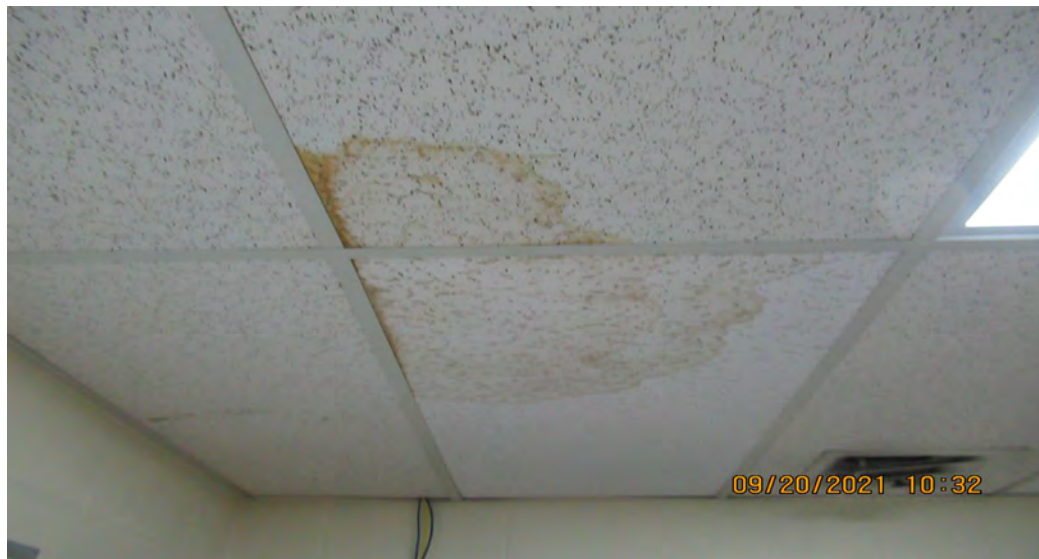
**PHOTO NO.: A-006
DATE: 9-20-2021**

**ARCHITECTURAL INSPECTION
LOCATION: ADMINISTRATION BUILDING**

WATER STAINS ON CEILING TILES (ROOM NUMBER 1 & 2)

ITEM NOTED TO BE ADDRESSED BY MDX MAINTENANCE

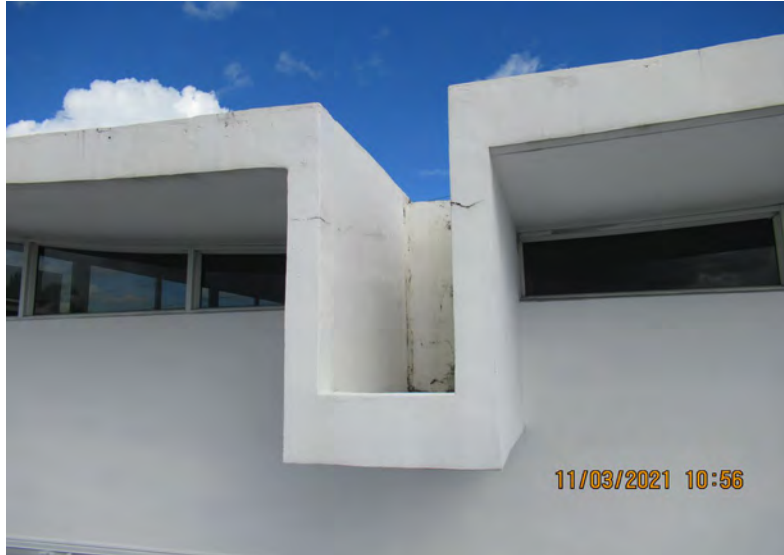
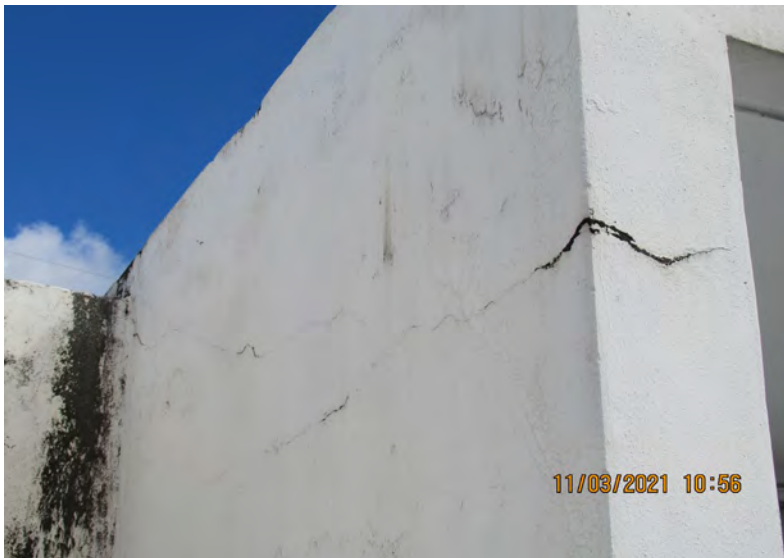
**PHOTO NO.: A-002
DATE: 11-3-2021**

**ARCHITECTURAL INSPECTION
LOCATION: BLDG. 2**

SURFACE CRACKS ON EXTERIOR PARAPET WALL

ITEM NOTED TO BE ADDRESSED BY MDX MAINTENANCE

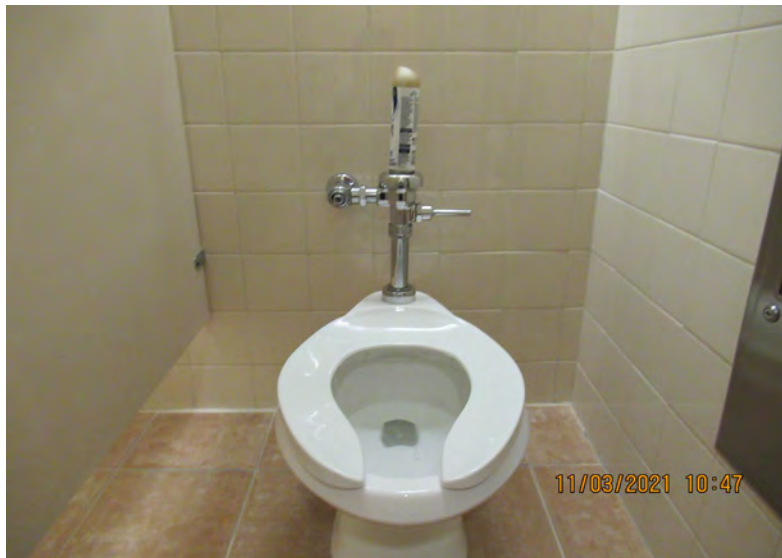
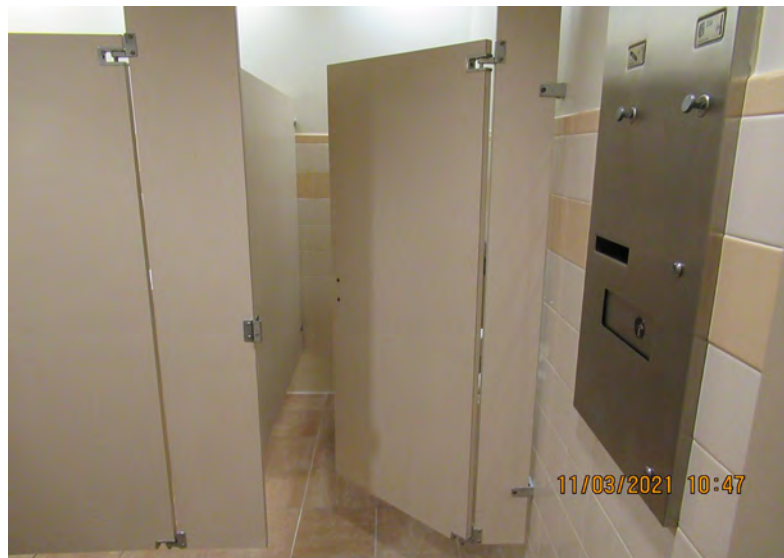
**PHOTO NO.: A-003
DATE: 11-3-2021**

MALFUNCTIONING TOILET VALVE

ITEM NOTED TO BE ADDRESSED BY MDX MAINTENANCE

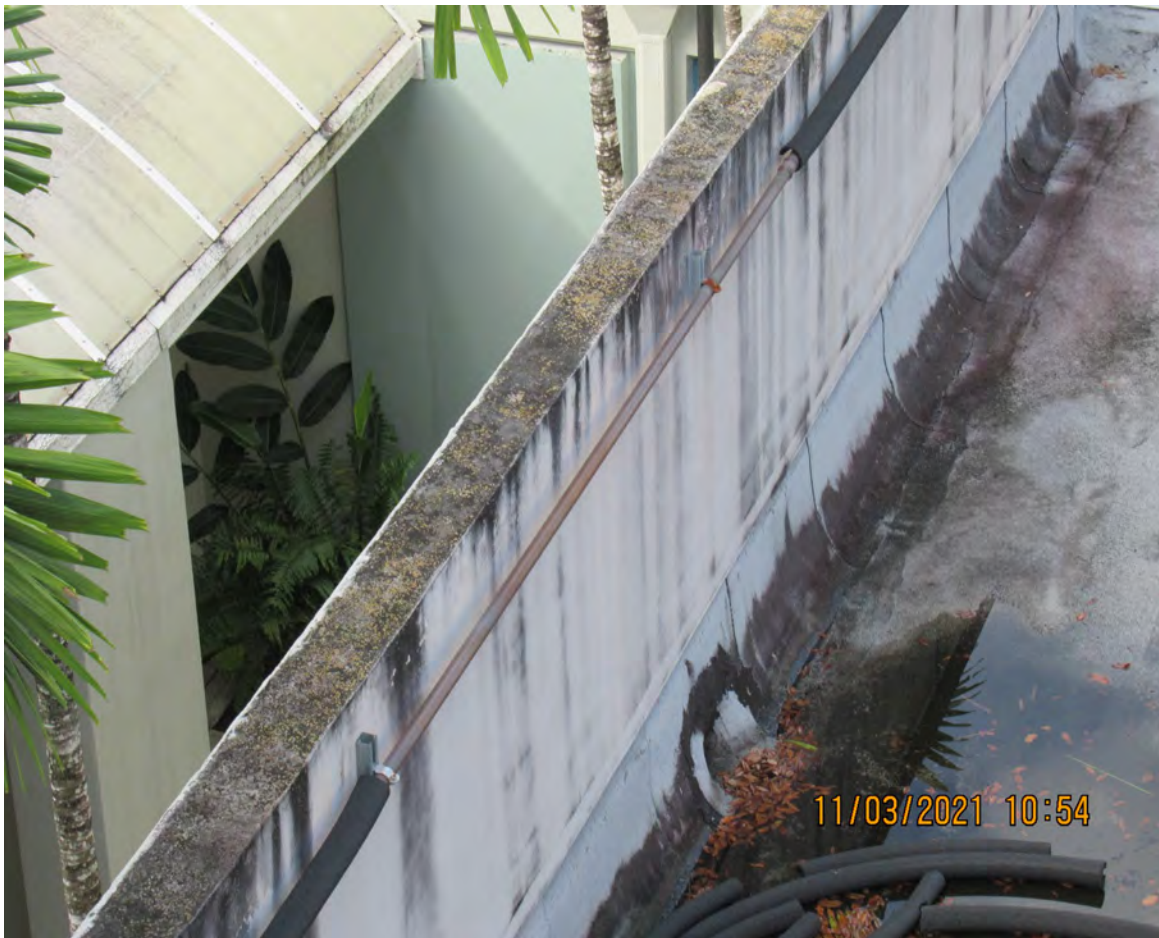
**PHOTO NO.: A-004
DATE: 11-3-2021**

MECHANICAL		
HVAC EQUIPMENT	MISSING INSULATION ON REFRIGERANT LINE	A-004
HVAC GRILLES/ OUTLETS	No Work Needs Were Identified	
EXHAUST FANS	No Work Needs Were Identified	
WATER COOLER	No Work Needs Were Identified	
PLUMBING		
TOILETS	MALFUNCTIONING VALVE	A-003
URINALS	No Work Needs Were Identified	
VANITIES	No Work Needs Were Identified	
PLUMBING FIXTURES	LEAKING FAUCET	A-005
HOSE BIBBS	No Work Needs Were Identified	
FLOOR DRAINS	No Work Needs Were Identified

MISSING INSULATION ON REFRIGERANT LINE

ITEM NOTED TO BE ADDRESSED BY MDX MAINTENANCE
