Annual Inspection Report 2021

General Engineering Consultant to the
Miami-Dade County Expressway Authority

ANNUAL INSPECTION REPORT 2021

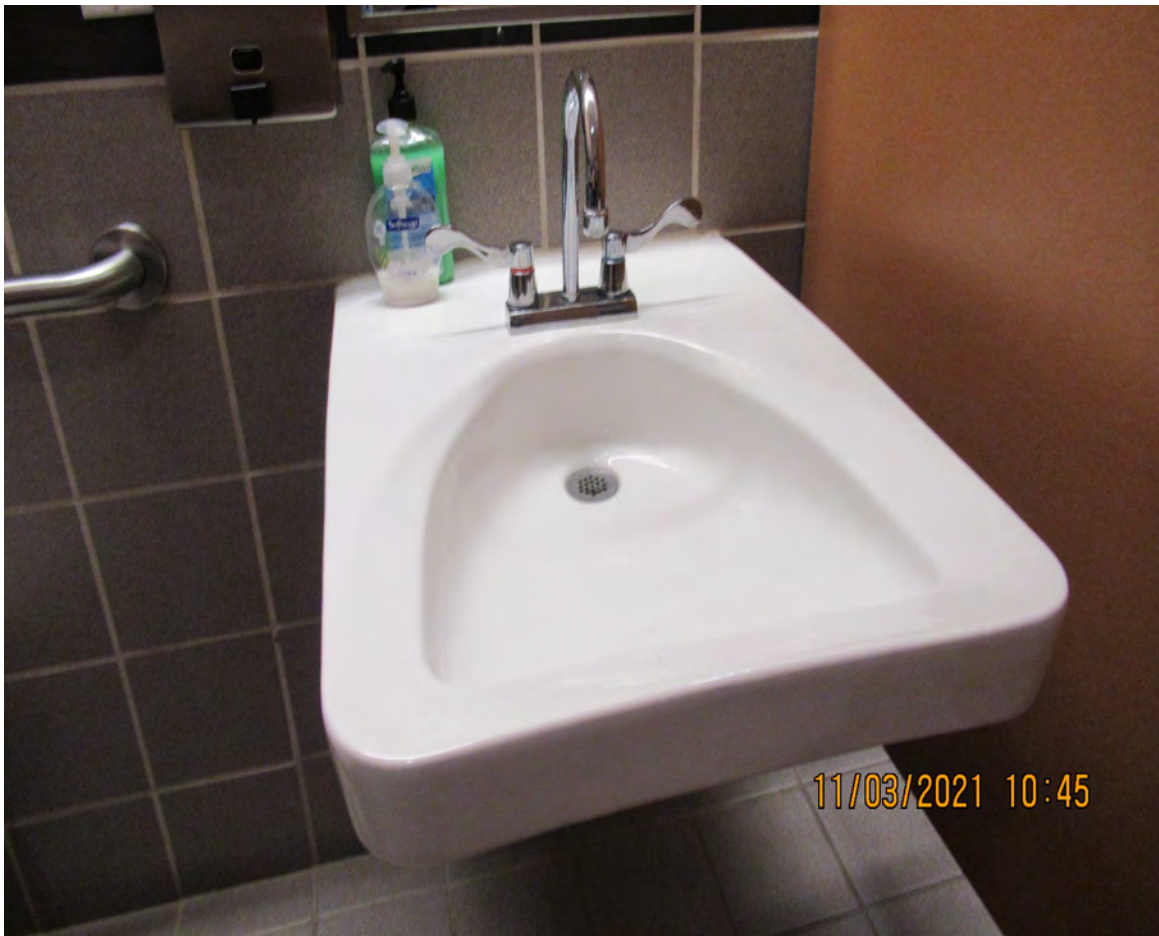
**PHOTO NO.: A-005
DATE: 11-3-2021**

LEAKING FAUCET

ITEM NOTED TO BE ADDRESSED BY MDX MAINTENANCE
