ANNUAL INSPECTION REPORT 2022

ANNUAL INSPECTION REPORT

In 1996, the Miami-Dade County Expressway Authority (MDX) acquired operational and financial control of five expressways in Miami-Dade County from the Florida Department of Transportation (FDOT). This group of expressways, toll facilities and the MDX headquarters facility, all as described below, are hereinafter referred to as the “MDX System”. In accordance with the Trust Indenture requirements, MDX retained EAC Consulting, Inc. (EAC), as the General Engineering Consultant to perform, among other duties assigned by the Authority, the yearly inspection of the MDX System. This report represents the annual inspection results for Fiscal Year (FY) 2022.

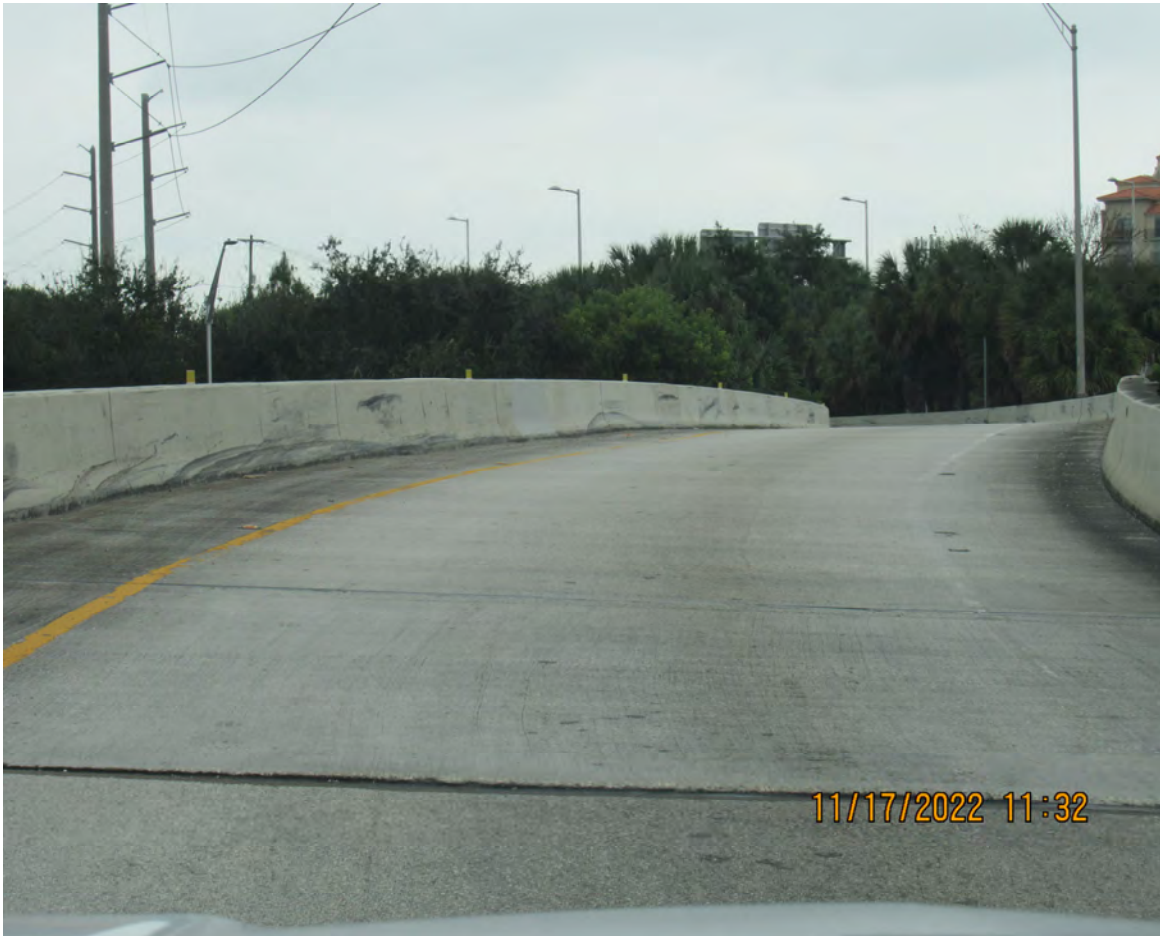
**PHOTO NO.: EB-001
DATE: 11-17-2022**

DETERIORATED STRIPING (BRIDGE No. 870962)

ITEMS NOTED TO BE ADDRESSED BY MDX WORK PROGRAM NO. 30033

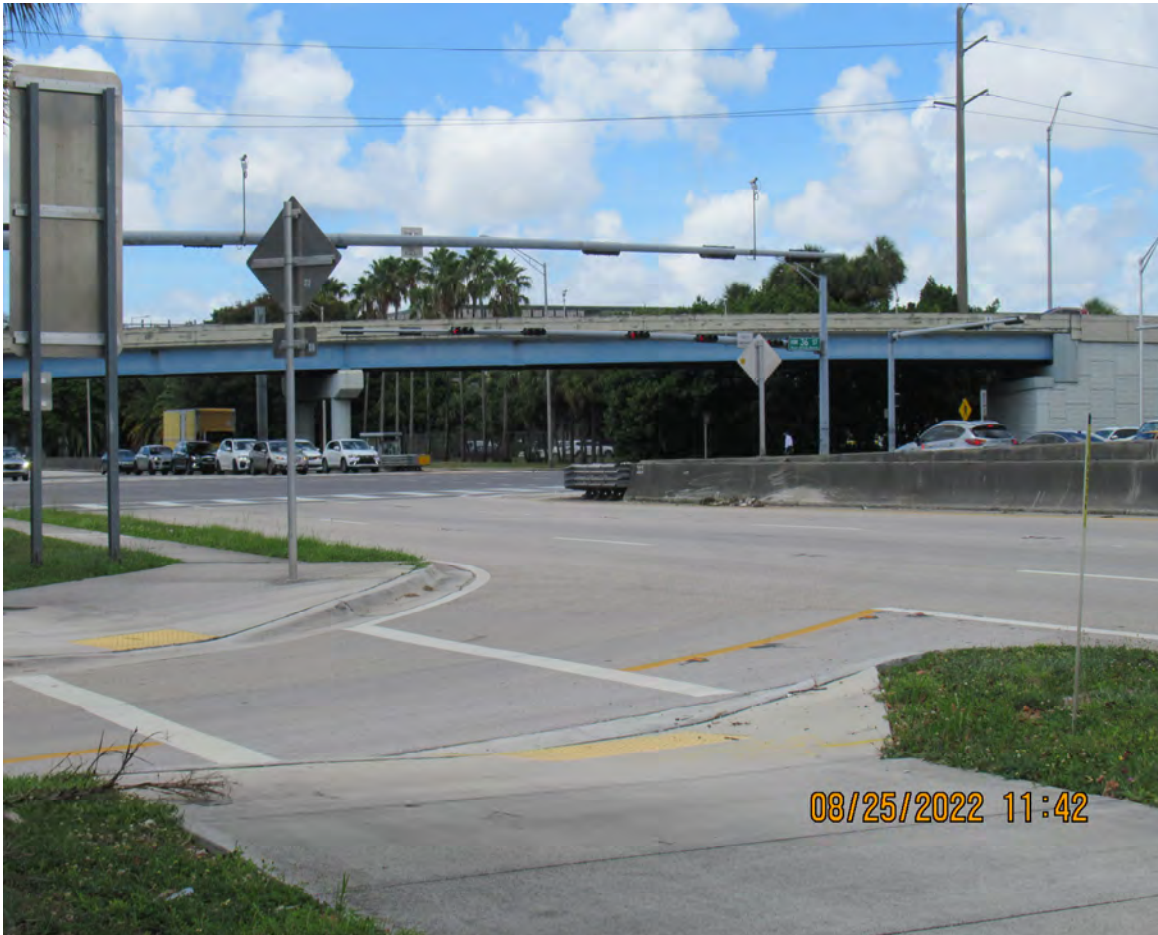
**PHOTO NO.: EB-002
DATE: 8-25-2022**

**DETERIORATED PAINT ON STEEL BRIDGE
(BRIDGE No. 870962)**

ITEMS NOTED TO BE ADDRESSED BY MDX WORK PROGRAM NO. TBD

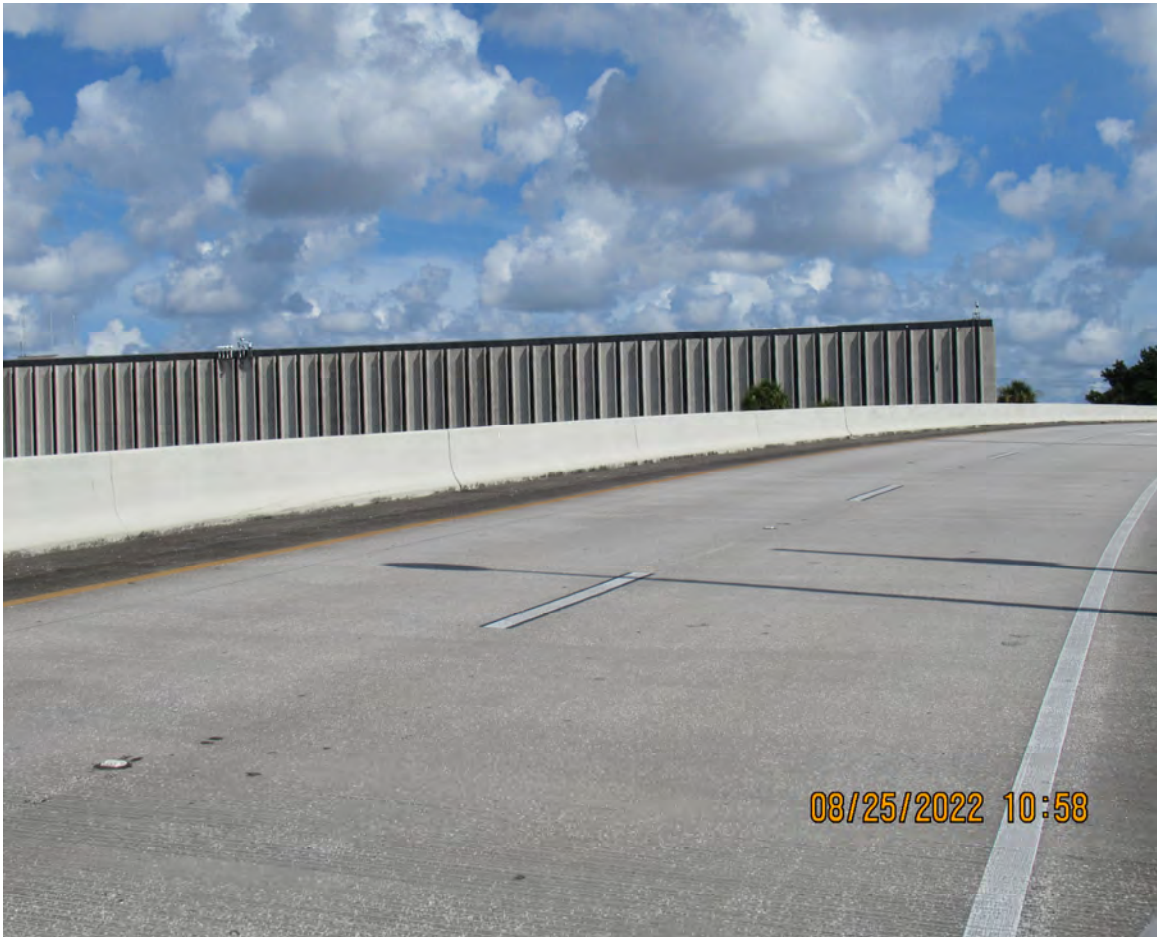
**PHOTO NO.: EB-003
DATE: 8-25-2022**

**DETERIORATED EDGELINE STRIPING
(BRIDGE No. 870726)**

ITEMS NOTED TO BE ADDRESSED BY MDX WORK PROGRAM NO. 30033

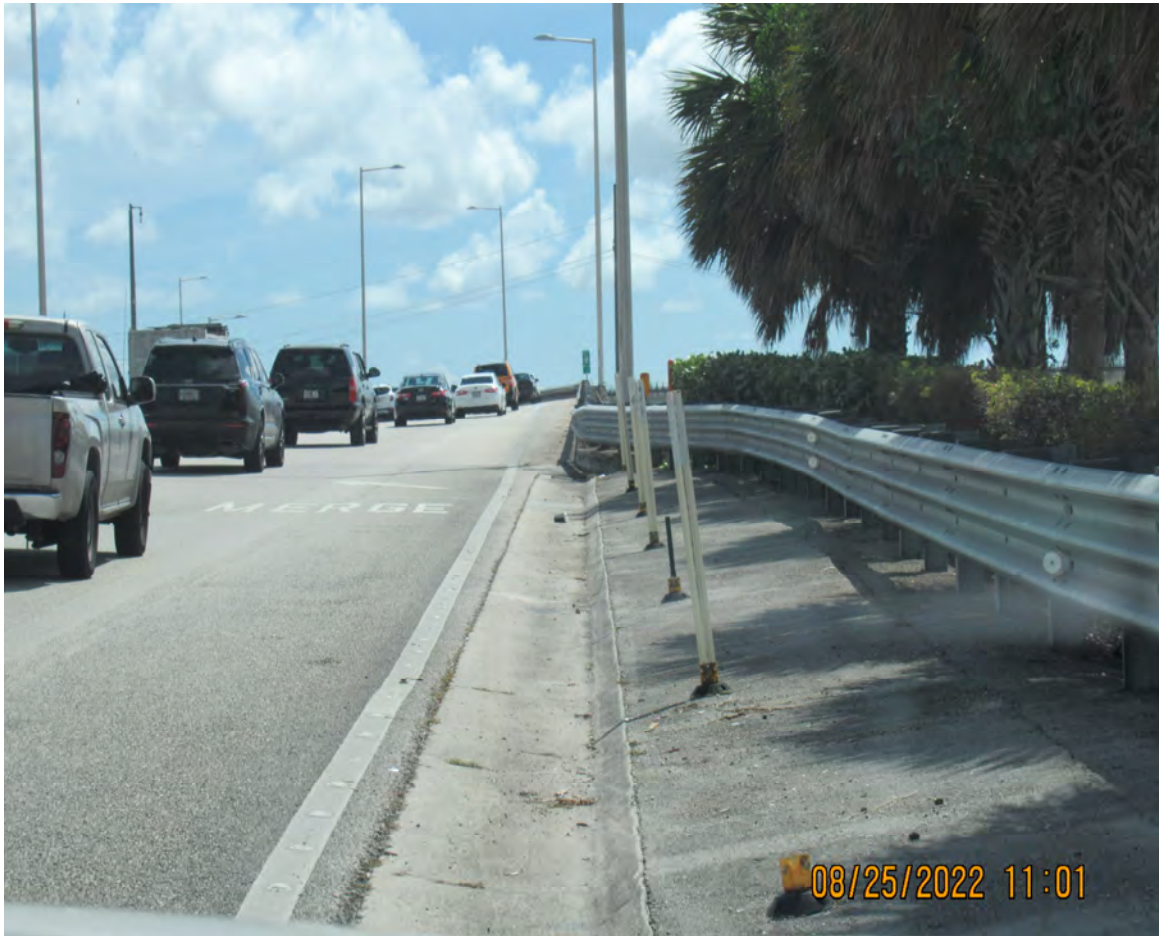
**PHOTO NO.: EB-004
DATE: 8-25-2022**

MISSING DELINEATORS

ITEMS NOTED TO BE ADDRESSED BY MDX MAINTENANCE

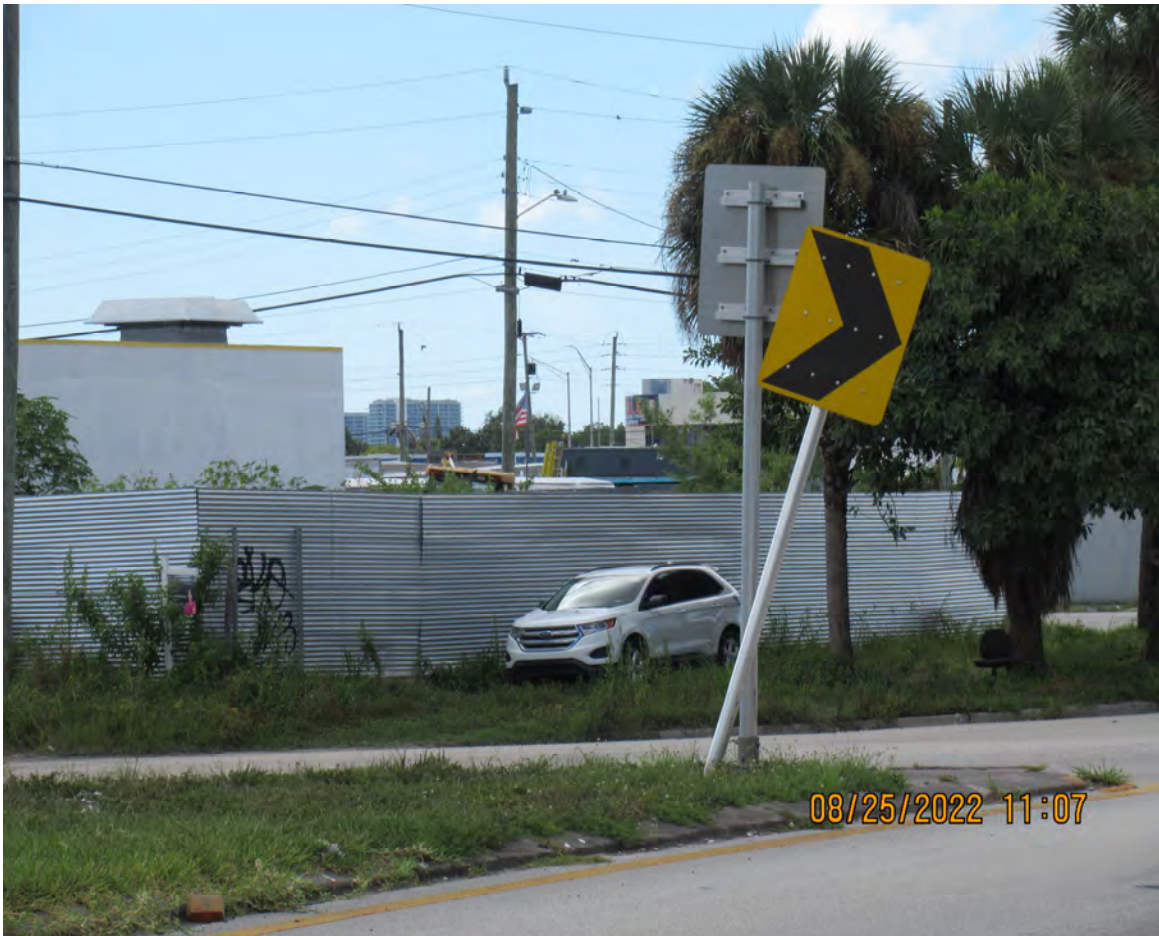
**PHOTO NO.: EB-006
DATE: 8-25-2022**

LEANING CHEVRON SIGN

ITEMS NOTED TO BE ADDRESSED BY MDX MAINTENANCE

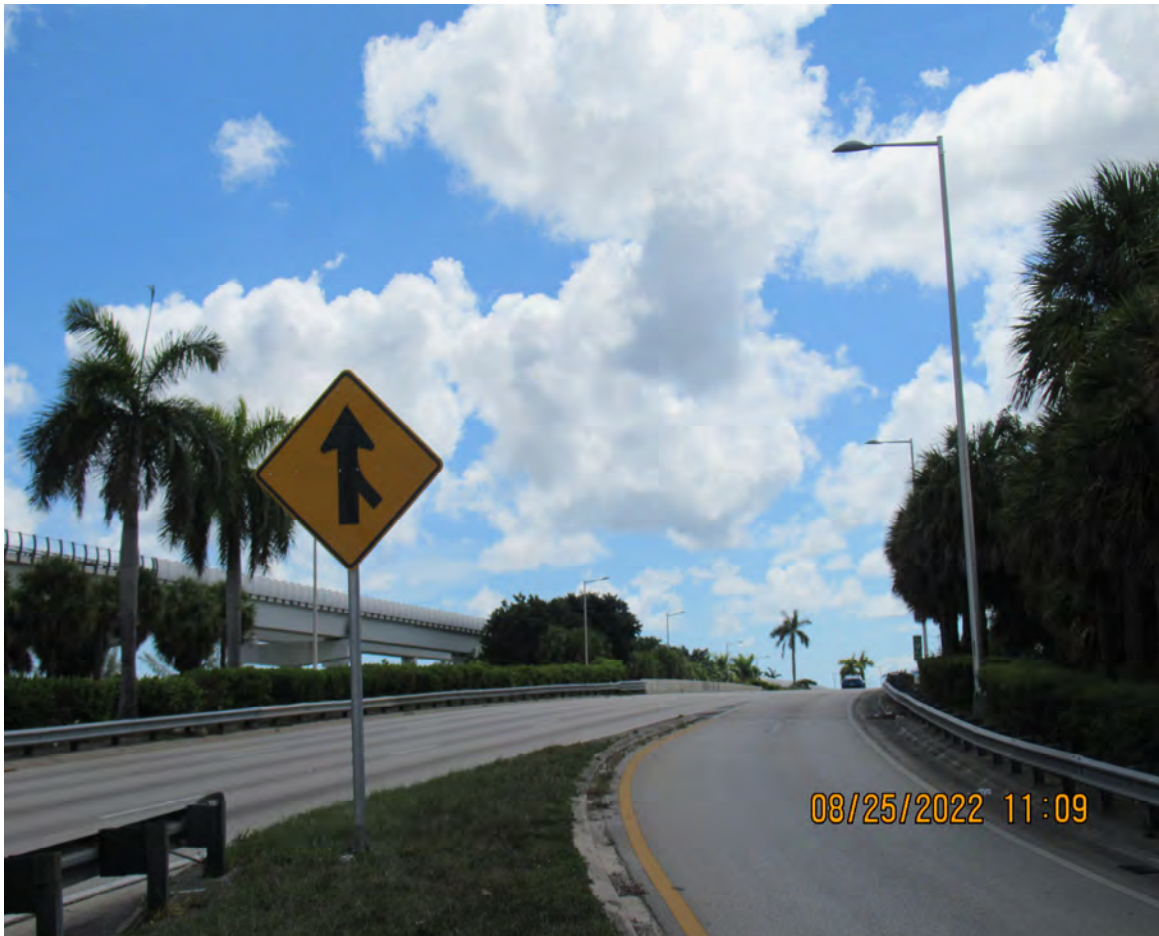
**PHOTO NO.: EB-008
DATE: 8-25-2022**

DETERIORATED REFLECTIVE SHEETING

ITEMS NOTED TO BE ADDRESSED BY MDX MAINTENANCE

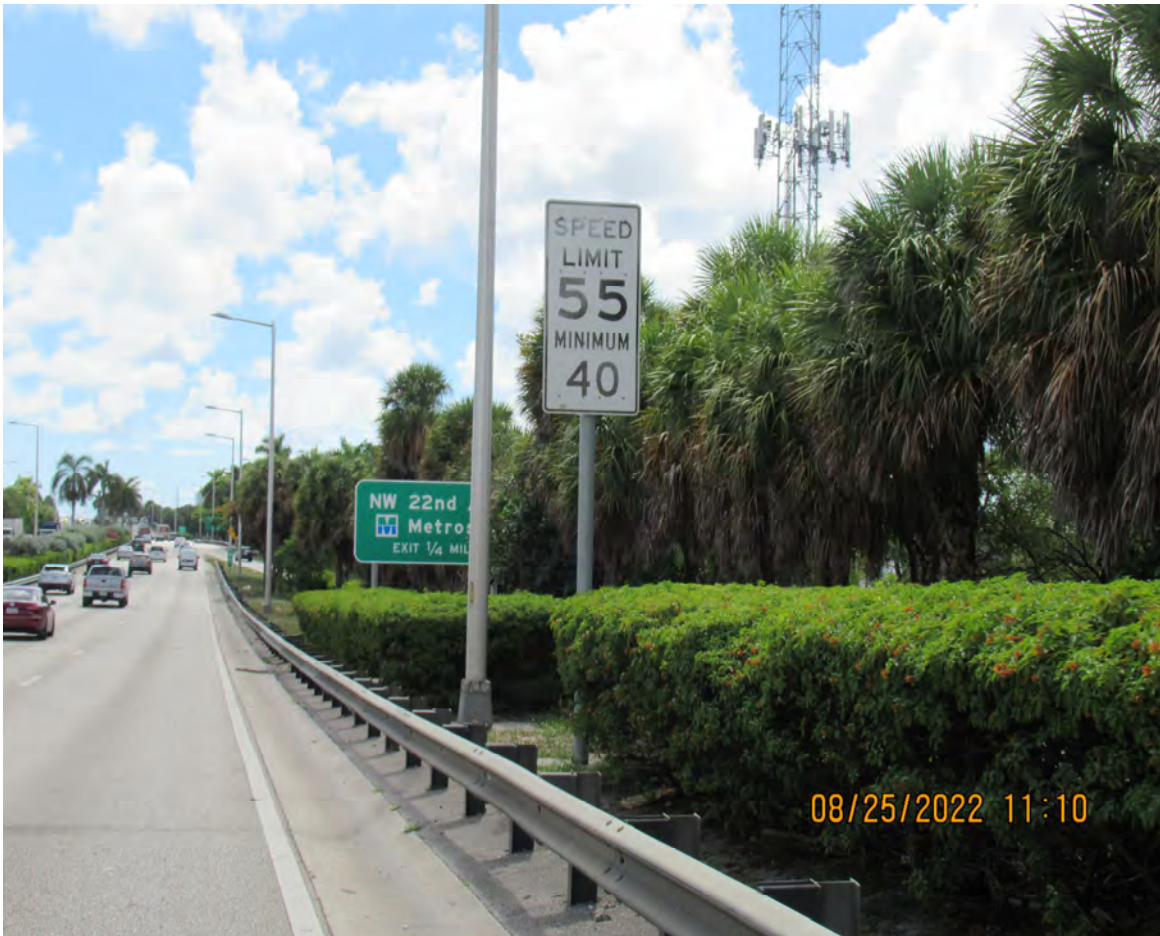
**PHOTO NO.: EB-009
DATE: 8-25-2022**

OVERGROWN VEGETATION OBSTRUCTING SIGN

ITEMS NOTED TO BE ADDRESSED BY MDX MAINTENANCE

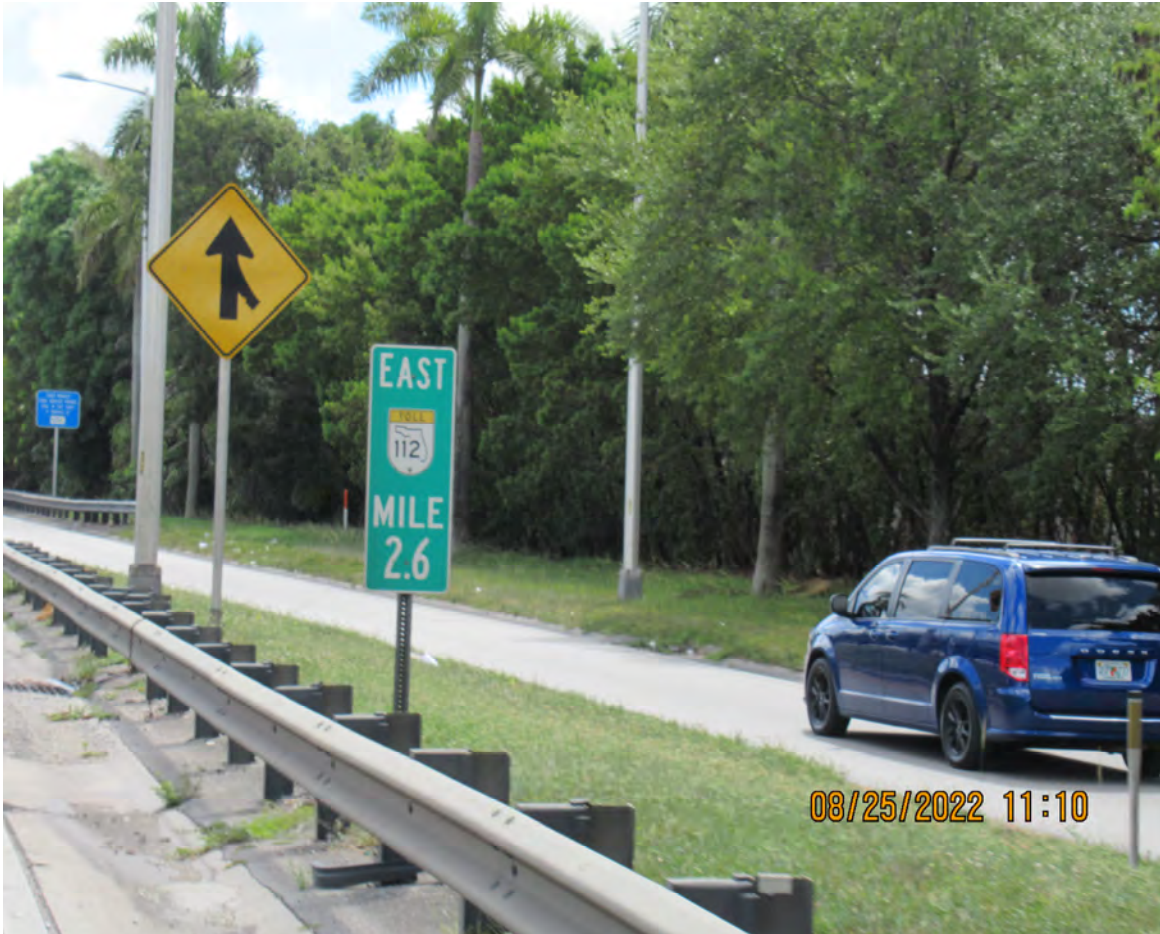
**PHOTO NO.: EB-010
DATE: 8-25-2022**

DETERIORATED REFLECTIVE SHEETING ON MERGE SIGN

ITEMS NOTED TO BE ADDRESSED BY MDX MAINTENANCE

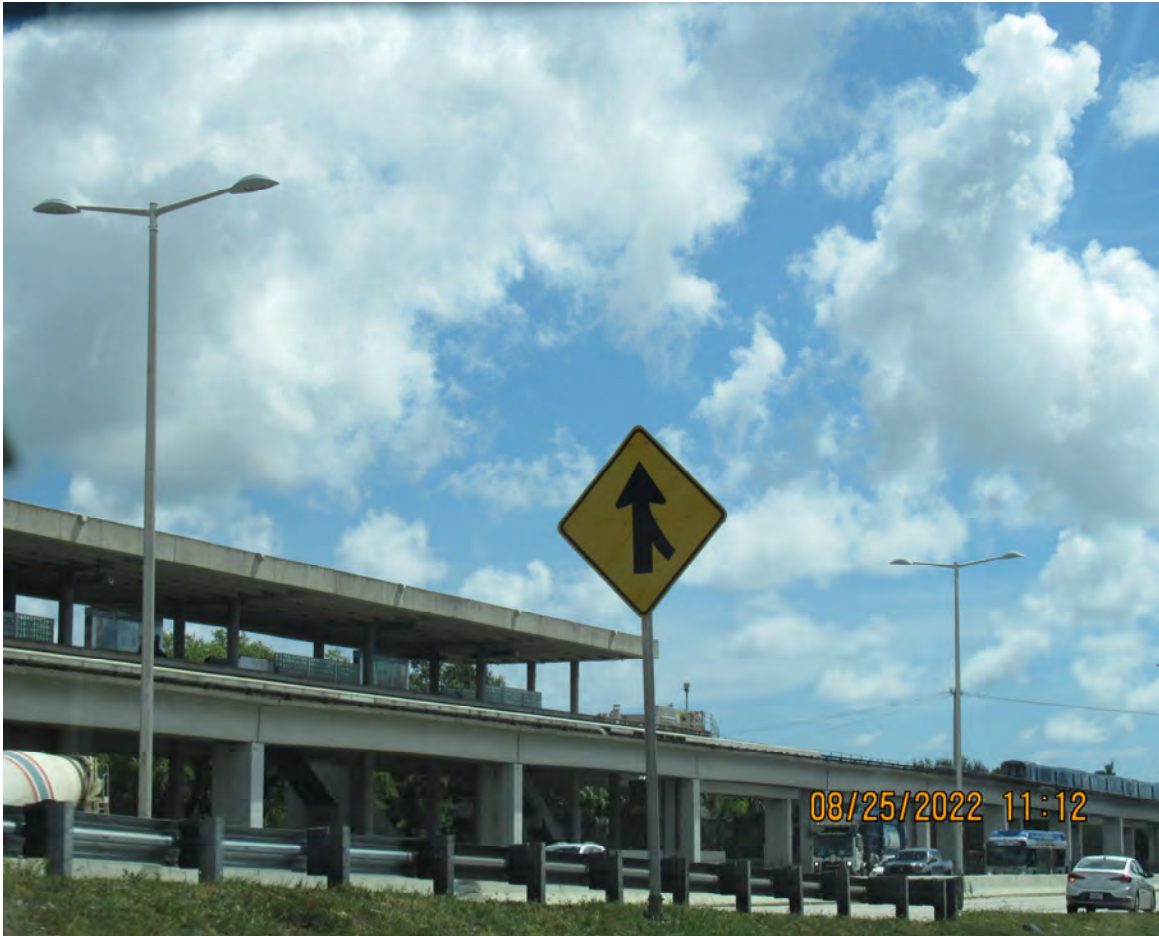
**PHOTO NO.: EB-011
DATE: 8-25-2022**

DETERIORATED REFLECTIVE SHEETING ON MERGE SIGN

ITEMS NOTED TO BE ADDRESSED BY MDX MAINTENANCE

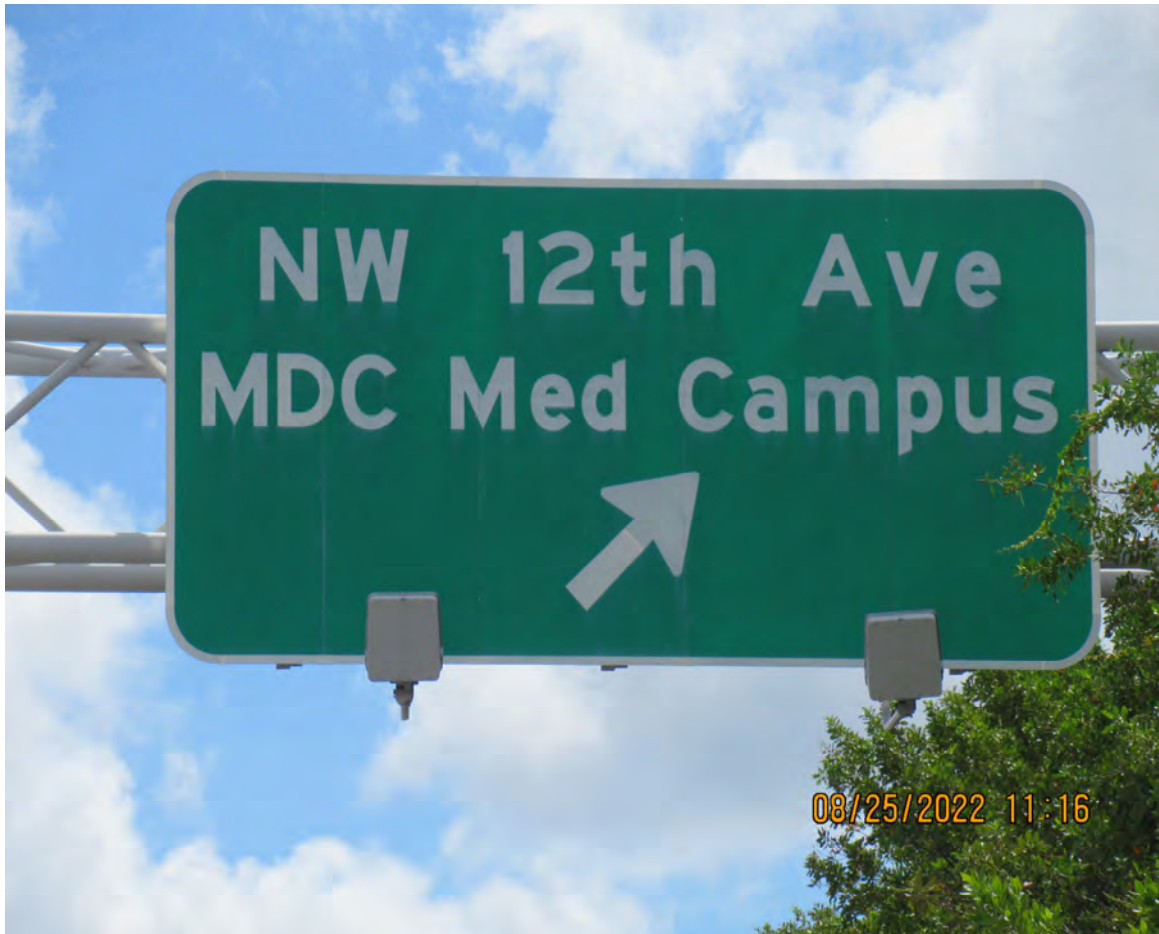
**PHOTO NO.: EB-012
DATE: 8-25-2022**

DETERIORATED REFLECTIVE SHEETING

ITEMS NOTED TO BE ADDRESSED BY MDX WORK PROGRAM NO. 30058

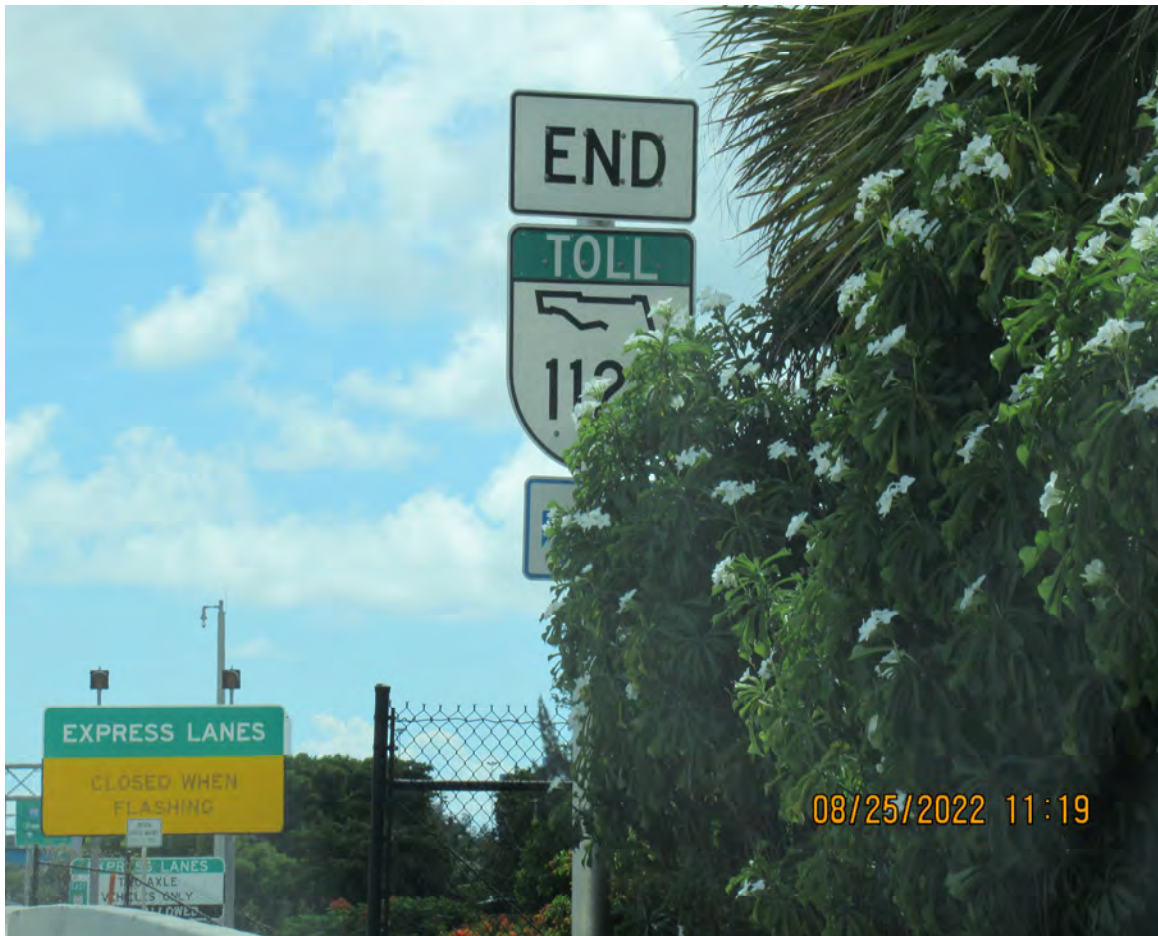
**PHOTO NO.: EB-013
DATE: 8-25-2022**

OVERGROWN VEGETATION OBSTRUCTING SIGN

ITEMS NOTED TO BE ADDRESSED BY MDX MAINTENANCE

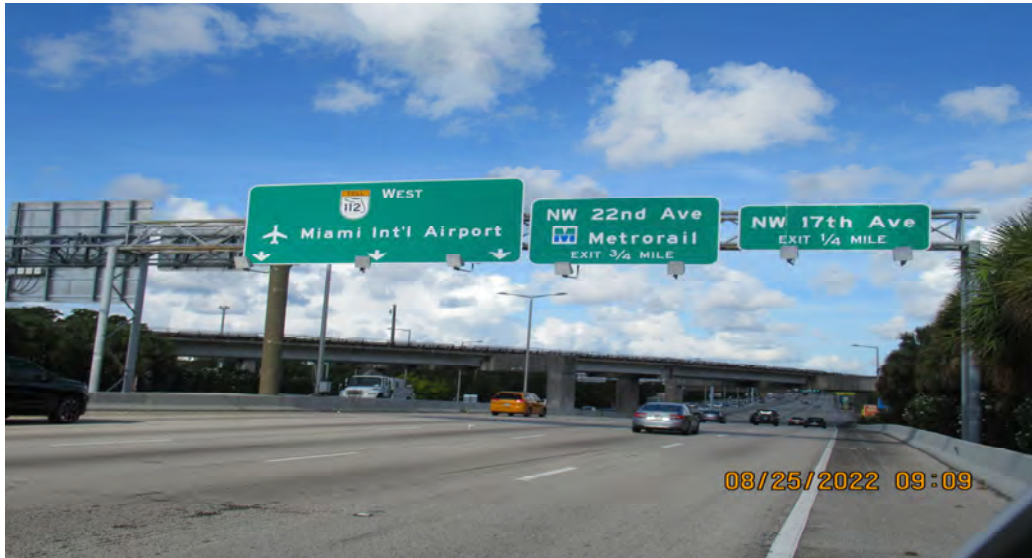
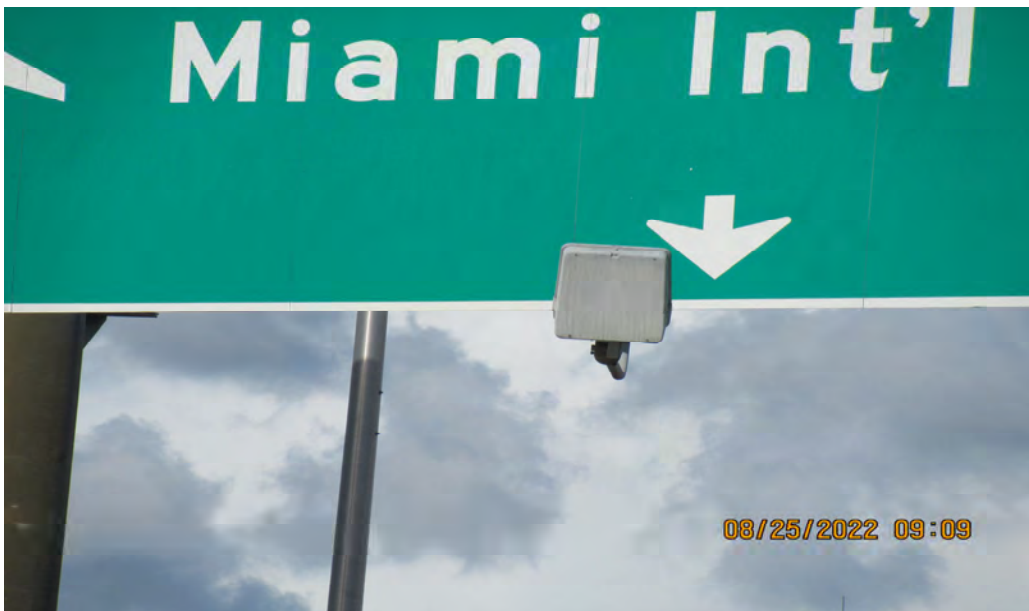
**PHOTO NO.: WB-001
DATE: 8-25-2022**

TWISTED LUMINAIRE (STRUCTURE # 87S422)

ITEM NOTED TO BE ADDRESSED BY MDX MAINTENANCE

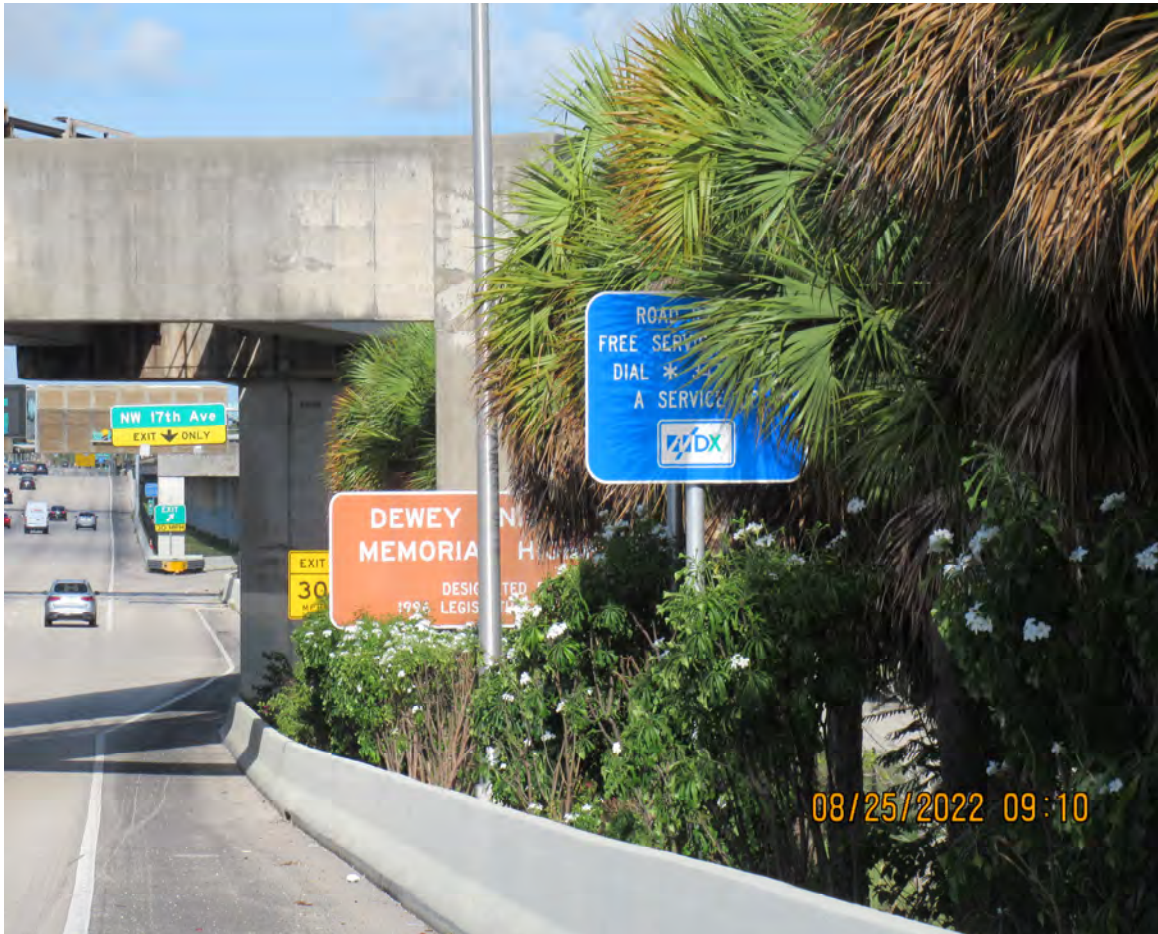
**PHOTO NO.: WB-002
DATE: 8-25-2022**

OVERGROWN VEGETATION OBSTRUCTING SIGN

ITEM NOTED TO BE ADDRESSED BY MDX MAINTENANCE

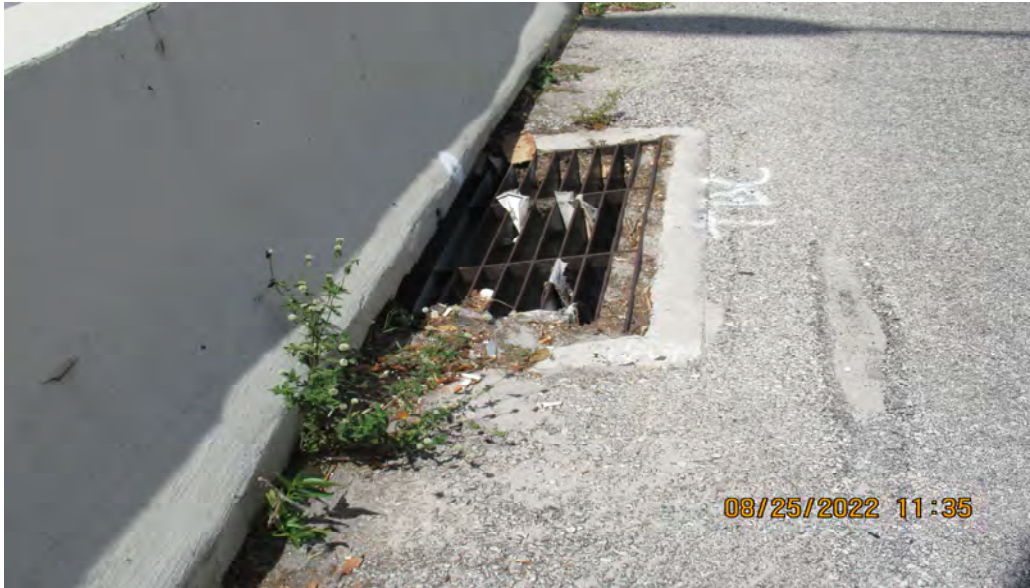
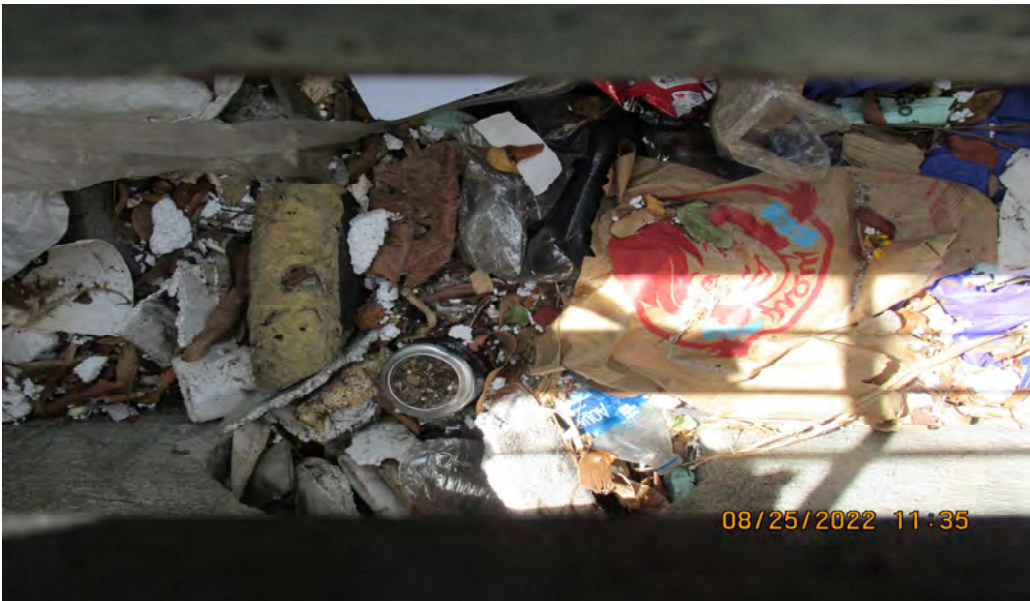
**PHOTO NO.: WB-003
DATE: 8-25-2022**

SILTED DRAINAGE STRUCTURE (TYPICAL THROUGHOUT THE CORRIDOR)

ITEM NOTED TO BE ADDRESSED BY MDX MAINTENANCE

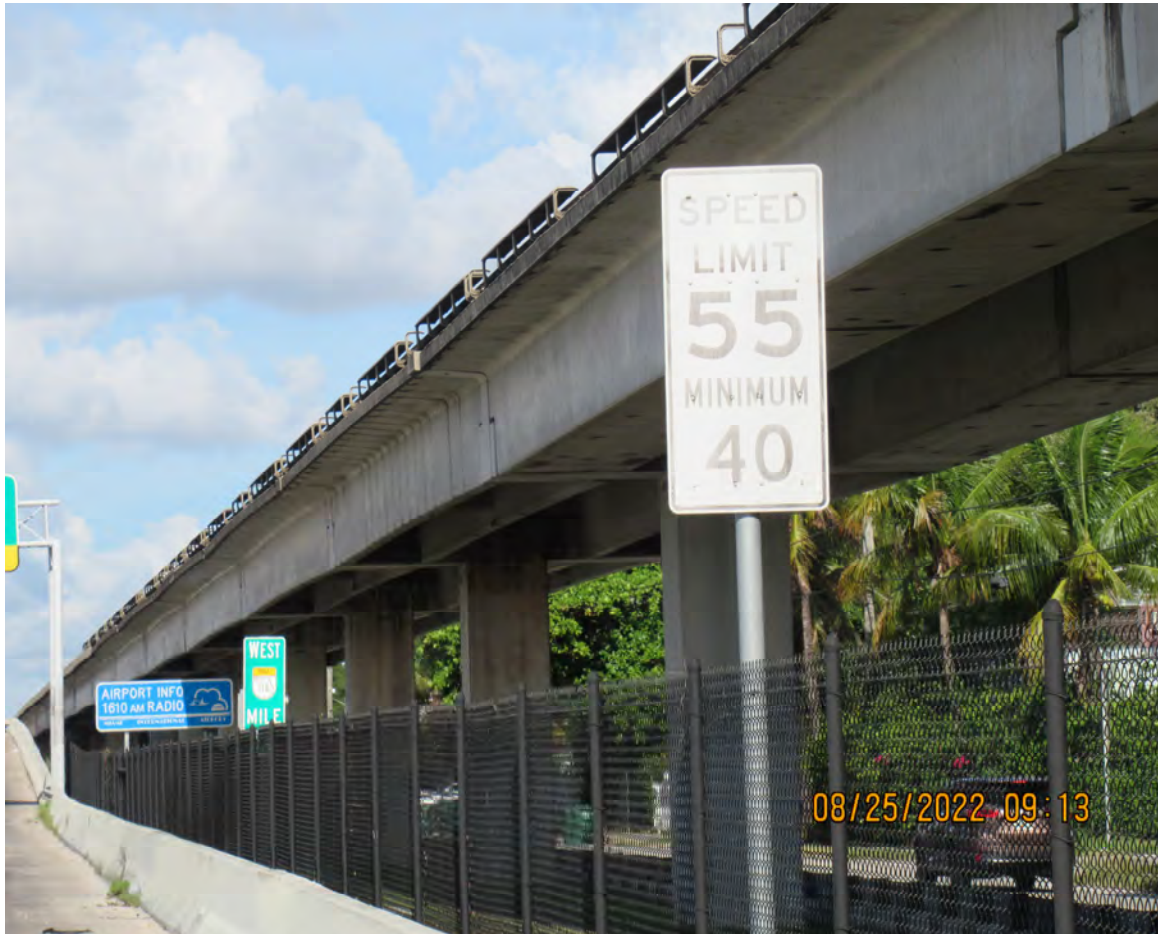
**PHOTO NO.: WB-004
DATE: 8-25-2022**

DETERIORATED REFLECTIVE SHEETING ON SPEED LIMIT SIGN

ITEM NOTED TO BE ADDRESSED BY MDX MAINTENANCE

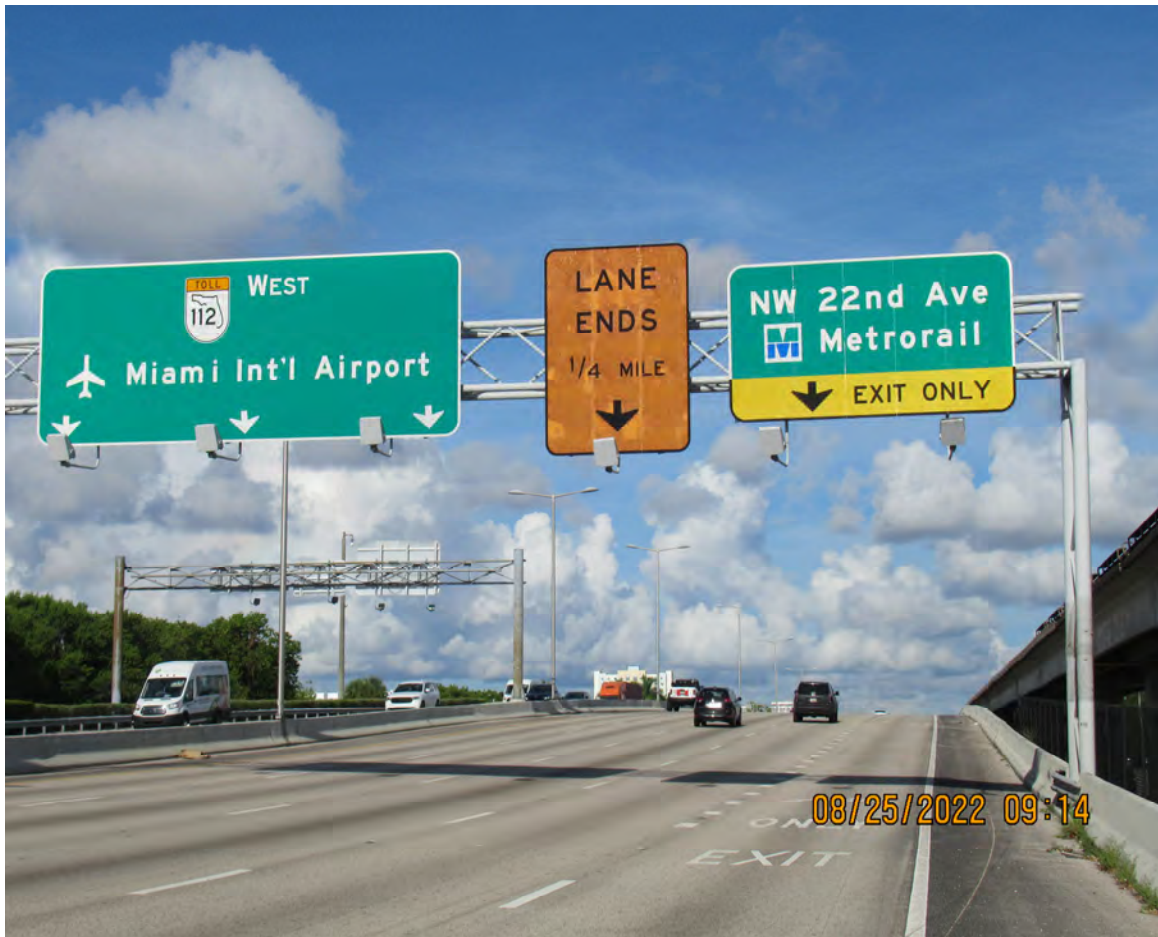
**PHOTO NO.: WB-005
DATE: 8-25-2022**

**DETERIORATED REFLECTIVE SHEETING ON LANE ENDS SIGN
(STRUCTURE # 87S418)**

ITEM NOTED TO BE ADDRESSED BY MDX WORK PROGRAM NO. 30058

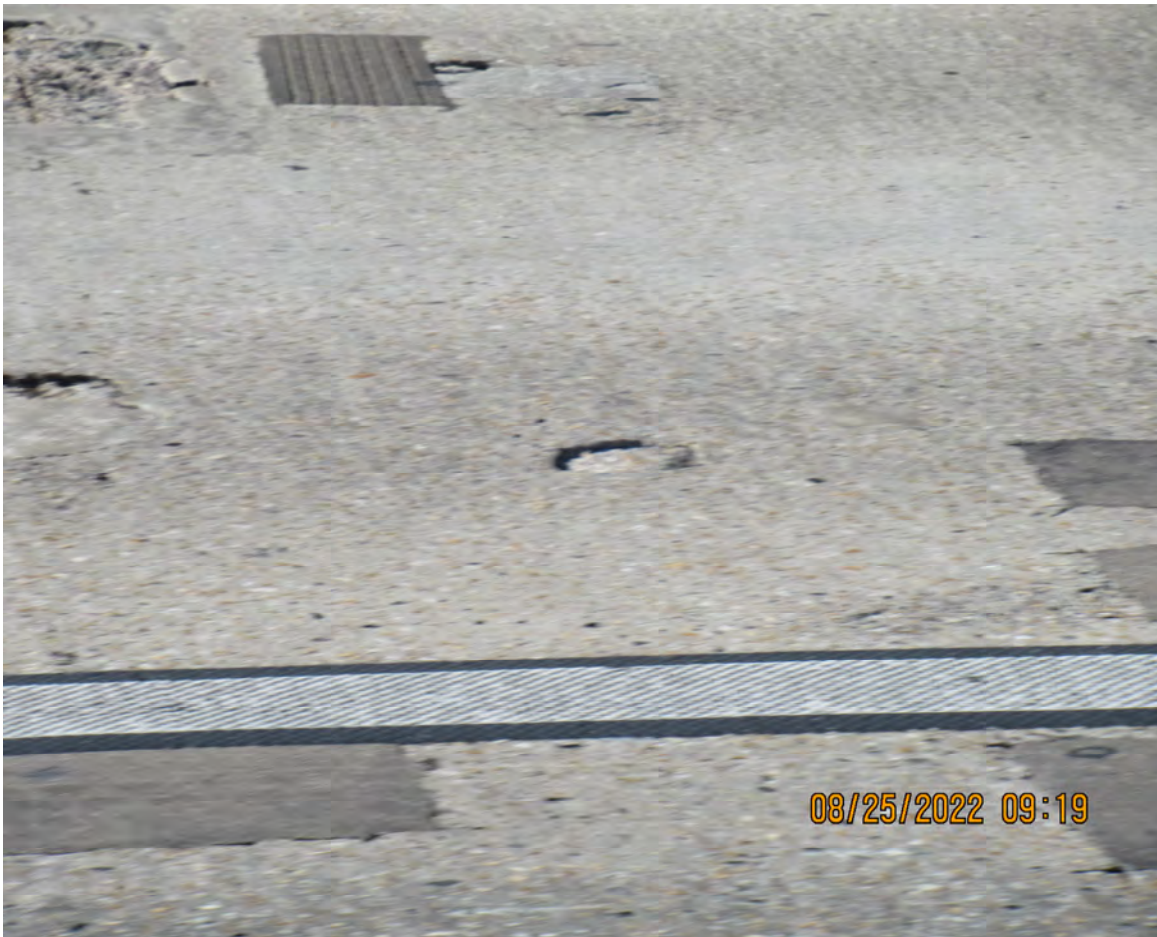
**PHOTO NO.: WB-006
DATE: 8-25-2022**

CONCRETE SPALLS ON BRIDGE DECK (BRIDGE # 870120)

ITEM NOTED TO BE ADDRESSED BY MDX MAINTENANCE

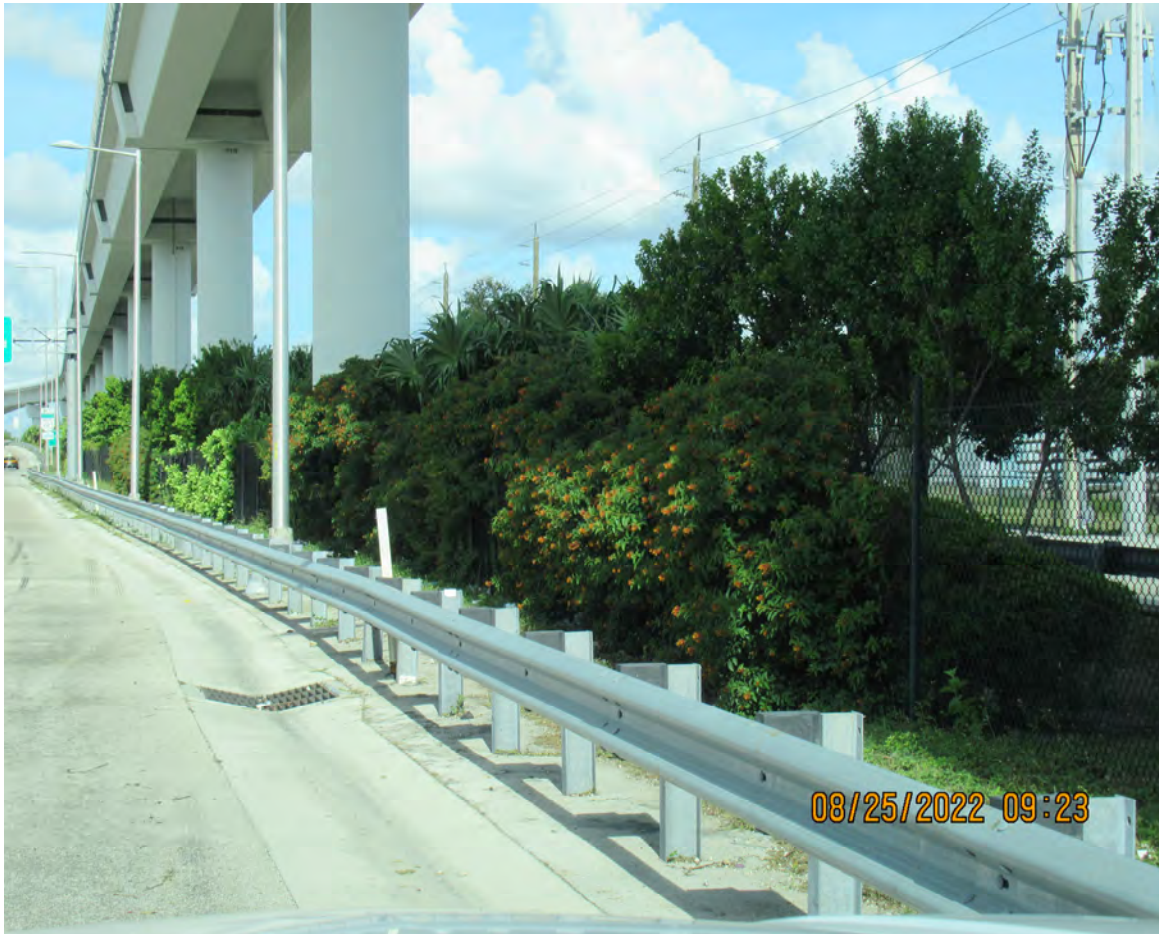
**PHOTO NO.: WB-007
DATE: 8-25-2022**

**OVERGROWN VEGETATION ON FENCE
(TYPICAL THROUGHOUT THE CORRIDOR)**

ITEM NOTED TO BE ADDRESSED BY MDX MAINTENANCE

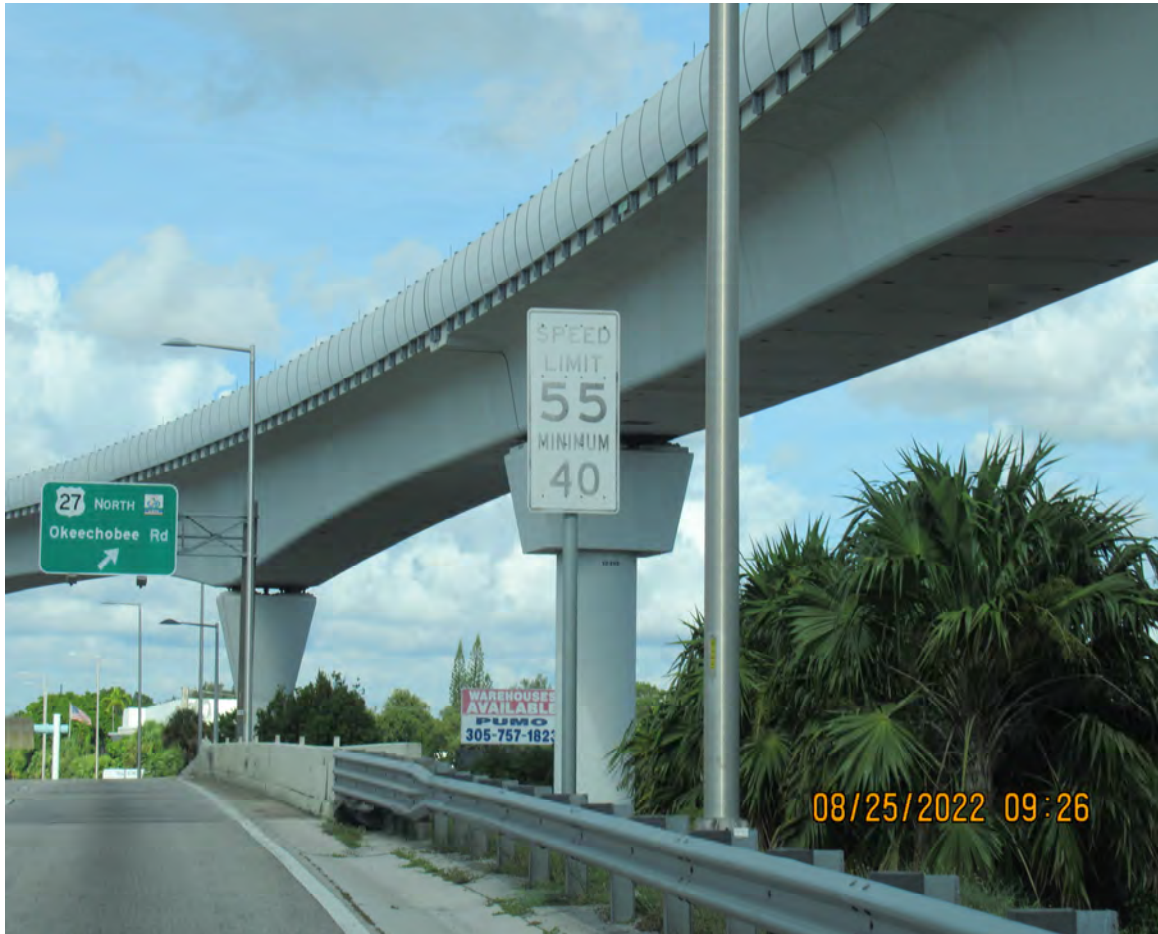
**PHOTO NO.: WB-009
DATE: 8-25-2022**

DETERIORATED REFLECTIVE SHEETING ON SPEED LIMIT SIGN

ITEM NOTED TO BE ADDRESSED BY MDX MAINTENANCE

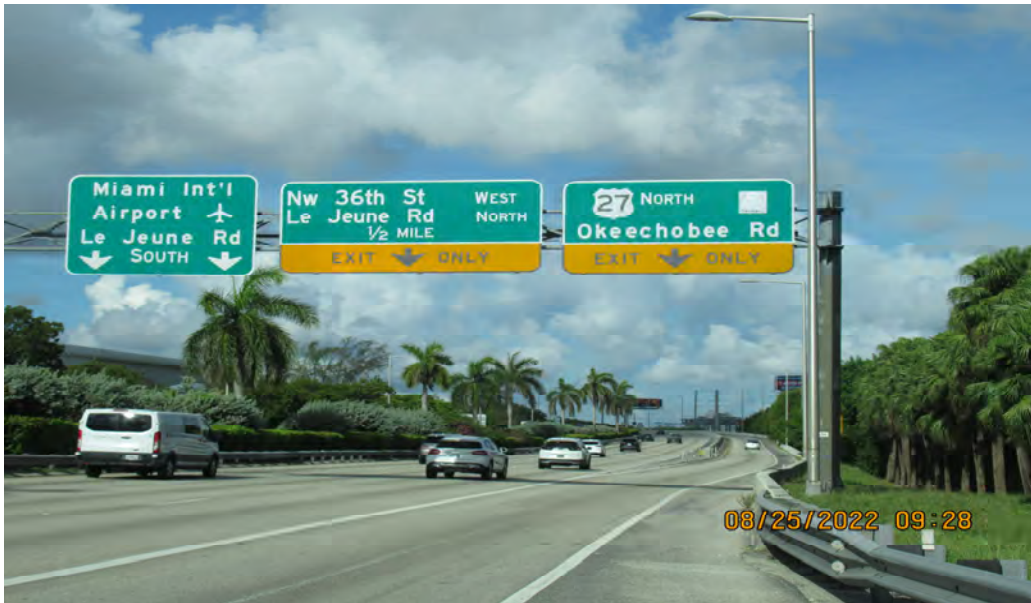
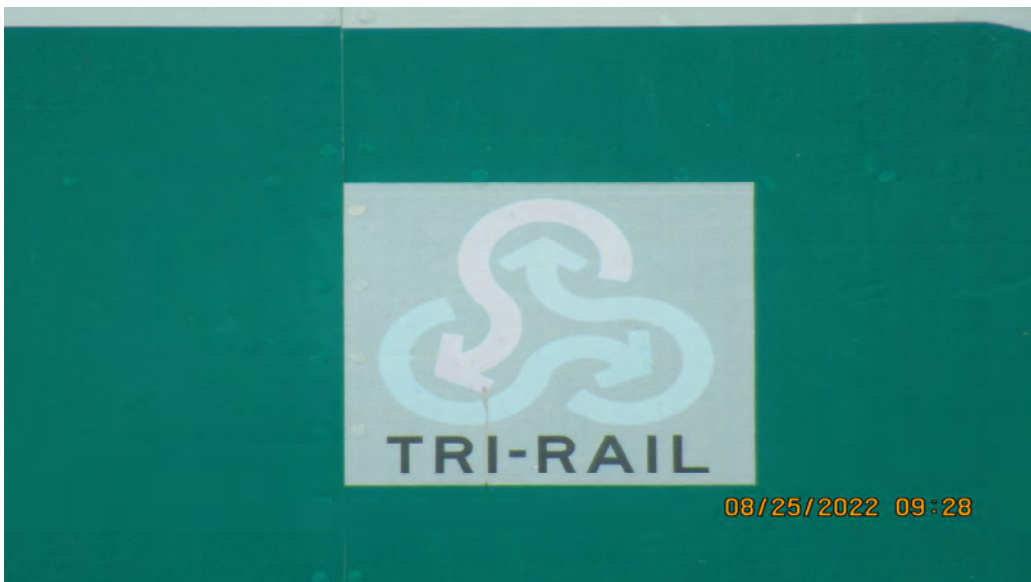
**PHOTO NO.: WB-010
DATE: 8-25-2022**

**DETERIORATED REFLECTIVE SHEETING ON TRI-RAIL SIGN OVERLAY
(STRUCTURE # 87S706)**

ITEM NOTED TO BE ADDRESSED BY MDX MAINTENANCE
