ANNUAL INSPECTION REPORT 2022

ANNUAL INSPECTION REPORT

In 1996, the Miami-Dade County Expressway Authority (MDX) acquired operational and financial control of five expressways in Miami-Dade County from the Florida Department of Transportation (FDOT). This group of expressways, toll facilities and the MDX headquarters facility, all as described below, are hereinafter referred to as the “MDX System”. In accordance with the Trust Indenture requirements, MDX retained EAC Consulting, Inc. (EAC), as the General Engineering Consultant to perform, among other duties assigned by the Authority, the yearly inspection of the MDX System. This report represents the annual inspection results for Fiscal Year (FY) 2022.

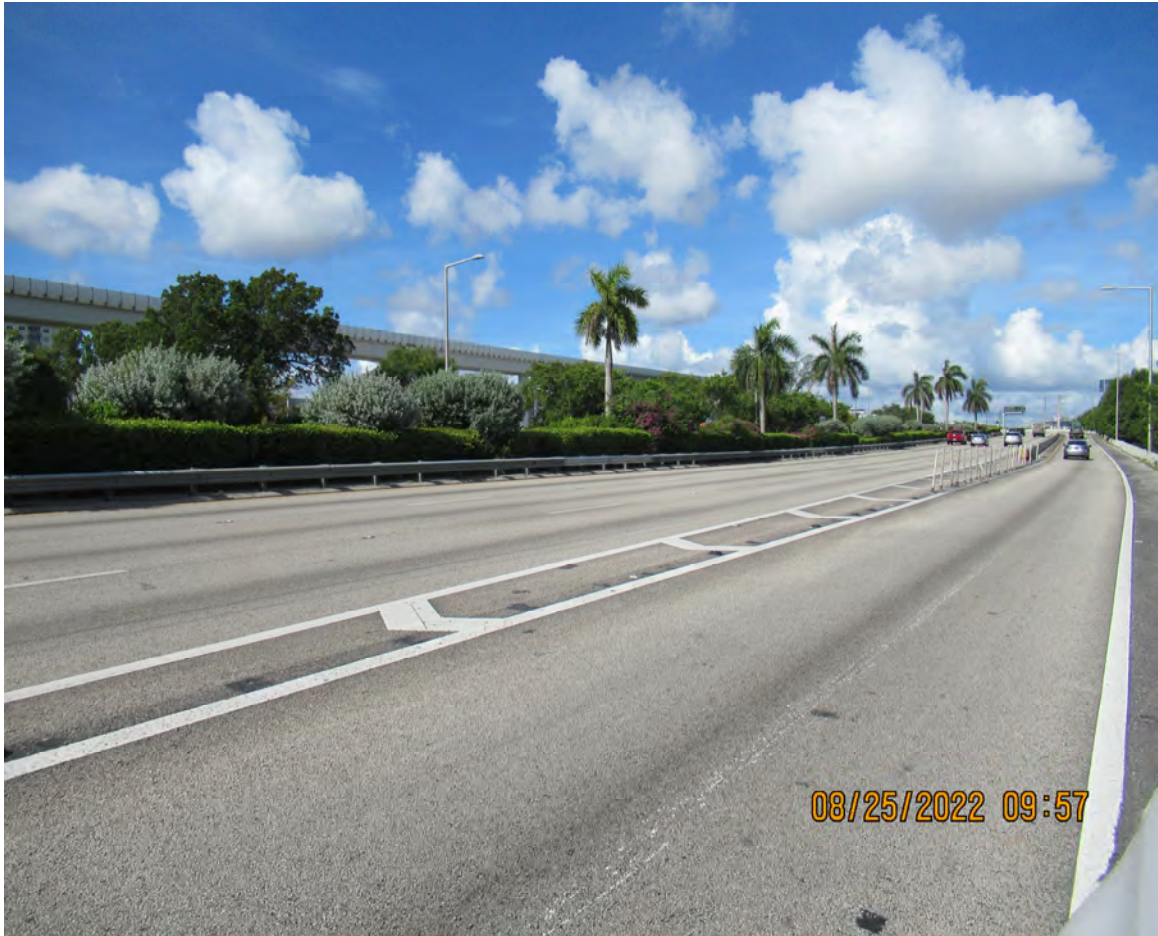
**PHOTO NO.: WB-011
DATE: 8-25-2022**

MISSING DELINEATORS

ITEM NOTED TO BE ADDRESSED BY MDX MAINTENANCE

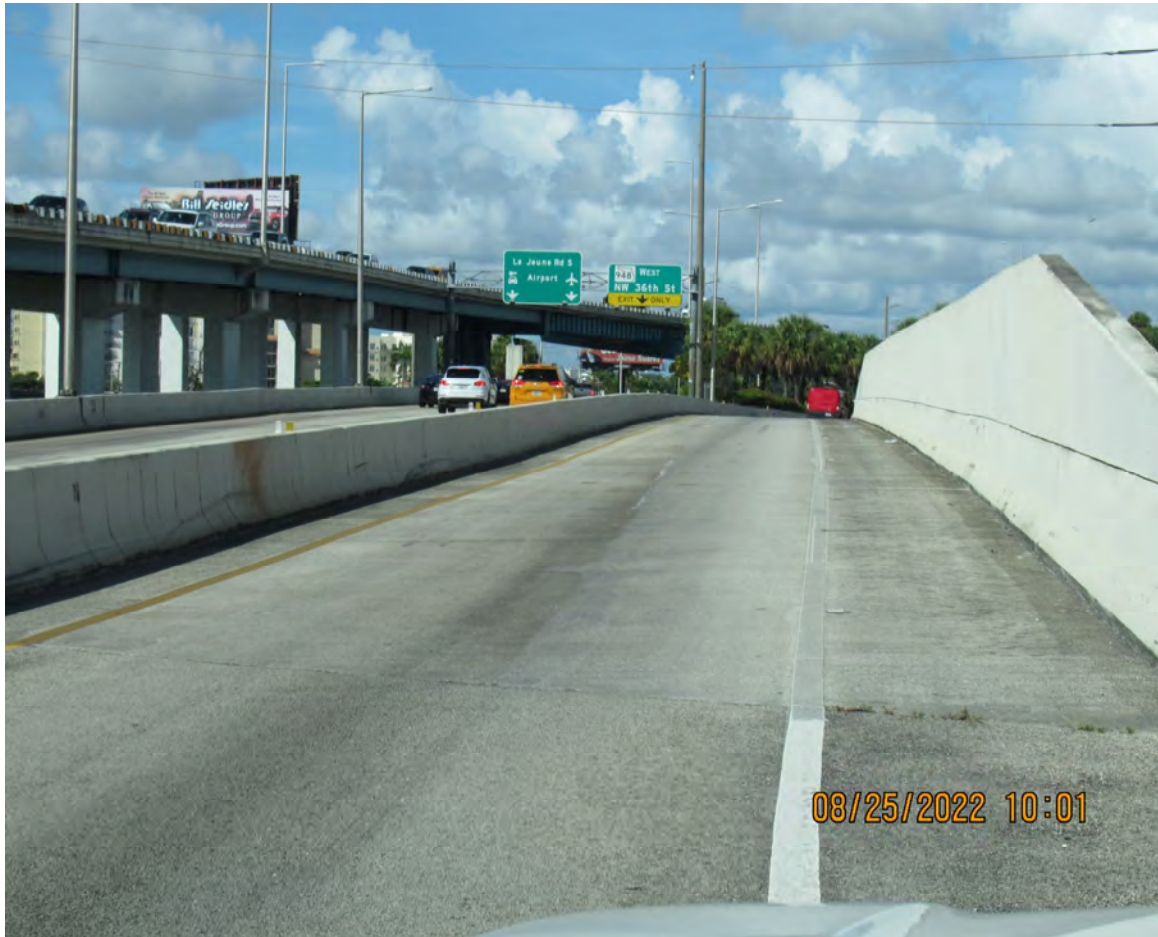
**PHOTO NO.: WB-015
DATE: 8-25-2022**

**DETERIORATED STRIPING ON BRIDGE
(BRIDGE # 870026)**

ITEM NOTED TO BE ADDRESSED BY MDX WORK PROGRAM NO. 30033

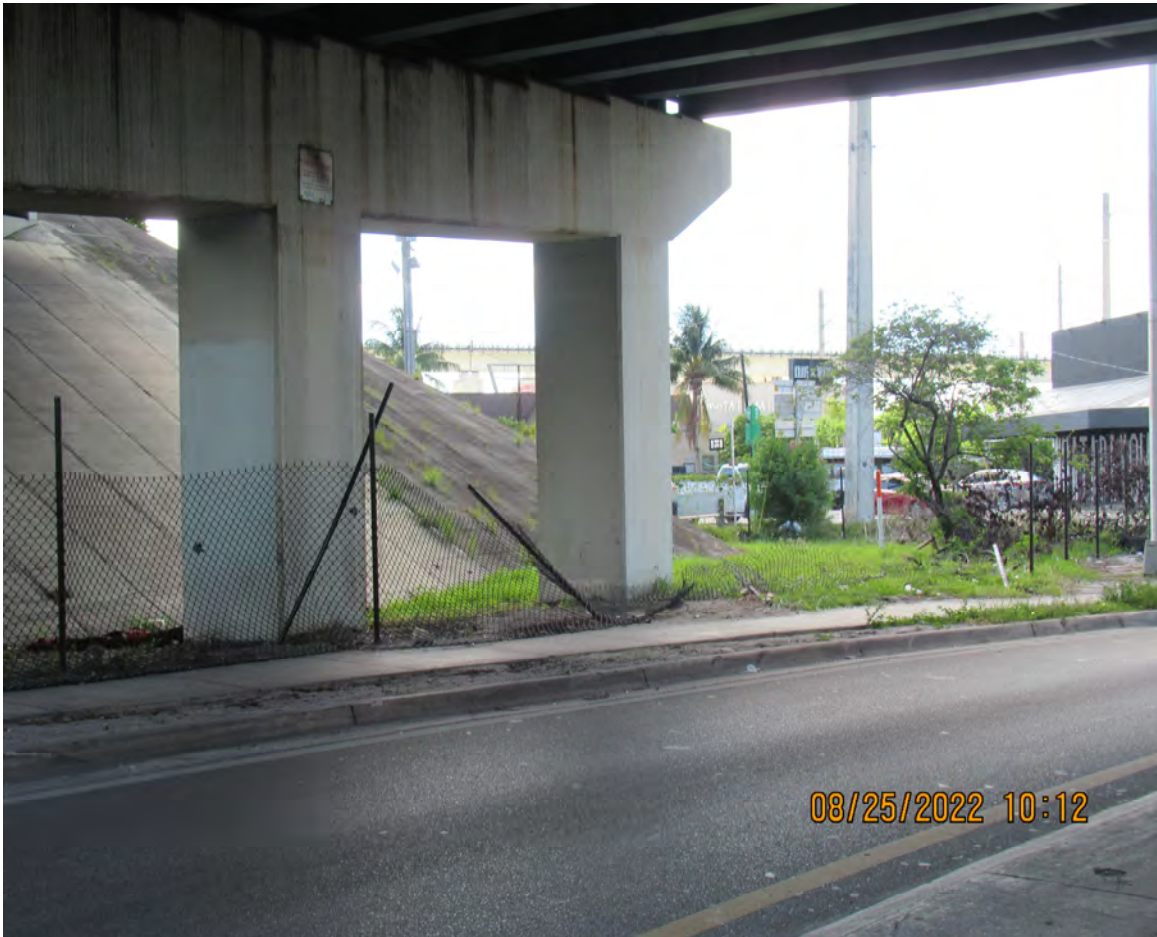
**PHOTO NO.: WB-017
DATE: 8-25-2022**

DAMAGED FENCE UNDERNEATH BRIDGE # 870238

ITEM NOTED TO BE ADDRESSED BY MDX MAINTENANCE

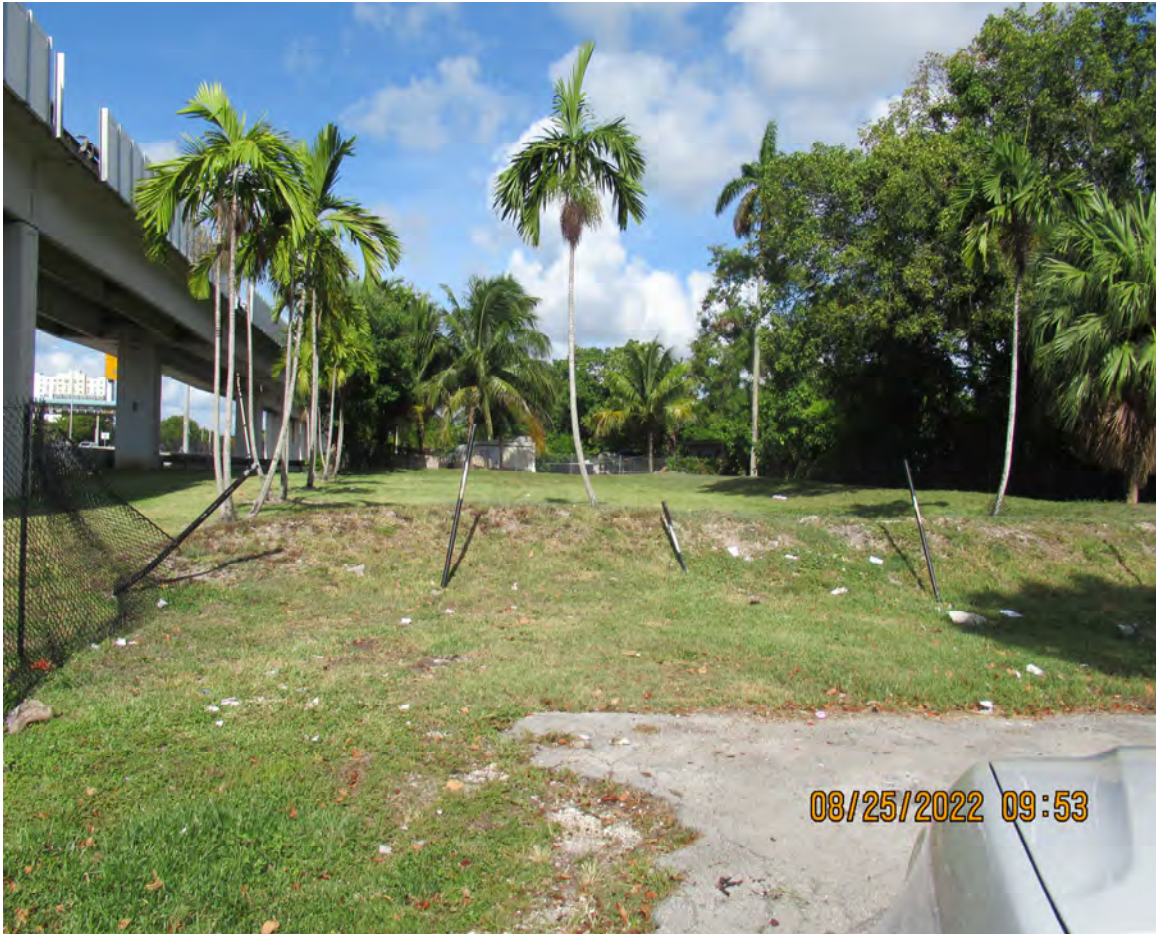
**PHOTO NO.: WB-022
DATE: 8-25-2022**

DAMAGED FENCE

ITEM NOTED TO BE ADDRESSED BY MDX MAINTENANCE

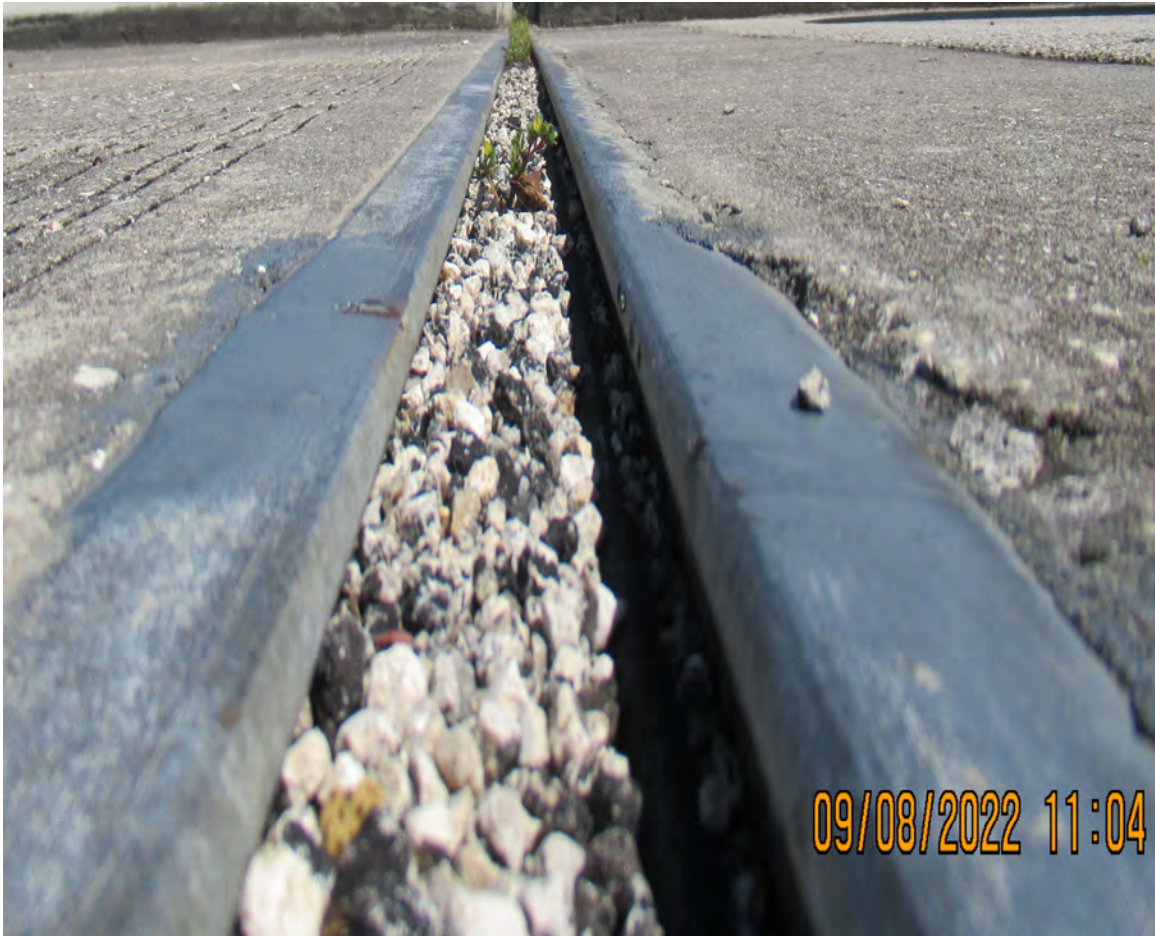
**PHOTO NO.: EB-002
DATE: 9-8-2022**

**DEBRIS ON BRIDGE EXPANSION JOINT (BRIDGE No. 871008)
(TYPICAL THROUGHOUT)**

ITEM NOTED TO BE ADDRESSED BY MDX MAINTENANCE

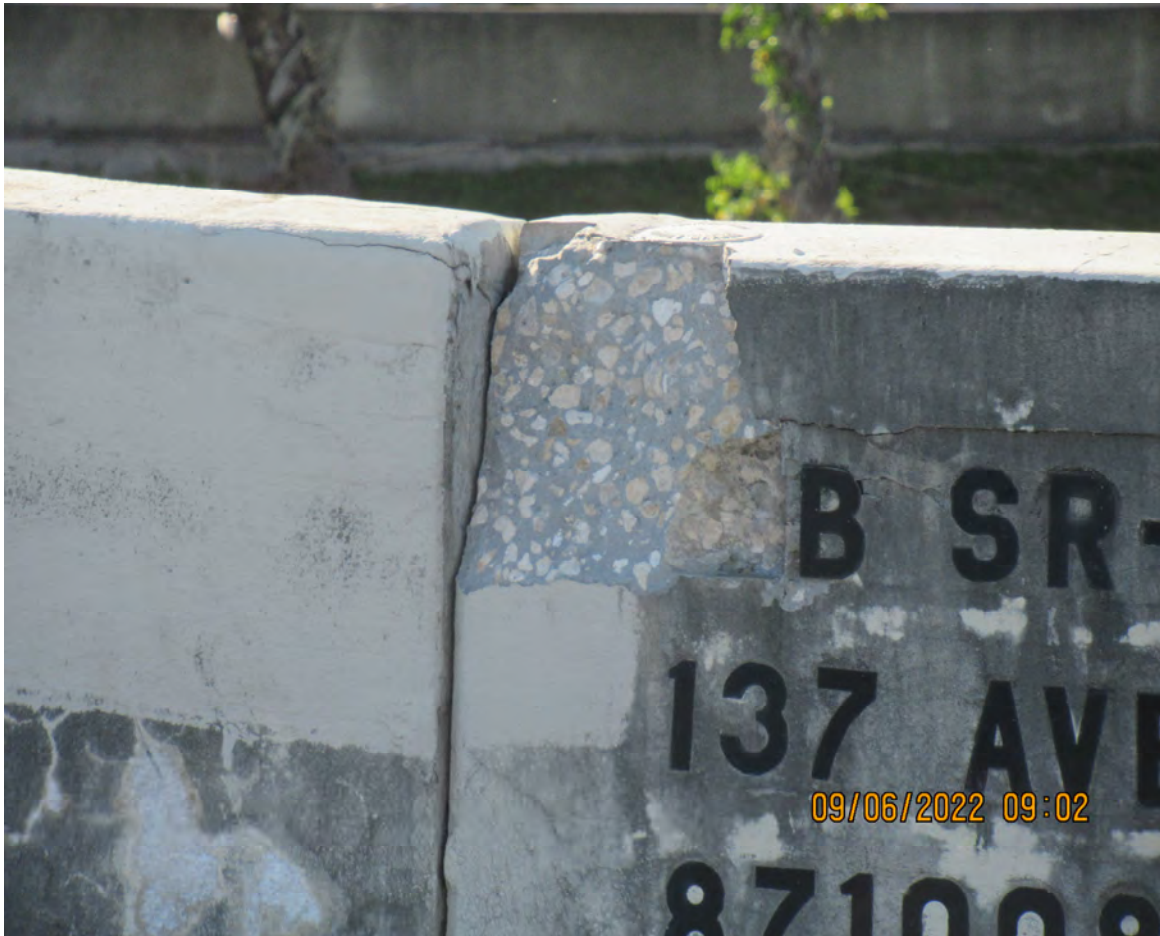
**PHOTO NO.: EB-003
DATE: 9-6-2022**

SPALL ON TRAFFIC RAILING (ABUTMENT 1, BRIDGE No. 871008)

ITEM NOTED TO BE ADDRESSED BY MDX MAINTENANCE

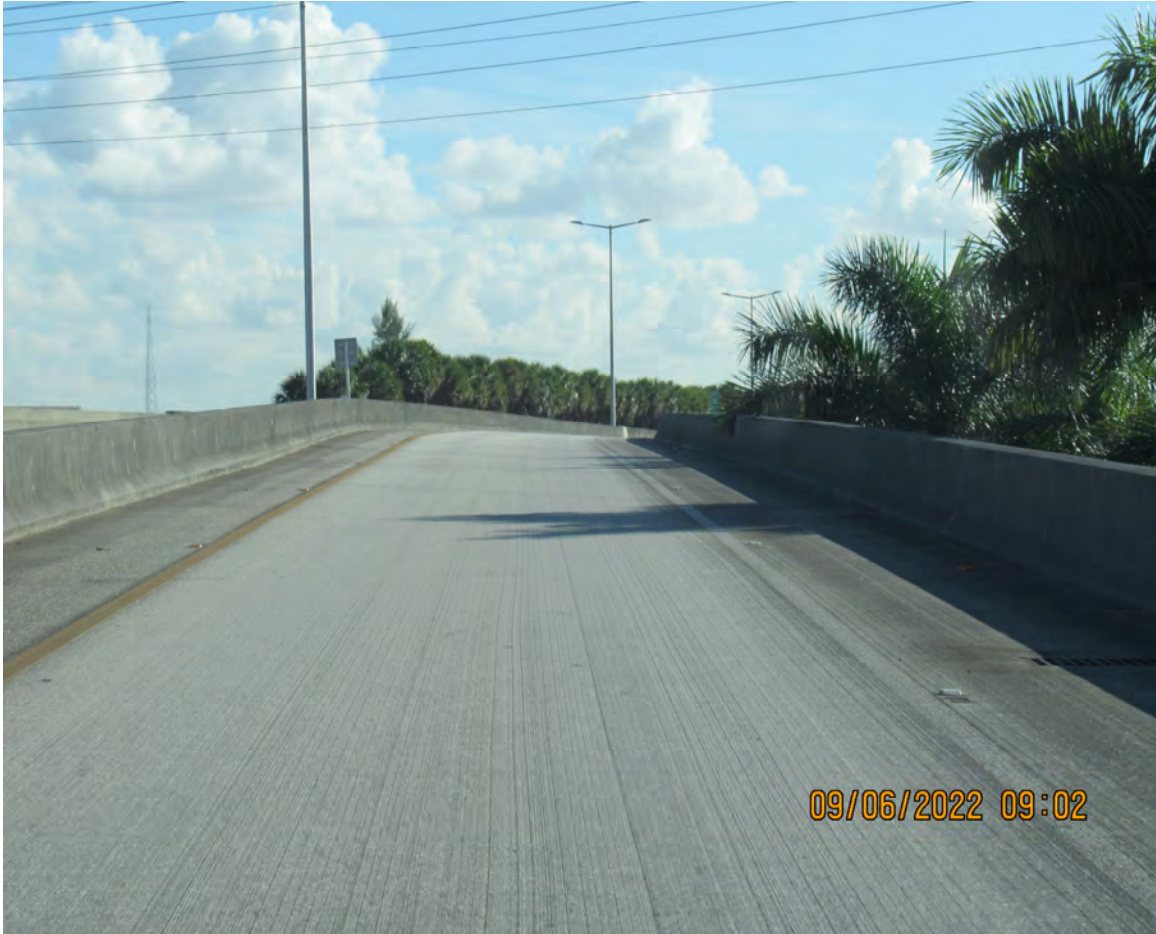
**PHOTO NO.: EB-004
DATE: 9-6-2022**

DETERIORATED STRIPING (BRIDGE No. 871008)

ITEM NOTED TO BE ADDRESSED BY MDX WORK PROGRAM NO. 30033

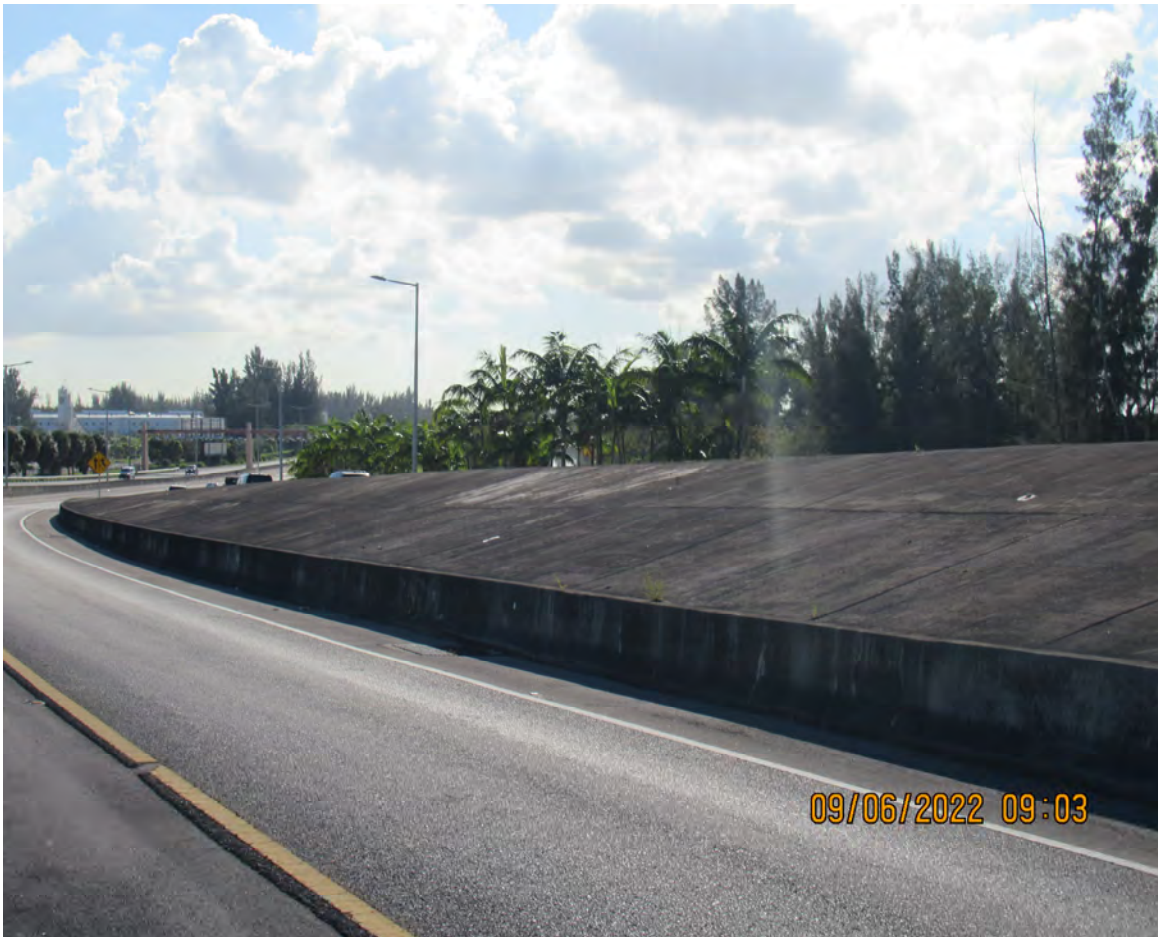
**PHOTO NO.: EB-005
DATE: 9-6-2022**

DETERIORATED CLASS V COATING ON CONCRETE MEDIAN

ITEM NOTED TO BE ADDRESSED BY MDX WORK PROGRAM NO. 30037

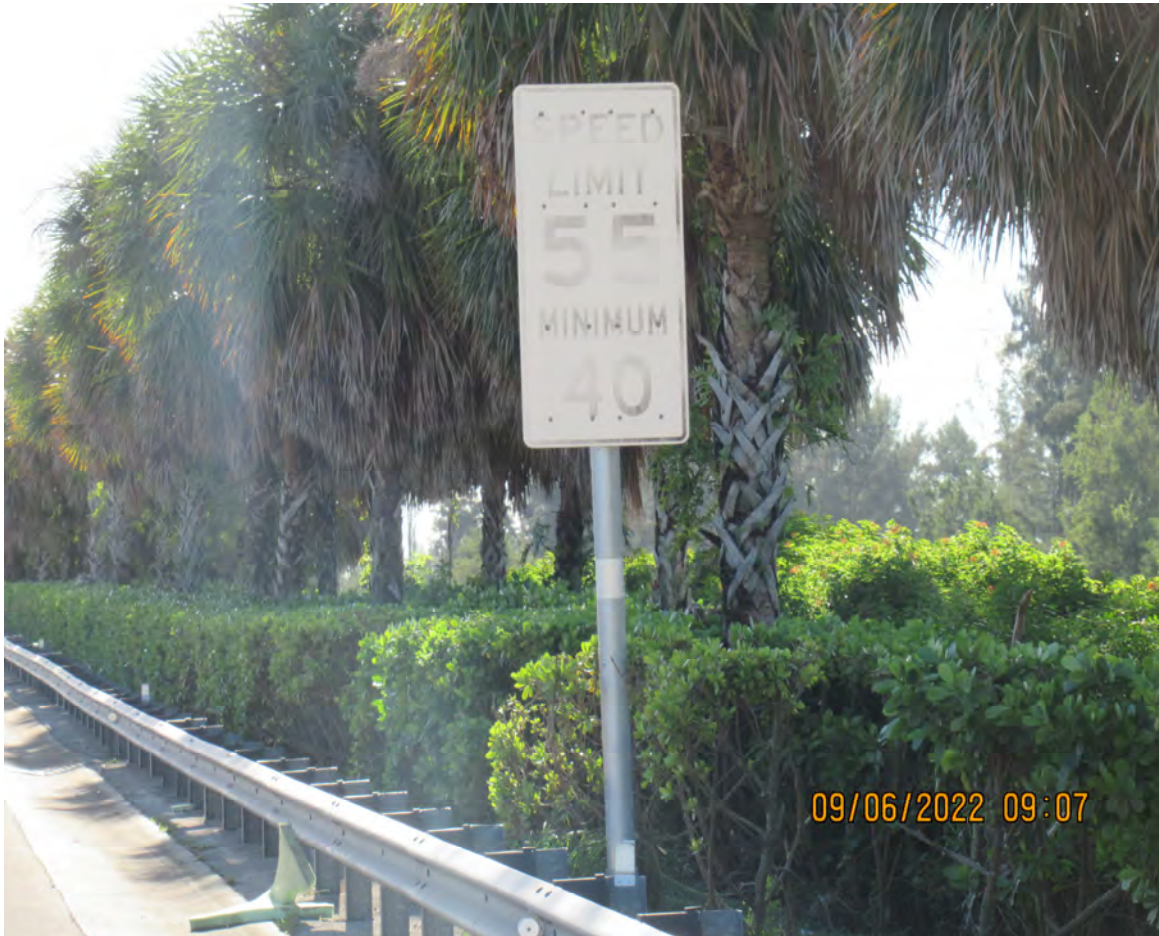
**PHOTO NO.: EB-006
DATE: 9-6-2022**

DETERIORATED REFLECTIVE SHEETING ON SPEED LIMIT SIGN

ITEM NOTED TO BE ADDRESSED BY MDX MAINTENANCE

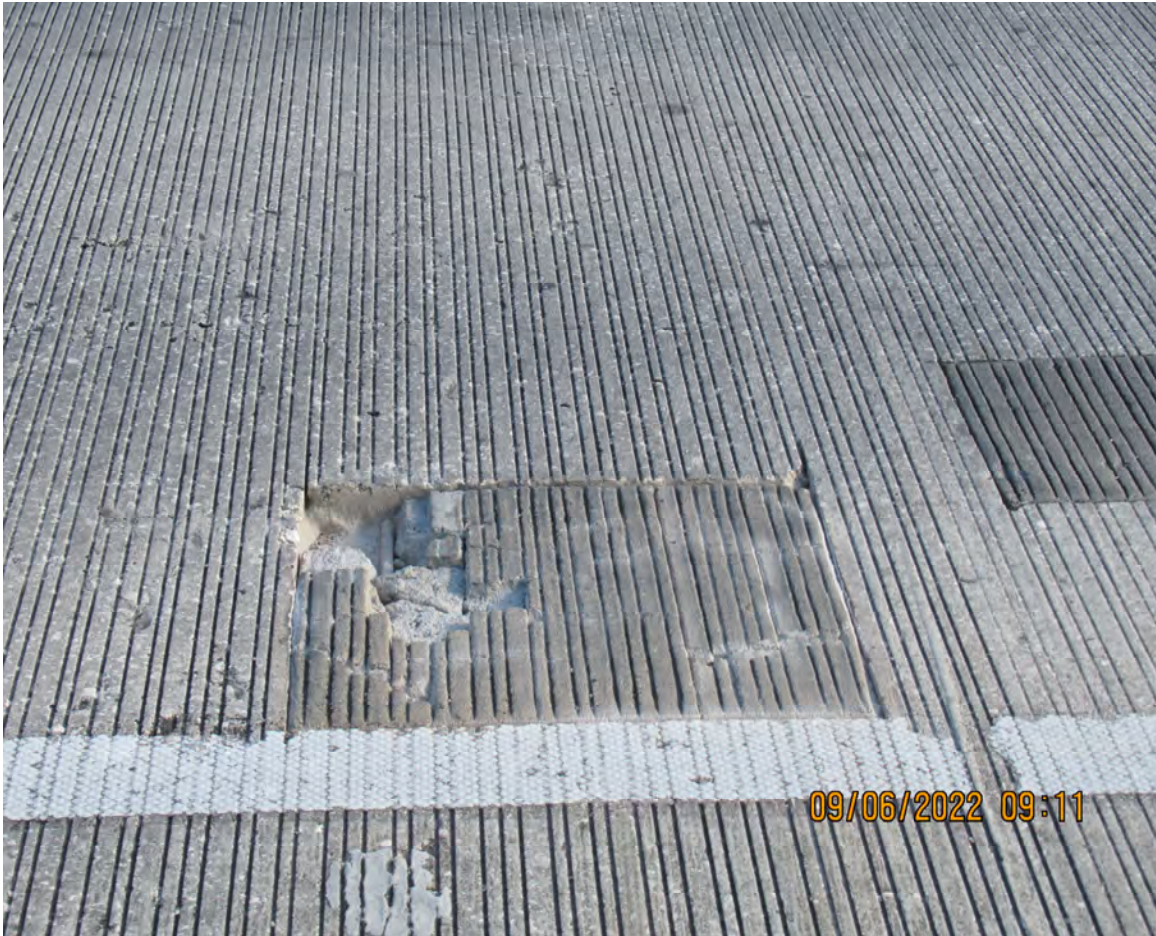
**PHOTO NO.: EB-007
DATE: 9-6-2022**

SPALL ON BRIDGE DECK (BRIDGE No. 871002)

ITEM NOTED TO BE ADDRESSED BY MDX MAINTENANCE

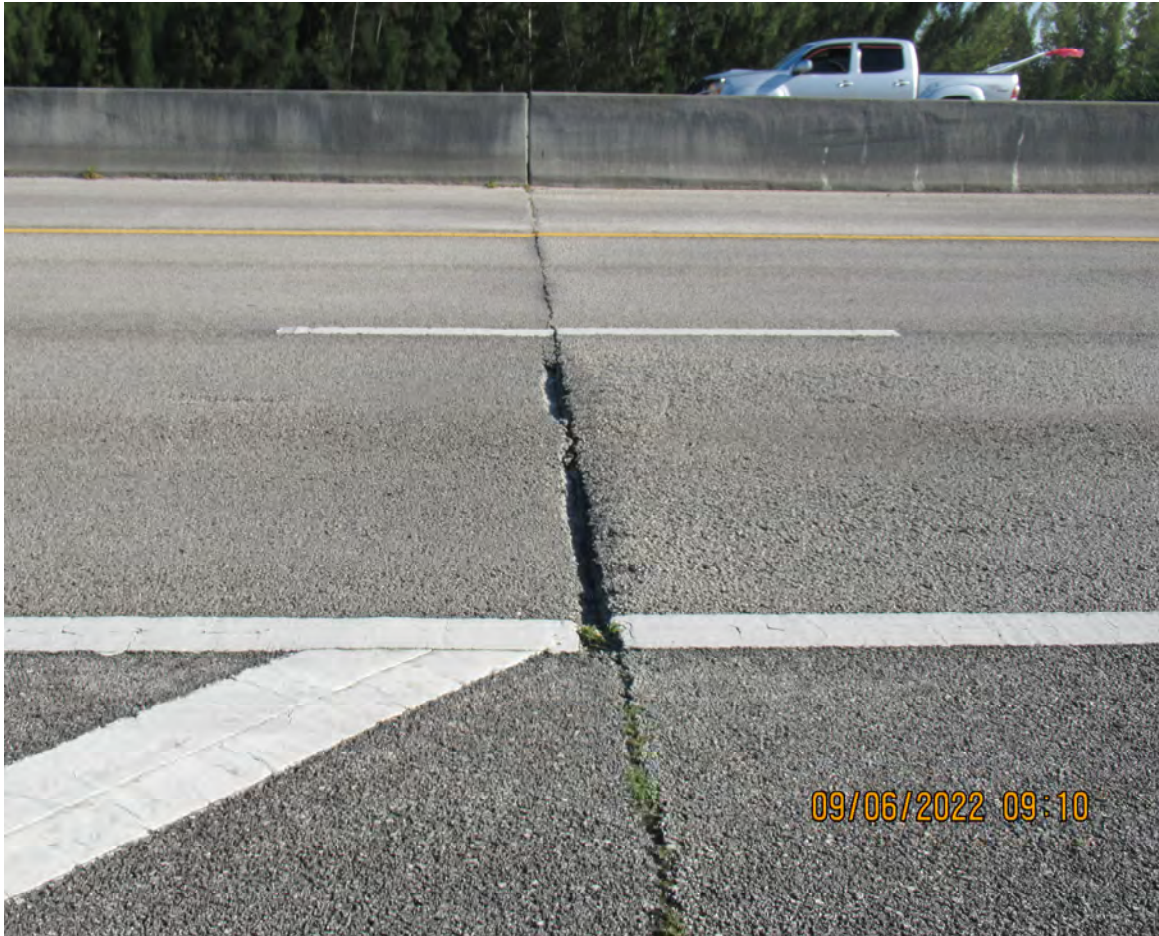
**PHOTO NO.: EB-008
DATE: 9-6-2022**

**TRANSVERSE CRACK ON PAVEMENT AT APPROACH SLAB
(BRIDGE No. 871002)**

ITEM NOTED TO BE ADDRESSED BY MDX MAINTENANCE

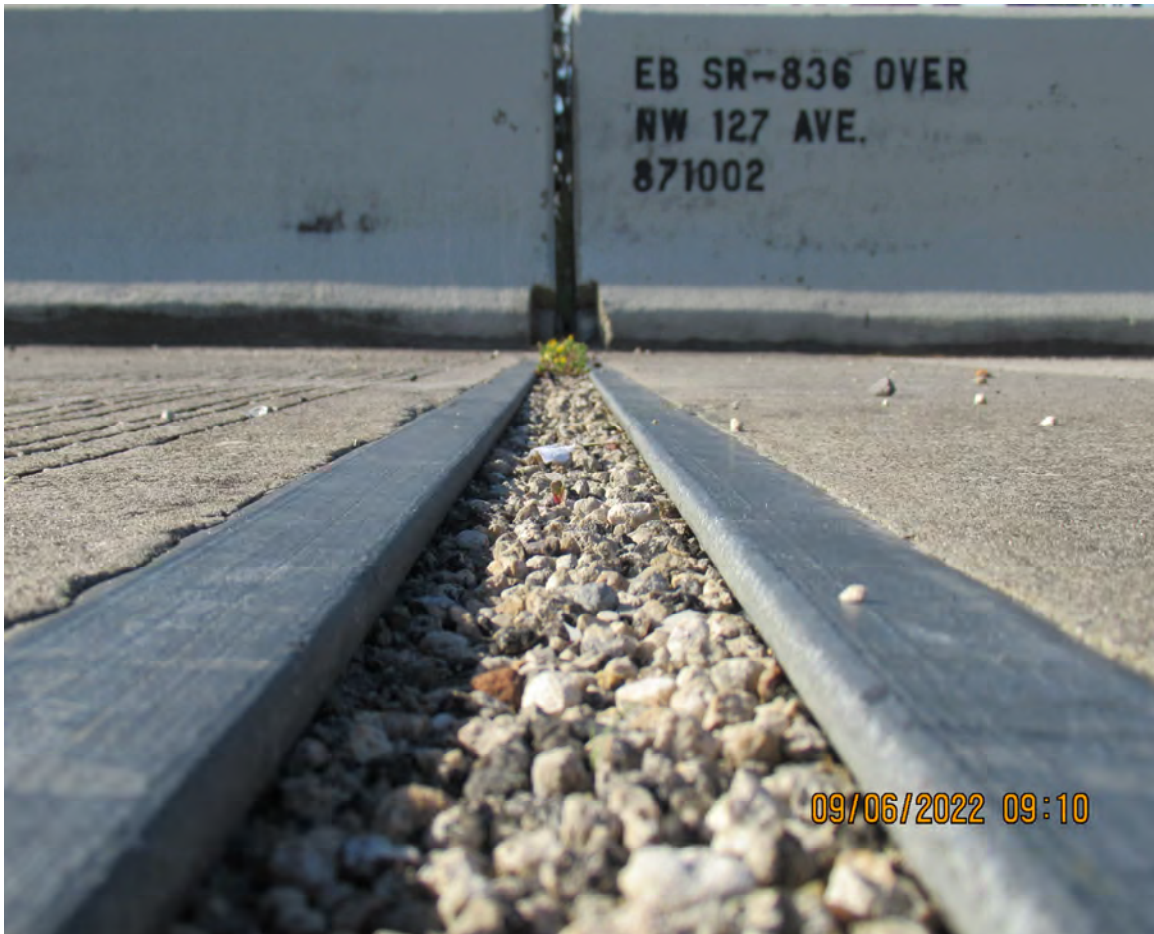
**PHOTO NO.: EB-009
DATE: 9-6-2022**

**DEBRIS ON BRIDGE EXPANSION JOINT (TYPICAL THROUGHOUT
(BRIDGE No. 871002)**

ITEM NOTED TO BE ADDRESSED BY MDX MAINTENANCE

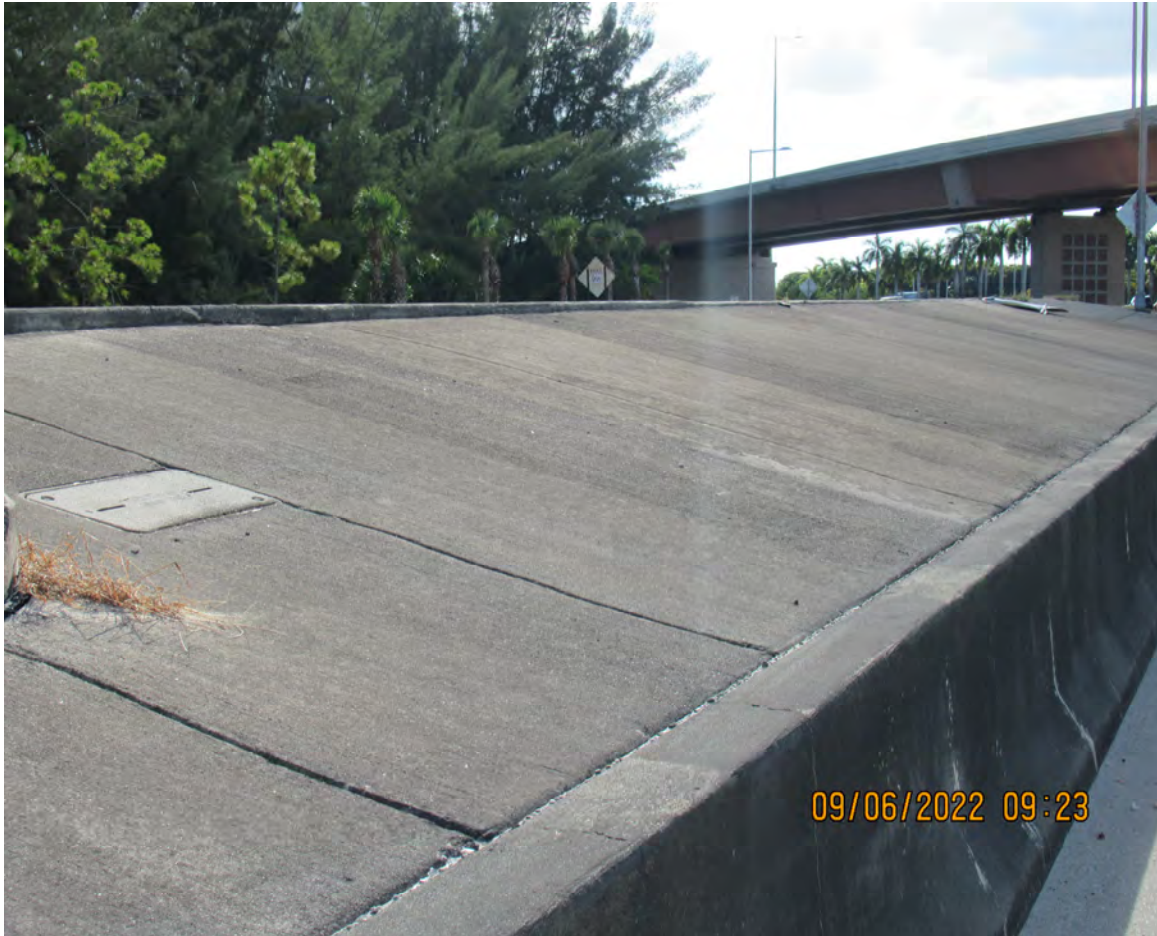
**PHOTO NO.: EB-010
DATE: 9-6-2022**

**DETERIORATED CLASS V COATING ON MEDIAN TRAFFIC SEPARATOR AND
BARRIER WALL**

ITEM NOTED TO BE ADDRESSED BY MDX WORK PROGRAM NO. 30037

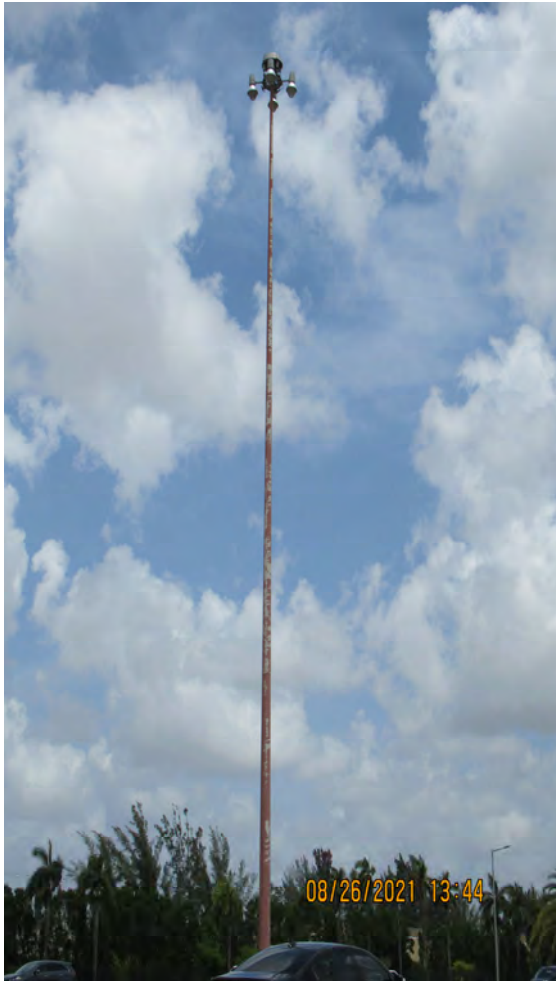
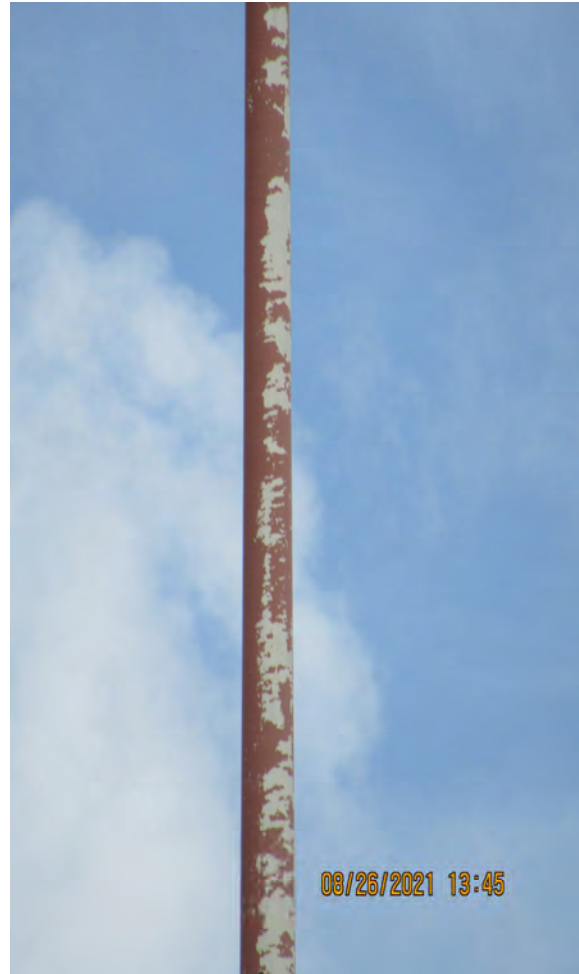
**PHOTO NO.: EB-012
DATE: 8-26-2021**

DETERIORATED PAINT ON HIGH MAST LIGHT POLE

ITEM NOTED TO BE ADDRESSED BY MDX WORK PROGRAM NO. TBD

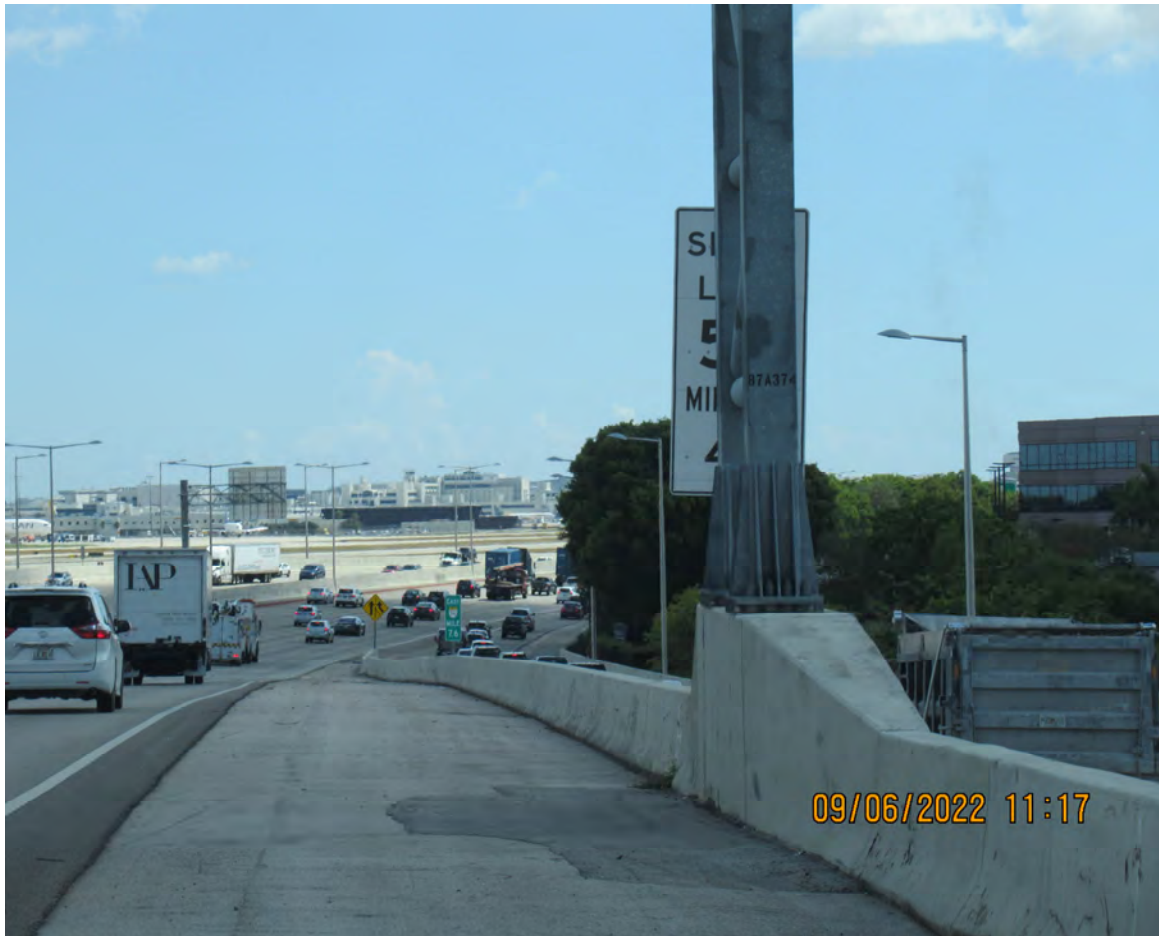
**PHOTO NO.: EB-014
DATE: 9-6-2022**

SPEED LIMIT SIGN PARTIALLY OBSTRUCTED BY OVERHEAD SIGN STRUCTURE

ITEM NOTED TO BE ADDRESSED BY MDX MAINTENANCE

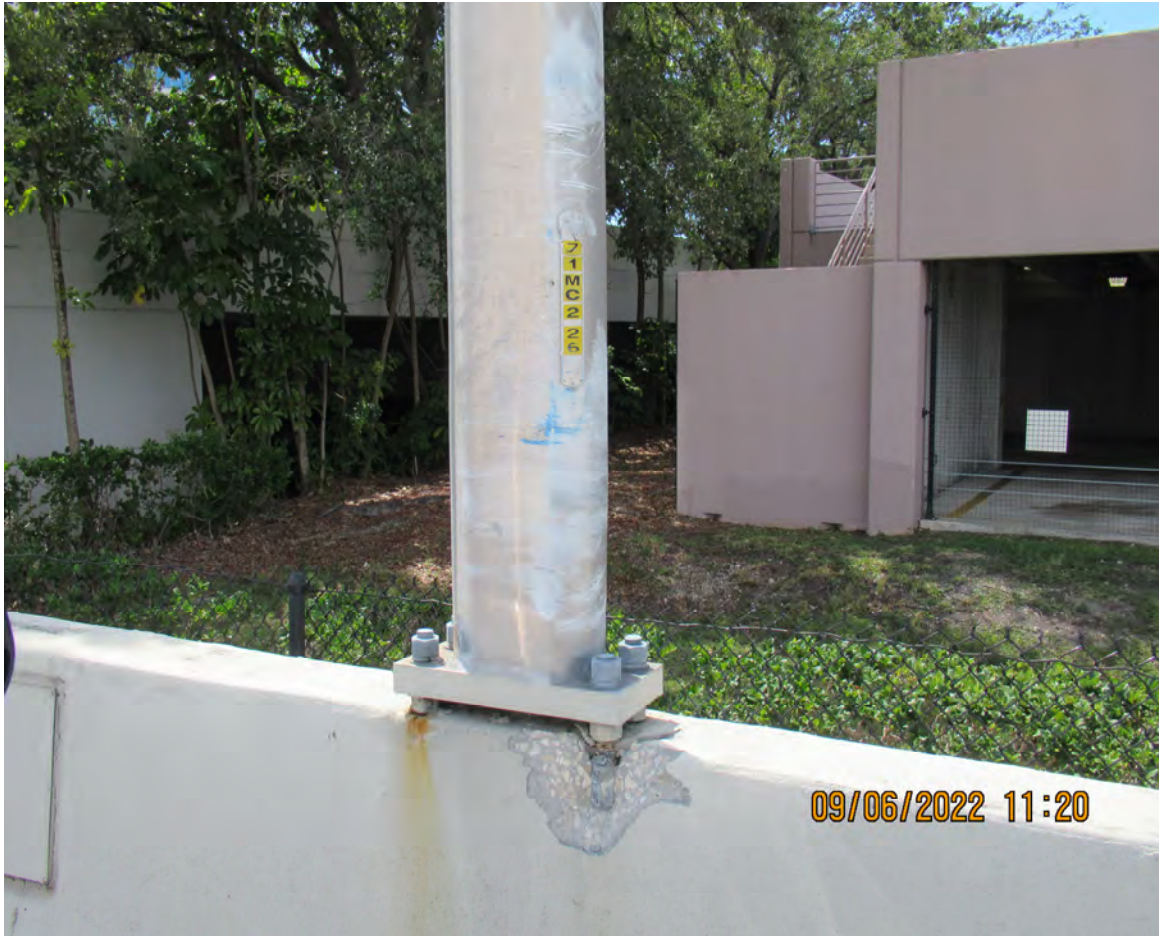
**PHOTO NO.: EB-015
DATE: 9-6-2022**

DAMAGED BARRIER WALL EXPOSING LIGHTPOLE ANCHOR BOLT

ITEM NOTED TO BE ADDRESSED BY MDX MAINTENANCE

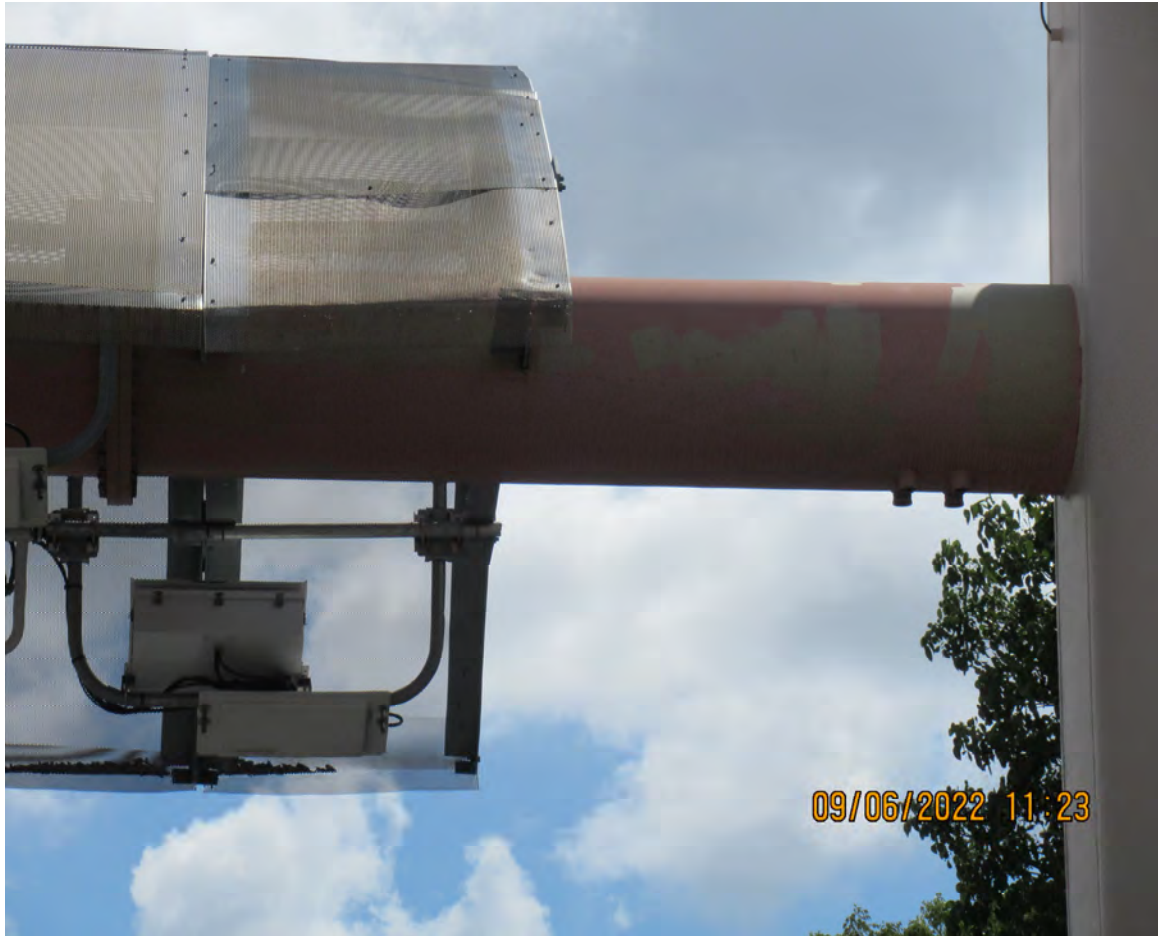
**PHOTO NO.: EB-016
DATE: 9-6-2022**

**DETERIORATED PAINT ON ORT GANTRY MONOTUBE AND CORROSION ON
DECORATIVE PANELS**

ITEM NOTED TO BE ADDRESSED BY MDX WORK PROGRAM NO. 30043

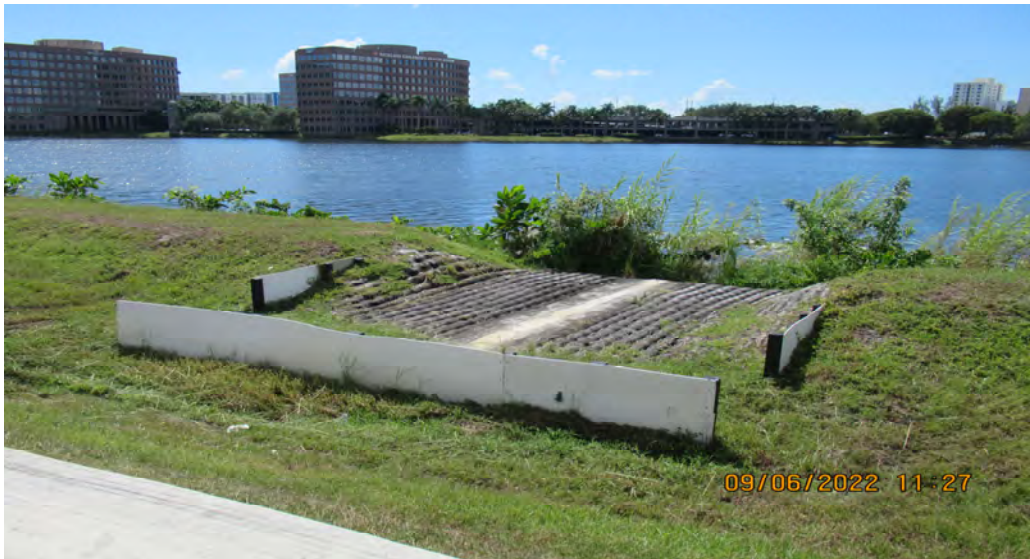
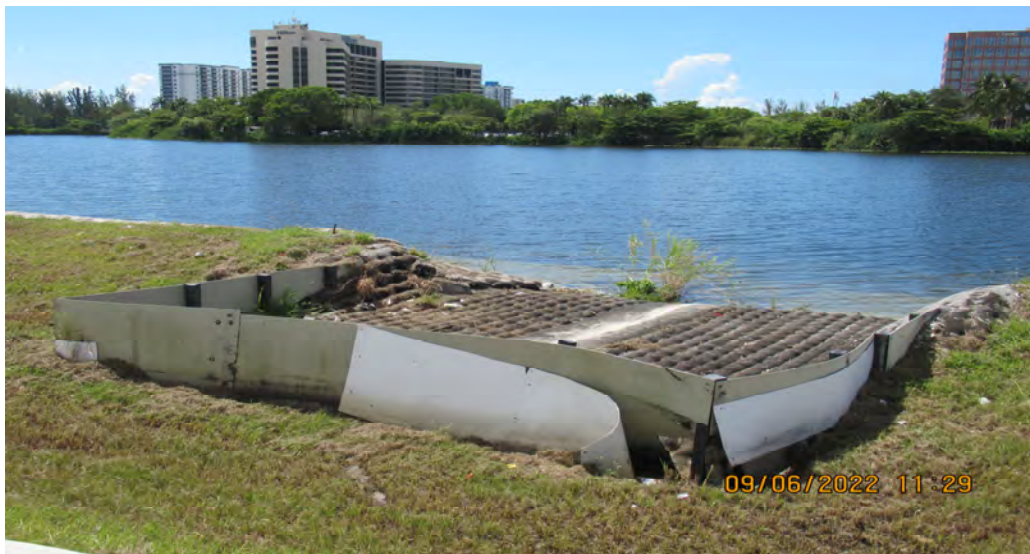
**PHOTO NO.: EB-017
DATE: 9-6-2022**

DAMAGED SKIMMER (TYPICAL AT VARIOUS LOCATIONS)

ITEM NOTED TO BE ADDRESSED BY MDX MAINTENANCE

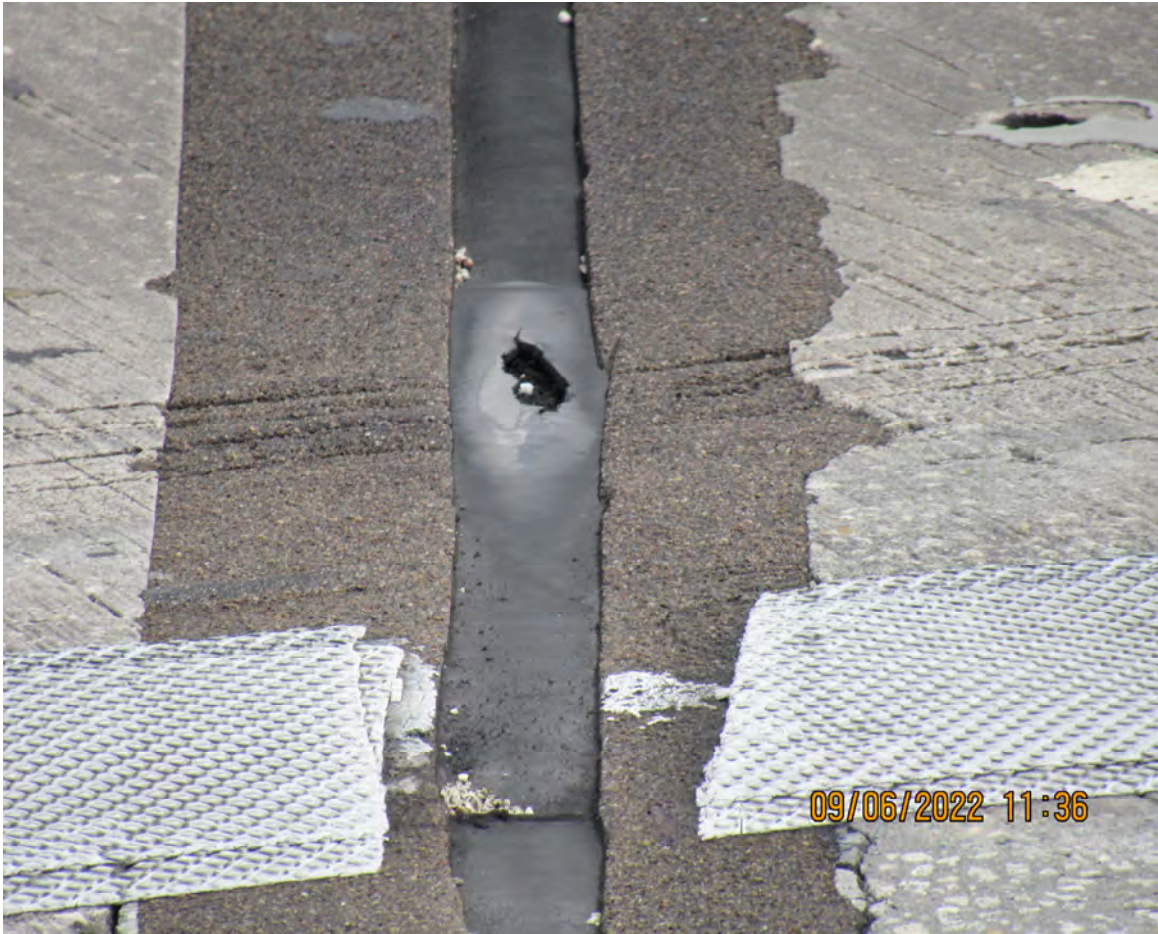
**PHOTO NO.: EB-019
DATE: 9-6-2022**

DAMAGED JOINT SEALANT (BRIDGE # 870291)

ITEM NOTED TO BE ADDRESSED BY MDX MAINTENANCE

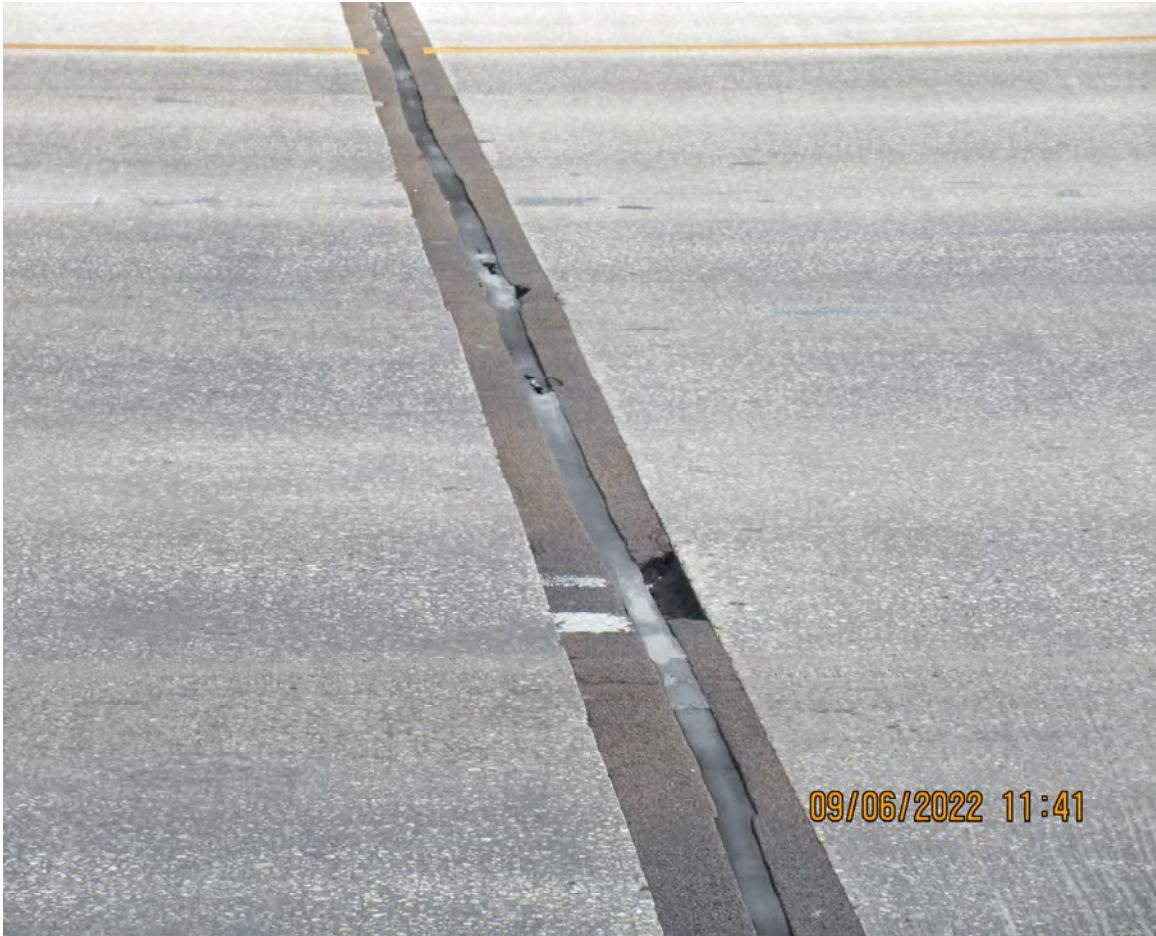
**PHOTO NO.: EB-020
DATE: 9-6-2022**

**DAMAGED POLYMER NOSING JOINT HEADER & JOINT SEALANT
(BRIDGE # 870292)**

ITEM NOTED TO BE ADDRESSED BY MDX MAINTENANCE
