ANNUAL INSPECTION REPORT 2022

ANNUAL INSPECTION REPORT

In 1996, the Miami-Dade County Expressway Authority (MDX) acquired operational and financial control of five expressways in Miami-Dade County from the Florida Department of Transportation (FDOT). This group of expressways, toll facilities and the MDX headquarters facility, all as described below, are hereinafter referred to as the “MDX System”. In accordance with the Trust Indenture requirements, MDX retained EAC Consulting, Inc. (EAC), as the General Engineering Consultant to perform, among other duties assigned by the Authority, the yearly inspection of the MDX System. This report represents the annual inspection results for Fiscal Year (FY) 2022.

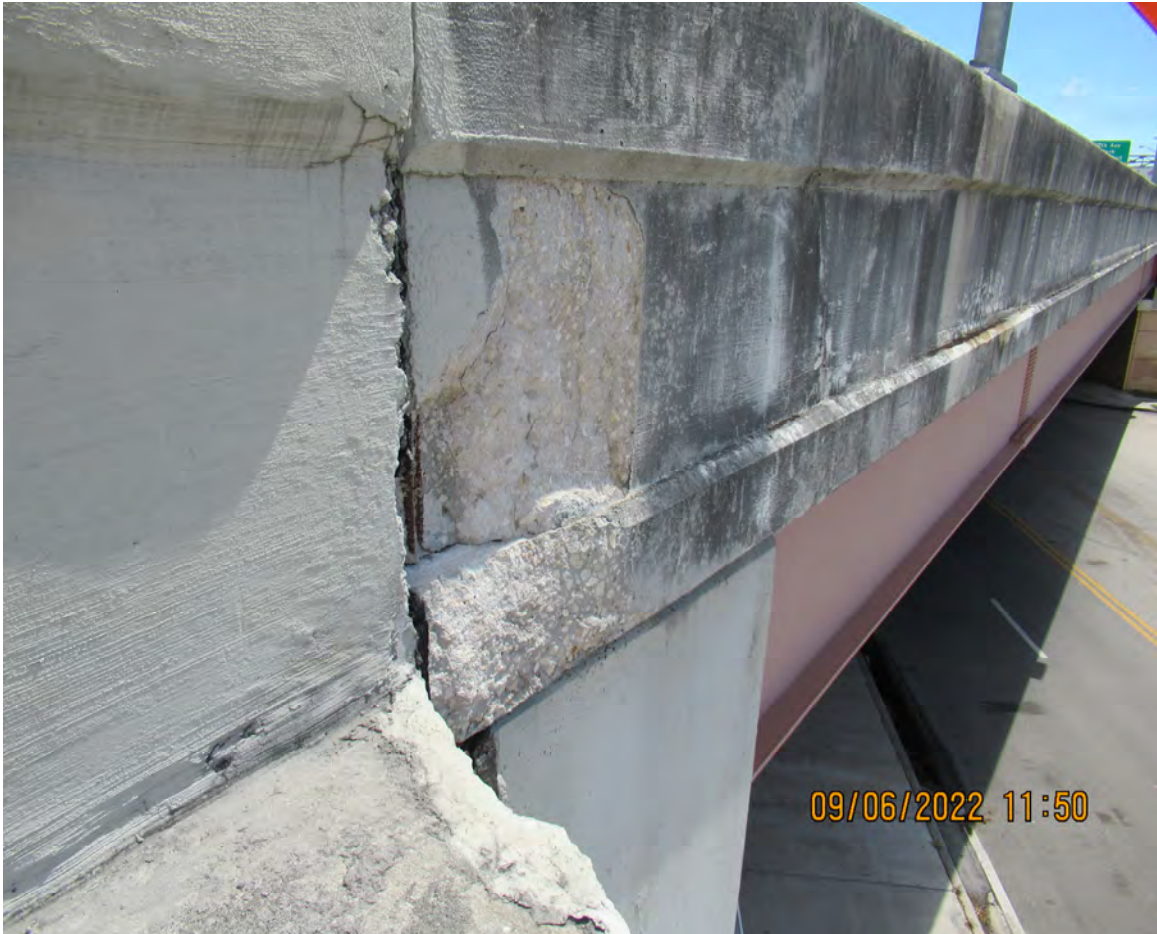
**PHOTO NO.: EB-022
DATE: 9-6-2022**

**SPALLS ON ABUTMENT 1 TRAFFIC RAILING AND SLAB
(BRIDGE # 870966)**

ITEM NOTED TO BE ADDRESSED BY MDX MAINTENANCE

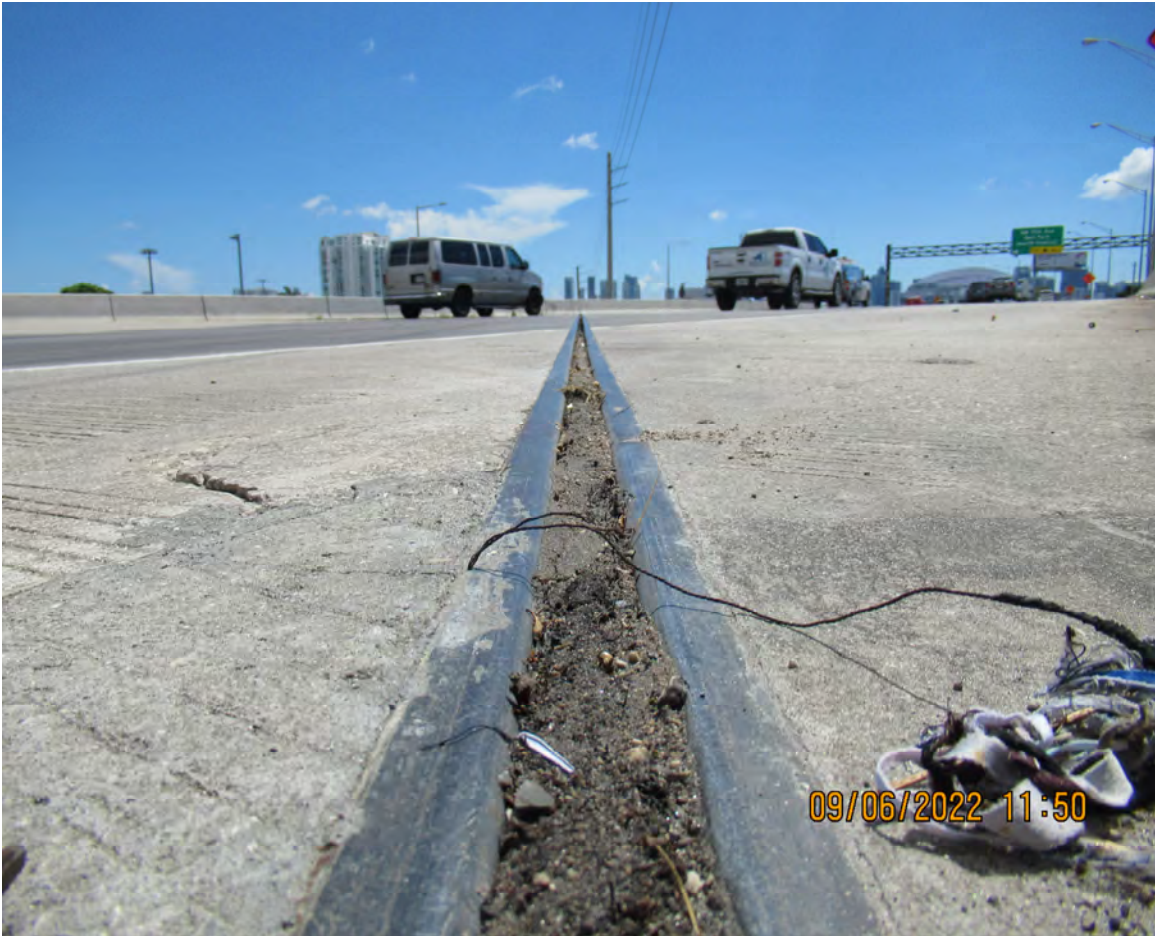
**PHOTO NO.: EB-023
DATE: 9-6-2022**

SEDIMENT AND DEBRIS ON BRIDGE EXPANSION JOINTS (BRIDGE # 870966)

ITEM NOTED TO BE ADDRESSED BY MDX MAINTENANCE

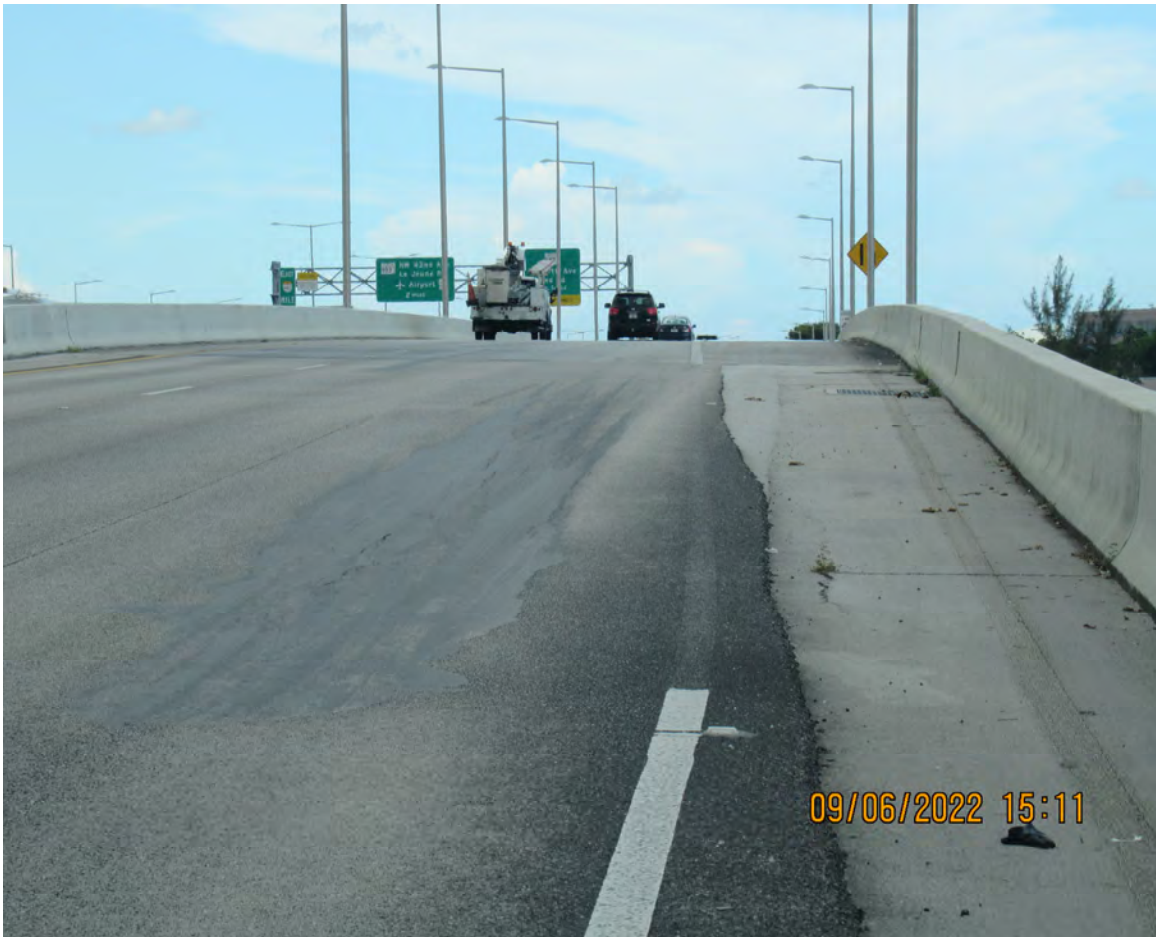
**PHOTO NO.: EB-025
DATE: 9-6-2022**

DETERIORATED WHITE EDGELINE STRIPING

ITEM NOTED TO BE ADDRESSED BY MDX MAINTENANCE

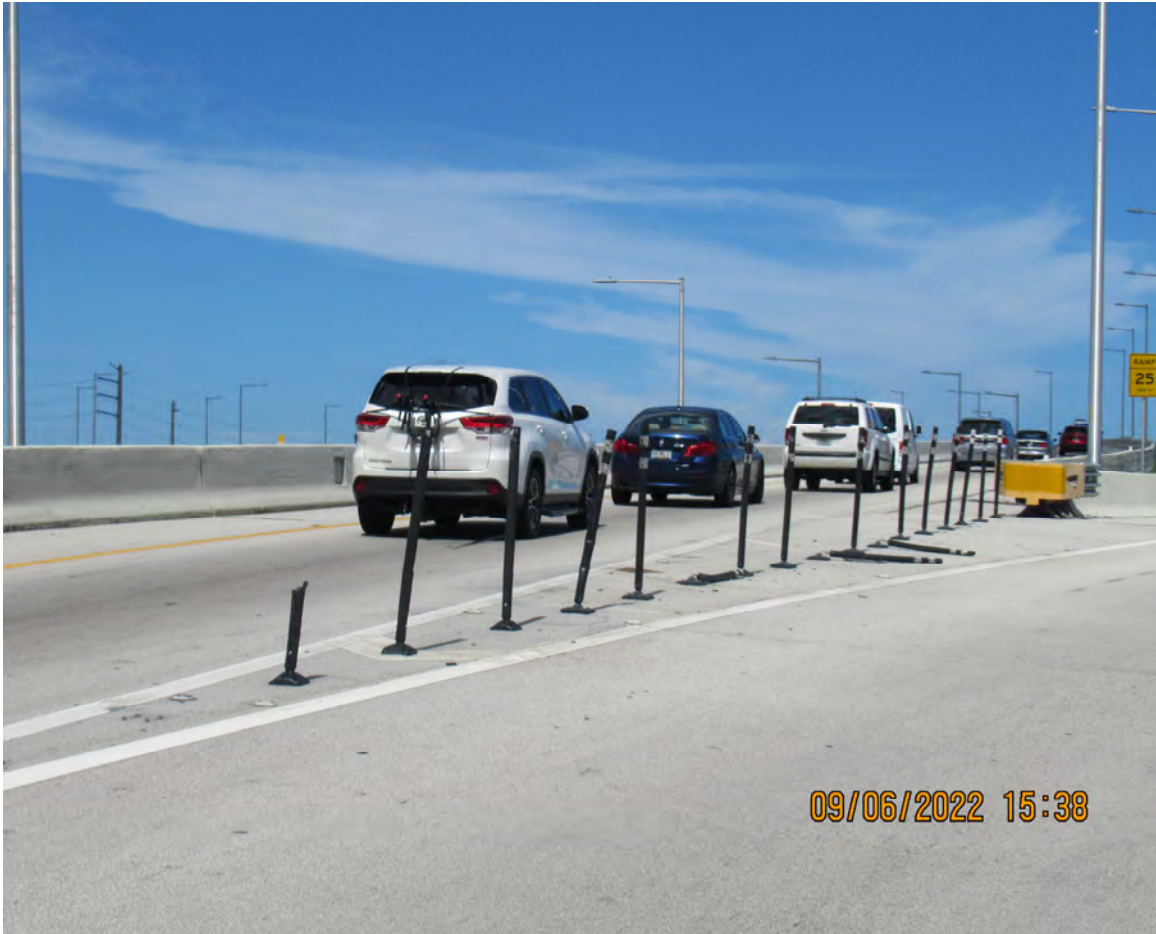
**PHOTO NO.: EB-026
DATE: 9-6-2022**

DAMAGED / MISSING DELINEATORS

ITEM NOTED TO BE ADDRESSED BY MDX MAINTENANCE

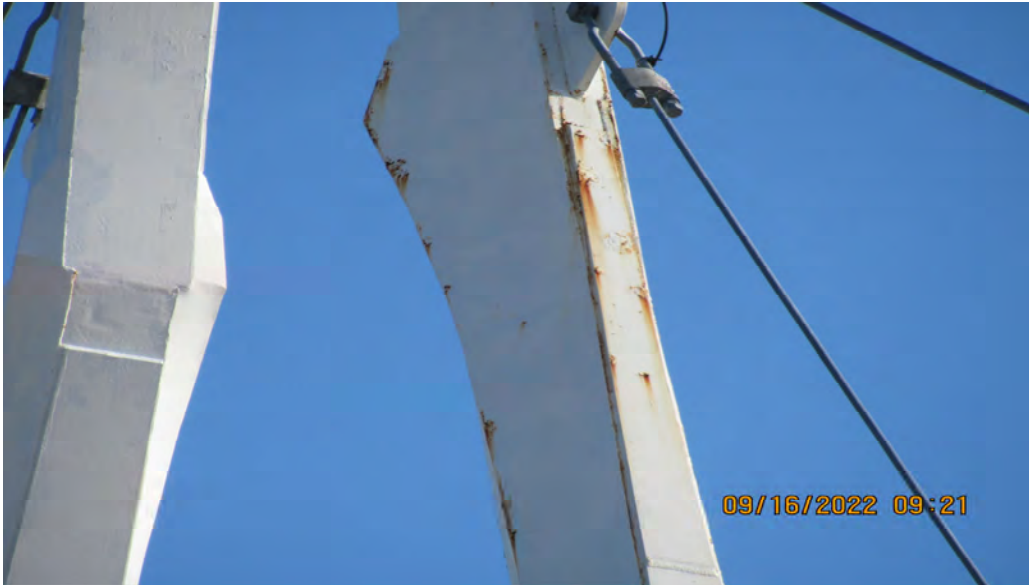
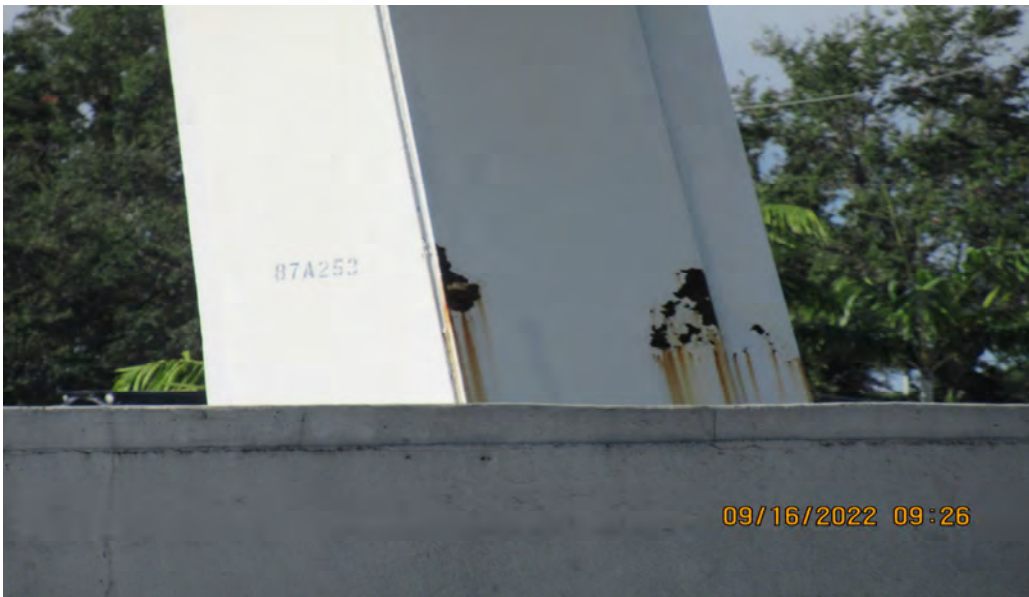
CORROSION ON PILONS (STRUCTURE # 87A253)

ITEM NOTED TO BE ADDRESSED BY MDX WORK PROGRAM NO. 30043

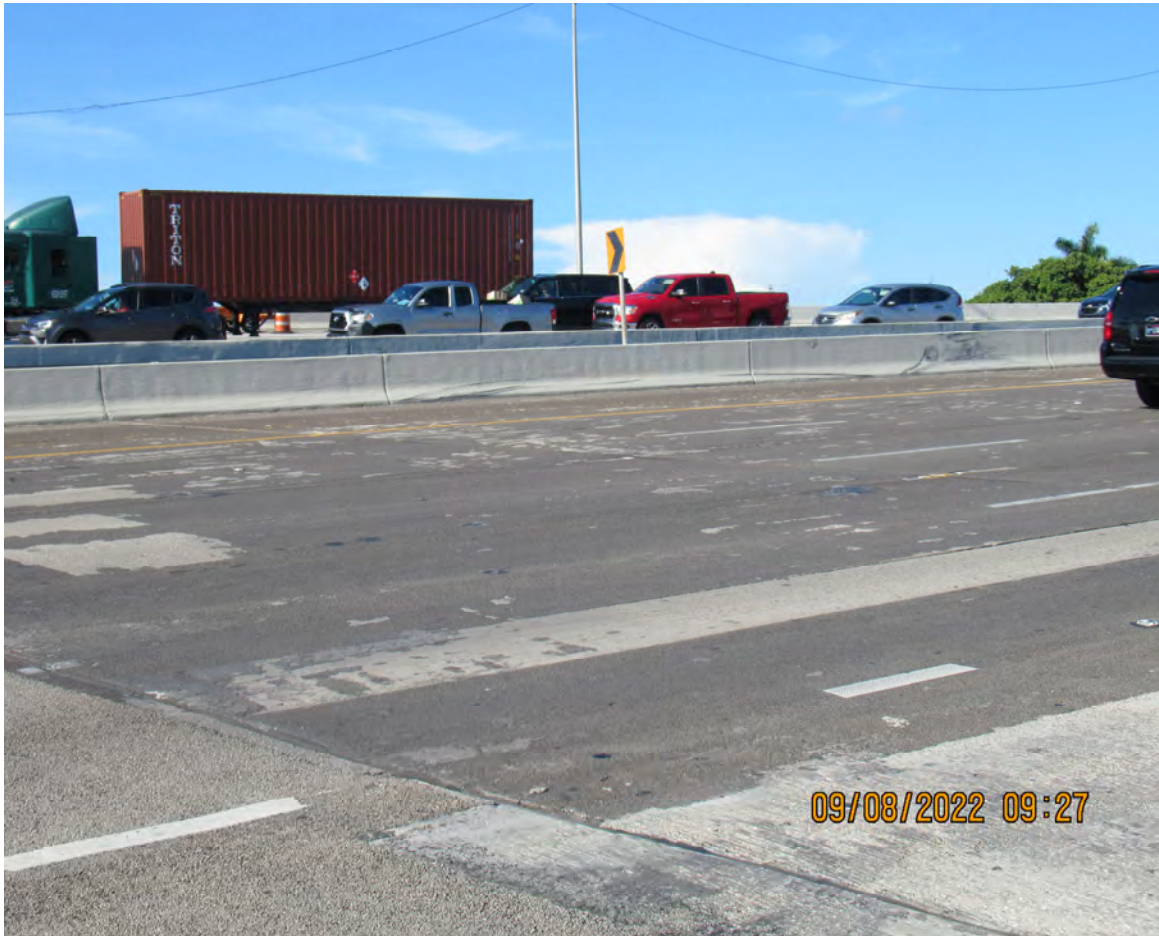
**PHOTO NO.: WB-003
DATE: 9-8-2022**

DETERIORATED TIRE GRIP COATING ON BRIDGE DECK (BRIDGE # 870145)

ITEM NOTED TO BE ADDRESSED BY WORK PROGRAM NO. TBD

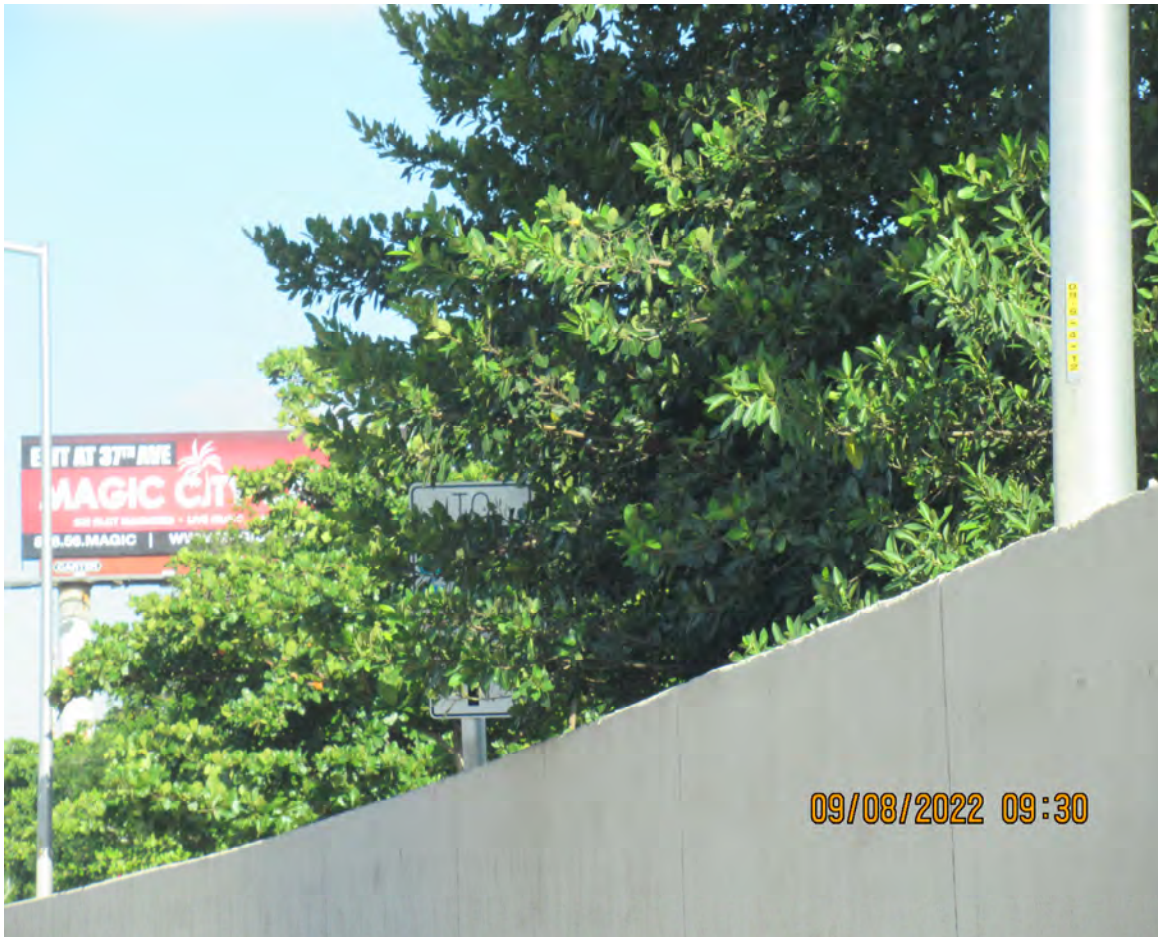
**PHOTO NO.: WB-004
DATE: 9-8-2022**

OVERGROWN VEGETATION OBSTRUCTING TRI-RAIL SIGN

ITEM NOTED TO BE ADDRESSED BY MDX MAINTENANCE

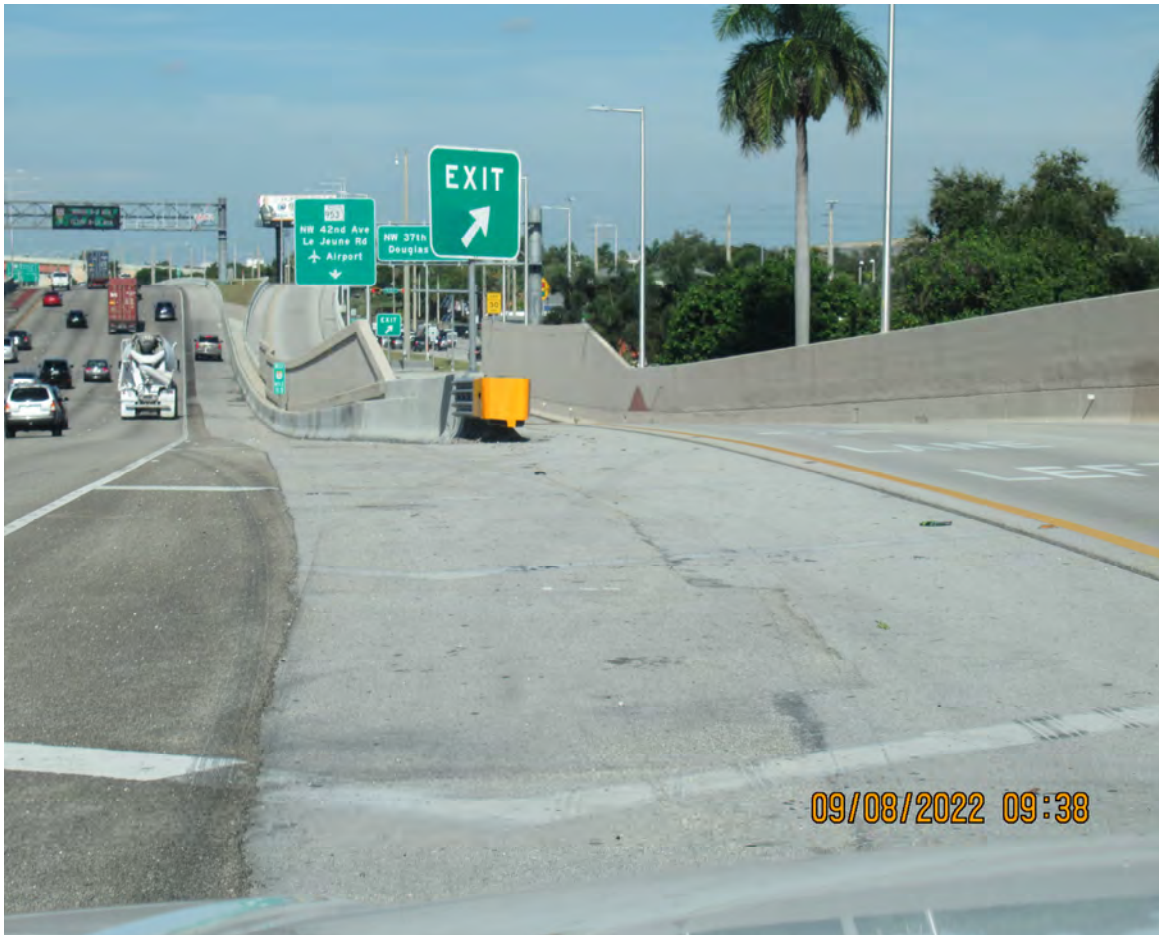
**PHOTO NO.: WB-005
DATE: 9-8-2022**

DETERIORATED CHEVRON STRIPING IN GORE AREA

ITEM NOTED TO BE ADDRESSED BY MDX MAINTENANCE

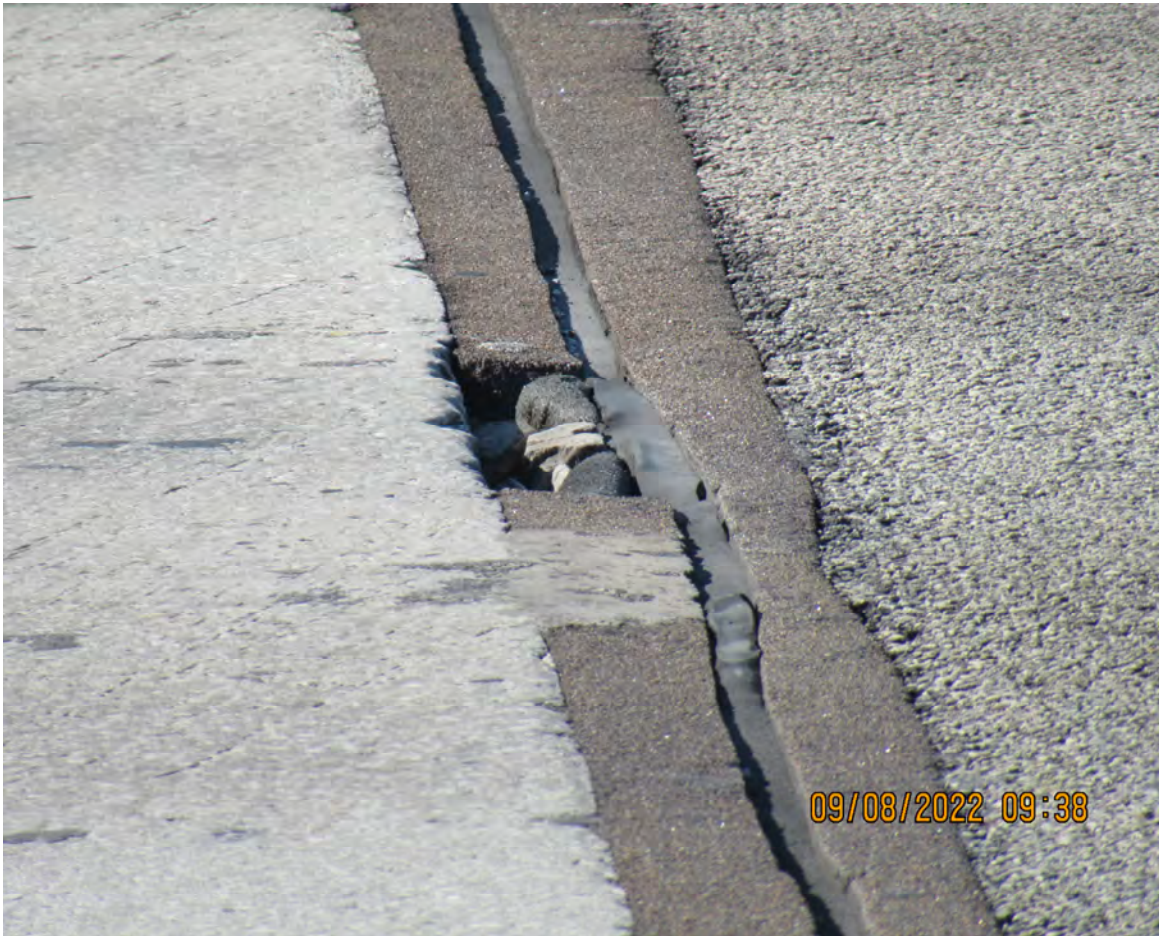
**PHOTO NO.: WB-006
DATE: 9-8-2022**

DAMAGED POLYMER NOSING JOINT HEADER (BRIDGE No. 870140)

ITEM NOTED TO BE ADDRESSED BY MDX MAINTENANCE

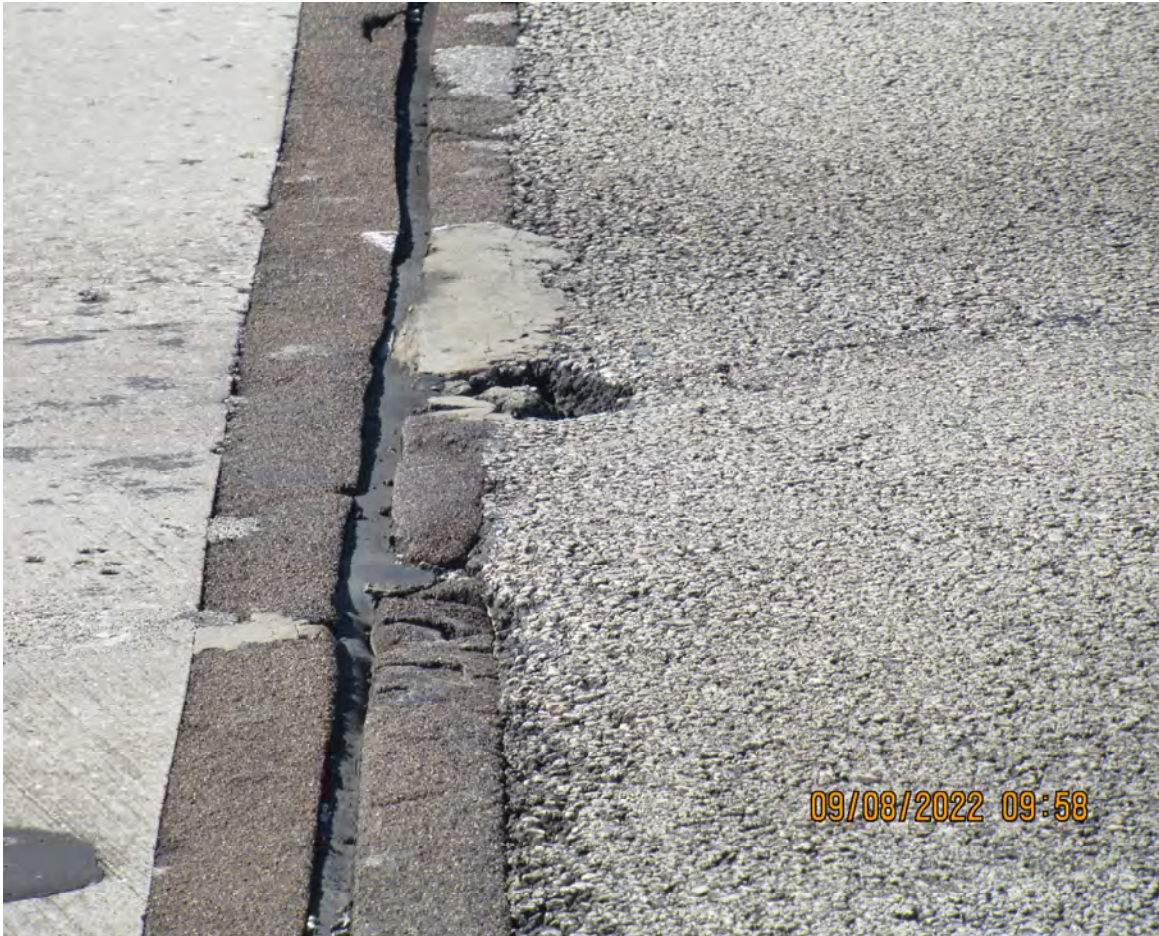
**PHOTO NO.: WB-007
DATE: 9-8-2022**

DAMAGED POLYMER NOSING JOINT HEADER (BRIDGE # 870138)

ITEM NOTED TO BE ADDRESSED BY MDX MAINTENANCE

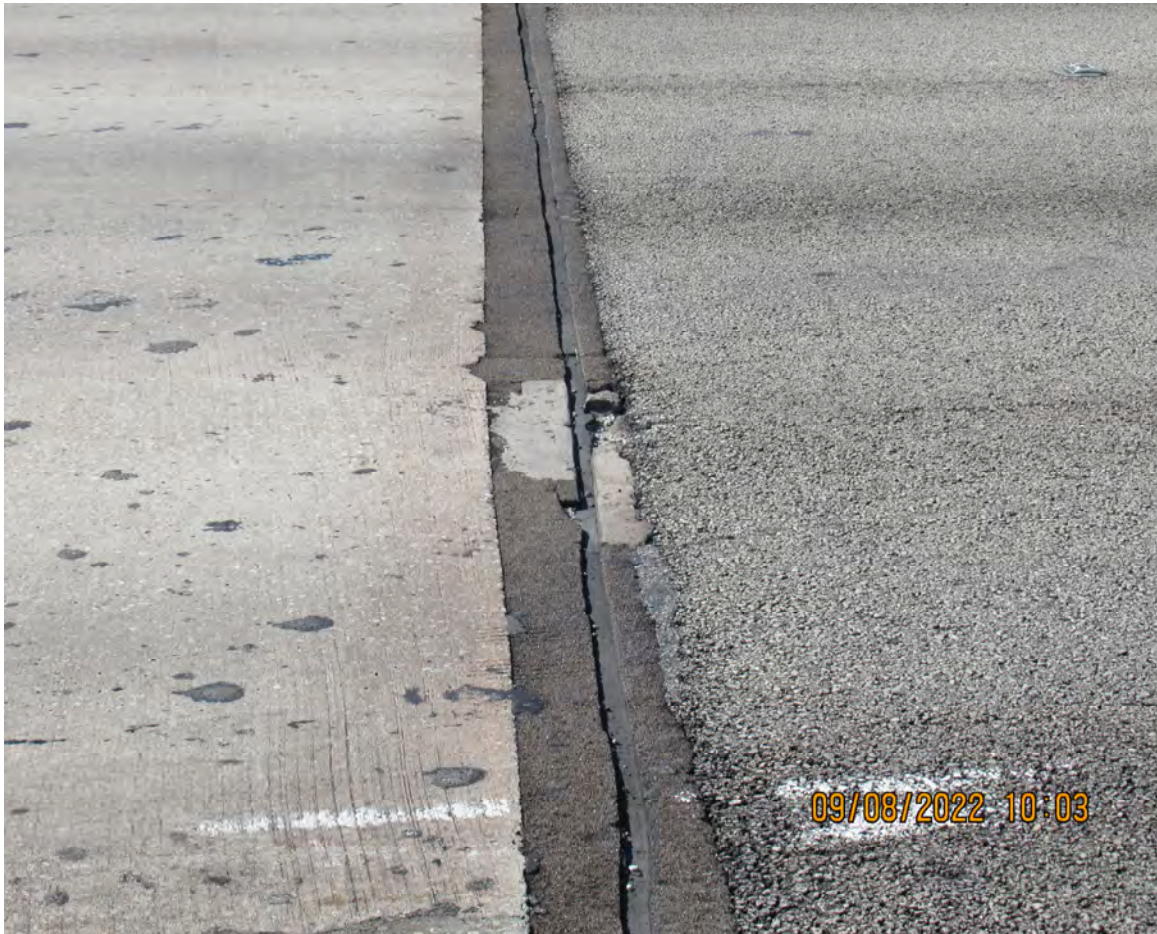
**PHOTO NO.: WB-008
DATE: 9-8-2022**

DAMAGED POLYMER NOSING JOINT HEADER (BRIDGE # 870137)

ITEM NOTED TO BE ADDRESSED BY MDX MAINTENANCE

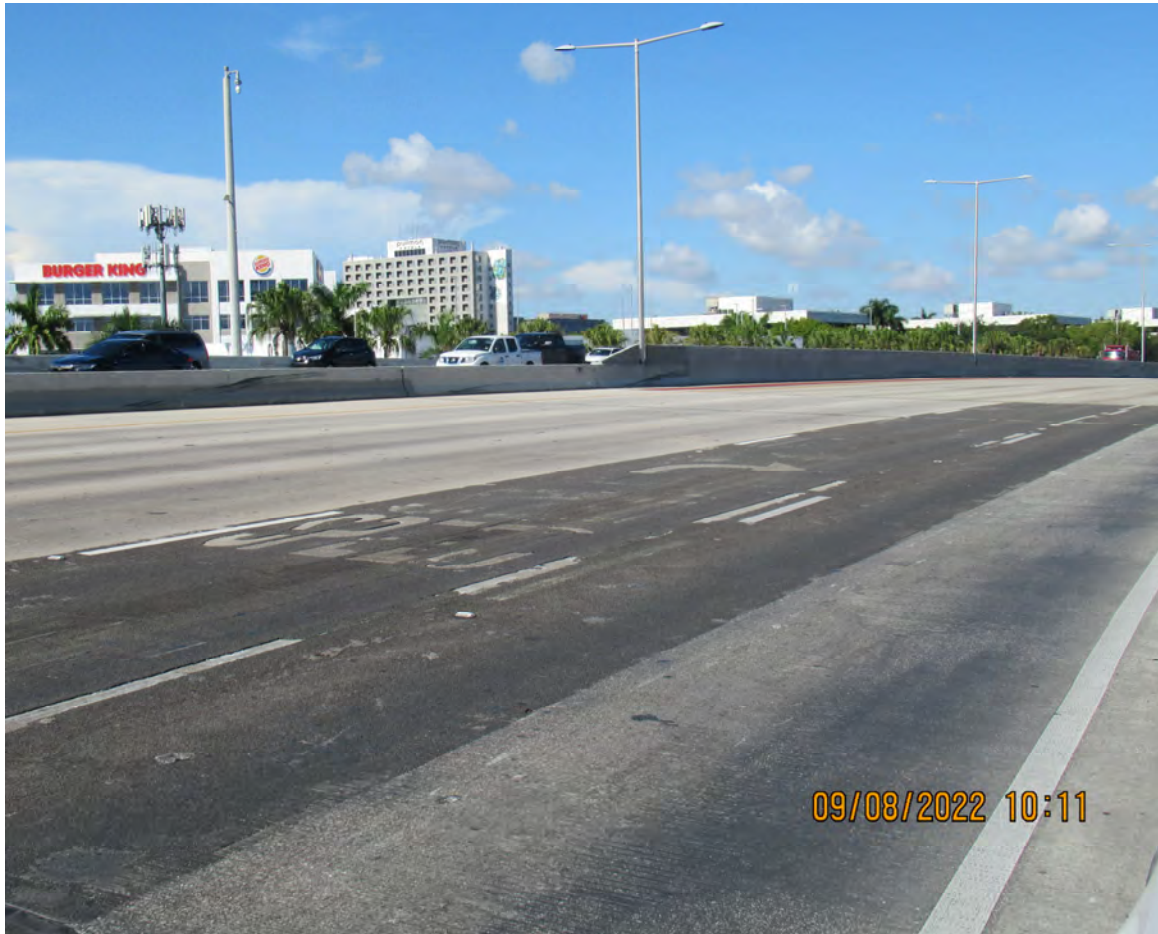
**PHOTO NO.: WB-010
DATE: 9-8-2022**

DETERIORATED TIRE GRIP COATING ON BRIDGE DECK (BRIDGE # 870135)

ITEM NOTED TO BE ADDRESSED BY MDX WORK PROGRAM NO. TBD

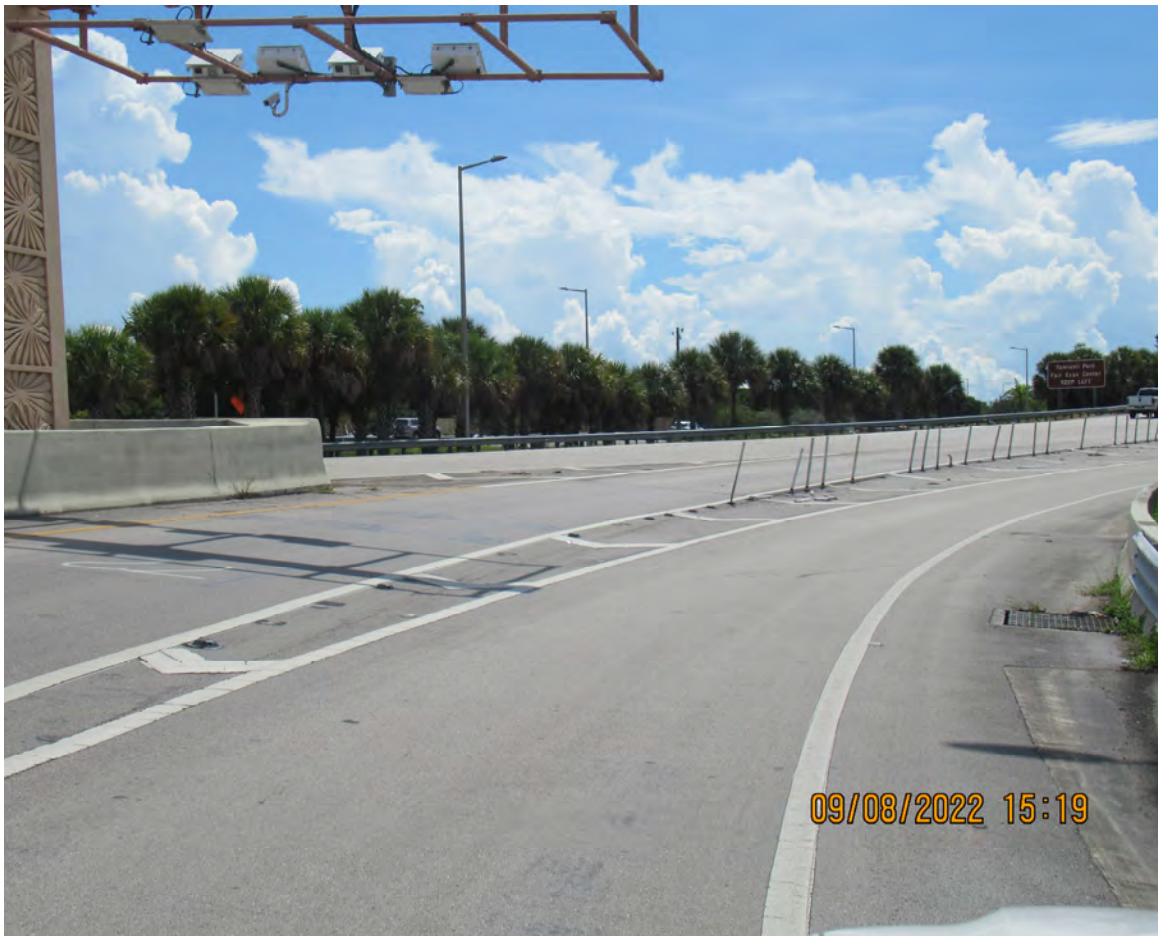
**PHOTO NO.: WB-011
DATE: 9-8-2022**

MISSING DELINEATORS

ITEM NOTED TO BE ADDRESSED BY MDX MAINTENANCE

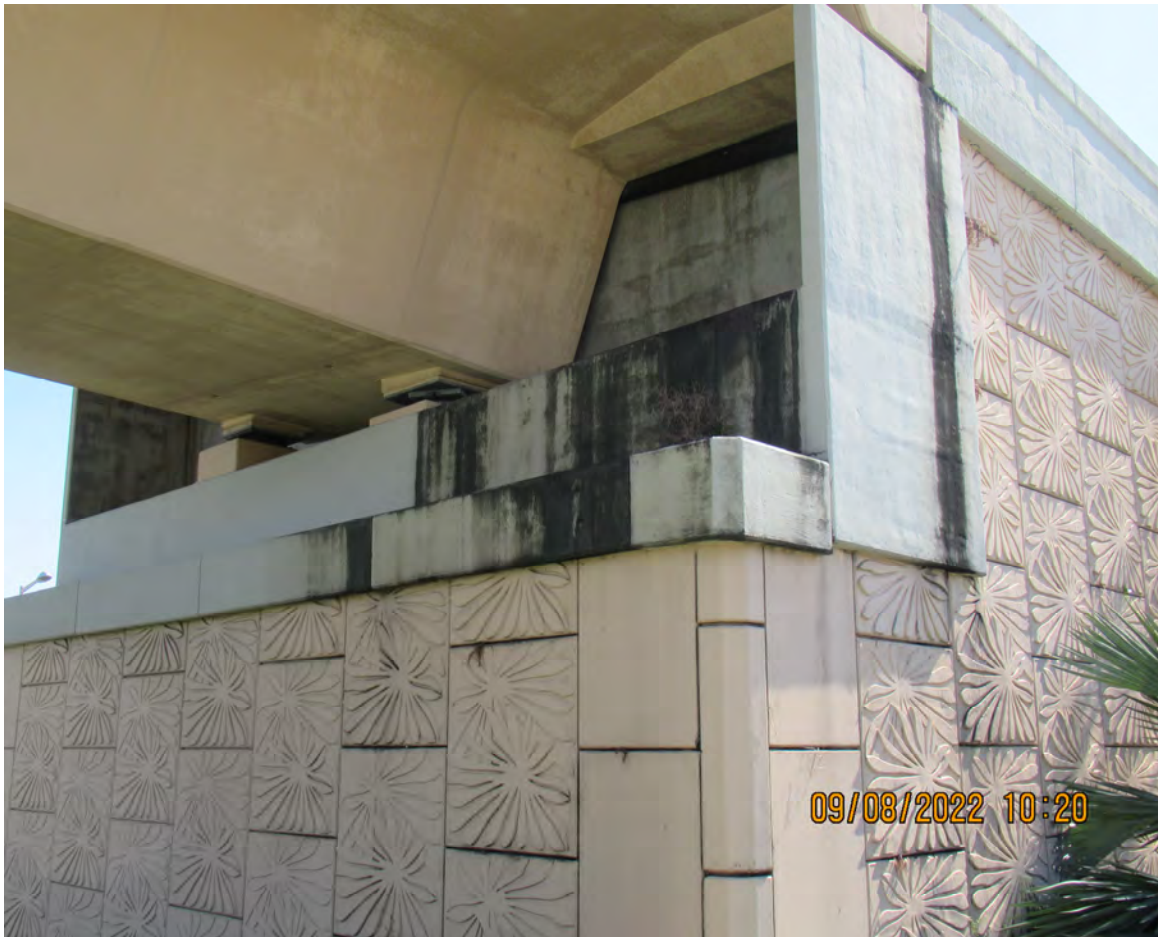
**PHOTO NO.: WB-012
DATE: 9-8-2022**

WATER STAINS FROM CLOGGED JOINT DRAINAGE (BRIDGE # 871046)

ITEM NOTED TO BE ADDRESSED BY MDX MAINTENANCE

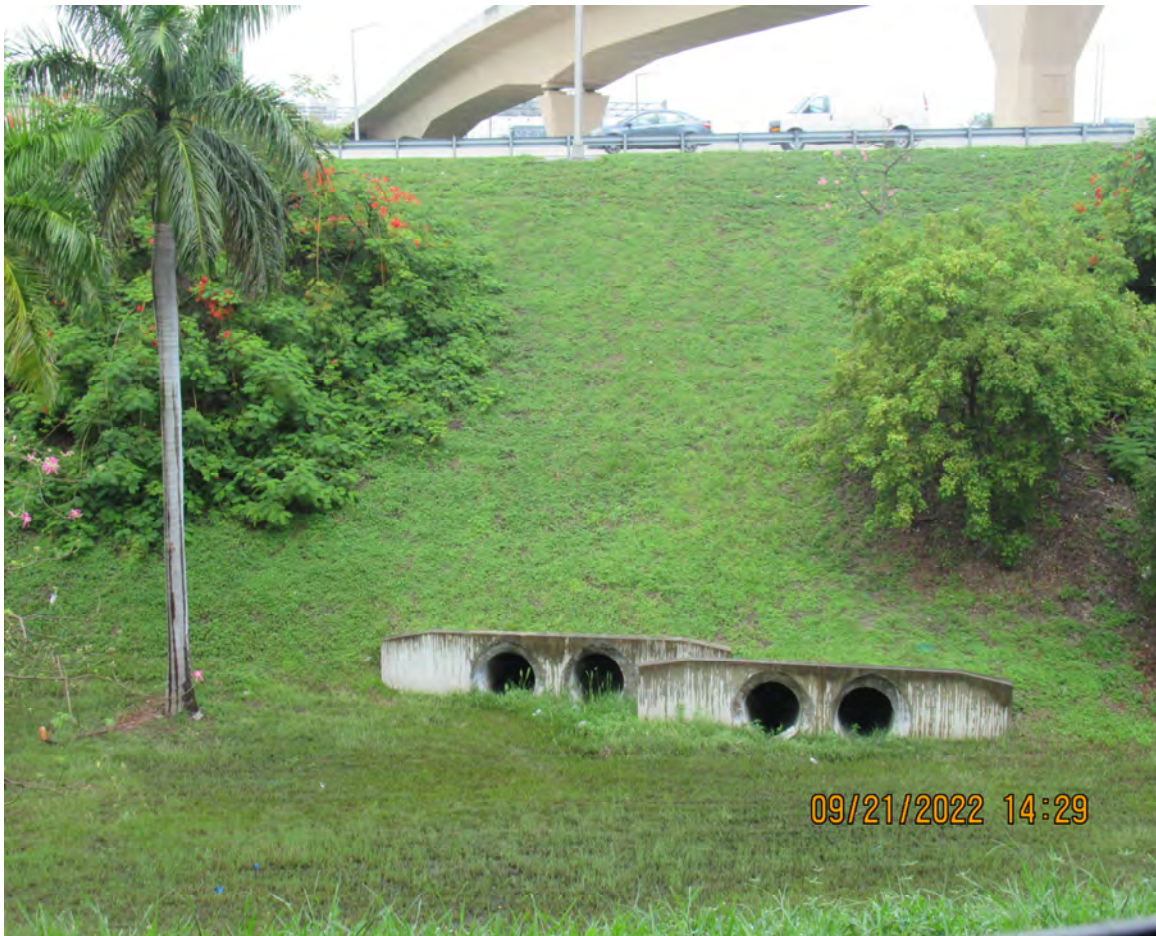
**PHOTO NO.: WB-013
DATE: 9-21-2022**

SEDIMENTATION INSIDE CROSS DRAINS

ITEM NOTED TO BE ADDRESSED BY MDX MAINTENANCE

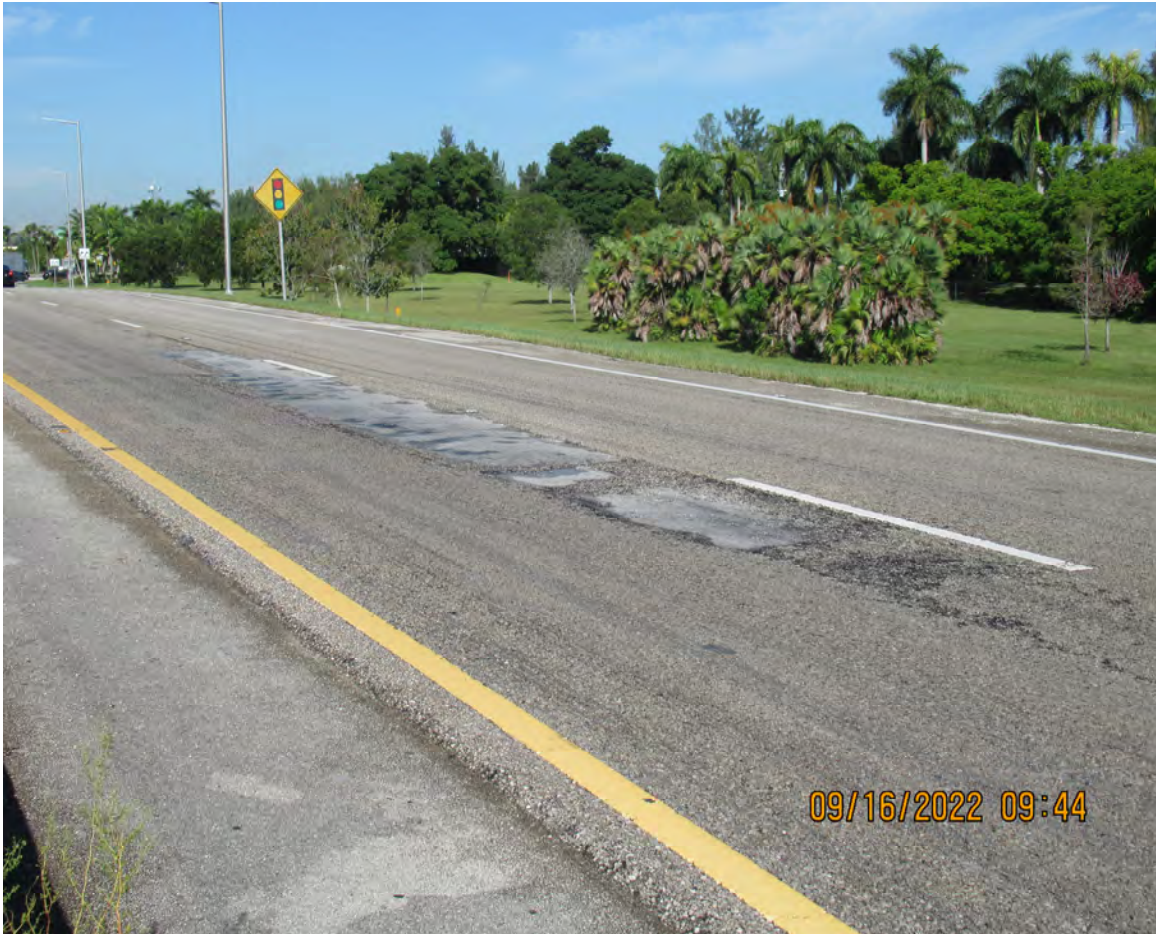
**PHOTO NO.: WB-014
DATE: 09-16-2022**

DETERIORATED PAVEMENT

ITEM NOTED TO BE ADDRESSED BY MDX MAINTENANCE

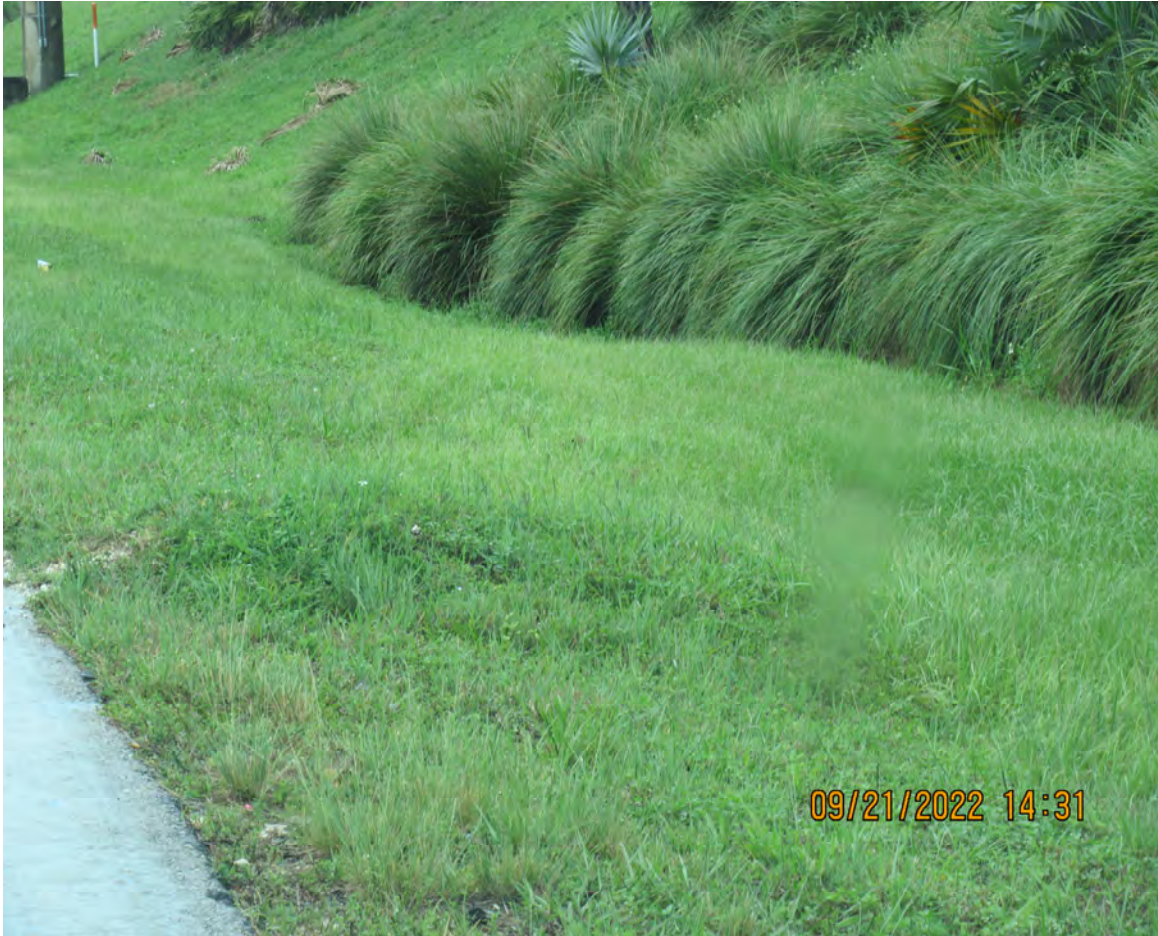
**PHOTO NO.: WB-015
DATE: 9-21-2022**

RAISED SHOULDER GRADE, DUE TO ILLEGAL DUMPING

ITEM NOTED TO BE ADDRESSED BY MDX MAINTENANCE

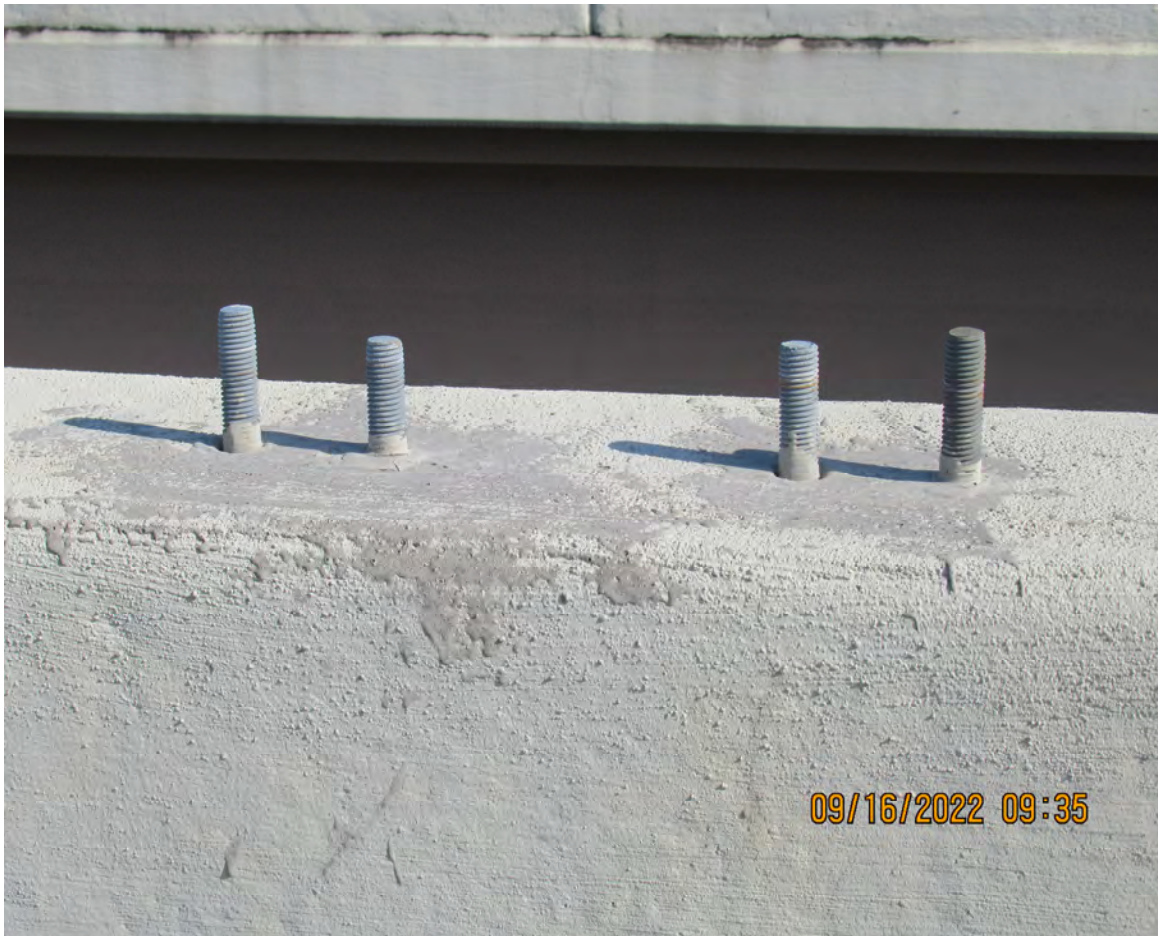
**PHOTO NO.: WB-016
DATE: 9-16-2022**

ANCHOR BOLTS FROM TEMPORARY CONSTRUCTION SIGN (BRIDGE # 871085)

ITEM NOTED TO BE ADDRESSED BY MDX MAINTENANCE

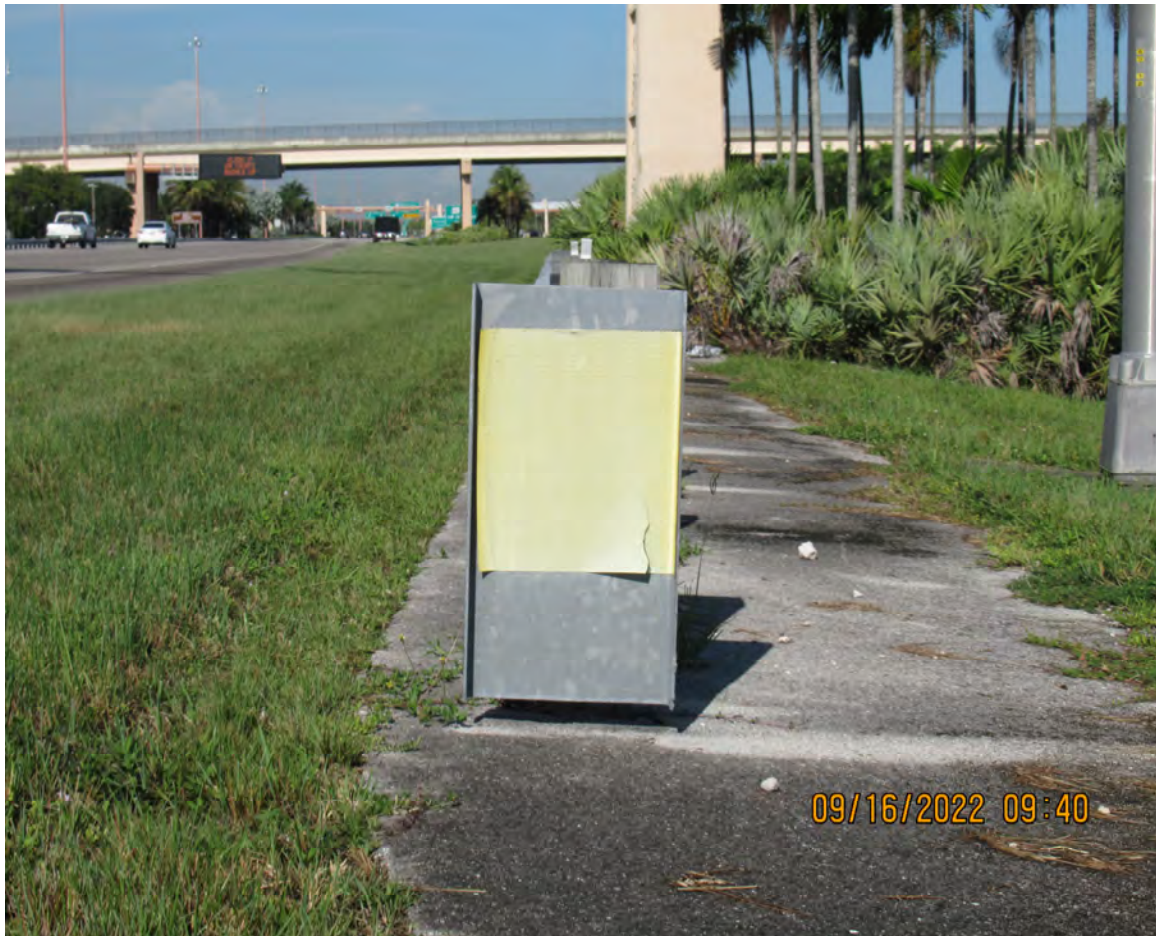
**PHOTO NO.: WB-017
DATE: 09-16-2022**

DETERIORATED REFLECTIVE SHEETING ON END-TREATMENT

ITEM NOTED TO BE ADDRESSED BY MDX MAINTENANCE

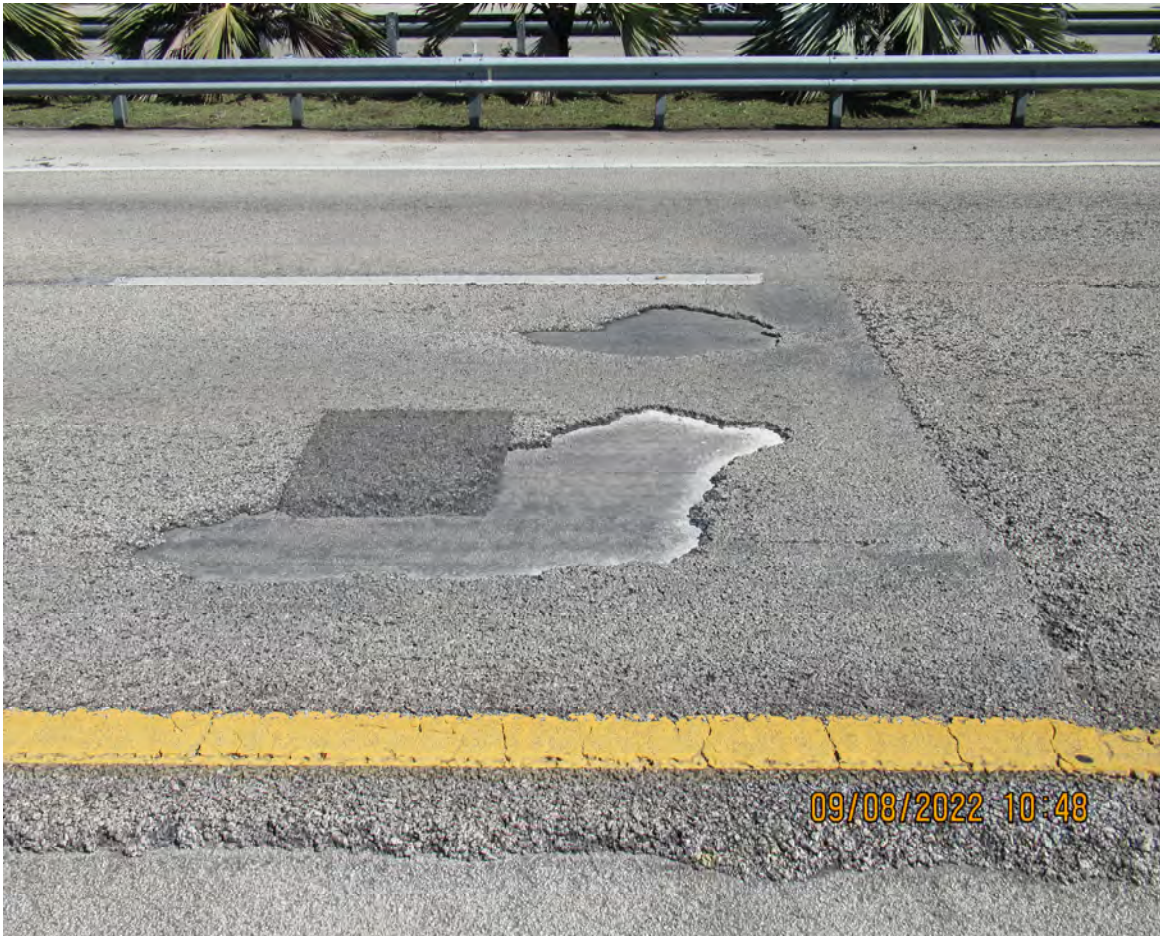
**PHOTO NO.: WB-018
DATE: 9-8-2022**

DAMAGED FRICTION COURSE PAVEMENT

ITEM NOTED TO BE ADDRESSED BY MDX MAINTENANCE
