ANNUAL INSPECTION REPORT 2022

ANNUAL INSPECTION REPORT

In 1996, the Miami-Dade County Expressway Authority (MDX) acquired operational and financial control of five expressways in Miami-Dade County from the Florida Department of Transportation (FDOT). This group of expressways, toll facilities and the MDX headquarters facility, all as described below, are hereinafter referred to as the “MDX System”. In accordance with the Trust Indenture requirements, MDX retained EAC Consulting, Inc. (EAC), as the General Engineering Consultant to perform, among other duties assigned by the Authority, the yearly inspection of the MDX System. This report represents the annual inspection results for Fiscal Year (FY) 2022.

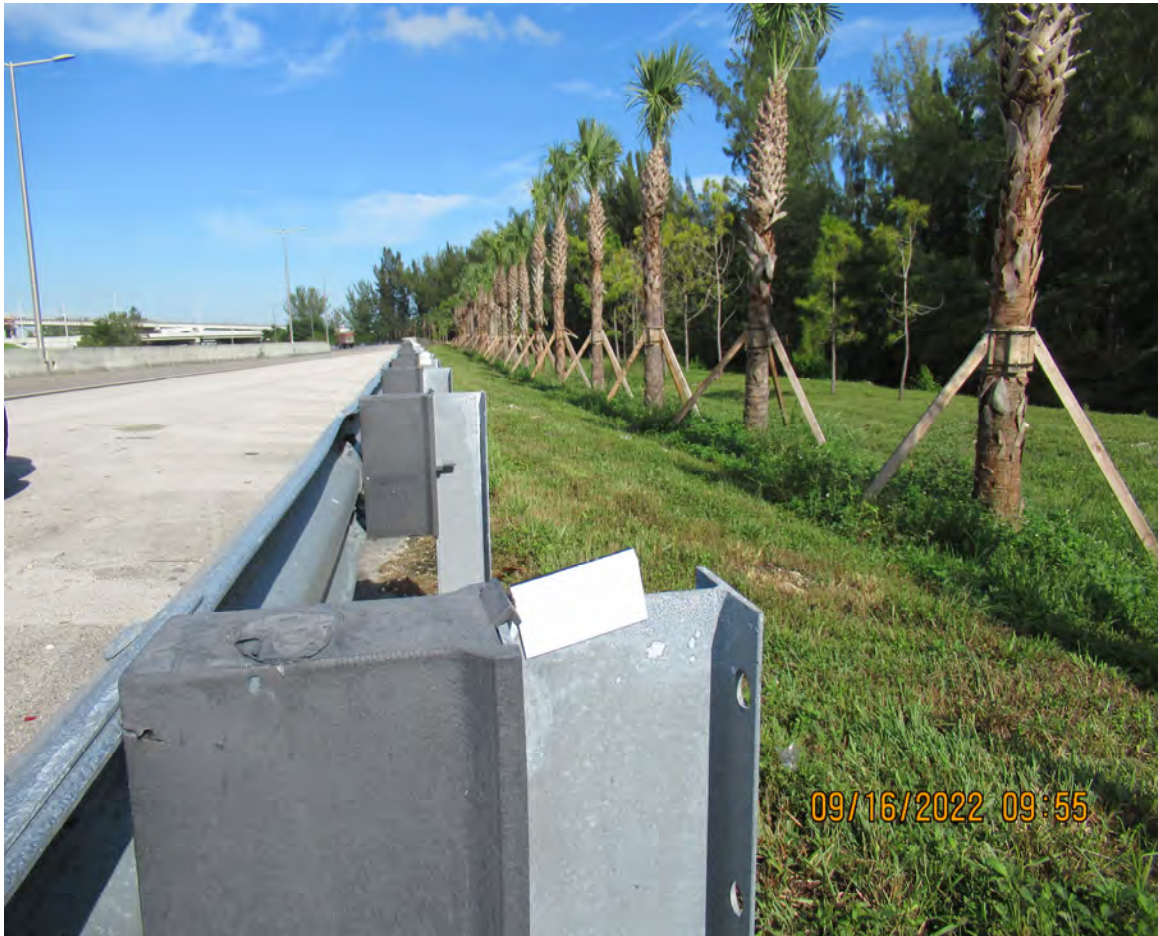
**PHOTO NO.: WB-019
DATE: 9-16-2022**

DAMAGED GUARDRAIL REFLECTORS (TYPICAL THROUGHOUT THE CORRIDOR)

ITEM NOTED TO BE ADDRESSED BY MDX MAINTENANCE

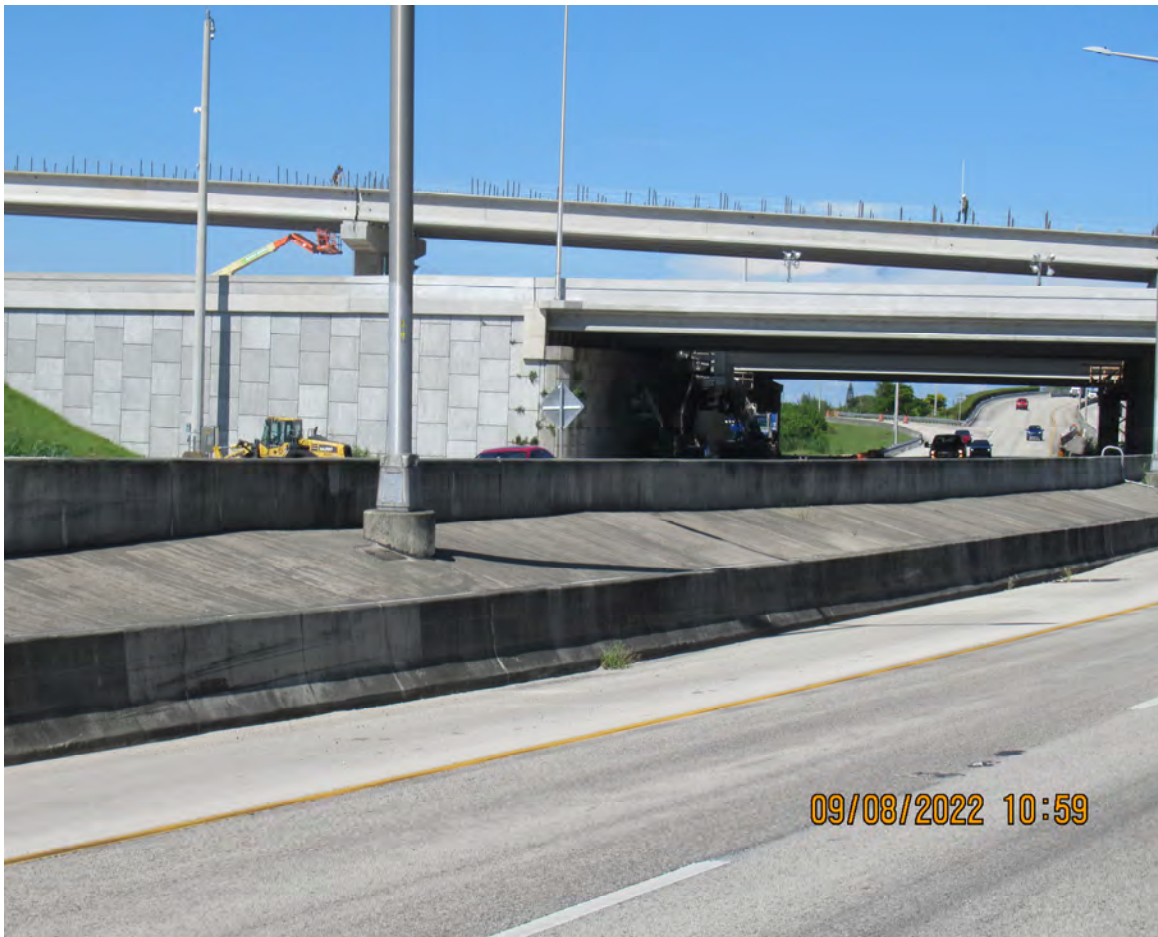
**PHOTO NO.: WB-020
DATE: 9-8-2022**

**DETERIORATED CLASS V COATING ON BARRIER WALL AND TRAFFIC
SEPARATOR**

ITEM NOTED TO BE ADDRESSED BY MDX WORK PROGRAM NO. 30037

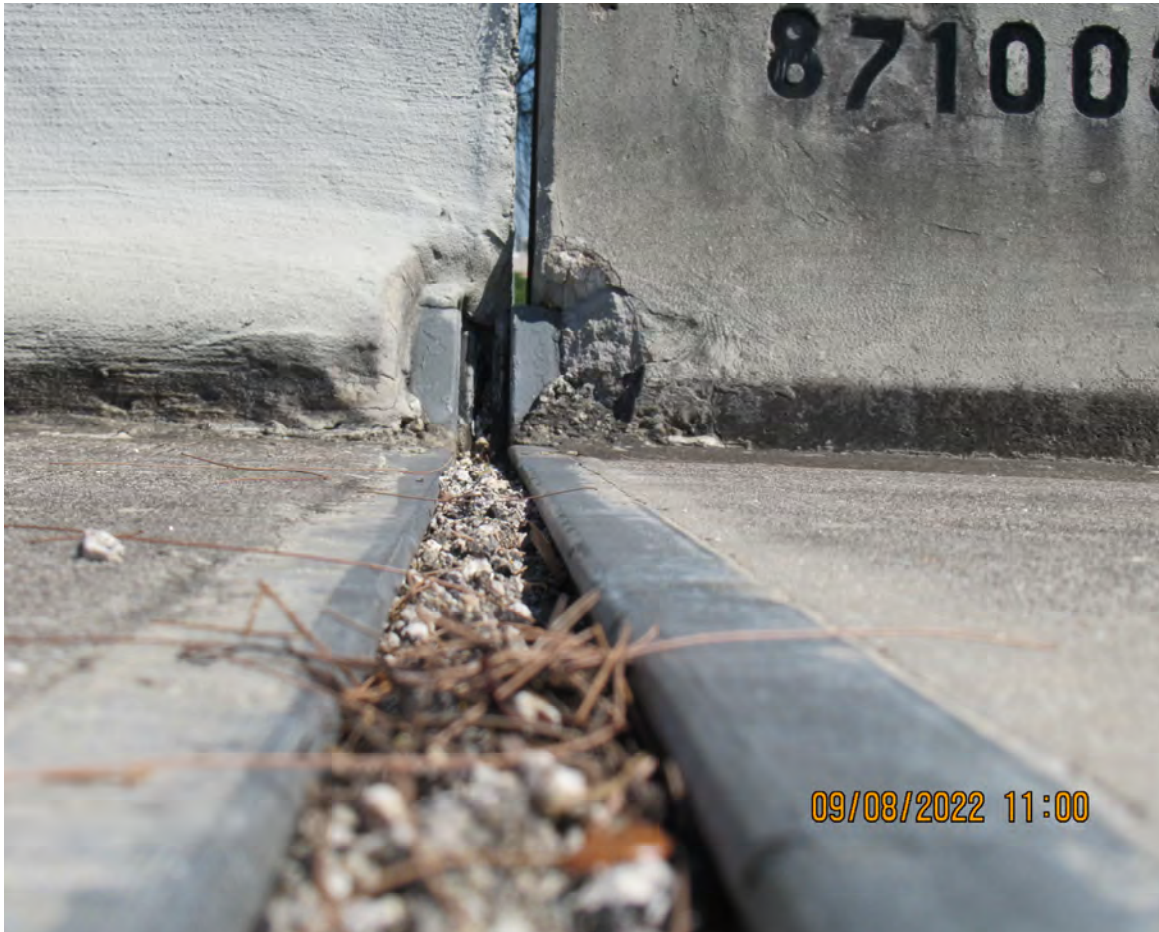
**PHOTO NO.: WB-021
DATE: 9-8-2022**

**SEDIMENT AND DEBRIS ACCUMULATED ON BRIDGE
EXPANSION JOINTS (BRIDGE No. 871003)
(TYPICAL THROUGHOUT THE CORRIDOR)**

ITEM NOTED TO BE ADDRESSED BY MDX MAINTENANCE

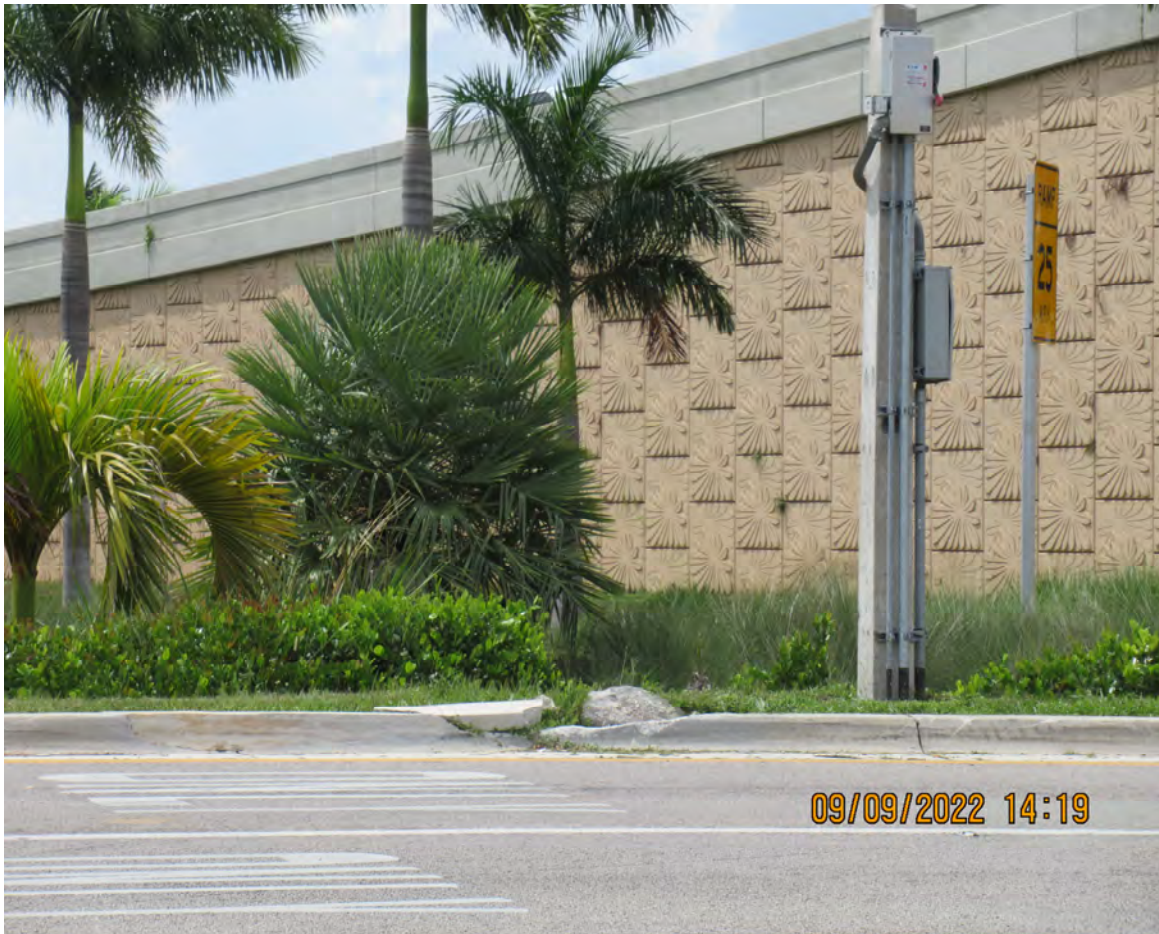
**PHOTO NO.: WB-027
DATE: 9-8-2022**

DAMAGED CONCRETE CURB

ITEM NOTED TO BE ADDRESSED BY MDX MAINTENANCE

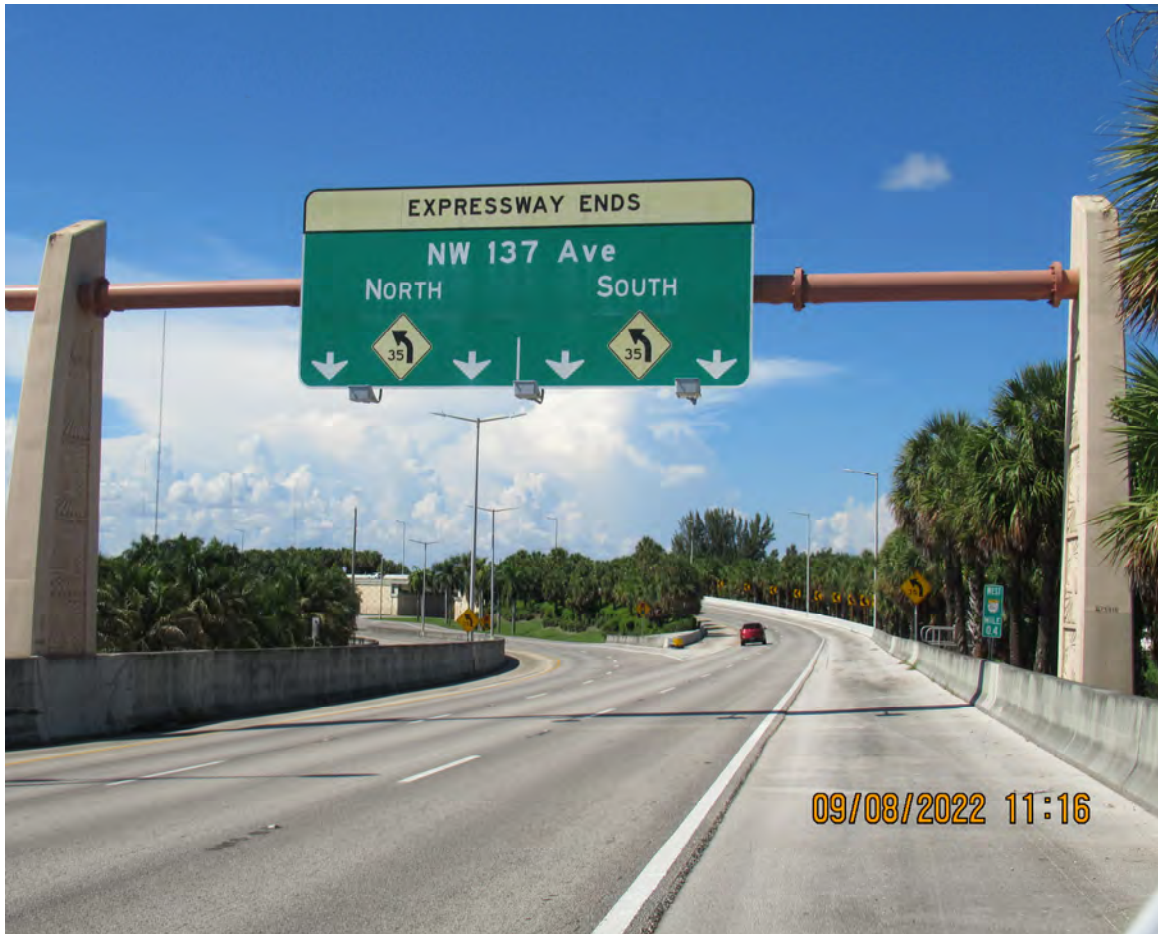
**PHOTO NO.: WB-028
DATE: 9-8-2022**

DETERIORATED REFLECTIVE SHEETING ON SIGN PANEL

ITEM NOTED TO BE ADDRESSED BY MDX WORK PROGRAM NO. 30058

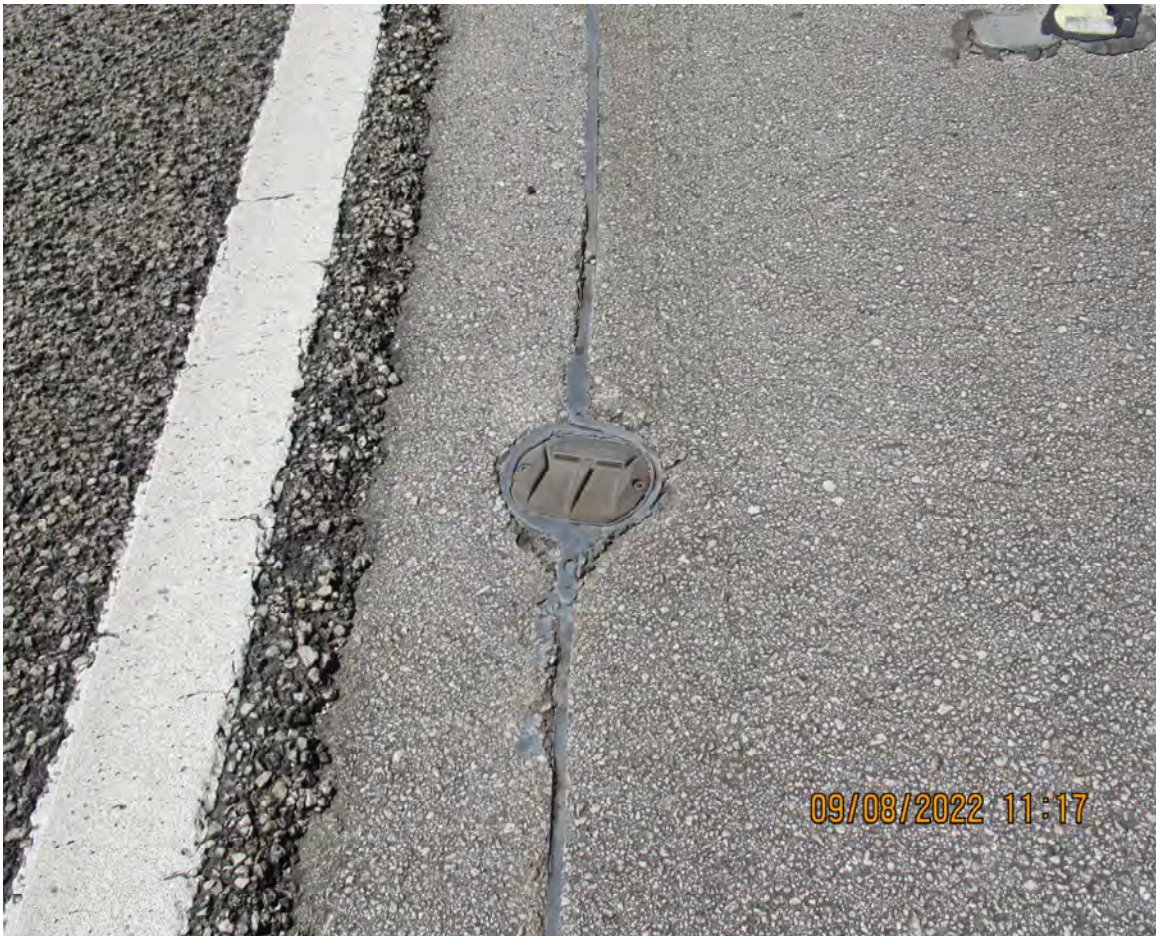
**PHOTO NO.: WB-029
DATE: 9-8-2022**

MALFUNCTIONING ILLUMINATED REFLECTIVE PAVEMENT MARKERS

ITEM NOTED TO BE ADDRESSED BY MDX MAINTENANCE

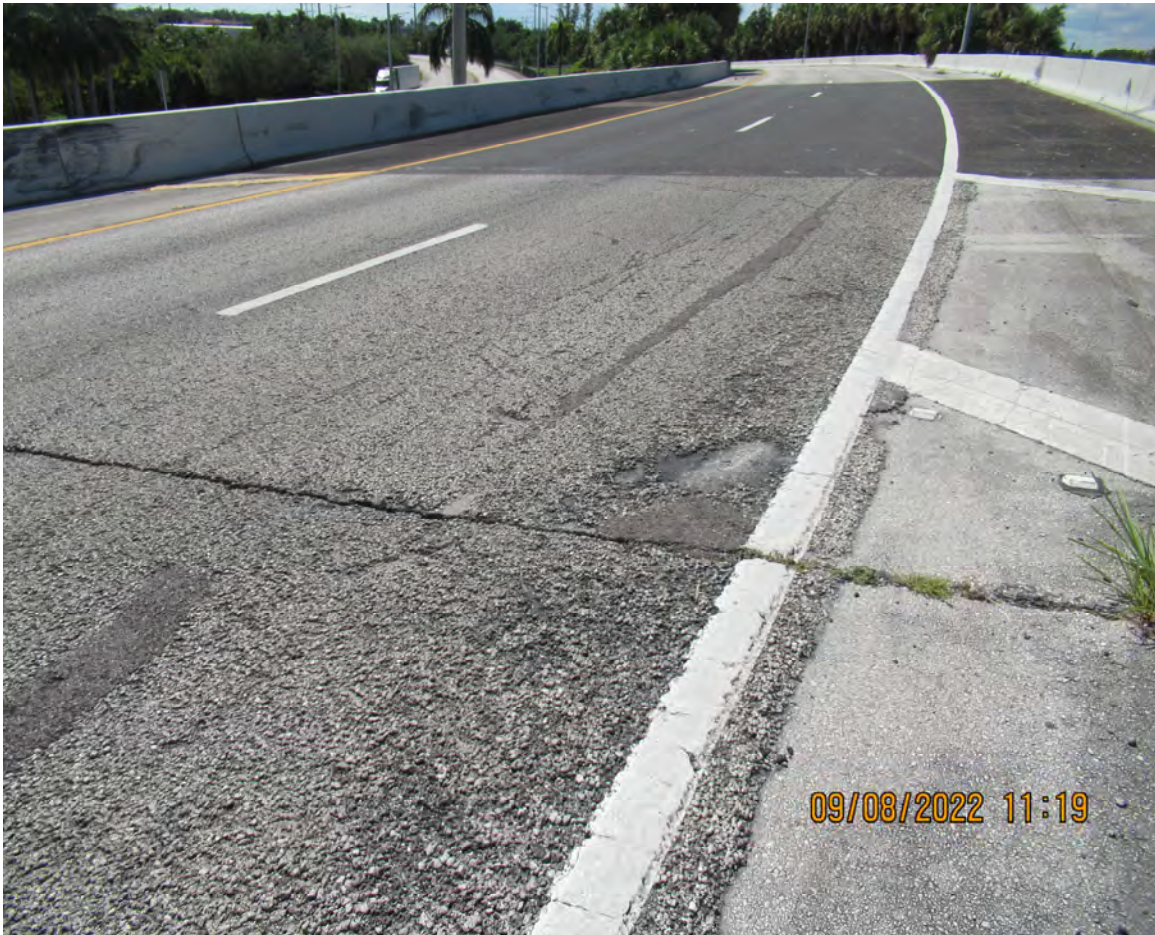
**PHOTO NO.: WB-030
DATE: 9-8-2022**

**DETERIORATED / DAMAGED FRICTION COURSE DUE TO NUMEROUS
ACCIDENTS**

ITEM NOTED TO BE ADDRESSED BY MDX MAINTENANCE

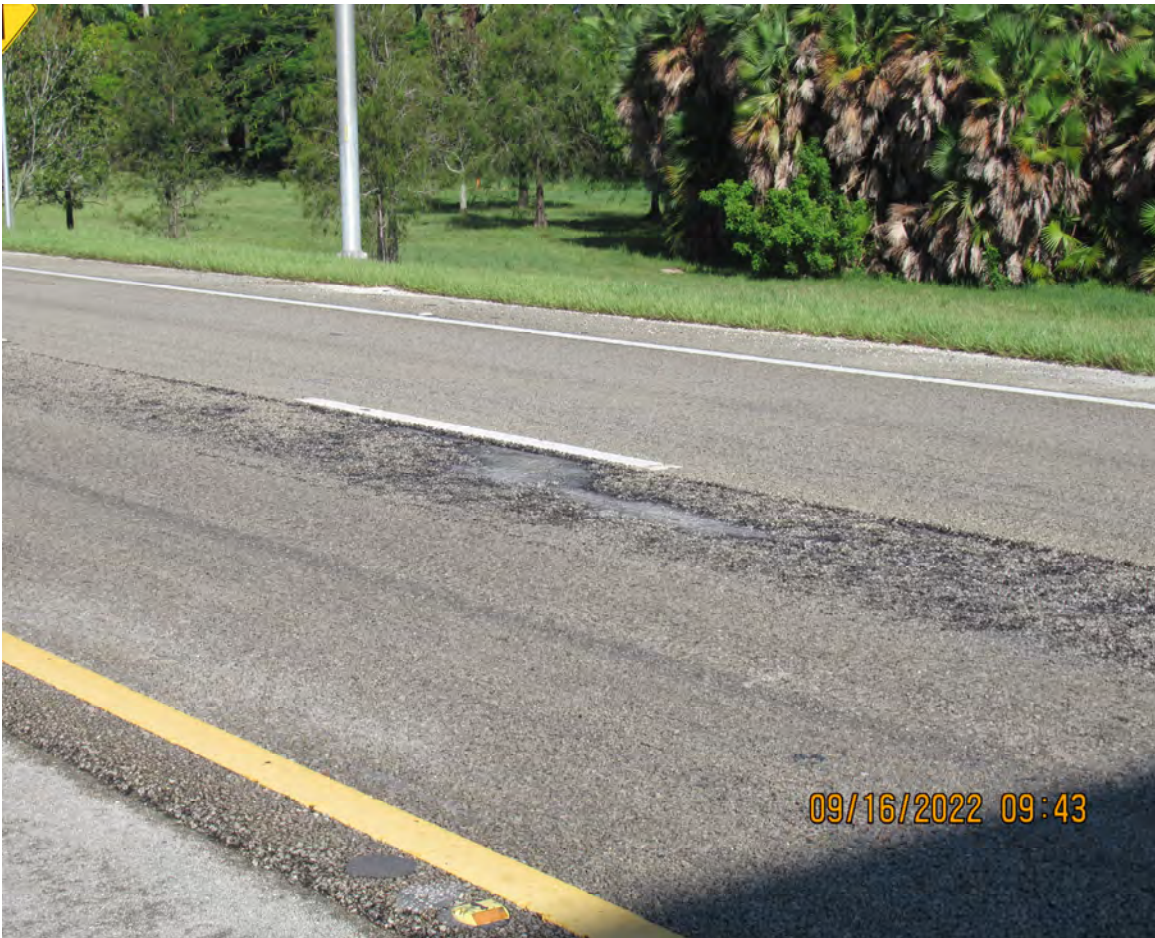
**PHOTO NO.: WB-032
DATE: 9-16-2022**

DETERIORATED PAVEMENT

ITEM NOTED TO BE ADDRESSED BY MDX MAINTENANCE

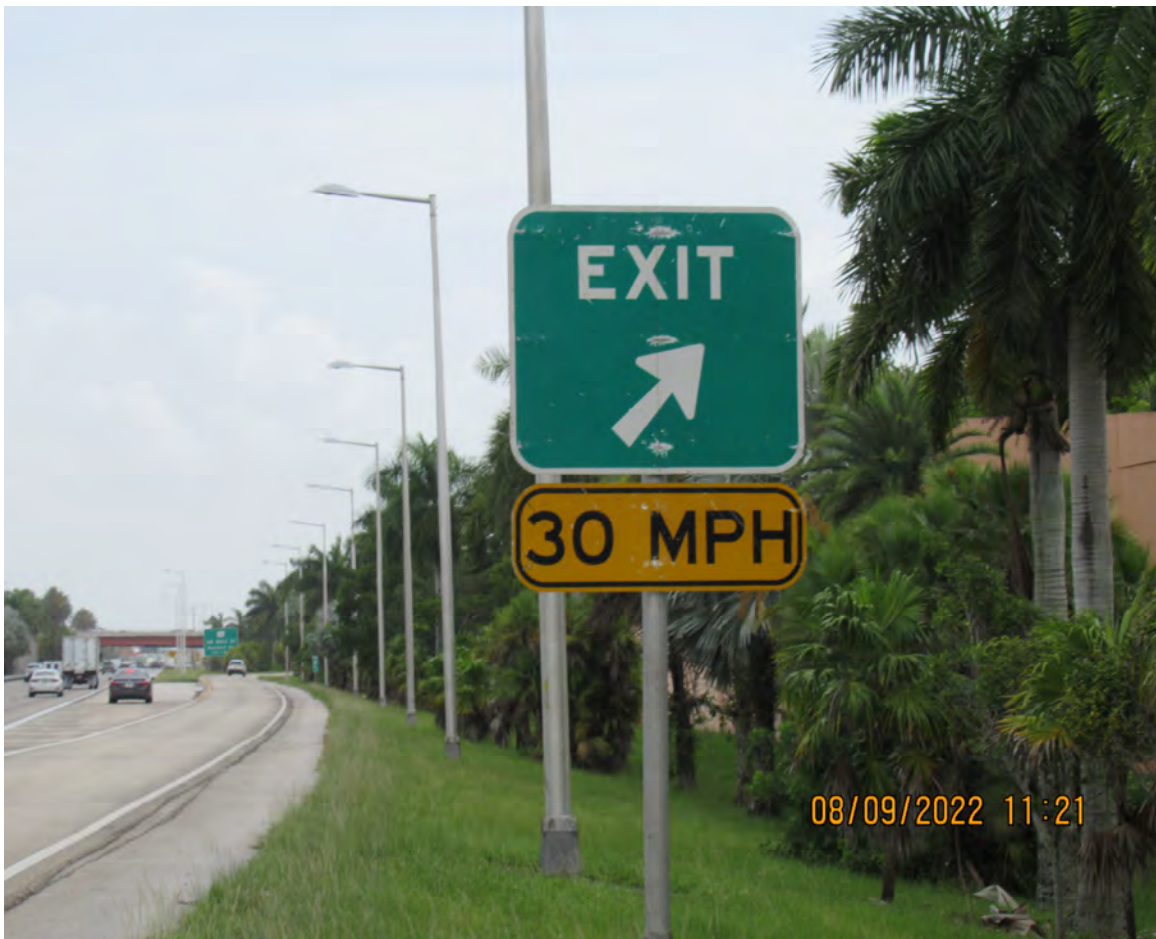
**PHOTO NO.: NB-007
DATE: 8-9-2022**

DETERIORATED REFLECTIVE SHEETING ON EXIT AND MPH SIGNS

ITEM NOTED TO BE ADDRESSED BY MDX MAINTENANCE

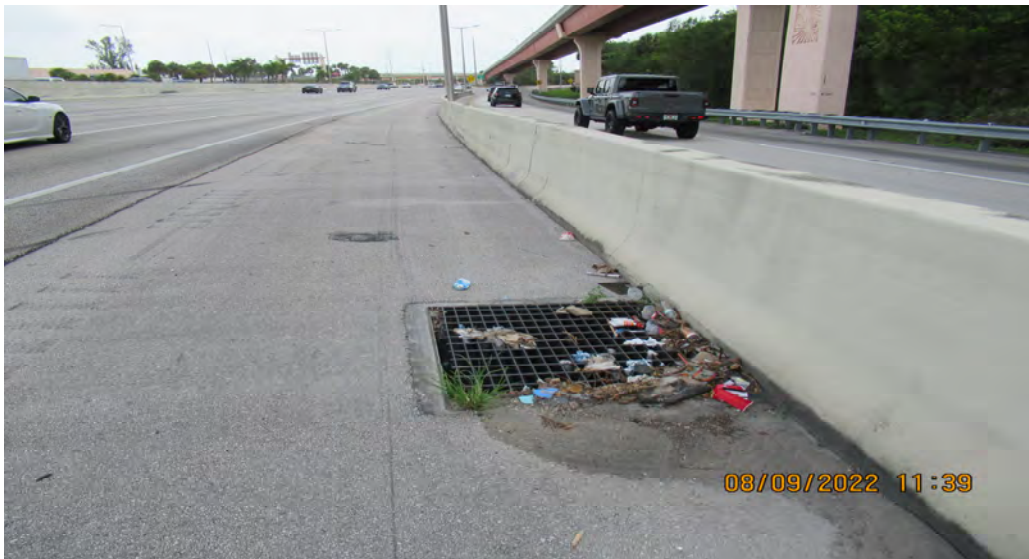
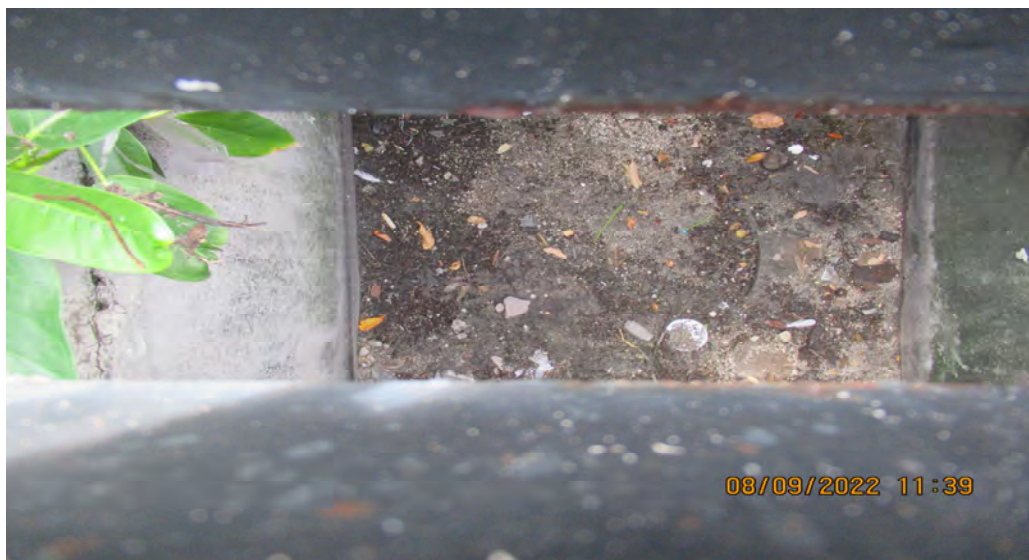
**PHOTO NO.: NB-011
DATE: 8-9-2022**

SILTED DRAINAGE INLET (TYPICAL AT VARIOUS LOCATIONS)

ITEM NOTED TO BE ADDRESSED BY MDX MAINTENANCE

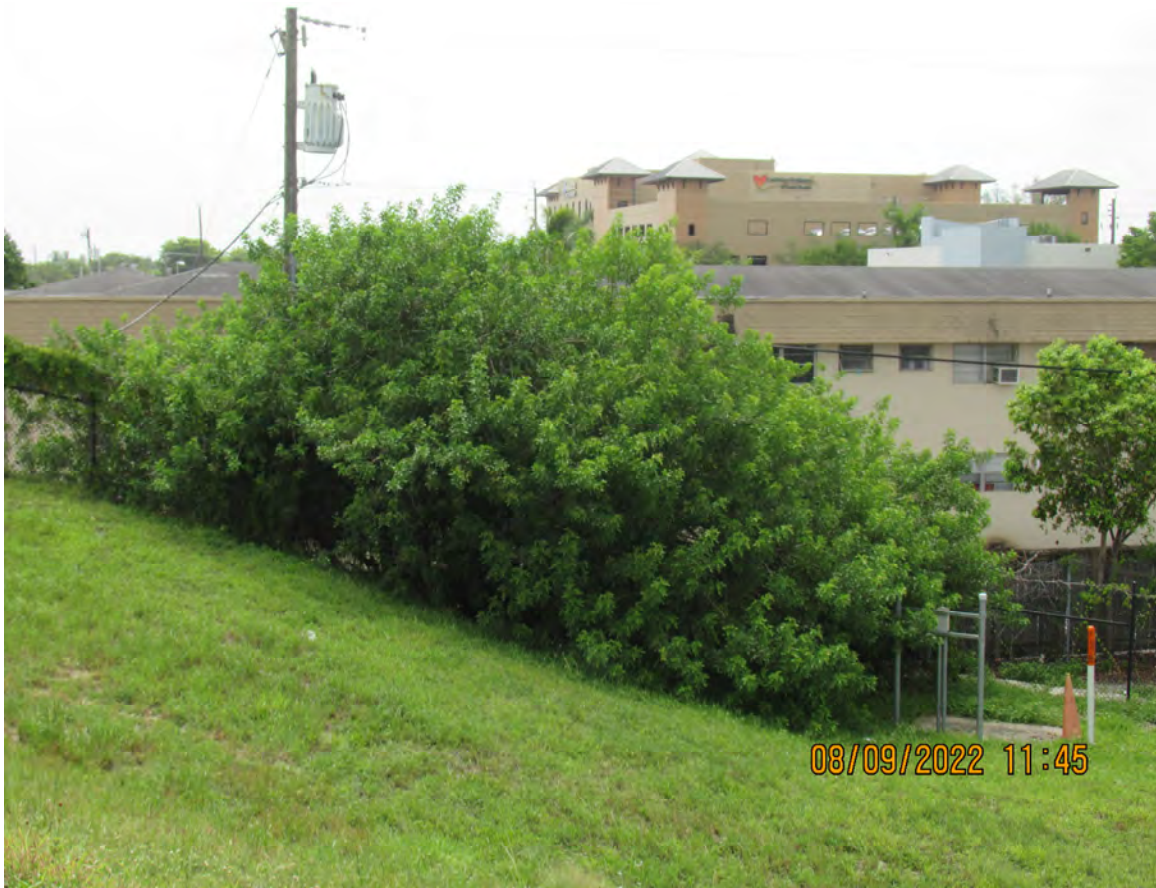
**PHOTO NO.: NB-014
DATE: 8-9-2022**

OVERGROWN VEGETATION ON FENCE AND LOAD CENTER

ITEM NOTED TO BE ADDRESSED BY MDX MAINTENANCE

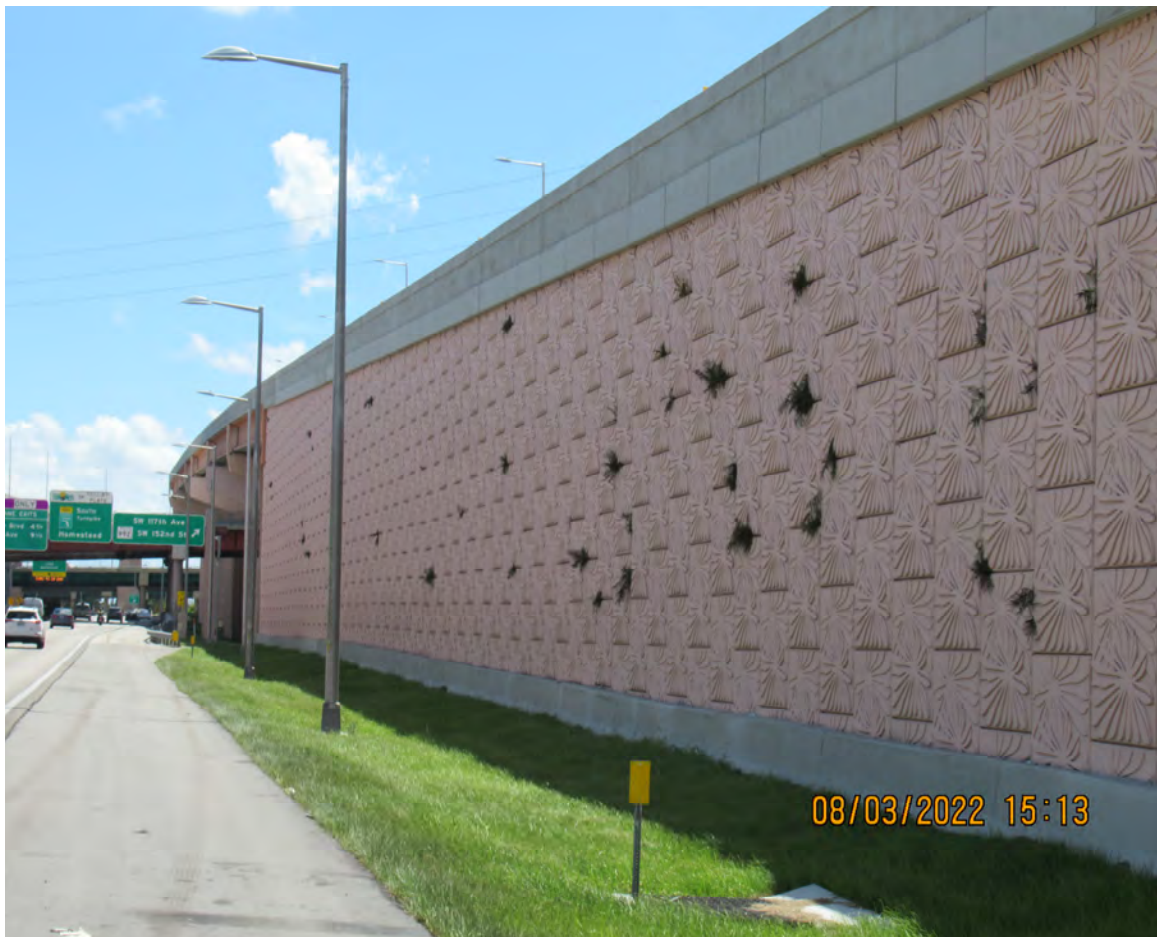
**PHOTO NO.: SB-002
DATE: 8-3-2022**

OVERGROWN VEGETATION ON MSE WALL

ITEM NOTED TO BE ADDRESSED BY MDX MAINTENANCE

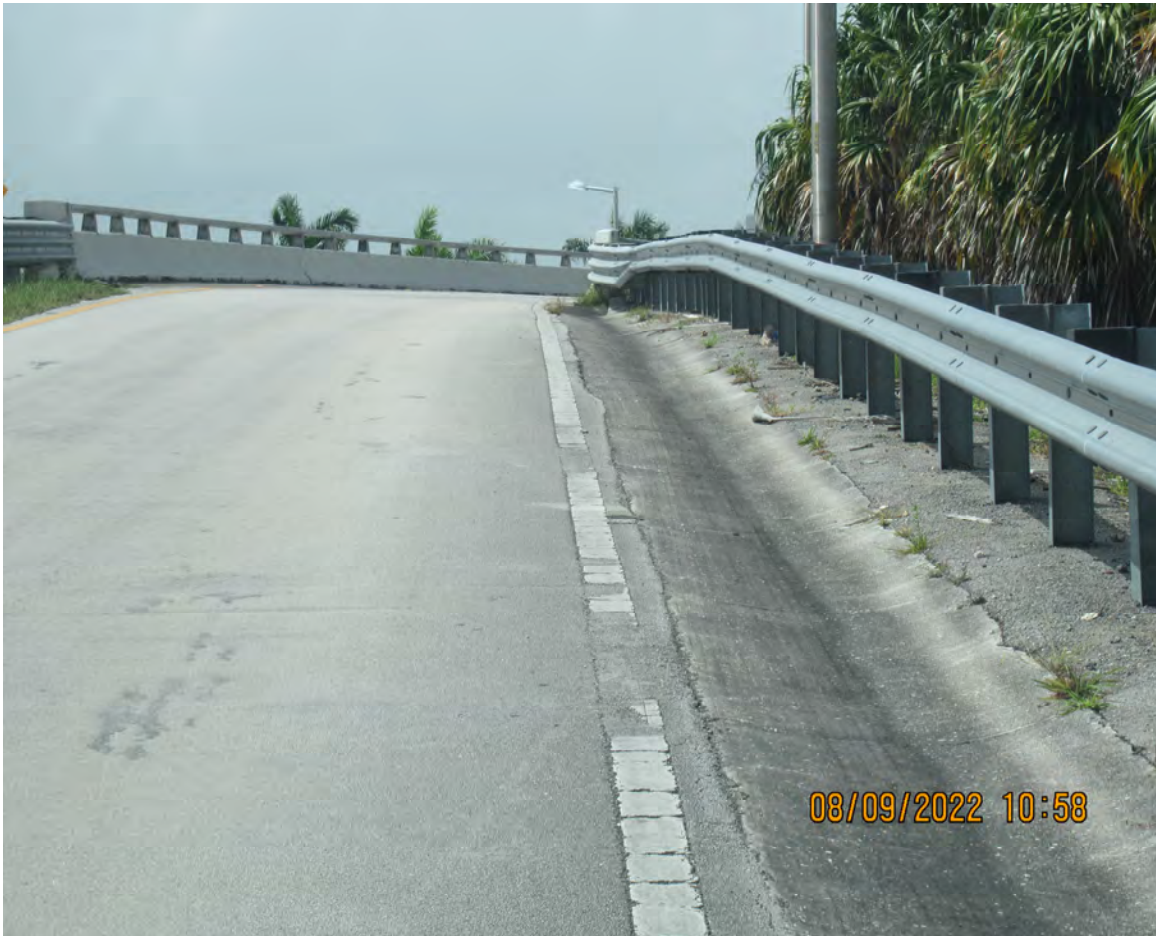
**PHOTO NO.: SB-003
DATE: 8-9-2022**

DETERIORATED THERMOPLASTIC STRIPING

ITEM NOTED TO BE ADDRESSED BY MDX WORK PROGRAM NO. 30033

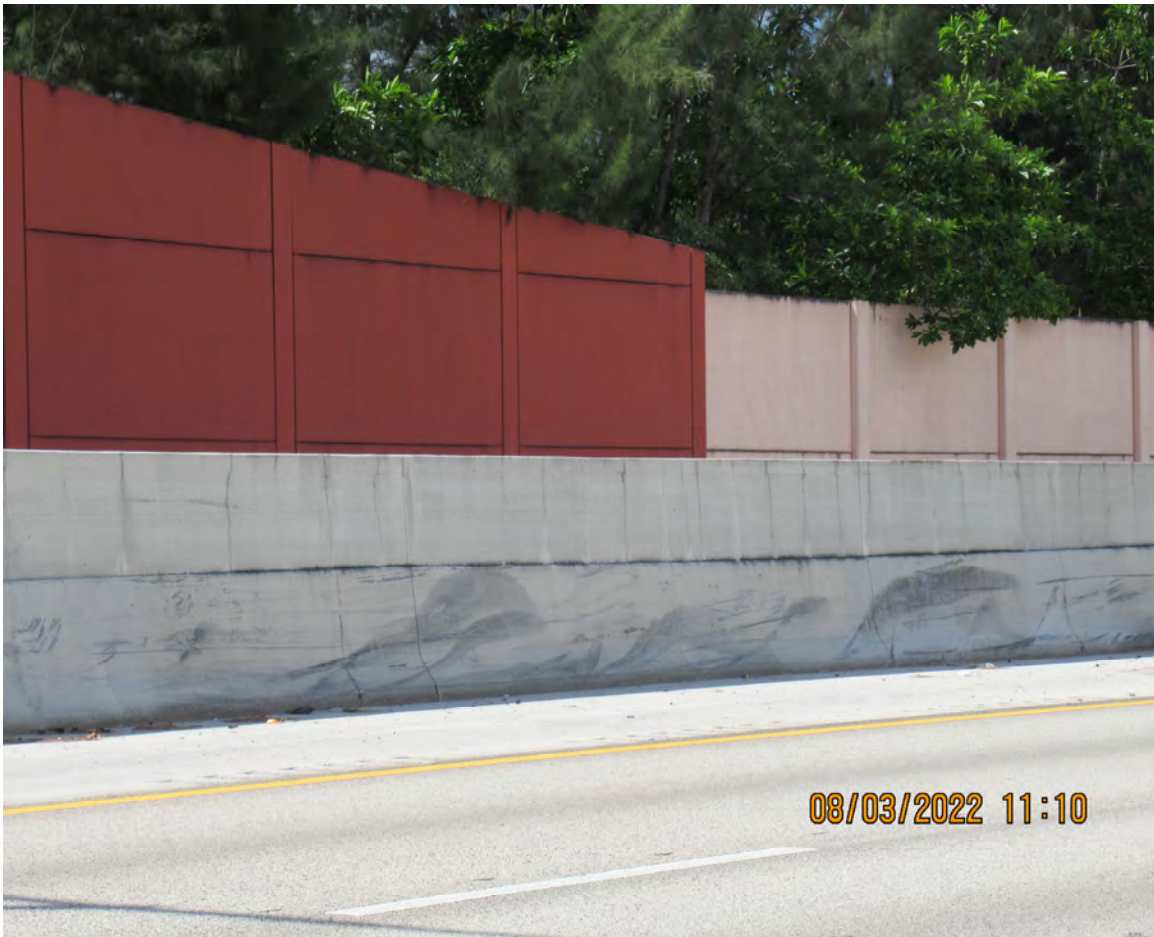
**PHOTO NO.: SB-005
DATE: 8-3-2022**

**SKUFF MARKS ON BARRIER WALL
(TYPICAL AT VARIOUS LOCATIONS)**

ITEM NOTED TO BE ADDRESSED BY MDX MAINTENANCE

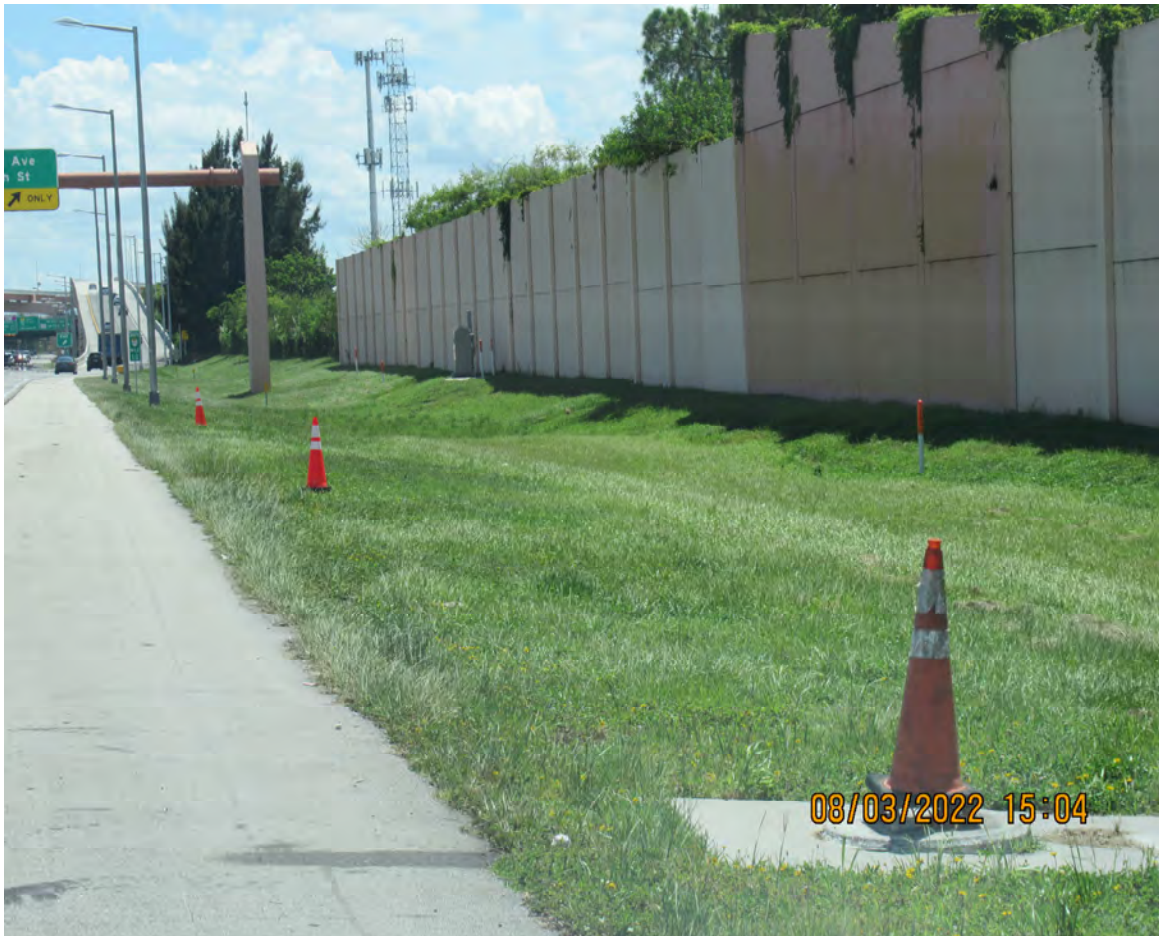
**PHOTO NO.: SB-006
DATE: 8-3-2022**

MISSING LIGHT POLES DUE TO VEHICULAR ACCIDENT

ITEM NOTED TO BE ADDRESSED BY MDX MAINTENANCE

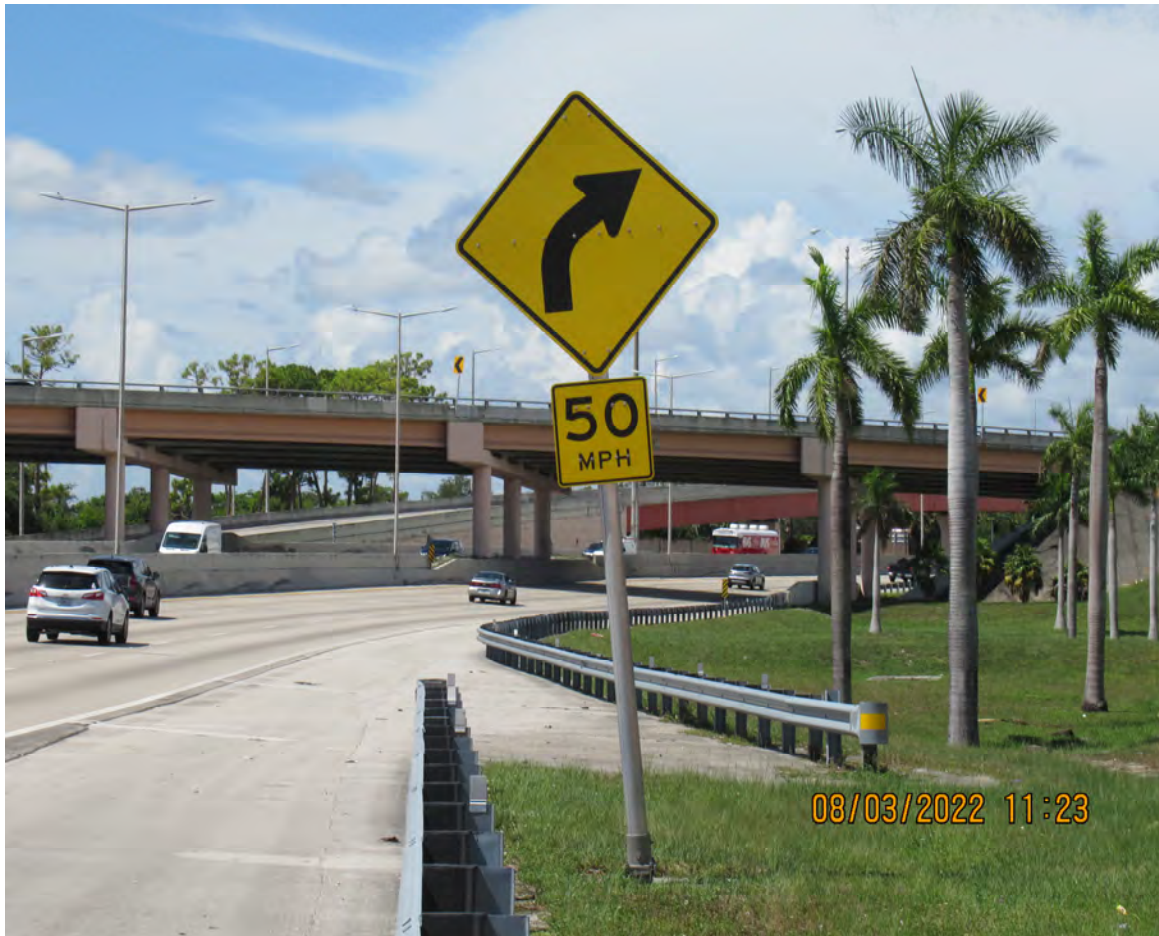
**PHOTO NO.: SB-009
DATE: 8-3-2022**

LEANING SIGN

ITEM NOTED TO BE ADDRESSED BY MDX MAINTENANCE

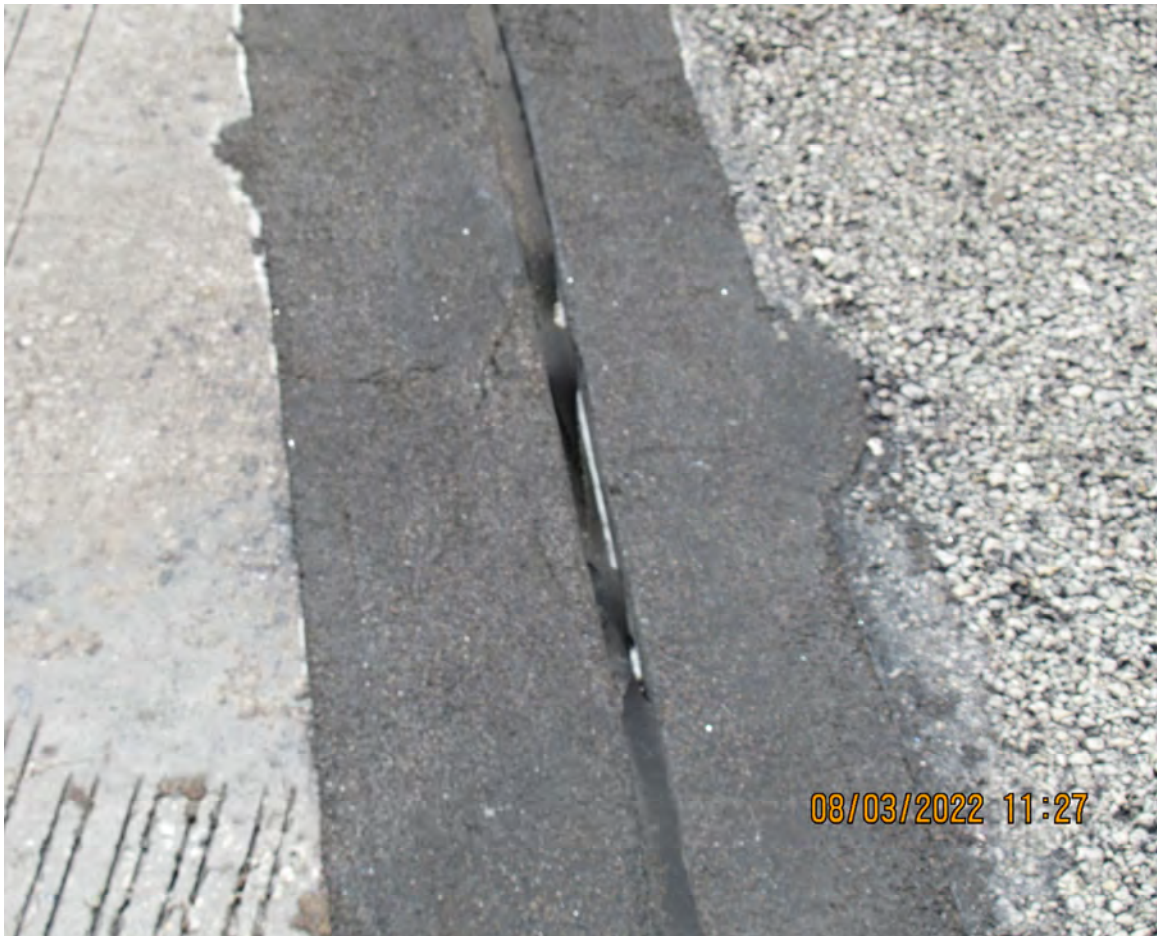
**PHOTO NO.: SB-010
DATE: 8-3-2022**

**DETERIORATED JOINT SEALANT BENT 1
(BRIDGE # 870495)**

ITEM NOTED TO BE ADDRESSED BY MDX MAINTENANCE

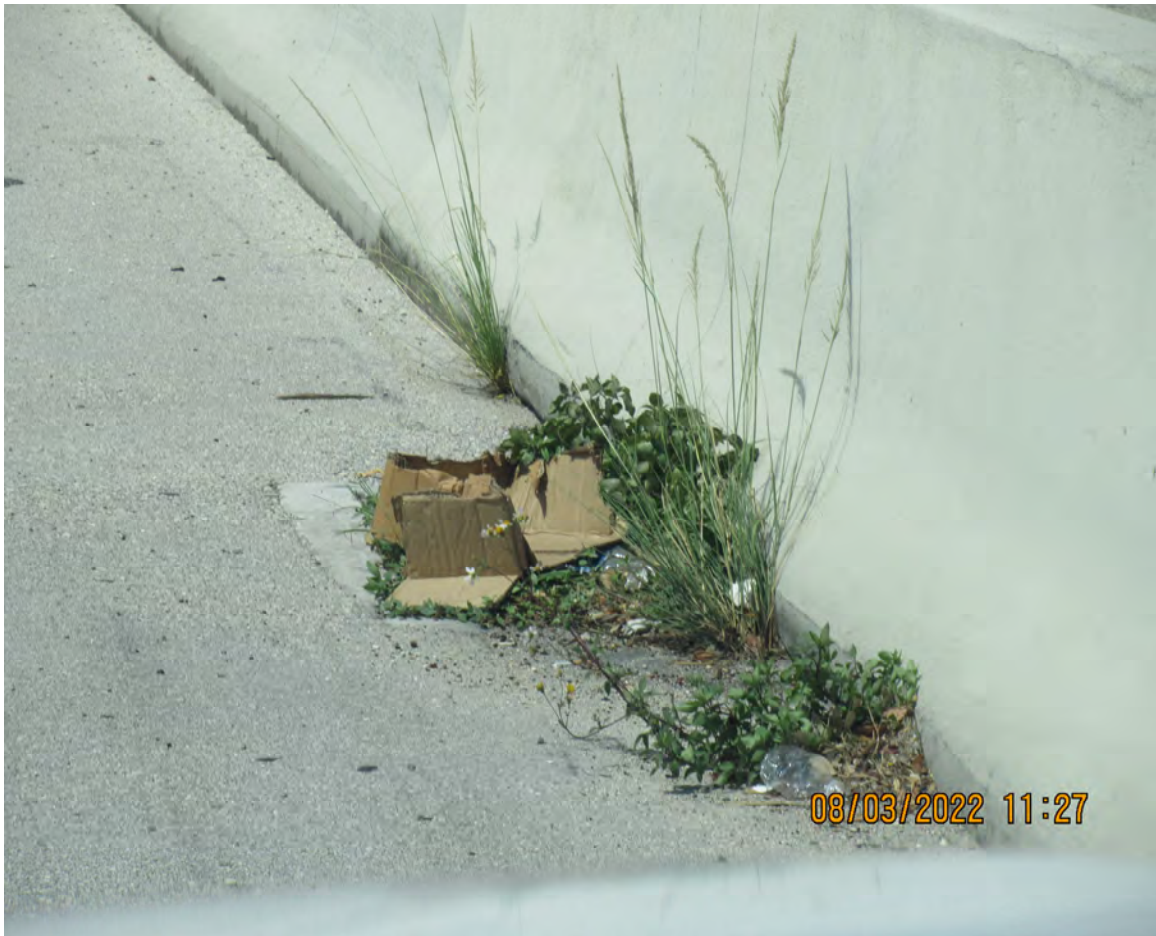
**PHOTO NO.: SB-011
DATE: 8-3-2022**

SILTED DRAINAGE STRUCTURE

ITEM NOTED TO BE ADDRESSED BY MDX MAINTENANCE

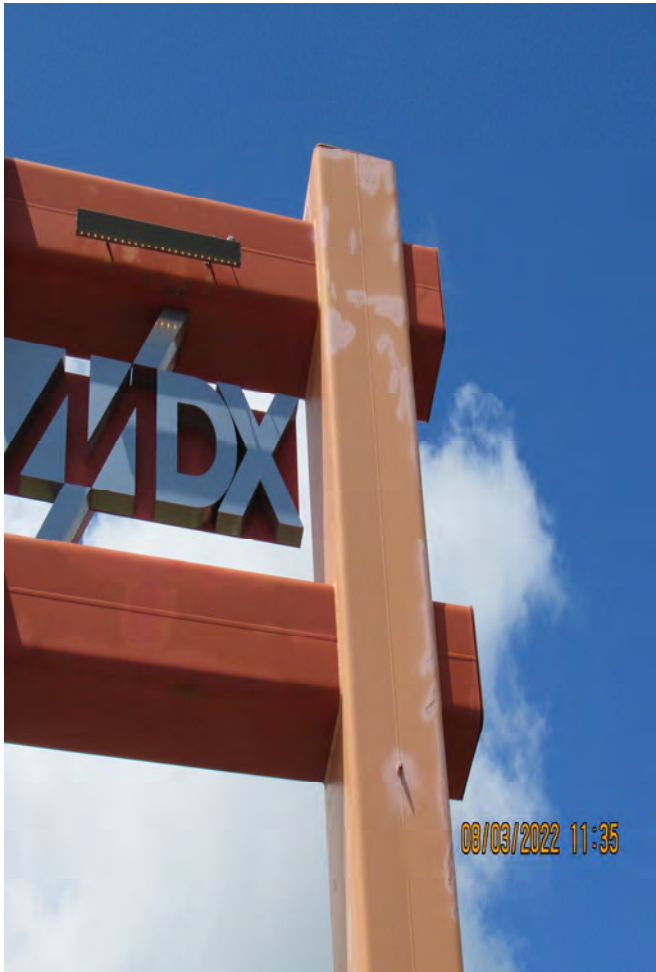
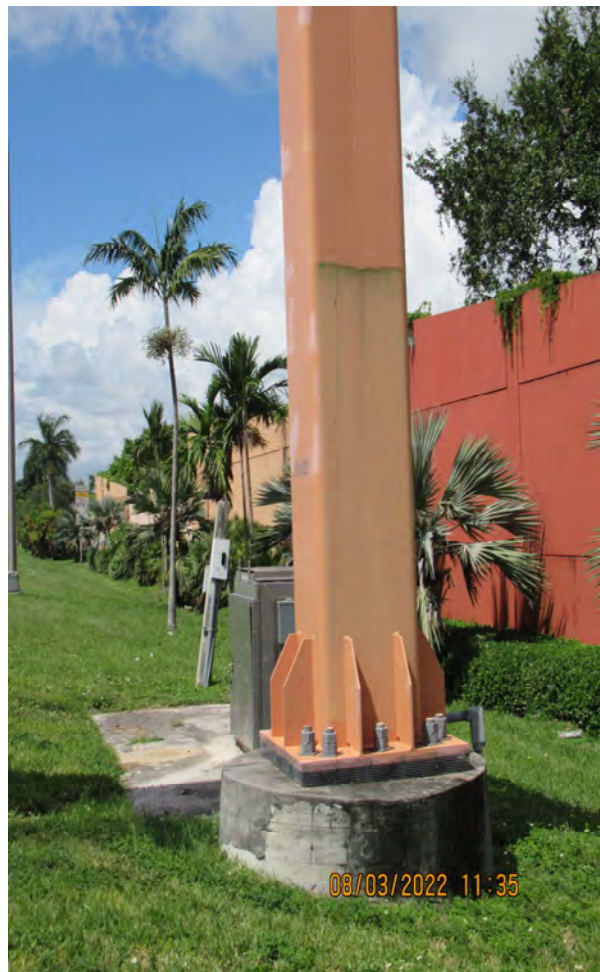
**PHOTO NO.: SB-013
DATE: 8-3-2022**

**DETERIORATED PAINT ON MONOTUBE
(STRUCTURE # 87A327)**

ITEM NOTED TO BE ADDRESSED BY MDX WORK PROGRAM NO. 30043

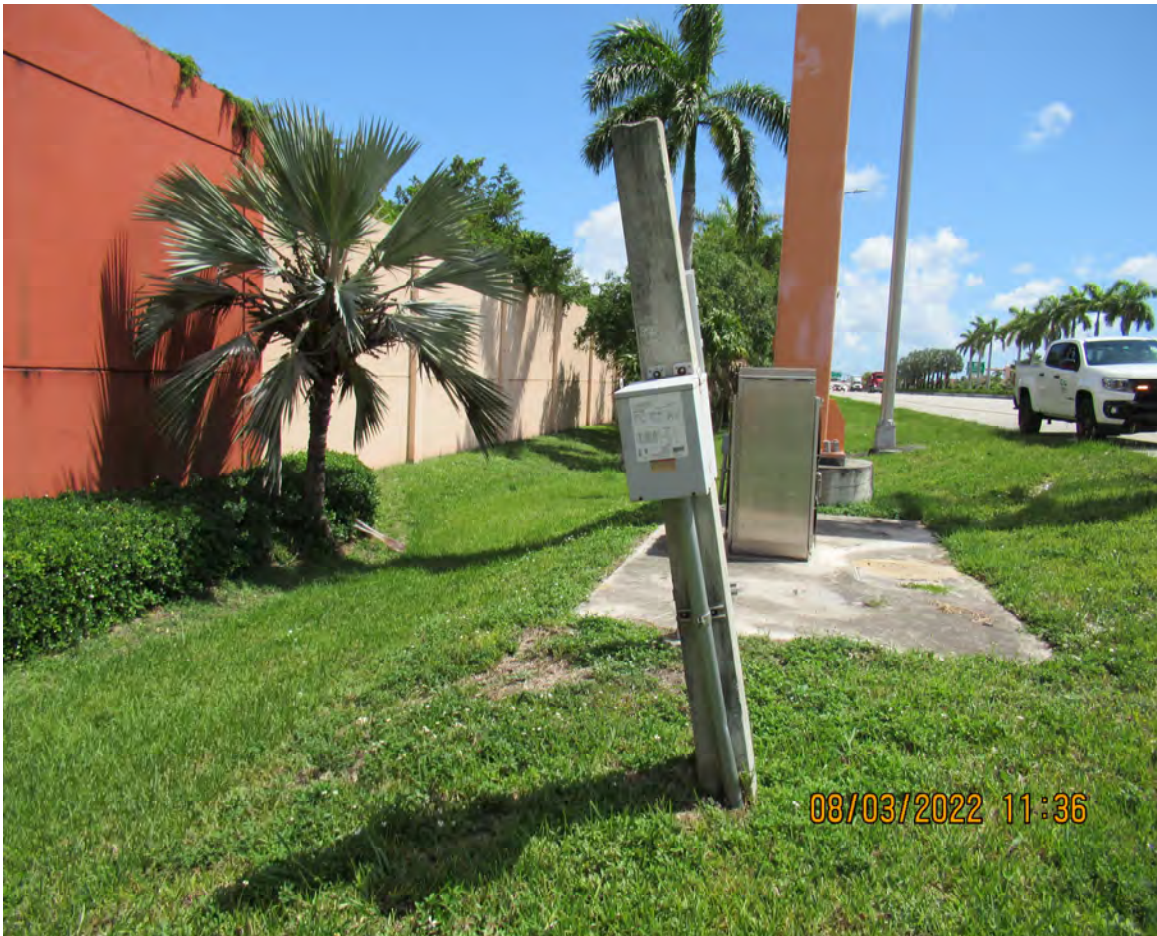
**PHOTO NO.: SB-014
DATE: 8-3-2022**

LEANING LOAD CENTER DUE TO VEHICULAR ACCIDENT

ITEM NOTED TO BE ADDRESSED BY MDX MAINTENANCE
