ANNUAL INSPECTION REPORT 2022

ANNUAL INSPECTION REPORT

In 1996, the Miami-Dade County Expressway Authority (MDX) acquired operational and financial control of five expressways in Miami-Dade County from the Florida Department of Transportation (FDOT). This group of expressways, toll facilities and the MDX headquarters facility, all as described below, are hereinafter referred to as the “MDX System”. In accordance with the Trust Indenture requirements, MDX retained EAC Consulting, Inc. (EAC), as the General Engineering Consultant to perform, among other duties assigned by the Authority, the yearly inspection of the MDX System. This report represents the annual inspection results for Fiscal Year (FY) 2022.

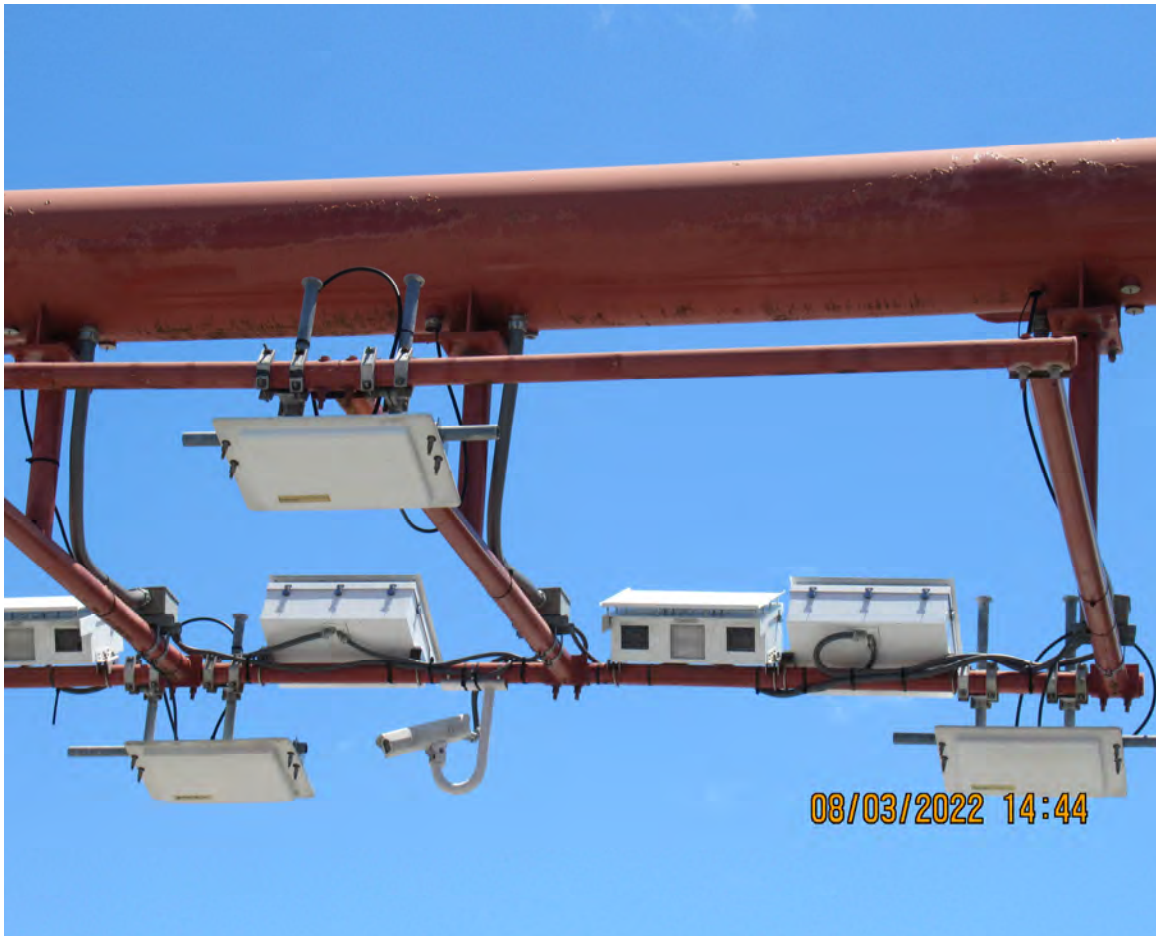
**PHOTO NO.: SB-016
DATE: 8-3-2022**

**DETERIORATED PAINT ON ORT GANTRY MONOTUBE
(STRUCTURE # 87S938)**

ITEM NOTED TO BE ADDRESSED BY MDX WORK PROGRAM NO. 30043

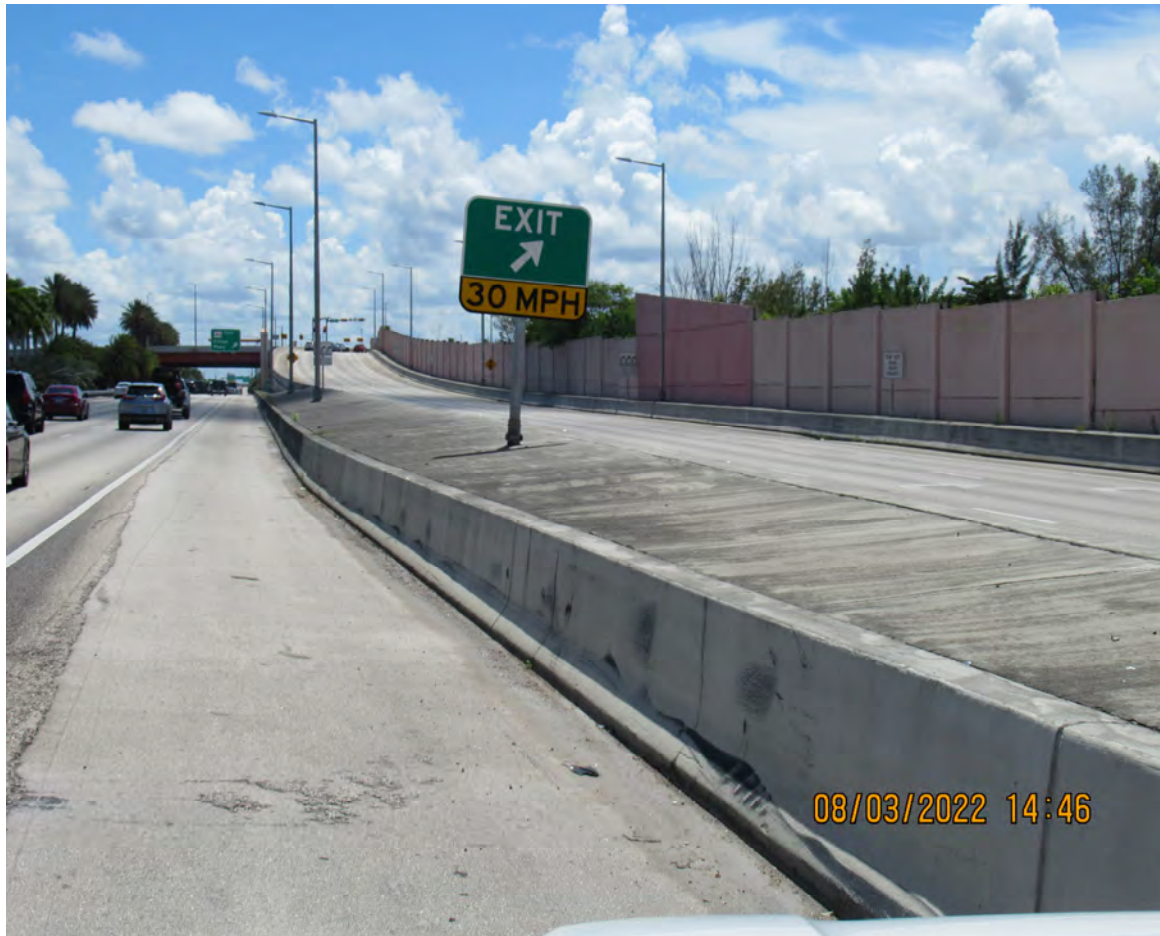
**PHOTO NO.: SB-017
DATE: 8-3-2022**

**DETERIORATED CLASS V COATING ON TRAFFIC SEPARATOR AND
BARRIER WALL**

ITEM NOTED TO BE ADDRESSED BY MDX WORK PROGRAM NO. 30037

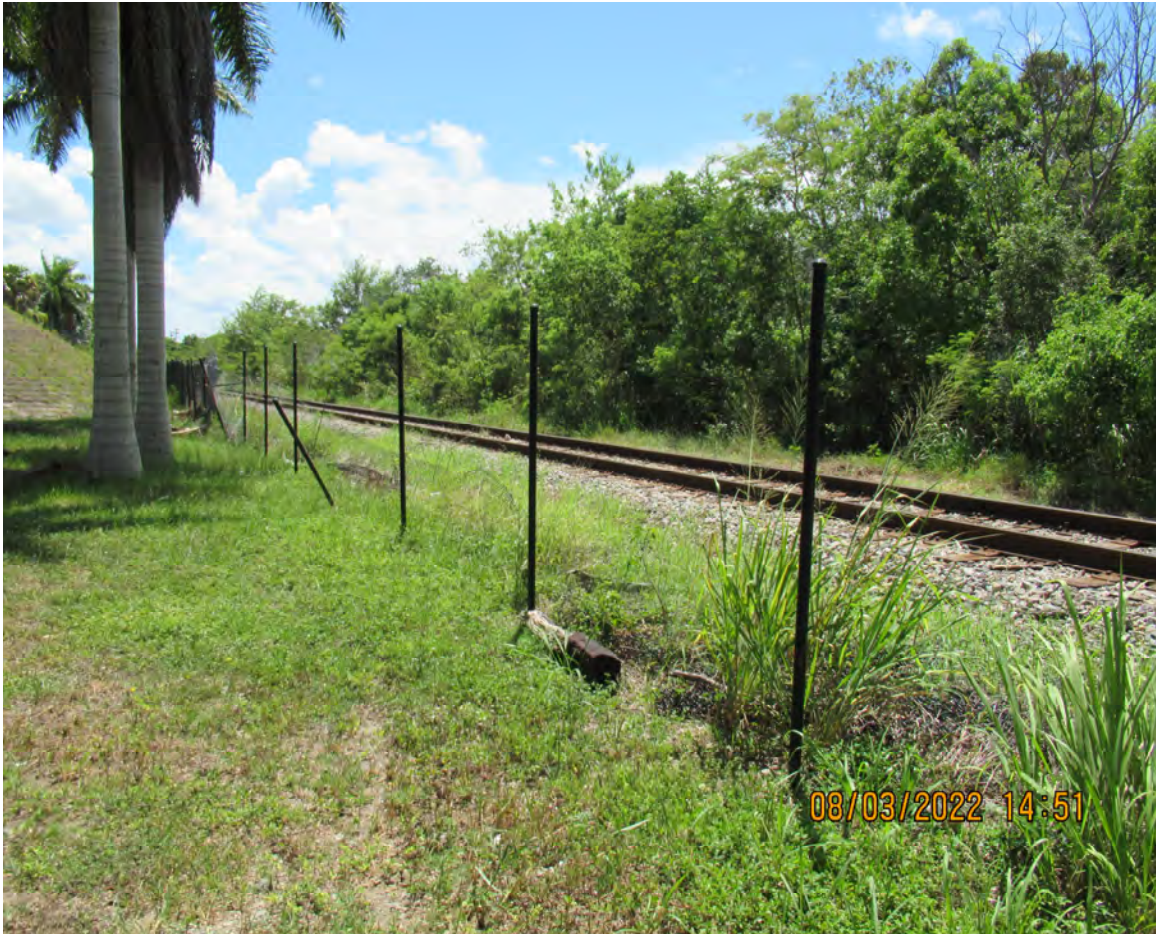
**PHOTO NO.: SB-018
DATE: 8-3-2022**

DAMAGED FENCE

ITEM NOTED TO BE ADDRESSED BY MDX MAINTENANCE

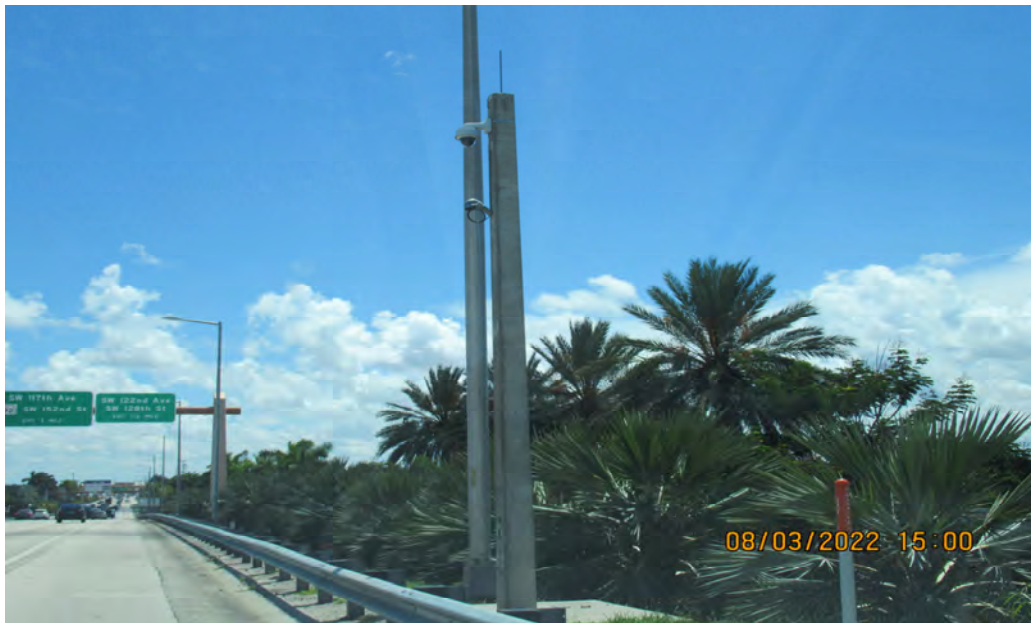
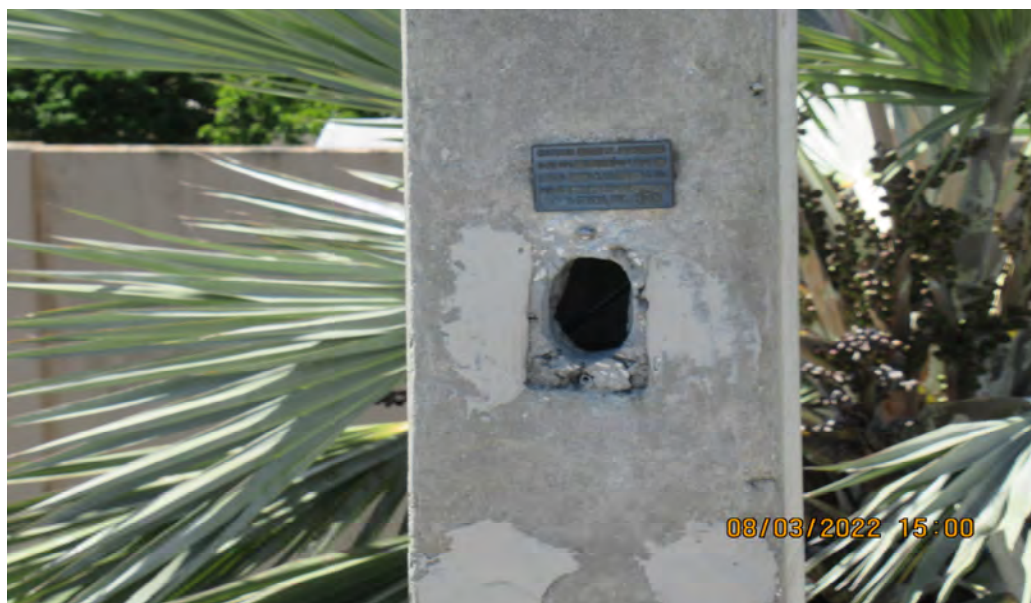
**PHOTO NO.: SB-020
DATE: 8-3-2022**

MISSING COVER PLATE

ITEM NOTED TO BE ADDRESSED BY MDX ITS

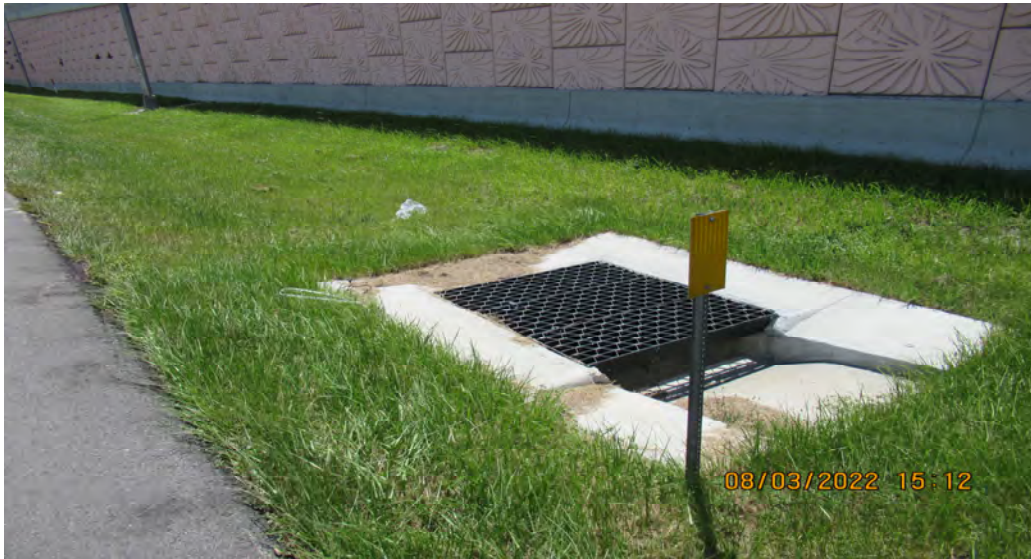
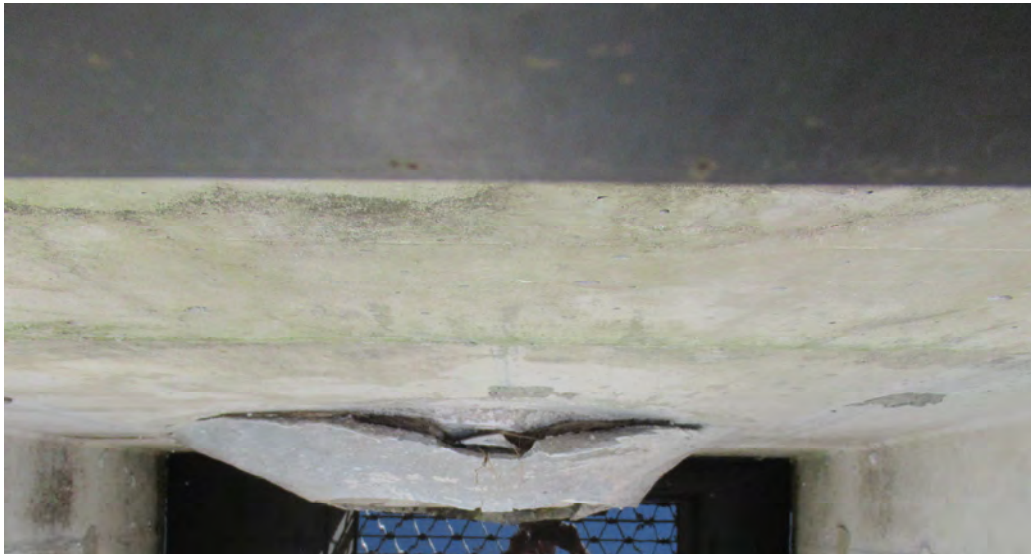
**PHOTO NO.: SB-021
DATE: 8-3-2022**

DETERIORATED PIPE SEAL

ITEM NOTED TO BE ADDRESSED BY MDX PROJECT 87410 WARRANTY

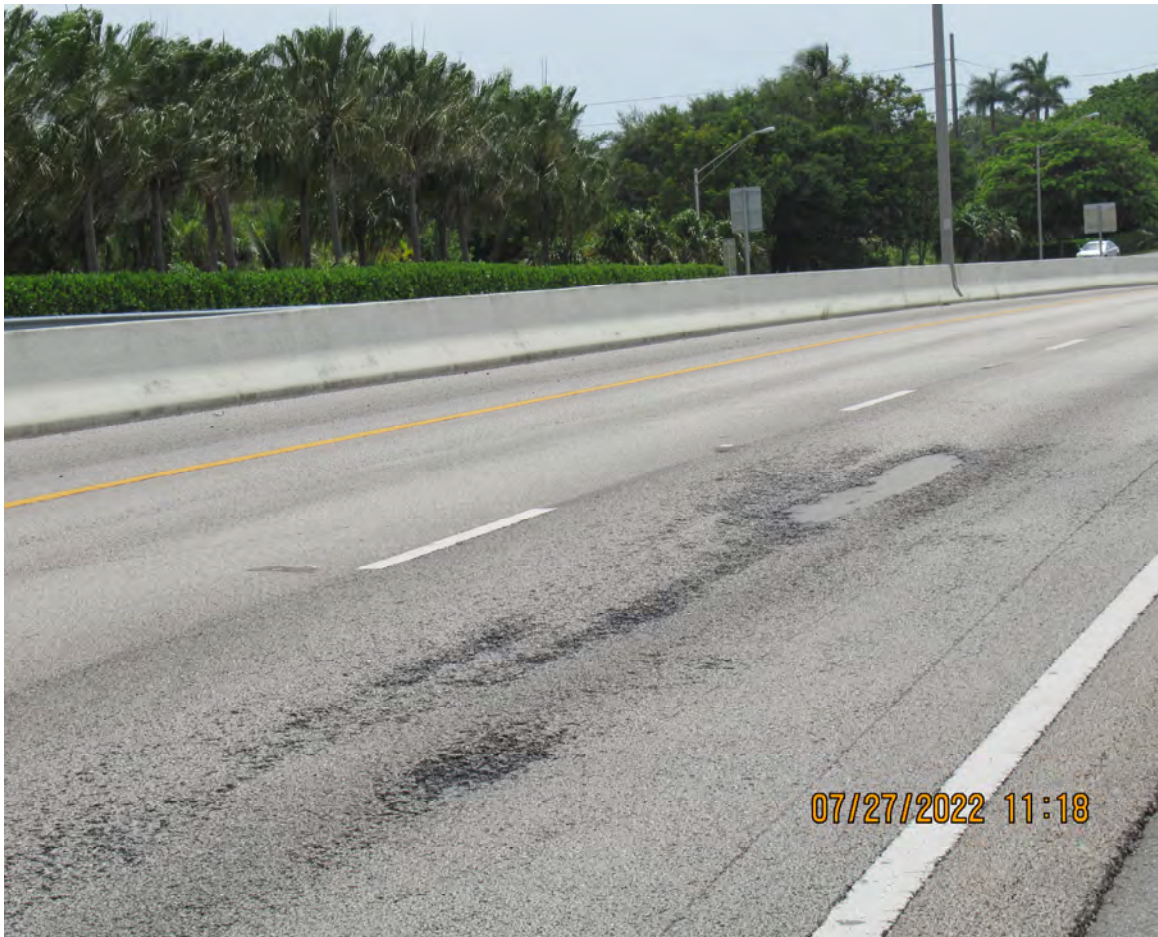
**PHOTO NO.: EB-003
DATE: 7-27-2022**

DETERIORATED PAVEMENT

ITEM NOTED TO BE ADDRESSED BY MDX WORK PROGRAM NO. 30044

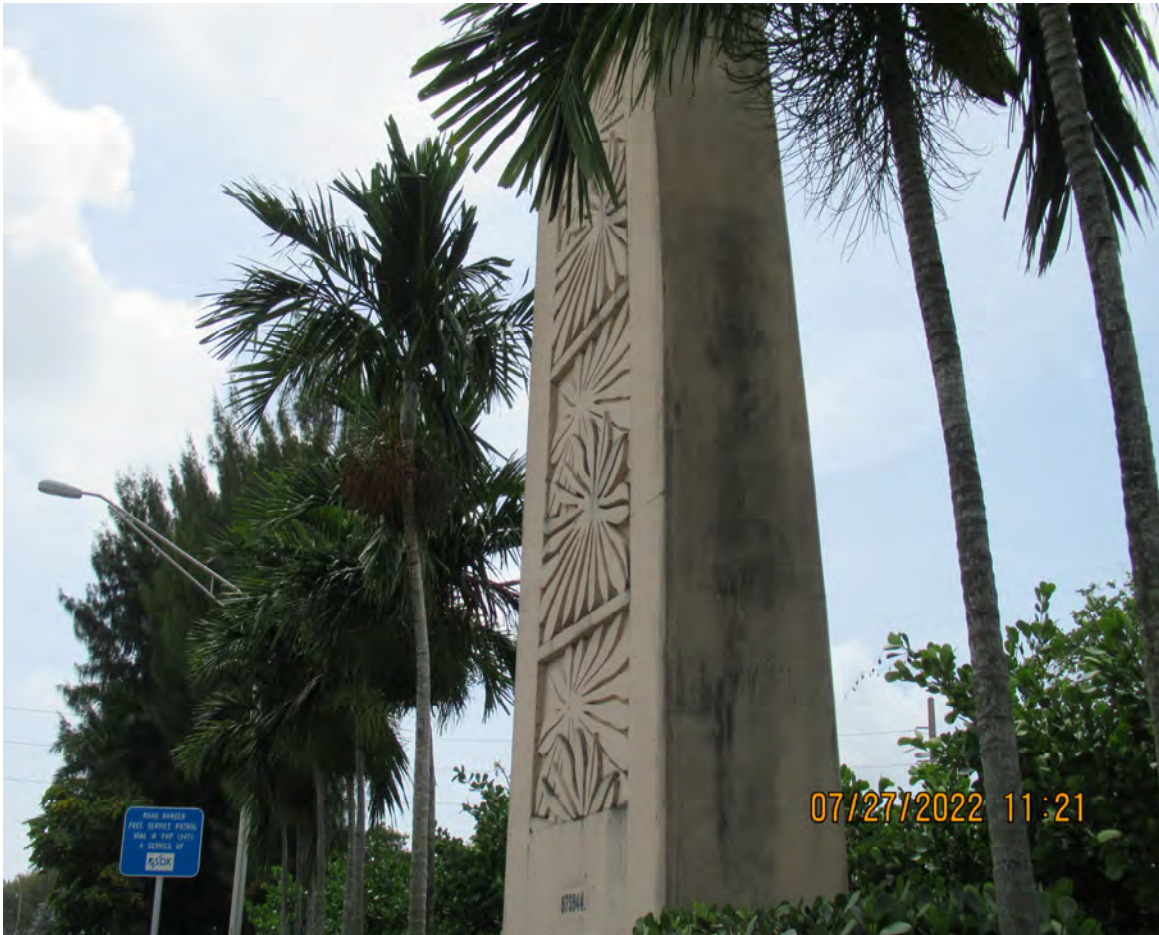
**PHOTO NO.: EB-005
DATE: 7-27-2022**

DETERIORATED CLASS V COATING ON STRUCTURE UPRIGHT

ITEM NOTED TO BE ADDRESSED BY MDX WORK PROGRAM 30037 & 30043

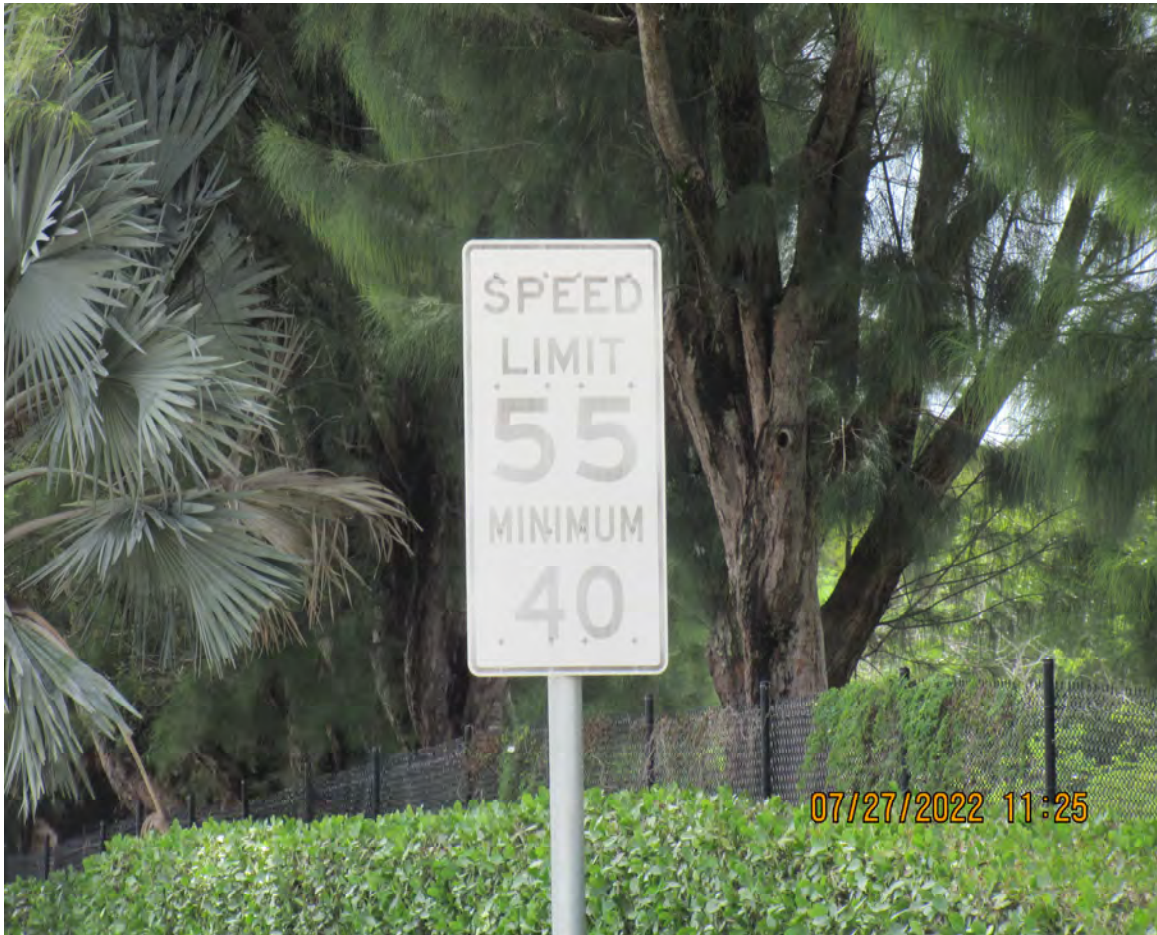
**PHOTO NO.: EB-006
DATE: 7-27-2022**

DETERIORATED REFLECTIVE SHEETING

ITEM NOTED TO BE ADDRESSED BY MDX MAINTENANCE

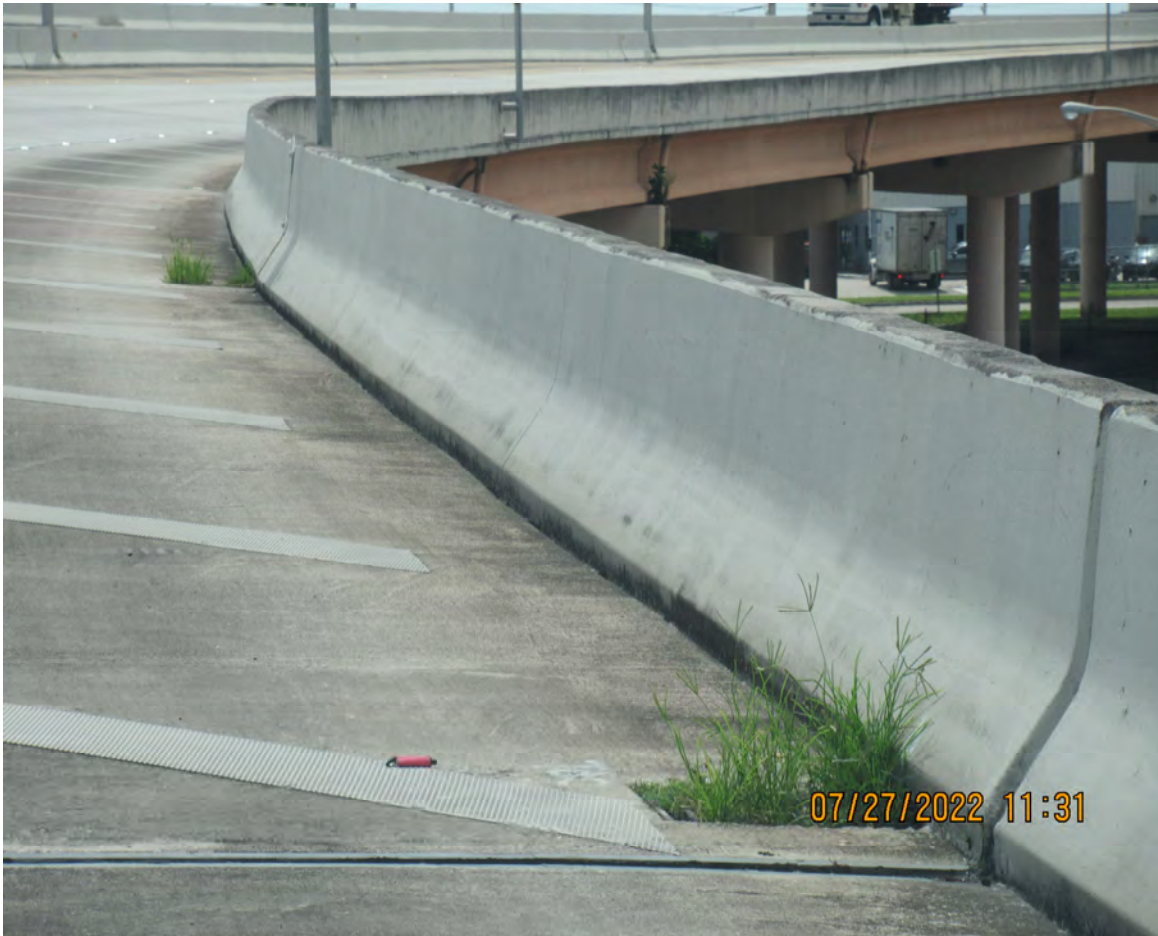
**PHOTO NO.: EB-007
DATE: 7-27-2022**

SILTED DECK DRAINS (TYPICAL AT VARIOUS LOCATIONS)

ITEM NOTED TO BE ADDRESSED BY MDX MAINTENANCE

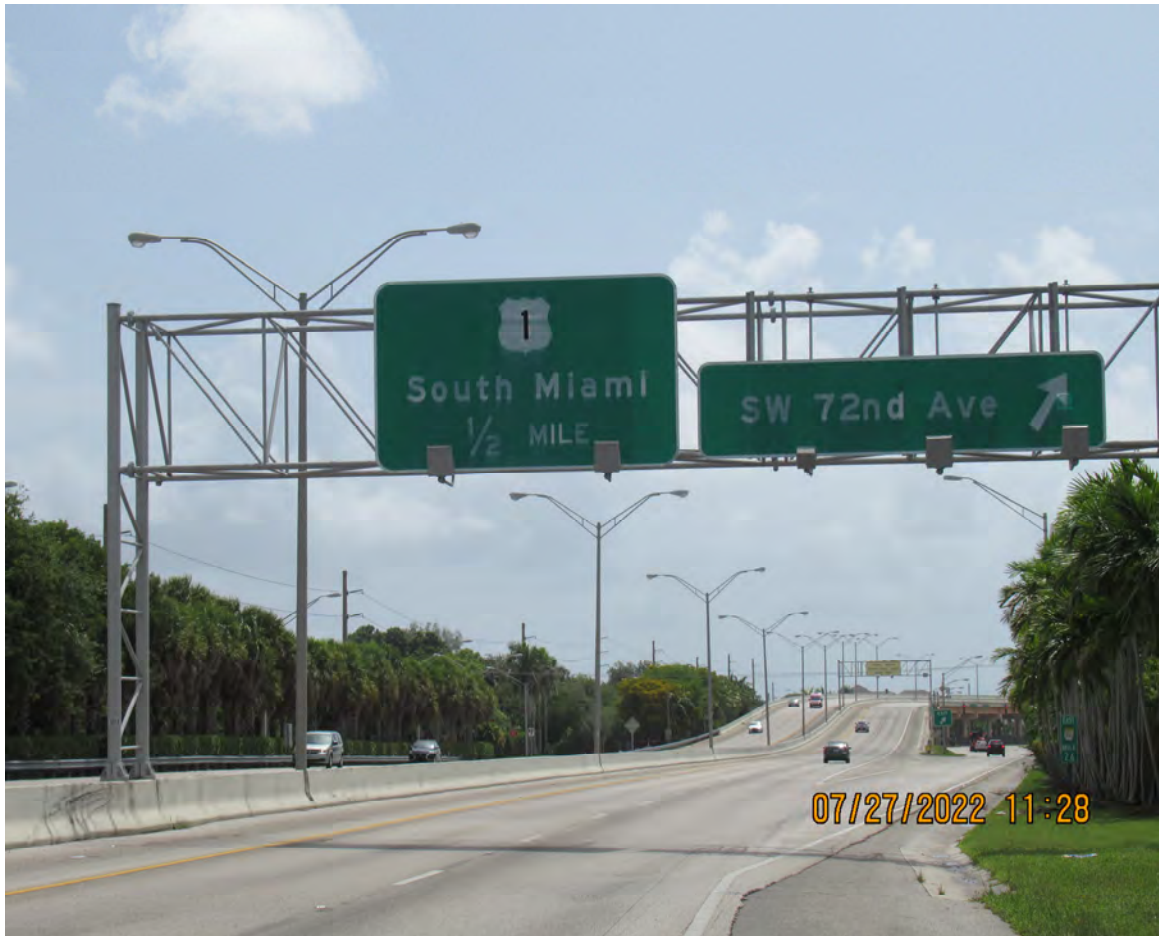
**PHOTO NO.: EB-008
DATE: 7-27-2022**

DETERIORATED REFLECTIVE SHEETING

ITEM NOTED TO BE ADDRESSED BY MDX WORK PROGRAM NO. 30058

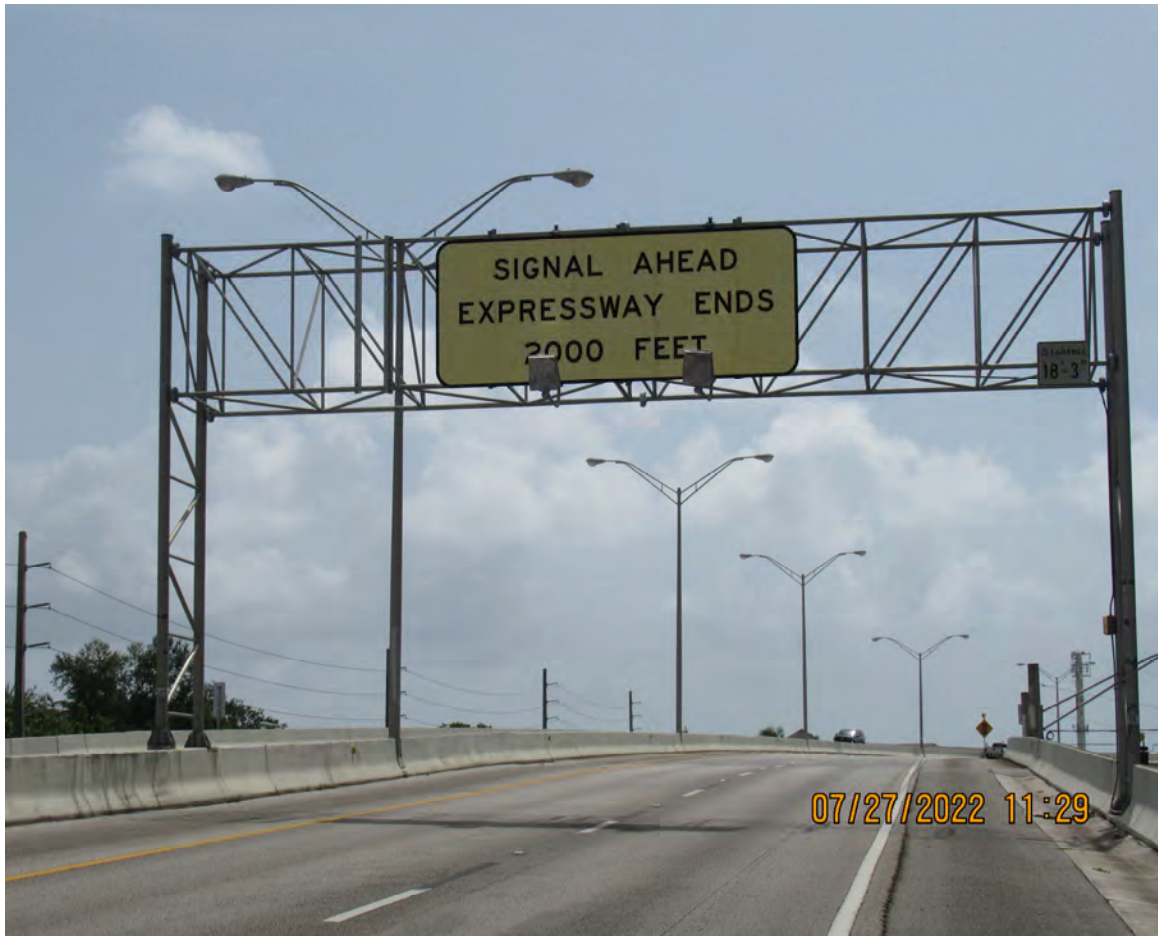
**PHOTO NO.: EB-009
DATE: 7-27-2022**

DETERIORATED REFLECTIVE SHEETING

ITEM NOTED TO BE ADDRESSED BY MDX WORK PROGRAM NO. 30058

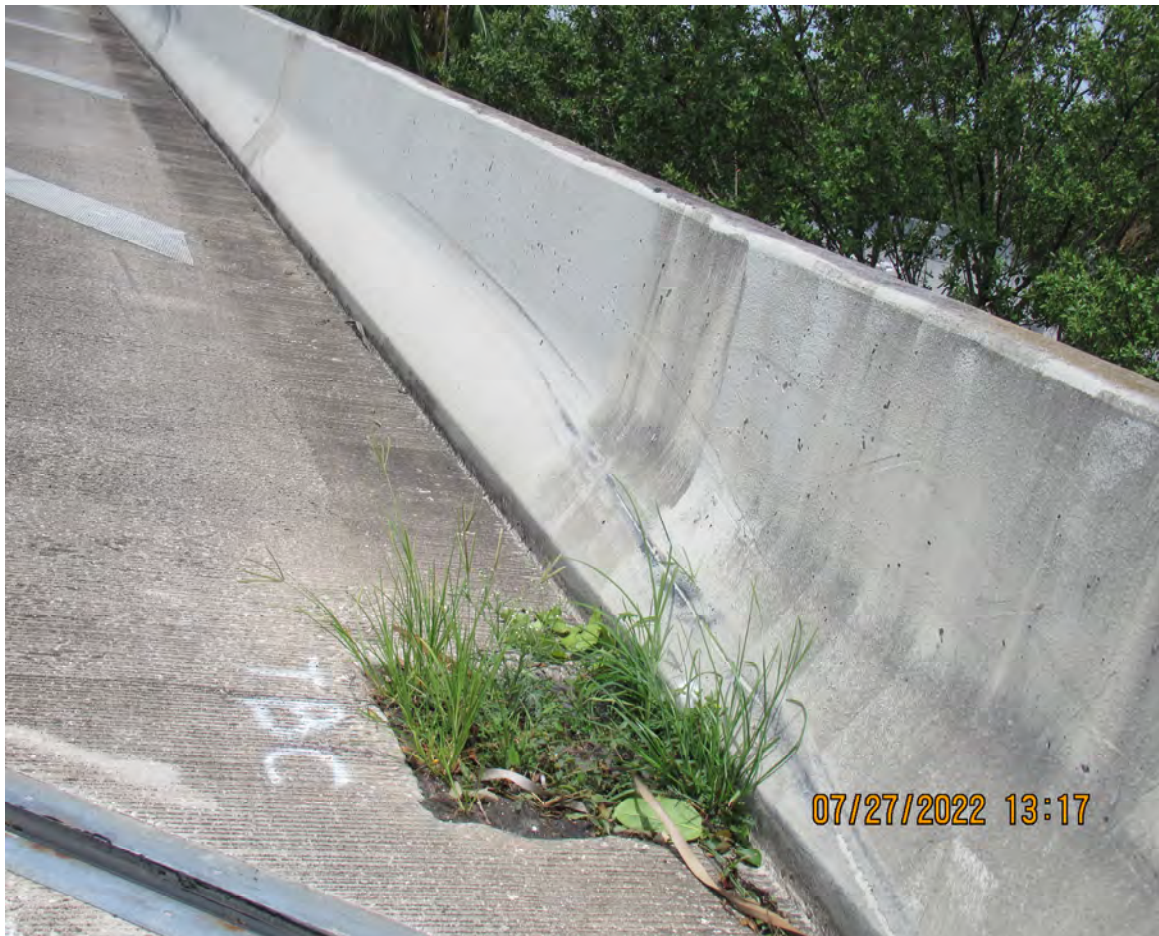
**PHOTO NO.: WB-002
DATE: 7-27-2022**

SILTED DECK DRAINS (TYPICAL AT VARIOUS LOCATIONS)

ITEM NOTED TO BE ADDRESSED BY MDX MAINTENANCE

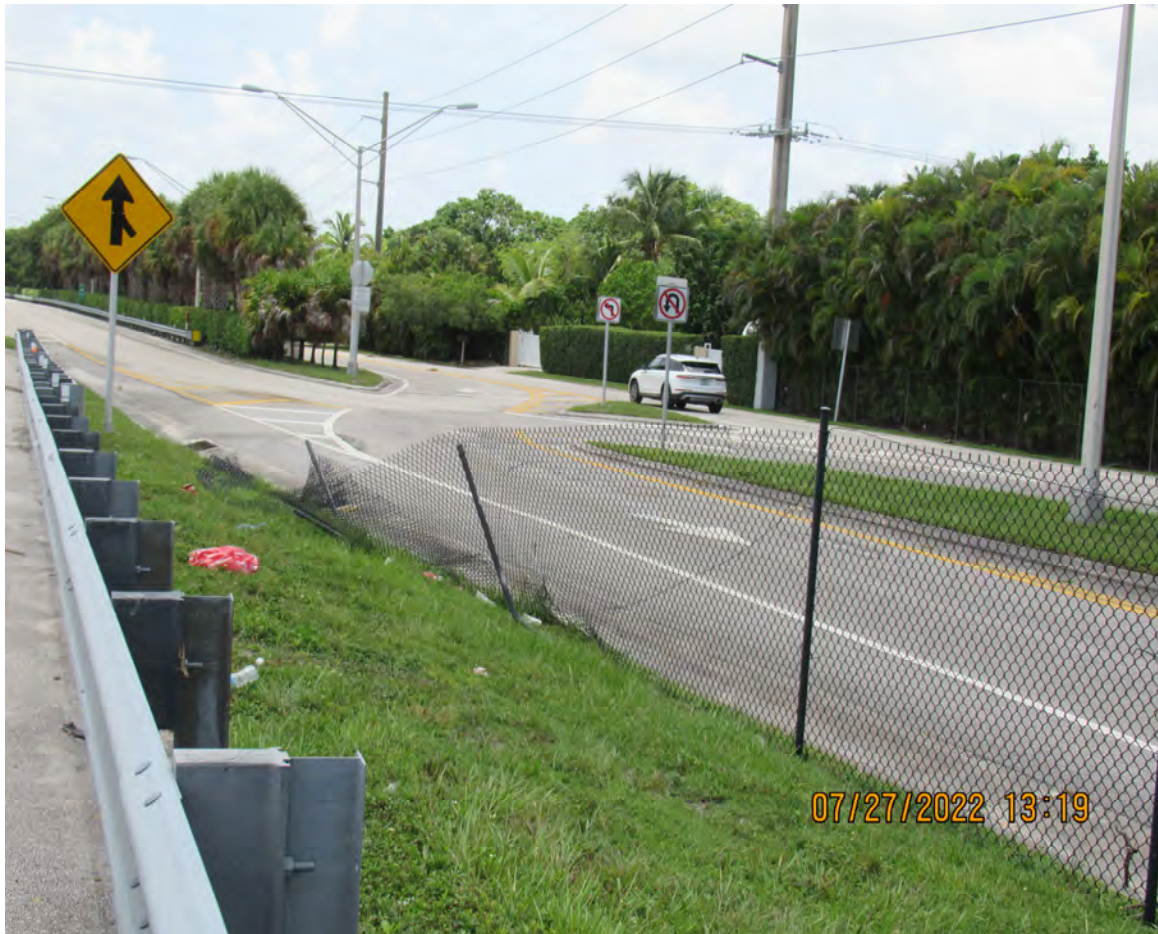
**PHOTO NO.: WB-003
DATE: 7-27-2022**

DAMAGED FENCE

ITEM NOTED TO BE ADDRESSED BY MDX MAINTENANCE

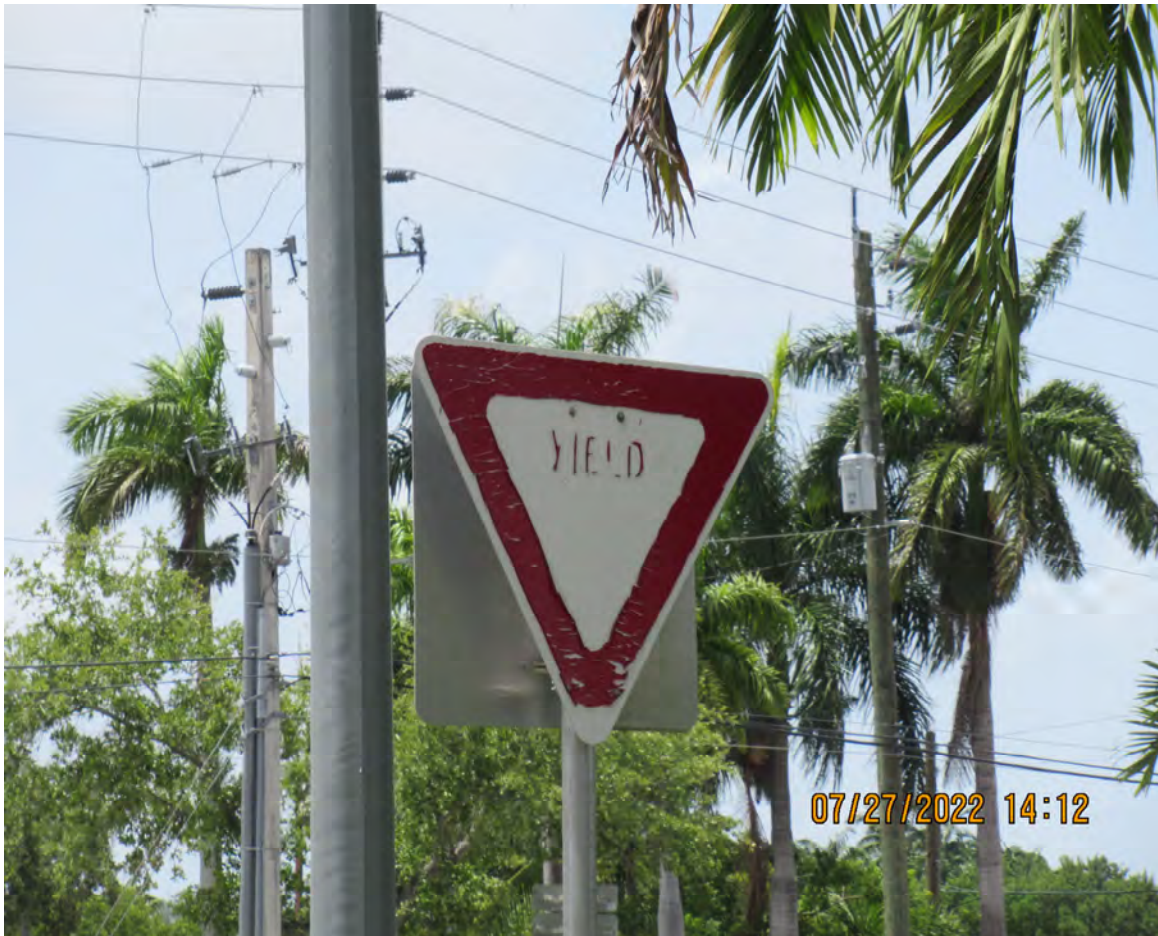
**PHOTO NO.: WB-005
DATE: 7-27-2022**

DETERIORATED REFLECTIVE SHEETING

ITEM NOTED TO BE ADDRESSED BY MDX MAINTENANCE

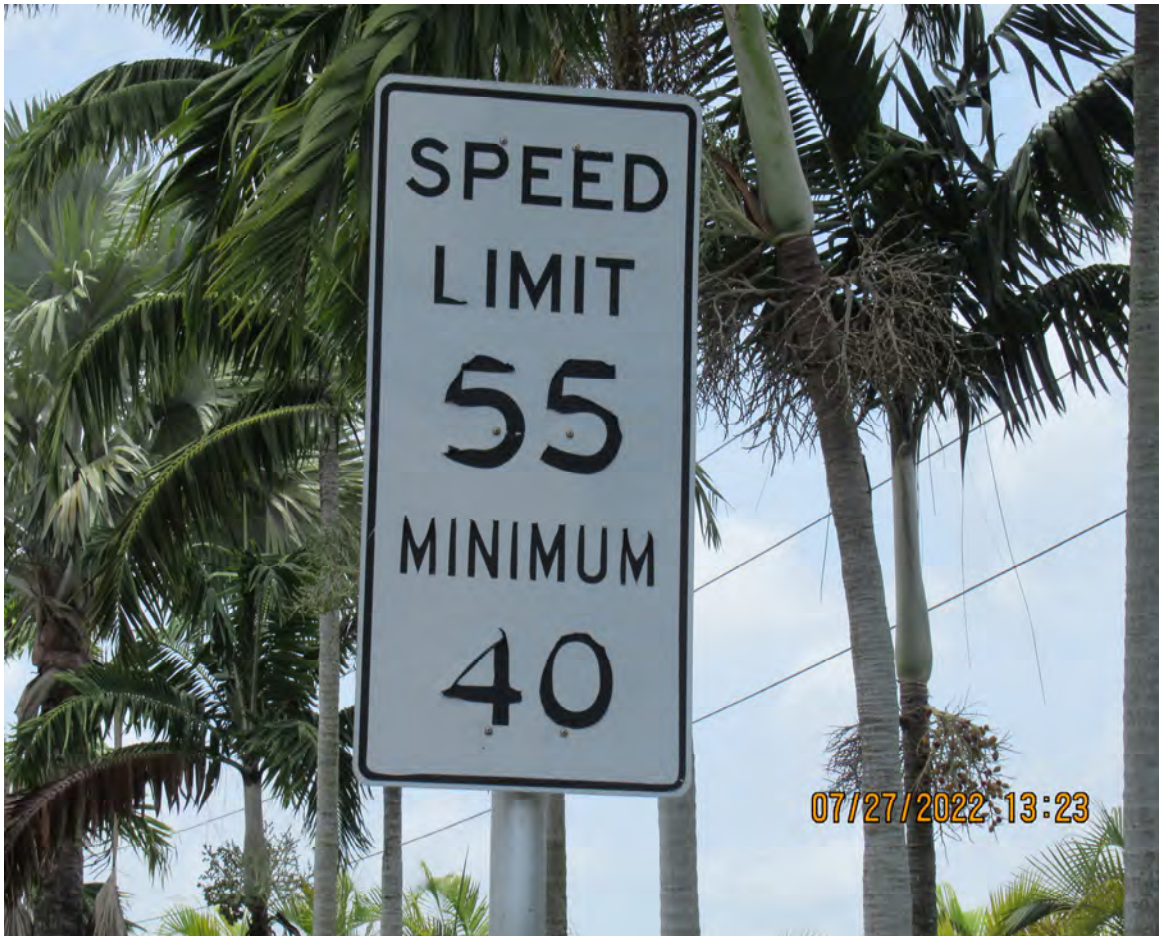
**PHOTO NO.: WB-006
DATE: 7-27-2022**

DETERIORATED REFLECTIVE SHEETING

ITEM NOTED TO BE ADDRESSED BY MDX MAINTENANCE

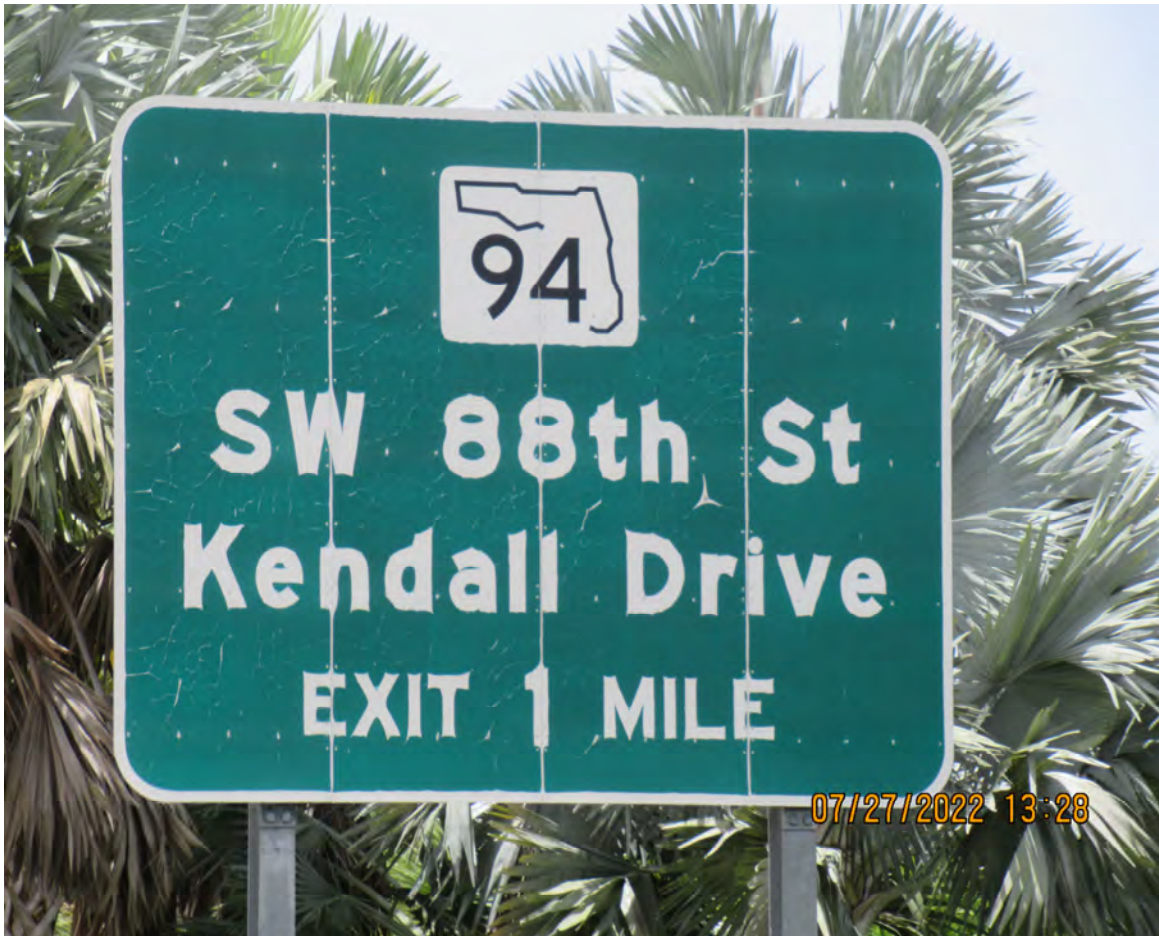
**PHOTO NO.: WB-007
DATE: 7-27-2022**

DETERIORATED REFLECTIVE SHEETING

ITEM NOTED TO BE ADDRESSED BY MDX WORK PROGRAM NO. 30058

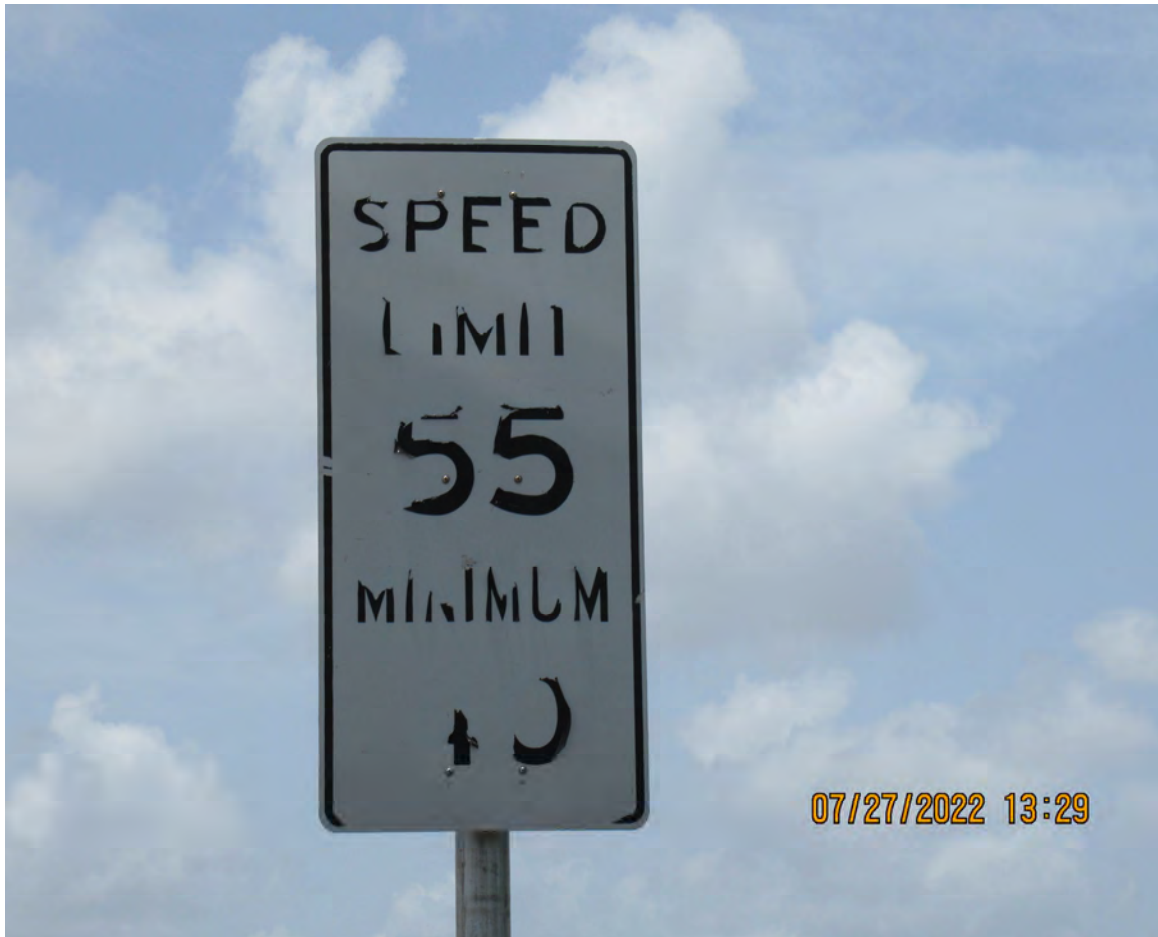
**PHOTO NO.: WB-009
DATE: 7-27-2022**

DETERIORATED REFLECTIVE SHEETING

ITEM NOTED TO BE ADDRESSED BY MDX MAINTENANCE

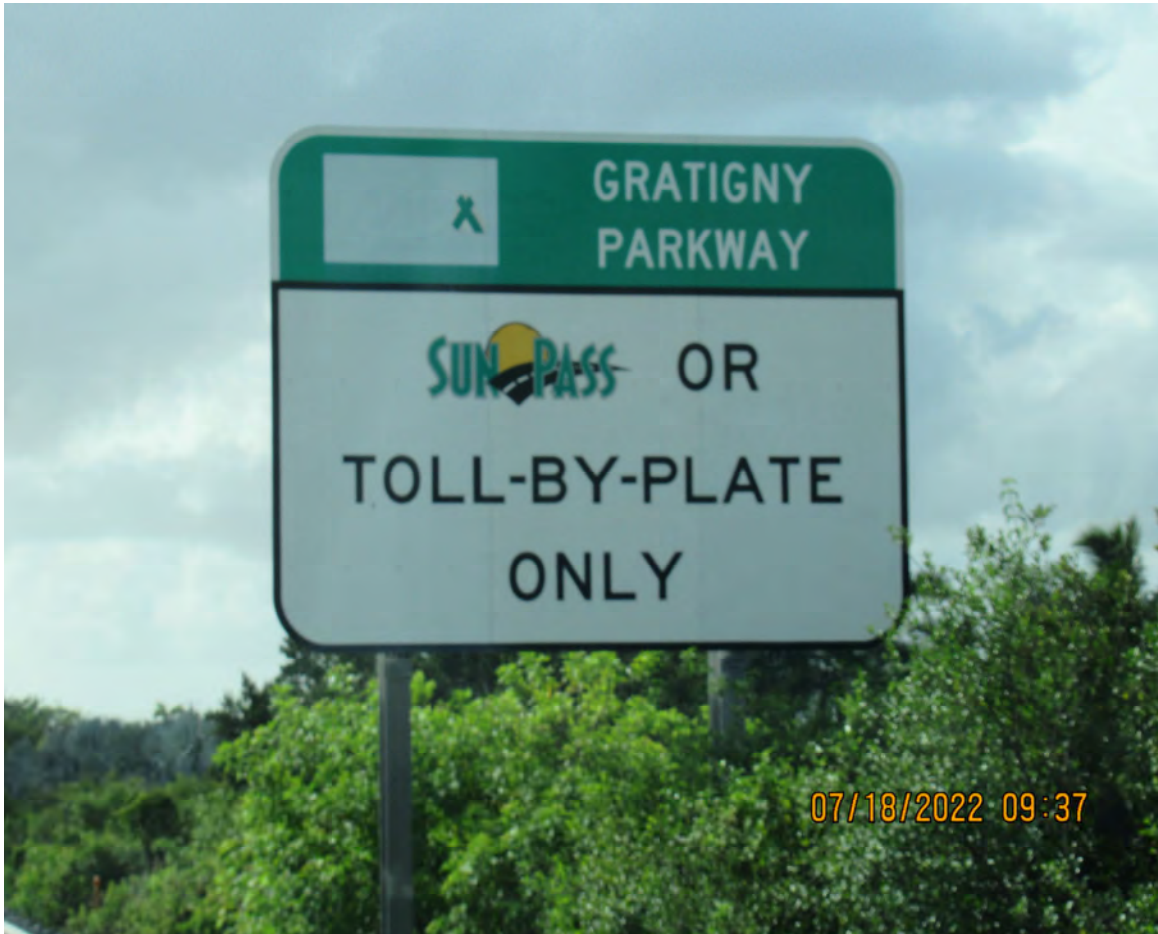
**PHOTO NO.: EB-001
DATE: 7-18-2022**

DETERIORATED MDX SYMBOL

ITEM NOTED TO BE ADDRESSED BY MDX MAINTENANCE

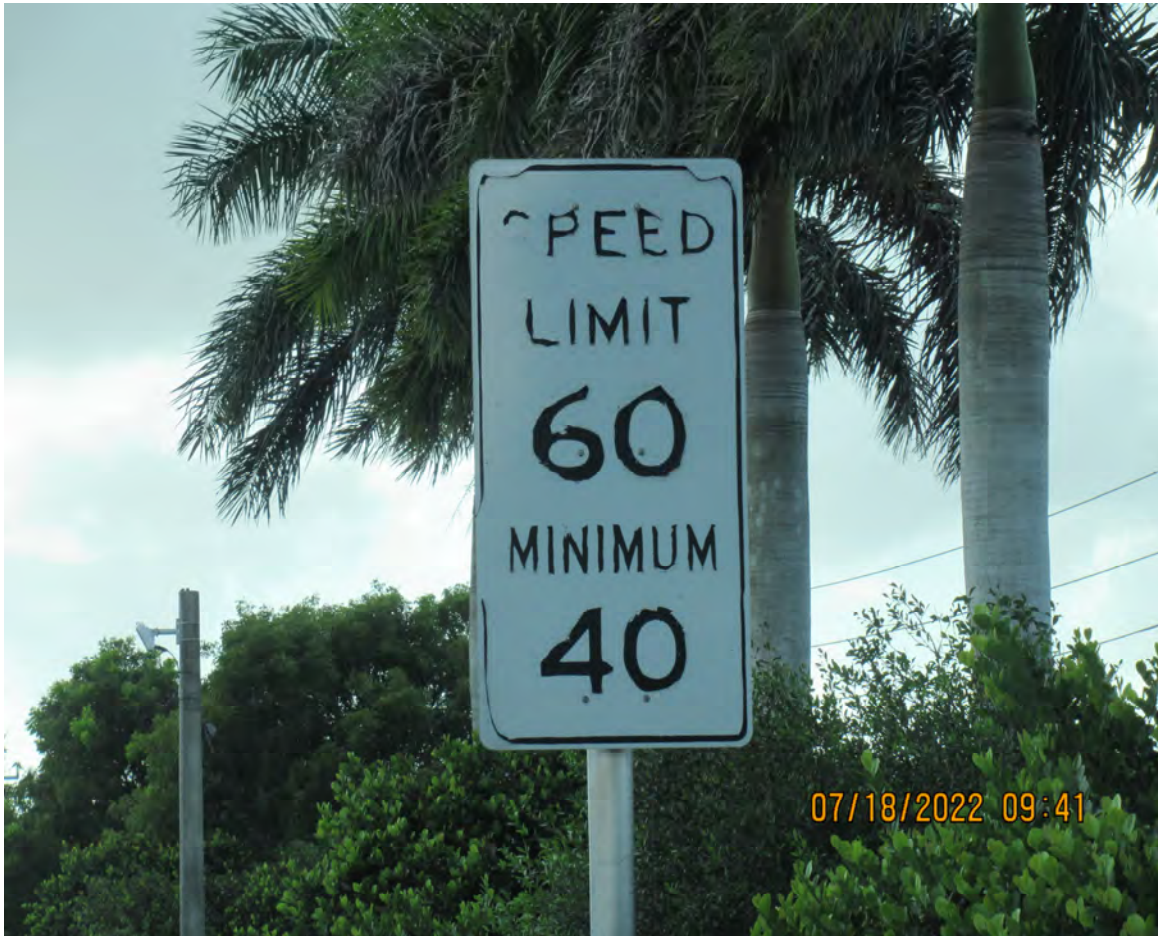
**PHOTO NO.: EB-003
DATE: 7-18-2022**

DETERIORATED SPEED LIMIT SIGN

ITEM NOTED TO BE ADDRESSED BY MDX MAINTENANCE

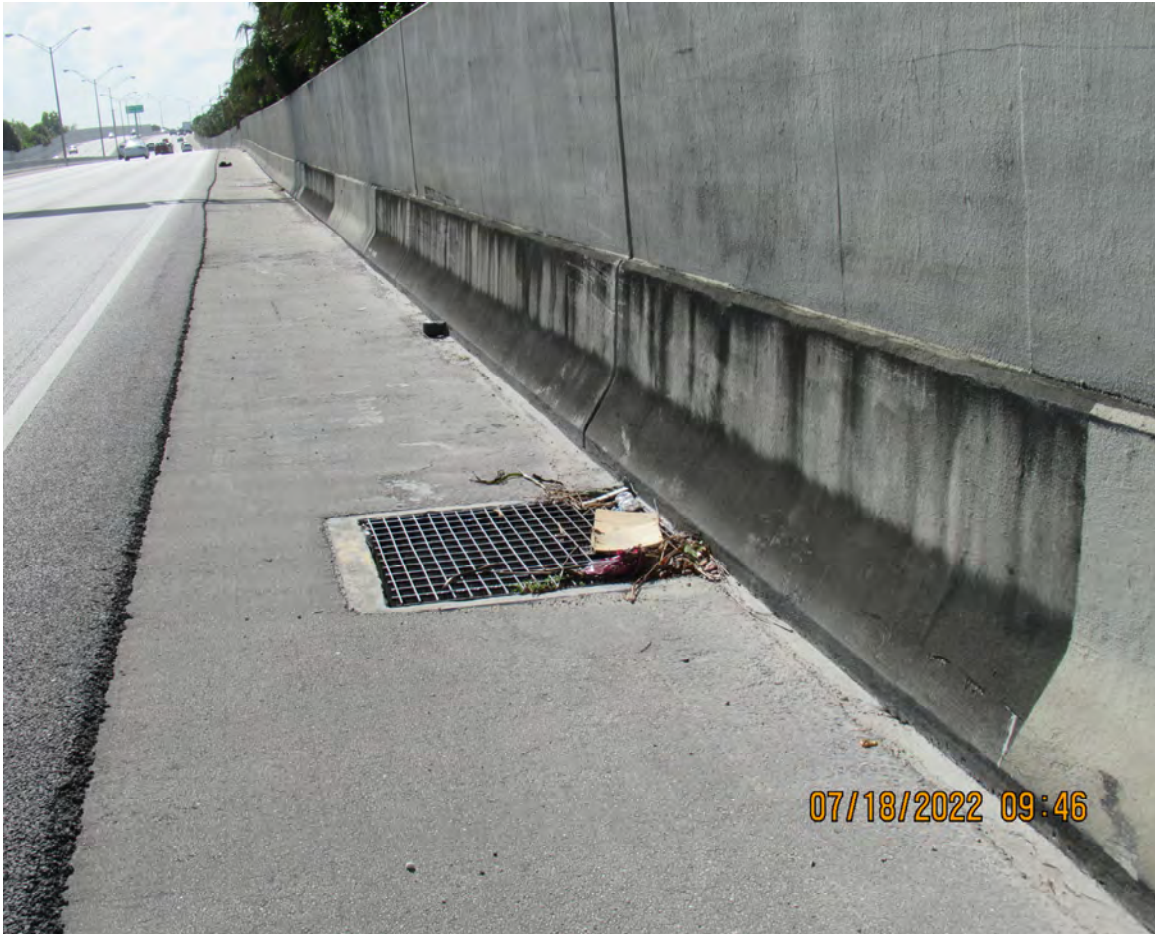
**PHOTO NO.: EB-004
DATE: 7-18-2022**

**DETERIORATED CLASS V COATING ON BARRIER & SOUND WALL
(TYPICAL THROUGHOUT THE CORRIDOR)**

ITEM NOTED TO BE ADDRESSED BY MDX WORK PROGRAM No. 30029
