ANNUAL INSPECTION REPORT 2022

ANNUAL INSPECTION REPORT

In 1996, the Miami-Dade County Expressway Authority (MDX) acquired operational and financial control of five expressways in Miami-Dade County from the Florida Department of Transportation (FDOT). This group of expressways, toll facilities and the MDX headquarters facility, all as described below, are hereinafter referred to as the “MDX System”. In accordance with the Trust Indenture requirements, MDX retained EAC Consulting, Inc. (EAC), as the General Engineering Consultant to perform, among other duties assigned by the Authority, the yearly inspection of the MDX System. This report represents the annual inspection results for Fiscal Year (FY) 2022.

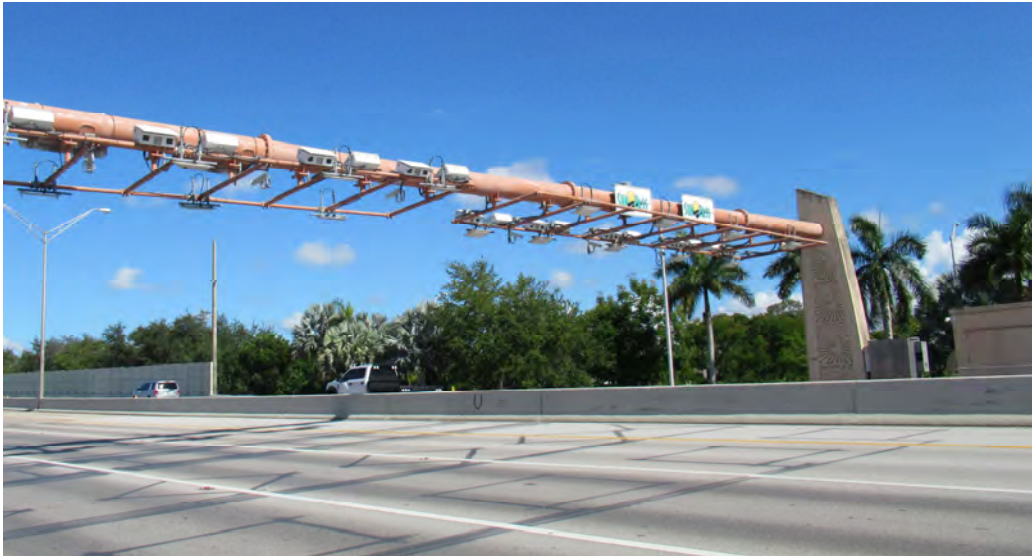
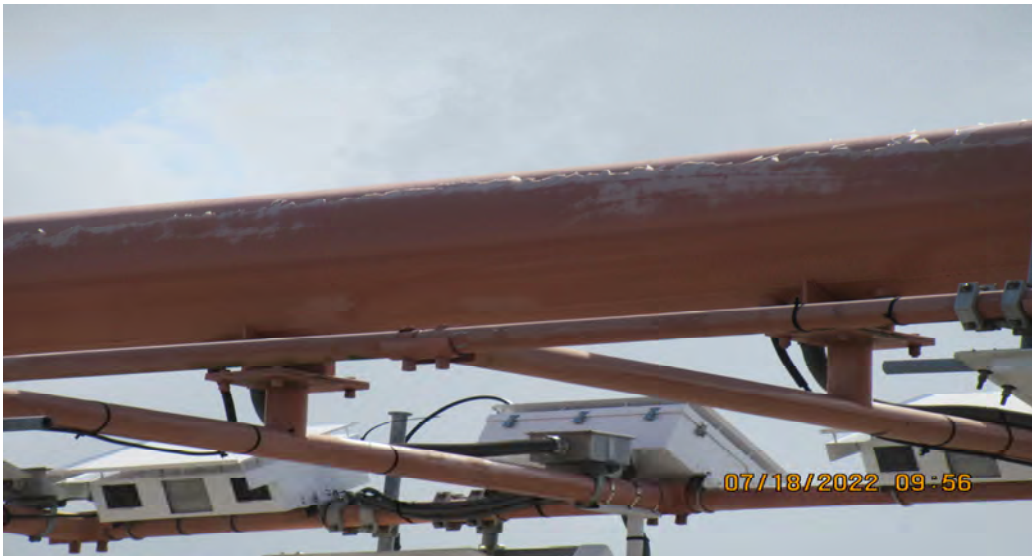
**PHOTO NO.: EB-005
DATE: 7-18-2022**

**DETERIORATED CLASS V COATING ON STRUCTURE UPRIGHT AND PAINT ON
MONOTUBE (STRUCTURE # 87S933)**

ITEM NOTED TO BE ADDRESSED BY MDX WORK PROGRAM NO. 30037 & 30043

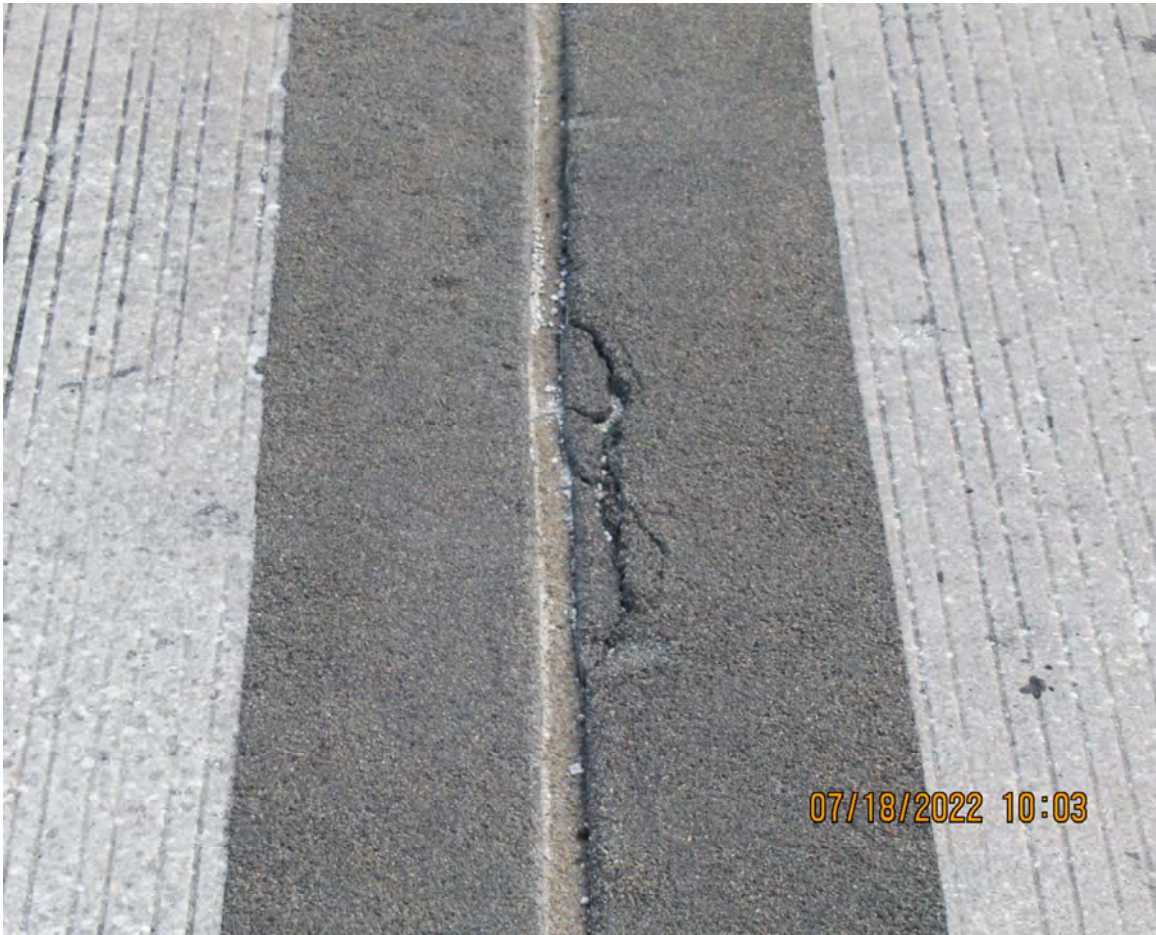
**PHOTO NO.: EB-006
DATE: 7-18-2022**

DETERIORATED EXPANSION JOINT HEADER (BRIDGE # 870720)

ITEM NOTED TO BE ADDRESSED BY MDX WORK PROGRAM No. 30029

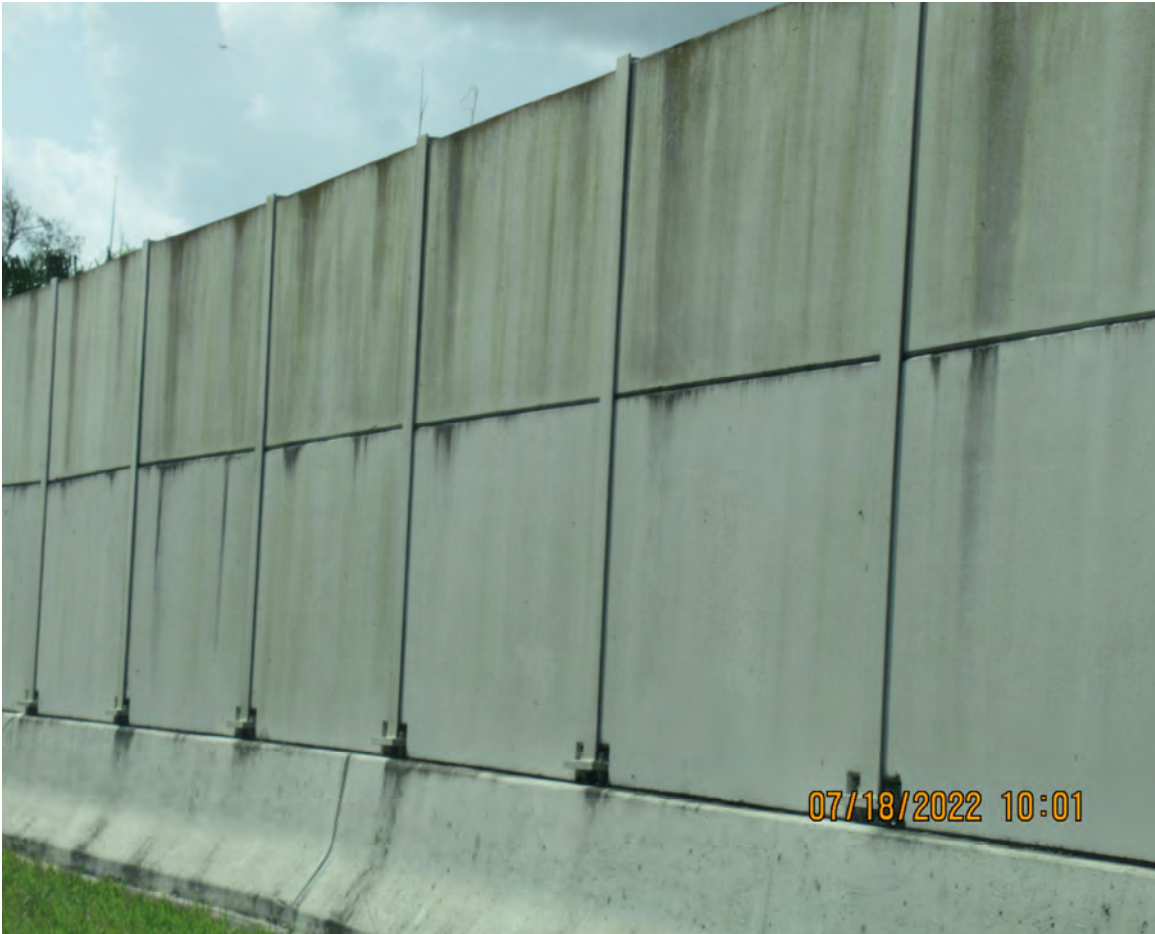
**PHOTO NO.: EB-007
DATE: 7-18-2022**

**DETERIORATED CLASS V COATING ON SOUND WALLS
(TYPICAL THROUGHOUT THE CORRIDOR)**

ITEM NOTED TO BE ADDRESSED BY MDX WORK PROGRAM No. 30037

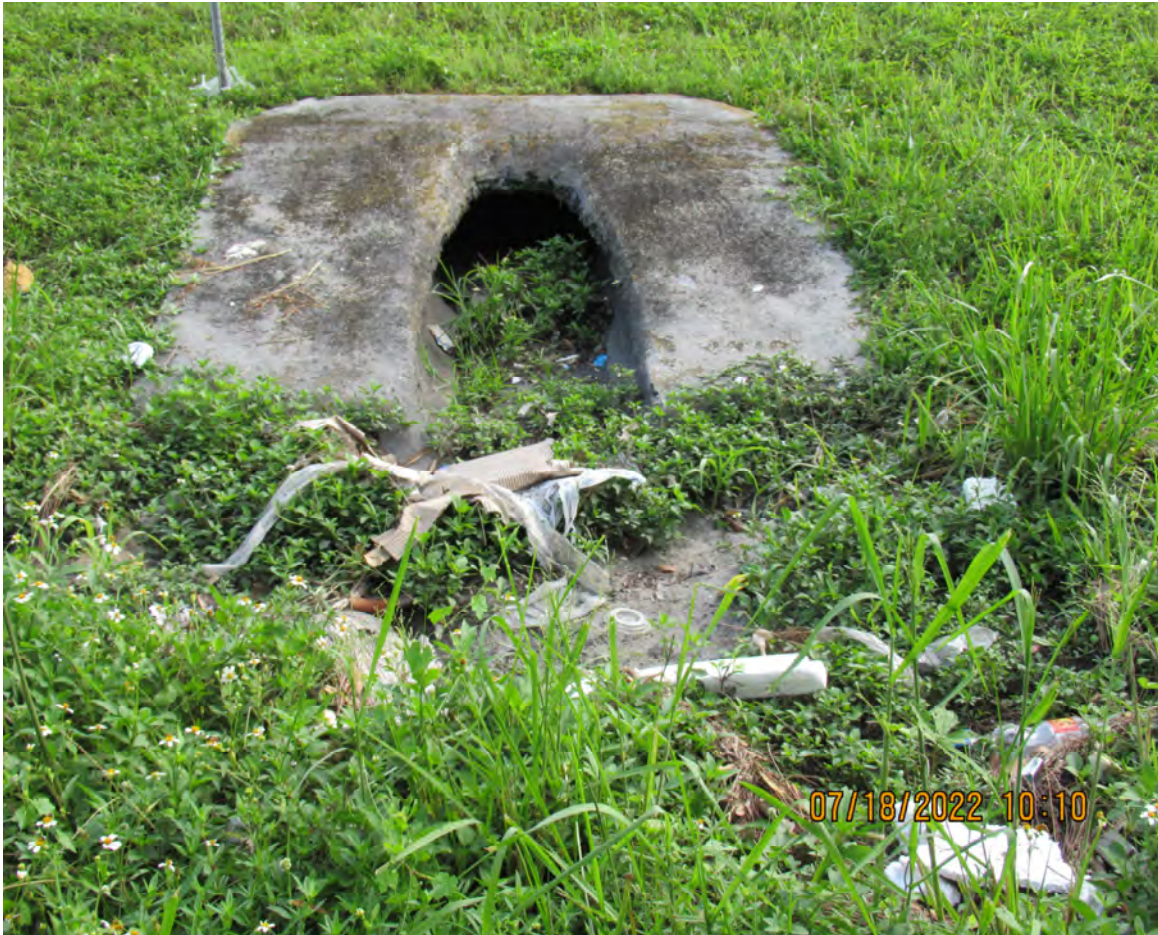
**PHOTO NO.: EB-009
DATE: 7-18-2022**

**SEDIMENT AND VEGETATION ON END WALL OBSTRUCTING WATER FLOW
(TYPICAL THROUGHOUT THE CORRIDOR)**

ITEM NOTED TO BE ADDRESSED BY MDX MAINTENANCE

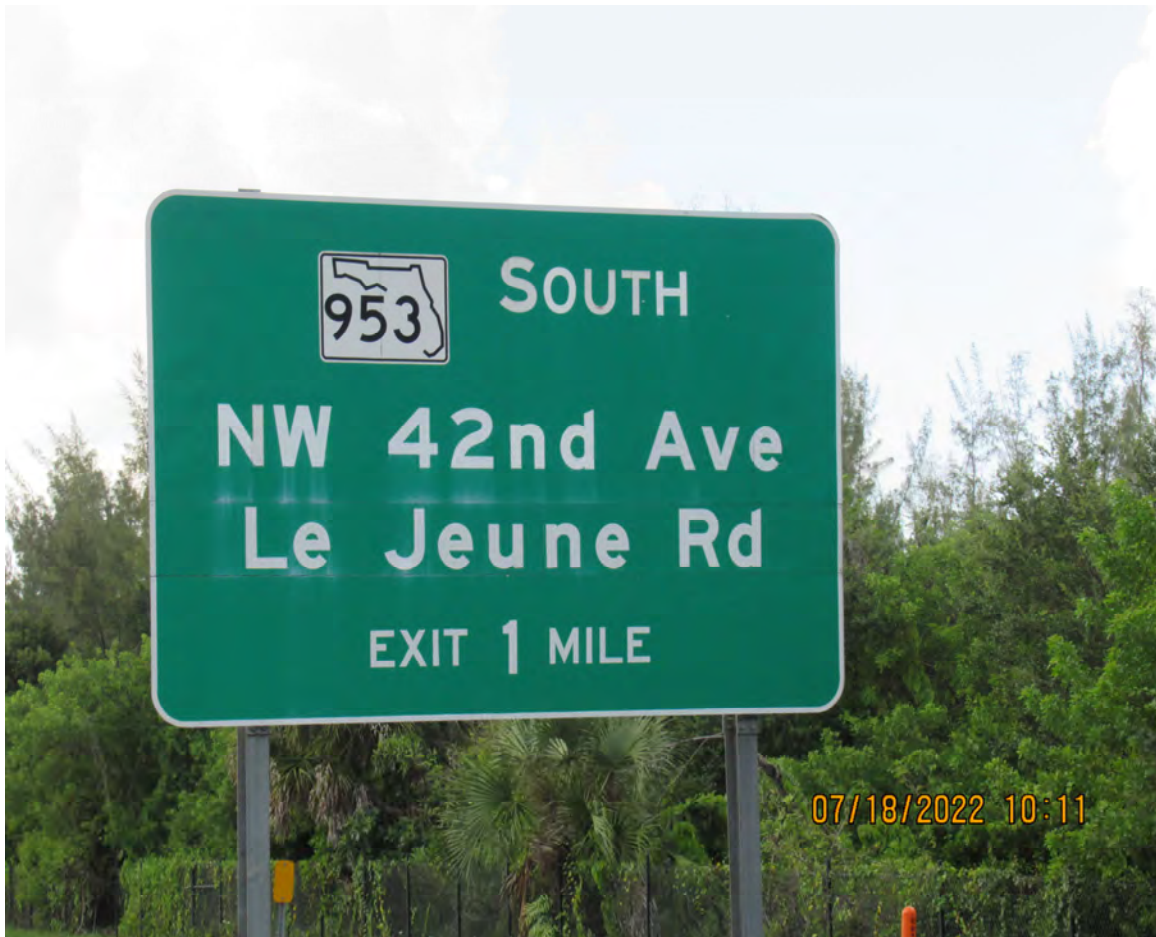
**PHOTO NO.: EB-010
DATE: 7-18-2022**

DETERIORATED REFLECTIVE SHEETING ON SIGN PANEL

ITEM NOTED TO BE ADDRESSED BY MDX WORK PROGRAM NO. 30058

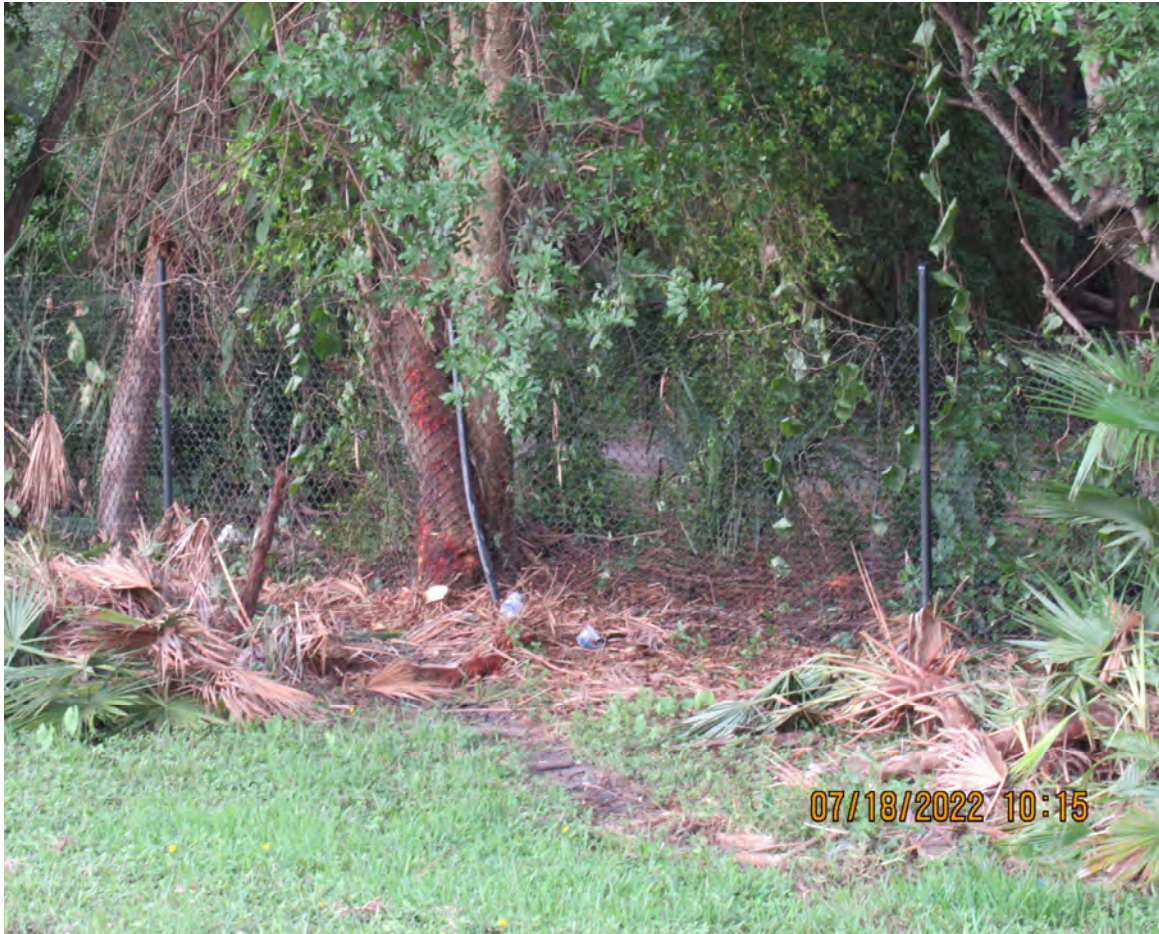
**PHOTO NO.: EB-011
DATE: 7-18-2022**

DAMAGED FENCE

ITEM NOTED TO BE ADDRESSED BY MDX MAINTENANCE

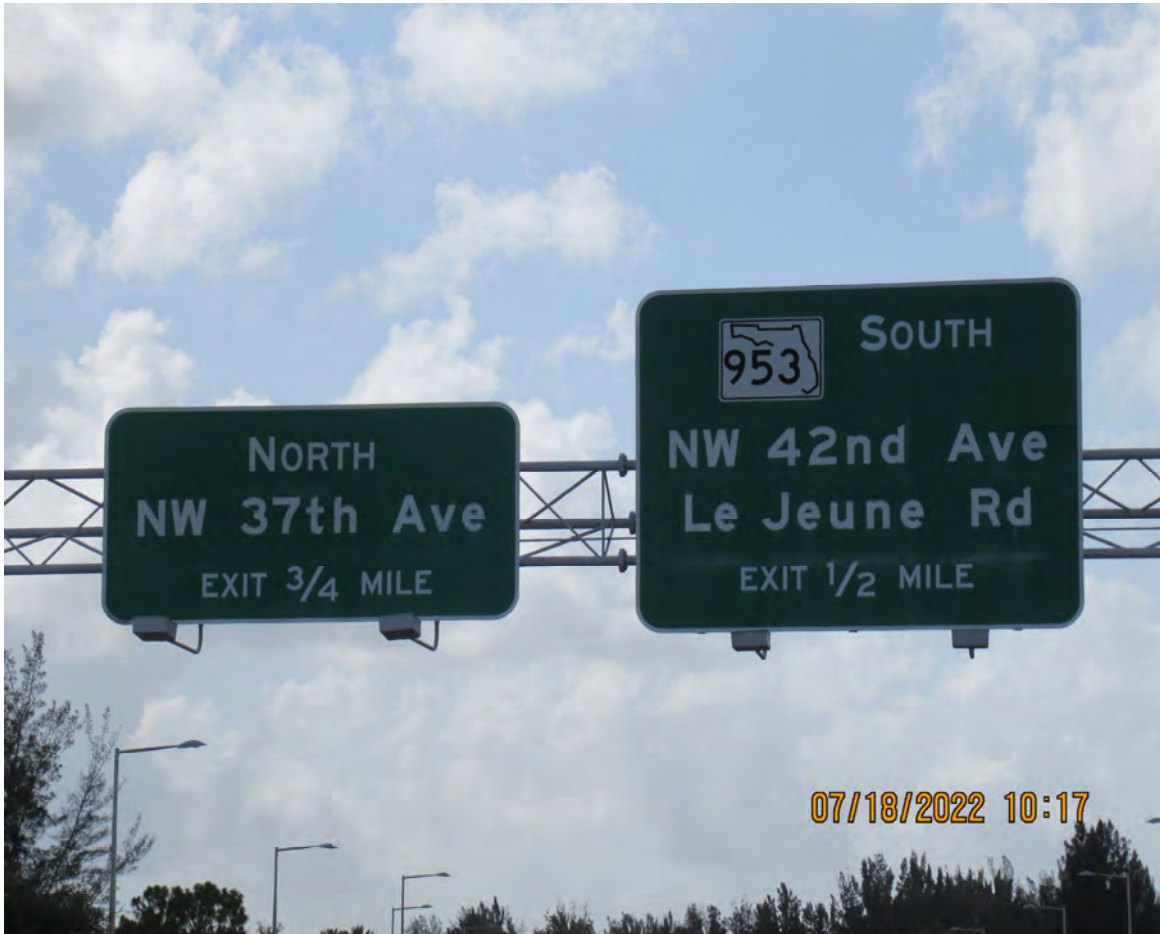
**PHOTO NO.: EB-012
DATE: 7-18-2022**

**DETERIORATED REFLECTIVE SHEETING ON SIGN PANEL
(STRUCTURE 87S524)**

ITEM NOTED TO BE ADDRESSED BY MDX WORK PROGRAM NO. 30058

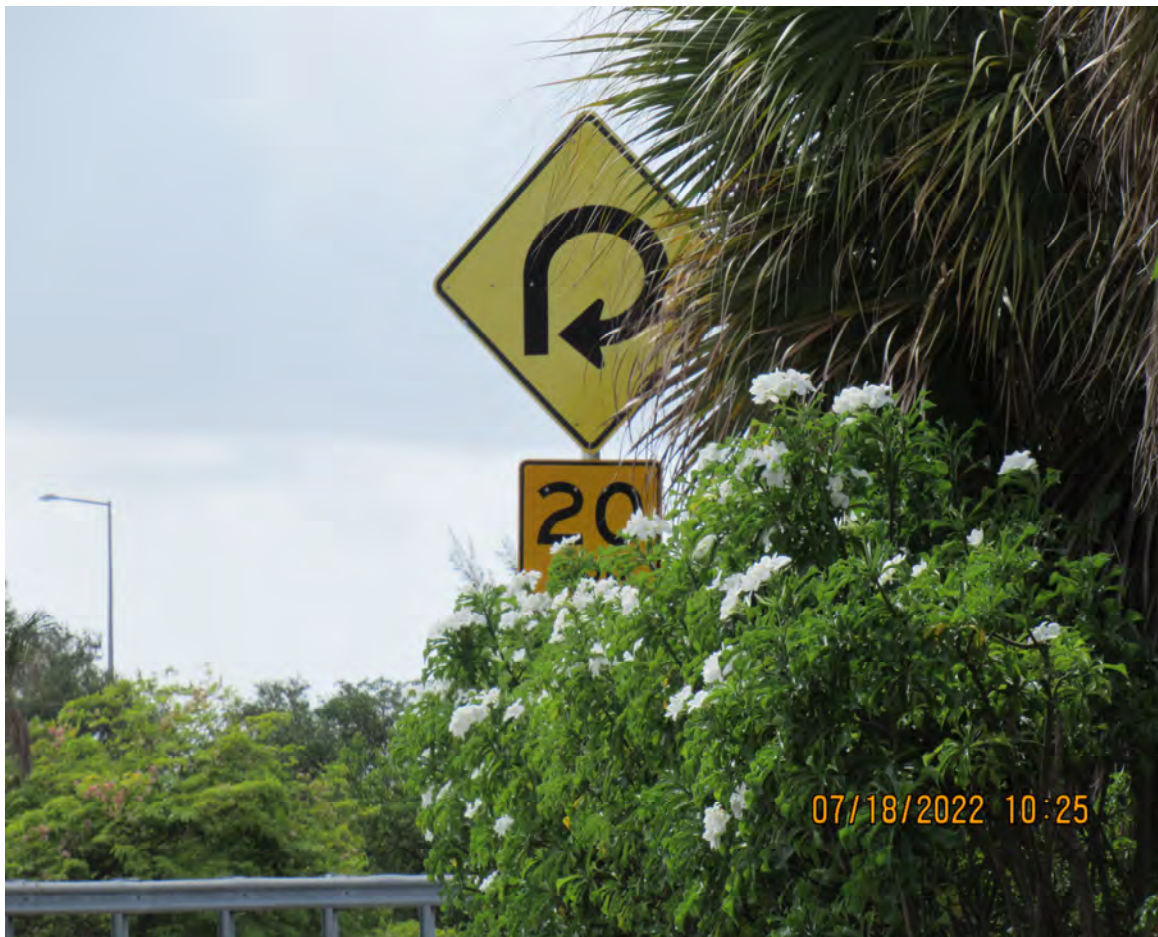
**PHOTO NO.: EB-013
DATE: 7-18-2022**

OVERGROWN VEGETATION OBSTRUCTING SIGN

ITEM NOTED TO BE ADDRESSED BY MDX MAINTENANCE

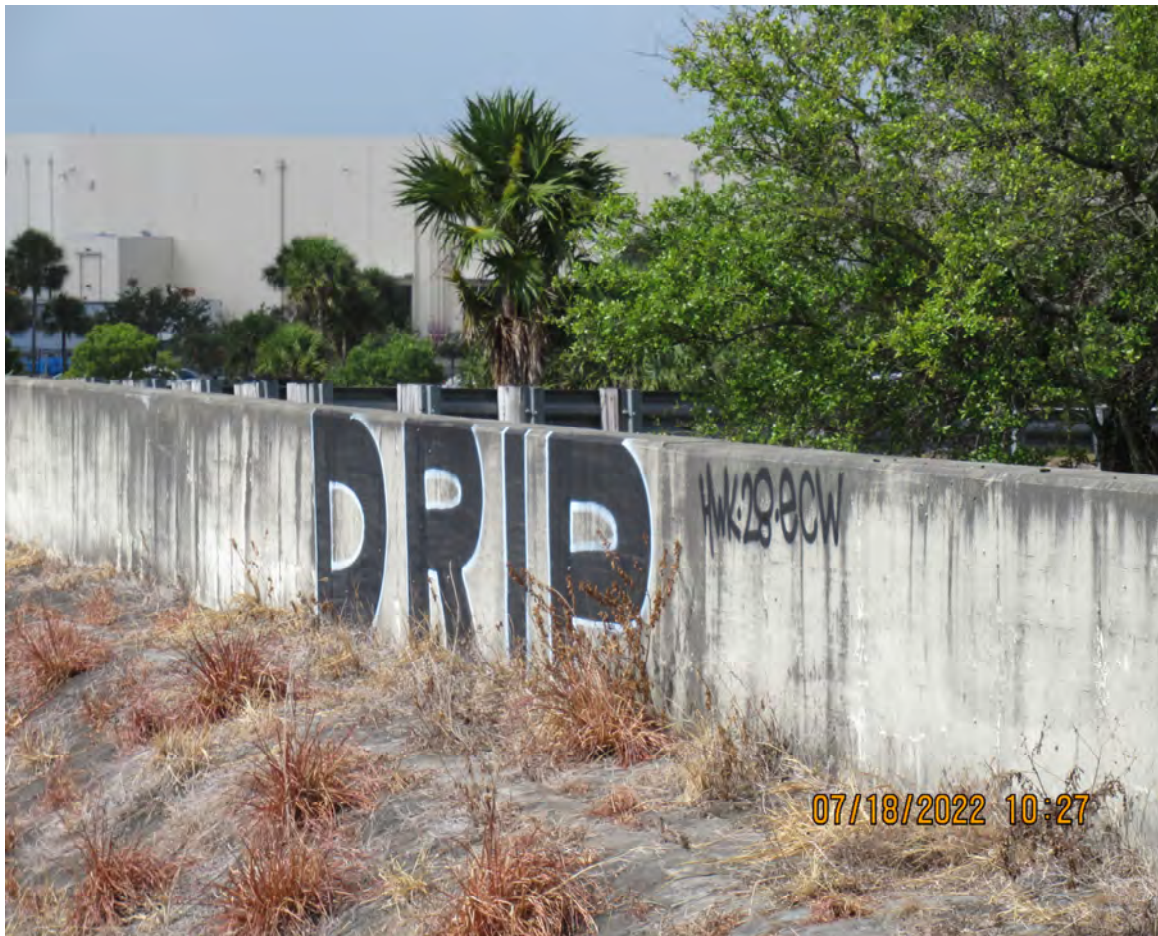
**PHOTO NO.: EB-014
DATE: 7-18-2022**

**GRAFFITI ON RETAINING WALL
(BRIDGE # 870740)**

ITEM NOTED TO BE ADDRESSED BY MDX MAINTENANCE

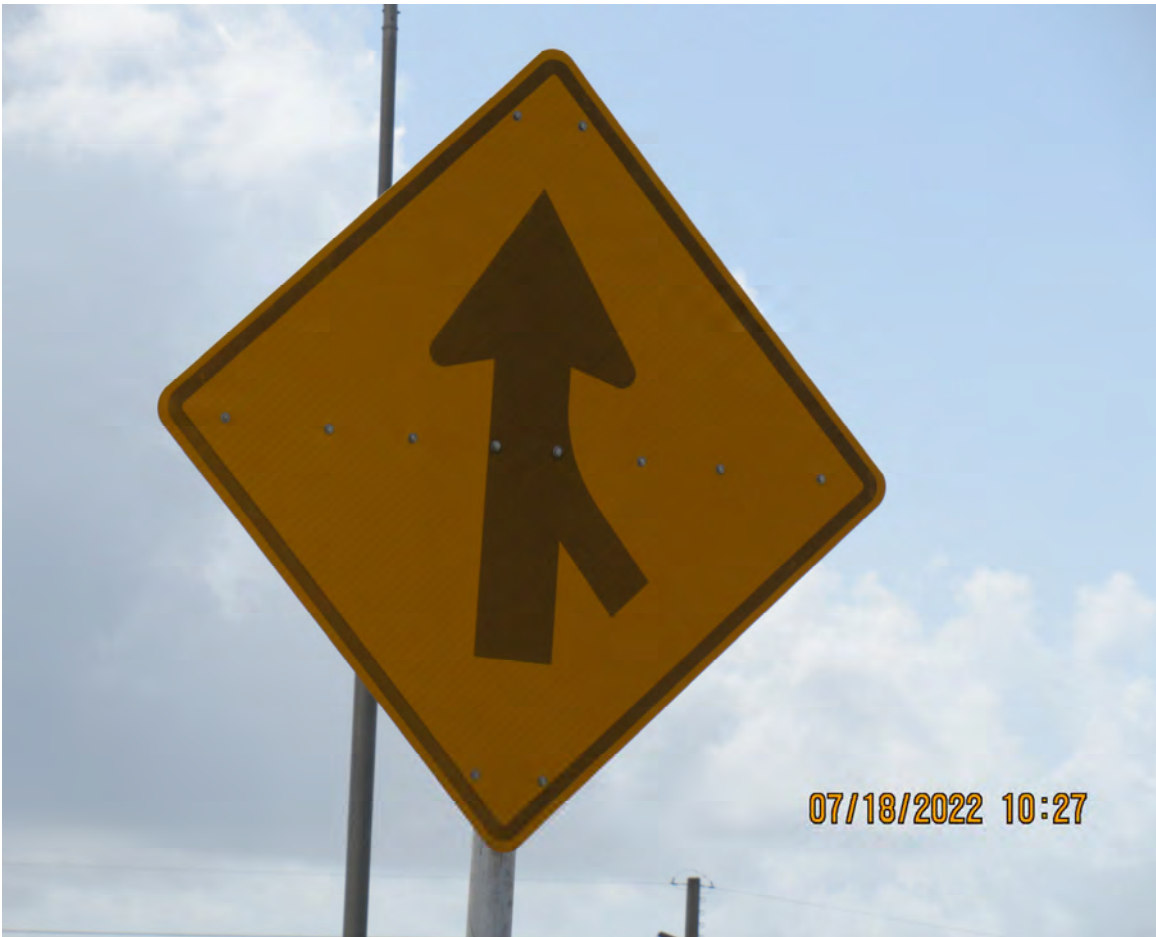
**PHOTO NO.: EB-015
DATE: 7-18-2022**

DETERIORATED REFLECTIVE SHEETING

ITEM NOTED TO BE ADDRESSED BY MDX MAINTENANCE

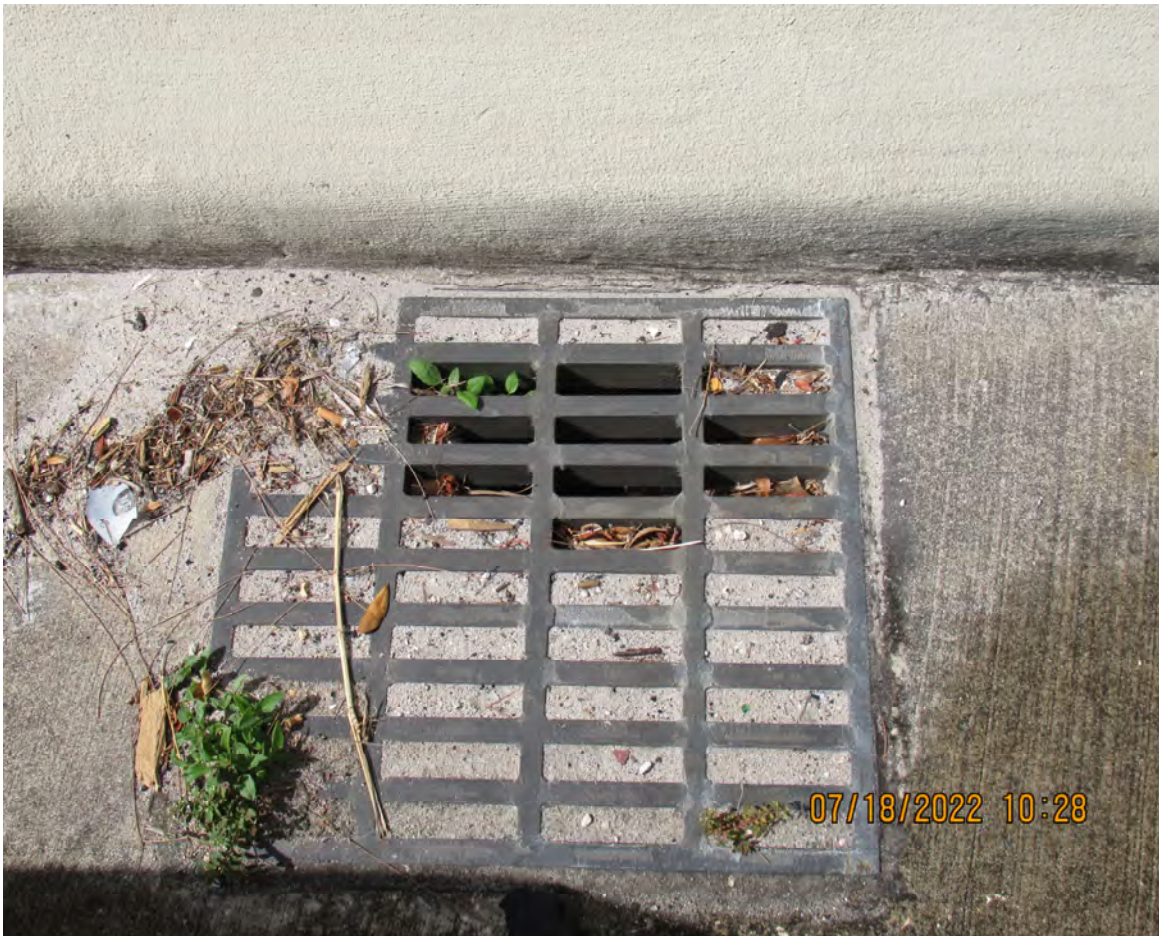
**PHOTO NO.: EB-016
DATE: 7-18-2022**

SILTED BRIDGE DECK DRAIN

ITEM NOTED TO BE ADDRESSED BY MDX MAINTENANCE

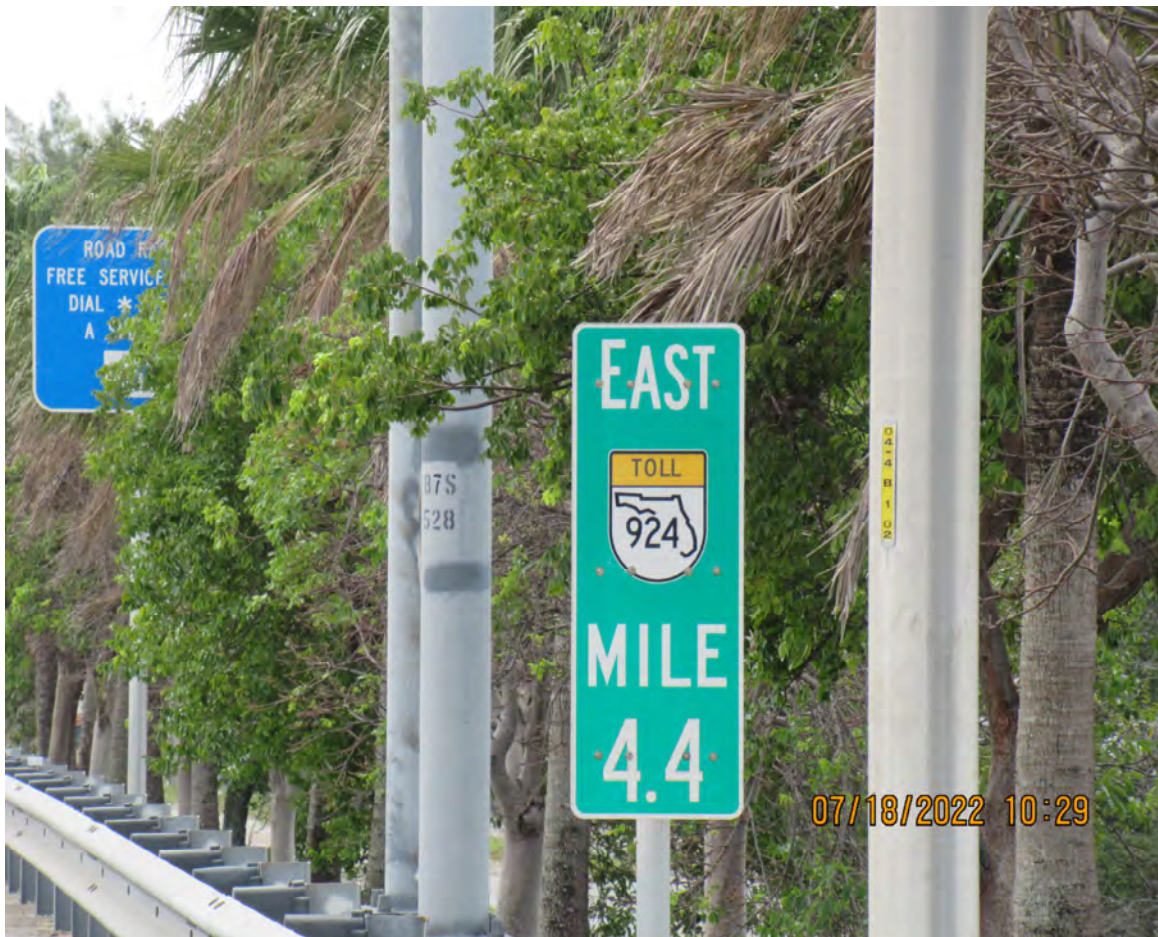
**PHOTO NO.: EB-017
DATE: 7-18-2022**

OVERGROWN VEGETATION OBSTRUCTING SIGN

ITEM NOTED TO BE ADDRESSED BY MDX MAINTENANCE

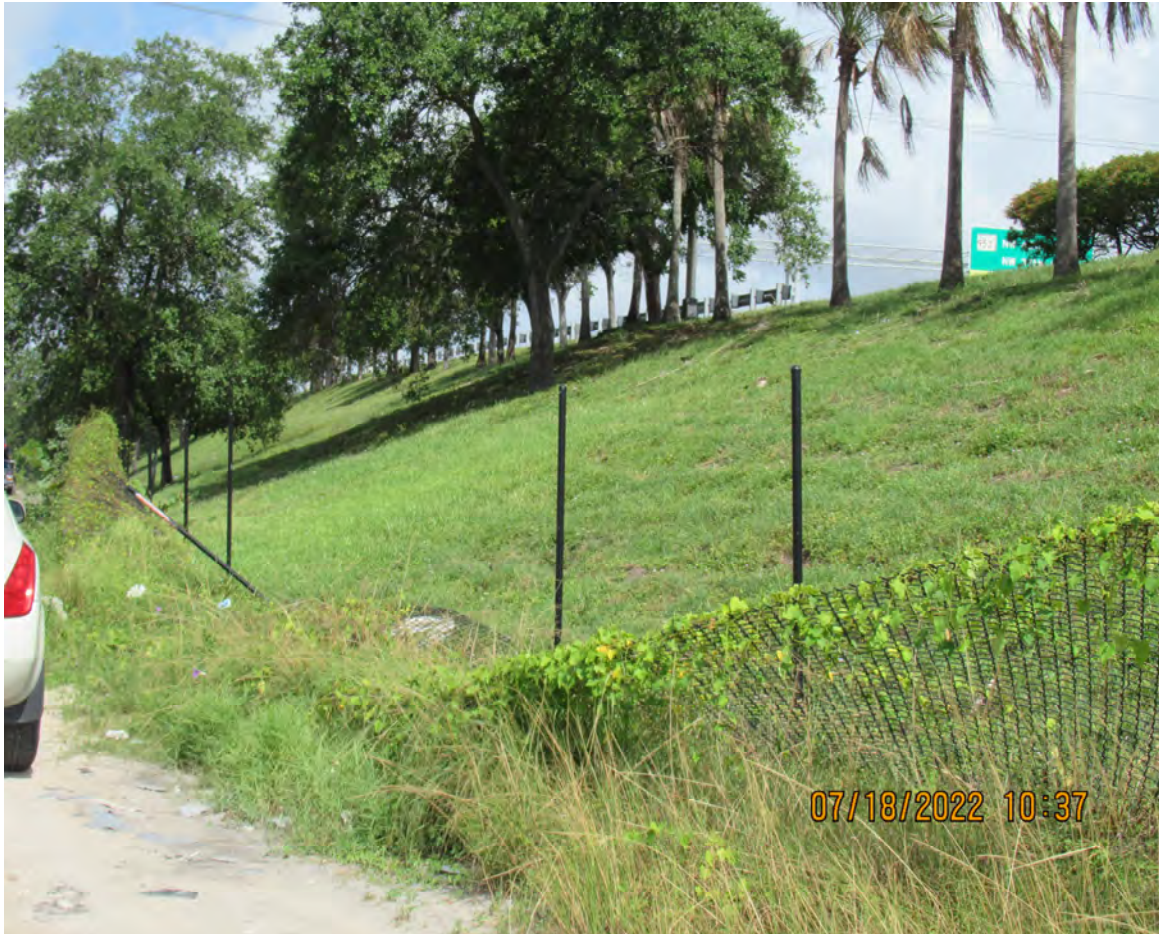
**PHOTO NO.: EB-018
DATE: 7-18-2022**

DAMAGED FENCE

ITEM NOTED TO BE ADDRESSED BY MDX MAINTENANCE

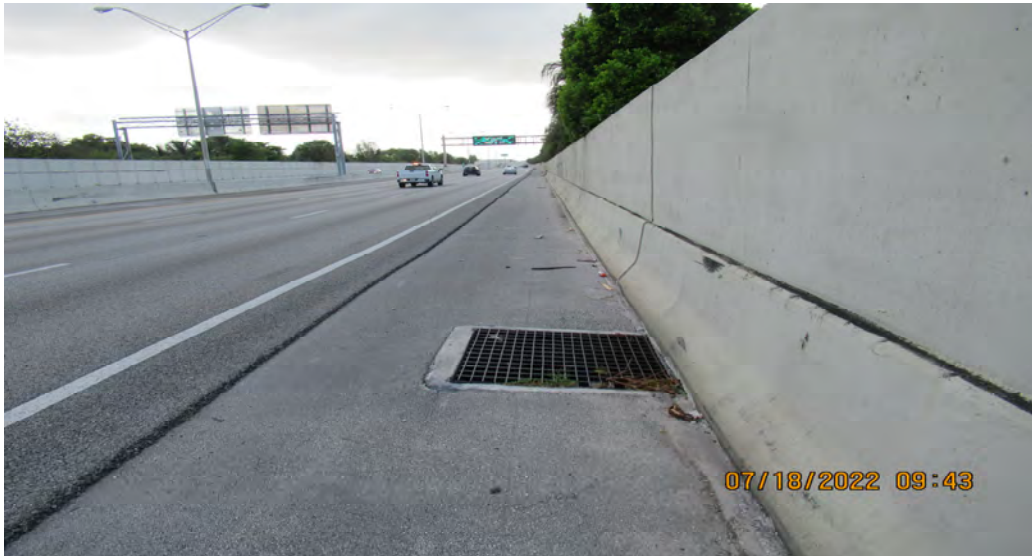
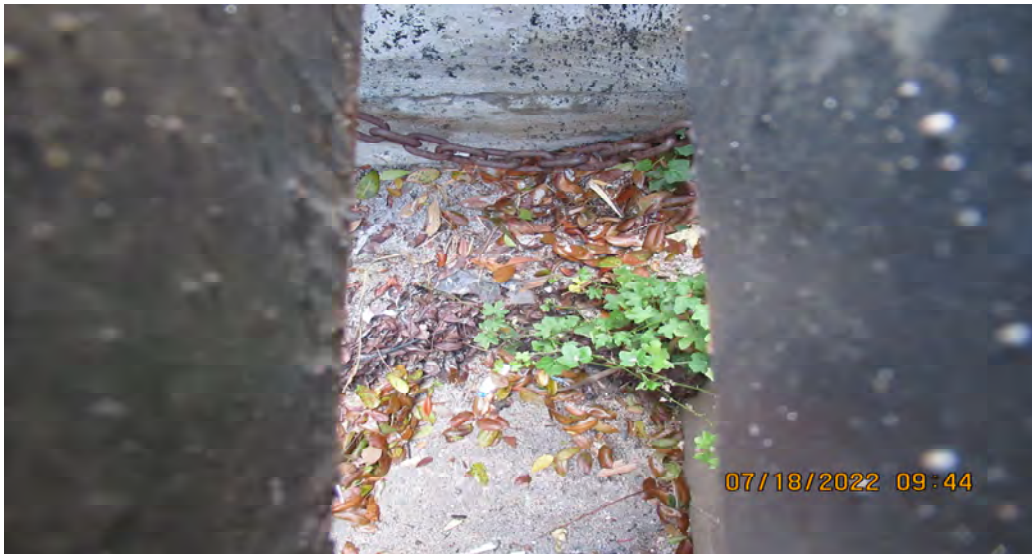
**PHOTO NO.: EB-019
DATE: 7-18-2022**

SILTED DRAINAGE STRUCTURE (TYPICAL THROUGHOUT THE CORRIDOR)

ITEM NOTED TO BE ADDRESSED BY MDX MAINTENANCE

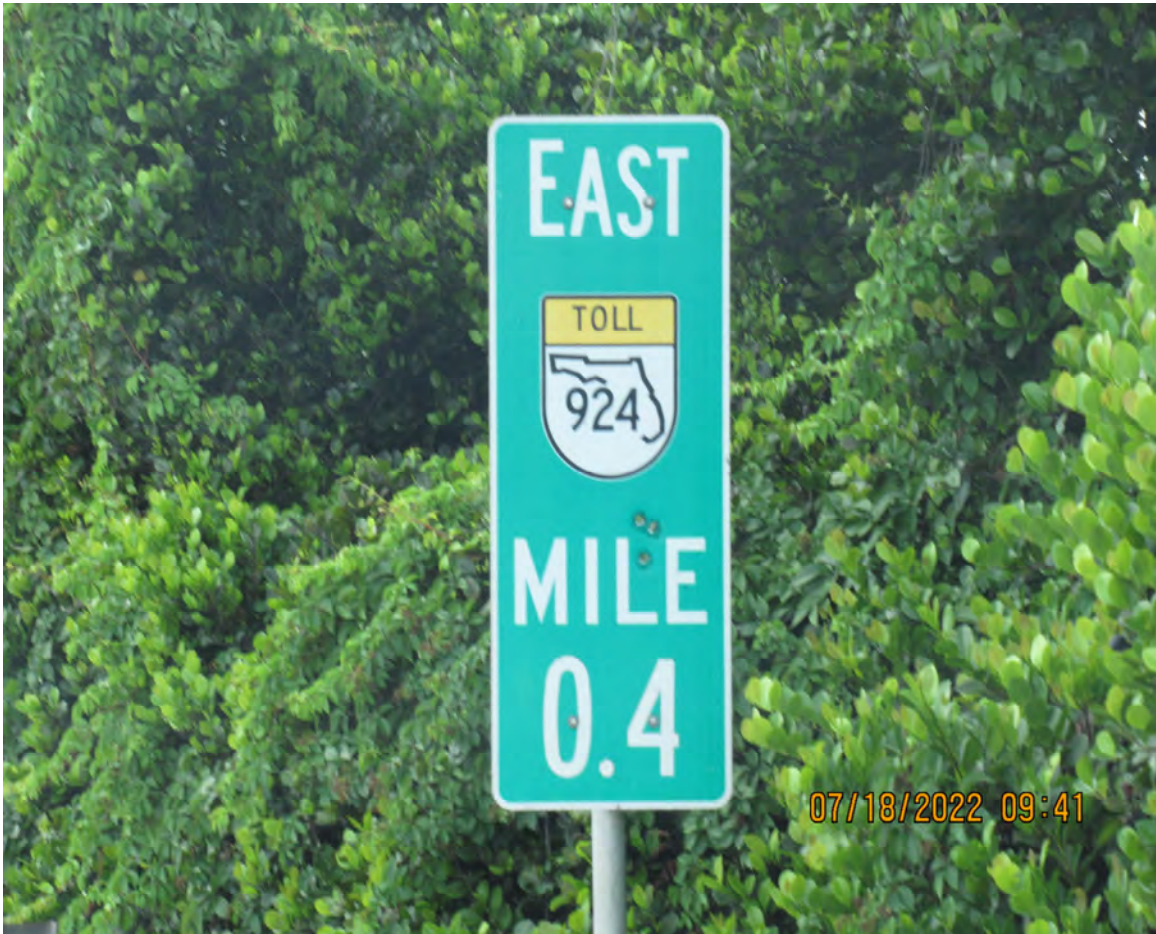
**PHOTO NO.: EB-020
DATE: 7-18-2022**

BULLET HOLES ON SIGN PANEL

ITEM NOTED TO BE ADDRESSED BY MDX MAINTENANCE

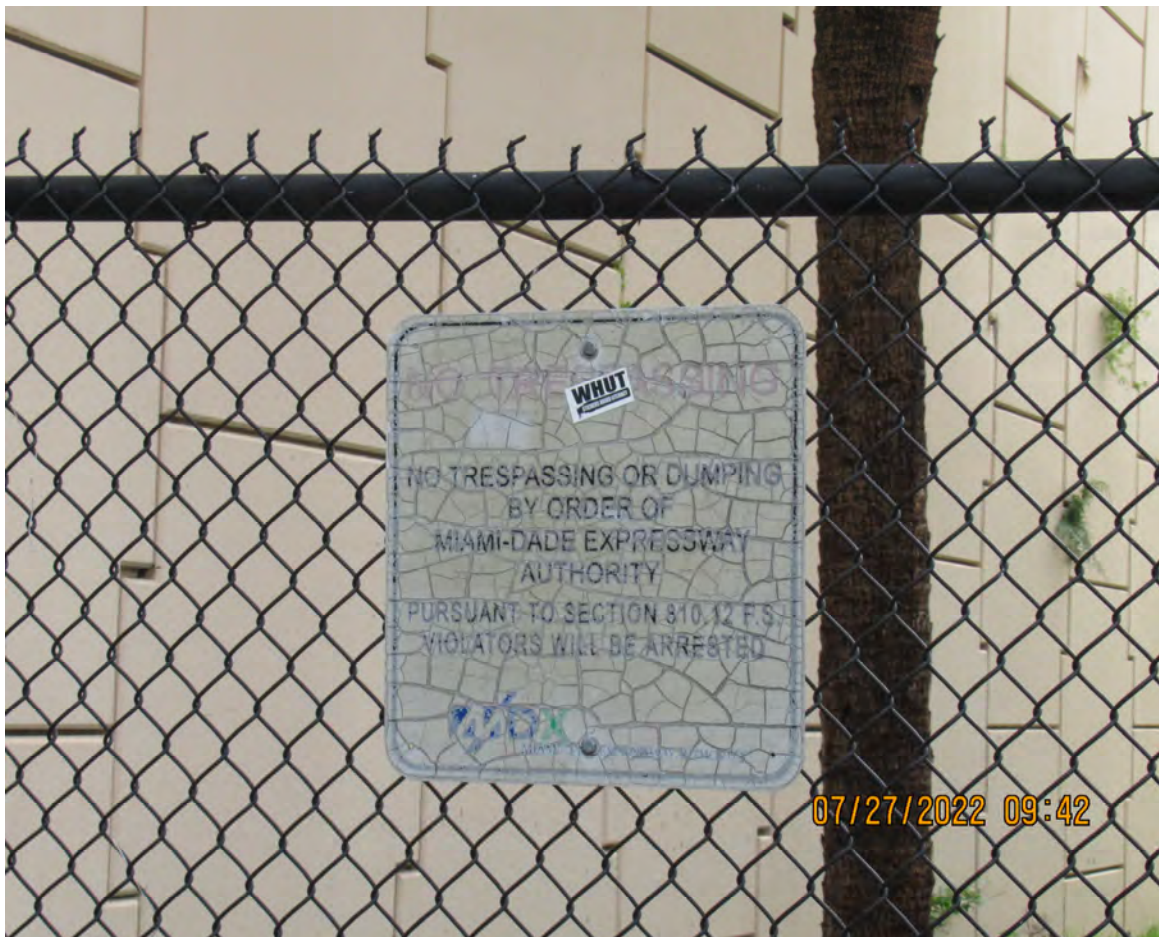
**PHOTO NO.: EB-022
DATE: 7-27-2022**

DETERIORATED NO TRESPASSING SIGN

ITEM NOTED TO BE ADDRESSED BY MDX MAINTENANCE

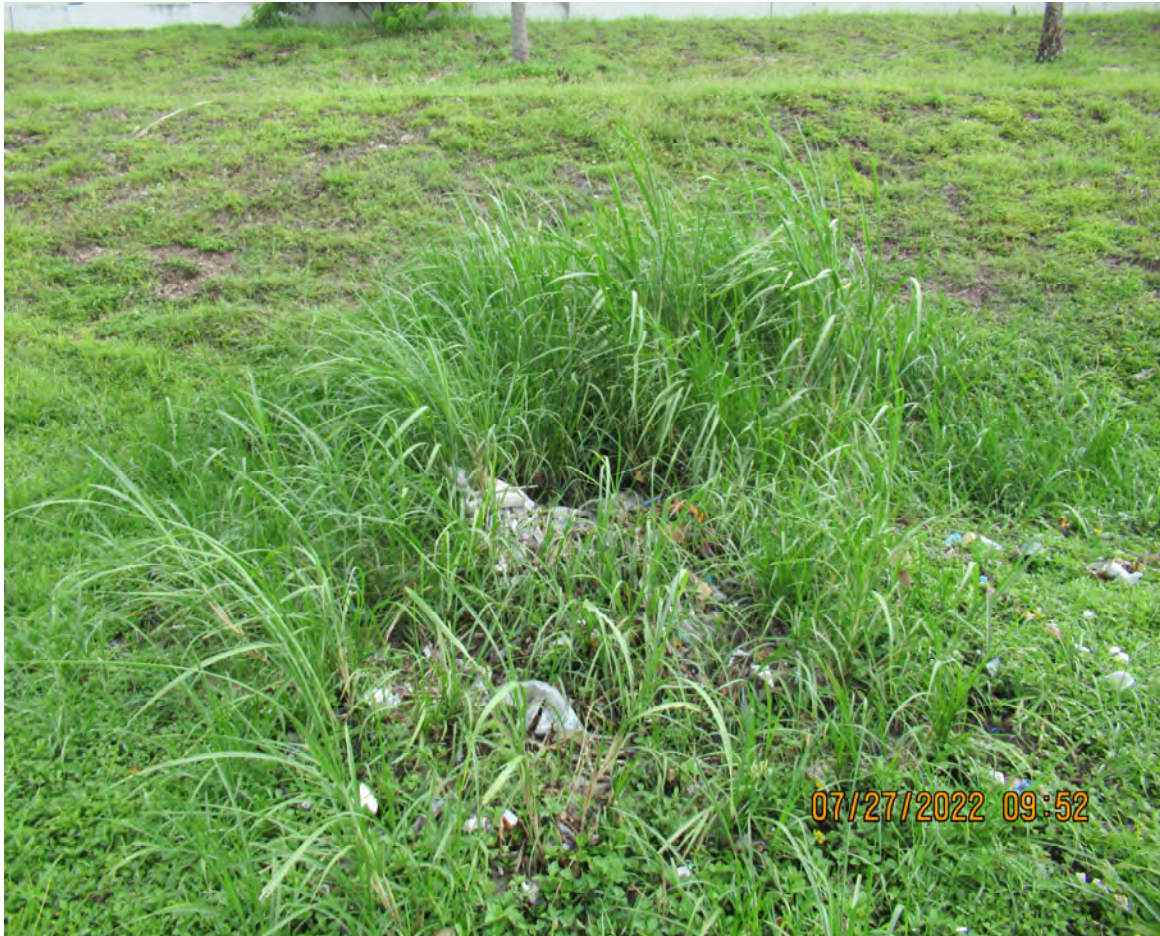
**PHOTO NO.: EB-023
DATE: 7-27-2022**

EXISTING GRADE ABOVE OUTFALL INVERT

ITEM NOTED TO BE ADDRESSED BY MDX MAINTENANCE

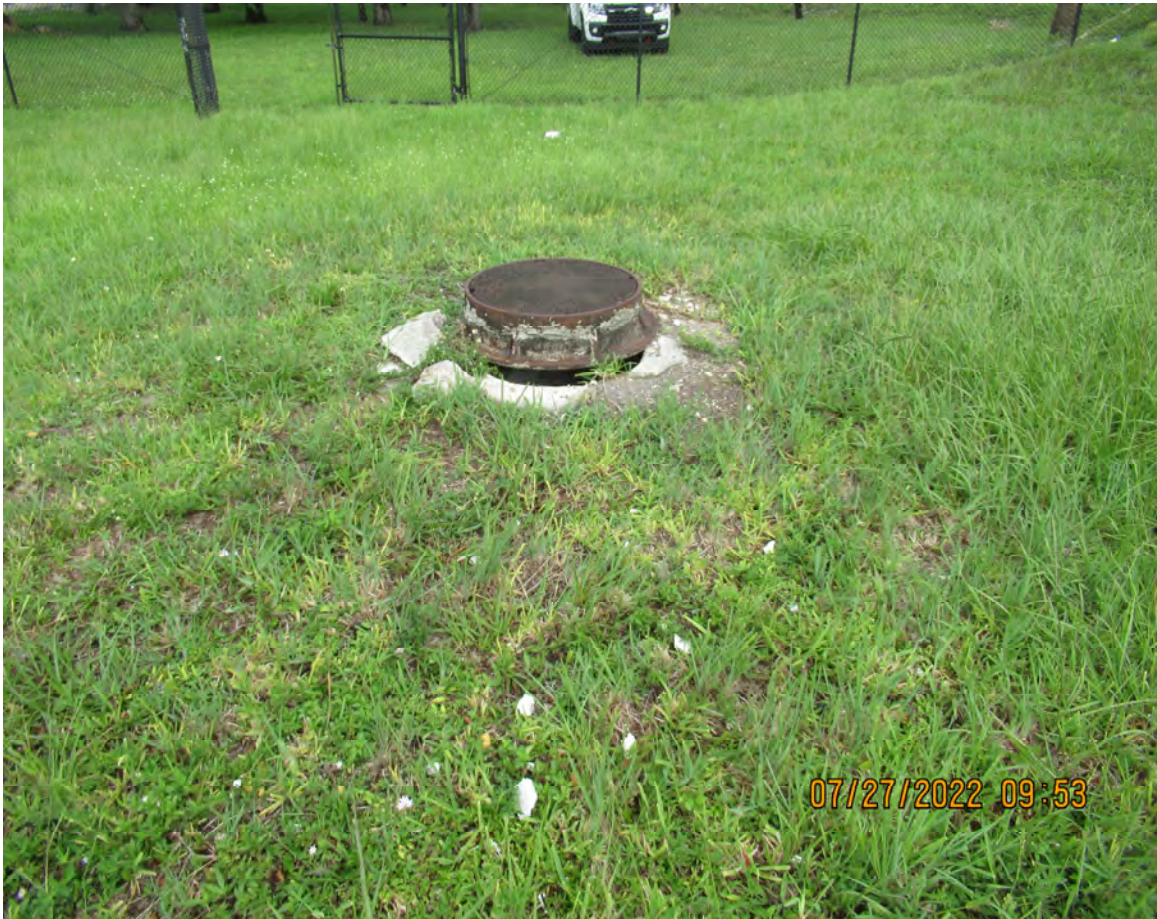
**PHOTO NO.: EB-024
DATE: 7-27-2022**

LOOSE MANHOLE

ITEM NOTED TO BE ADDRESSED BY MDX MAINTENANCE

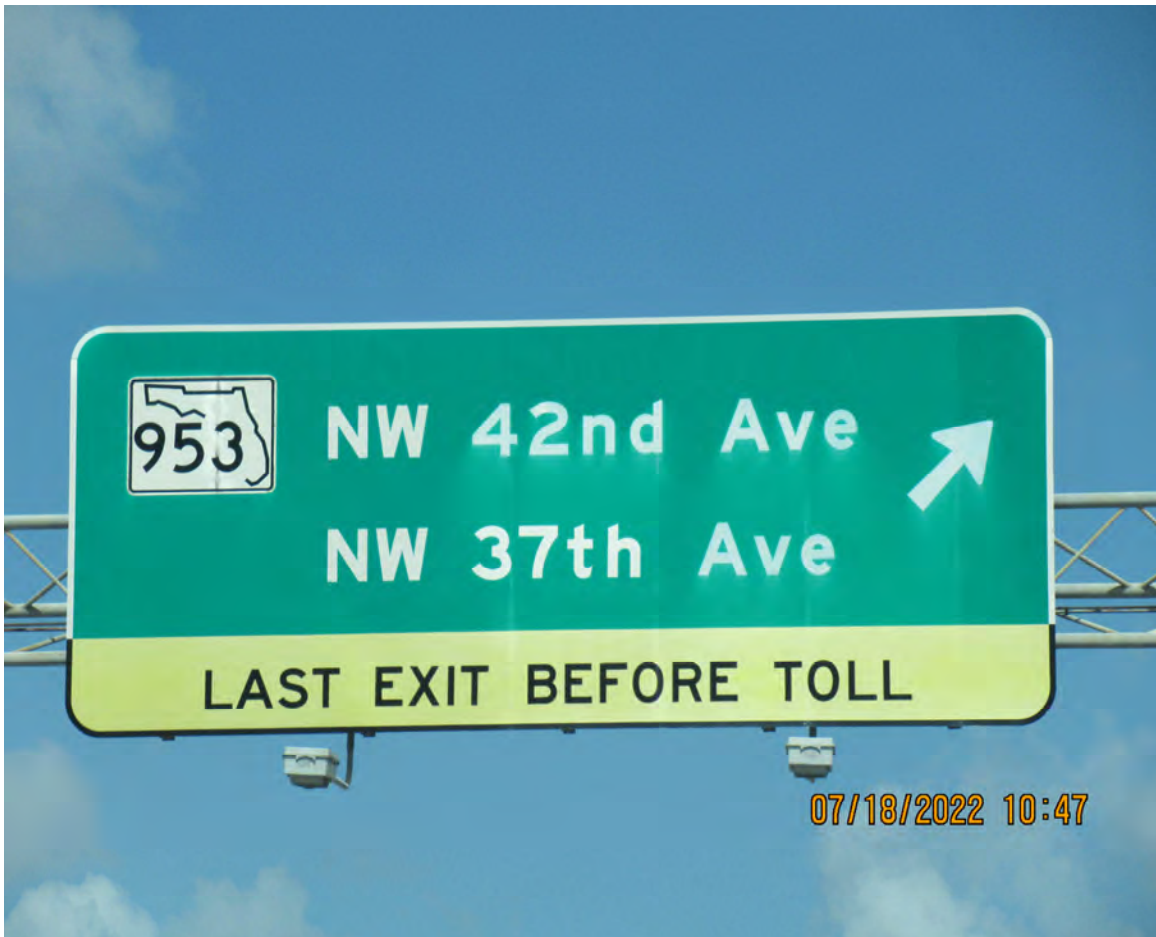
**PHOTO NO.: WB-001
DATE: 7-18-2022**

DETERIORATED REFLECTIVE SHEETING ON SIGN PANEL (STRUCTURE # 87S528)

ITEM NOTED TO BE ADDRESSED BY MDX WORK PROGRAM NO. 30058

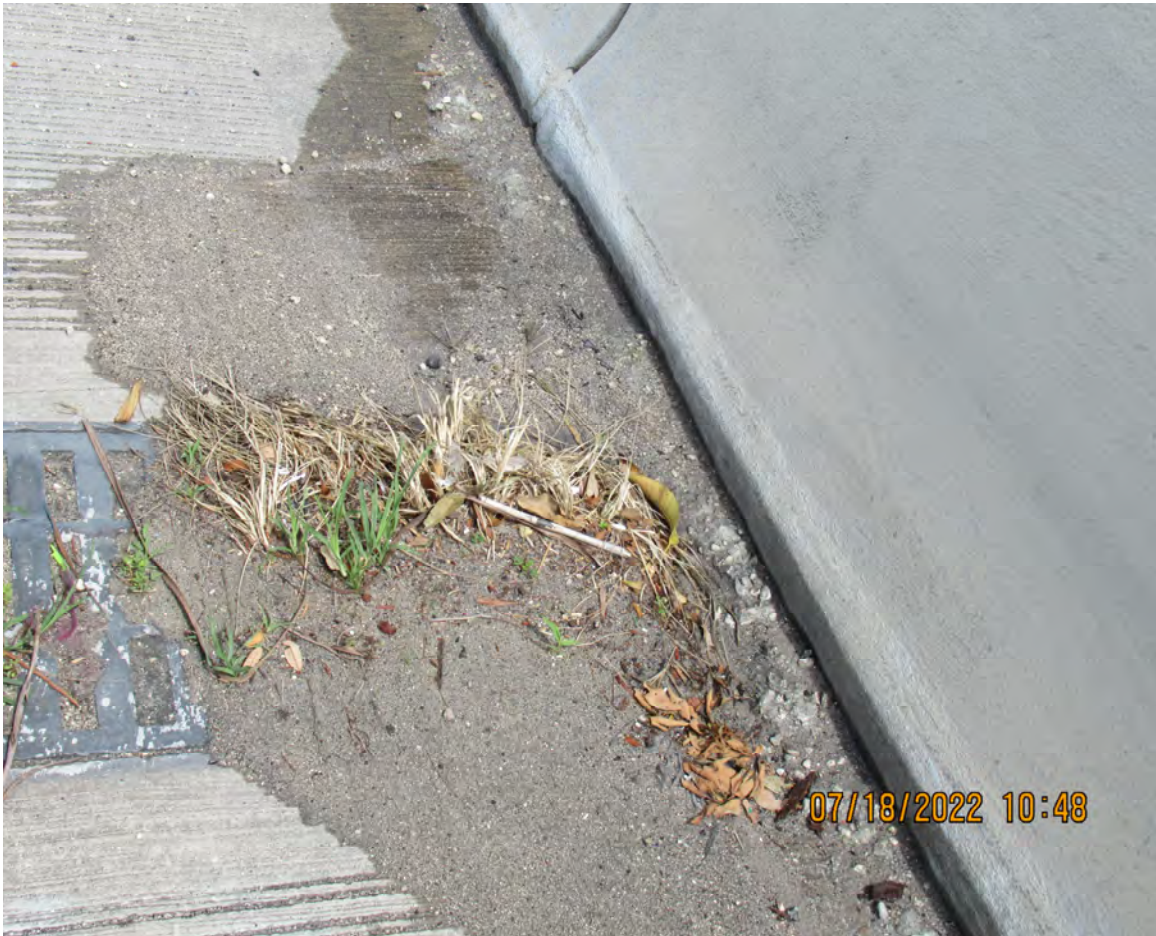
**PHOTO NO.: WB-002
DATE: 7-18-2022**

SILTED DECK DRAIN TYPICAL THROUGHOUT (BRIDGE # 870740)

ITEM NOTED TO BE ADDRESSED BY MDX MAINTENANCE
