ANNUAL INSPECTION REPORT 2022

ANNUAL INSPECTION REPORT

In 1996, the Miami-Dade County Expressway Authority (MDX) acquired operational and financial control of five expressways in Miami-Dade County from the Florida Department of Transportation (FDOT). This group of expressways, toll facilities and the MDX headquarters facility, all as described below, are hereinafter referred to as the “MDX System”. In accordance with the Trust Indenture requirements, MDX retained EAC Consulting, Inc. (EAC), as the General Engineering Consultant to perform, among other duties assigned by the Authority, the yearly inspection of the MDX System. This report represents the annual inspection results for Fiscal Year (FY) 2022.

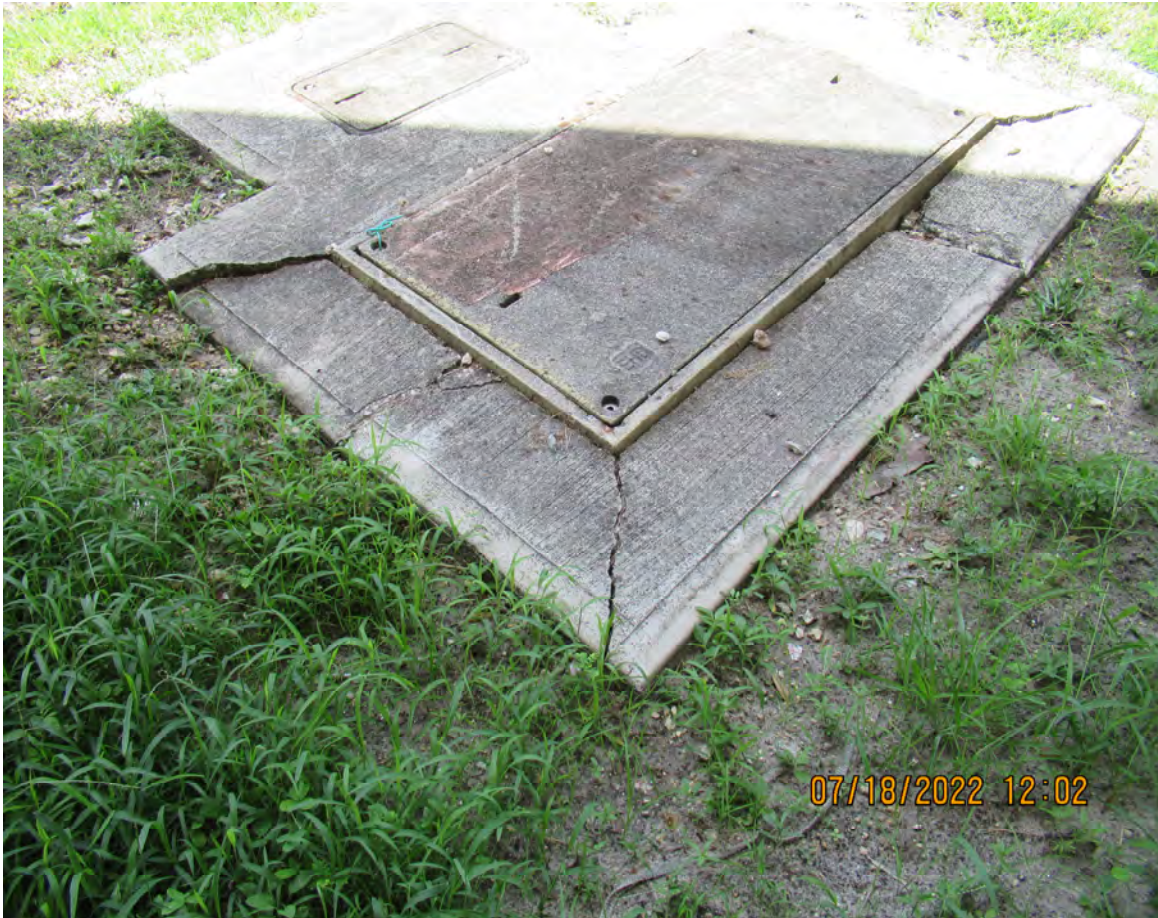
**PHOTO NO.: WB-005
DATE: 7-18-2022**

**DAMAGED ITS PULL BOX CONCRETE SLAB
(UNDERNEATH BRIDGE # 870708)**

ITEM NOTED TO BE ADDRESSED BY MDX ITS

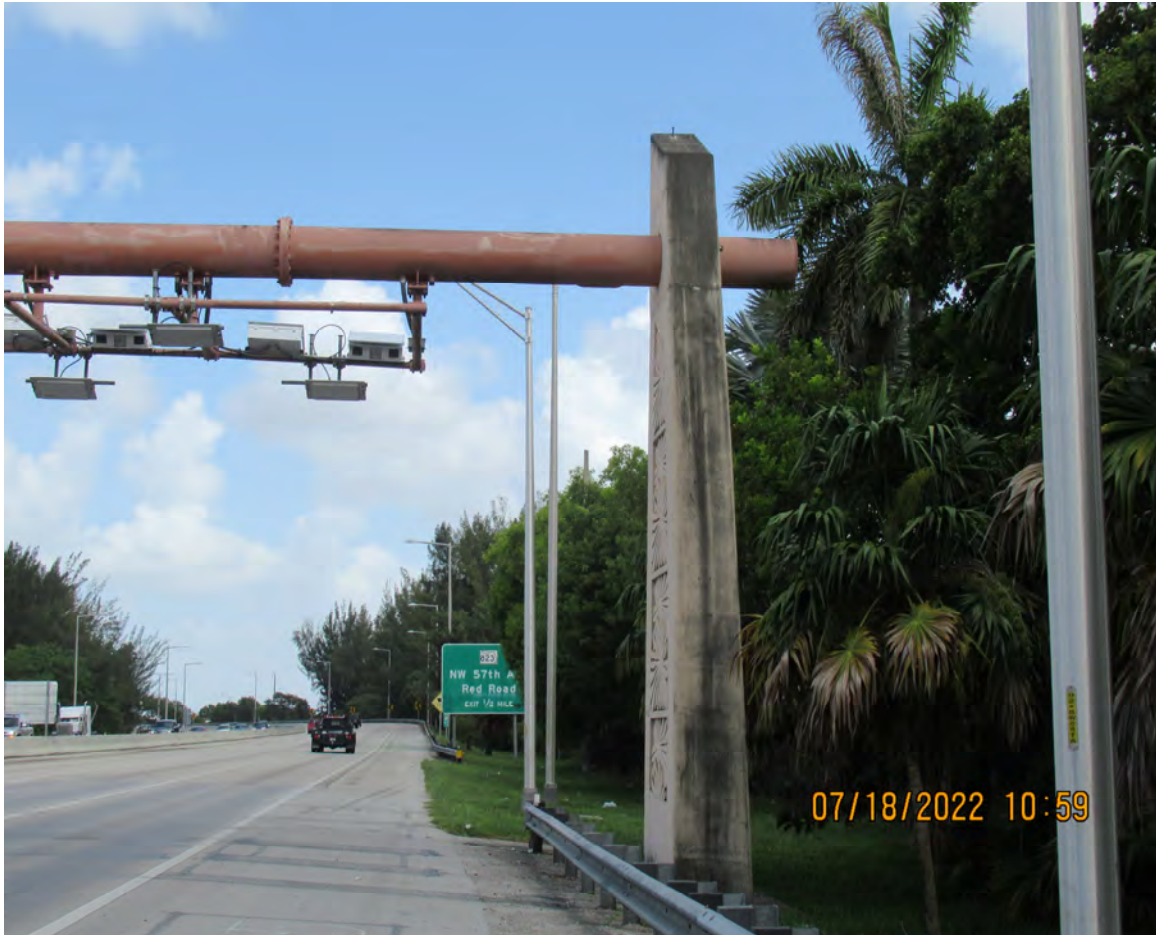
**PHOTO NO.: WB-006
DATE: 7-18-2022**

**DETERIORATED PAINT ON STRUCTURE UPRIGHT AND MONOTUBE
(STRUCTURE # 87S932)**

ITEM NOTED TO BE ADDRESSED BY MDX WORK PROGRAM No. 30037 & 30043

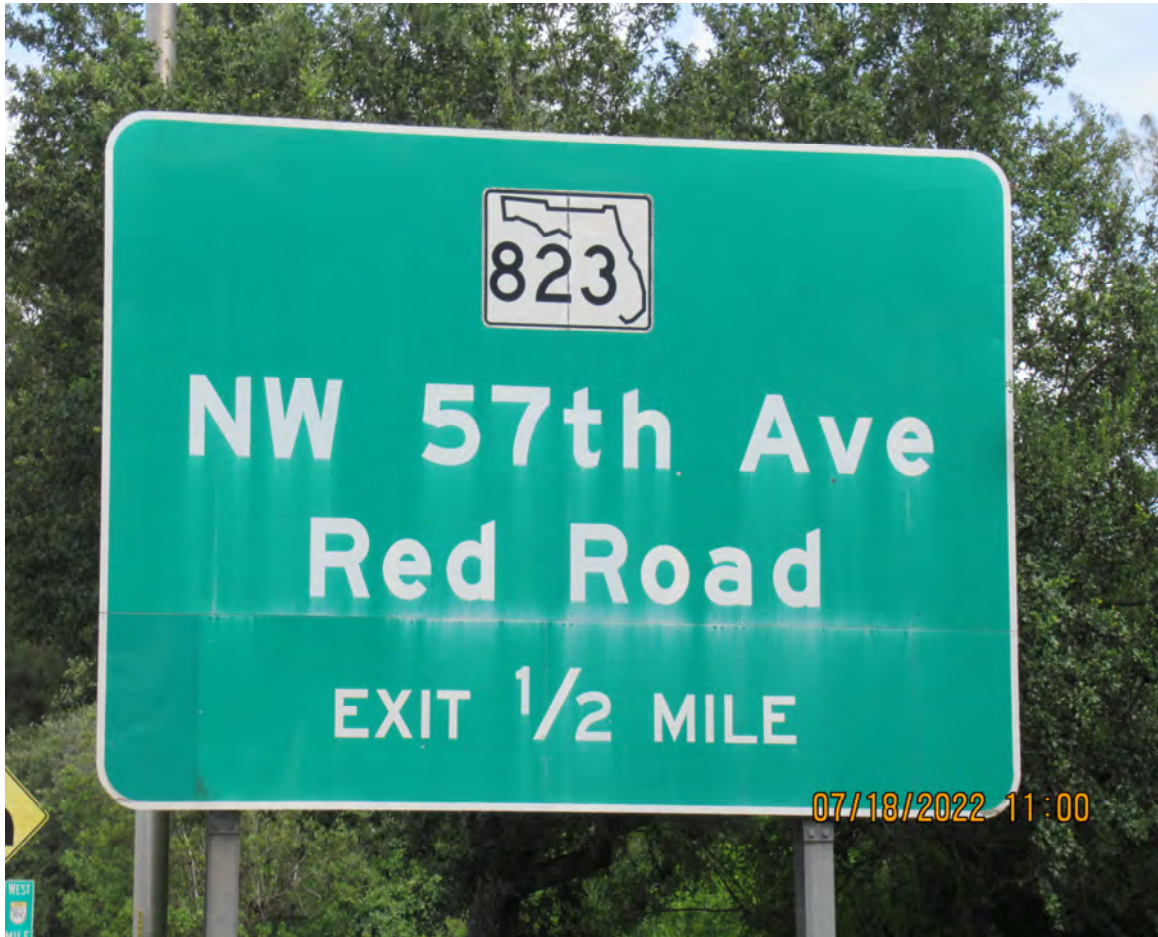
**PHOTO NO.: WB-007
DATE: 7-18-2022**

DETERIORATED REFLECTIVE SHEETING

ITEM NOTED TO BE ADDRESSED BY MDX WORK PROGRAM NO. 30058

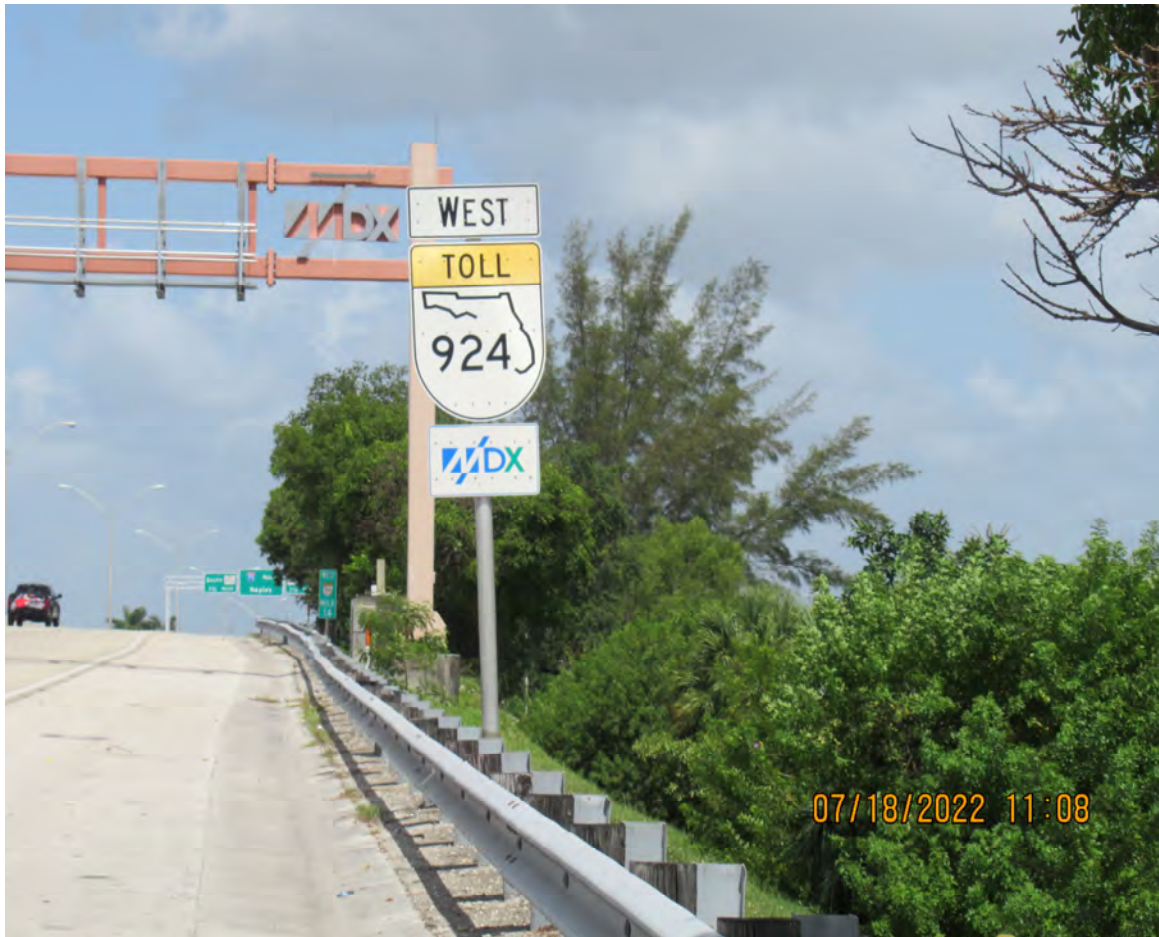
**PHOTO NO.: WB-012
DATE: 7-18-2022**

LEANING SIGN

ITEM NOTED TO BE ADDRESSED BY MDX MAINTENANCE

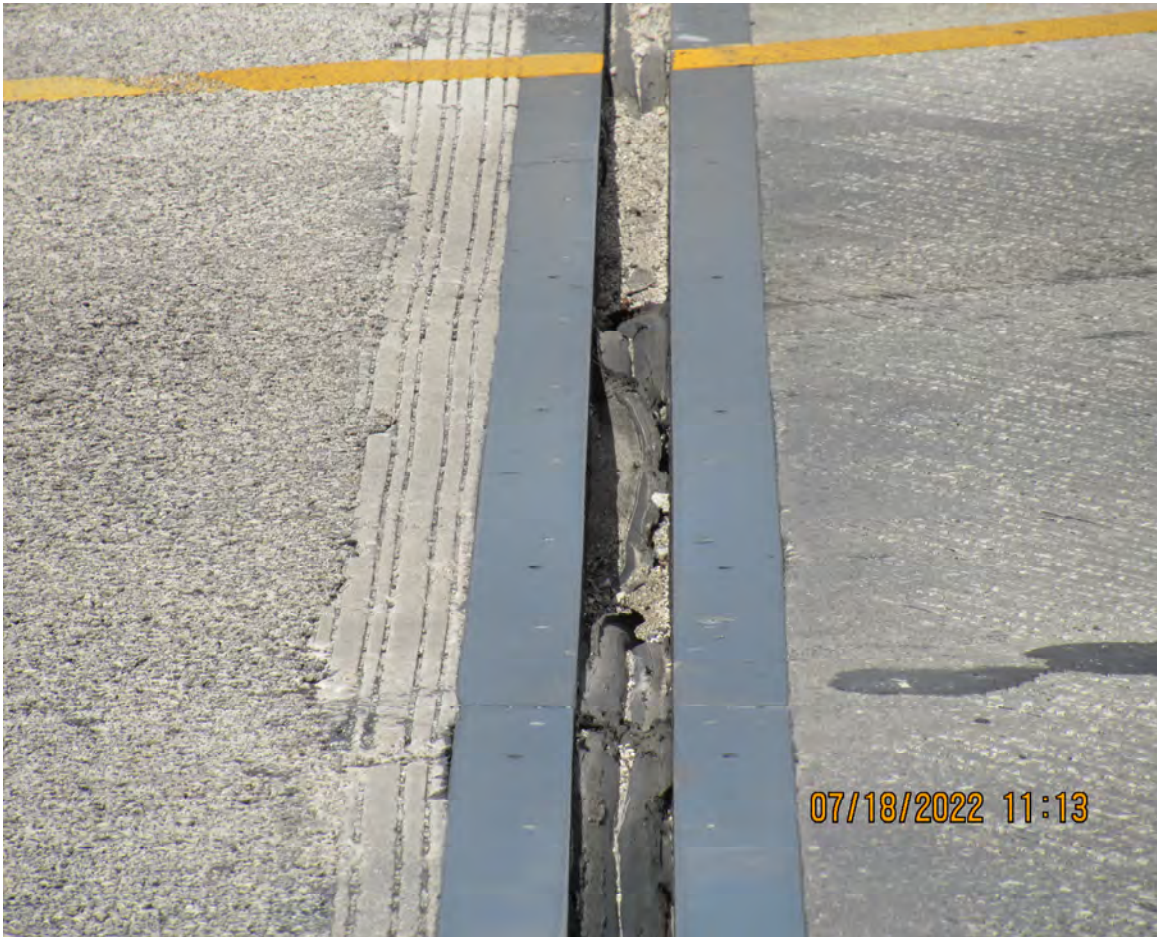
**PHOTO NO.: WB-013
DATE: 7-18-2022**

FAILURE ON EXPANSION JOINT AT BENTS 1 & 5 (BRIDGE # 870708)

ITEM NOTED TO BE ADDRESSED BY MDX PROJECT 30029 WARRANTY

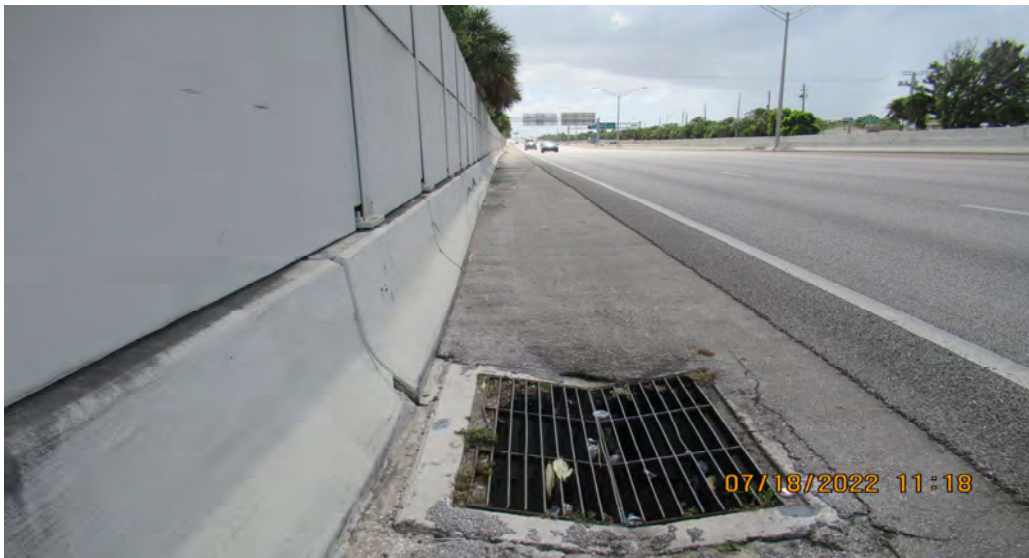
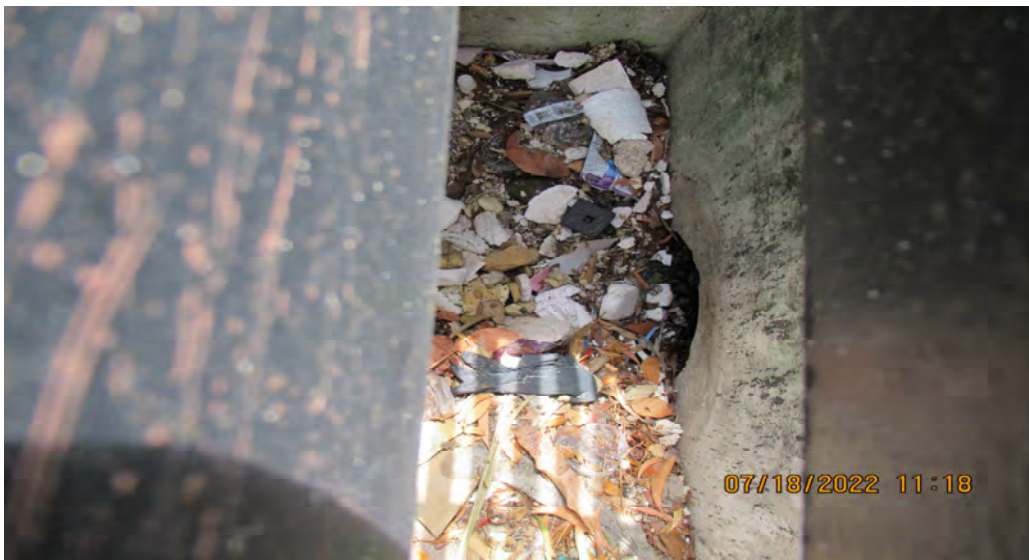
**PHOTO NO.: WB-014
DATE: 7-18-2022**

**SILTED DRAINAGE INLET (TYPICAL AT VARIOUS LOCATIONS THROUGHOUT THE
CORRIDOR)**

ITEM NOTED TO BE ADDRESSED BY MDX MAINTENANCE

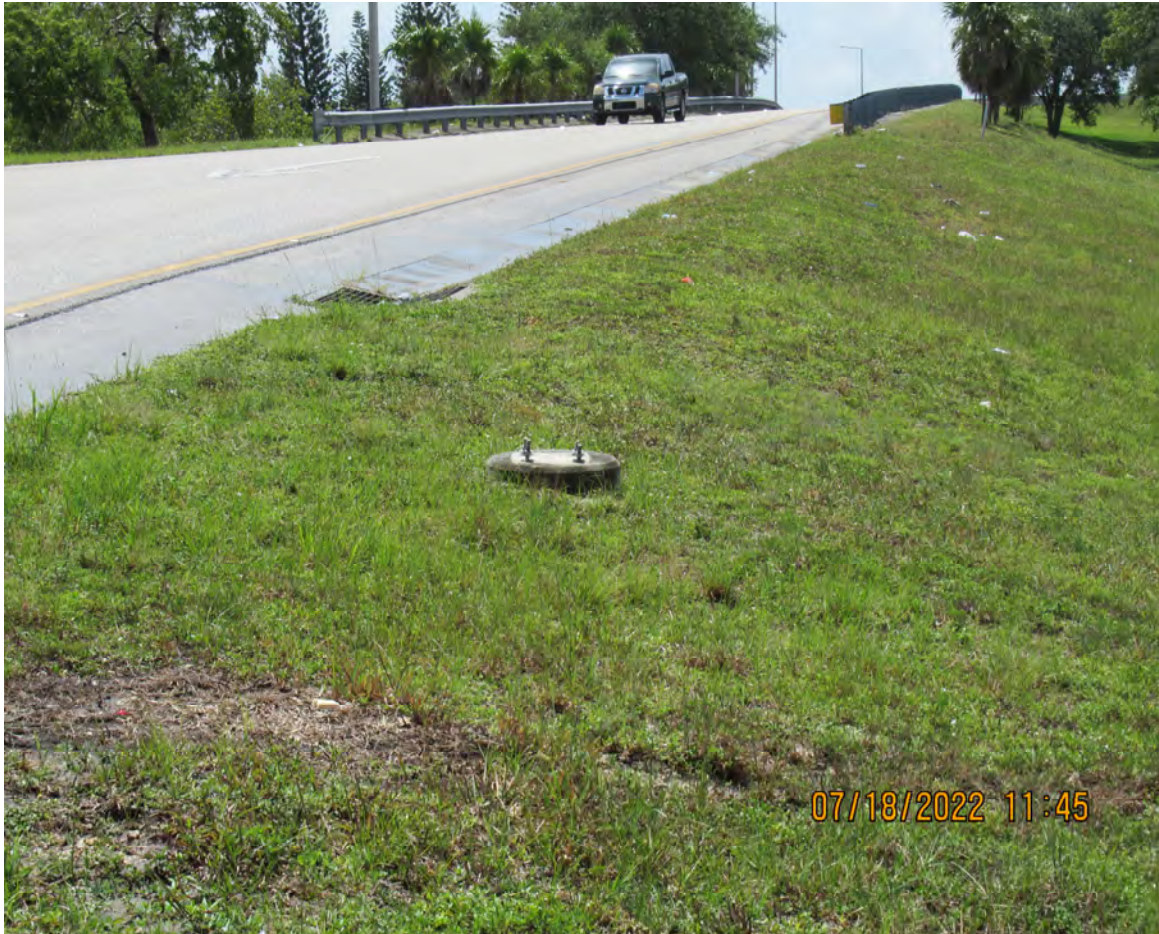
**PHOTO NO.: WB-015
DATE: 7-18-2022**

MISSING ILLUMINATED WRONG-WAY WARNING SIGN

ITEM NOTED TO BE ADDRESSED BY MDX MAINTENANCE

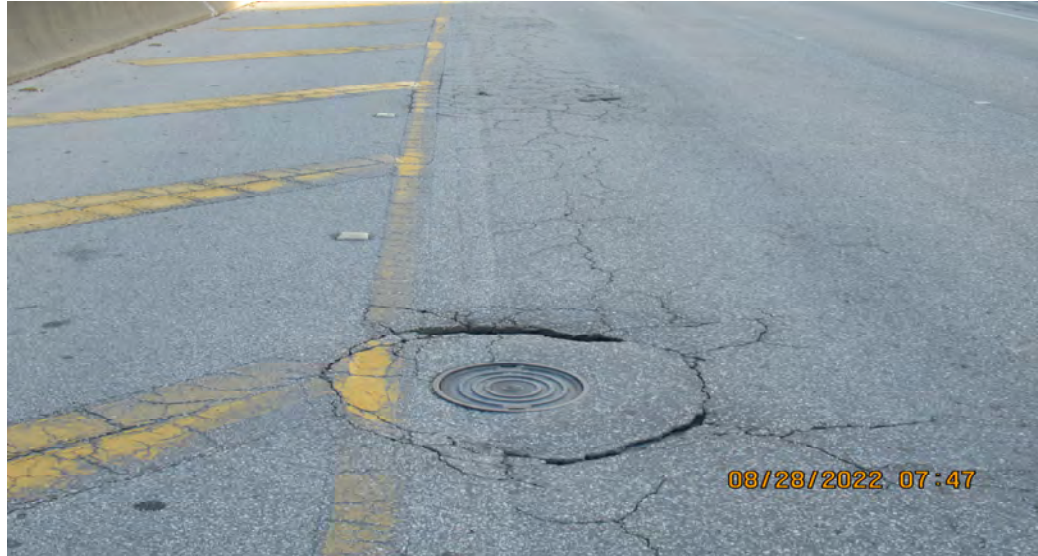
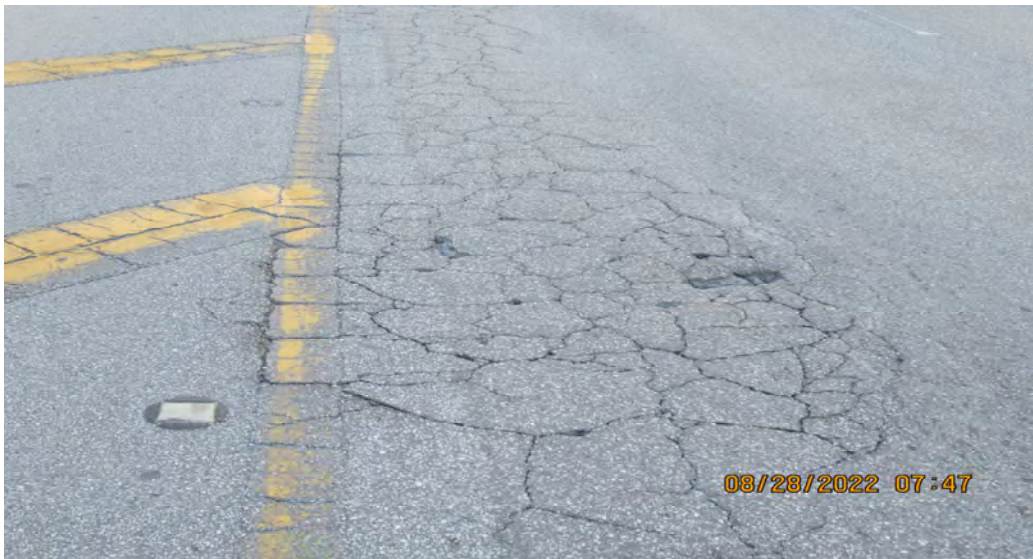
**PHOTO NO.: EB-001
DATE: 8-28-2022**

DETERIORATED PAVEMENT AND STRIPING

ITEM NOTED TO BE ADDRESSED BY MDX MAINTENANCE

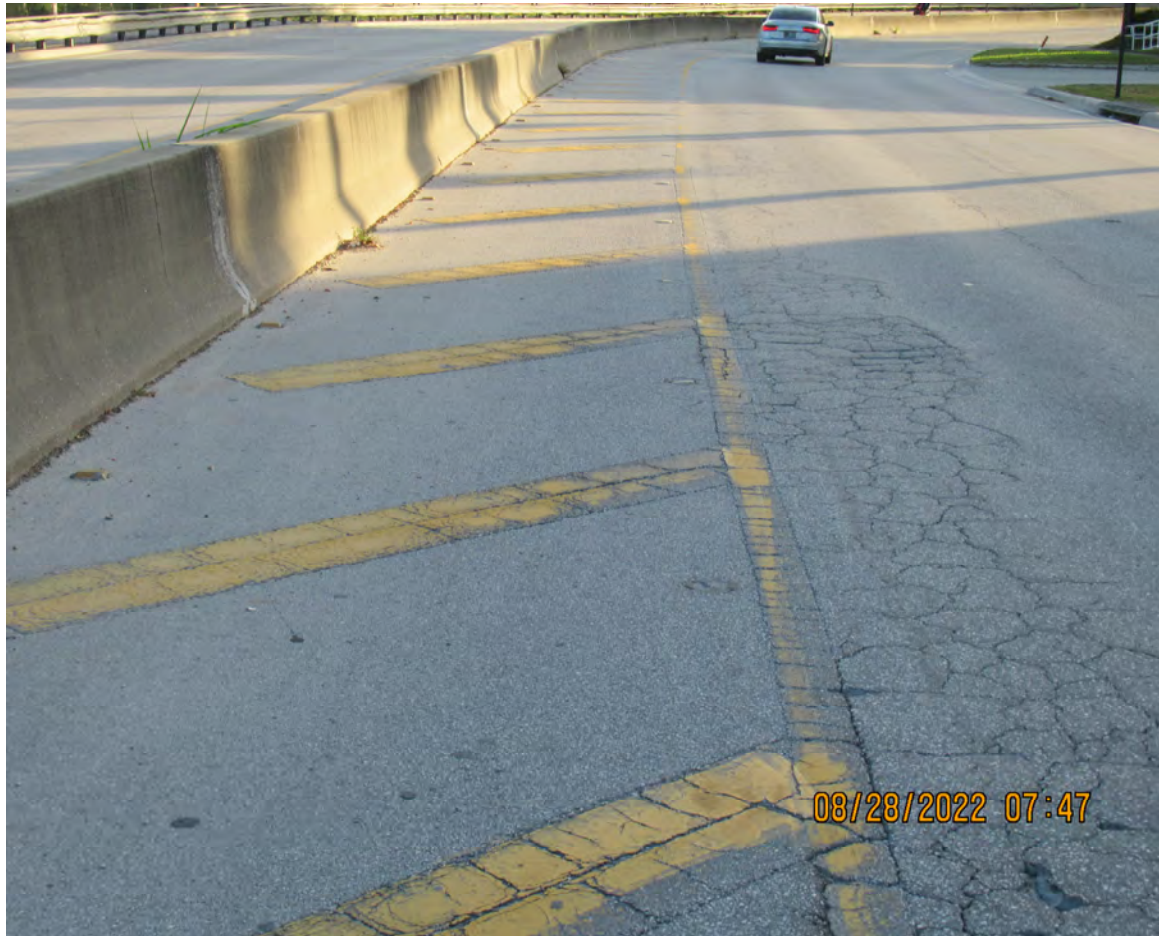
**PHOTO NO.: EB-002
DATE: 8-28-2022**

DETERIORATED PAVEMENT, CHEVRONS, EDGE LINE WHITE AND SKIPS STRIPING

ITEM NOTED TO BE ADDRESSED BY MDX MAINTENANCE

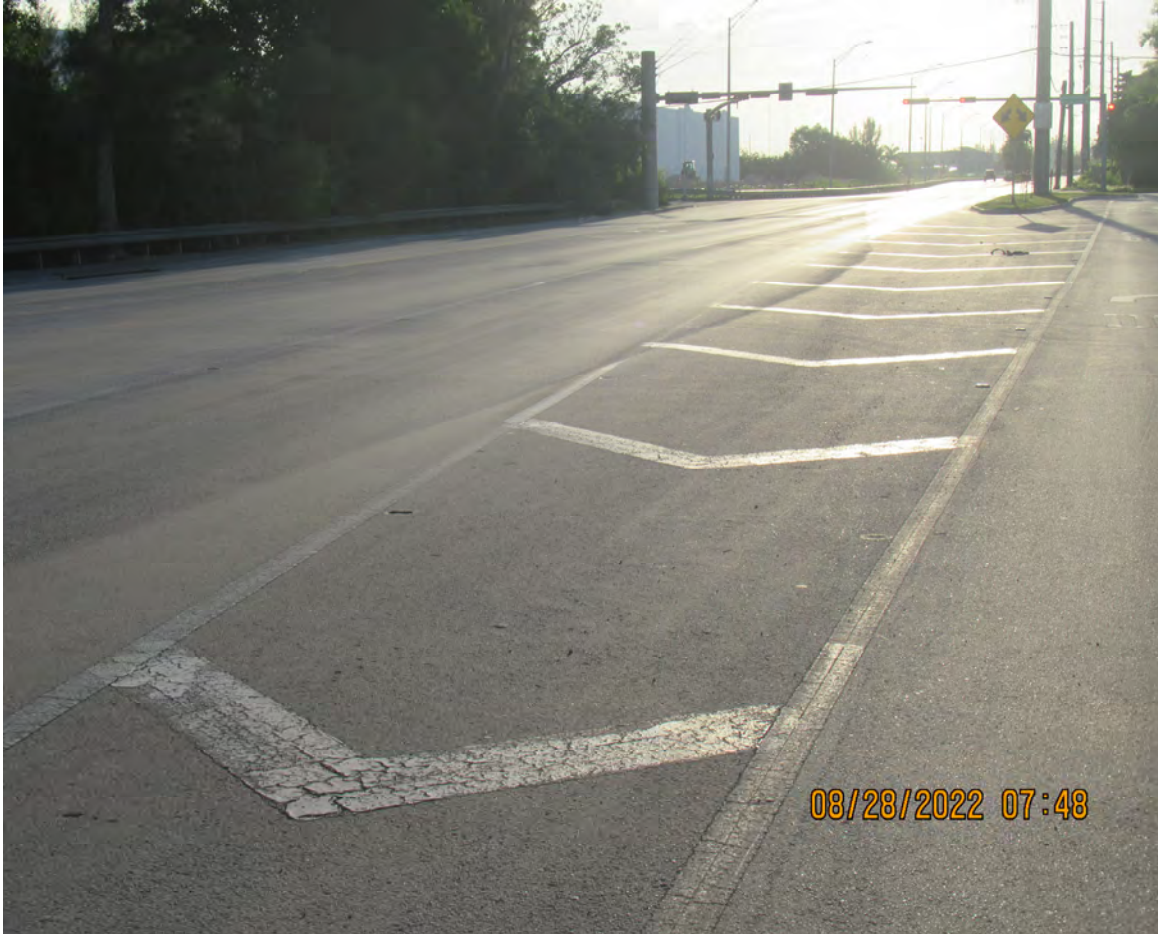
**PHOTO NO.: EB-003
DATE: 8-28-2022**

DETERIORATED STRIPING ON MAINLINE AND GORE

ITEM NOTED TO BE ADDRESSED BY MDX MAINTENANCE

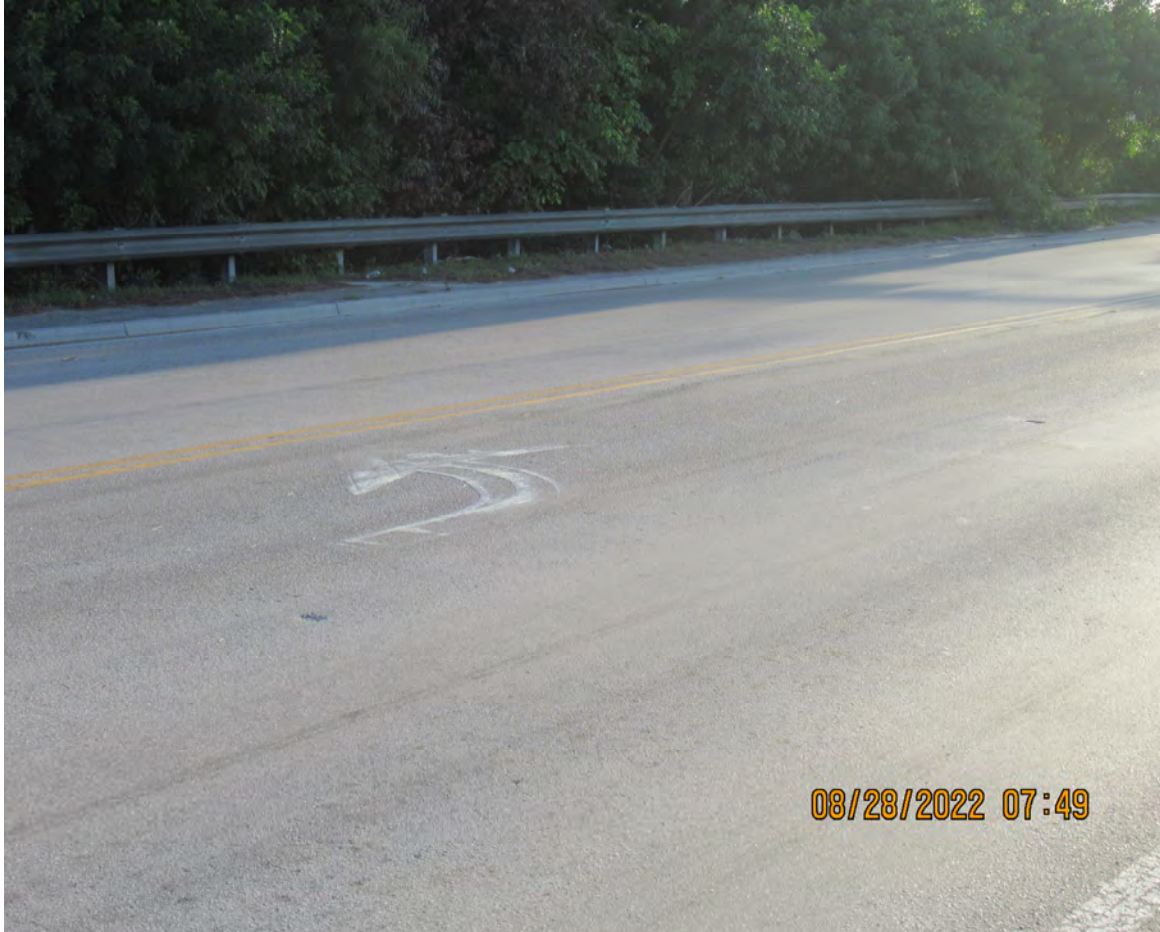
**PHOTO NO.: EB-004
DATE: 8-28-2022**

DETERIORATED PAVEMENT MESSAGE AND TURN ARROW

ITEM NOTED TO BE ADDRESSED BY MDX MAINTENANCE

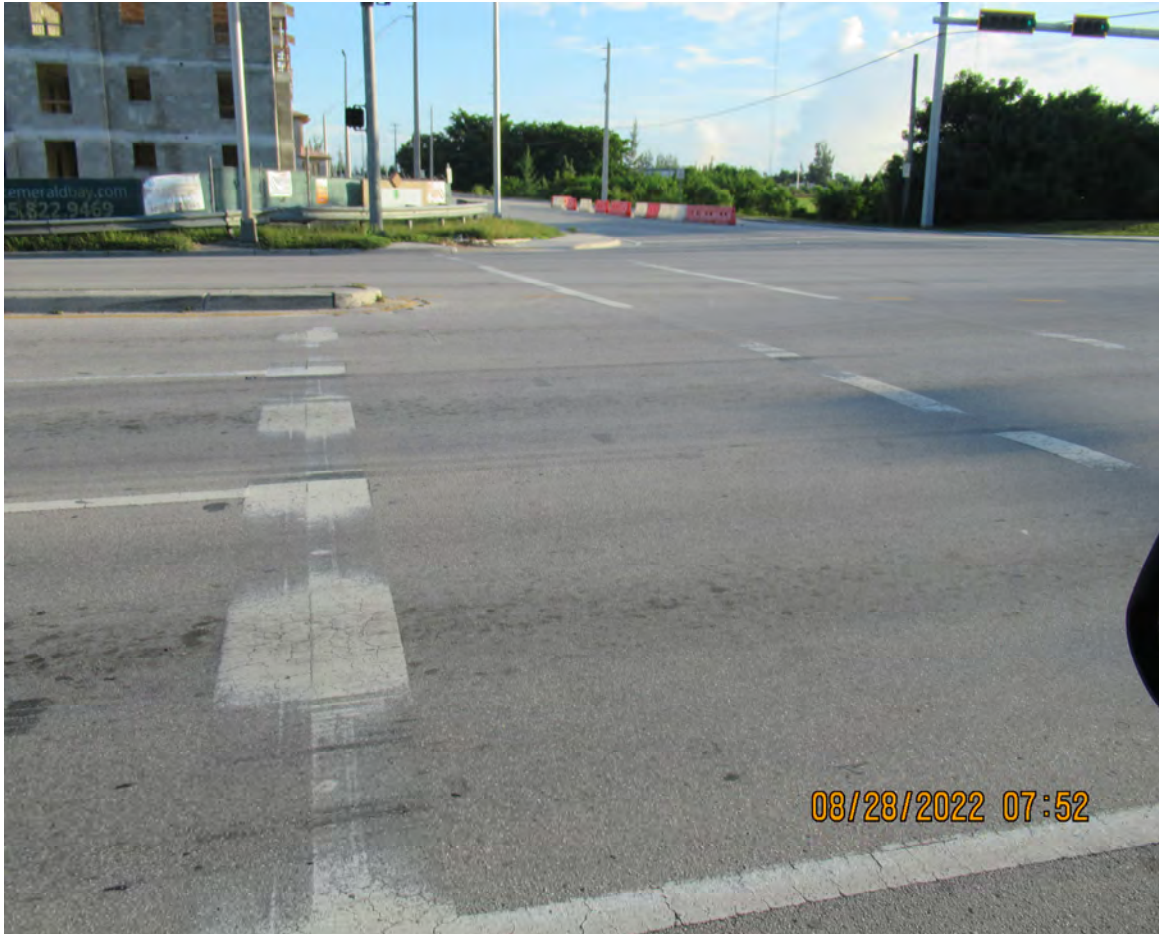
**PHOTO NO.: EB-005
DATE: 8-28-2022**

DETERIORATED STRIPING ON STOP BAR AND PEDESTRIAN CROSSWALK

ITEM NOTED TO BE ADDRESSED BY MDX MAINTENANCE

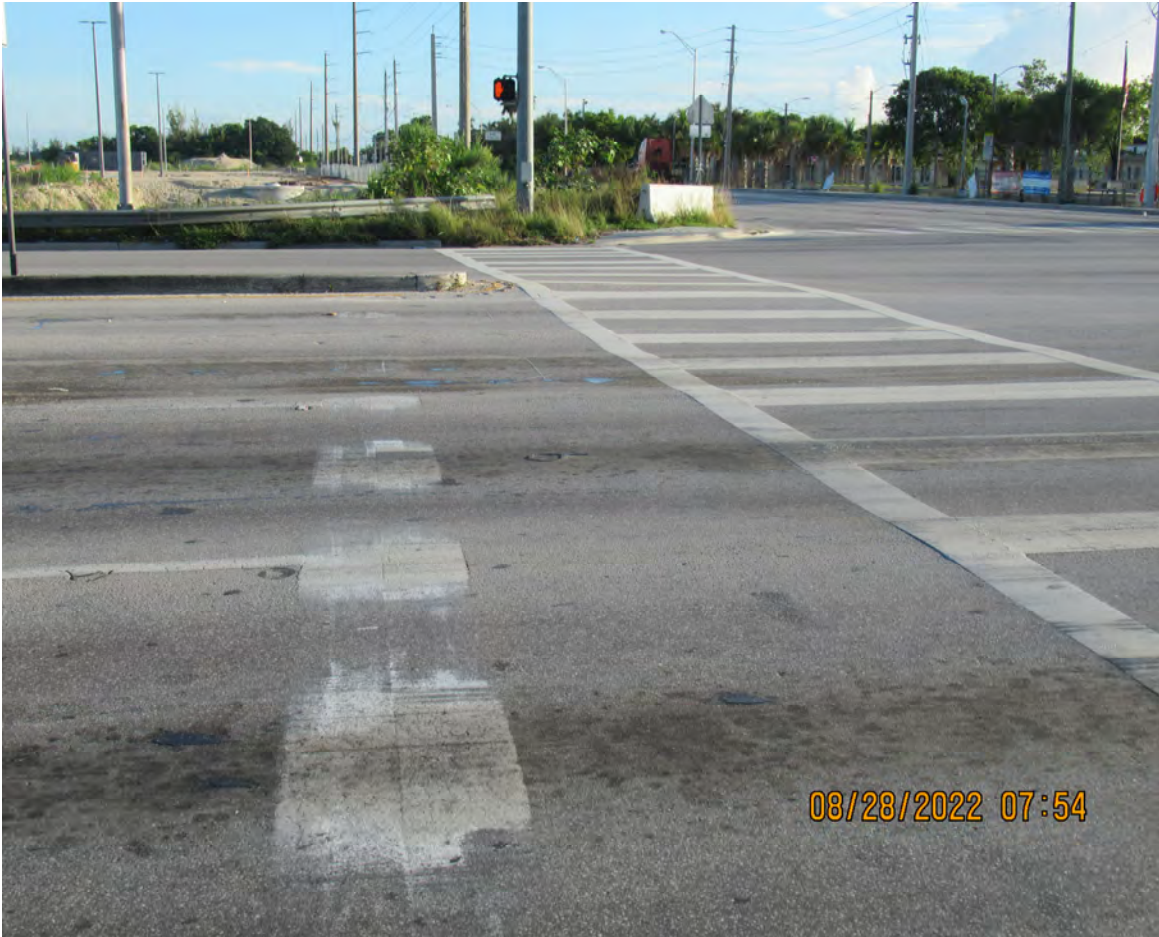
**PHOTO NO.: EB-006
DATE: 8-28-2022**

DETERIORATED STOP BAR, PEDESTRIAN CROSSWALK AND ROADWAY STRIPING

ITEM NOTED TO BE ADDRESSED BY MDX MAINTENANCE

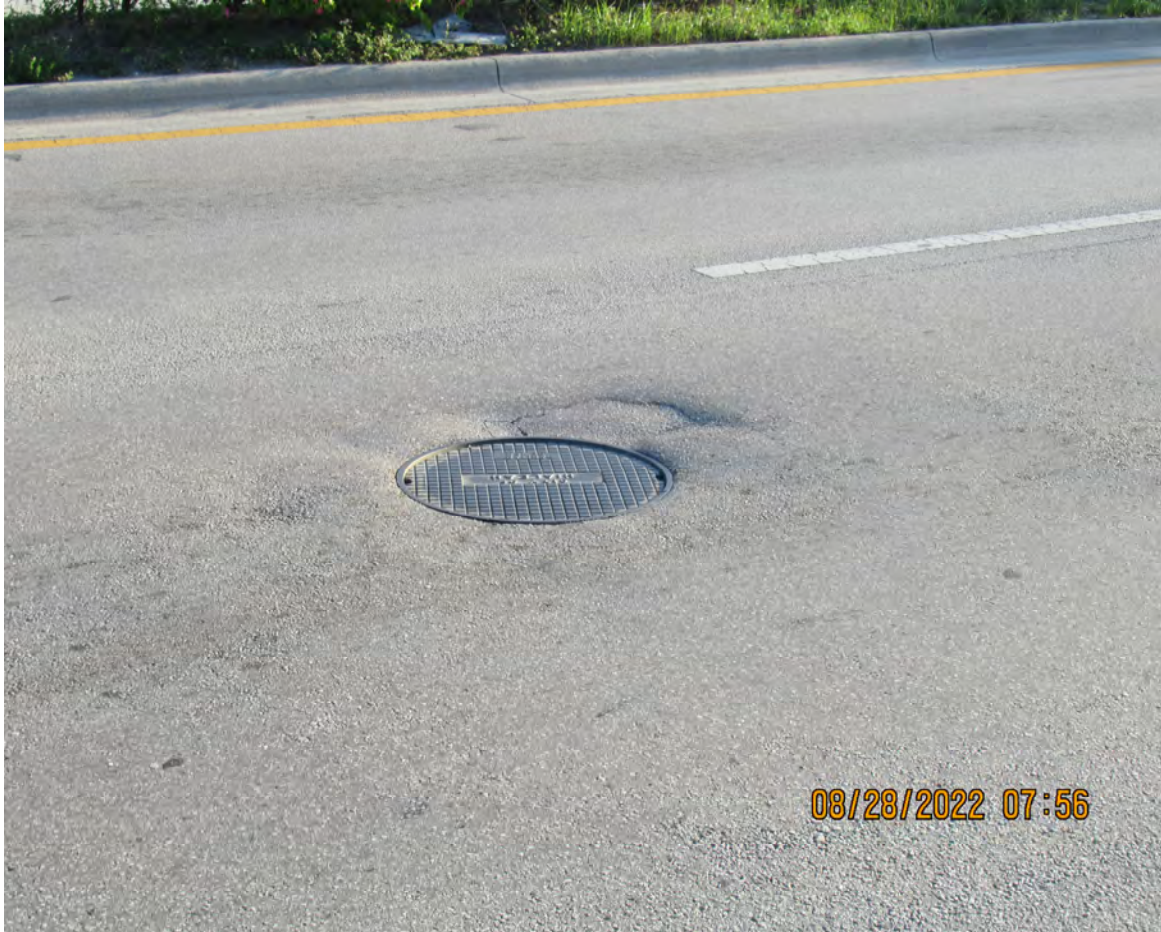
**PHOTO NO.: EB-007
DATE: 8-28-2022**

ROADWAY SETTLEMENT ADJACENT TO MANHOLE

ITEM NOTED TO BE ADDRESSED BY MDX MAINTENANCE

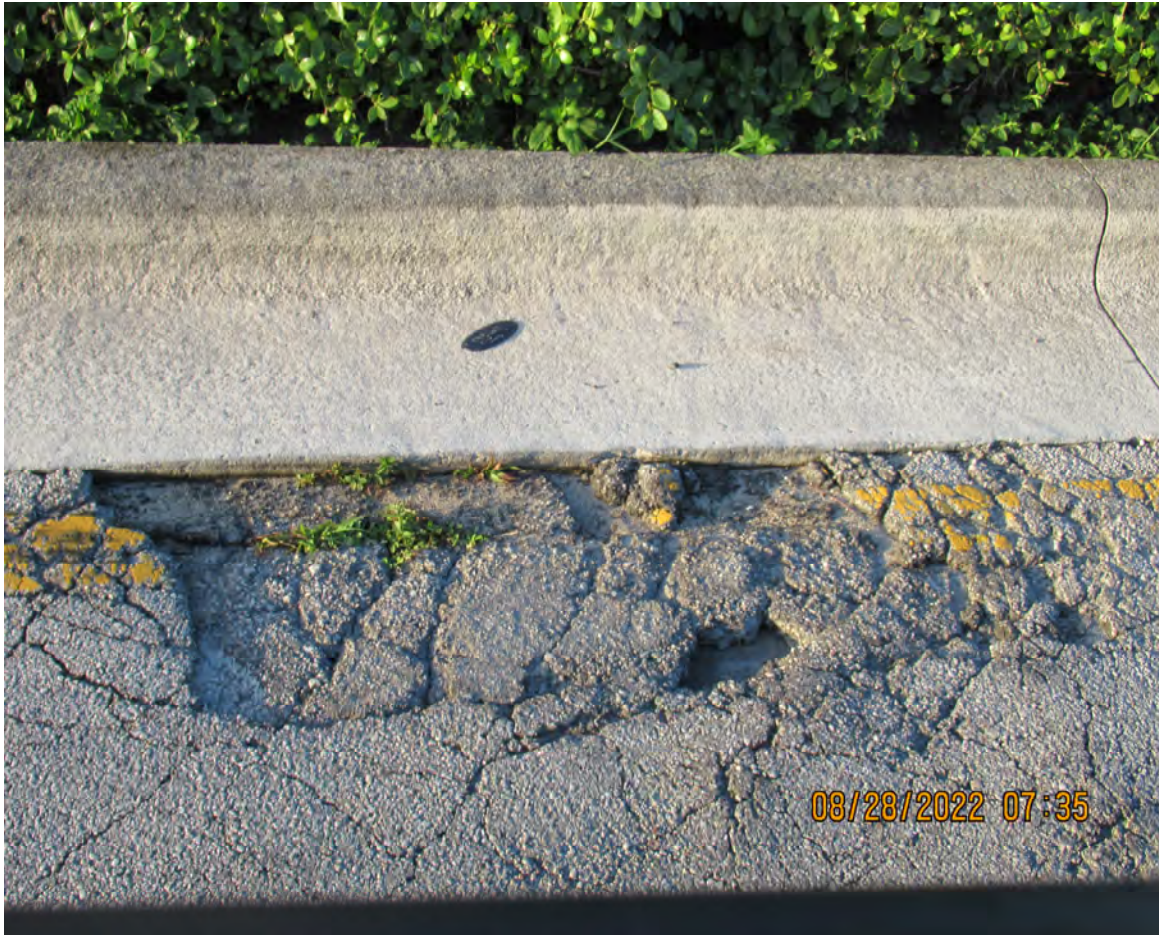
**PHOTO NO.: WB-001
DATE: 8-28-2022**

DETERIORATED ASPHALT PAVEMENT AND STRIPING

ITEM NOTED TO BE ADDRESSED BY MDX MAINTENANCE

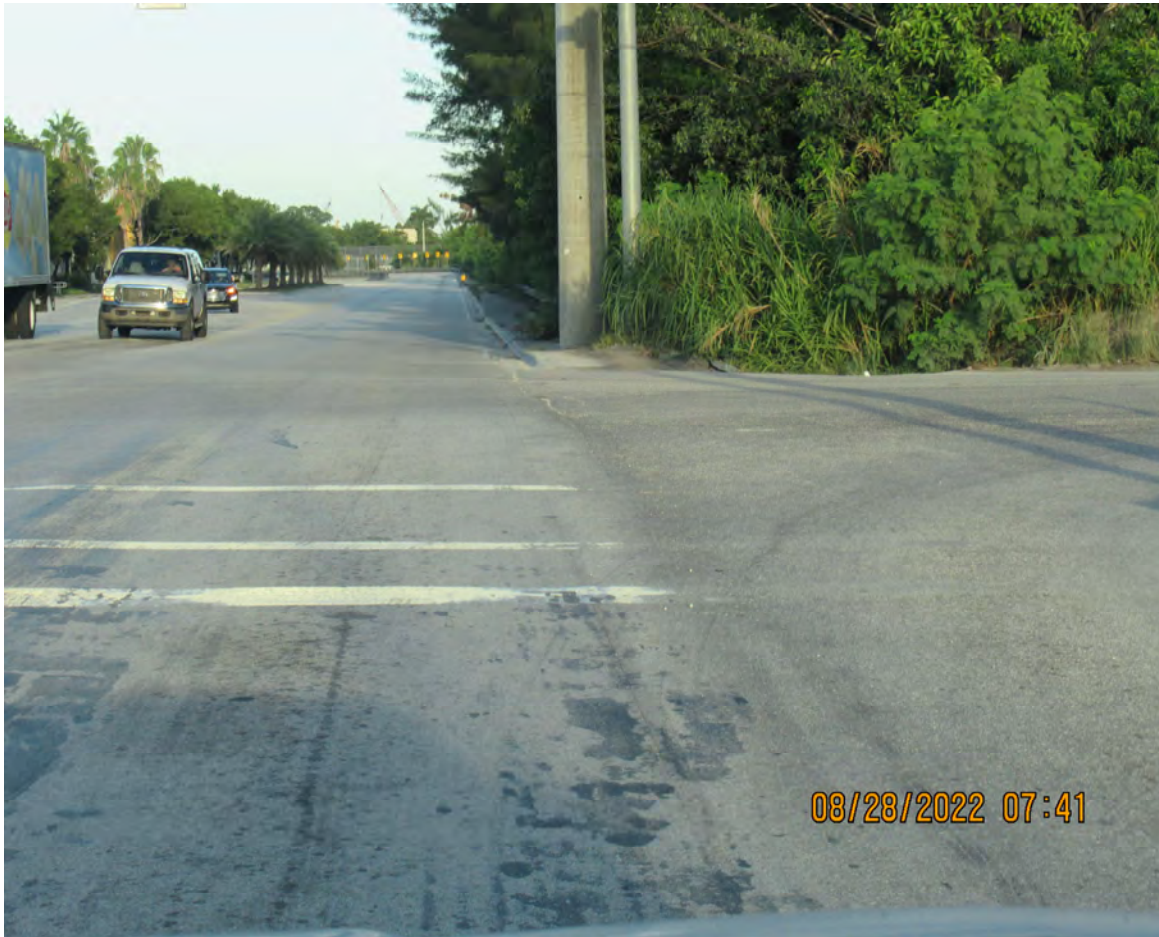
**PHOTO NO.: WB-006
DATE: 8-28-2022**

DETERIORATED STOP BAR AND STRIPING ON PEDESTRIAN CROSSWALK

ITEM NOTED TO BE ADDRESSED BY MDX MAINTENANCE

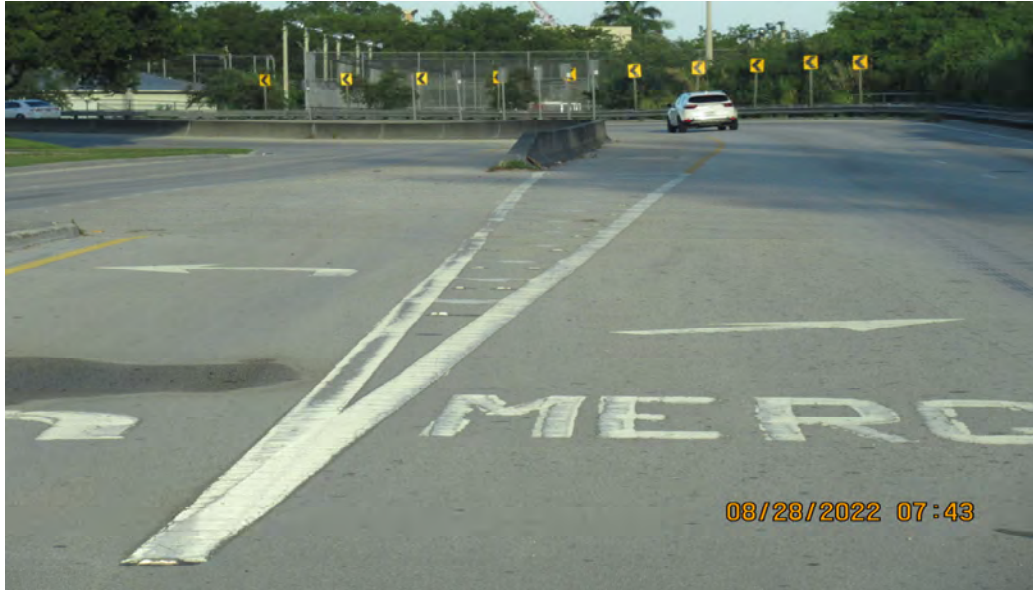
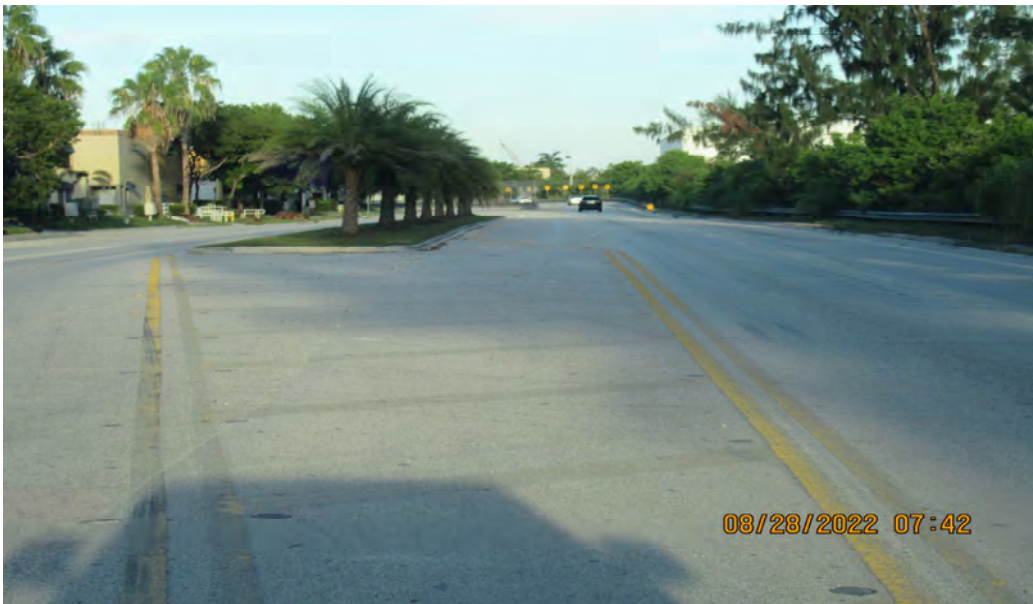
**PHOTO NO.: WB-007
DATE: 8-28-2022**

DETERIORATED CHEVRONS, YELLOW EDGE LINE & WHITE SKIPS

ITEM NOTED TO BE ADDRESSED BY MDX MAINTENANCE

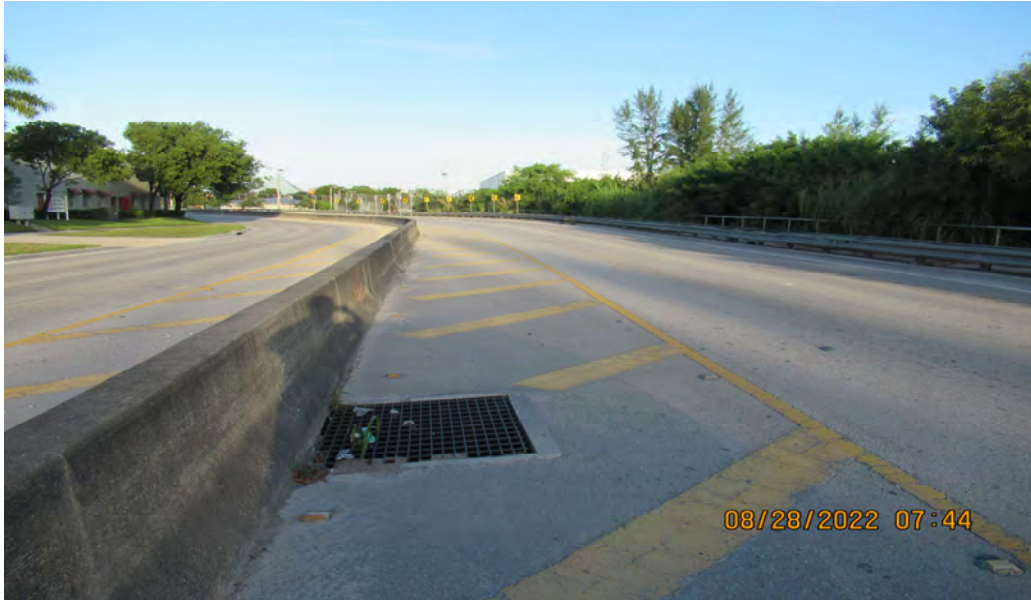
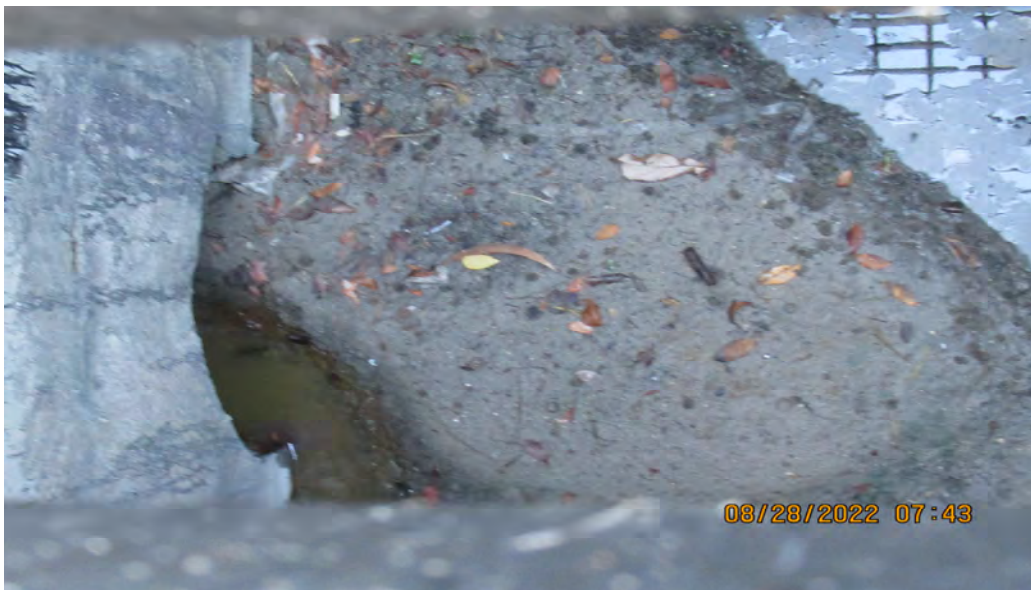
**PHOTO NO.: WB-008
DATE: 8-28-2022**

SILTED DRAINAGE STRUCTURE (TYPICAL AT VARIOUS LOCATIONS)

ITEM NOTED TO BE ADDRESSED BY MDX MAINTENANCE

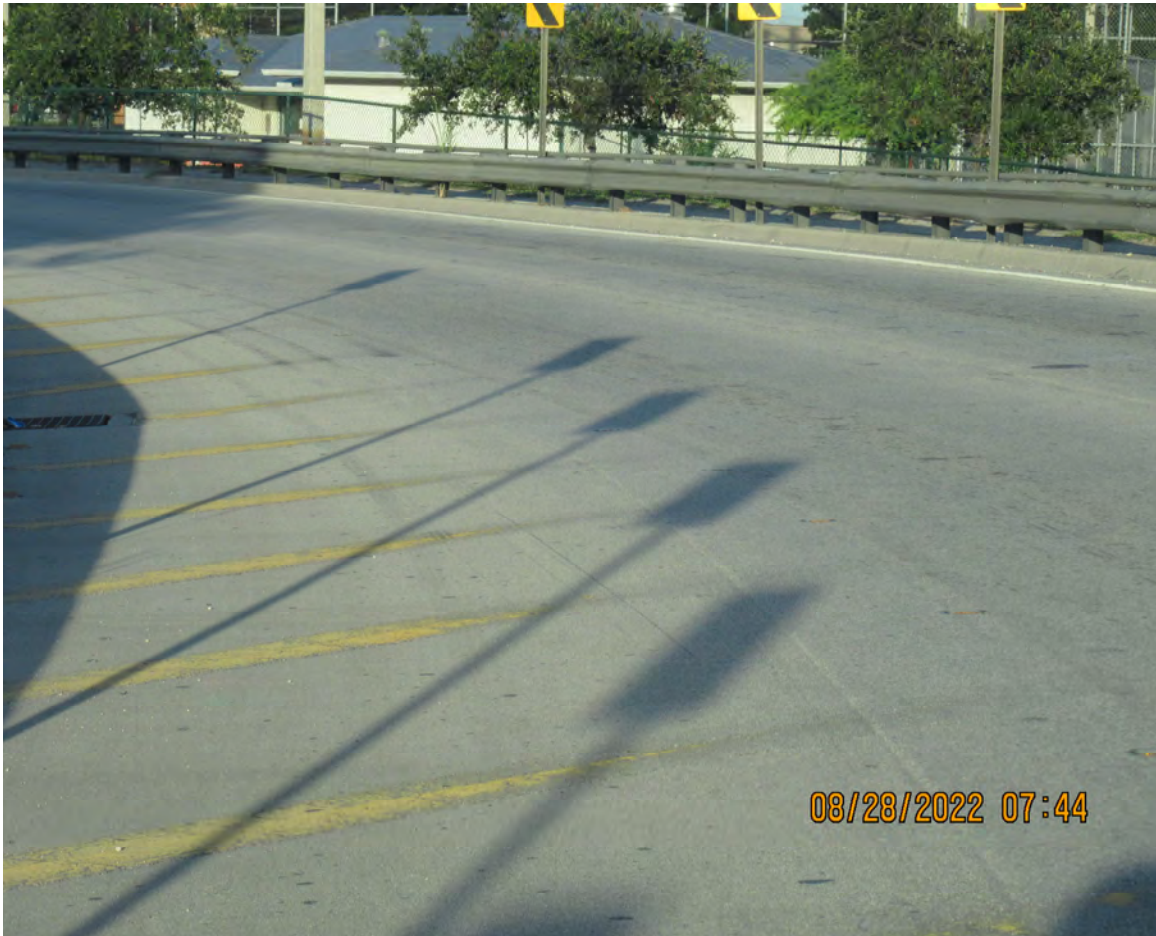
**PHOTO NO.: WB-009
DATE: 8-28-2022**

DETERIORATED CHEVRONS, YELLOW EDGE LINE & WHITE SKIPS

ITEM NOTED TO BE ADDRESSED BY MDX MAINTENANCE

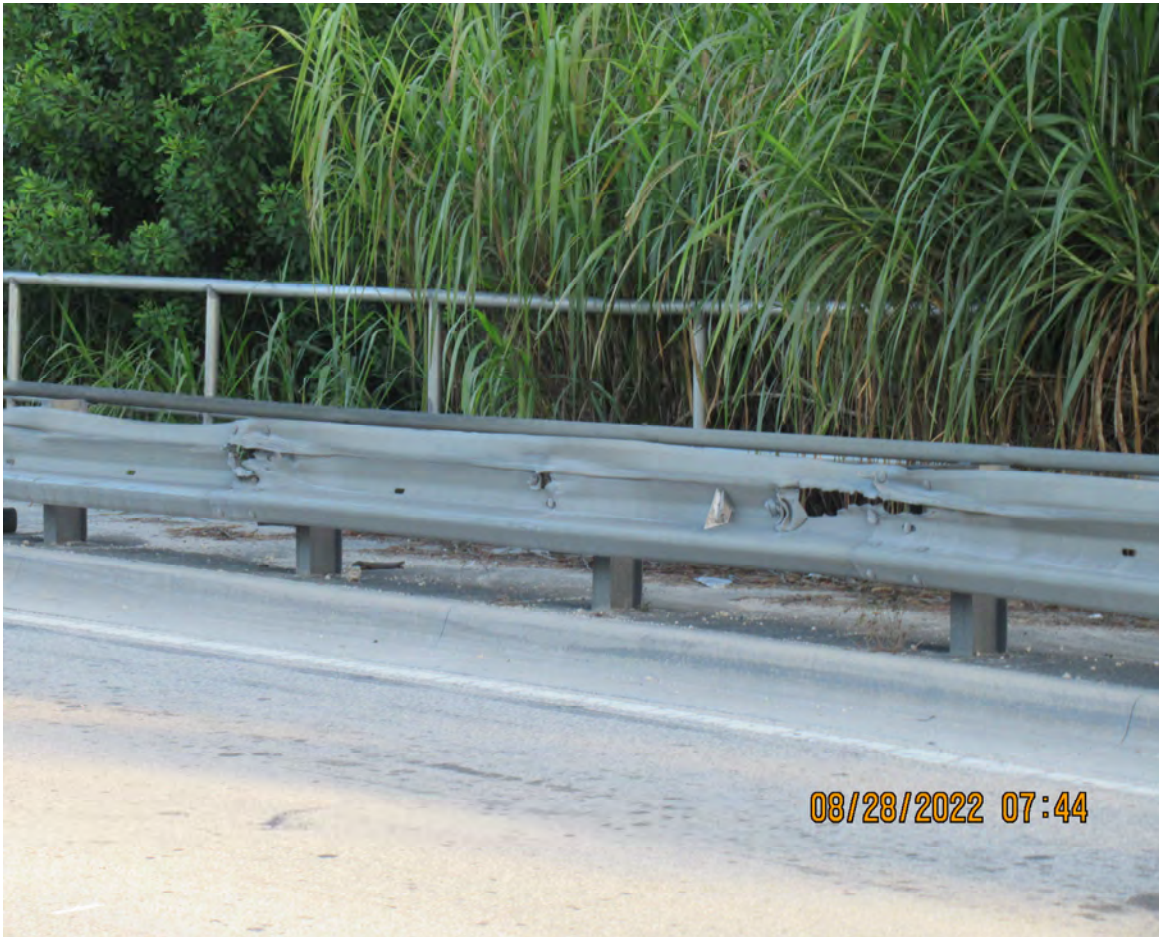
**PHOTO NO.: WB-010
DATE: 8-28-2022**

**ROADWAY INSPECTION
LOCATION: WESTBOUND NW 138th STREET BEFORE
OKEECHOBEE RD.**

DAMAGED GUARDRAIL

ITEM NOTED TO BE ADDRESSED BY MDX MAINTENANCE
