ANNUAL INSPECTION REPORT 2022

ANNUAL INSPECTION REPORT

In 1996, the Miami-Dade County Expressway Authority (MDX) acquired operational and financial control of five expressways in Miami-Dade County from the Florida Department of Transportation (FDOT). This group of expressways, toll facilities and the MDX headquarters facility, all as described below, are hereinafter referred to as the “MDX System”. In accordance with the Trust Indenture requirements, MDX retained EAC Consulting, Inc. (EAC), as the General Engineering Consultant to perform, among other duties assigned by the Authority, the yearly inspection of the MDX System. This report represents the annual inspection results for Fiscal Year (FY) 2022.

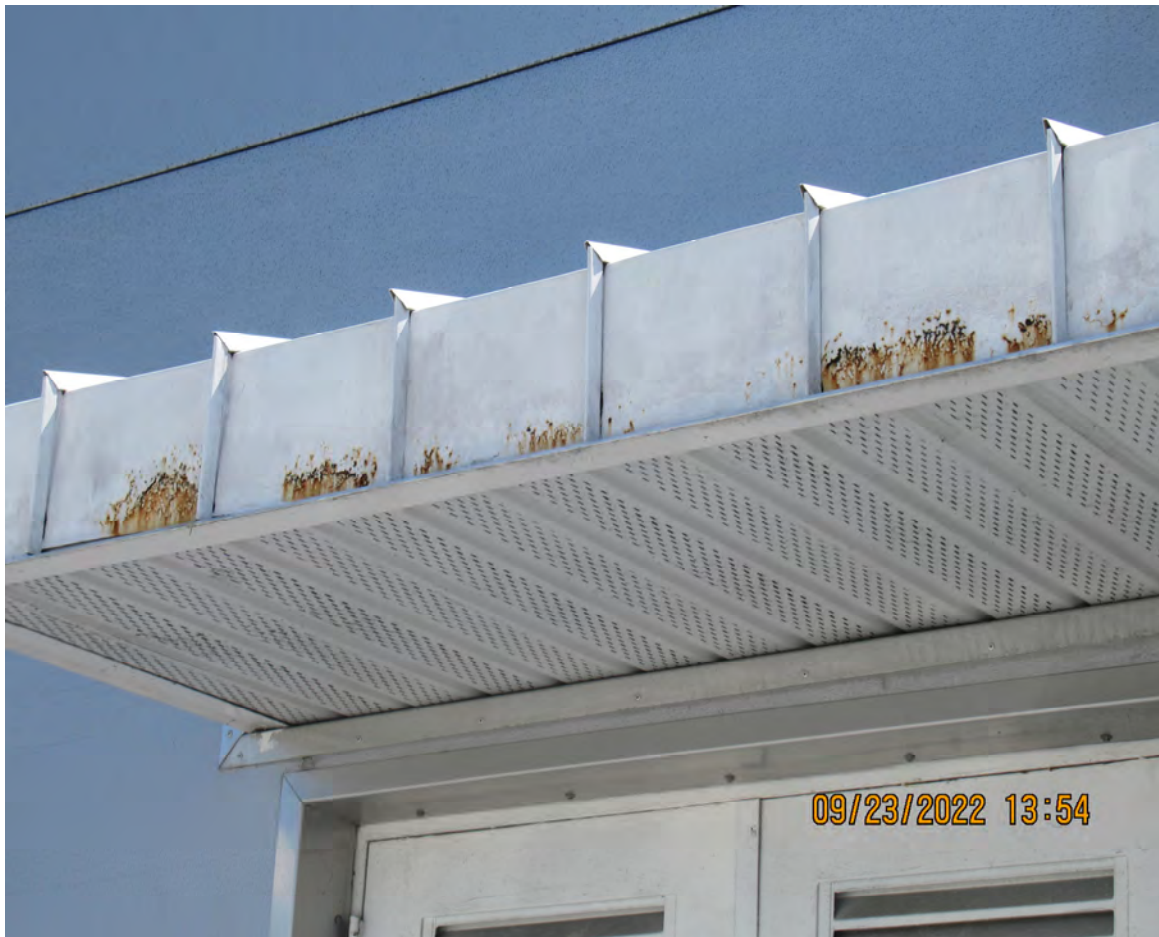
**PHOTO NO.: A-001
DATE: 9-23-2022**

**ARCHITECTURAL INSPECTION
LOCATION: SR-836 MAIN ADMINISTRATION BUILDING
(MECHANICAL ROOM)**

SURFACE CORROSION ON METAL AWNING

**ITEM NOTED TO BE ADDRESSED BY MDX SYSTEMWIDE JANITORIAL AND
FACILITIES MAINTENANCE CONTRACT**

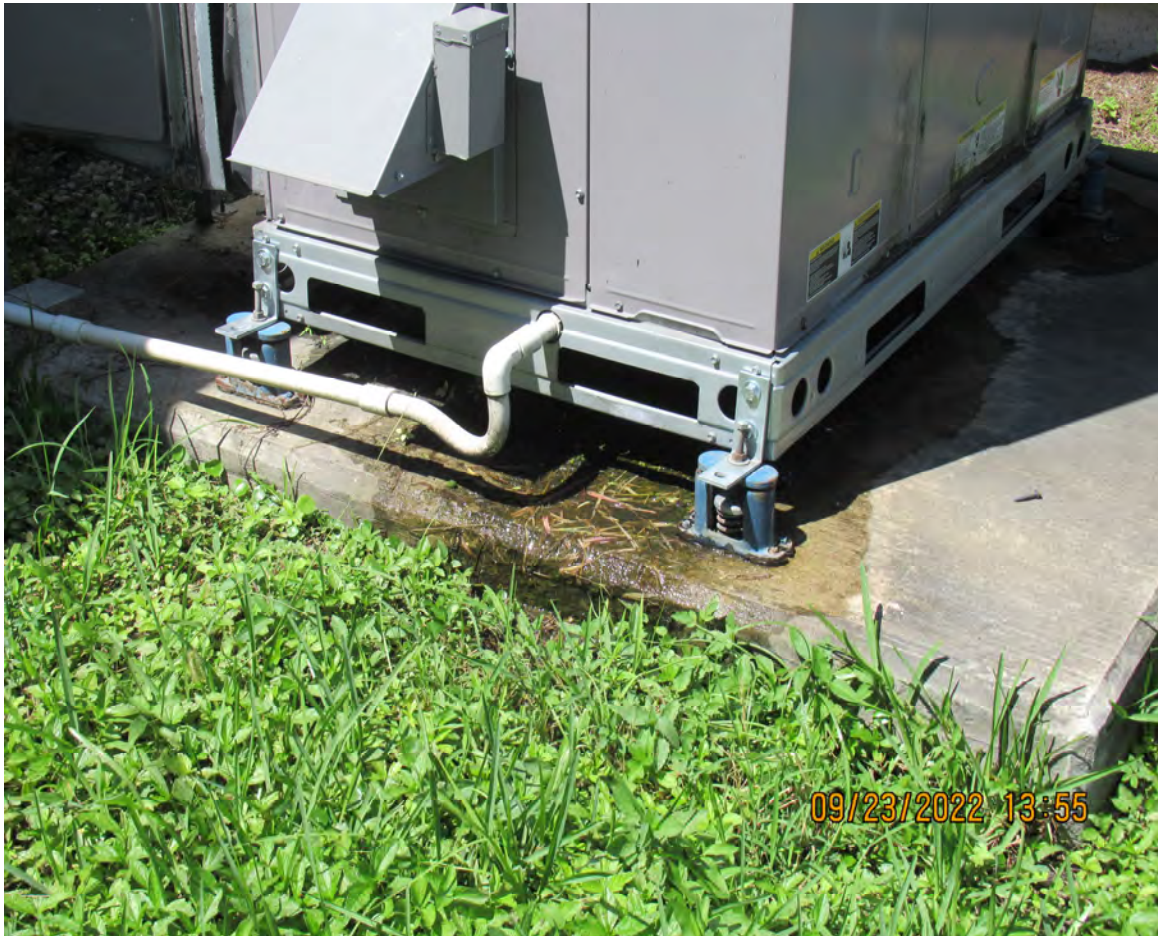
**PHOTO NO.: A-002
DATE: 9-23-2022**

**ARCHITECTURAL INSPECTION
LOCATION: SR-836 MAIN ADMINISTRATION BUILDING
(SOUTH ELEVATION)**

**CLOGGED CONDENSATE DRAIN
(TYPICAL OF BOTH HVAC UNITS)**

**ITEM NOTED TO BE ADDRESSED BY MDX SYSTEMWIDE JANITORIAL AND
FACILITIES MAINTENANCE CONTRACT**

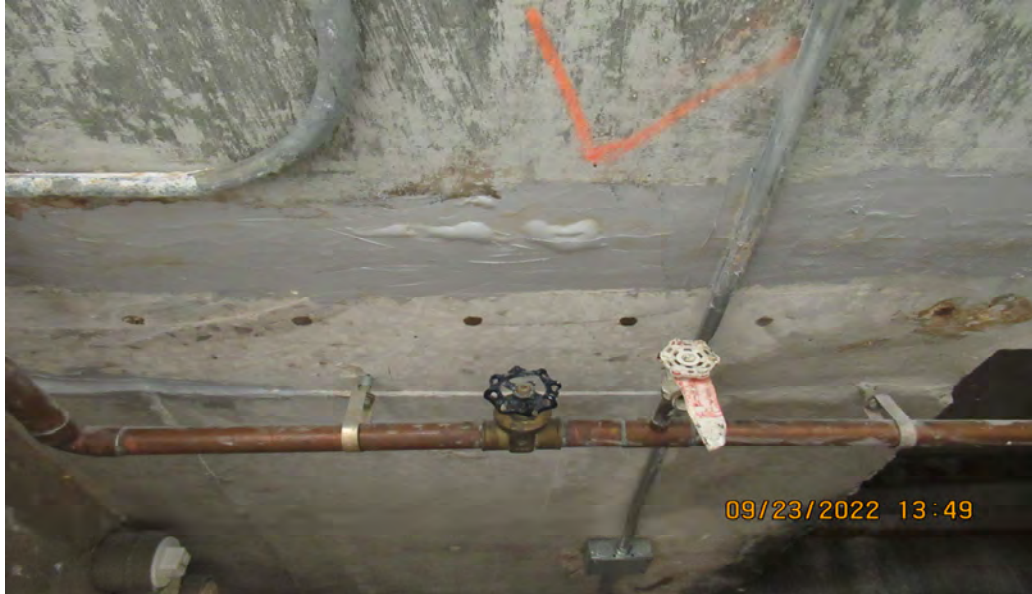
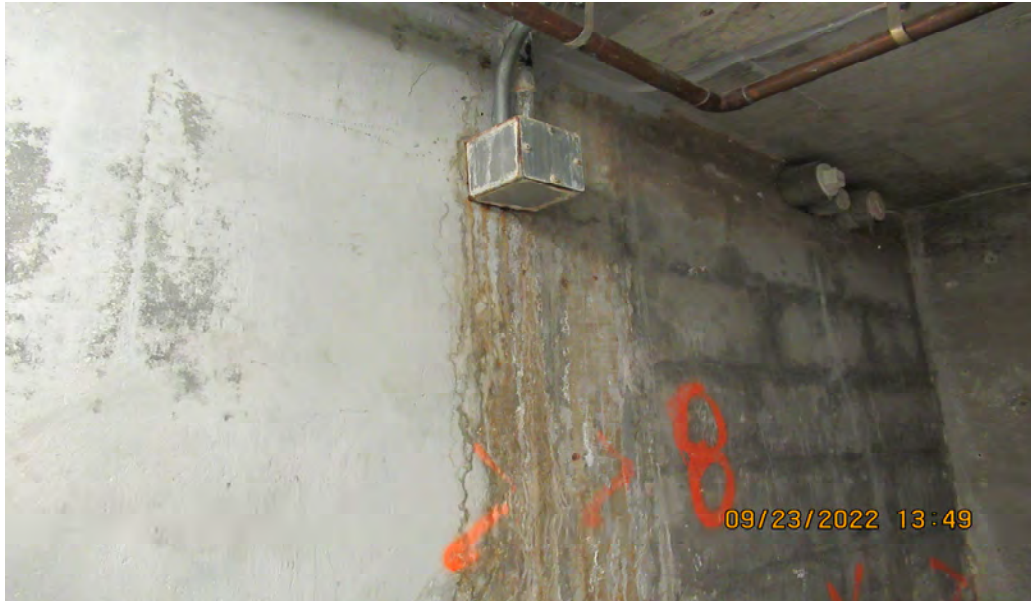
**PHOTO NO.: A-003
DATE: 9-23-2022**

**ARCHITECTURAL INSPECTION
LOCATION: SR-836 MAIN ADMINISTRATION BUILDING
(TUNNEL)**

WATER INTRUSION STAINS ON TUNNEL CEILING AND WALL

**ITEM NOTED TO BE ADDRESSED BY MDX SYSTEMWIDE JANITORIAL AND
FACILITIES MAINTENANCE CONTRACT**

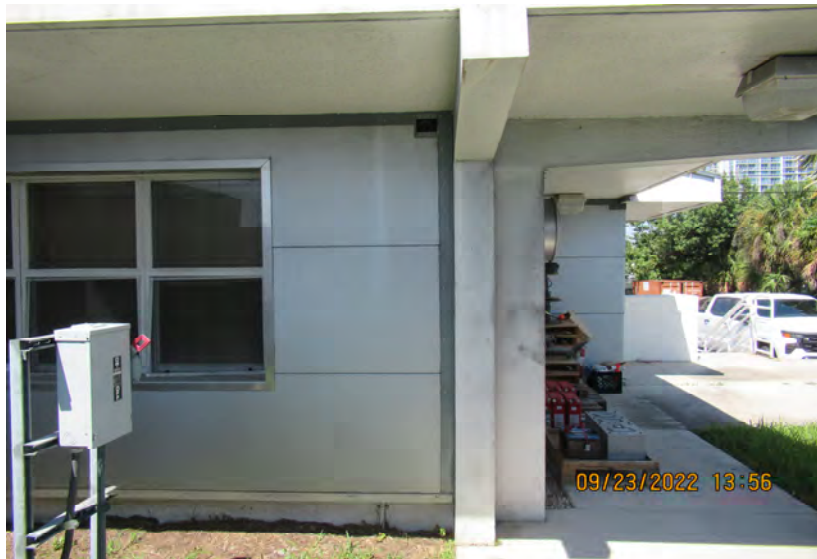
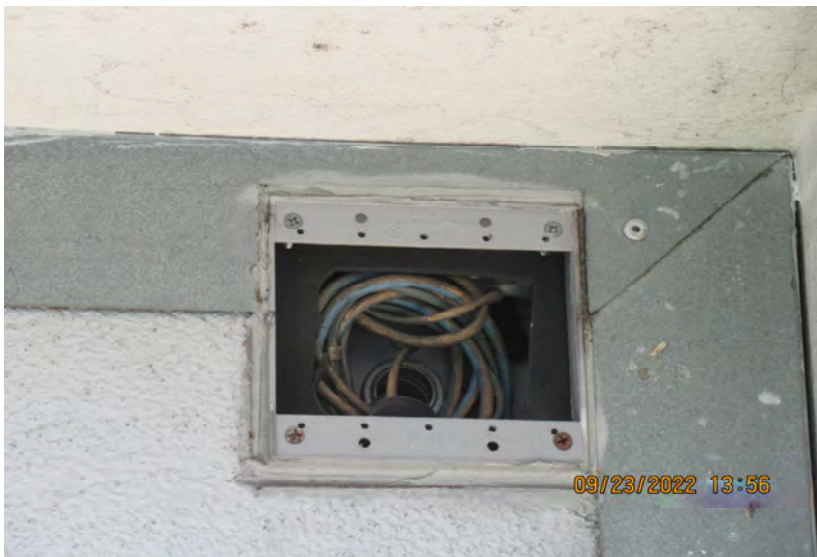
**PHOTO NO.: A-004
DATE: 9-23-2022**

**ARCHITECTURAL INSPECTION
LOCATION: SR-836 MAIN ADMINISTRATION BUILDING
NORTH ELEVATION**

MISSING COVER ON ITS BOX

ITEM NOTED TO BE ADDRESSED BY MDX ITS

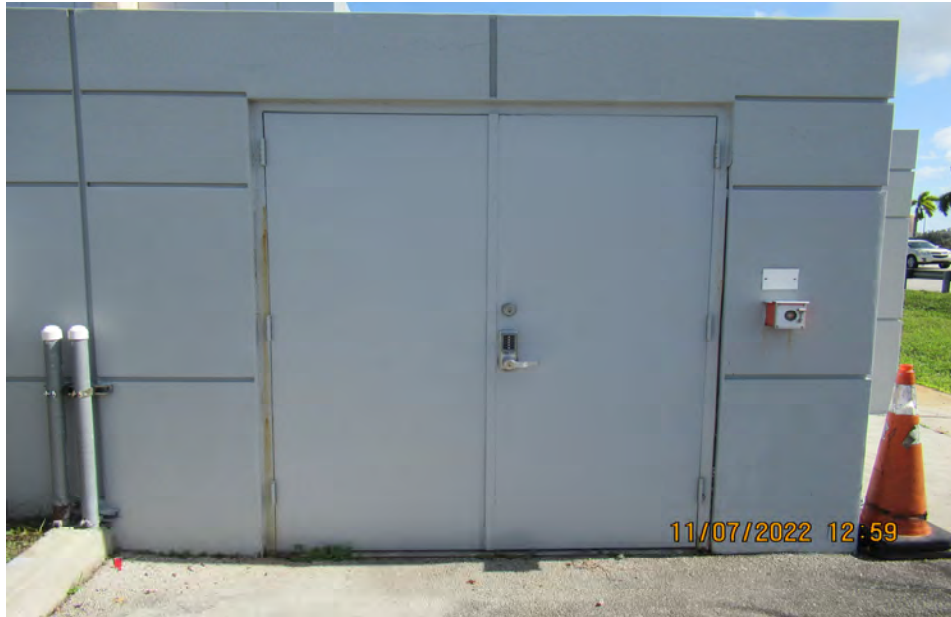
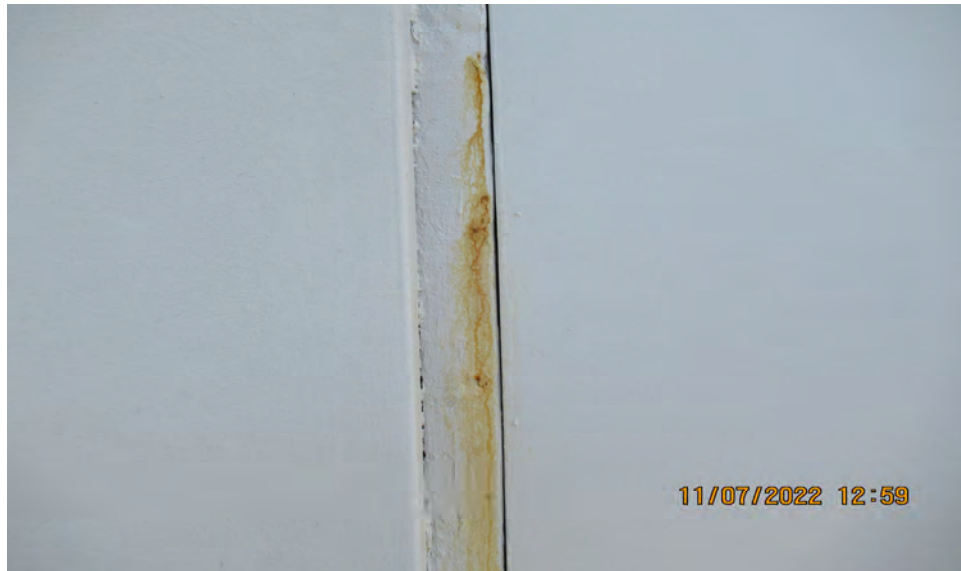
**PHOTO NO.: A-001
DATE: 11-7-2022**

**ARCHITECTURAL INSPECTION
LOCATION: SR-836 / NW 97th AVENUE WESTBOUND
TOLL PLAZA**

CORROSION ON METAL DOOR FRAME

**ITEM NOTED TO BE ADDRESSED BY MDX SYSTEMWIDE JANITORIAL FACILITIES
MAINTENANCE CONTRACT**

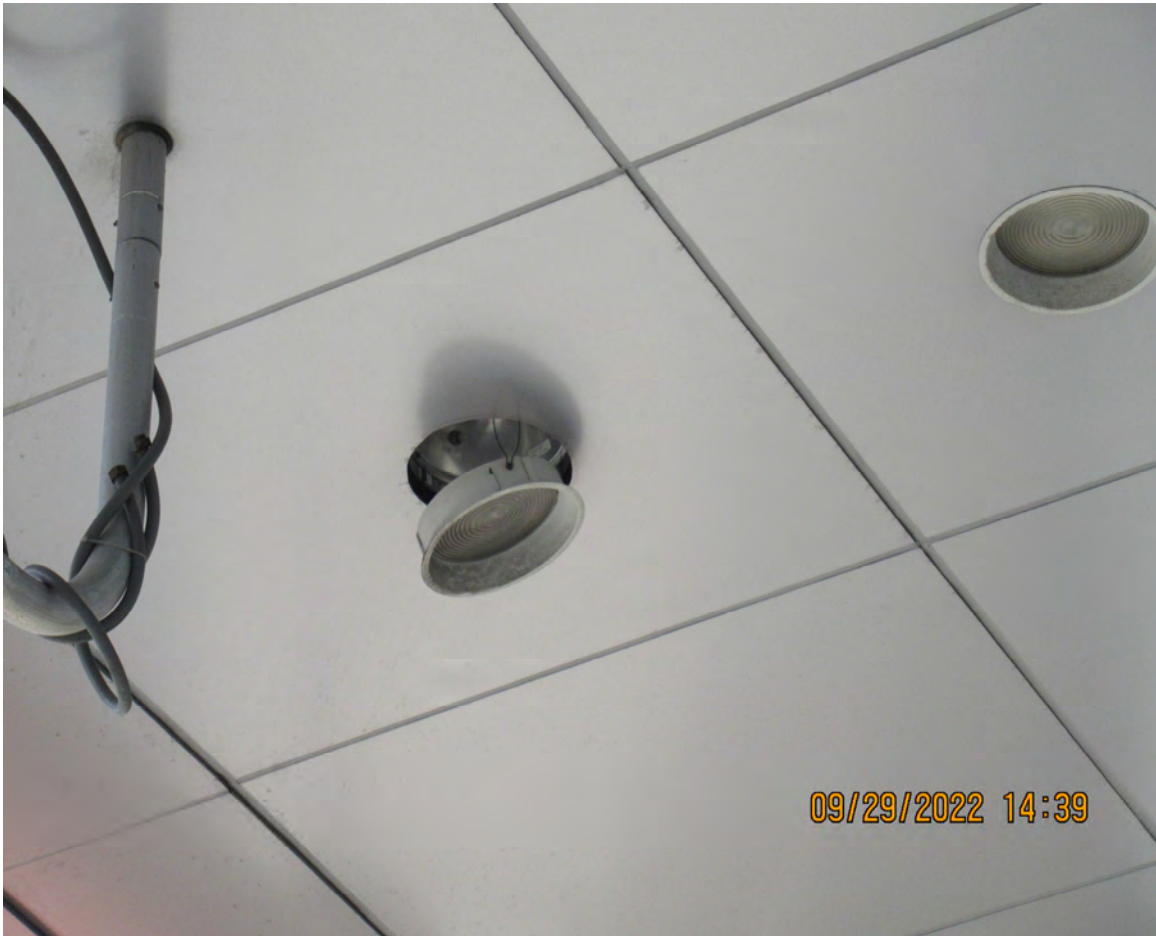
**PHOTO NO.: A-002
DATE: 9-29-2022**

**ARCHITECTURAL INSPECTION
LOCATION: SR-836 / NW 97th AVENUE WESTBOUND
TOLL PLAZA CANOPY**

HANGING RECESSED LUMINAIRE

**ITEM NOTED TO BE ADDRESSED BY MDX SYSTEMWIDE JANITORIAL FACILITIES
MAINTENANCE CONTRACT**

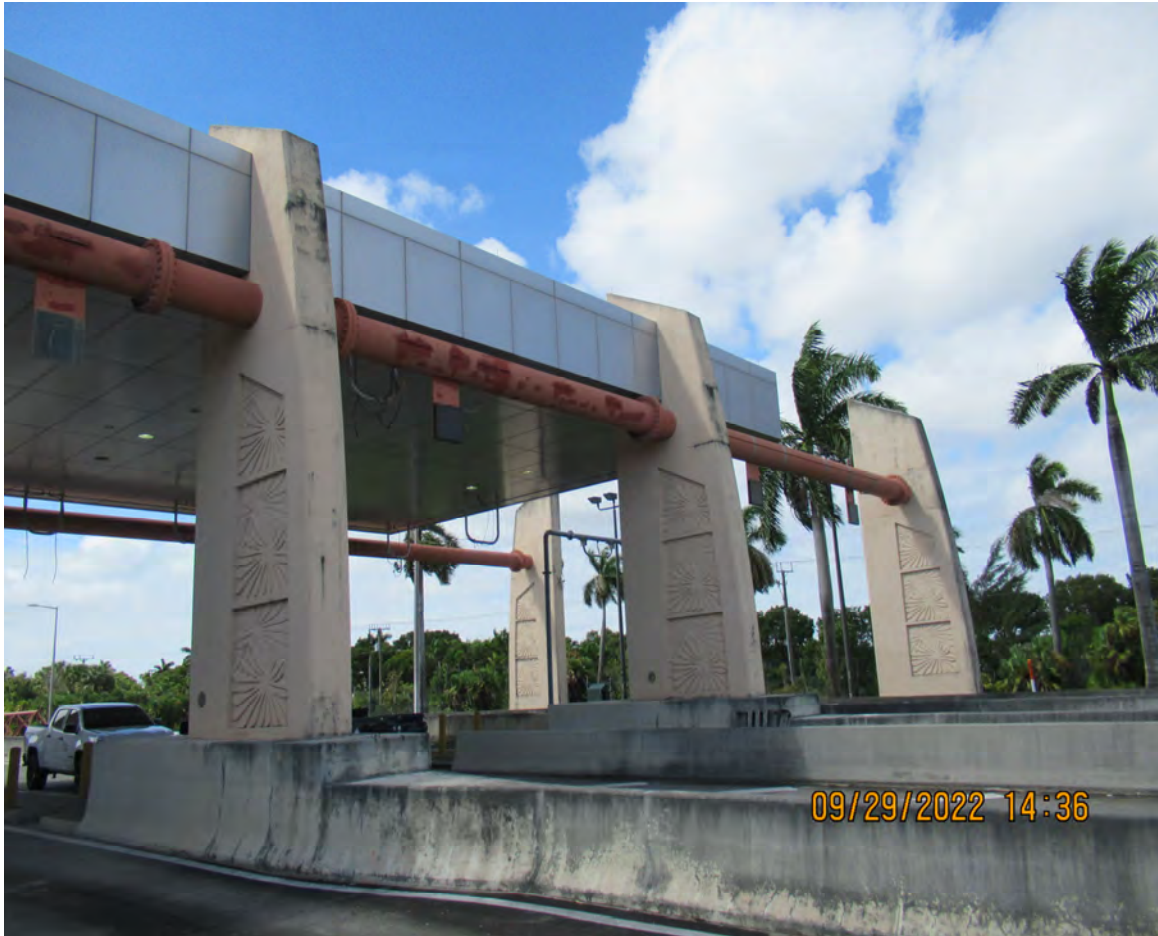
**PHOTO NO.: A-003
DATE: 9-29-2022**

**ARCHITECTURAL INSPECTION
LOCATION: SR-836 / NW 97th AVENUE WESTBOUND
TOLL PLAZA**

DETERIORATED PAINT ON CANOPY COLUMNS AND MONOTUBE STRUCTURE

**ITEM NOTED TO BE ADDRESSED BY MDX SYSTEMWIDE JANITORIAL FACILITIES
MAINTENANCE CONTRACT**

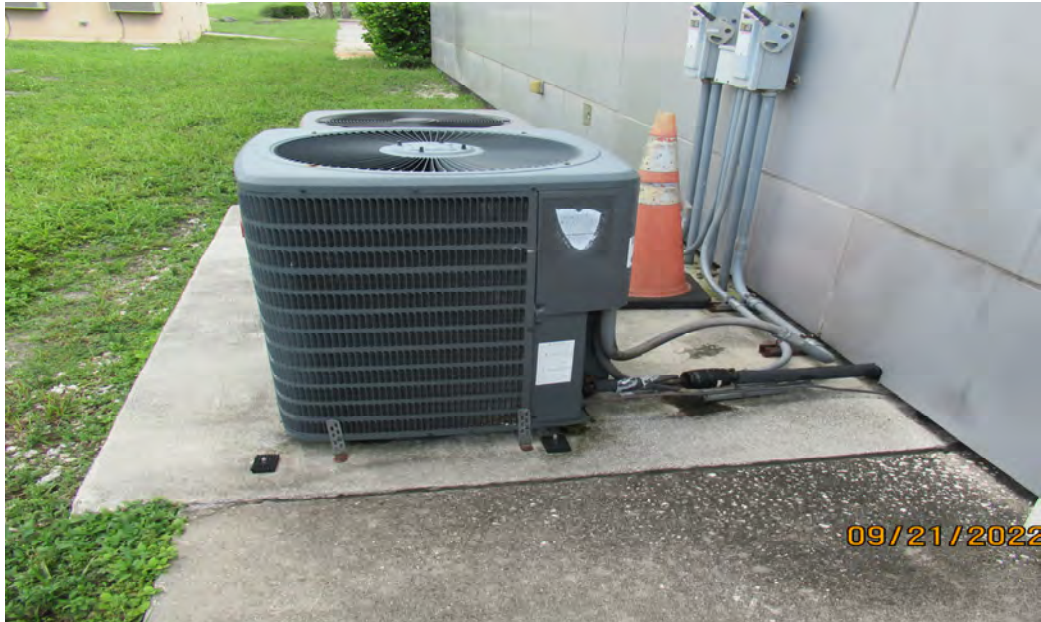
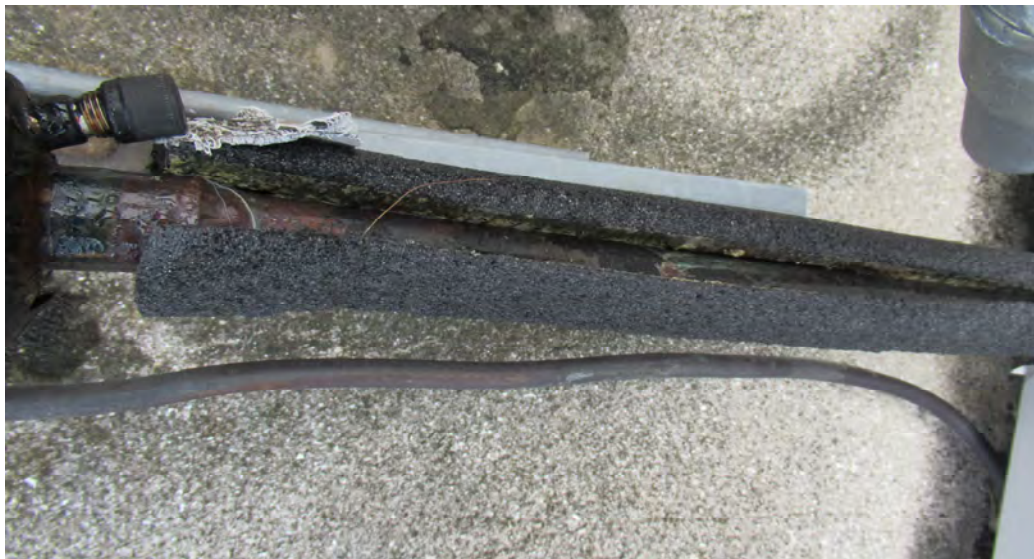
**PHOTO NO.: A-001
DATE: 9-21-2022**

**ARCHITECTURAL INSPECTION
LOCATION: SR-836 / NW 97th AVENUE EASTBOUND
ADMINISTRATION BUILDING (NORTH ELEVATION)**

DETERIORATED LINE INSULATION ON REFRIGERANT LINE

**ITEM NOTED TO BE ADDRESSED BY MDX SYSTEMWIDE JANITORIAL AND
FACILITIES MAINTENANCE CONTRACT**

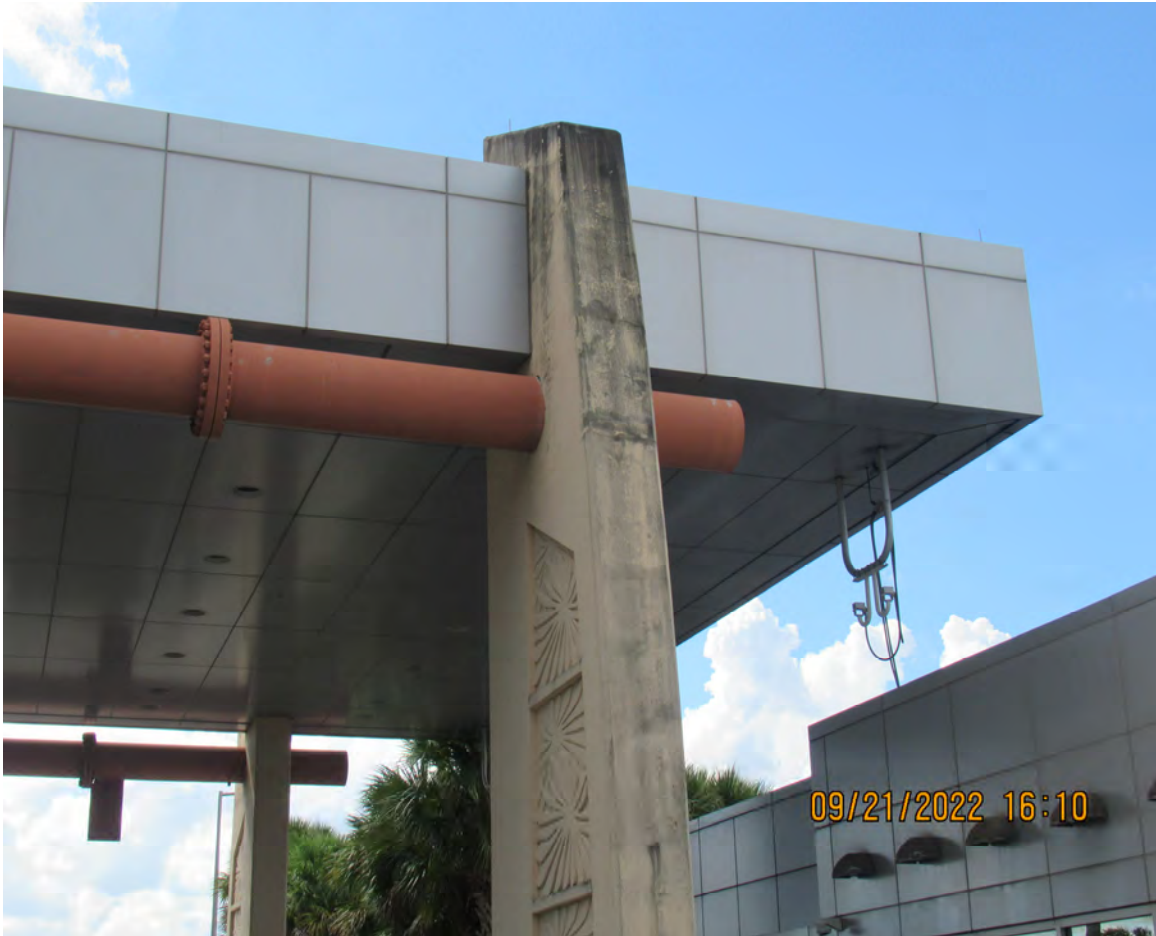
**PHOTO NO.: A-003
DATE: 9-21-2022**

**ARCHITECTURAL INSPECTION
LOCATION: SR-836 / NW 97th AVENUE EASTBOUND
TOLL PLAZA CANOPY**

DETERIORATED CLASS 5 COATING ON CANOPY COLUMNS

**ITEM NOTED TO BE ADDRESSED BY MDX SYSTEMWIDE JANITORIAL
AND FACILITIES MAINTENANCE CONTRACT**

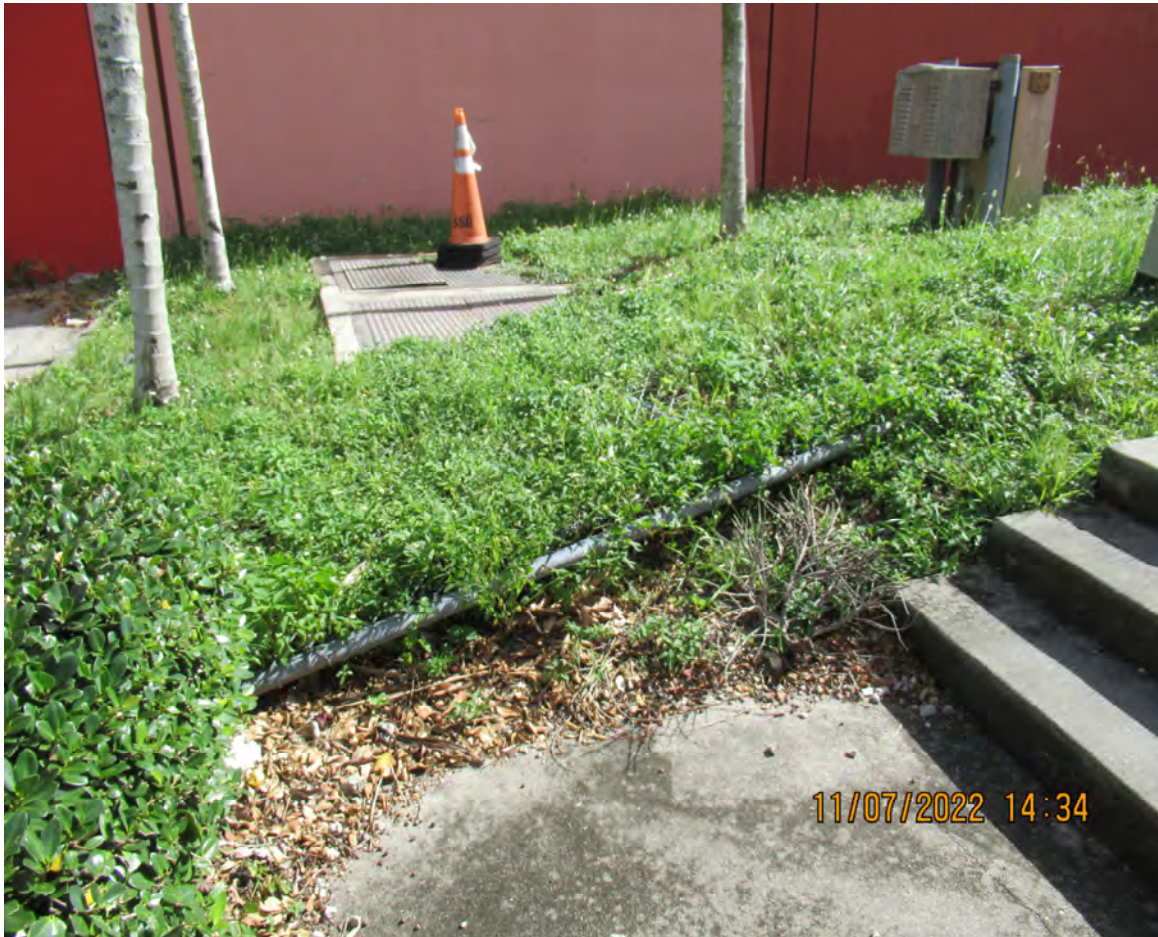
**PHOTO NO.: A-001
DATE: 11-7-2022**

**ARCHITECTURAL INSPECTION
LOCATION: ADMINISTRATION BUILDING
(WEST ELEVATION)**

ABANDONED CHAIN-LINK FENCE GATE

**ITEM NOTED TO BE ADDRESSED BY MDX SYTEMWIDE JANITORIAL AND
FACILITIES MAINTENANCE CONTRACT**

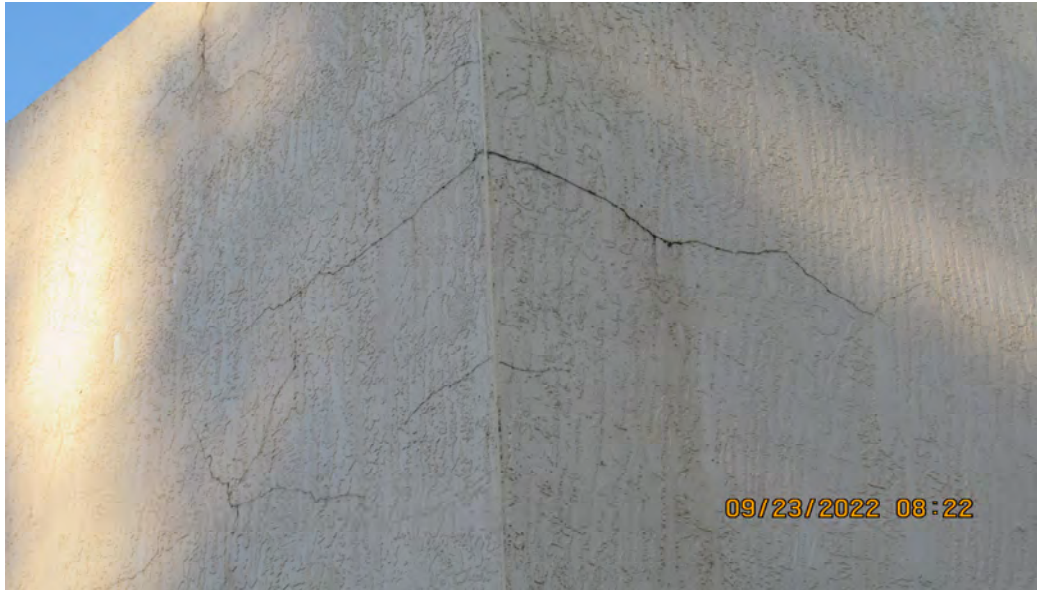
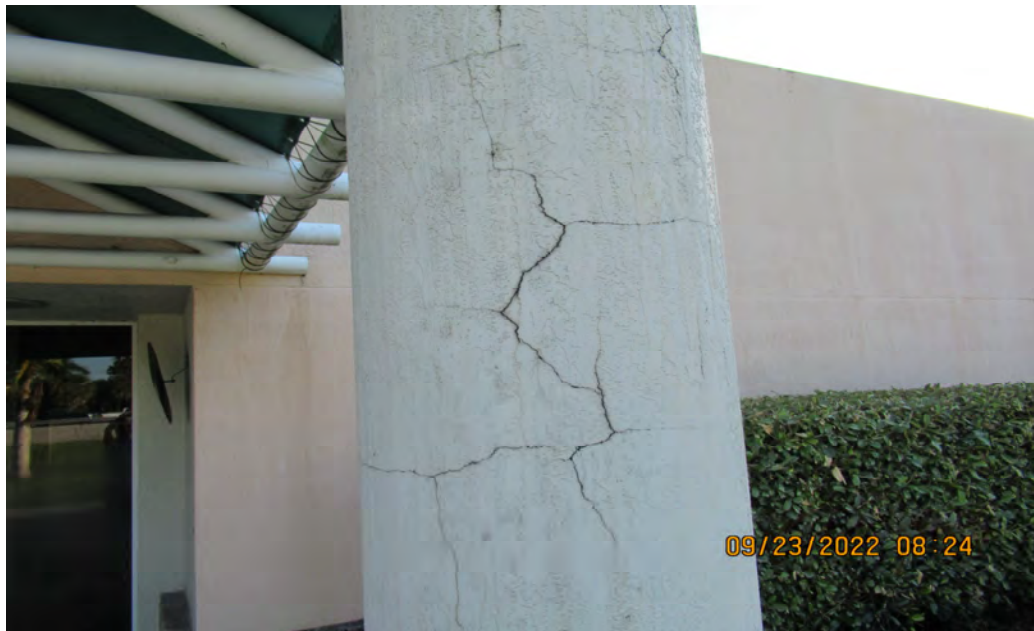
**PHOTO NO.: A-001
DATE: 9-23-2022**

**ARCHITECTURAL INSPECTION
LOCATION: ADMINISTRATION BUILDING**

CRACKS ON STUCCO

ITEM NOTED TO BE ADDRESSED BY MDX MAINTENANCE

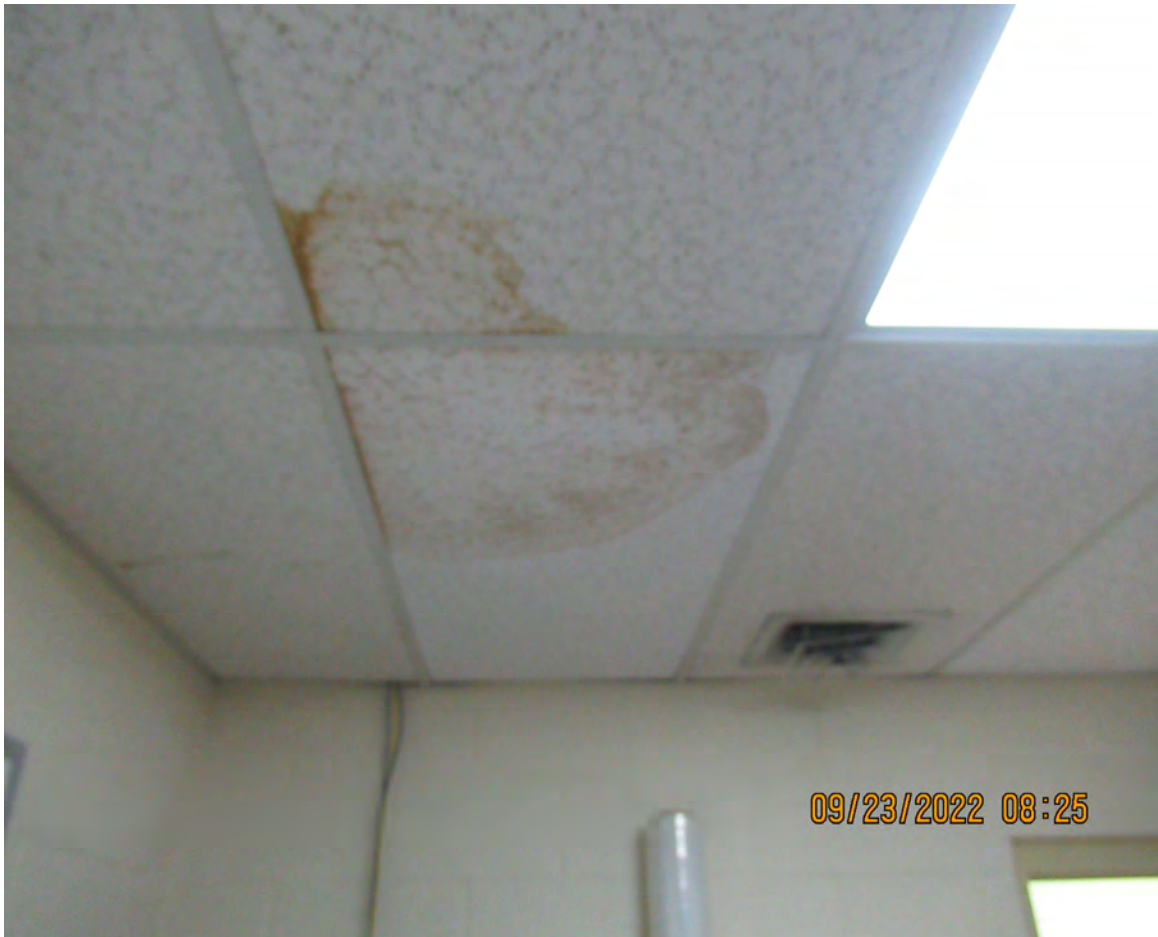
**PHOTO NO.: A-002
DATE: 9-23-2022**

**ARCHITECTURAL INSPECTION
LOCATION: ADMINISTRATION BUILDING**

WATER STAINS ON ACCOUSTICAL TILES

ITEM NOTED TO BE ADDRESSED BY MDX MAINTENANCE

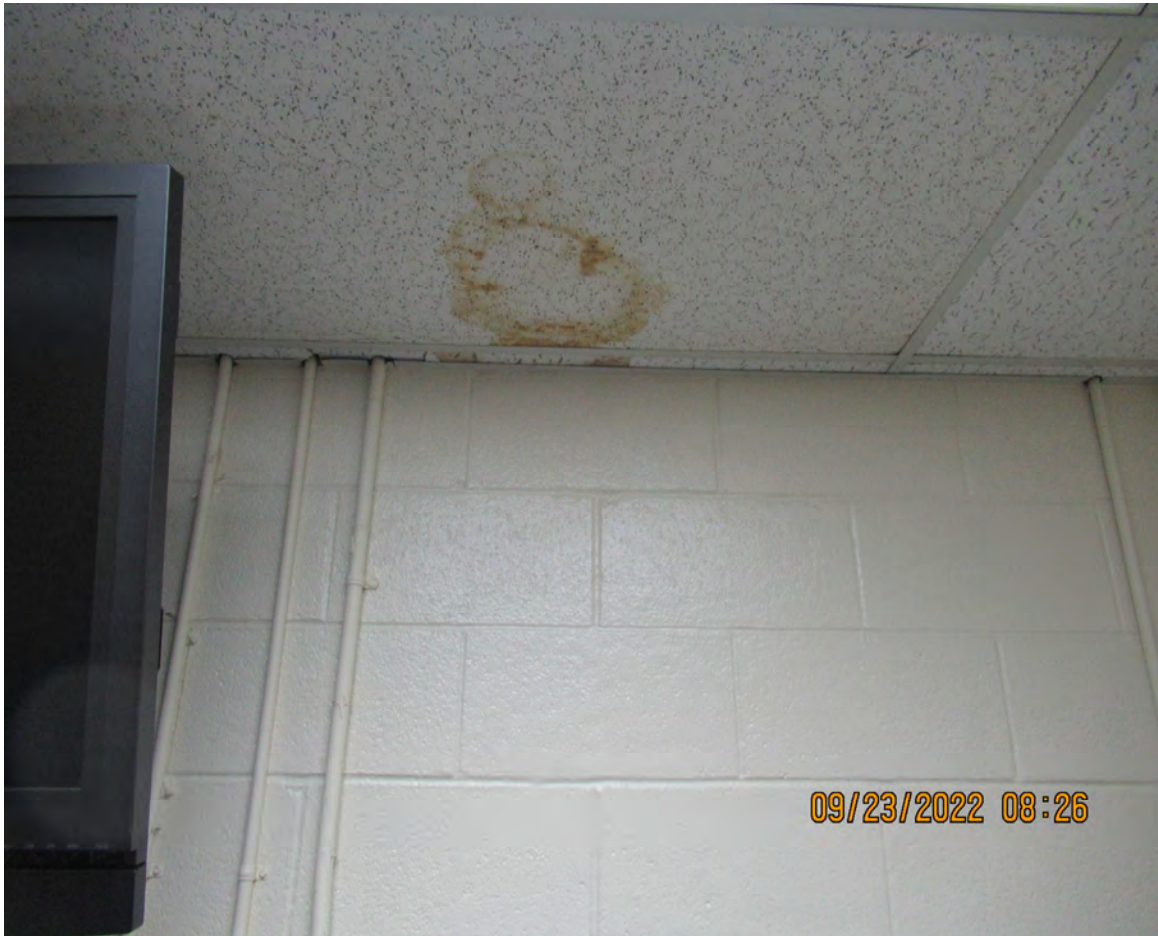
**PHOTO NO.: A-003
DATE: 9-23-2022**

**ARCHITECTURAL INSPECTION
LOCATION: ADMINISTRATION BUILDING**

WATER STAINS ON ACCOUSTICAL TILES

ITEM NOTED TO BE ADDRESSED BY MDX MAINTENANCE

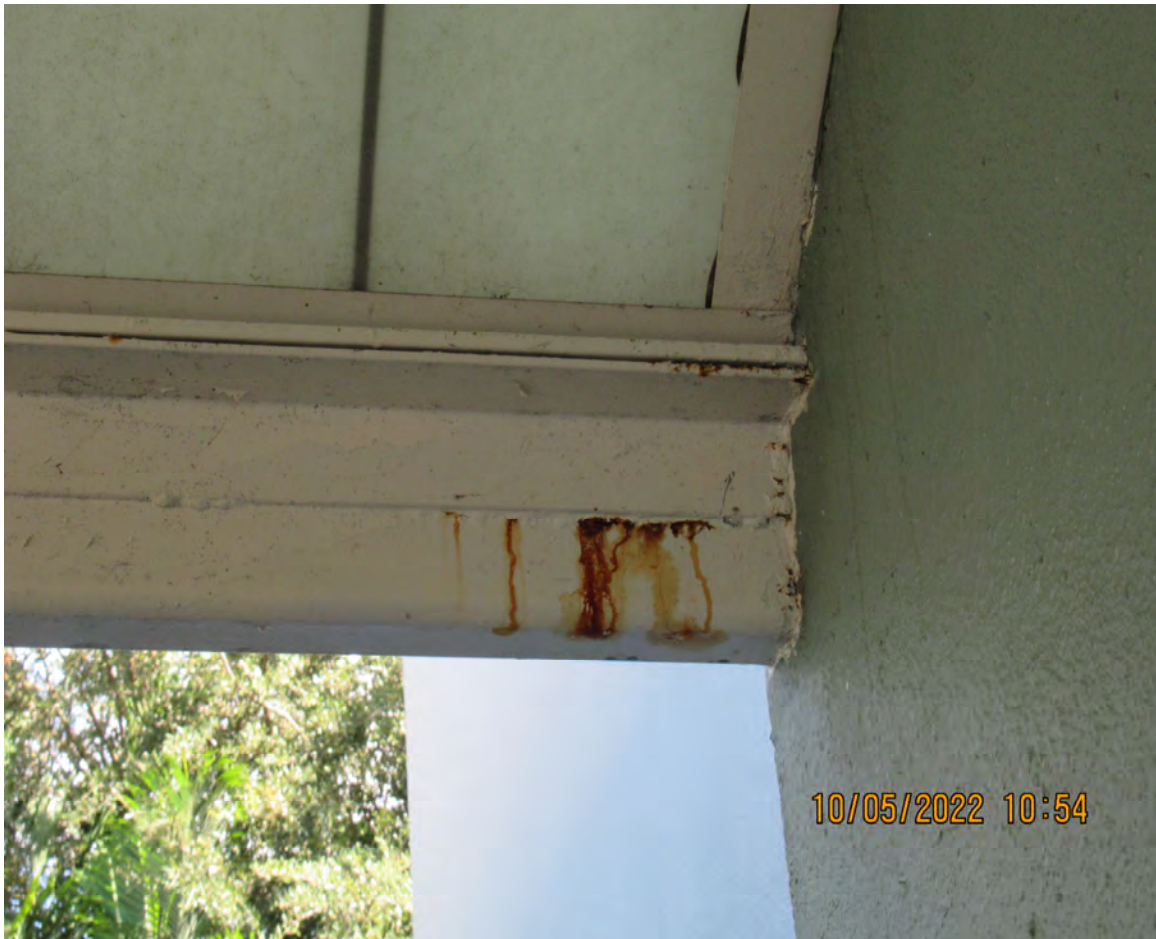
**PHOTO NO.: A-002
DATE: 10-5-2022**

**ARCHITECTURAL INSPECTION
LOCATION: COURTYARD**

RUST ON CANOPY FRAME

**ITEM NOTED TO BE ADDRESSED BY MDX SYTEMWIDE JANITORIAL AND
FACILITIES MAINTENANCE CONTRACT**

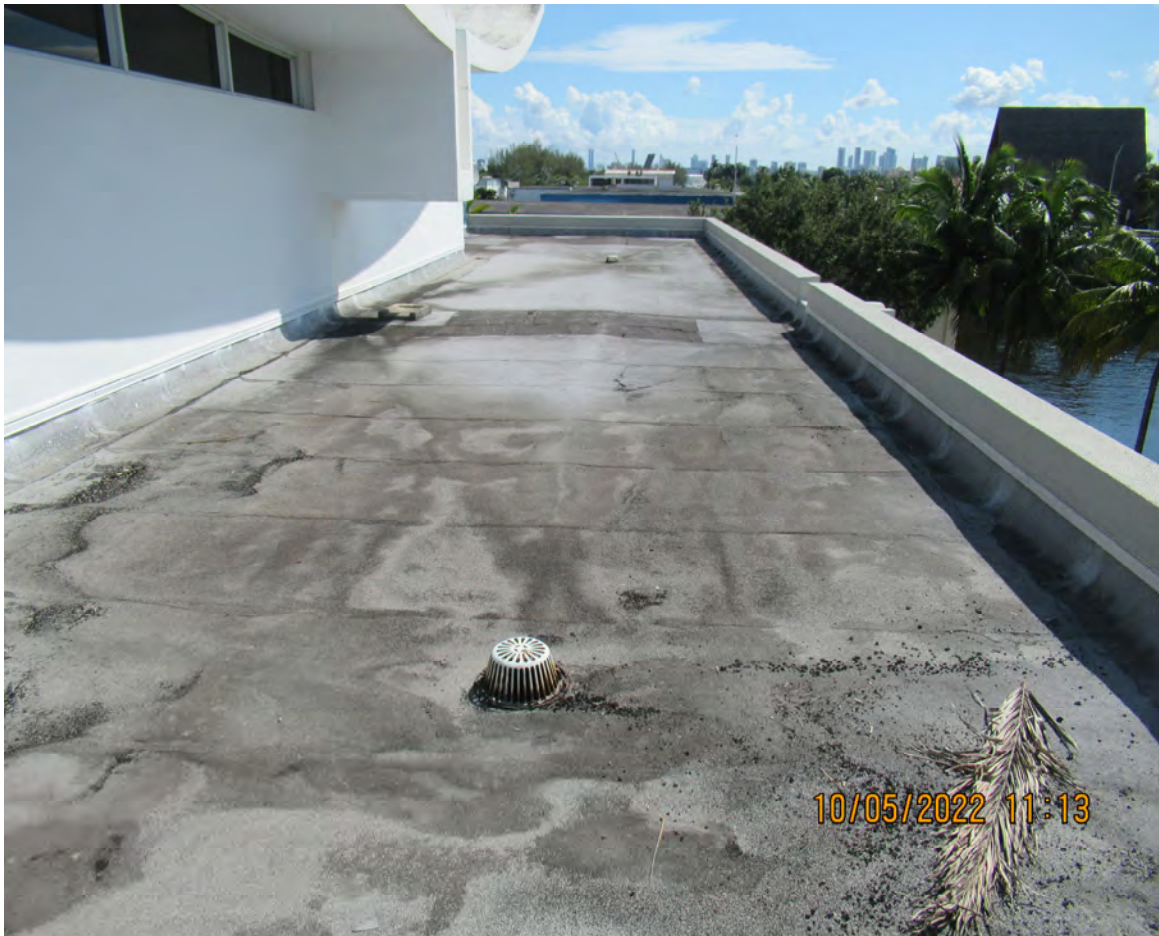
**PHOTO NO.: A-005
DATE: 10-5-2022**

**ARCHITECTURAL INSPECTION
LOCATION: BLDG. 2**

BLISTERING ON THE ROOFING MEMBRANE

ITEM NOTED TO BE ADDRESSED BY MDX WORK PROGRAM No. 30052
