# ANNUAL INSPECTION REPORT 2023

## ANNUAL INSPECTION REPORT

In July 1, 2023, the Greater Miami Expressway Agency (GMX) acquired operational and financial control of five expressways in Miami-Dade County. This group of expressways, toll facilities, acquisition parcels and the GMX headquarters facility, all as described below, are hereinafter referred to as one of the "GMX System". In accordance with the Trust Indenture requirements, GMX retained EAC Consulting, Inc. (EAC), as the General Engineering Consultant to perform, among other duties assigned by the Agency, the yearly inspection of the GMX System. This report represents the annual inspection results for Fiscal Year (FY) 2023.

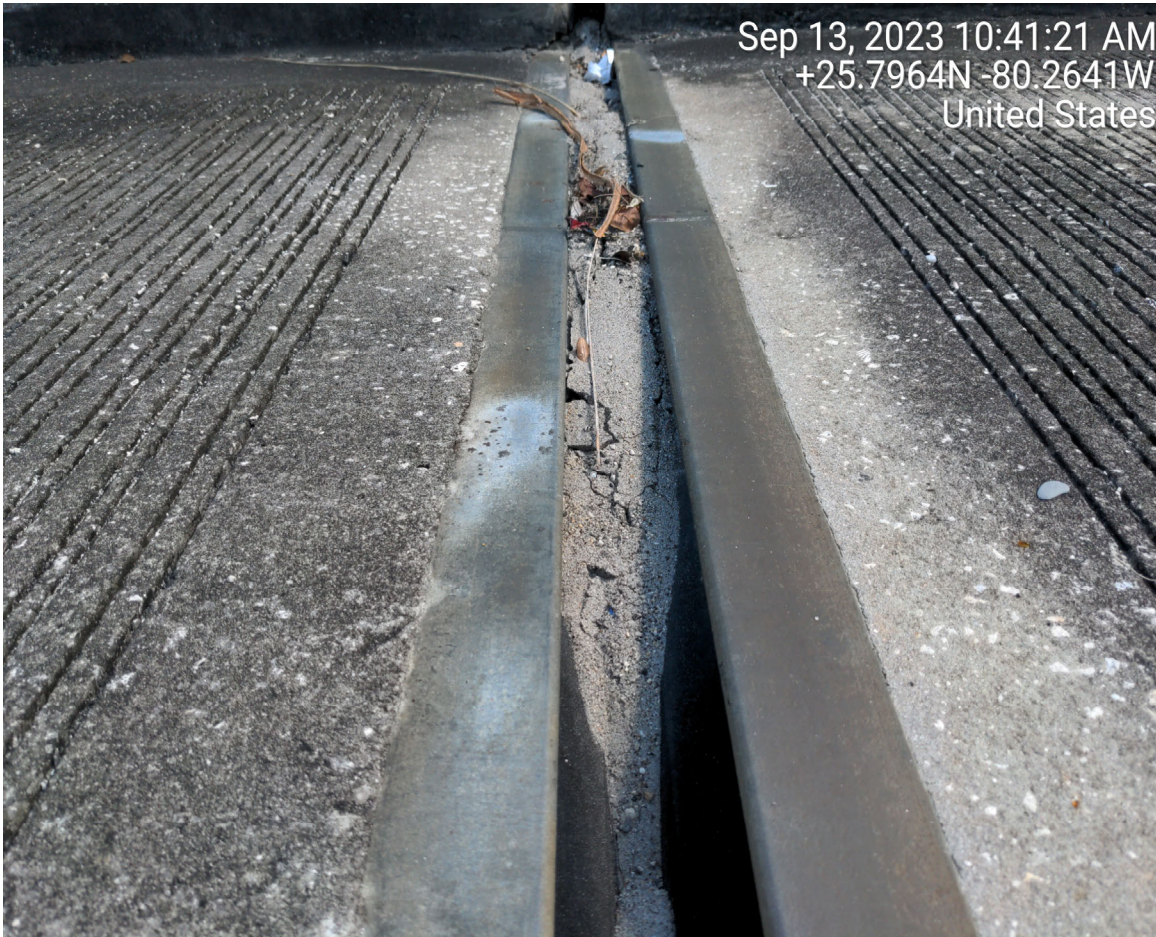
**PHOTO NO.: EB-001  
DATE: 9-13-2023**

**SILT AND DEBRIS ON BRIDGE JOINTS  
(TYPICAL AT VARIOUS LOCATIONS) BRIDGE No. 870725**

**ITEMS NOTED TO BE ADDRESSED BY GMX MAINTENANCE ITB-22-07**

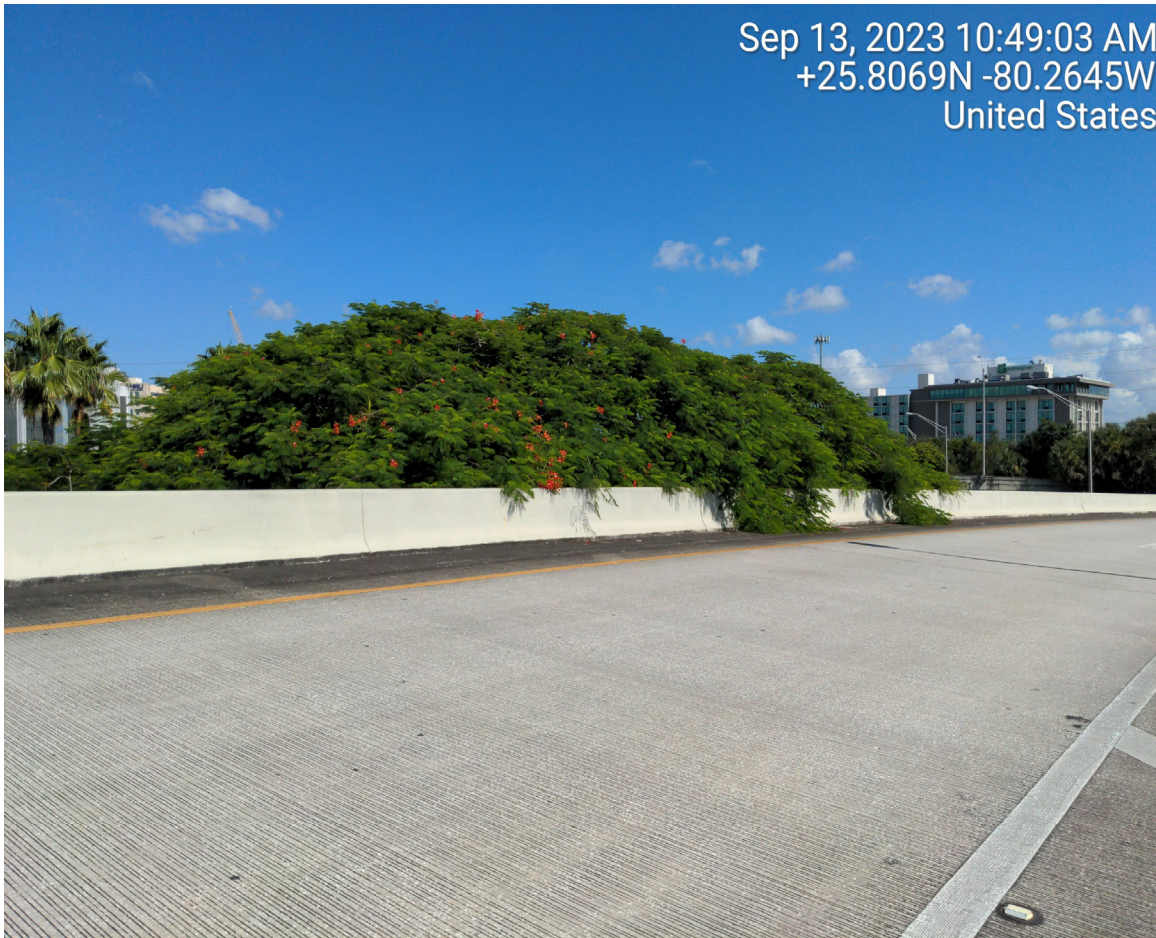
**PHOTO NO.: EB-002  
DATE: 9-13-2023**

**OVERGROWN VEGETATION  
(BRIDGE No. 870025)**

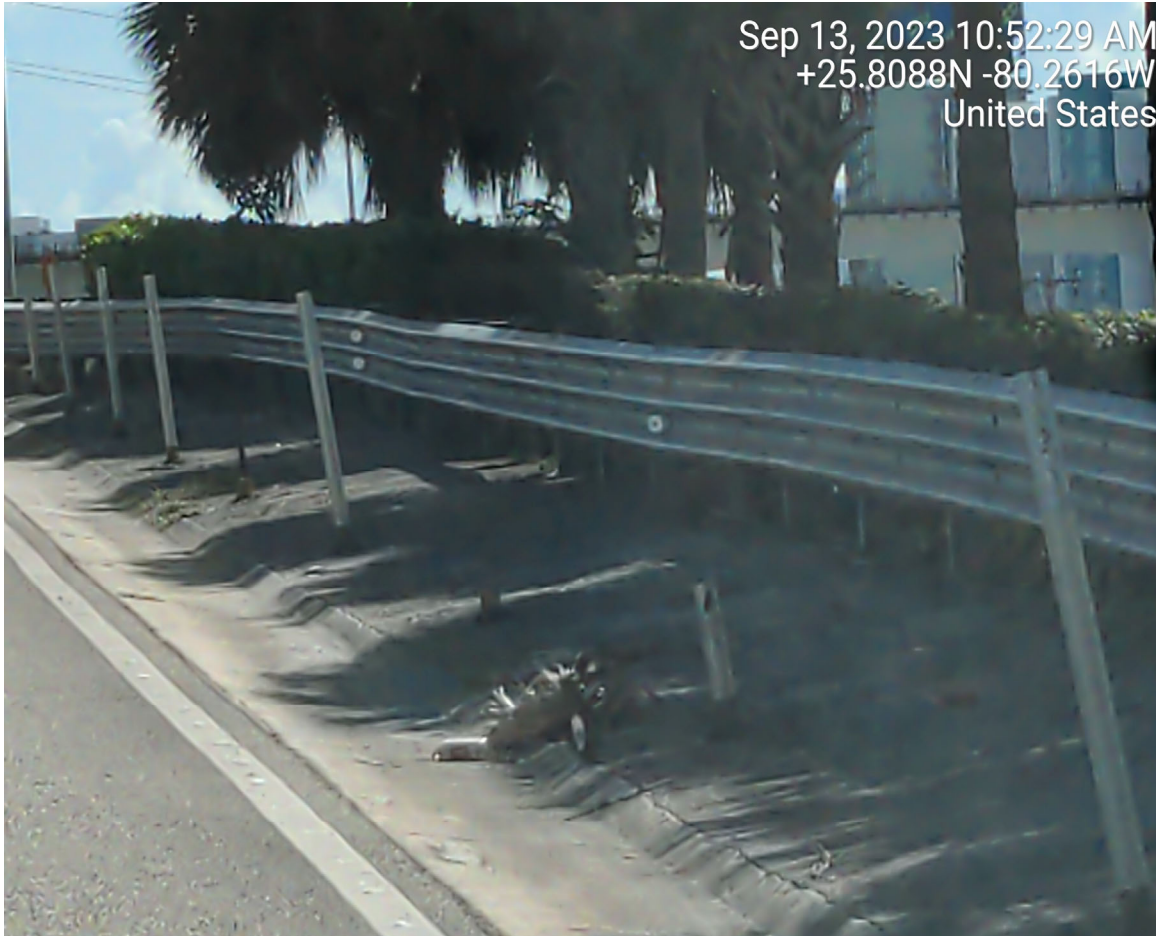
**PHOTO NO.: EB-003  
DATE: 9-13-2023**

**MISSING DELINEATORS**

**ITEMS NOTED TO BE ADDRESSED BY GMX MAINTENANCE ITB-23-17**

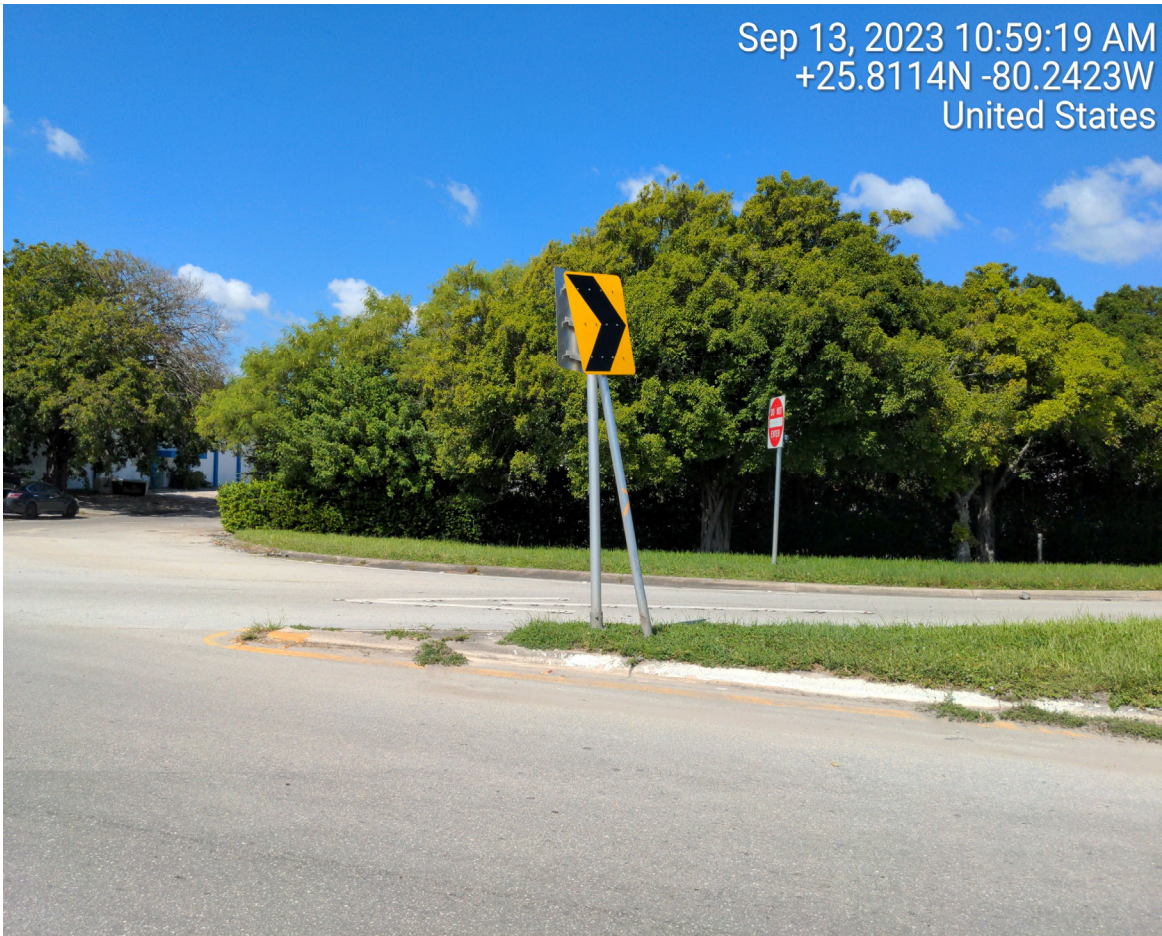
**PHOTO NO.: EB-004  
DATE: 9-13-2023**

**LEANING CHEVRON SIGN**

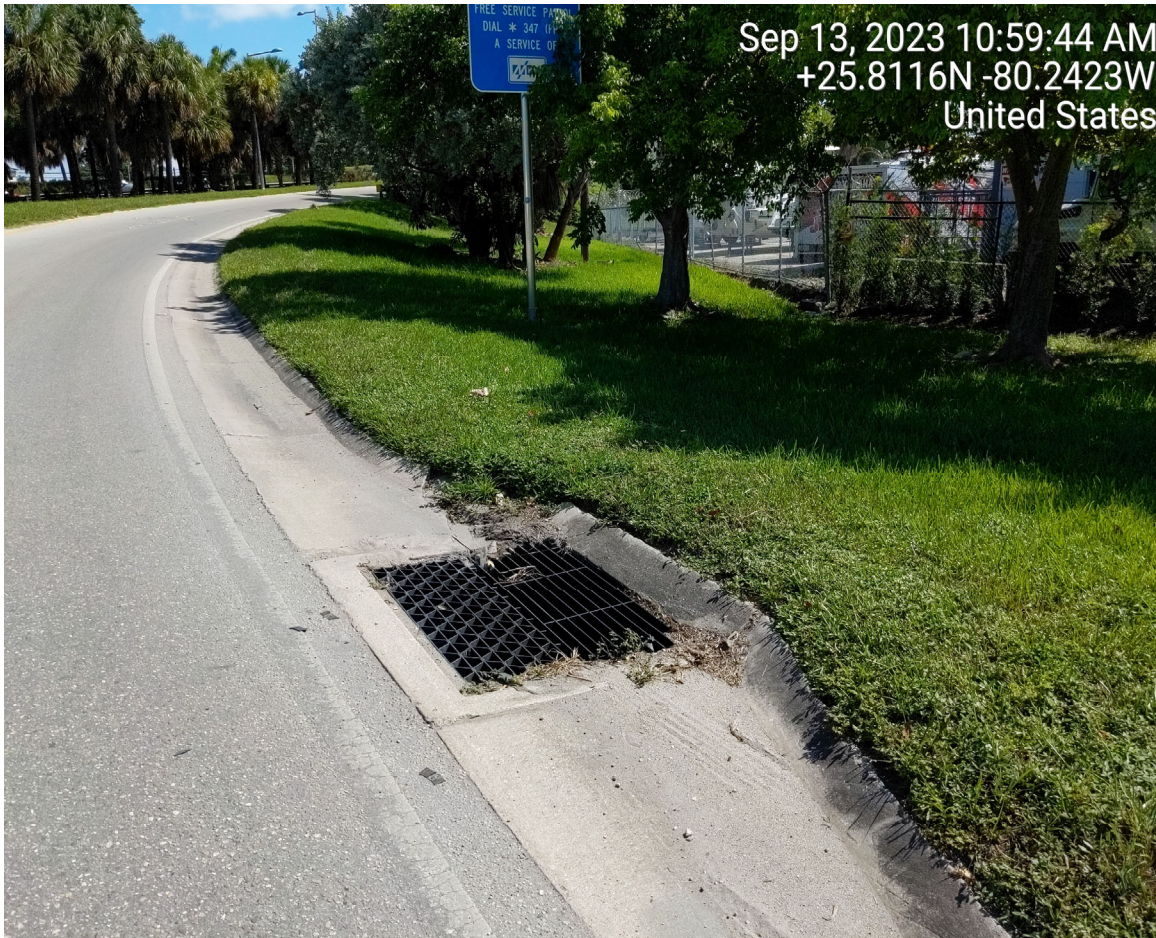
**PHOTO NO.: EB-005  
DATE: 9-13-2023**

**SILTED DRAINAGE STRUCTURE  
(TYPICAL AT VARIOUS LOCATIONS)**

**ITEMS NOTED TO BE ADDRESSED BY GMX MAINTENANCE ITB-22-09**

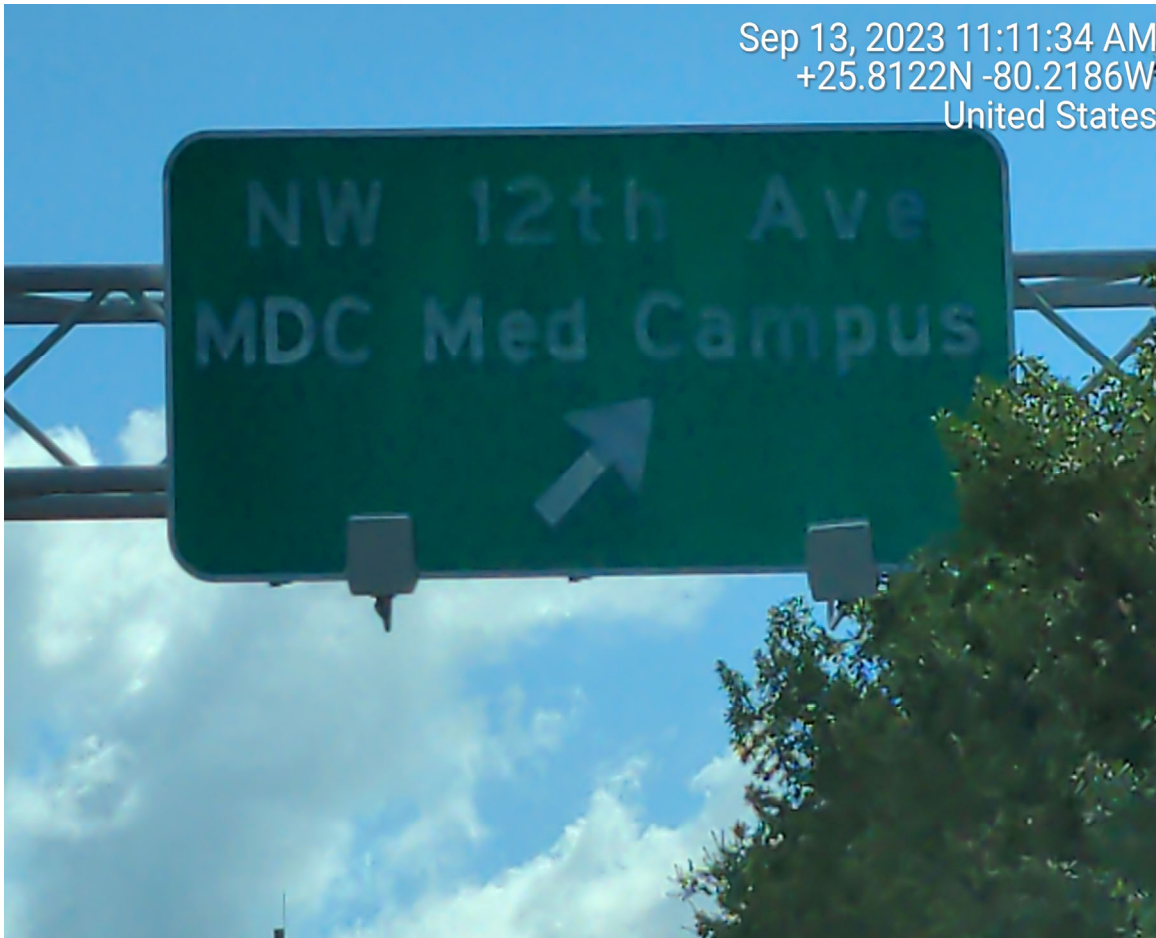
**PHOTO NO.: EB-006  
DATE: 9-13-2023**

**DETERIORATED REFLECTIVE SHEETING (STRUCTURE No. 178419)**

**ITEMS NOTED TO BE ADDRESSED BY GMX CONTRACT NO. 30058**

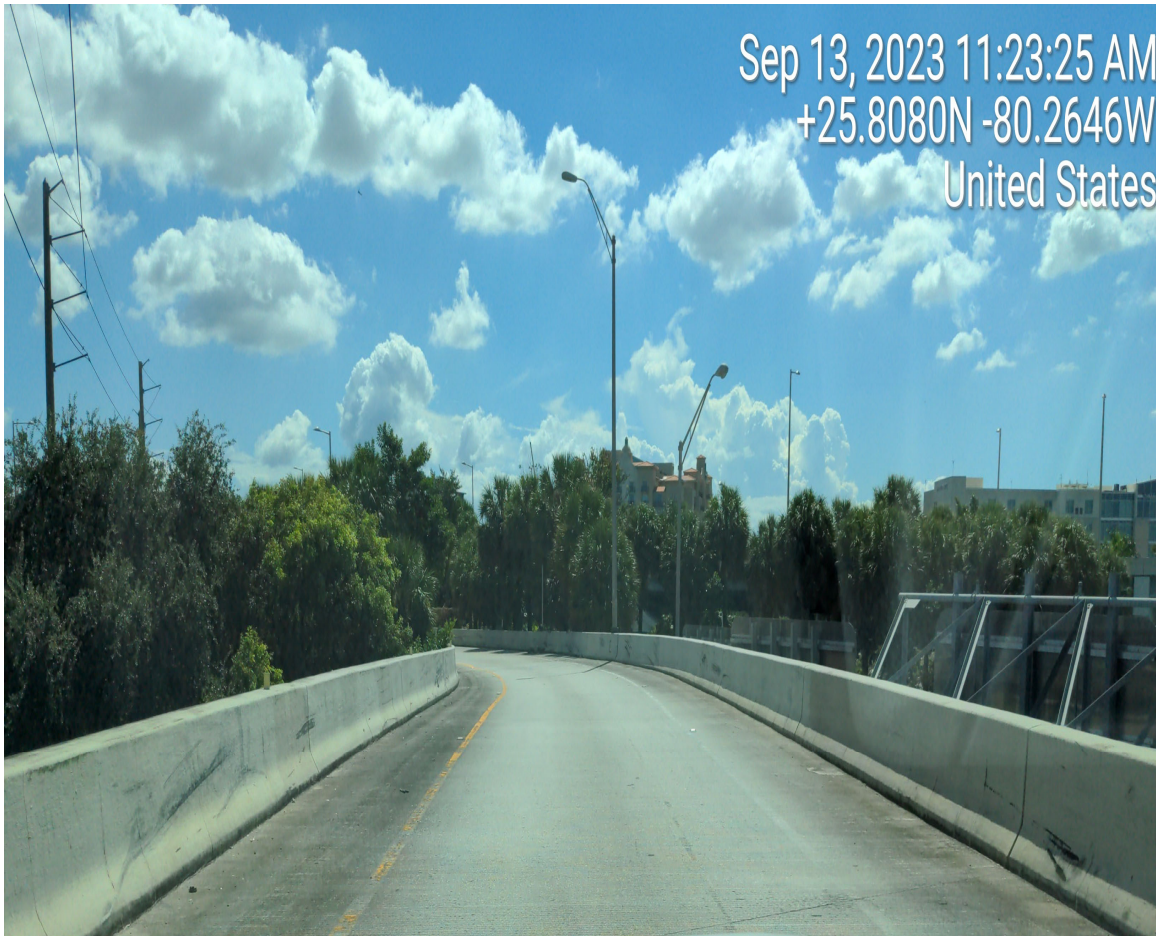
**PHOTO NO.: EB-008  
DATE: 9-13-2023**

**DETERIORATED YELLOW STRIPING  
(TYPICAL AT VARIOUS LOCATIONS)  
BRIDGE No. 870962**

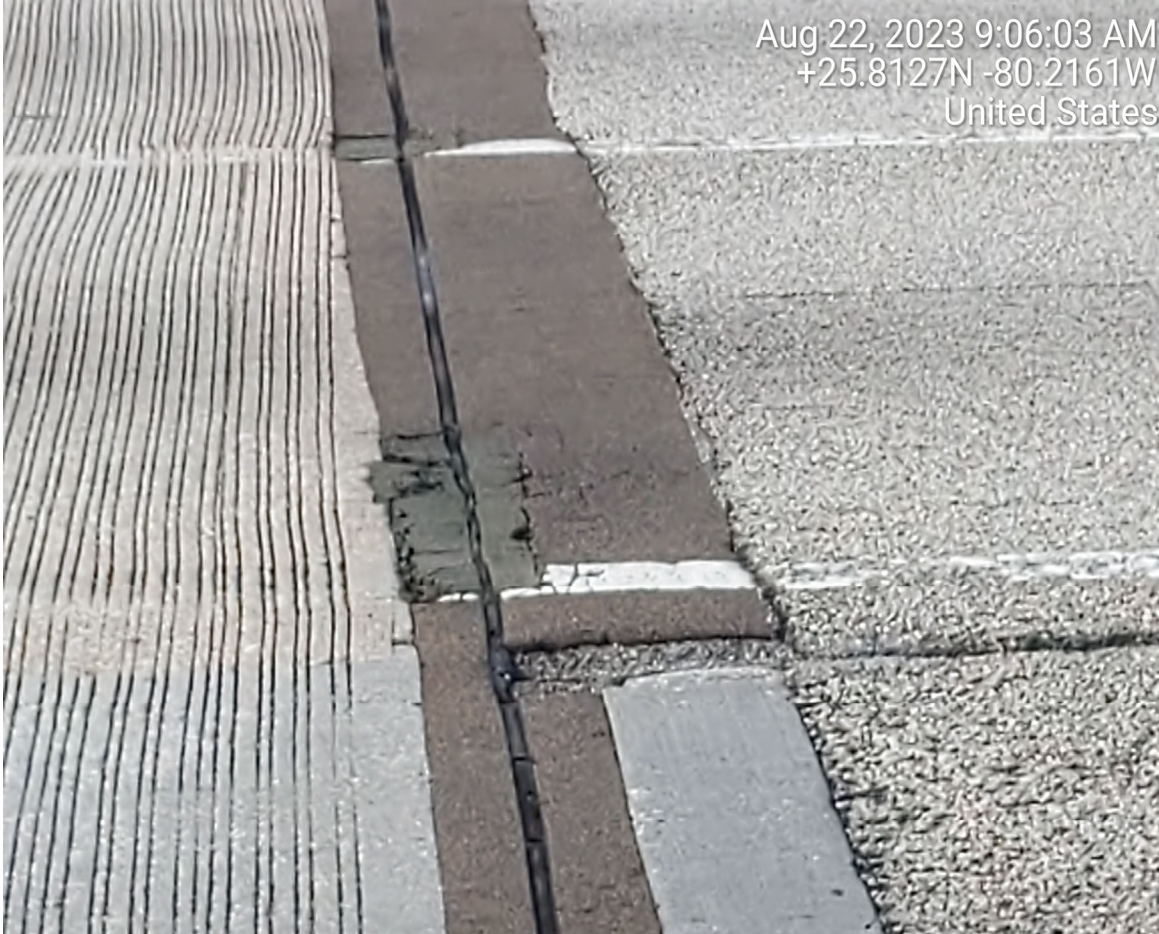
**PHOTO NO.: WB-002  
DATE: 8-22-2023**

**DETERIORATED BIRGDE JOINT HEADER BRIDGE NO. 870022**

**ITEM NOTED TO BE ADDRESSED BY GMX MAINTENANCE ITB-22-07**

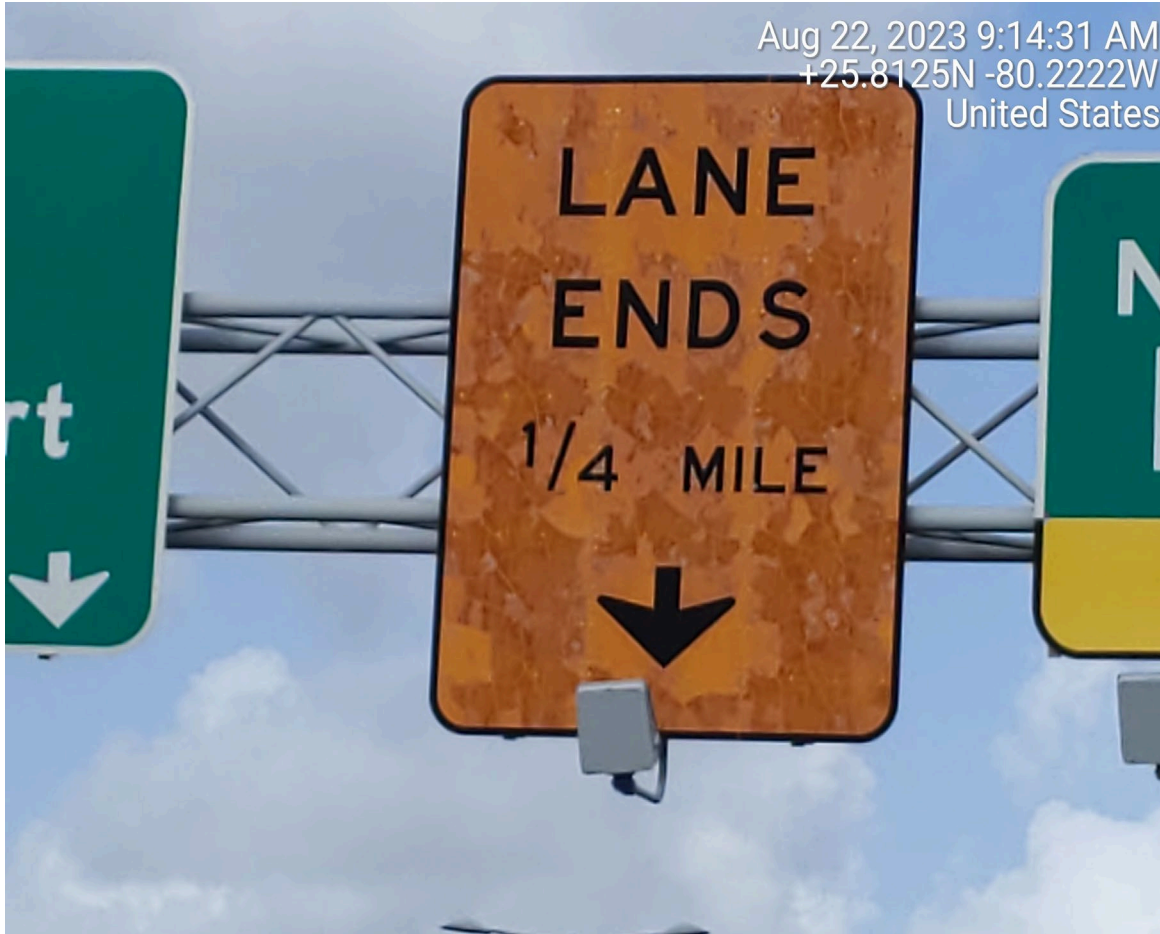
**PHOTO NO.: WB-005  
DATE: 8-22-2023**

**DETERIORATED REFLECTIVE SHEETING ON LANE ENDS SIGN  
(STRUCTURE # 87S418)**

**ITEM NOTED TO BE ADDRESSED BY GMX WORK PROGRAM NO. 30058**

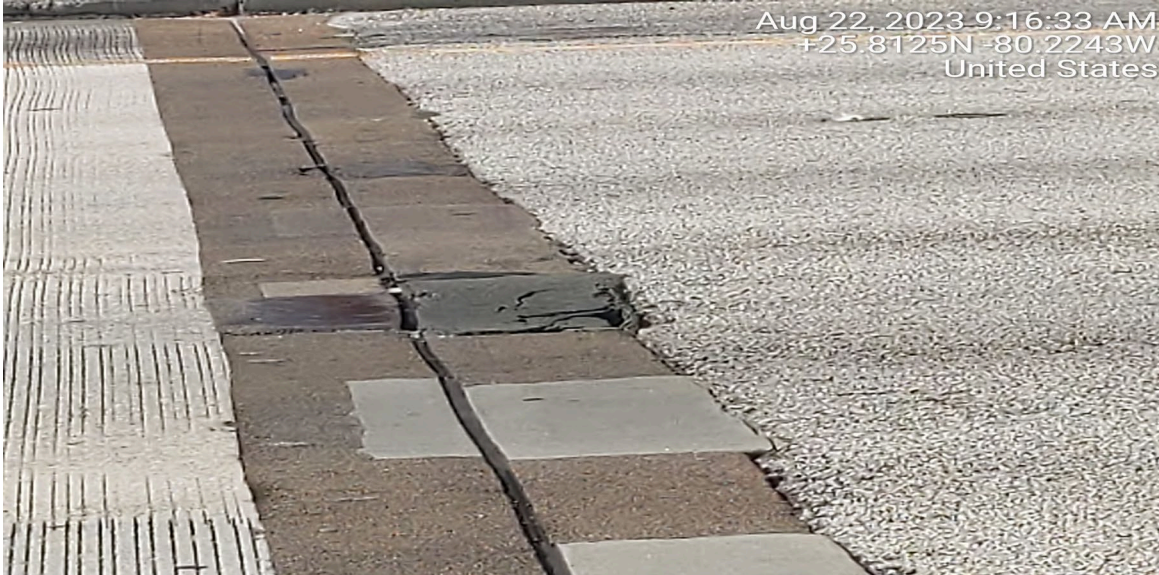
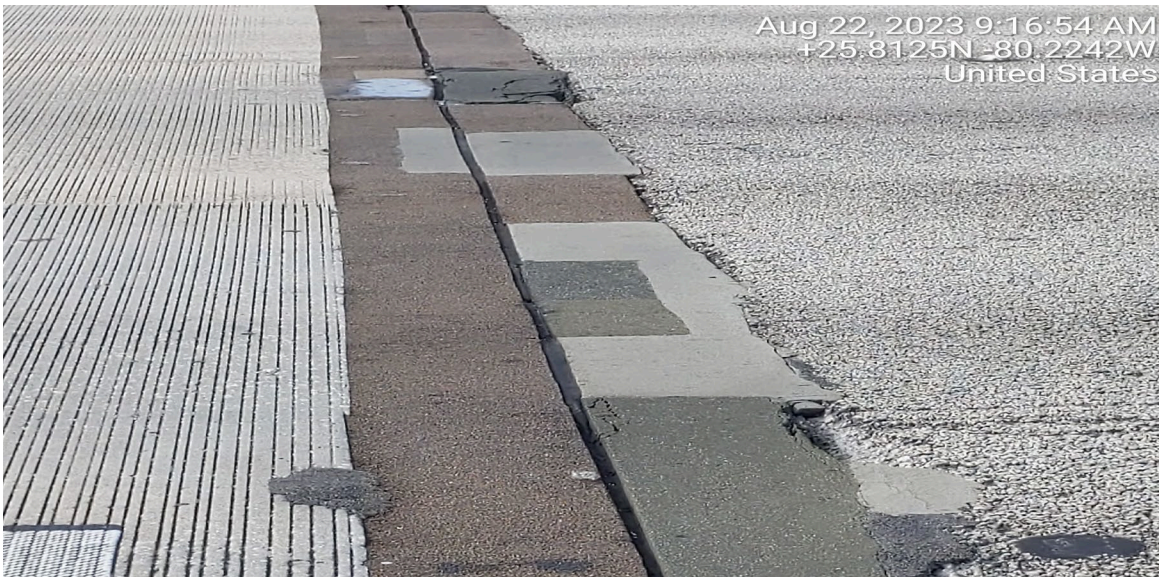
**PHOTO NO.: WB-006  
DATE: 8-22-2023**

**DETERIORATED BRIDGE JOINT HEADER (BRIDGE # 870111)**

**ITEM NOTED TO BE ADDRESSED BY GMX MAINTENANCE ITB-22-07**

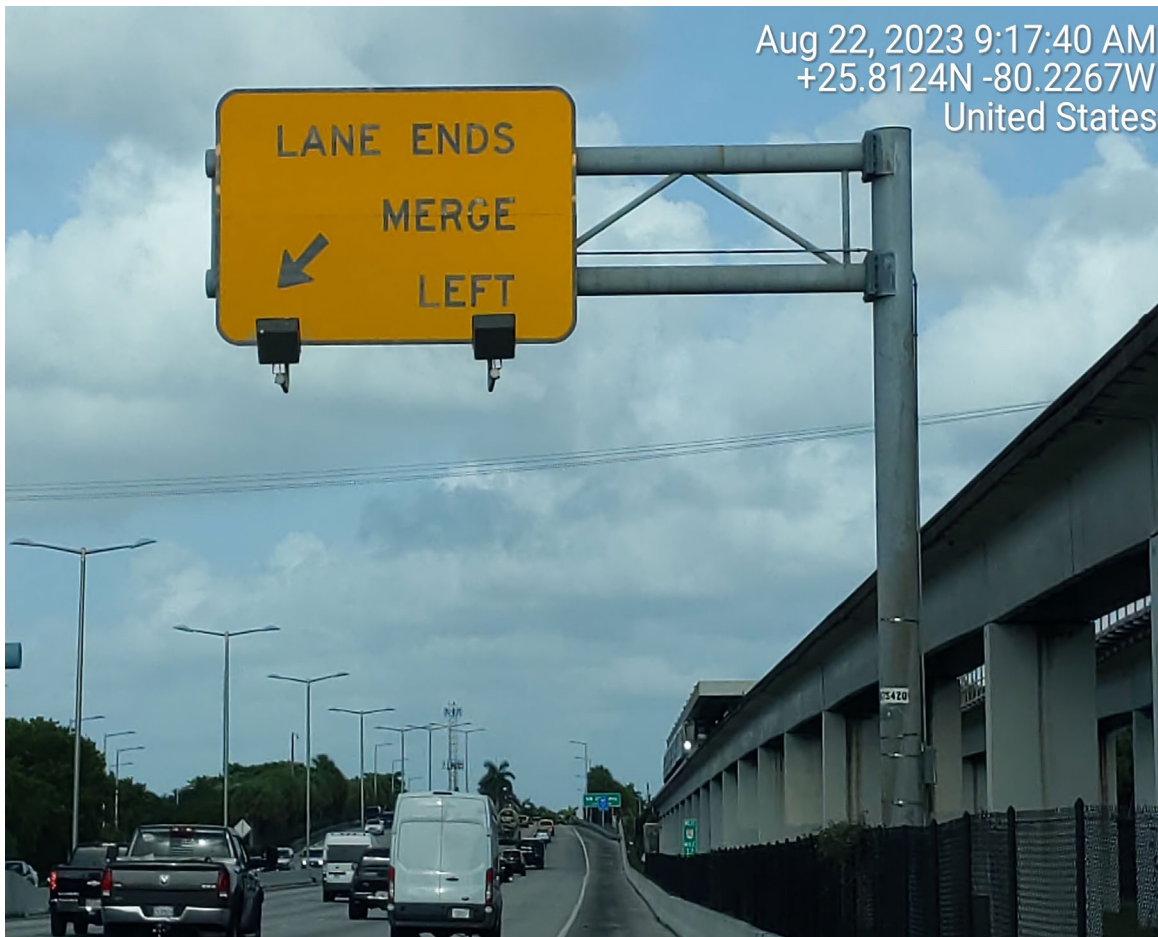
**PHOTO NO.: WB-007  
DATE: 8-22-2023**

**DETERIORATED REFLECTIVE SHEETING  
(87S420)**

**ITEM NOTED TO BE ADDRESSED BY GMX WORK PROGRAM 30058**

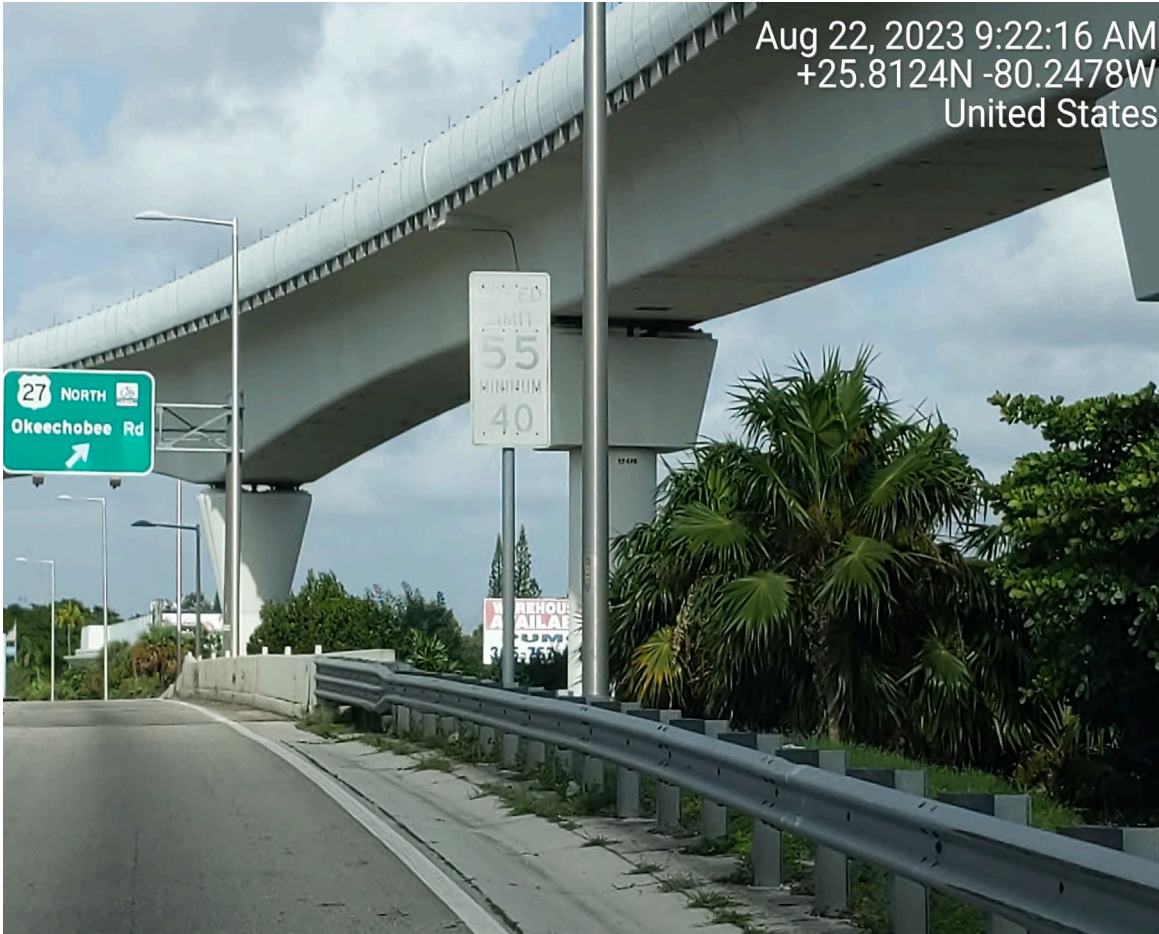
**PHOTO NO.: WB-009  
DATE: 8-22-2023**

**DETERIORATED REFLECTIVE SHEETING ON SPEED LIMIT SIGN**

**ITEM NOTED TO BE ADDRESSED BY GMX MAINTENANCE ITB-23-17**

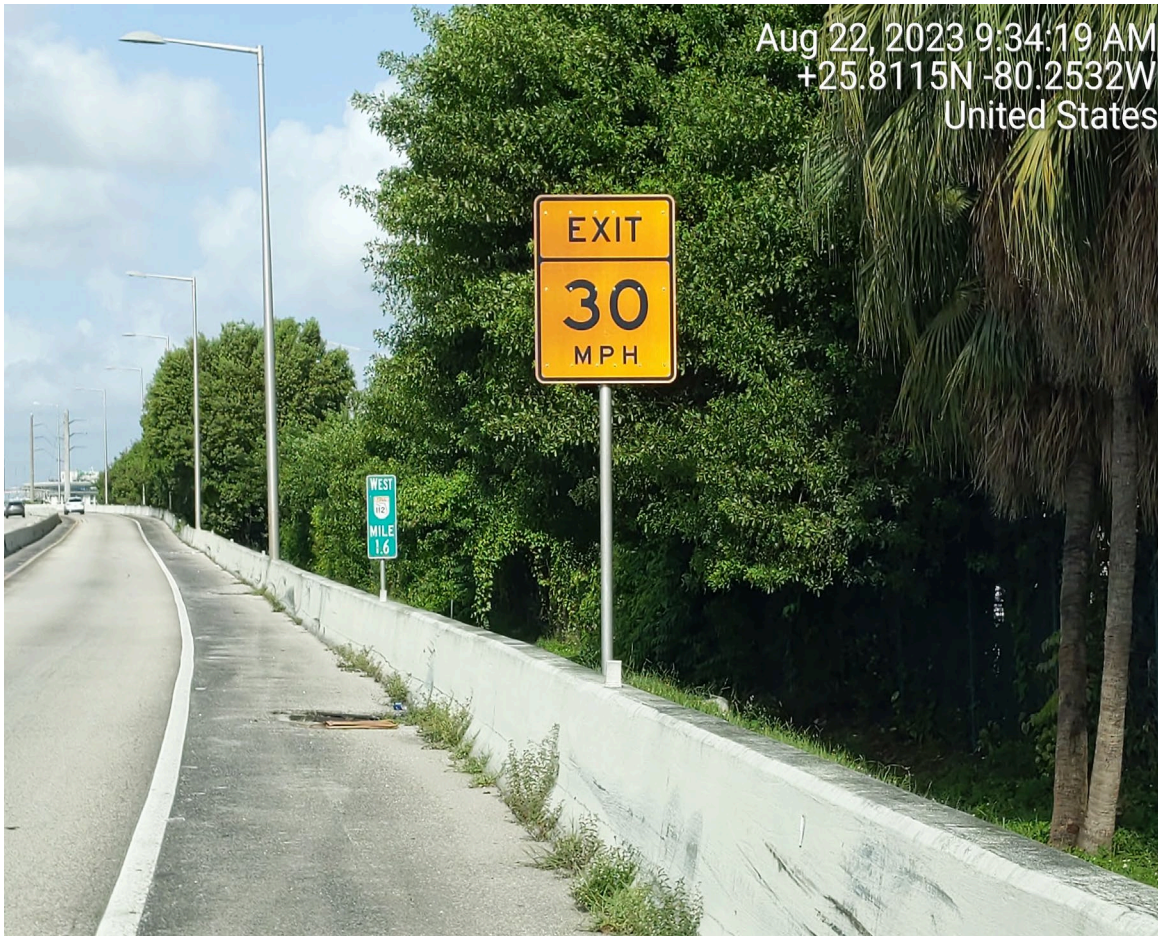
**PHOTO NO.: WB-010  
DATE: 8-22-2023**

**DETERIORATED REFLECTIVE SHEETING ON SPEED LIMIT SIGN/ OVERGROWN  
VEGETATION ON BARRIER WALL**

**ITEM NOTED TO BE ADDRESSED BY GMX MAINTENANCE ITB-23-17 / RFP-23-01**

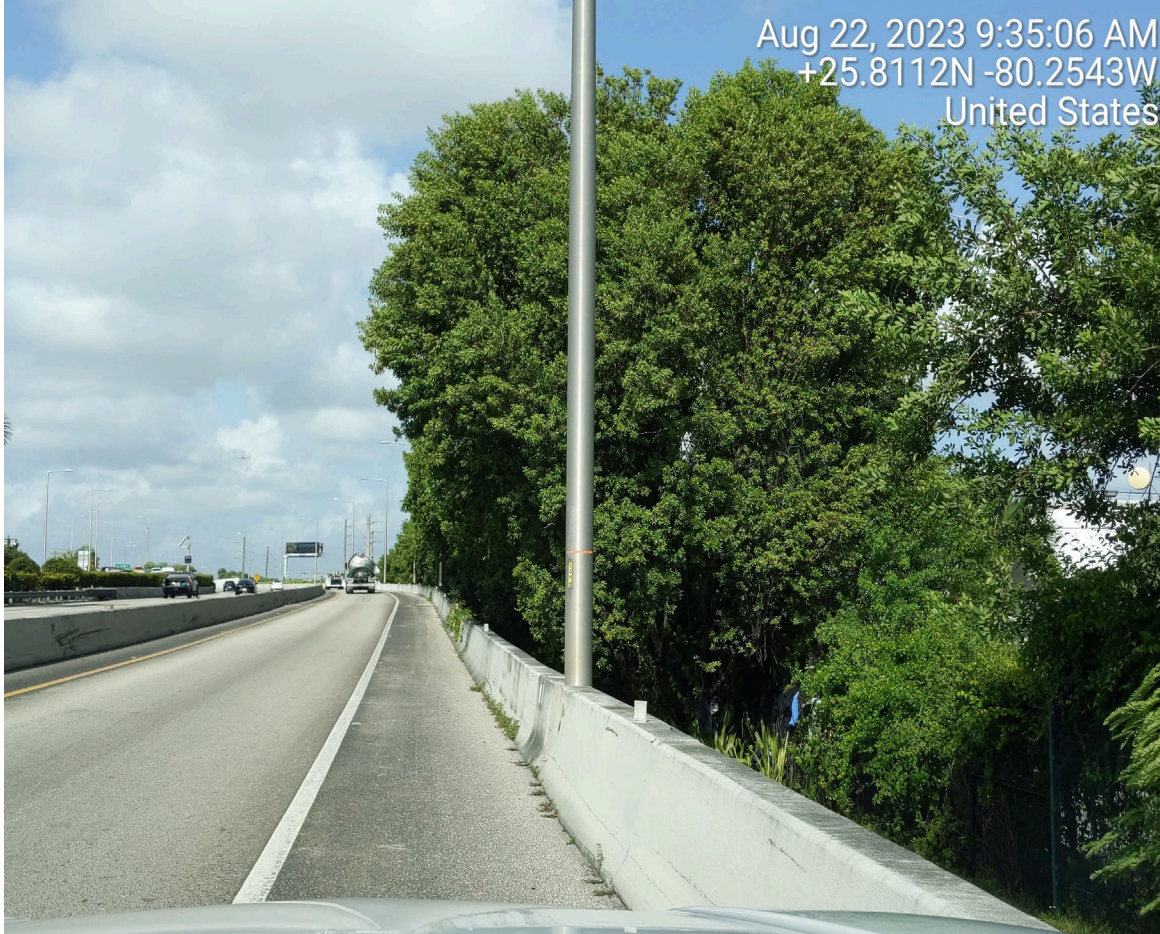
**PHOTO NO.: WB-011  
DATE: 8-22-2023**

**OVERGROWN TREES ENCHROACHING OVER THE BARRIER WALL / OVERGROWN  
VEGETATION AT THE BOTTOM OF THE BARRIER WALL**

**ITEM NOTED TO BE ADDRESSED BY GMX MAINTENANCE RFP 23-01**

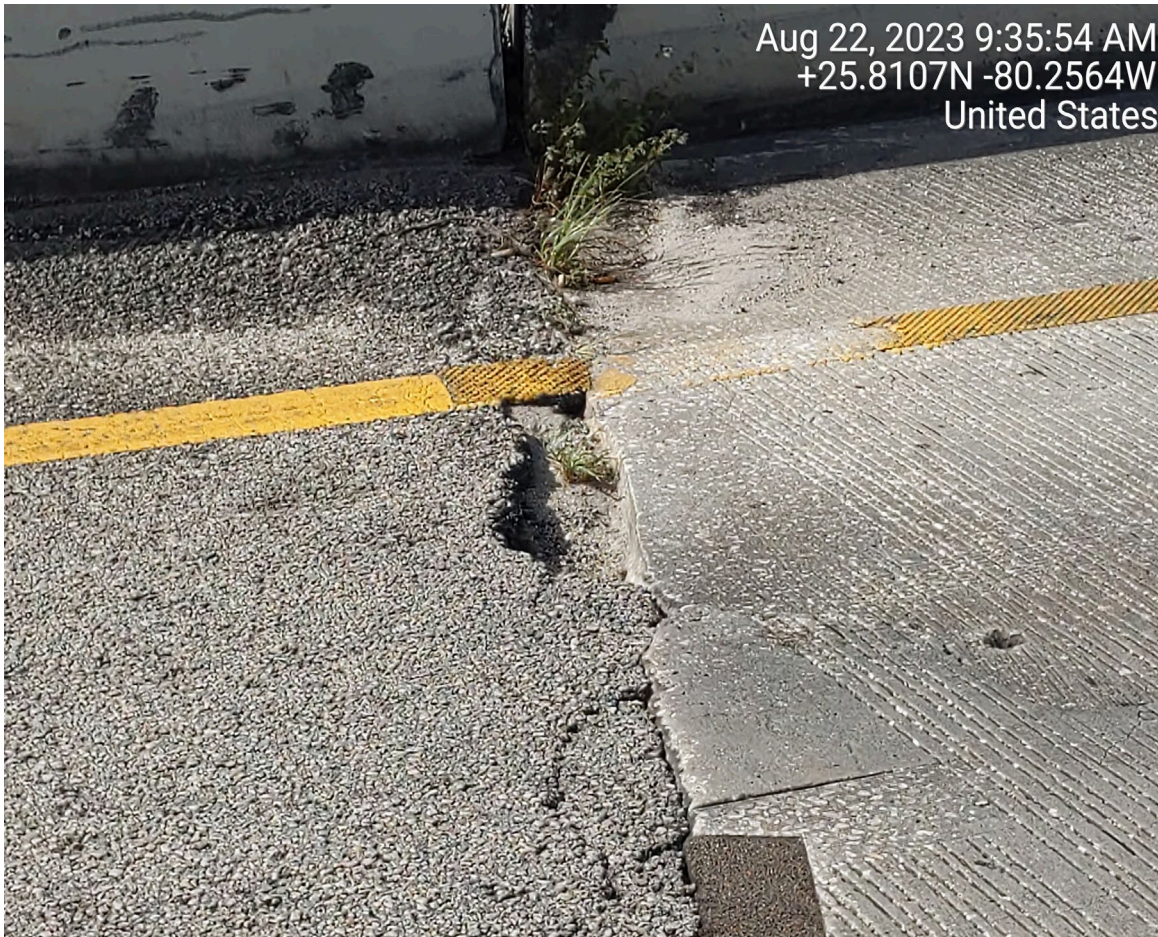
**PHOTO NO.: WB-012  
DATE: 8-22-2023**

**DETERIORATED ASPHALT PAVEMENT AT BENT #2  
(BRIDGE NO 870122)**

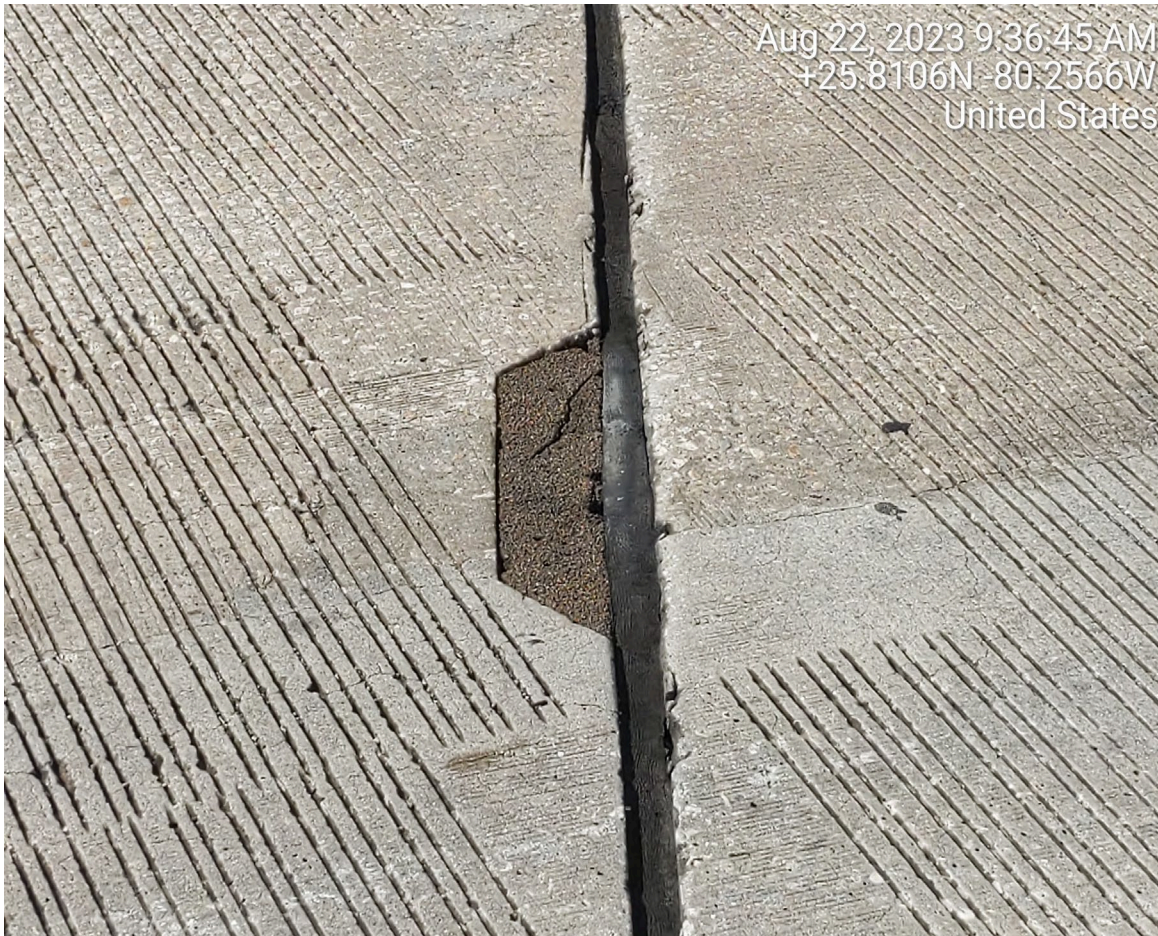
**PHOTO NO.: WB-013  
DATE: 8-22-2023**

**DETERIORATED JOINT REPAIR  
(BRIDGE # 870122)**

**ITEM NOTED TO BE ADDRESSED BY GMX MAINTENANCE ITB-22-07**

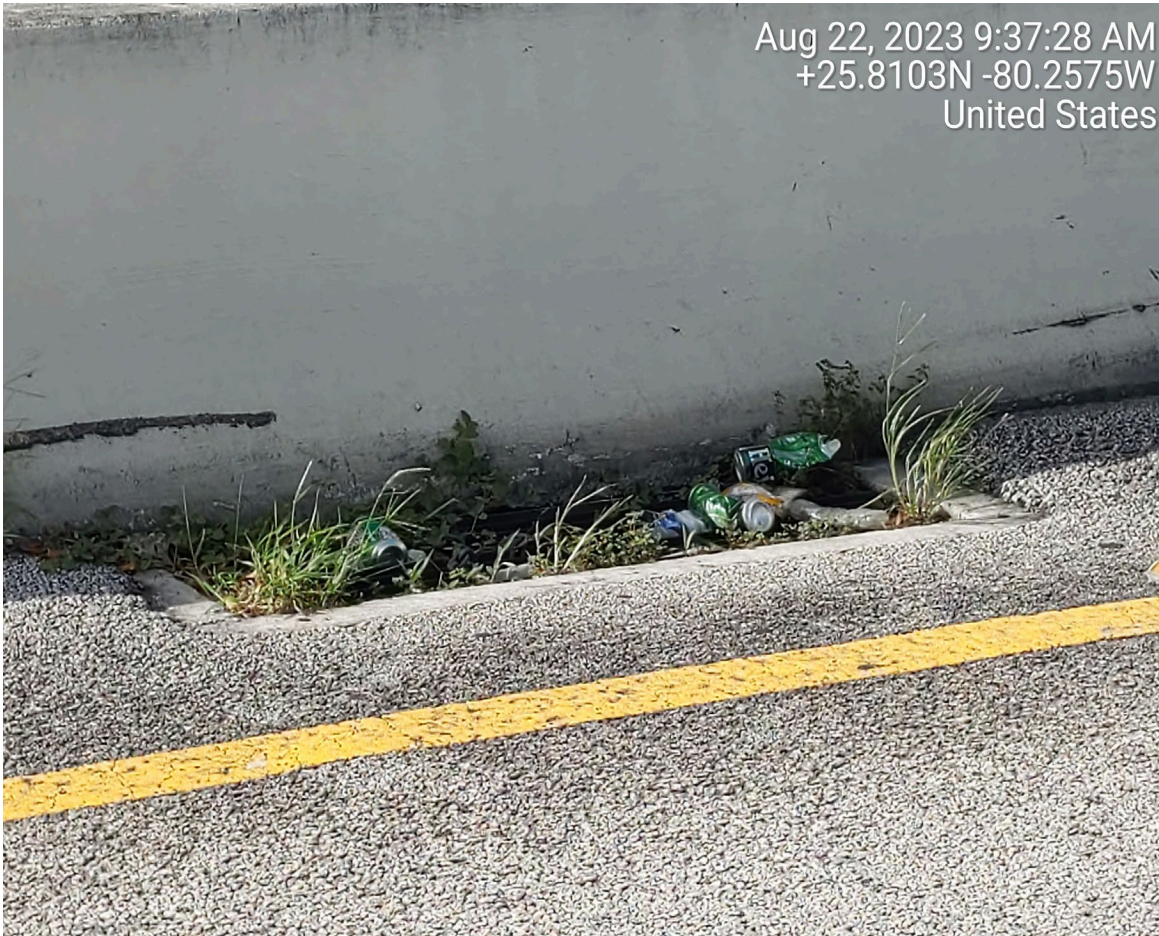
**PHOTO NO.: WB-014  
DATE: 8-22-2023**

**SILTED DRAINAGE STRUCTURE**

**ITEM NOTED TO BE ADDRESSED BY GMX MAINTENANCE ITB-22-07**

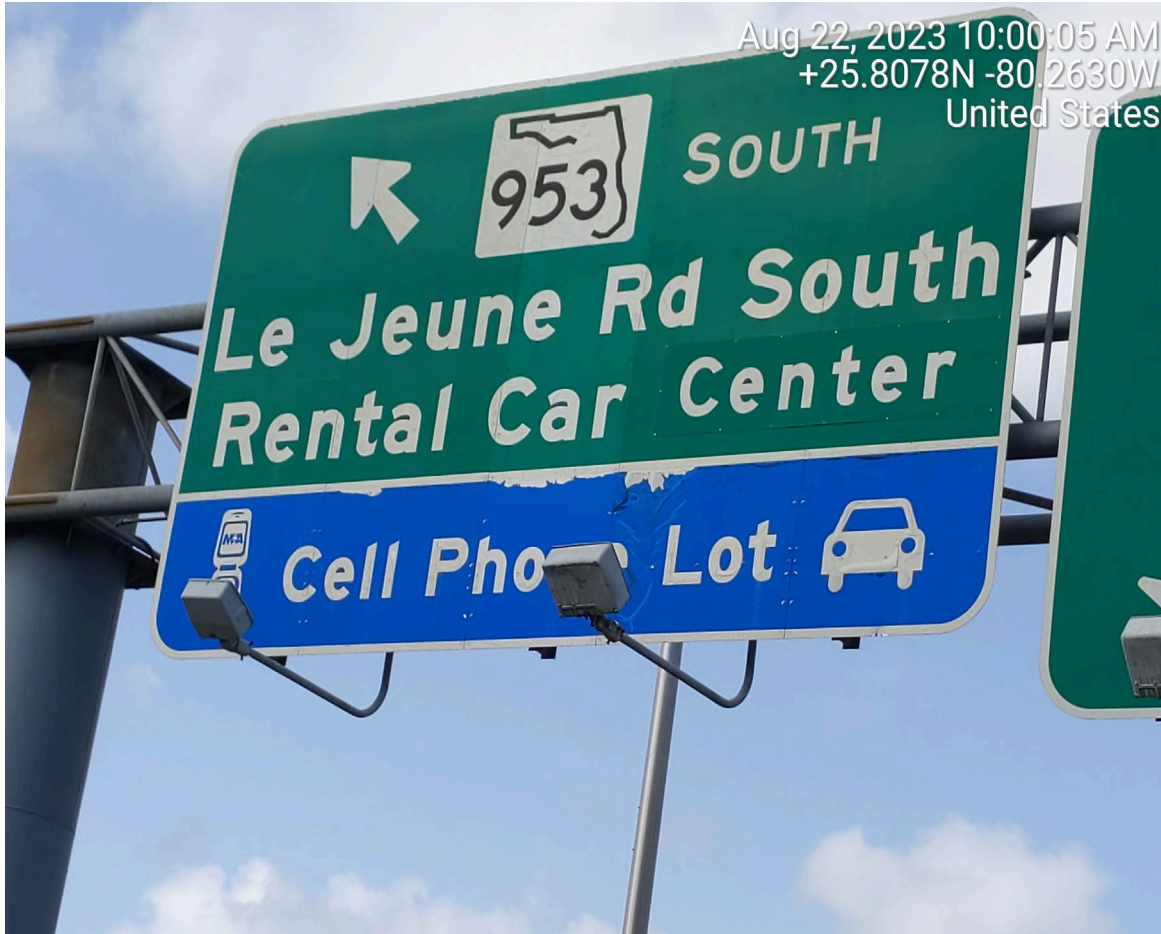
**PHOTO NO.: WB-018  
DATE: 8-22-2023**

**DETERIORATED REFLECTIVE SHEETING**

**ITEM NOTED TO BE ADDRESSED BY GMX WORK PROGRAM 30058**

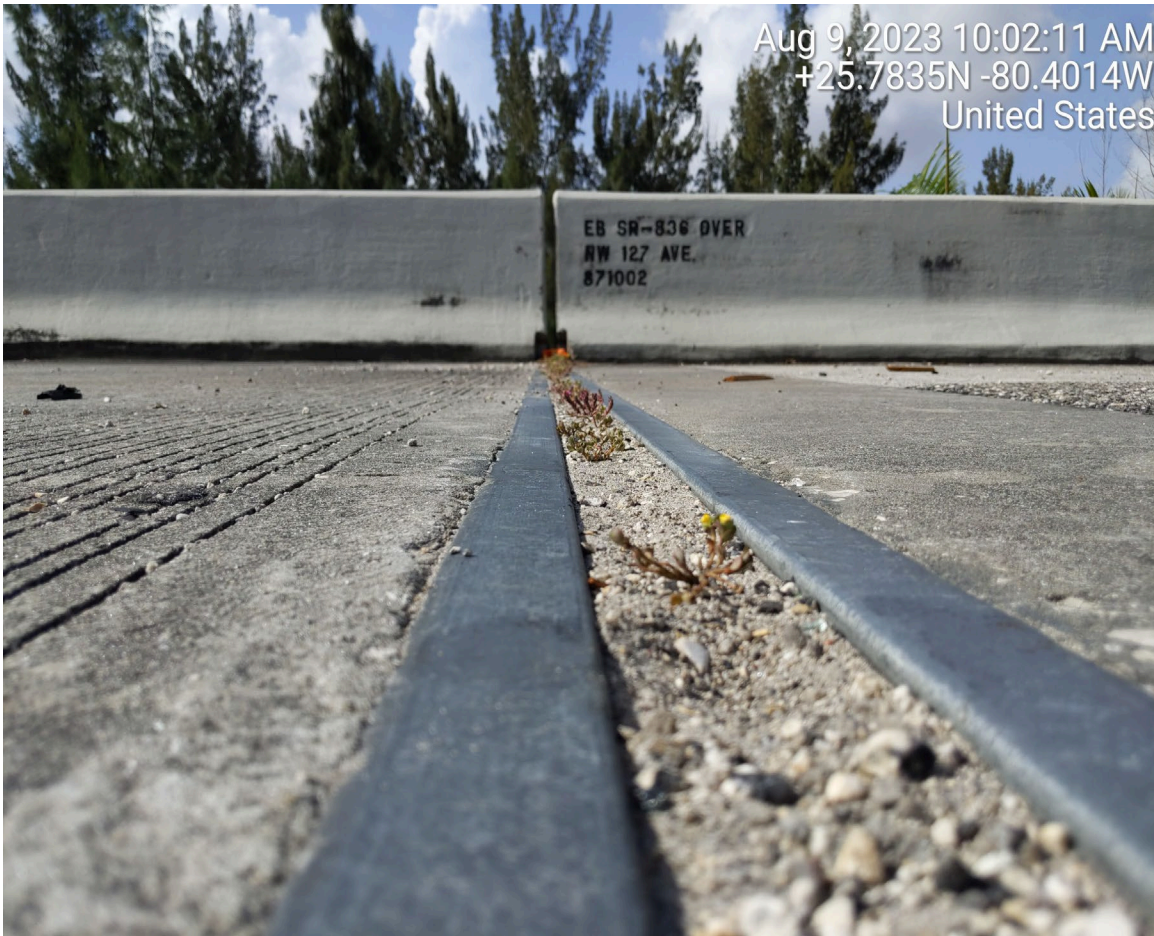
**PHOTO NO.: EB-002  
DATE: 8-9-2023**

**DEBRIS ON BRIDGE EXPANSION JOINT (TYPICAL THROUGHOUT  
(BRIDGE No. 871002)**

**ITEM NOTED TO BE ADDRESSED BY GMX MAINTENANCE ITB 22-07**

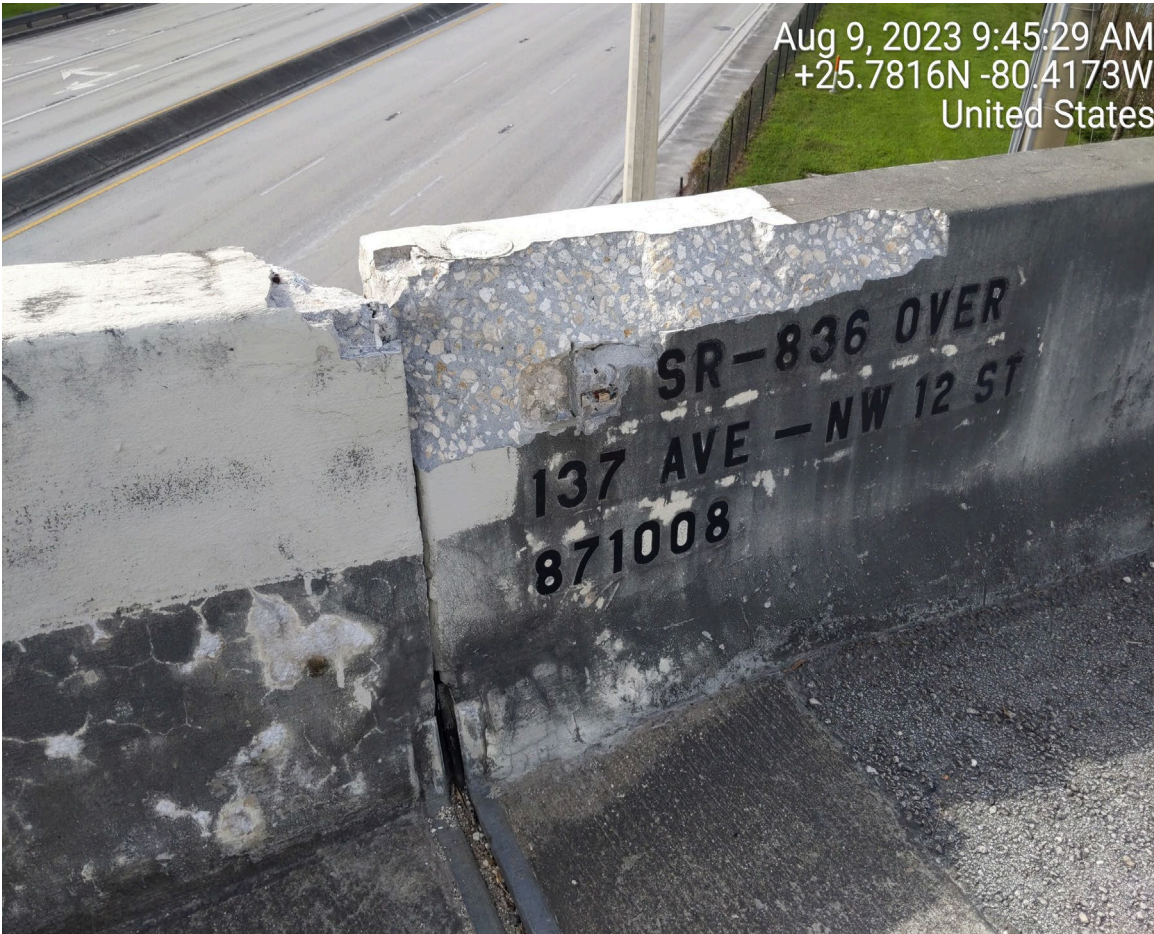
**PHOTO NO.: EB-003  
DATE: 8-9-2023**

**SPALL ON TRAFFIC RAILING (ABUTMENT 1, BRIDGE No. 871008)**

**ITEM NOTED TO BE ADDRESSED BY GMX MAINTENANCE ITB 22-07**
