# ANNUAL INSPECTION REPORT 2023

## ANNUAL INSPECTION REPORT

In July 1, 2023, the Greater Miami Expressway Agency (GMX) acquired operational and financial control of five expressways in Miami-Dade County. This group of expressways, toll facilities, acquisition parcels and the GMX headquarters facility, all as described below, are hereinafter referred to as one of the "GMX System". In accordance with the Trust Indenture requirements, GMX retained EAC Consulting, Inc. (EAC), as the General Engineering Consultant to perform, among other duties assigned by the Agency, the yearly inspection of the GMX System. This report represents the annual inspection results for Fiscal Year (FY) 2023.

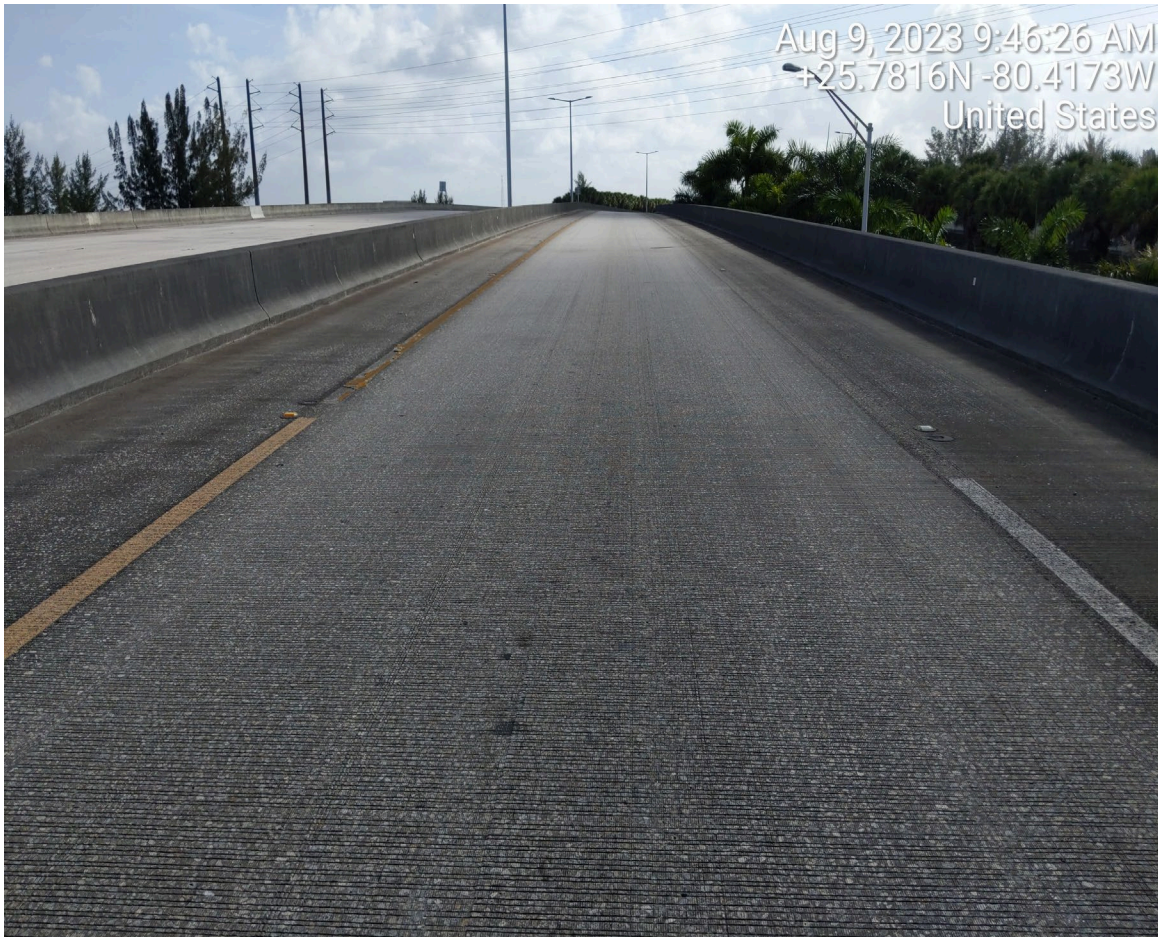
**PHOTO NO.: EB-004  
DATE: 8-9-2023**

**DETERIORATED STRIPING (BRIDGE No. 871008)**

**ITEM NOTED TO BE ADDRESSED BY GMX MAINTENANCE ITB 23-17**

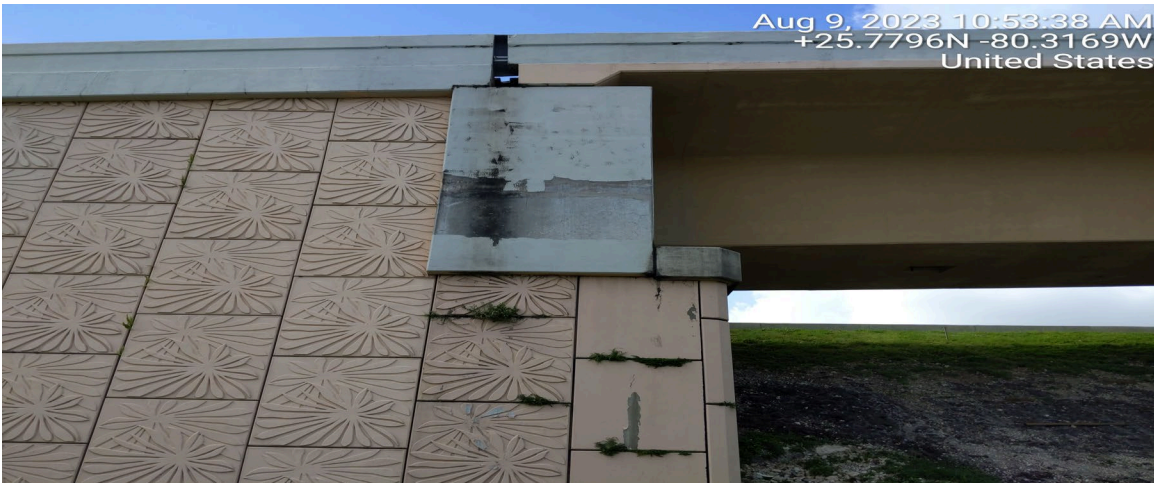
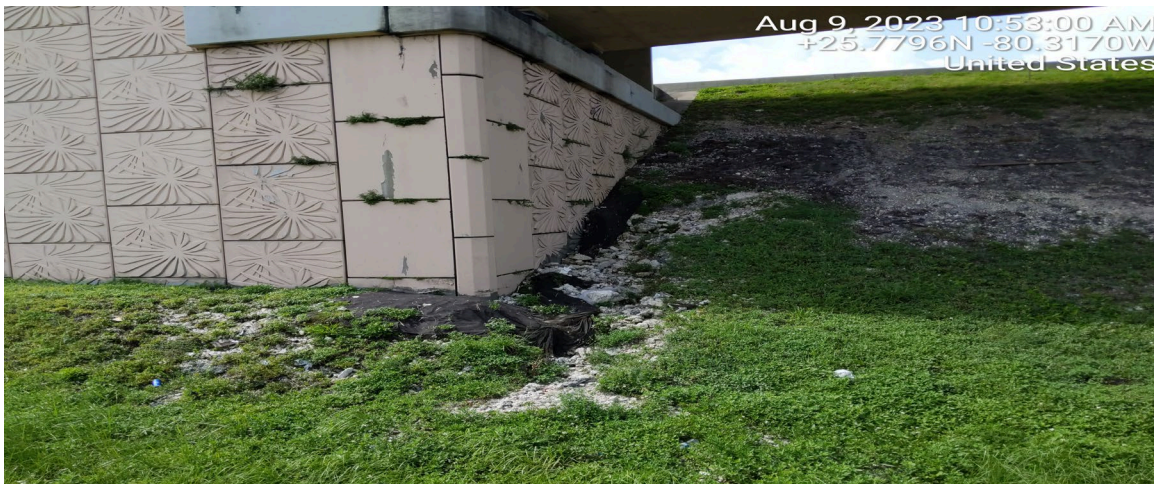
**PHOTO NO.: EB-008  
DATE: 8-9-2023**

**DETERIORATED CLASS V COATING AT WING WALL 12 & ERROSION ON SLOPE  
(BRIDGE # 871050)**

**ITEM NOTED TO BE ADDRESSED BY GMX MAINTENANCE ITB 22-07**

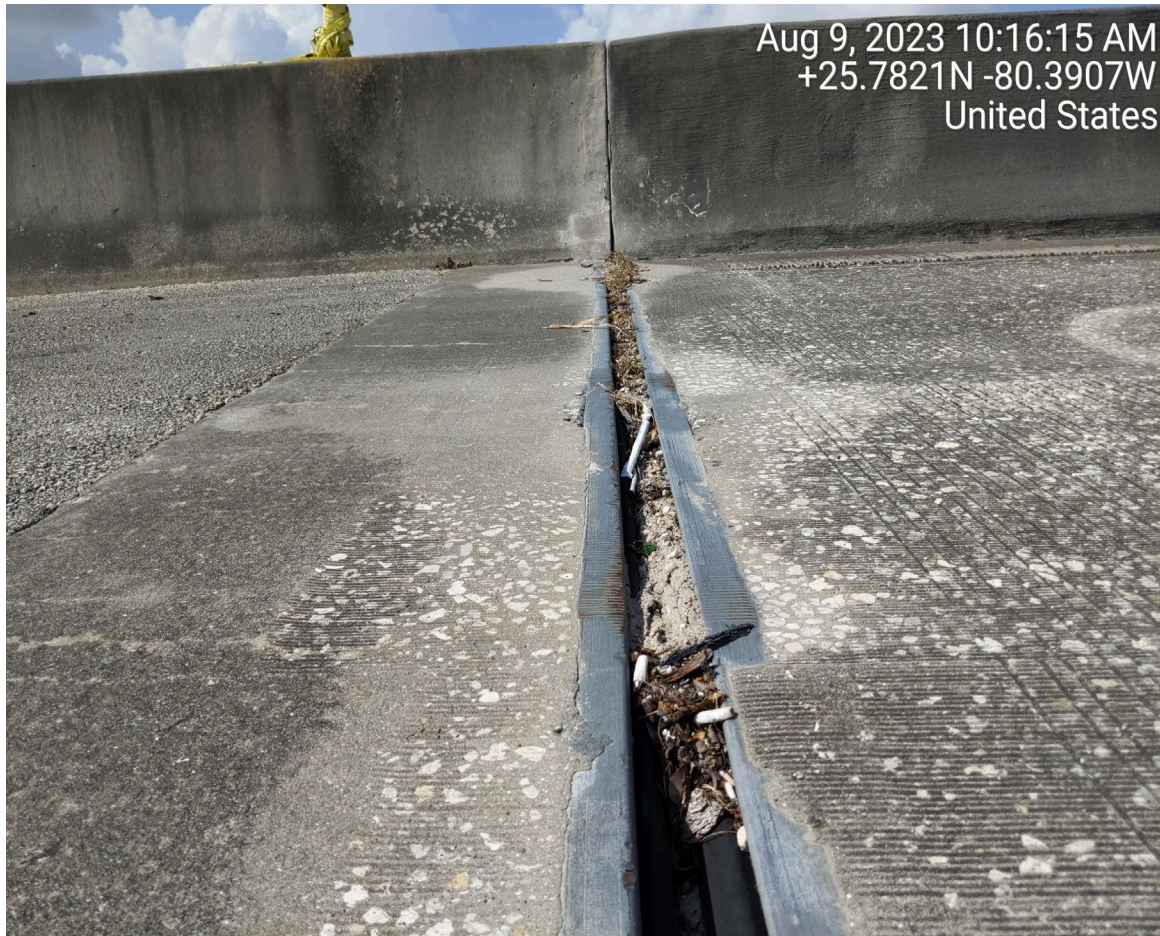
**PHOTO NO.: EB-011  
DATE: 8-9-2023**

**DEBRIS ON BRIDGE EXPANSION JOINTS BRIDGE NO. 871004  
(TYPICAL THROUGH THE CORRIDOR)**

**ITEM NOTED TO BE ADDRESSED BY GMX MAINTENANCE ITB 22-07**

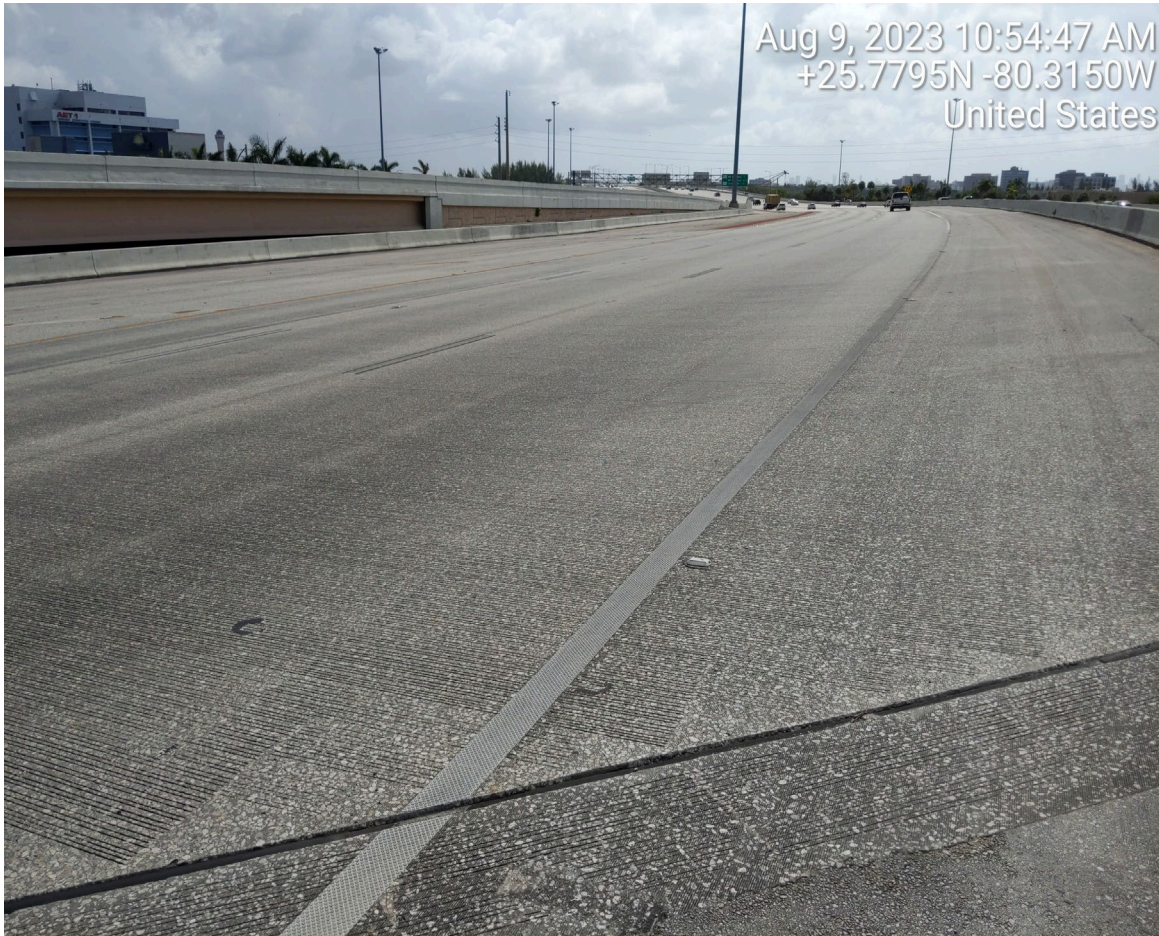
**PHOTO NO.: EB-012  
DATE: 8-9-2023**

**DETERIORATED WHITE EDGELINE STRIPING BRIGE NO. 871039**

**ITEM NOTED TO BE ADDRESSED BY GMX MAINTENANCE ITB 23-17**

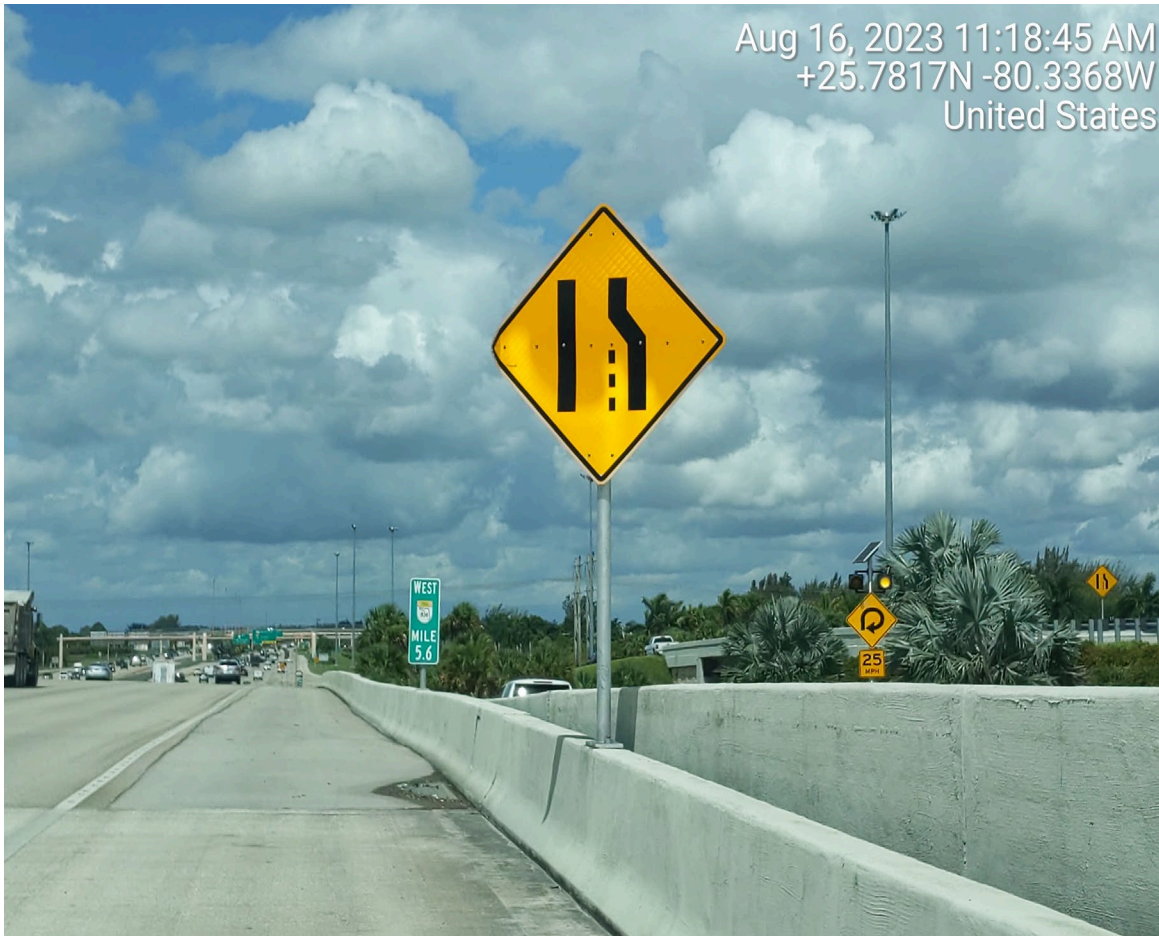
**PHOTO NO.: WB-003  
DATE: 8-16-2023**

**TWISTED SIGN PANEL**

**ITEM NOTED TO BE ADDRESSED BY GMX MAINTENANCE ITB 23-17**

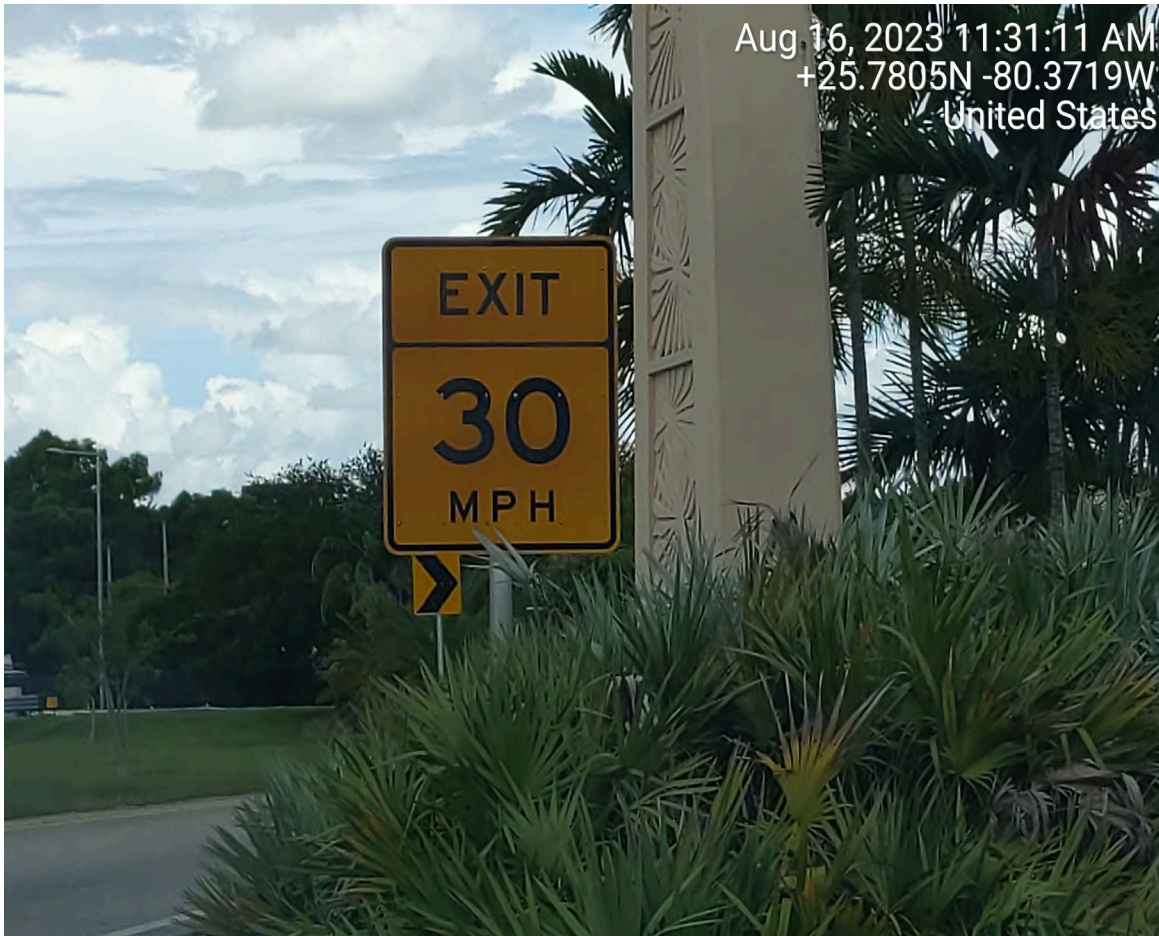
**PHOTO NO.: WB-006  
DATE: 8-16-2023**

**DETERIORATED REFLECTIVE SHEETING ON SIGN PANEL**

**ITEM NOTED TO BE ADDRESSED BY GMX MAINTENANCE CONTRACT ITB-23-17**

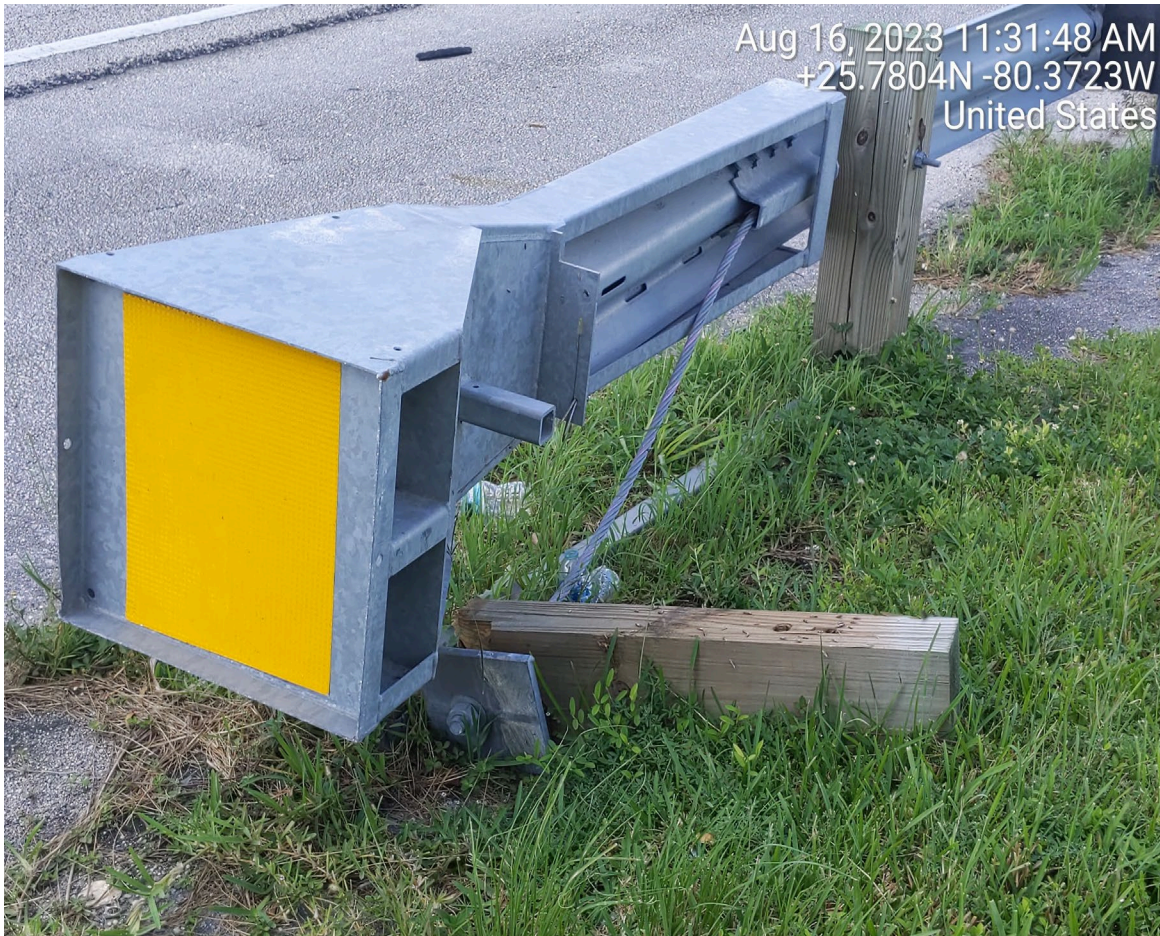
**PHOTO NO.: WB-007  
DATE: 8-16-2023**

**DAMAGED POST ON END TREATMENT**

**ITEM NOTED TO BE ADDRESSED BY GMX MAINTENANCE CONTRACT ITB-23-02**

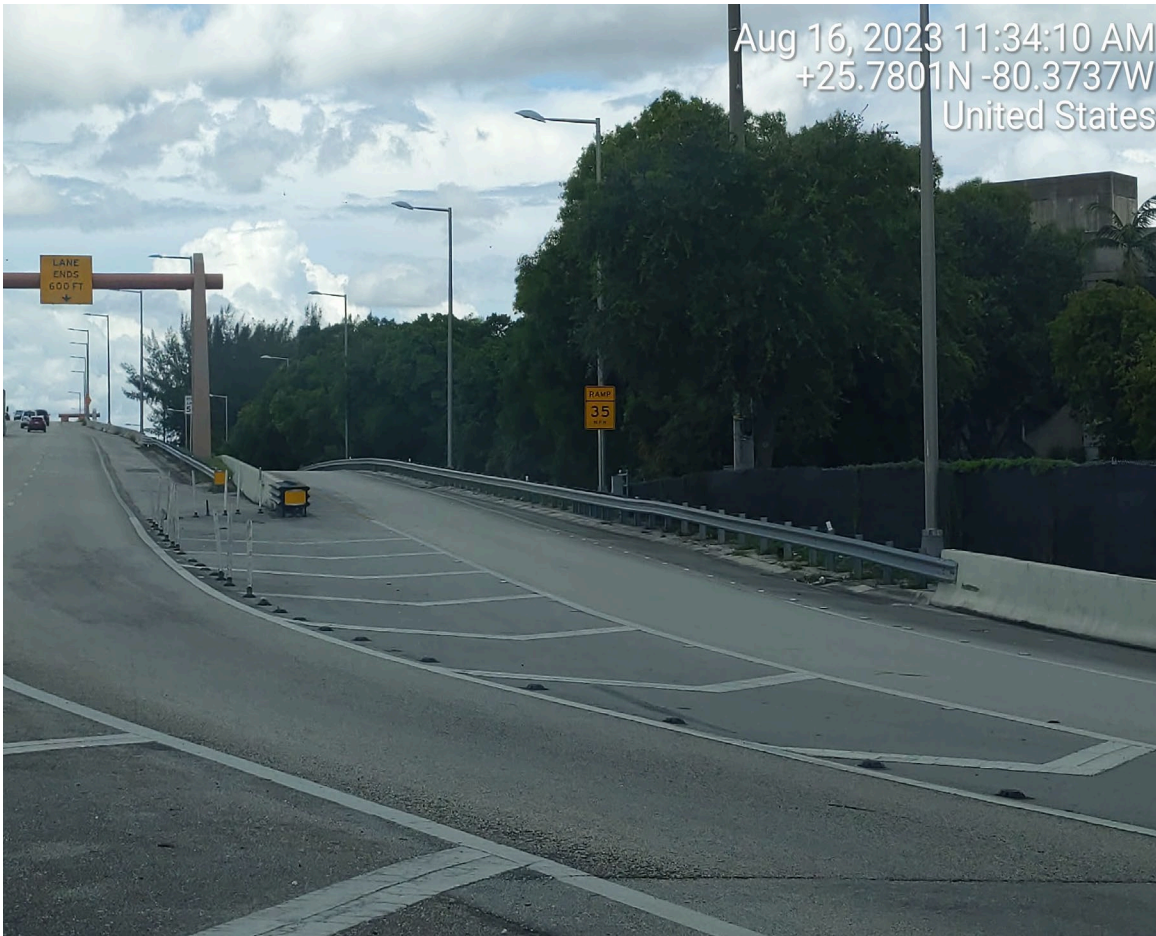
**PHOTO NO.: WB-008  
DATE: 8-16-2023**

**MISSING DELINEATORS**

**ITEM NOTED TO BE ADDRESSED BY GMX MAINTENANCE CONTRACT ITB-23-17**

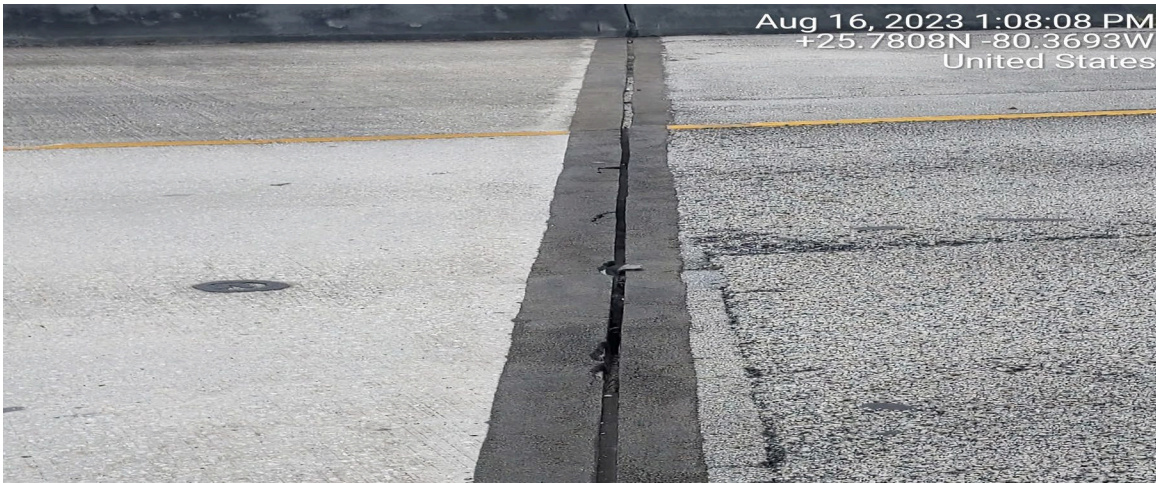
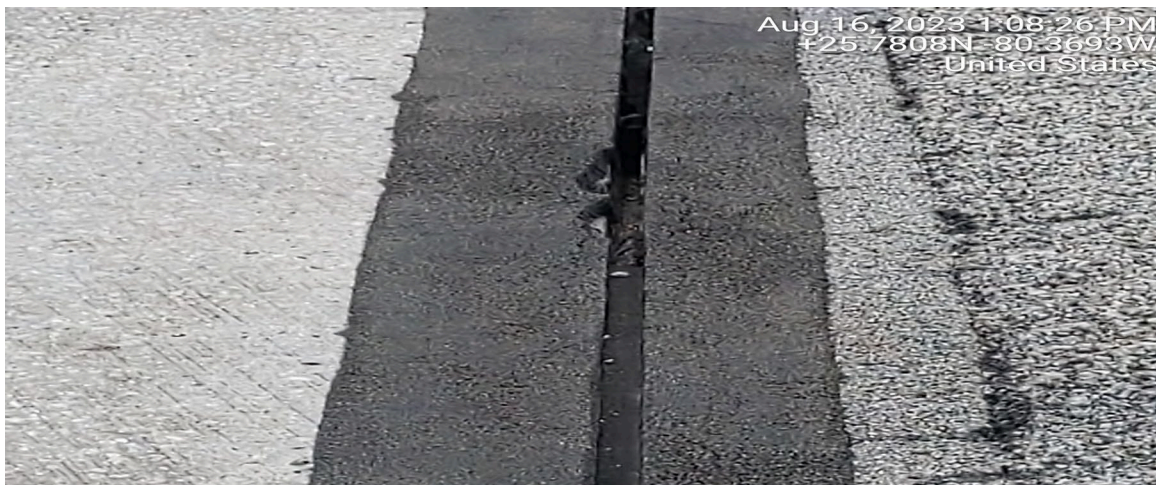
**PHOTO NO.: WB-009  
DATE: 8-16-2023**

**DETERIORATED JOINT HEADER (BRIDGE # 870535)**

**ITEM NOTED TO BE ADDRESSED BY GMX MAINTENANCE ITB 22-07**

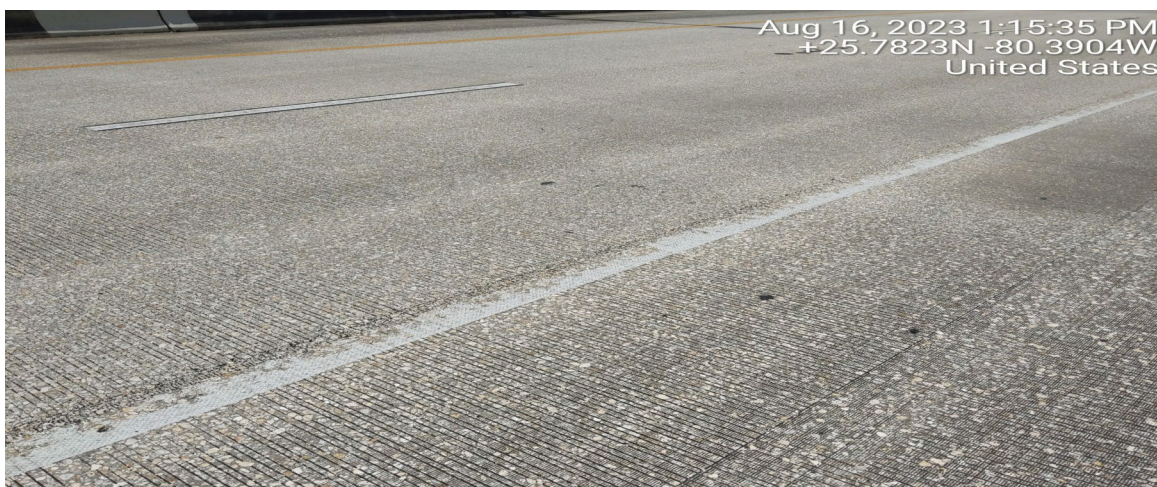
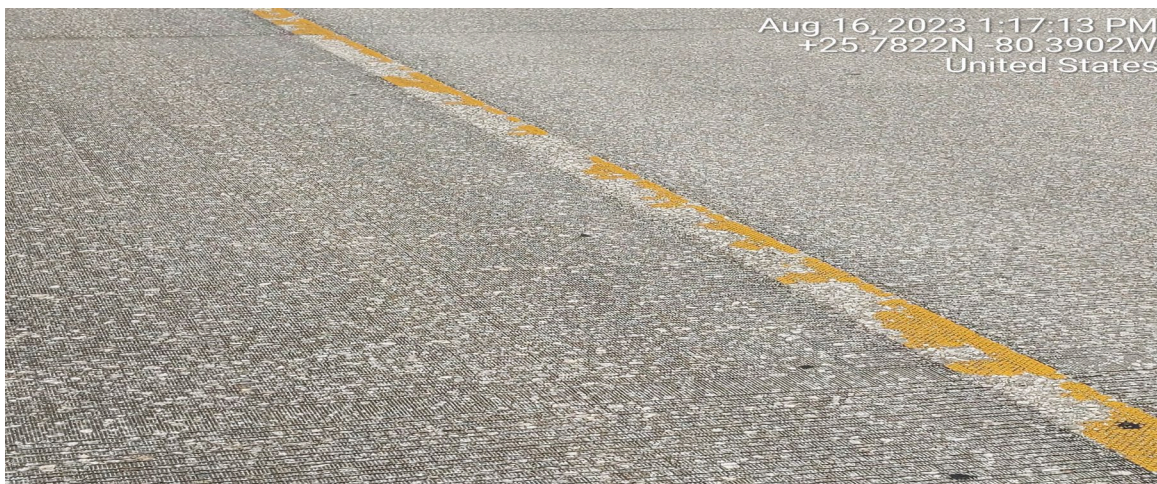
**PHOTO NO.: WB-010  
DATE: 8-16-2023**

**DETERIORATED STRIPING**

**ITEM NOTED TO BE ADDRESSED BY GMX CONTRACT NO. 83634**

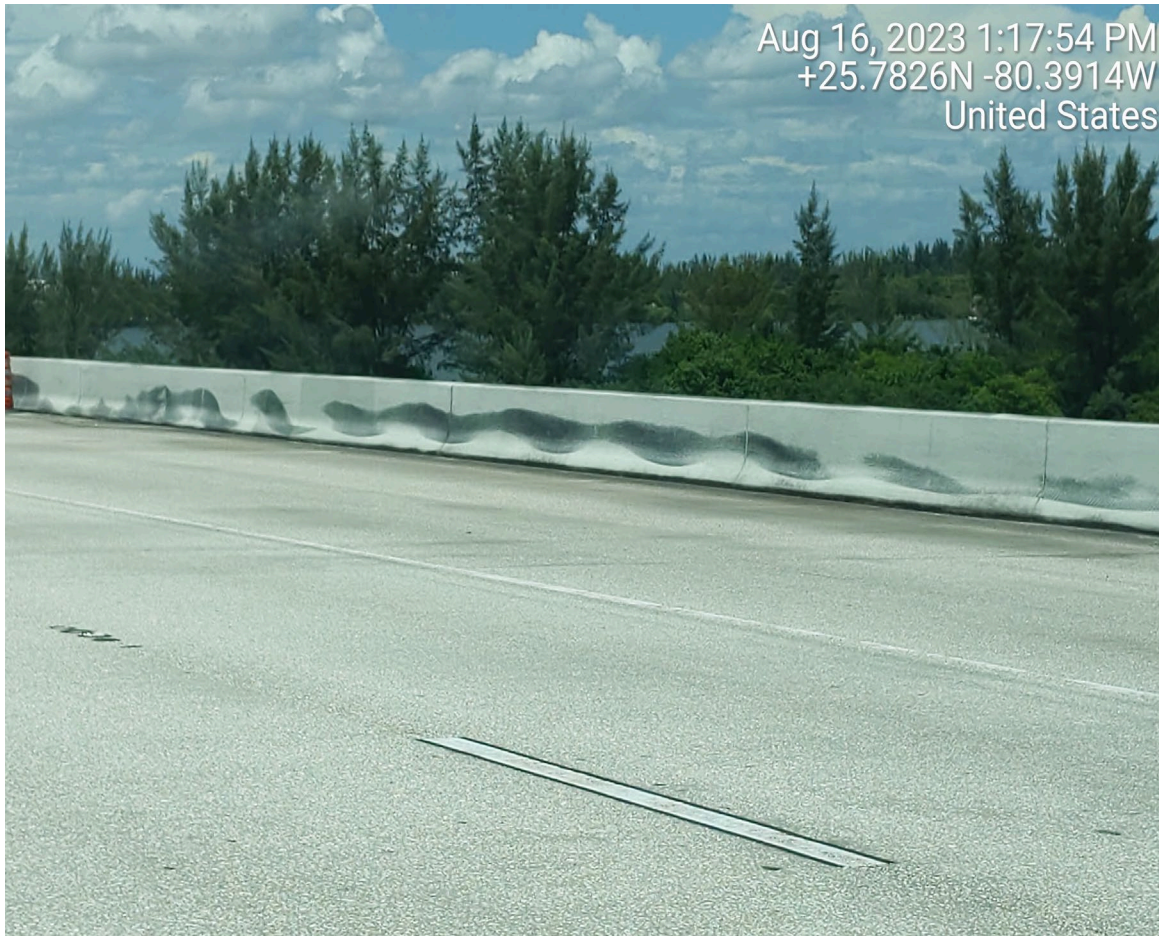
**PHOTO NO.: WB-011  
DATE: 08-16-2023**

**SCUFF MARKS ON BARRIER WALL**

**ITEM NOTED TO BE ADDRESSED BY GMX PROJECT NO. 30037**

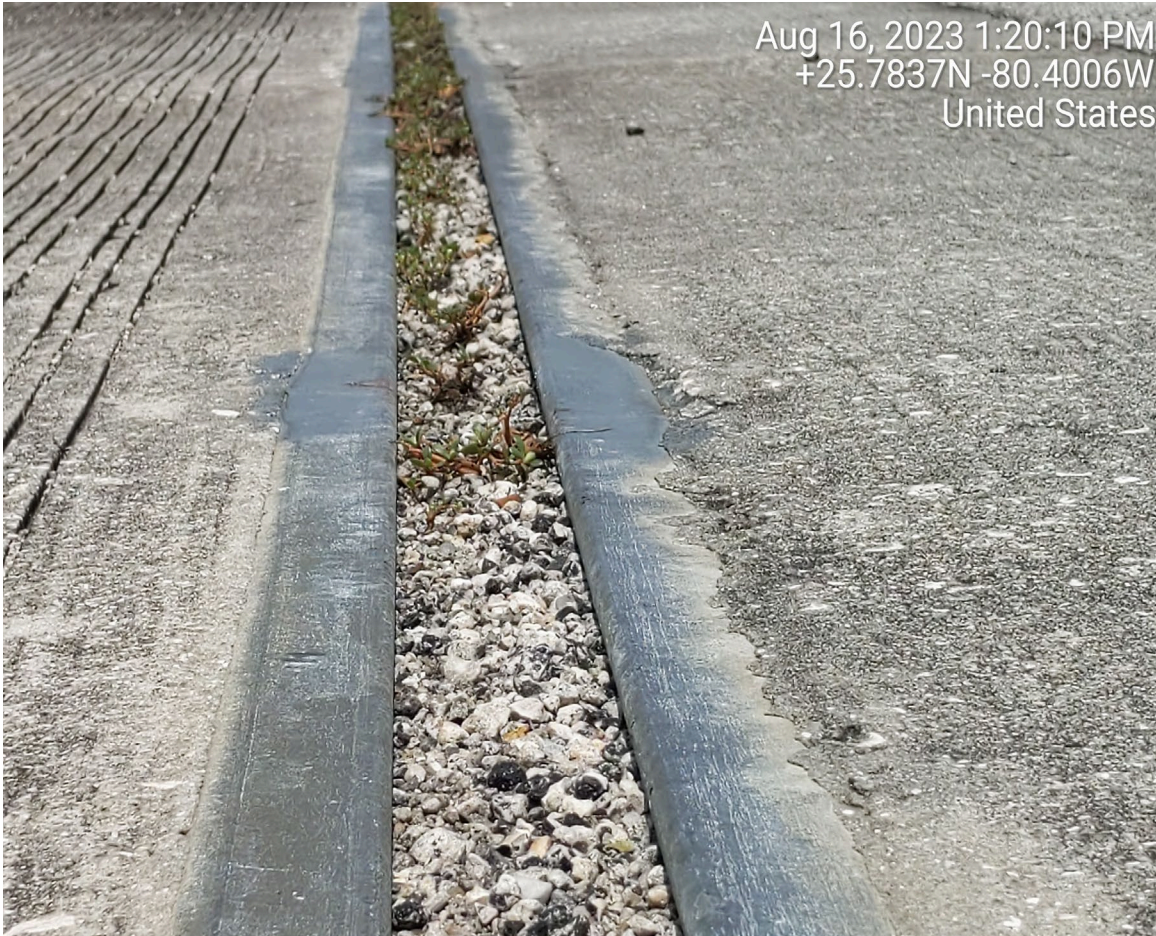
**PHOTO NO.: WB-012  
DATE: 8-16-2023**

**SEDIMENT AND DEBRIS ACCUMULATED ON BRIDGE  
EXPANSION JOINTS (BRIDGE No. 871002)**

**ITEM NOTED TO BE ADDRESSED BY GMX MAINTENANCE CONTRACT ITB-22-07**

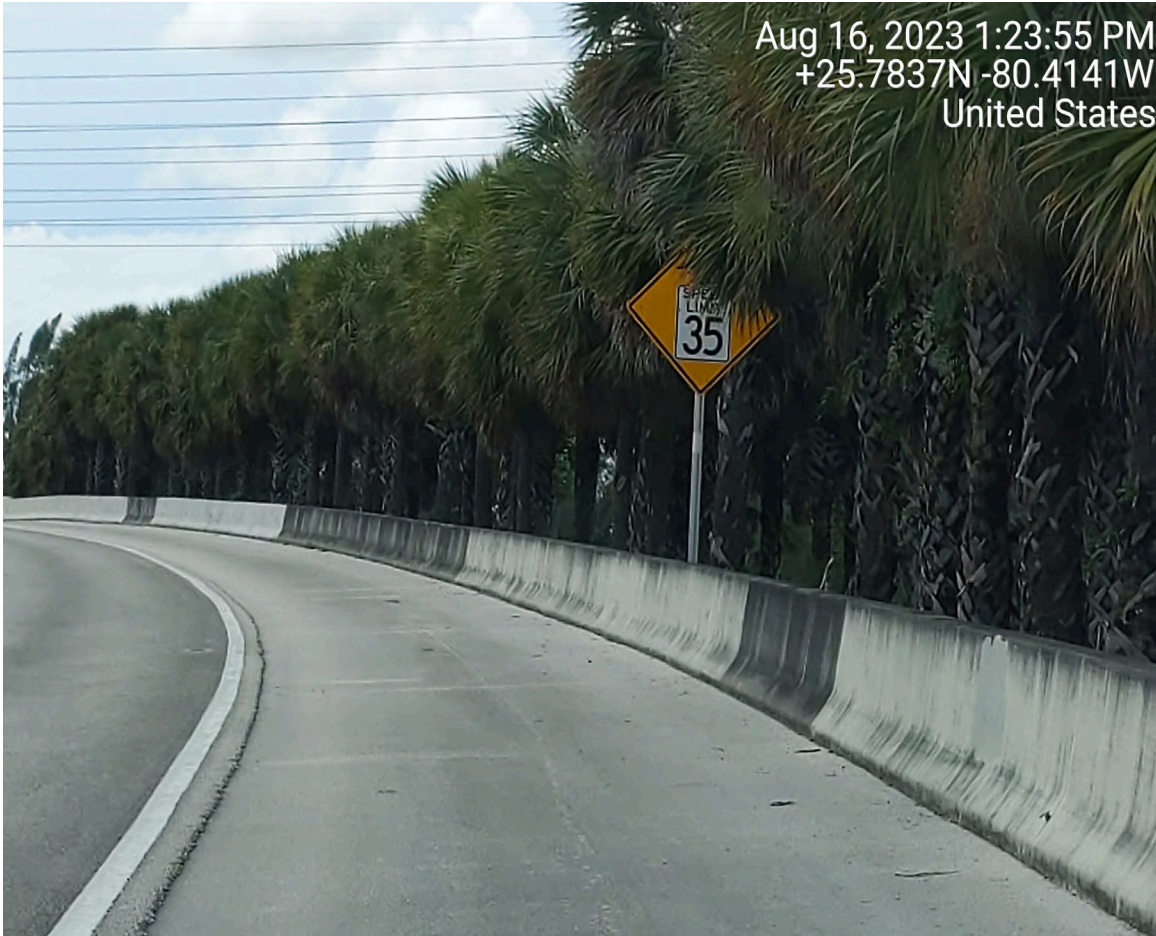
**PHOTO NO.: WB-016  
DATE: 8-16-2023**

**OVERGROWN VEGETATION OBSTRUCTING SIGN & DETERIORATED CLASS V  
COATING ON BARRIER WALL**

**ITEM NOTED TO BE ADDRESSED BY GMX MAINTENANCE RFP 23-01 & WORK  
PROGRAM 30037**

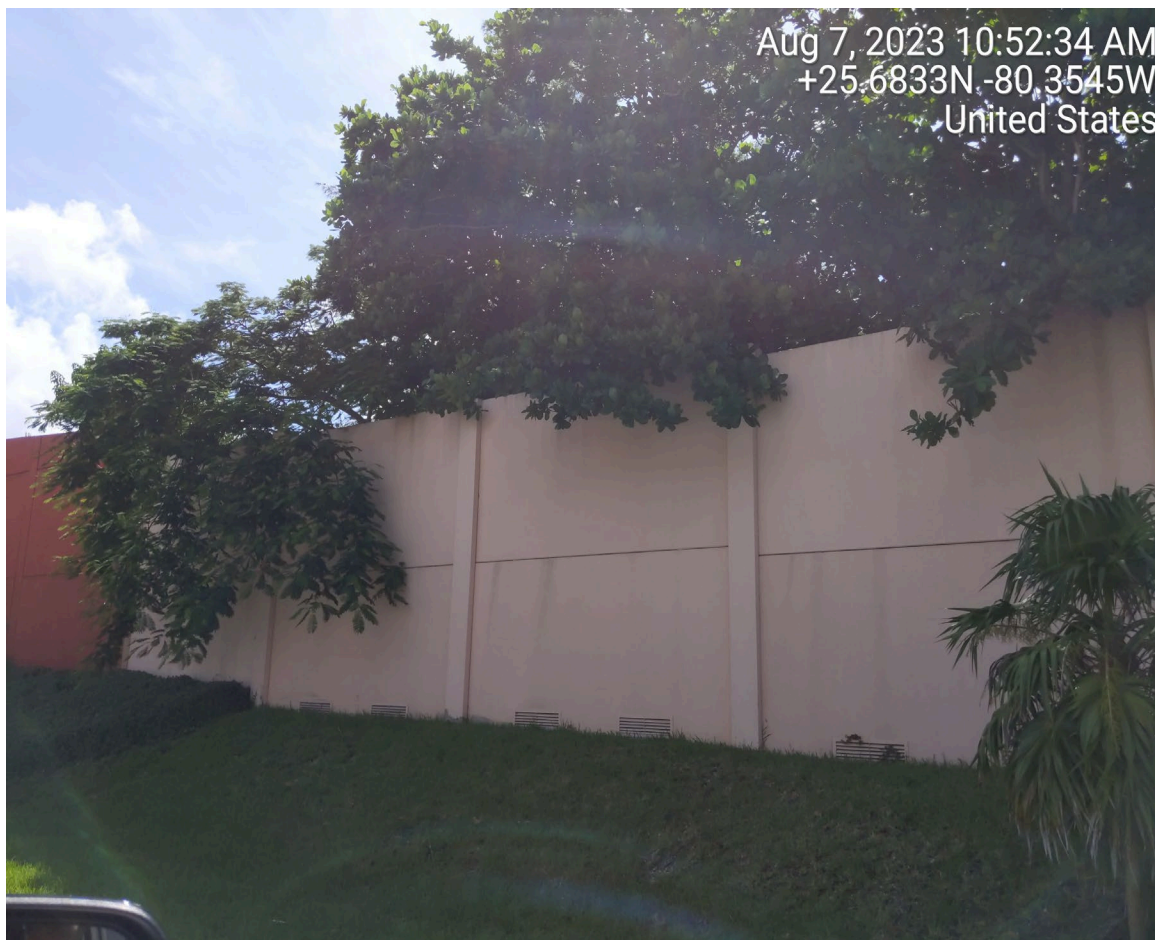
**PHOTO NO.: NB-002  
DATE: 8-7-2023**

**OVERGROWN VEGETATION ON SOUND WALL  
(TYPICAL THROUGHOUT THE CORRIDOR)**

**ITEM NOTED TO BE ADDRESSED BY GMX MAINTENANCE RFP-23-01**

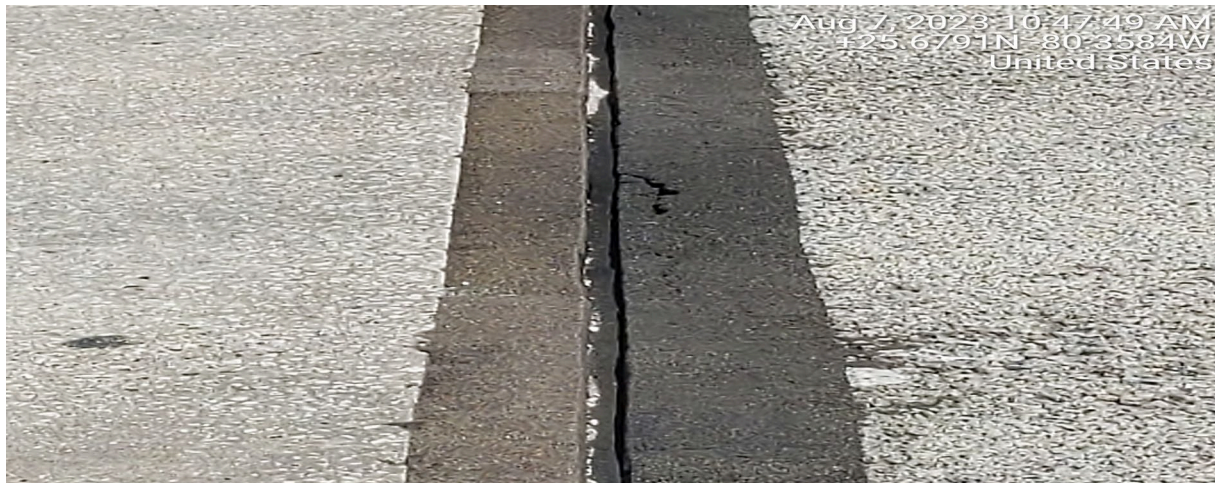
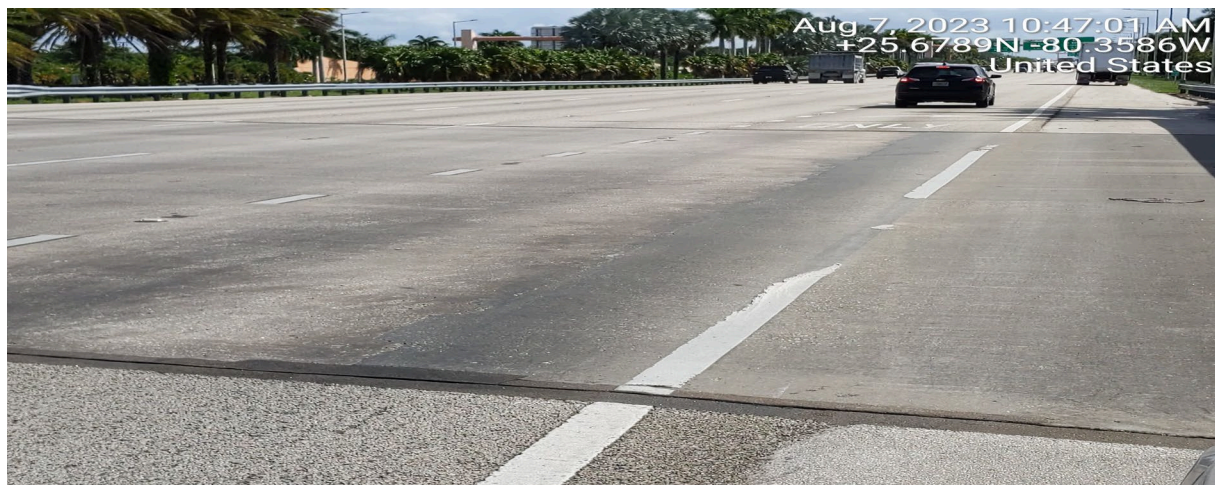
**PHOTO NO.: NB-004  
DATE: 8-7-2023**

**DETERIORATED JOINT SEALANT AND DETERIORATED STRIPING  
(BRIDGE # 870465)**

**ITEM NOTED TO BE ADDRESSED BY GMX MAINTENANCE ITB 22-07  
& ITB 23-17**

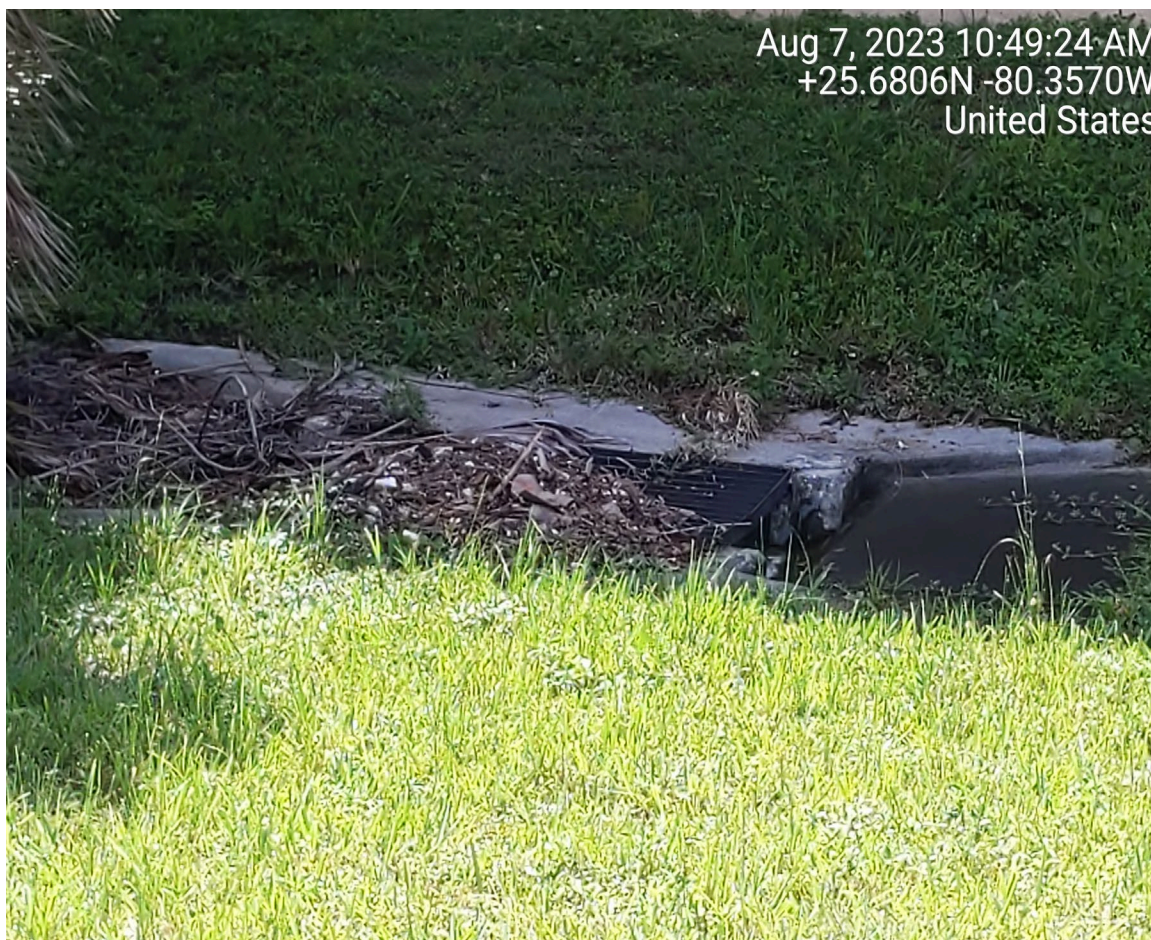
**PHOTO NO.: NB-007  
DATE: 8-7-2023**

**DEBRIS ON DRAINAGE STRUCTURE**

**ITEM NOTED TO BE ADDRESSED BY GMX MAINTENANCE RFP-23-01**

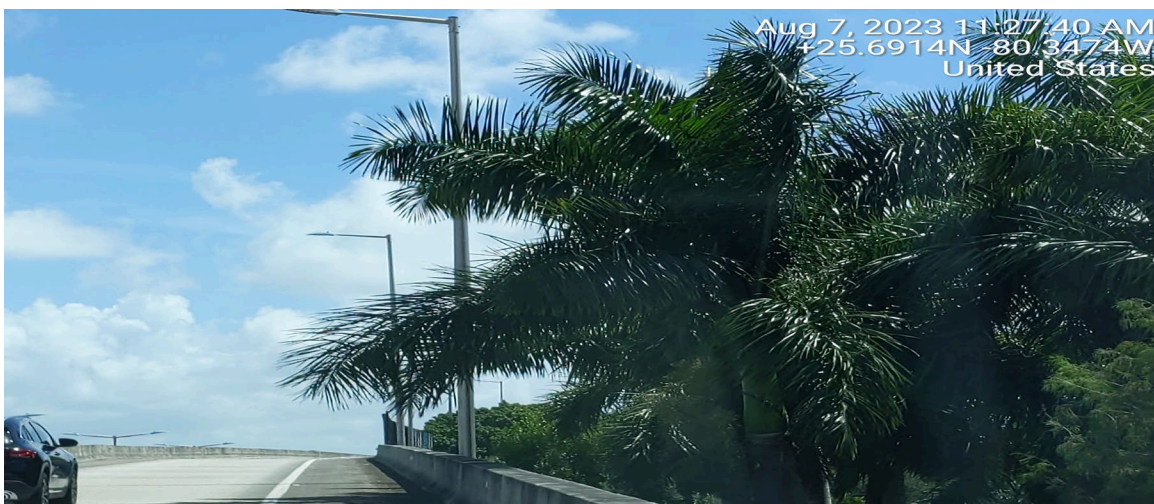
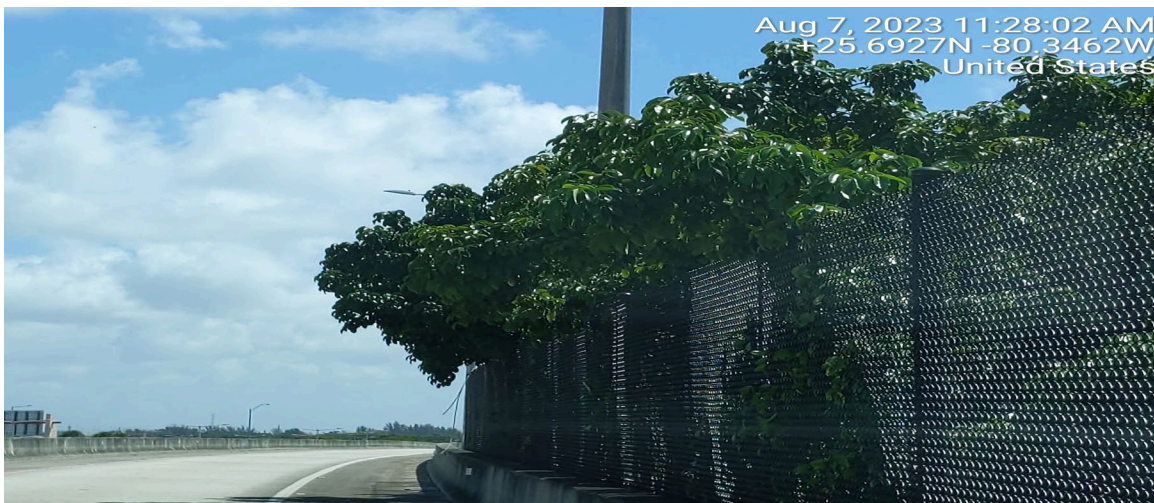
**PHOTO NO.: NB-010  
DATE: 8-7-2023**

**OVERGROWN VEGETATION ON BRIDGE**

**ITEM NOTED TO BE ADDRESSED BY GMX MAINTENANCE RFP-23-01**

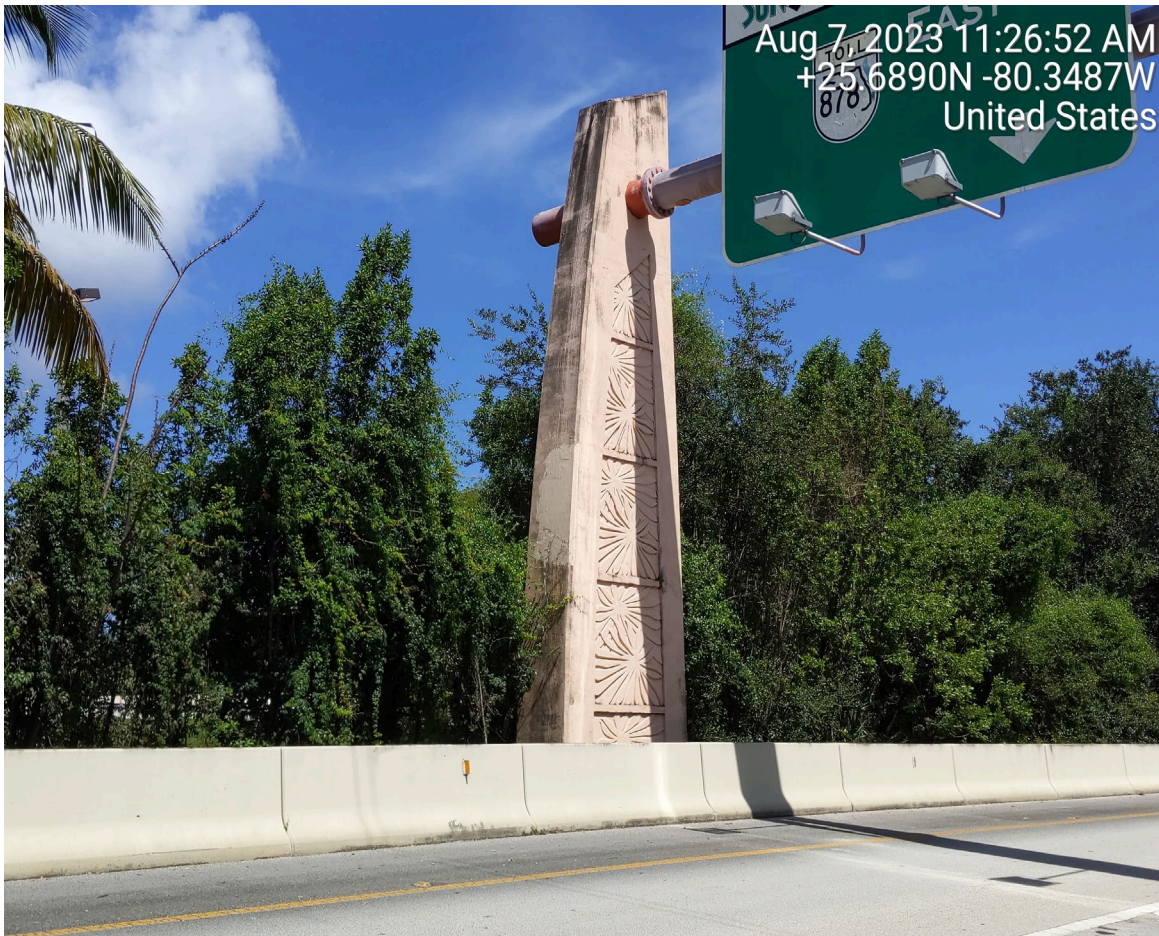
**PHOTO NO.: NB-011  
DATE: 8-7-2023**

**DETERIORATED CLASS V COATING (STRUCTURE # 87S897)**

**ITEM NOTED TO BE ADDRESSED BY GMX WORK PROGRAM 30037**

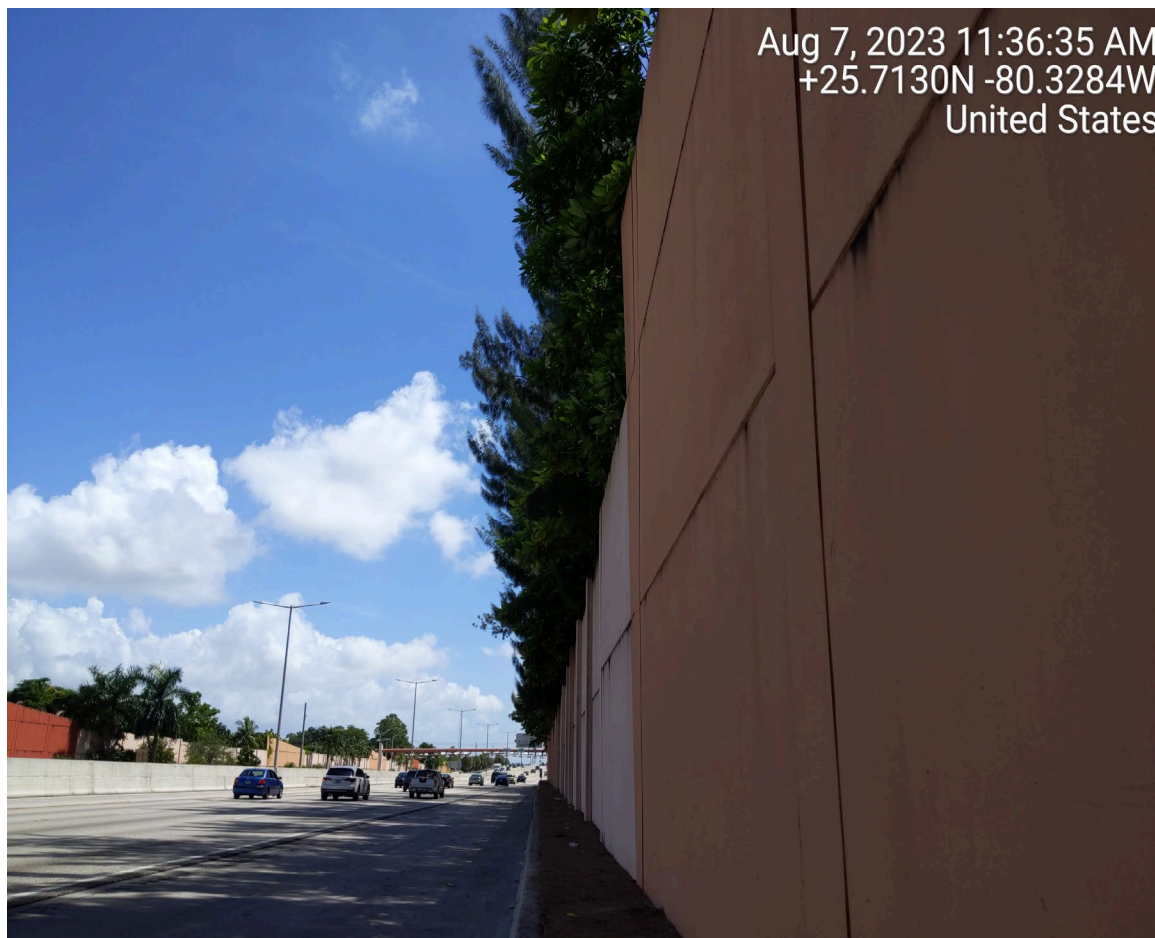
**PHOTO NO.: NB-013  
DATE: 8-7-2023**

**OVERGROWN VEGETATION ON SOUND WALL  
(TYPICAL THROUGHOUT THE CORRIDOR)**

**ITEM NOTED TO BE ADDRESSED BY GMX MAINTENANCE RFP-23-01**

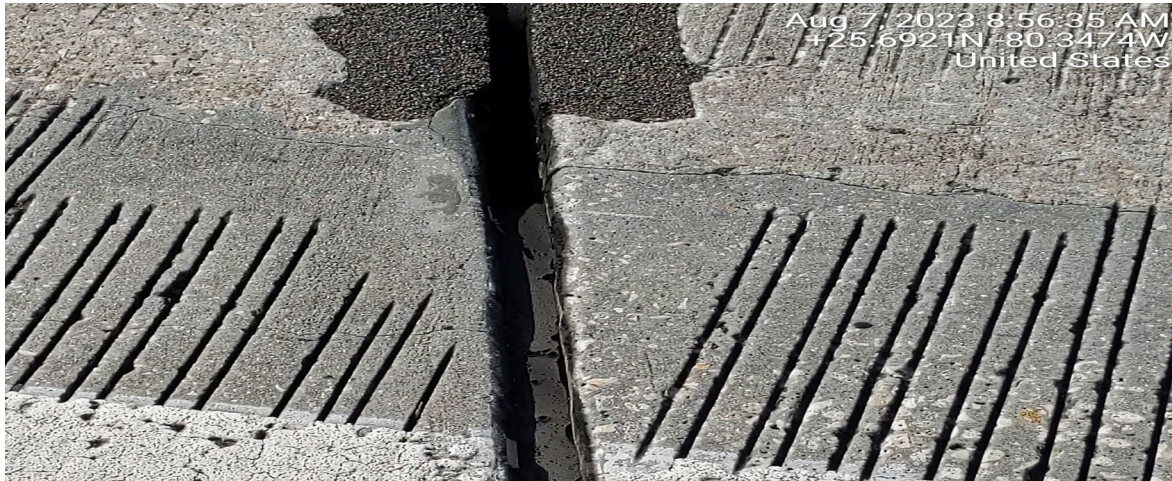
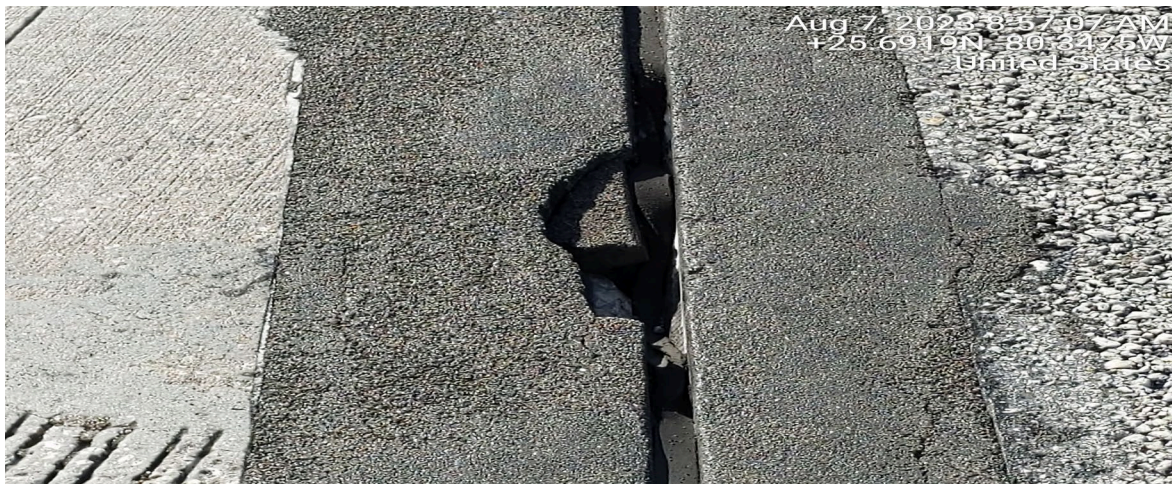
**PHOTO NO.: SB-008  
DATE: 8-7-2023**

**DETERIORATED JOINT SEALANT / DAMAGED HEADER  
(BENT 1 BRIDGE # 870495)**

**ITEM NOTED TO BE ADDRESSED BY GMX MAINTENANCE ITB-22-07**
