# ANNUAL INSPECTION REPORT 2023

## ANNUAL INSPECTION REPORT

In July 1, 2023, the Greater Miami Expressway Agency (GMX) acquired operational and financial control of five expressways in Miami-Dade County. This group of expressways, toll facilities, acquisition parcels and the GMX headquarters facility, all as described below, are hereinafter referred to as one of the "GMX System". In accordance with the Trust Indenture requirements, GMX retained EAC Consulting, Inc. (EAC), as the General Engineering Consultant to perform, among other duties assigned by the Agency, the yearly inspection of the GMX System. This report represents the annual inspection results for Fiscal Year (FY) 2023.

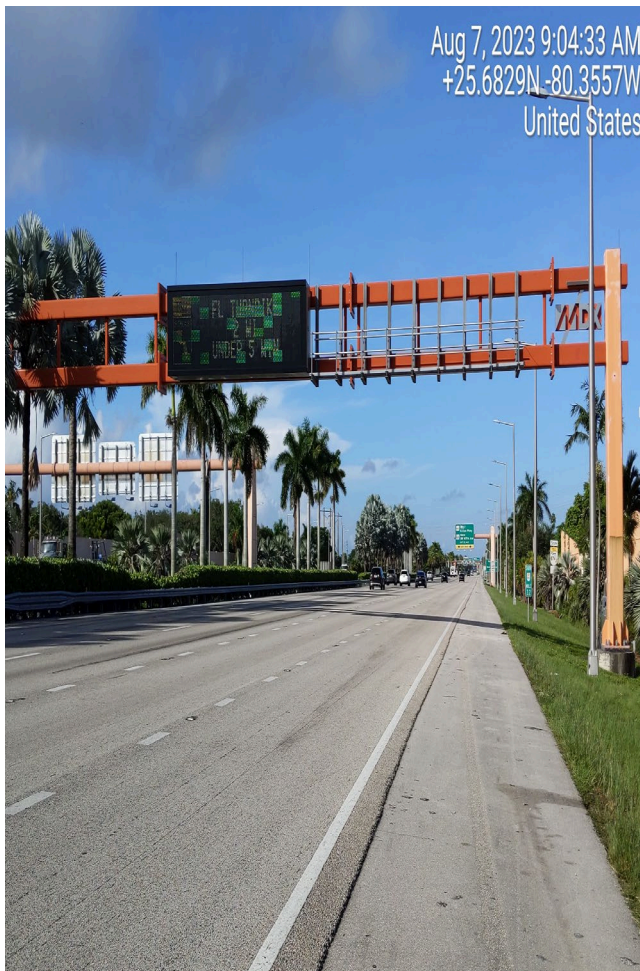
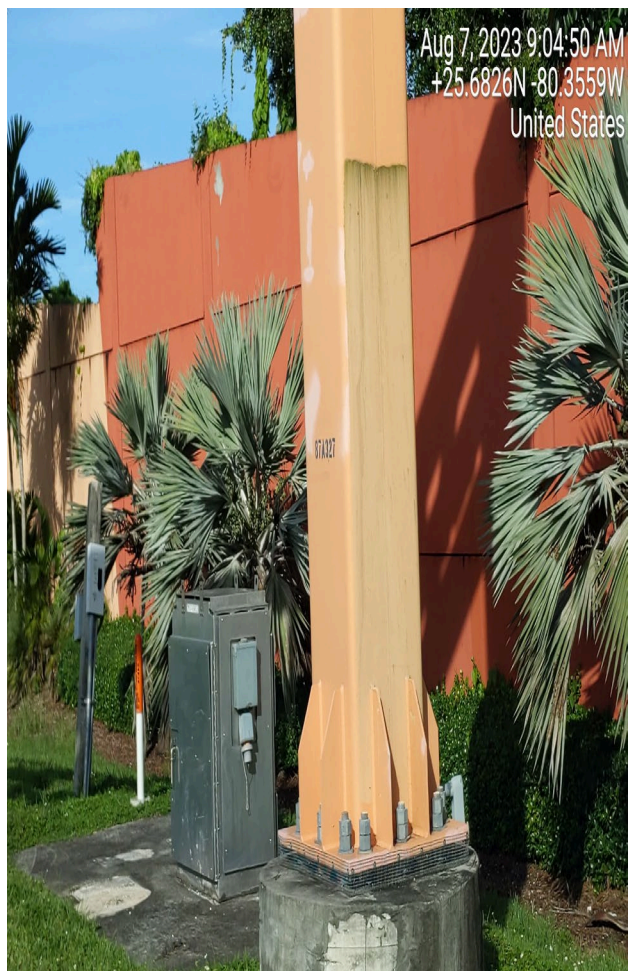
**PHOTO NO.: SB-010  
DATE: 8-7-2023**

**DETERIORATED PAINT ON OVERHEAD SIGN  
(STRUCTURE # 87A327)**

**ITEM NOTED TO BE ADDRESSED BY GMX WORK PROGRAM NO. 30043**

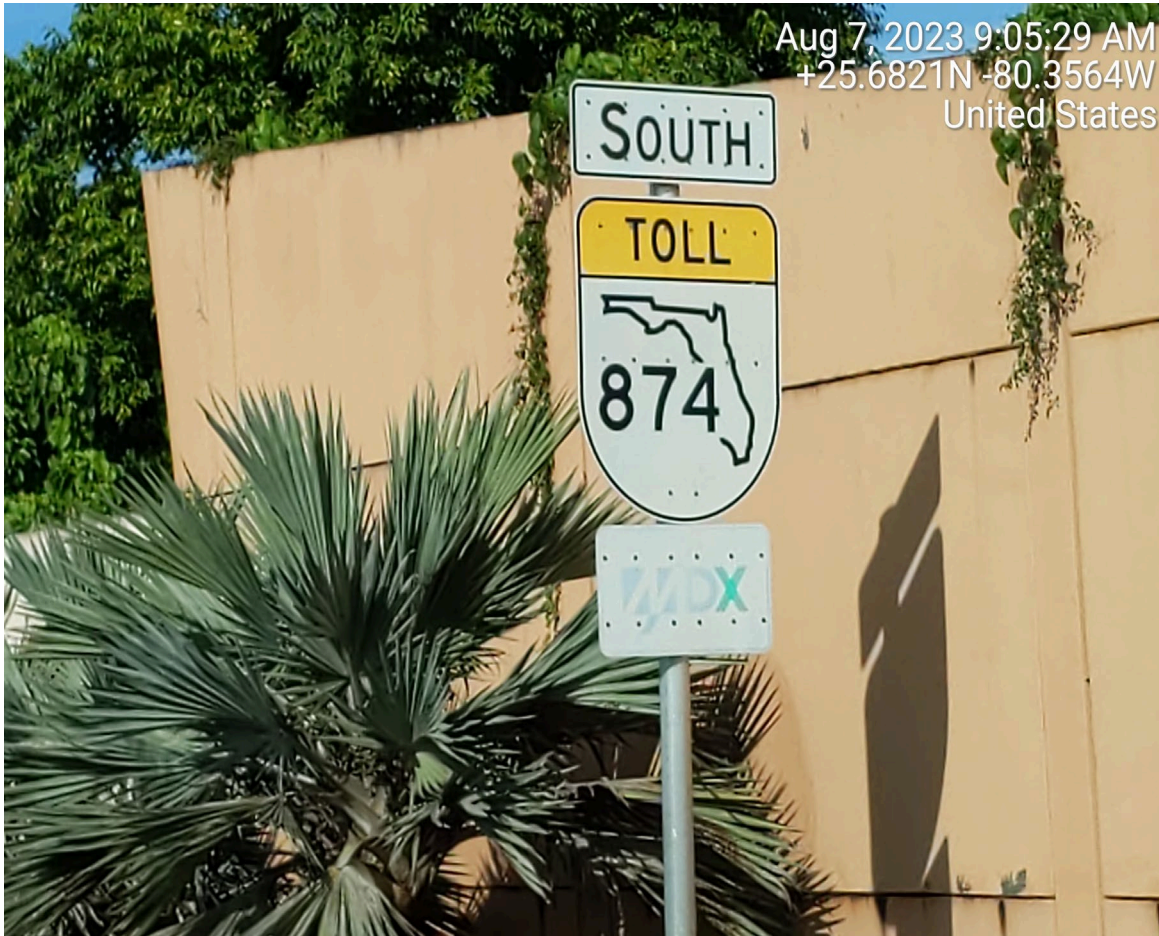
**PHOTO NO.: SB-011  
DATE: 8-7-2023**

**DETERIORATED REFLECTIVE SHEETING ON MDX SIGN**

**ITEM NOTED TO BE ADDRESSED BY GMX MAINTENANCE ITB-23-17**

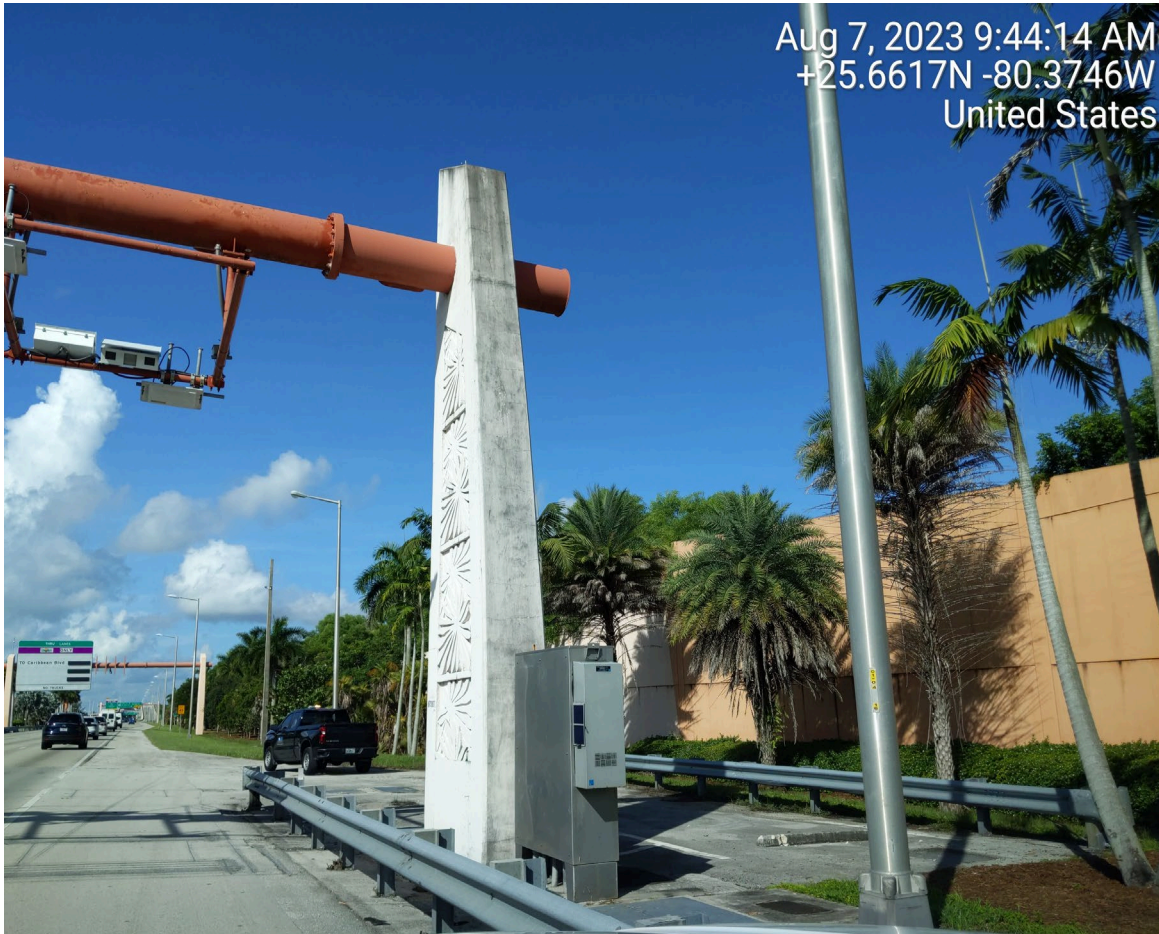
**PHOTO NO.: SB-012  
DATE: 8-7-2023**

**DETERIORATED PAINT ON ORT GANTRY MONOTUBE  
(STRUCTURE # 87S937)**

**ITEM NOTED TO BE ADDRESSED BY GMX WORK PROGRAM NO. 30043**

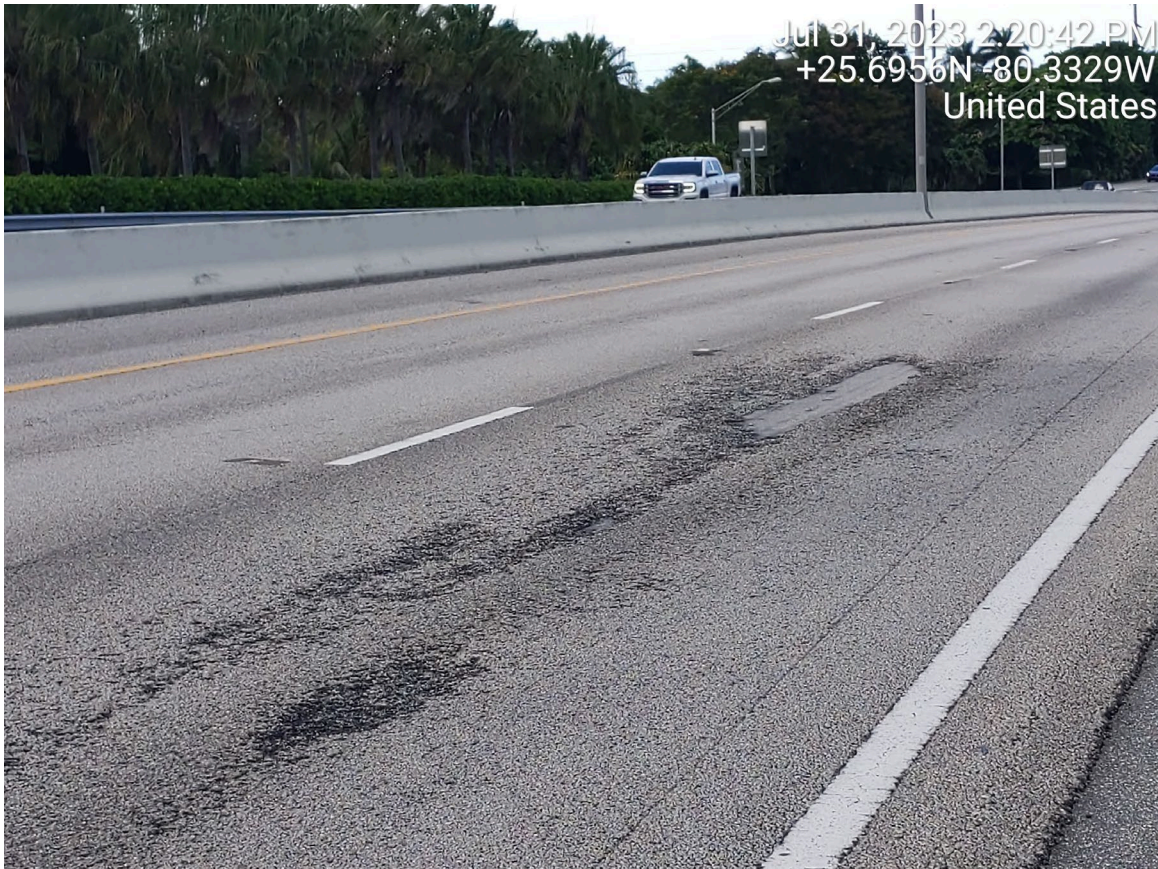
**PHOTO NO.: EB-002  
DATE: 7-31-2023**

**DETERIORATED PAVEMENT**

**ITEM NOTED TO BE ADDRESSED BY GMX WORK PROGRAM NO. 30044**

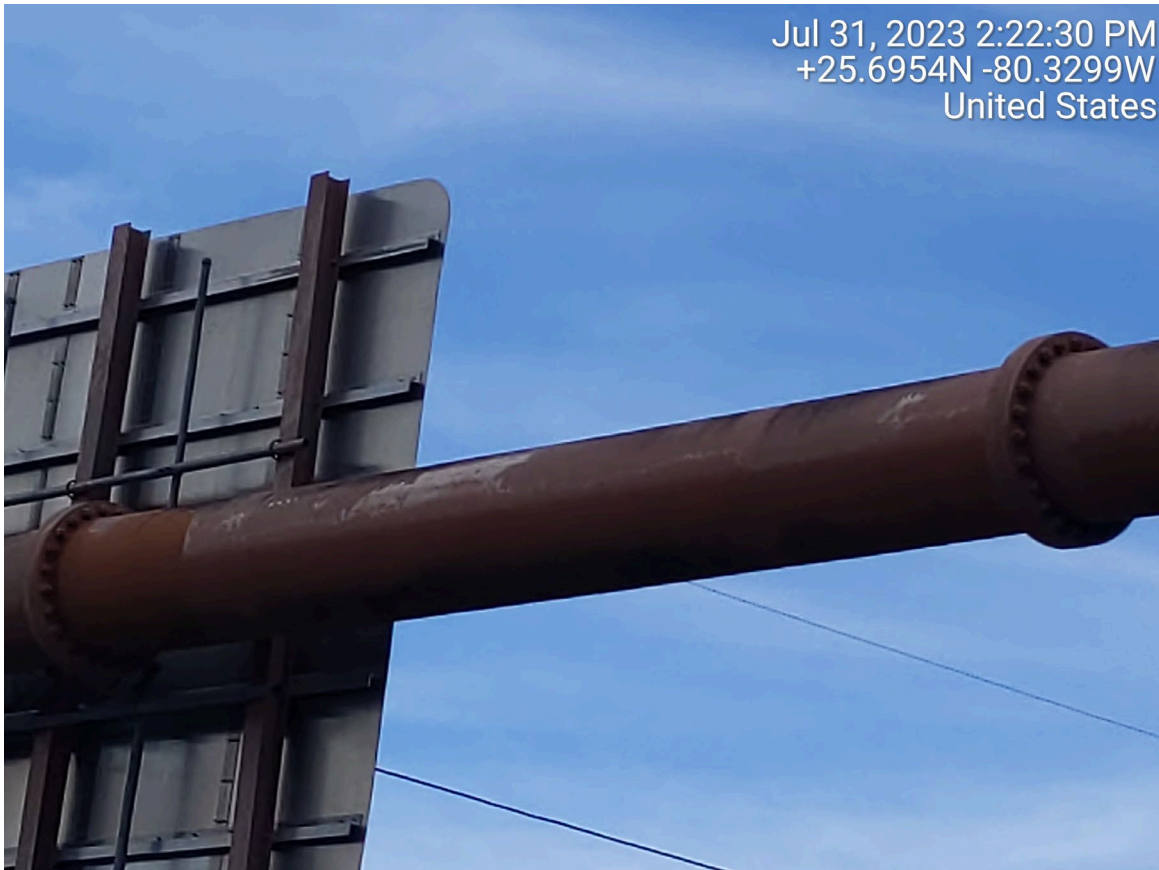
**PHOTO NO.: EB-003  
DATE: 07-31-2023**

**DETERIORATED PAINT ON MONOTUBE**

**ITEM NOTED TO BE ADDRESSED BY GMX WORK PROGRAM 30043**

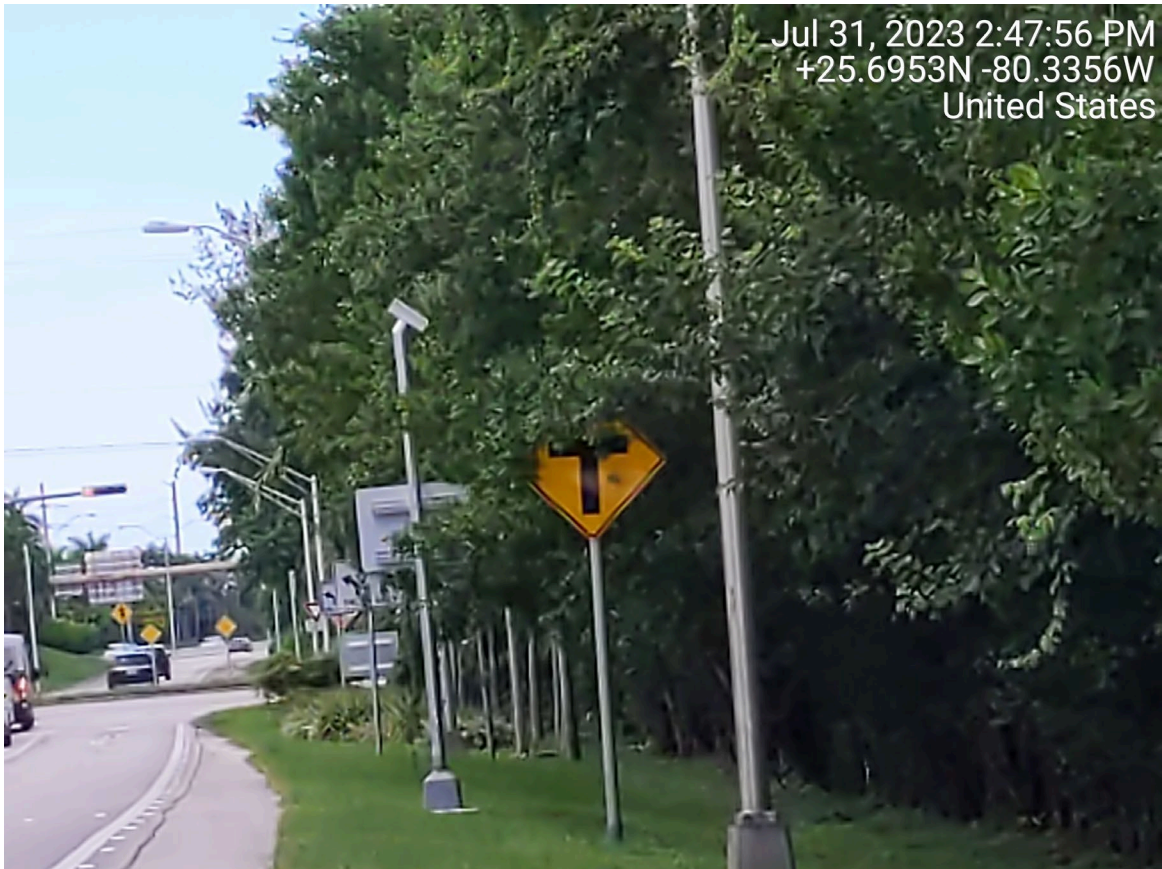
**PHOTO NO.: EB-005  
DATE: 7-31-2023**

**OVERGROWN VEGETATION OBSTRUCTING SIGN**

**ITEM NOTED TO BE ADDRESSED BY GMX MAINTENANCE RFP-23-01**

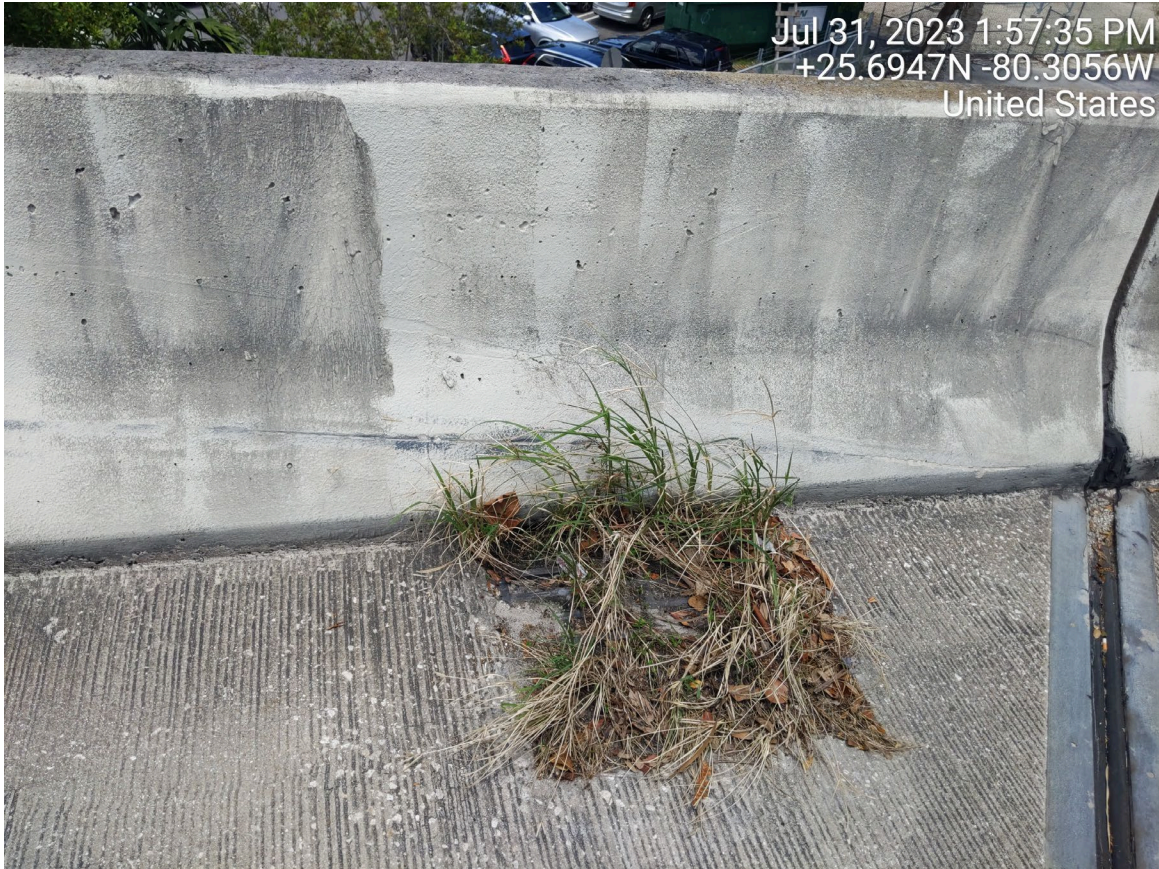
**PHOTO NO.: WB-002  
DATE: 7-31-2023**

**SILTED DECK DRAINS (TYPICAL AT VARIOUS LOCATIONS)**

**ITEM NOTED TO BE ADDRESSED BY GMX MAINTENANCE ITB-22-09**

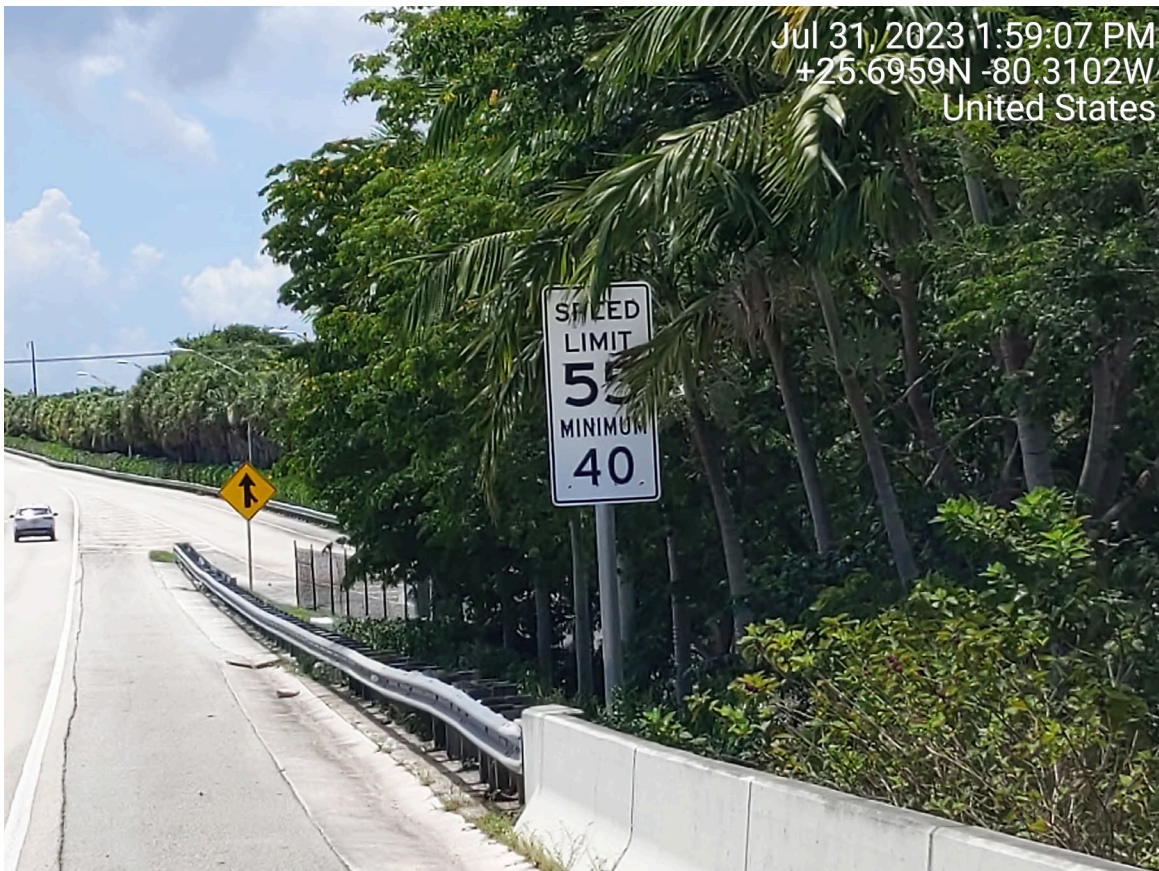
**PHOTO NO.: WB-003  
DATE: 7-31-2023**

**OVERGROWN VEGETATION OBSTRUCTING SIGN**

**ITEM NOTED TO BE ADDRESSED BY GMX MAINTENANCE RFP-23-01**

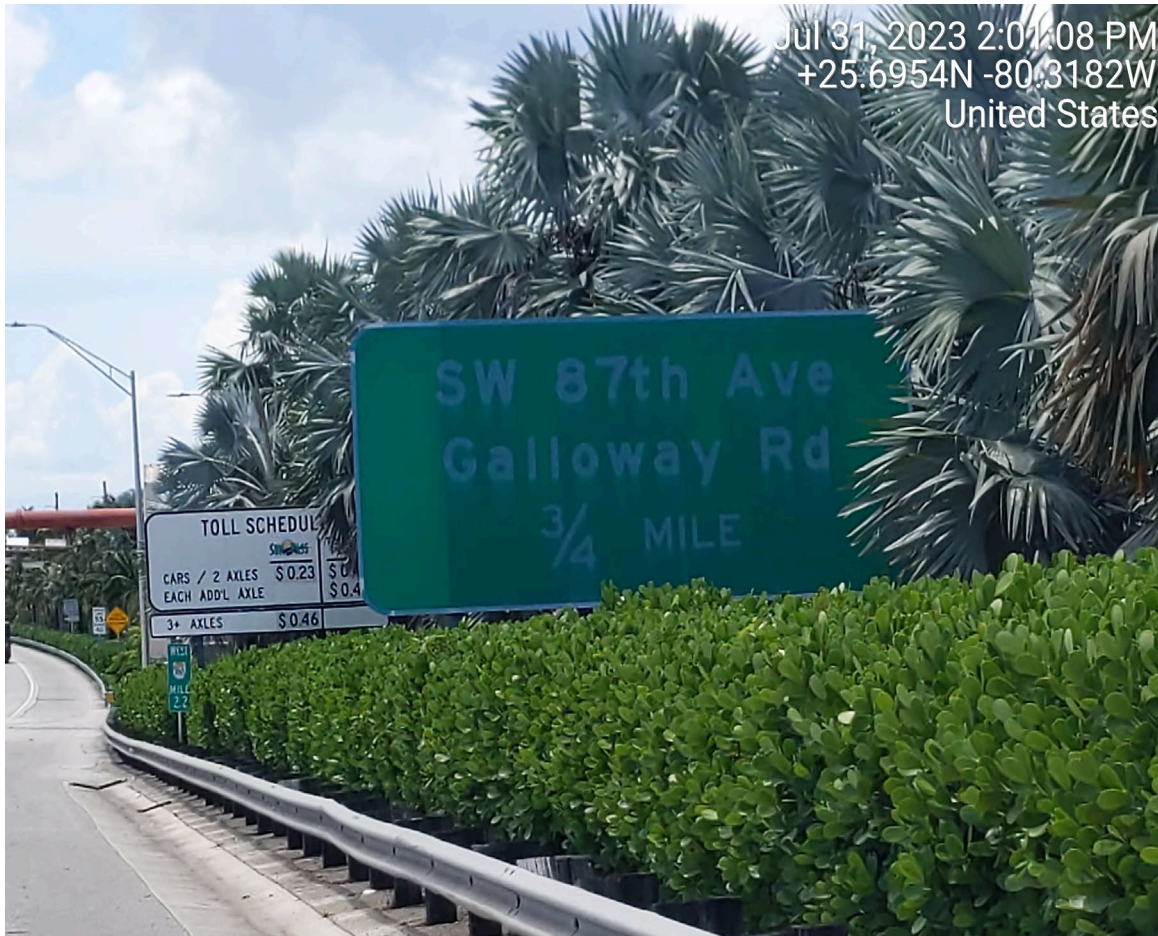
**PHOTO NO.: WB-004  
DATE: 7-31-2023**

**DETERIORATED REFLECTIVE SHEETING**

**ITEM NOTED TO BE ADDRESSED BY GMX WORK PROGRAM NO. 30058**

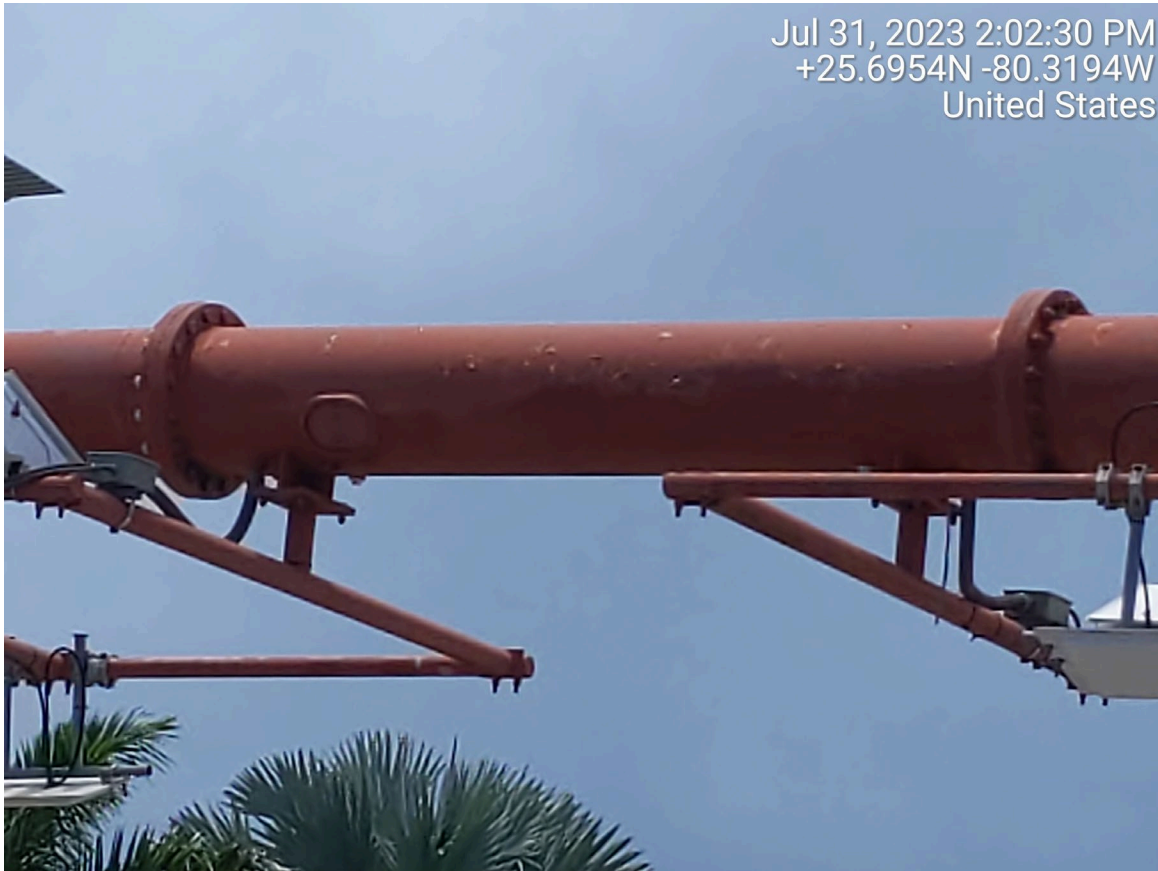
**PHOTO NO.: WB-005  
DATE: 7-31-2023**

**DETERIORATED PAINT ON ORT MONOTUBE**

**ITEM NOTED TO BE ADDRESSED BY GMX WORK PROGRAM 30043**

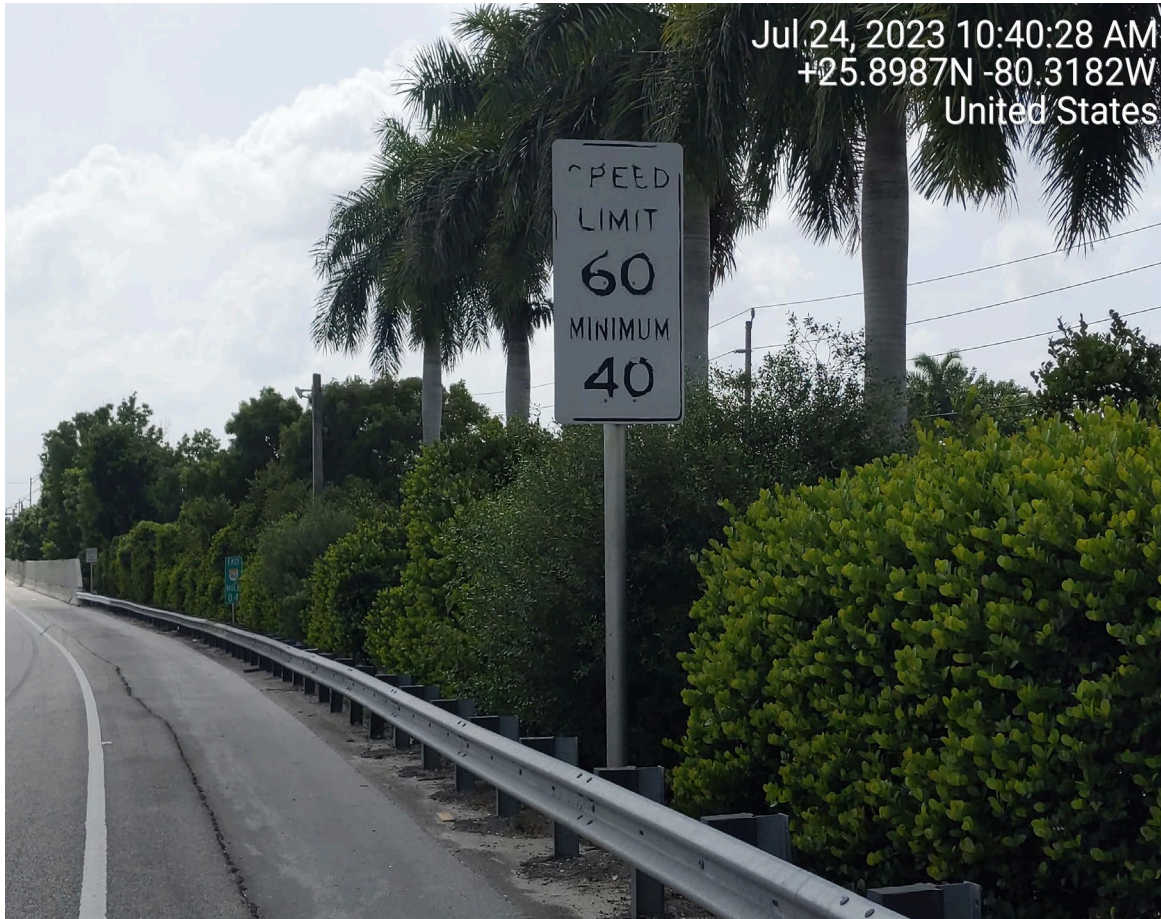
**PHOTO NO.: EB-002  
DATE: 7-24-2023**

**DETERIORATED REFLECTIVE SHEETING ON SPEED LIMIT SIGN**

**ITEM NOTED TO BE ADDRESSED BY GMX MAINTENANCE ITB-23-17**

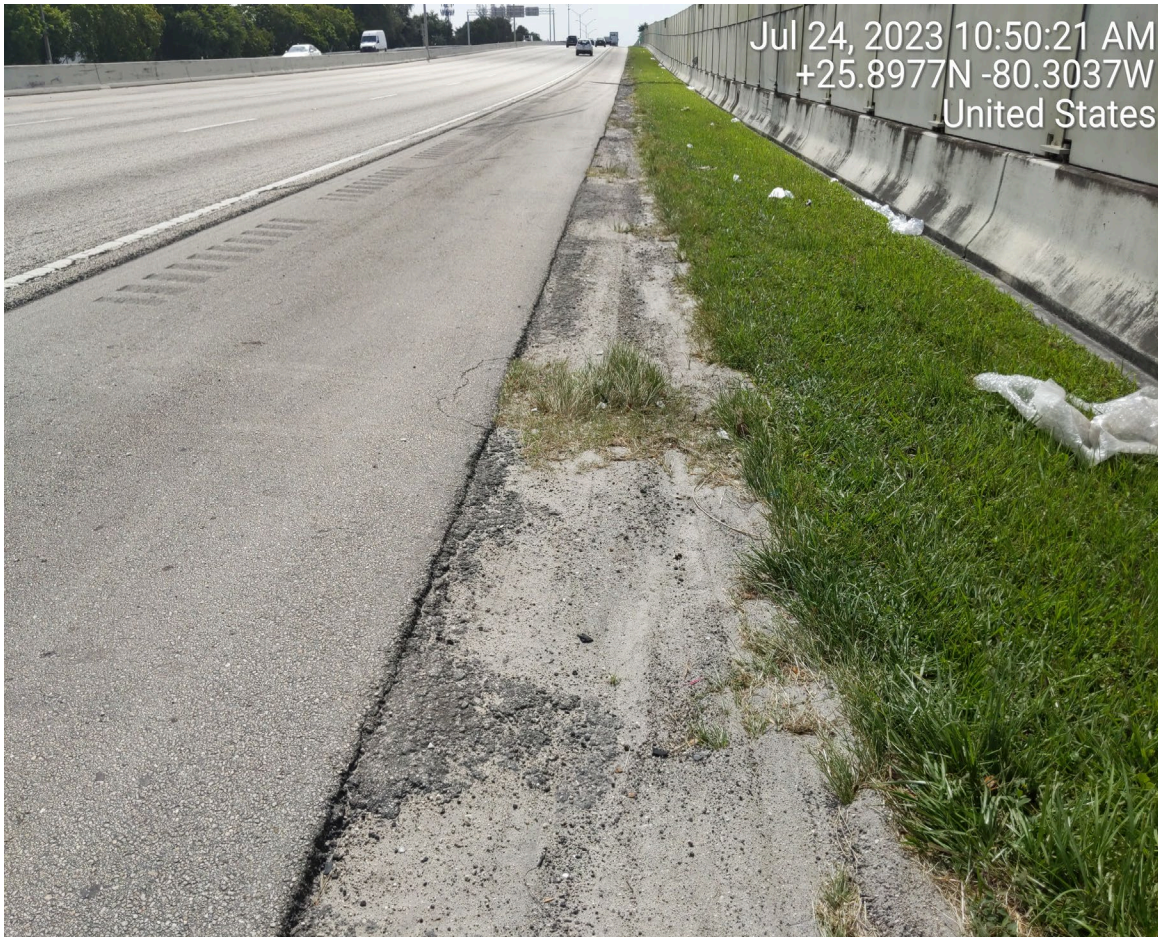
**PHOTO NO.: EB-004  
DATE: 7-24-2023**

**SHOULDER DROP OFF AND MISSING TURF**

**ITEM NOTED TO BE ADDRESSED BY GMX MAINTENANCE RFP-23-01**

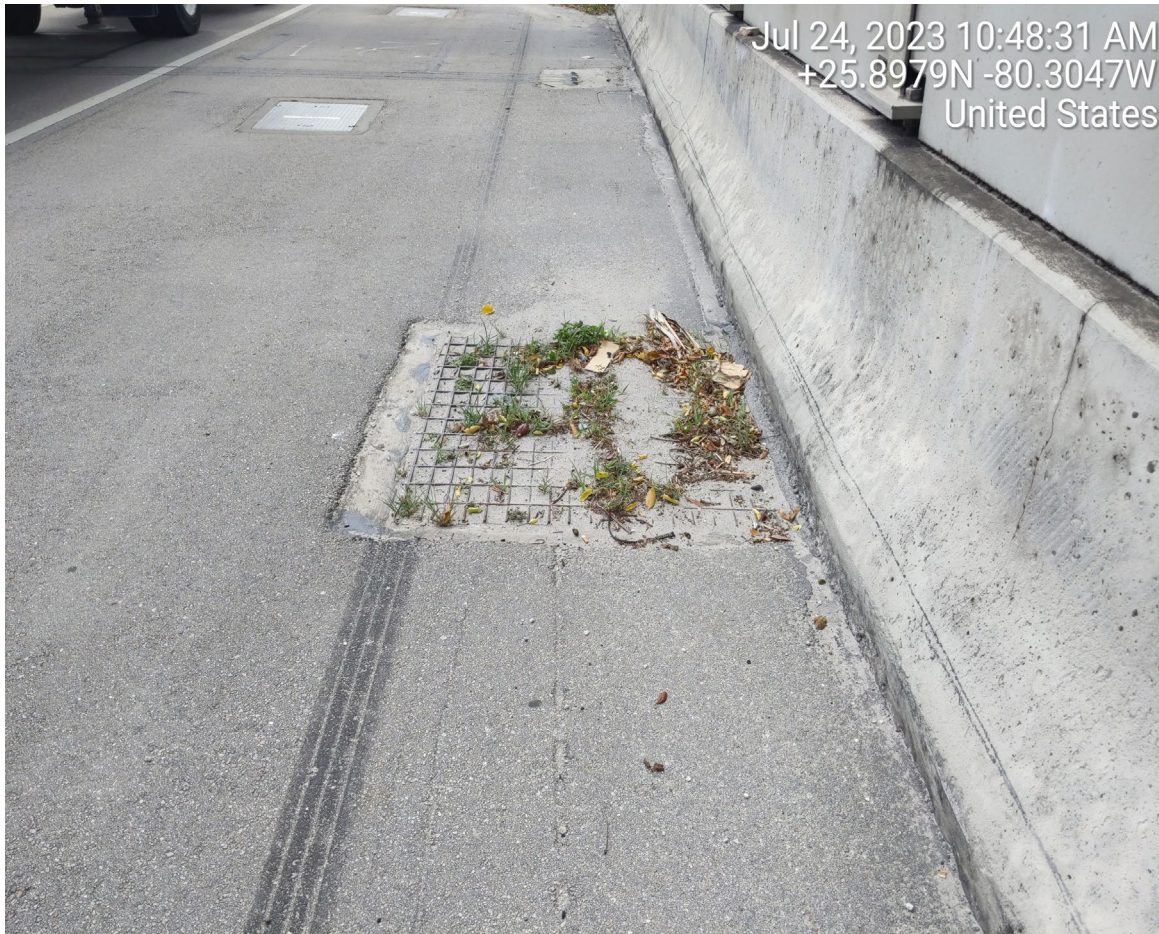
**PHOTO NO.: EB-05  
DATE: 7-24-2023**

**SILTED DRAINAGE STRUCTURE (TYPICAL AT VARIOUS LOCATIONS)**

**ITEM NOTED TO BE ADDRESSED BY GMX MAINTENANCE ITB-22-09**

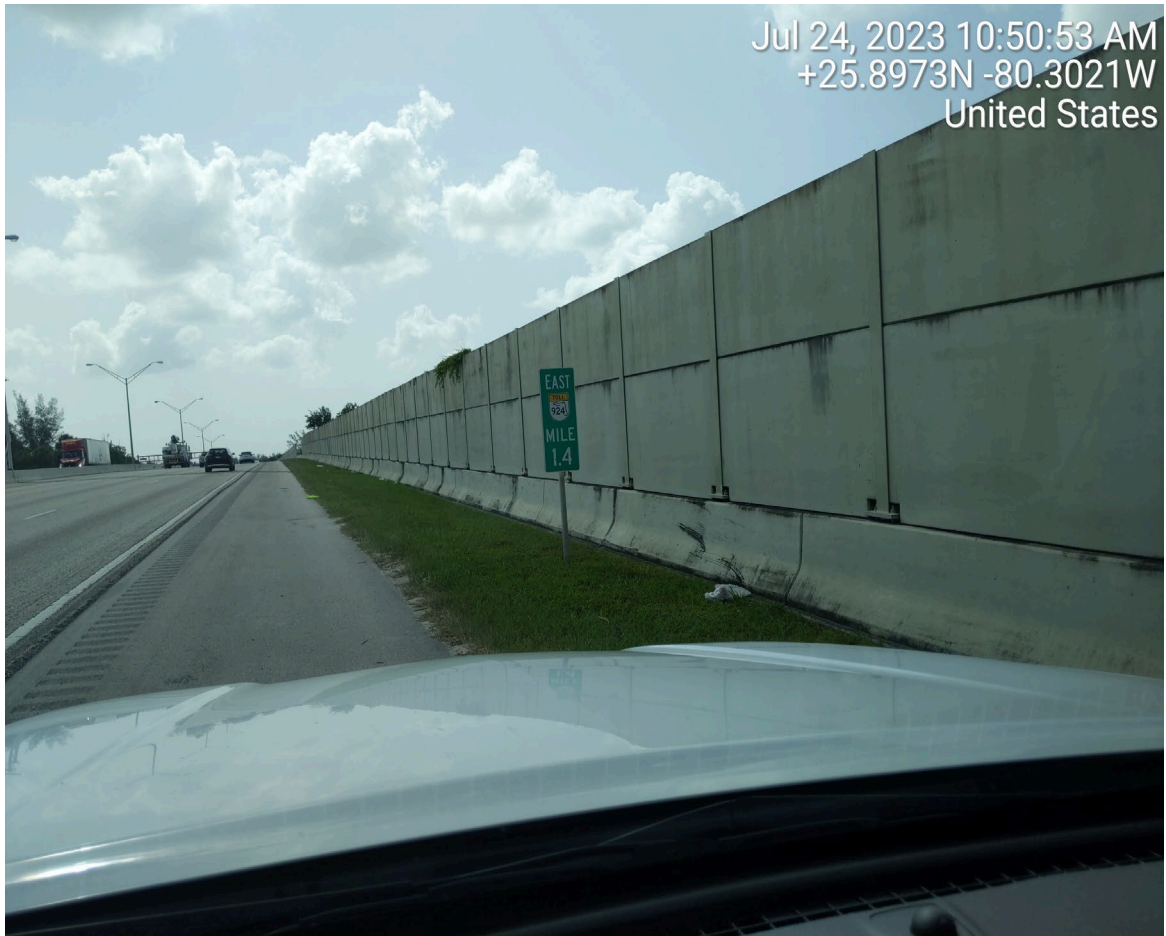
**PHOTO NO.: EB-006  
DATE: 7-24-2023**

**DETERIORATED CLASS V COATING ON SOUND WALLS  
(TYPICAL THROUGHOUT THE CORRIDOR)**

**ITEM NOTED TO BE ADDRESSED BY GMX WORK PROGRAM No. 30037**

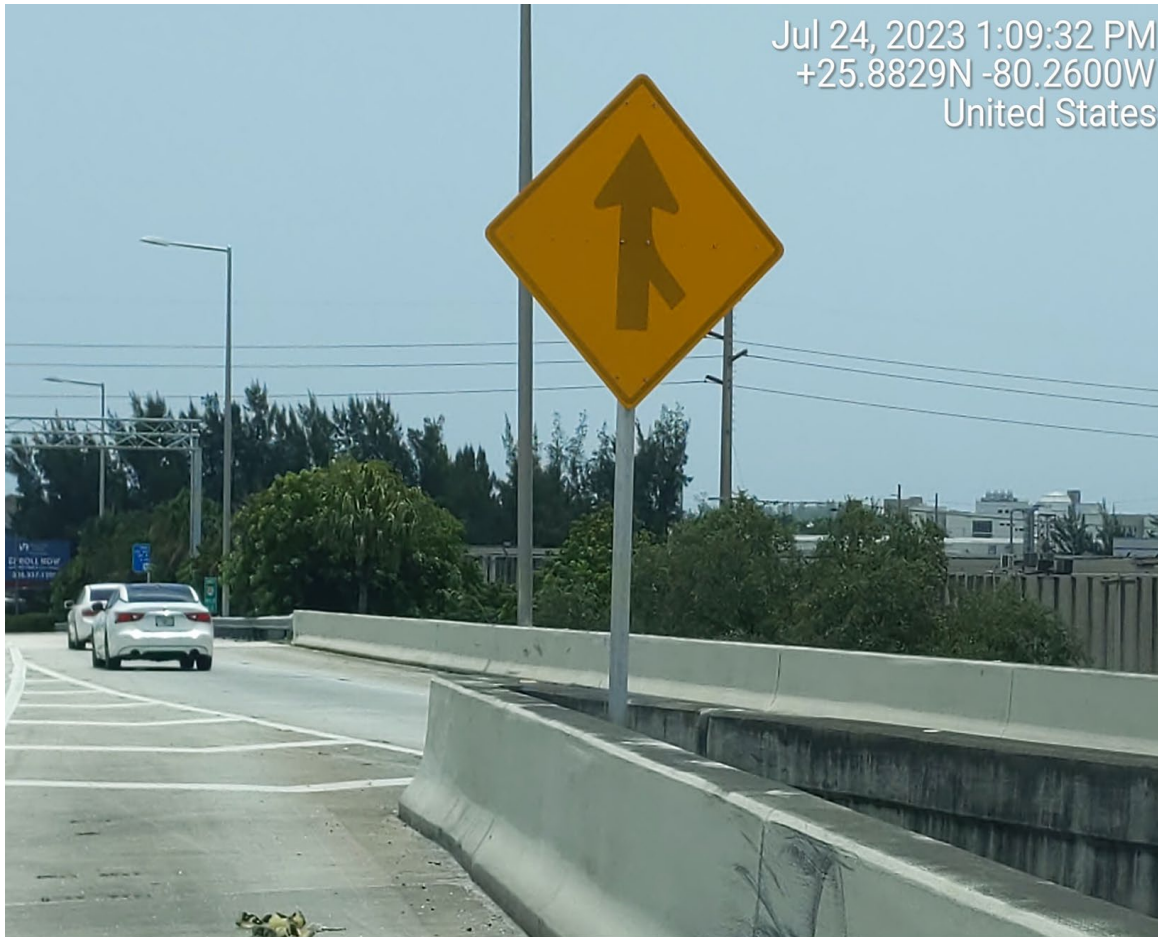
**PHOTO NO.: EB-007  
DATE: 7-24-2023**

**DETERIORATED REFLECTIVE SHEETING (TYPICAL AT VARIOUS LOCATIONS)**

**ITEM NOTED TO BE ADDRESSED BY GMX MAINTENANCE ITB-23-17**

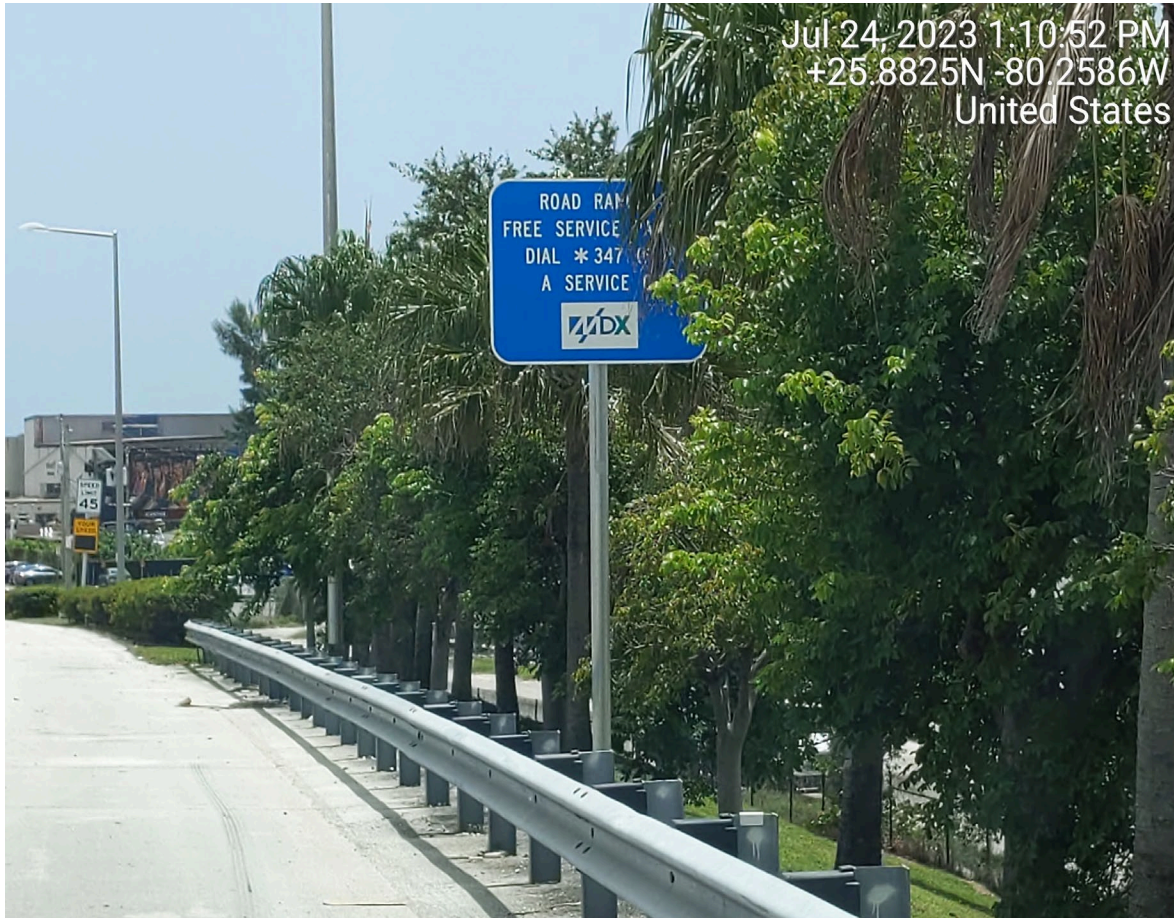
**PHOTO NO.: EB-009  
DATE: 7-24-2023**

**OVERGROWN VEGETATION OBSTRUCTING SIGN**

**ITEM NOTED TO BE ADDRESSED BY GMX MAINTENANCE RFP-23-01**

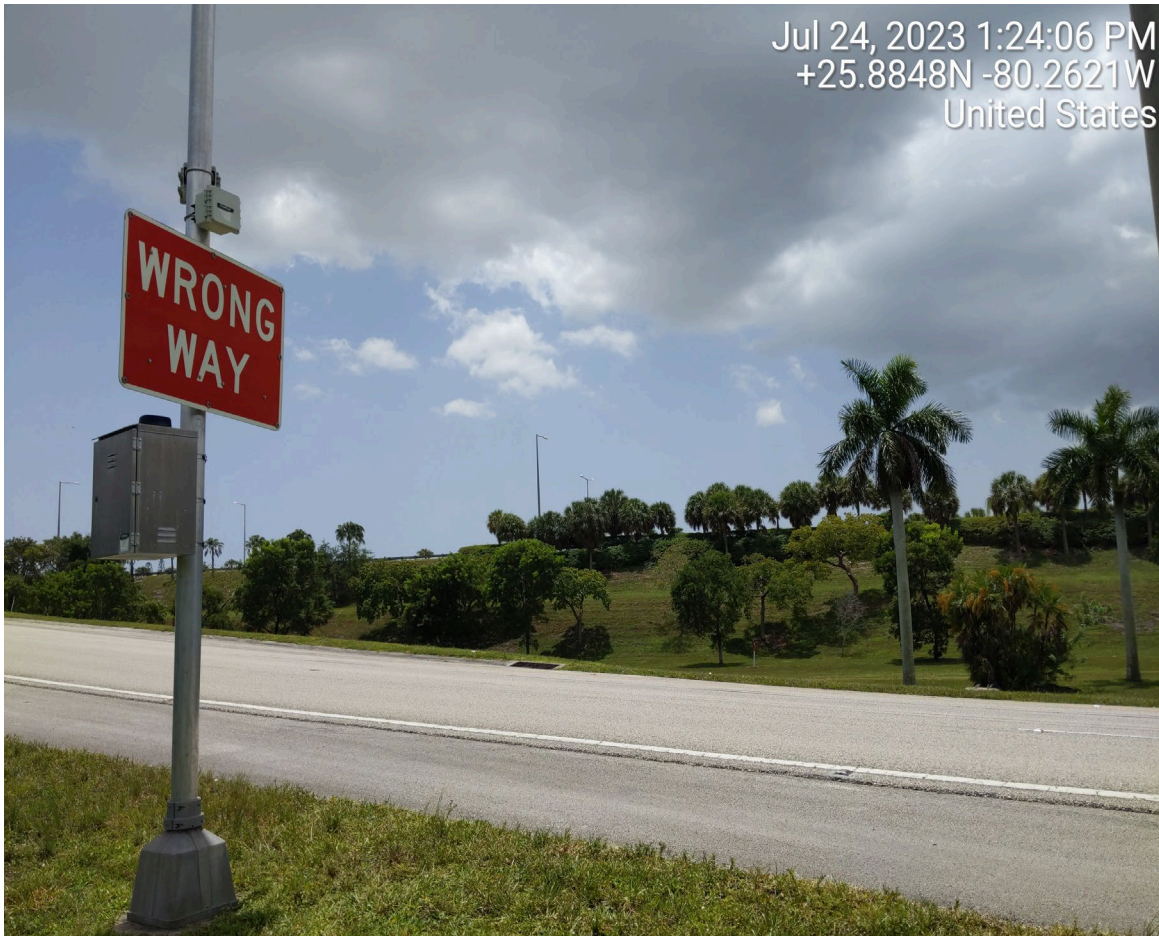
**PHOTO NO.: EB-011  
DATE: 7-24-2023**

**MISSING WRONG WAY SIGN ASSEMBLY (LEFT SHOULDER)**

**ITEM NOTED TO BE ADDRESSED BY GMX MAINTENANCE ITB-23-17**

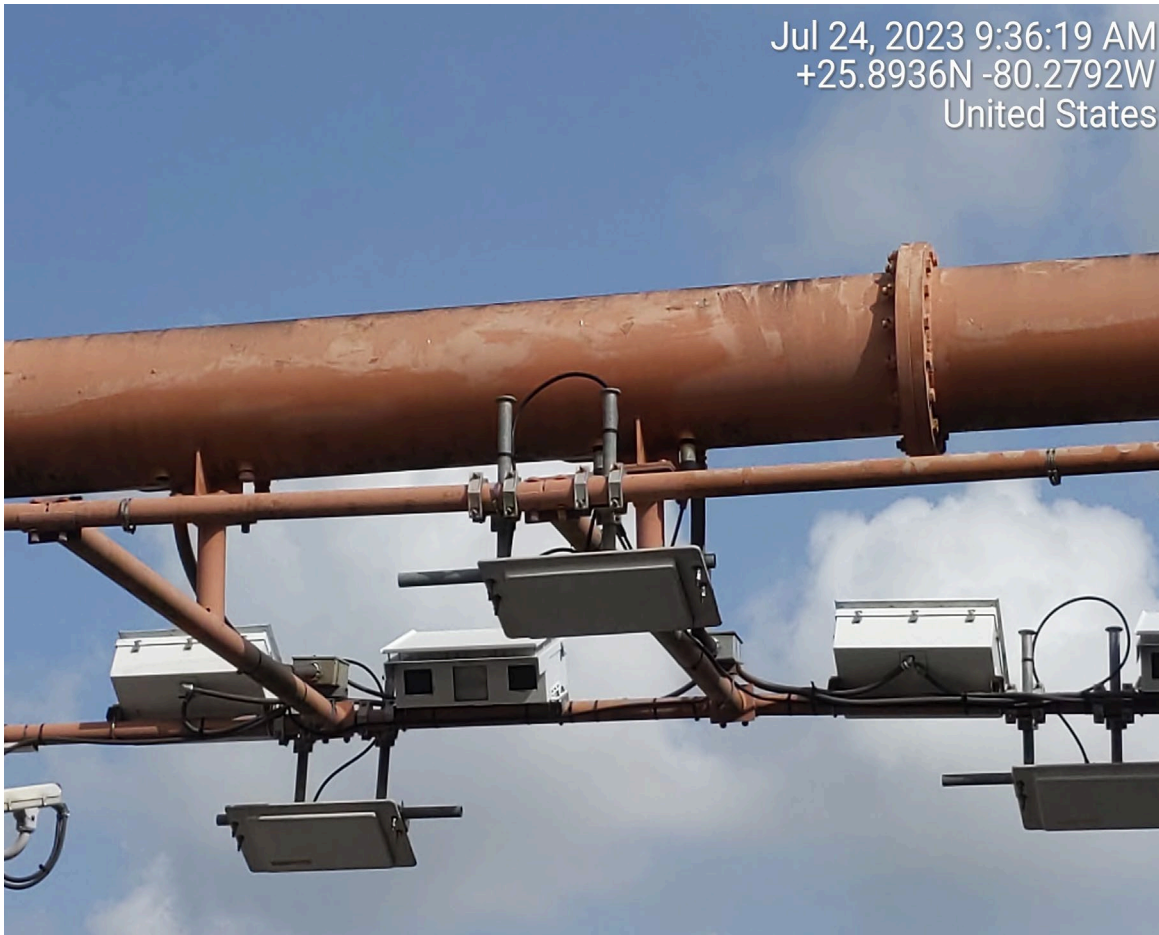
**PHOTO NO.: WB-001  
DATE: 7-24-2023**

**DETERIORATED PAINT ON ORT MONOTUBE (STRUCTURE # 87S932)**

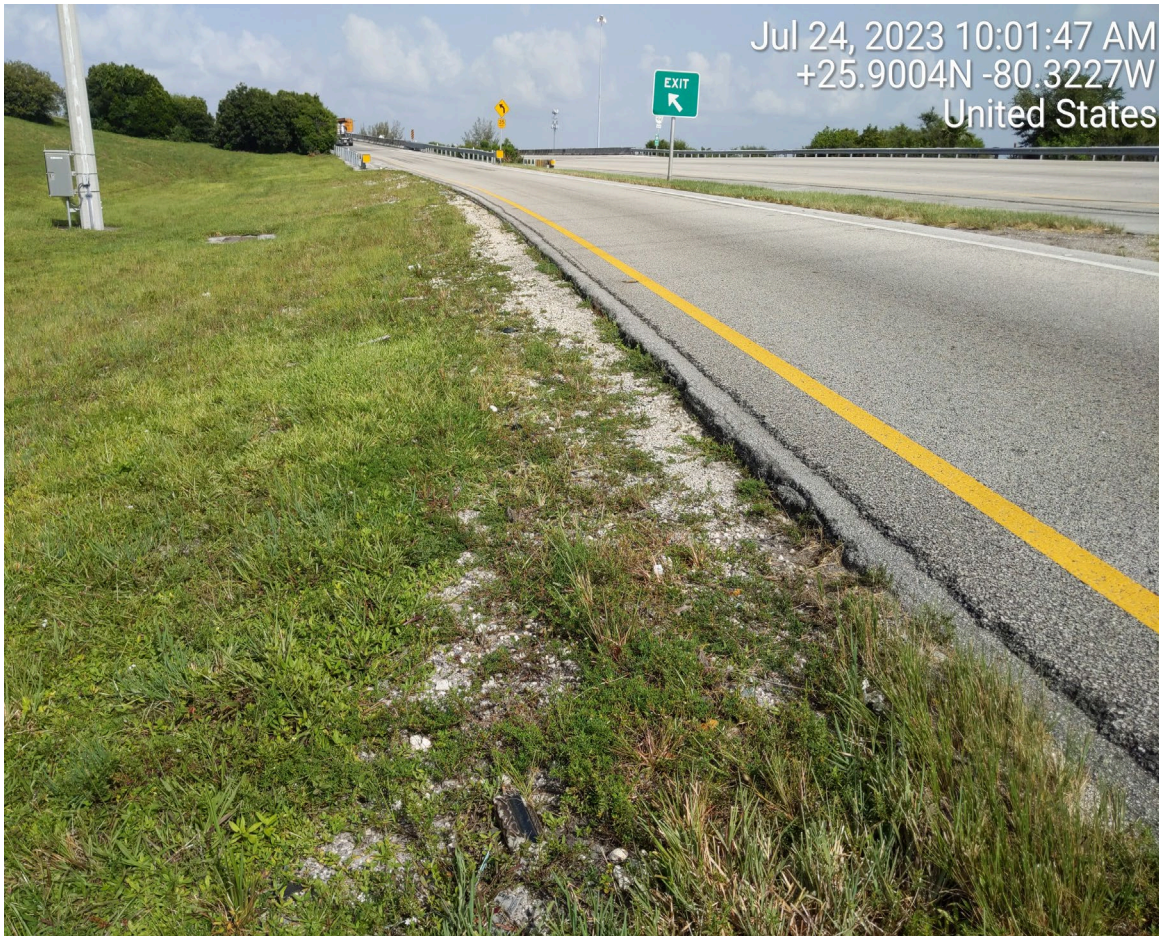
**PHOTO NO.: WB-002  
DATE: 7-24-2023**

**ROADWAY INSPECTION  
LOCATION: MILE MARKER 0.1 MILES  
WESTBOUND RAMP TO SOUTHBOUND SR 826  
(LEFT SHOULDER)**

**SHOULDER DROP OFF AND MISSING TURF**

**ITEM NOTED TO BE ADDRESSED BY GMX MAINTENANCE RFP-23-01**

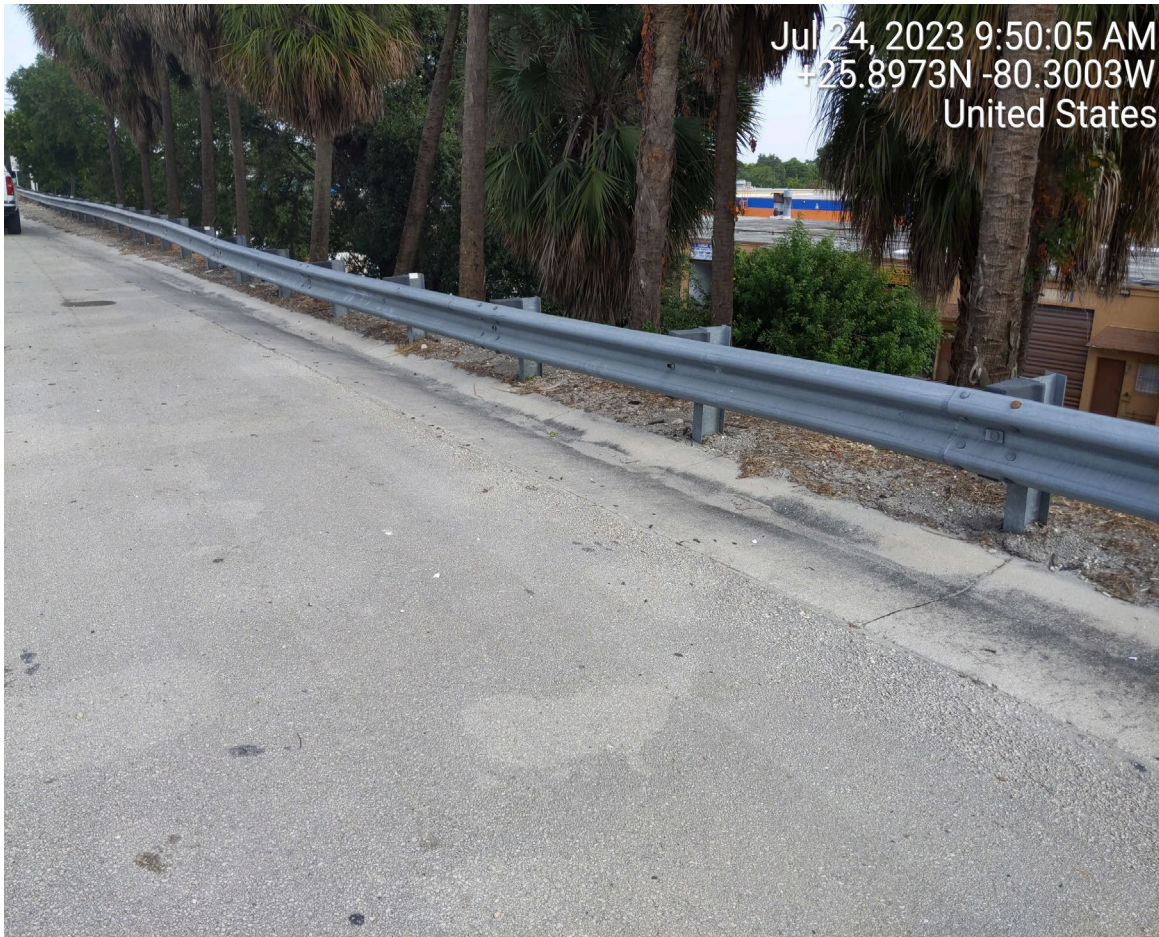
**PHOTO NO.: WB-004  
DATE: 7-24-2023**

**ROADWAY INSPECTION  
LOCATION: MILE MARKER 0.96 MILES  
WESTBOUND MAINLINE**

**GUARDRAIL HEIGHT NOT UP TO STANDARDS**

**ITEM NOTED TO BE ADDRESSED BY GMX MAINTENANCE ITB-23-02**
