# ANNUAL INSPECTION REPORT 2023

## ANNUAL INSPECTION REPORT

In July 1, 2023, the Greater Miami Expressway Agency (GMX) acquired operational and financial control of five expressways in Miami-Dade County. This group of expressways, toll facilities, acquisition parcels and the GMX headquarters facility, all as described below, are hereinafter referred to as one of the "GMX System". In accordance with the Trust Indenture requirements, GMX retained EAC Consulting, Inc. (EAC), as the General Engineering Consultant to perform, among other duties assigned by the Agency, the yearly inspection of the GMX System. This report represents the annual inspection results for Fiscal Year (FY) 2023.

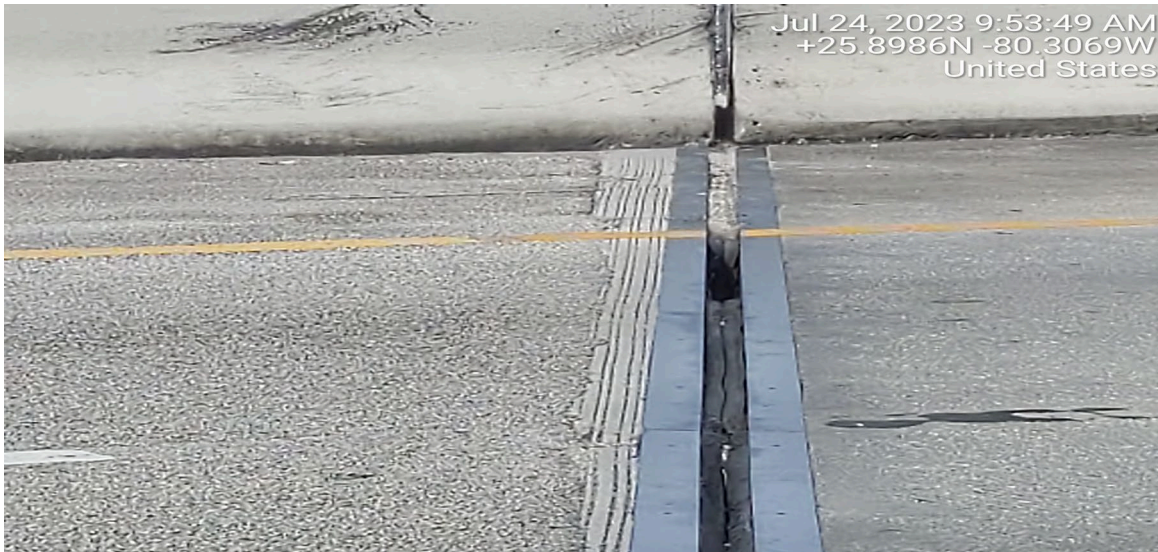
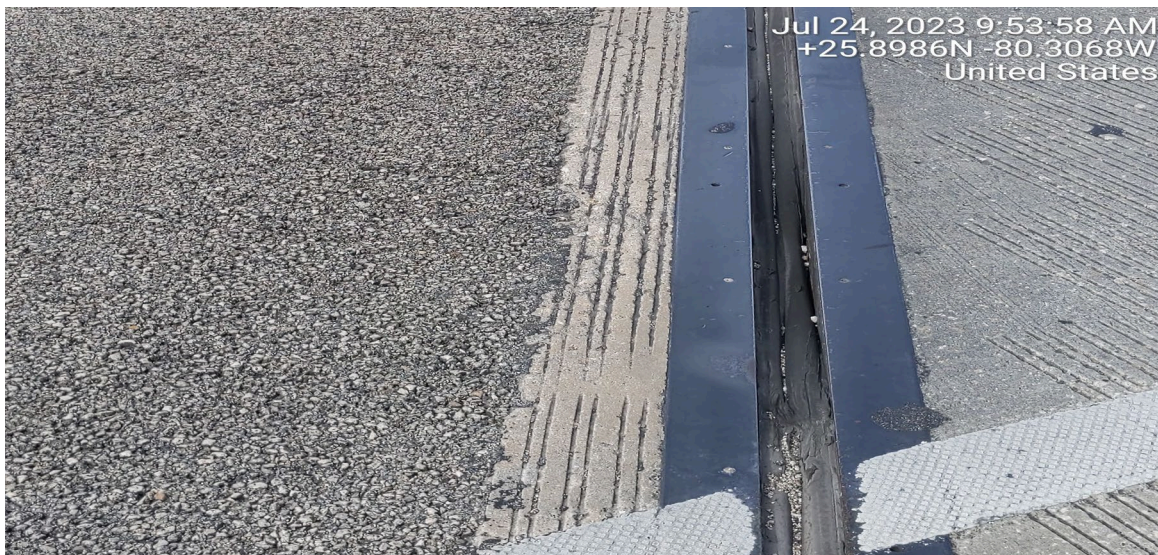
**PHOTO NO.: WB-005  
DATE: 7-24-2023**

**ROADWAY INSPECTION  
LOCATION: MILE MARKER 1.08 MILES  
WESTBOUND MAINLINE (INSIDE AND OUTSIDE LANES)**

**DAMAGED BRIDGE EXPANSION JOINT (BRIDGE # 870708)**

**ITEM NOTED TO BE ADDRESSED BY GMX MAINTENANCE ITB-22-07**

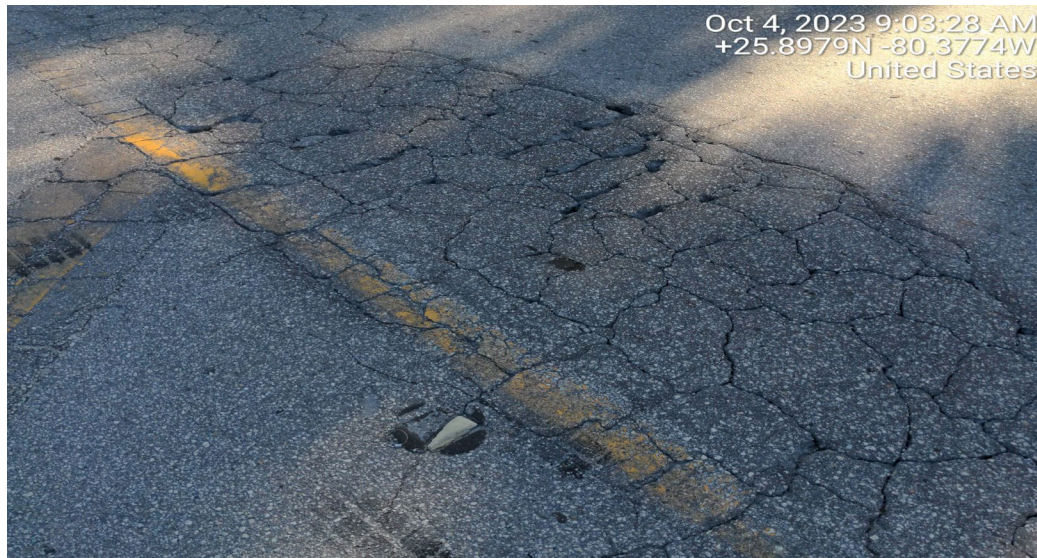
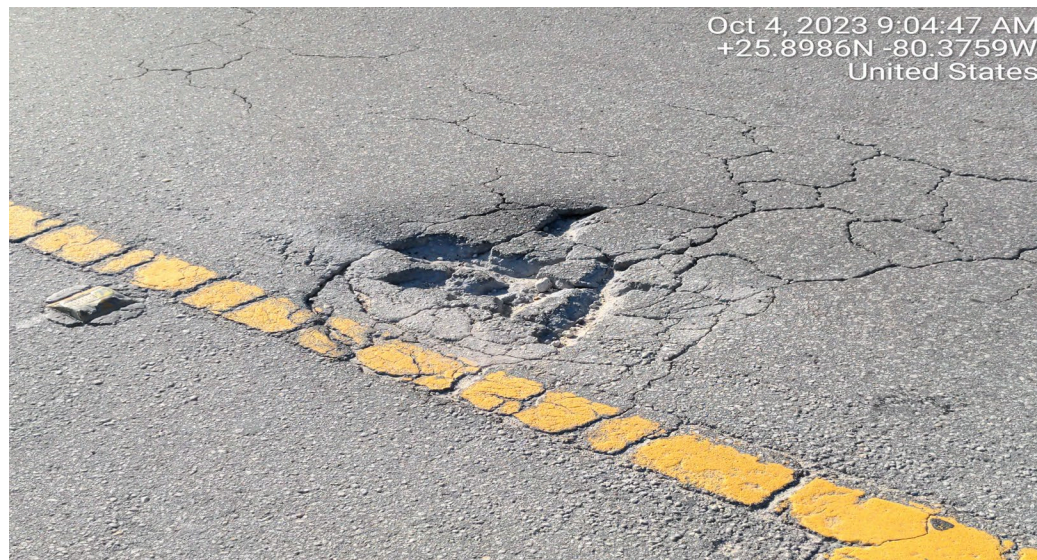
**PHOTO NO.: EB-001  
DATE: 10-4-2023**

**ROADWAY INSPECTION  
LOCATION: EASTBOUND NW 138<sup>TH</sup> STREET  
700 FT NORTH OF FRONTAGE ROAD.**

**DETERIORATED STRIPING AND POTHOLE**

**ITEM NOTED TO BE ADDRESSED BY GMX WORK PROGRAM NO. TBD**

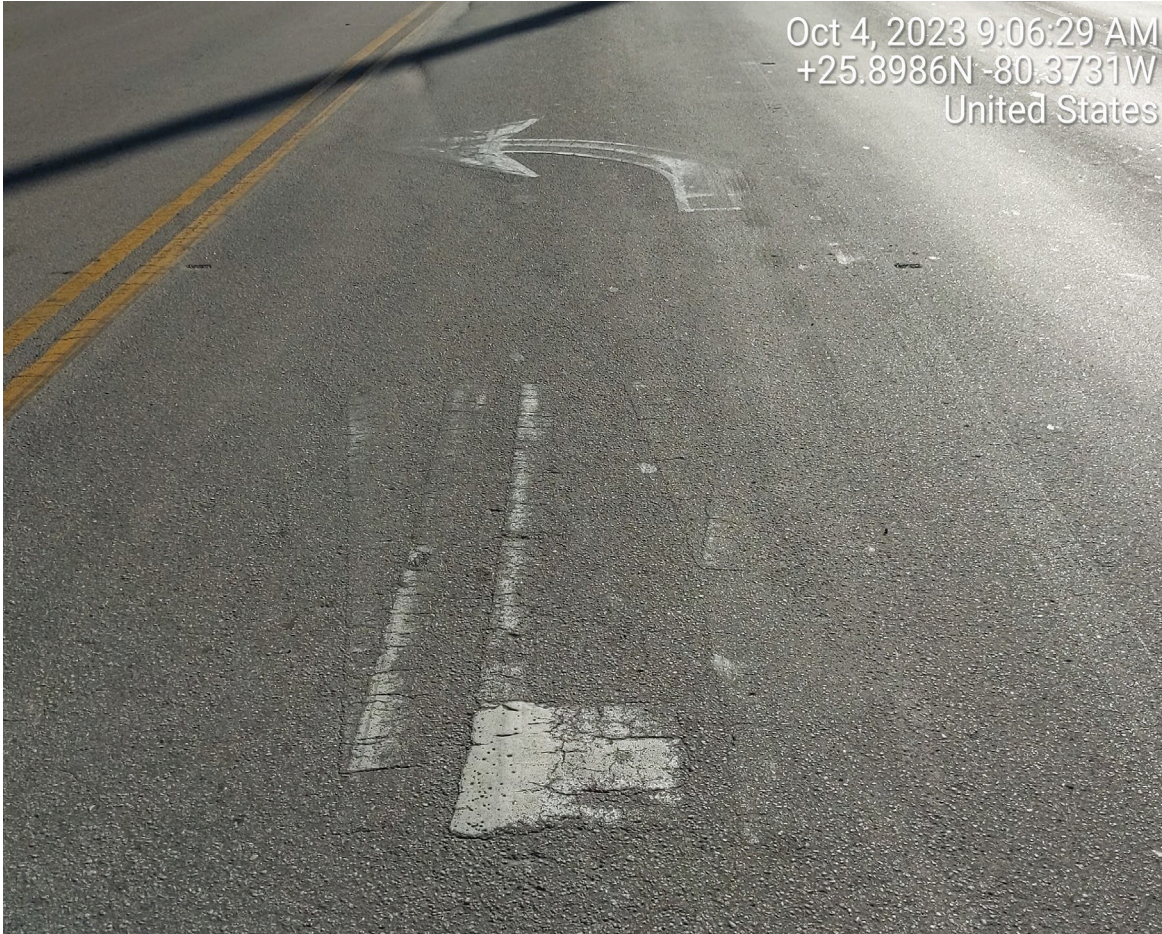
**PHOTO NO.: EB-004  
DATE: 10-4-2023**

**ROADWAY INSPECTION  
LOCATION: EASTBOUND NW 138<sup>TH</sup> ST  
MAINLINE AT NW 107<sup>TH</sup> AVENUE.**

**DETERIORATED PAVEMENT MESSAGE AND TURN ARROW**

**ITEM NOTED TO BE ADDRESSED BY GMX WORK PROGRAM NO. TBD**

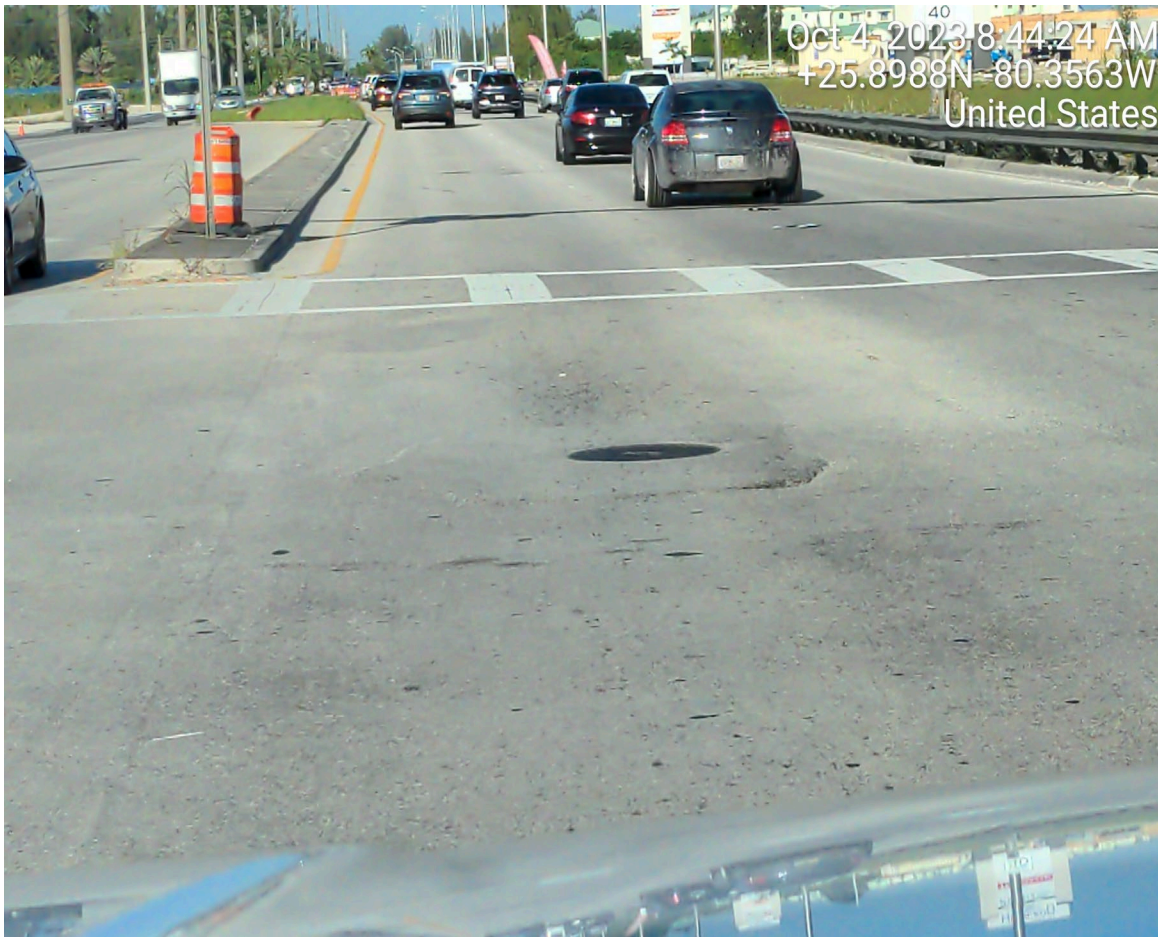
**PHOTO NO.: WB-002  
DATE: 10-4-2023**

**ROADWAY INSPECTION  
LOCATION: WESTBOUND NW 138<sup>th</sup> STREET  
AT NW 97<sup>TH</sup> AVENUE.**

**SETTLEMENT AT DRAINAGE STRUCTURE (TYPICAL AT VARIOUS LOCATIONS)**

**ITEM NOTED TO BE ADDRESSED BY GMX WORK PROGRAM NO. TBD**

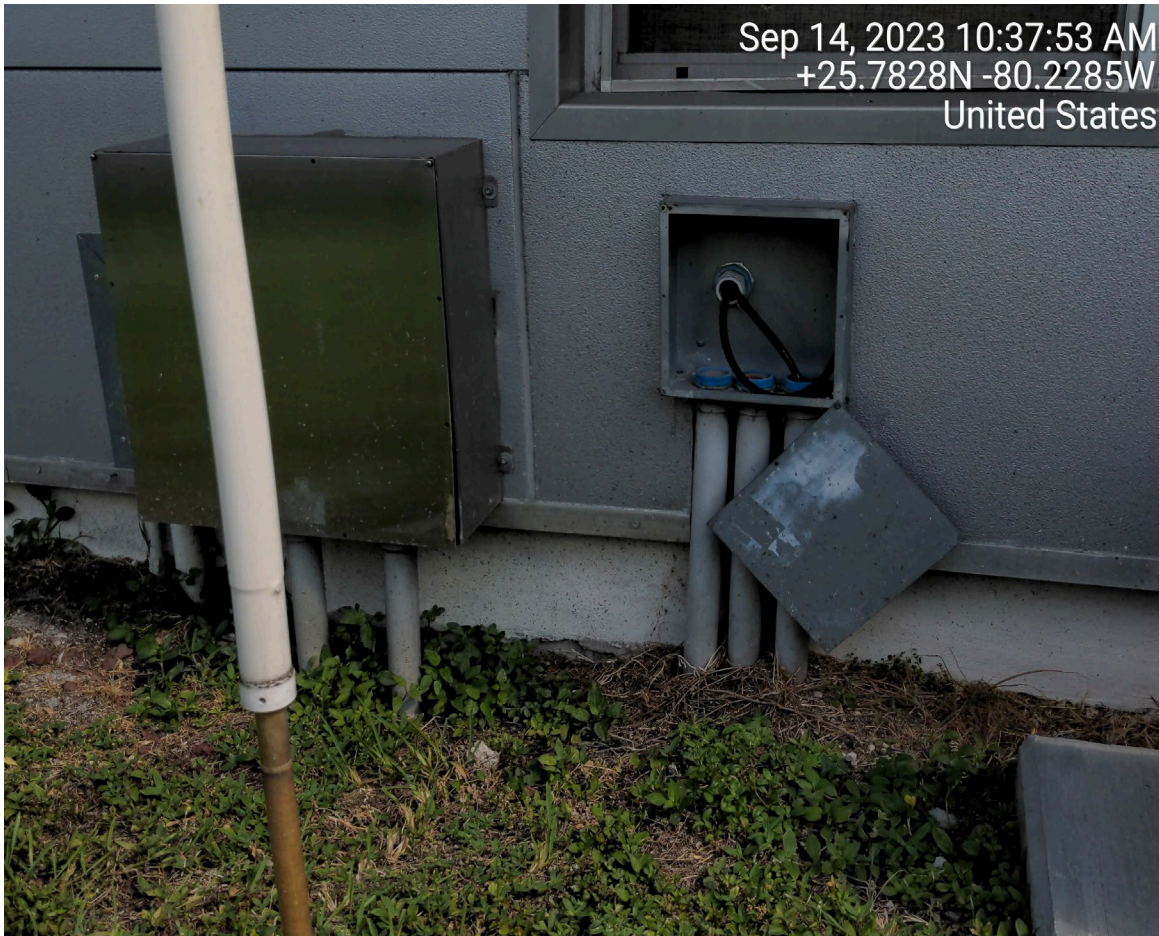
**PHOTO NO.: A-002  
DATE: 9-14-2023**

**ARCHITECTURAL INSPECTION  
LOCATION: SR-836 MAIN ADMINISTRATION BUILDING  
(SOUTH ELEVATION)**

**LOOSE PULL BOX COVER PLATE**

**ITEM NOTED TO BE ADDRESSED BY GMX ITS**

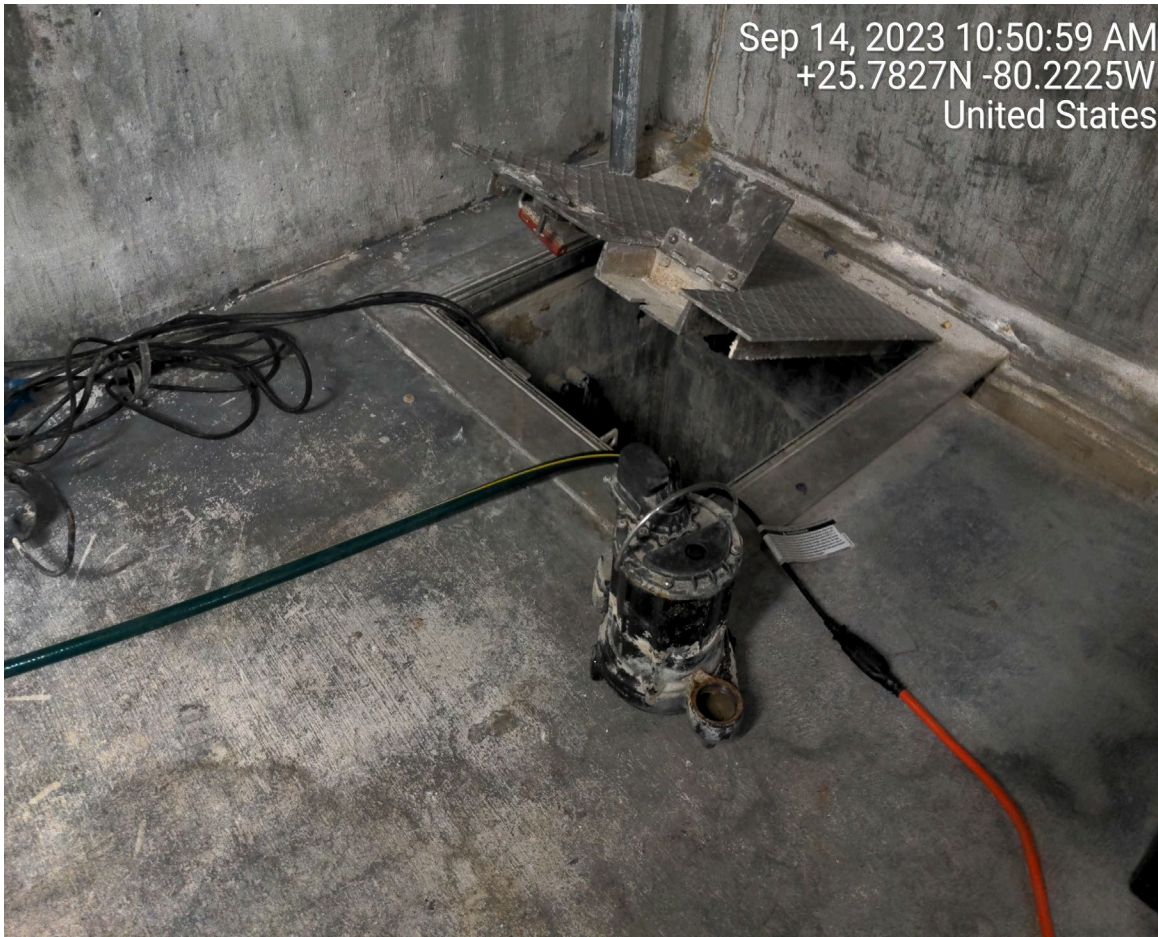
**PHOTO NO.: A-003  
DATE: 9-14-2023**

**ARCHITECTURAL INSPECTION  
LOCATION: SR-836 MAIN ADMINISTRATION BUILDING  
(TUNNEL)**

**DAMAGED SUMP PUMP**

**ITEM NOTED TO BE ADDRESSED BY GMX FACILITIES MAINTENANCE ITB-23-12**

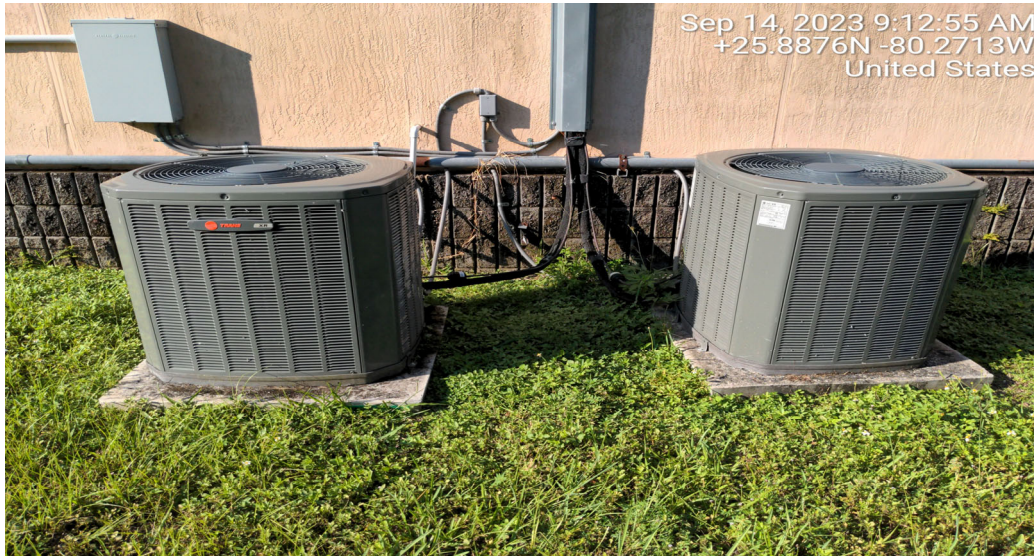
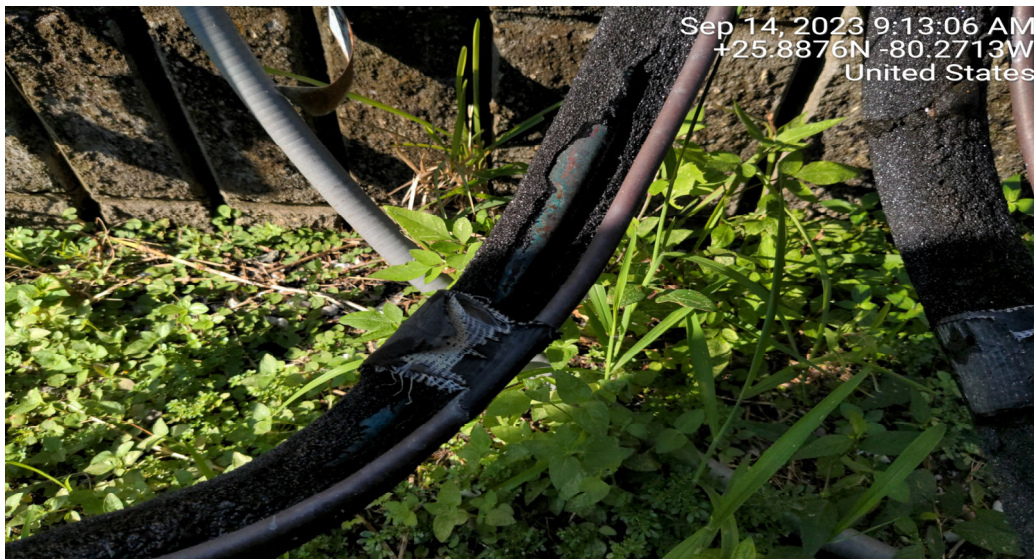
**PHOTO NO.: A-002  
DATE: 9-14-2023**

TANK VENT	No Work Needs Were Identified	
	MONITORING WELLS	No Work Needs Were Identified	
	OTHER	No Work Needs Were Identified	
<b>MECHANICAL</b>			
	HVAC EQUIPMENT	<b>DETERIORATED ISULATION ON HVAC REFRIGERANT LINE</b>	<b>A-002</b>
	HVAC GRILLES/ OUTLETS	No Work Needs Were Identified	
	EXHAUST FANS	No Work Needs Were Identified	
	WATER COOLER	No Work Needs Were Identified

**ARCHITECTURAL INSPECTION  
LOCATION: ADMINISTRATION BUILDING**

**DETERIORATED ISULATION ON HVAC REFRIGERANT LINE**

**ITEM NOTED TO BE ADDRESSED BY GMX MAINTENANCE RFQ-2021**

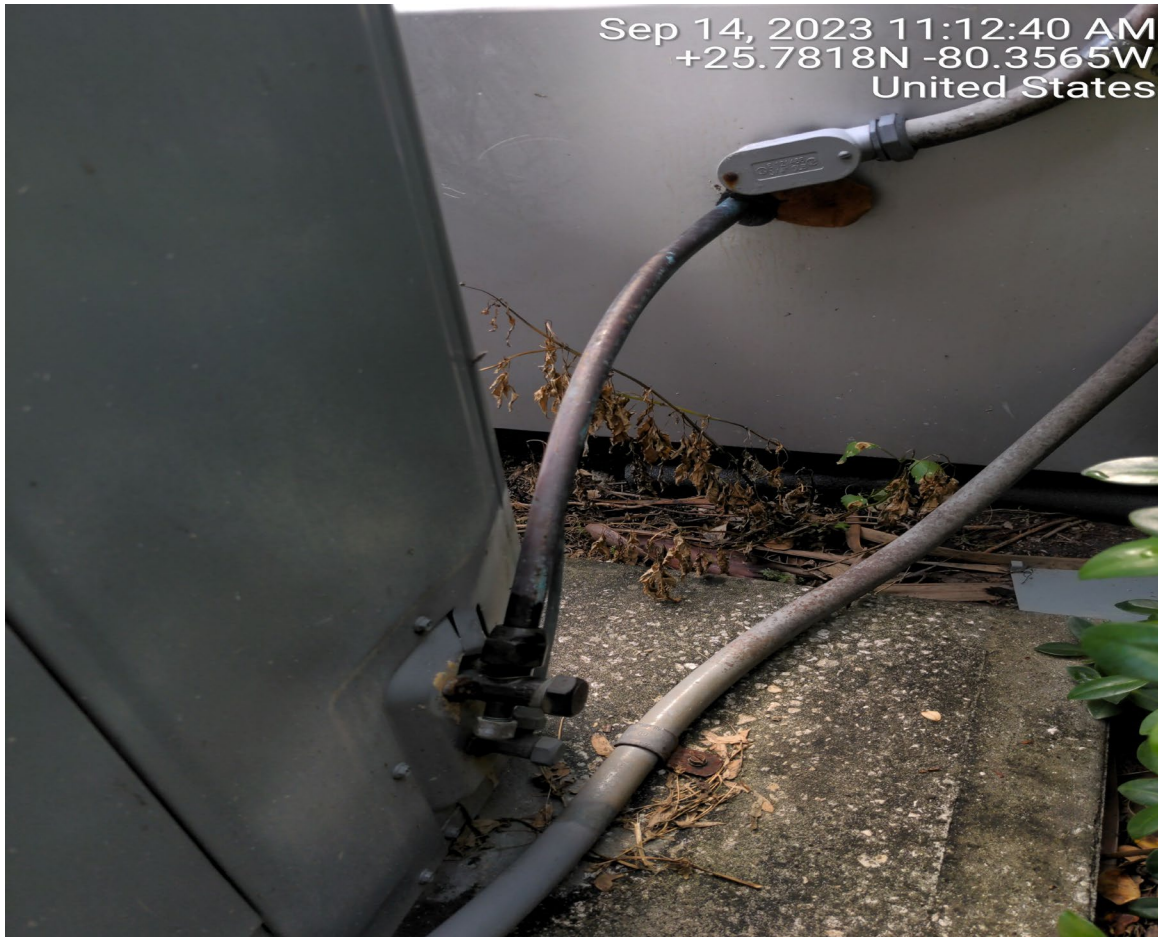
**PHOTO NO.: A-001  
DATE: 9-14-2023**

TANK VENT	No Work Needs Were Identified	
MECHANICAL		
HVAC EQUIPMENT	MISSING INSULATION ON REFRIGERANT LINE	A-001
HVAC GRILLES/ OUTLETS	No Work Needs Were Identified	
EXHAUST FANS	No Work Needs Were Identified	
WATER COOLER	No Work Needs Were Identified	
PLUMBING		
TOILETS	No Work Needs Were Identified	
URINALS	No Work Needs Were Identified	
VANITIES	No Work Needs Were Identified	
PLUMBING FIXTURES	No Work Needs Were Identified	
HOSE BIBBS	No Work Needs Were Identified	
FLOOR DRAINS	No Work Needs Were Identified	
ROOF DRAINS	No Work Needs Were Identified	
CLEANOUT	No Work Needs Were Identified

**ARCHITECTURAL INSPECTION  
LOCATION: SR-836 / NW 97<sup>th</sup> AVENUE WESTBOUND  
TOLL PLAZA**

**MISSING INSULATION ON HVAC REFRIGERANT LINE**

**ITEM NOTED TO BE ADDRESSED BY GMX MAINTENANCE RFQ-2021**

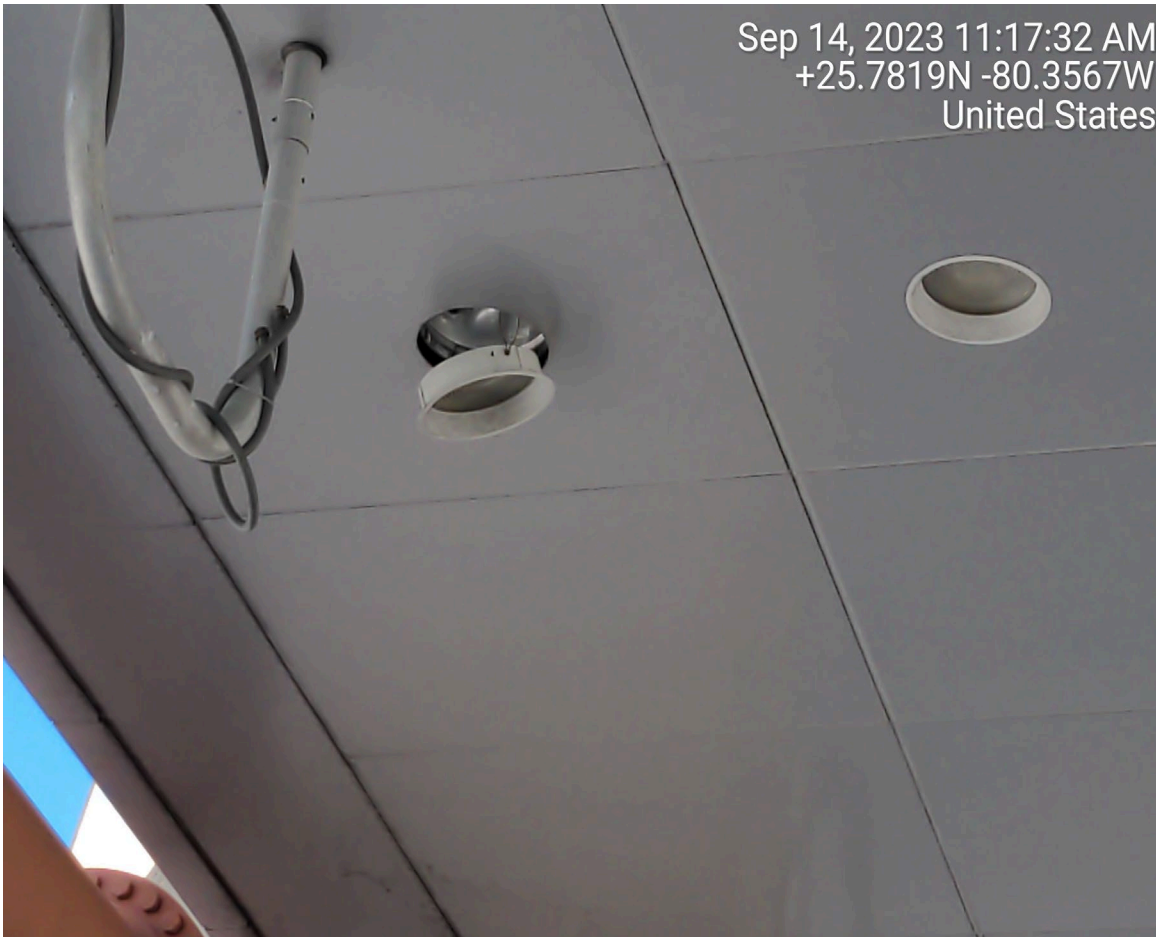
**PHOTO NO.: A-002  
DATE: 9-14-2023**

**ARCHITECTURAL INSPECTION  
LOCATION: SR-836 / NW 97<sup>th</sup> AVENUE WESTBOUND  
TOLL PLAZA CANOPY**

**HANGING RECESSED LUMINAIRE COVER**

**ITEM NOTED TO BE ADDRESSED BY GMX CONTRACT ITB-23-12**

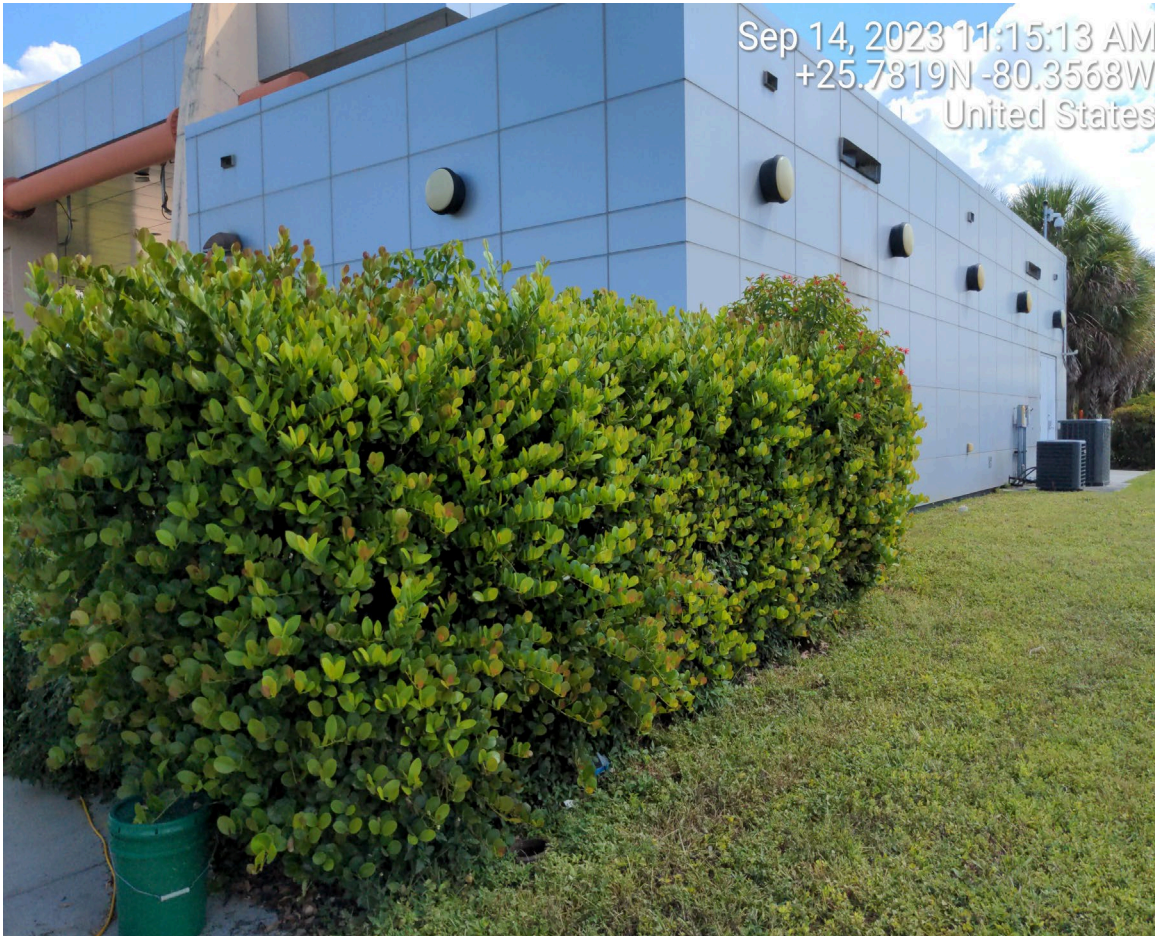
**PHOTO NO.: A-003  
DATE: 9-14-2023**

**ARCHITECTURAL INSPECTION  
LOCATION: SR-836 / NW 97<sup>th</sup> AVENUE WESTBOUND  
TOLL PLAZA**

**OVERGROWN LANDSCAPING**

**ITEM NOTED TO BE ADDRESSED BY GMX MAINTENANCE CONTRACT RFP-23-01**

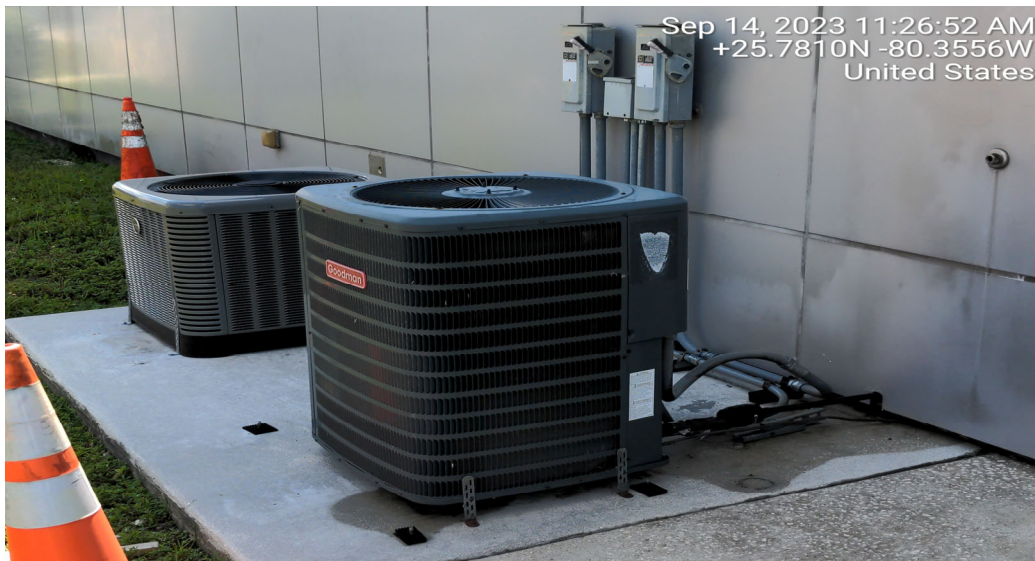
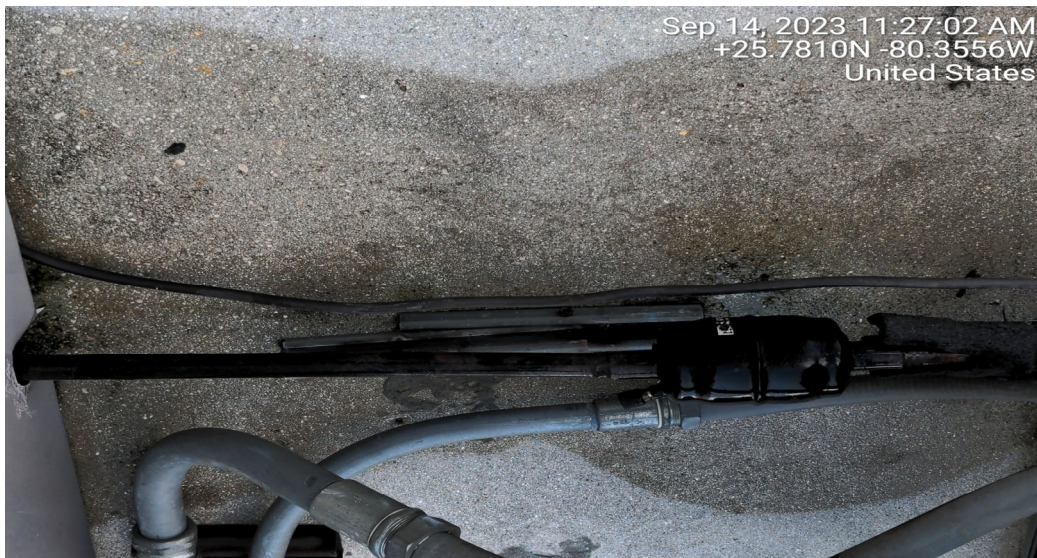
**PHOTO NO.: A-001  
DATE: 9-14-2023**

**ARCHITECTURAL INSPECTION  
LOCATION: SR-836 / NW 97<sup>th</sup> AVENUE EASTBOUND  
ADMINISTRATION BUILDING (NORTH ELEVATION)**

**DETERIORATED INSULATION ON REFRIGERANT LINE  
ITEM NOTED TO BE ADDRESSED BY GMX MAINTENANCE**

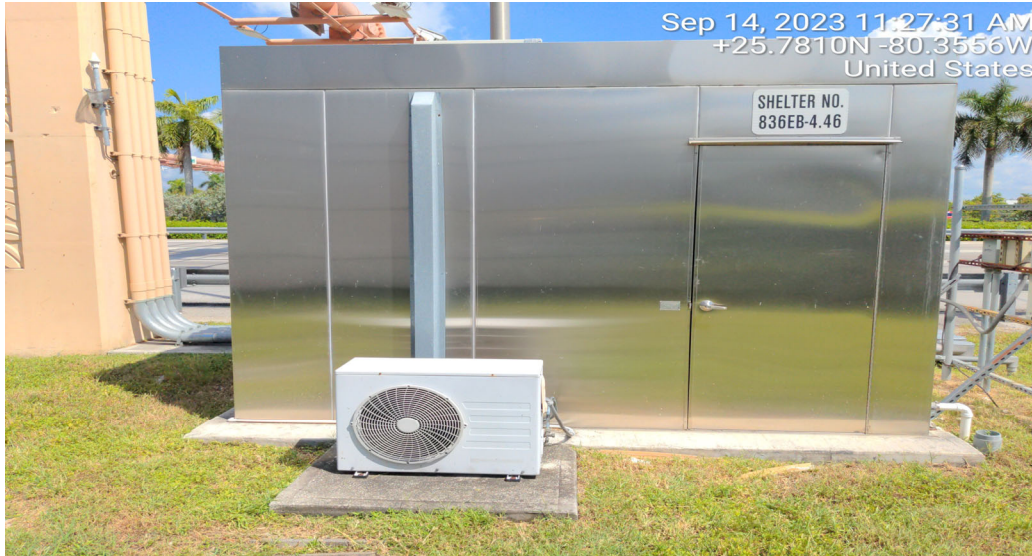
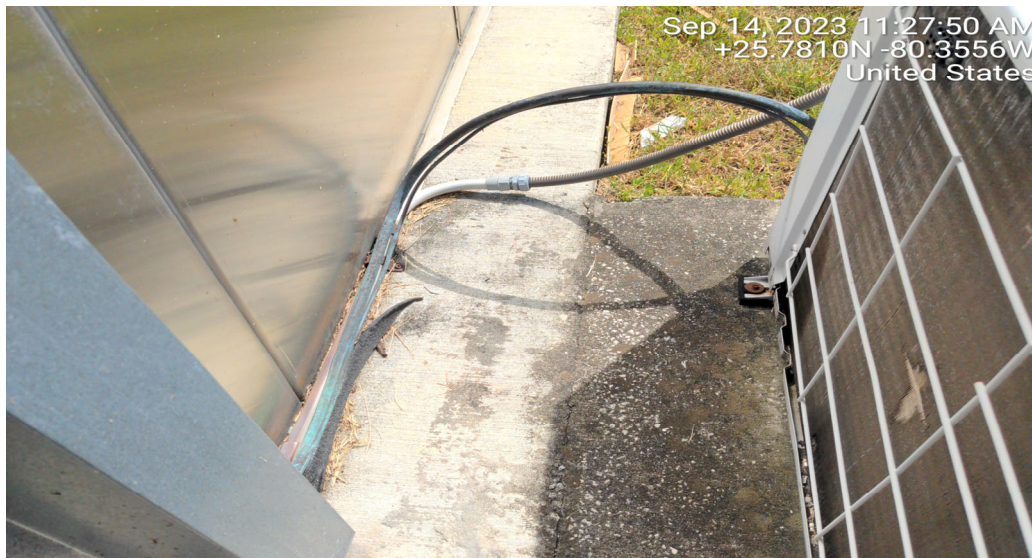
**PHOTO NO.: A-002  
DATE: 9-14-2023**

**ARCHITECTURAL INSPECTION  
LOCATION: SR-836 / NW 97<sup>th</sup> AVENUE EASTBOUND  
SHELTER NO. 836EB-4.46**

**MISSING INSULATION ON HVAC REFRIGERANT LINE**

**ITEM NOTED TO BE ADDRESSED BY GMX MAINTENANCE**

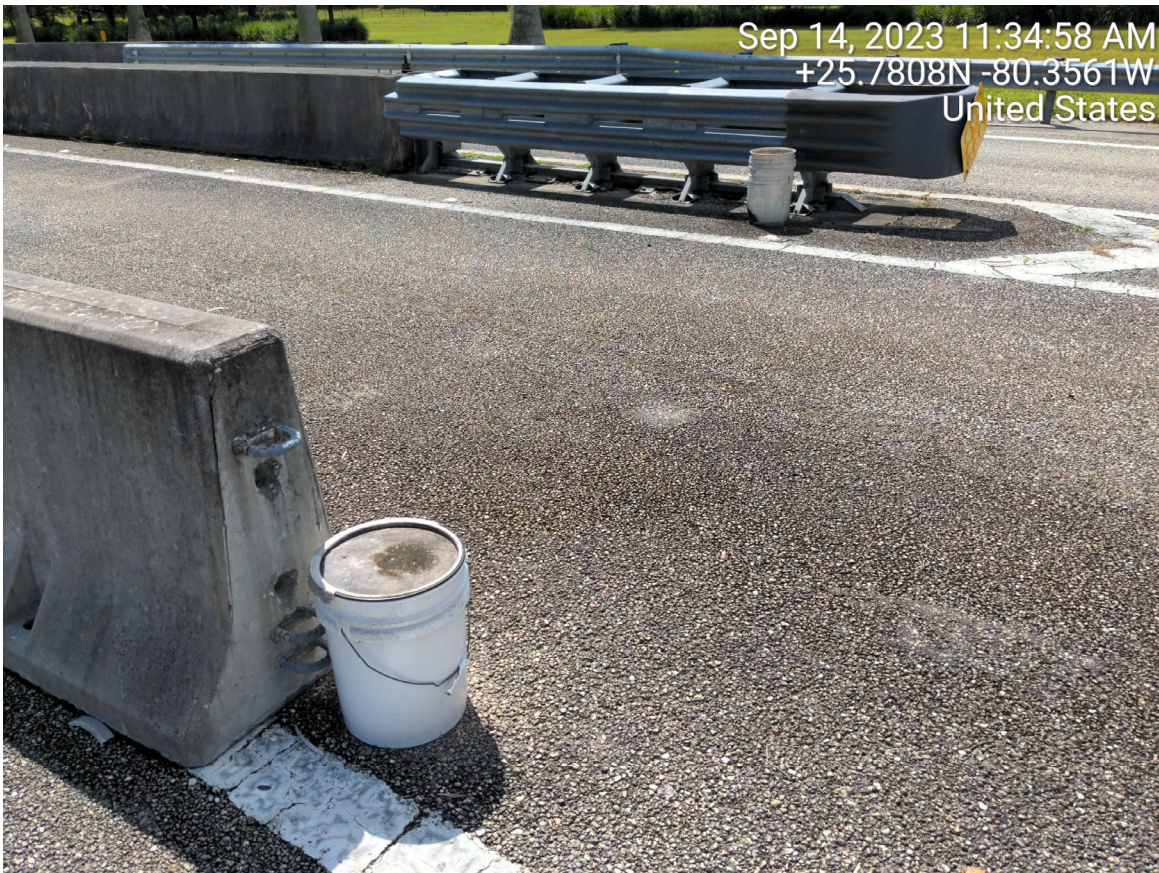
**PHOTO NO.: A-003  
DATE: 9-14-2023**

**ARCHITECTURAL INSPECTION  
LOCATION: SR-836 / NW 97<sup>th</sup> AVENUE EASTBOUND  
TOLL PLAZA CANOPY**

**ABANDONED FIVE GALLON CONTAINERS**

**ITEM NOTED TO BE ADDRESSED BY GMX MAINTENANCE CONTRACT RFP 23-01**

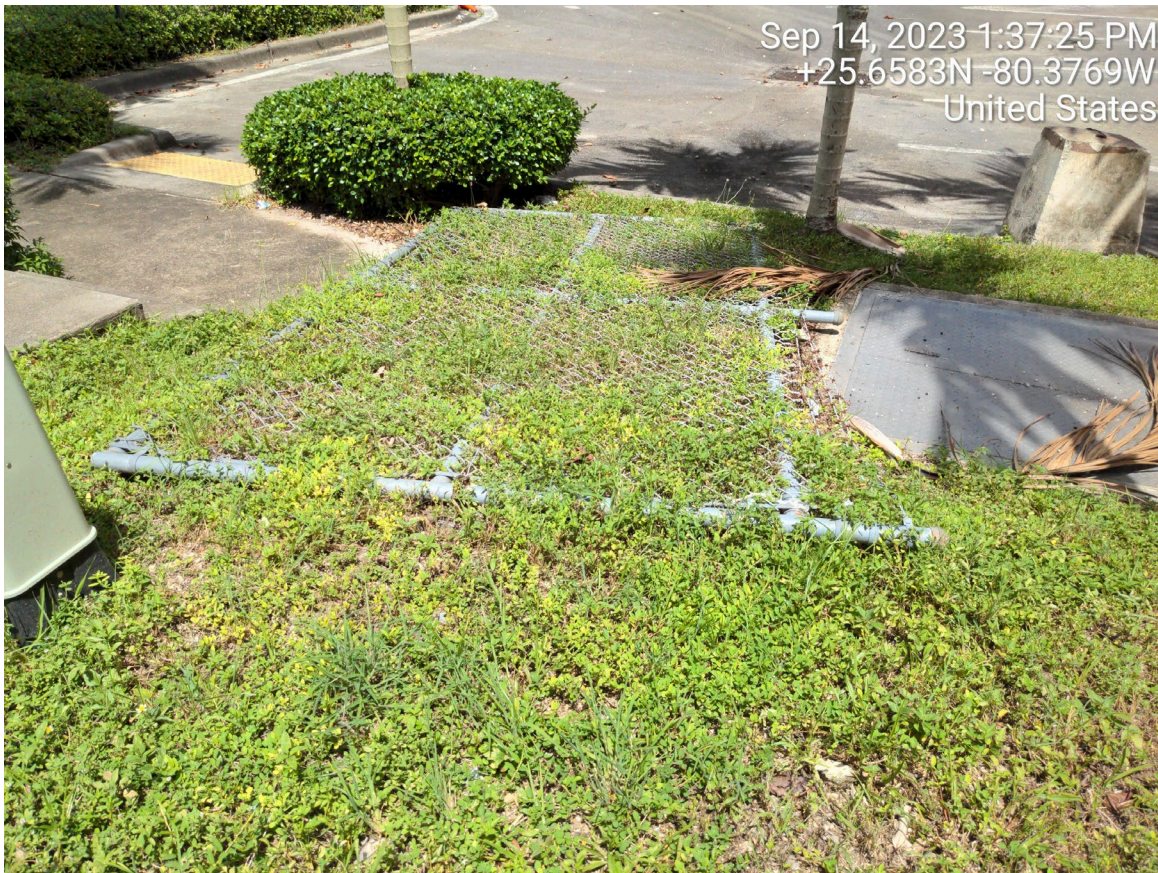
**PHOTO NO.: A-001  
DATE: 9-14-2023**

**ARCHITECTURAL INSPECTION  
LOCATION: ADMINISTRATION BUILDING  
(WEST ELEVATION)**

**ABANDONED CHAIN-LINK GATE**

**ITEM NOTED TO BE ADDRESSED BY GMX MAINTENANCE RFP-23-01**

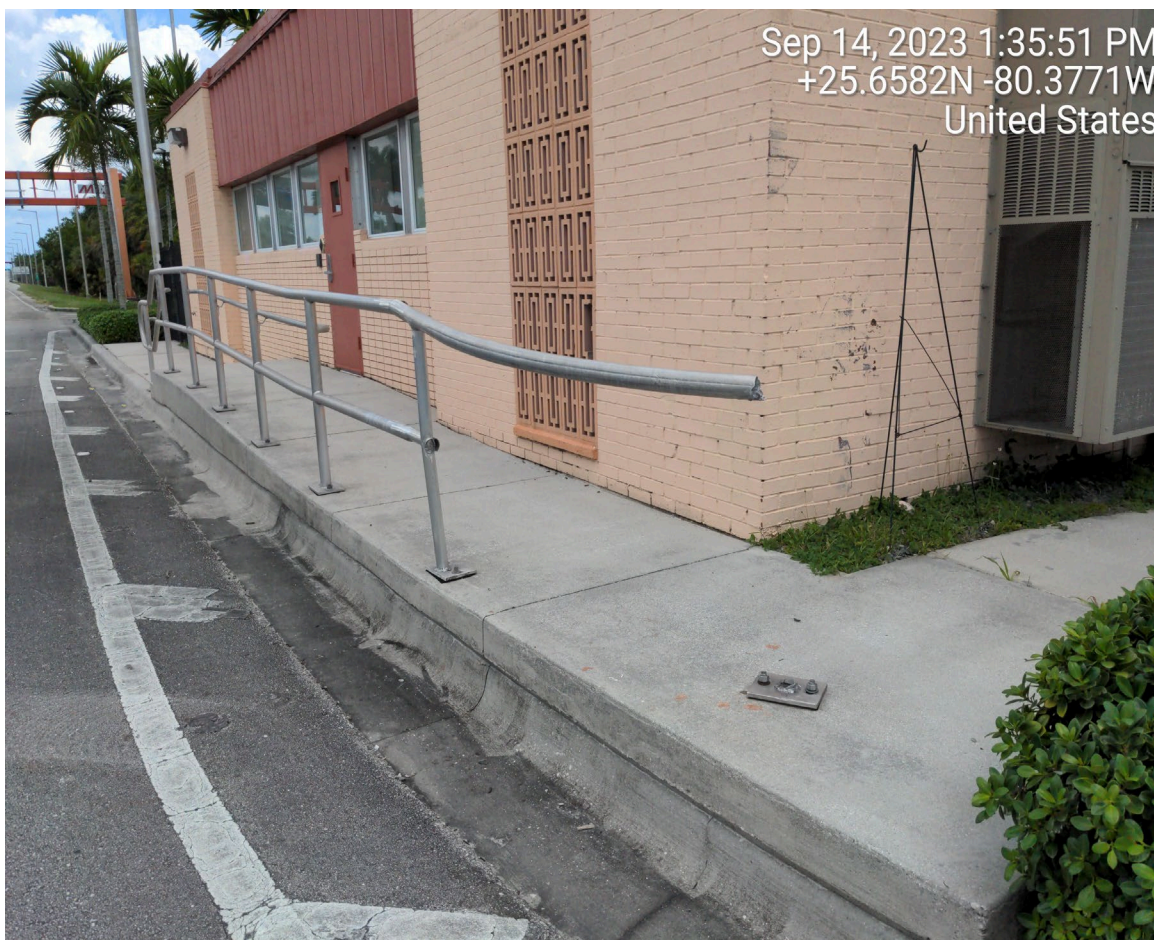
**PHOTO NO.: A-002  
DATE: 9-14-2023**

**ARCHITECTURAL INSPECTION  
LOCATION: ADMINISTRATION BUILDING  
(EAST ELEVATION)**

**DAMAGED PEDESTRIAN RAILING**

**ITEM NOTED TO BE ADDRESSED BY GMX MAINTENANCE ITB-23-12**
